RECREATIONAL USE RE-EVALUATION OF THE ENGINEERED CHANNELS OF THE LOS ANGELES RIVER WATERSHED

**FIELD RECONNAISSANCE REPORT
NOVEMBER 2010- MARCH 2011**

**LOS ANGELES REGIONAL WATER QUALITY CONTROL BOARD
MARCH, 2011**

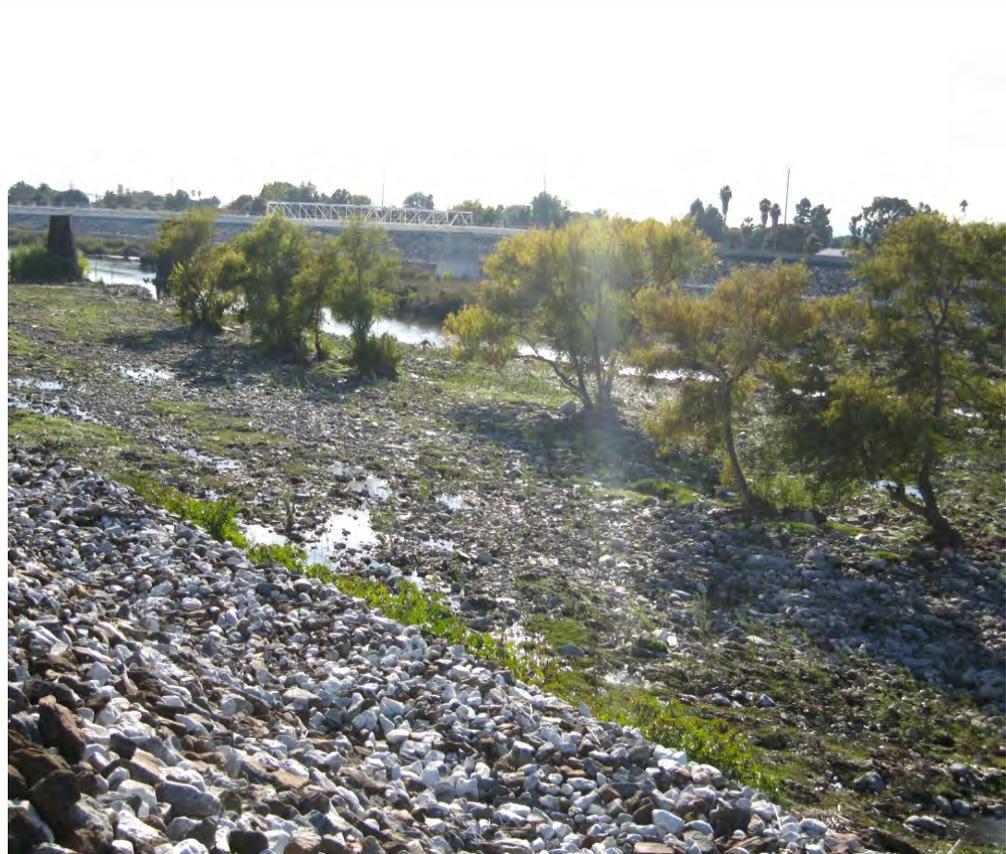
Time: 2:11pm	Photo No. 2
Direction Photo Taken: Downstream	
Other Signs of Access: Homeless, Entrapment	
Channel Characteristics: - Earthen bottom - Trapezoidal Earthen/rip-rap banks - Concrete bottom and trapezoid concrete banks immediately upstream	
Water Characteristics: - Presence of flow - Presence of algae	
Extent Water body Surveyed: From Willow to Imperial (9.3 miles)	
Field Team: RB: Ginachi Amah, Michael Morales County: Emiko Innes, Giles Coon, Jared Deck

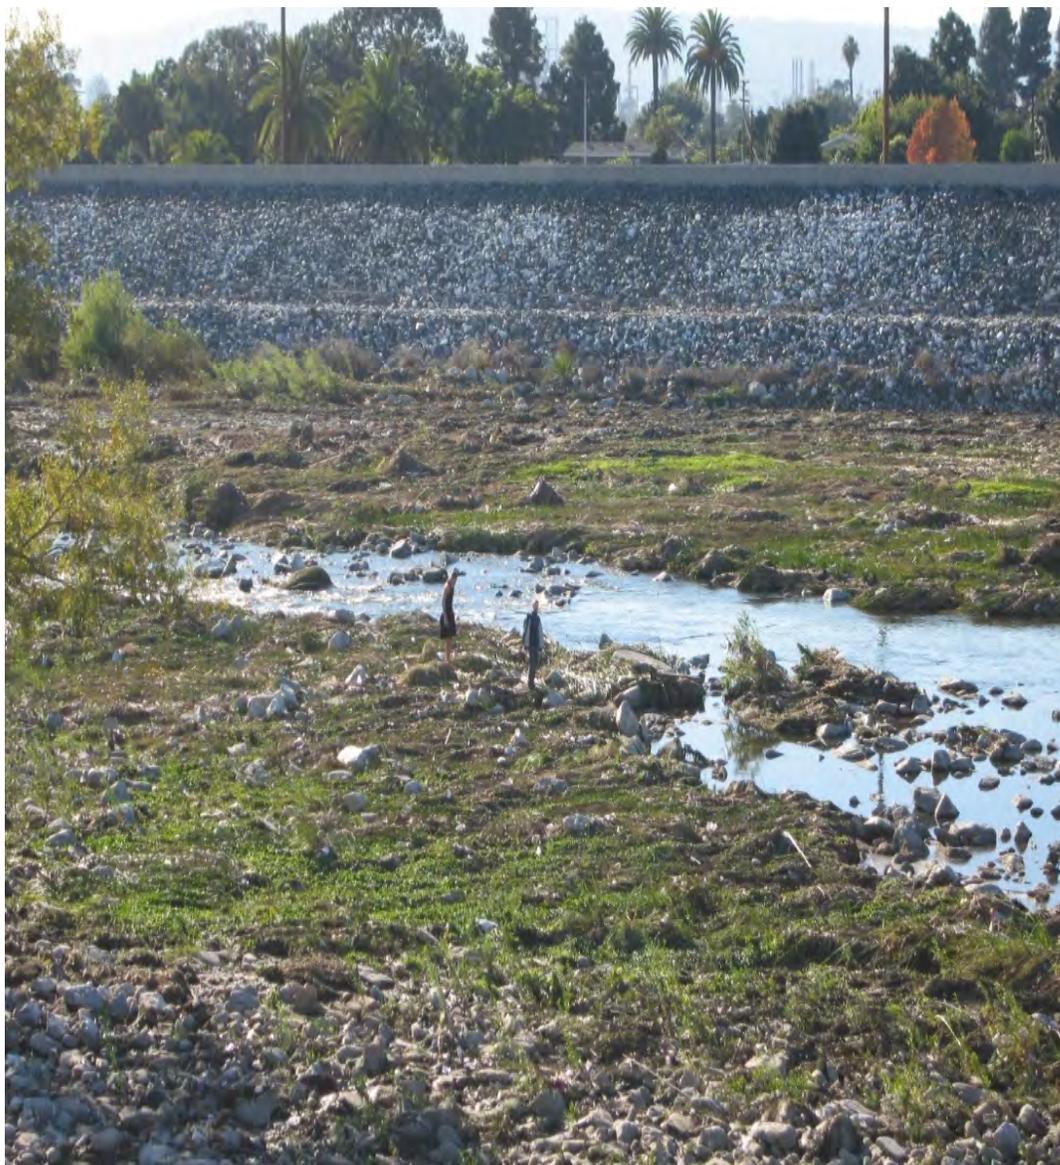
Photo No.
3

*** Creek details refer to preceding page*

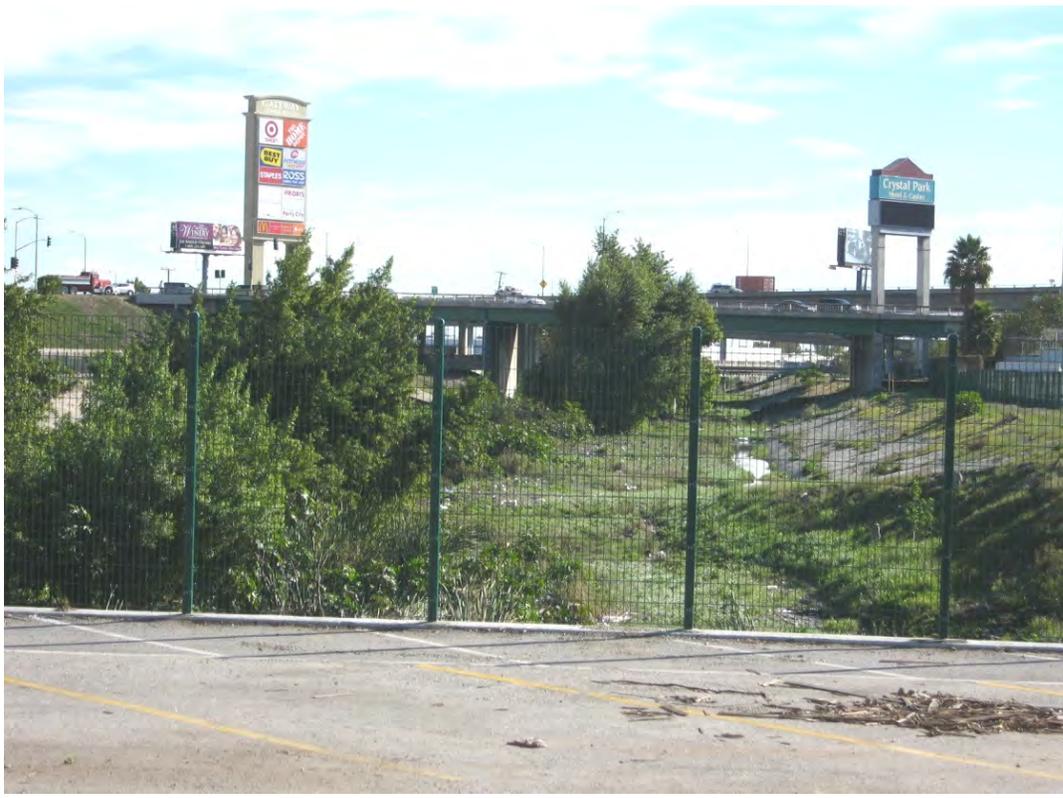
Additional Comments:
Massive culvert b/w up- and down-stream. channel widens at this point. Earthen bottom begins downstream

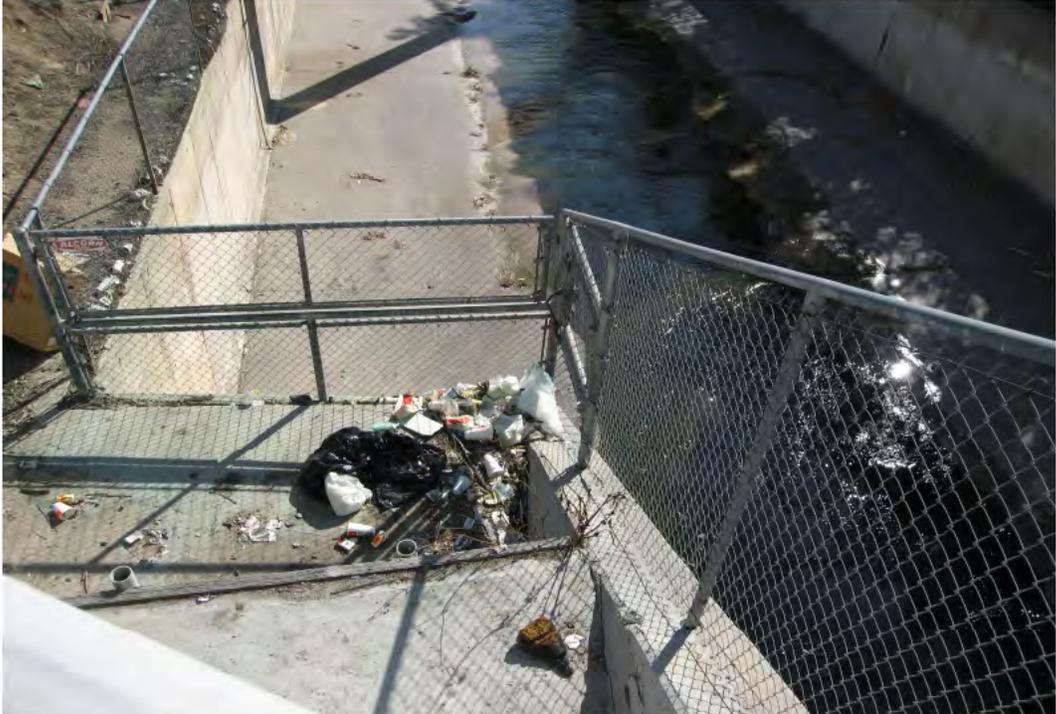
Direction Photo Taken:					
Mode of Access: Over Pass					
Potential Access Points: Half gate & upstream damaged fence, fenced (both sides of channel wall)					
Adj. Rec Facility: None					
Adj. Land Uses: Commercial					
Low Flow Channel: None					
Bike Path: Absent					
Ext. Surveyed: 250 ft ↓ & ↑ approx.

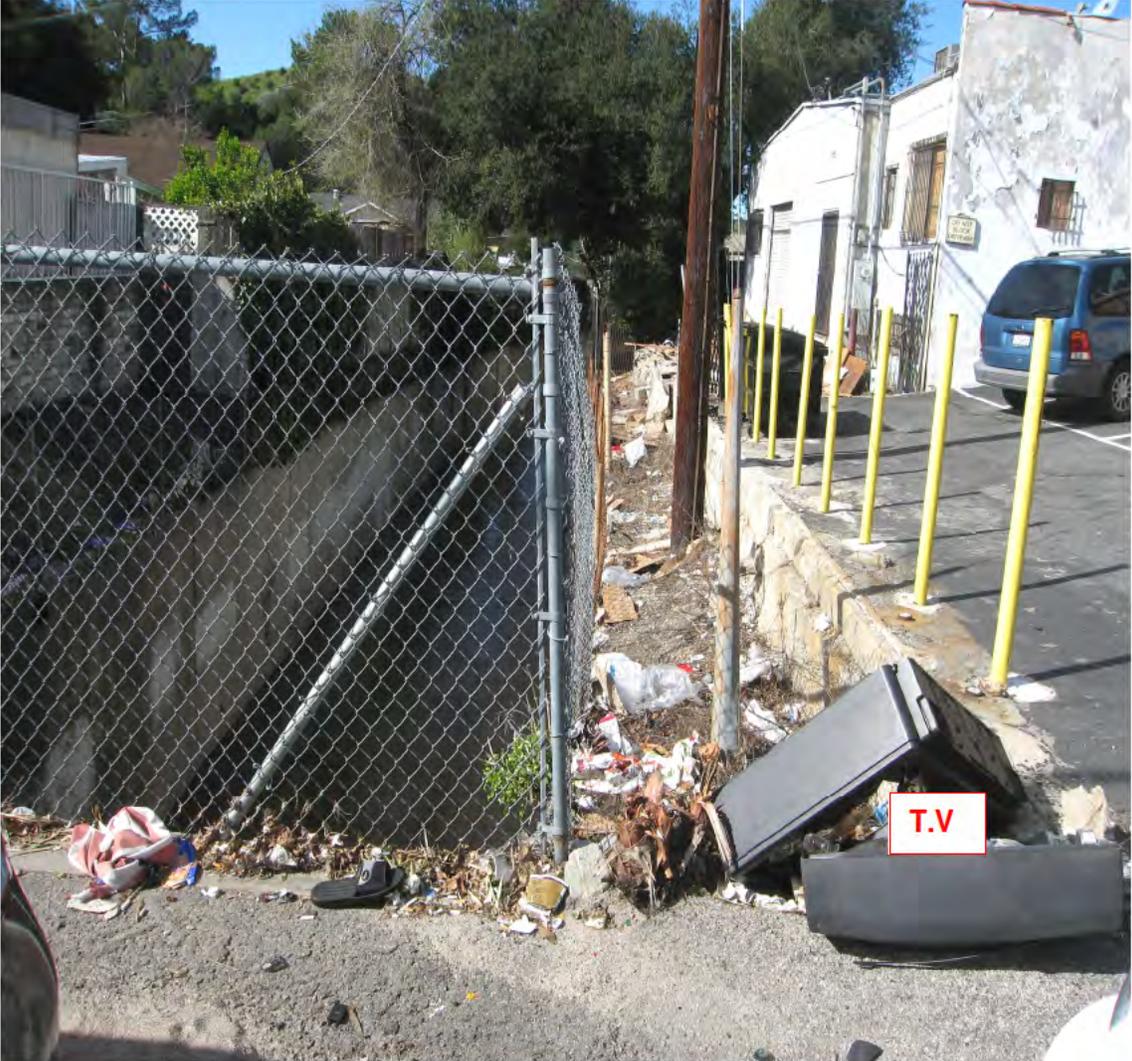
Photo details: Trash along the fencing		
<u>Additional Comments:</u> Trash build-up along exterior of channel fence. <i>** Other creek details refer to preceding page</i>

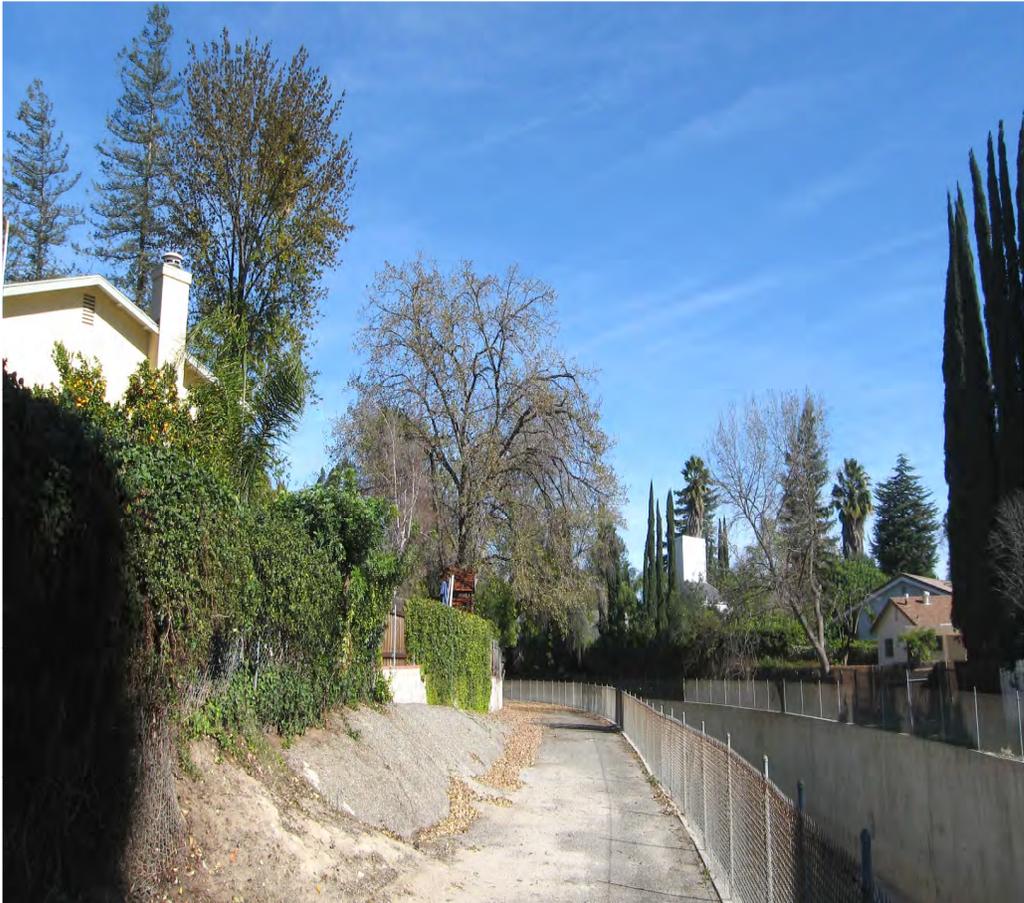
Direction Photo Taken: Houses lining the Channel on both sides		
<p>Additional Comments: Houses back both sides of creek while the drive through maintenance ramp from Valley circle.</p> <p>** Other creek details refer page one</p>
