6 BEFORE THE CALIFORNIA
7 STATE WATER RESOURCES CONTROL BOARD

8 JON AND DEANN GREEN)
9)
10) Petitioner,) PETITION FOR REVIEW
11) and)
12) [Cal. Water Code §13320]
13) CALIFORNIA REGIONAL WATER)
14) QUALITY CONTROL BOARD - NORTH)
15) COAST REGION)
16) Respondent.)

Subject: Notice of Violation for Failure to Comply with Active Regional Board Orders and for New Basin Plan violations, and Order Requiring Technical Reports Investigating New Sources of Waste Discharge pursuant to California Water Code (Water Code) Section 13267(b)

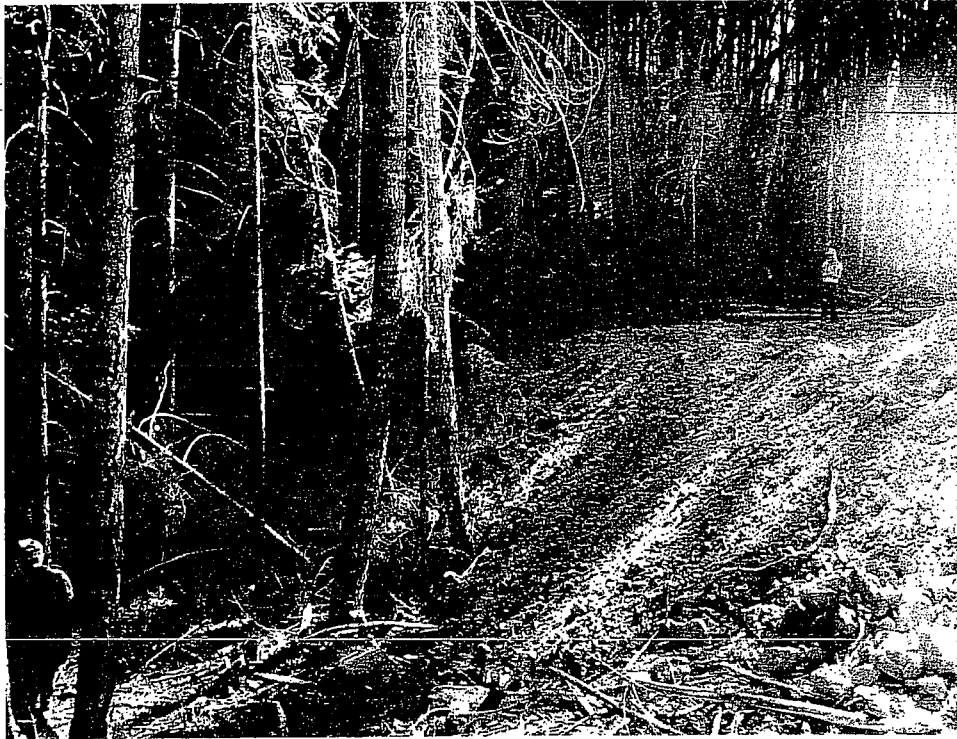
9/25/2009 wide spot in road at saddle filled top of ephemeral swale

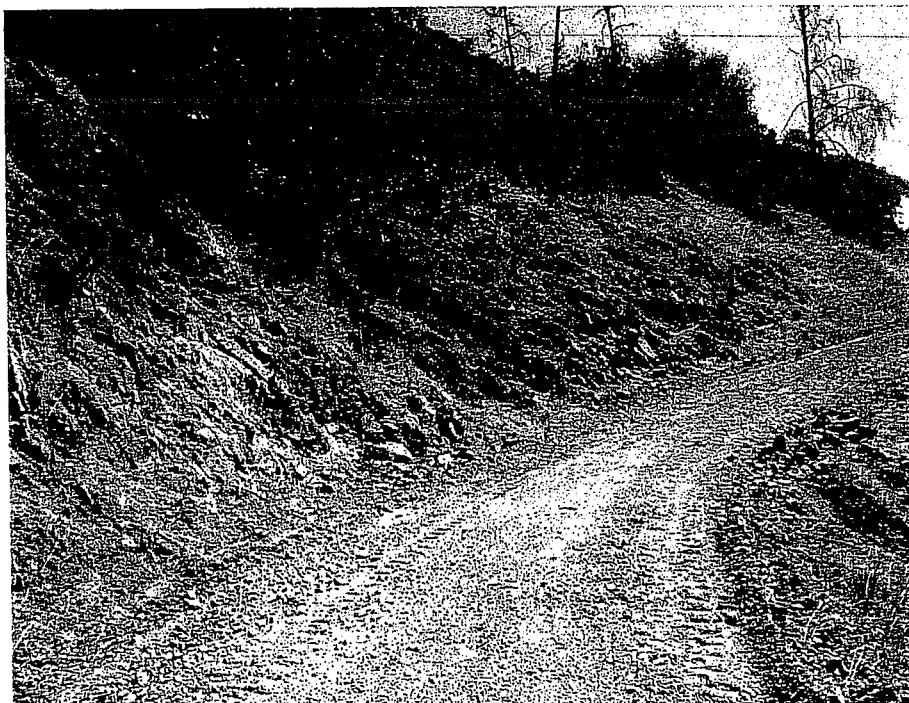
9/25/2009 new road fill across ephemeral swale with no drainage structure

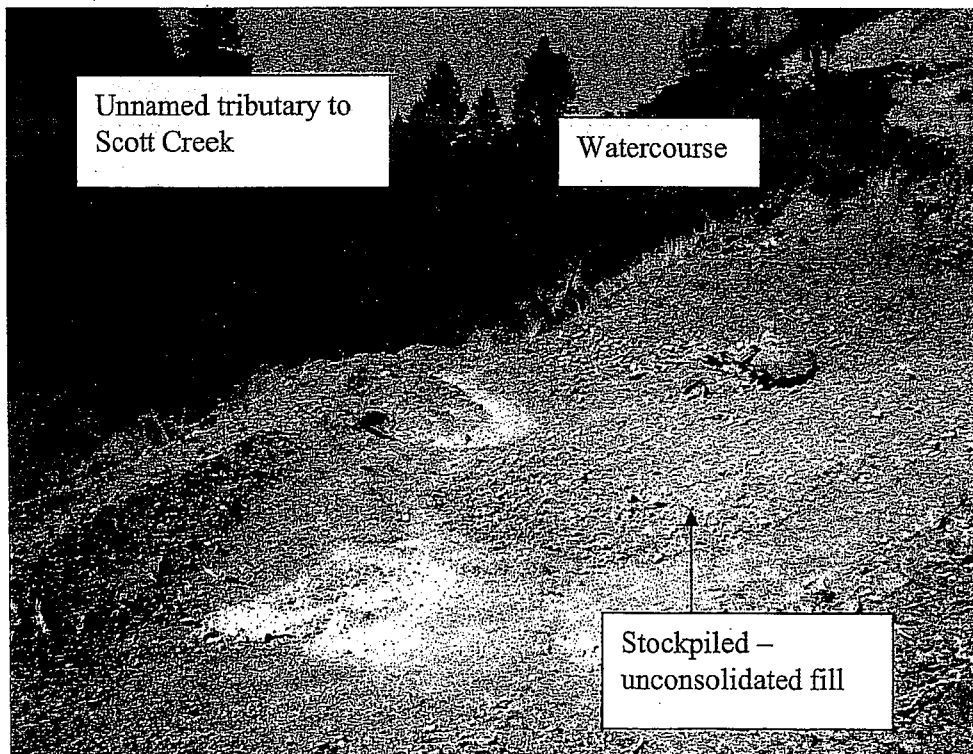
9/25/2009 photo of rock quarry on right and fill material with crude sediment basin at end of road within the flood plain of the Scott Creek.

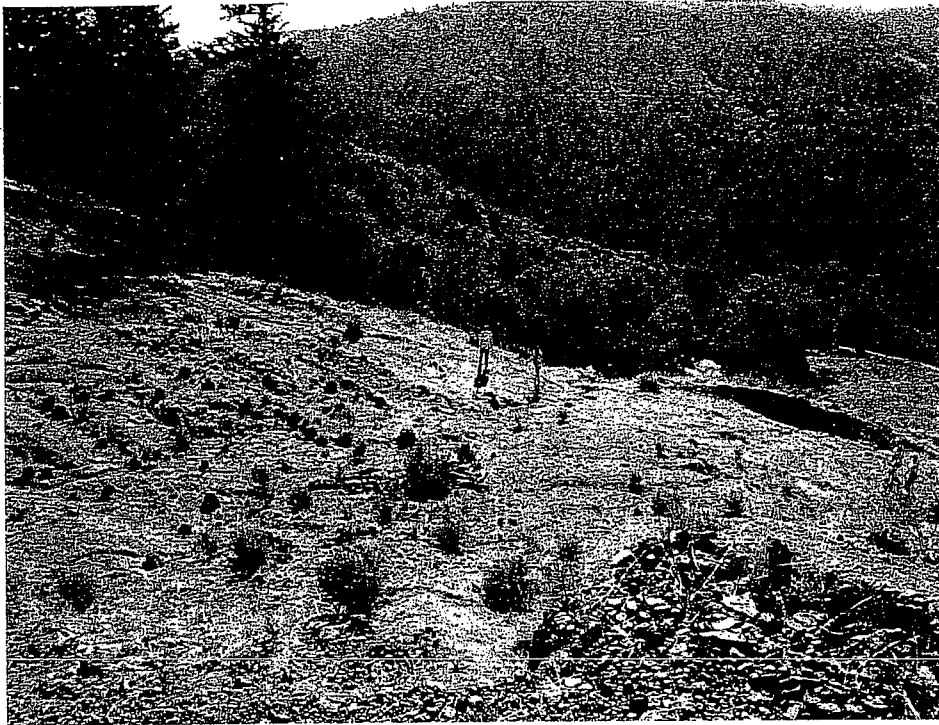
10/17/2008 Site 8 failure surface mid portion of slide materials

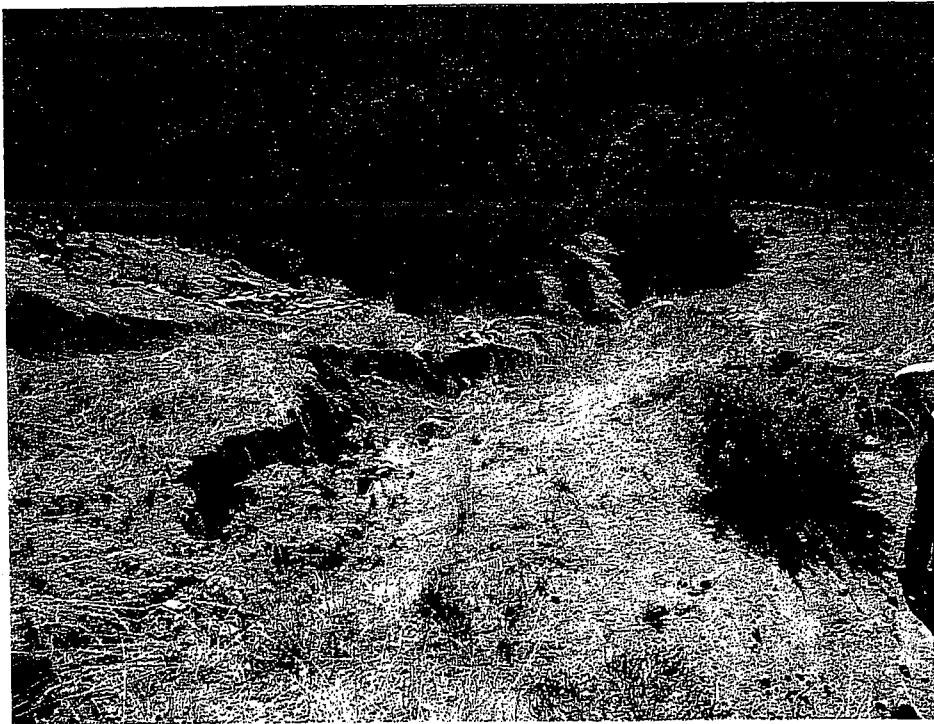
10/17/08 Lower end of Site 8 slide with surface erosion present delivering to watercourse below

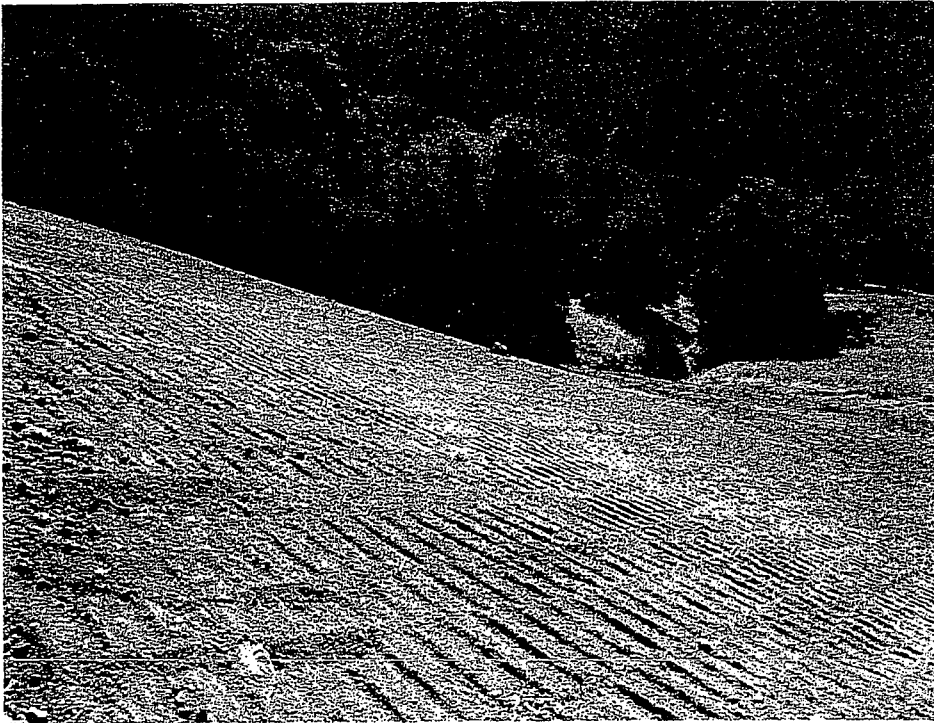
9/25/2009 Site 8 reconstructed by filling in slide body and sloping to a 2:1 slope

The approach of reconstructing the Site 8 slide with engineered fills may be appropriate in this instance. However, it should be noted that this area when overburdened with fill previously suffered mass failure and erosion. The location of the reconstruction is a concern, as I do not know if the reconstruction is back to native ground or is placing fills back into an unstable feature that has already failed once. Reconstruction on the fill or slope failure would extend the surface area of the original pad above. The progress report designs required that the fills be laid back to a 2:1 slope from the original edge of the excavation and construction. Starting on the slide mass does not appear to moving fill back but rather extending fill out. It should be further noted that the approach of creating a planar even slope will require that the entire planar slope be reconstructed and that overland flow from above be routed away from the planar slopes, prior to the onset of winter rains. Concentrated surface flows over these fills are likely to result in rill and gully erosion, and discharge of sediment to the watercourse below. No construction was occurring during the inspection.

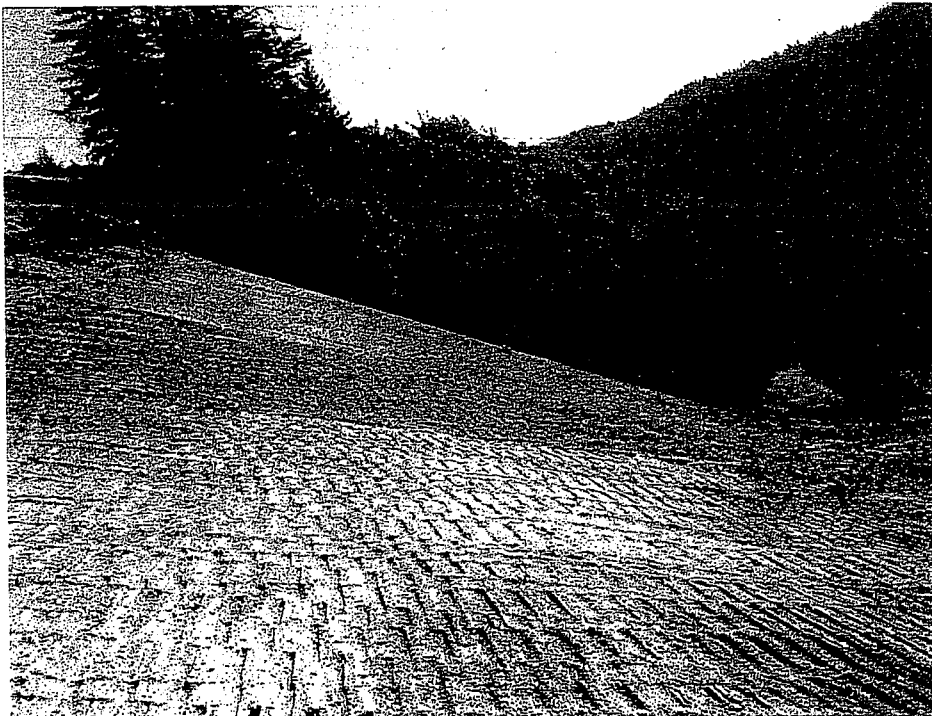
9/25/2009 Site 8 overview of slide body reconstructed with earthen materials at 2:1 slope

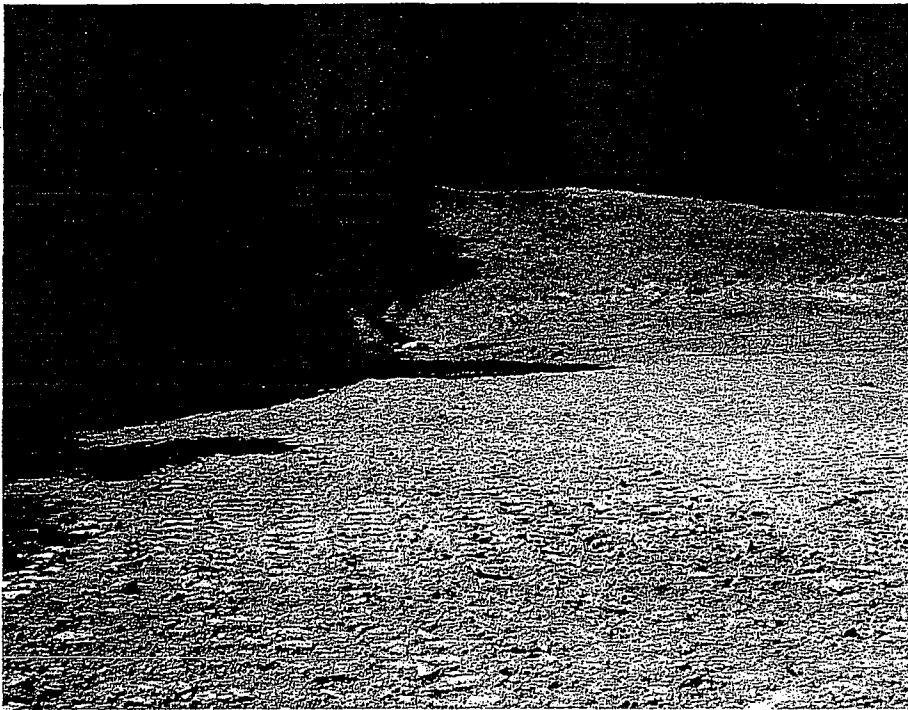
9/25/2009 Site 8 reconstructed slope above a watercourse this area corresponds roughly to where the erosion channels were photographed on 10/17/2008

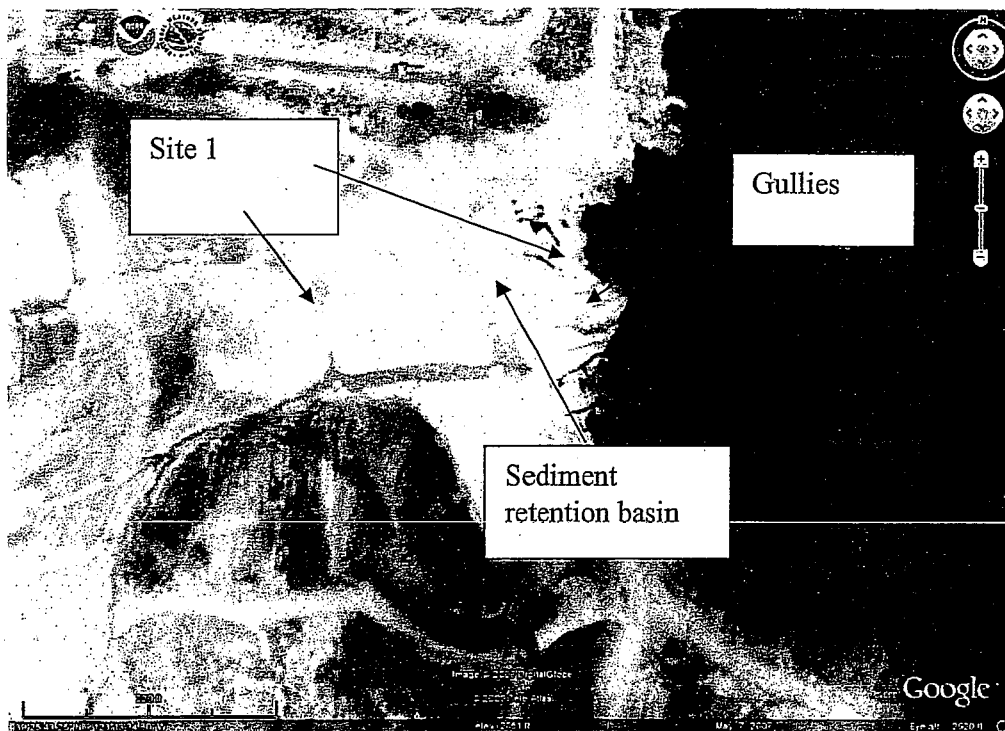
Site 1 represents a large area of fill placement and grading within a drainage basin. Due to the significant amount of material that has been placed in a natural drainage there is the potential for fill failure. However, this site has remained in place through the December 31/January 1 2005/2006 rainfall year in which at Howard Forest rain gauge 33 inches of rain fell in the month of December 2005 with 9.5 inches of rain on 12/30/2005, which was approximately a 20 -25 year event for surface runoff.

Site 1 Google Earth aerial photo: Site 1 is a valley that has been filled with earthen materials. Note the gully erosion at the outlet and the sediment retention basin that is on fill materials. The arrows with the Site 1 identification box above identify the estimated extent of fill placement.

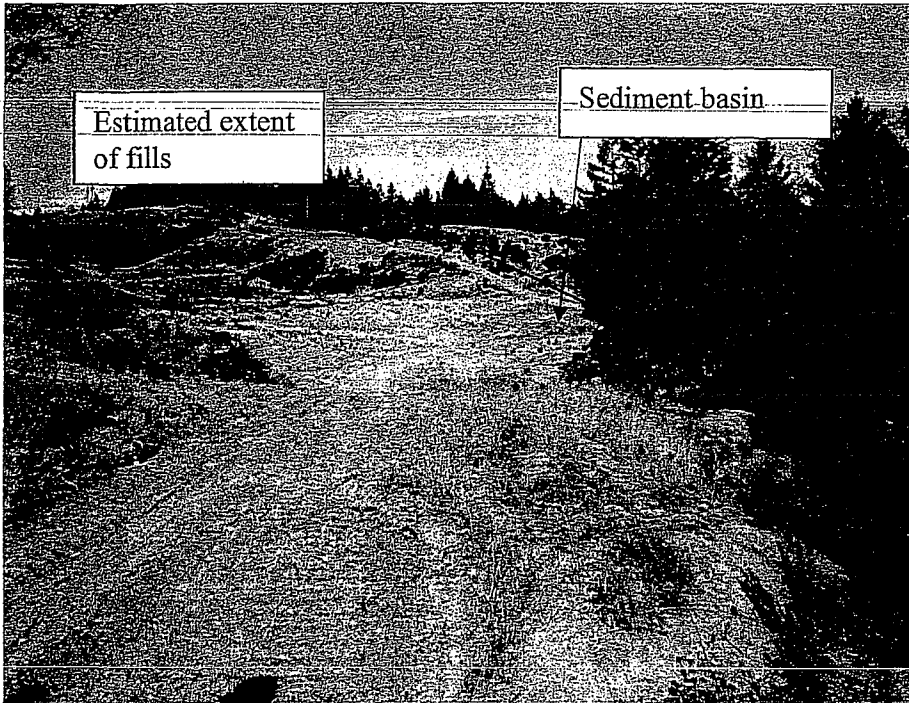
10/17/2008 Overview of Site 1 approaching from the South

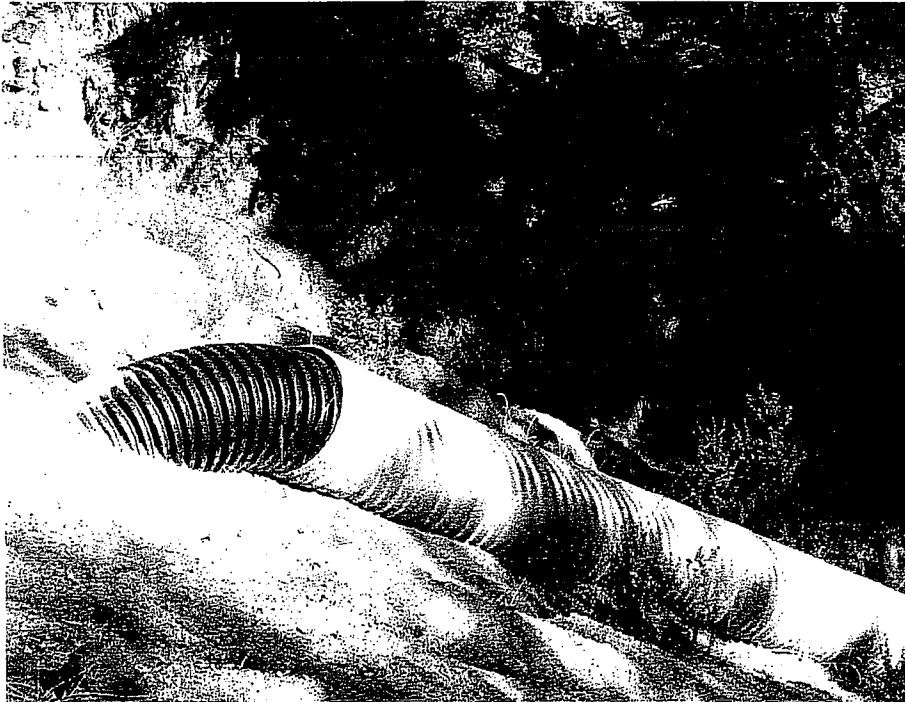
10/17/2008 Site 1 Culvert from sediment basin. Note the erosion of the fill slopes and the adjacent banks beyond where fill materials were placed against native ground creating an artificial drainage pattern.

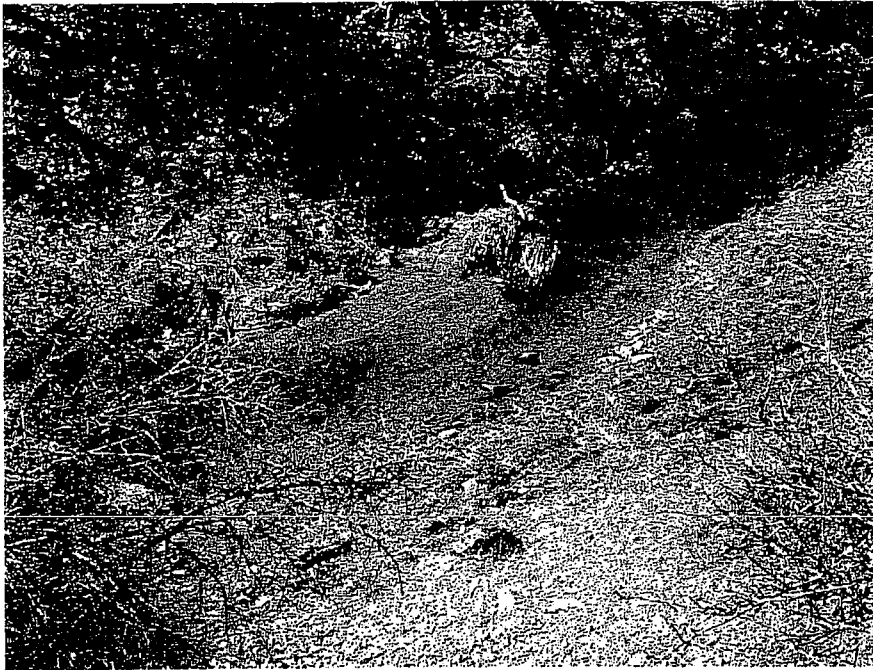
3/26/2008 sediment deposition in unnamed tributary to Scott Creek.

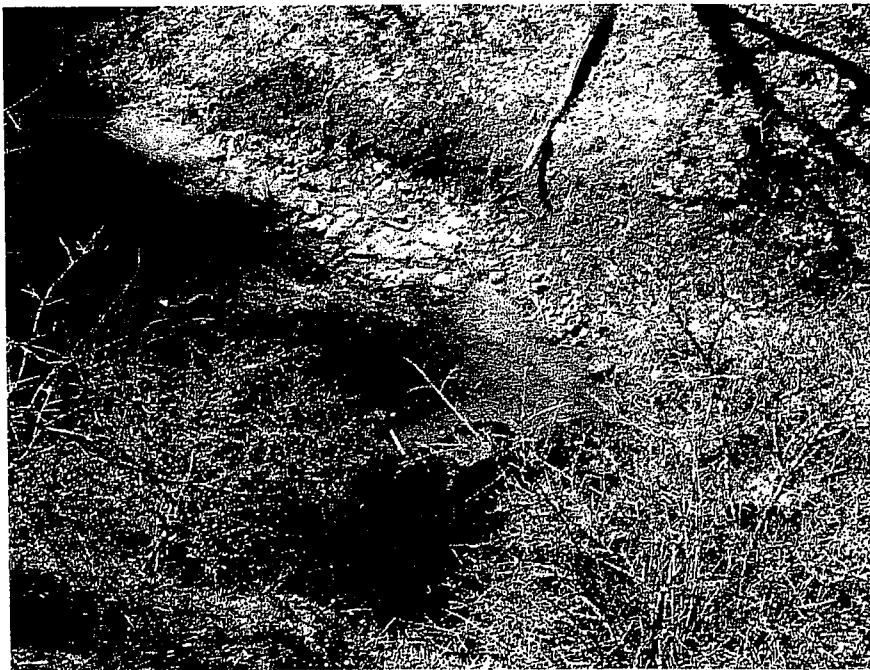
3/26/2008 sediment deposition in unnamed tributary to Scott Creek

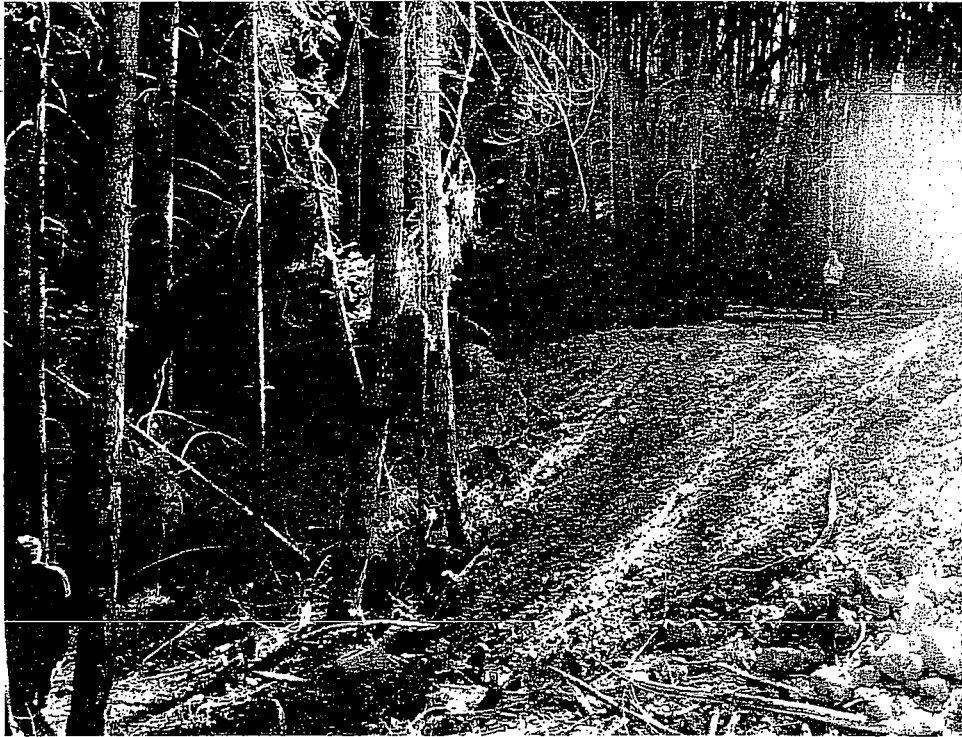
9/25/2009 northeast side of cleared area on new road constructed at the head of a Class III watercourse.

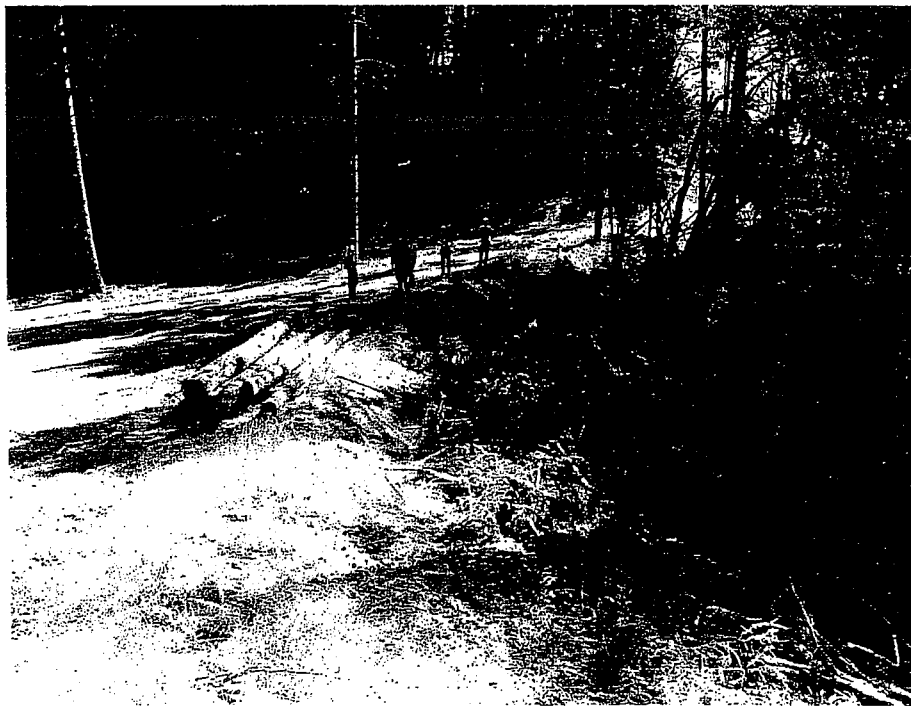
9/25/2009 southwest side of cleared area fills are perched above the head of a class III watercourse and tension cracks are visible in the perched fills.

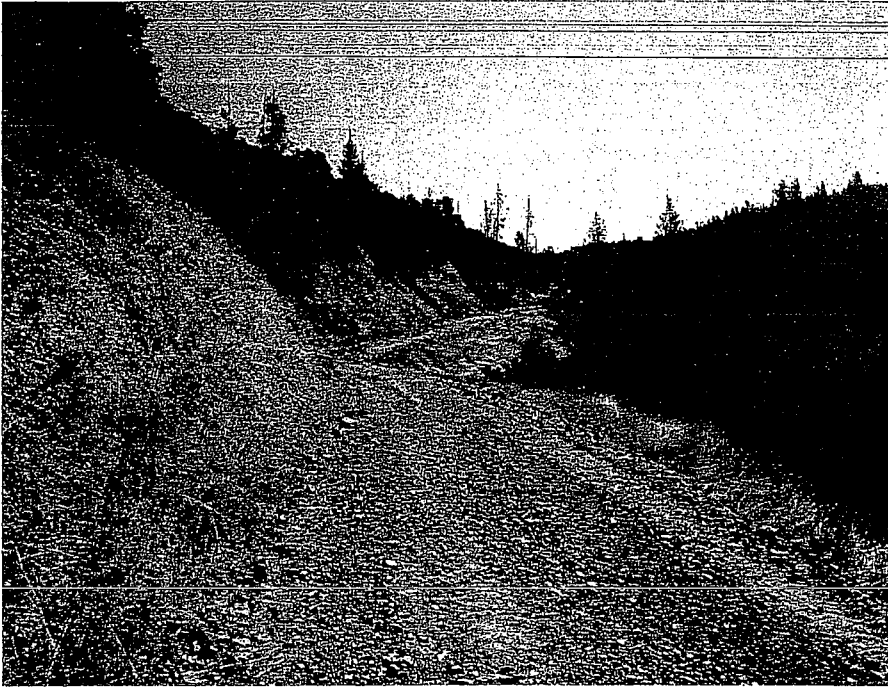
9/25/2009 Lower road segment overview of mid slope road construction. The extent of side cast fill material is likely relative to the extent of grass growing, as the grass appears to be an annual rye often used for erosion control.

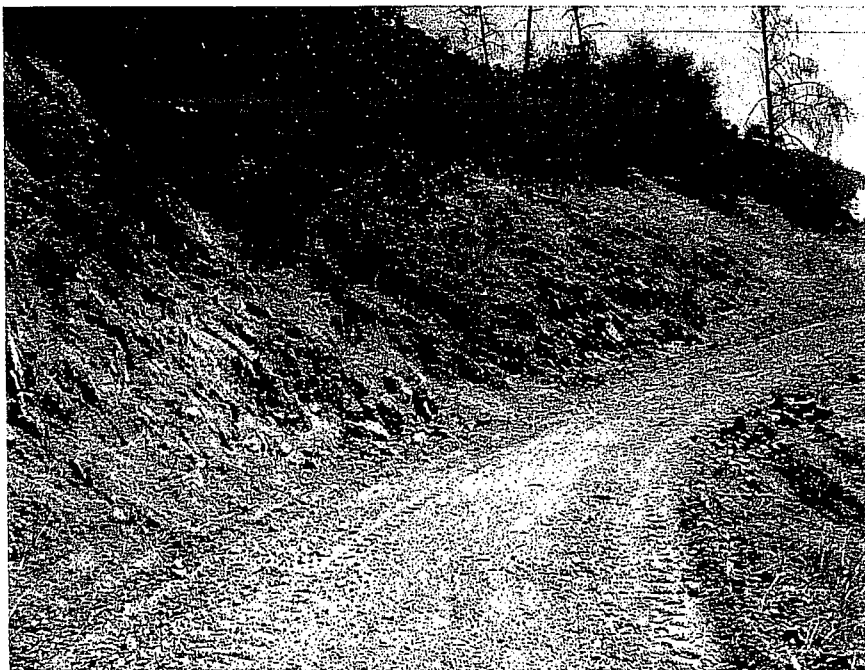
9/25/2009 road fill in a watercourse crossing on the new road, with no constructed water conveyance facility.

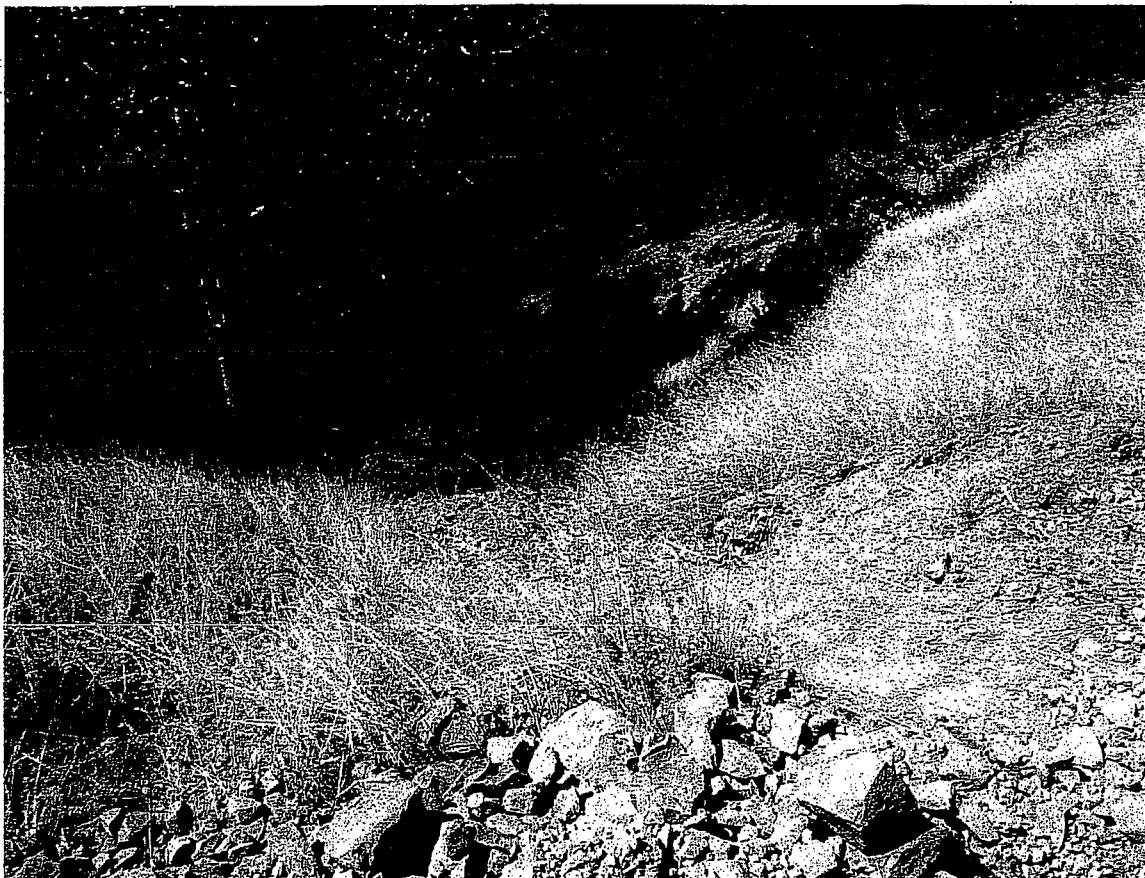
9/25/2009 fill failure below the watercourse crossing displayed previously. This failure extends to the watercourse below.

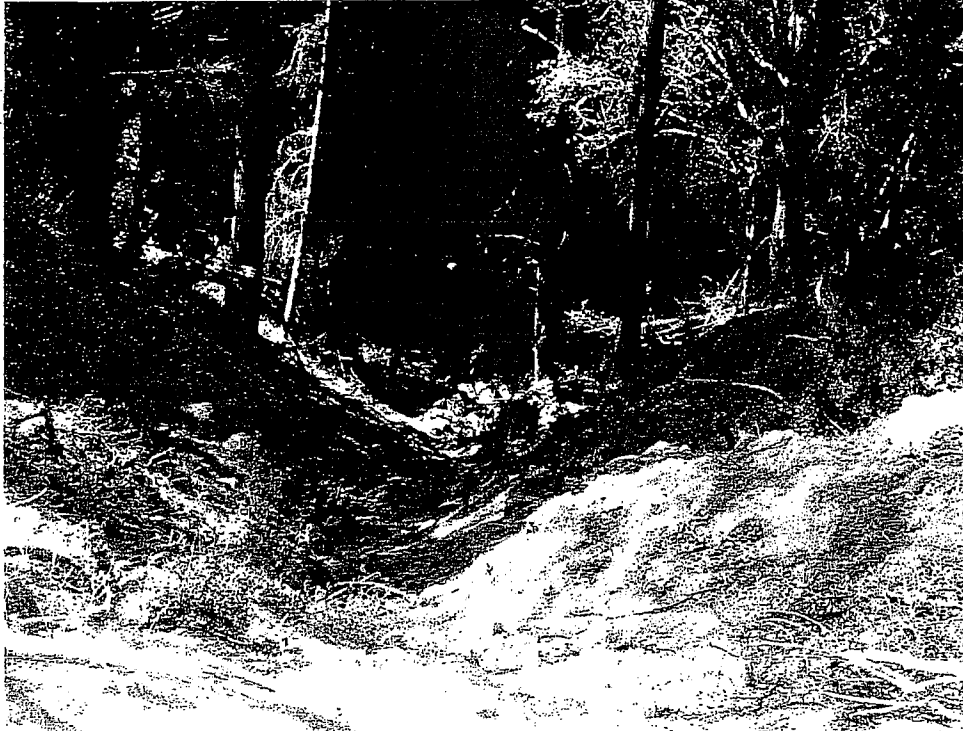
9/25/2009 Close up of delivery point to stream of the failure in the previous photo

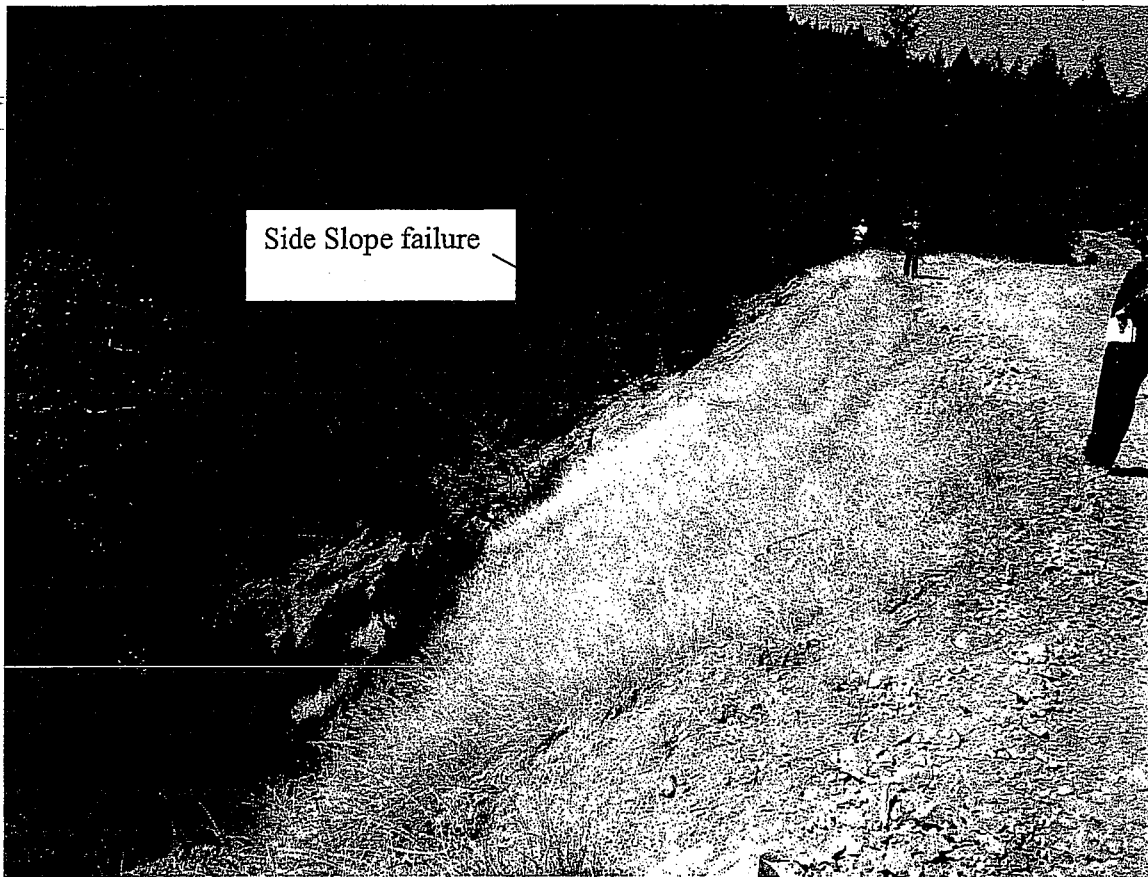
9/25/2009 This photo is taken at the top of the previous road fill failure and shows the side slope failure integrating into the debris chute. The side slope failure may in part be due to side cast of earthen debris during road construction.

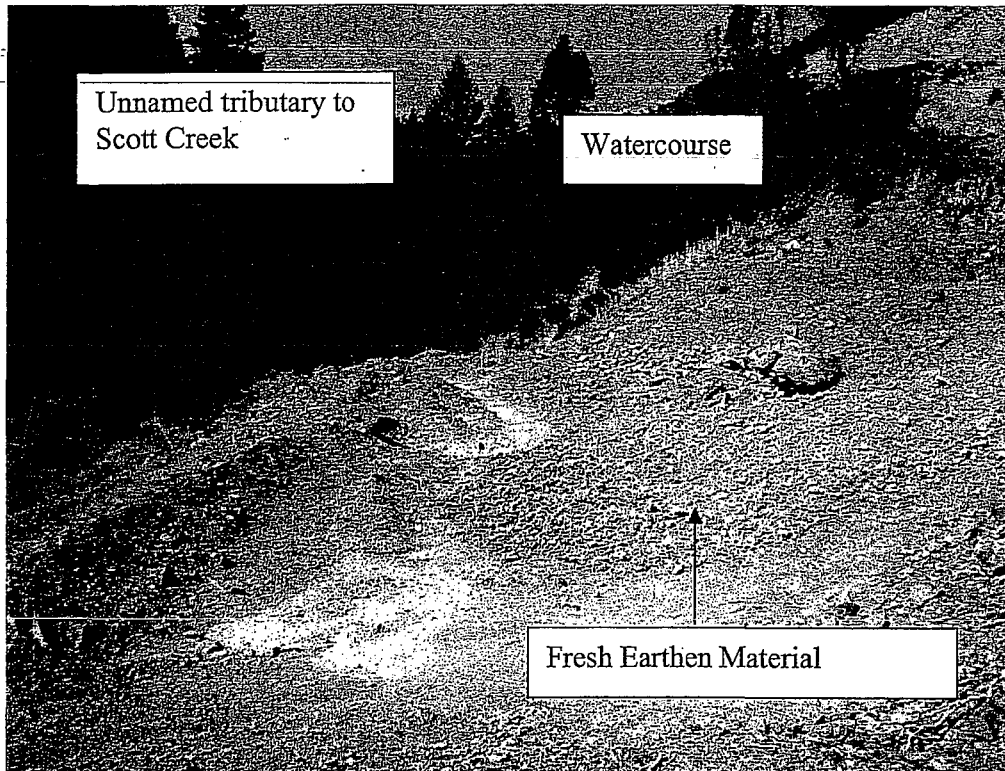
9/25/2009 end of the new road with the pond or water retaining basin, note the fresh earthen material deposited in right side of photo.

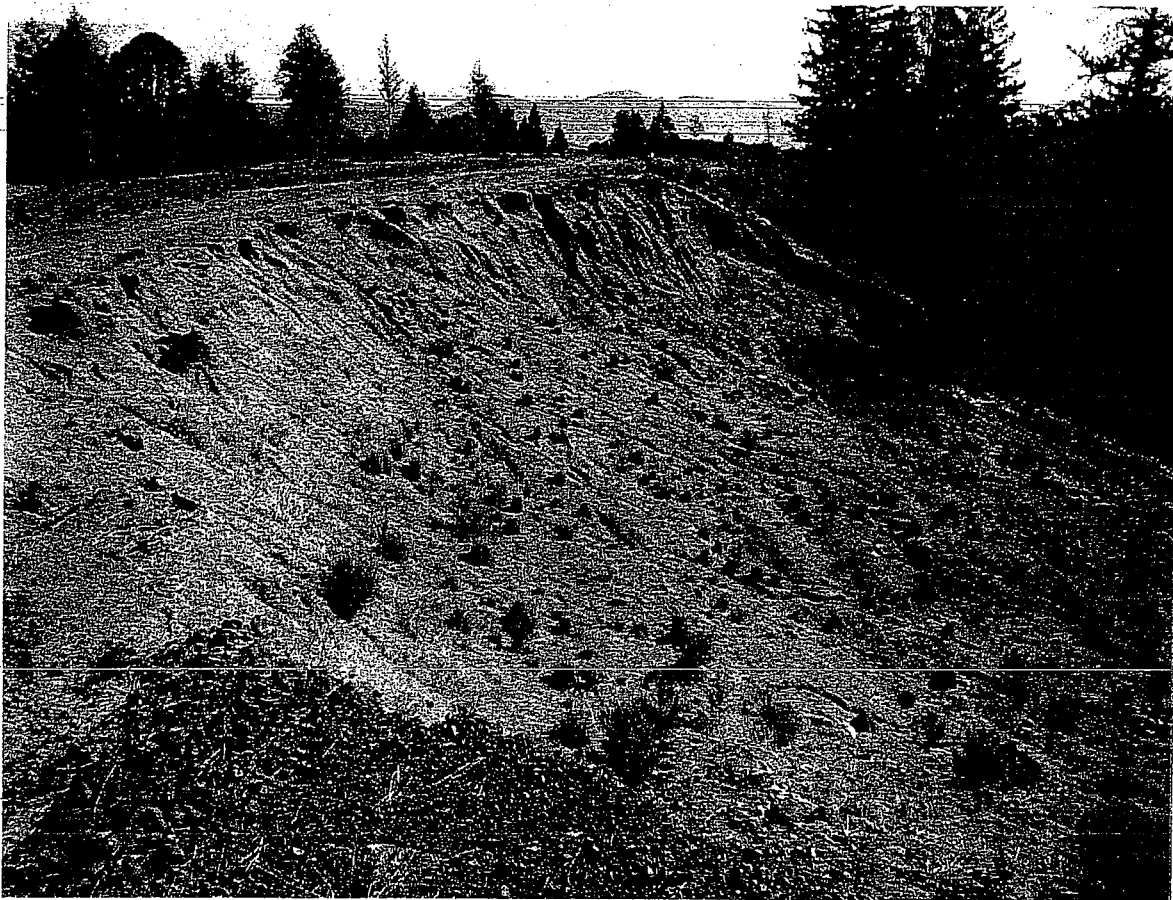
10/17/2008 Upper extent of Site 8 failure
