Los Angeles Regional Water Quality Control Board

NOTICE OF VIOLATION: FEDERAL WATER POLLUTION CONTROL ACT SECTIONS 301 AND 401, AND PORTER COLOGNE WATER QUALITY CONTROL ACT SECTIONS 13260, 13376, and 13385(a)(1) and (5) FOR PROPERTIES LOCATED IN SANTA SUSANA MOUNTAINS, PARCELS 2821009030, 2821009031, and 2821009023; LOS ANGELES COUNTY

October 17, 2016 Inspection Report

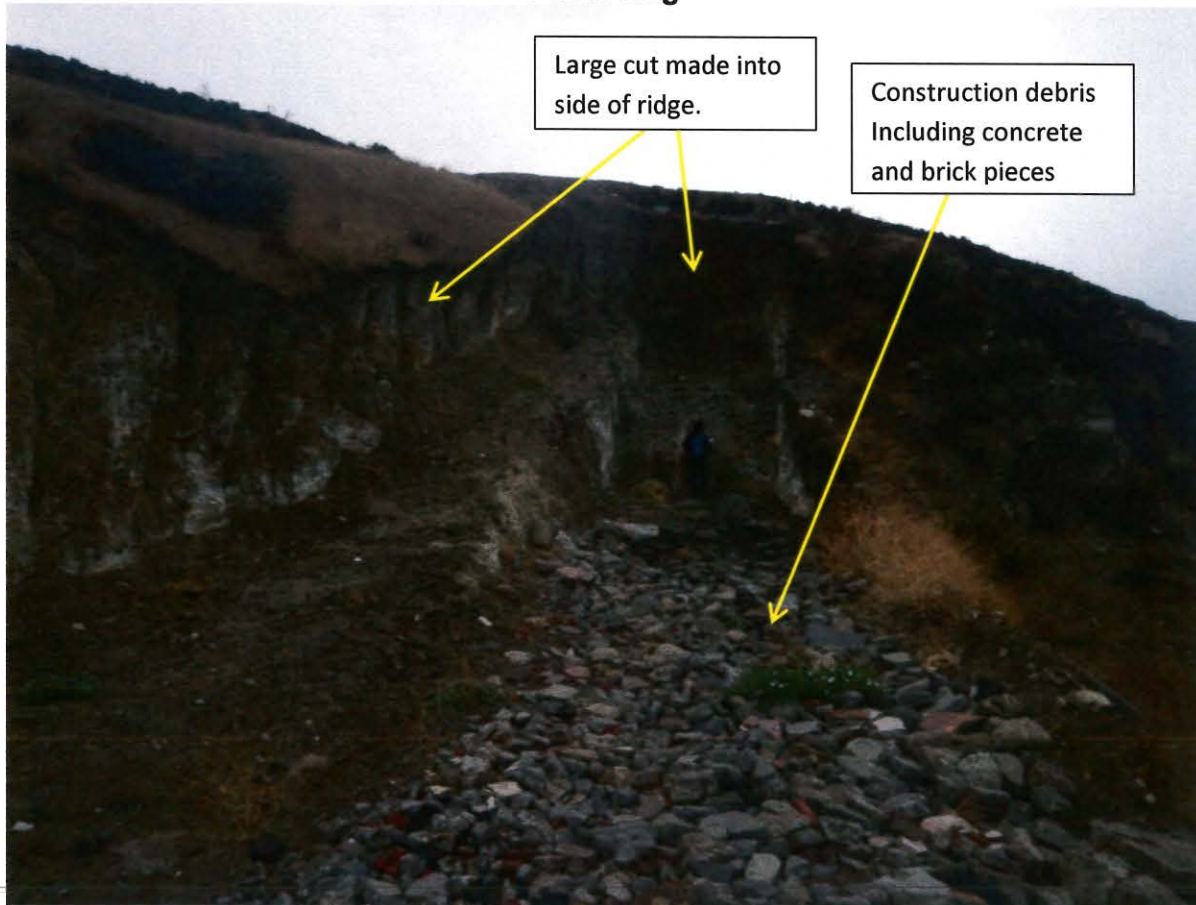
- **Grading activity on the ridge on the western side of the parcel** - Construction debris consisting of broken pieces of concrete and bricks were observed in a cut graded into a ridge along the west portion of the parcel. There were no erosion and/or sediment control Best Management Practices (BMPs) in place to prevent the sides of the cut from eroding and releasing sediment into Devil's Creek during a rain event (Photo 1). This cut was a recent development as it was not noted in the September 2015 inspection report.

Photo 1. This photo shows a cut made into the side of a ridge. Concrete and brick debris has been deposited in the cut. The sides of the cut have exposed, unstabilized sediment at risk of eroding. This photo was taken in Parcel 2821-002-025, at latitude and longitude 34 18.653, -118 37.263.

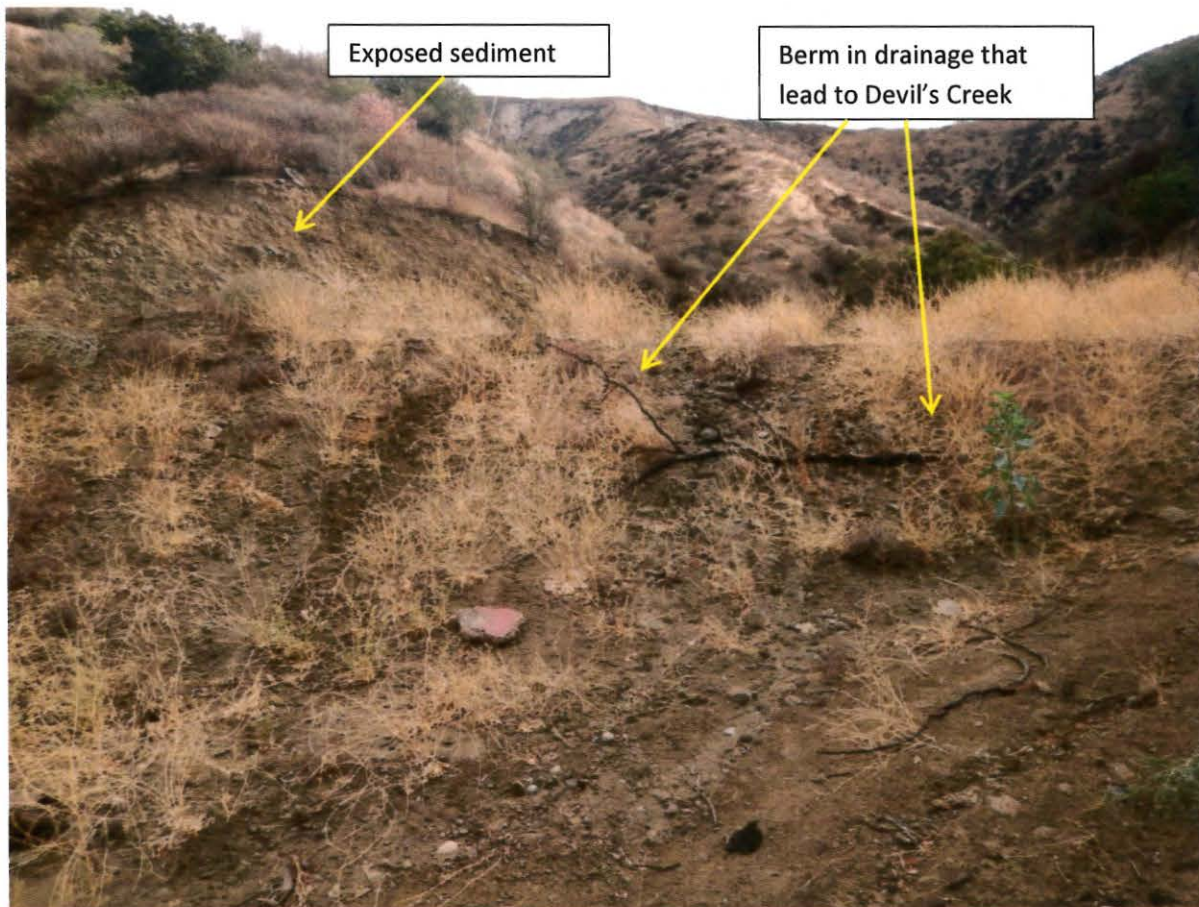
Photo 2. This photo shows a berm in a drainage that leads to Devil's Creek. This photo was taken in Parcel 2821-002-025 at latitude and longitude of 34 18.729, -118 37.356.

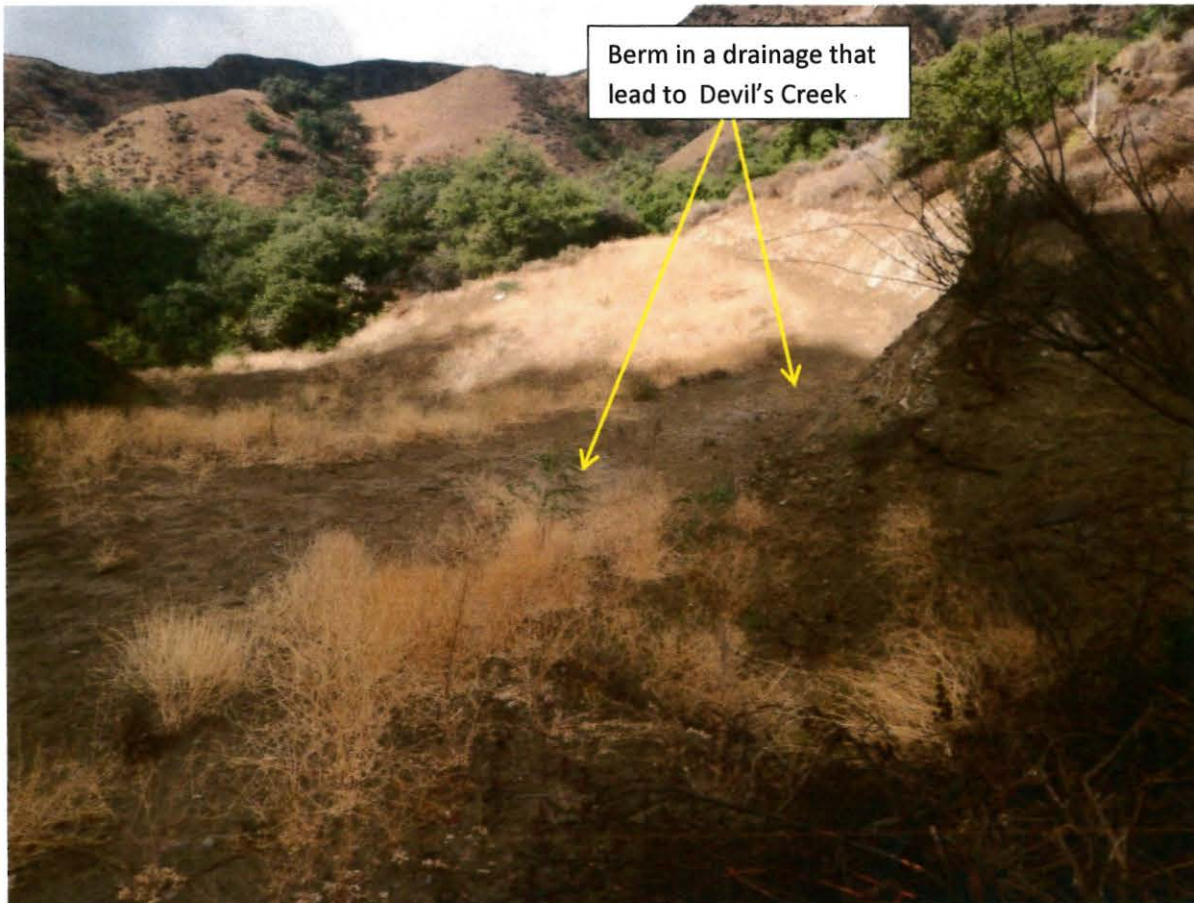
Photo 3. This photo shows another view of the berm in drainage that lead to Devil's Creek that was also shown in Photo 2. This photo was taken in Parcel 2821-002-025 at latitude: 34 18.729 and longitude: -118 37.367.

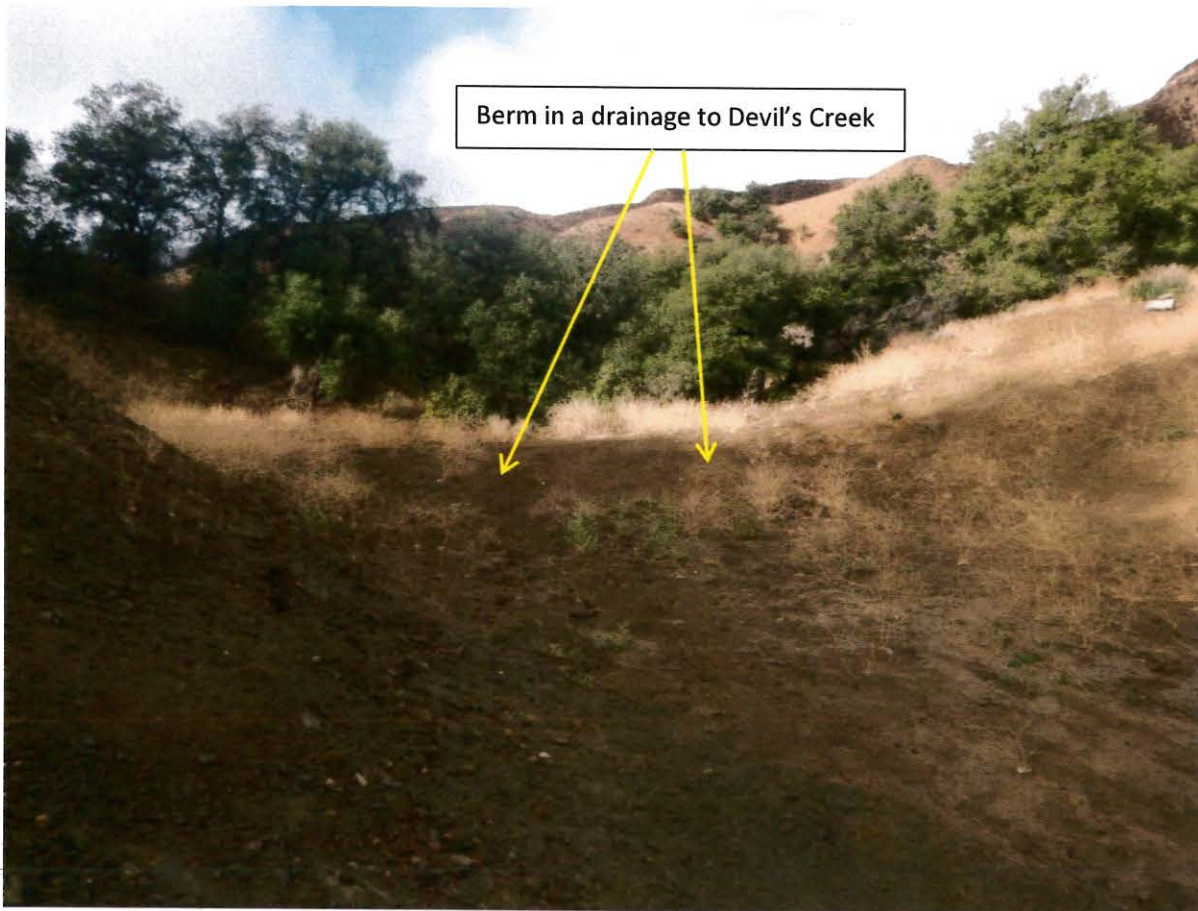
Photo 4. This photo shows a berm in a drainage that lead to Devil's Creek and is the same as shown in Photos 2 and 3. This photo was taken in Parcel 2821-002-025, latitude: 34 18.717 and longitude: -118 37.365.

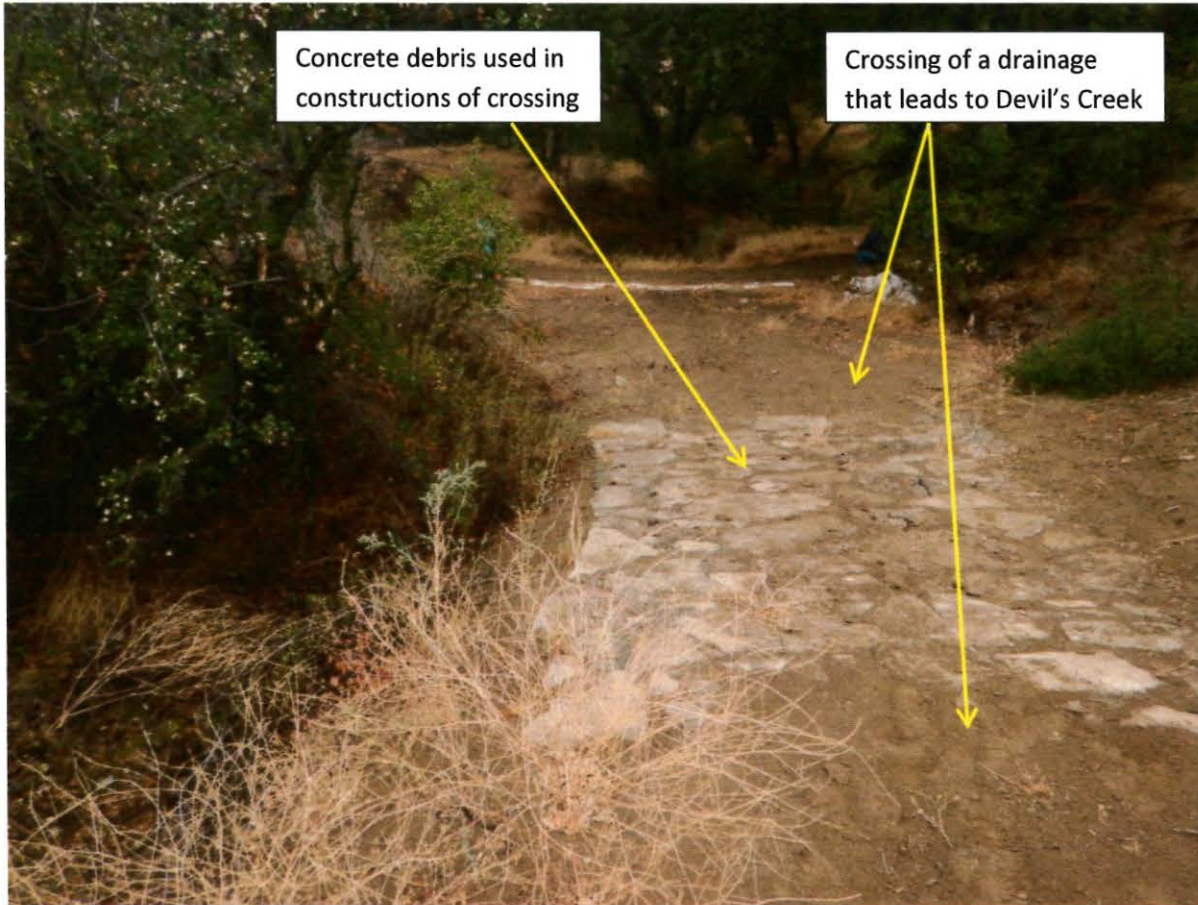
Photo 5. This photo shows a suspected crossing of drainage of Devil's Creek made of concrete debris. Ultimately, the stream on the left side of the photo discharges to Devil's Creek on the other side of the trail at the top of the photo. This tributary is the same tributary shown in Photos 2, 3, and 4. This photo was taken on Parcel 2821-002-025 at latitude: 34 18.714 and longitude: -118 37.393.

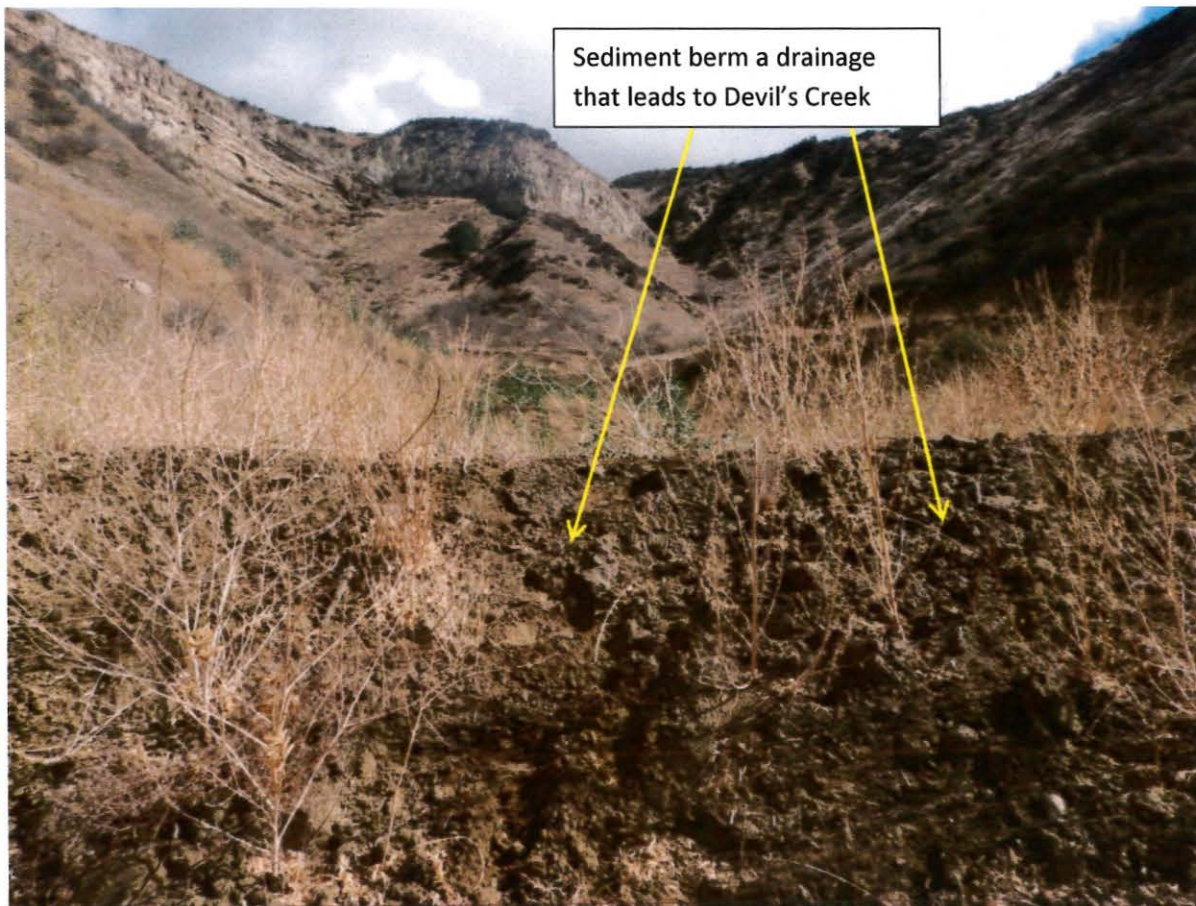
Photo 6. This photo shows a sediment berm in a drainage to Devil's Creek. This photo was taken on Parcel 2821-002-025 at latitude: 34 18.586 and longitude:-118 37.344.

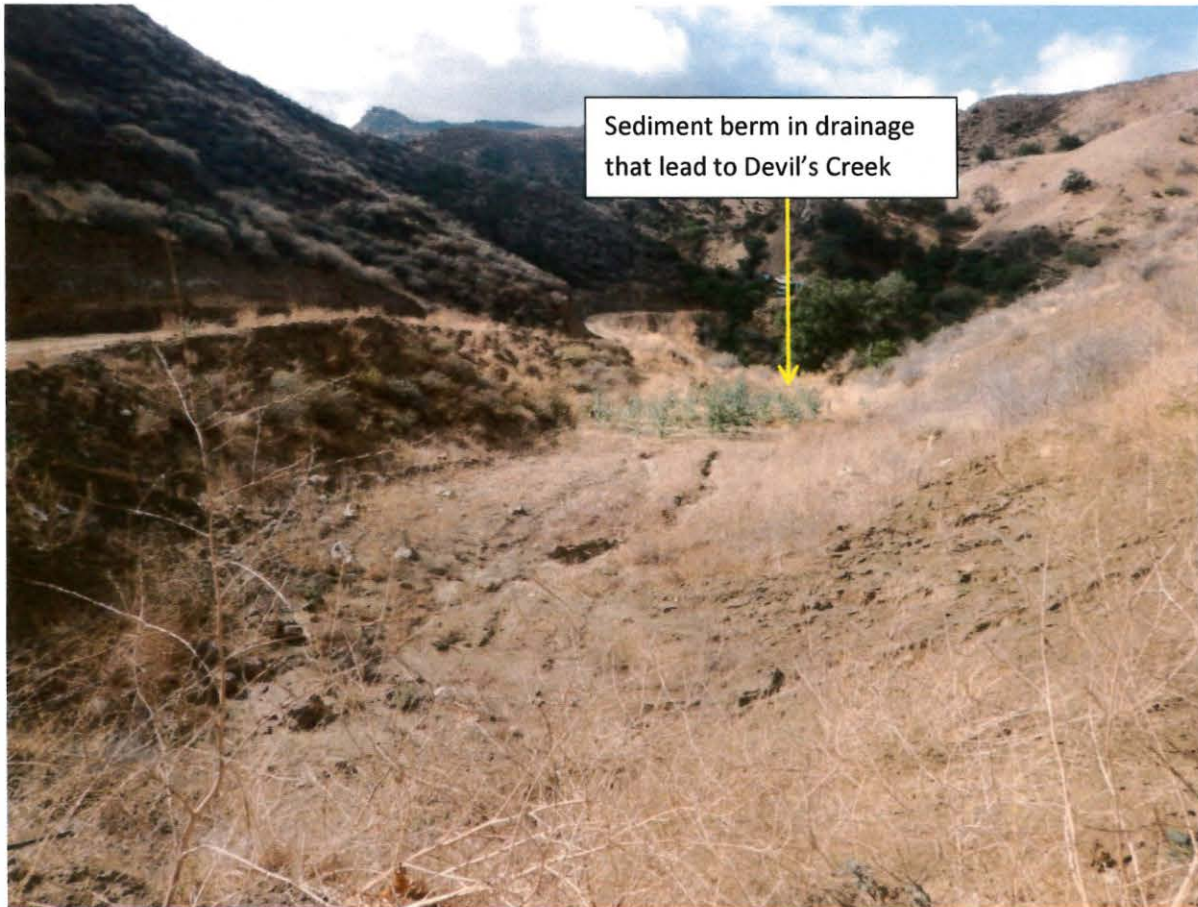
Photo 7. This photo shows a drainage that leads to Devil's Creek. This is another view of the sediment berm from Photo 6. This photo was taken on Parcel 2821-002-025, at latitude: 34 18.603 and longitude:-118 37.304.

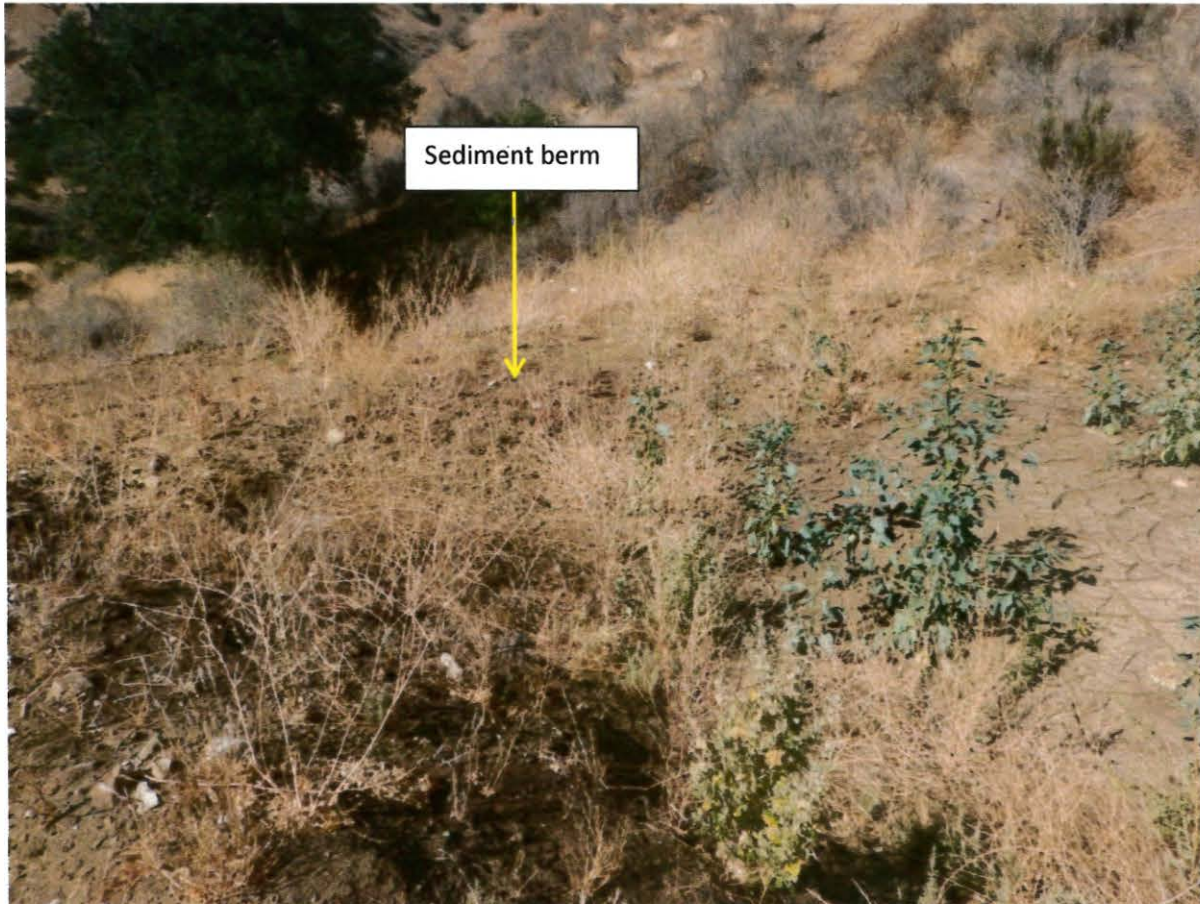
Photo 8. Showing another sediment berm in a drainage that leads to Devil's Creek. This photo was taken on Parcel 2821-002-025 at latitude: 34 18.583 and longitude: -118 37.344.

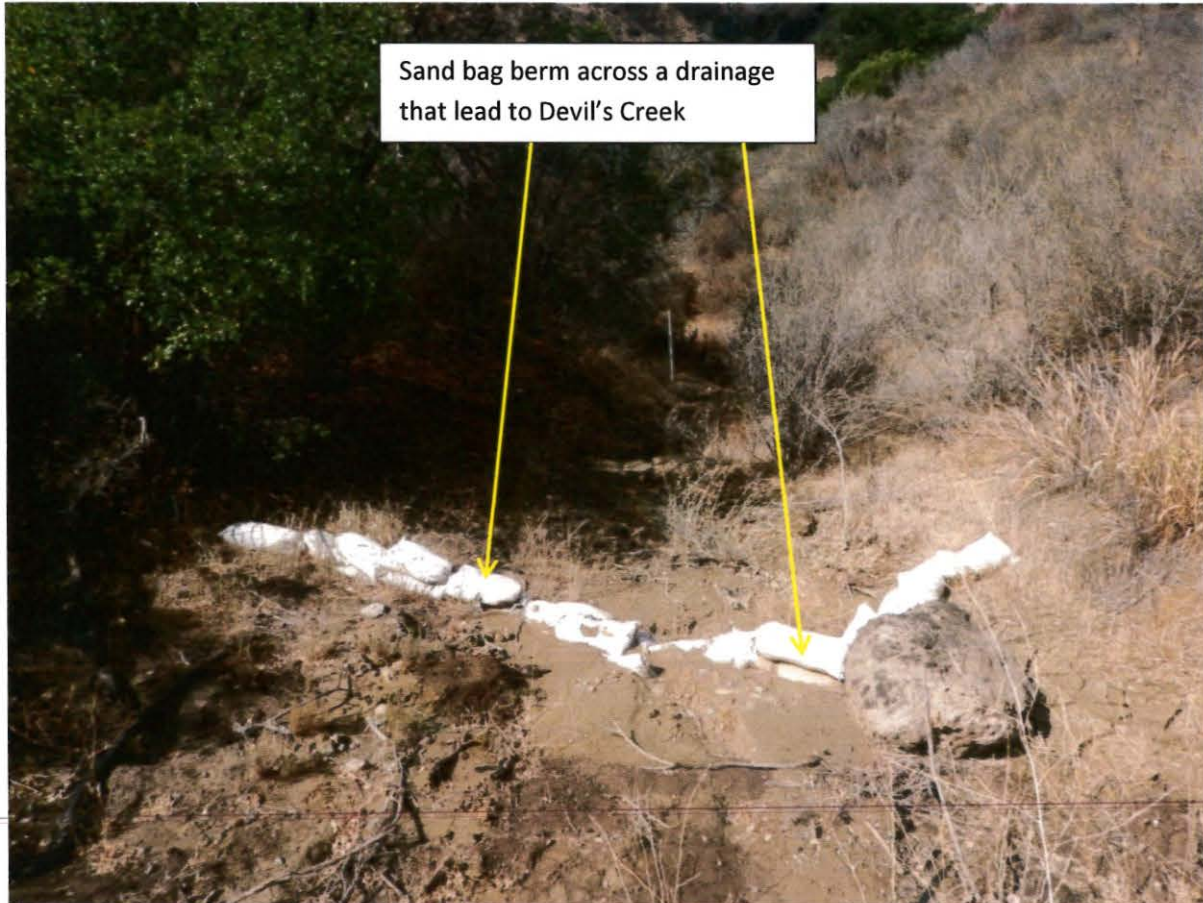
- **Sand bag berm** – A berm constructed across the unnamed tributary with sand bags was observed in the same area where the soil berms referenced above and in Photos 6, 7, 8 were found (Photos 9 and 10). This sand bag berm was a recent disturbance as it was not noted in the in the September 2015 inspection report.

Photo 9. This photo shows a sand bag berm located in drainage that leads to Devil's Creek. This photo was taken on parcel 2821-002-025, at latitude: 34 18.568 and longitude: -118 37.358. This area lacked erosion control best management practices, and there was loose sediment accumulated behind the berm.

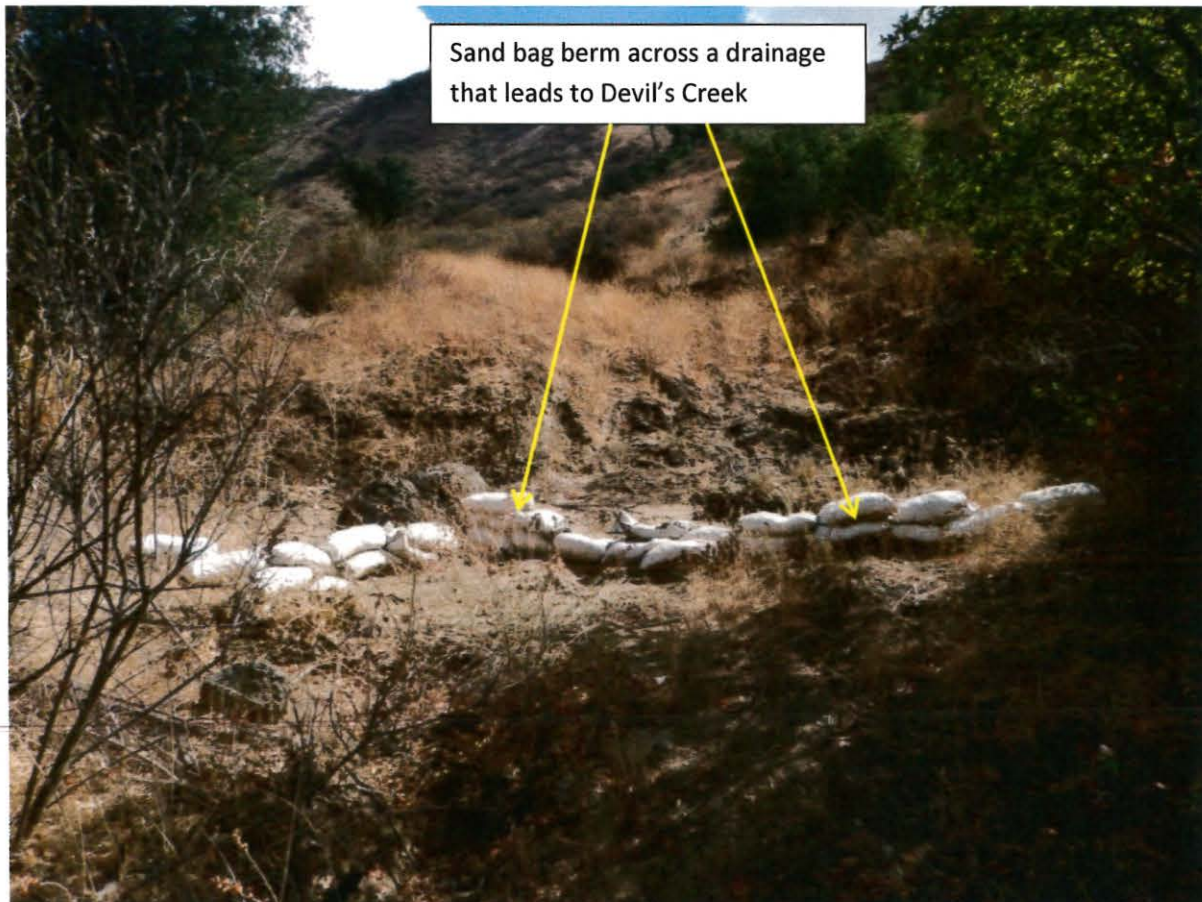
Photo 10. This photo shows another view of the sand bag berm located in a drainage that leads to of Devil's Creek. The sand bag berm shown is the same sand bag berm shown in Photo 8. This photo was taken on Parcel 2821-002-025, at latitude: 34 18.568 and longitude: -118 37.418.

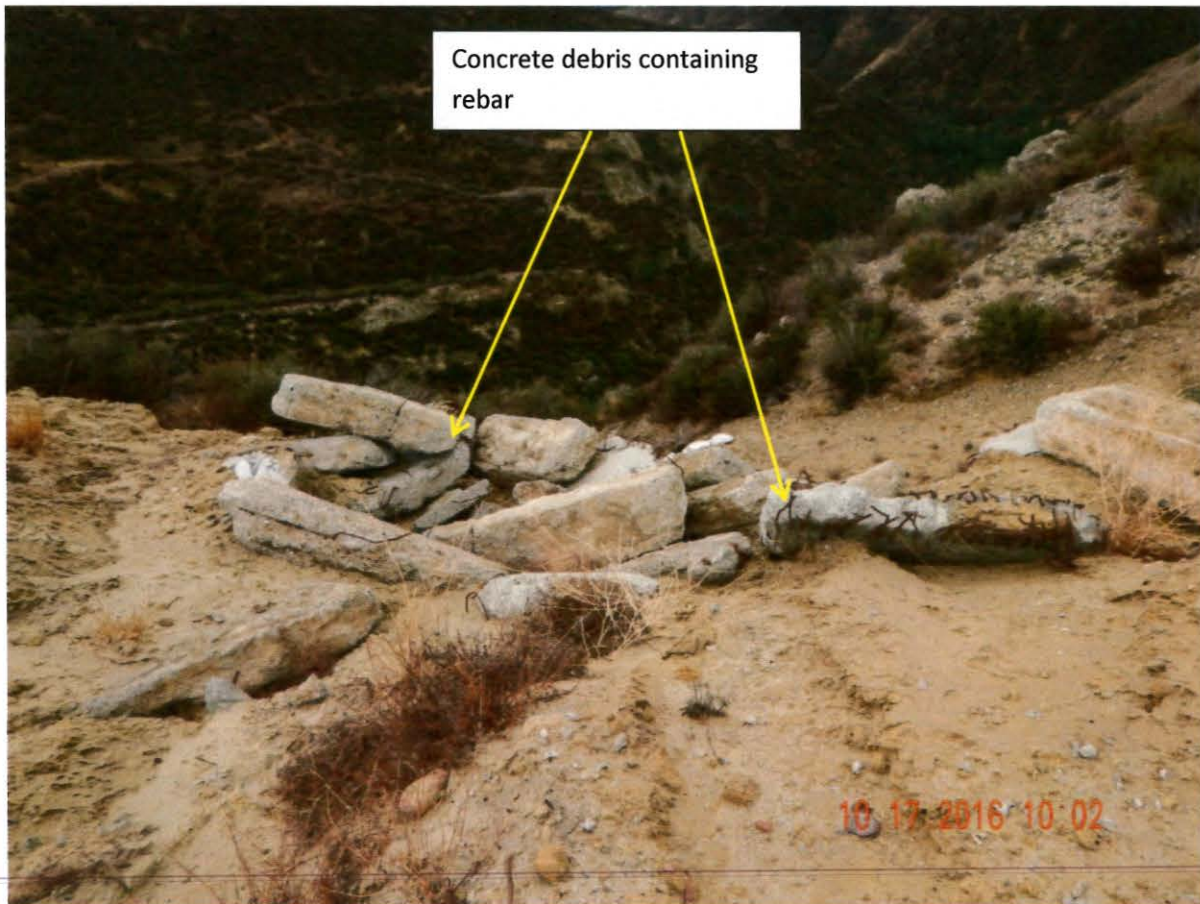
- **Stockpiled concrete debris** – Concrete debris was observed stockpiled throughout the parcel. Concrete debris was also seen partially buried at different locations within the parcel (Photo 11 and Photo 14).

Photo 11. This photo shows concrete debris partially buried in Parcel 2821-002-025 from sediment build up. The pieces of concrete debris contained rebar. This photo was taken near latitude: 34 18.574 and longitude: -118 37.078.

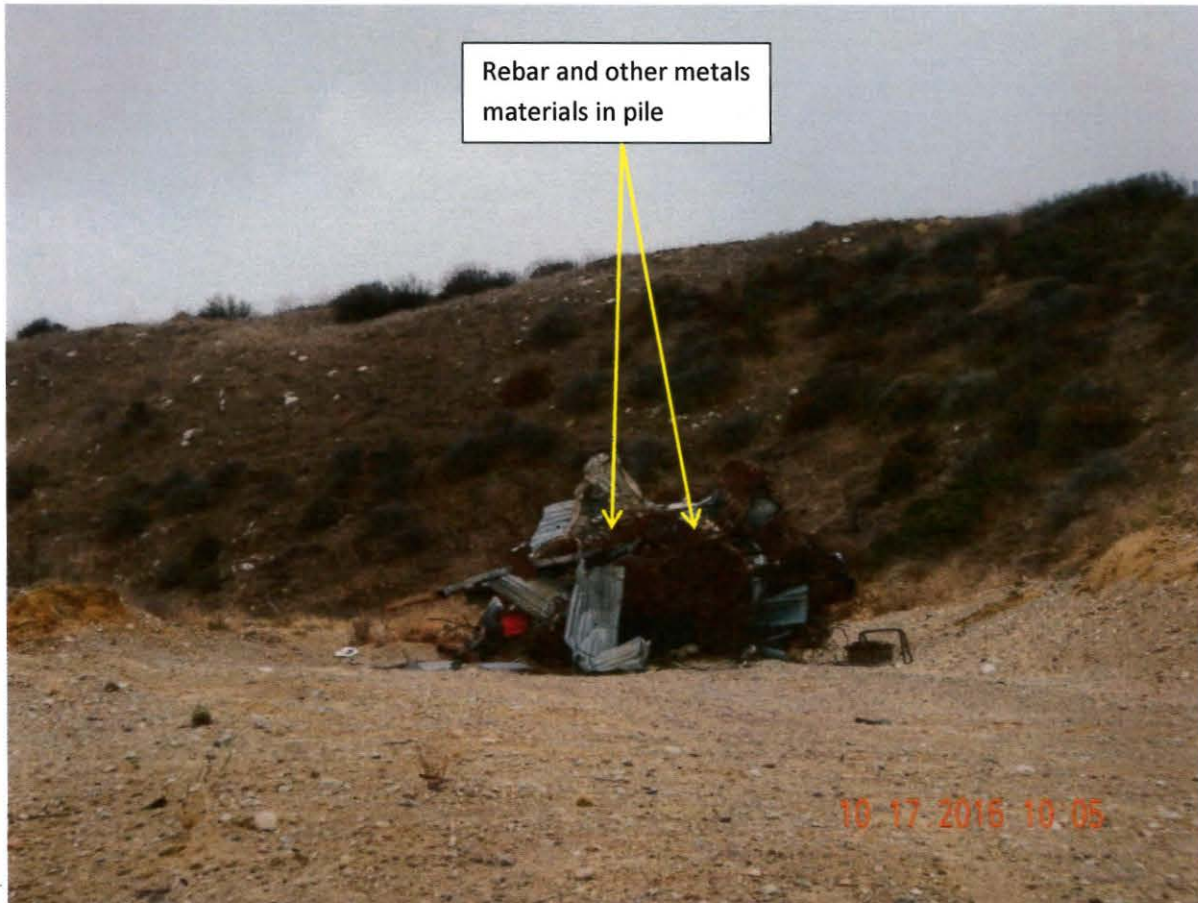
- **Rebar and metal stockpiles** – A stockpile of rebar and other miscellaneous metal was observed in a graded area located on the eastern side of the parcel. There were no BMPs in place to keep rust from the metals from discharging into Ybarra Creek and Devil's Creek (Photo 12). This stockpile rebar was not previously noted in the September 2015 inspection report.

Photo 12. This photo shows a stockpile of rebar and other miscellaneous metals found in Parcel 2821-002-025. This photo was taken near latitude: 34 18.594 and longitude: -118 37.078.

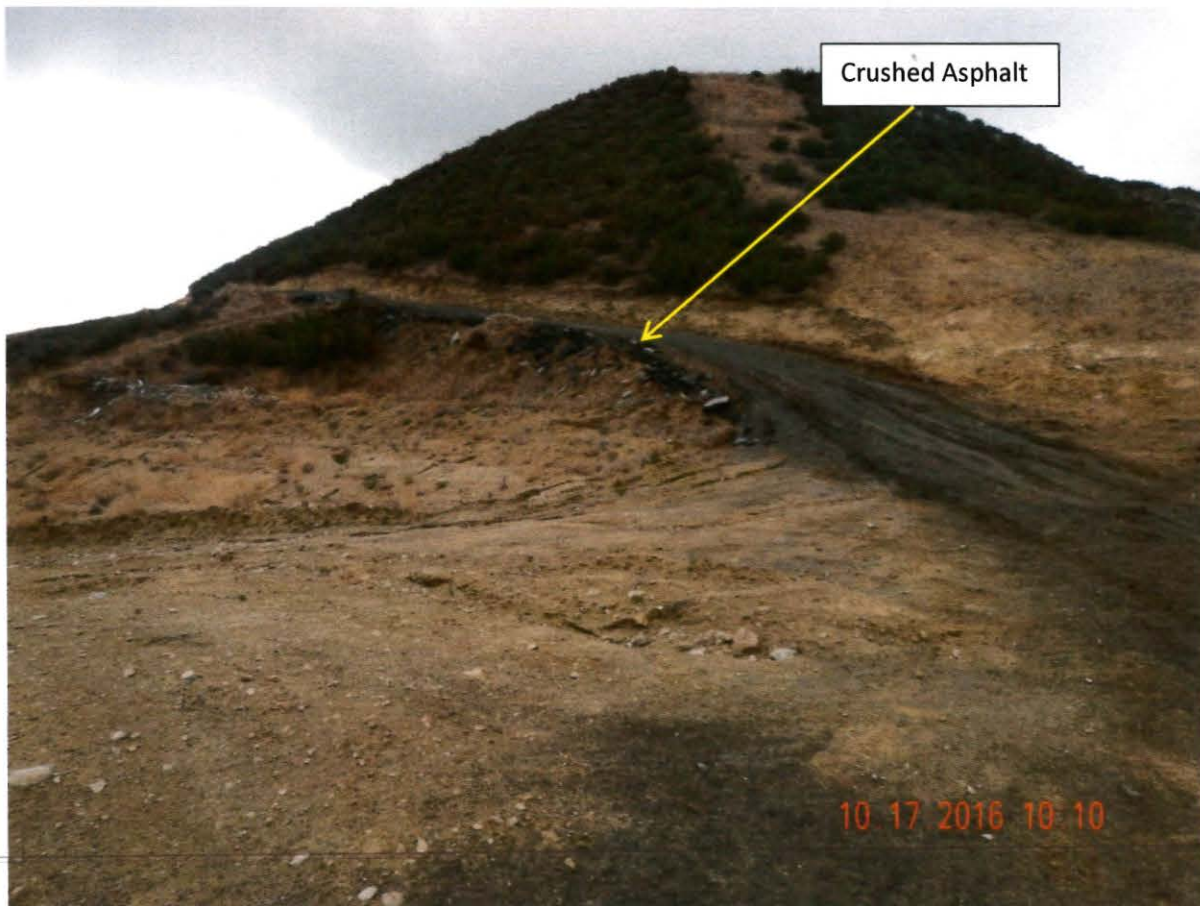
Photo 13. This photo shows crushed asphalt that was used to build the road. This photo was taken near latitude: 34 18.574 and longitude: -118 37.078 in Parcel 2821-002-025.

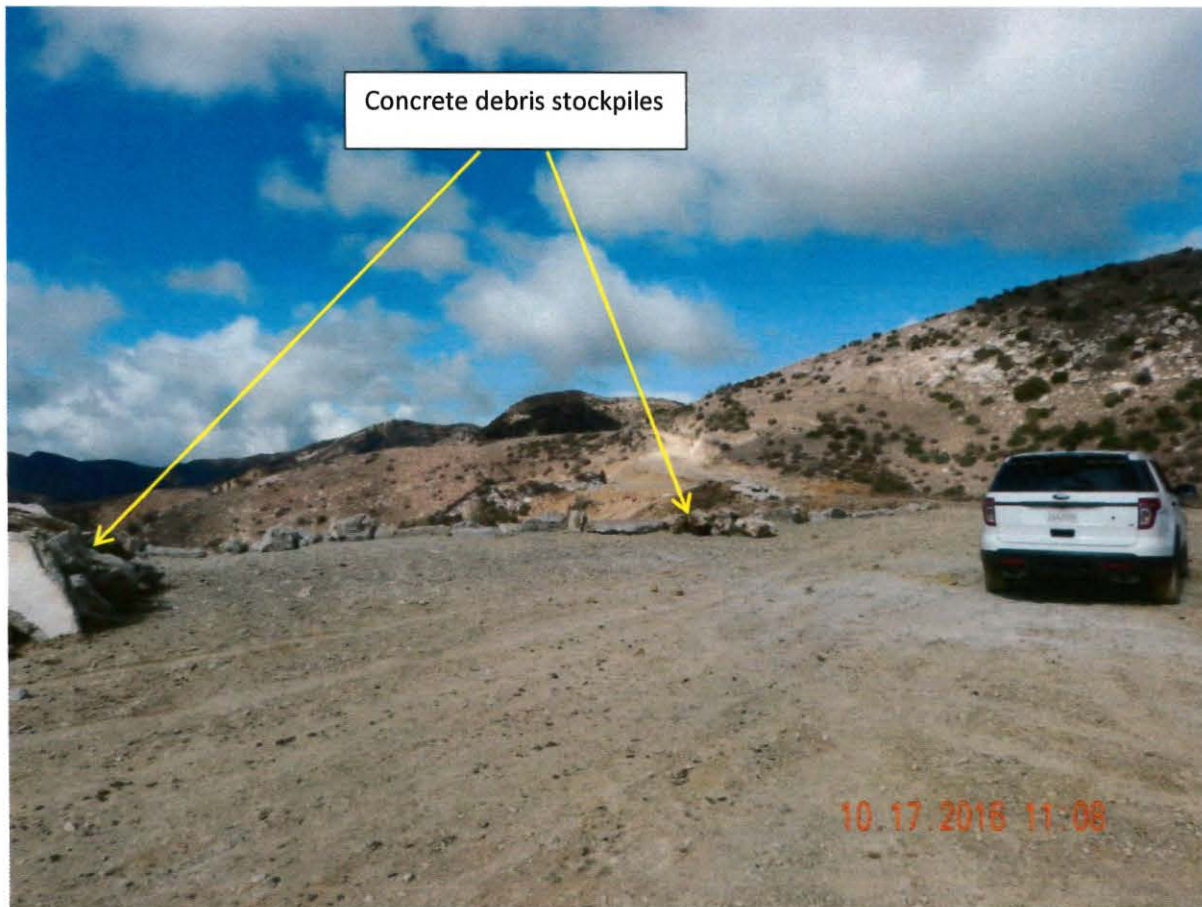
- **Large graded areas** – Areas within the parcel have been graded. Some of these graded areas contain stockpiles of construction debris. These large graded areas can erode and release sediment and other fill materials into creek waters (Photo 14). At least three separate areas within the parcel had been graded flat. These three areas had not been noted in the September 2015 inspection report and are likely new disturbances.

Photo 14. This photo shows a large graded area in Parcel 2821-002-025. This area contains stockpiles of concrete. This area lacked erosion control best management practices (BMPs), or sediment control BMPs. This photo was taken near latitude: 34 18.574 and longitude: -118 37.078.

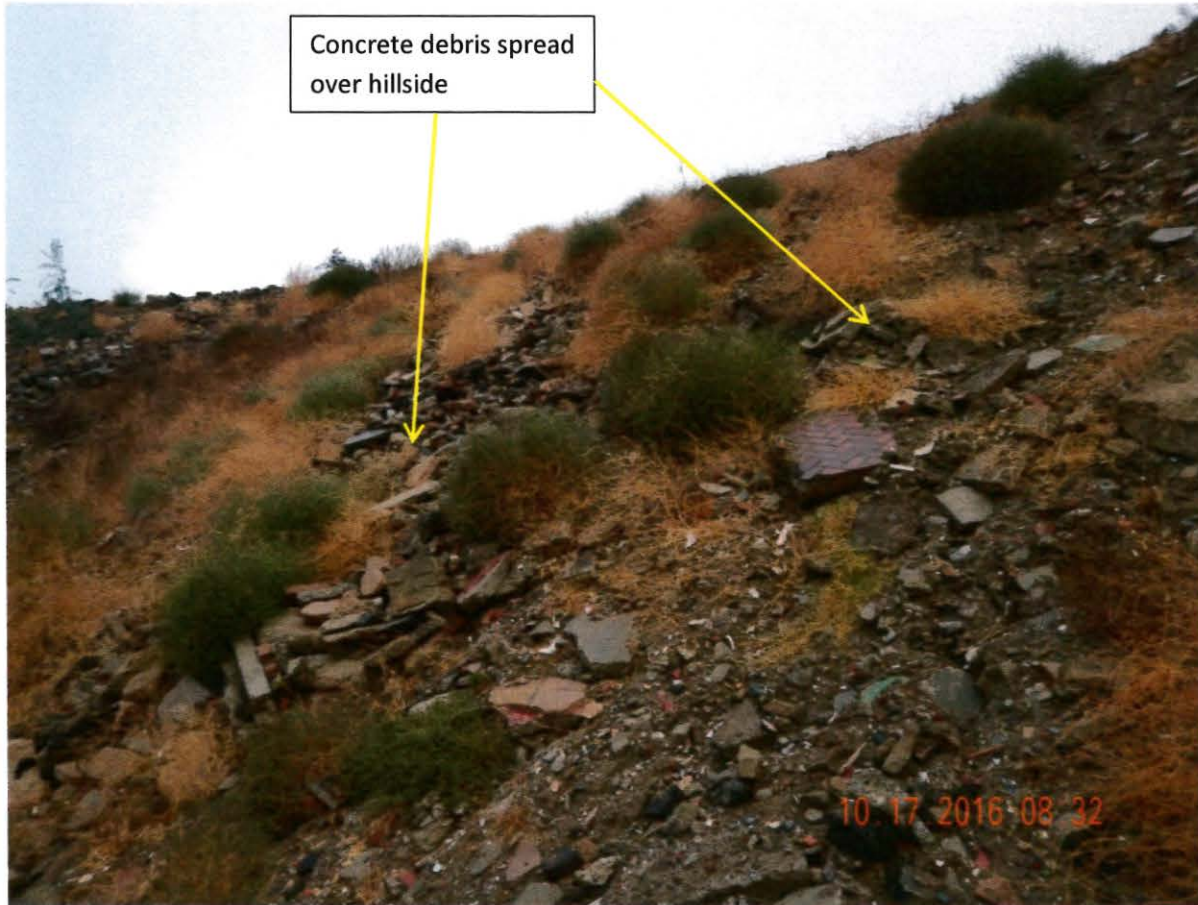
Photo 17. This photo shows construction debris piles found in the northeast section of Parcel 2821-002-023, near latitude: 34 18.622 and longitude: -118 36.766.

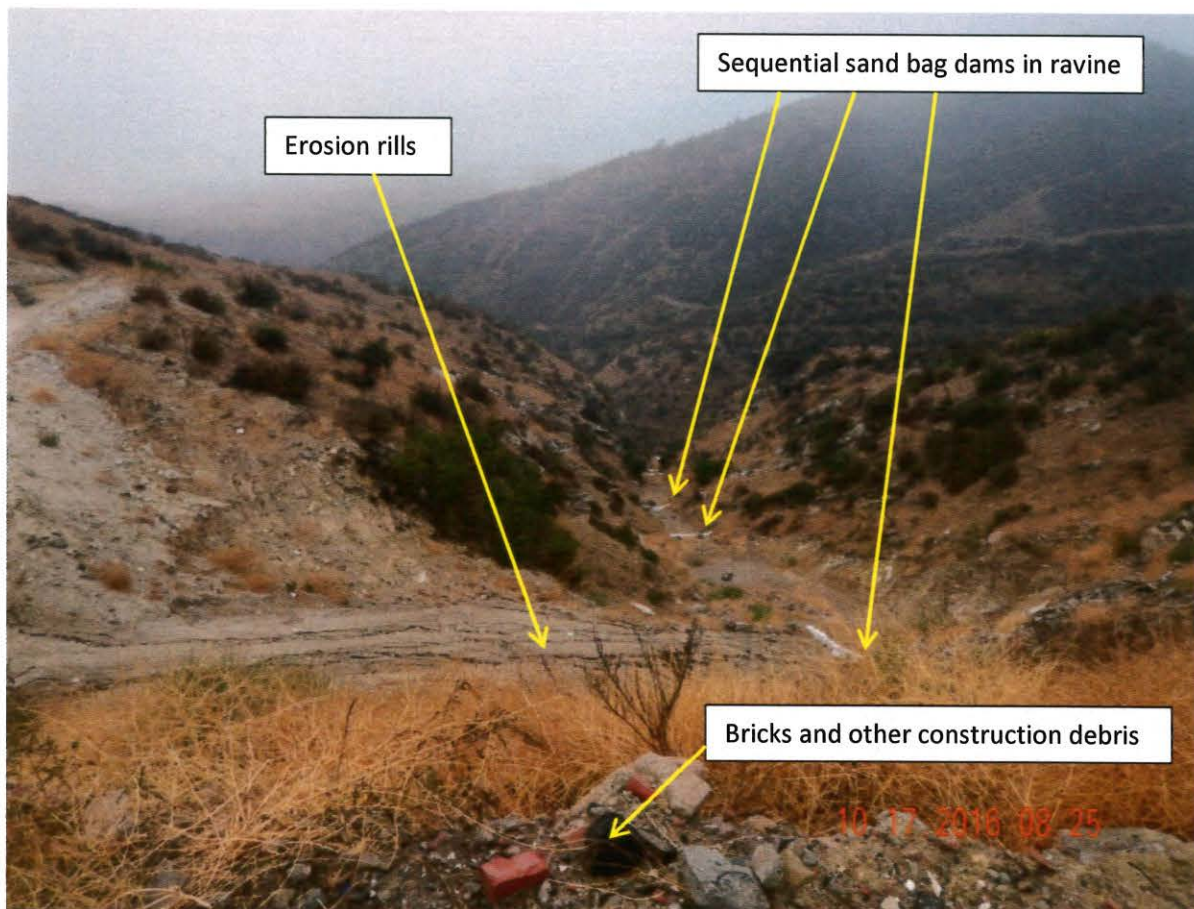
Photo 18. This photo shows sequentially placed sand bag dams on a steep ravine. The steep ravine leads to Ybarra Creek. This photo was taken on Parcel 2821-002-023 near latitude: 34 18.600 and longitude: -118 36.755.

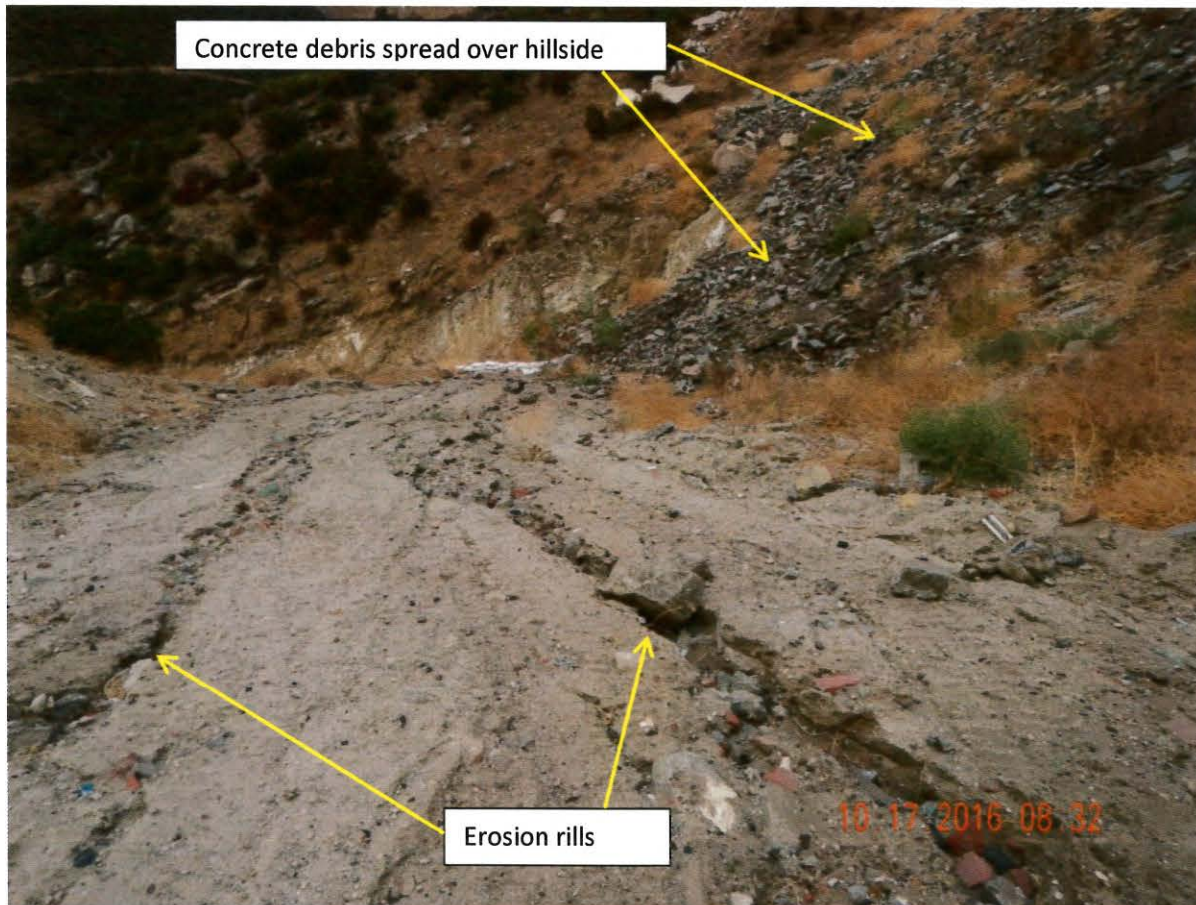
Photo 19. This photo shows erosion occurring on the road in Parcel 2821-002-023 above the sand bag dams. This photo was taken near latitude: 34 18.626 and longitude -118 36.767.

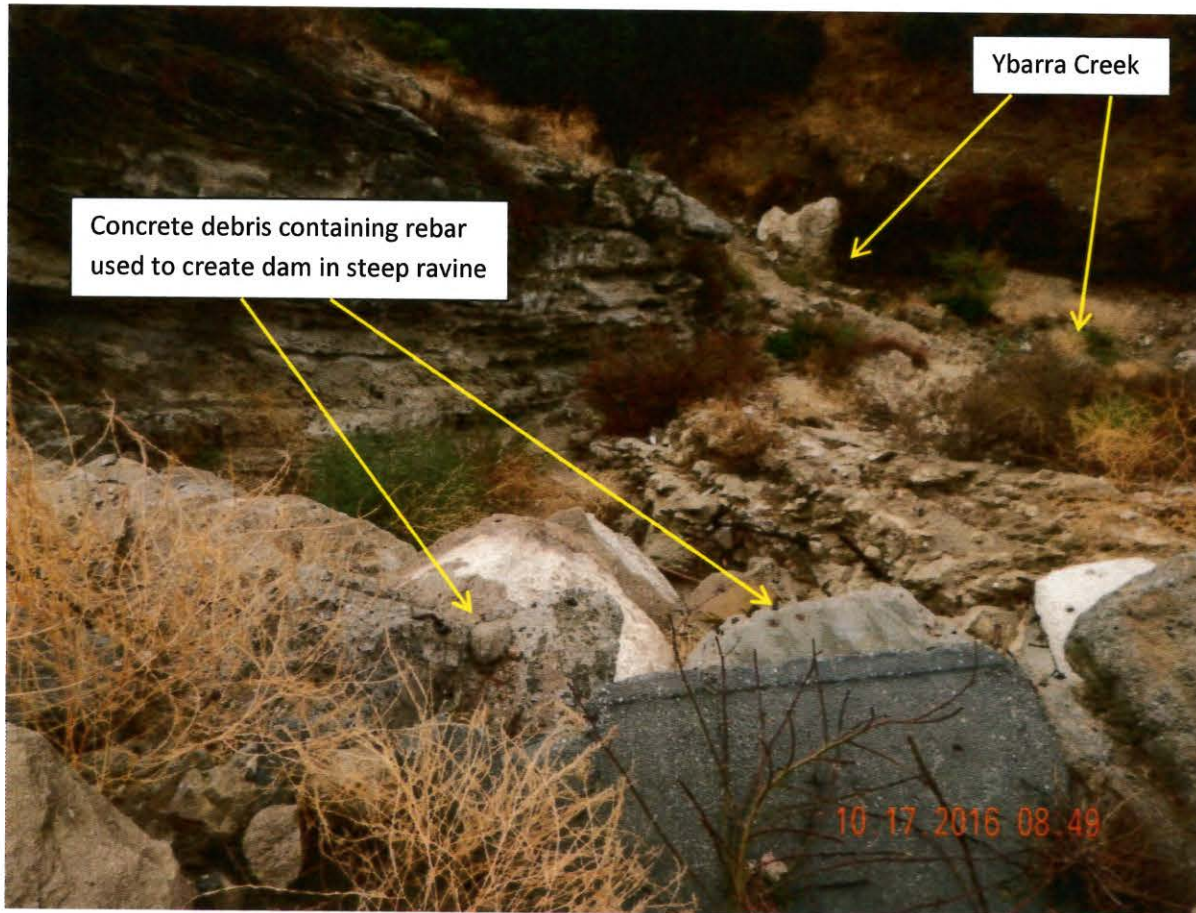
- **Concrete rubble dam** – The final dam on steep ravine above Ybarra Creek was constructed with broken concrete containing exposed and rusty rebar (Photo 20).

Photo 20. This photo shows a dam in a steep ravine. The dam was made of broken pieces of concrete that contained rebar. This photo was taken on parcel 2821-002-023 above Ybarra Creek near latitude: 34 18.547 and longitude: -118 36.769.

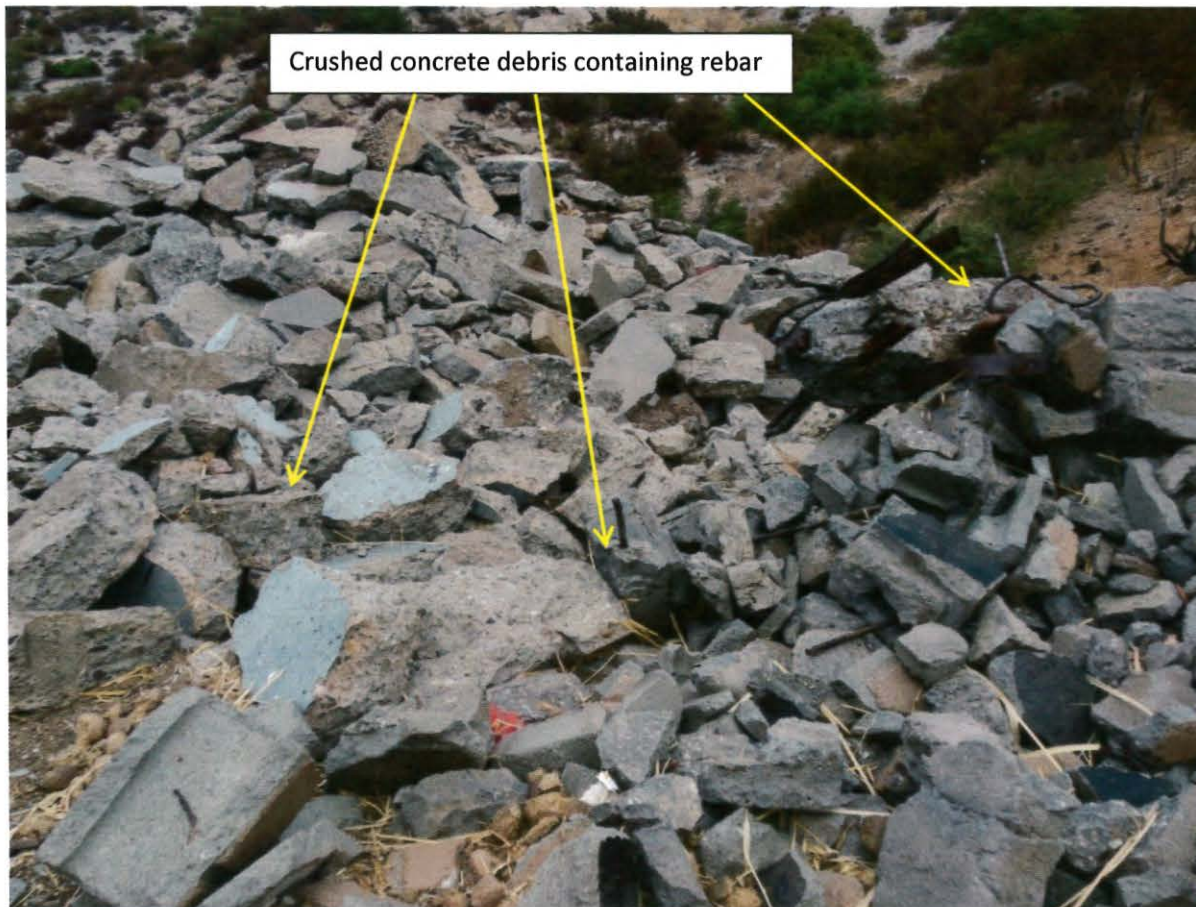
- **Crushed concrete stockpiles** – Crushed piles of concrete were found throughout the parcel. The crushed concrete contained exposed and rusty metal rebar (Photo 21).
- **Construction material stockpiling** – Construction materials that included brick, tile, stones, and wood were stockpiled in a large graded area (Photo 22).

Photo 21. This photo shows piles of crushed concrete. The crushed pieces of concrete have rebar in them. This photo was taken in Parcel 2821-009-030 near latitude: 34 18.338 and longitude: -118 36.687. While reviewing photos of the inspection it was found that the camera used by Team 1 had the incorrect date. The camera had the date of October 16, 2016, when it should have had the correct date of October 17, 2016.
