Los Angeles Regional Water Quality Control Board

NOTICE OF VIOLATION: FEDERAL WATER POLLUTION CONTROL ACT SECTIONS 301 AND 401, AND PORTER COLOGNE WATER QUALITY CONTROL ACT SECTIONS 13260, 13376, and 13385(a)(1) and (5) FOR PROPERTIES LOCATED IN SANTA SUSANA MOUNTAINS, PARCELS 2821009030, 2821009031, and 2821009023; LOS ANGELES COUNTY

October 17, 2016 Inspection Report

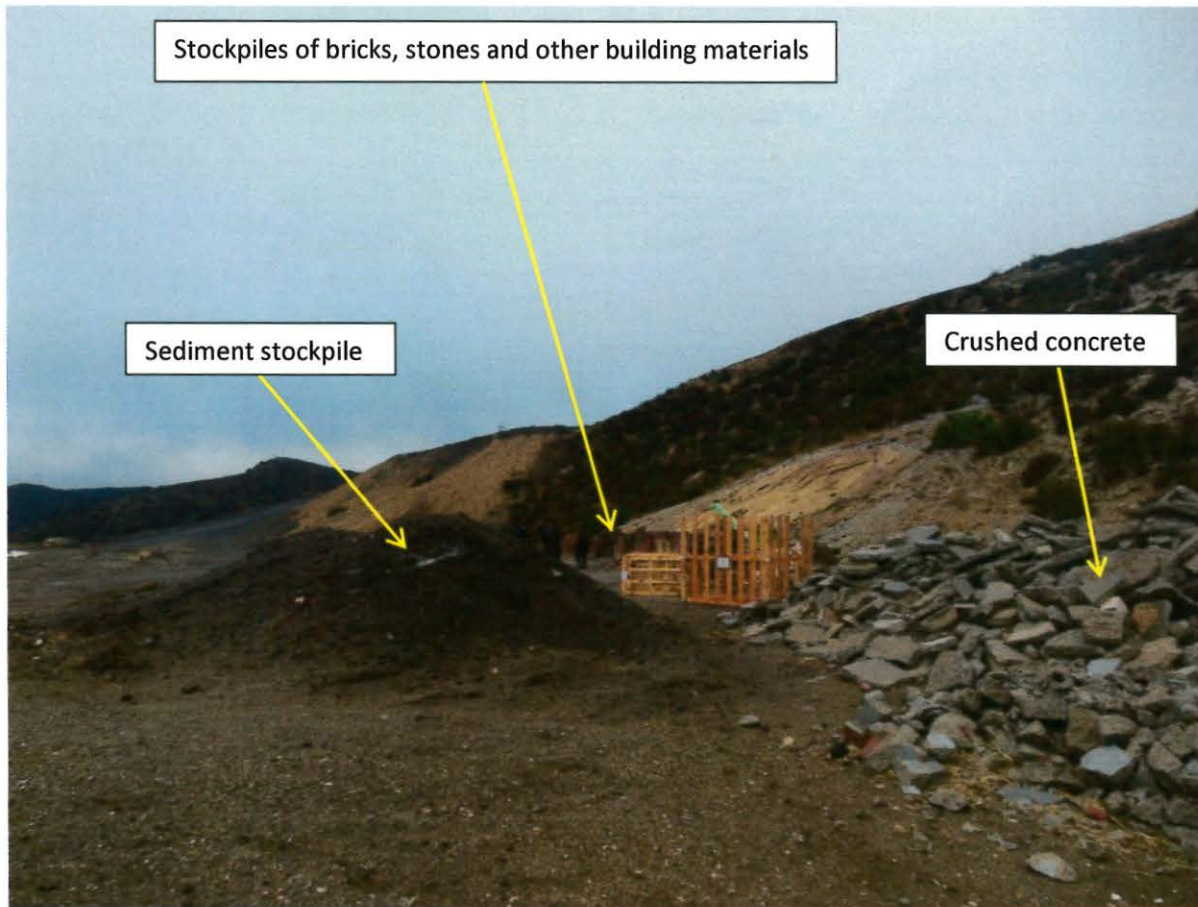
- **Sediment Stockpiling** – Stockpiles of sediment were found on the parcel at various locations. These stockpiles were not covered; BMPs were not implemented to prevent sediment from being released into Ybarra Creek. (Photo 22)

Photo 22. This photo shows stockpiles of sediment, crushed concrete debris, and construction materials. This area lacked erosion or sediment control BMPs. This photo was taken in Parcel 2821-009-030 near latitude: 34 18.338 and longitude: -118 36.687.

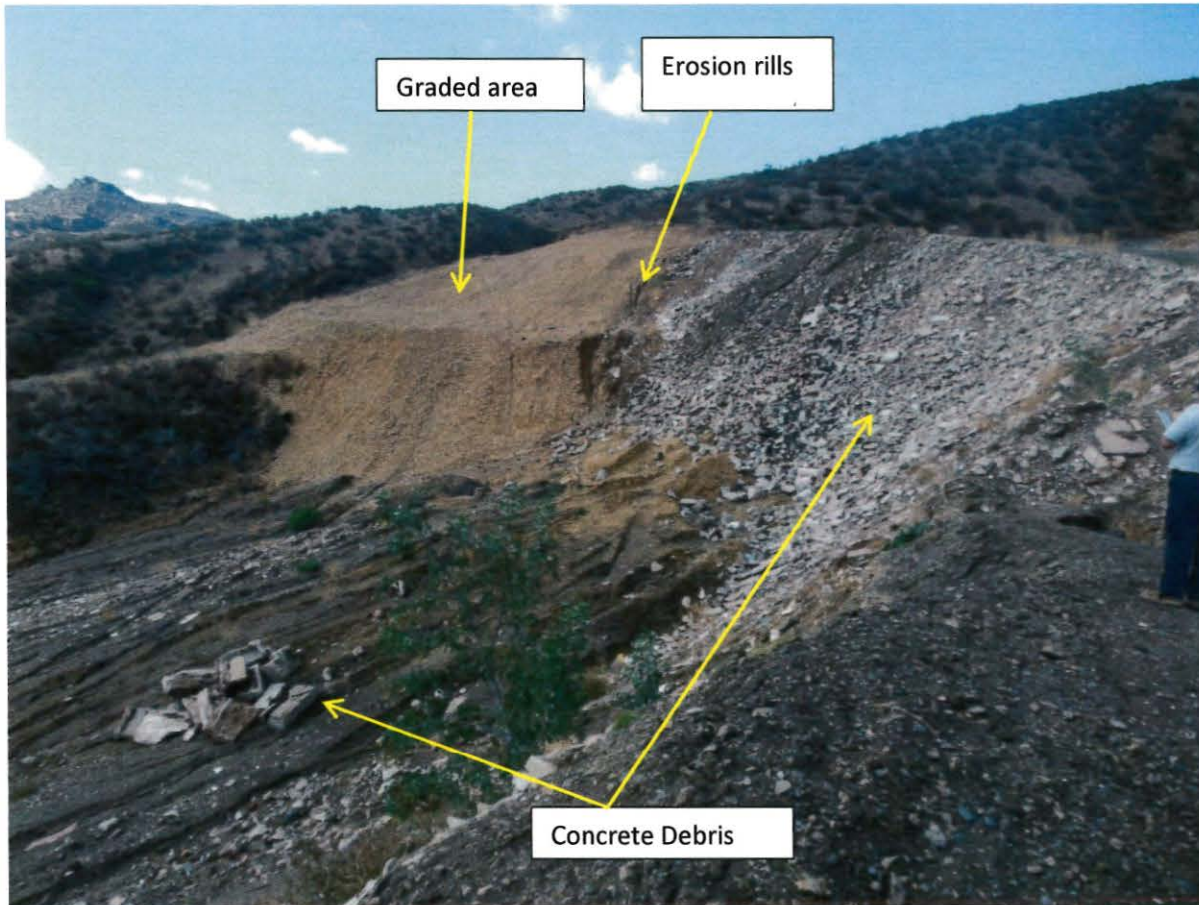
- **Ravine with concrete debris fill** – Crushed concrete debris partially filled a ravine within the southern section of the parcel. There were no BMPs present to prevent concrete debris and other fill material from being released into Ybarra Creek. (Photos 23 and 24) The ravine filled with concrete debris was not noted in the September 2015 inspection report.

Photo 23. This photo shows graded slopes and crushed concrete being used to fill a ravine. This photo was taken in Parcel 2821-009-030 near latitude: 34 18.260 and longitude: -118 36.831.

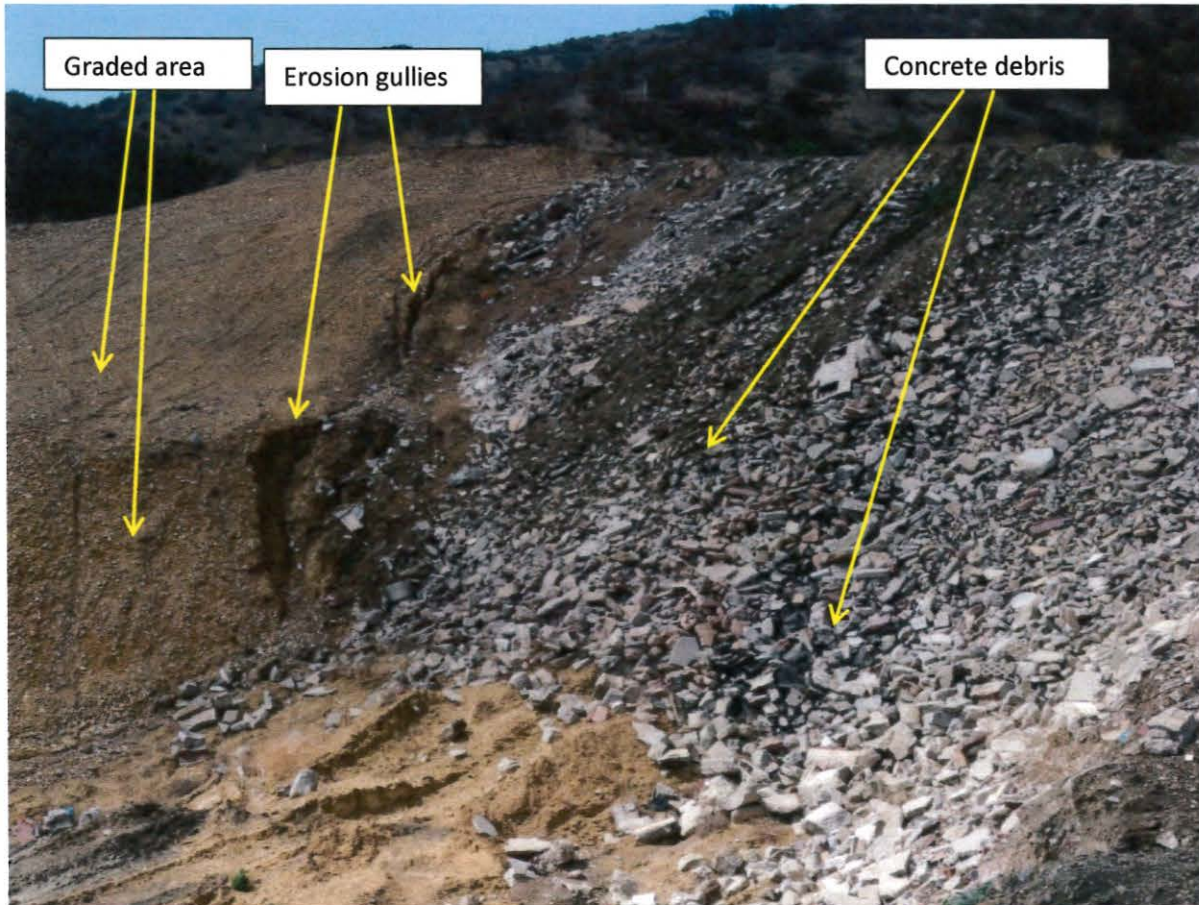
- **Erosion of large graded areas** – Areas within the parcel have been graded. Erosion gullies were observed on these graded areas. There were no BMPs in place to prevent sediment and other materials from being released into Ybarra Creek. (Photos 23 and 25) The September 17 and 18, 2015, inspection report describes these areas as having been recently graded and that no evidence of erosion was present.

Photo 24. This photo shows graded slopes and crushed concrete being used to fill a ravine. Erosion gullies are visible on the graded slopes. This photo was taken in Parcel 2821-009-030 near latitude: 34 18.260 and longitude: -118 36.831.

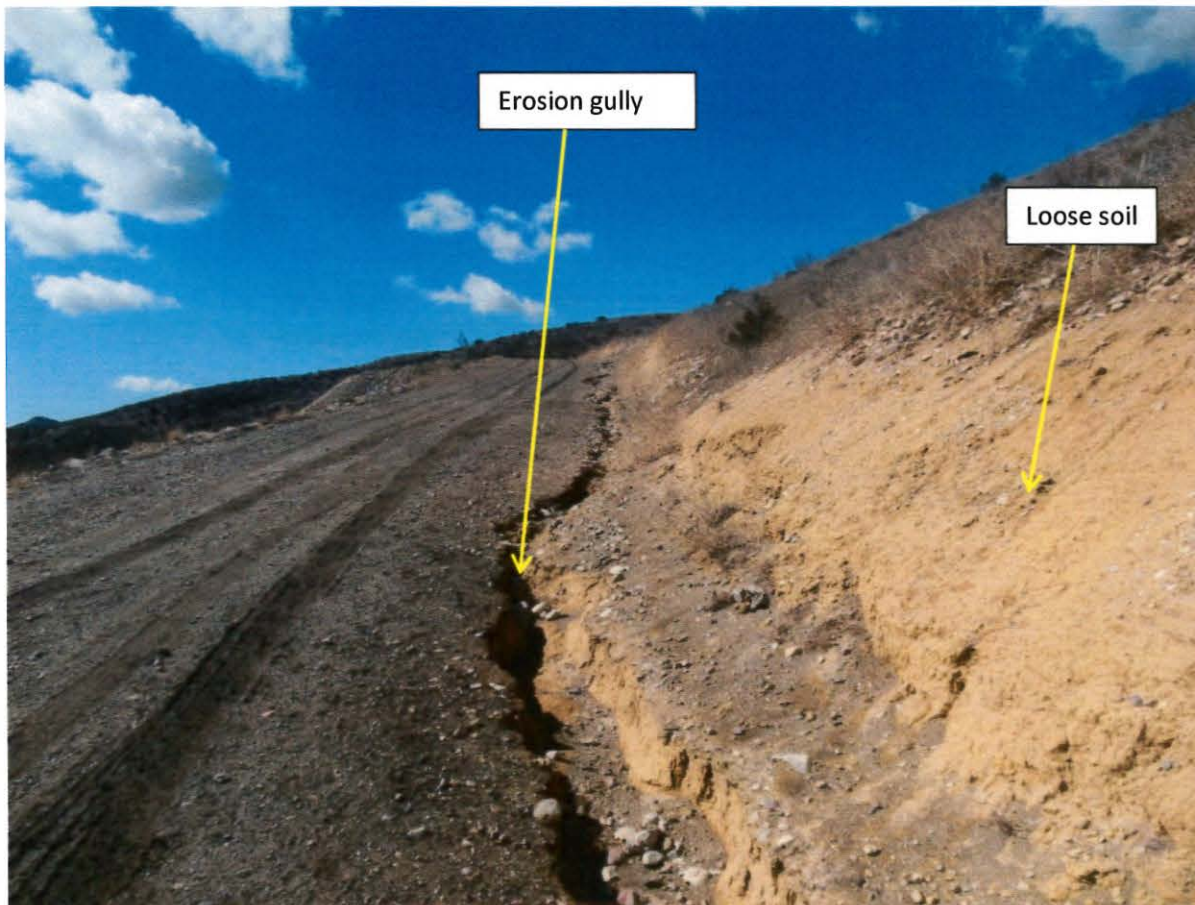
- **Dirt roads** – Graded dirt roads are found within the parcel. These roads split off of each other and met back up which formed a road network. Erosion gullies were found on these dirt roads. There were no BMPs in place to prevent sediment from being released into Ybarra Creek (Photo 25).

Photo 25. This photo shows a dirt road with an erosion gully running along its edge. This photo was taken in Parcel 2821-009-030 near latitude: 34 18.260 and longitude: -118 36.831. This area lacked erosion control BMPs.

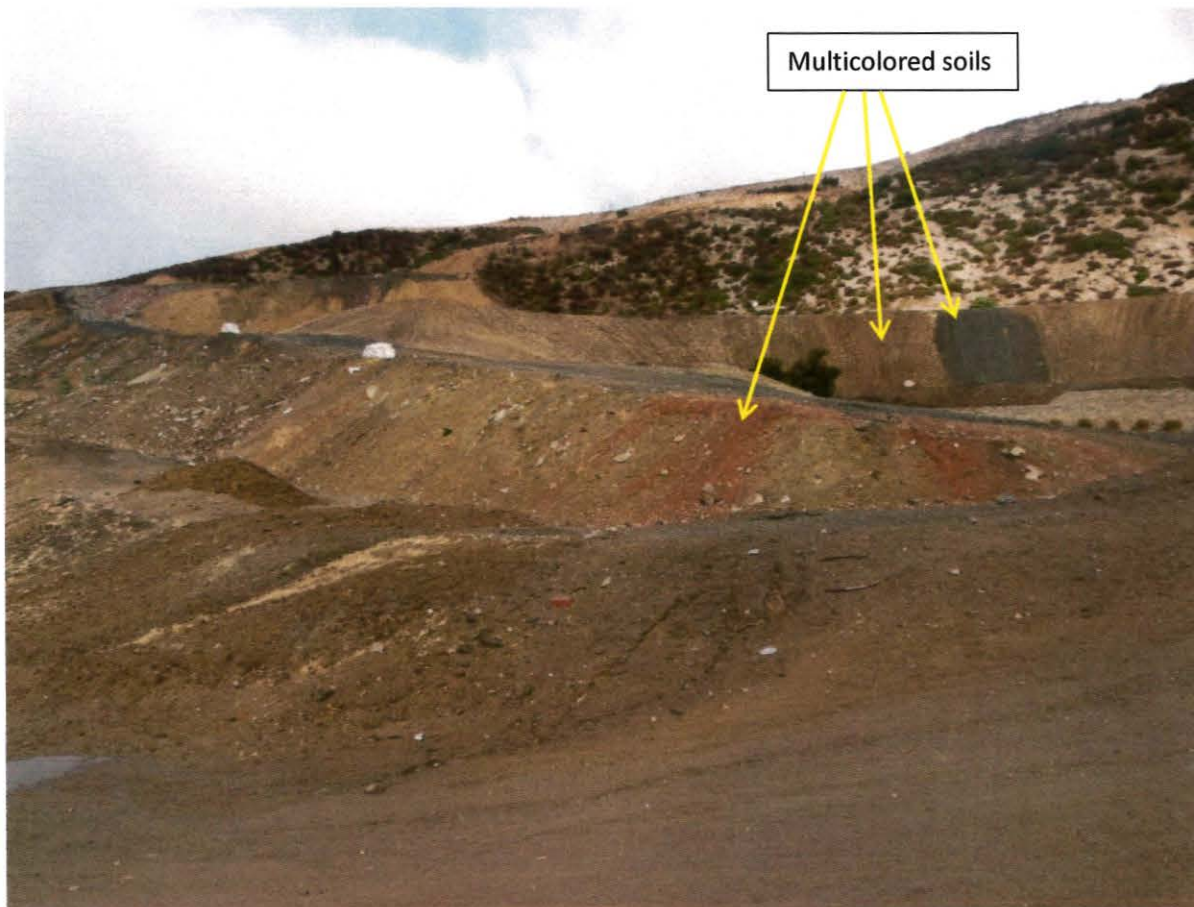
- **Slopes constructed with fill** – Slopes in this parcel contained multicolored imported fill material. There were no BMPs in place to prevent the release of sediment into Ybarra Creek (Photo 26).
- **Damaged sand bag berms at the top of a graded slope** – Sand bag berms were placed at the top of a slope in the general vicinity of latitude 34 18.264 and longitude -118 36.644 next to an area that had been graded flat. BMPs consisting of the sand bags were ineffective as the bags were damaged and were releasing sediment. Some of the sand bags had rolled down the slope (Photo 27).

Photo 26. This photo shows terraced multicolored soil in Parcel 2821-009-031. The multicolored soils indicate that non-native soils and potentially crushed construction debris may have deposited in the area. This area lacked erosion and sediment control BMPs. This photo was taken near latitude: 34 18.264 and longitude -118 36.644.

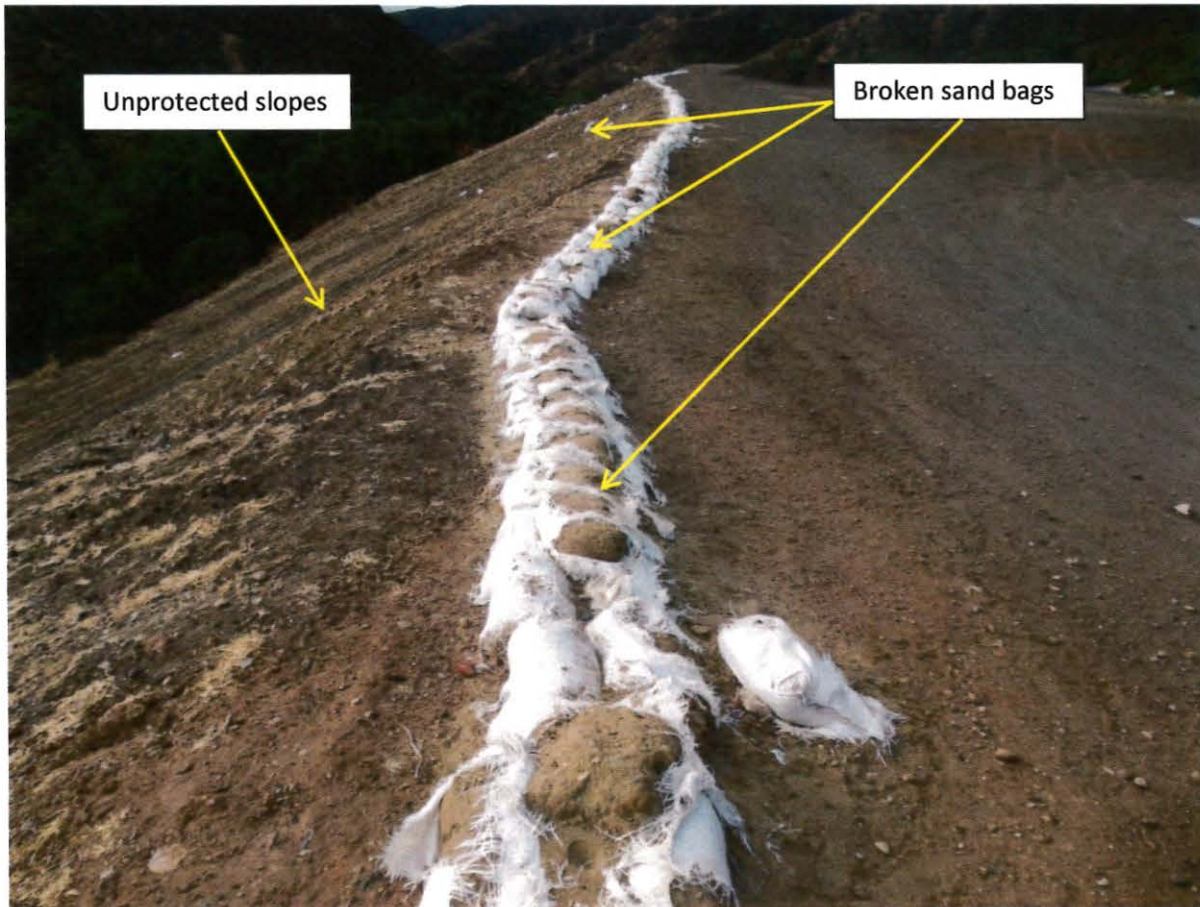
Photo 27. This photo shows a damaged sand bag berm placed at top of slope at the edge of an area that was graded flat. This photo was taken in Parcel 2821-009-031 near latitude: 34 18.264 and longitude: -118 36.644.

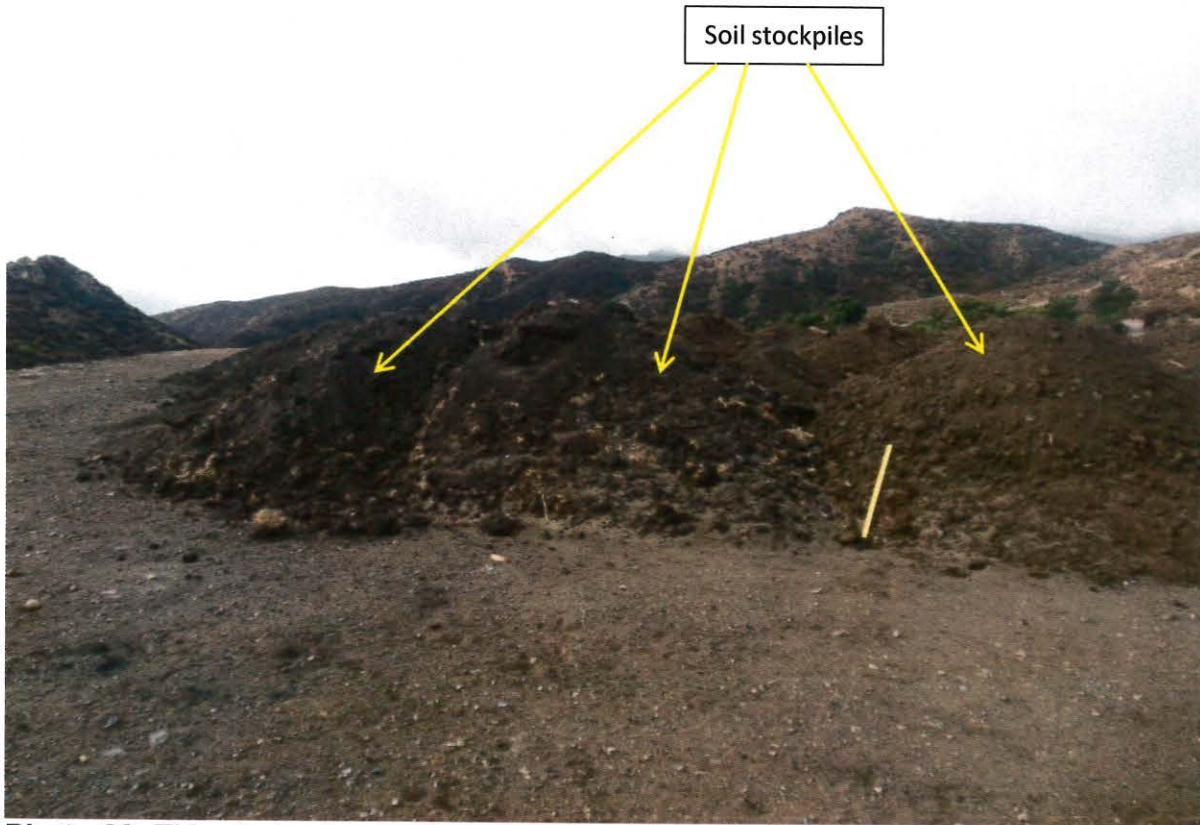
- **Sediment stockpiles** – Sediment stockpiles were found on the parcel at various locations. BMPs were not implemented to prevent sediment from being released into Ybarra Creek (Photo 28).

Photo 28. This photo shows stockpiles of soil found in Parcel 2821-009-031. This area lacked erosion or sediment control BMPs. This photo was taken near latitude: 34 18.264 and longitude -118 36.644.

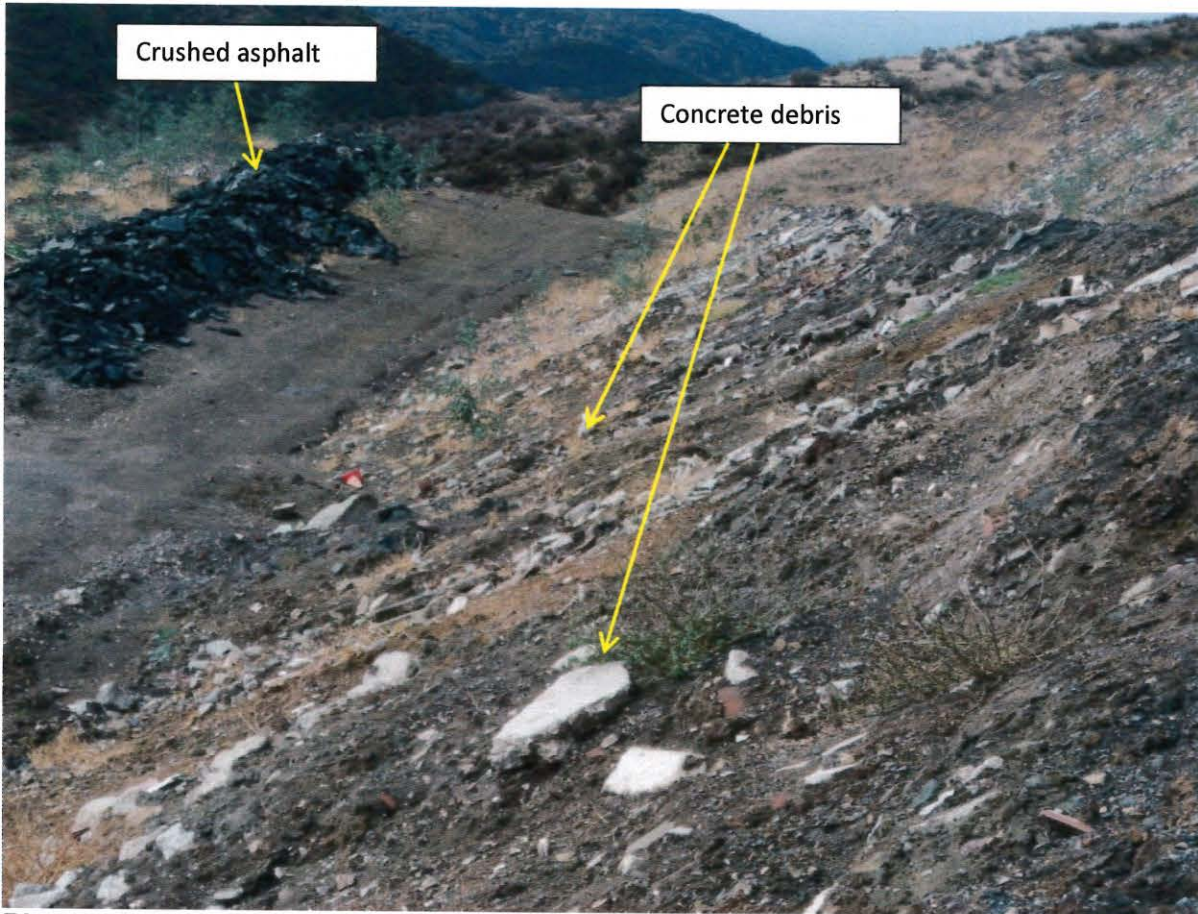
- **Buried and stockpiled construction debris** – Construction debris that had been deposited in graded terraces is visible at different areas within the parcel. Construction debris consisted of crushed asphalt, concrete and bricks. BMPs were not implemented to prevent these materials from eroding and discharging into Ybarra Creek (Photos 29 and 30). The buried and stockpiled construction debris was noted during the September 2015 inspection.

Photo 29. This photo shows crushed piles of asphalt and concrete in Parcel 2821-009-031 near latitude: 34 18.271 and longitude: -118 36.713.

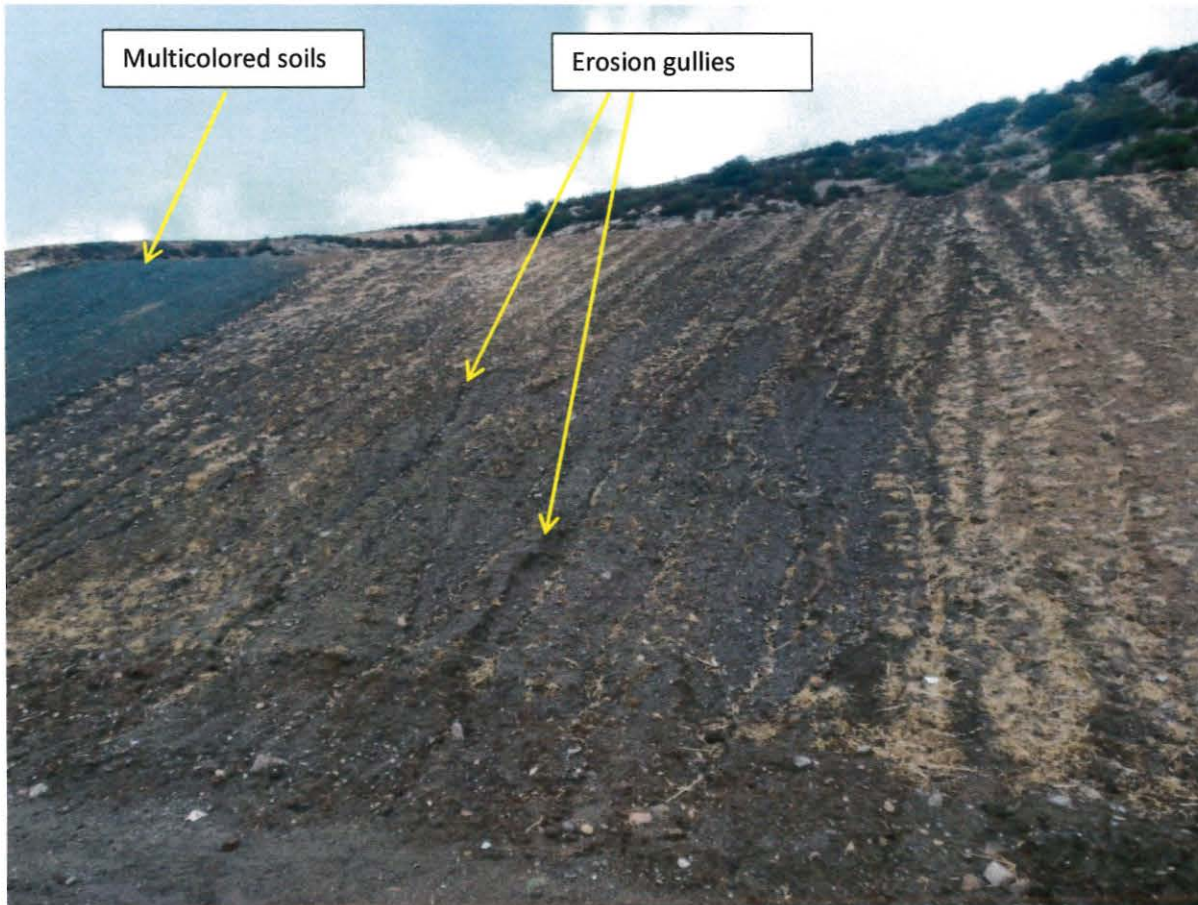
- **Evidence of erosion** – Erosion rills were found on graded slopes located between two areas that had been graded flat in the northeastern part of the parcel (Photo 30). The deposited sediment will slowly erode and eventually discharged into Ybarra Creek. These erosion rills on the graded slopes have developed since the September 2015 inspection.

Photo 30. This photo shows erosion rills on a graded slope located between two terraced areas. There are multi colored soils on the slopes. This photo was taken in Parcel 2821-009-031 near latitude: 34 18.308 and longitude: -118 36.671.

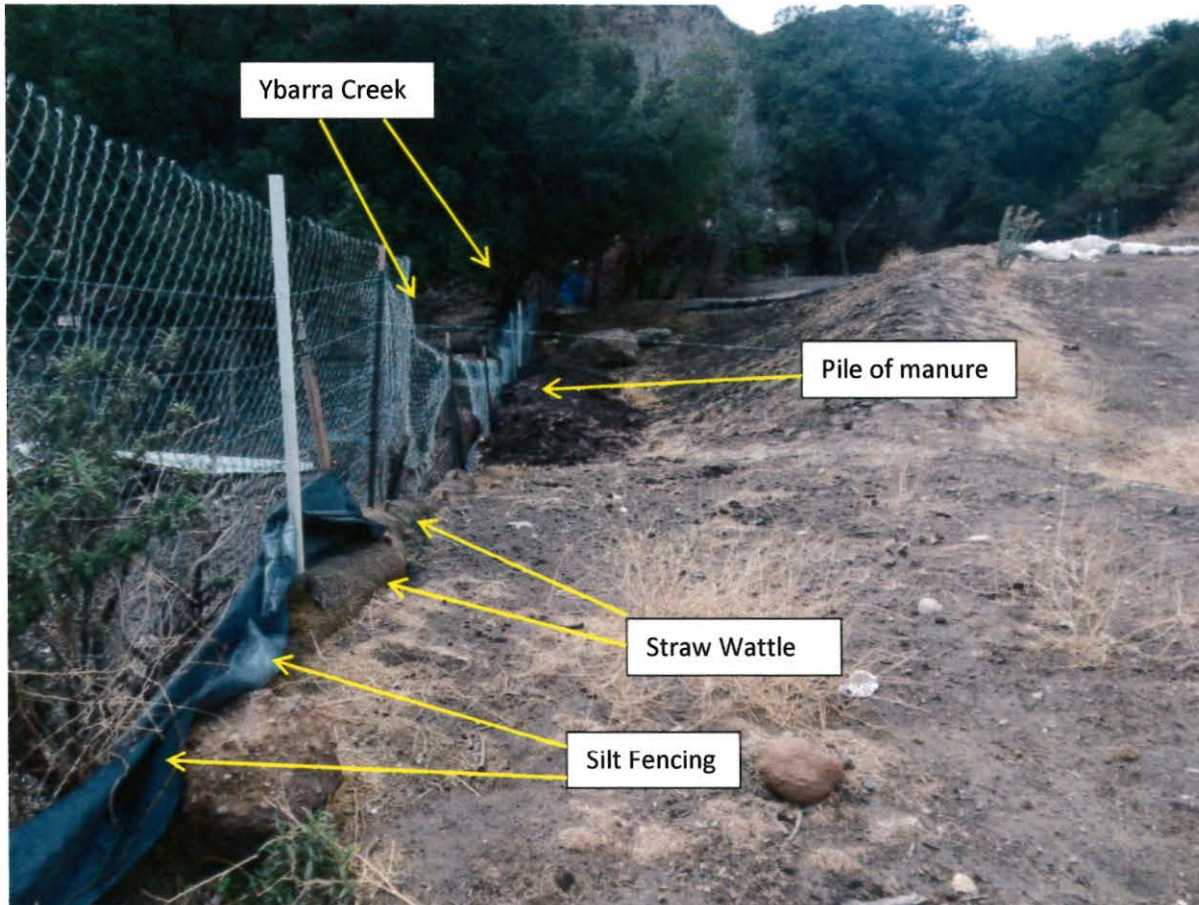
- **Silt fence and straw wattle BMPs in poor condition** – Sediment control BMPs including a silt fence and straw wattle were placed along the fence line adjacent to Ybarra Creek. However, the BMPs were in poor condition. The straw wattle was ripped and releasing straw (Photo 31).

- **Manure stockpile** – A pile of manure was placed against the fence line that was adjacent to Ybarra Creek. There were no BMPs in place to prevent the stockpile of manure from being discharged into the creek (Photo 31). The pile of manure was sixty (60) feet from Ybarra Creek. The manure stockpile was not noted in during the September 2015, inspection.

Photo 31. This photo shows sediment control BMPs placed along the fence line including a straw wattle and parts of silt fencing. A pile of manure is also along the edge of the fence line. This area lacked erosion control BMPs. This photo was taken in Parcel 2821-009-031 near latitude: 34 18.248 and longitude: -118 36.630. Ybarra Creek is on the other side of the chain-linked fence.

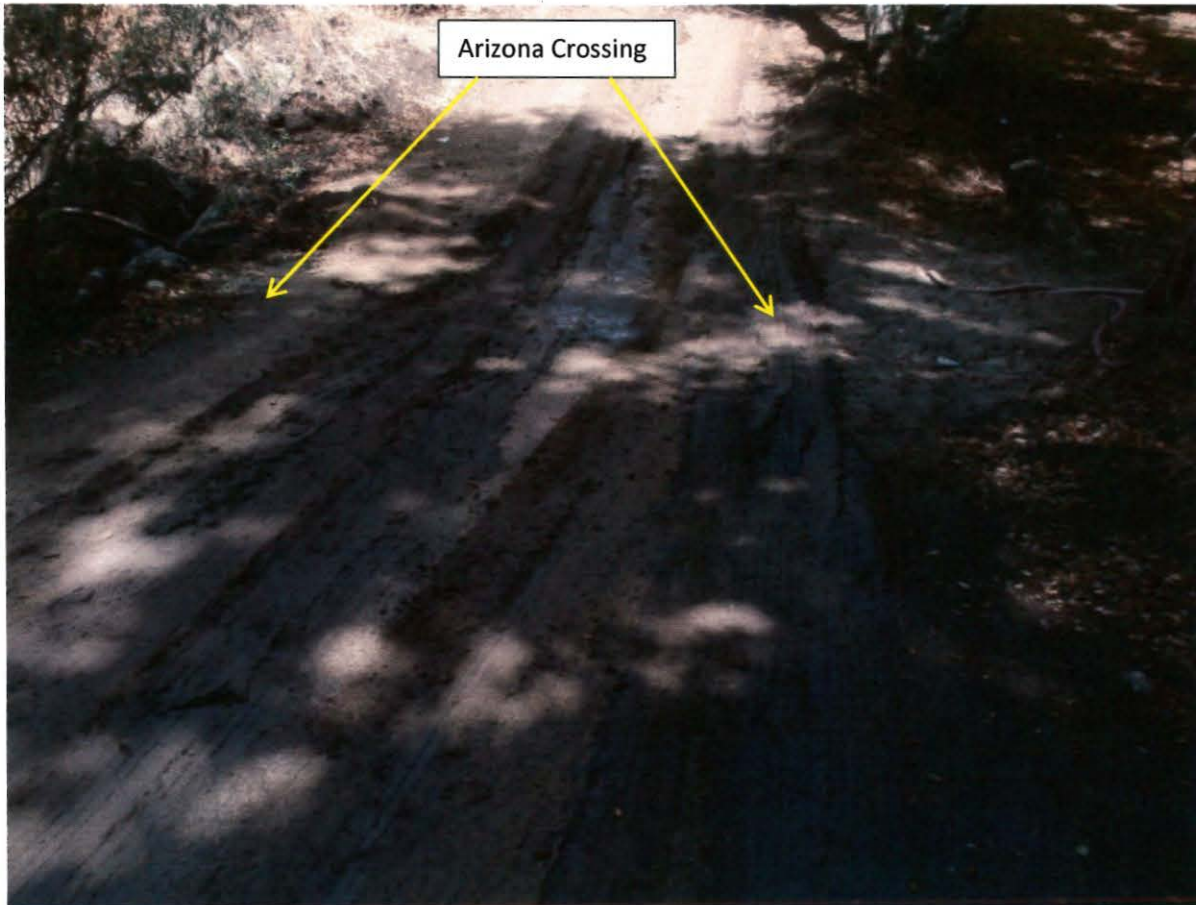
- **Arizona Crossing** – In this parcel, Regional Board staff found an Arizona crossing in Ybarra Creek. The Arizona crossing consisted of rip rap made of crushed concrete debris. The Arizona crossing is an unpermitted discharge of sediment and concrete material to Ybarra Creek (Photo 32 and 33).

Photo 32. This photo shows an Arizona crossing in Ybarra Creek in Parcel 2821-009-023. This photo was taken near latitude: 34 18.158 and longitude:-118 36.665.

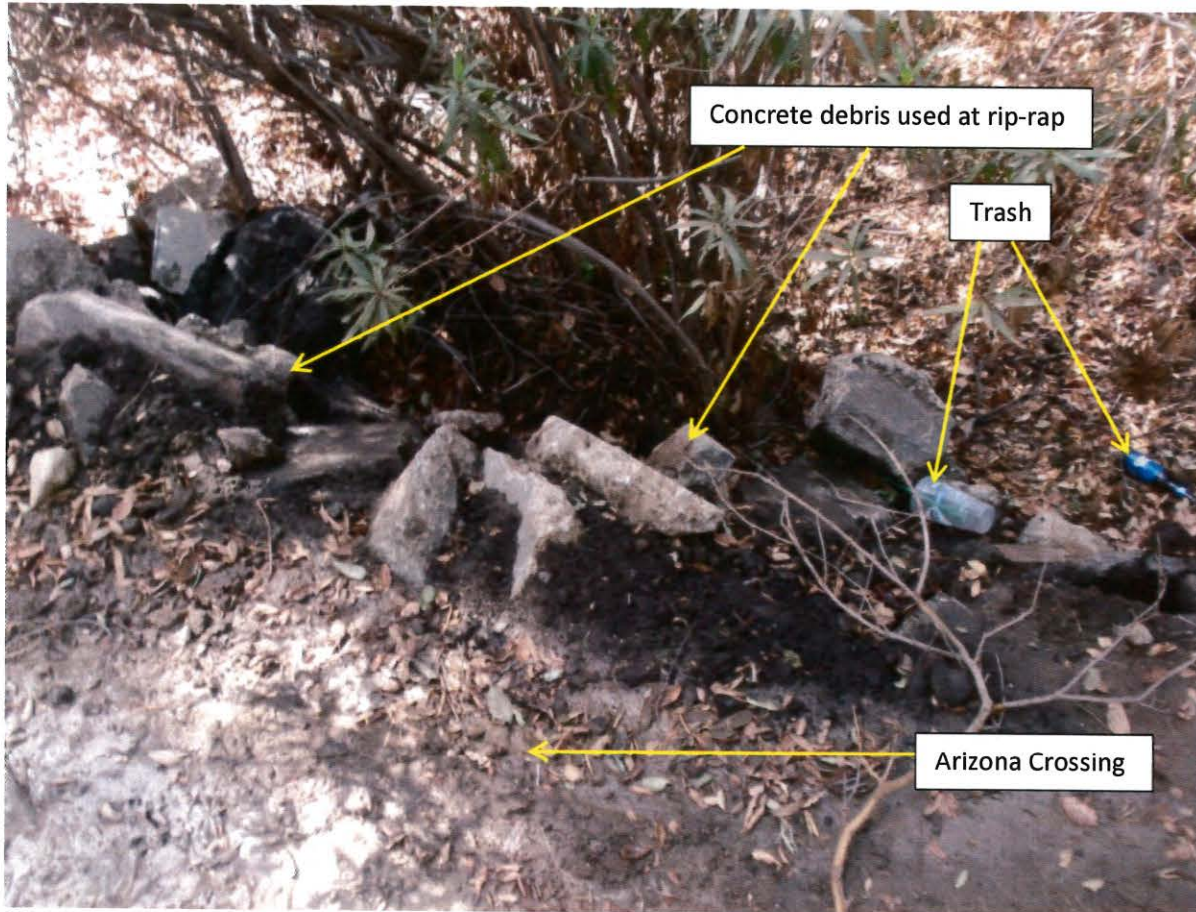
Photo 33. This photo shows crushed concrete used to create the Arizona crossing in Parcel 2821-009-023 near latitude: 34 18.158 and longitude:-118 36.665.

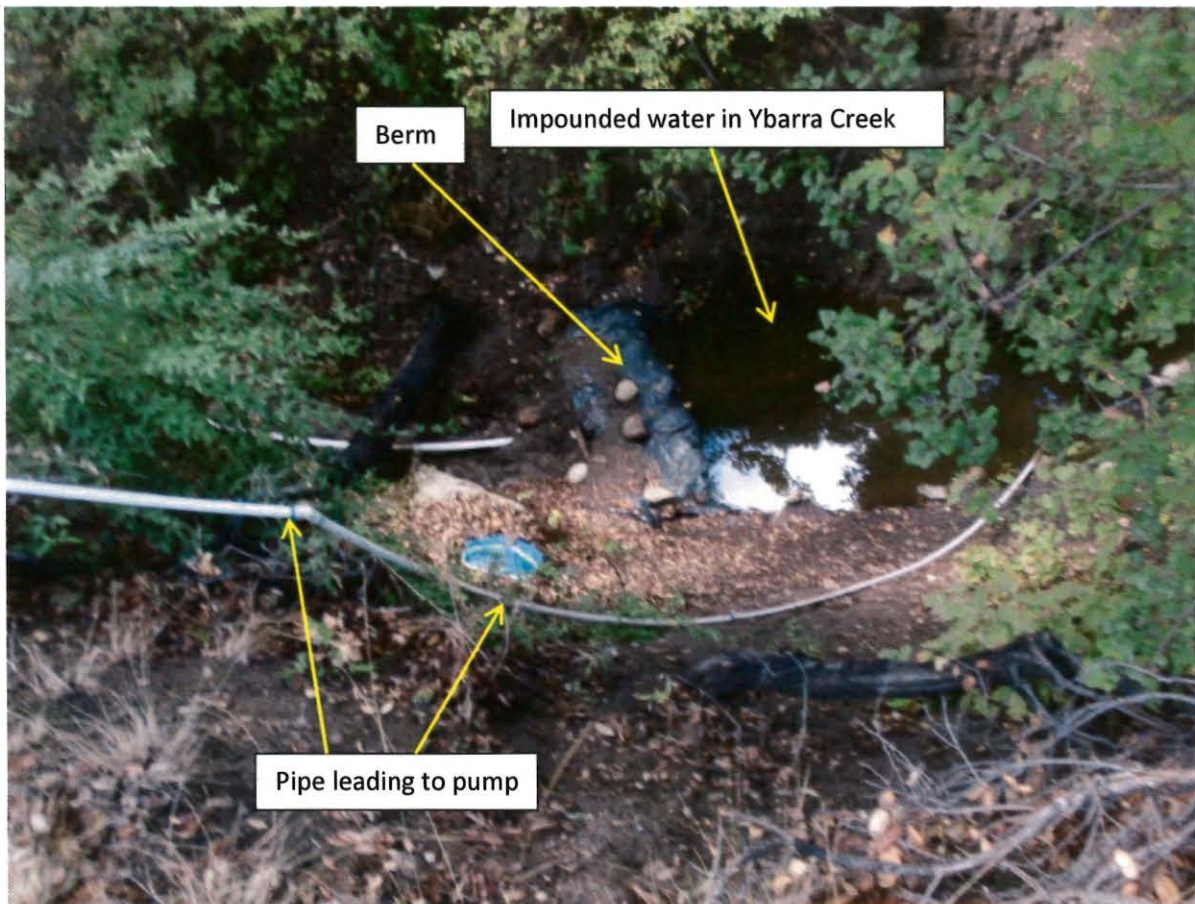
- **Berms in Ybarra Creek** – Two berms were found in the creek that caused in-stream diversion and impoundment of water (Photo 34). The berms consisted of sediment and plastic sheeting. Pipes were found coming from these pooled areas, and one set of these pipes lead to a pump and spigot (Photo 35). Any water removed from the parcel and not used for riparian uses is likely an unauthorized water diversion. Therefore, on December 16, 2016, Regional Board staff contacted Jeffrey Yeazell from the State Water Resources Control Board's Department of Water Rights to determine if a water rights permit had been filed for parcel 2821-009-023. Mr. Yeazell stated that according to their GIS database, there was no water rights permit for parcel 2821-009-023.

Photo 34. This photo shows an in-stream diversion and water impoundment in Ybarra Creek that was created with plastic sheeting and sediment. Pipes leading to a pump were observed coming from the pooled water behind the sediment berm. The pump was not operational during the inspection. This photo was taken in parcel 2821-009-023 near latitude: 34 18.158 and longitude:-118 36.665.

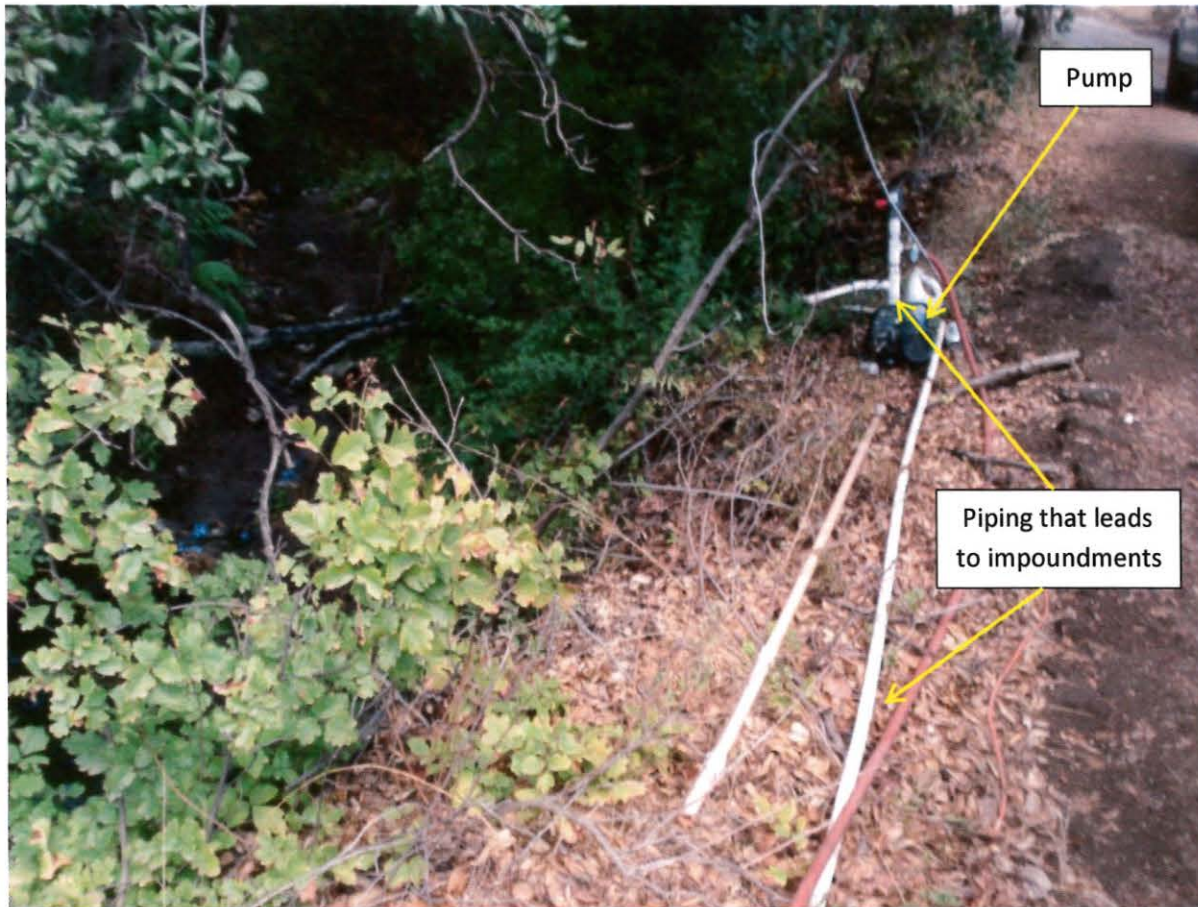
Photo 35. This photo shows the pipes in Photo 34 were connected to a pump. The pump was not in operation at the time of the inspection. This photo was taken in Parcel 2821-009-023 near latitude: 34 18.158 and longitude:-118 36.665.

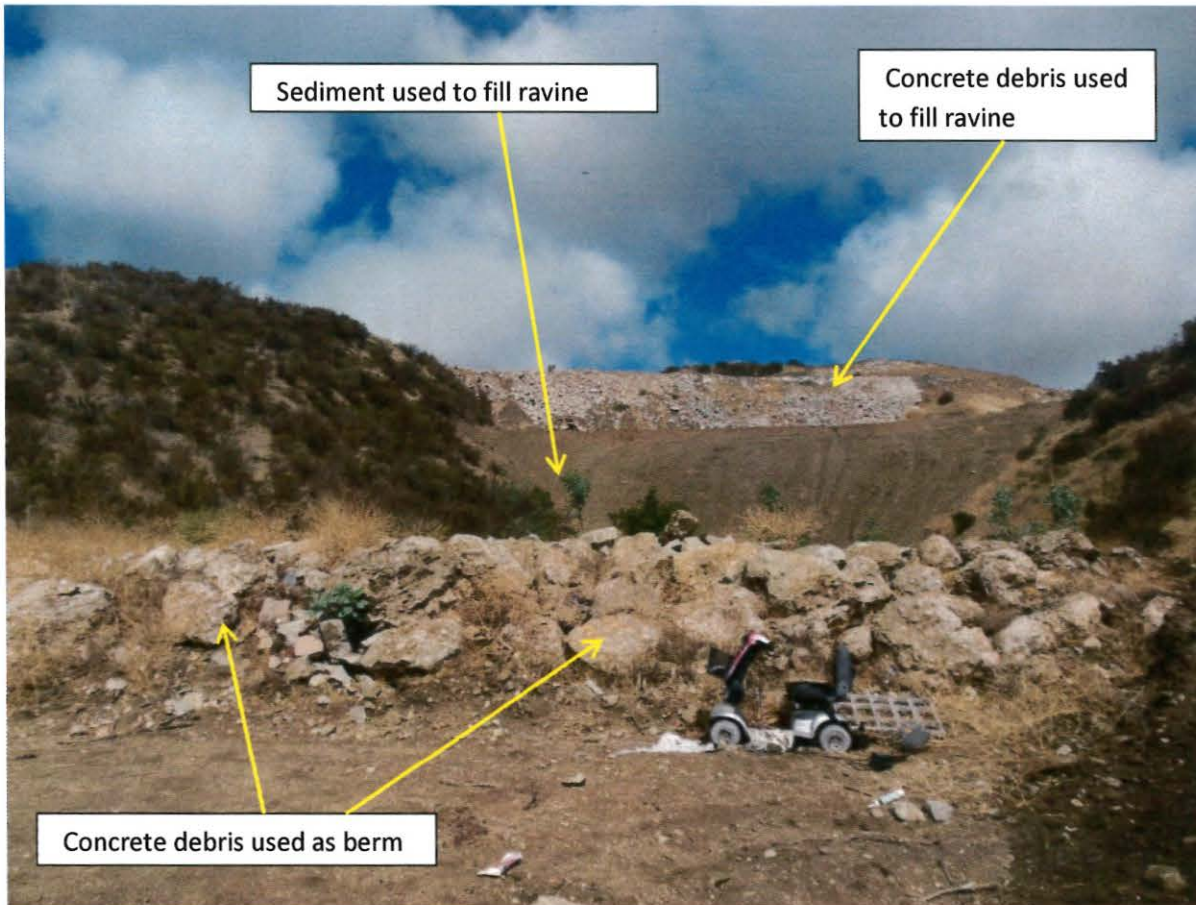
- **Sediment and construction debris in ravine** – Large amount of sediment and broken concrete were deposited in a ravine. The deposited debris appears to have been graded and terraced. Construction debris was also deposited throughout the parcel. This deposited construction debris threatens to discharge into Ybarra Creek (Photo 36).

Photo 36. This photo shows a ravine filled with sediment and crushed concrete debris. This area lacked erosion control BMPs. This photo was taken in Parcel 2821-009-023 near latitude: 34 18.184 and longitude: -118 36.812.

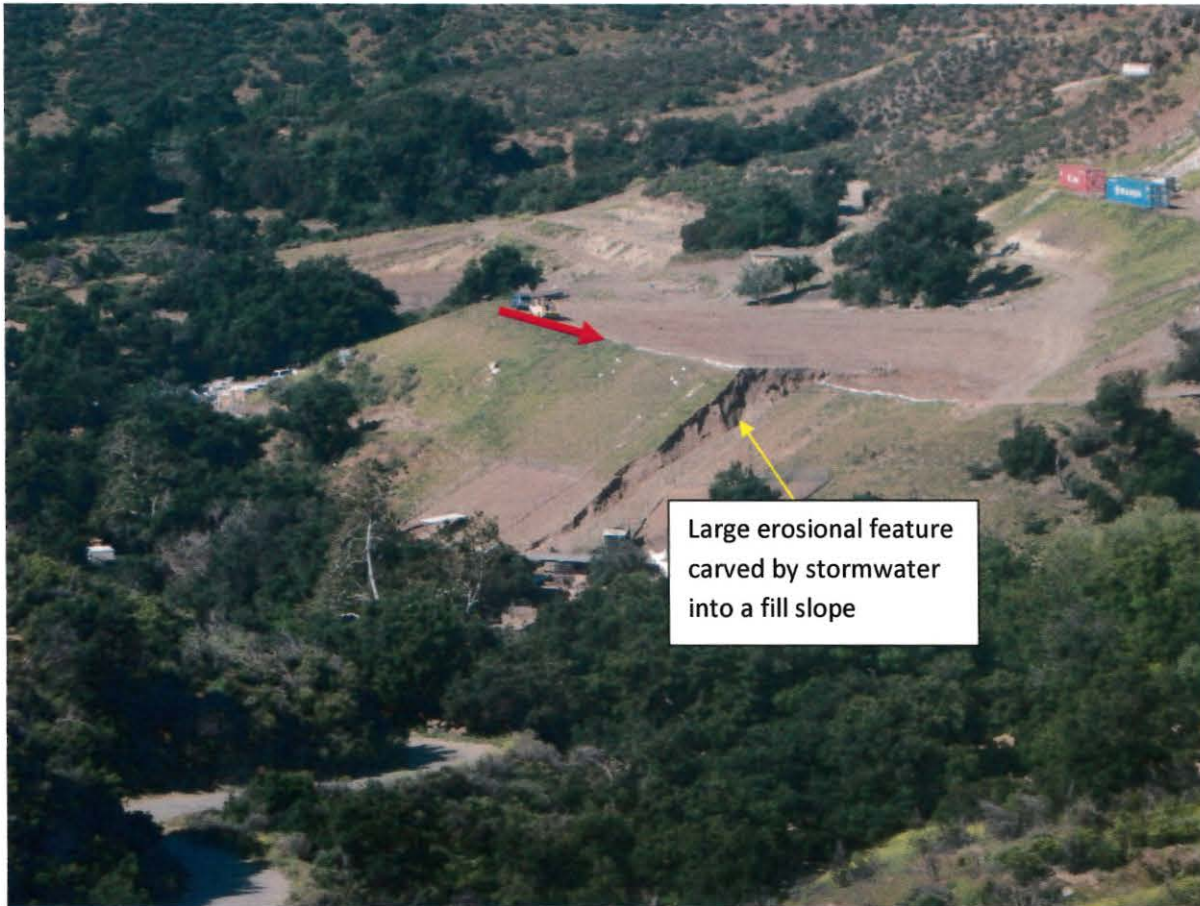
Photo 3. View looking southwest from Photo Location 1. Showing canyon carved into slope in parcels 2821-009-030 and 2821-009-031, which are owned by Mr. Wayne Fishback and Cepheid V, LLC respectively. The base elevation of the large erosional scour is in the immediate vicinity of the Ybarra Creek bed. It can be inferred from this photo that all the stormwater scoured fill materials were transported into Ybarra Creek. The red arrow indicates the remnant sandbag wall, presumably the wall that Mr. Fishback alleges was sabotaged. The photo was taken at Longitude -118 36 21.75 and Latitude 34 18 22.79 on April 12, 2017.

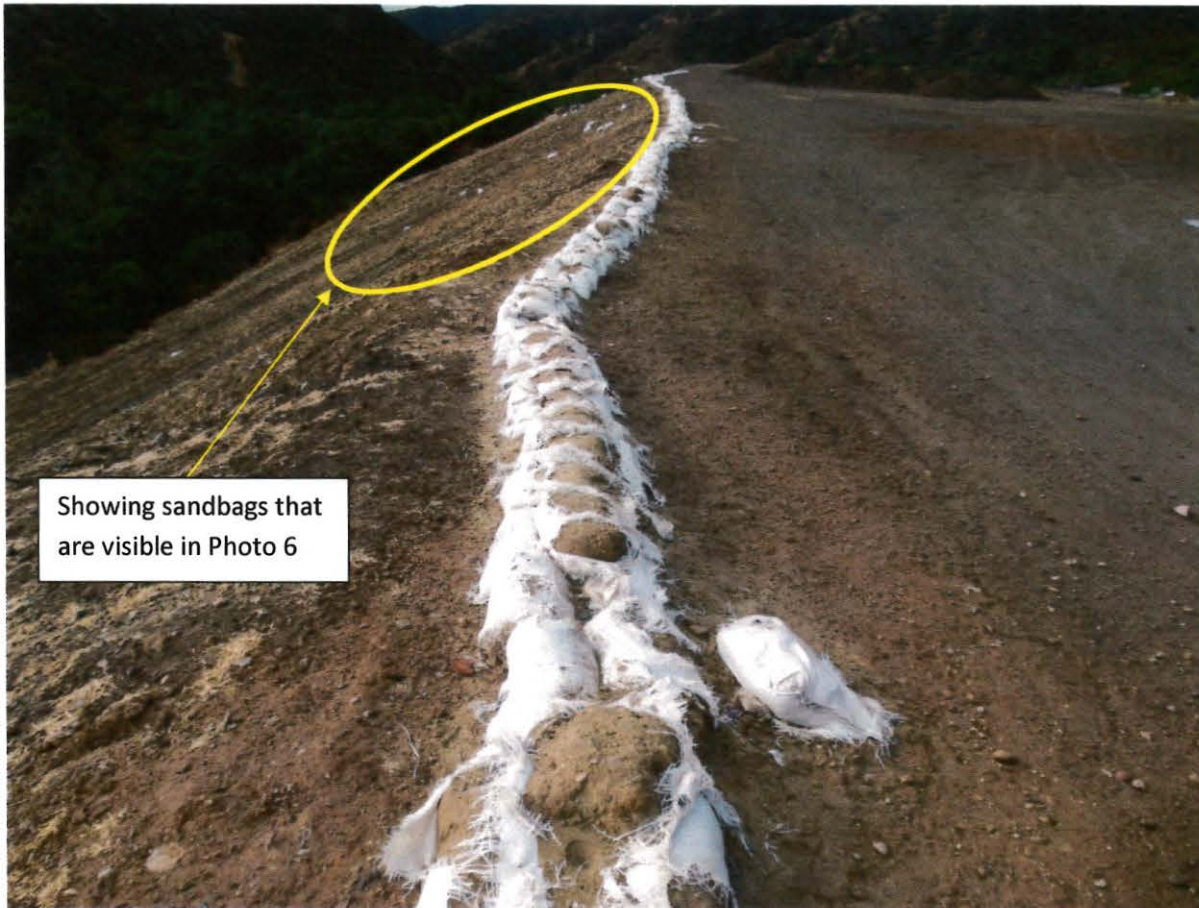
Photo 6. Close up of the sandbag wall along the slope break of the fill slope in Photos 3 and 4 during the October 17, 2016 inspection. The sandbag wall is above the large erosional scour that later developed during the February 2017 rainstorms. The photo shows that number sandbags from the sandbag wall have already fallen down the fill slope. The photo also shows that the sandbags, as of October 17, 2016, were deteriorated and releasing sediment so that they could not function as an effective best management practice (BMP) for subsequent winter storms.

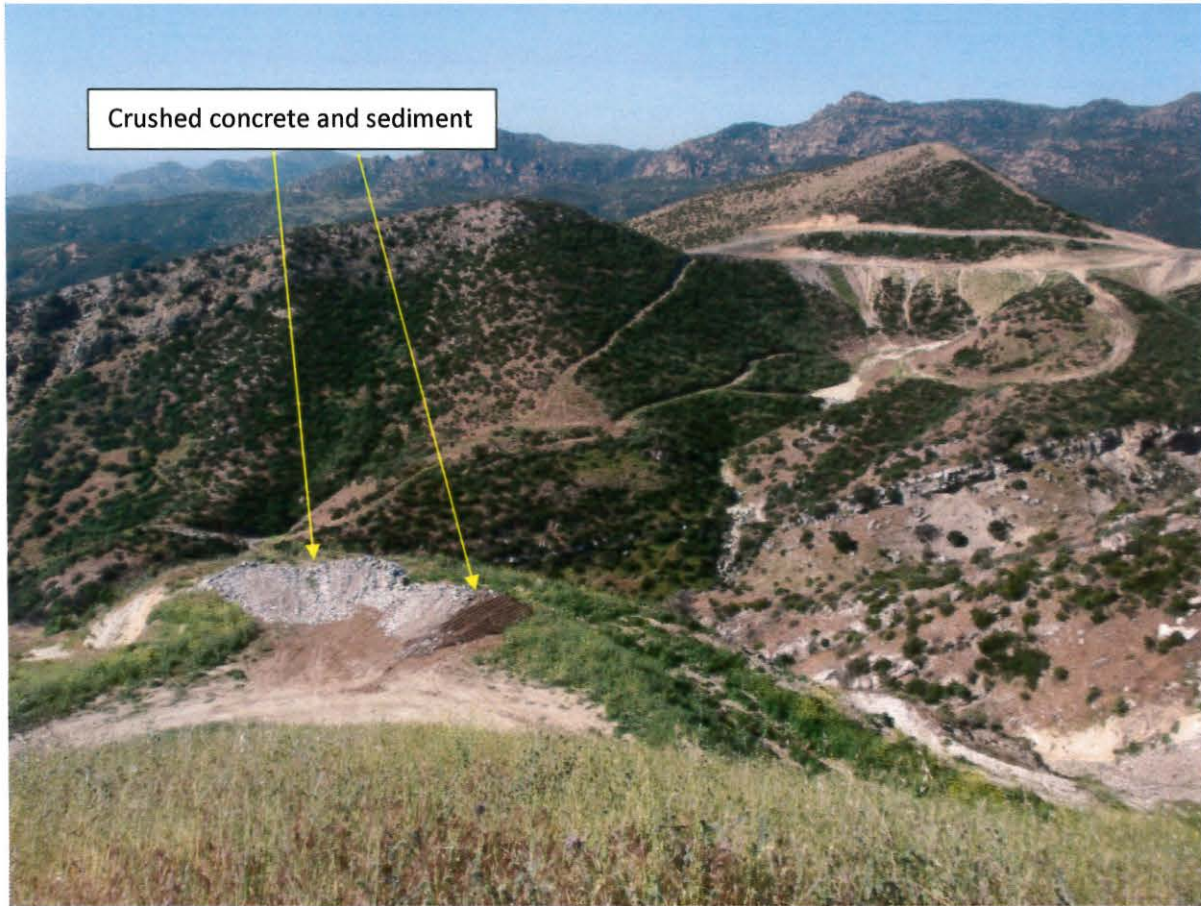
Photo 8. View looking south from Photo Location 2. Showing parcel 2821-002-023 owned by Mr. Wayne Fishback and what appears to be crushed concrete and sediment near an access road in the parcel. This photo was taken from parcel 2821-002-905 owned by MRCA at Longitude -118 36 41.788 and Latitude 34 18 39.224 on April 12, 2017.
