# MCR Monitoring: Watercourse Crossings

# Hillslope Monitoring Program 1996-2001

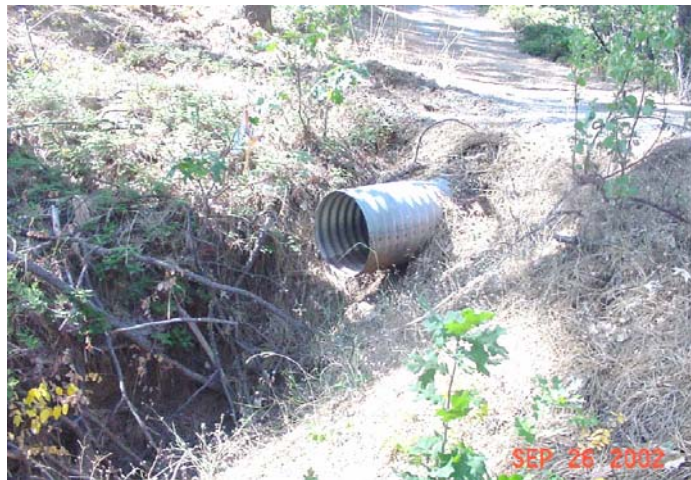
Figure 31. Example of an existing culvert with scour at the outlet for a central Sierra Nevada THP included in the MCR sample.

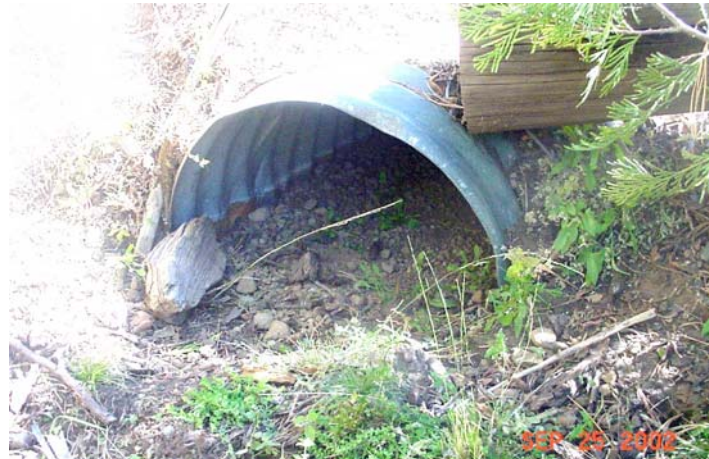
Figure 32. Example of an existing culvert that is partially plugged with sediment on a central Sierra Nevada THP included in the MCR sample.

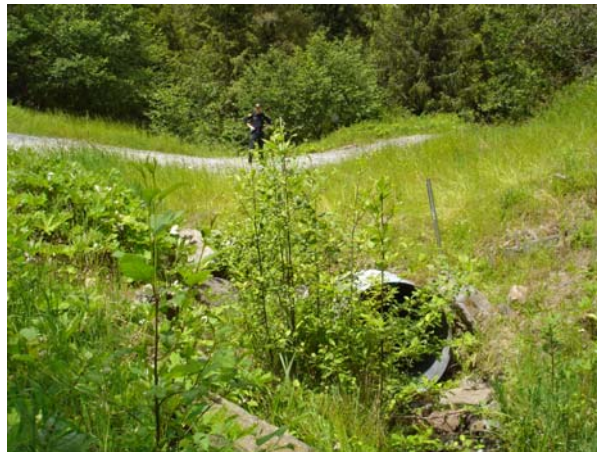
Figure 36. John Munn, CDF, at a culverted watercourse crossing in a forested watershed on the North Coast of California without diversion potential. Munn is standing in the critical dip.

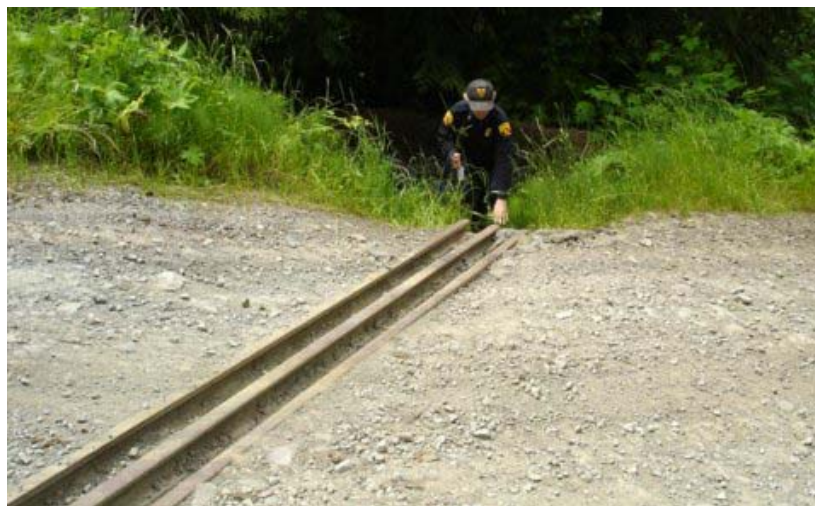
Figure 37. Pete Cafferata, CDF, points to the outlet of a uniquely-designed 3-rail cutoff-drainage structure on the approach to a watercourse crossing located in a forested watershed on the North Coast of California. Features like this, commonly a rolling dip without the rails, are used to prevent direct discharge of road runoff into watercourse channels.
