Re: 2016-2017 Annual Credit Verification and Monitoring and Reporting for Pepperwood Preserve Sediment Reduction Project SRNO-2H

Pepperwood Preserve Sediment Reduction Implementation Project  
Appendix A- BMP Monitoring Field Sheets

Pepperwood Preserve Sediment Reduction Implementation Project  
Appendix B- Photo Plates 2016-2017 Annual Monitoring Report

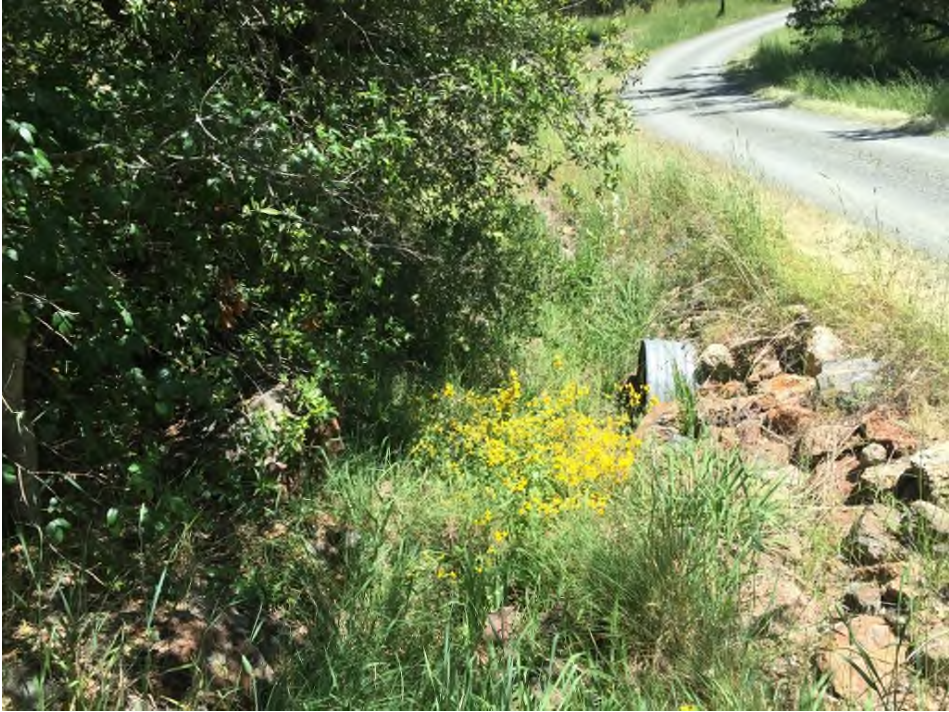
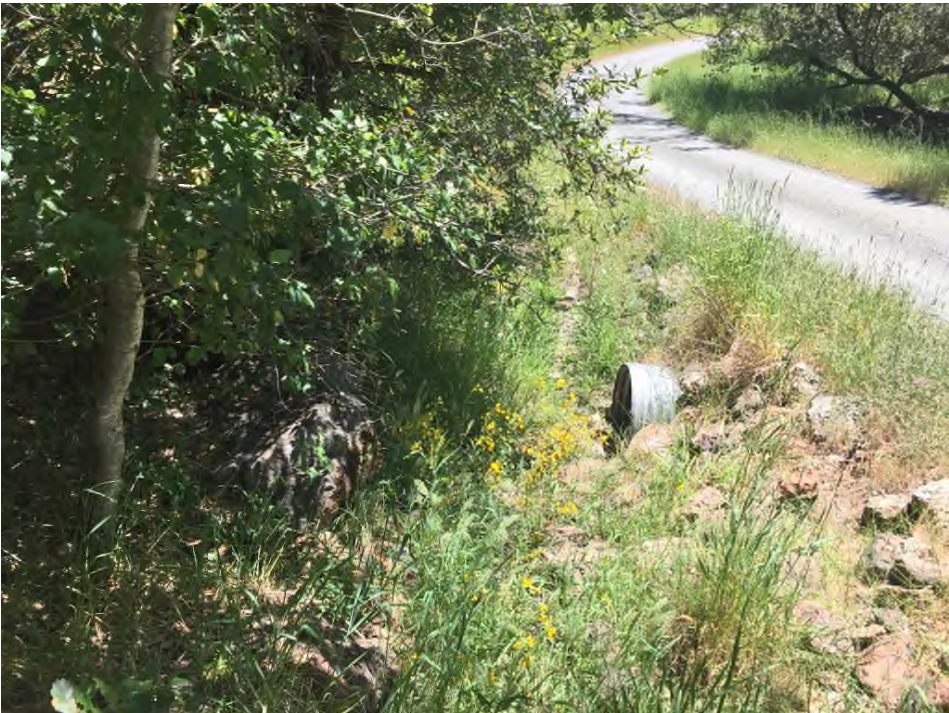
50+10	2	DRC 3/ Start CCD 3	<b>Site 2: 12" ditch relief culvert draining spring and diverted stream.</b> 1. Replaced with a 30" x 40' long culvert. 2. Installed 25 yd <sup>3</sup> of 0.5'-1.5' riprap on inboard fillslope and ditch. 3. Installed 10 yd <sup>3</sup> of 1'-3' riprap on outboard fillslope. 4. Started clean and cut ditch for 110' to better direct flow from diverted stream crossing. 5. Re-rocked the road surface.	Culvert in good conditioning and rock armor intact at IBF and OBF. Ditch looks stable, and is vegetated well.	<input checked="" type="checkbox"/> Y <input type="checkbox"/> N	<input checked="" type="checkbox"/> Refer to page 2 Appendix B.

PWA Site #2 (May 2016)

PWA Site #2 (May 2017)

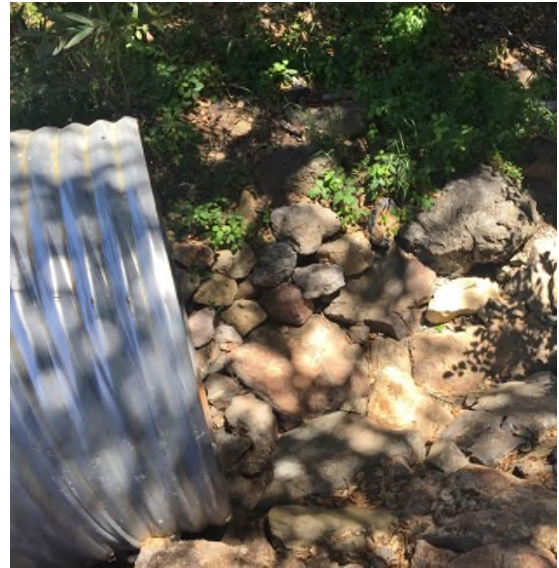
PWA Site #5 scour pool re-rocked (May 2017)

- Site 5: One-foot diameter rock was added to the scour area below the pipe outlet and filled in with smaller 4-8" rock. Treatment was observed to be stable.
- Bechtel House Road 44+50: Vegetation trimming and outlet clearing was completed.
- Site 8.1: The two lower head cuts were slightly regraded to a gentler slope and filled in with 4 – 6" rock. The other headcuts and holes further upslope were filled in with 4 – 6" rock. All areas appear stable.
- Goodman Road 04+05 near RD11: The built up sediment has been cleared out from the pipe and an outlet has been re-established.

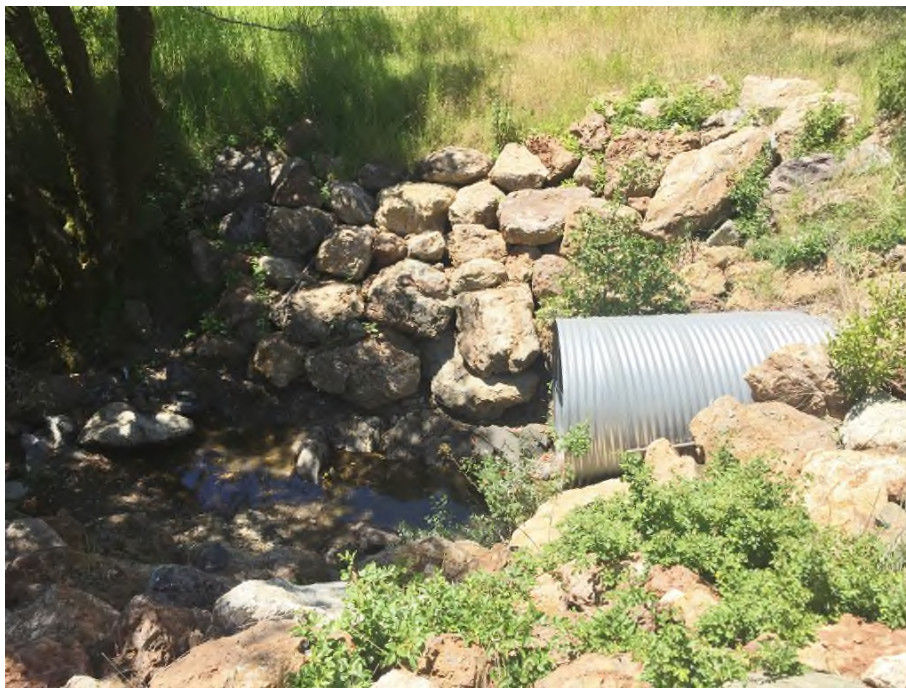
PWA Site #6 outlet (May 2017). Repair work on 9/26/2015 still holding up.

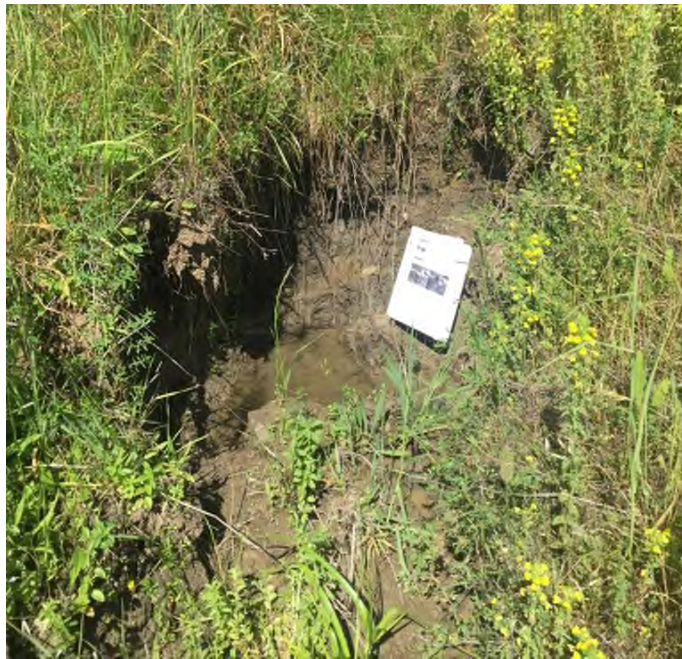
View of headcut above PWA Site #6.2, below PWA Site #8.1 (May 2016)

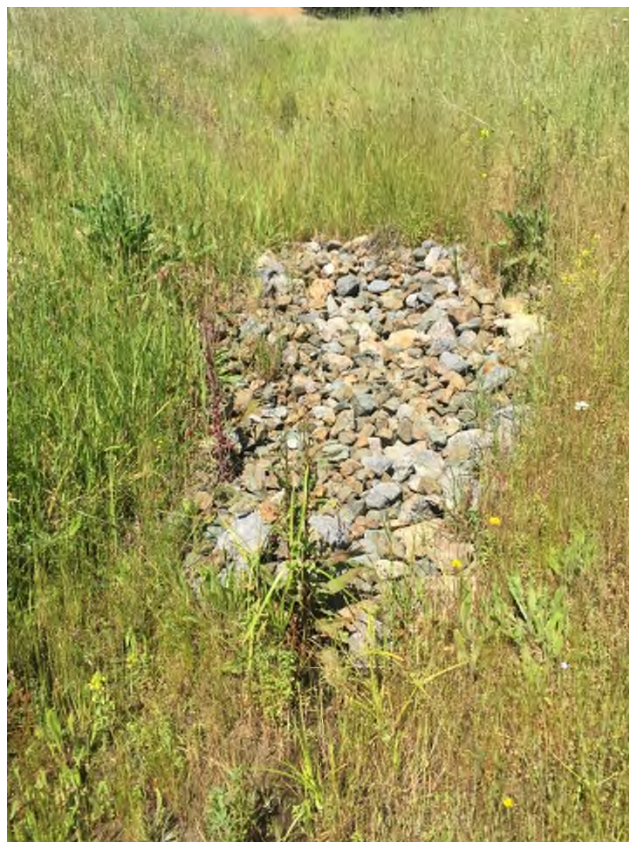
View of rock-armored headcut above PWA Site #6.2, below PWA Site #8.1 (May 2017)

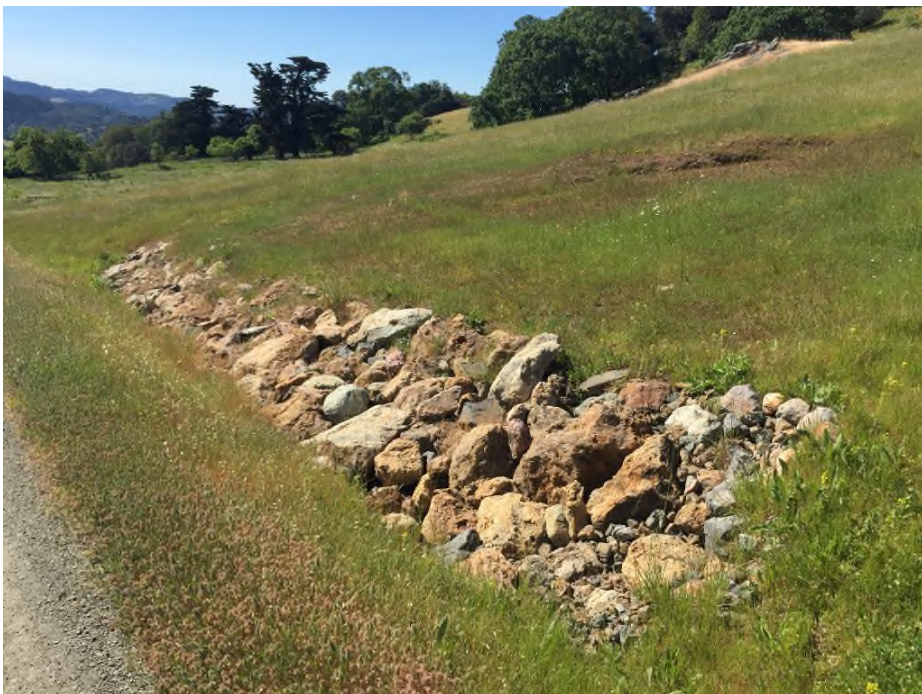
PWA Site 7.2 (May 2017)

- All BMPs were found to be operating properly with some needing maintenance as follows:
  - Site 7.2: Vegetation is more established at the landslide area this year than in 2015 or 2016 but there are still few sparsely vegetated areas. Maintenance recommendation is to continue to exclude cattle during wet months to help establish vegetation.
  - Site 10: Grasses on the outside edge of the road are preventing some of the water from draining down the site and are creating some ponding on the road surface. Maintenance recommendation is to mow vegetation and re-establish path for water to flow down the rock fill face.

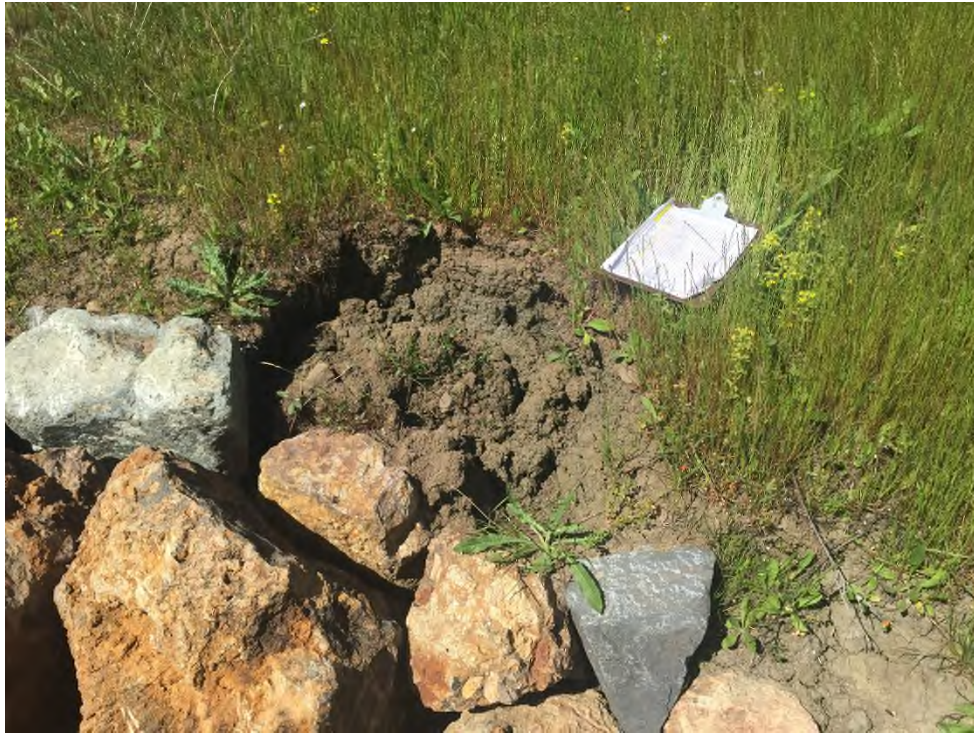
PWA Site 7.2b - Headcut has developed at the top right corner of the rockslope protection (May 2016)

- Site 7.2a: Headcut was rocked with 4-6" rock to prevent further migration up the inboard ditch.
- Site 7.2b: Headcut was rock with 4-6" rock to prevent further migration of headcut at the top right corner of the rockslope protection.
- Site 7.2c: Holes were filled in with 4-6" rock. Pepperwood staff also stated that cattle had been excluded from this area during the wet season and that 3000 native grass seeds have been planted in this area for the past 2 years but still had trouble establishing vegetation in this area.
- Bechtel House Road 23+90 at RD1: A box scraper was used to regrade the outslope on this rolling dip to improve drainage.
- Site 6: Observed that previous treatment of rock armoring done in May 2016 looked stable.

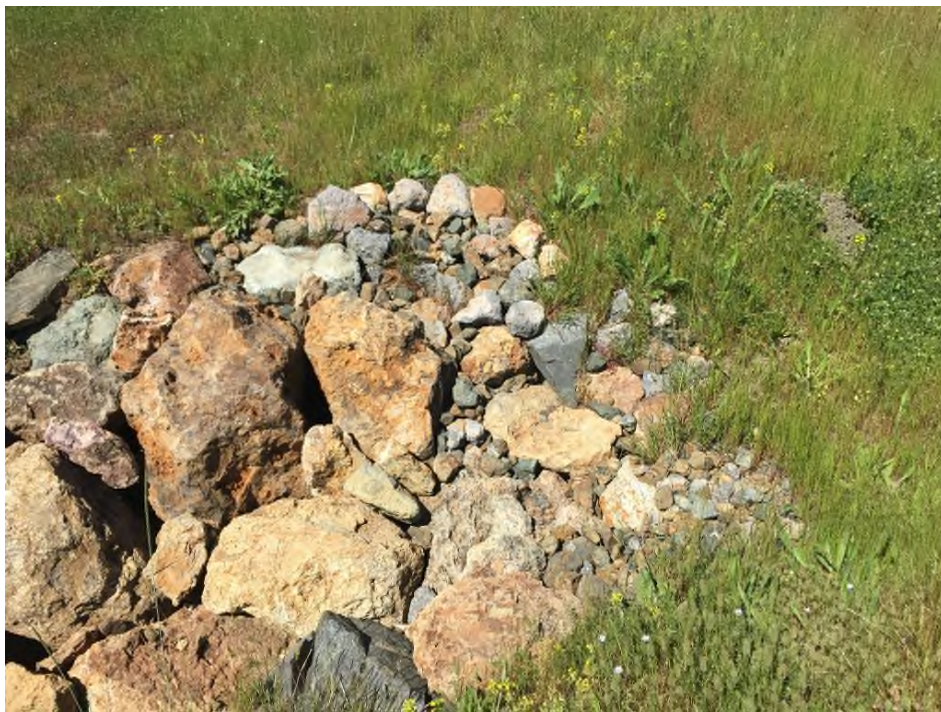
PWA Site 7.2b – Rock armor treatment repair where inboard road ditch drains to rock armor (May 2017)

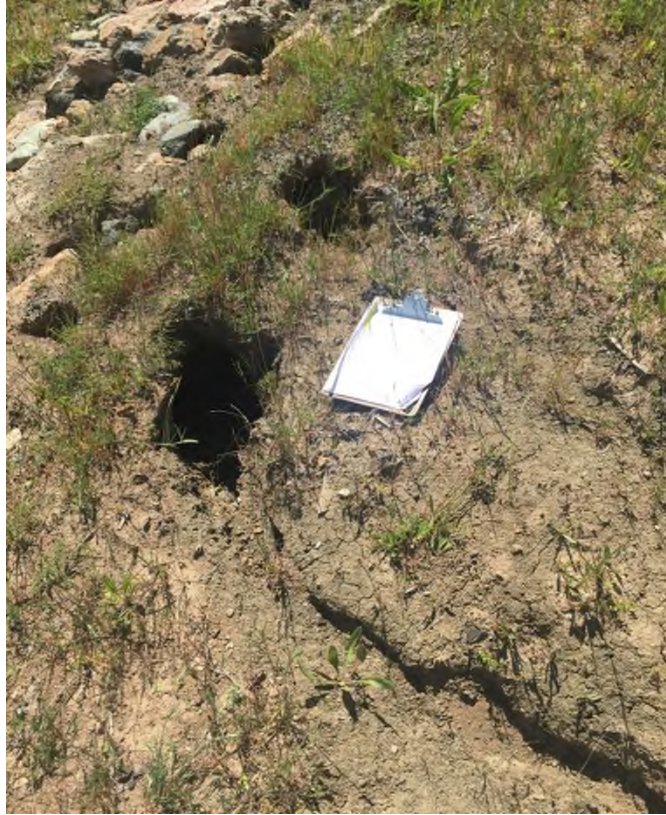
PWA Site 7.2c Rill into hole above rock armor one of two sets (May 2016)

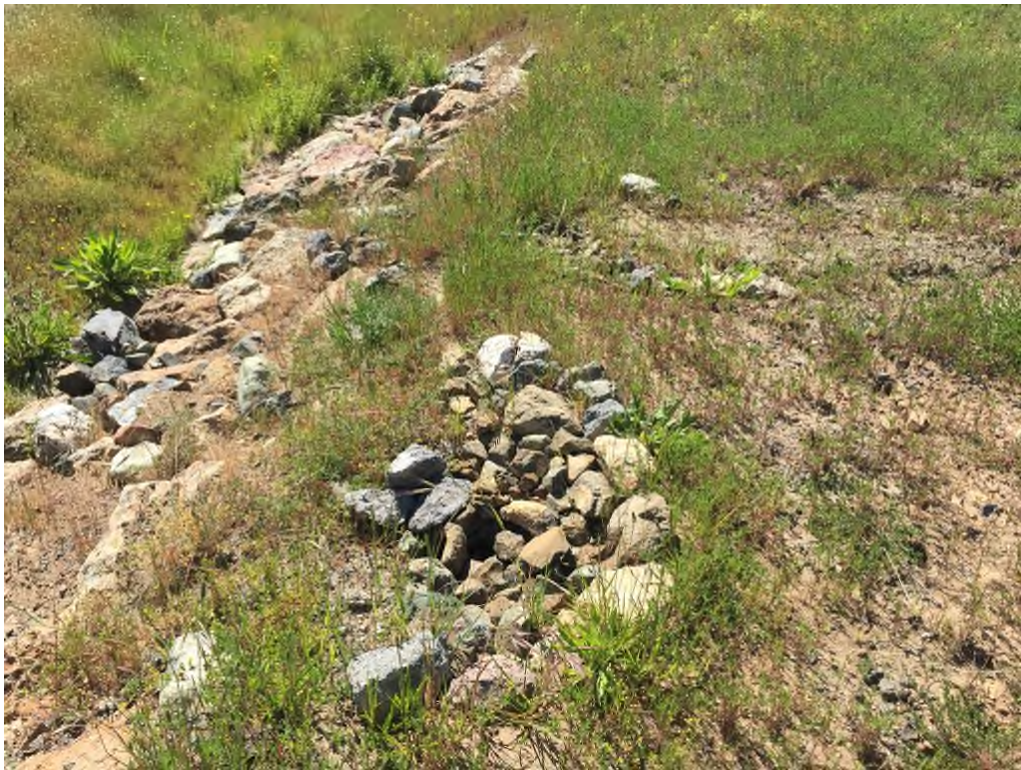
PWA Site 7.2c Rock armor treatment for holes above rock armor one of two sets (May 2017)

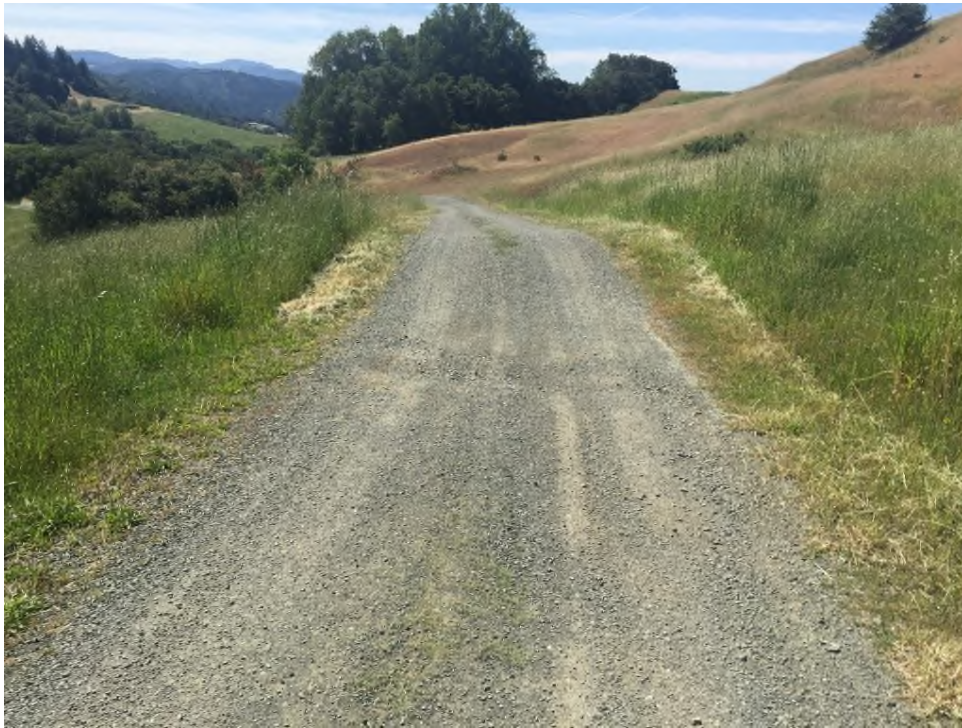
PWA RD1: Shallow depression (May 2016)

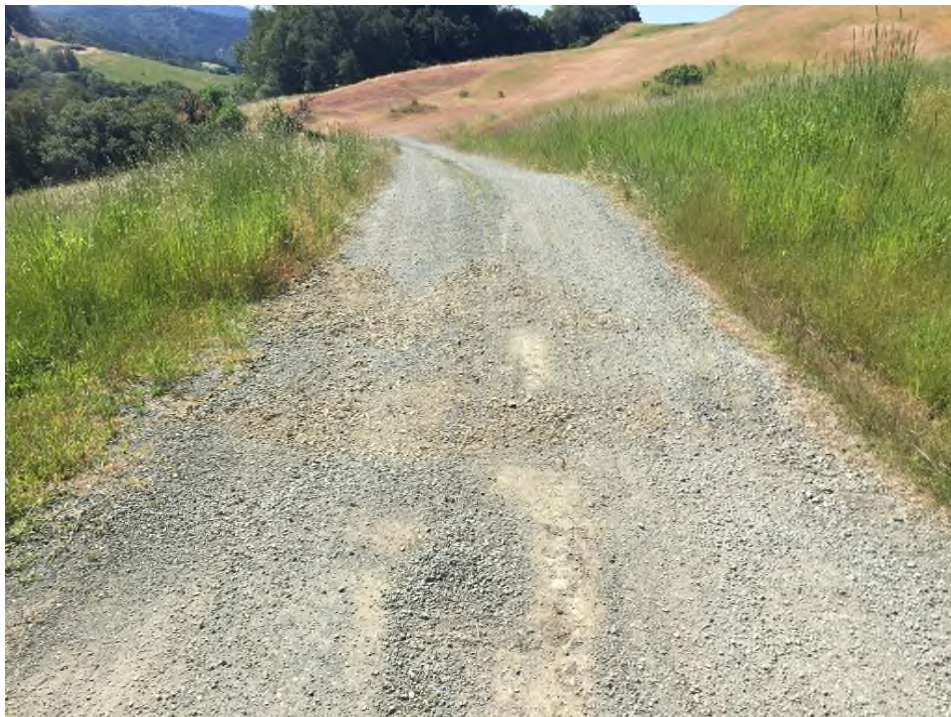
PWA RD1: Gravel patch work to fill shallow depression (May 2017)

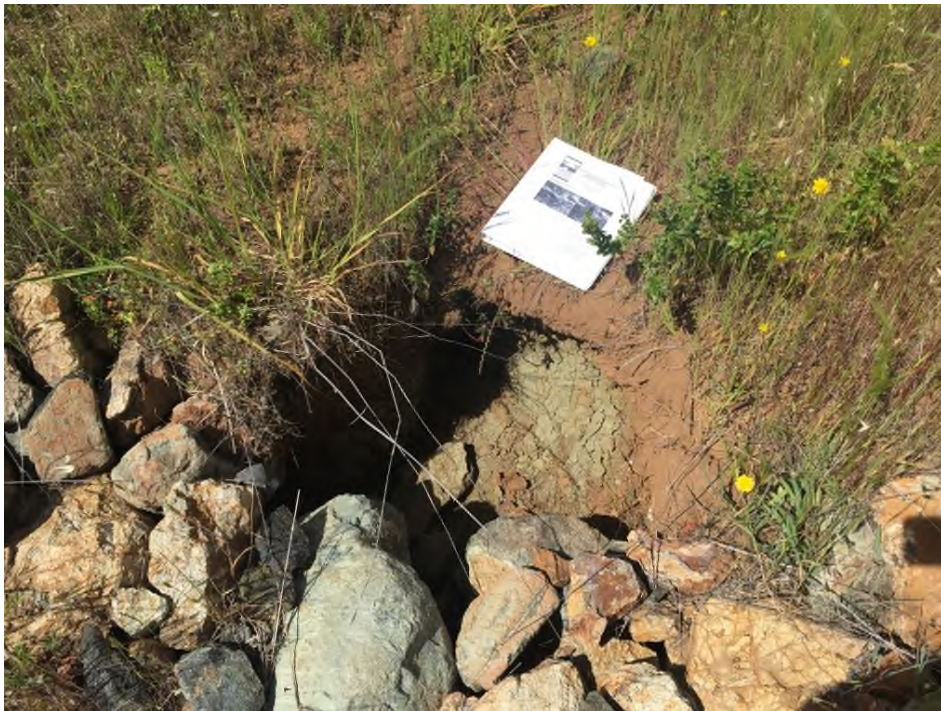
PWA Site #8.1 Grade Control Structure Headcut (May 2016)

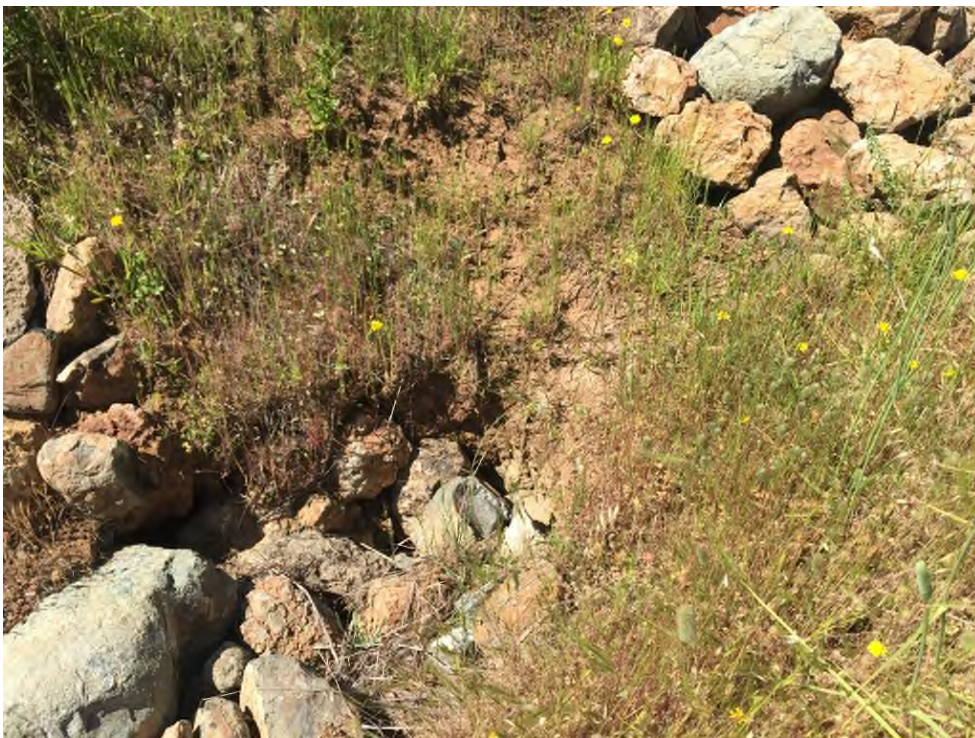
PWA Site #8.1 Rock armor repair at Grade Control Structure Headcut (May 2017)

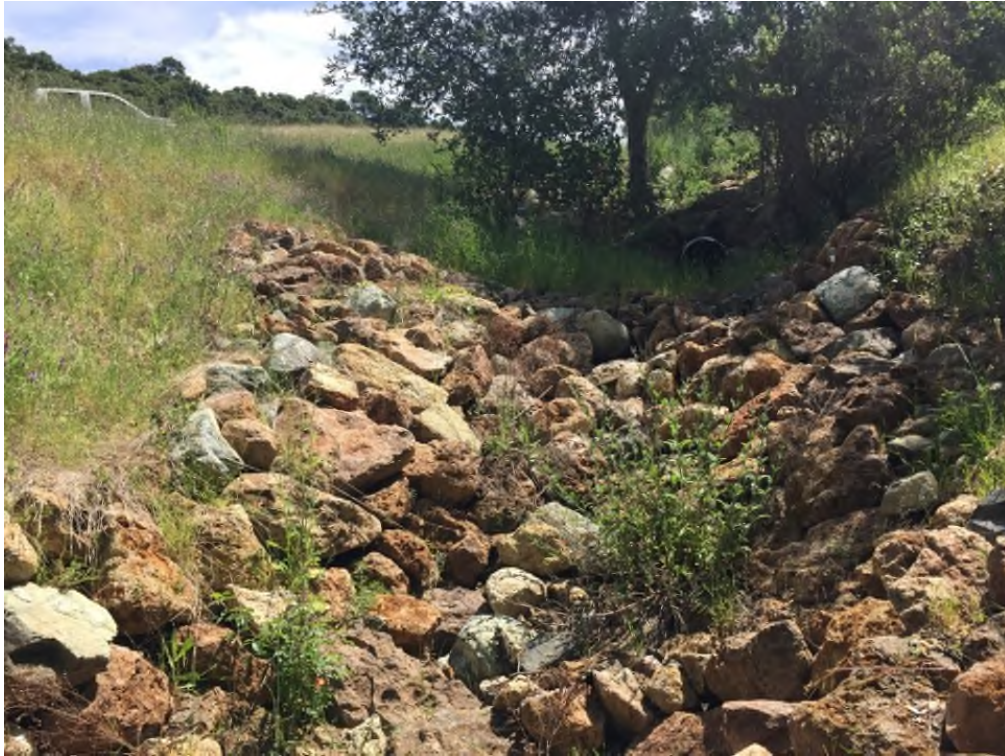
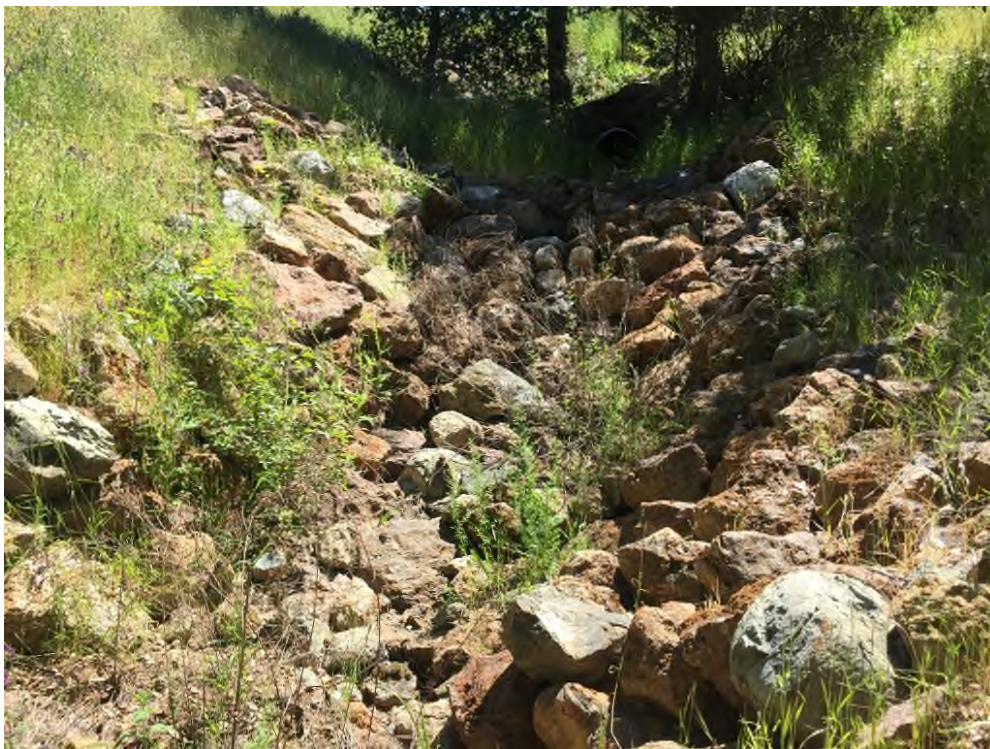
42+95	11	CD 4/ GCS 2	<b>Site 11: Stream crossing with 24" culvert and active 8' tall headcut below culvert.</b> 1. Replaced with a 24" x 60' long culvert. 2. Installed a critical dip on right hingeline. 3. Defined inboard ditch on left for 20' and directed flow into new inlet. 4. Installed a total of 30 yd <sup>3</sup> of 0.5' - 2' riprap to inboard and outboard fillslopes. 5. Installed a grade control structure to headcut in channel below outlet 30 yd <sup>3</sup> of 0.5' - 2' riprap.	Culvert in good condition. Rock armor intact and stable, no erosion observed, critical dip in good condition and well vegetated.	<input checked="" type="checkbox"/> Y <input type="checkbox"/> N	<input checked="" type="checkbox"/> Refer to page 15 Appendix B.
43+80			Steel unlocked gate-livestock present, keep closed.		N/A

PWA Site #11 (May 2016)

PWA Site #11 (May 2017)

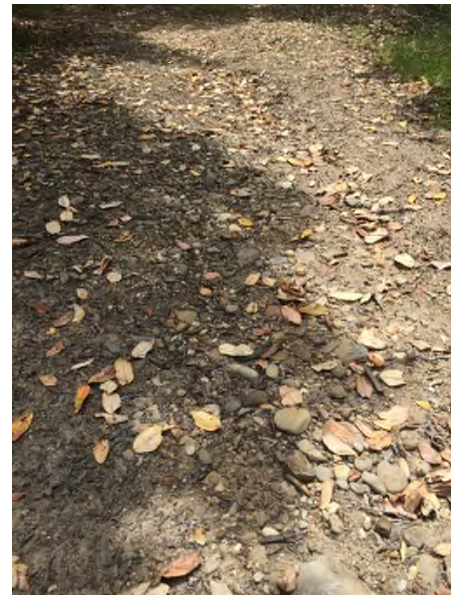
PWA RD #37 further down road, rill hits gravelly native road layer before exiting at RD #38 (May 2016)

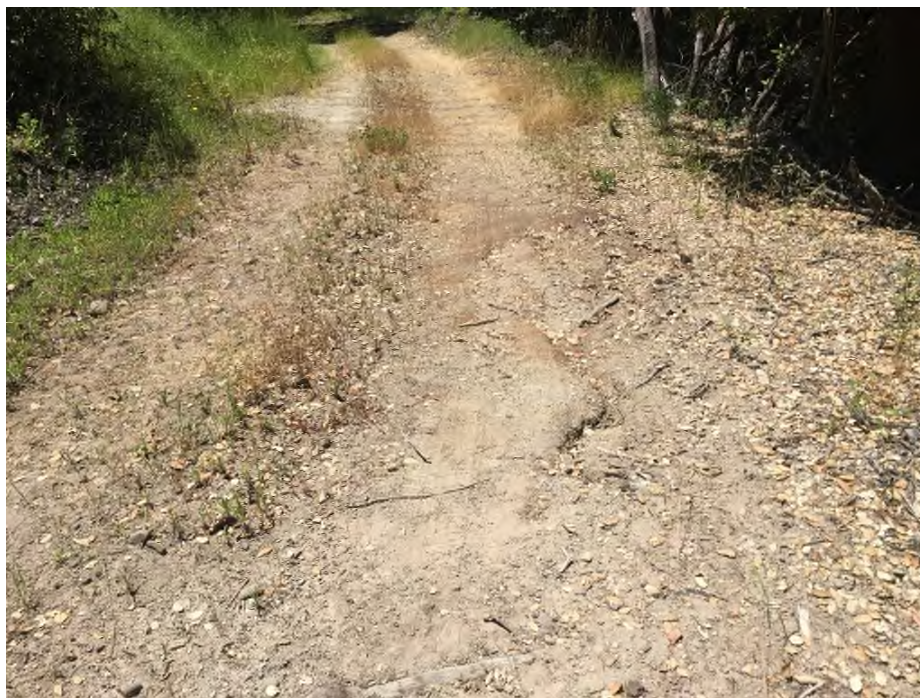
PWA RD #37 small rill which exits road bed to right (May 2017)

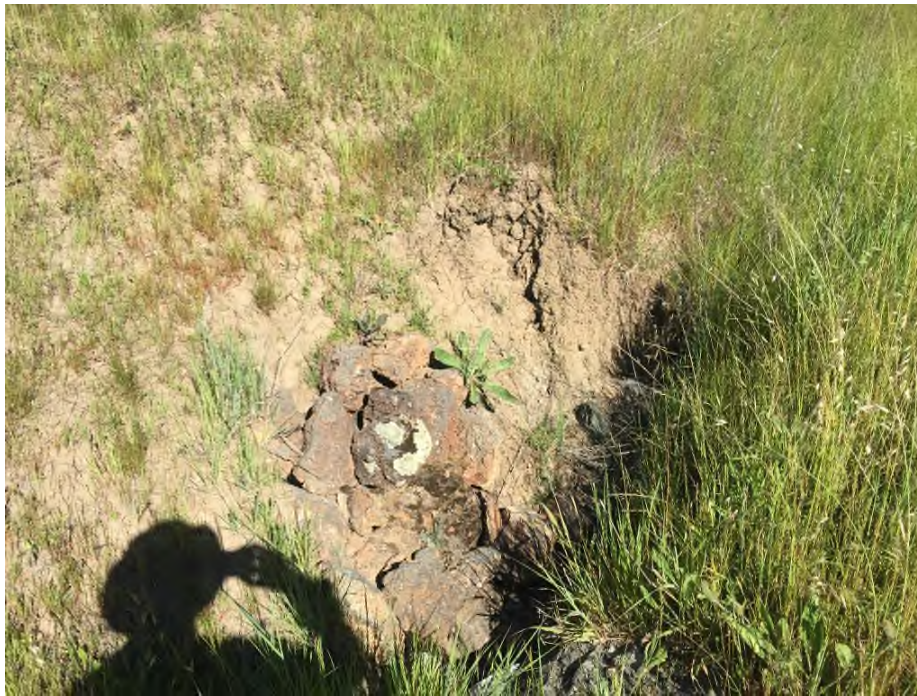
08+30		RD 46.1	1. Installed a type 1 rolling dip. 2. Re-rocked the road surface. 3. No treatments at existing 12" ditch relief culvert.	RD functioning well.	<input checked="" type="checkbox"/> Y <input type="checkbox"/> N	<input checked="" type="checkbox"/> See photo on page 22 of Appendix B.

PWA RD #46.1 A 1-foot vertical headcut and 2-foot wide scour area has developed in the ditch above the DRC inlet (May 2017)

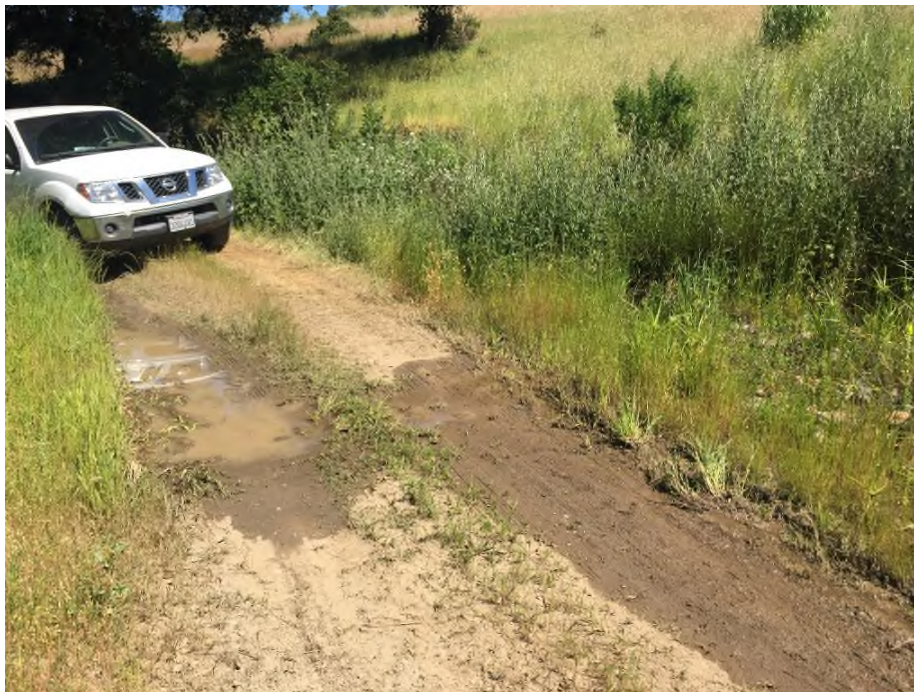
PWA Site #10. Overgrown vegetation preventing proper road drainage. (May 2017)
