Re: 2015-2016 Annual Monitoring and Reporting for Pepperwood Preserve Sediment Reduction Project SRNO-2H

Pepperwood Preserve Sediment Reduction Implementation Project
Appendix B- Photo Plates 2015-2016 Annual Monitoring Report

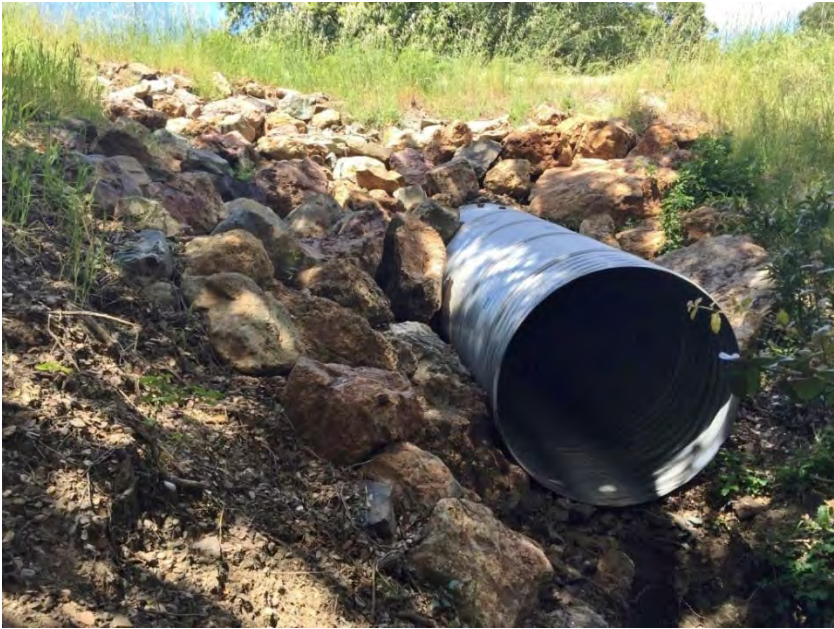
PWA Site #5 outlet (May 2016)

- Site 5: A 2.5-foot wide by 2-foot deep by 4-foot long scour pool has developed below the pipe outlet (See Photo Plates page 5). This site has actively eroded since monitoring in May 2015. The volume of eroded sediment is estimated at 20 cubic feet or 0.74 cubic yards. This scour pool may continue to enlarge in future winter storms and may eventually undermine the rock armor at the outboard fill slope, destabilizing the crossing. Armoring the culvert outfall with rock (1 to 2ft in diameter) is recommended to prevent further erosion.

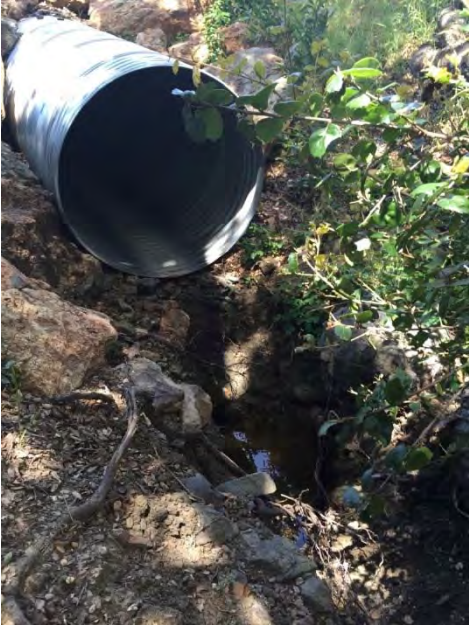
PWA Site #5 scour pool (May 2016)

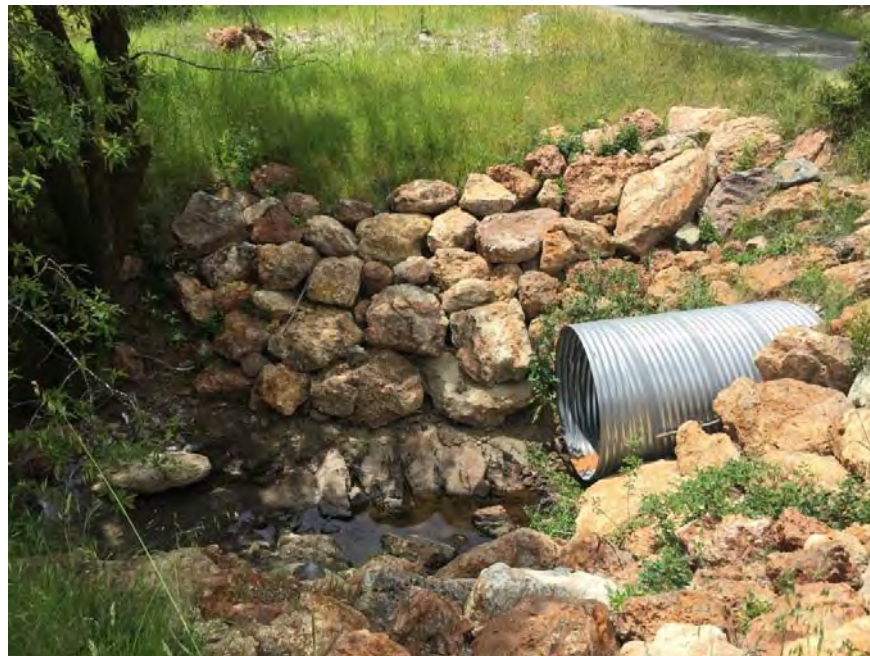
- Site 6: Repair work was completed in September 2015 at this site to replace rock armor on the right bank of the outboard fillslope that had been knocked out of place and grade the hillslope to a 2:1 slope angle. During BMP inspection in May 2016 the rock armor appeared to be stable and holding up (See Photo Plates page 6).

PWA Site #6 outlet (May 2016). Repair work on 9/26/2015.

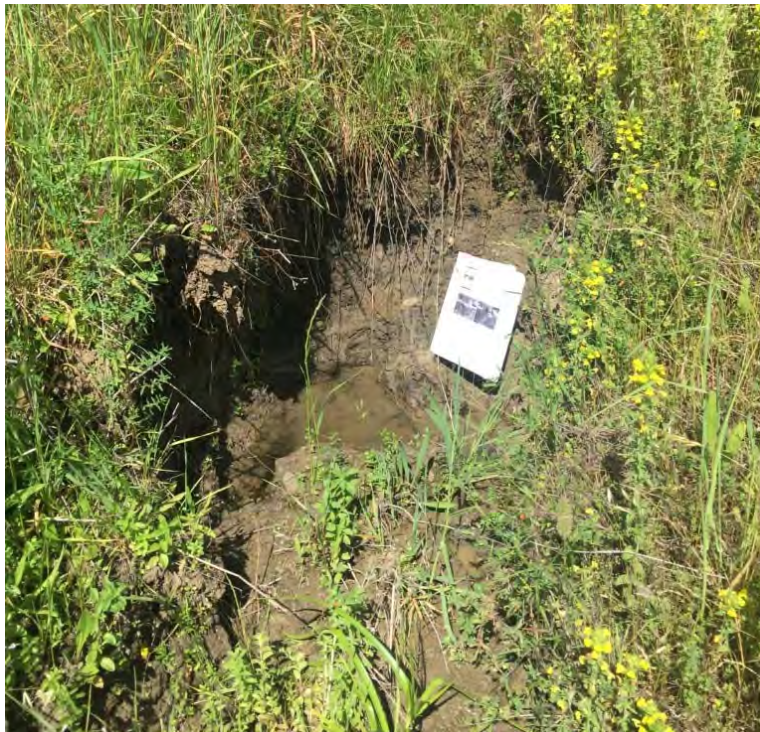
View of headcut above PWA Site #6.2, below PWA Site #8.1 (May 2016)

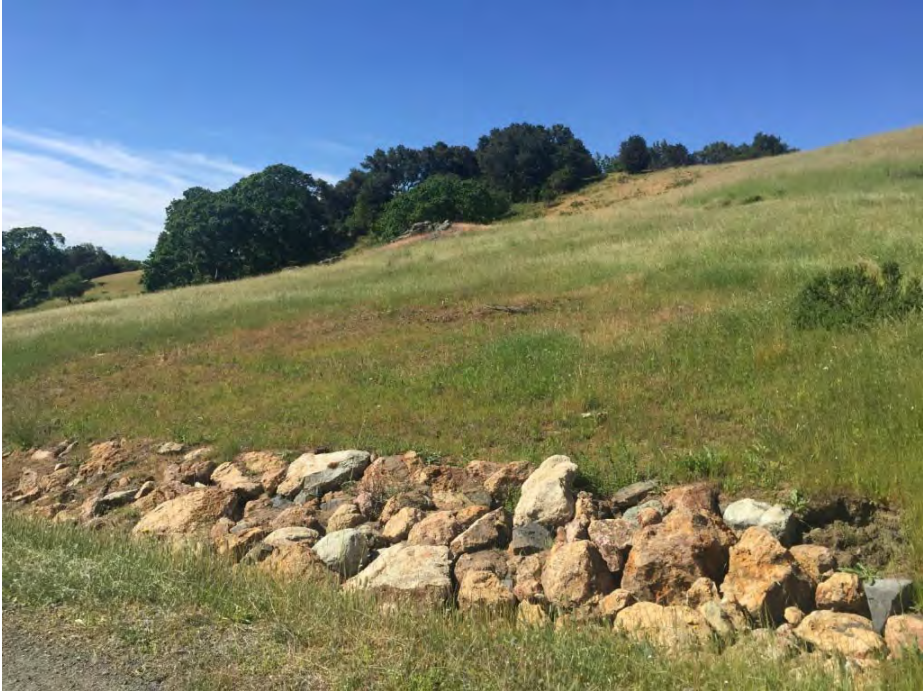
PWA Site 7.2 (May 2016)

- Site 7.2:
 - 7.2a: A 1-foot wide x 1-foot deep headcut has developed where the inboard ditch meets the rock slope protection. Recommendation to rock this headcut to prevent further migration of the headcut up the inboard ditch (See Photo Plate page 10).

- 7.2b: A 2-foot wide by 10 inch deep headcut has developed at the top right corner of the rockslope protection. Recommendation to monitor this area for any further movement (See Photo Plate page 10).

- 7.2c: Two sets of two 1-foot wide by 1.5-foot deep holes have formed near the top left end of the rock slope. A small 5-inch wide by 4-inch deep rill has formed near the left side of the landslide and is draining to one of the four holes at the top of the rockslope protection. A section of this rill has been rocked near one of the old straw wattles by Pepperwood staff (See Photo Plates page 11), but the rilling continues upslope of the rock. This area is sparsely vegetated.

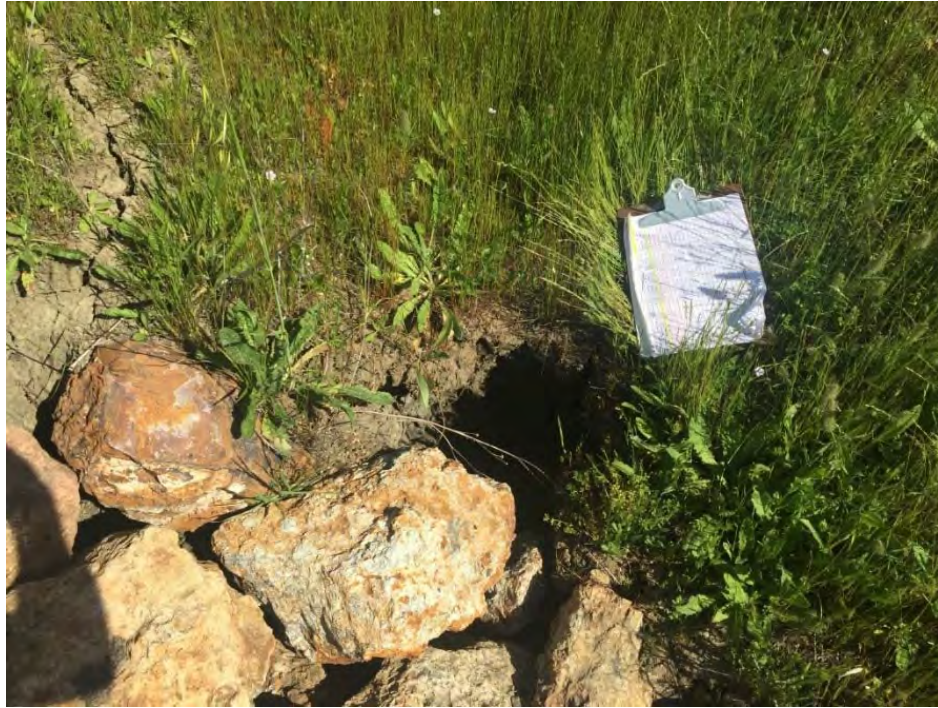
PWA Site 7.2a - Hole where inboard road ditch drains to rock armor (May 2016)

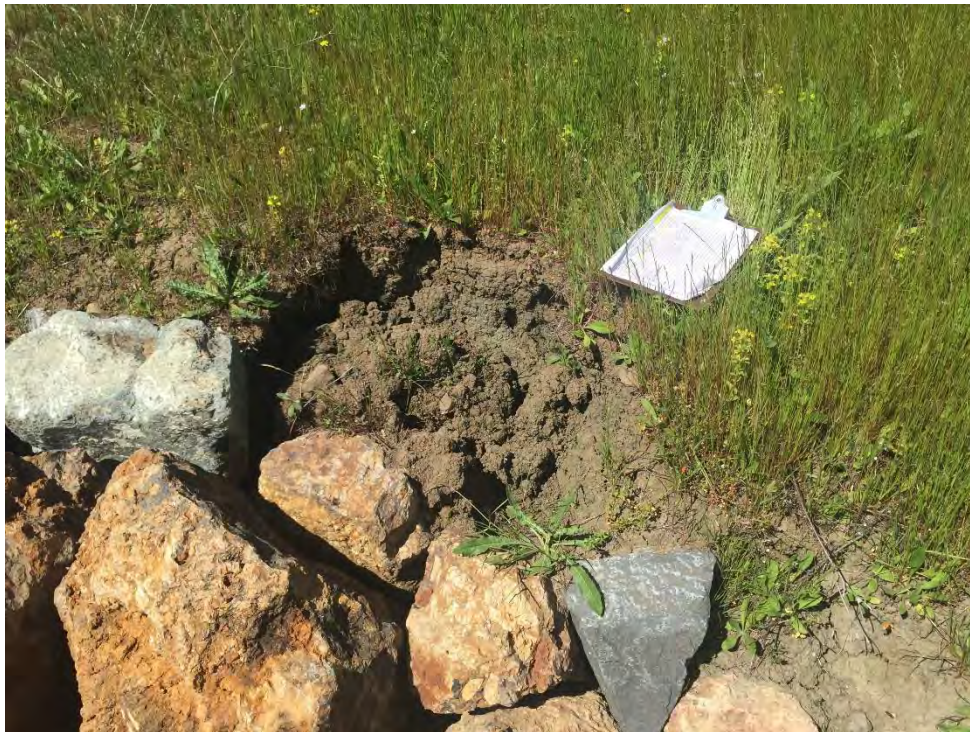
PWA Site 7.2b - Headcut has developed at the top right corner of the rock slope protection (May 2016)

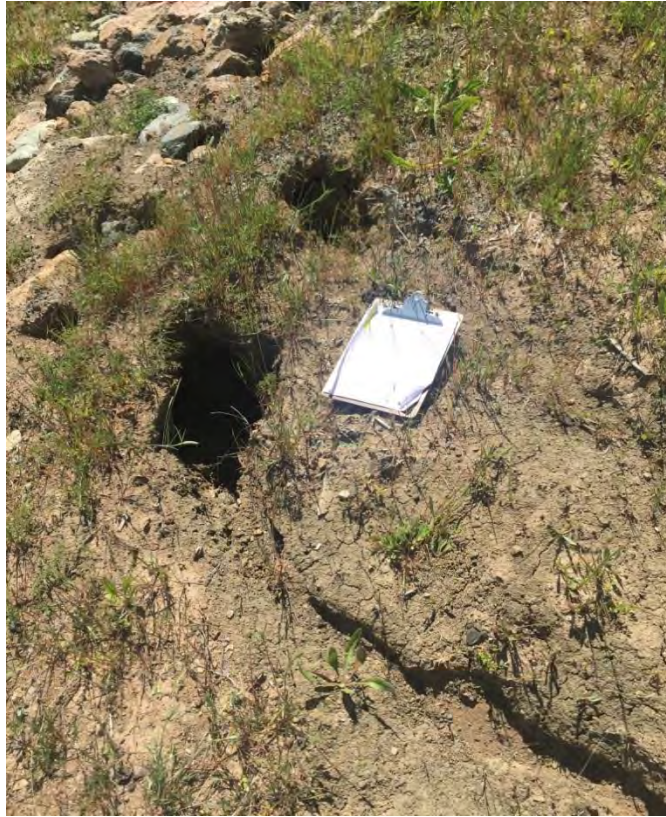
PWA Site 7.2c Rill into hole above rock armor one of two sets (May 2016)

Recommendation to exclude cattle activity from this site to help establish vegetation.

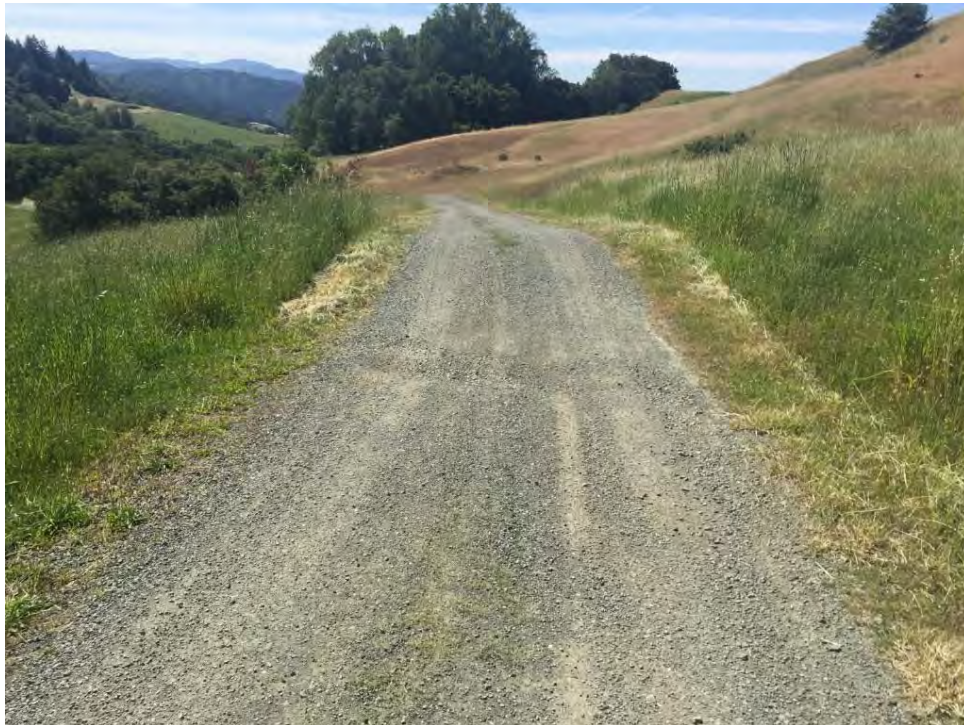
- Bechtel House Road 23+90 at RD1: A low spot at the uphill side of the RD has caused the development of a shallow depression. Establishing a keyway such that road drainage can exit the outboard side of the road is recommended (See Photo Plates page 11).

PWA RD1: Shallow depression (May 2016)

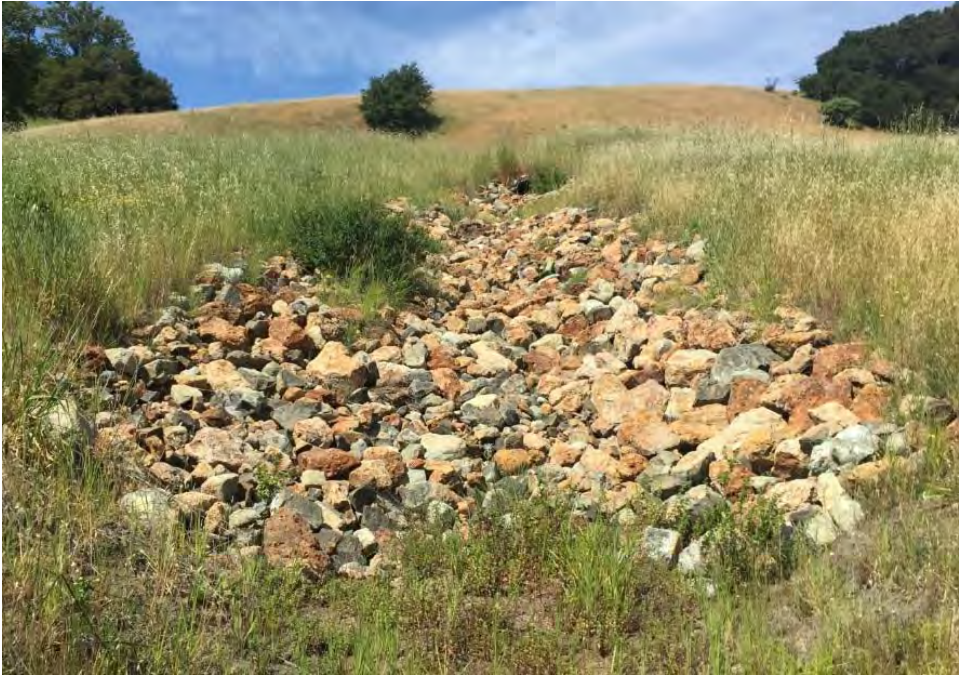
PWA Site # 8.1 (May 2016)

- Site 8.1: A 3' deep by 2.5' wide headcut is still present at the bottom of this site. In addition, two 1ft wide by 2ft deep headcuts have developed between the main headcut and Grade Control Structure 1.3 (See Photo Plates page 7). Armoring with 0.5-1.0 ft keyed-in rock, under-laid with gravel or landscape fabric at each of the headcuts is recommended to prevent further erosion and migration of the headcut.

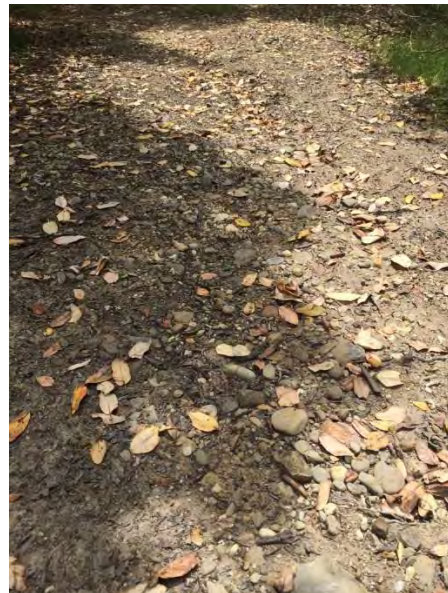
PWA RD #37 further down road, rill hits gravelly native road layer before exiting at RD #38 (May 2016)
