# ASHBY USA, LLC

Ref: WPN: 10-3020657.02, 18-2001091.02:schwk  
NOV No. R9-2006-0135

Subject: Required Technical Report

Ashby USA  
Notice of Violation Response  
Photos  
November 28, 2006

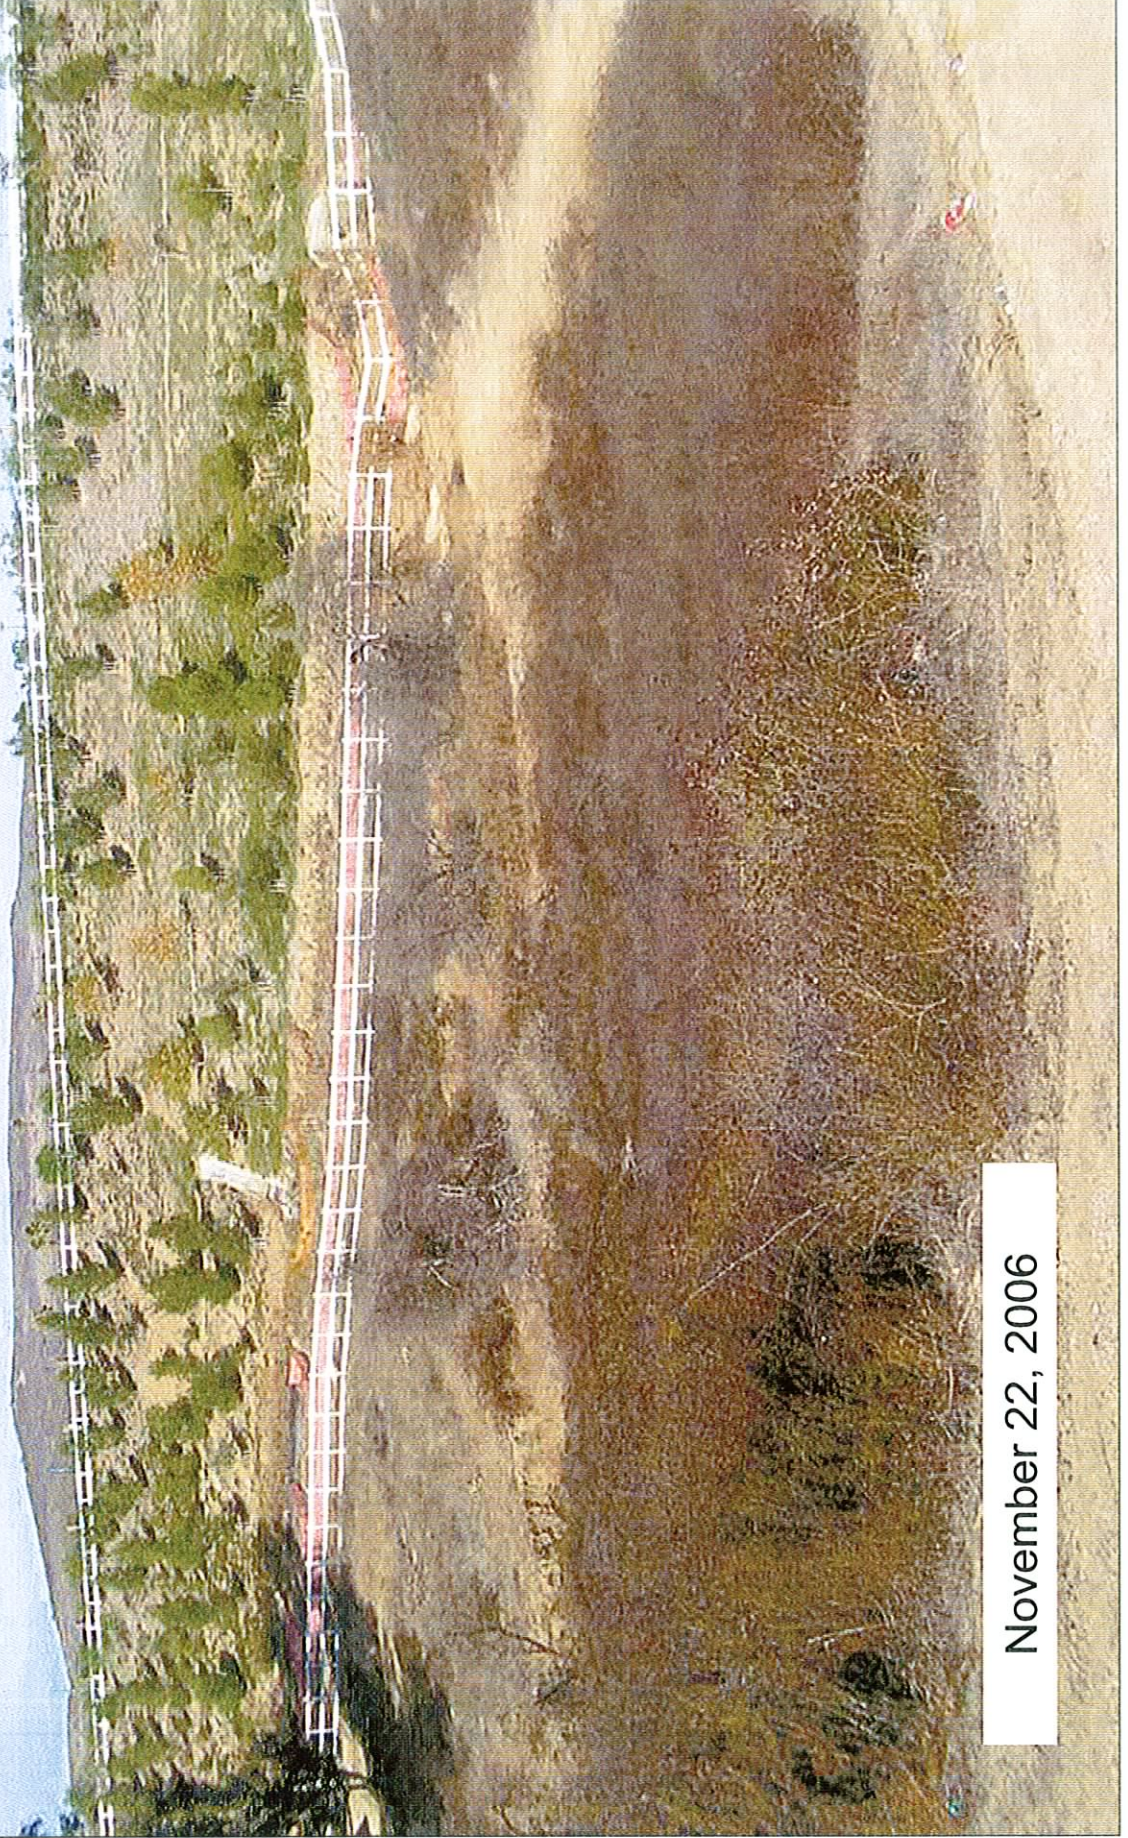
Disturbed road leading to tributary to Santa Gertrudis Creek and head wall  
from sediment basin from Prairie Area.

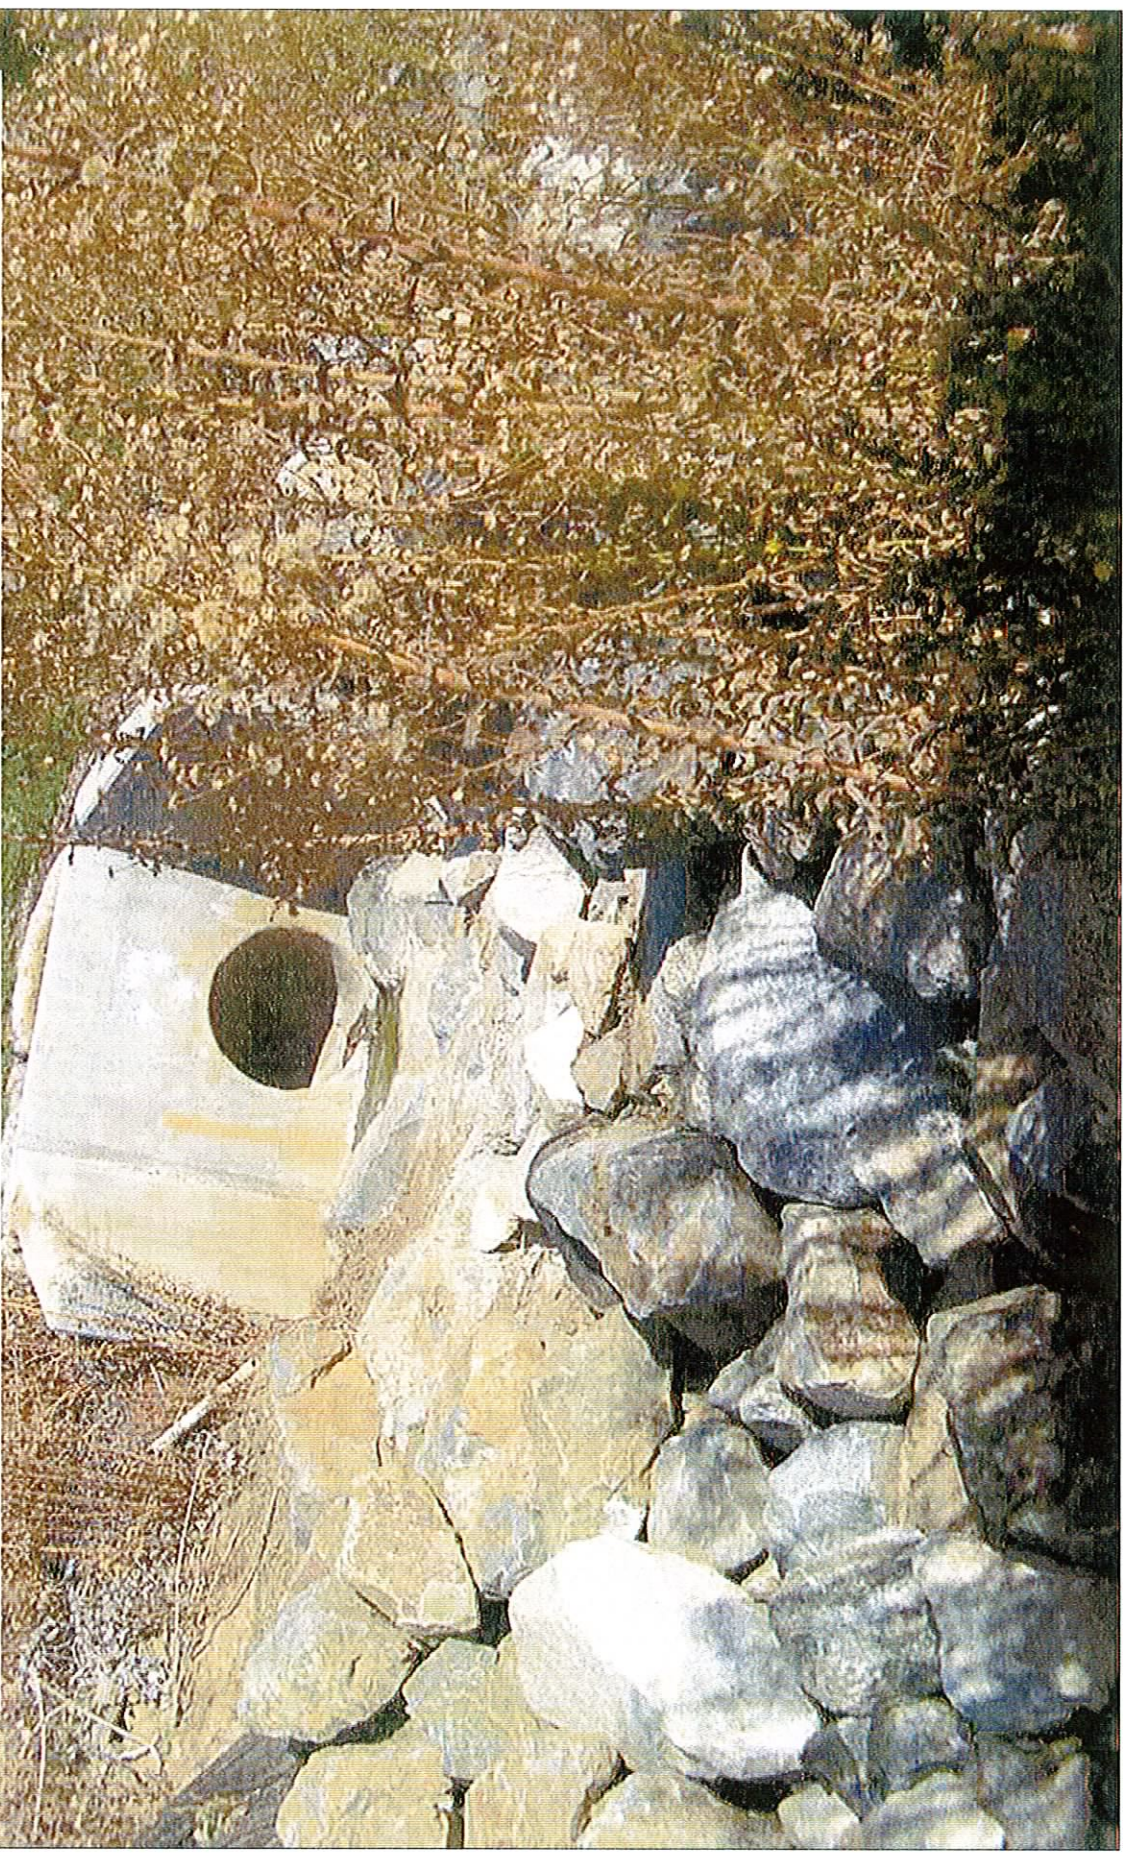
The rip rap at the headwall appeared ineffective in minimizing downstream erosion. The rip rap was covered with sediment eliminating its usefulness in reducing the velocity and energy of concentrated storm water flows from the sediment basin.

Outfall headwall from sediment basin with rip rap for Phases 1-5  
(The Plateau)

These impacts were addressed in NOV R9-2003-0197 issued April 22, 2003, NOV R9-20030392 issued on November 4, 2003, and ACL Order R9-2003-0302 issued on November 12, 2003. As a result of these violations, the following significant construction and post construction BMP's were installed per the direction of the City of Temecula, the discharge point was reduced to a 6" opening; the rip rap at the discharge point was increased. As well as the fact that all season BMP's on the plateau include Silt fencing and wattle on all lots, Storm Drain inlet protection with filter fabric with gravel bag dams. Photo 10 of the inspection report is inaccurate, as shown in the photos in exhibit "A" it is clearly identified that the outlet of the detention basin is on the Roripaugh Ranch Property, photo 10 from the NOV identifies an abandoned check dam that was placed in 2003 and it is not on the Roripaugh Ranch Project as located by the proximity of the property line fence in the background (white rail fence). As directed by the City of Temecula a secondary downstream rip rap area was added to further reduce velocity. Gravel bag check dams have also been placed between the primary and

secondary rip rap to reduce velocities for any additional seasonal flow. Please see the photos in exhibit "A" to view existing conditions.

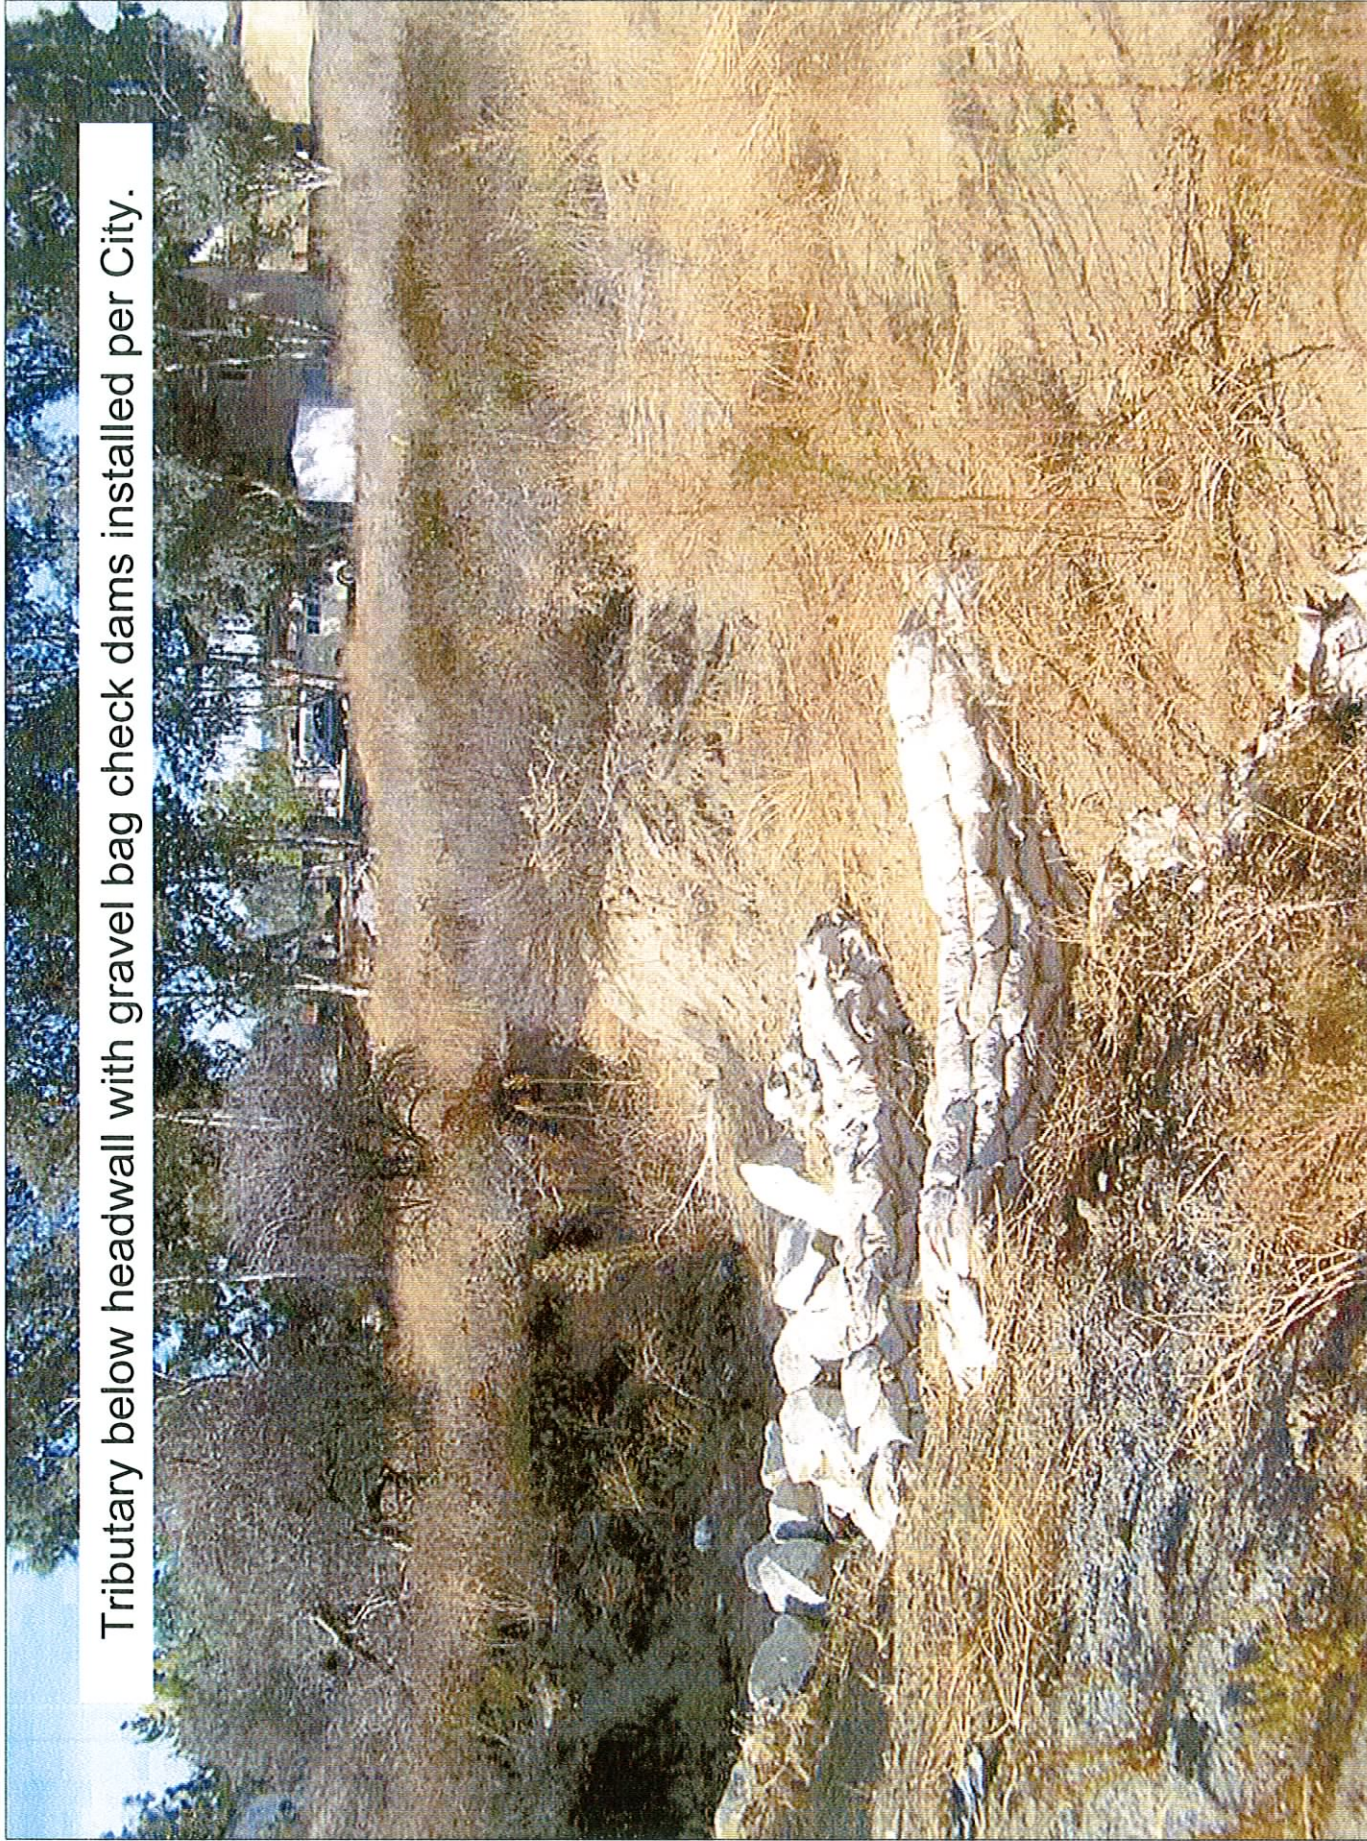
Tributary below headwall with gravel bag check dams installed per City.

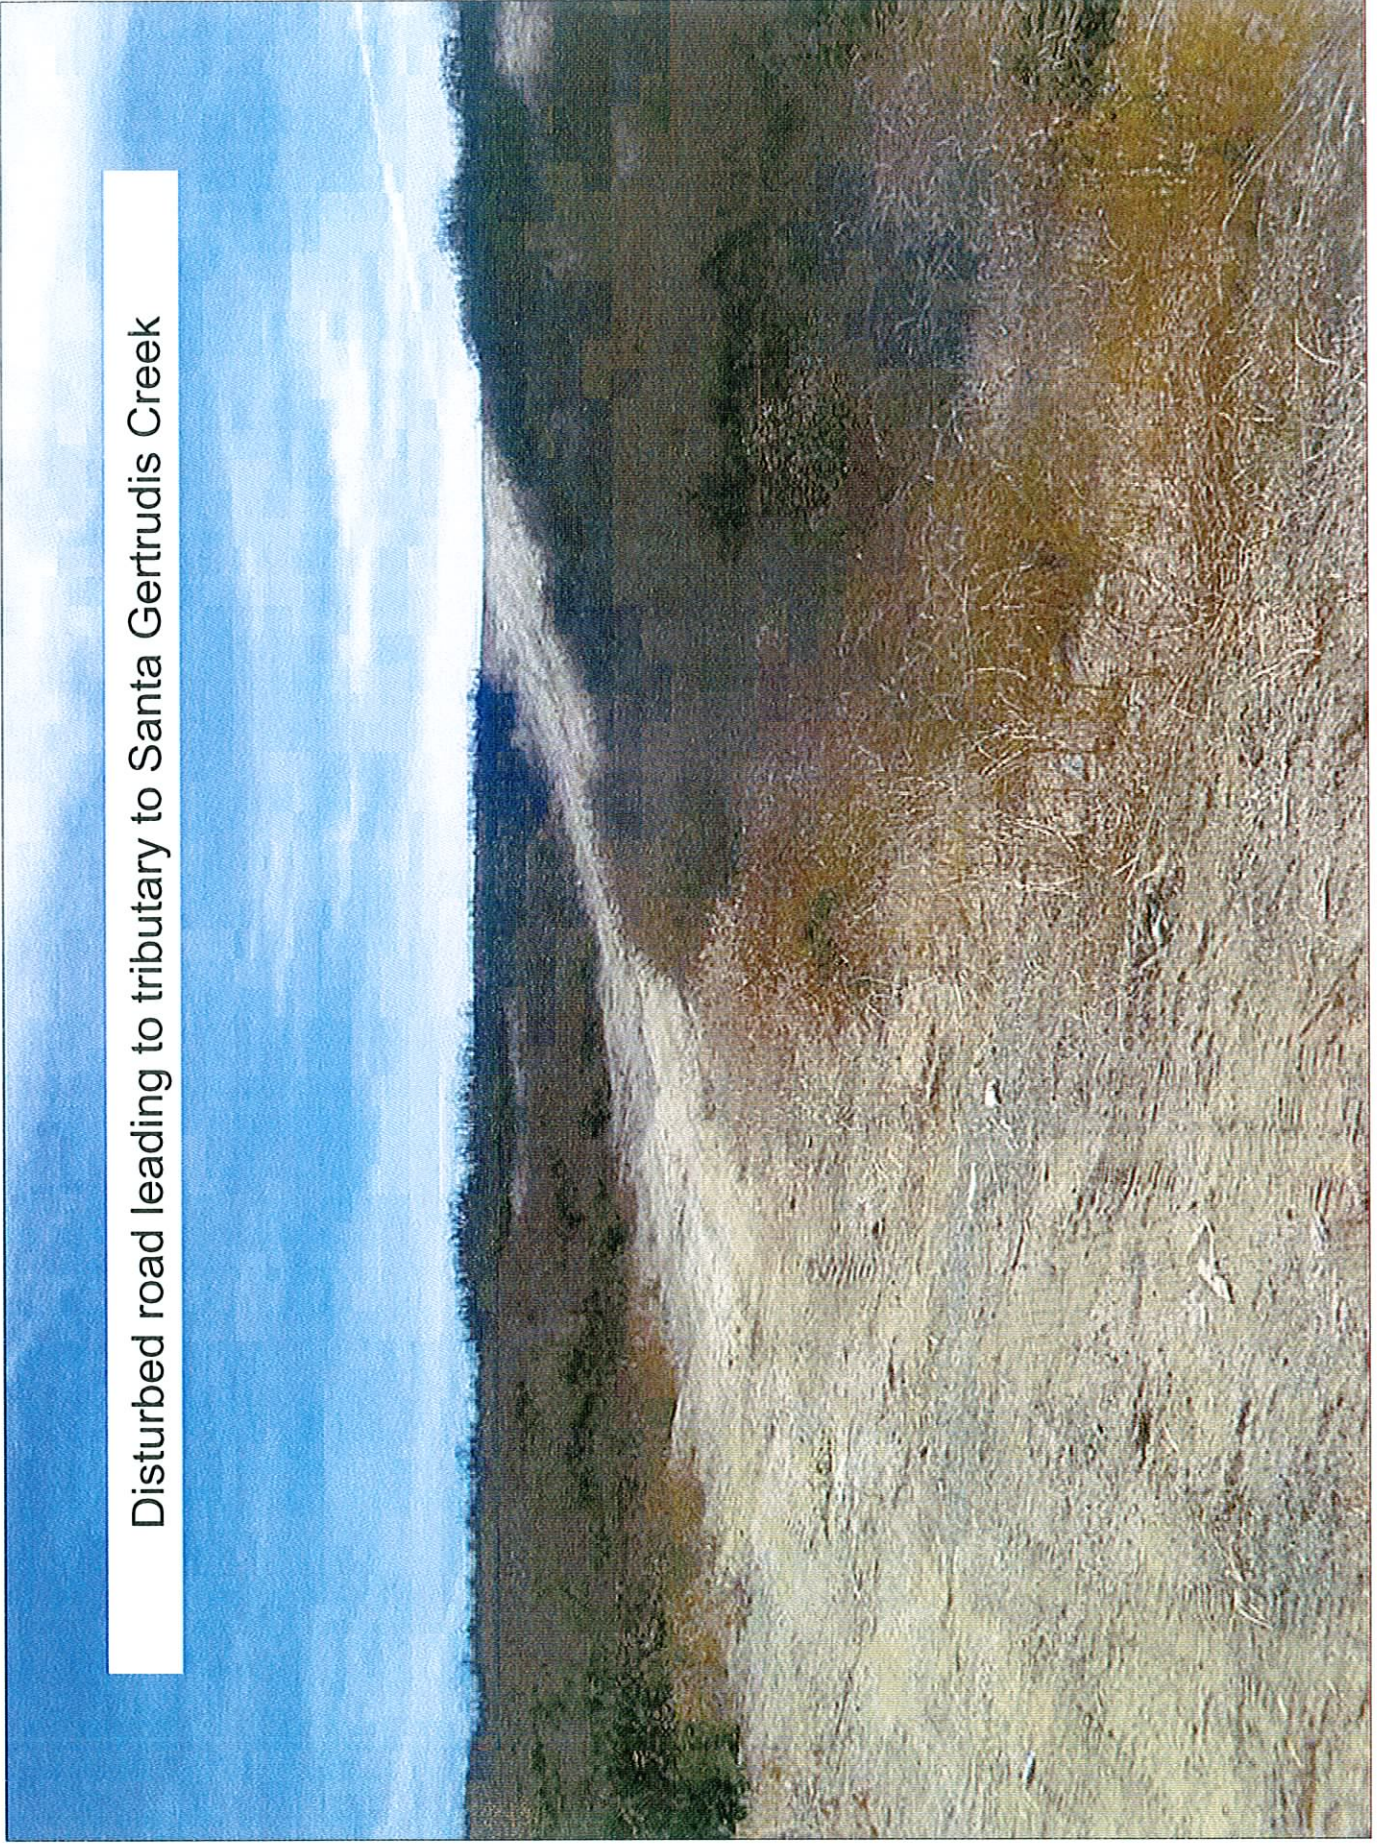
Disturbed road leading to tributary to Santa Gertrudis Creek

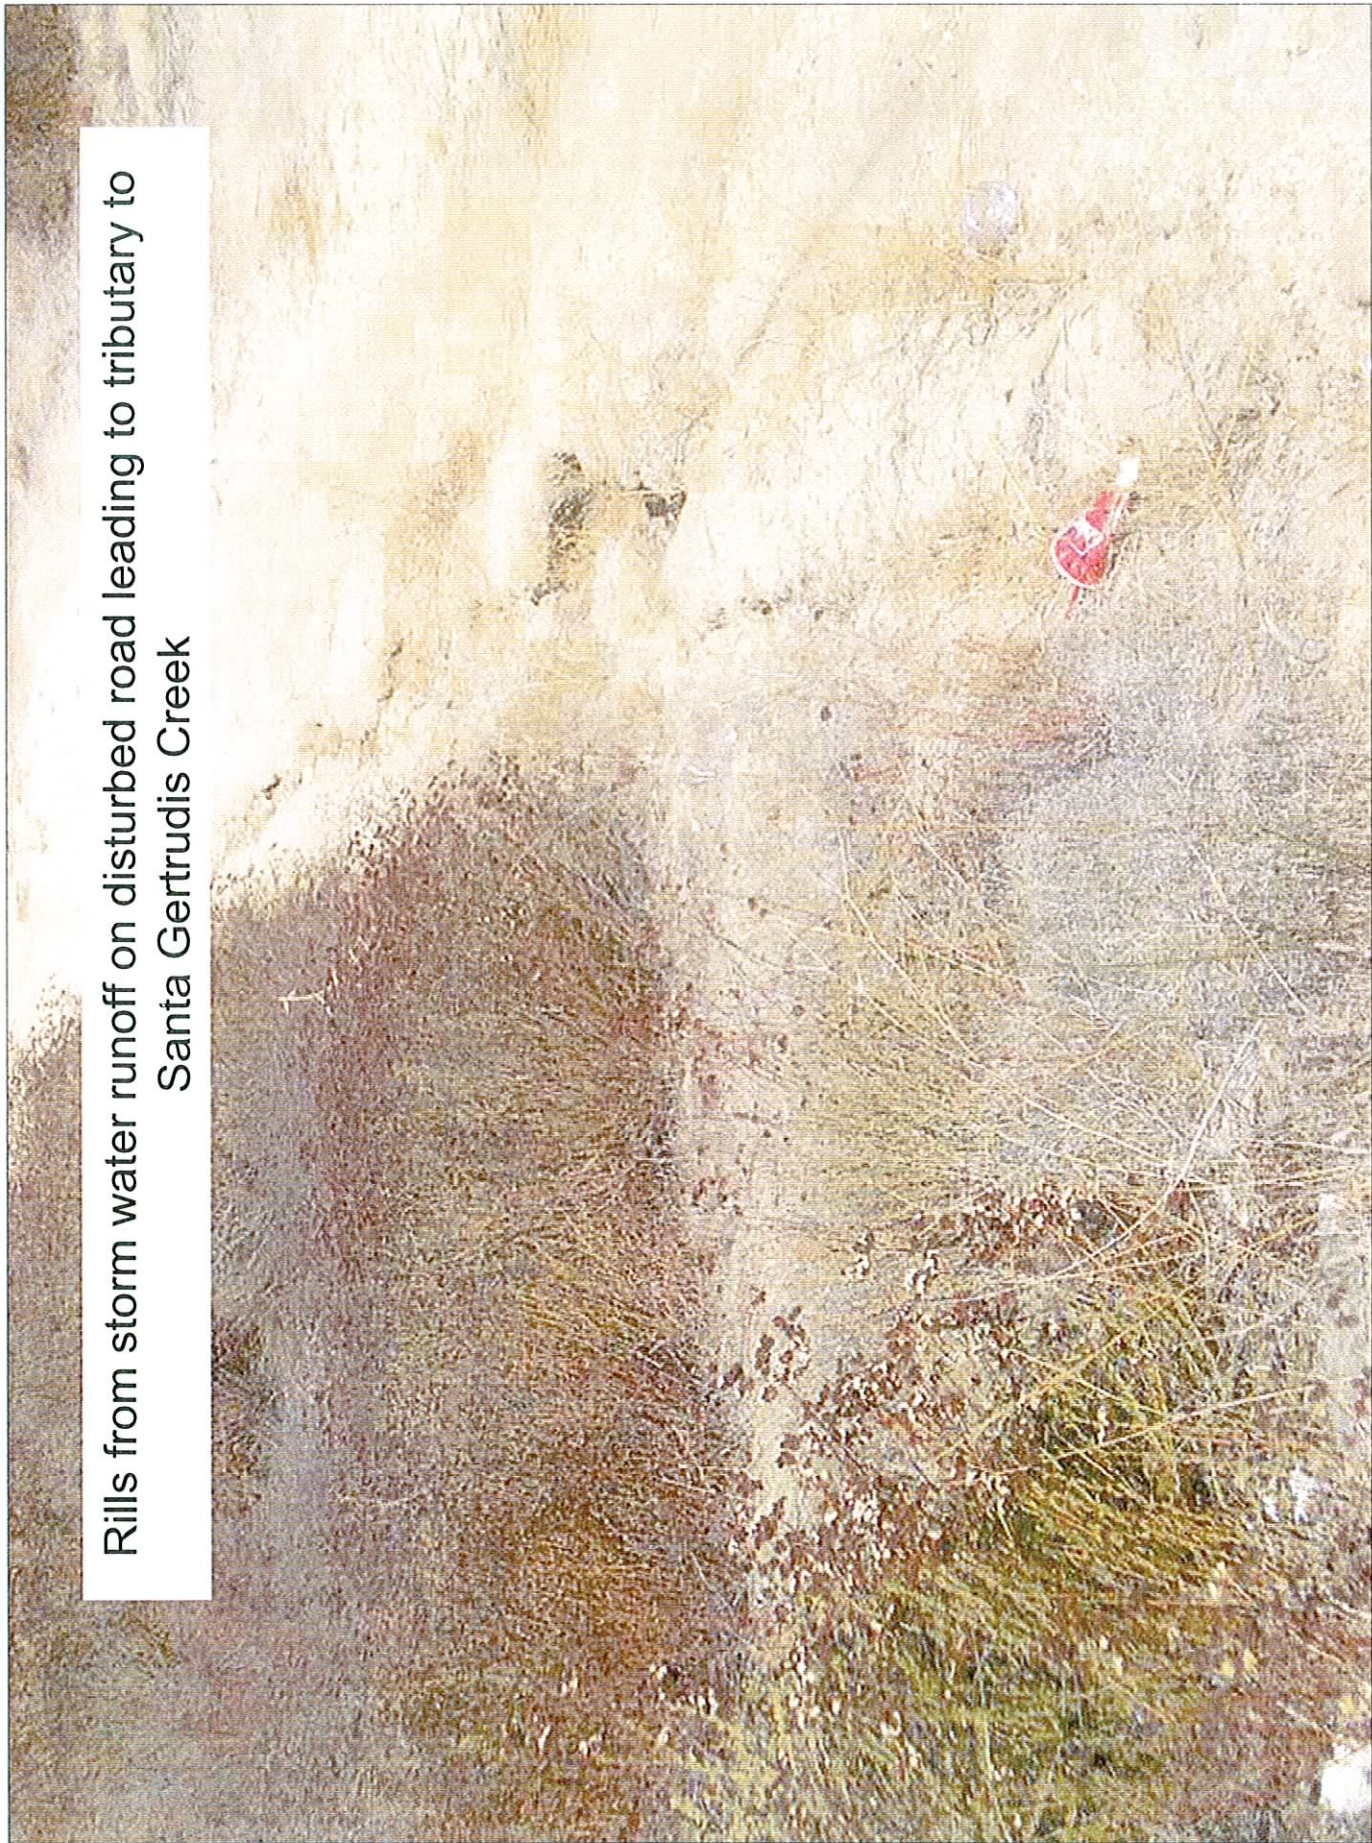
Rills from storm water runoff on disturbed road leading to tributary to  
Santa Gertrudis Creek

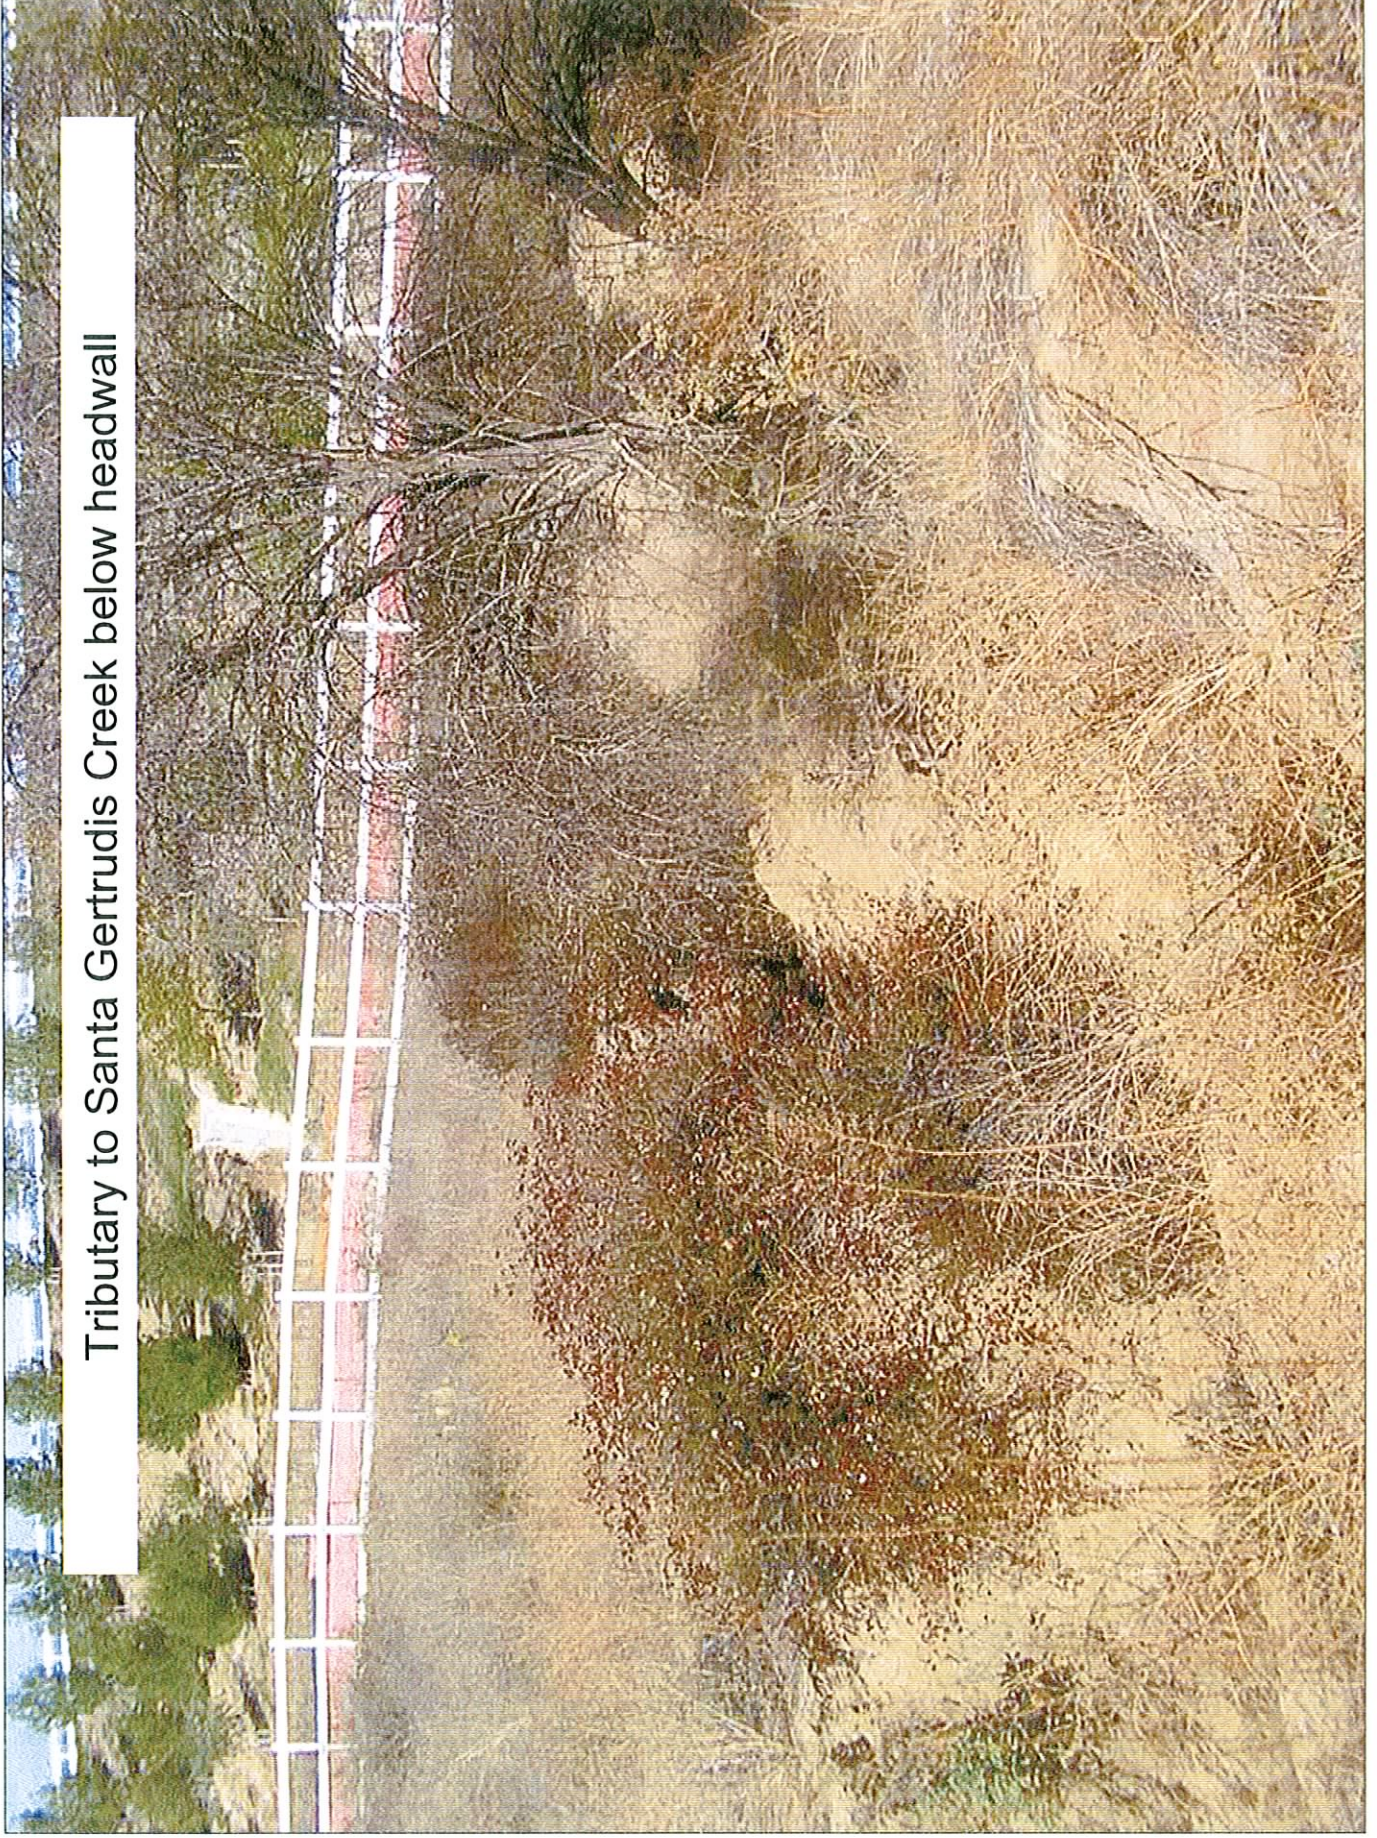
Tributary to Santa Gertrudis Creek below headwall

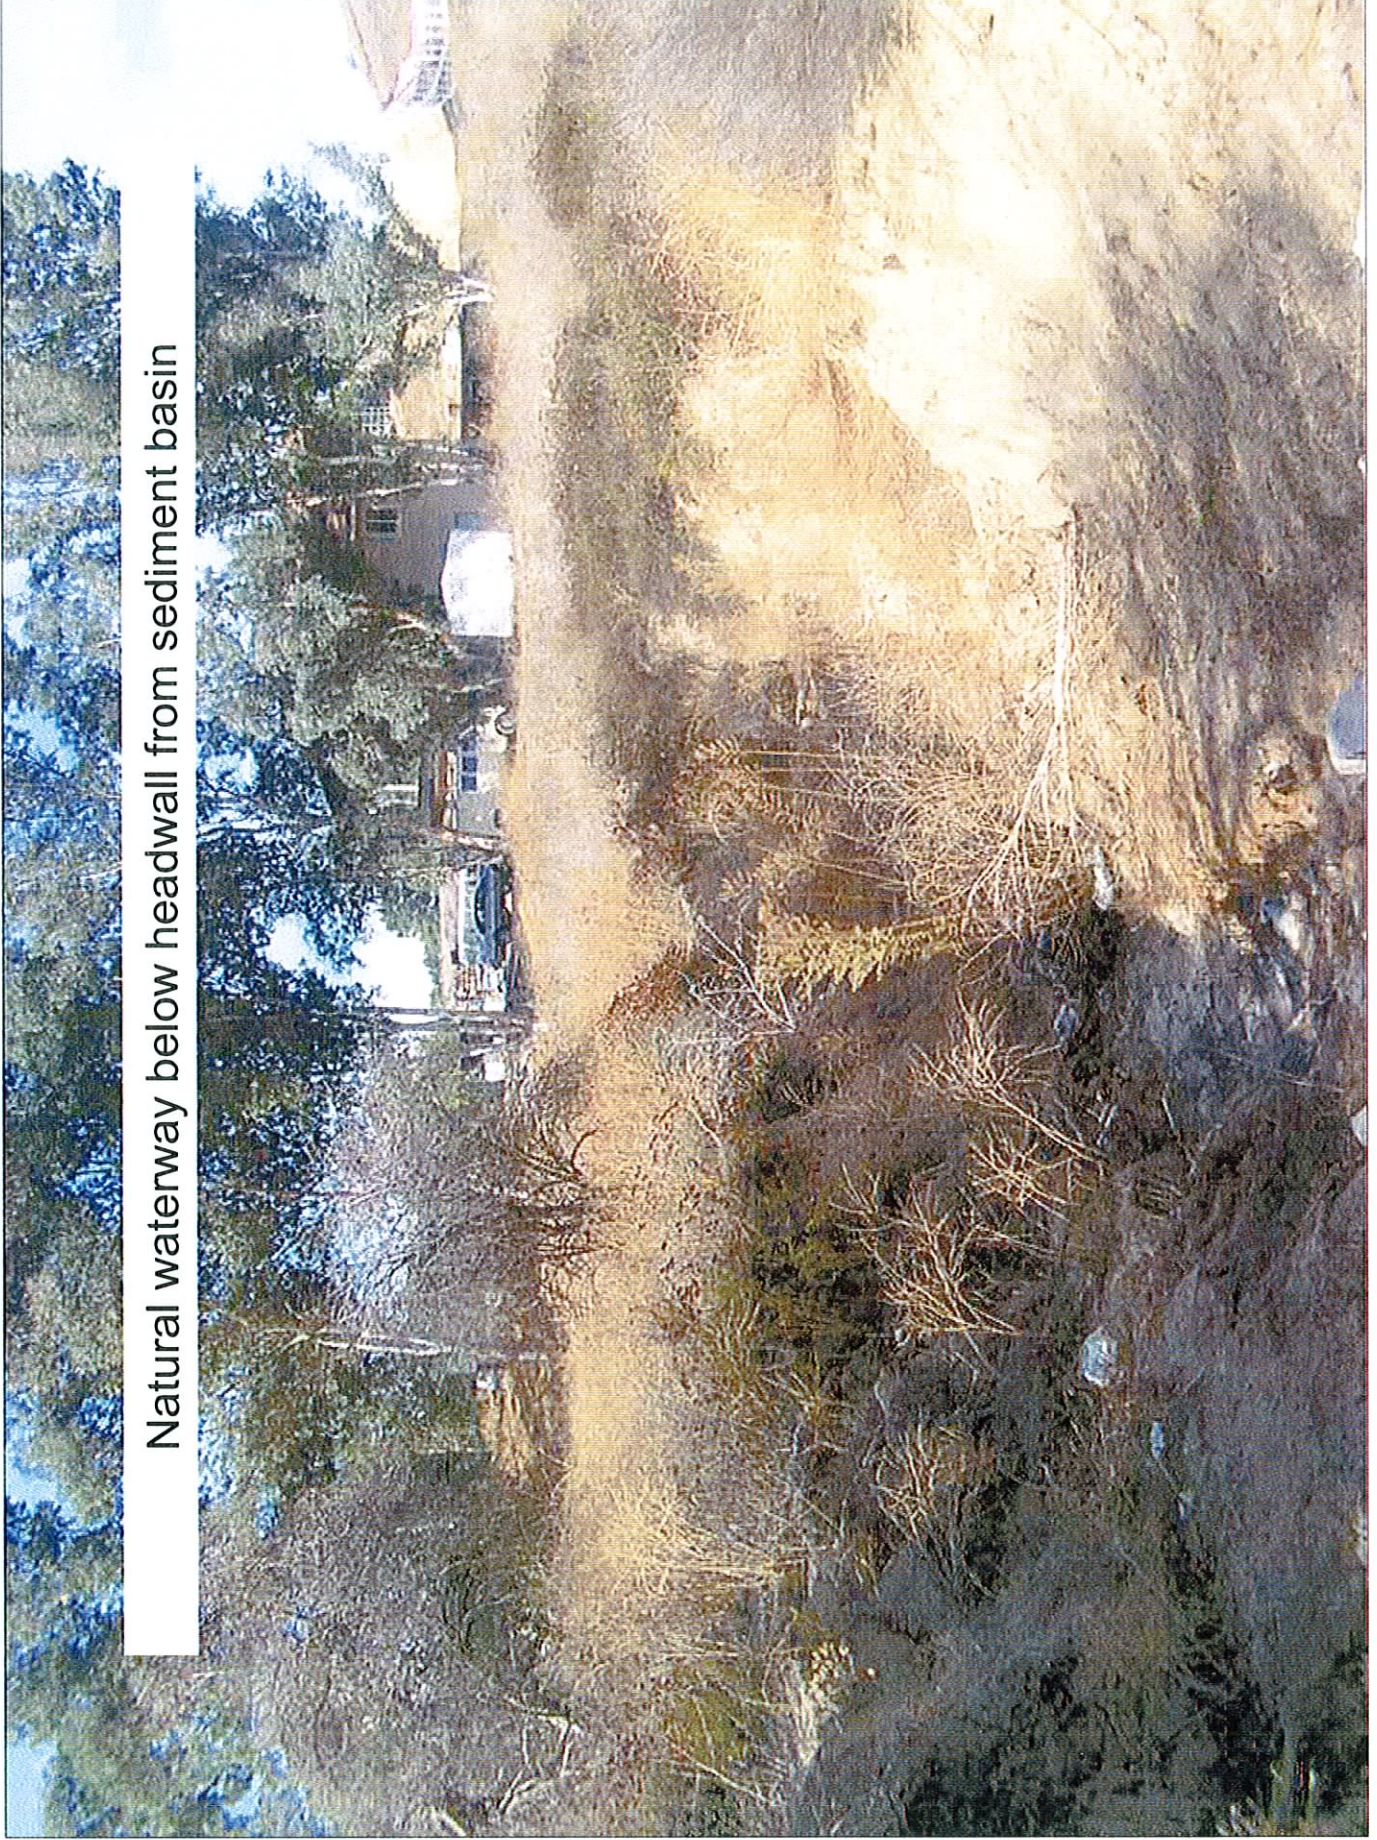
Natural waterway below headwall from sediment basin

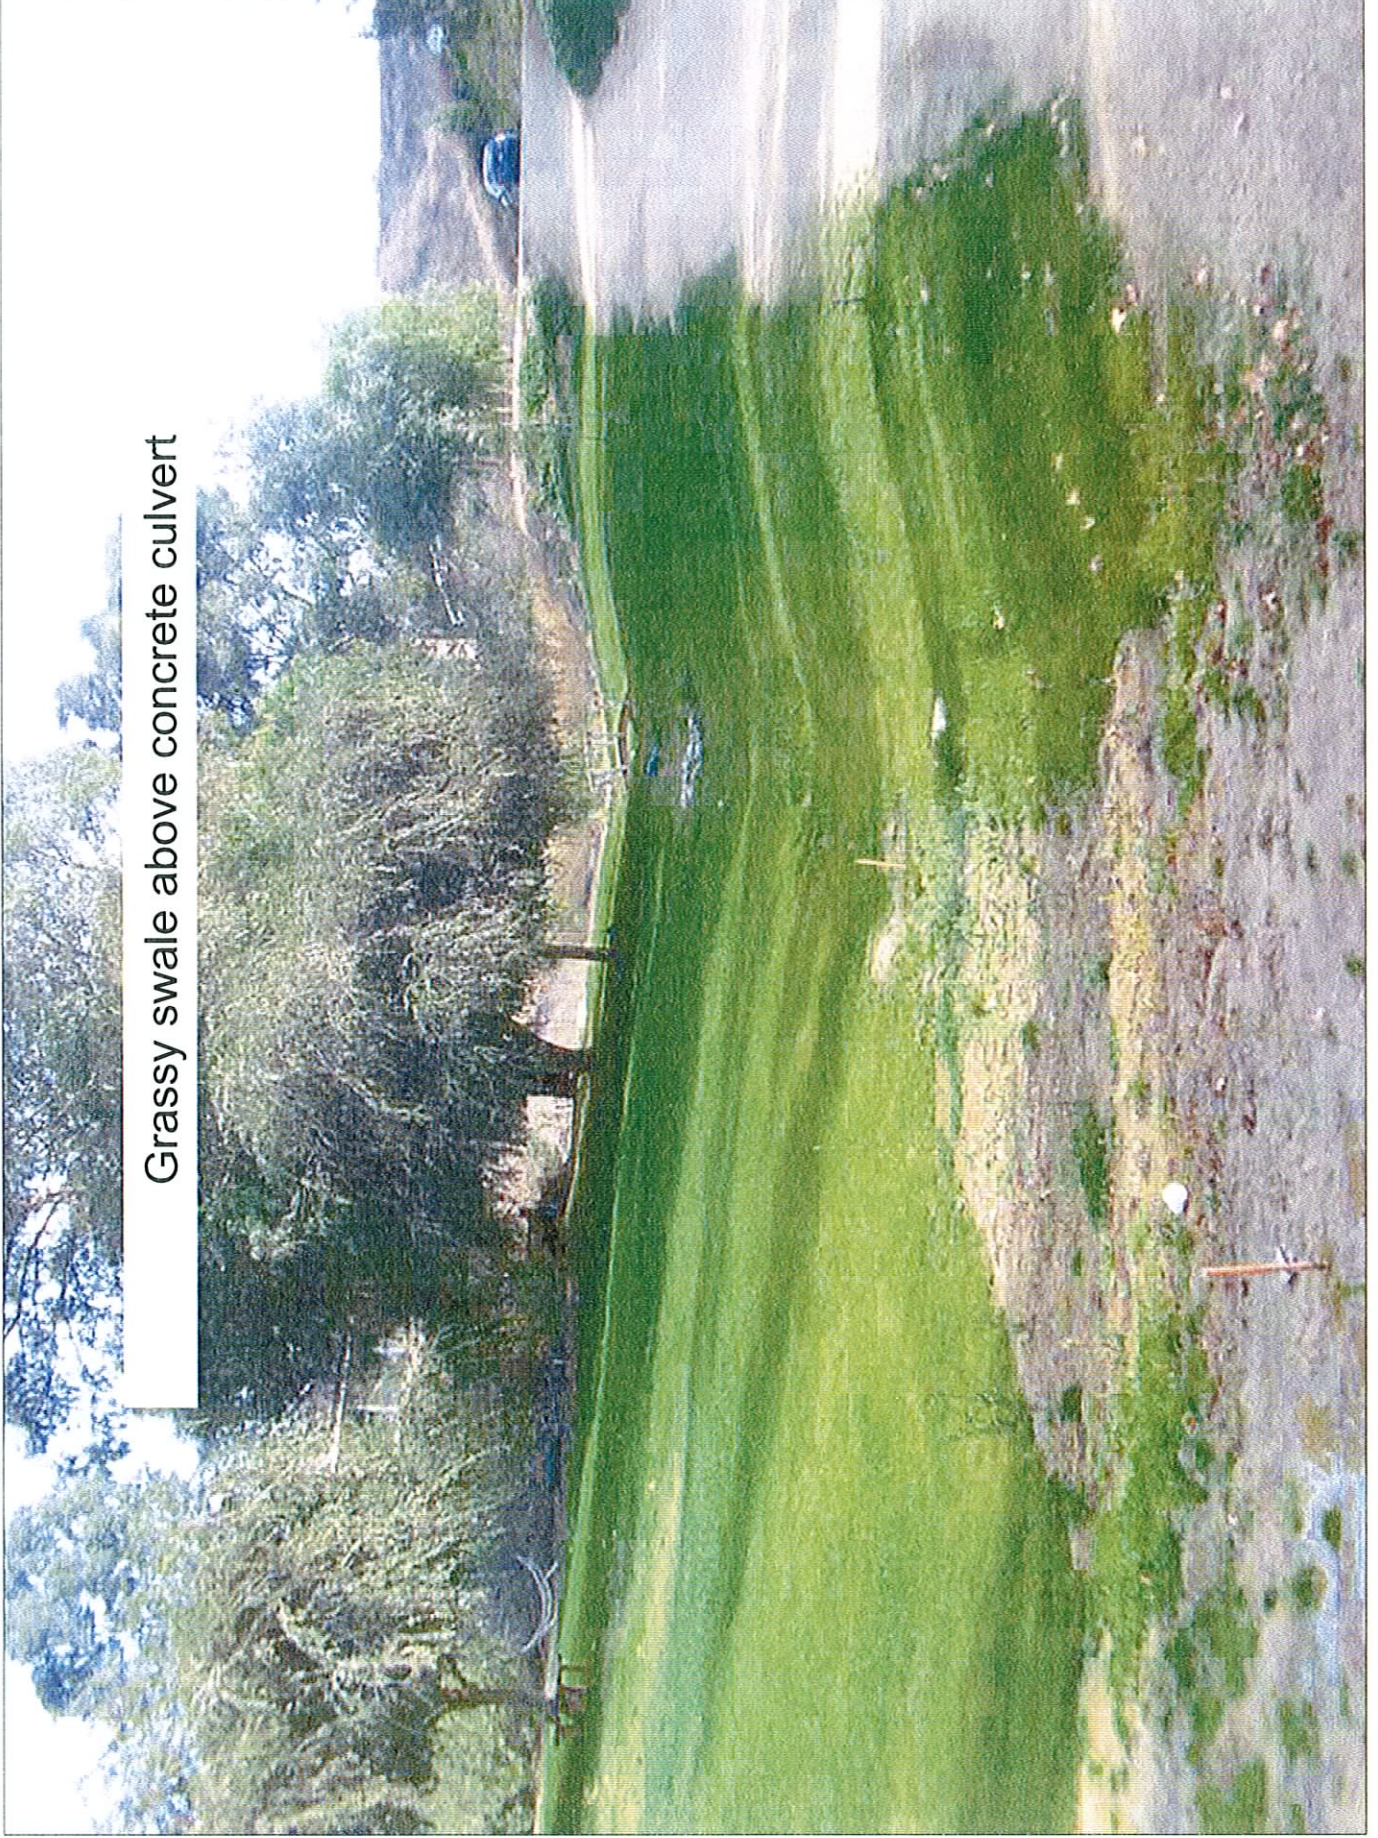
Grassy swale above concrete culvert

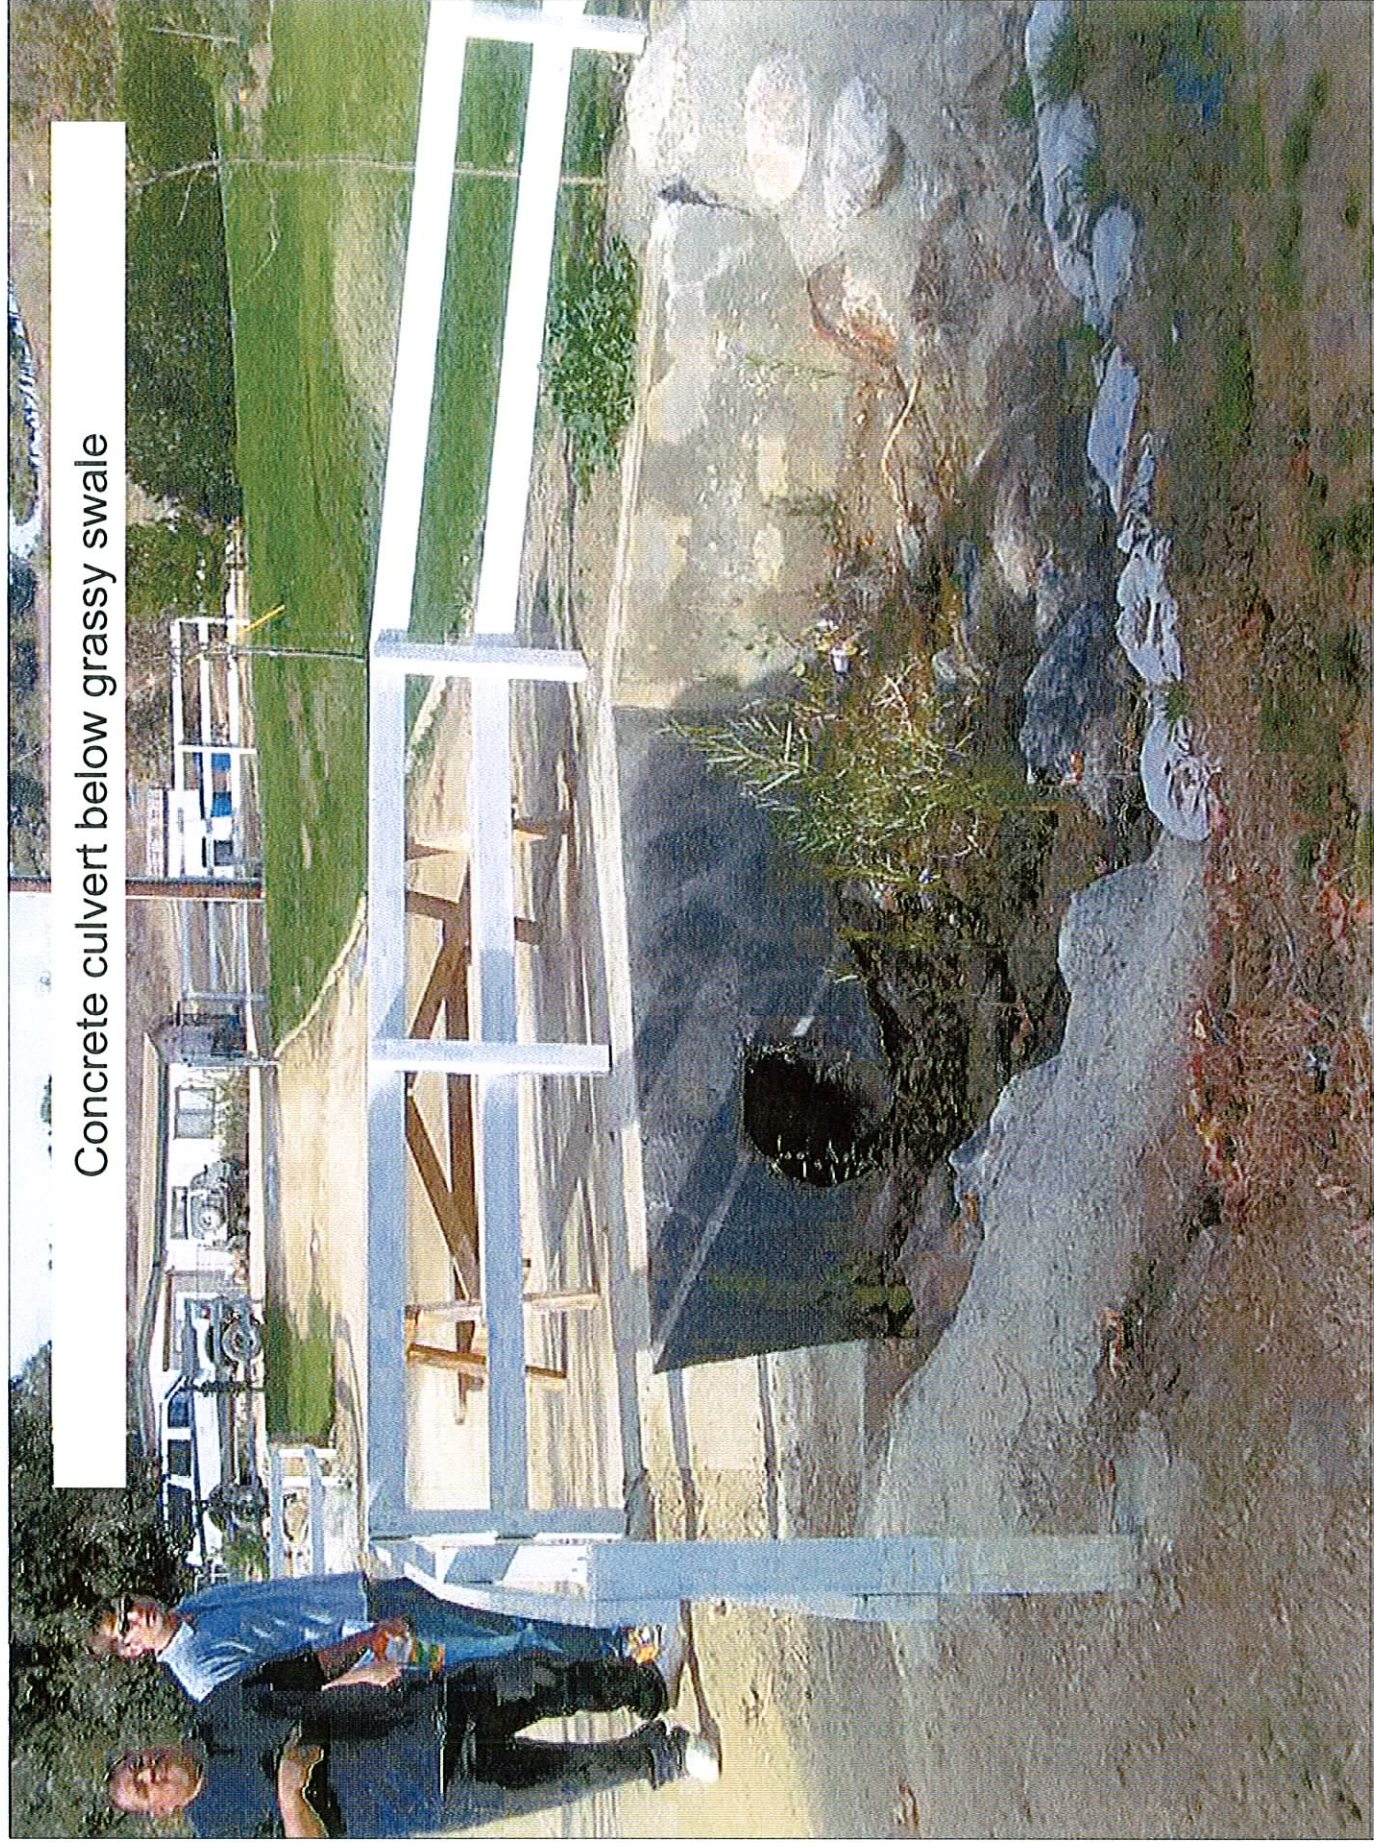
Concrete culvert below grassy swale
