# ASHBY USA, LLC

Ref: WPN: 10-3020657.02, 18-2001091.02:schwk  
NOV No. R9-2006-0135

Subject: Required Technical Report

Ashby USA  
Notice of Violation Response  
Photos  
November 28, 2006

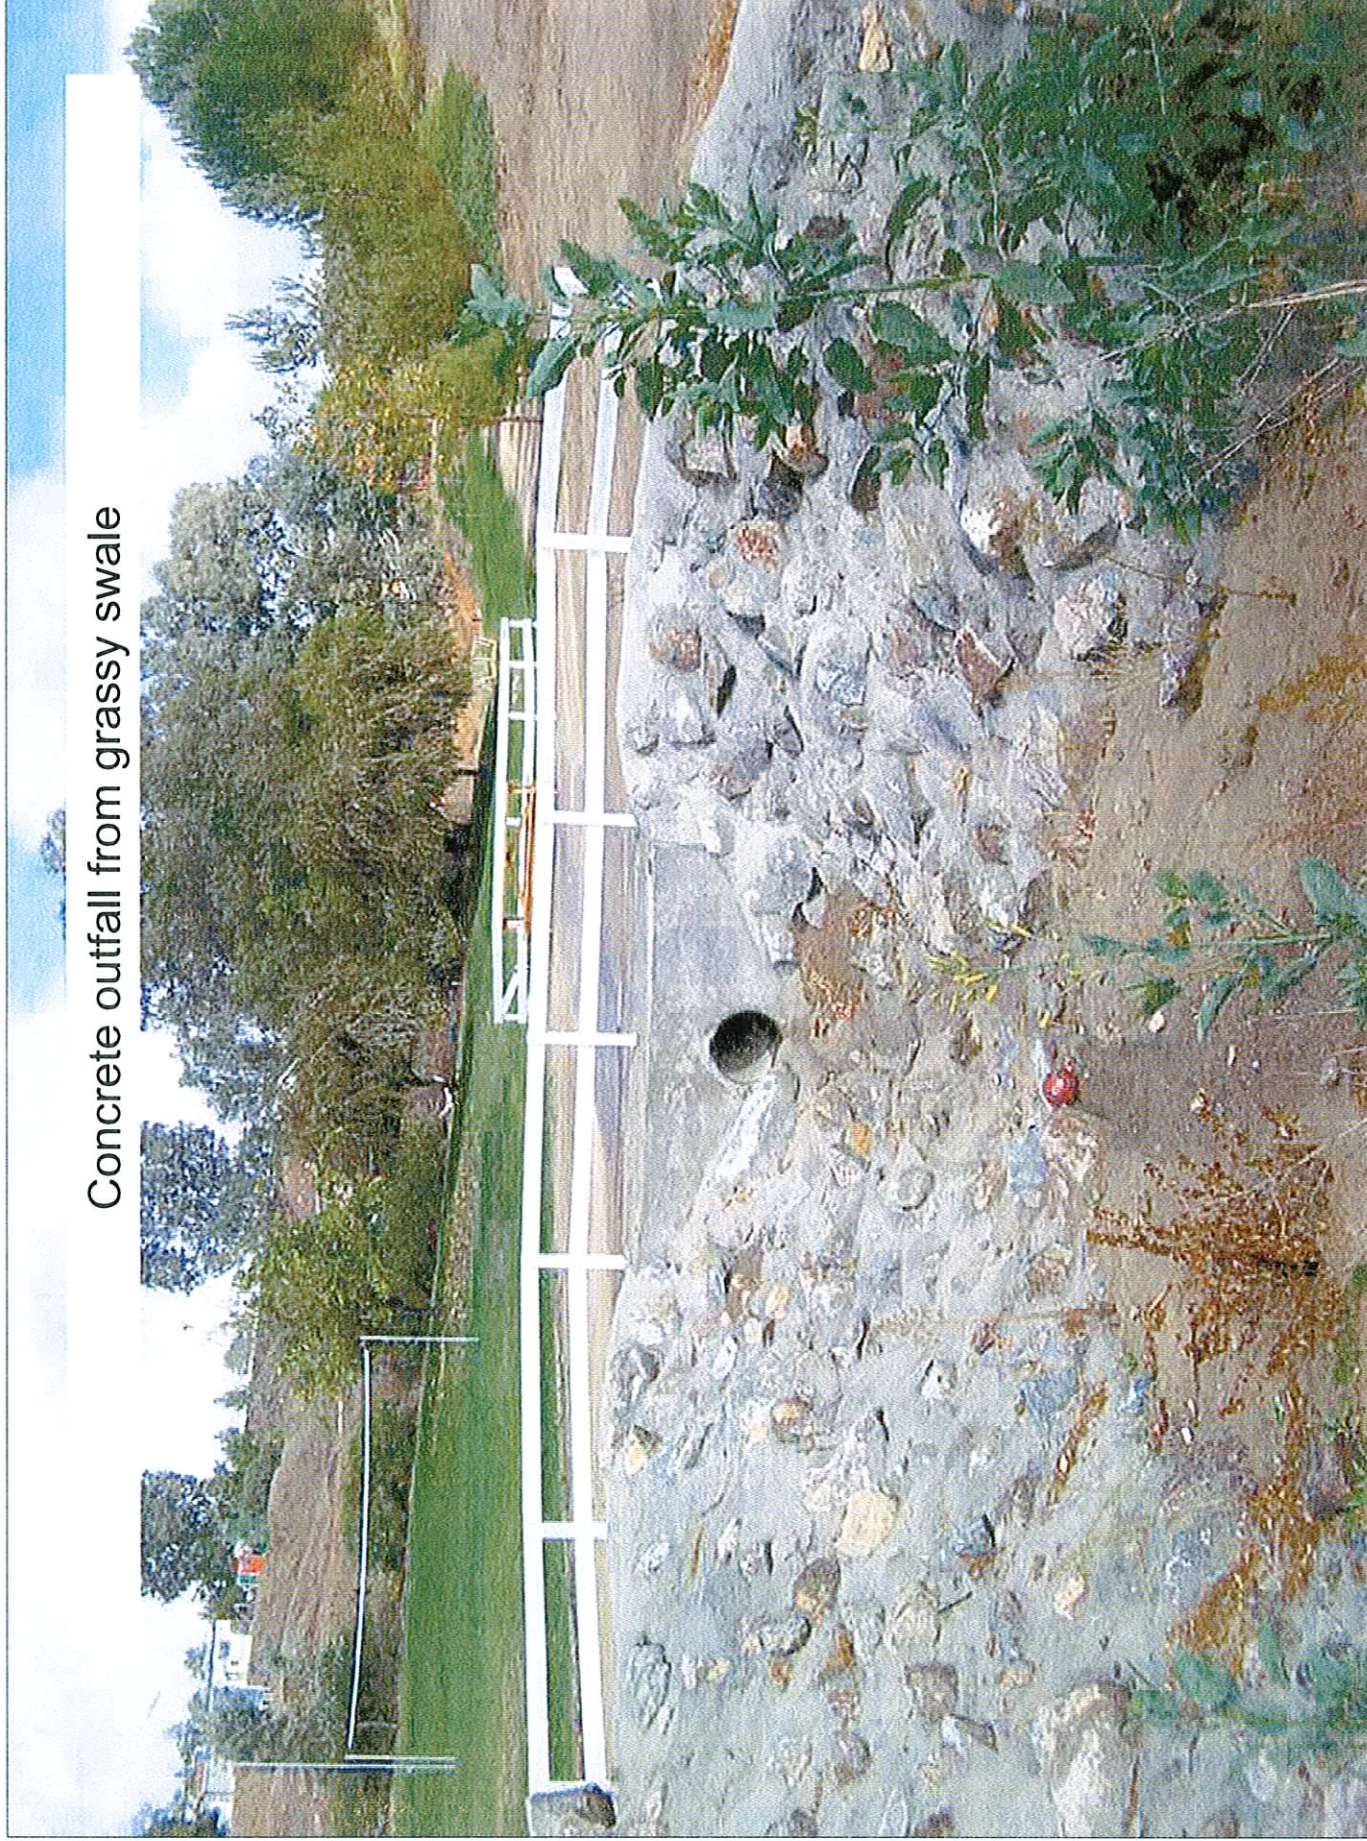
Concrete outfall from grassy swale

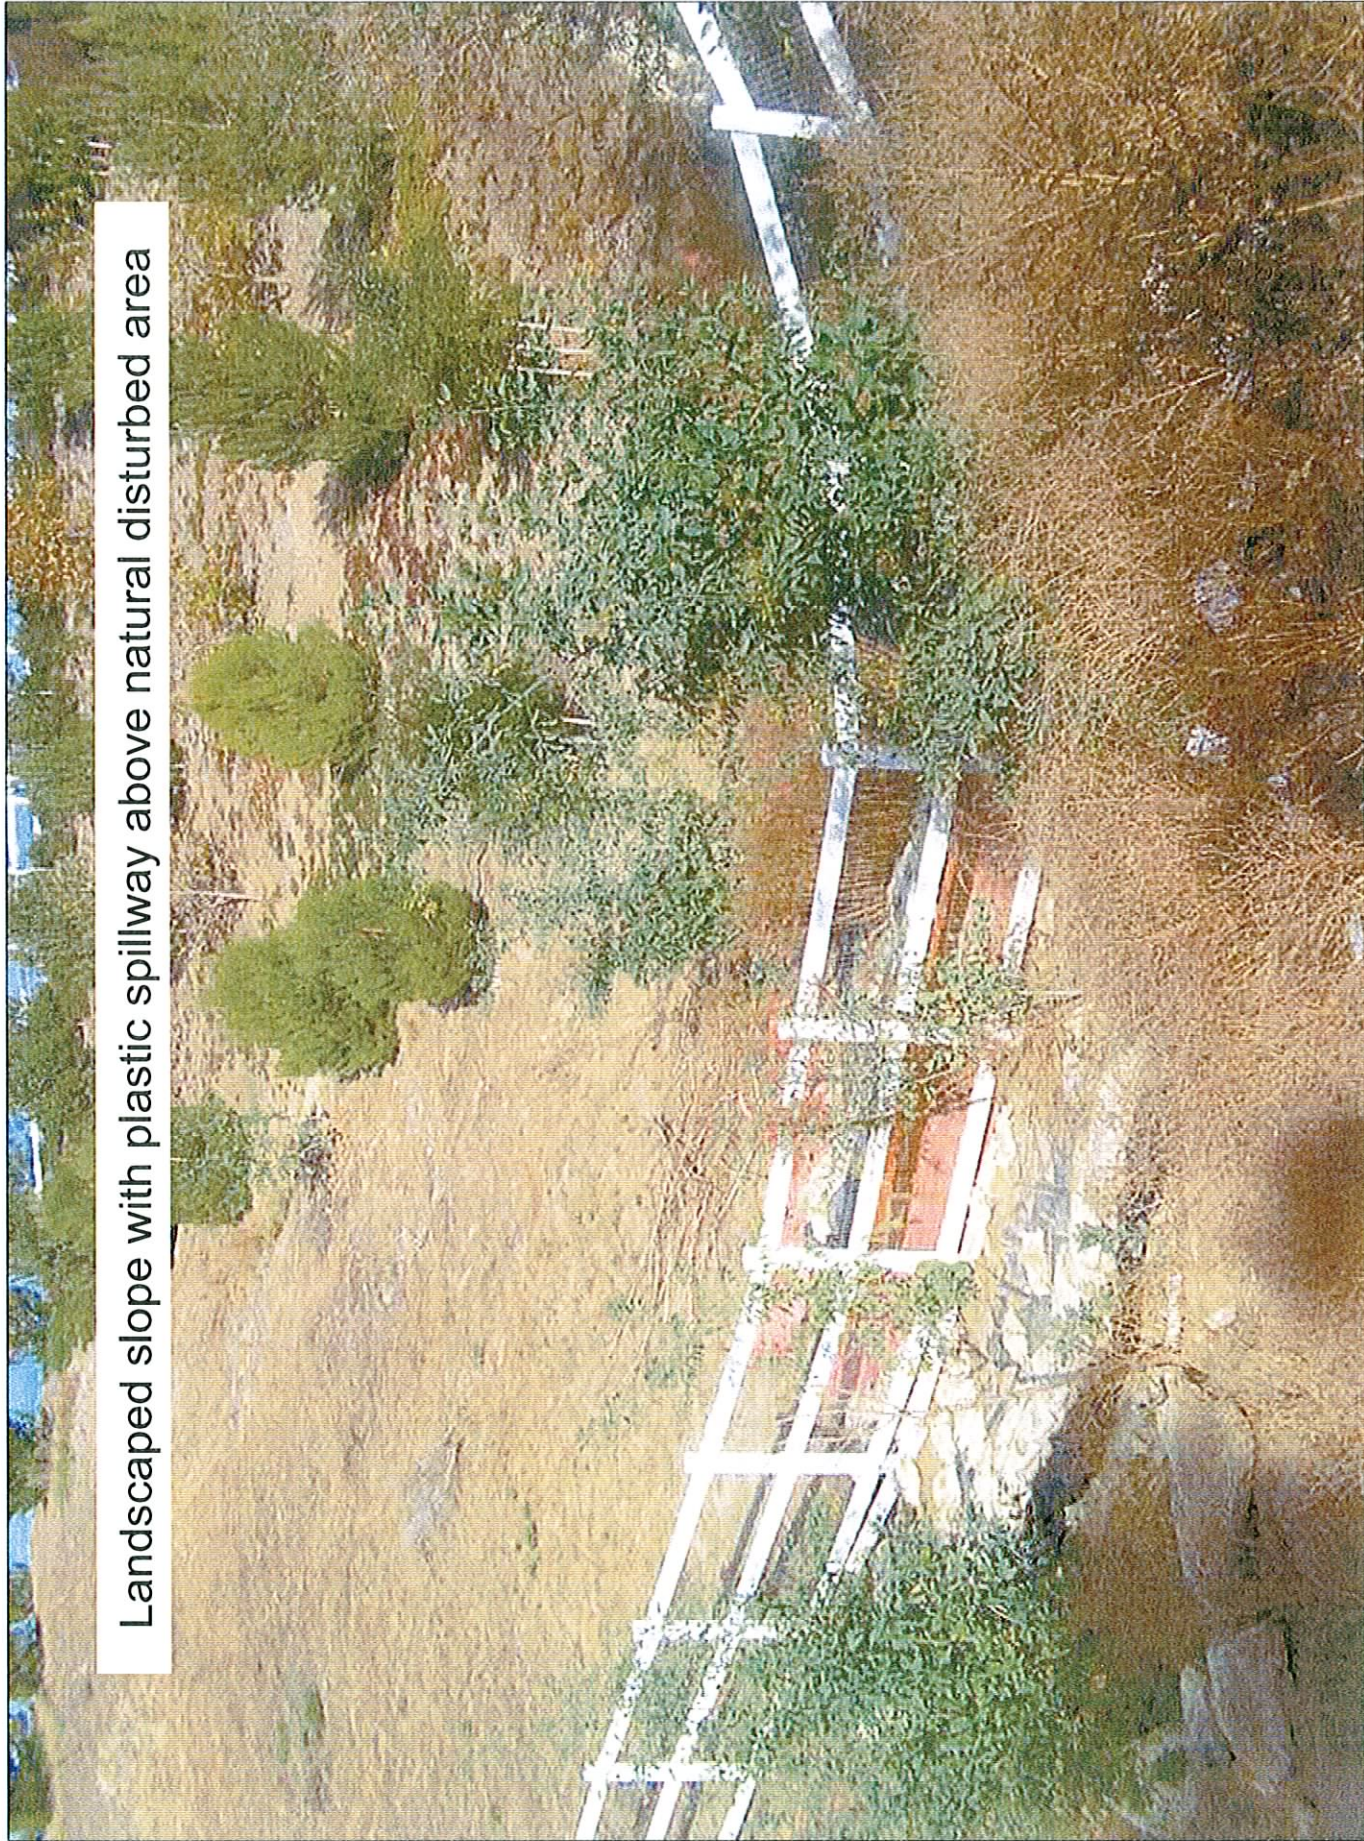
Landscaped slope with plastic spillway above natural disturbed area

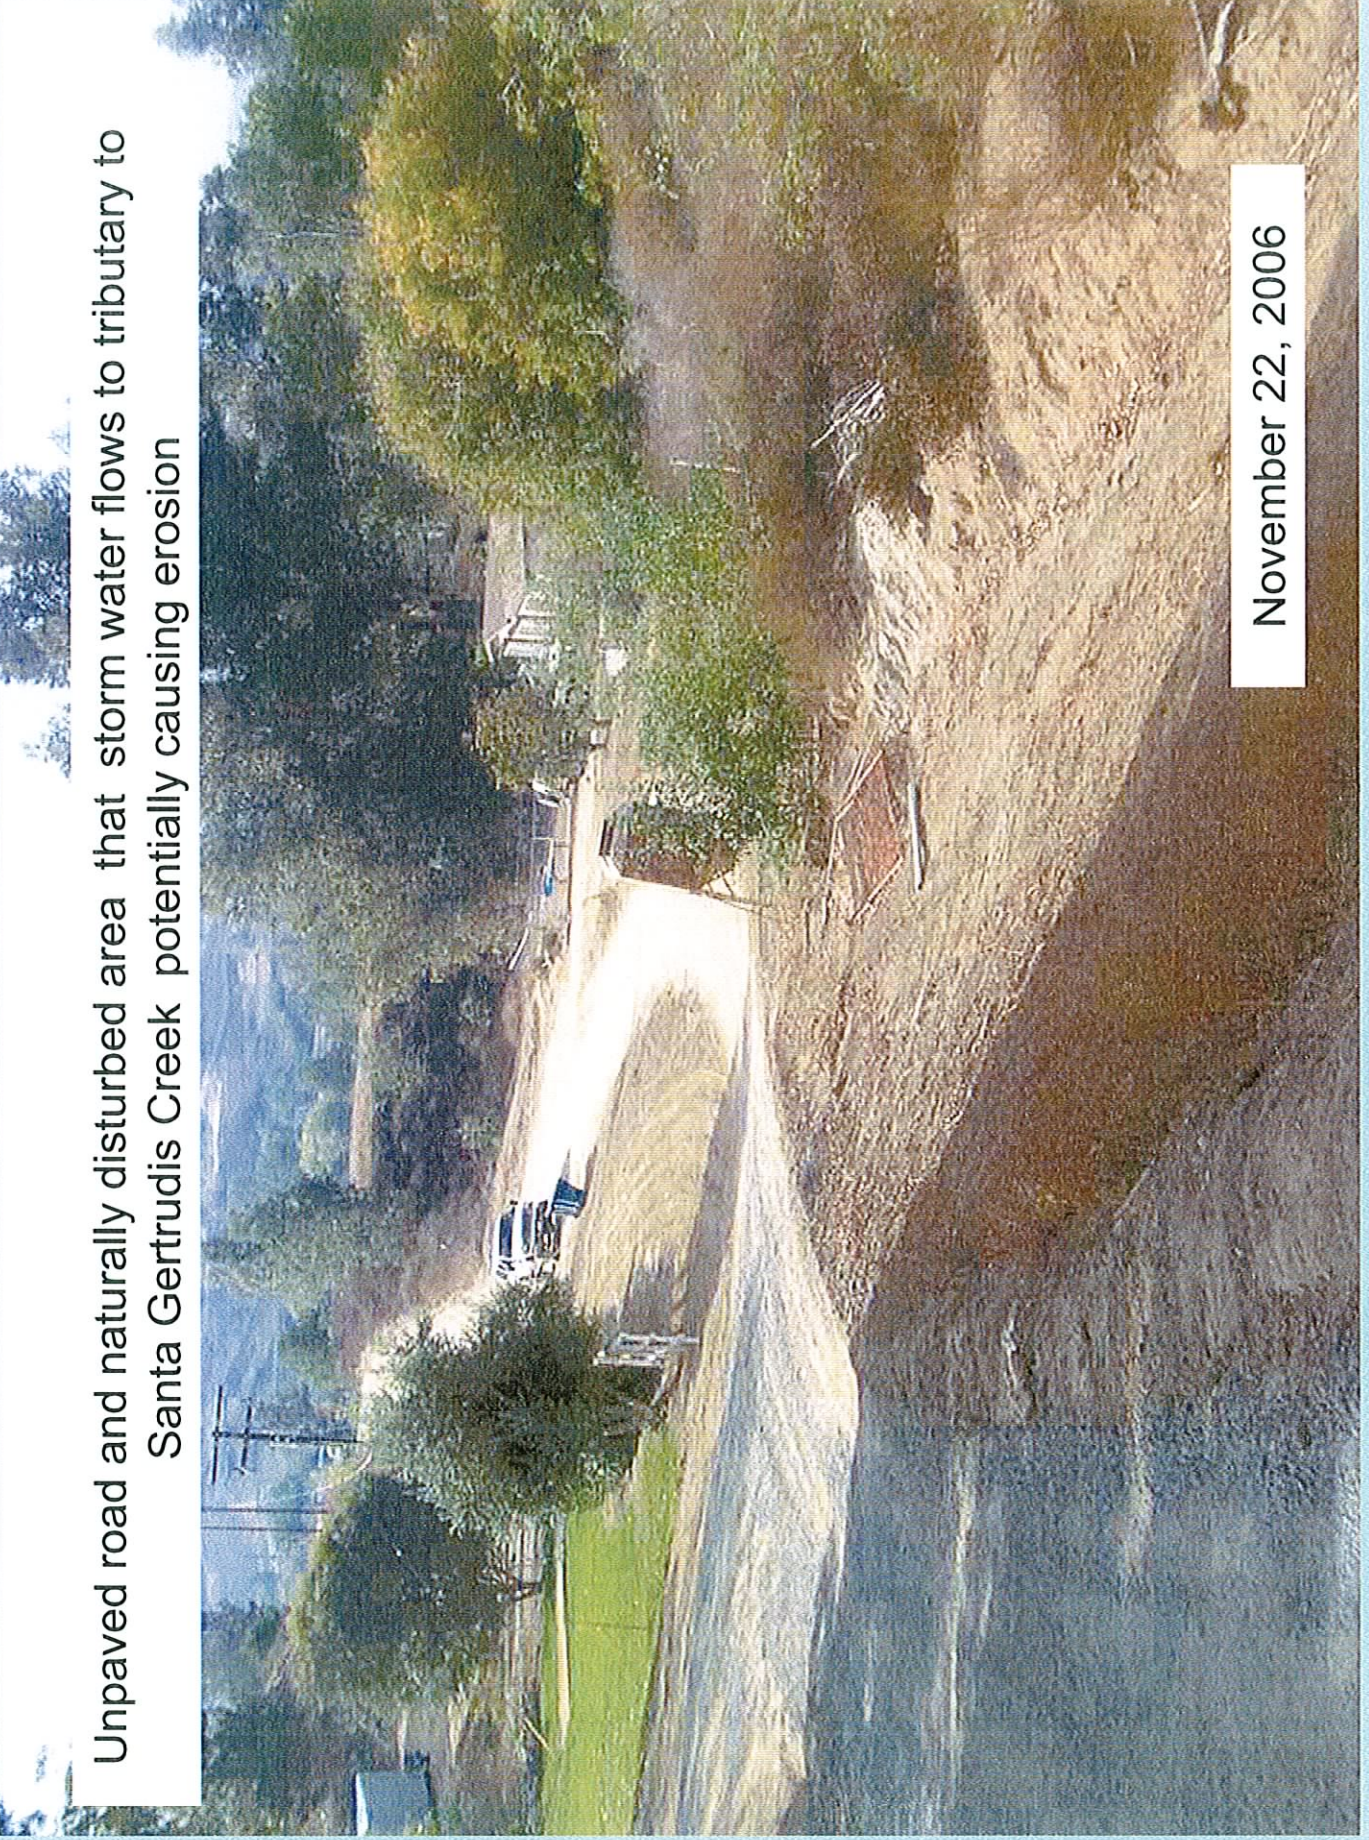
Unpaved road and naturally disturbed area that storm water flows to tributary to Santa Gertrudis Creek potentially causing erosion

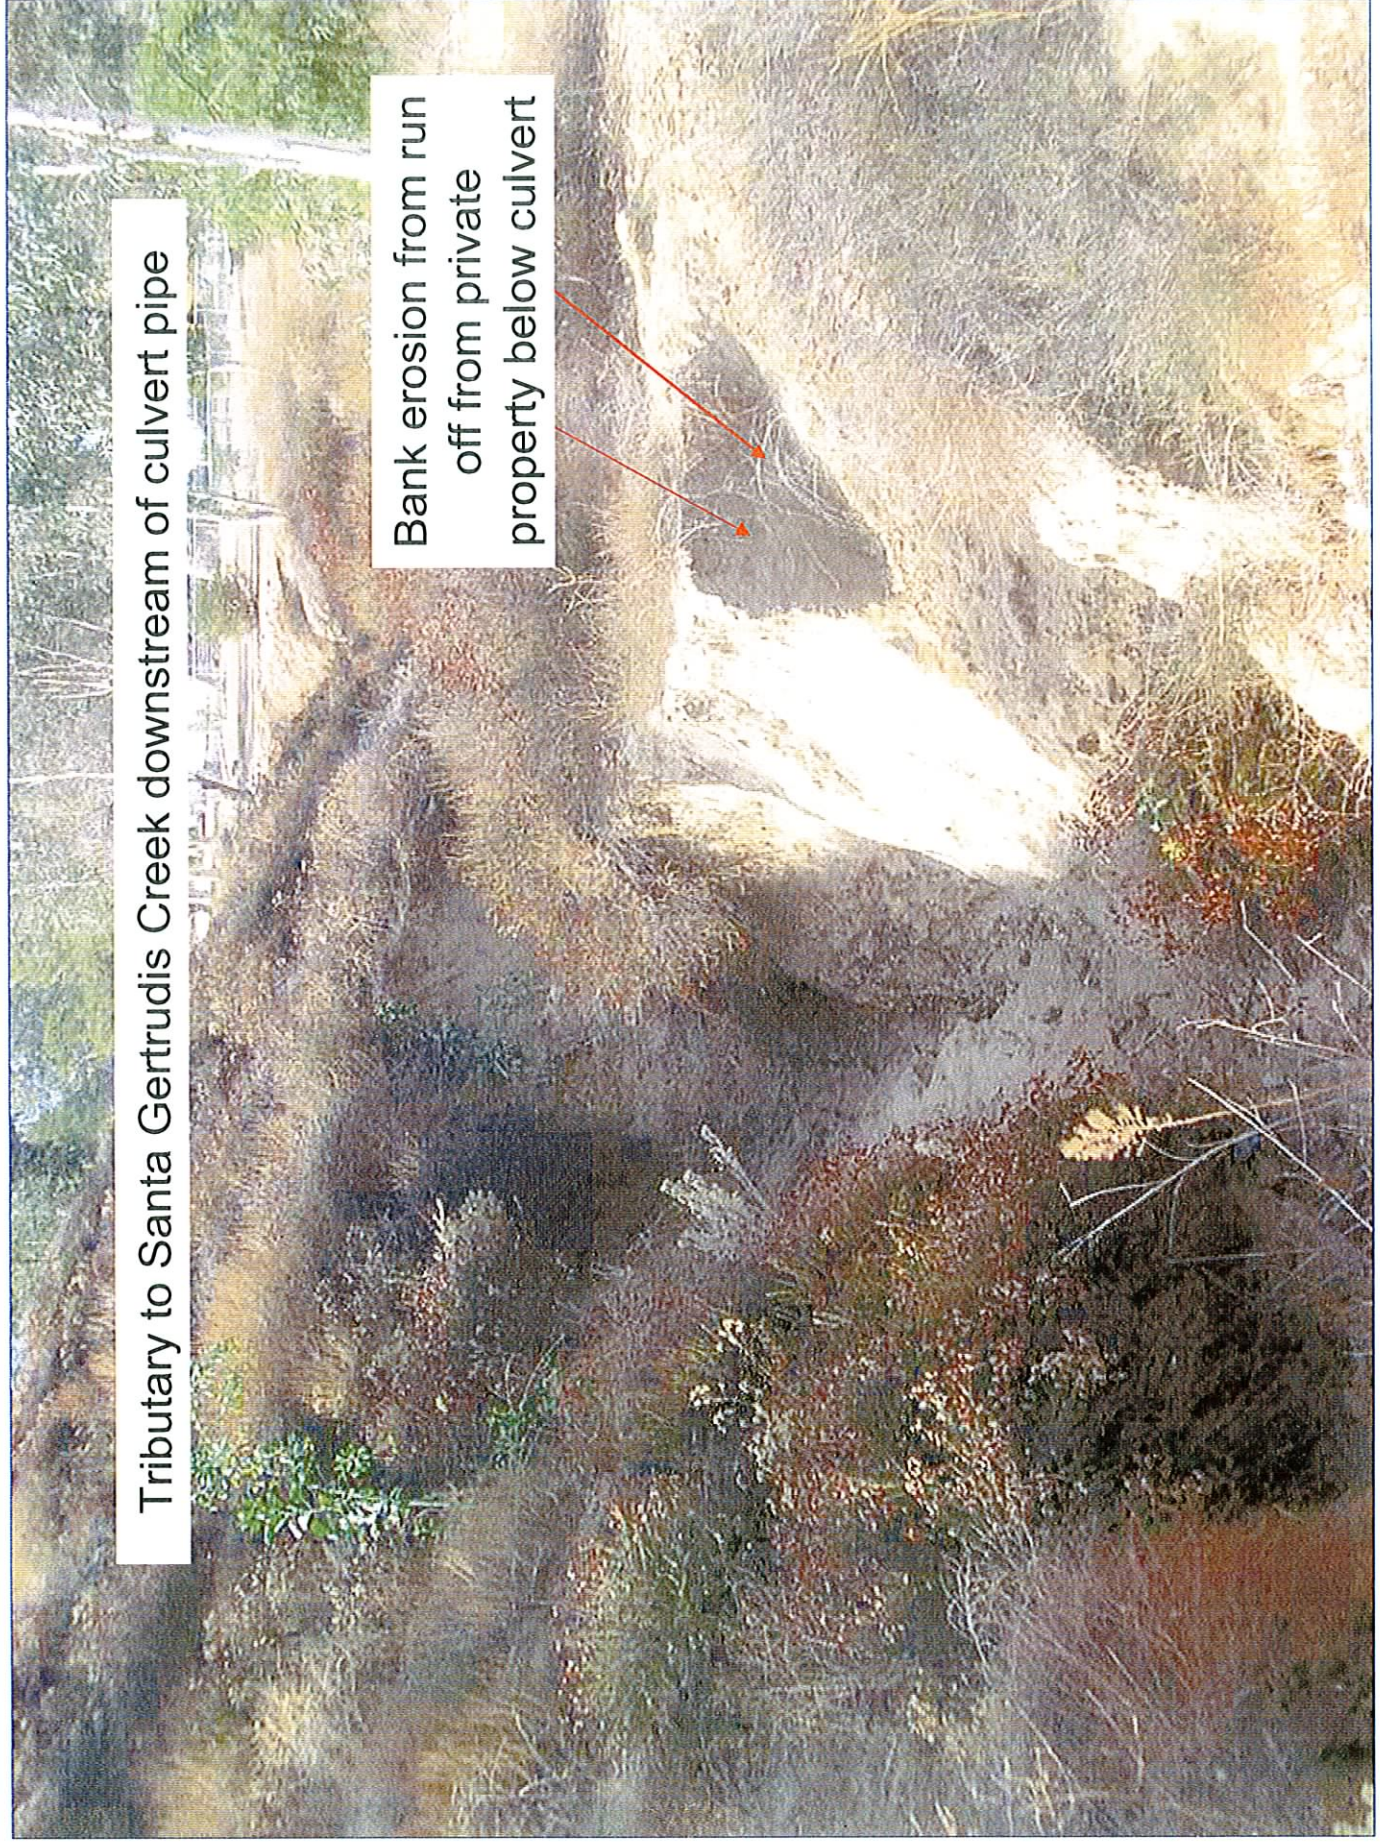
Tributary to Santa Gertrudis Creek downstream of culvert pipe

Bank erosion from run  
off from private  
property below culvert

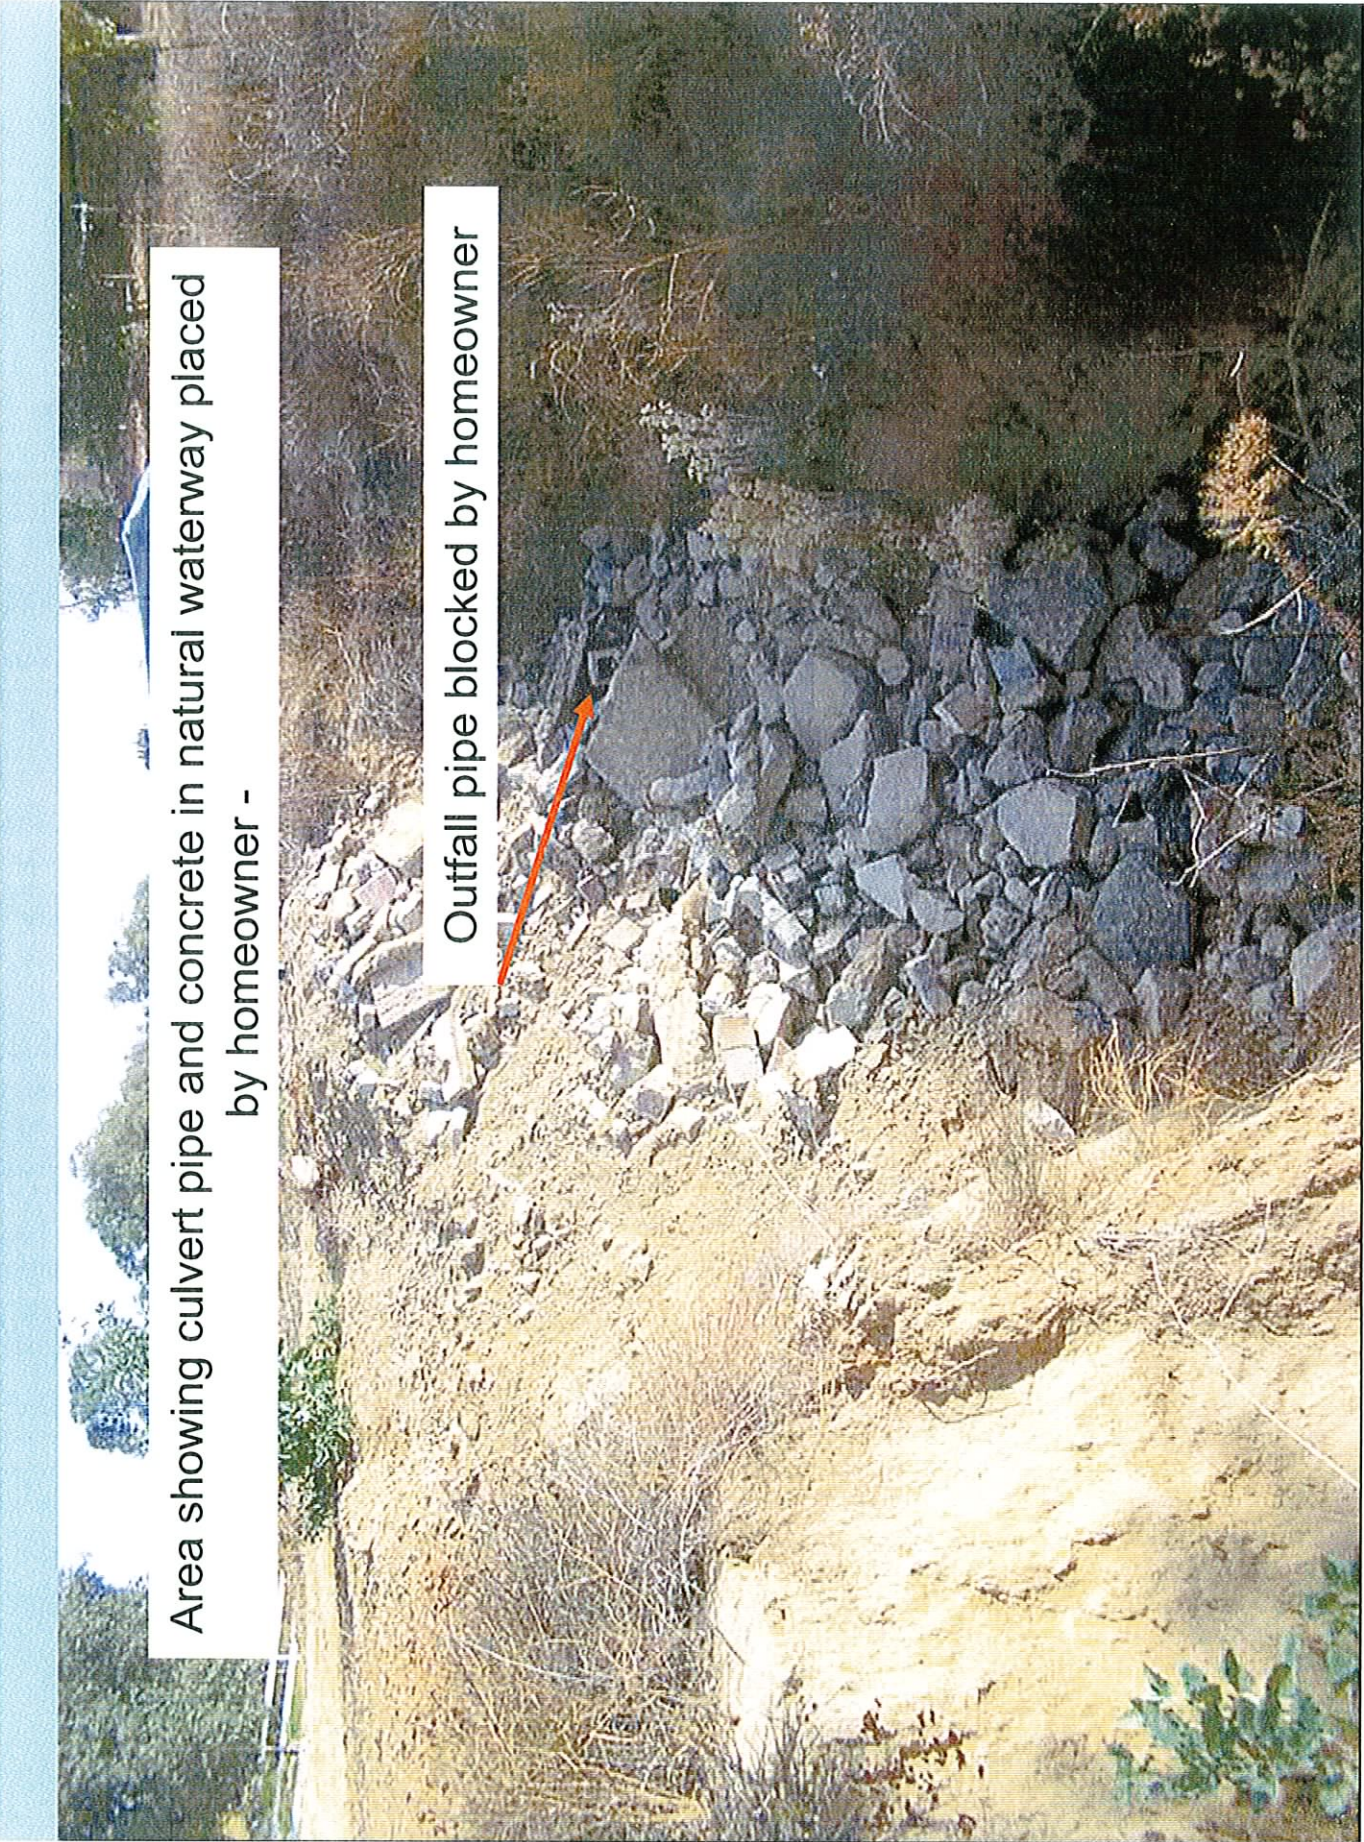
Area showing culvert pipe and concrete in natural waterway placed by homeowner -

Outfall pipe blocked by homeowner

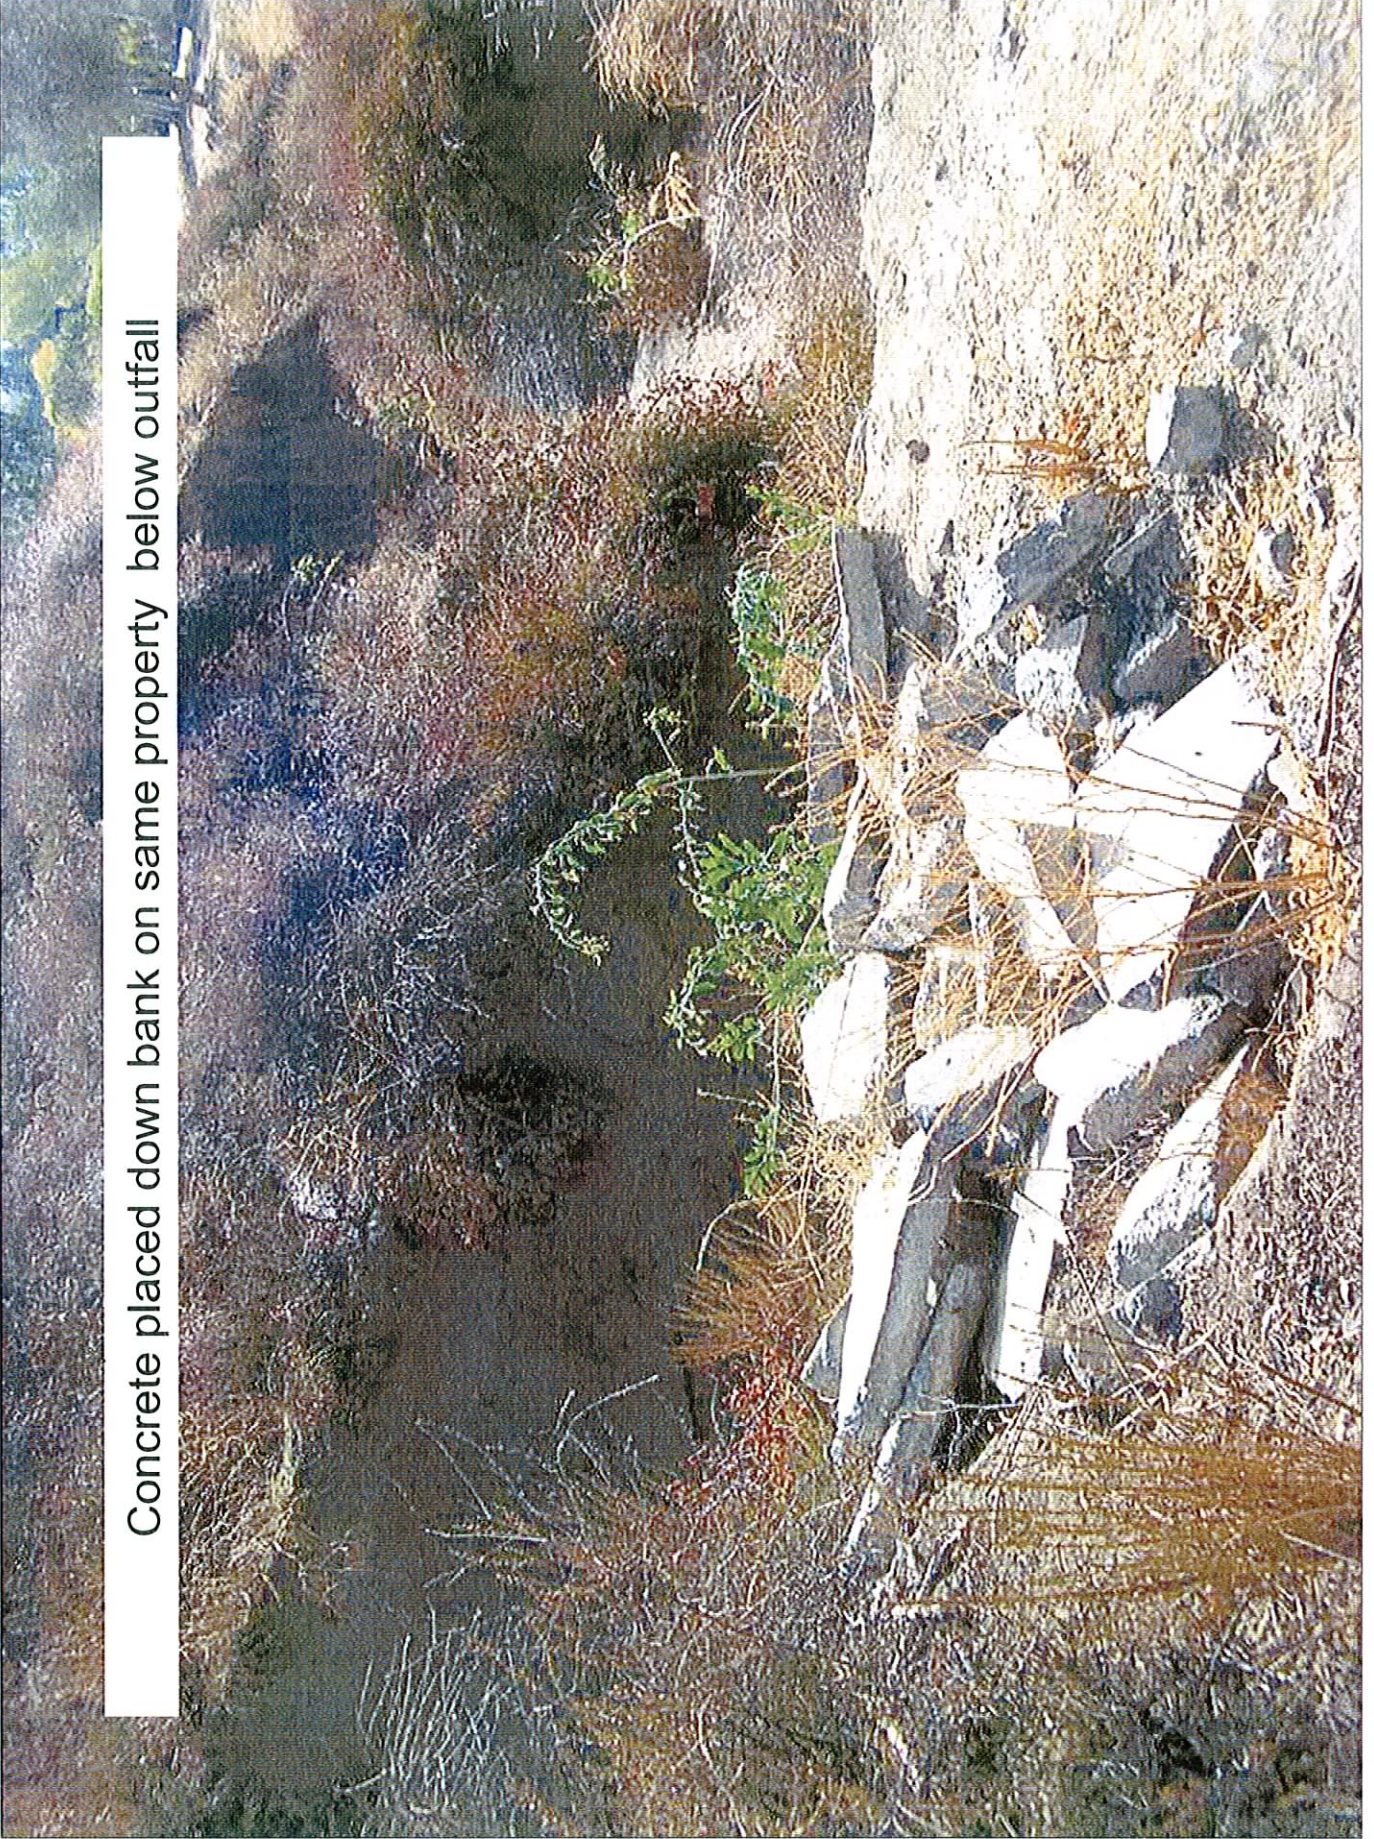
Concrete placed down bank on same property below outfall

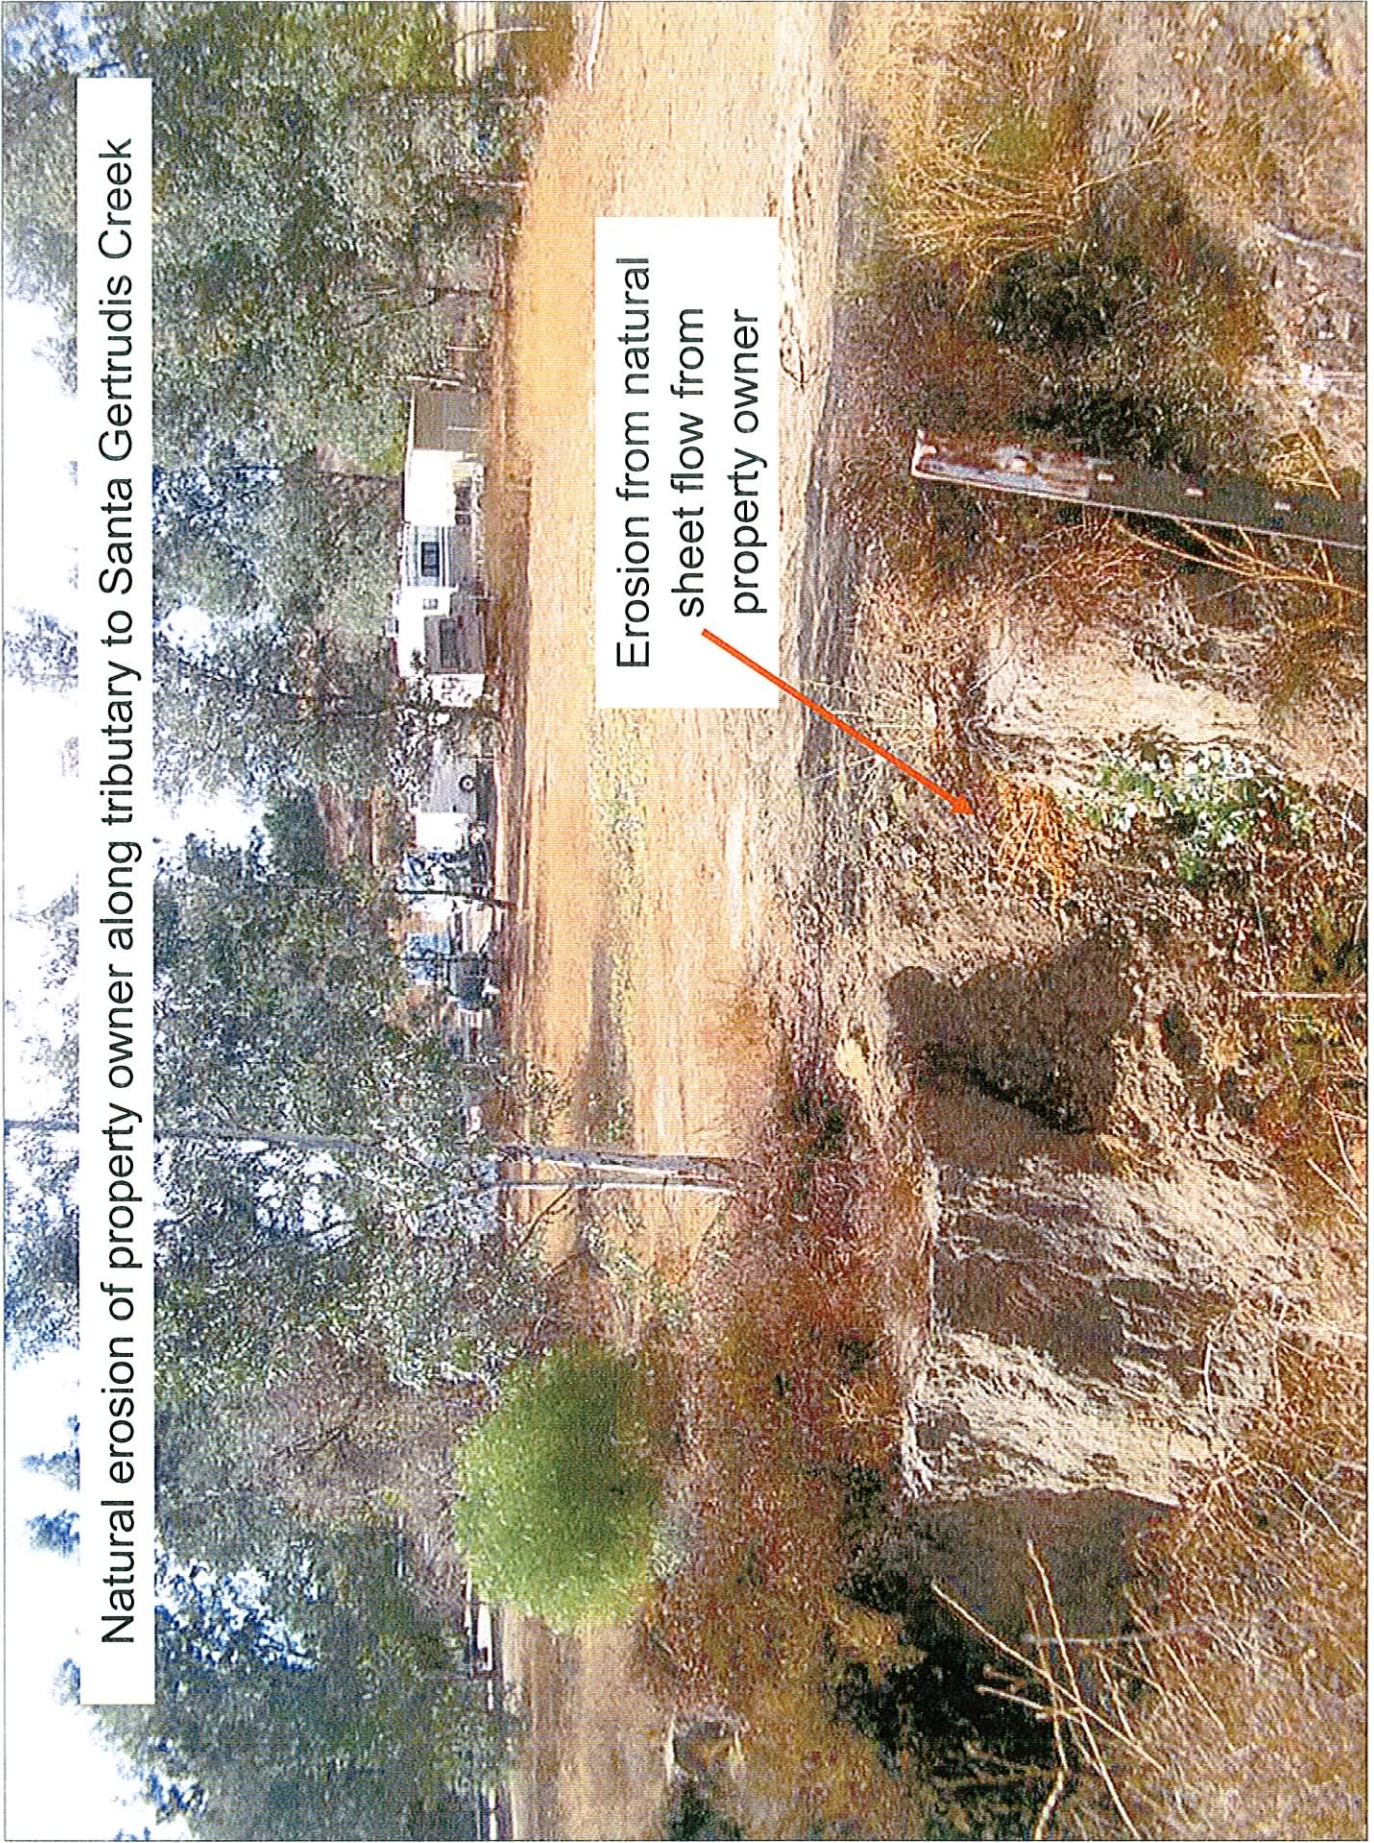
Natural erosion of property owner along tributary to Santa Gertrudis Creek

Erosion from natural sheet flow from property owner

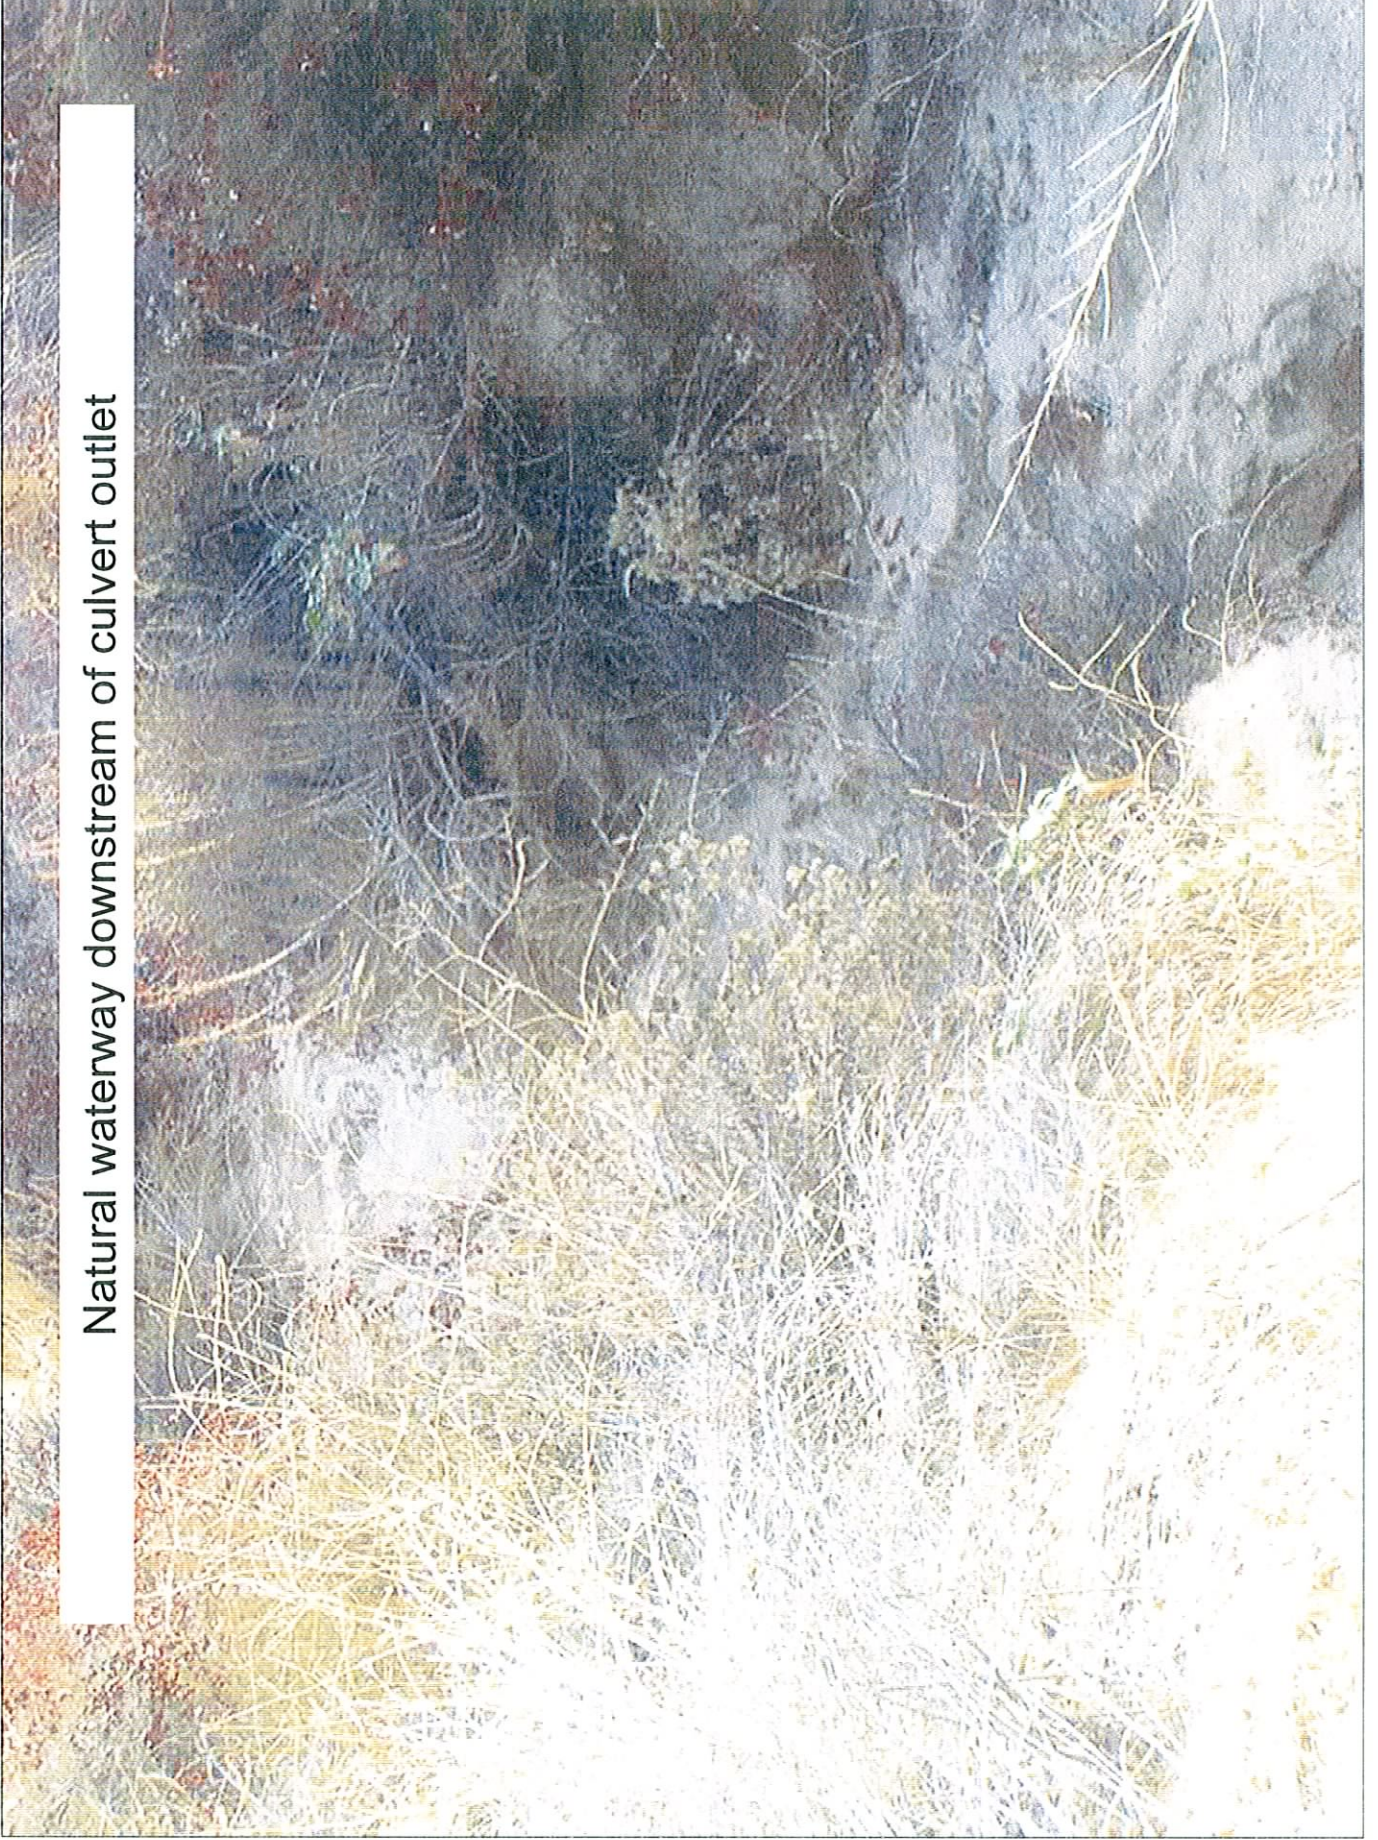
Natural waterway downstream of culvert outlet

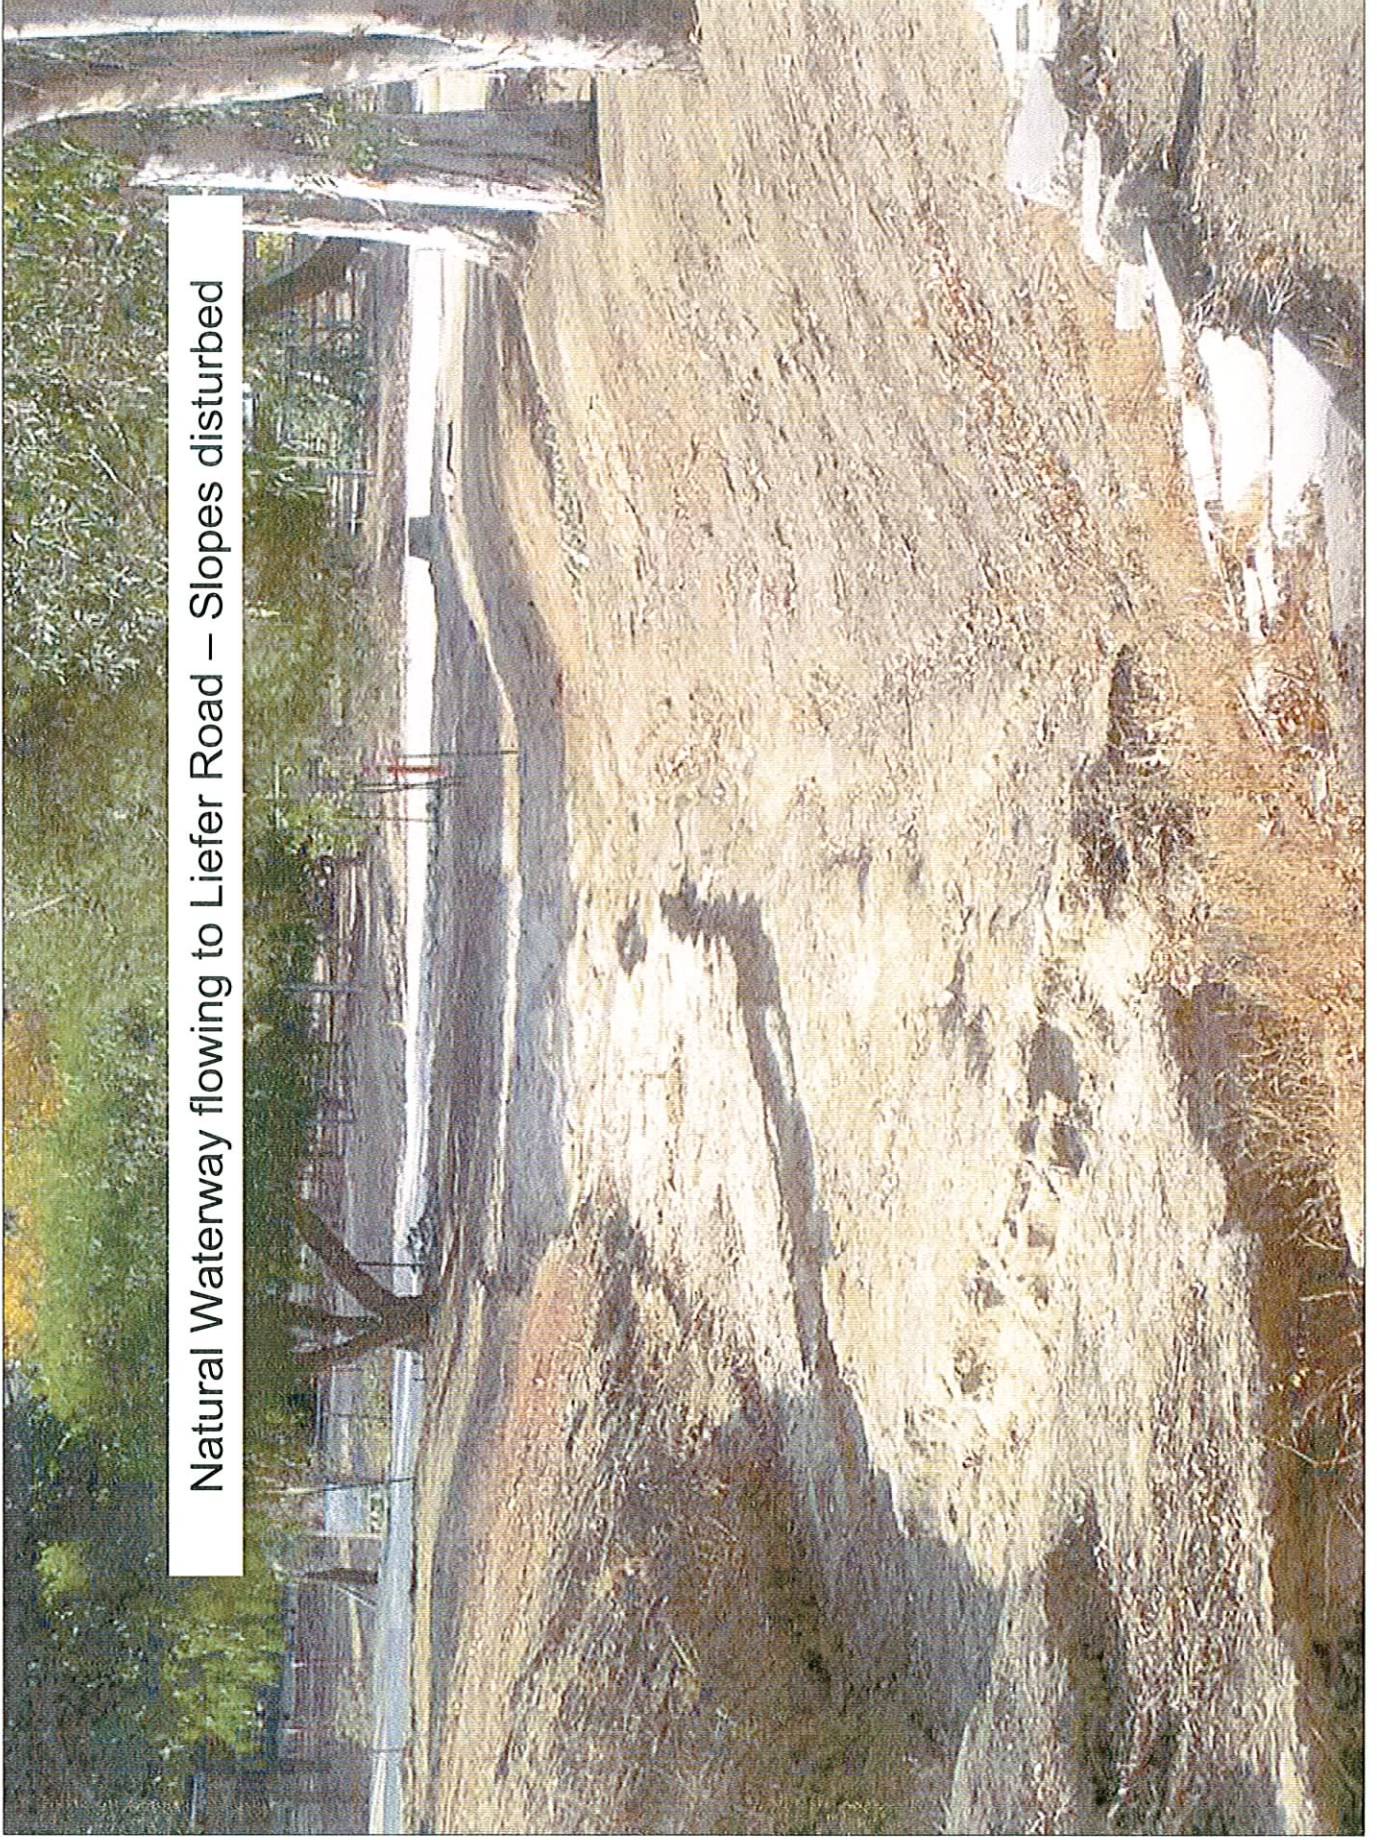
Natural Waterway flowing to Liefer Road – Slopes disturbed
