# ASHBY USA, LLC

Ref: WPN: 10-3020657.02, 18-2001091.02:schwk  
NOV No. R9-2006-0135

Subject: Required Technical Report

Ashby USA  
Notice of Violation Response  
Photos  
November 28, 2006

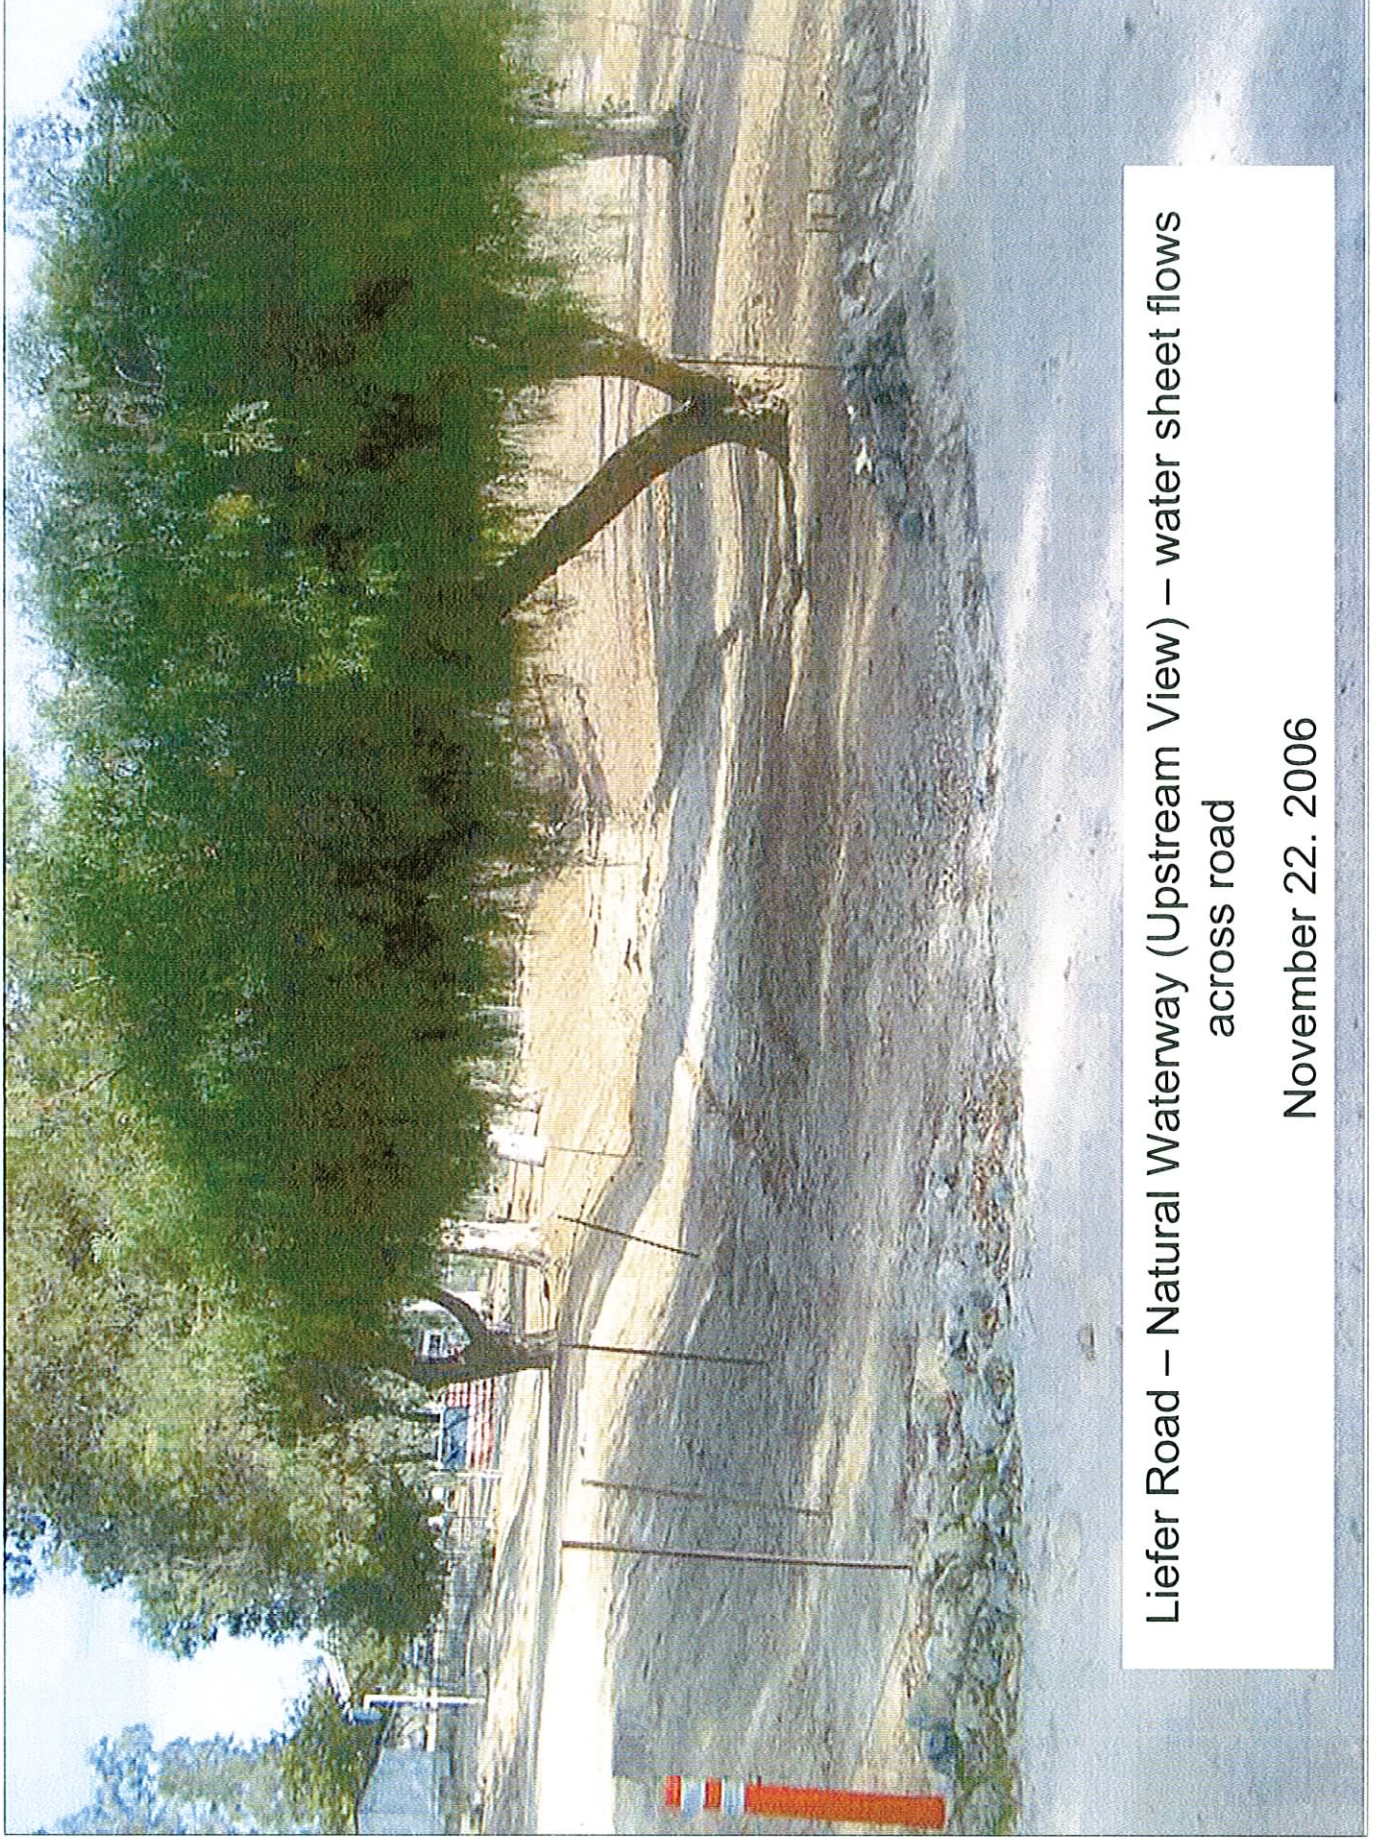
Liefer Road – Natural Waterway (Upstream View) – water sheet flows across road  
November 22. 2006

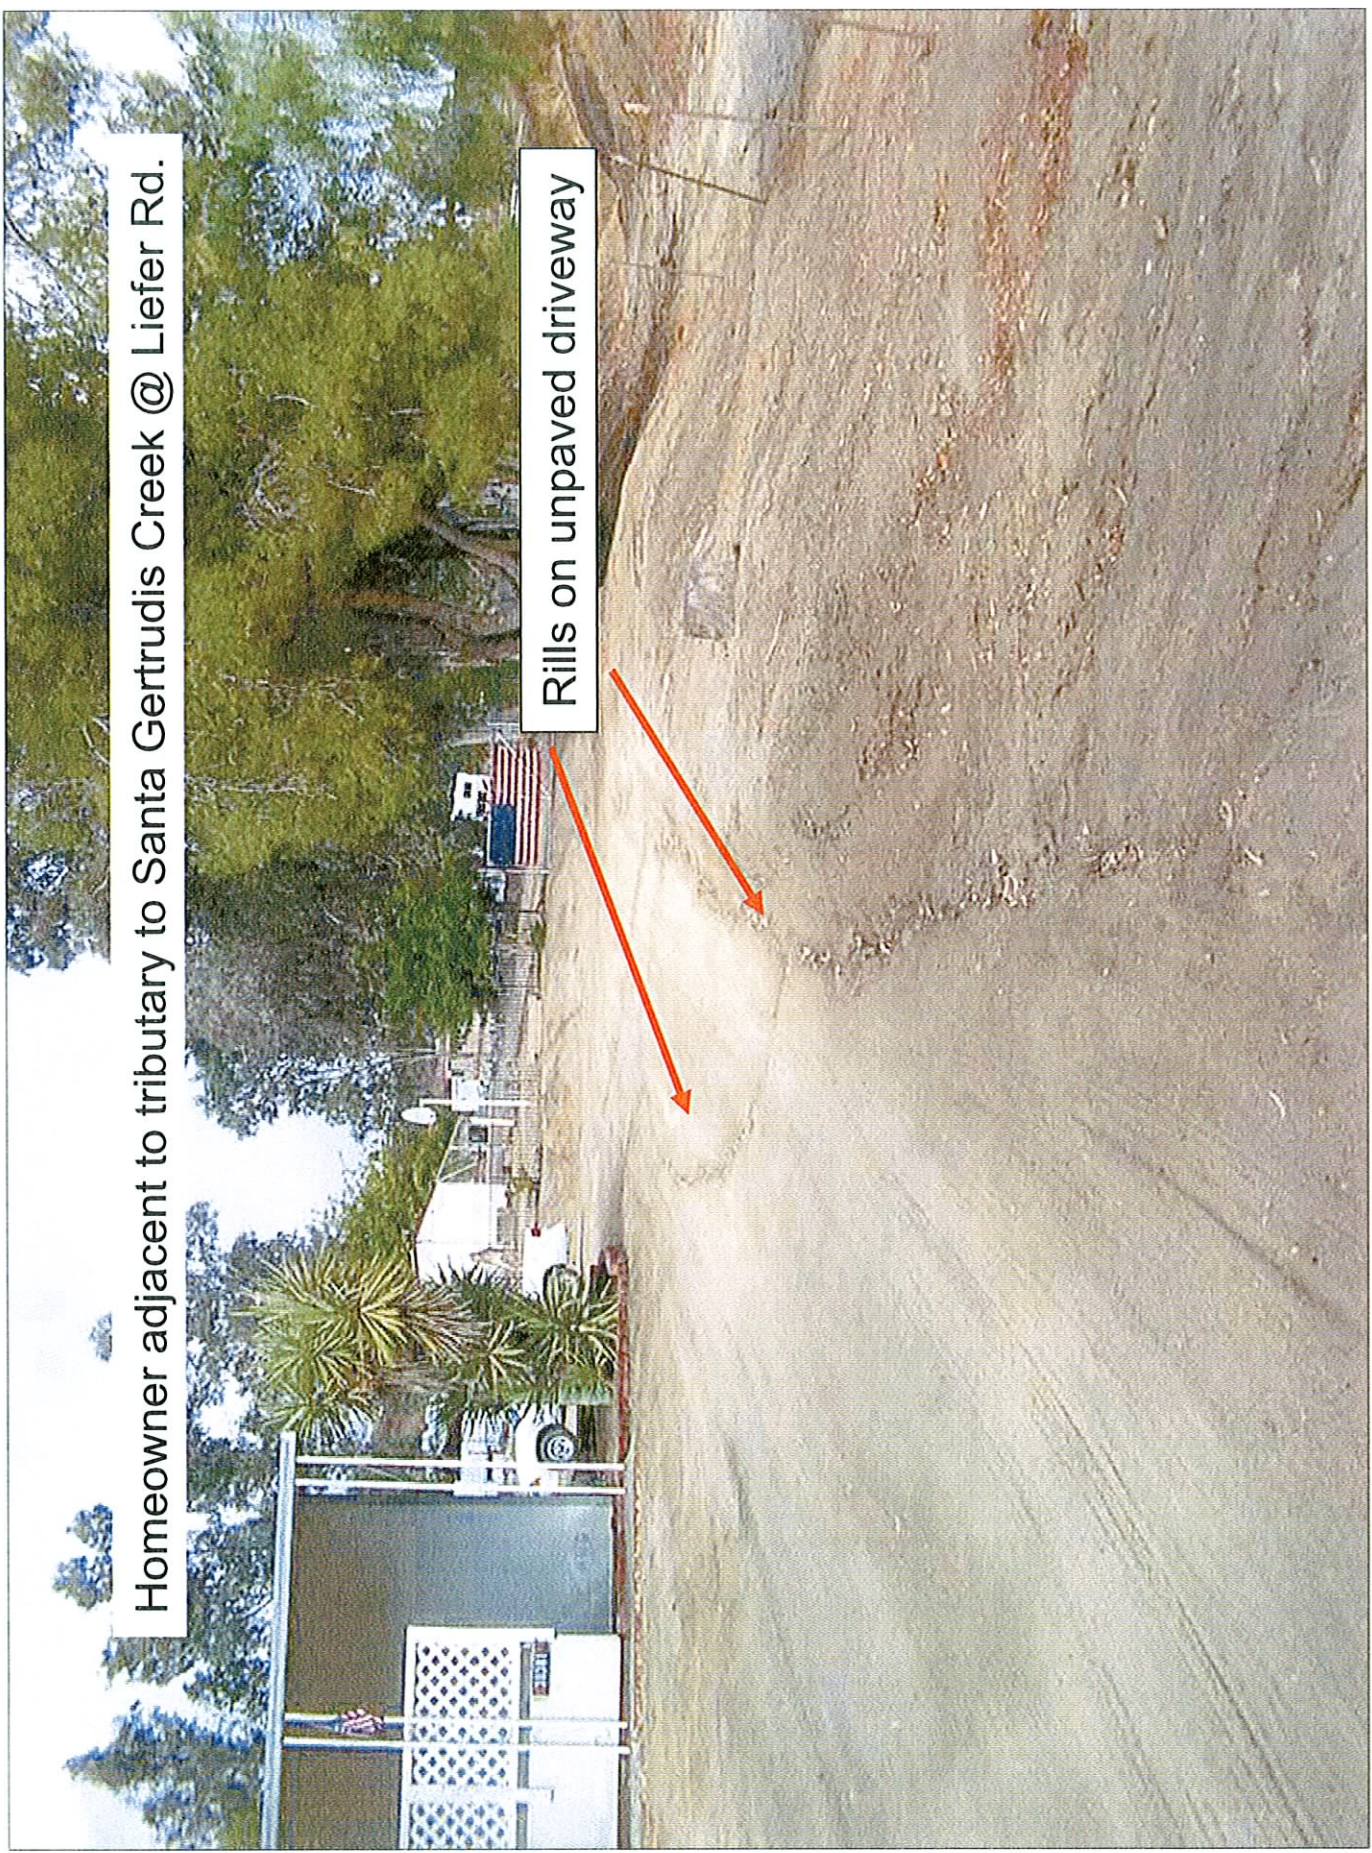
Homeowner adjacent to tributary to Santa Gertrudis Creek @ Liefer Rd.

Rills on unpaved driveway

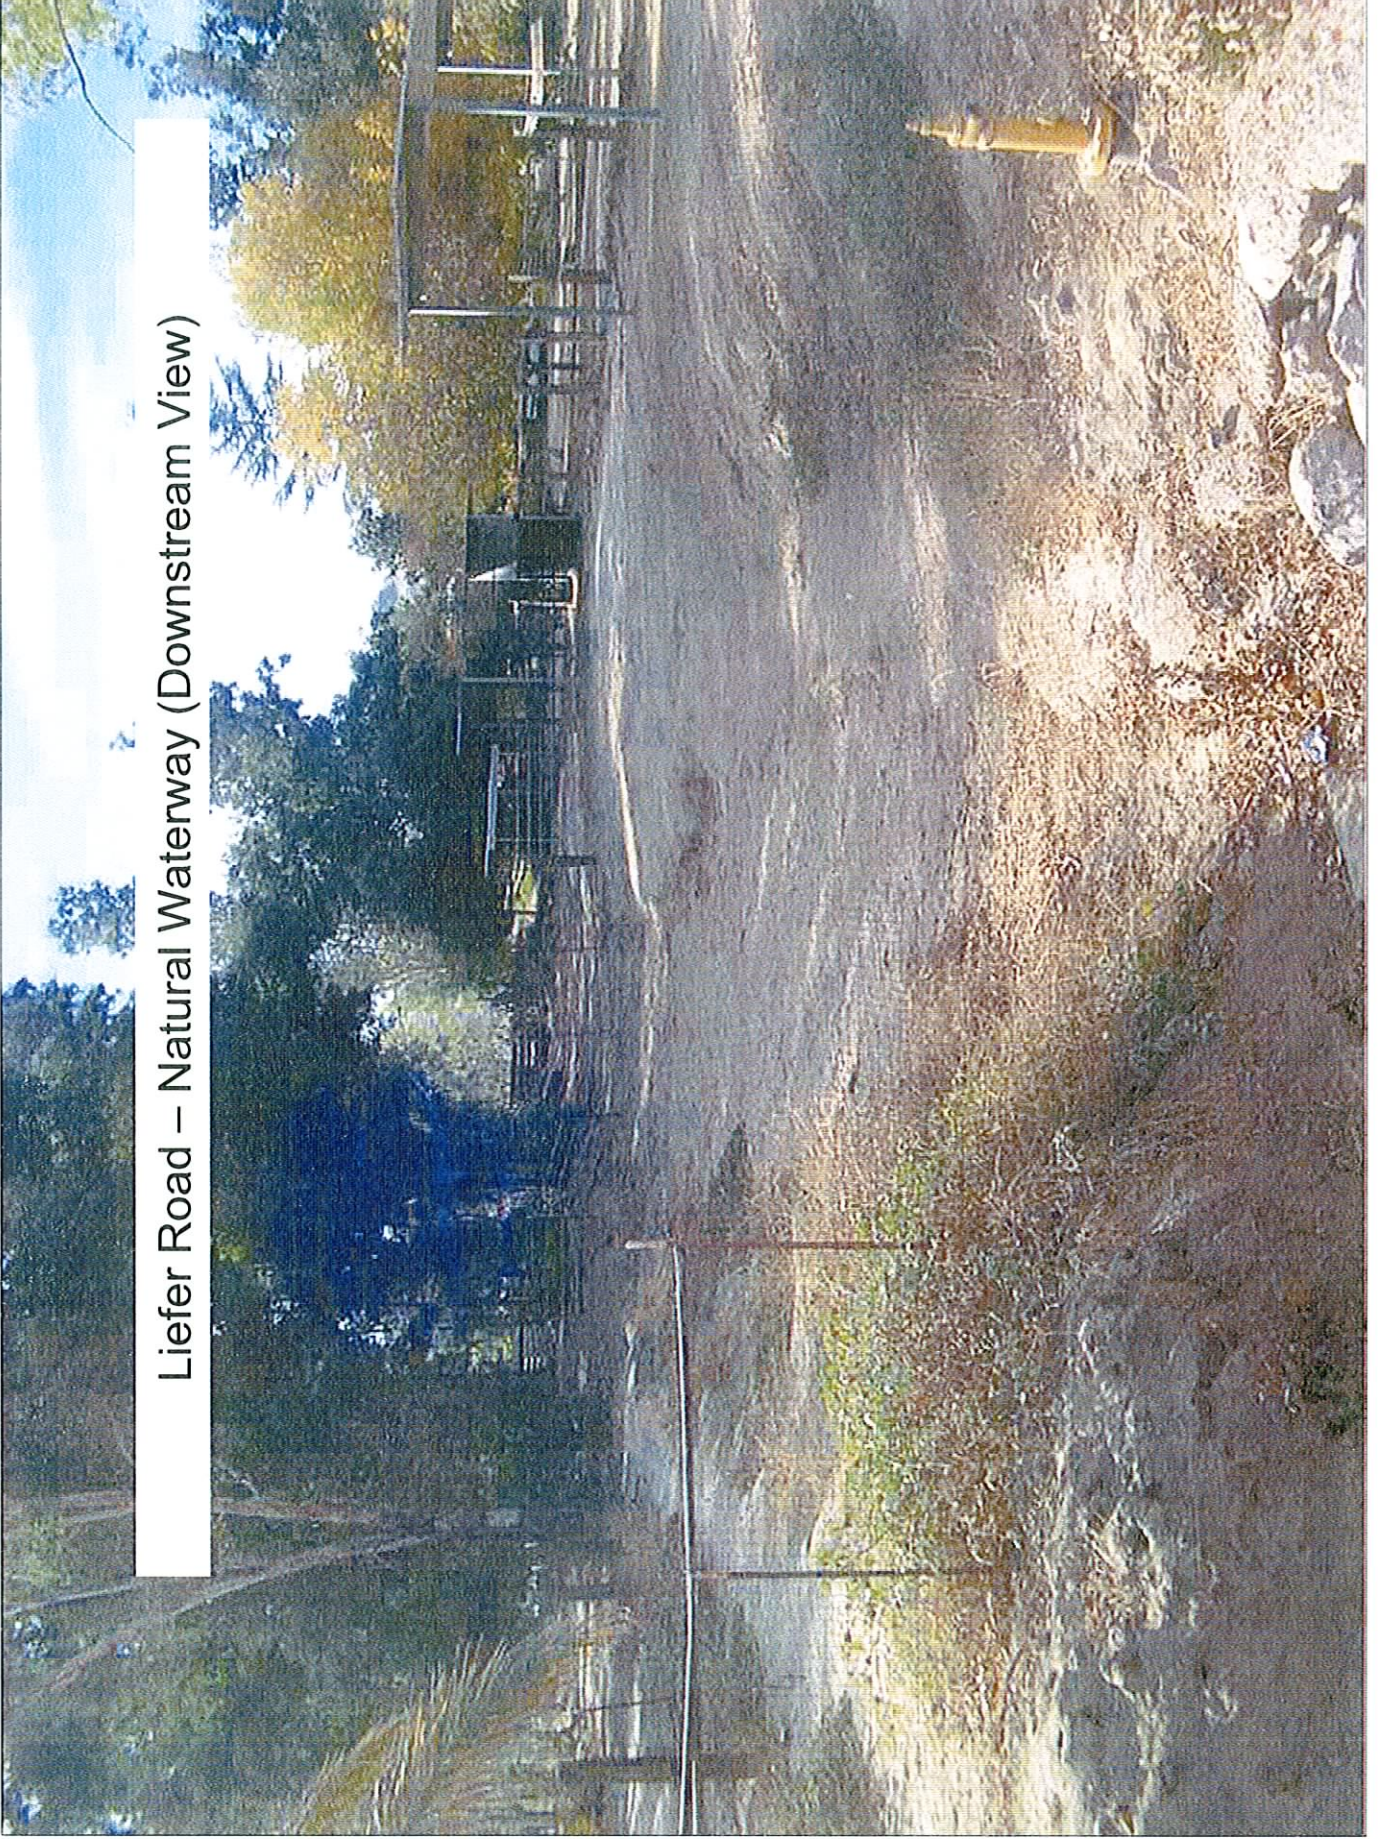
Liefer Road – Natural Waterway (Downstream View)

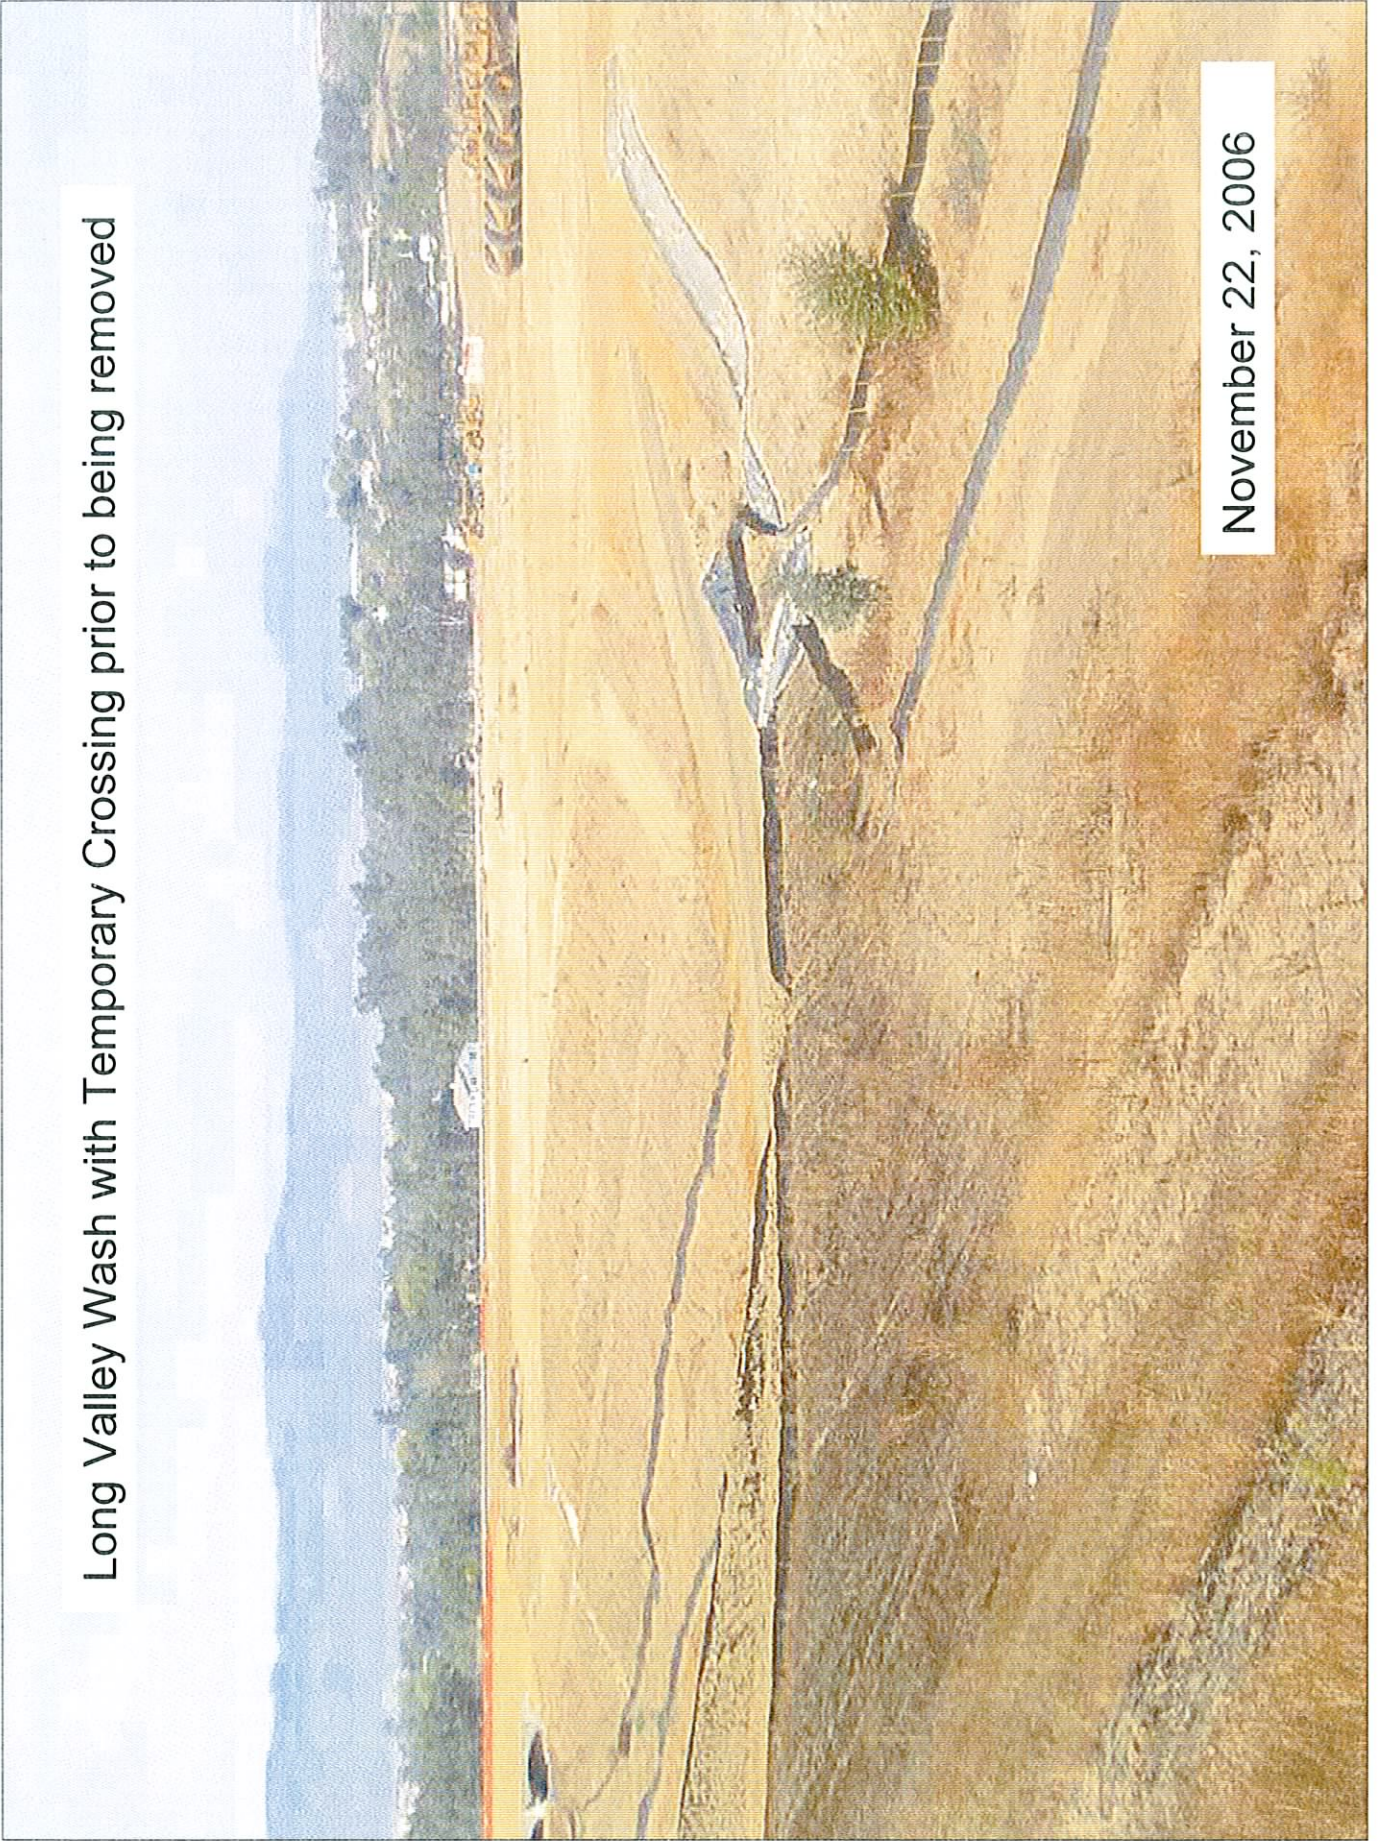
Long Valley Wash with Temporary Crossing prior to being removed

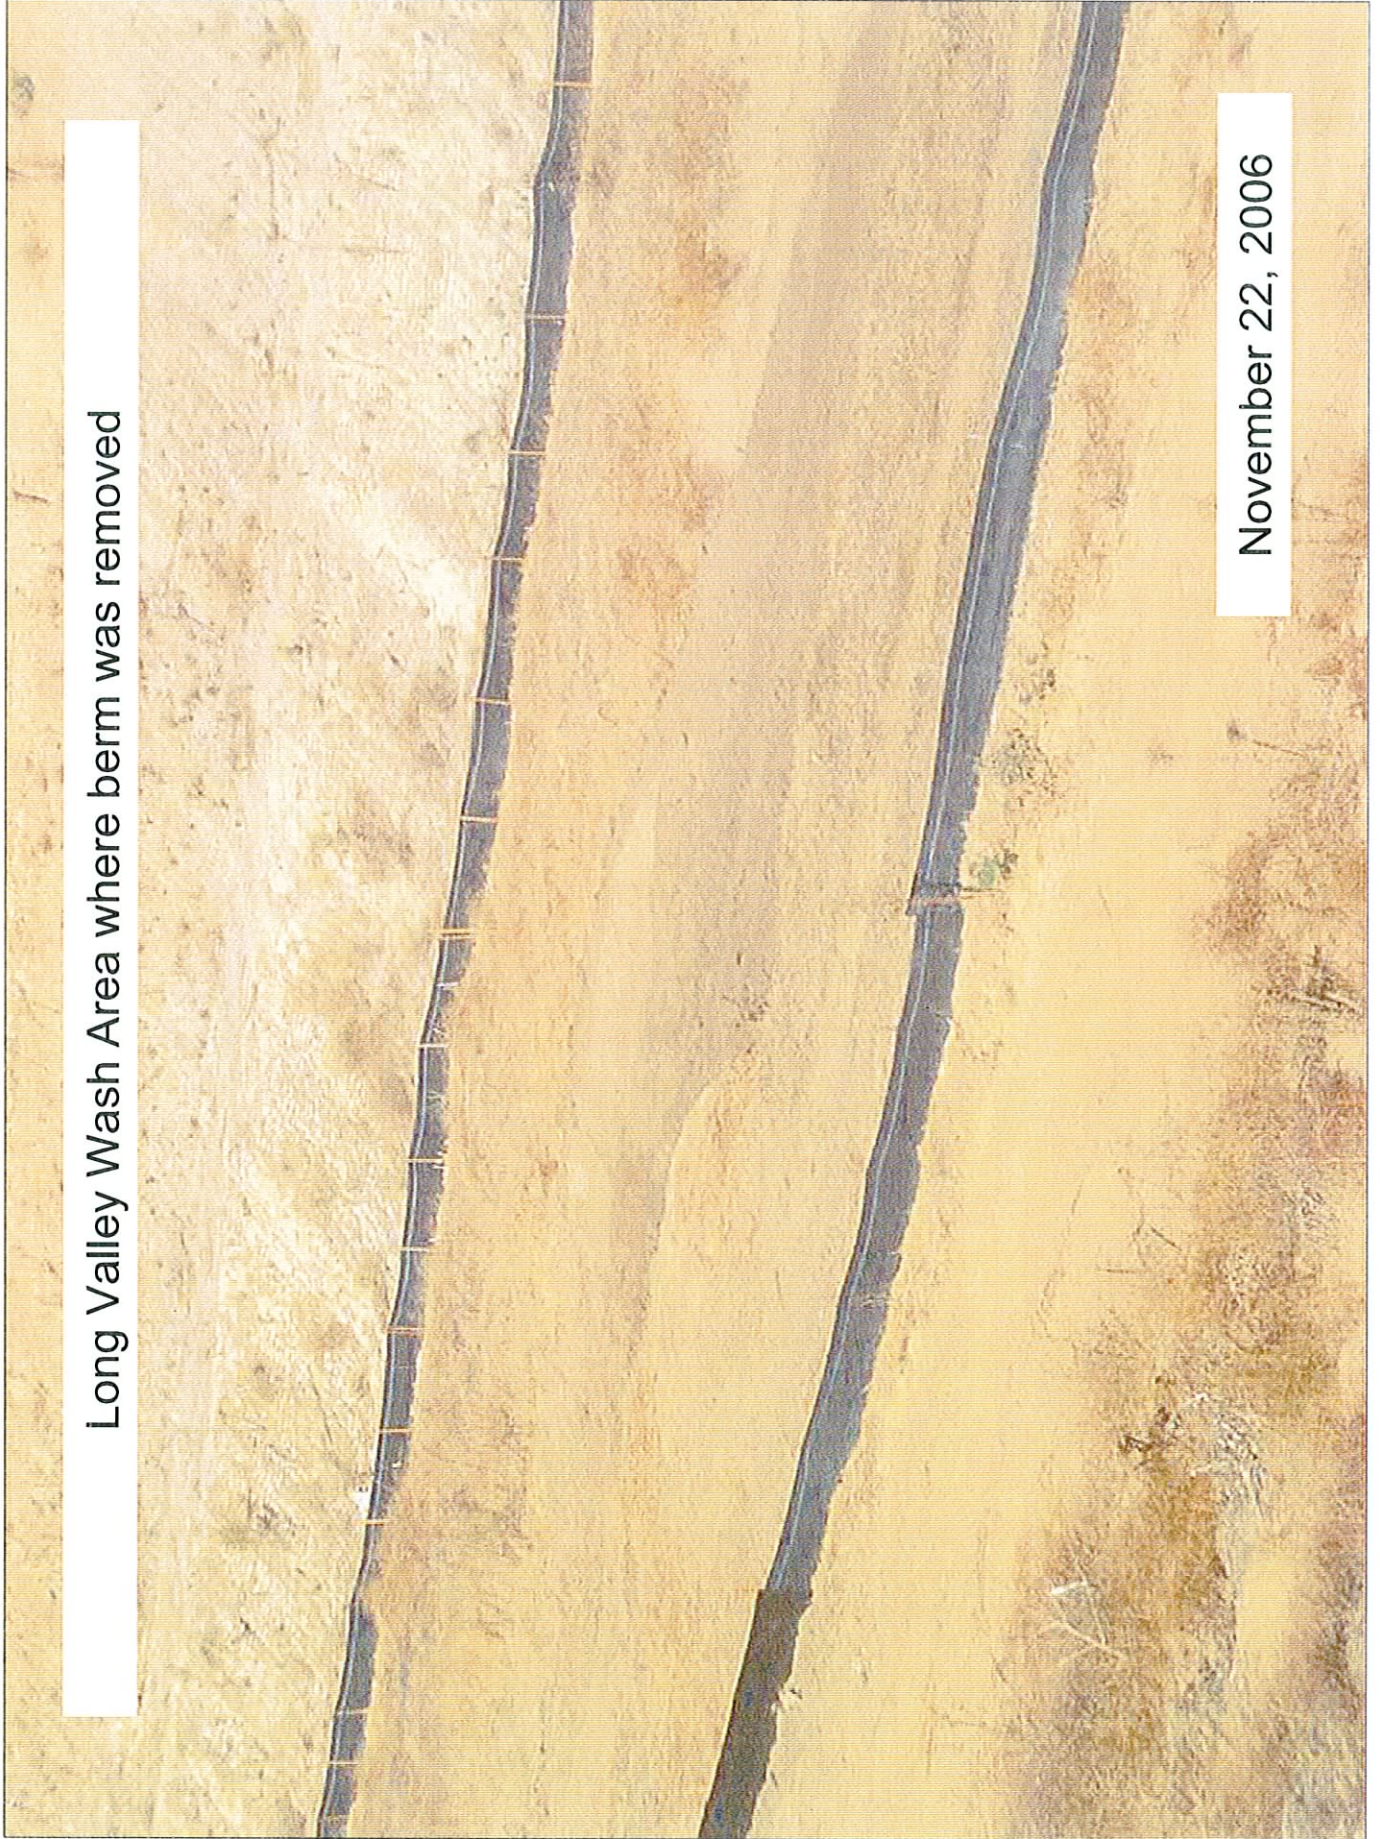
Long Valley Wash Area where berm was removed

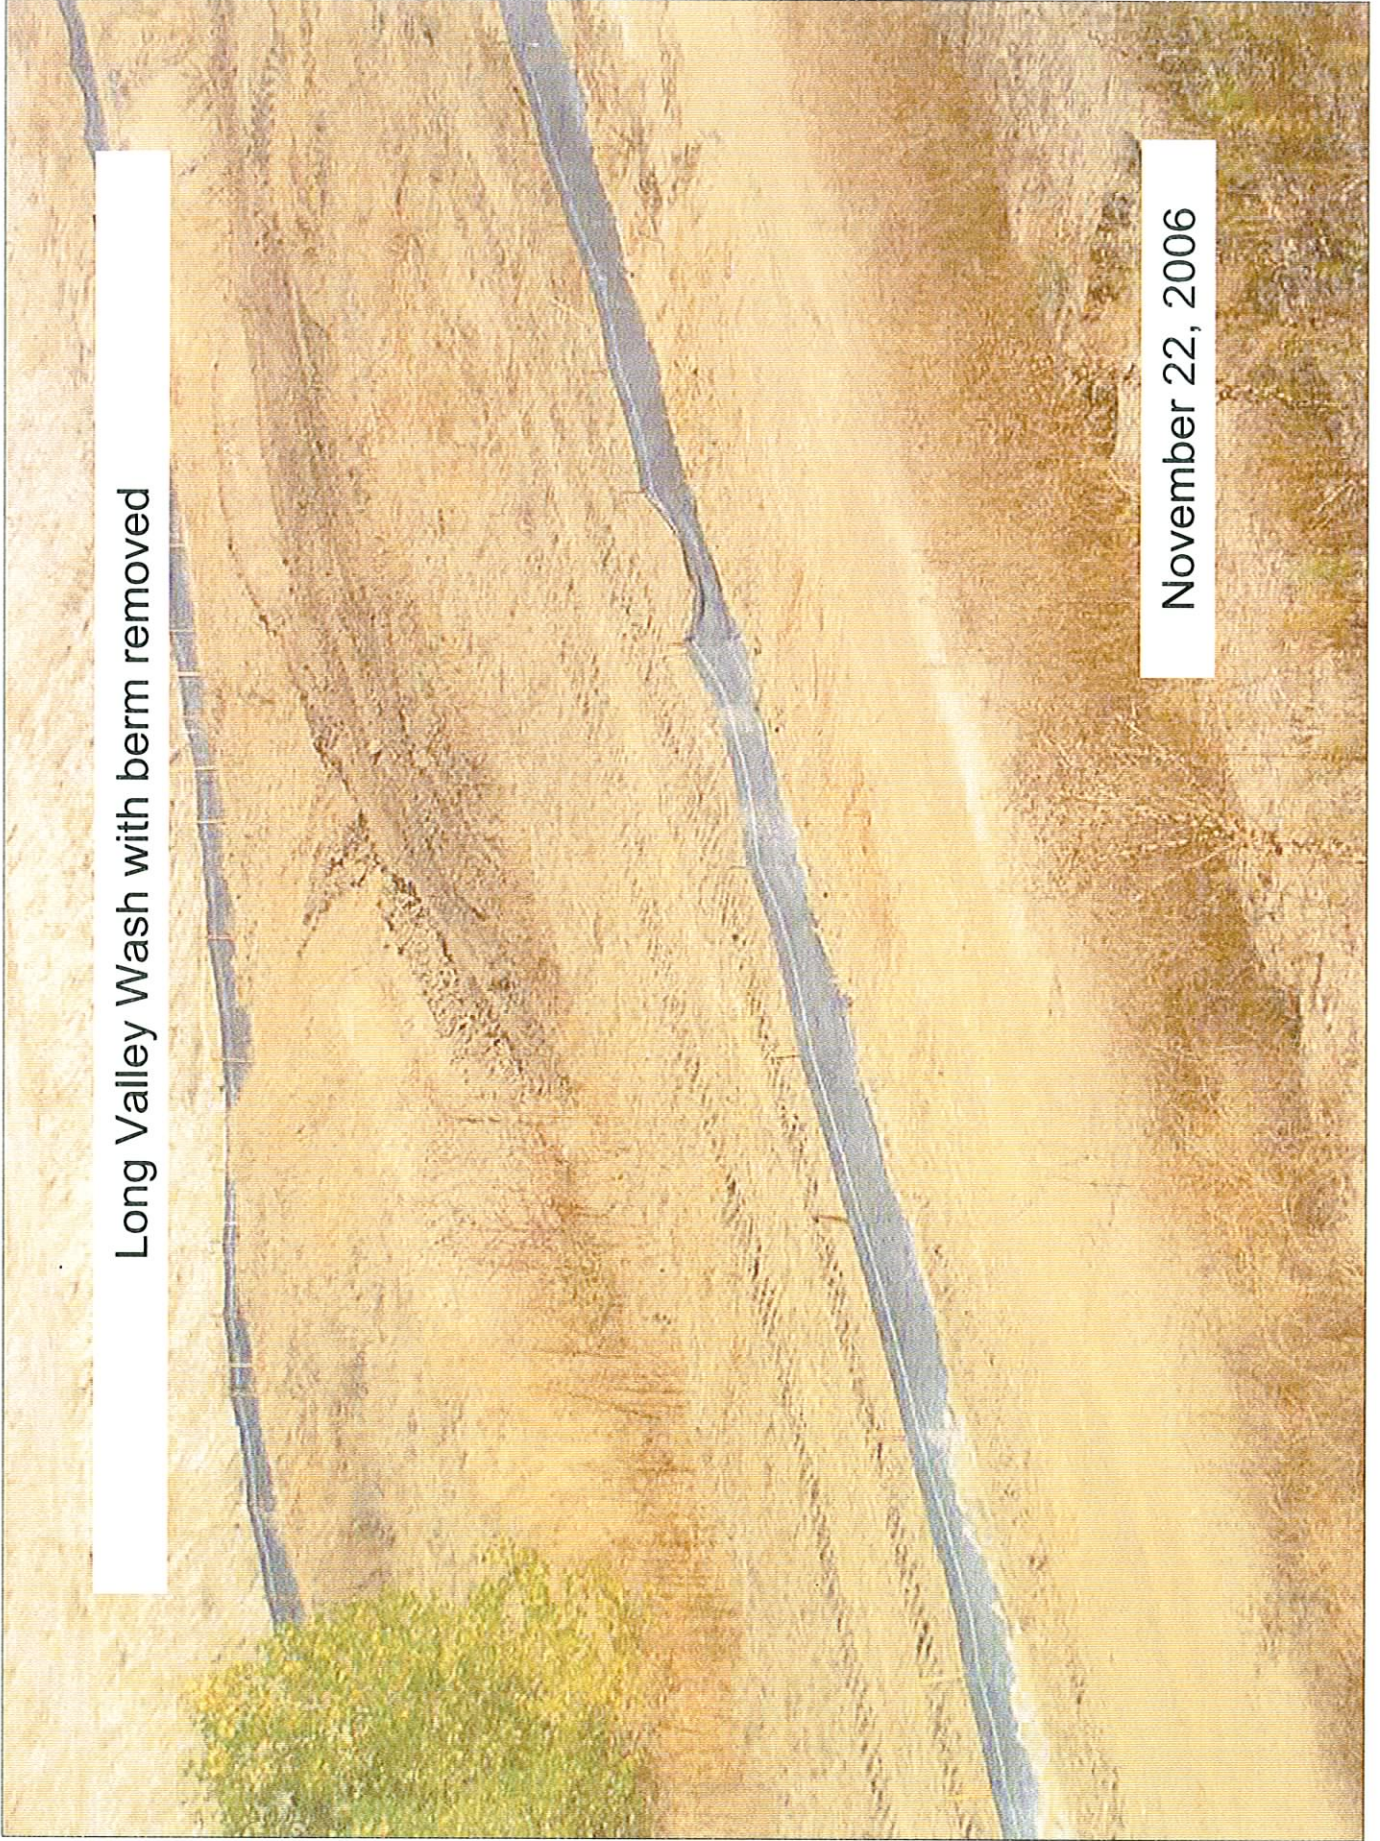
Long Valley Wash with berm removed

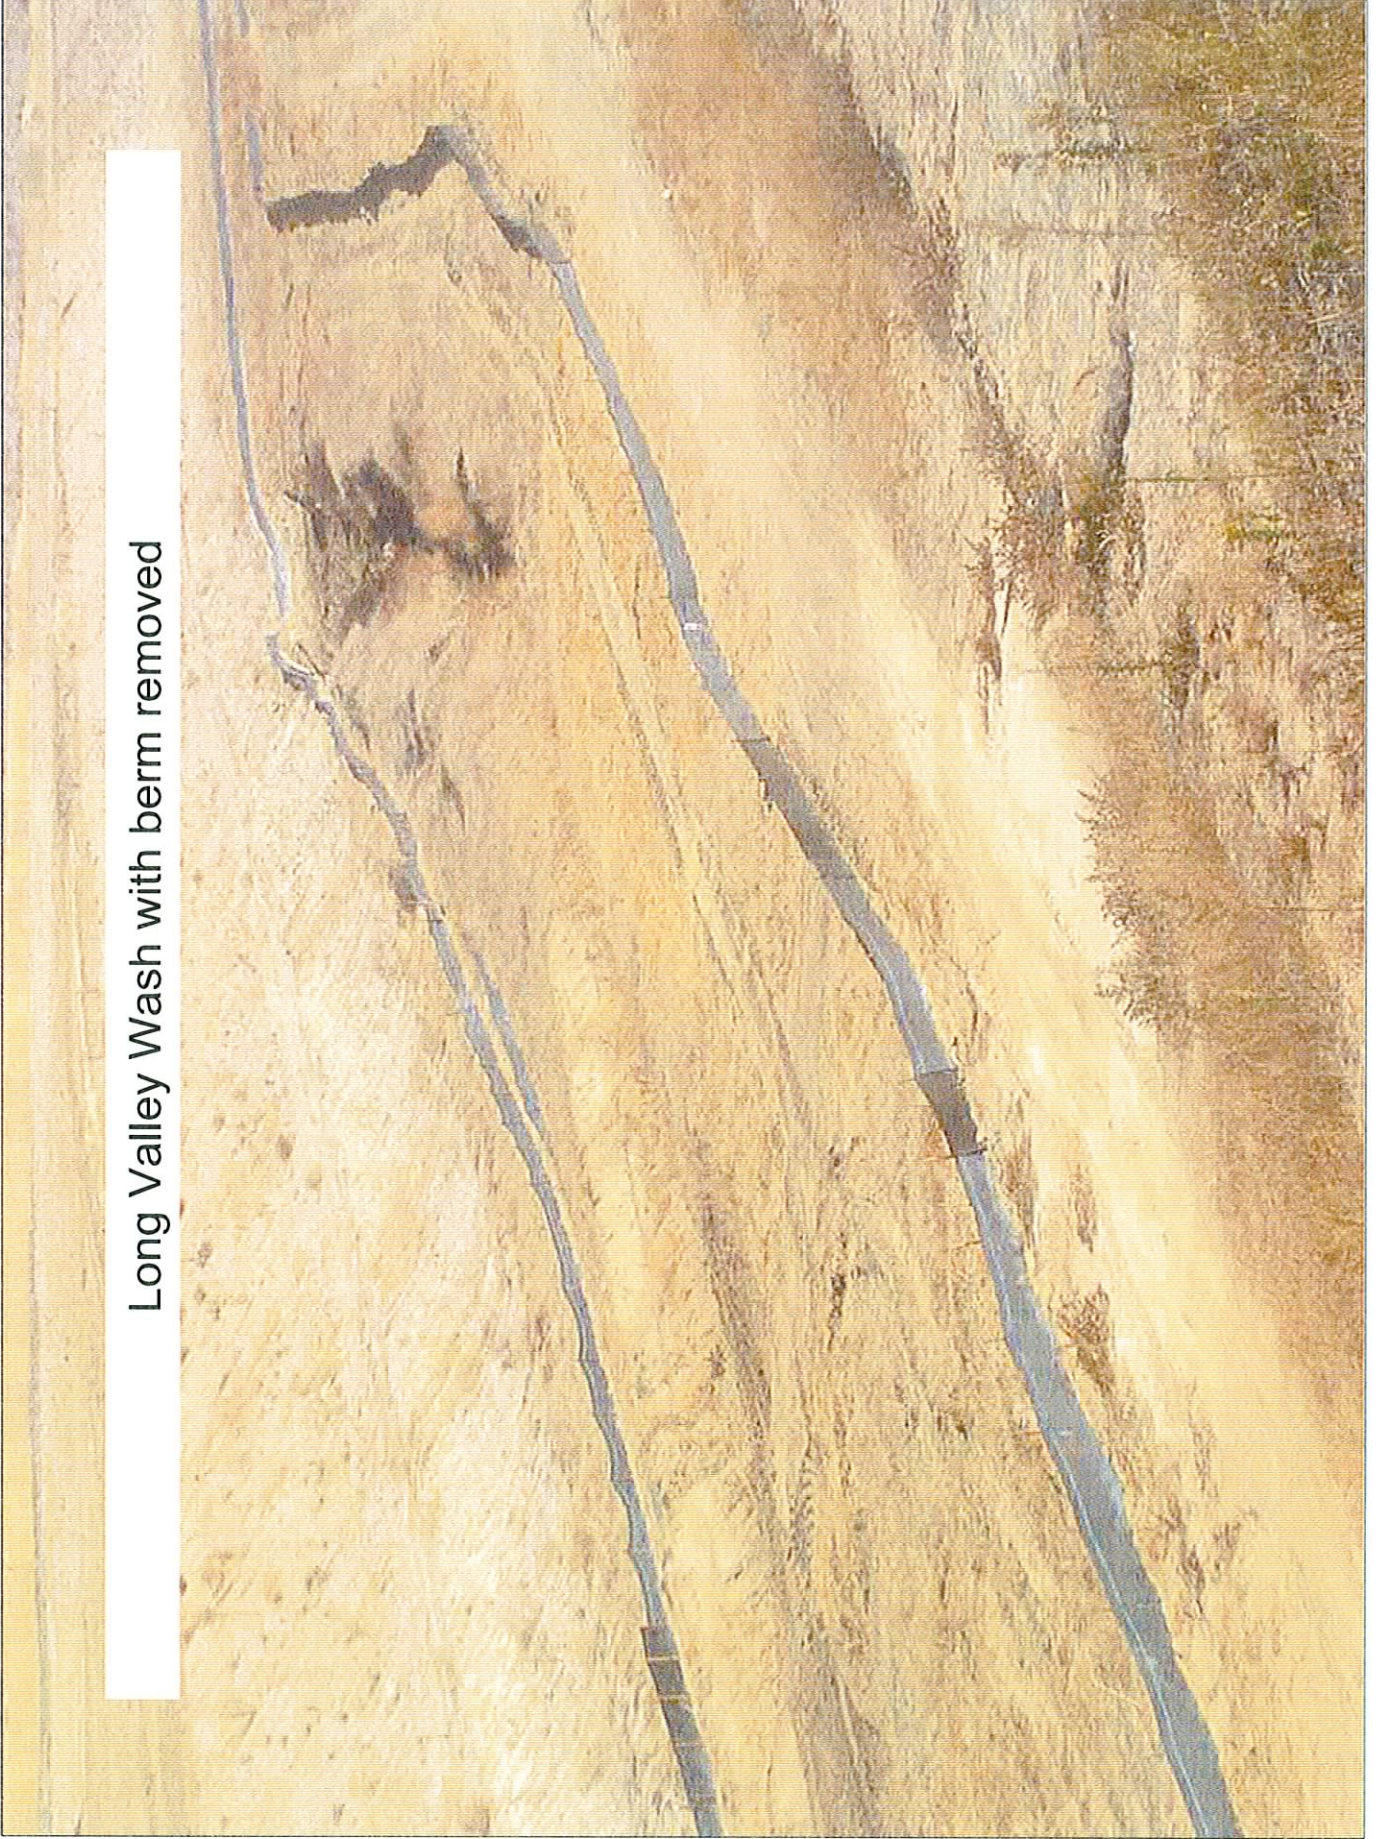
Long Valley Wash with berm removed

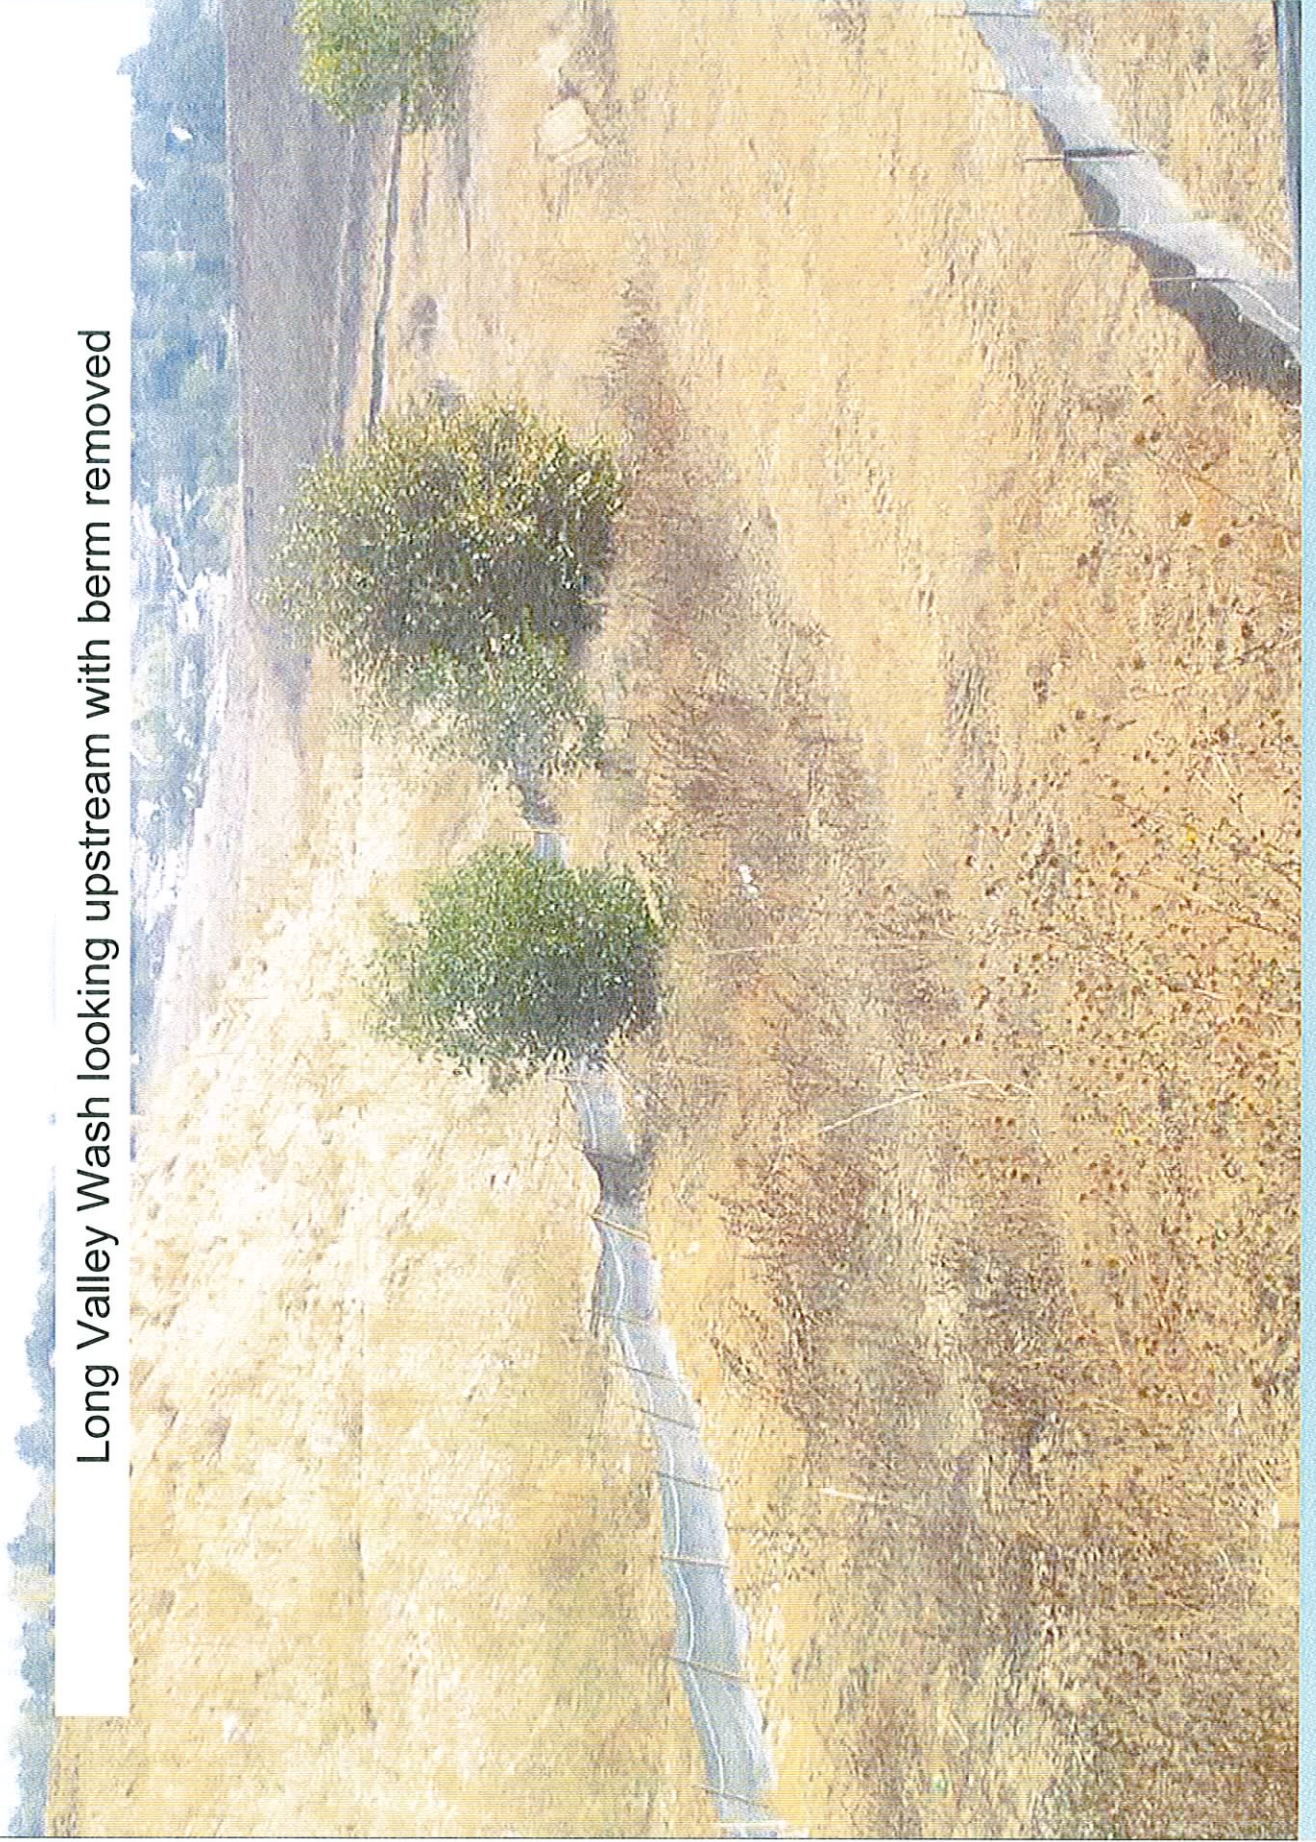
Long Valley Wash looking upstream with berm removed

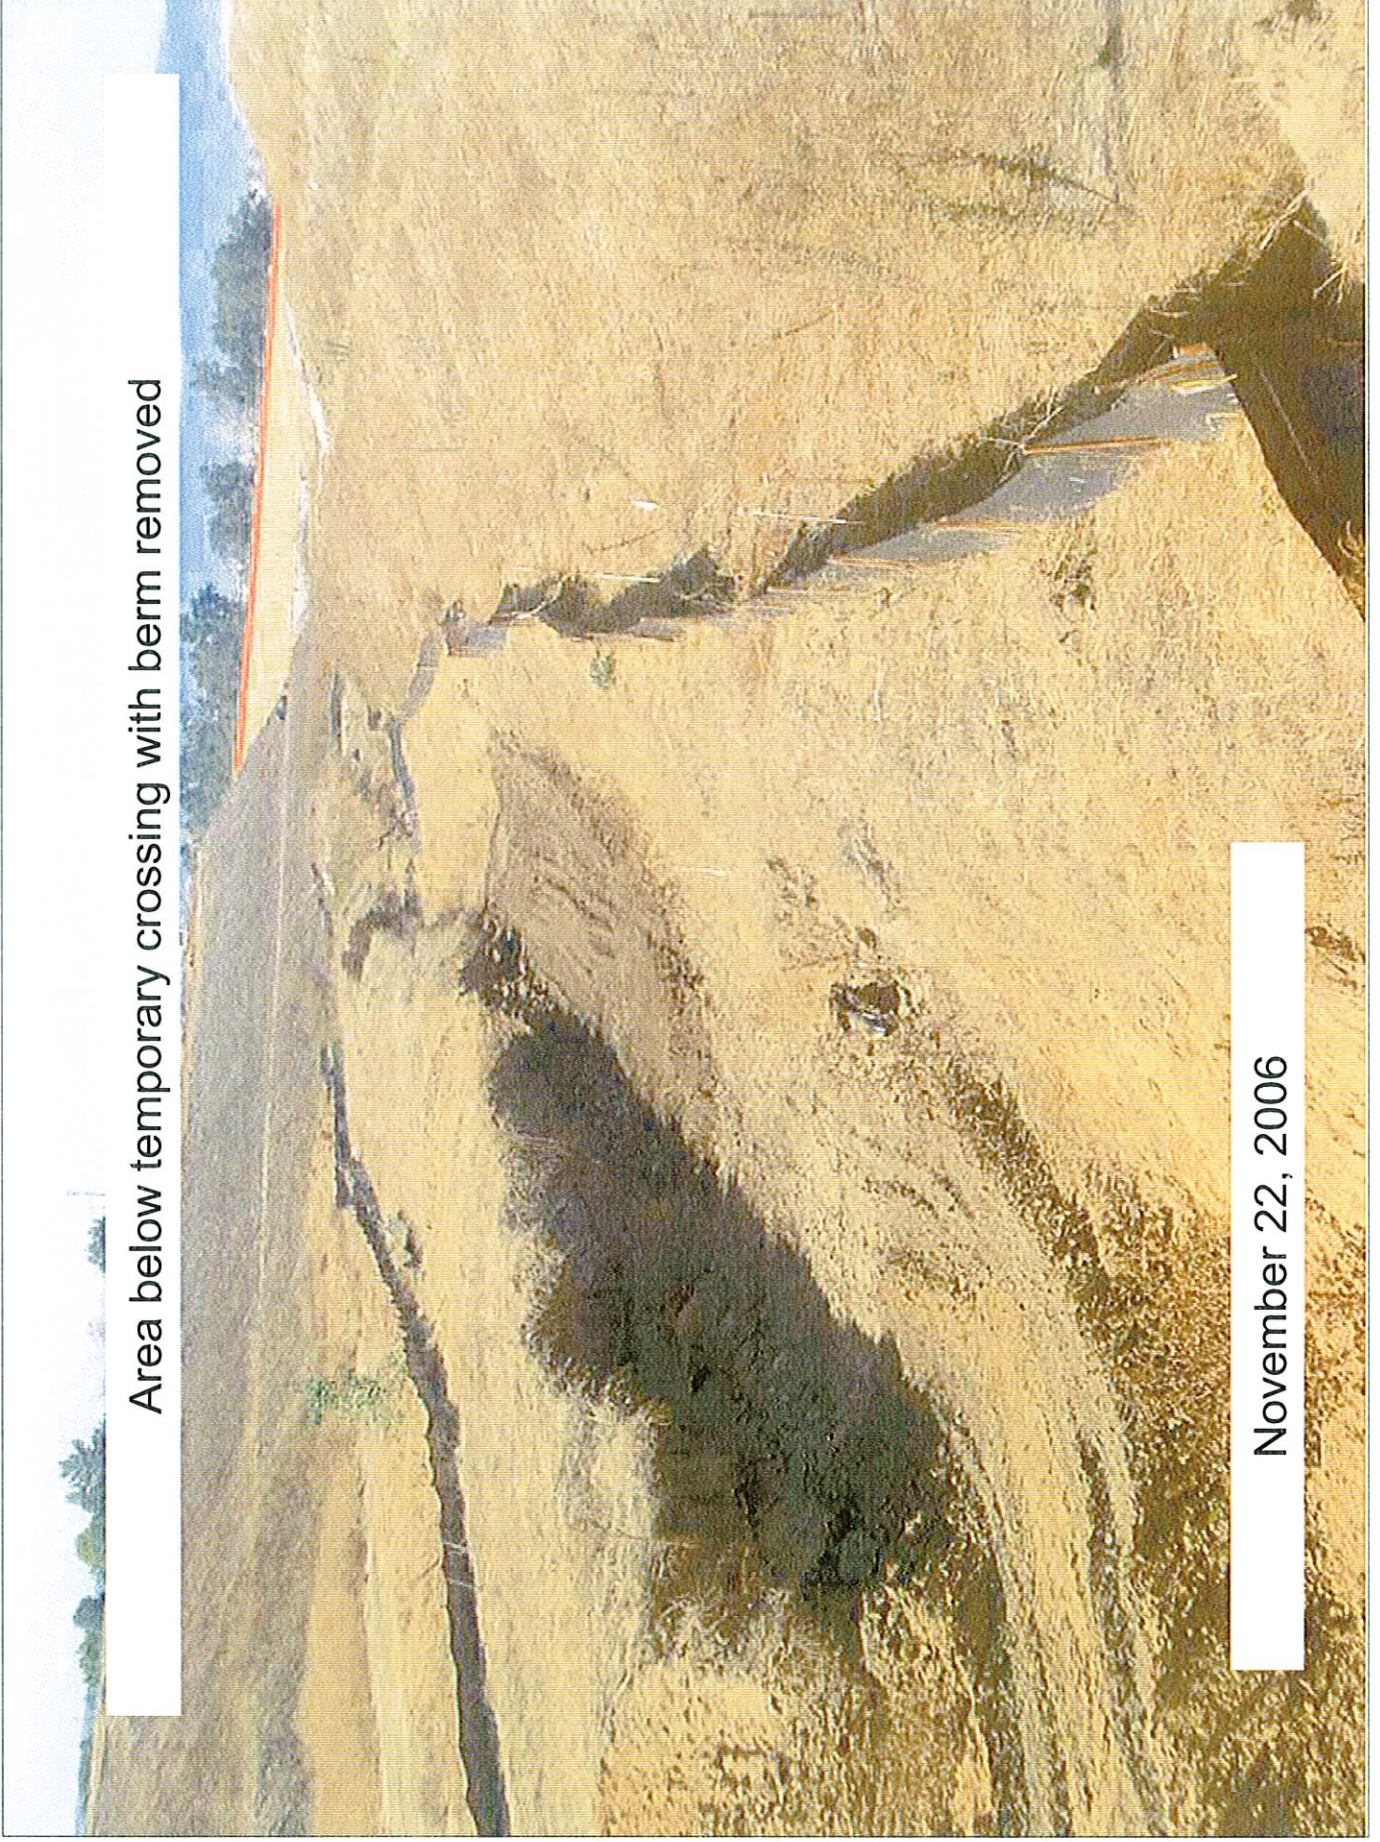
Area below temporary crossing with berm removed
