**CALIFORNIA REGIONAL WATER QUALITY CONTROL BOARD - SAN DIEGO REGION
WATERSHED MANAGEMENT PROGRAM**

FACILITY INSPECTION REPORT

FACILITY: Moritz Residence **WDID/401 File #:** none **INSPECTION DATE/Time:** 8/29/08 9:00 am

FACILITY: Moritz Residence (APN # 321-040-49)

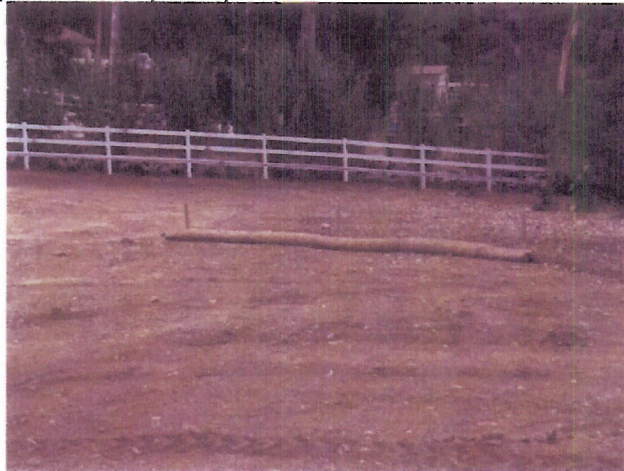
Observation: The straw wattles were not properly keyed into the ground, and they need to be staked in to prevent failure during a rain event. RWQCB staff provided Dr. Moritz's counsel with a CASQA BMP fact sheet after the inspection. With the amount of disturbed soil on site, the implementation of only three straw wattles on site does not seem to provide effective coverage of the entire disturbed area, should soil become mobilized during a rain event.

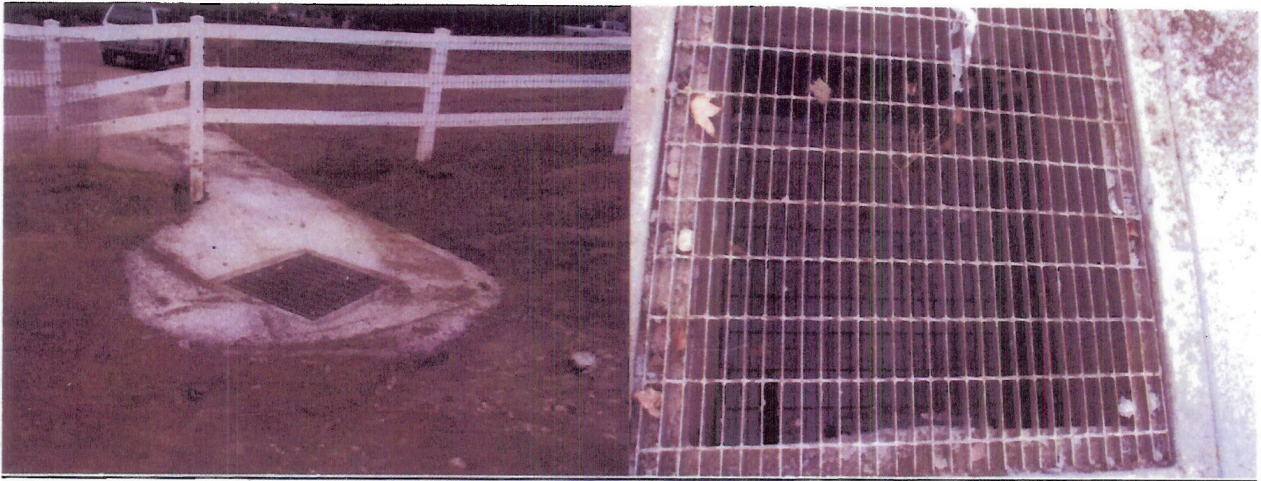
Observation: The inlet that was constructed to convey runoff from Jerome Drive to drainage pipe installed across the property lacked sediment control BMPs to prevent the discharge of sediment into the inlet. Either gravel bags or straw wattles placed around the perimeter could alleviate this problem. The inlet also has standing water in the bottom of the inlet which could pose vector problems.

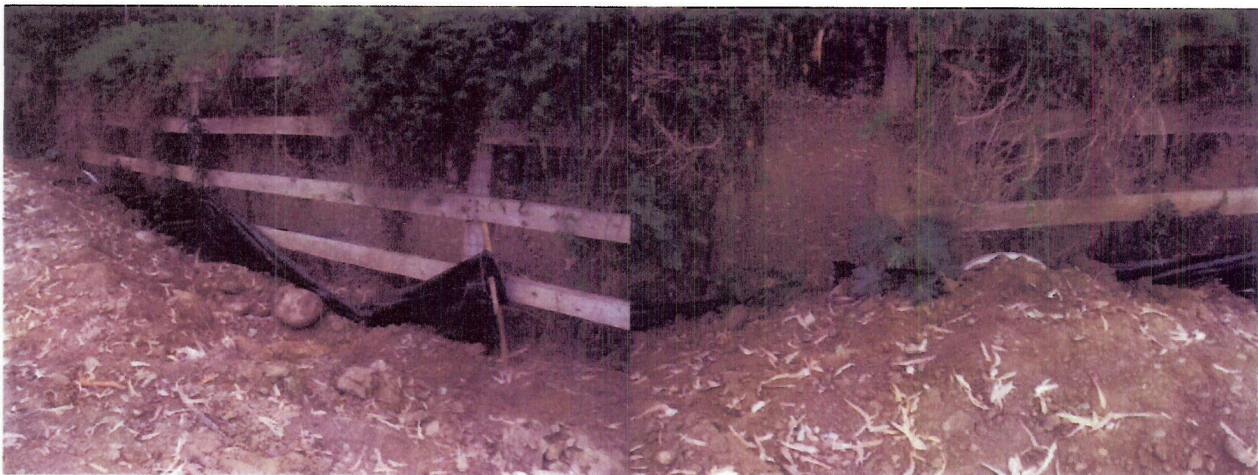
Observation: The silt fence at the southern perimeter of the project was in a state of disrepair and sediment could potentially discharge offsite during a rain event if the silt fence is not repaired/replaced. RWQCB staff recommended to the Moritz's engineer that sediment at the southern boundary be removed from the southern property boundary and the silt fence be repaired. In the picture above right, sediment covering the outlet of the installed HDPE pipe is overtopping the silt fence. RWQCB staff provided Dr. Moritz's counsel with a CASQA BMP fact sheet on the proper installation and use of silt fence.

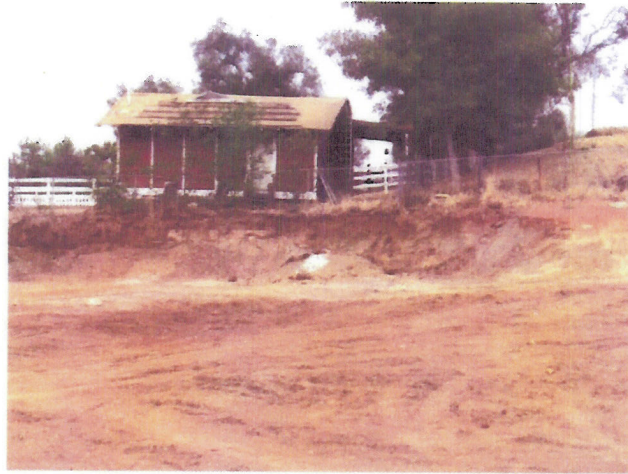
Observation: Sediment stock piles on site were not adequately protected in the area near the barn, where a slope cut had been made. It is recommended that during the non-rainy season, soil stockpiles should be covered with plastic or protected with a temporary perimeter sediment barrier prior to the onset of precipitation. A CASQA BMP fact sheet on stockpile stabilization is available on the web at:

<http://www.cabmphandbooks.com/Documents/Construction/WM-3.pdf>

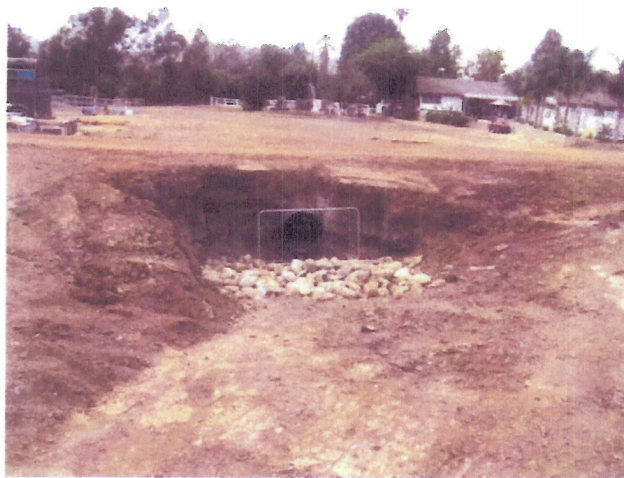
Observation: A great deal of discussion took place at the inspection regarding how (in the interim period prior to removal of the drain pipe) to manage offsite flows passing through the pipe and to prevent downstream erosion on adjacent properties. RWQCB staff suggested creating a temporary sediment trap/basin at the southern end of the property, by pulling back the pipe outlet away from the property line, and providing a temporary basin to collect sediment and runoff and discharging onto the adjacent property via a perforated standpipe. It was also suggested by Doug Simpson that the inlet (shown above) be blocked off either by capping the pipe, allowing the offsite drainage to collect there, or that a 90 degree perforated pipe extension be fitted at the upstream end to release collected runoff at a slower pace. Utilizing the upstream end of the pipe as a detention basin/ sediment trap could potentially cause the collected runoff to back up onto the property to the north of Dr. Moritz, and if this management measure is used the upstream property owner should be made aware of the possibility. It was determined during the inspection that the inlet structure was constructed on the adjacent property to the north. RWQCB staff provided Dr. Moritz's counsel with a CASQA BMP fact sheet on the proper implementation of temporary sediment traps.
