Figure 6 Location Willow Creek Intake (6/6/08)

Figure 7 Existing Willow Creek Intake & Sedimentation Box (8/24/04)

Figure 8 Existing Willow Creek Intake Pipeline (8/24/04)

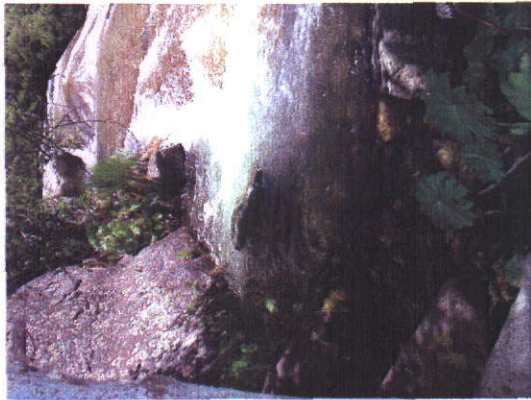
Proposed raw water intake location from the west bank of creek. Loose rock and sediment will be removed from the pool.

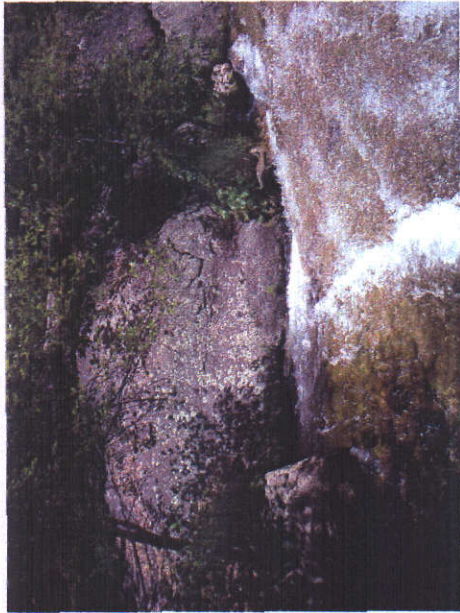
View of intake location from the downstream side of the pool. Suction pipe will be anchored to the large granite formation behind the pool.

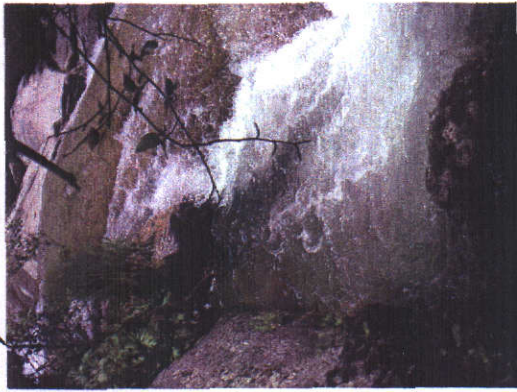
View of the intake pool from the proposed pump location.

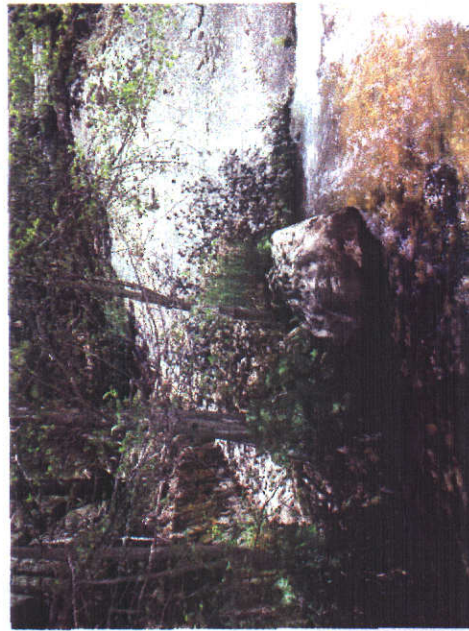
View of the proposed pump location from the creek. Suction pipe will run up the granite formation and over to the pump or along the retaining wall to the alt. location.

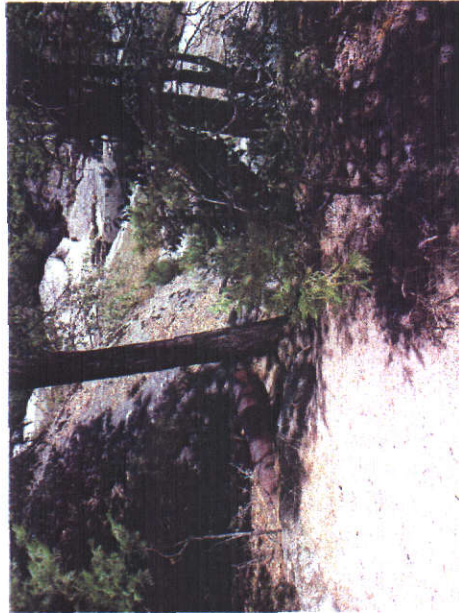
Proposed location for pump.

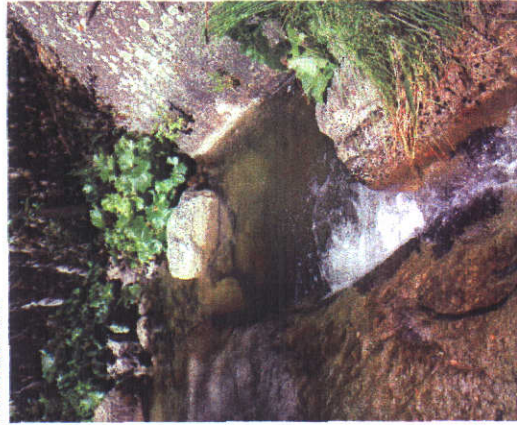
View of intake pool taken from upstream. The date of this photo is 8/19/08.

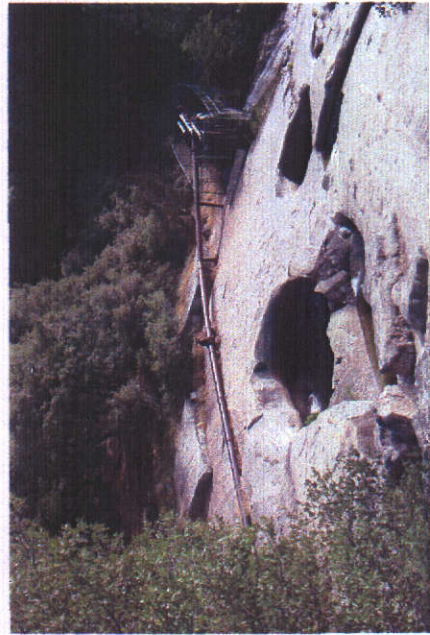
Pipeline from intake screen to sedimentation boxes. Intake screen is to the left.

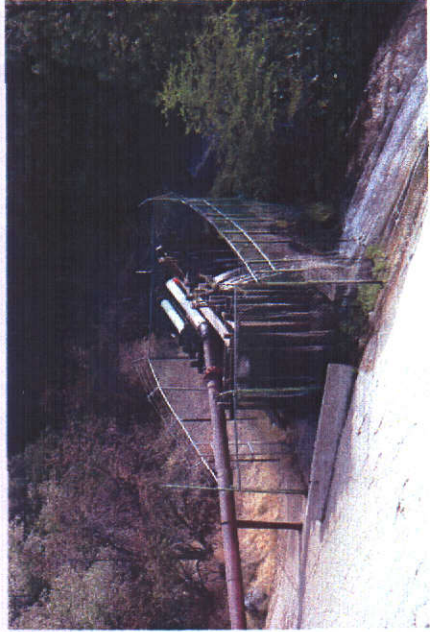
2-stage sedimentation boxes

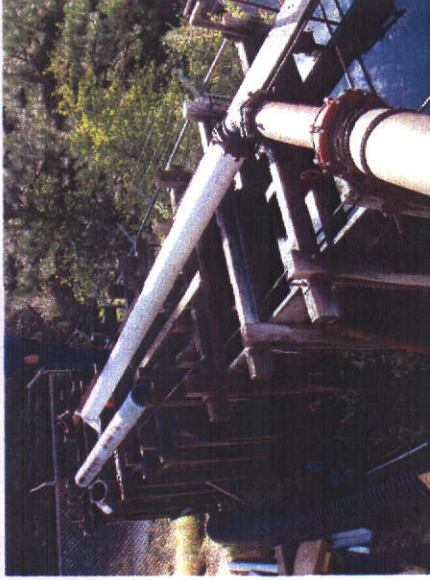
Top view of sedimentation boxes.

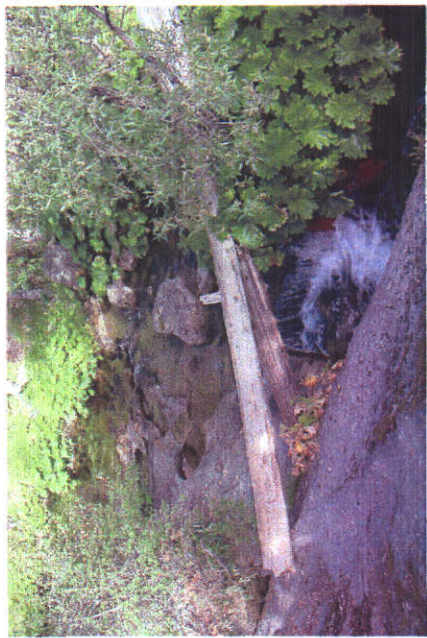
Just upstream of the intake screen.

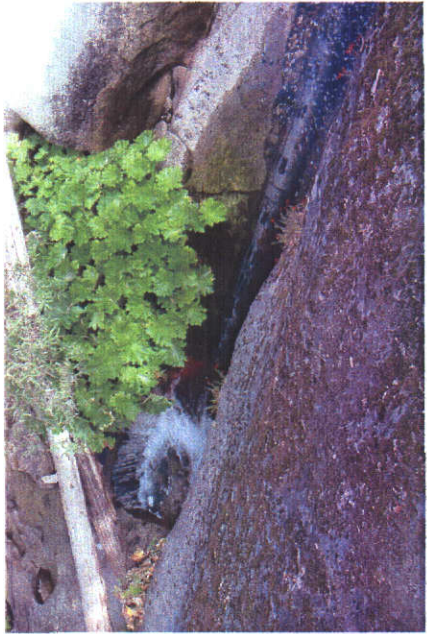
16" diameter intake screen.

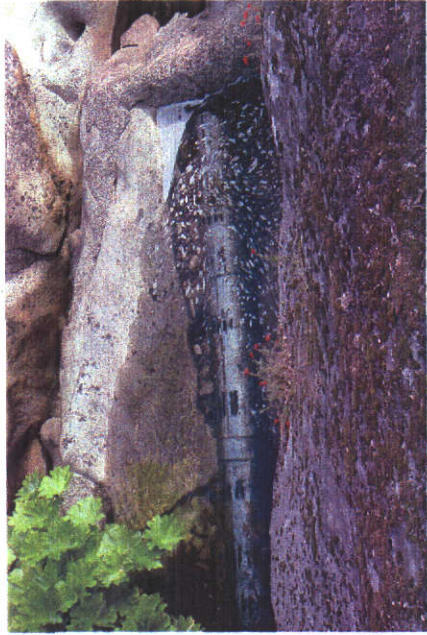
Concrete berm constructed over downstream side of intake screen to help pool water.

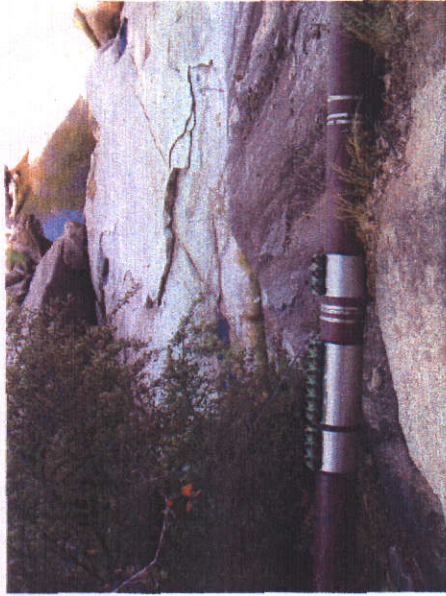
Damaged and repaired pipe just downstream of intake.

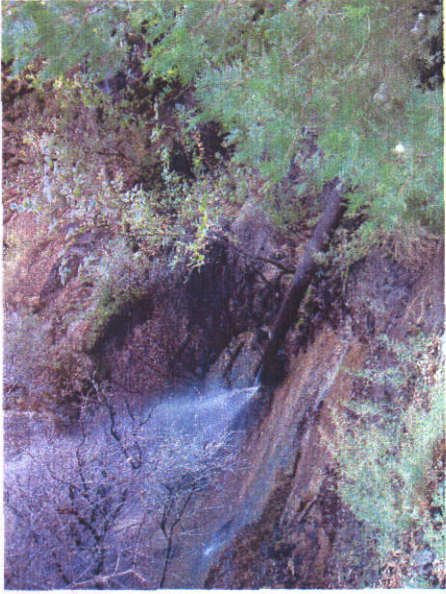
Damaged pipe just downstream of intake.

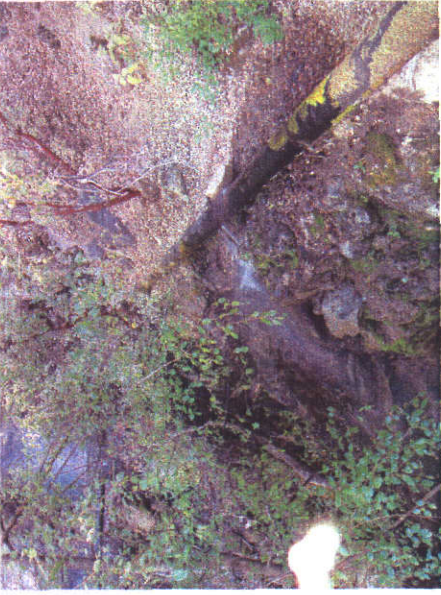
More damaged pipe downstream of intake.

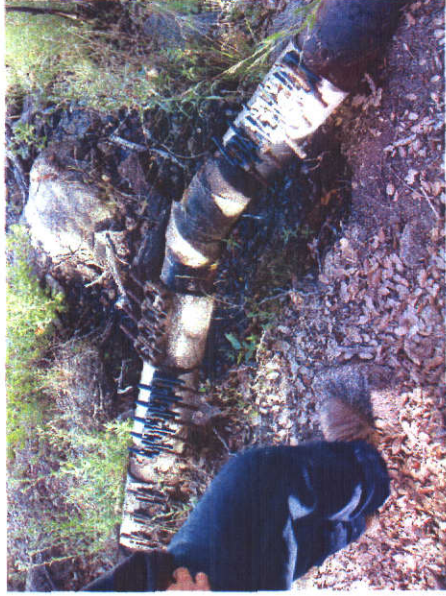
Multiple repairs over a short distance.

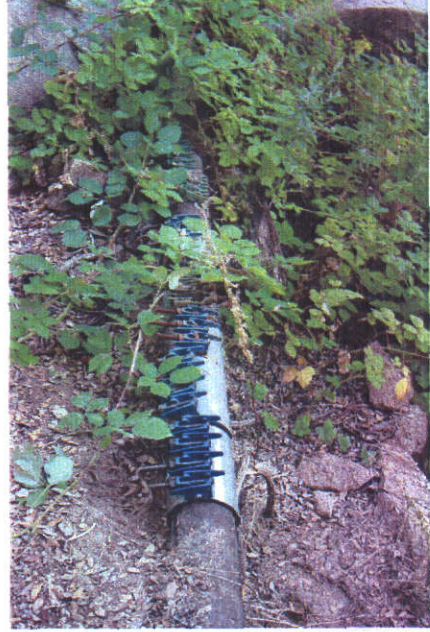
Multiple repairs over a short distance.

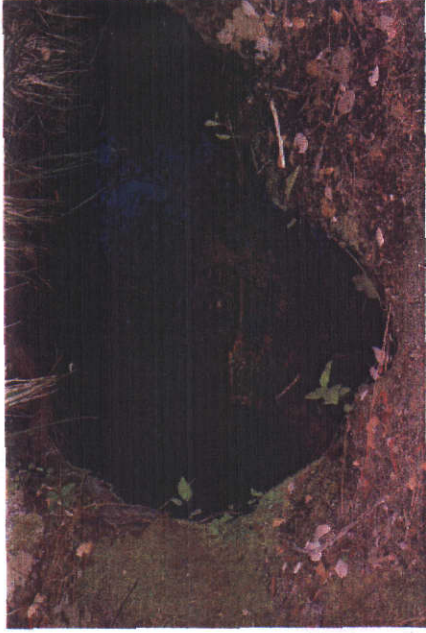
Pool created by leak in underground portion of pipe.
