Re: Kilarc-Cow Creek {FERC P-606} CEQA

ATTACHMENT I

SOUTH COW CREEK {FERC P-606} DIVERSION DAM AREA “PG & E CLEAR CUT OPERATION in MARCH 2011”

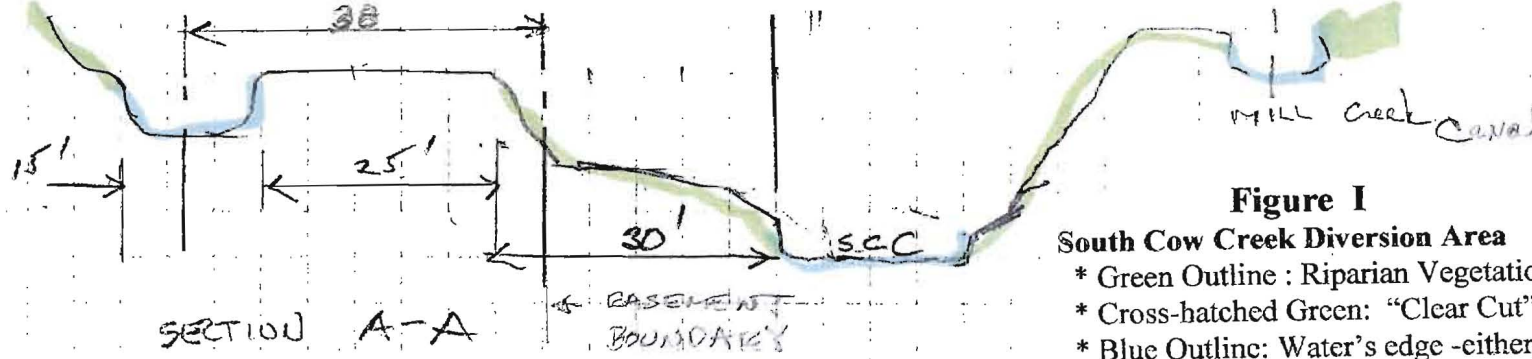
2. All mature riparian vegetation (mostly Alder and Willow) was cleared to the ground between the main canal berm all the to the very edge of South Cow Creek (a distance of about 30 ft.); and for an approximate length of 95 ft. (about 0.065 acres). The “clear cut area” is illustrated in a schematic diagram (Figure I, page 3) of this document {softcopy file is Page 3 001.jpg} The “Clear Cut” starts about 80 feet downstream of the Diversion Structure.

3. As shown in the Figure I schematic; on the main canal side before the 'clear-cut' area begins, there is now left standing downstream of the dam only about a 40 ft long X 40 feet wide stand of alders and willows. Unfortunately it seems it will be necessary to remove at least 50% of this remaining riparian vegetation during the dam removal process in order to remove the old "metal bypass pipe" that is embedded in this region. It would be totally inappropriate to leave such a metal structure in direct proximity of the Creek. Therefore if the dam is actually removed in the near future (< 3years), there effectively will be zero mature vegetation along the Creek bank on the main canal side for a distance of about 175 ft downstream of the dam location.

Figure 1
South Cow Creek Diversion Area
 * Green Outline : Riparian Vegetation
 * Cross-hatched Green: "Clear Cut" area
 * Blue Outline: Water's edge -either Creek or Cana

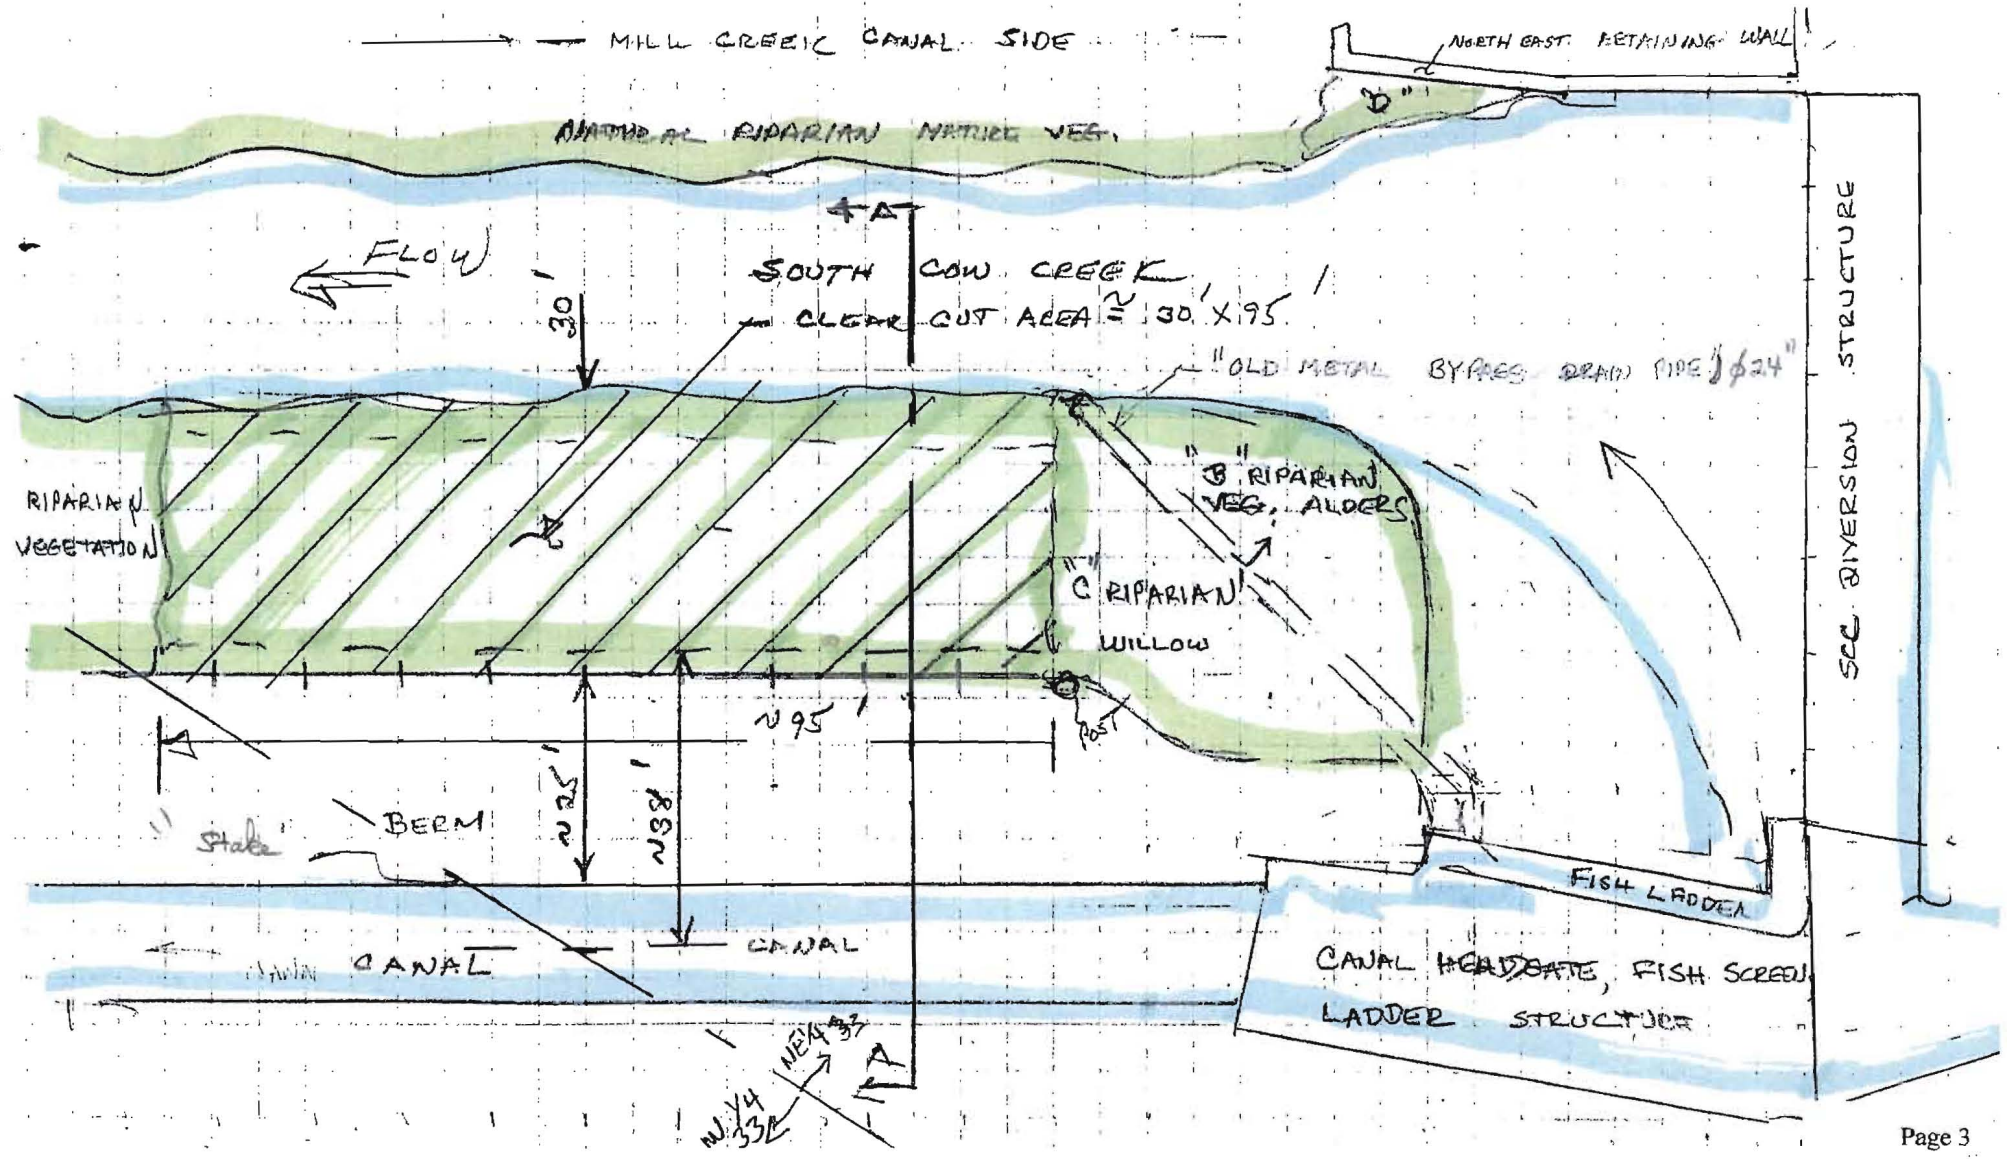
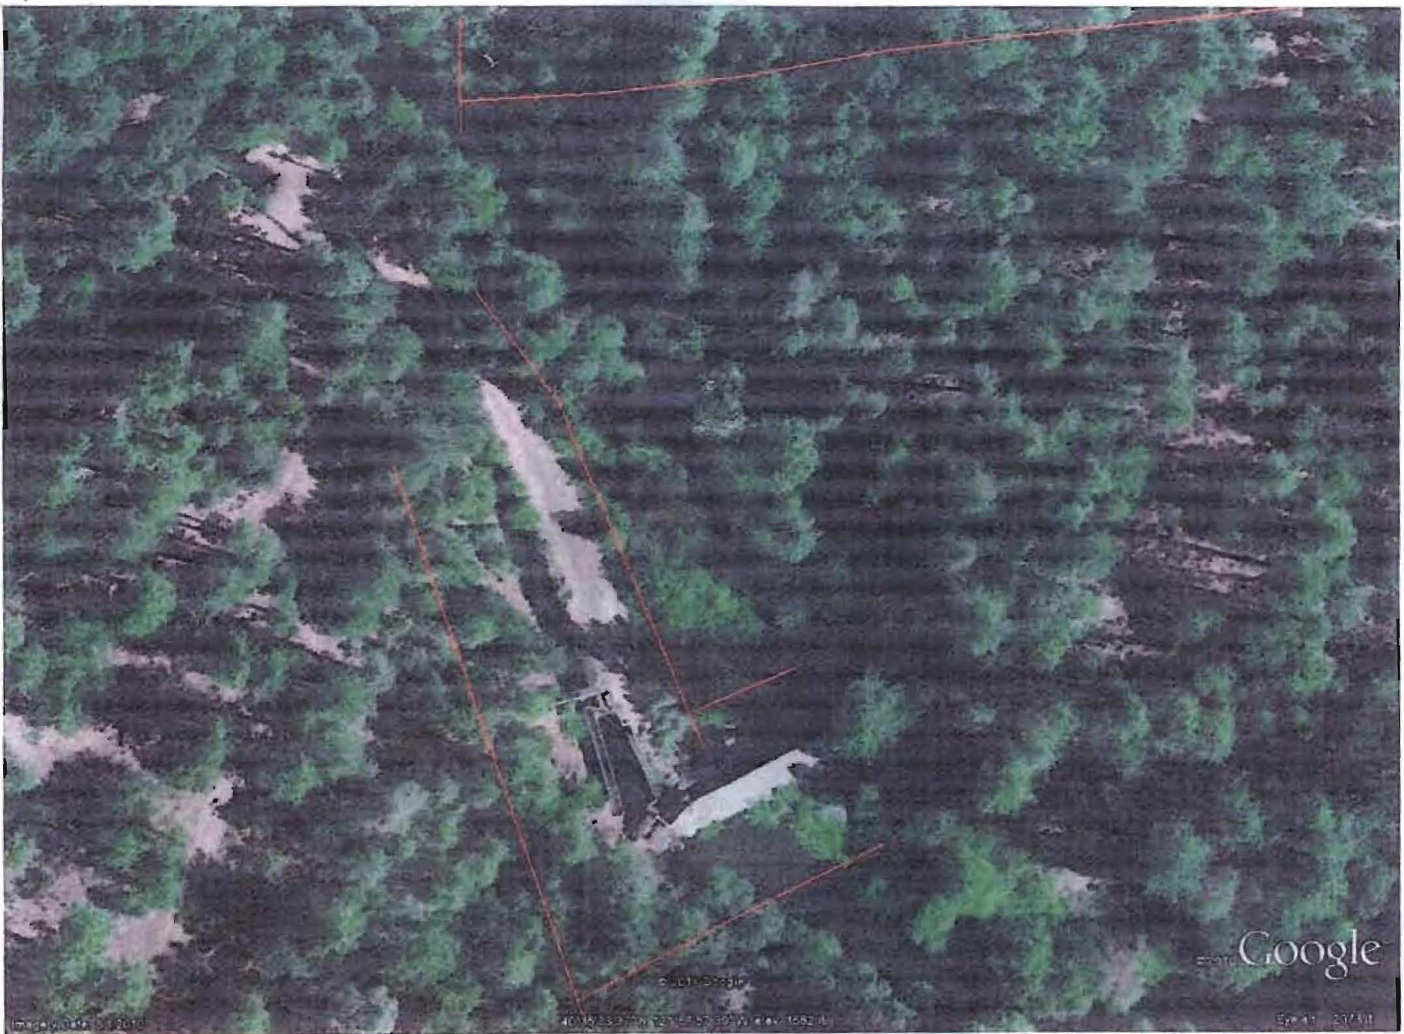
b. The “pre-cut” nature of the riparian vegetation lying along South Cow Creek is best understood from a “Google Earth” August 2010 aerial view of this area shown as Figure II on page 4 {Softcopy file is Page 4 001.jpg}. The 1907 deeded easement requirements of 75 feet for the Project bounds in the NE¼ of Section 33 are projected onto this Figure together with the generally accepted definition* of the N¼ point of Section 33. *Generally accepted means per PGE K-2 documents, PG&E LSA documents, USGA maps, projections from century old landowner fences, etc.

August 2010 Google Earth View of South Cow Creek Dam Area

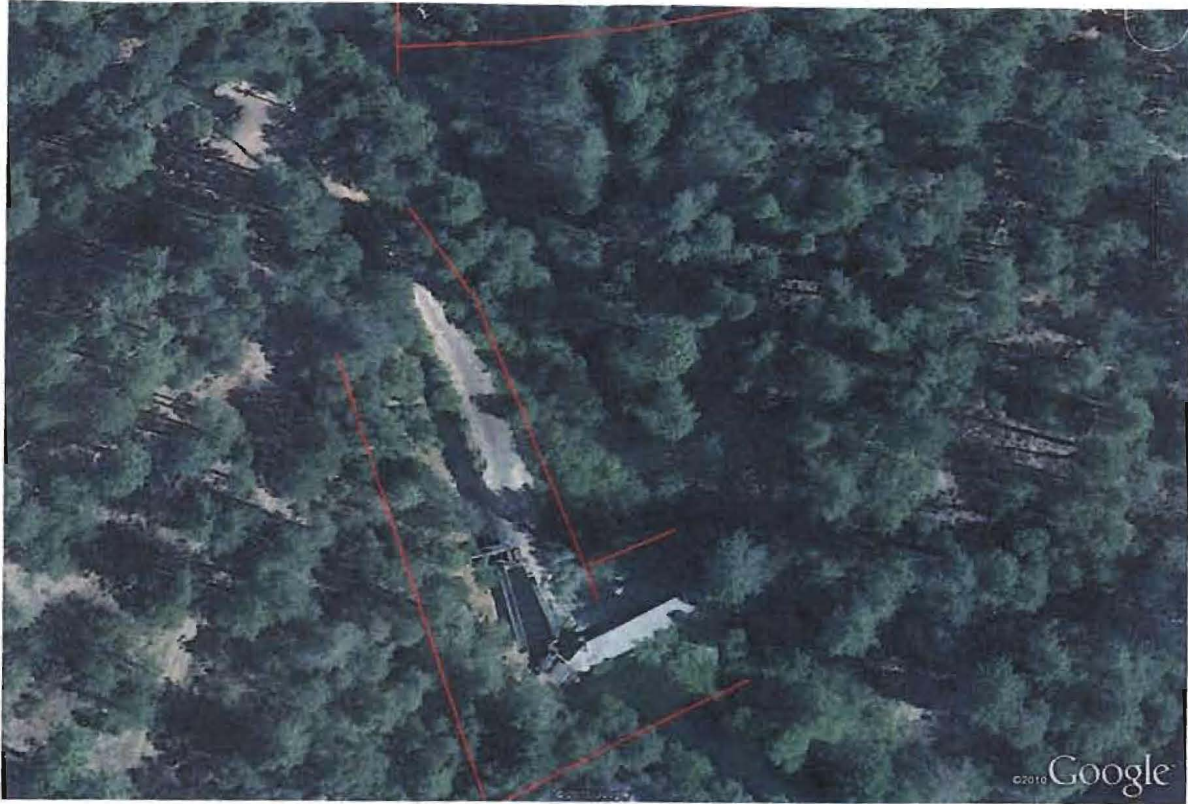
August 1 2010 Google Earth View { Before March 2011 Clear Cut }

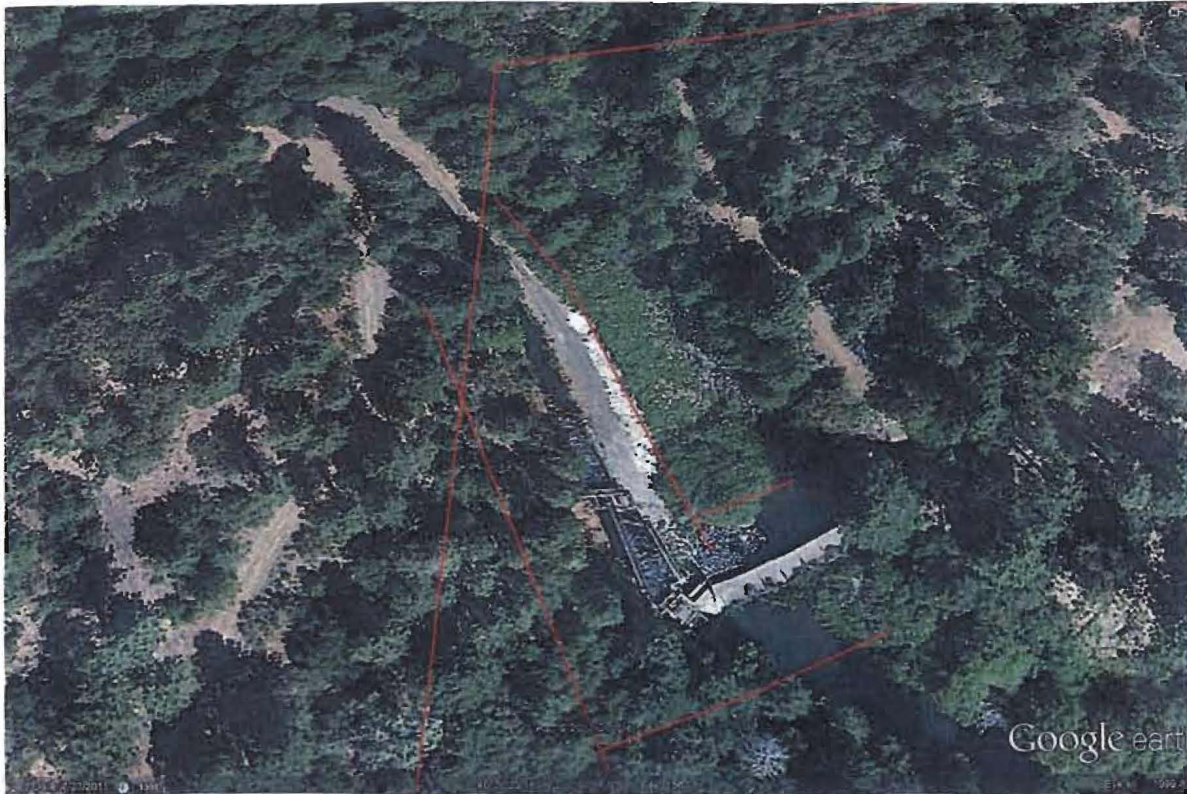
July 27 2011 Google Earth View { After March 2011 Clear Cut }

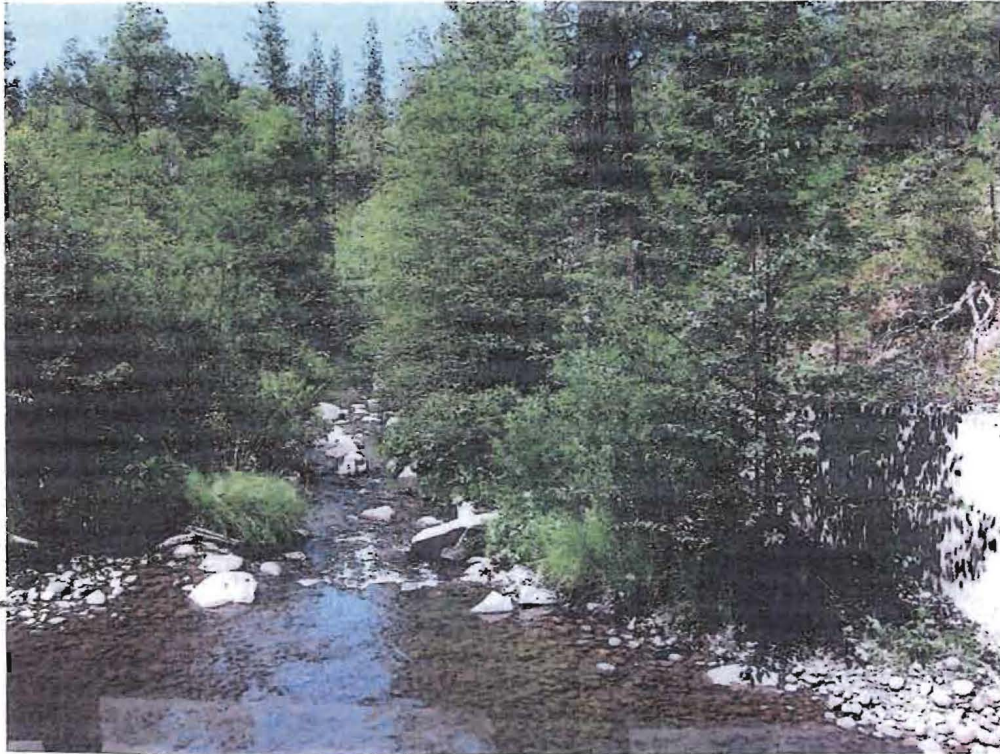
c. Figures III A & B { Page 5 001.jpg file} shows a 2009 lands eye view of South Cow Creek looking immediately downstream from points on the dam surface. Figure IV {Softcopy file Page6 001.jpg } shows the old bypass pipe exit in a 2009 picture at the Creek edge. This point is less than a yard upstream of where the 2011 March “clear-cut” was initiated.

Figure III-A {South Cow Creek immediately downstream of dam - July 2009}

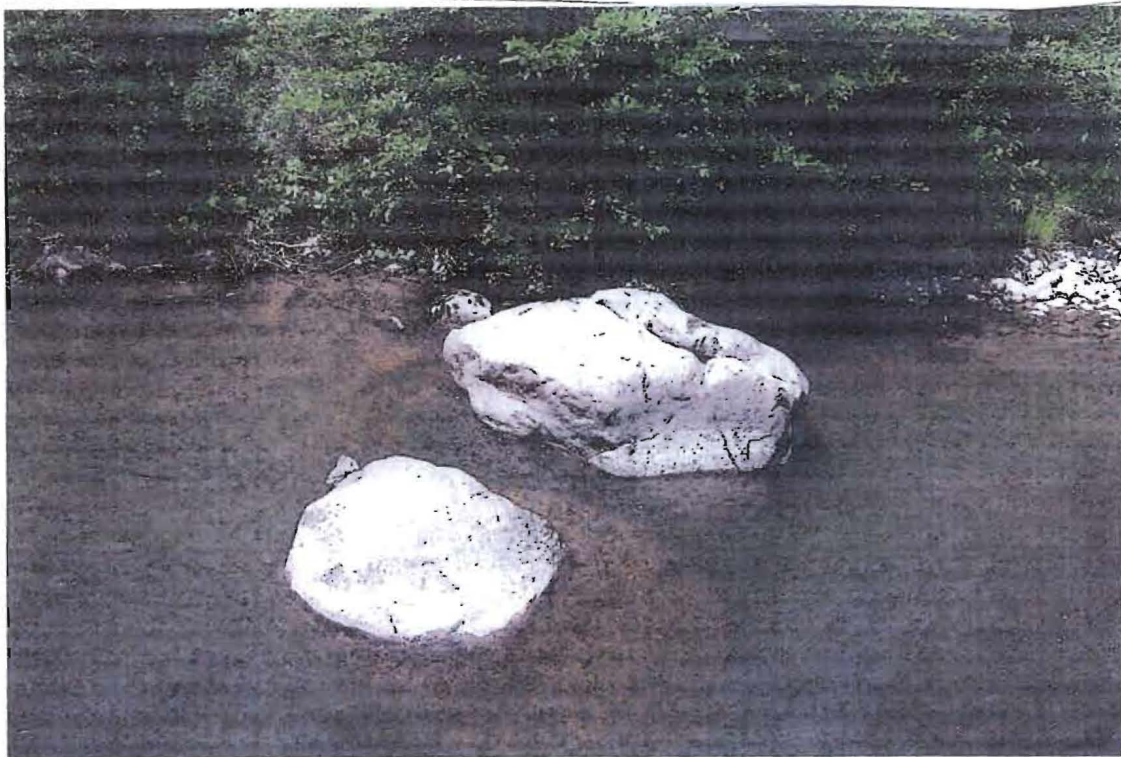
Figure III-B { South Cow Creek below dam just to left of Figure IV-A - July 2009}
+ Fish ladder just to left of this picture
+ *pointer represents corresponding areas between photos A & B

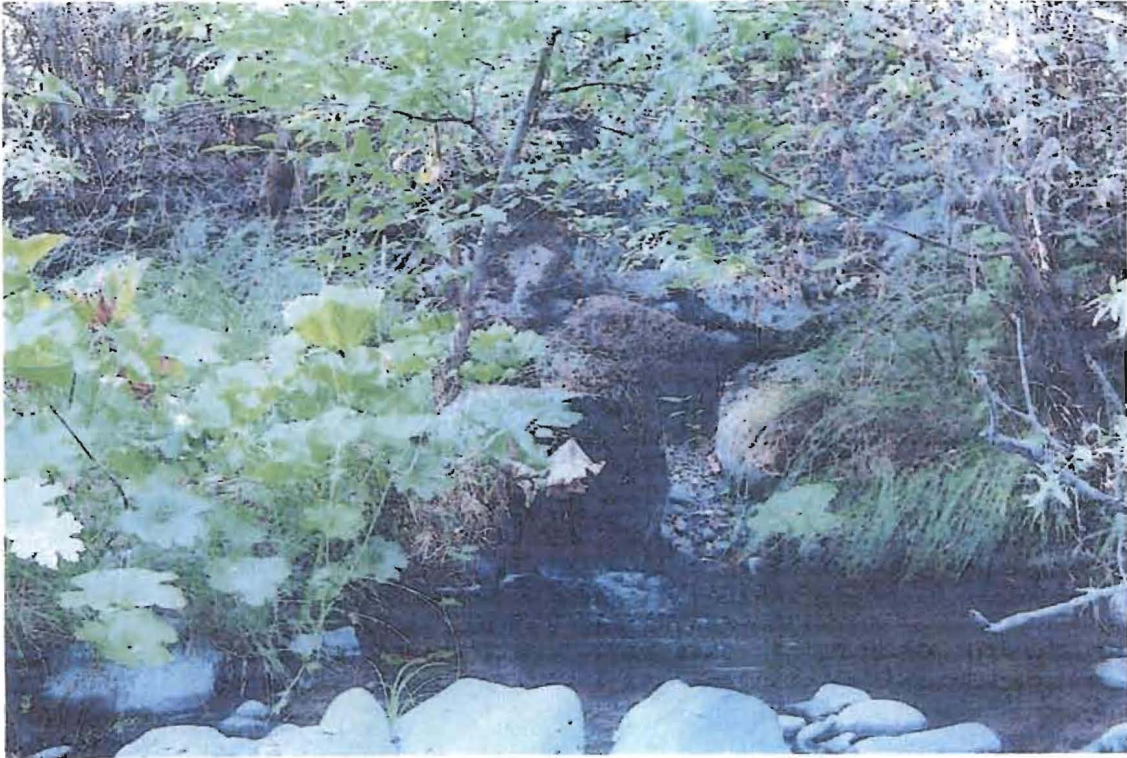
Figure IV
{ Exposed exit area of now embedded Old Metal Bypass Drain Pipe - Sept 2009 }

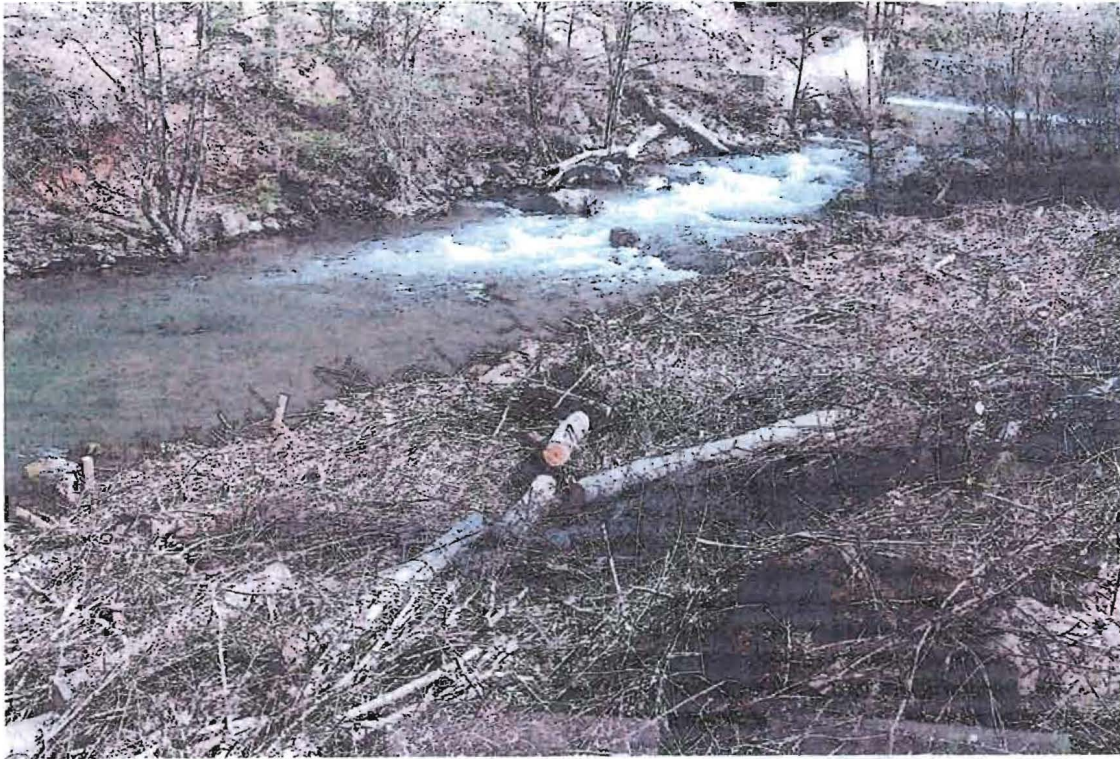
d. Figures V-A & V-B {Softcopy file is Page7 001.jpg} show pictures of the "clear-cut" area taken in early April 2011 before the down riparian vegetation was latter "chipped" latter that month. Figure V-A is taken from the main canal berm looking towards the Mill Creek canal side with that side retaining wall and the NE side of the diversion structure in the upper right corner. Figure V-B is the "clear-cut area" taken from the Mill Creek Canal side. Neither the main canal or the berm top shows in this picture as they are at the same elevation as the camera. The wooded area in the background is that on the upslope beyond the far side of the main canal.

Figure V-A { Clear cut area viewed from main canal side looking towards dam}
+ Early April 2011

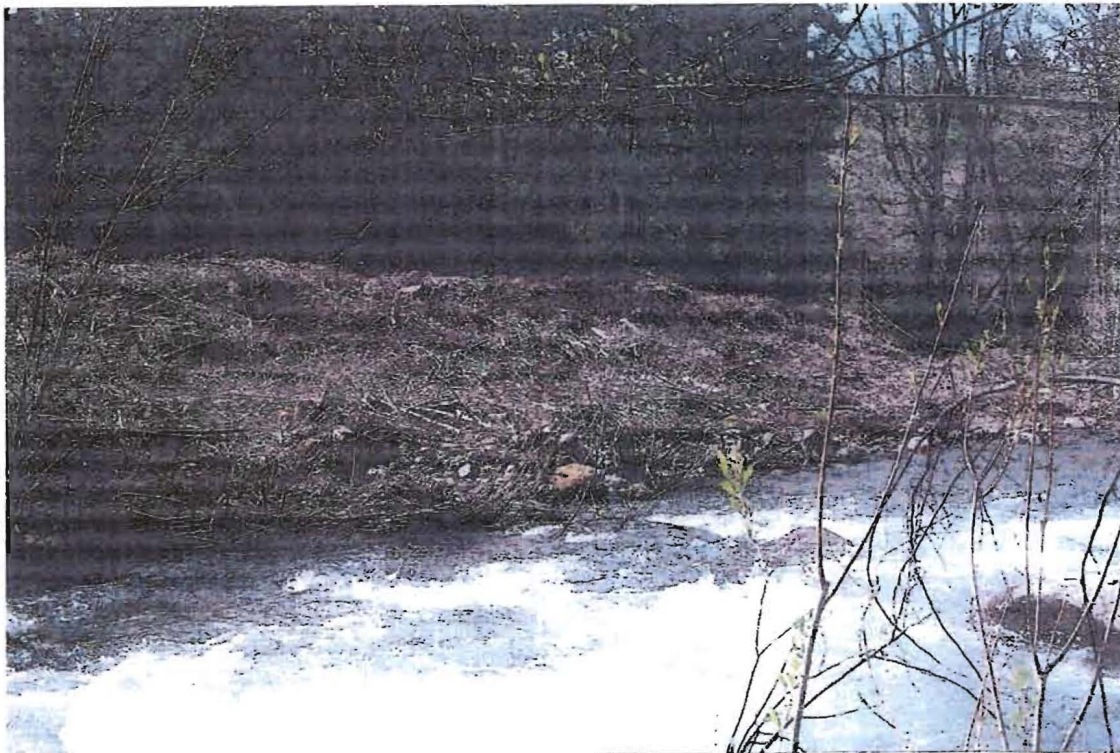
Figure V-B { Clear cut area viewed from Mill creek canal side looking downstream}
+ Early April 2011

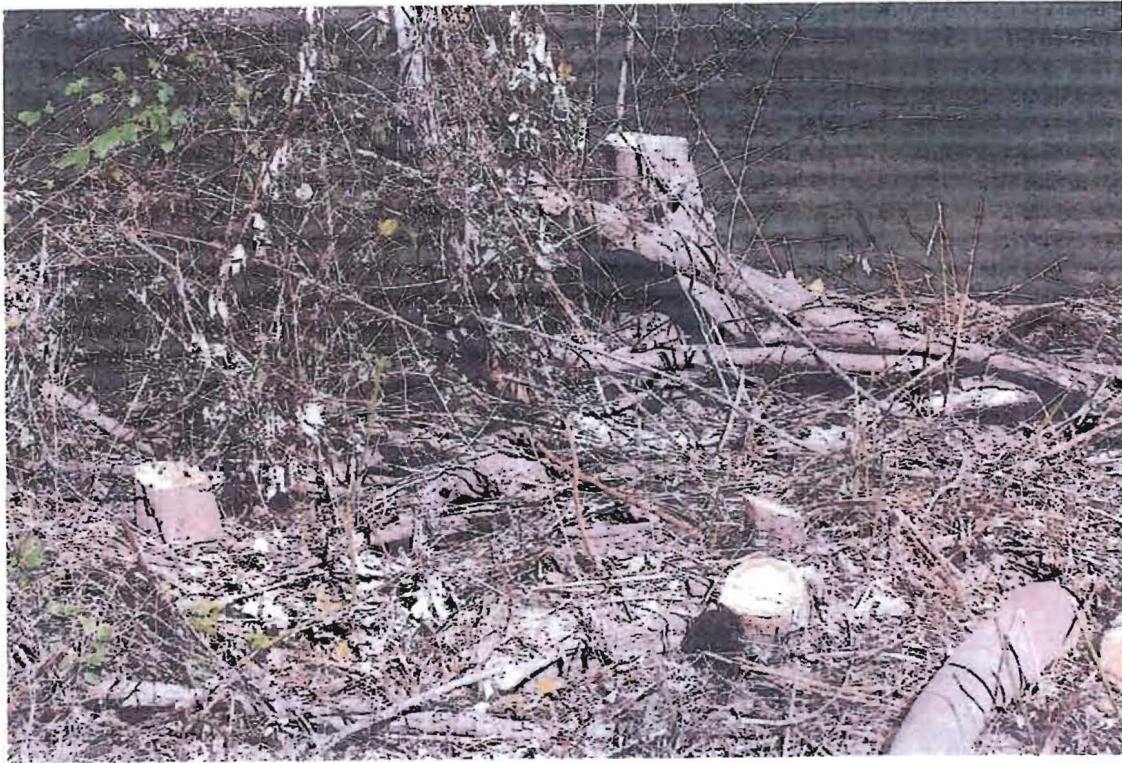
e. Figures VI-A & B {Softcopy file is Page 8 001.jpg } give some perspective of the size of riparian vegetation removed near the Creek.

Figure VI-A {Typical Mature Riparian Vegetation cut 3/21 - Picture early April 2011}

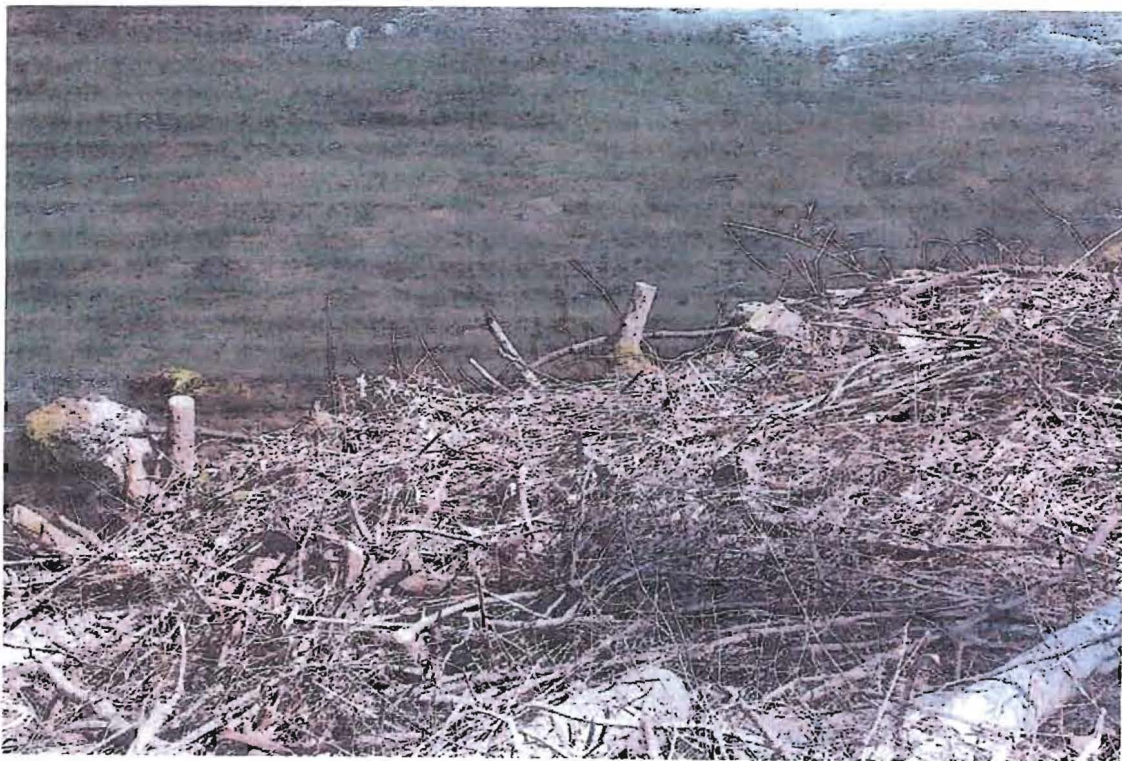
Figure VI-B {Typical Mature Riparian Vegetation cut 3/21 - Picture early April 2011}

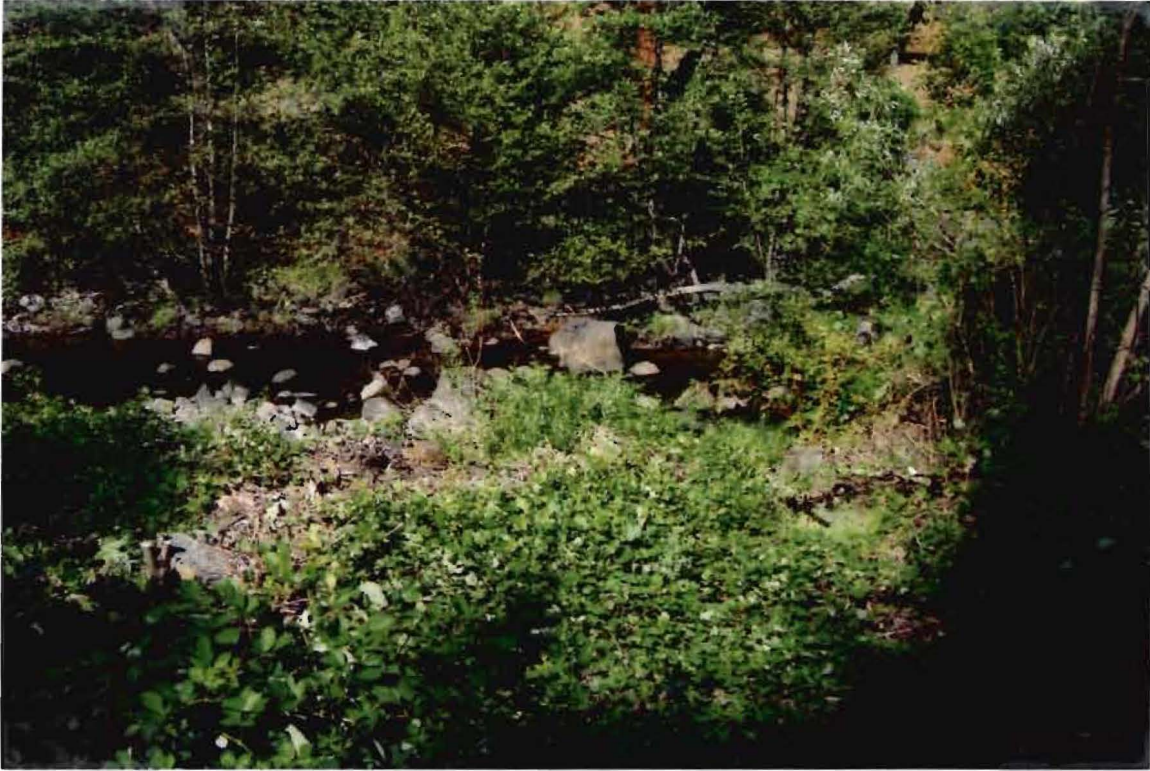
f. Figure VII-A & B {Softcopy file is Page 9 001.jpg } are pictures of the clear cut area taken from the main canal berm side on 7/25/2011 show the berry and vine vegetation that has started to regenerate.

Figure VII-A { Clear cut area upstream end - Picture 7/25/2011 }

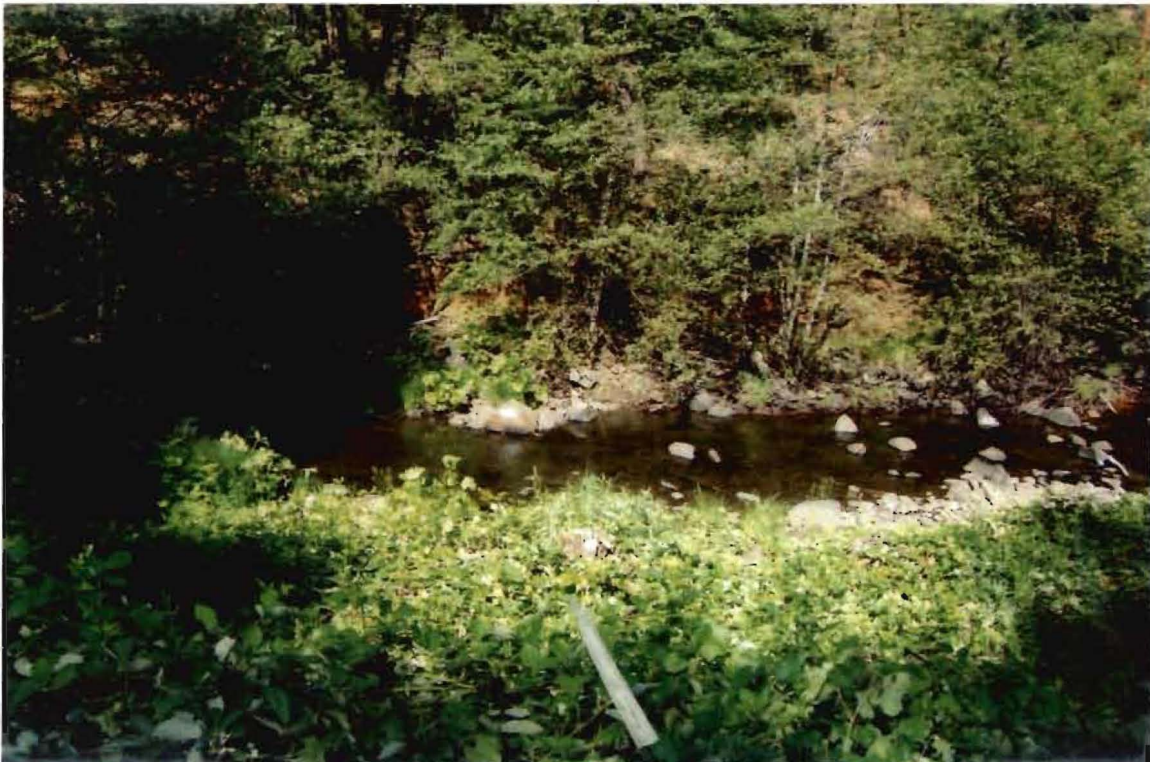
Figure VII-B { Clear-cut area downstream end - Picture 7/25/2011 }
