Buckhorn Mountain Mine, Washington

STRATUS CONSULTING

Buckhorn Mountain Mine

Independent Monitoring Goal

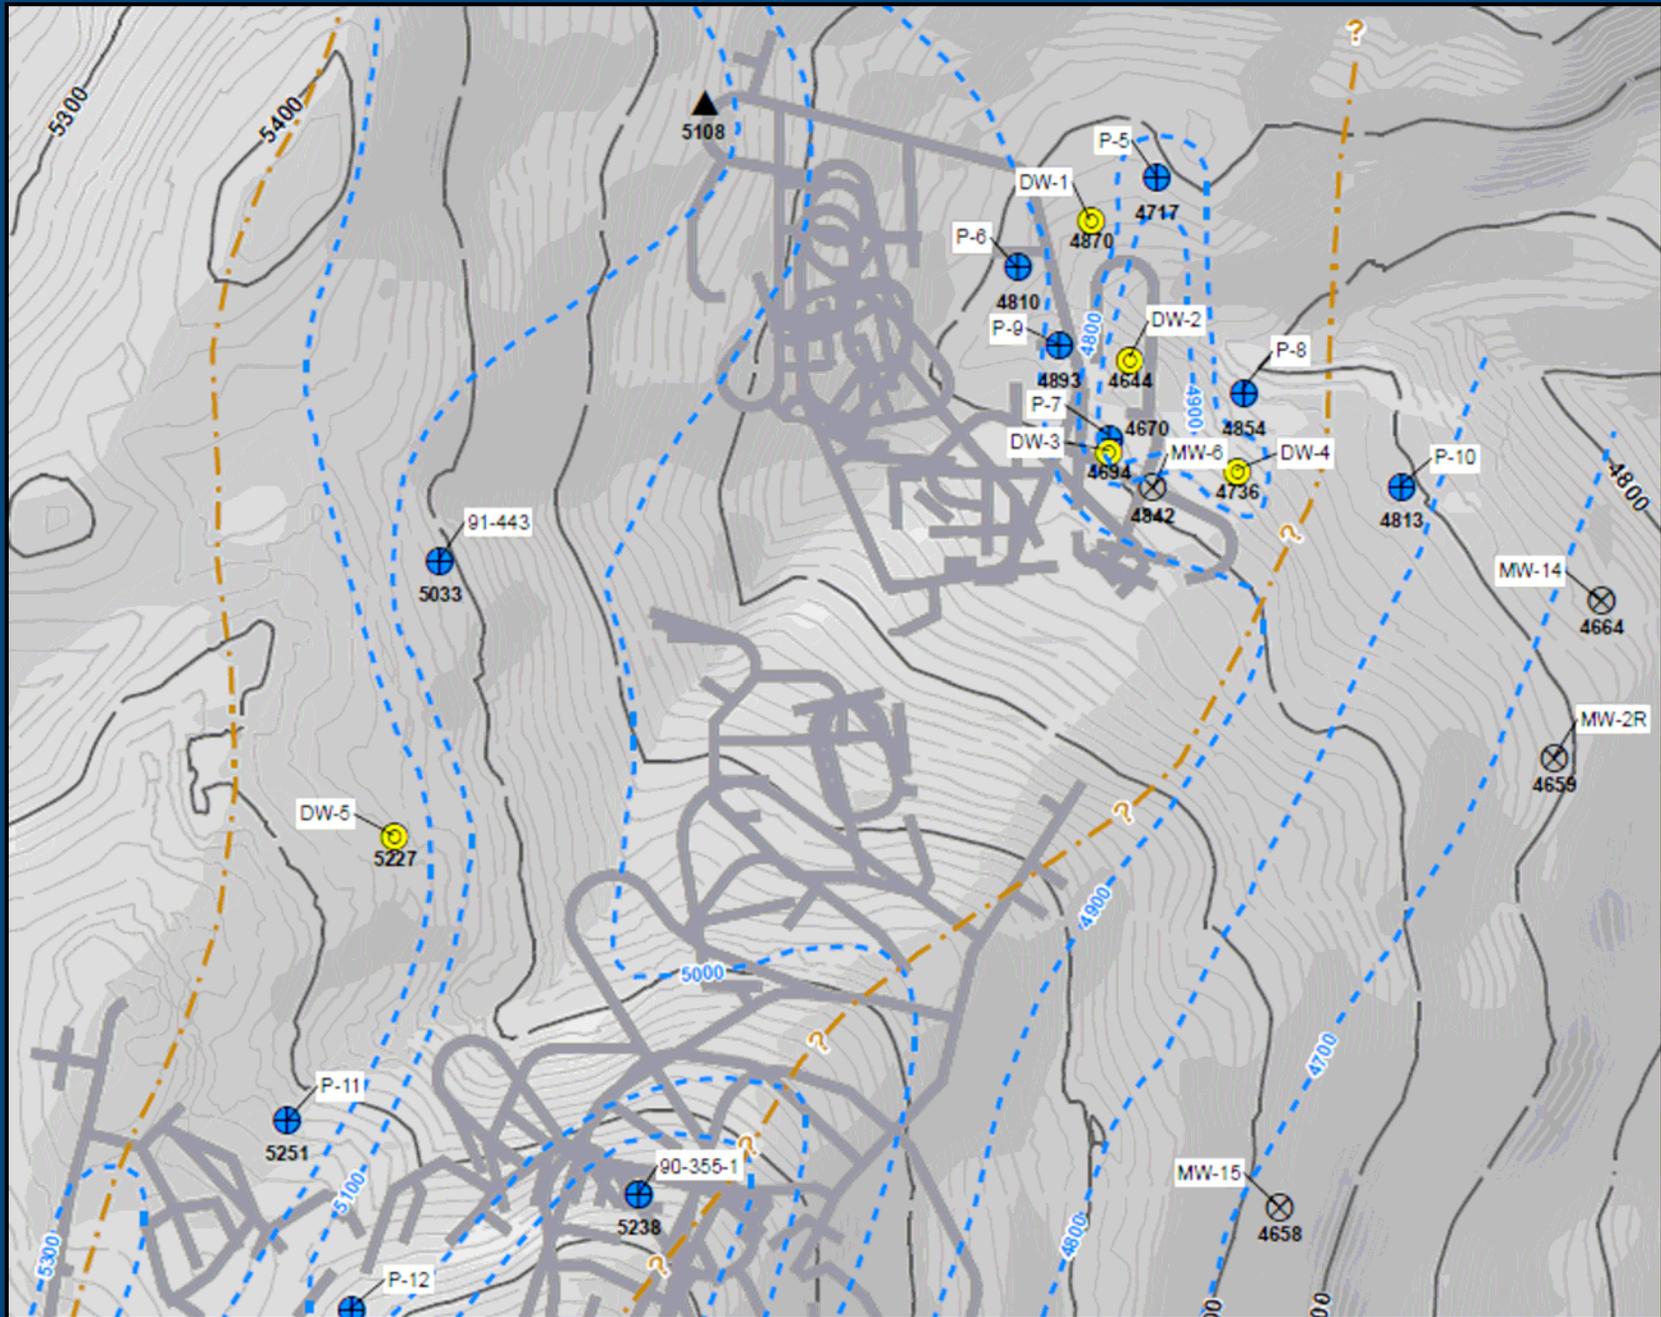
Capture Zone?

- Increased nitrate, ammonia, chloride in groundwater related infiltration of treated effluent from surge pond and outfall 002 infiltration trench
- Increased sulfate related to oxidation of sulfides from blasting and mining
- Capture zone isn't capturing all mine water - violation
- Actual water quality in treatment plant inflow is much higher than predicted
- Measured flows in streams are often higher than predicted – need on-site meteorological station
- Need to increase dewatering and monitoring wells to improve capture

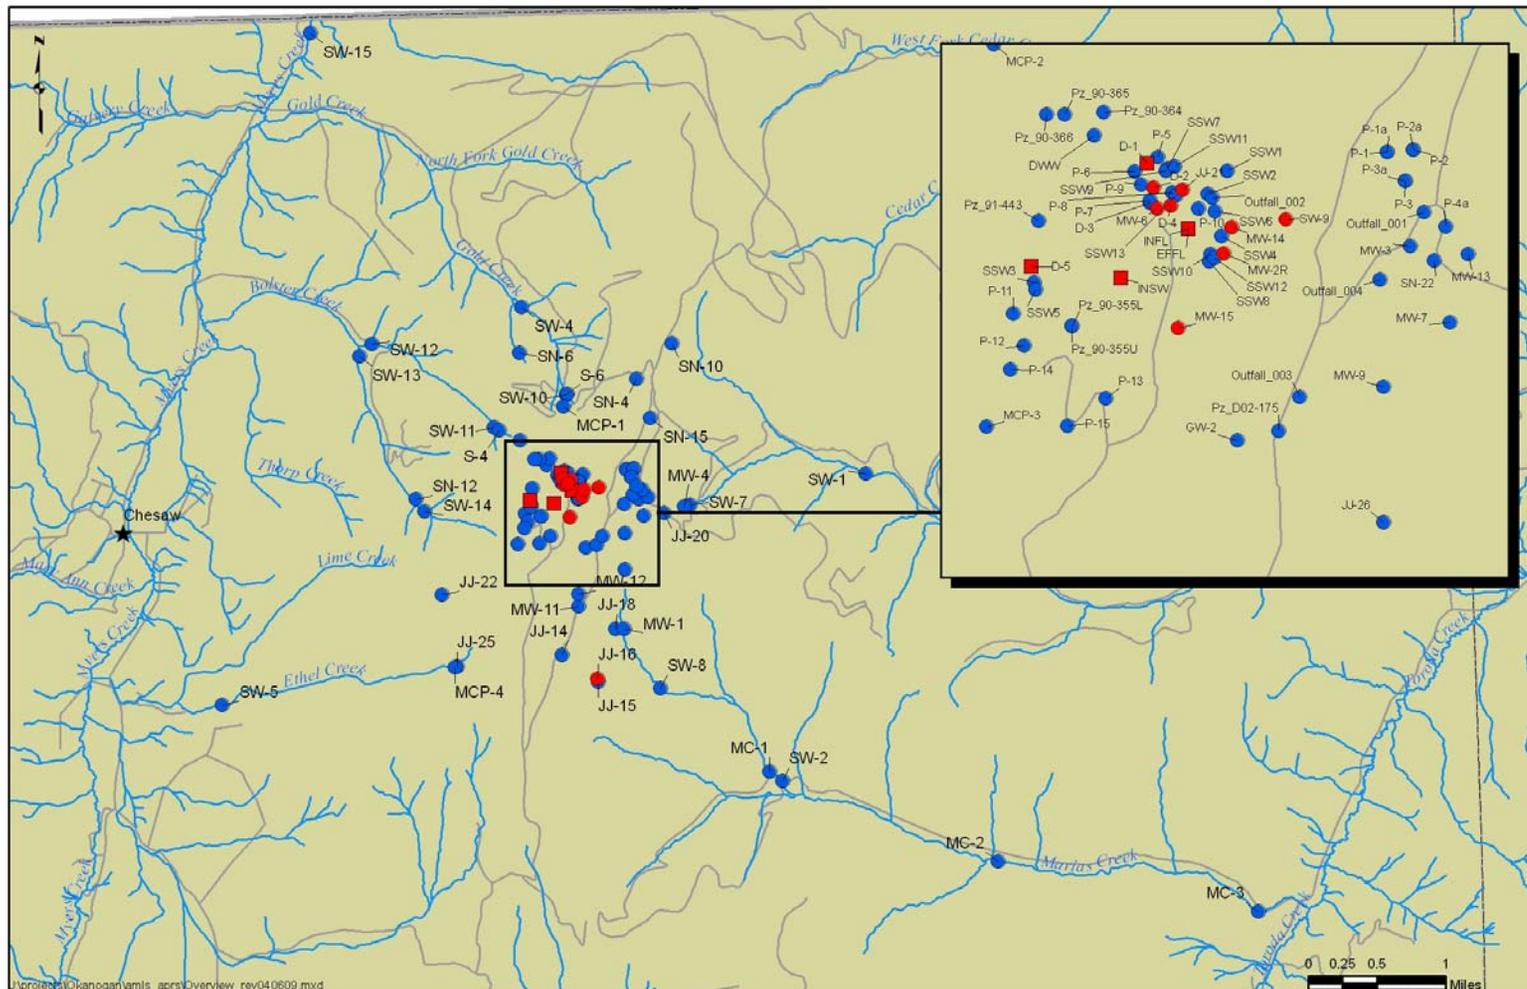
Locations with Elevated Nitrate and/or Ammonia Concentrations

Baselines for:
 GW Ammonia (as N) = 0.51 mg/L
 SW Ammonia (as N) = 0.70 mg/L
 GW Nitrogen (Nitrite + Nitrite) = 2.34 mg/L
 SW Nitrogen (Nitrite + Nitrite) = 3.23 mg/L

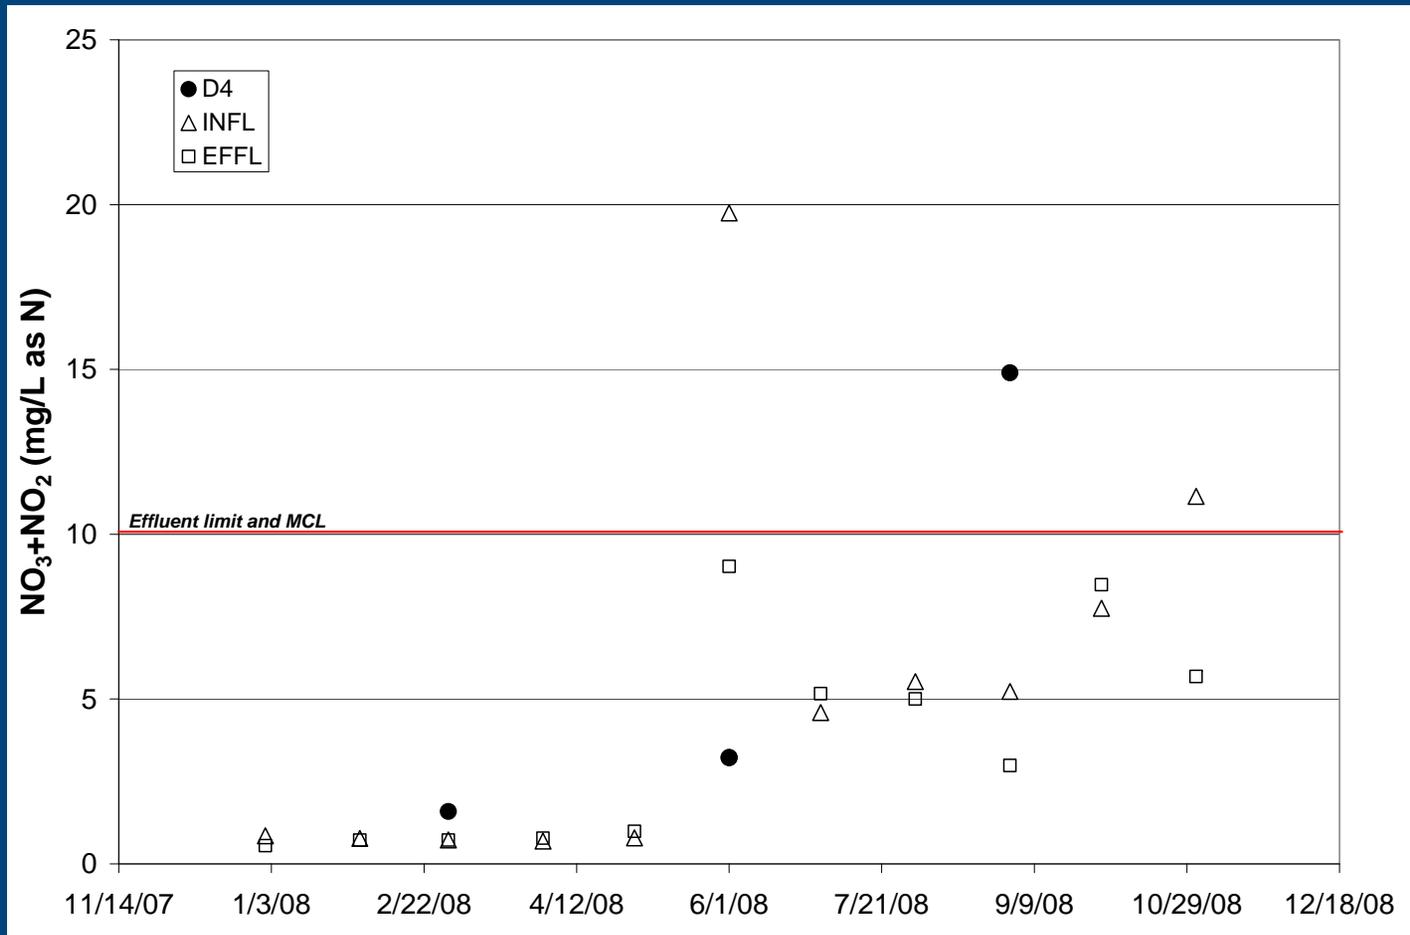
Increasing Nitrate Concentrations

INFL = WWTP influent from mine; EFFL = WWTP effluent to streams, groundwater

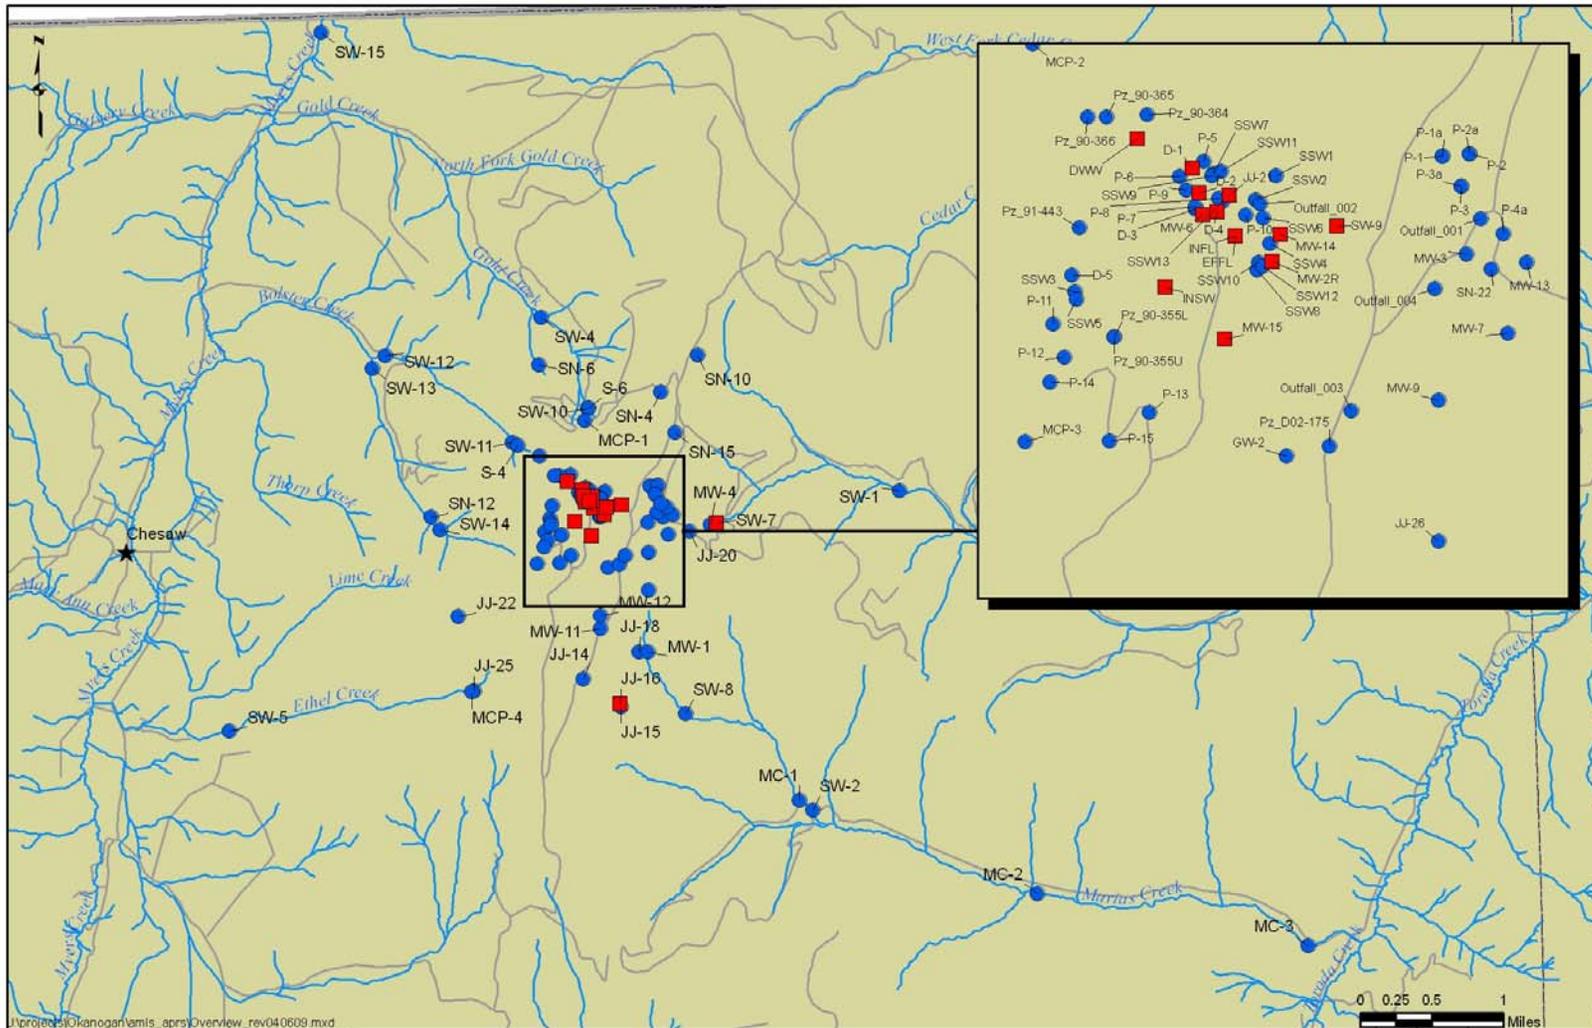
Locations with Elevated Sulfate Concentrations

Baseline for:
 GW Sulfate = 77.4 mg/L
 SW Sulfate = 51.7 -- 95% UTL for SW-7

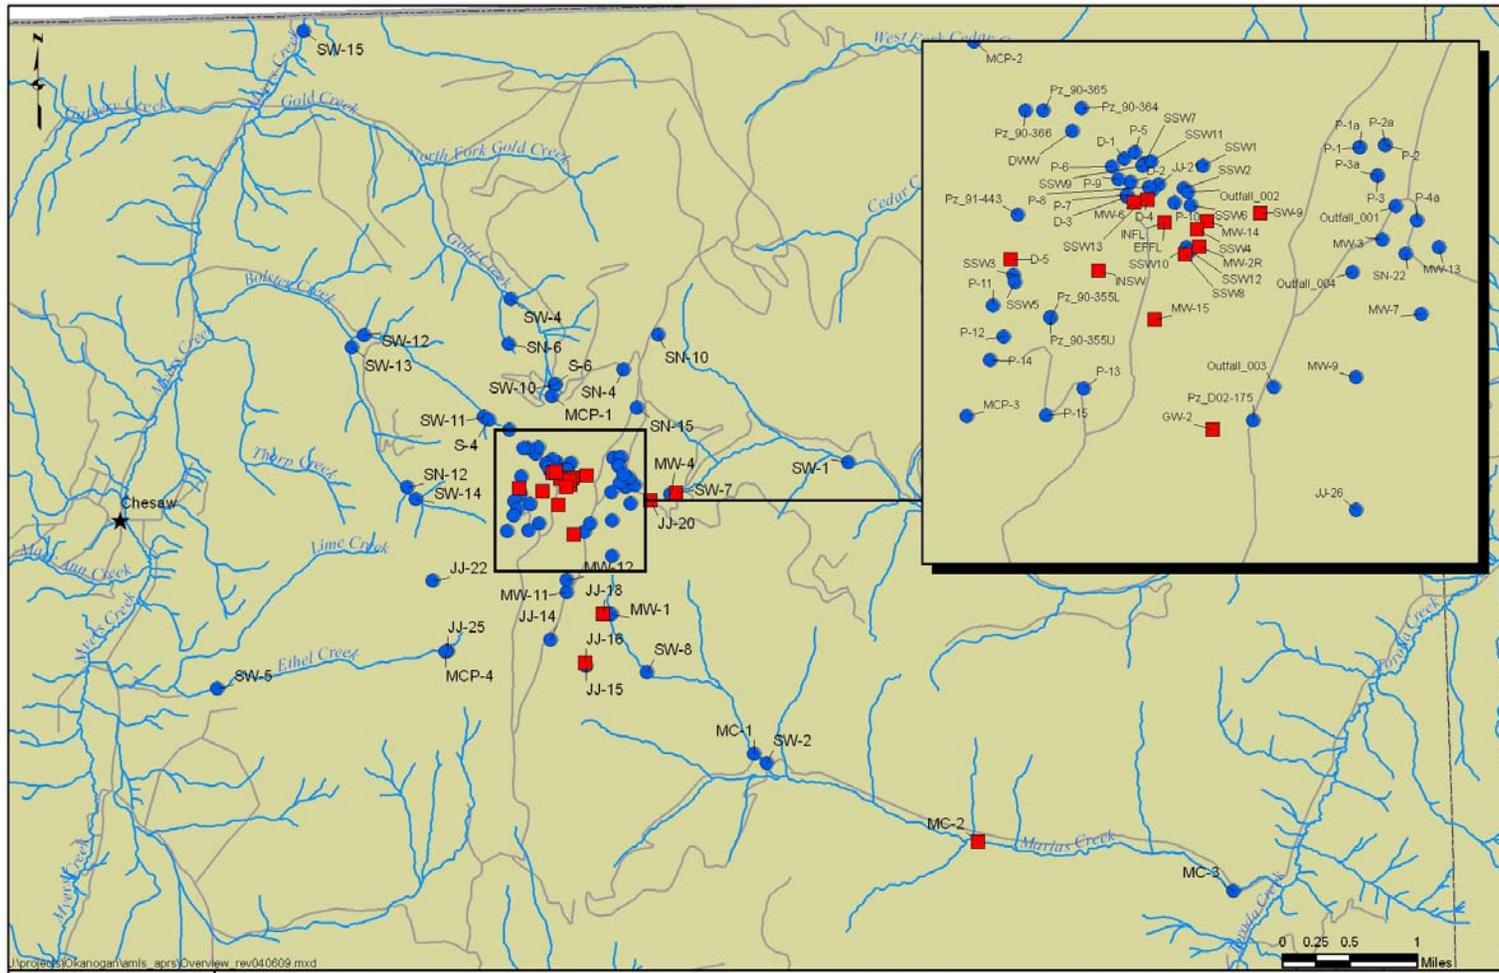
Locations with Elevated Chloride Concentrations

Baseline for:
 GW Chloride = 3.48 mg/L
 SW Chloride = 2.22 mg/L

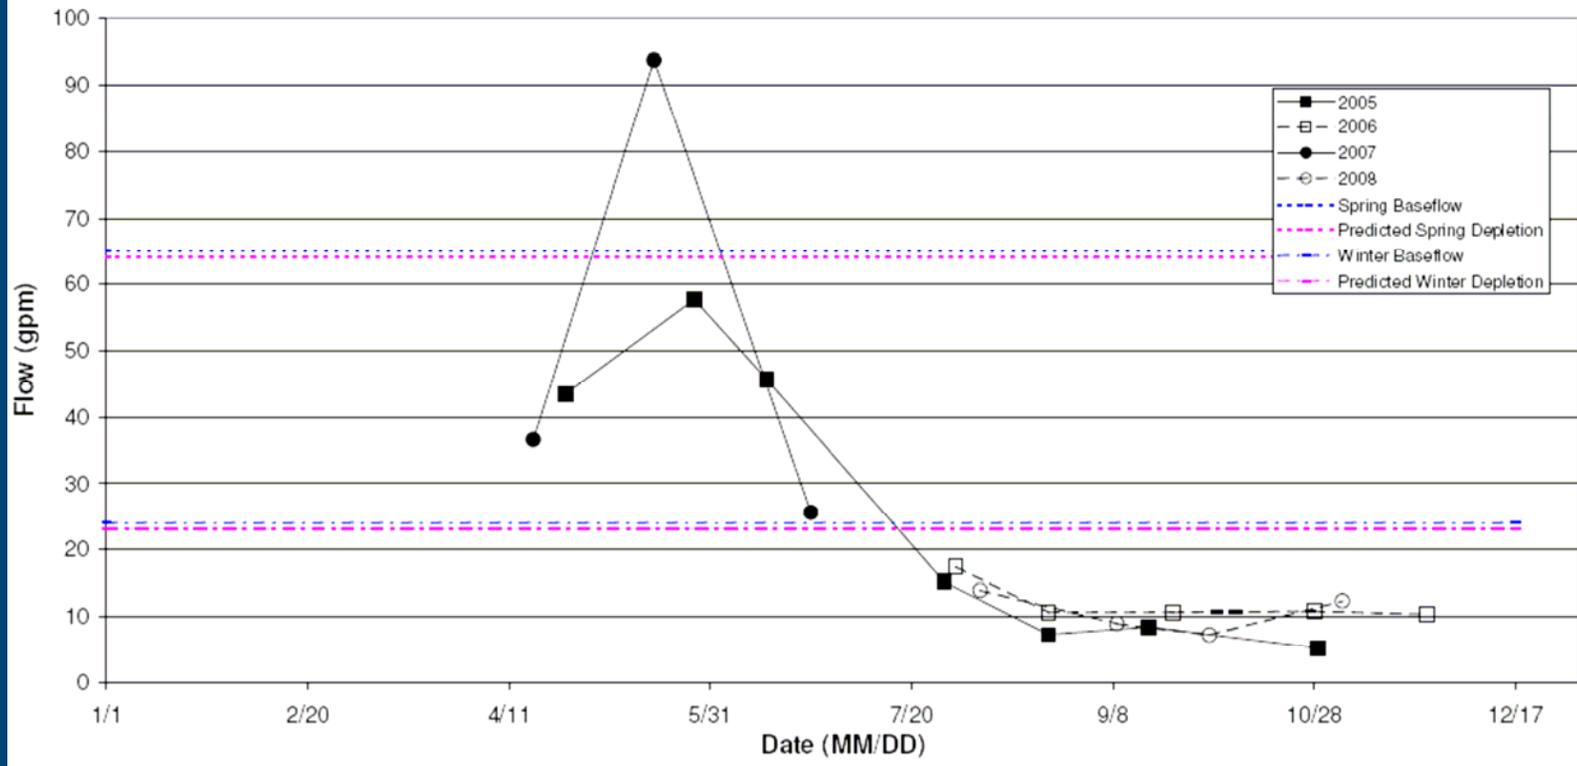
Figure 1. Comparison of Measured and Predicted Flows at SW-4, Lower Gold Creek: 2005-2008

- Measured low flows (fall/winter) are often substantially lower than modeled baseflows
- FEFLOW model does not adequately simulate pre-mining conditions
- Need precipitation data from the mine and historic streamflows as input to model

Modeled low flows are substantially larger than the measured flows
