# California Regional Water Quality Control Board Central Valley Region

1 March 2010

## **ADMINISTRATIVE CIVIL LIABILITY ORDER R5-2010-0508, DEL RAPINI CONSTRUCTION INC., PINE GROVE BLUFFS, AMADOR COUNTY**

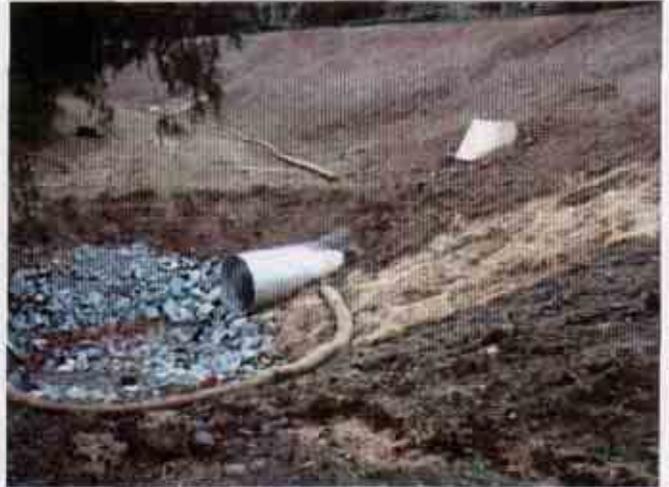
**Figure 2:** Poor BMPs directly around a outfall location

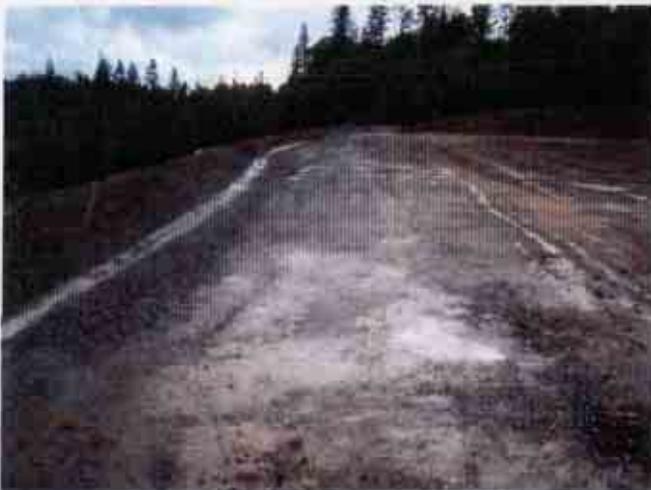
**Figure 3:** A portion of the site

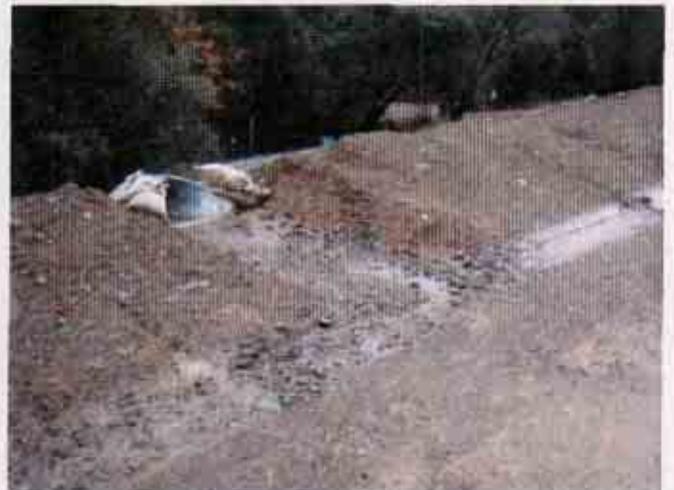
**Figure 4:** Poorly protected down drain inlet

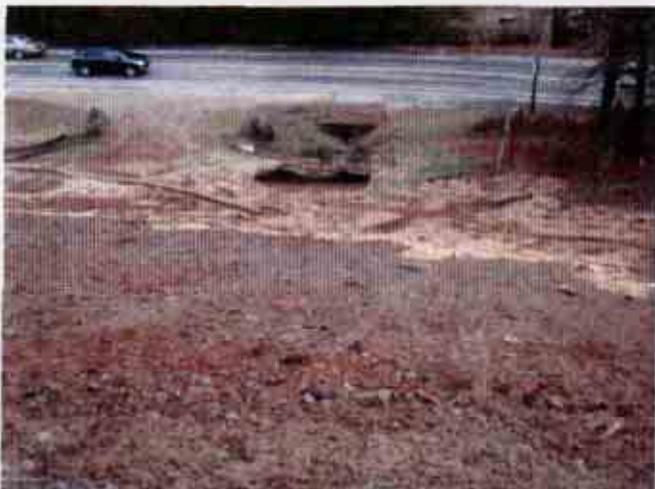
**Figure 5:** Rilling on the slope

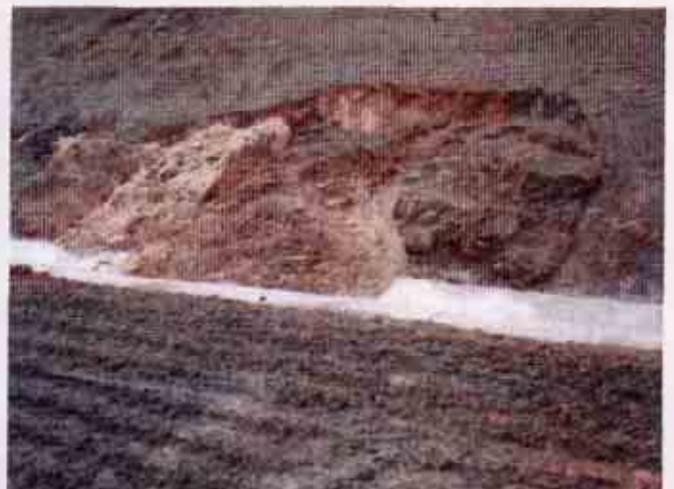
**Figure 6:** Slump that has deposited sediment in the concrete lined storm water conveyance system

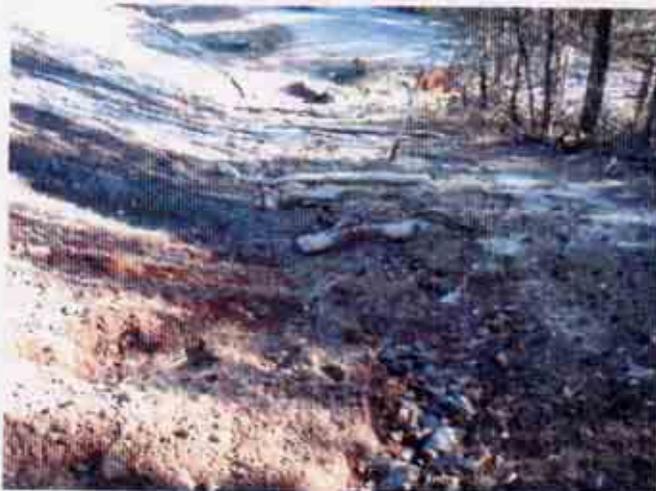
**Figure 5:** Poorly installed and maintained BMPs

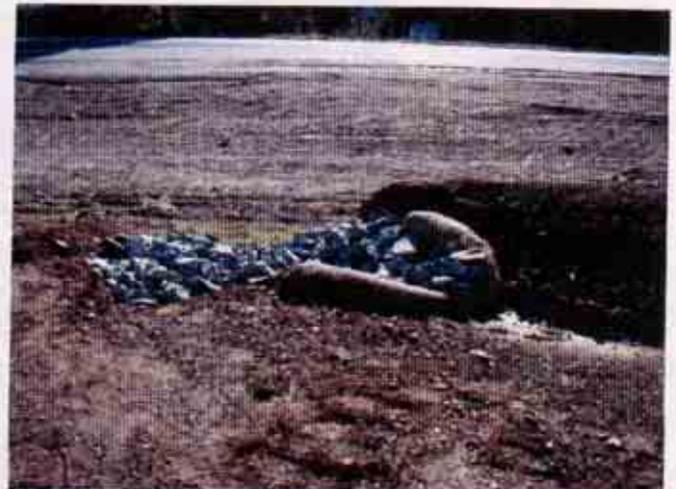
**Figure 6:** Another poorly installed and maintained BMP

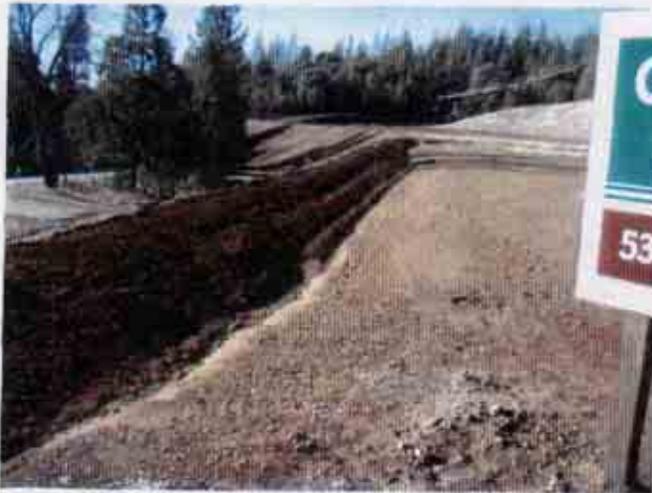
**Figure 7:** Lack of an effective combination of erosion and sediment control BMPs

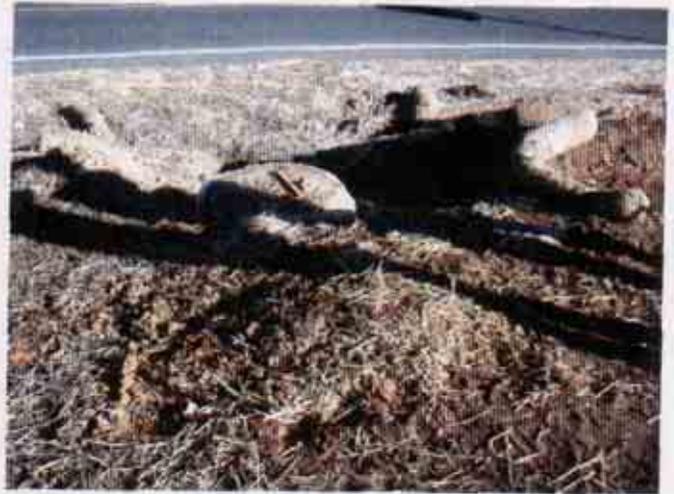
**Figure 8:** Poorly protected drain inlet

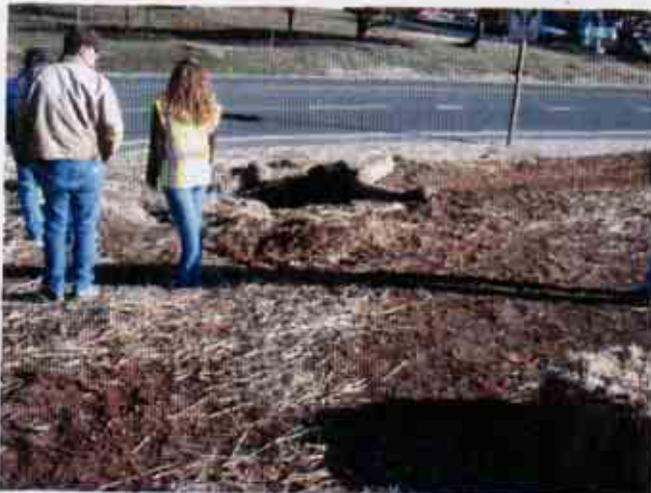
**Figure 9:** Another view of the poorly protected drain inlet

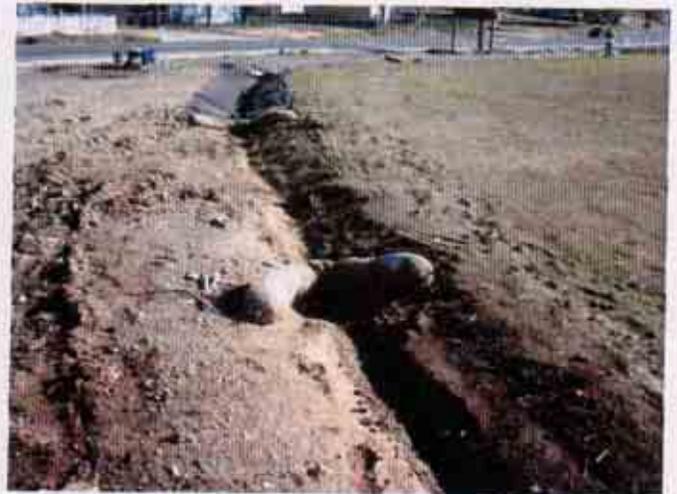
**Figure 10:** Poorly installed and maintained BMPs

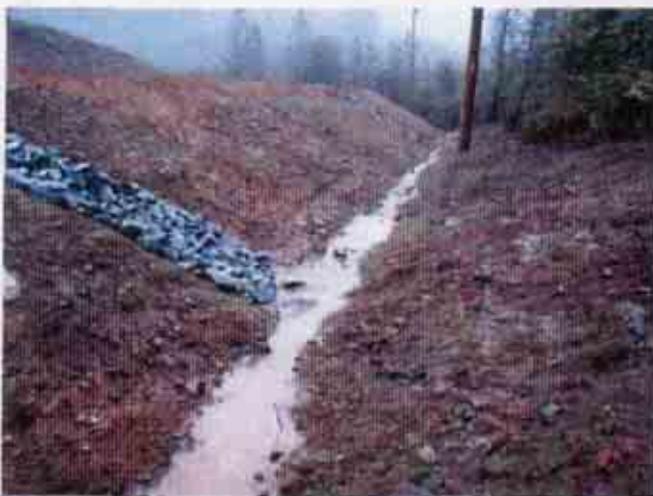
**Figure 5:** Lack of effective BMPs on the slopes and lack of BMPs in a defined drainage channel

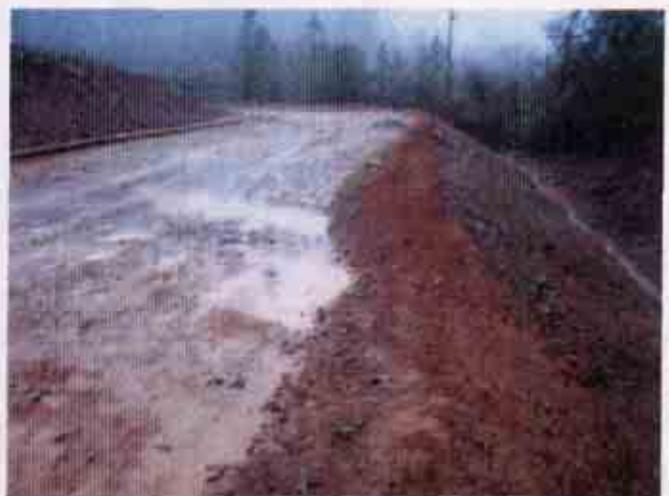
**Figure 6:** Lack of an effective combination of erosion and sediment control BMPs

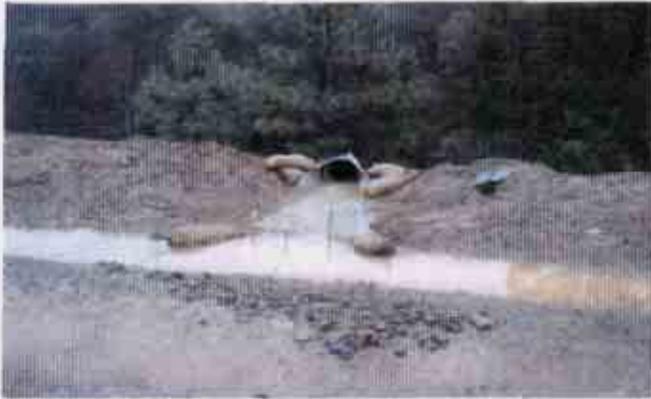
**Figure 13:** Inadequate BMPs at a location where storm water flows from the site into a down drain which directly flows under the roadway and into the creek

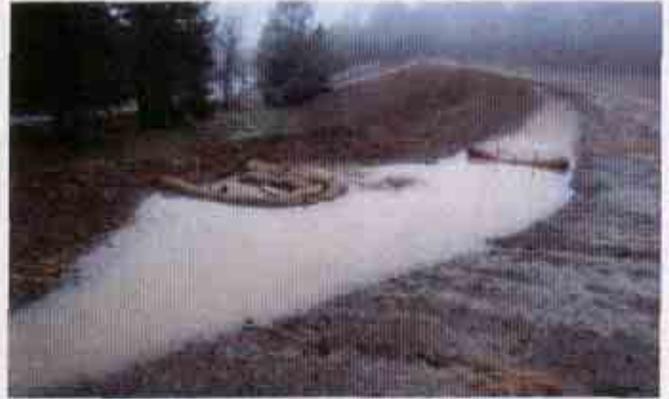
**Figure 14:** Inadequate BMPs at another one of the discharge areas

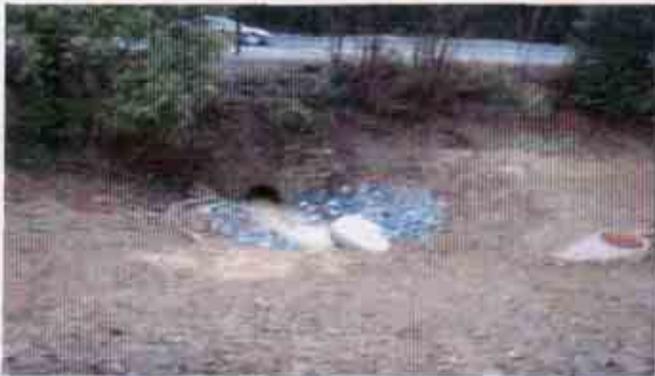
**Figure 15:** Storm water discharge from the site entering the culvert which flows under the highway and directly into the creek

The discharge of sediment-laden water from your site is a violation of Discharge Prohibition A.3 of the General Permit, which states, *"Storm water discharges shall not cause or threaten to cause pollution, contamination, or nuisance."* Sediment-laden storm water from your construction site threatened to cause a condition of pollution and/or nuisance in Jackson Creek, therefore, is a violation of Prohibition A. 3. (See photographs 8, 15, 23-25).

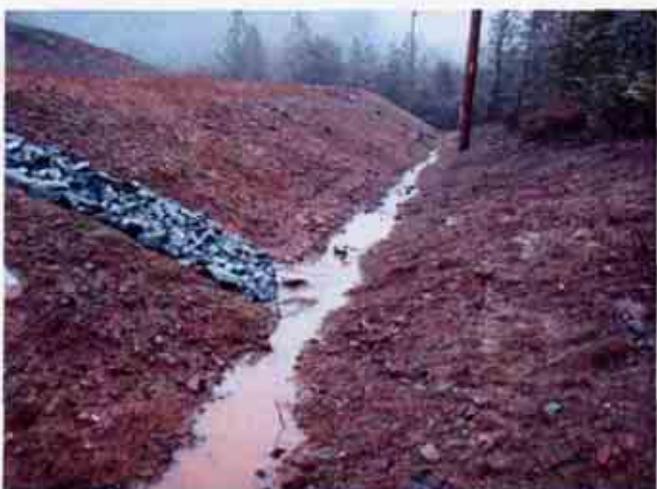
**Figure 5:** Lack of effective BMPs on the slopes and lack of BMPs in a defined drainage channel

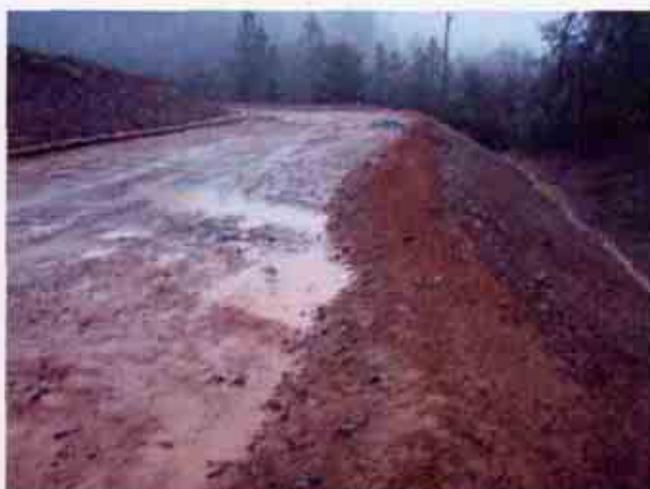
**Figure 6:** Lack of an effective combination of erosion and sediment control BMPs

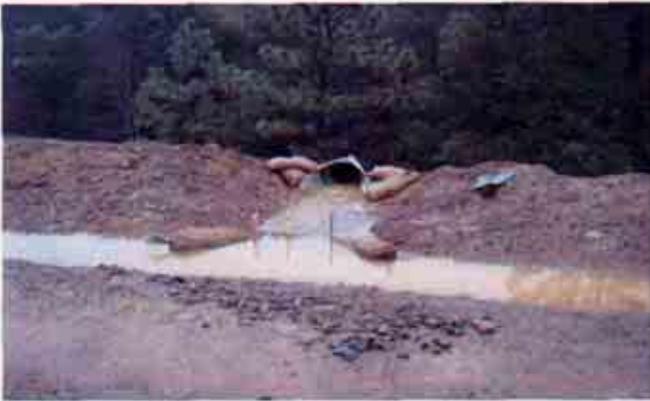
**Figure 13:** Inadequate BMPs at a location where storm water flows from the site into a down drain which directly flows under the roadway and into the creek

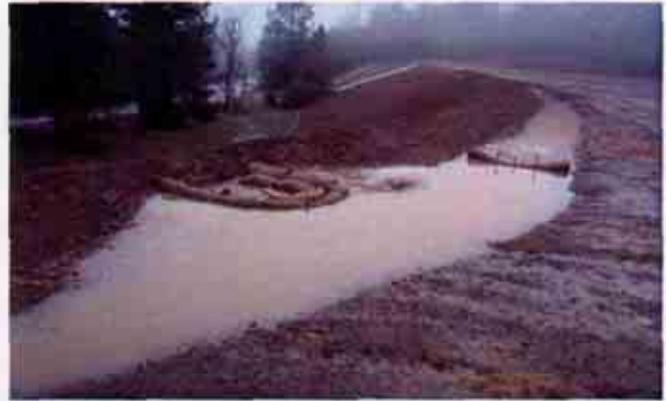
**Figure 14:** Inadequate BMPs at another one of the discharge areas

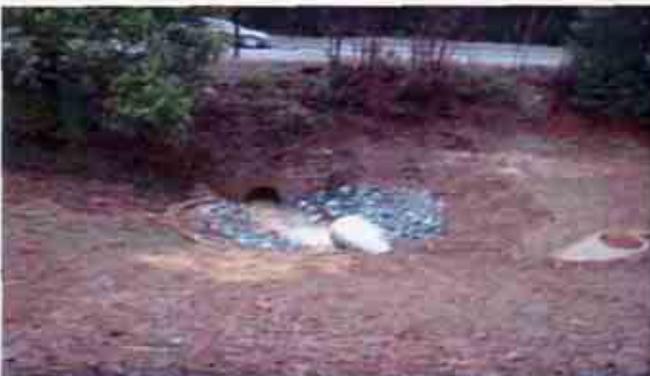
**Figure 15:** Storm water discharge from the site entering the culvert which flows under the highway and directly into the creek

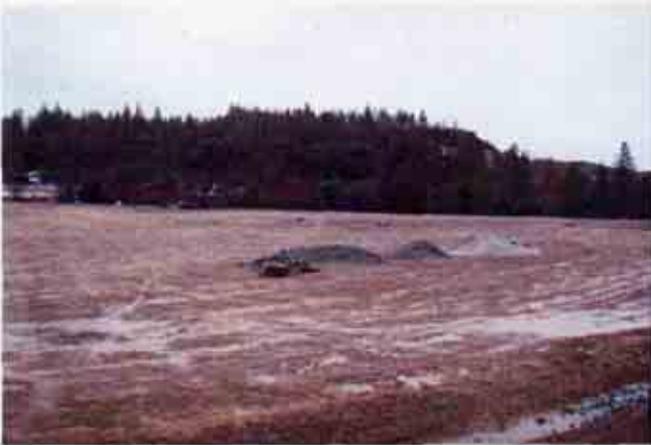
**Figure 1:** Overview of site, showing inadequate storm water BMPs. Storm water sheet flows to conveyance channels like that shown in Figure 2.

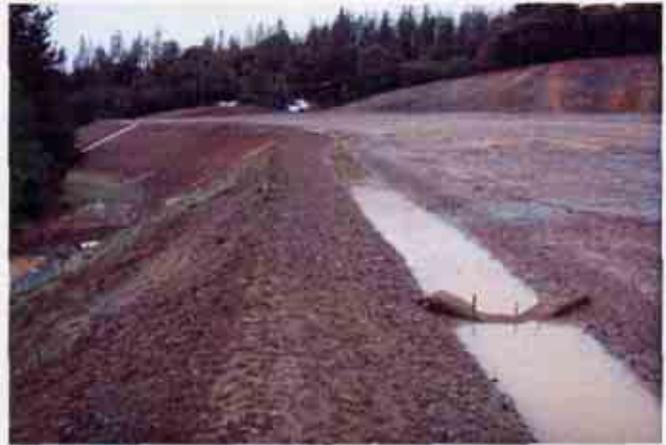
**Figure 2:** One of the channels directing storm water to a culvert that discharges under Highway 88, directly into Jackson Creek.

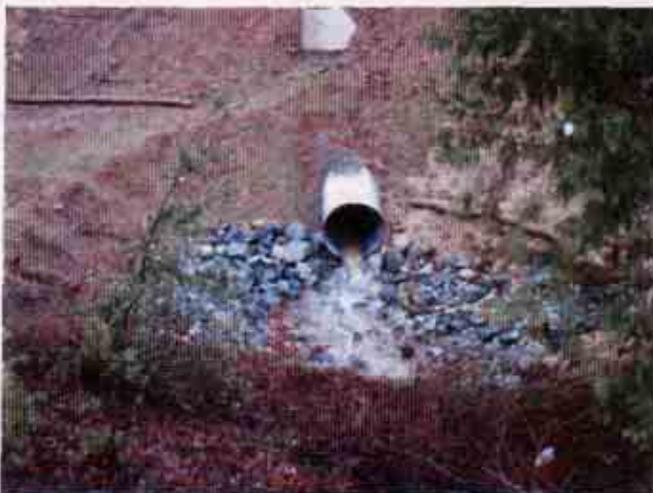
**Figure 5:** Another view of turbid storm water discharging into the eastern culvert which flows into Jackson Creek

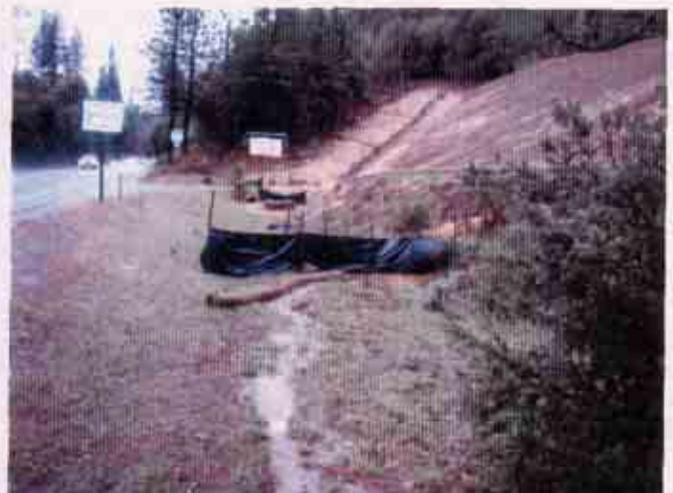
**Figure 6:** Looking at the western discharge location in the distance

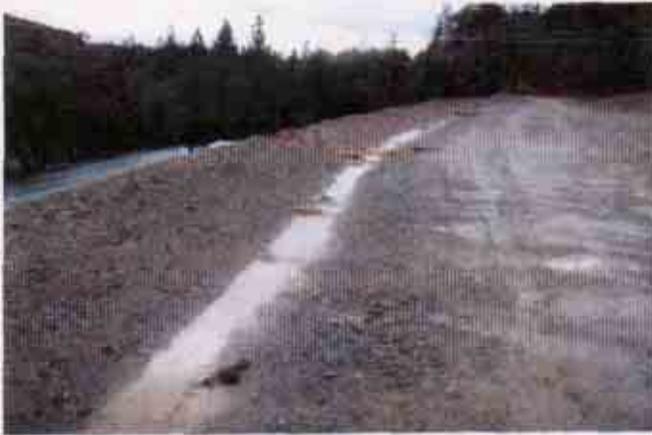
**Figure 25:** Lack of an effective combination of erosion and sediment control BMPs Note: the only BMPs observed were a few small fiber rolls

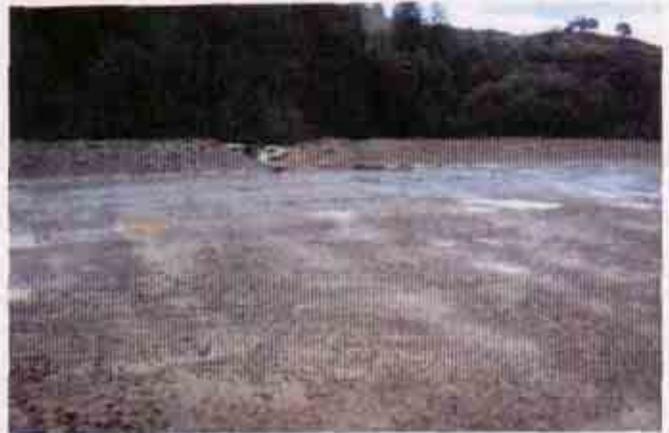
**Figure 26:** Lack of an effective combination of erosion and sediment control BMPs around one of the discharge locations

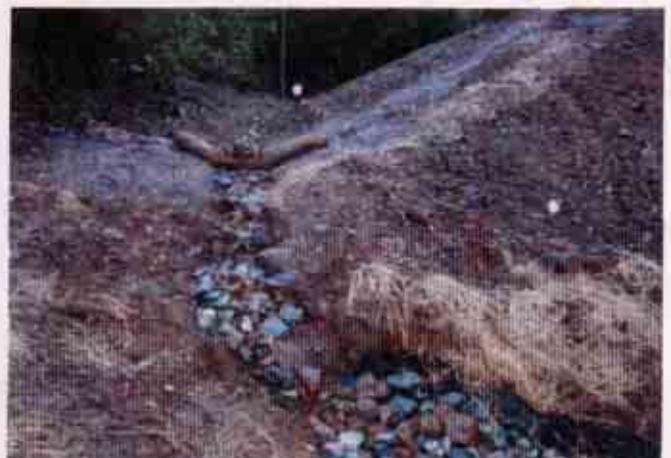
**Figure 6:** Area above the western discharge location where staff observed no effective storm water management BMPs

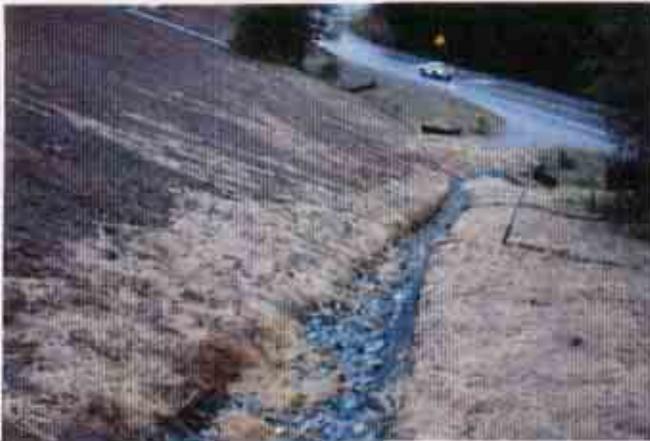
**Figure 7:** Area directly below the area shown in Figure 6

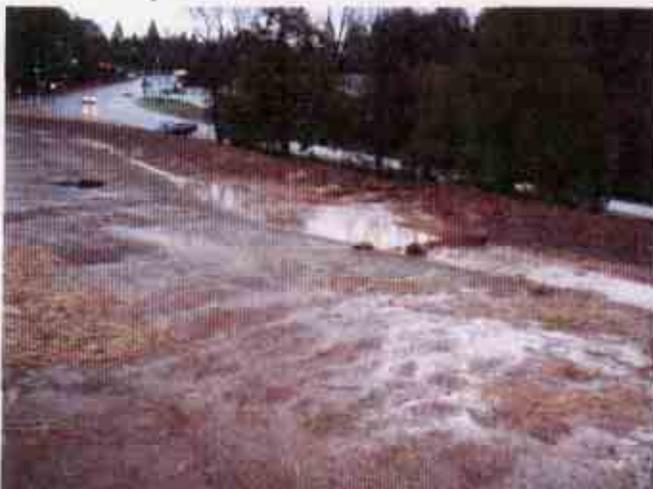
**Figure 23:** Another view of the same area Note: the general lack of erosion control BMPs

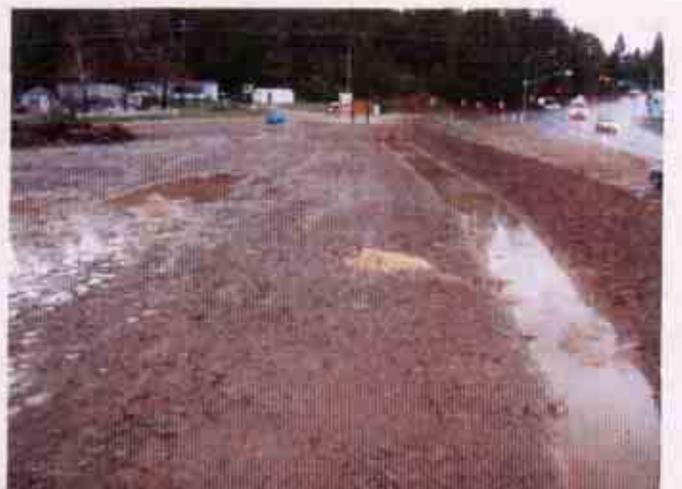
**Figure 24:** Lack of an effective combination of erosion and sediment control BMPs

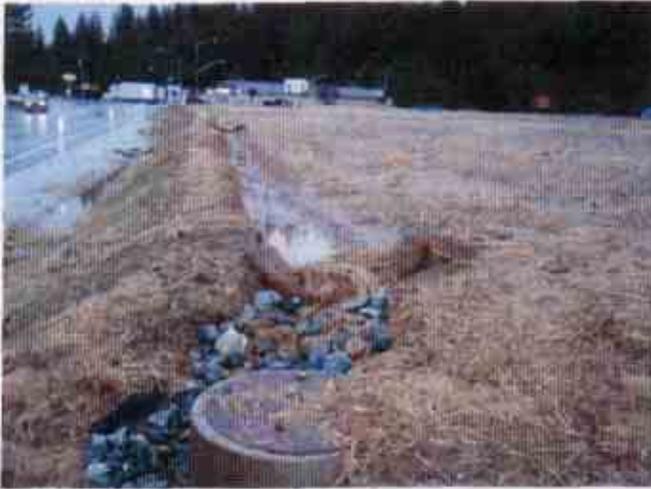
**Figure 31:** Another view of the area just above the drain inlet on Ridge Road

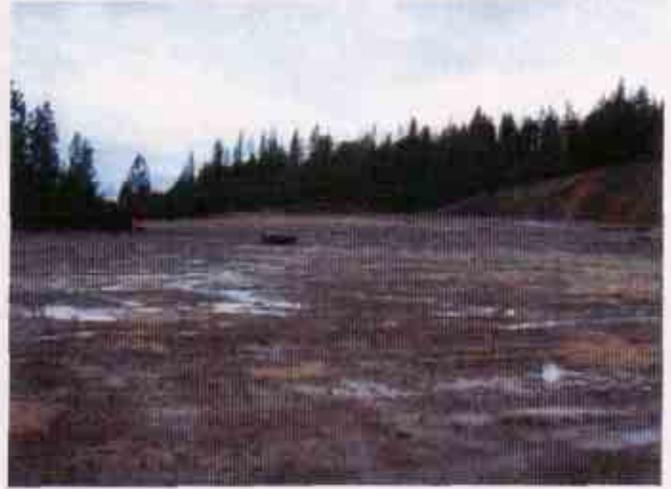
**Figure 32:** Lack of an effective combination of erosion and sediment control BMPs
