**FINAL CONSTRUCTION  
QUALITY ASSURANCE REPORT  
WASTE PILE COMPOSTING PAD and  
SURFACE IMPOUNDMENT A and B**

**HAWES COMPOSTING FACILITY**

September 2012

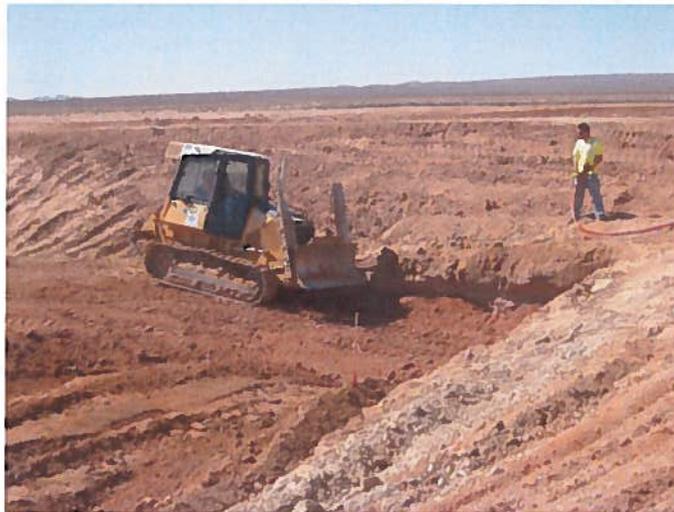
**Replacing and compacting soil in Lysimeter sump in pond B**

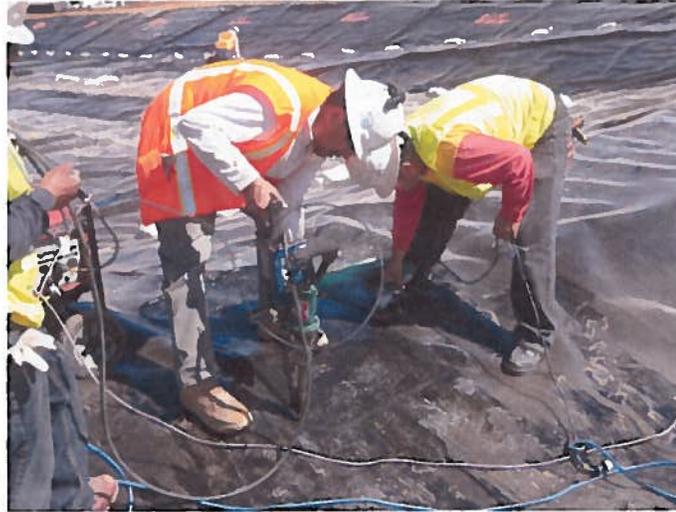
**Extrusion welding repair made to HDPE liner in pond B**

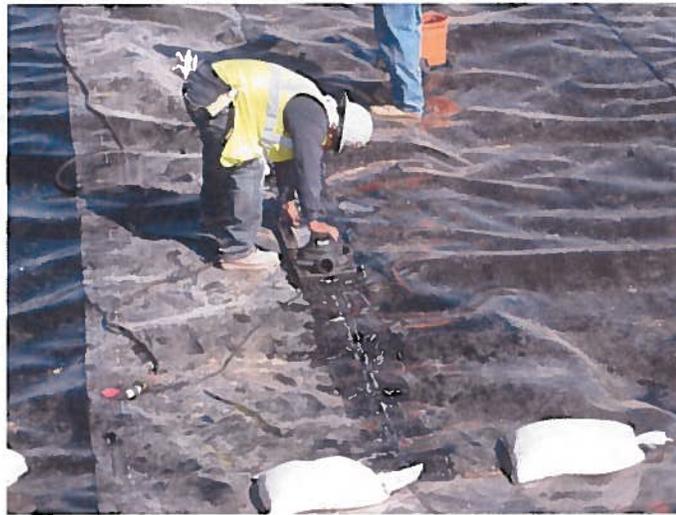
**Vacuum box testing extrusion weld on cap of anchor trench in pond B**

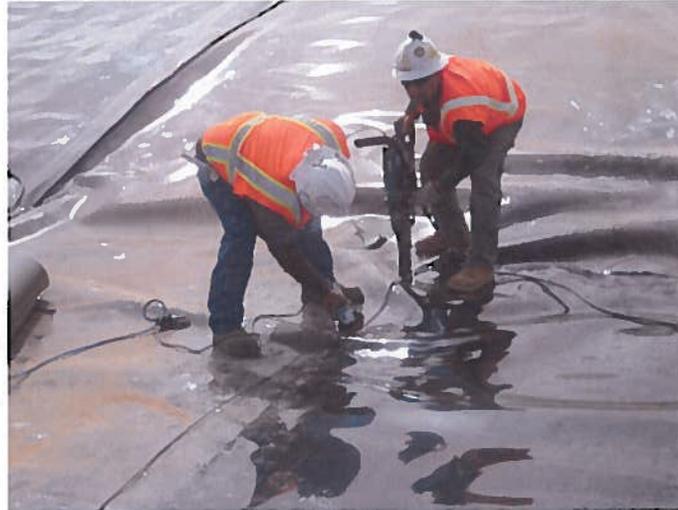
**Extrusion welding repair made to HDPE liner in pond B**

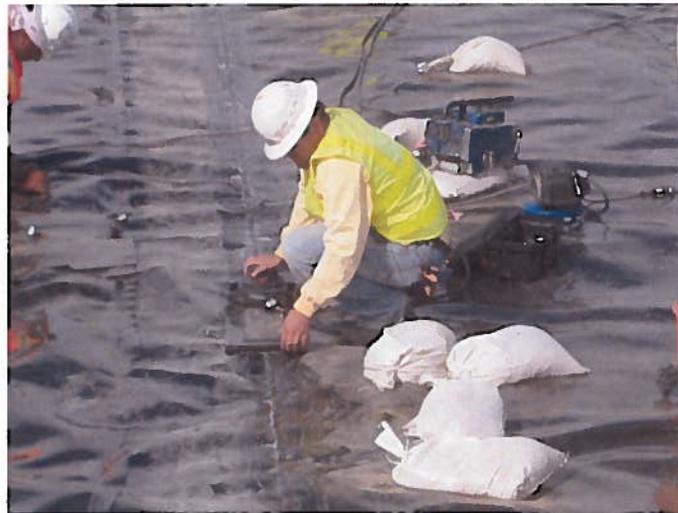
**Vacuum box testing extrusion weld on cap of anchor trench in pond B**

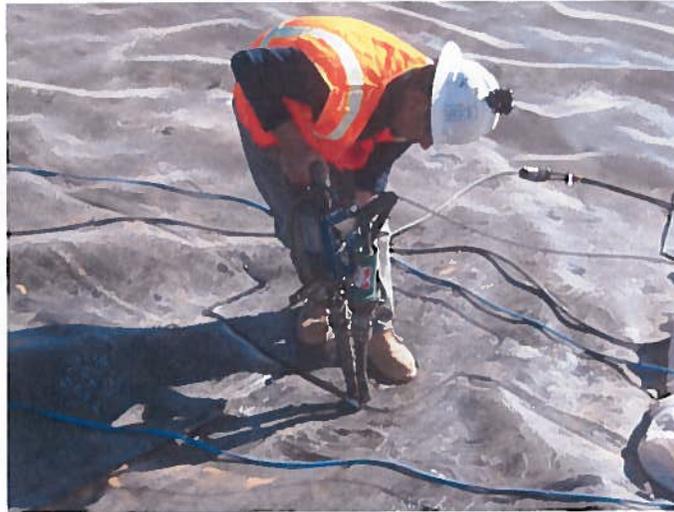
**Extrusion welding repair made to HDPE liner in pond B**

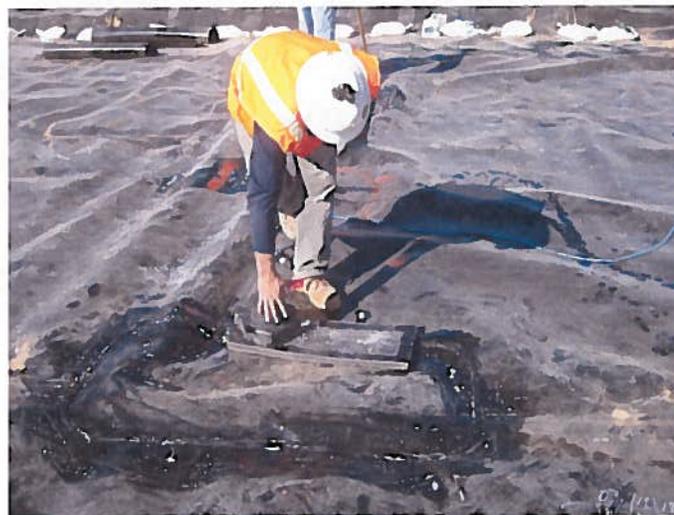
**Vacuum box testing extrusion weld on repair in pond B**

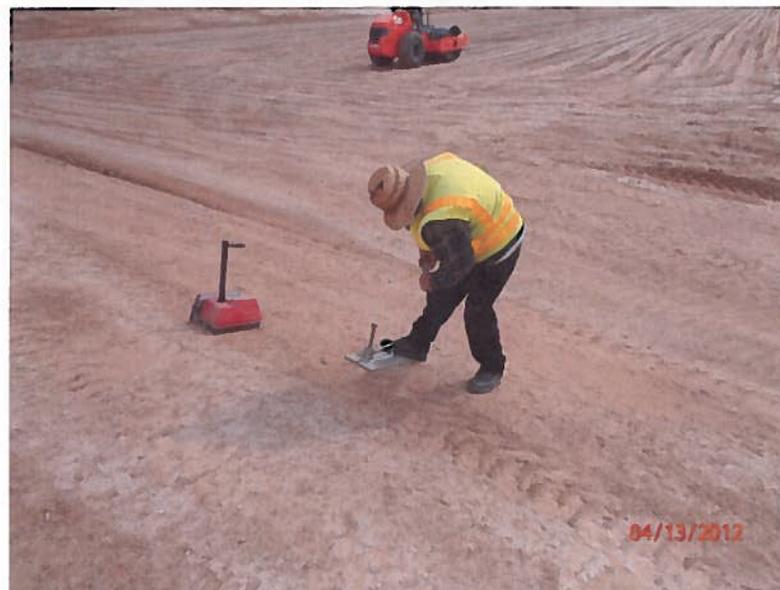
**Pond A Moisture/Density Test Side-slopes**

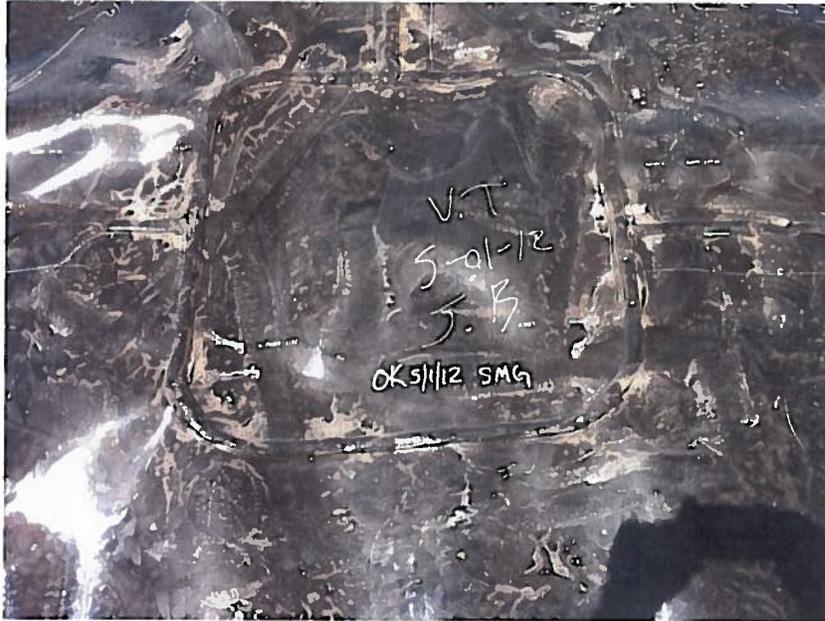
**Pond A Quality Control Documentation Repair**

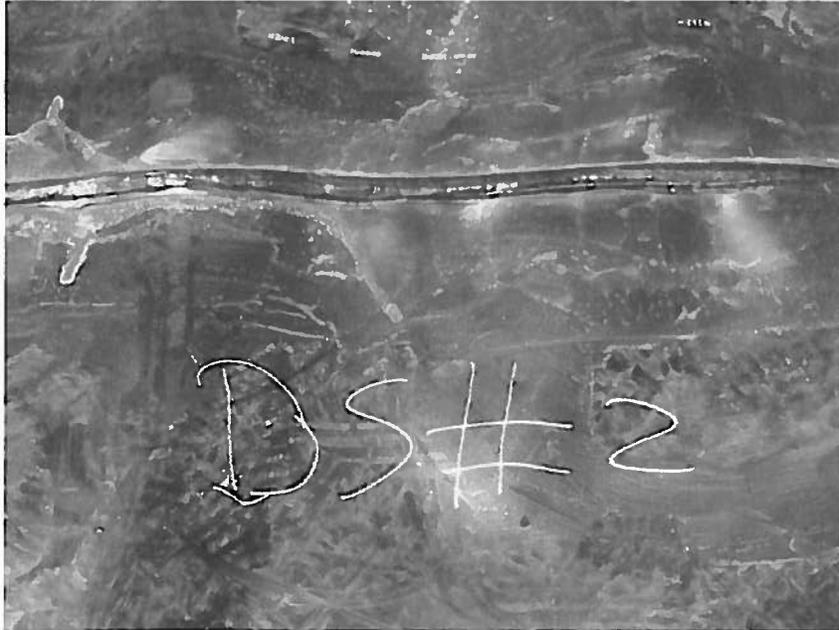
**Pond A HDPE Liner Seam Destruct #2 Location and Repair**

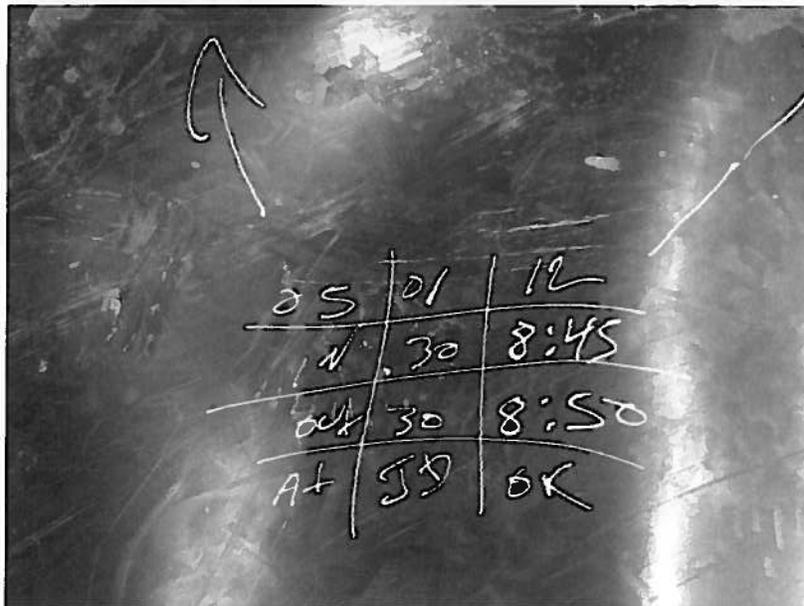
**Pond A Quality Control Air Test Data**

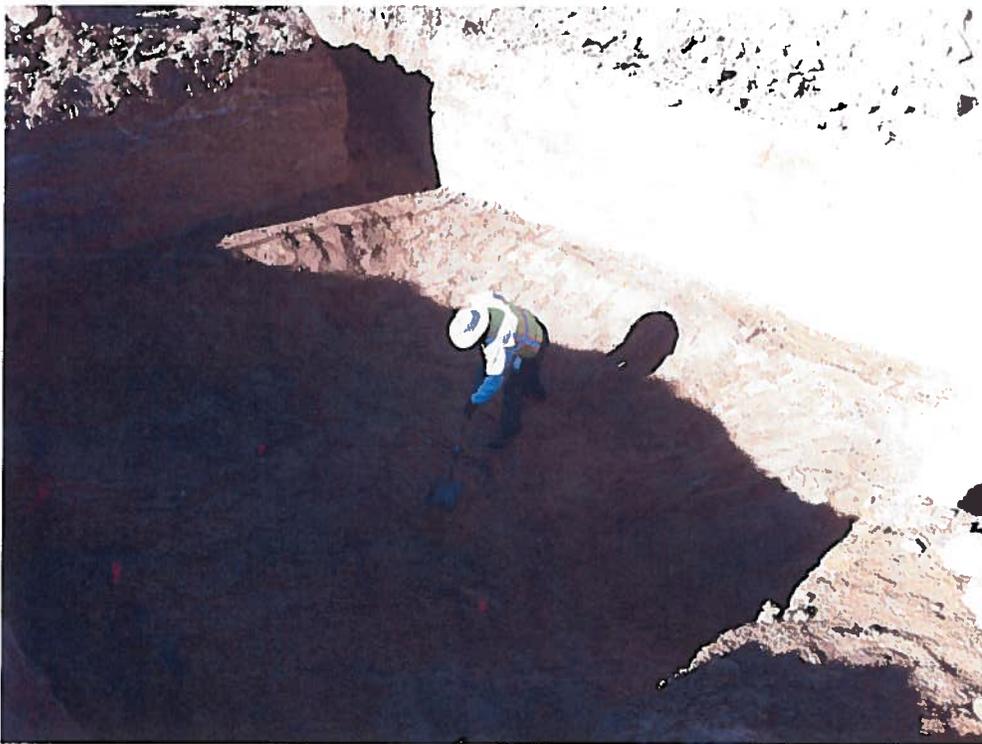
***The Leak Detection Monitoring Sumps (LDMS) and Lysimeters where constructed in accordance with the approved drawings, detail M (detail leak detection sump plan view) and detail N (detail lysimeter plan view) of the approved construction drawings, revision 2, sheet 8 of 9 respectfully. In section view, the Leak Detection Monitoring Sump and Lysimeter where constructed in accordance with Section H, Leak Detection Monitoring Sump and Lysimeter. The in-place liner system includes a Lysimeter (22'-0" feet long by 22'-0" feet wide) constructed five (5) feet below the lowest portion of each surface impoundment, at elevation 2,300. The Lysimeters are located directly below the LDMS and separated by a five (5'-0") foot vertical select soil fill. The Lysimeters consist of, from top to bottom including the trench line, a GCL, geomembrane, cushion geotextile fabric, 2-feet of clean washed gravel, and enveloped in a nonwoven geotextile wrap. A 6-inch diameter PVC pipe is installed within the gravel layer to allow access for liquid monitoring and or removal. The bottom 2-feet of the PVC monitoring pipe are perforated per plan.***

**Figure 1 - Lysimeter Bottom Soil QC Moisture/Density Test**

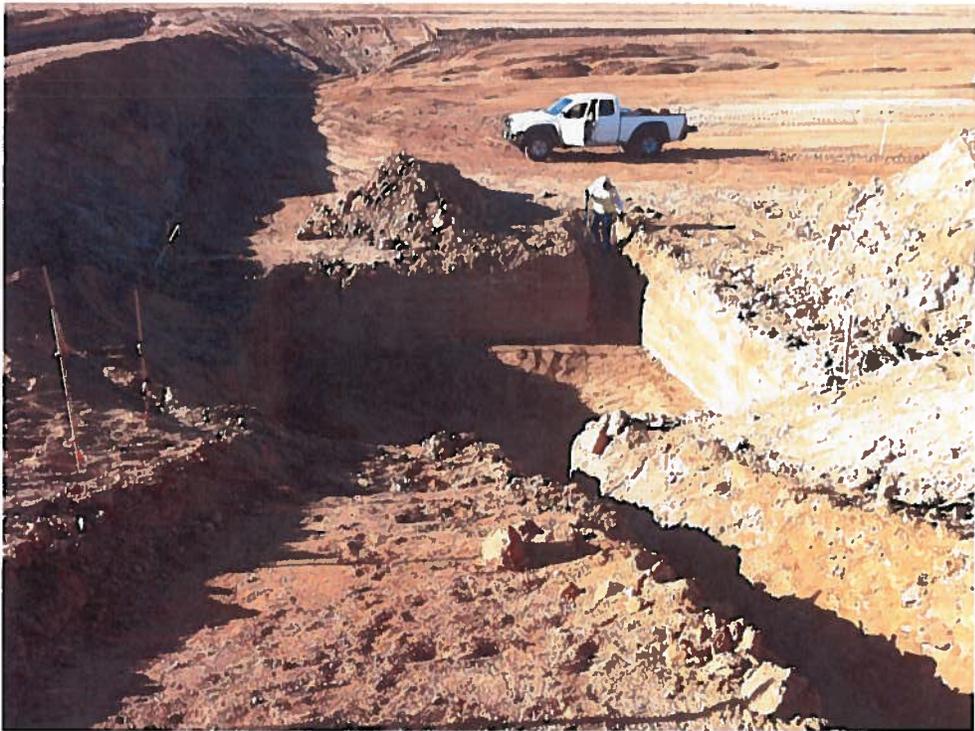
**Figure 2 - Completed Lysimeter Grading @ Elevation 2,300+/-.**

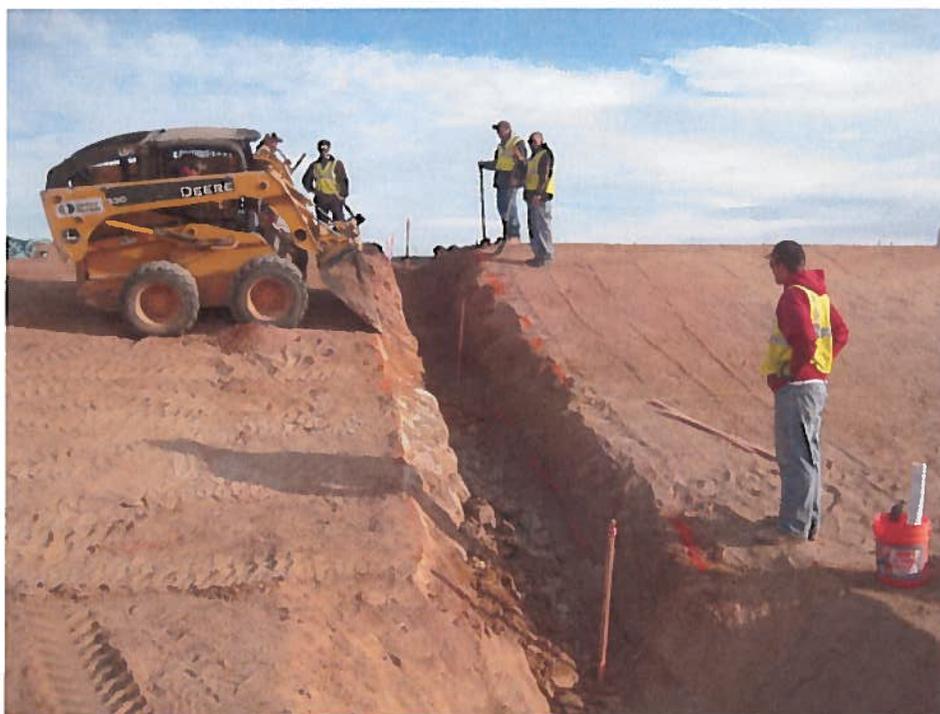
**The Surface Impoundment Leak Detection Monitoring Sumps (LDMS) are constructed below the lowest portion of each surface impoundment at or around elevation 2,305 respectfully, and located directly above the bottom Lysimeter (separated by 5-feet vertical). The LDMS are built per detail M, sheet 8 of 9 and Section view H, sheet 7 of 9. The LDMS allows for detection of the potential vertical migration of water through the primary HDPE liner system and removal of a water sample for testing. The LDMS is composed of, from top to bottom, a prepared subgrade, a GCL, a geomembrane, cushion Geotextile fabric, 2-feet of clean gravel, and a nonwoven filter Geotextile wrap. A 6-inch diameter PVC pipe is installed within the gravel layer to allow access for moisture detecting device and to allow for sampling and/or pumping of liquids from the LDMS. The LDMS was constructed as follows:**

**Figure 10 - Excavation of the LDMS Slope Trench to the Lines and Grades.**

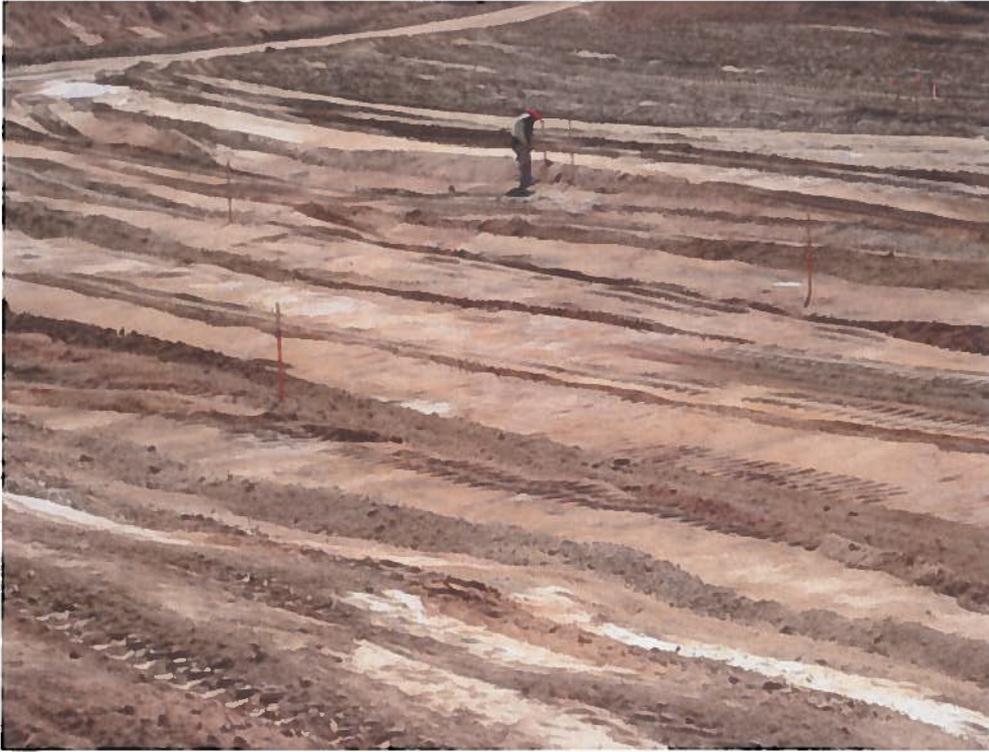
**Figure 26 - Sladden Eng. Performs In-Place Moisture Density Tests West Portion Final Grade**

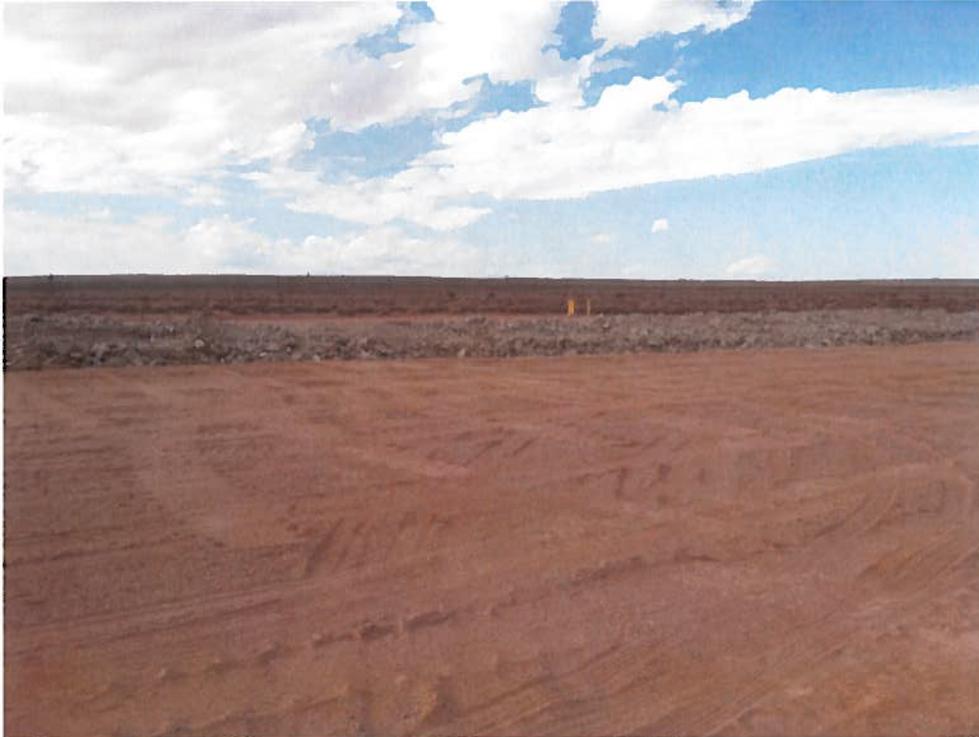
***Stormwater control consist of a drainage channel approximately 1,000 feet long at the southern end of the facility, designed and constructed to capture offsite stormwater run-on and redirect offsite flows around the HCF to the west and northwest. The drainage channel was constructed with 3:1 (horizontal/vertical) and a 25-wide channel bottom. The entire drainage channel is protected by a light armor lined ¼ ton rip-rap for erosion protection place approximately 3-feet thick.***

**Figure 27 - Perimeter Drainage Channel with Rip-Rap Armor- - Looking South**
