April 8, 2009

Subject: Summary Report for Removal Action to Stabilize the Impoundment Berm
Mount Diablo Mercury Mine
Clayton, California

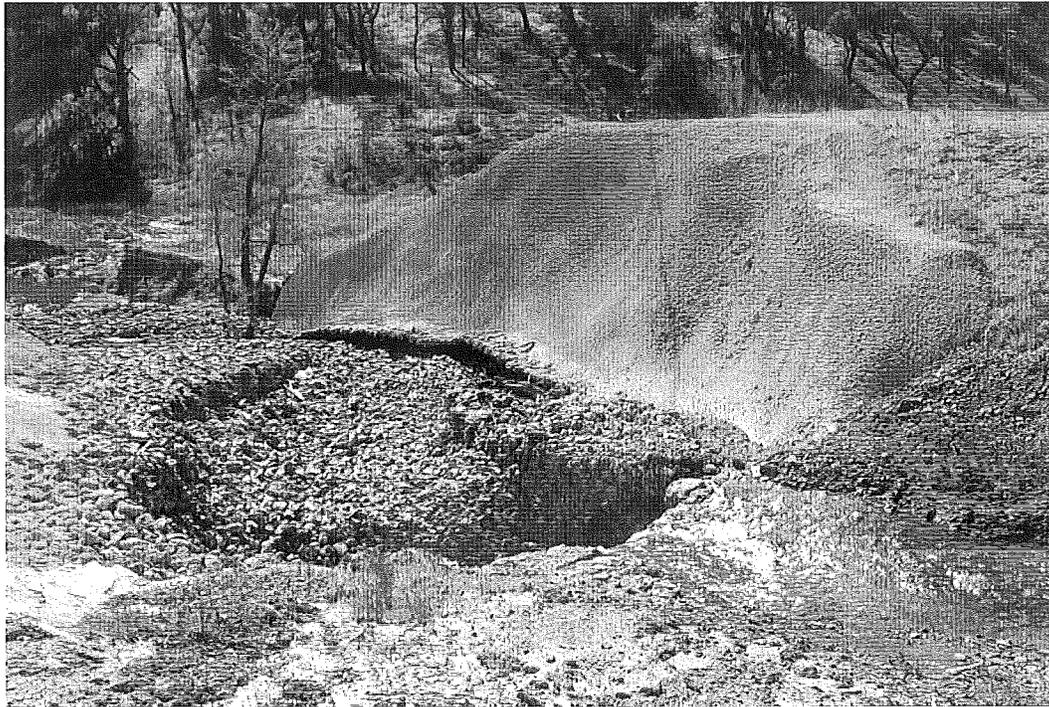
Photograph 1: Before Repair Work

As a result, on March 24, 2009, SGI mobilized personnel, equipment, and materials to the Site to temporarily excavate and stockpile some of the existing three to five-inch crushed rock within the portion of Dunn Creek adjacent to the northwest corner of the impoundment berm. Then the existing shotcrete embankment was scored and chipped at the bottom, back to native slope material to relieve the undermined edge. Stabilization fabric was installed along the low flowline of Dunn Creek and up the sides of the creek embankment. Subsequent to laying the stabilization fabric, the repair area was recontoured using the three to five-inch crushed rock, and two loads (approximately 40 tons) of rip-rap/rock (6 to 18-inch) were placed above the crushed rock and under vertical wall of shotcrete for structural stability. Upon reestablishing the

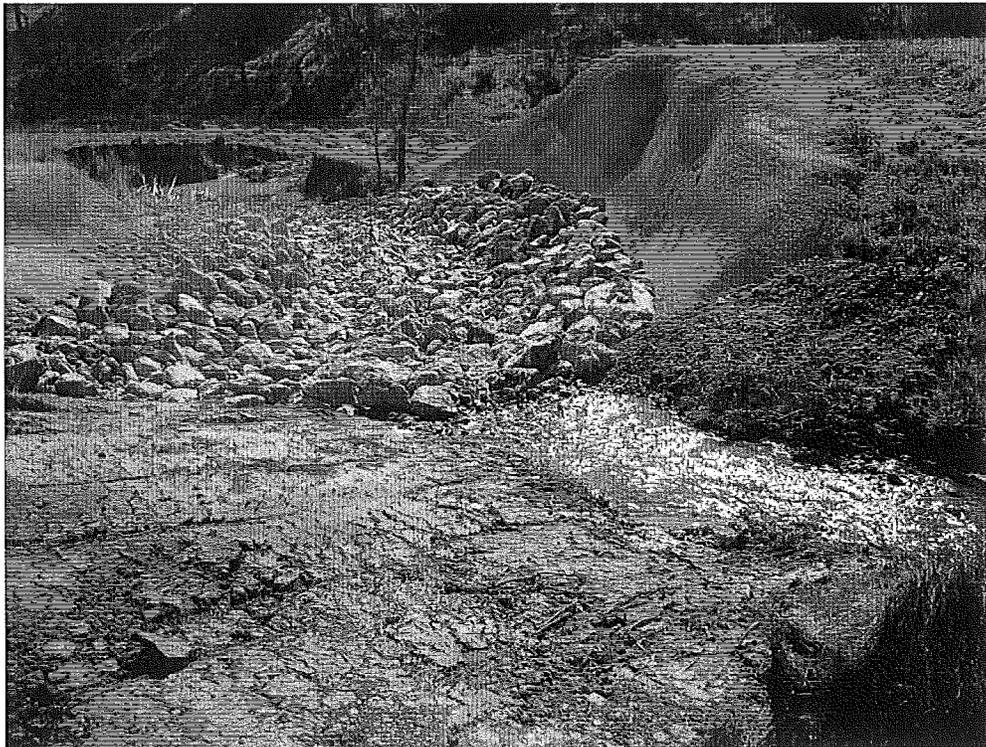
Photograph 2: After Repair Work

Dunn Creek flow line within the embankments and locally downstream, the Site was returned to conditions prior to project initiation and equipment and materials were demobilized. The work was completed in one day. EPA On-Scene Coordinator, Chris Reiner, was onsite during the completion of the removal action repair work performed by SGI under the UAO. Photos showing the project area before and after repairs were completed are attached for reference.
