7 January 2015 Inspection Report

Irrigated Lands Regulatory Program Enrollment Confirmation Inspection Report

| Parcel Number: | 023-050-016 | Acres: | 56.5 | | |

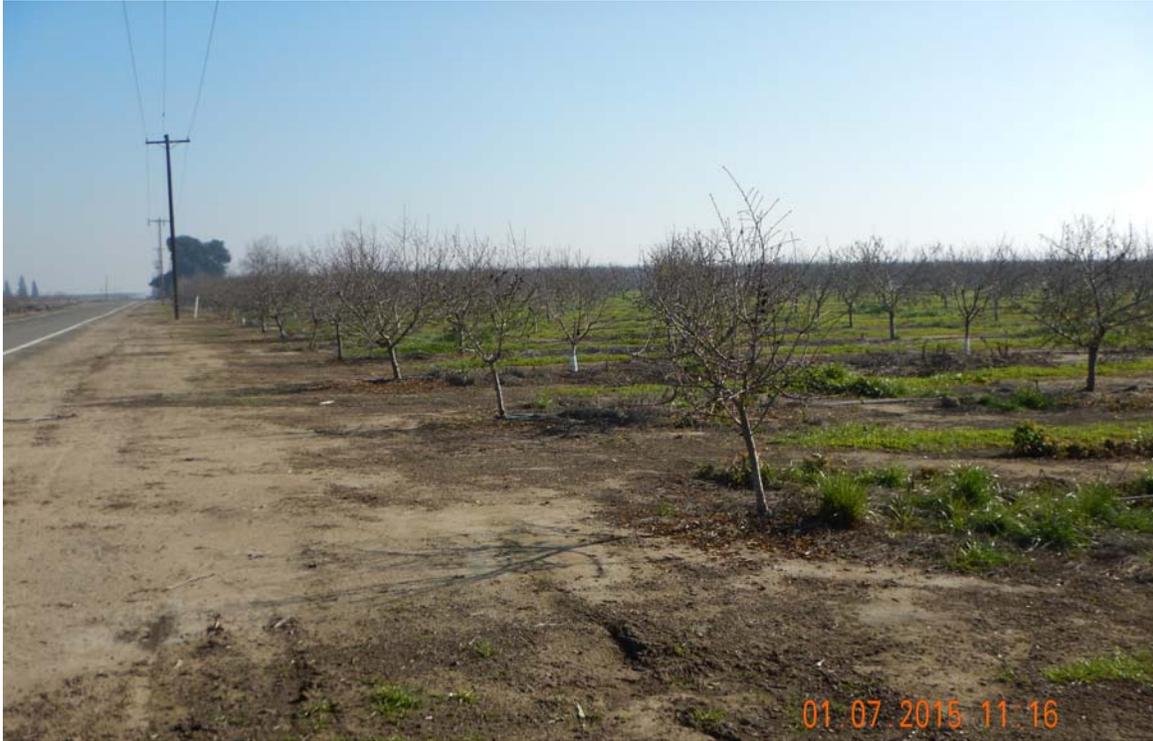
Photo Site 1:

| Discharge Notes: (Photos included on subsequent pages.) | <p>Photo Site 1: North side of property: No discharge points seen. Supply canal between property and road.</p> <p>Photo Site 2: Northeast Corner of Property: No discharge points seen. Supply canal between property and road. No pipes or erosion features at canal. Property sits below canal.</p> <p>Inspection found no direct evidence of potential to discharge to surface waters.</p> |

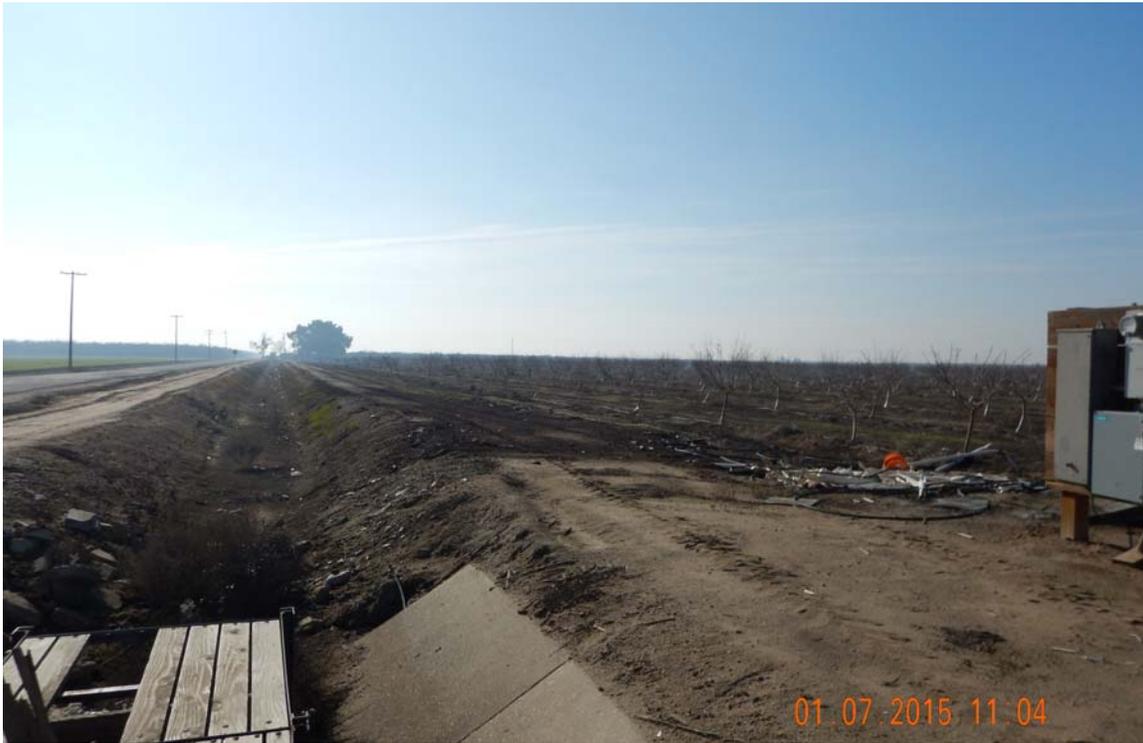
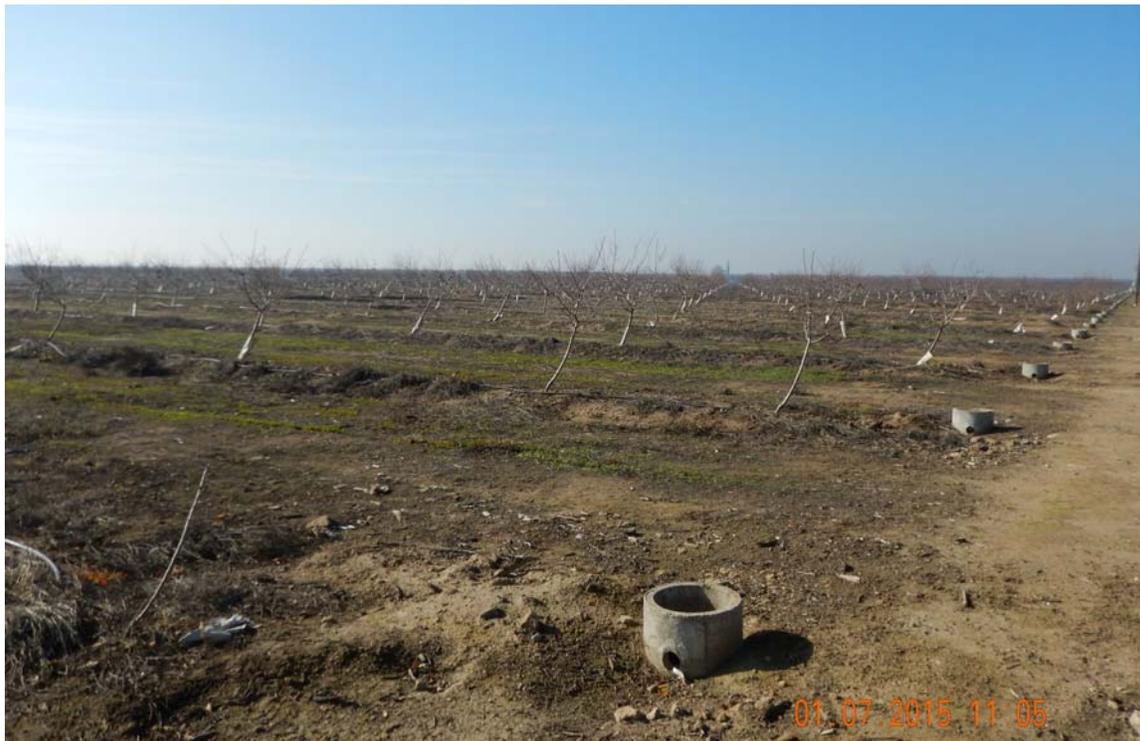
| Discharge Notes: (Photos included on subsequent pages.) | <p>Photo Site 1: Northeast corner of property: No discharge points seen. Supply canal between property and road. No pipes or erosion features at canal. Property sits below canal. Trees are small, most likely not producing.</p> <p>Photo Site 2: Southwest corner of property. Concrete pipe goes underground to concrete stand pipe. Staff believe may be remnants of old flood system. Stand pipe includes a float valve.</p> <p>Inspection found no direct evidence of potential to discharge to surface waters.</p> |

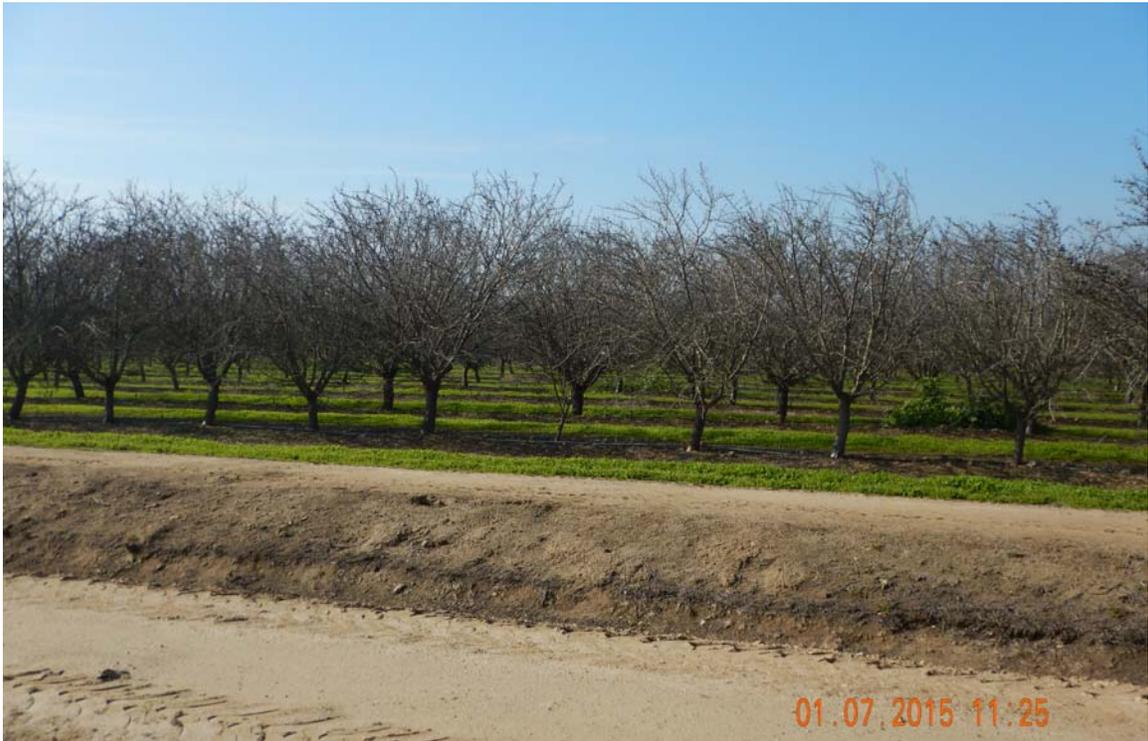
Photo Site 1: Photo 1

| Discharge Notes: (Photos included on subsequent pages.) | <p>Photo Site 1 (West side of Property) & Photo Site 2 (Northeast side of Property) have same features: No discharge points seen. No ditch between property and road. No erosion features. Property sits at/slightly lower than road. Major storm event to create a possible surface water discharge. Canal near property has no discharge pipes to property and sits above property/road.</p> <p>Inspection found no direct evidence of potential to discharge to surface waters.</p> |
