## Central Valley Regional Water Quality Control Board

### ***SITE INSPECTION REPORT, RECOLOGY YUBA SUTTER LANDFILL, YUBA COUNTY***

## Site Inspection Photo Log

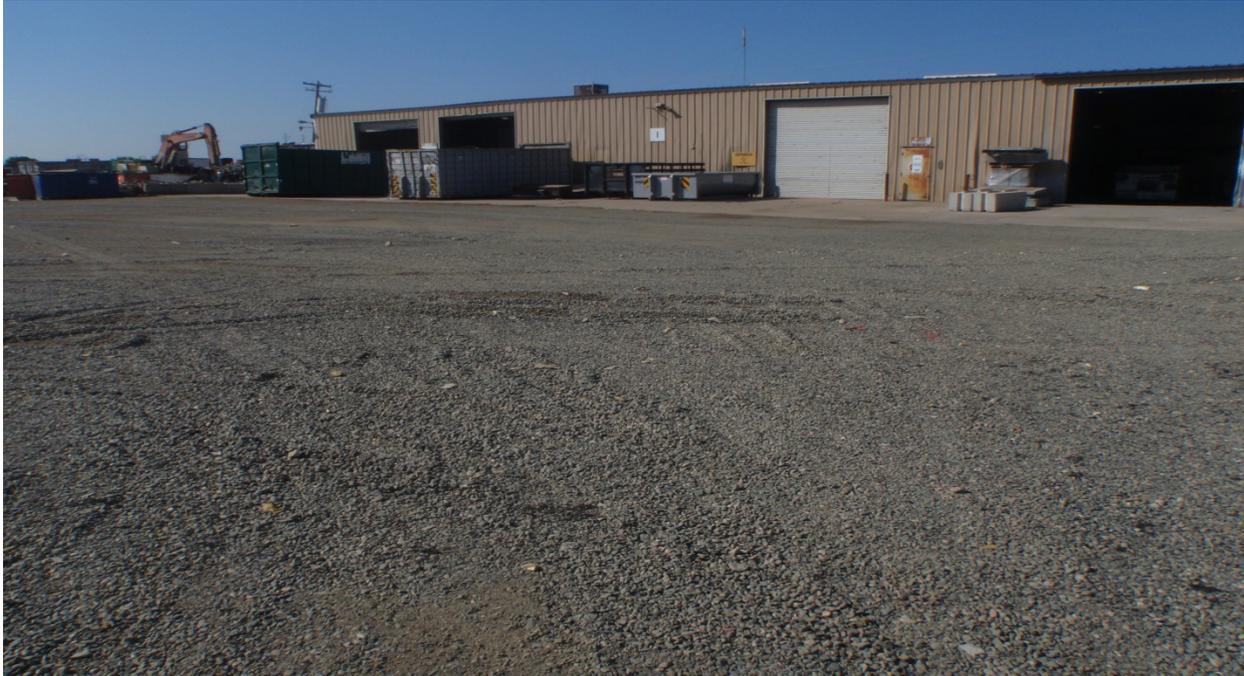
Staff walked the drive paths of LF-1 through the metal yard (Photos 1 – 3) where storm water ponding had been observed during previous inspections. This area is extensively used to store white goods, scrap metal, and debris boxes and the area is subject to heavy truck traffic throughout the year. The main area of concern focuses on the lack of drainage. The area is flat, with little grade and has settled with time. During this site inspection, it appeared the Discharger is attempting to fill the settled areas with a Class II Road Base. However, this material does not appear to have sufficient fines to create a barrier to percolation through the final cover of LF-1.

In summary, the area of concern noted during this site inspection is the southern portion of LF-1 where ponding water has been observed by staff during past inspections. Furthermore, the use of Class II Road Base to fill locations that have settled does not appear to have the proper amount of fines to prevent storm water from infiltrating the final cover.

Photo 1: Southern area of LF-1 cover that recently received additional class II road base to repair settlement and grading issues at this location. Note loose gravel on drive path.

However, in an email dated 30 August 2013 the Discharger has acknowledged staff's concerns and has proposed to take additional steps to address the southern portion of LF-1. The issues noted above are also being addressed by the Discharger through a Cleanup and Abatement Order R5-2013-0704 issued on 29 August 2013. The first report is due **31 October 2013**.

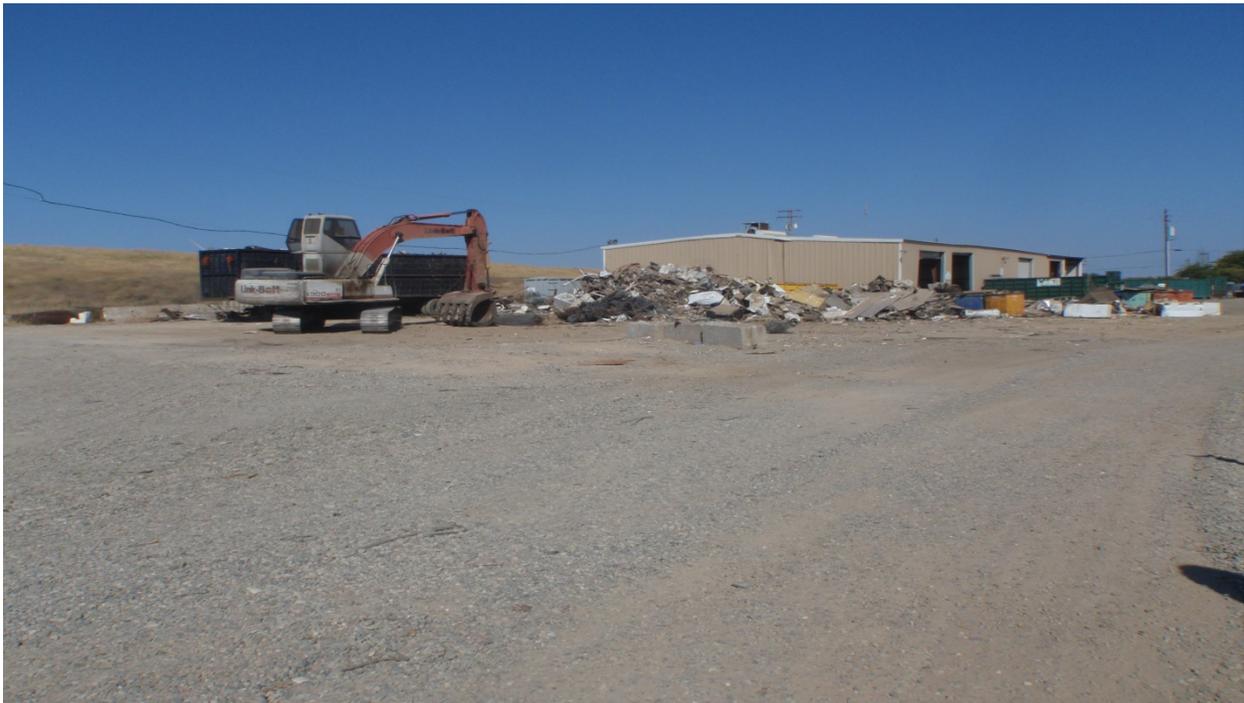
Photo 2: Looking southwest across southern portion of LF-1. Note area has been filled with class II road base and appears to be flat with little grade for drainage.

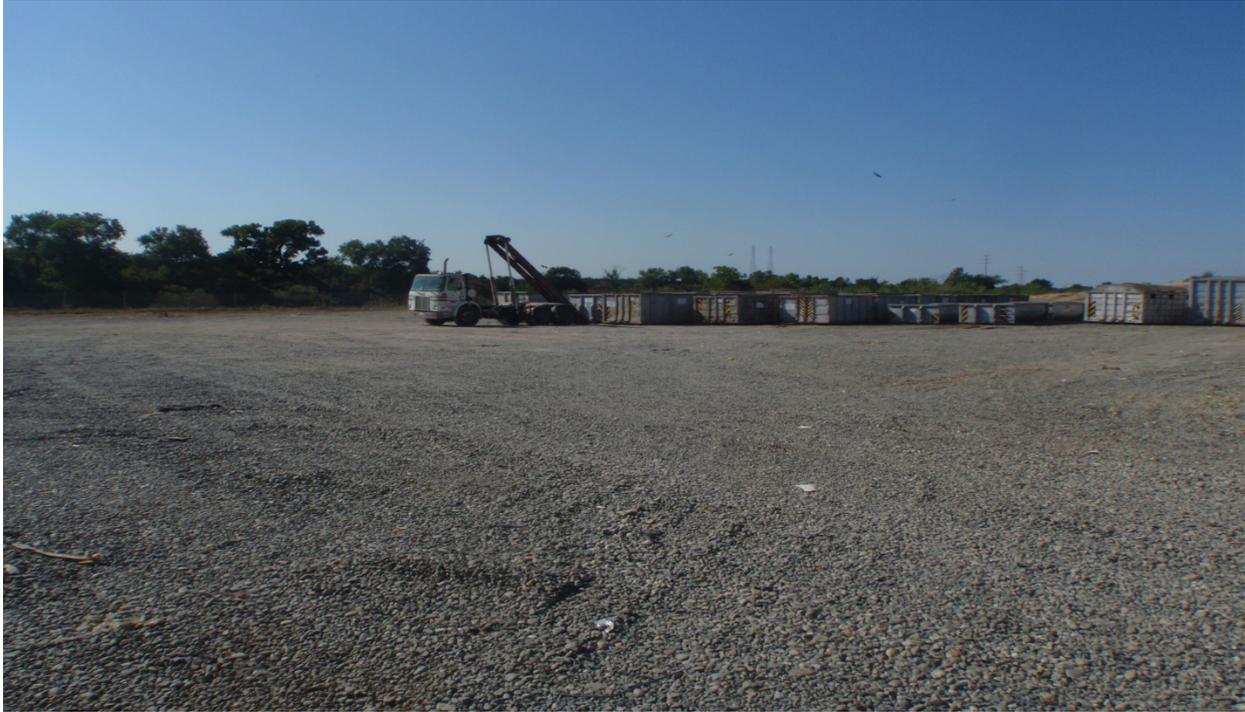
Photo 3: Looking southwest across southern portion of LF-1. Note area has been filled with class II base rock to address settlement. Landfill area is used to store debris boxes and is regularly driven on with heavy vehicles.

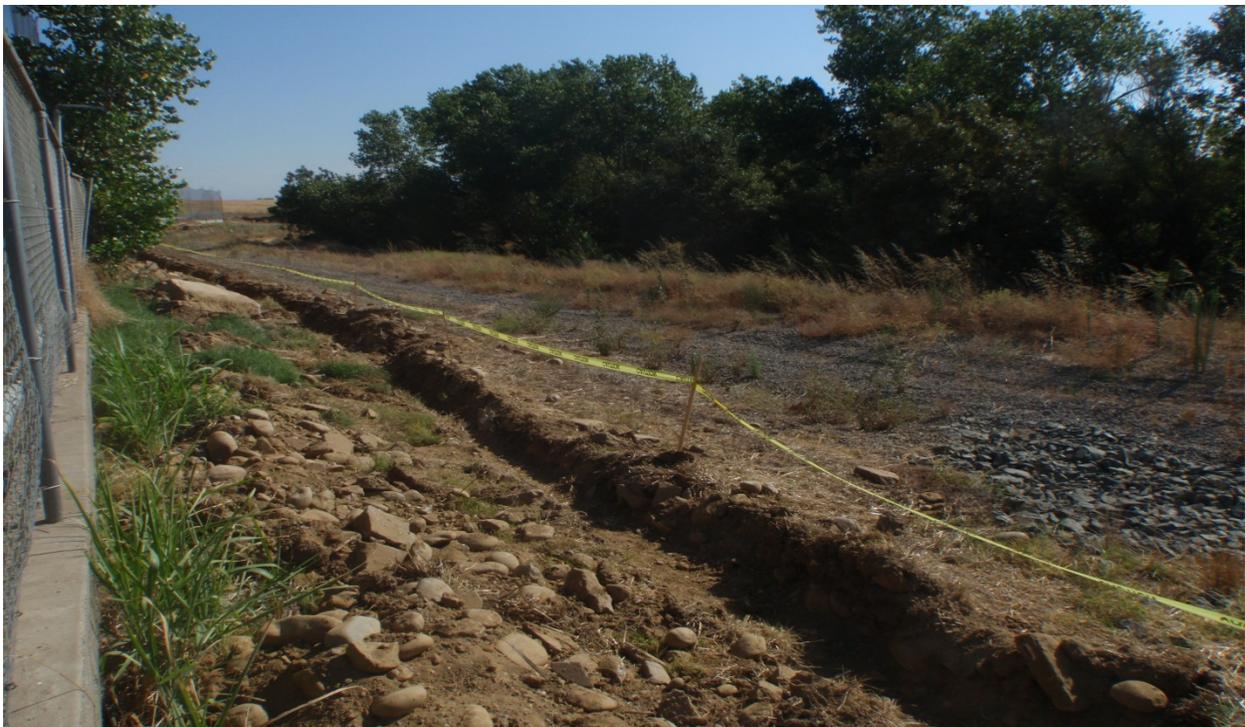
During this site inspection staff observed excavation for the installation of piping (Photos 4 and 5) for connection to the LFG system. This is an expansion of the system into LF-1 where methane has been detected within and beyond the boundary of LF-1. As shown in the Photos, progress with the installation was being made.

Photo 4: Trench for LFG system header pipe extension into LF-1.

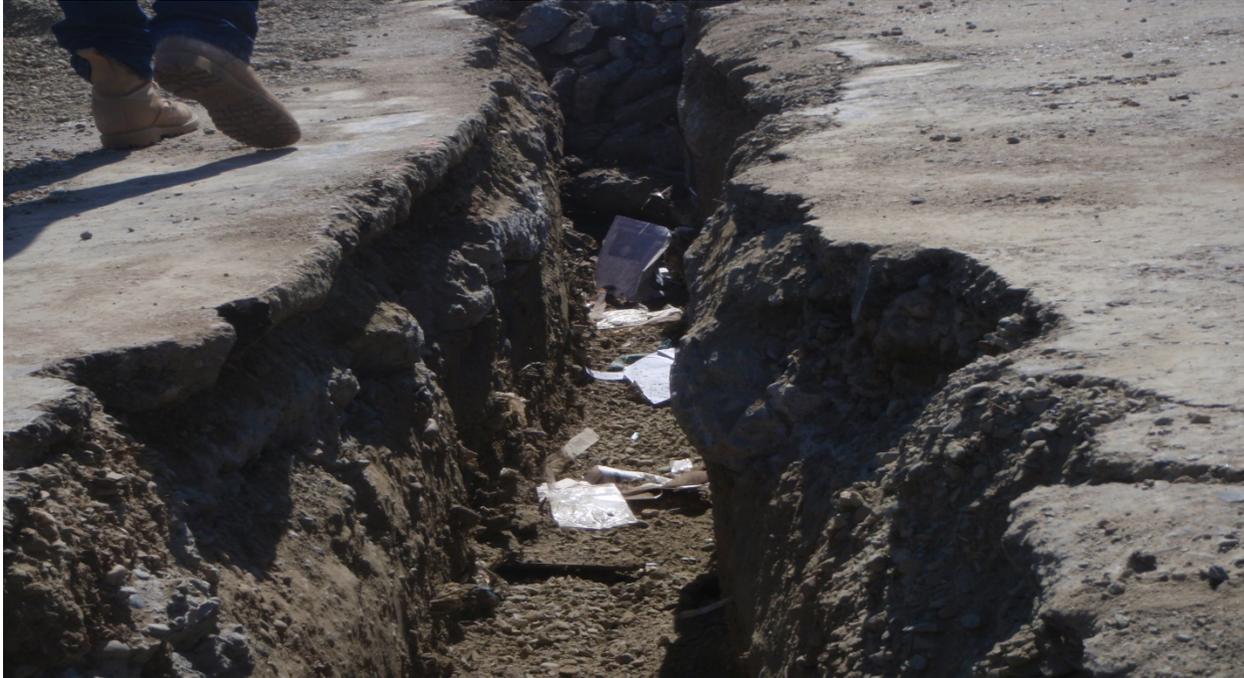
Photo 5: Lateral trench for LFG extraction well. Sidewall of trench revealed several asphalt or concrete layers indicating repair work over time. Refuse was observed in the sidewalls of the trench. Loose litter can be seen in this photo.

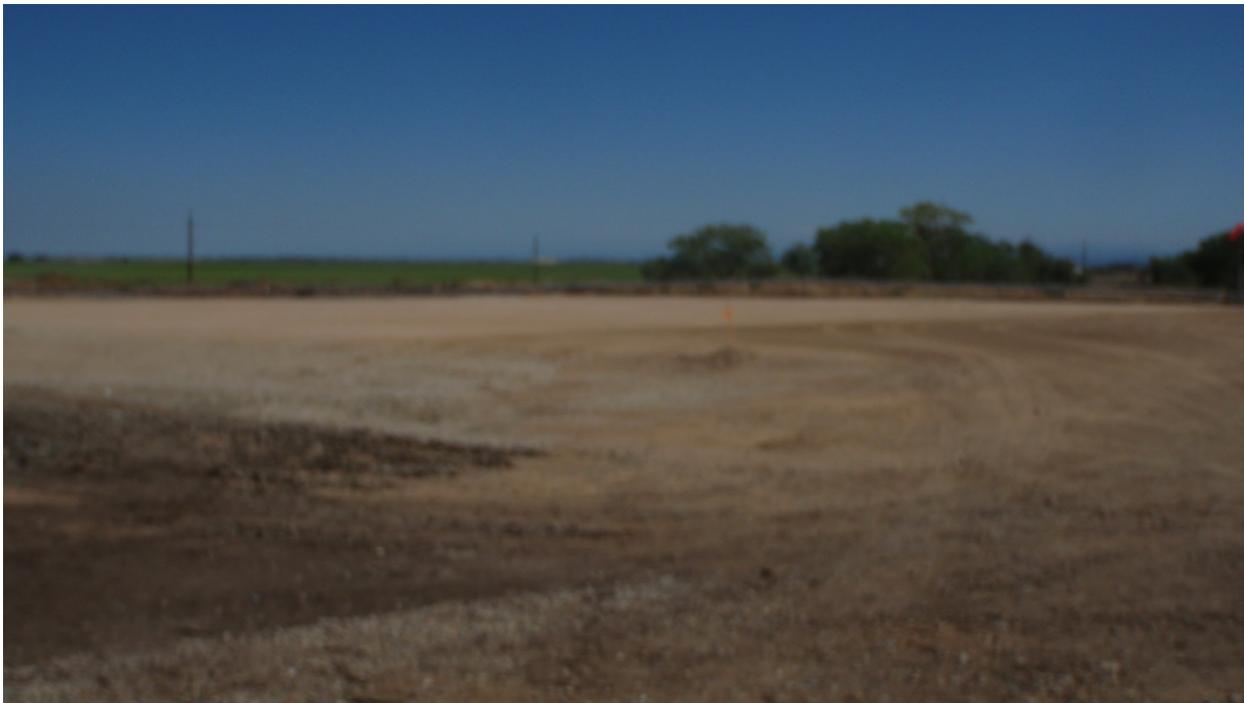
Staff also inspected the Compost Area with specific focus on the efforts to recondition the operations pad. As shown in Photos 6 and 7, the Discharger has built up a section of the pad where future composting will take place. The pad was reconditioned to specifications recommended by the Discharger's consultant and based on this site inspection, appears to contain a significant amount of fines. The information regarding construction specifications has not been provided to staff for review.

Photo 6: Reconstructed operations pad, northern end of compost operation.

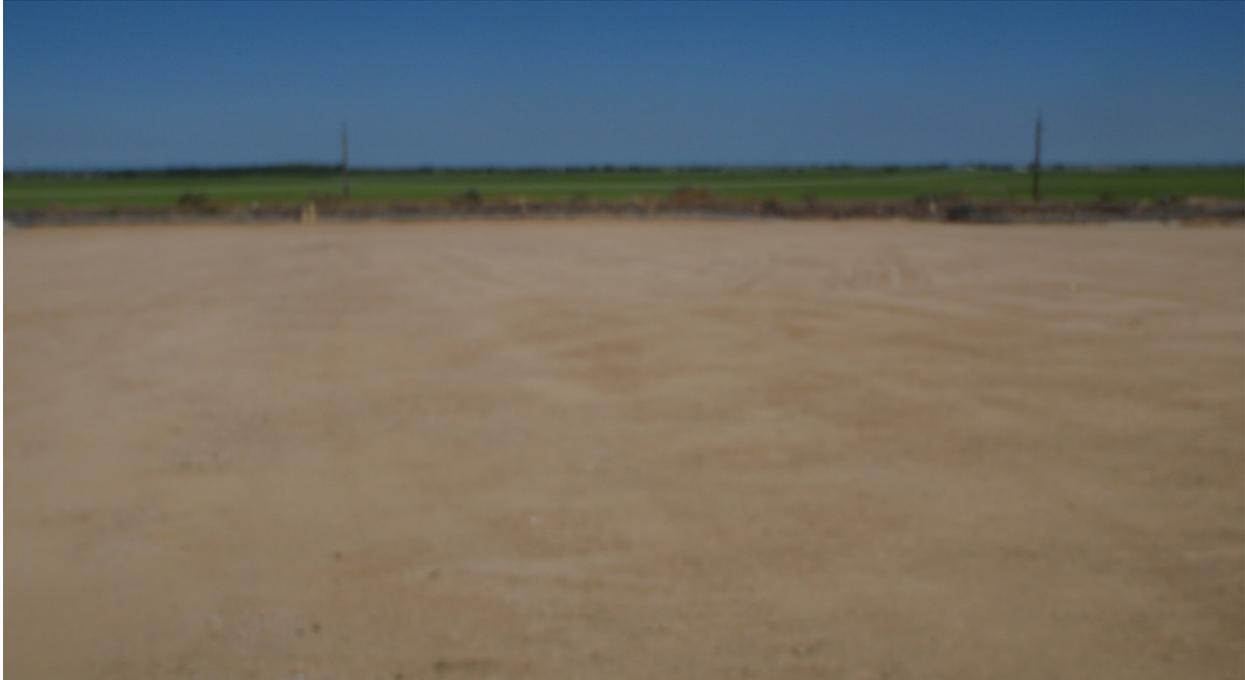
Photo 7: Looking northwest across reconstructed compost operations pad graded to drain to far corner. The operations pad was compacted, conditioned, and dense creating a hard working surface.
