Re: Report on the Evaluation of the Integrity of the Subsurface Pipelines and Paved Surfaces
at LF-1, Recology Yuba Sutter, Yuba County, California

Project No. 053-7442-123

**RE: REPORT ON THE EVALUATION OF THE INTEGRITY OF THE SUBSURFACE PIPELINES
AND PAVED SURFACES AT LF-1, RECOLOGY YUBA SUTTER LANDFILL**

Appendix A
Example Pipeline Damage Photos

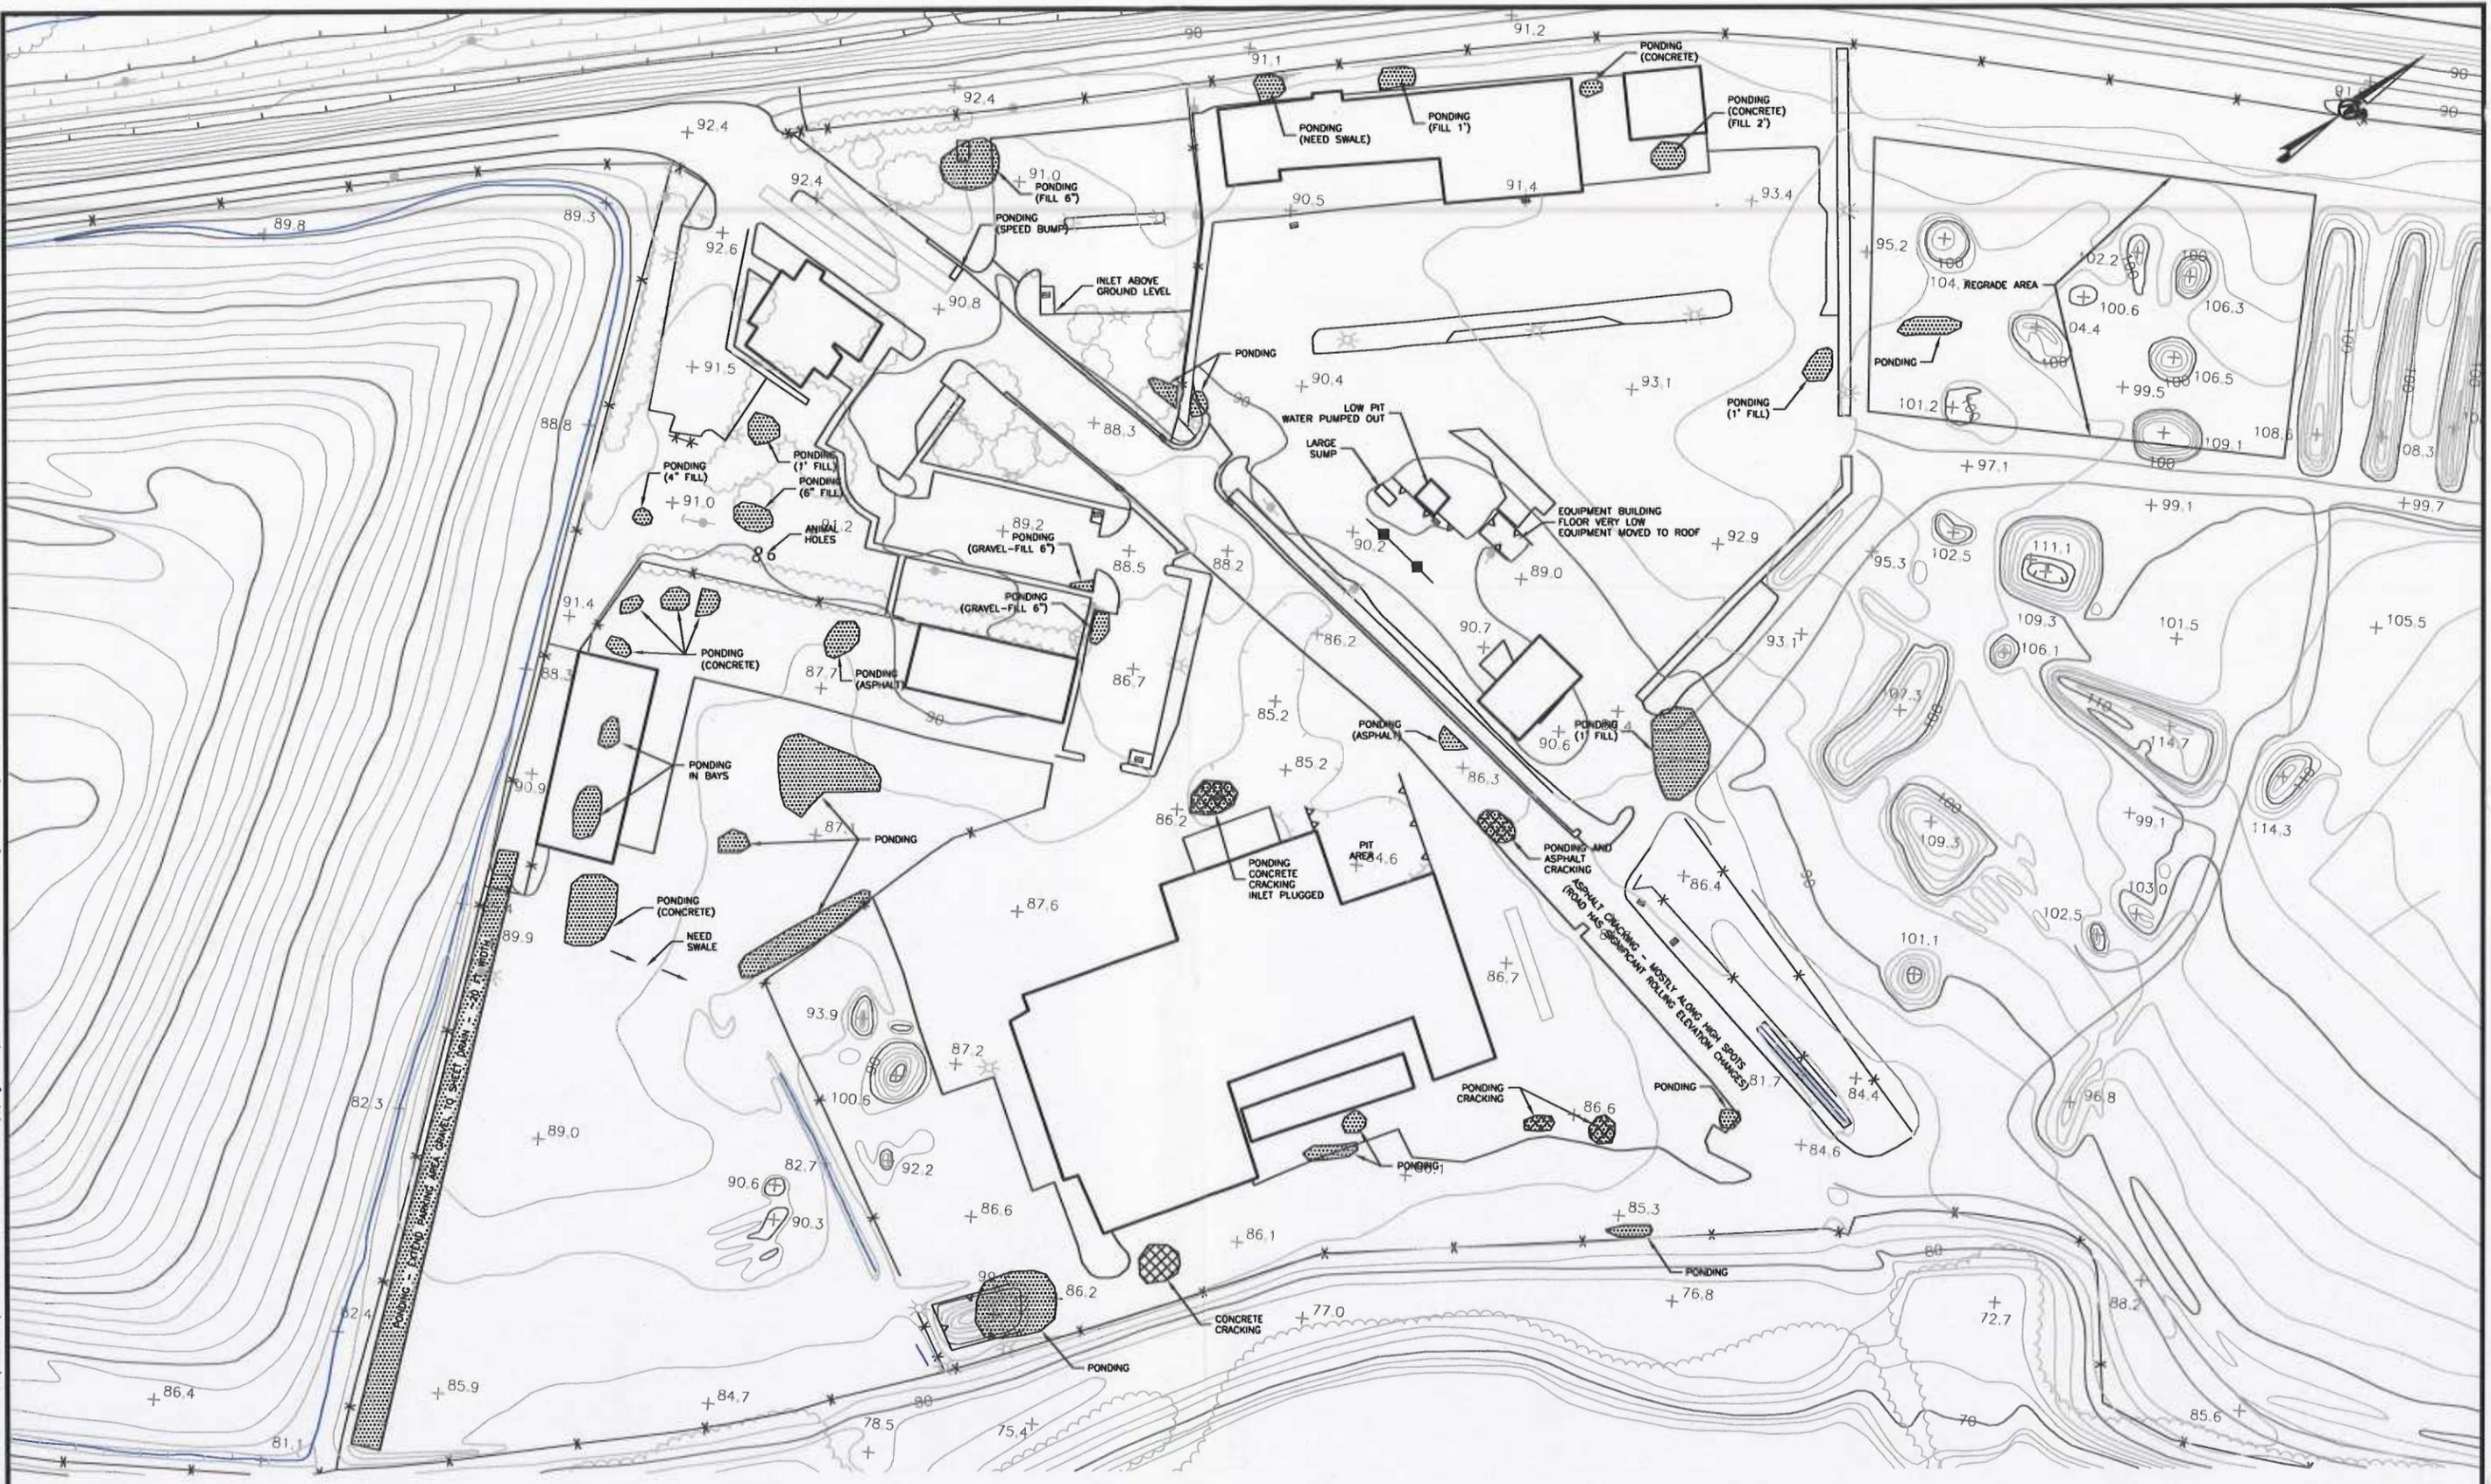
FIGURE 4
LF-1 DRAINAGE REVIEW
RECOLOGY YUBA-SUTTER FACILITY

Golder evaluated the landfill surface on October 31, 2012. The landfill surface evaluation identified areas where ponding of surface water runoff can occur. These areas are shown on Figure 4 and include:

- Locally depressed areas on unpaved surfaces (compacted gravel, landscaped areas, and bare soil)
- Locally depressed areas on paved surfaces with cracked or broken pavement
- Drain inlets that are clogged or located above surrounding grade

Accumulation of water on top of the landfill surface can increase the rate of water infiltration into the landfill. The surfaces where ponding can occur can be repaired by filling to grade to remove depressions in unpaved areas, filling and then repairing damaged pavement, clearing clogged drain inlets, and reconstructing drain inlets to match the local grade to allow water flow to enter the inlets. Several potential areas of ponding are located in the southern portion of the compost area. This area should be re-graded to promote drainage and remove low spots where surface water runoff can accumulate.

- Grading drainage swales to promote drainage west of the truck maintenance building and in the southeastern area of LF-1.

- Cutting a notch in the speed bump by the site entrance to promote drainage.
- Extending the compacted gravel area to the southern fence line to promote sheet flow runoff and reduce potential for ponding.
- Repair or replace the small equipment shed at the truck wash area, where water can accumulate on the subsided floor.

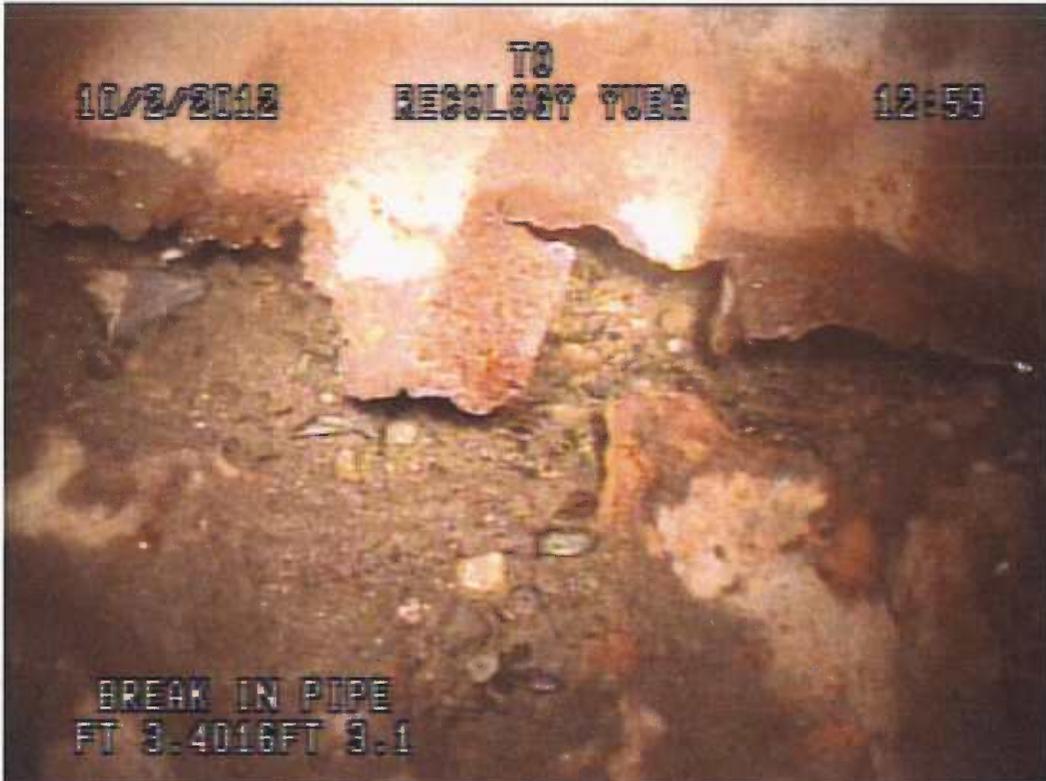
- Storm drain from #14 to clarifier sump has a broken left side wall at 3 feet from #14.
 - Storm drain from #7 to 7B, pipe broken and partially missing at 41 feet from #7.

Storm drain from manhole #14 to clarifier sump. Break in left side wall just below water line at 3 ft.

- Complete the video survey and evaluation of the remaining subsurface storm drain and sewer pipelines.
- Repair the damaged pipelines that are:
 - Broken and potentially leaking,
 - Clogged with debris and impeding water flow,
 - Collapsed and impeding water flow,
 - Sagging or back-graded and not allowing water flow.
- Periodically (before the start of the next rainy season) inspect and re-evaluate the pipelines that showed minor damage (e.g., warped sections).
- Fill the low areas where ponding can occur on the unpaved surfaces.
- Fill and repave the low areas on damaged pavement (concrete and asphalt) when weather allows.
- Construct drainage swales and make other repairs where identified.
- Periodically (annually prior to the rainy season) inspect the landfill surface for low areas where surface water runoff ponding can occur and make repairs as needed.

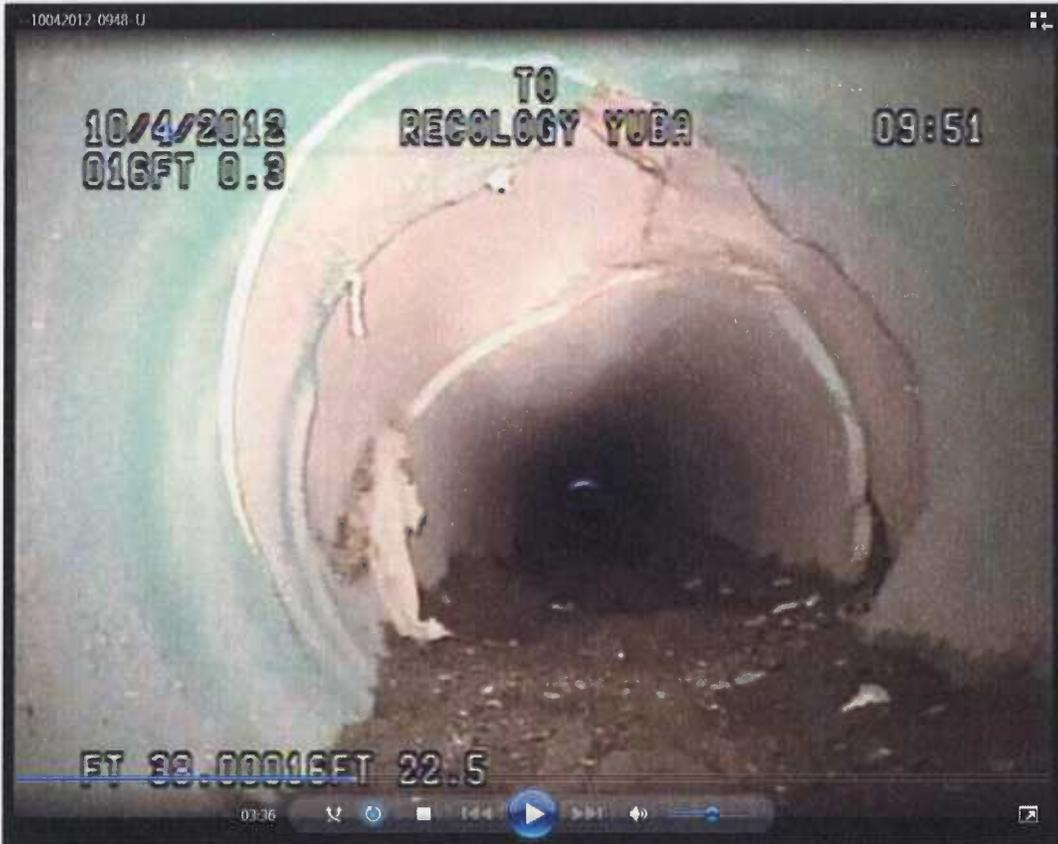
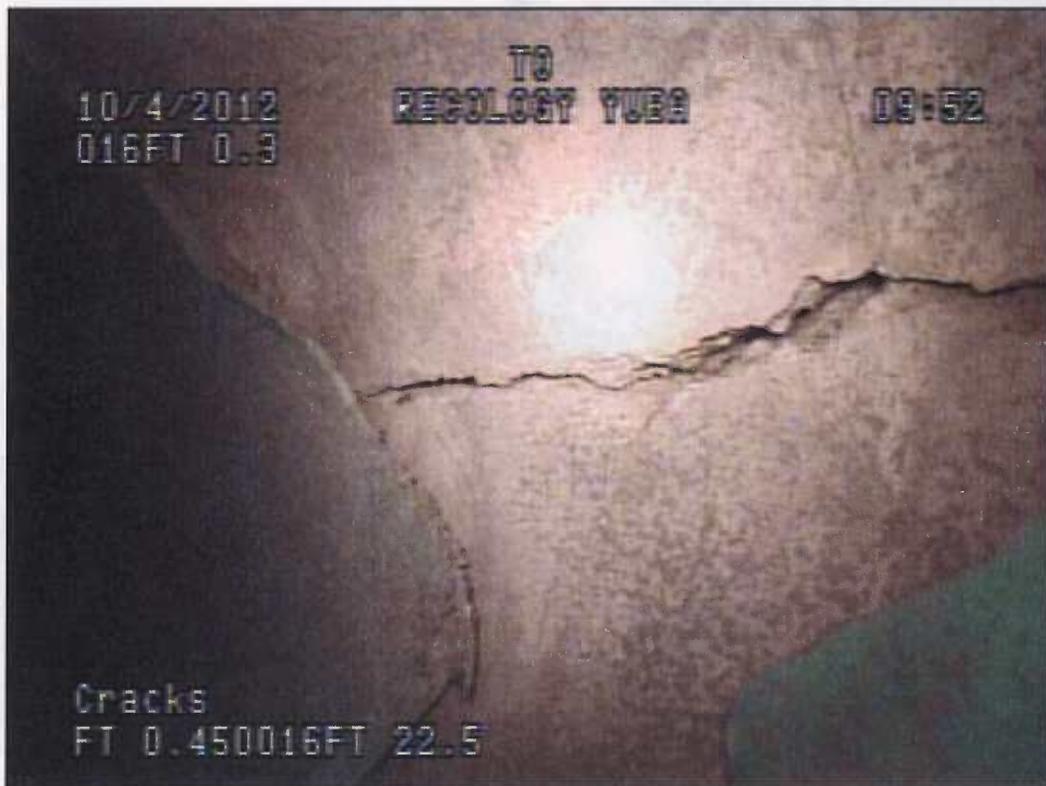
Storm drain from manhole #7 to #7B. Pipe broken and partially missing at 41 ft.

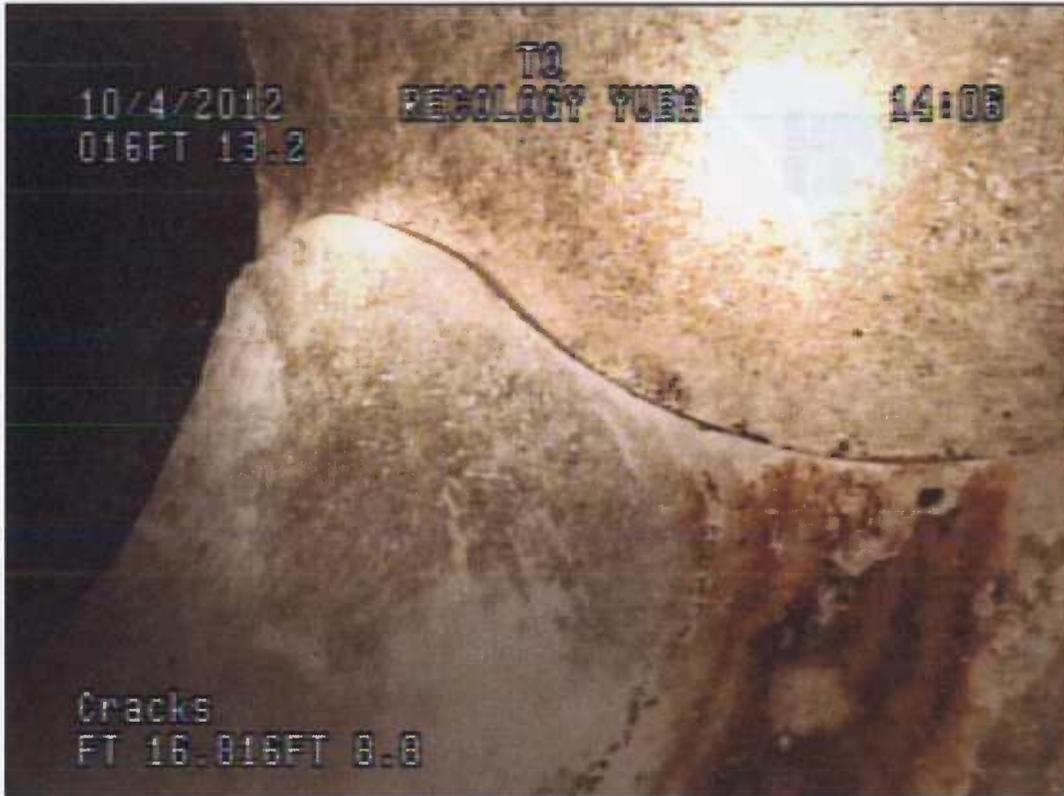
- Storm drain from SH1 to SH2 is broken on the bottom and cracked in right side wall at 17 feet west of SH1, and has may have a small diameter rod or pipe protruding from the bottom of a pipe joint at 178 feet.

Storm drain from SH#1 to SH#2. Crack in right wall at pipe joint at 17 ft.

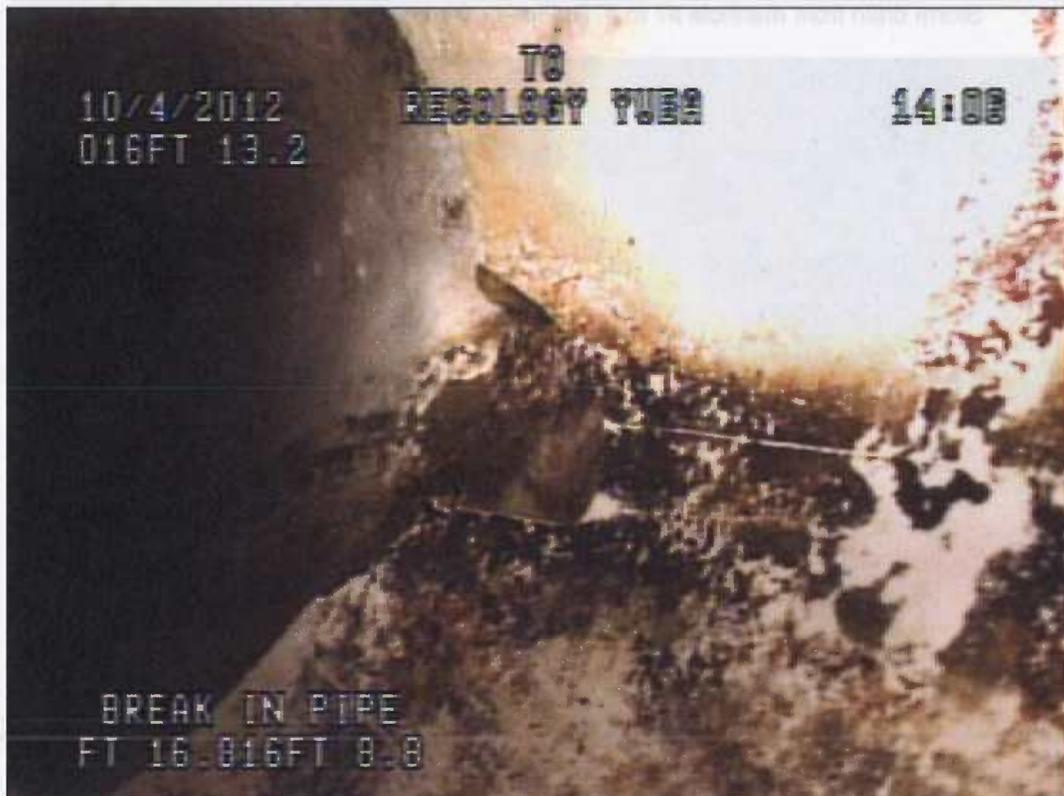
Storm drain from SH#1 to SH#2. Break in bottom at pipe joint at 17 ft.

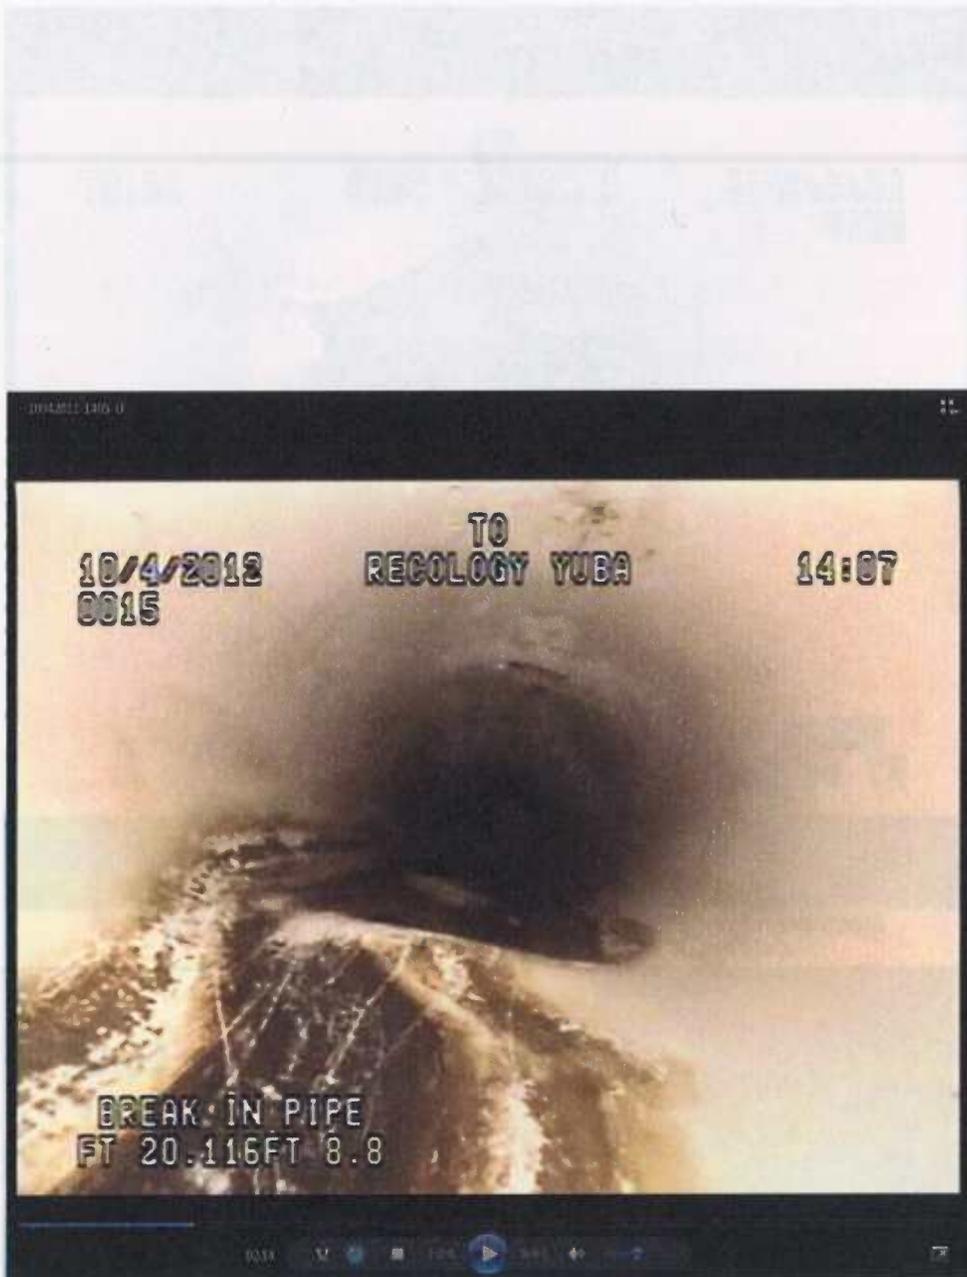
Storm drain from SH#1 to SH#2. Several warped sections on bottom of pipe.

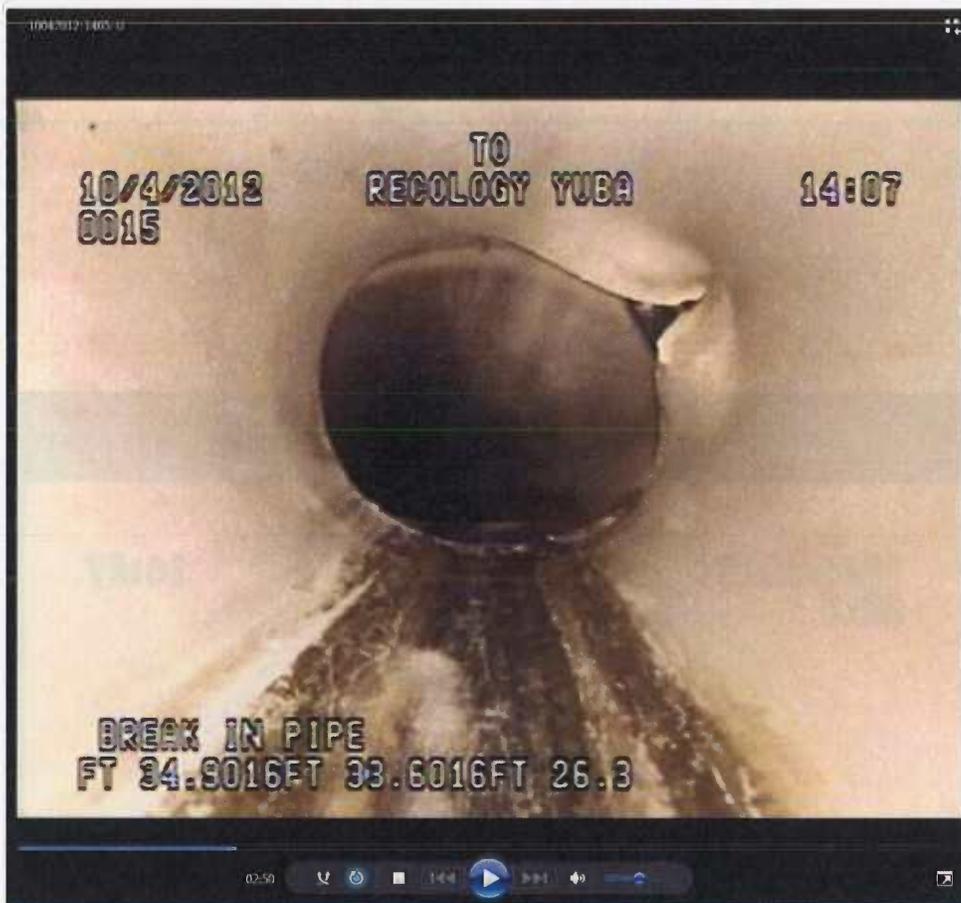
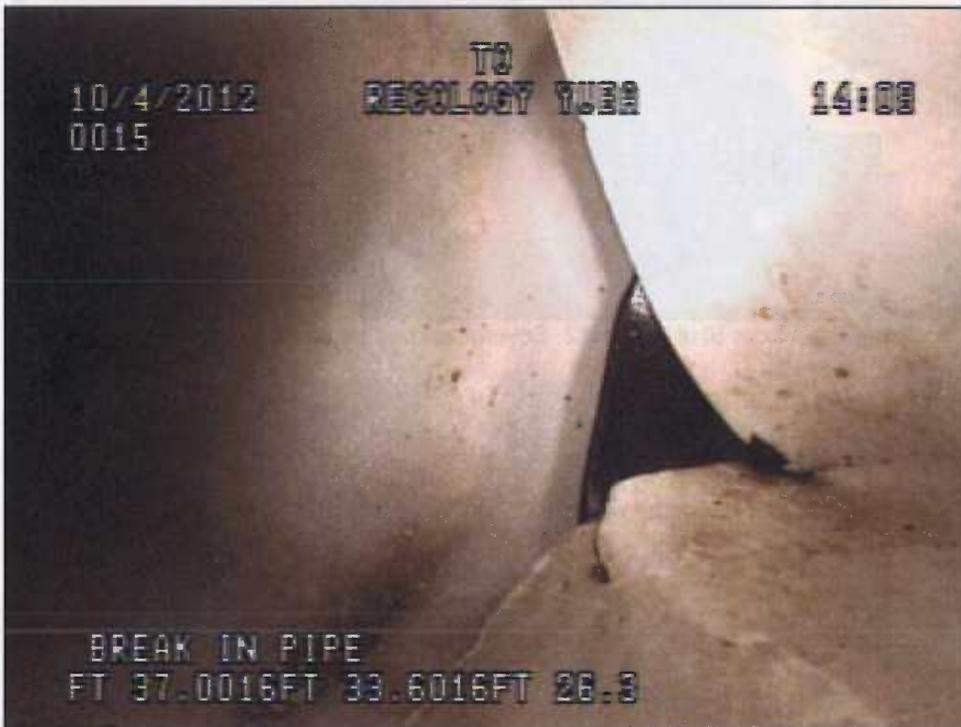
- Storm drain from SH1 to SH2 has a crack in the upper right side wall at 37 feet, several warped sections in pipe bottom, an inward bulge on right side wall at a pipe joint at 57 feet, and

Storm drain from SH#1 to SH#2. Break in upper right side wall at 37 ft.

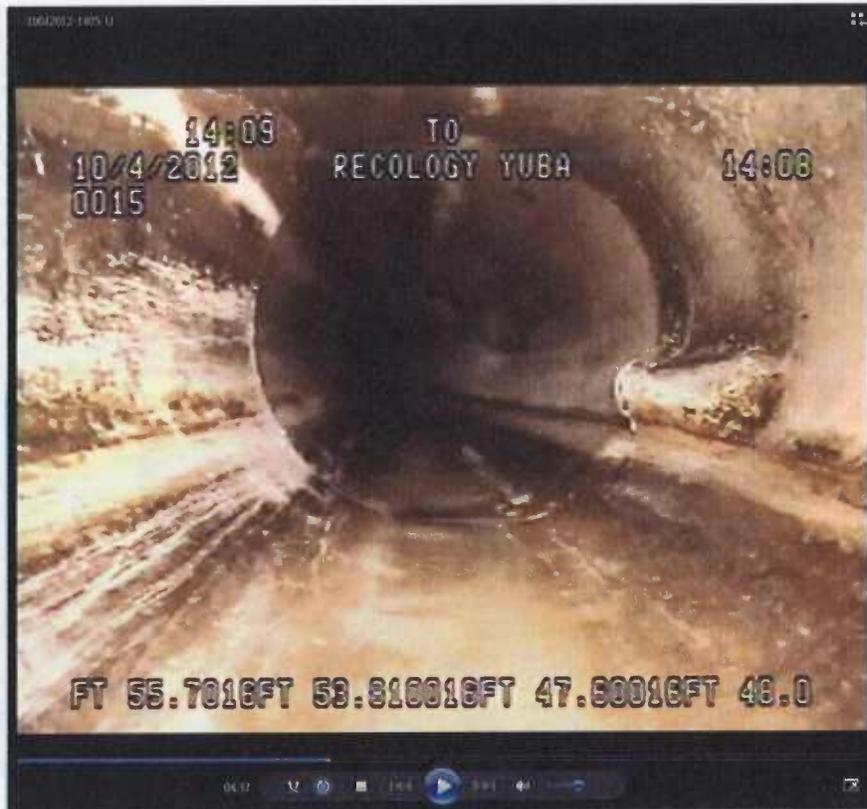
Storm drain from SH#1 to SH#2. Inward bulge in middle right side wall at pipe joint at 57 ft.

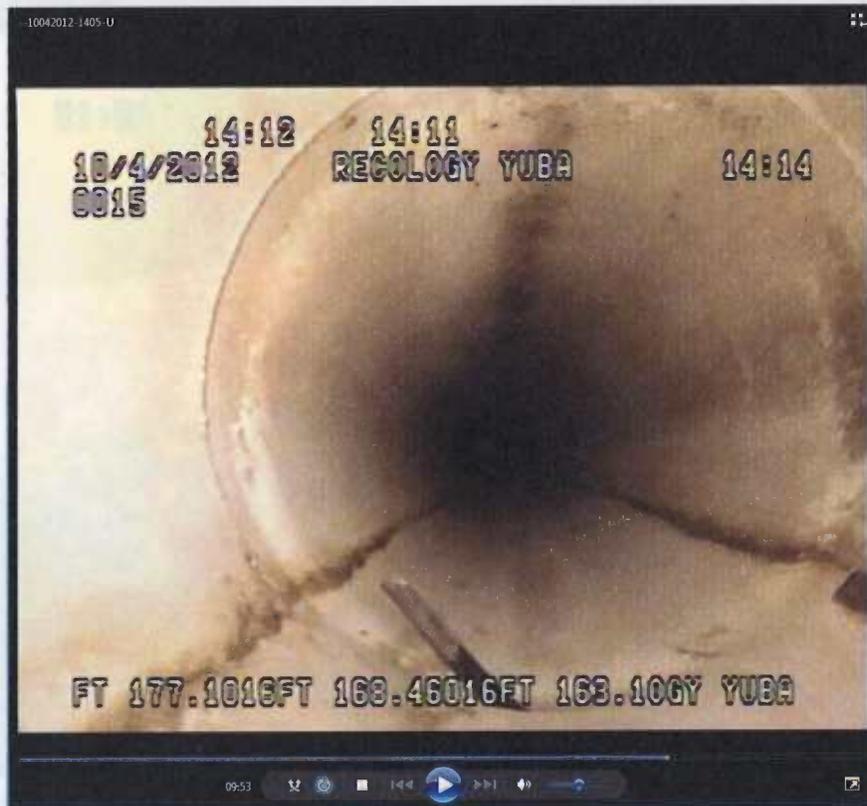
Storm drain from SH#1 to SH#2. Small pipe sticking out of bottom of pipe joint at 178 ft.

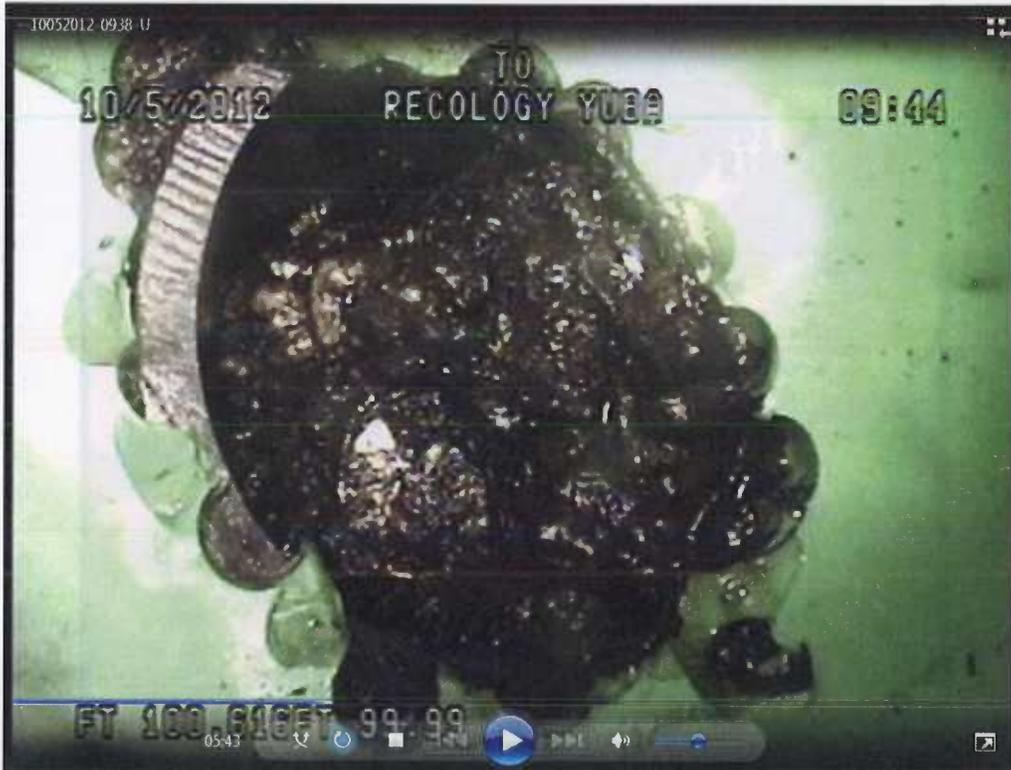
Storm drain from manhole #5 to #2. Improper inlet connection in ceiling at 100 ft.

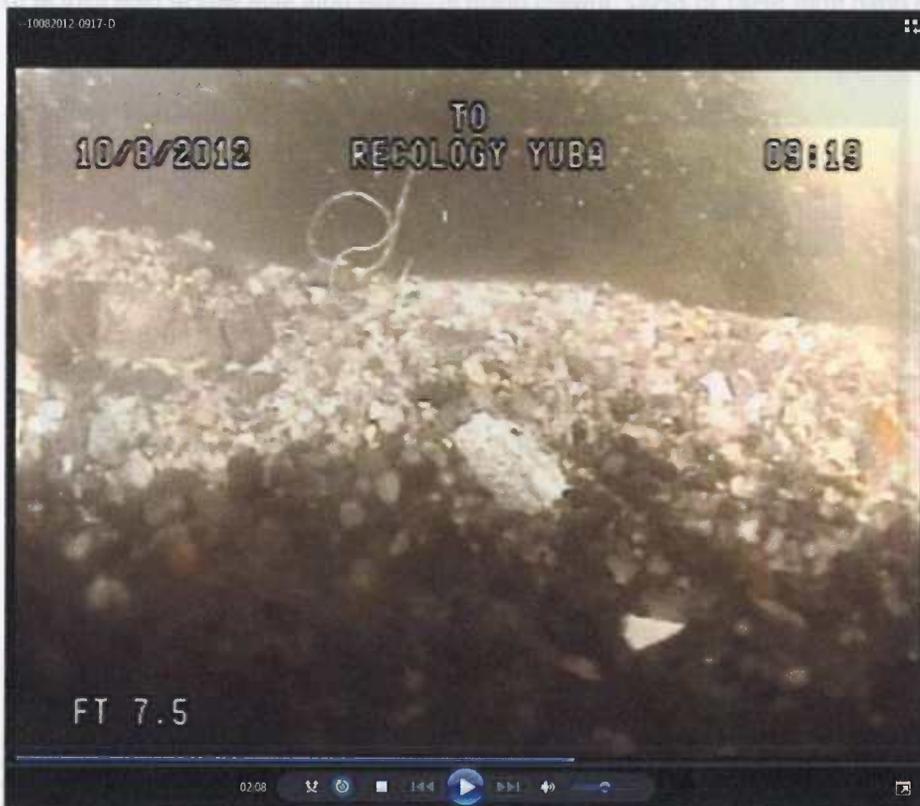
Storm drain from manhole #14 to #8. Build-up of solids may indicate back-graded pipe.

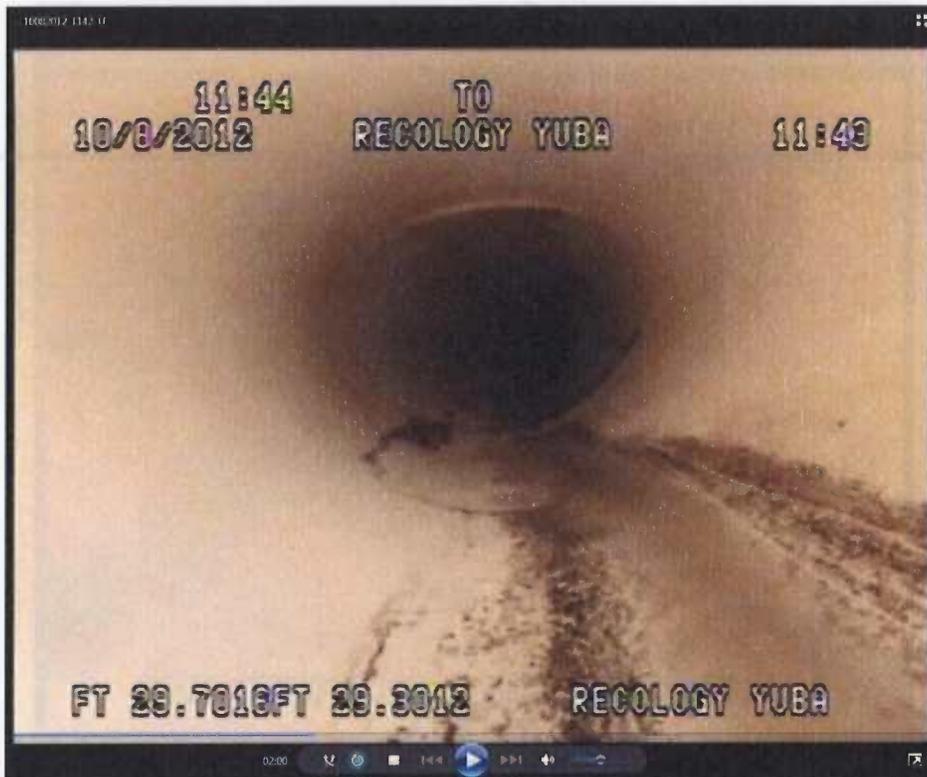
- Storm drain from E to D2 might be broken on the bottom left wall at 32 feet from E, and the pipe is partially collapsed from 30 feet to 70 feet with a bottom warp at 50 feet from E.

Storm drain from manhole E to D2. Partial ceiling collapse visible from 30 ft. to 70 ft.

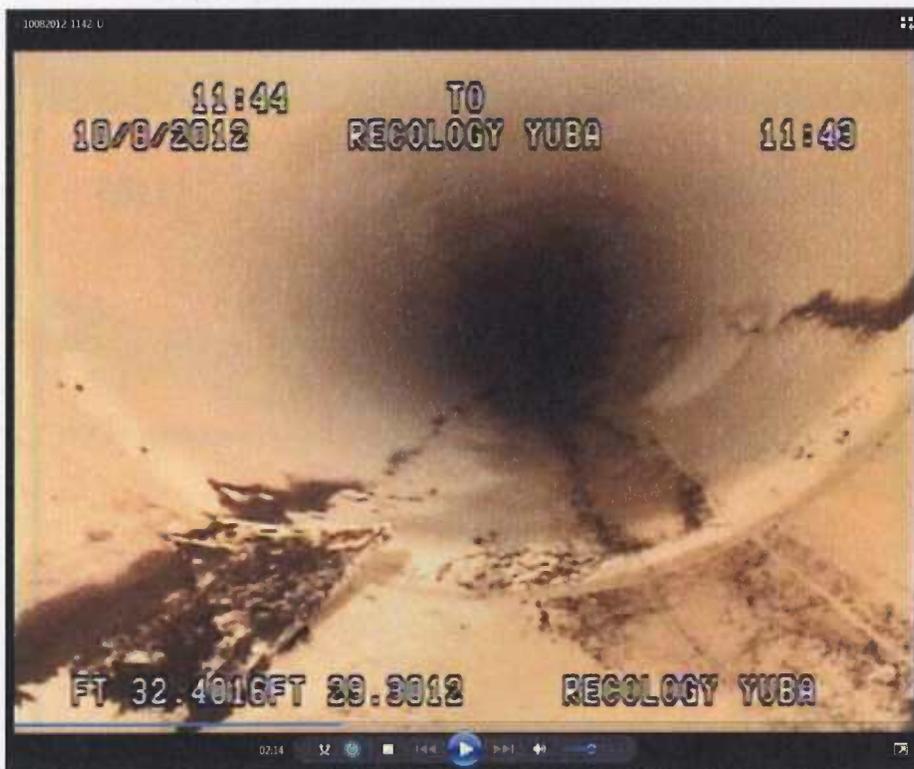
Storm drain from manhole E to D2. Possible break on bottom left at 32 ft.

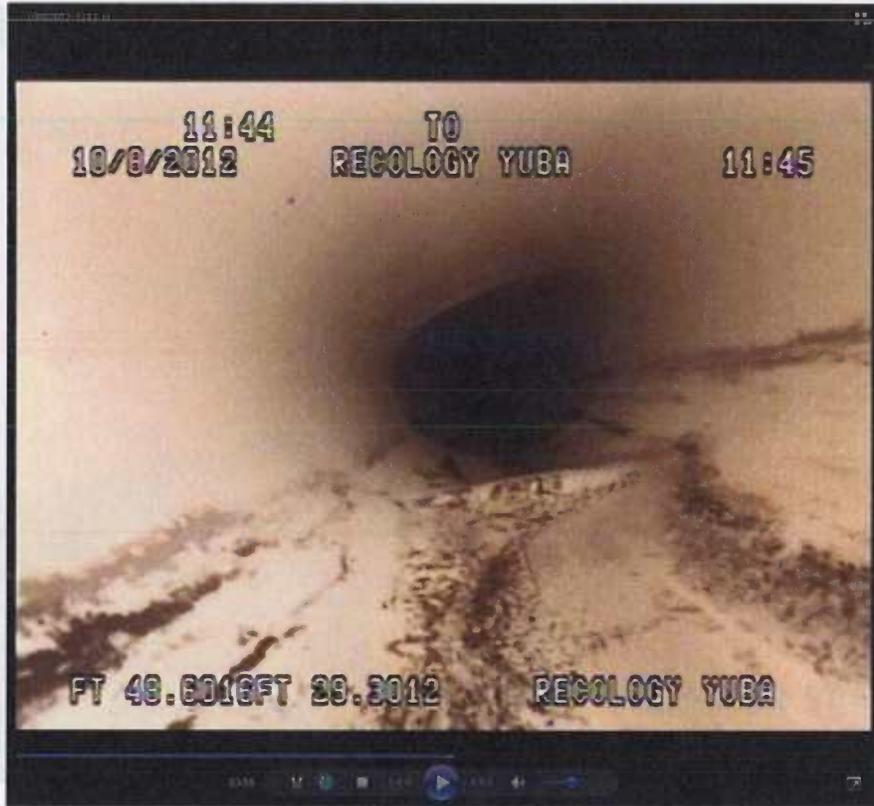
Storm drain from manhole E to D2. Bottom warp at 50 ft.

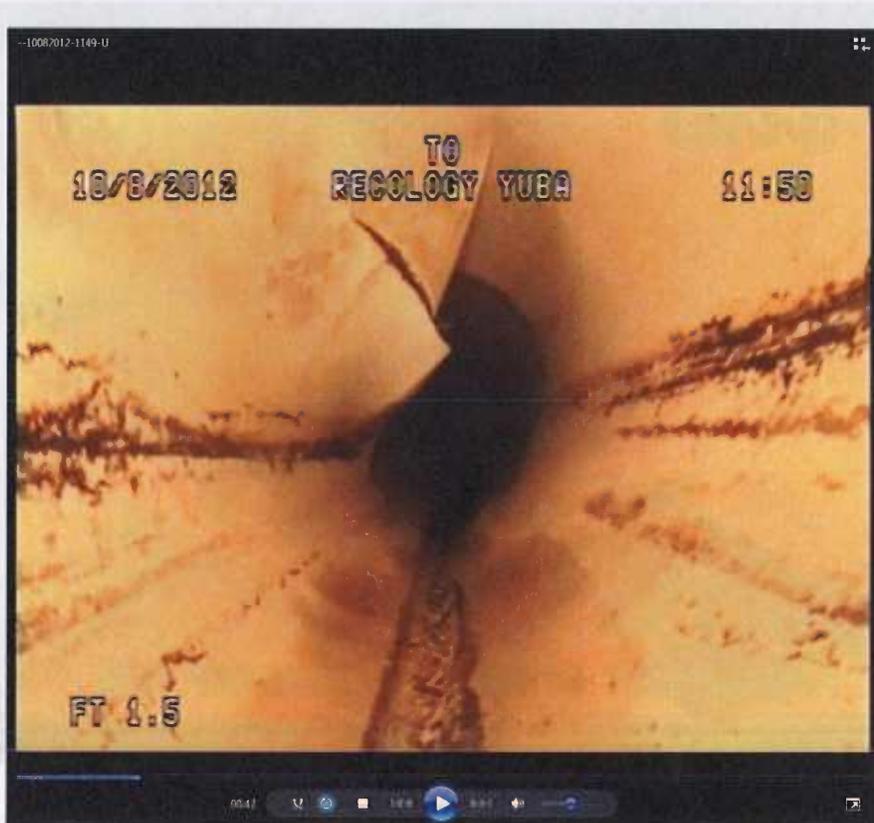
- Storm drain from D2 to D1 is broken in the upper left side wall at a pipe joint 3 feet west of D2.
 - Storm drain from D1 to C has a partially collapsed ceiling 30 feet and onward from D1.

Storm drain from manhole D2 to D1. Break in upper left wall at pipe joint at 3 ft.

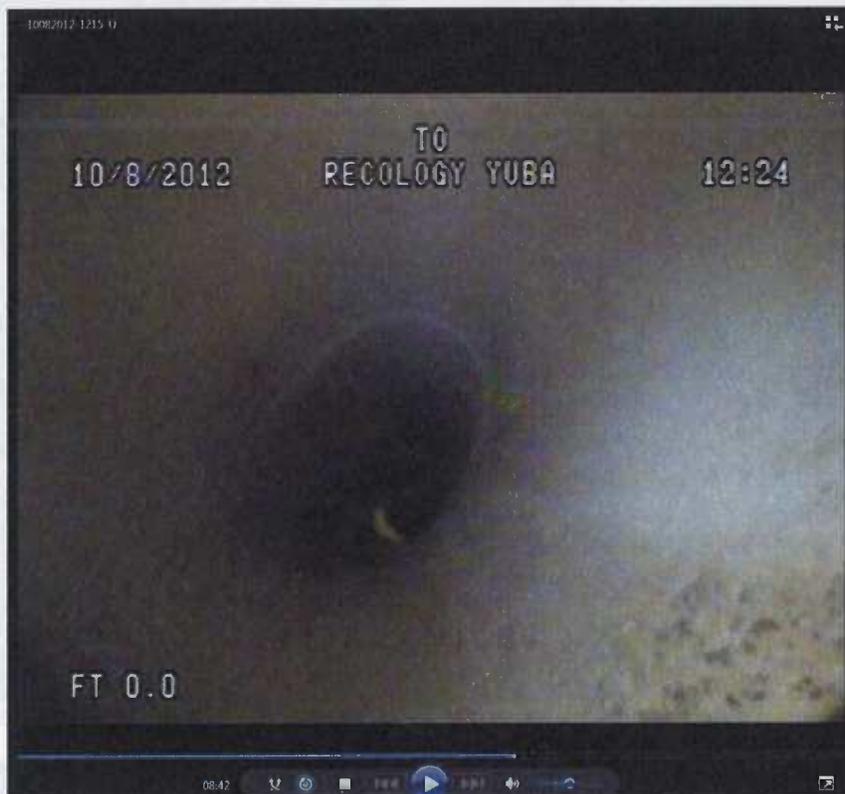
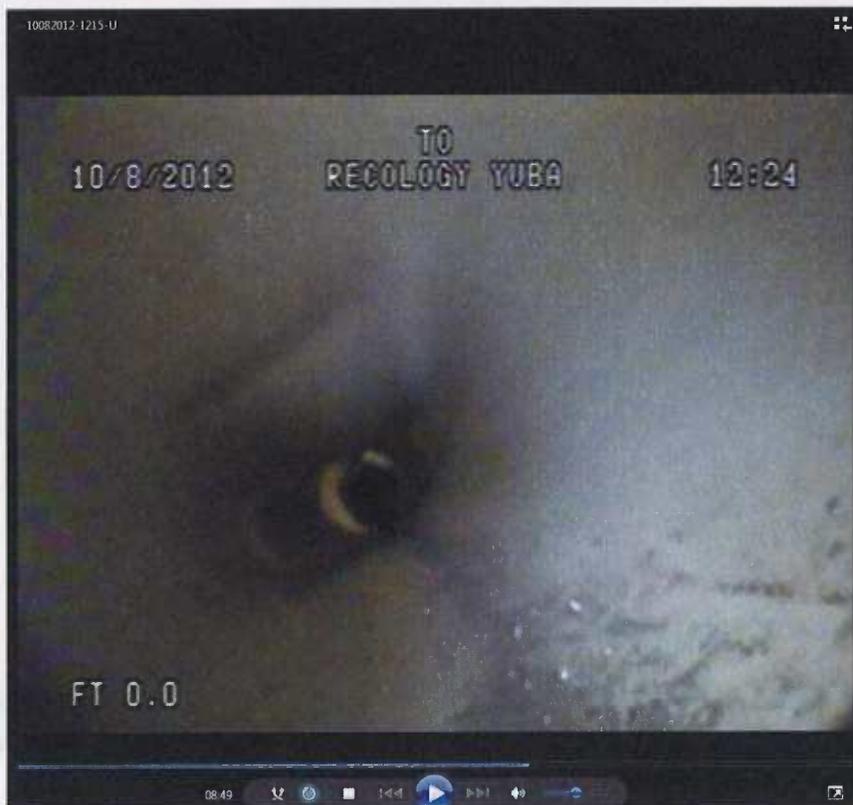
Storm drain from manhole D1 to C. Partially collapsed ceiling from 30 feet and onward from D1.

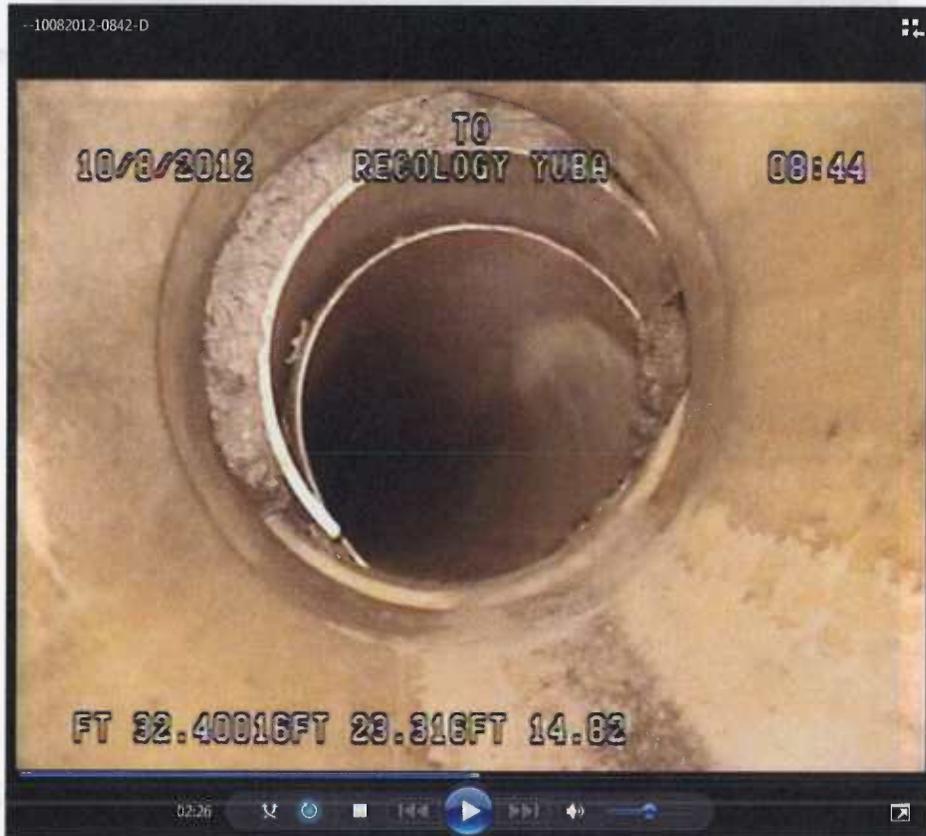
- Storm drain from the clarifier sump going east has a misaligned pipe joint at 34 feet from clarifier sump.
 - Sewer pipeline from F4 toward materials recycling facility appears to be broken in pipe bottom at 132 feet from F4.

Storm drain from clarifier sump going east. Misaligned pipe joint at 34 feet.
