**Re: Amendment to Report of Waste Discharge (ROWD); Feather River Organics Compost Facility; Waste Discharge Requirements Order R5-2003-0093 (WDR Order); Recology Yuba-Sutter; Yuba County, CA**

PROJECT: RECOLOGY YUBA-SUTTER FACILITY  
MARYSVILLE, CALIFORNIA

TITLE: COMPOST OPERATIONS AREA AND TEST PIT LOCATIONS

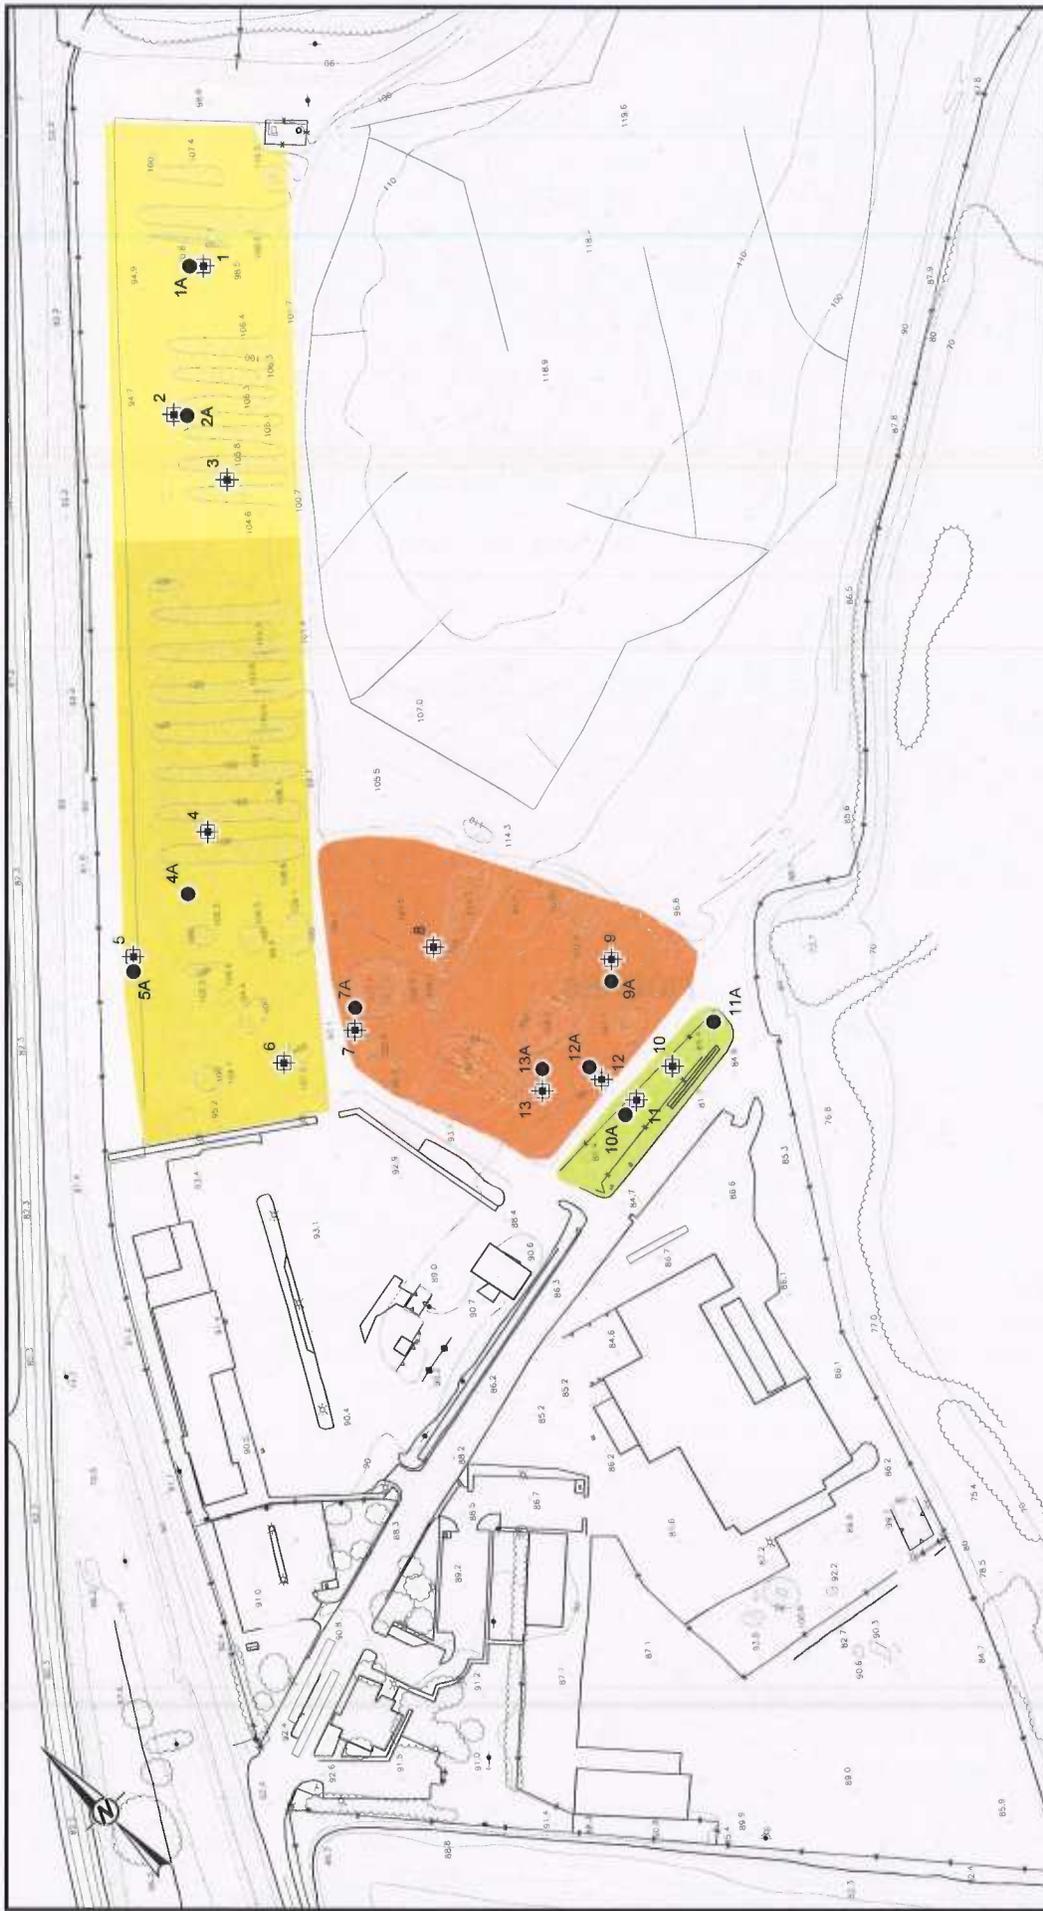
- The compost pad was extended westward. As noted above, this extension area is depicted in Figure 1 of this report as Area 3 (Compost Extension Pad). Recology used recycled concrete admixed with clay imported from Recology's Ostrom Road Facility to

- A compost storage and staging area was extended southward. As noted above, this extension area is depicted in Figure 1 of this report as Area 4 (Compost Storage Area). This area was reported surfaced with the recycled concrete aggregate underlain by a geotextile fabric.

In addition to the test pits, Golder completed supplemental hand auger explorations on January 3, 2013 at 10 locations adjacent to the previously excavated test pits (Figure 1) to collect samples for moisture content measurements. The hand augers were completed by advancing a 3-inch diameter auger. Summary test pit logs are included in Appendix A. Figure 2 provides selected photographs of the field excavation program.

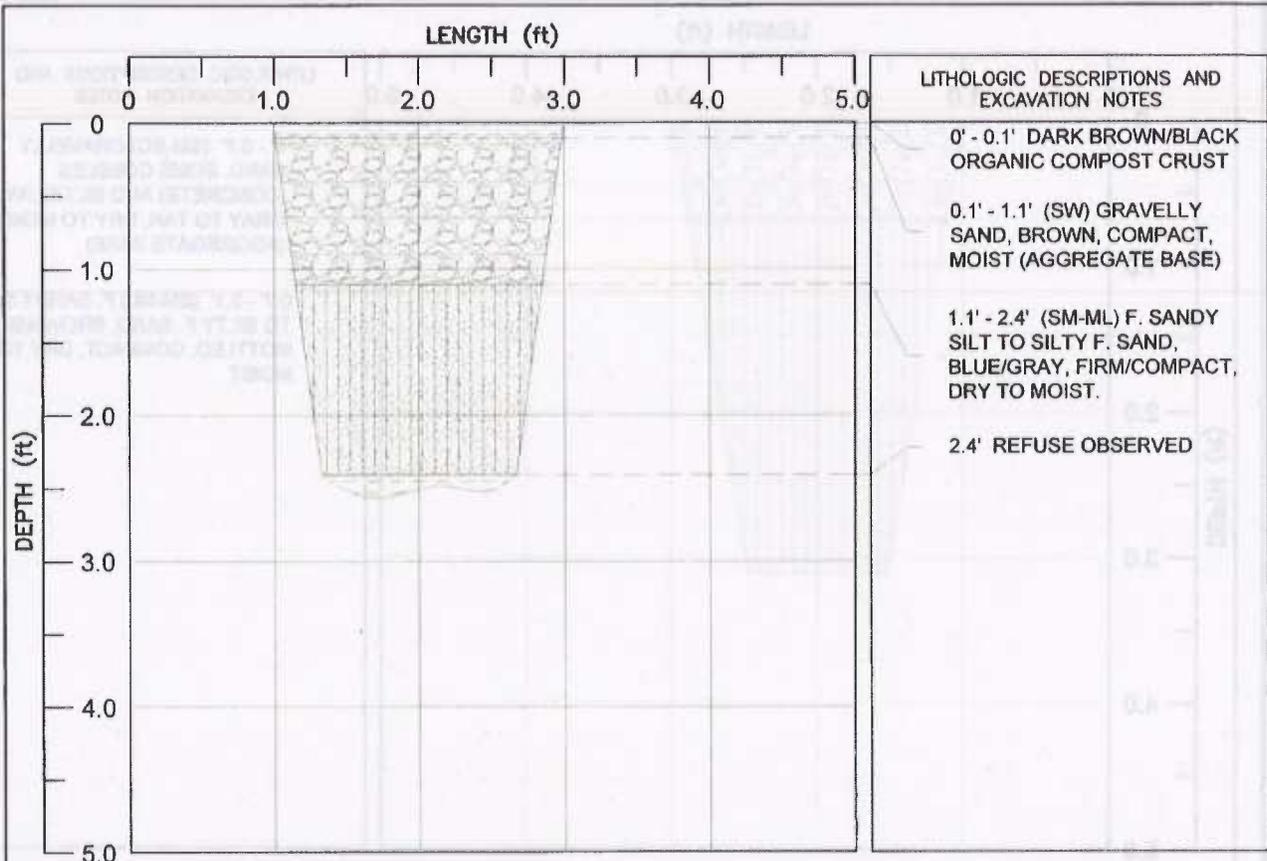
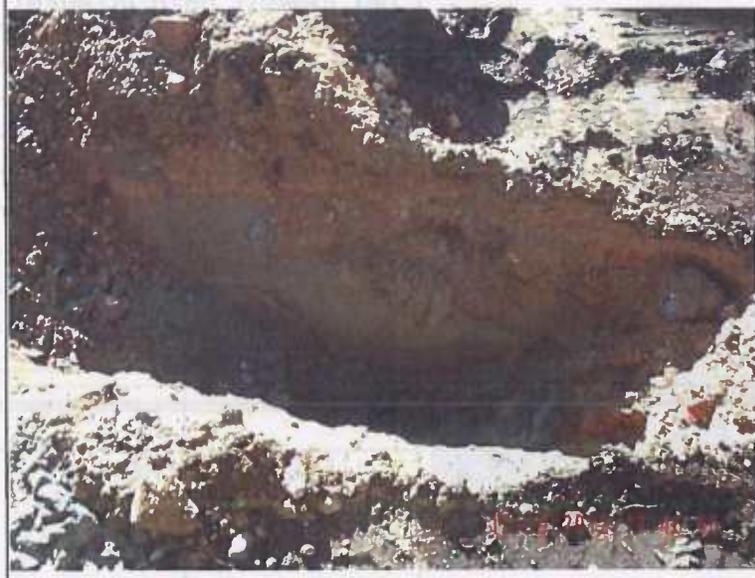
No. TP-7

0' - 0.1' DARK BROWN/BLACK ORGANIC COMPOST CRUST

0.1' - 1.1' (SW) GRAVELLY SAND, BROWN, COMPACT, MOIST (AGGREGATE BASE)

1.1' - 2.4' (SM-ML) F. SANDY SILT TO SILTY F. SAND, BLUE/GRAY, FIRM/COMPACT, DRY TO MOIST.

2.4' REFUSE OBSERVED
