Appendix F: System-wide Evaluation to Identify Restoration Opportunities Technical Memorandum

**System-wide Evaluation to Identify Restoration
Opportunities**

**San Bernardino County
Flood Control District**

January 2011

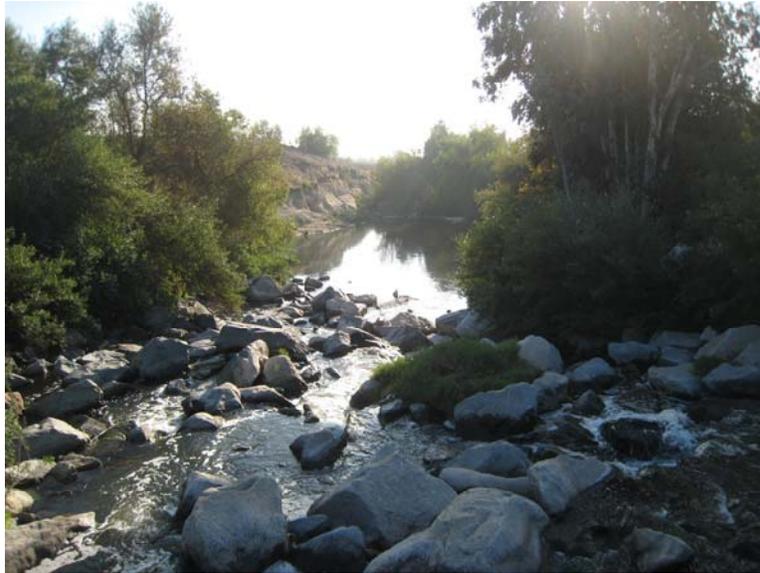
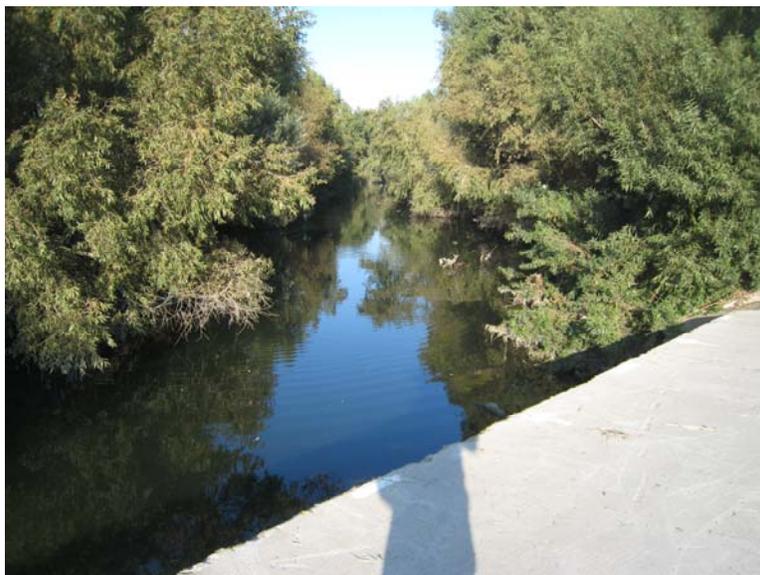
Site No. 1: Cucamonga Channel Restoration Site is located near the Chino Corona Road crossing in the City of Chino, CA. This section of the channel is classified as non- Engineered, Hardened, and Maintained (EHM) with significant degradation and stretches from an upstream EHM channel to Prado Damhere. There is ample space to widen and restore the natural channel.

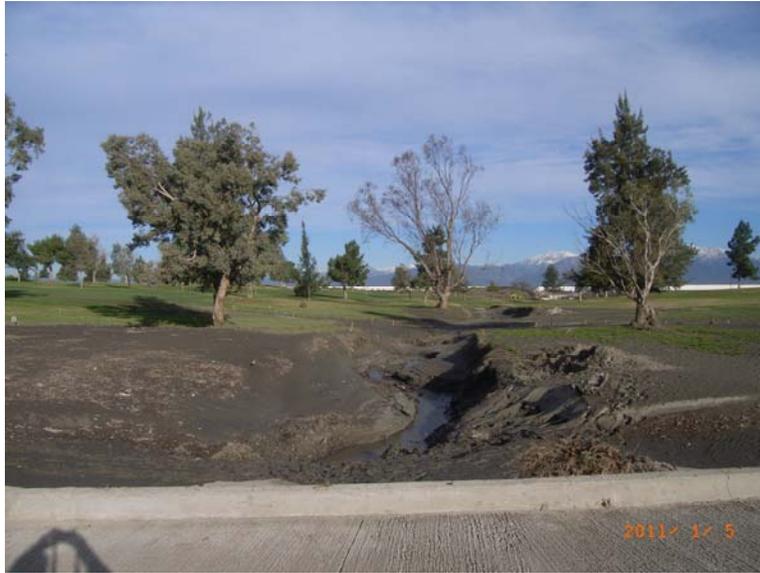
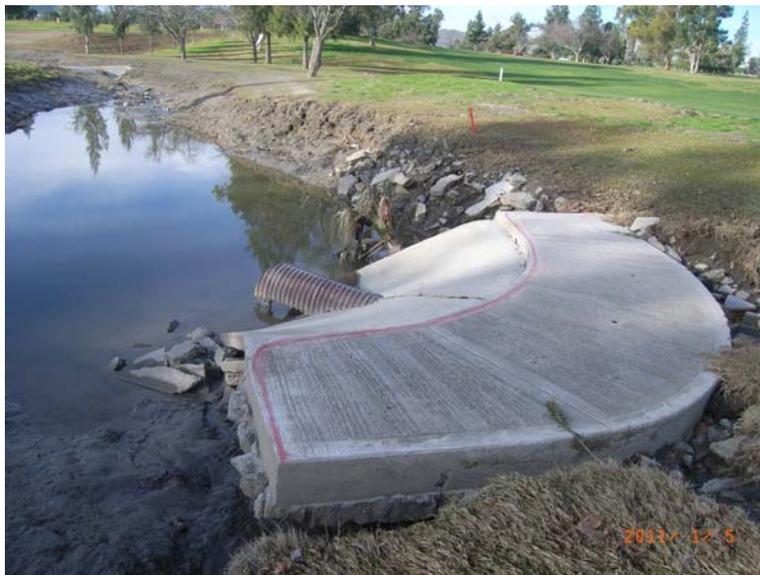
Site No. 2: Cypress Channel Restoration Site is located within the El Prado Golf Course along Pine Avenue in the City of Chino. This section of the channel is classified as non-EHM and varies in size and shape throughout the site. Generally, the channel is a natural earthen trapezoidal channel with turf as the bank protection. There is significant degradation and erosion, and aesthetically, restoration would be very beneficial. This site is owned by the U.S. Army Corps of Engineers.

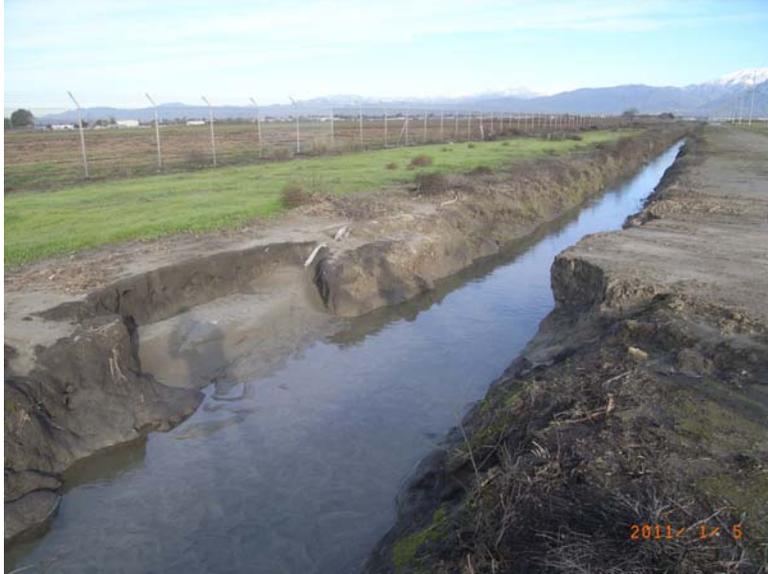
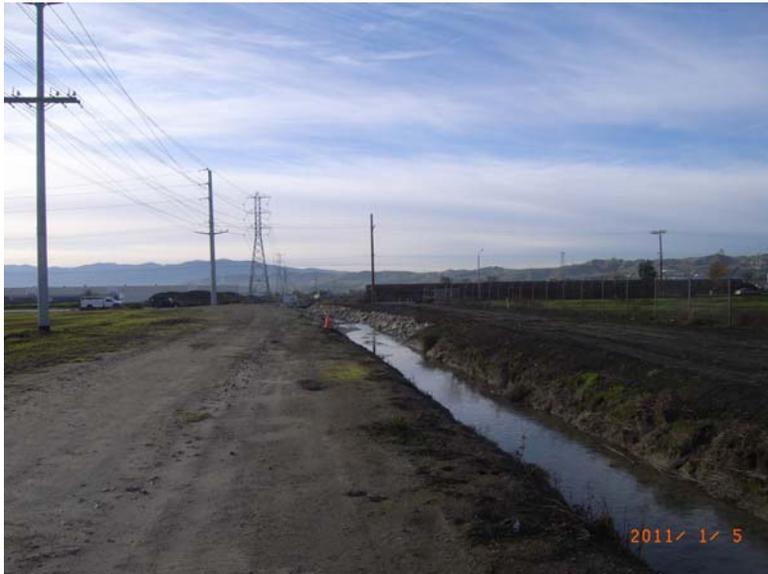
Site No. 3: Magnolia Channel Restoration Site is located between Edison Avenue and Kimball Avenue in the City of Chino, CA. The channel has not been classified but is an earthen trapezoidal channel with a bottom width of approximately 5 feet. The bank protection is in poor condition, and there are signs of bank and toe erosion. There is some potential for widening the channel to the west.

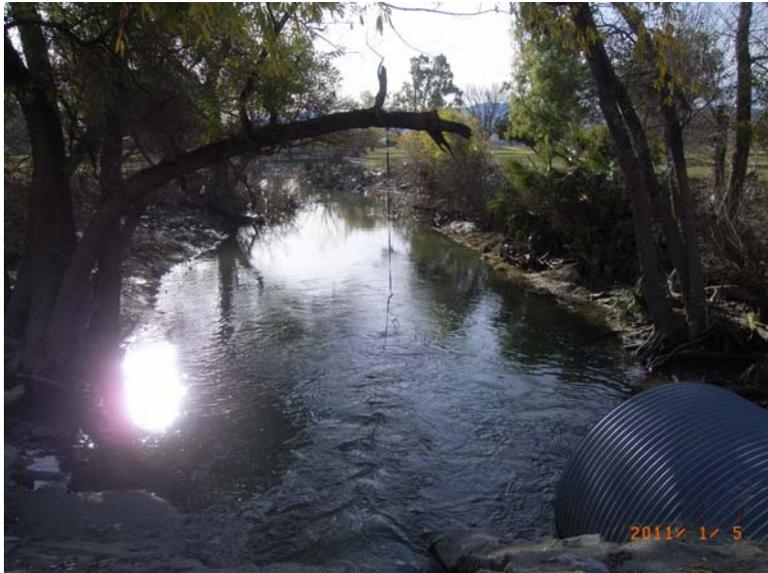
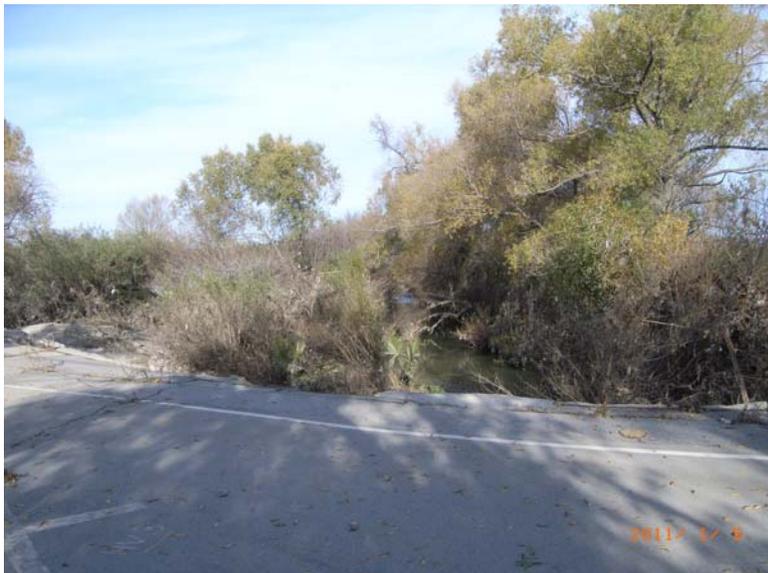
Site No. 4: San Antonio Channel Restoration Site is located within the El Prado Golf Course along Pine Avenue in the City of Chino, CA. This section of the channel is classified as non-EHM and is a trapezoidal channel with riprap bank protection. There is some toe erosion, but the majority of the channel is stabilized. Restoration would most likely only consist of a general cleanup of the channel and vegetation stabilization, but there is sufficient room for widening the channel.

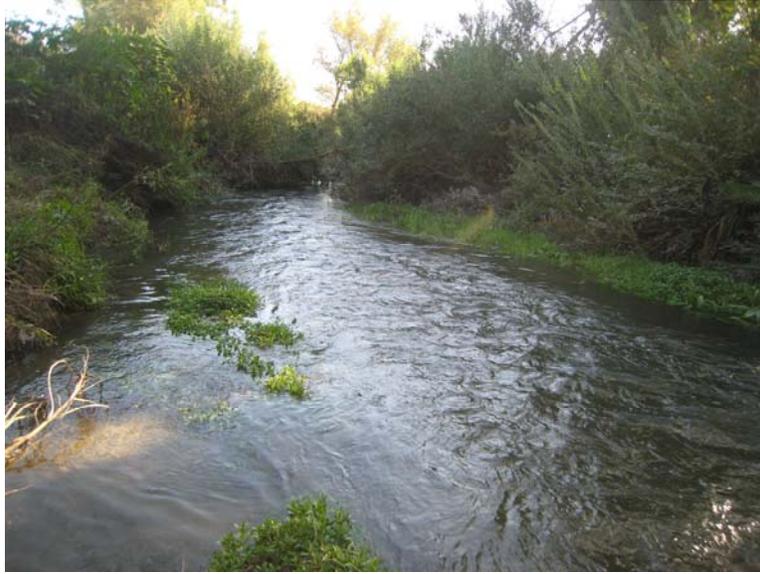
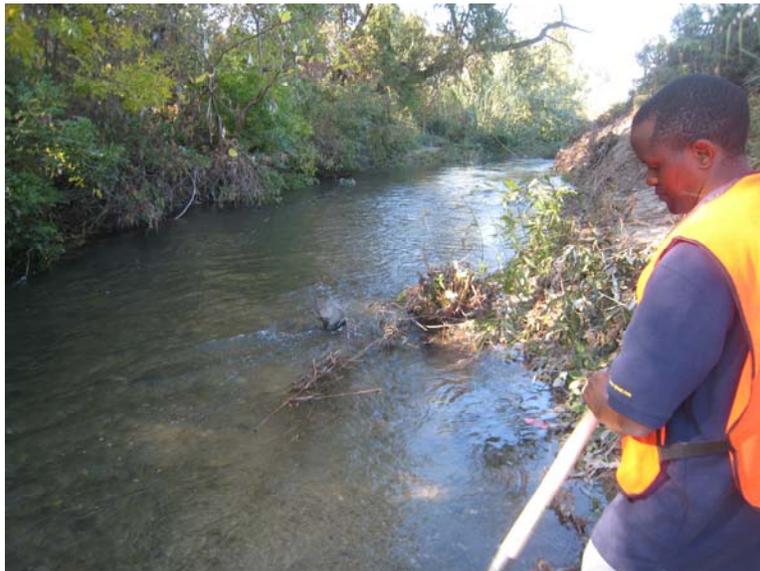
Site No. 5: San Antonio Channel Restoration Site is located adjacent to El Prado Road and between Central Avenue and the wastewater plant in the City of Chino. This section of the channel is classified as non-EHM and is a natural channel. There is heavy vegetation along the banks, but significant degradation has occurred to the invert of the channel. There is sufficient room to widen the channel.

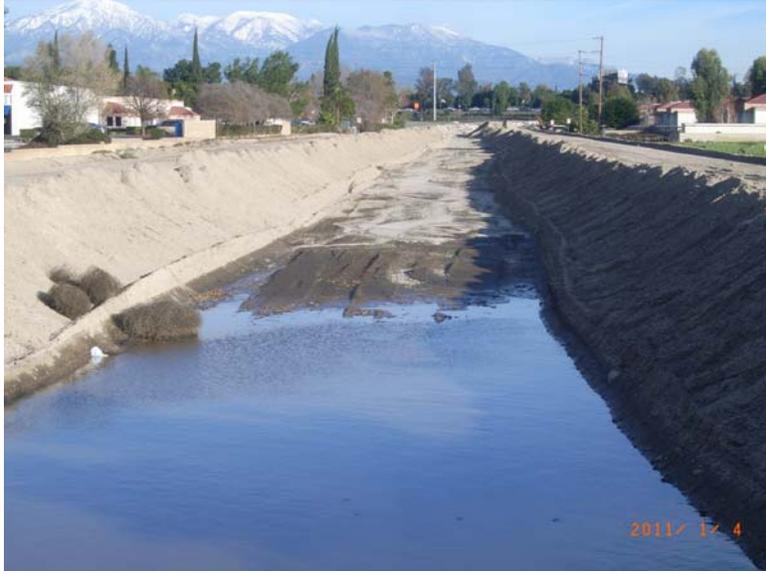
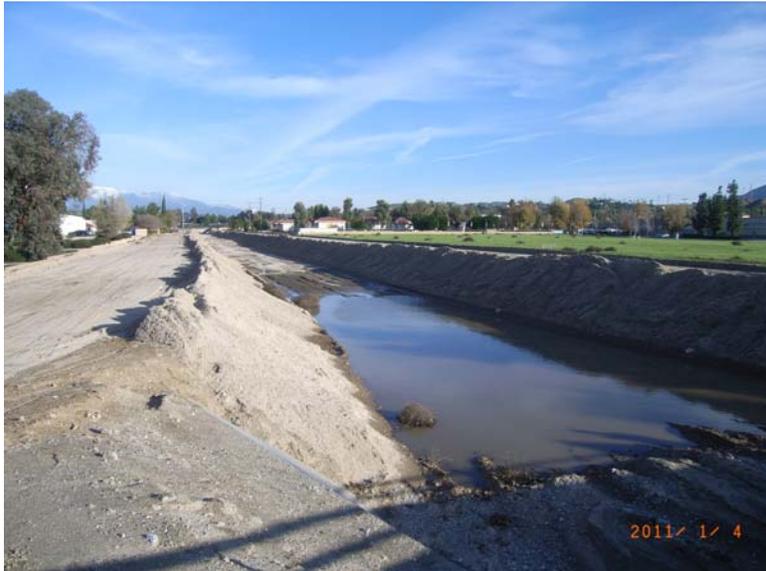
Site No. 6: Reche Canyon Channel Restoration Site is located between Interstate 215 and the Santa Ana River in the City of Colton. This section of the channel is classified as EHM and is an earthen trapezoidal channel. The channel had recently been maintained at the time of the site visit, but there were signs that toe and bank erosion had occurred. The access roads would need to be modified to widen the channel.

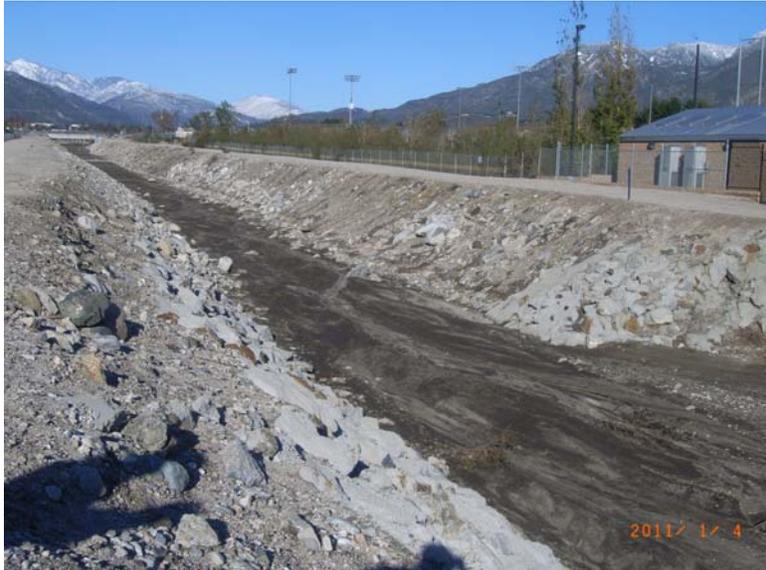
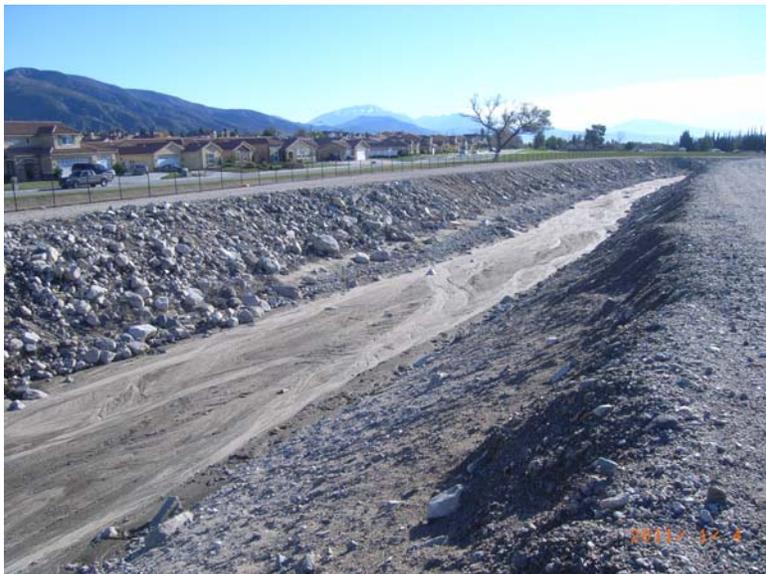
Site No. 7: Cable Creek Restoration Site is located between N. Little League Drive and Palm Avenue in the City of San Bernardino. This stretch of Cable Creek is classified as an EHM channel and has riprap-lined banks. The channel invert is showing signs of aggradation, most likely due to the downstream drop structures. There is ample room for widening the channel.

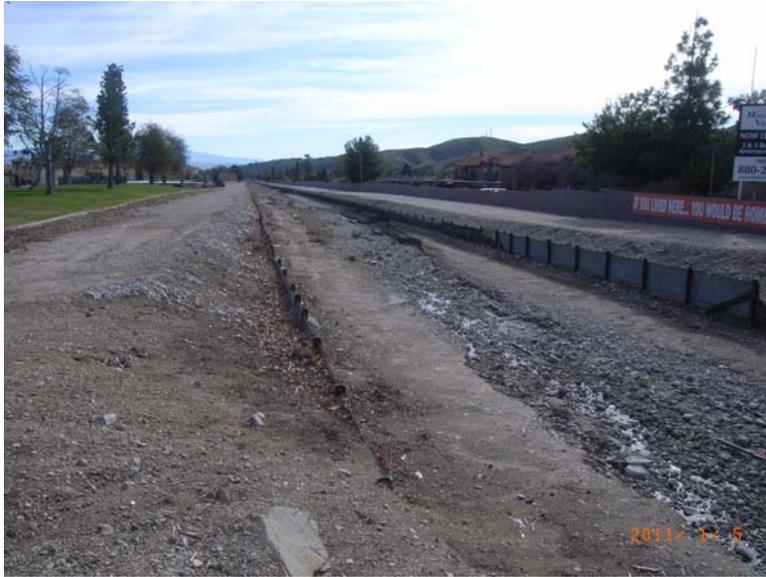
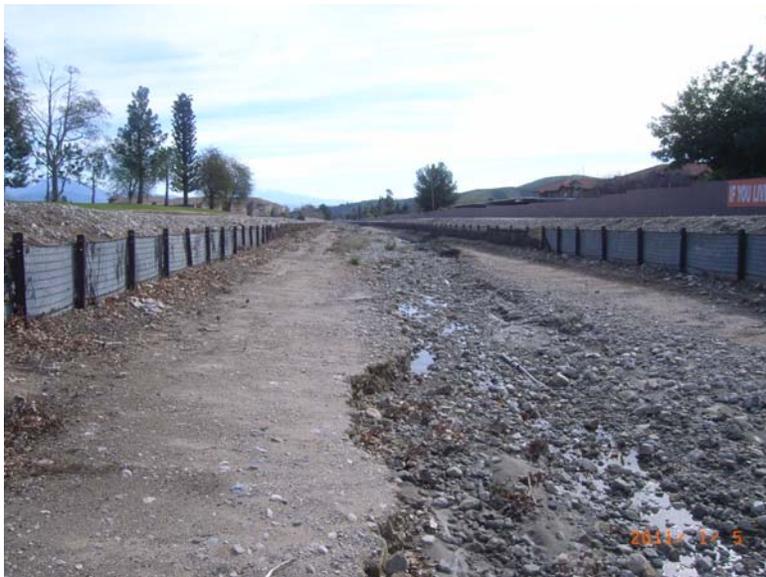
Site No. 8: Devil Creek Channel Restoration Site is located between University Parkway and Western Avenue in the City of San Bernardino. This section of the channel is classified as EHM and the bank protection consists of corrugated metal piles, which are in poor condition. The channel shows signs of minor toe erosion and invert degradation. Stretches of the channel have sufficient room for widening, but the majority of the channel would require modification to the access roads.

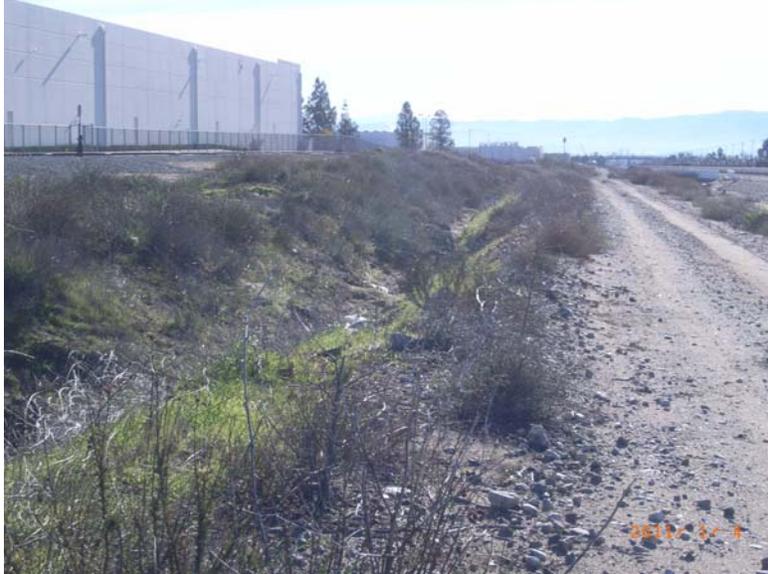
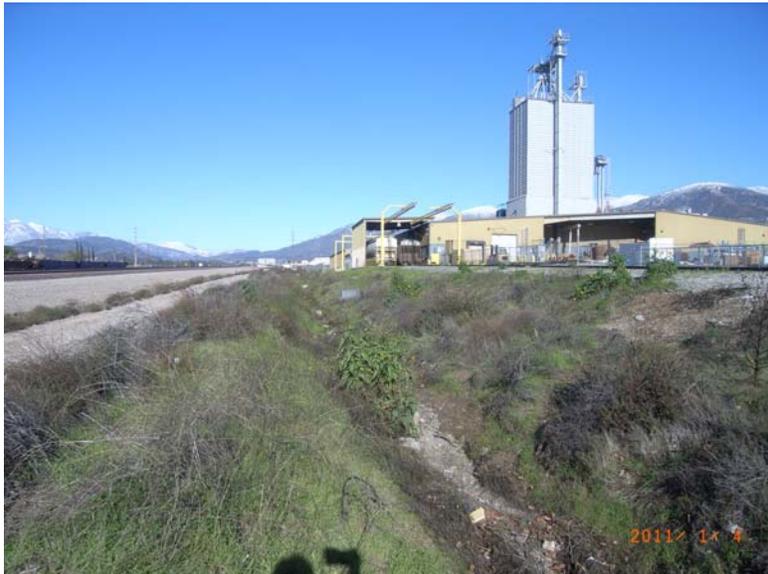
Site No. 9: Ono Storm Drain Restoration Site is located adjacent to Cajon Boulevard and the railroad tracks in the City of San Bernardino. This section of the channel is classified as EHM and is a small, vegetated trapezoidal channel. There are signs of toe erosion and invert degradation, but neither is significant. This site will likely require additional right-of-way from the adjacent owner in order to widen the channel.

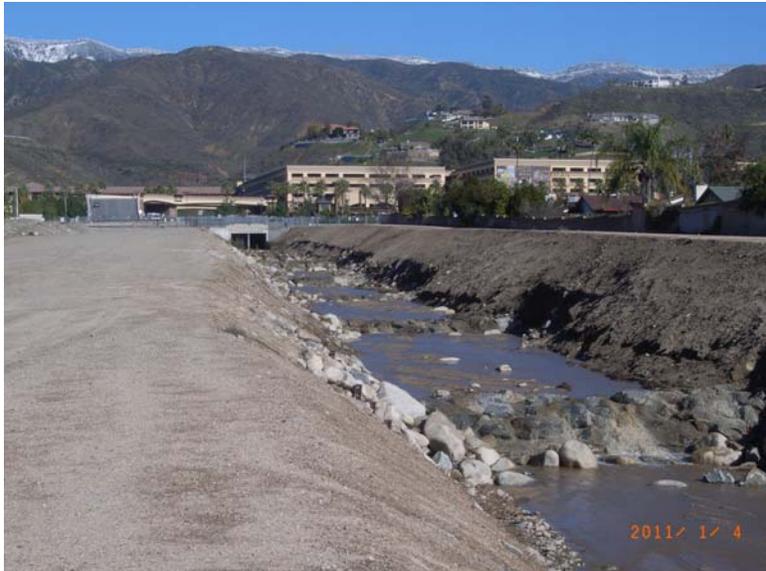
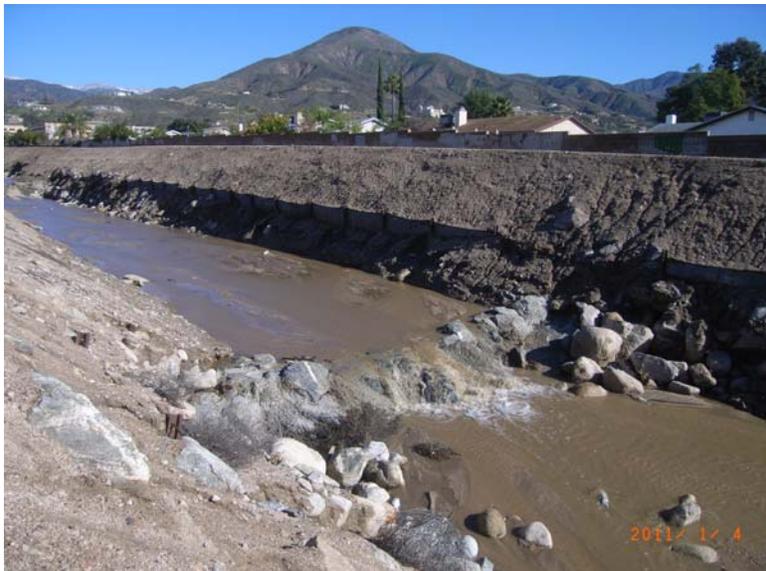
Site No. 10: Sand Creek Restoration Site is located between Lynwood Drive and Patton Basin in the City of Highland. This section of the channel is classified as EHM and is a trapezoidal shaped channel with corrugated metal piles protecting the banks. The channel also has drop structures every 100-200 feet along the invert. Downstream is a large drop structure into Patton Basin. There is some bank and toe erosion, but the invert appears stabilized. There is sufficient room to widen the channel. Restoration could be aesthetically beneficial, because the San Manuel Indian Bingo and Casino has a direct line of sight to the channel.

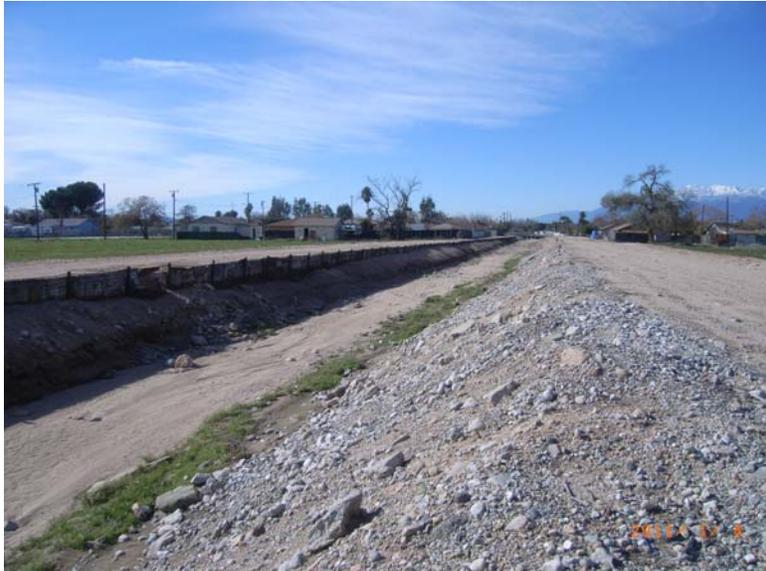
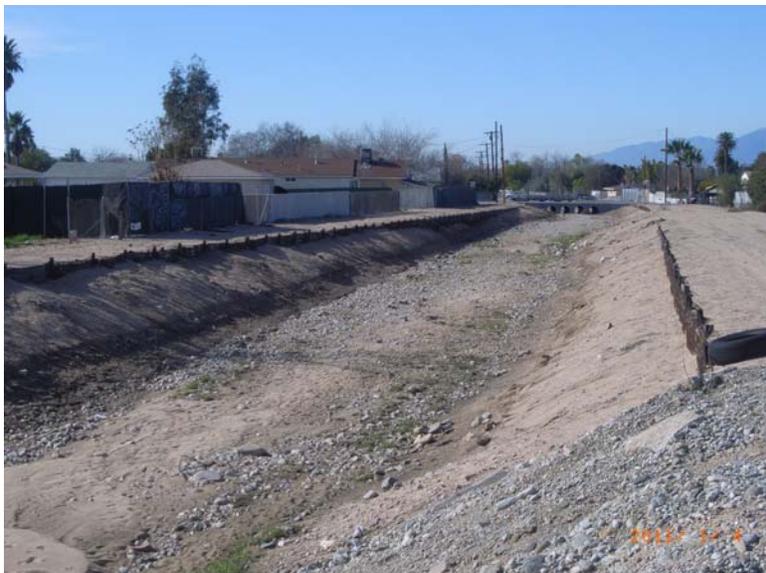
Site No. 11: City Creek Restoration Site is located between 3rd Street and Twin Creek Channel in the City of San Bernardino. This section of the channel is classified as EHM, with the banks being protected by corrugated metal piles and some river rock along the invert. The corrugated metal piles are starting to fail, and there are signs of toe and bank erosion. For approximately 1000 feet downstream of 3rd Street, there is plenty of space for widening the channel, but over the majority of the restoration site, the access roads would have to be modified to accommodate the wider channel.

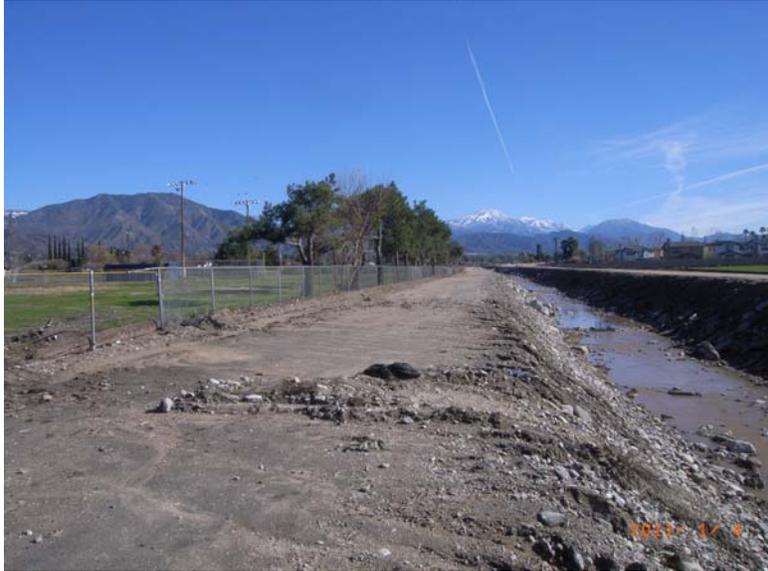
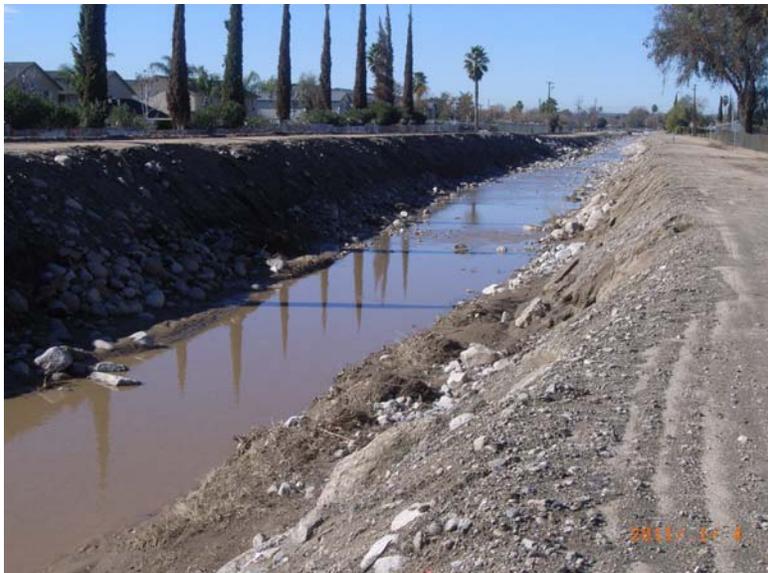
Site No. 12: Upper Warm Creek Restoration Site is located adjacent to Baseline Road, between the confluence with Sand Creek and Sterling Avenue in the City of San Bernardino. This section of the channel is classified as EHM and is an earthen trapezoidal channel with river rock along the invert. The channel is fairly stabilized, but it does show signs of bank erosion. The majority of the site has room to widen the channel with Belcher Park, undeveloped land, and San Gorgonio Senior High School to the north, but portions of the channel would require modifications to the access road.

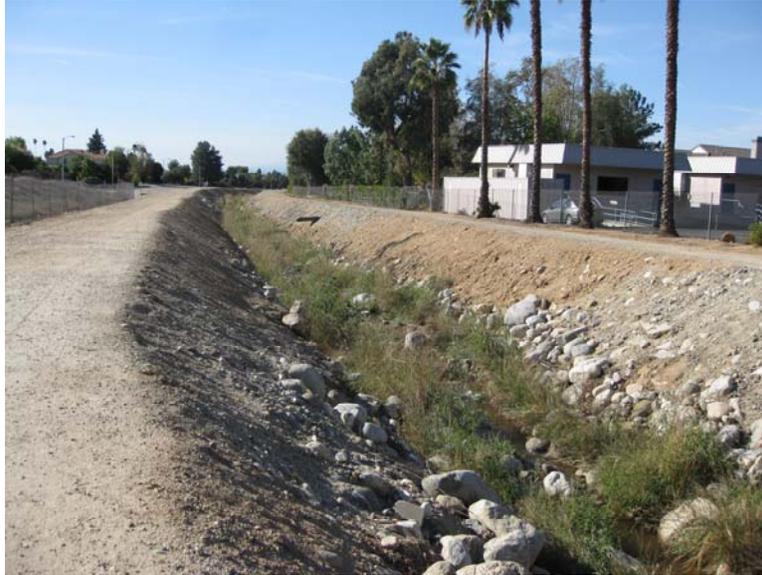
Figure 26: Site No. 13 Upstream View

Site No. 13: Zanja Creek Restoration Site is located adjacent to Laramie Avenue and Herrington Drive, and between Wabash Avenue and Lincoln Street in the City of Redlands. This section of the channel is classified as EHM and is an earthen trapezoidal channel. There are non-EHM sections of channel up- and downstream of the site. There is very little invert degradation, and the banks appear stable. Modification of the access roads would be required if the channel were widened.

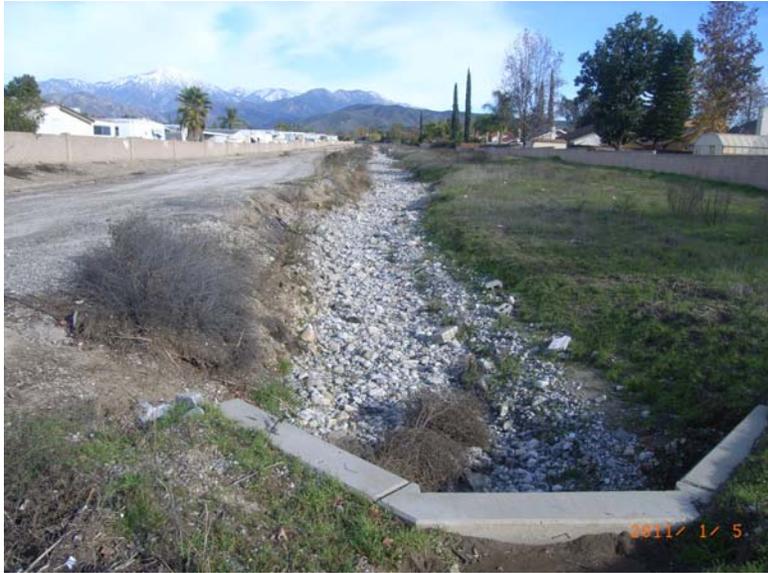
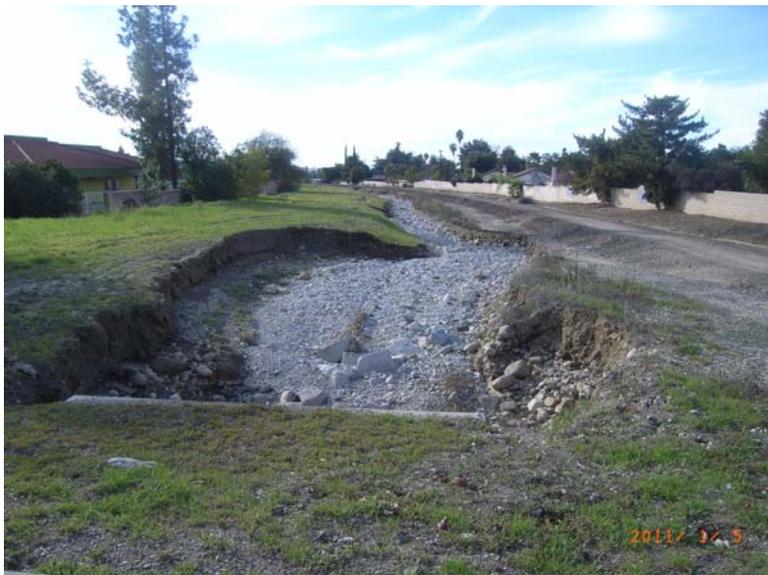
Site No. 14: Zanja Creek Restoration Site is an unnamed channel tributary to Zanja Creek and conveys water from the north. The site is located between Wabash Avenue and Sylvan Boulevard in the City of Redlands. This section of the channel is classified as EHM and is an earthen channel with river rock along the invert. The channel invert appears stable, but there is bank and toe erosion. There is sufficient room to widen the channel to the north where railroad tracks have been removed.

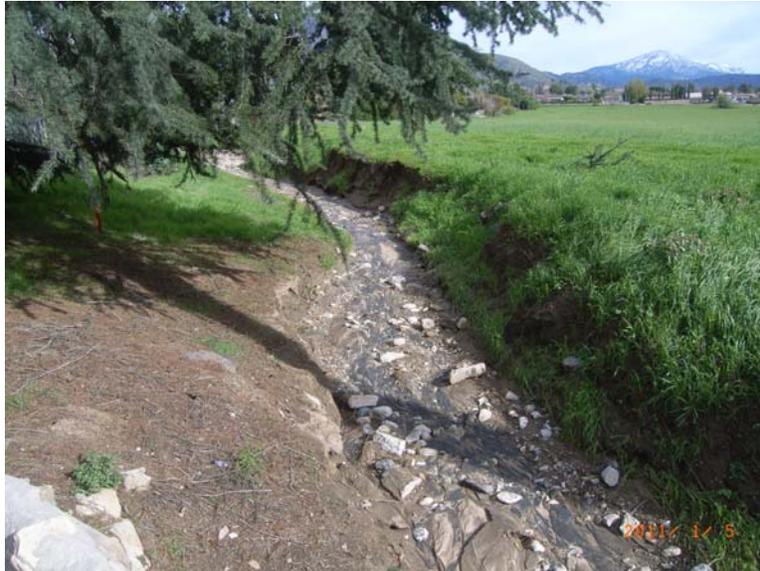
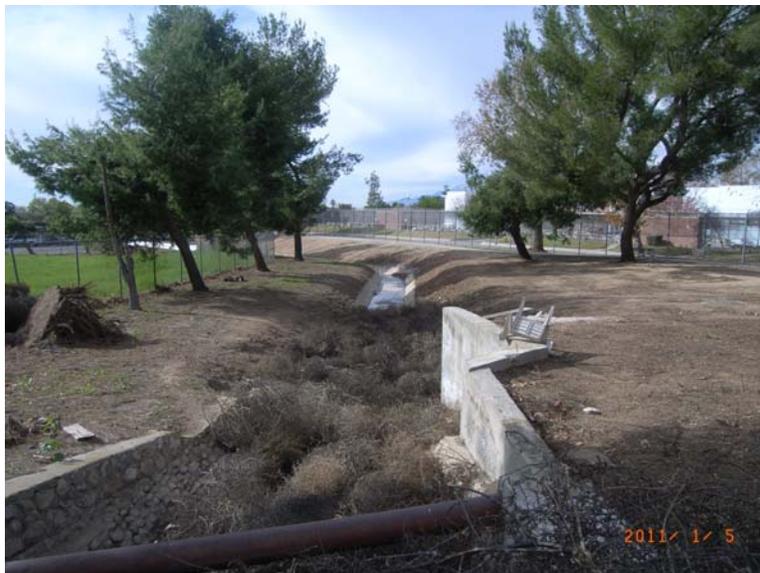
Site No. 15: Baldrige Channel Restoration Site is located at the North Orange Street crossing in the City of San Bernardino. Two sections of the channel were assessed: the downstream EHM channel that conveys water through the upstream non-EHM (Figure 1) and the jail (Figure 2). The downstream section is a trapezoidal earthen channel with a riprap-lined invert for low flow. There is plenty of room to lower the side slopes. Upstream of North Orange Street is approximately 250 feet of non-EHM channel. The channel is showing signs of toe and bank erosion due to the poor condition of the bank protection and has room to the east for widening.

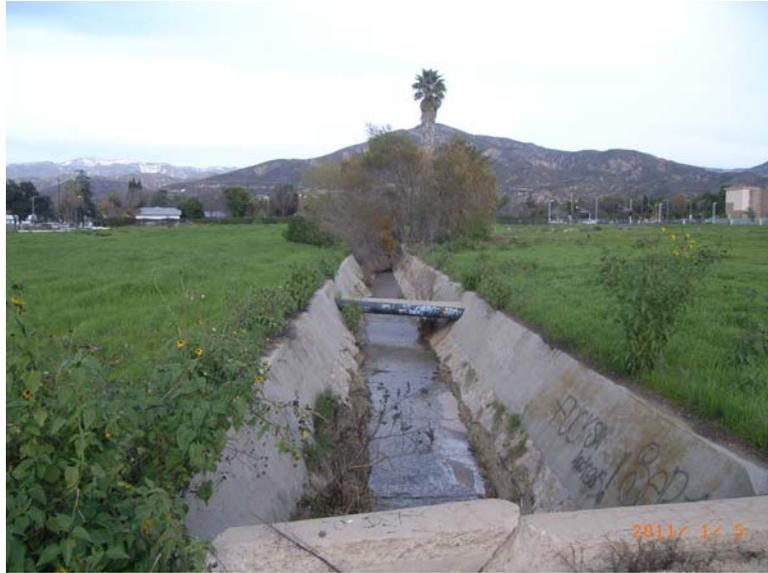
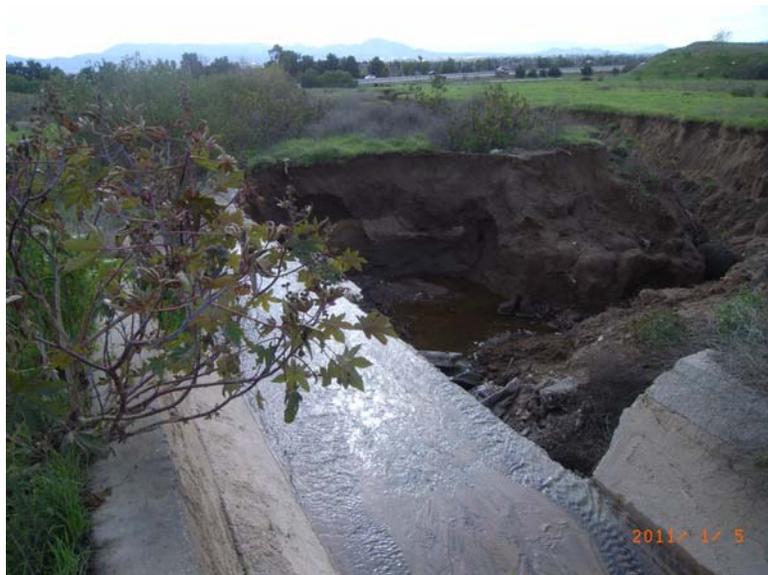
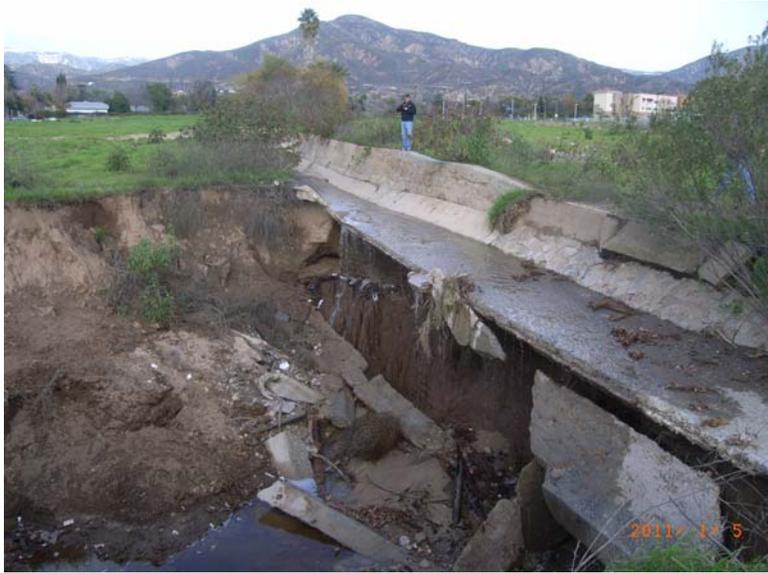
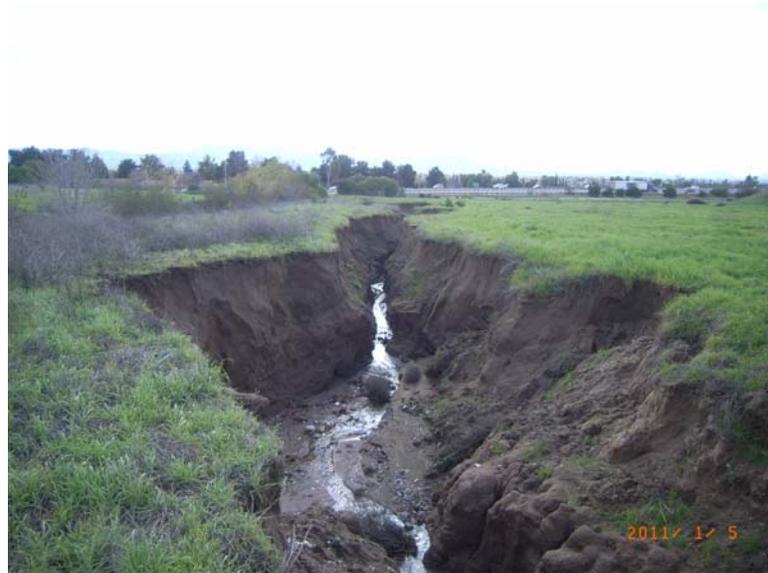
Site No. 16: Baldrige Channel Restoration Site is located between E. Highland Avenue and Highway 210 in the City of San Bernardino. (Figure 31). This section of the channel is classified as EHM due to the concrete lining. The majority of the channel is in fair condition, but a portion has failed and allowed a large scour channel to manifest to the west of the concrete channel. (Figure 32) The scour channel is approximately 15 feet deep. There is ample room to widen the channel.

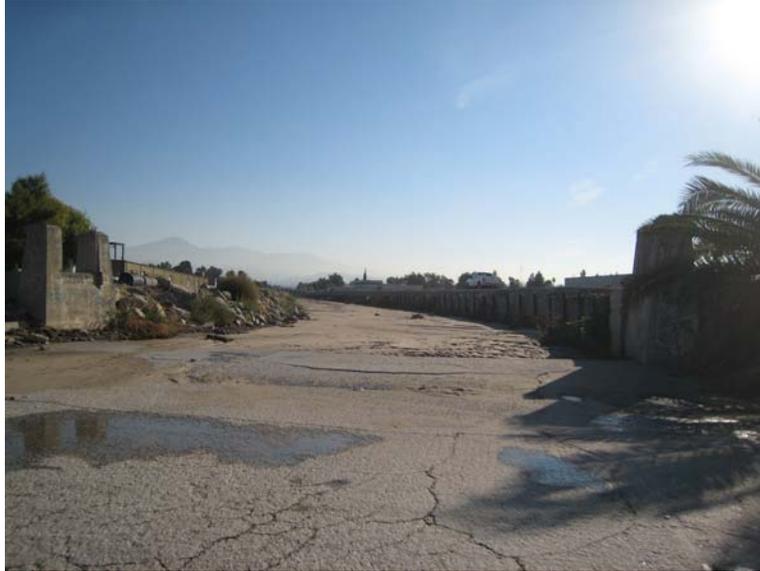
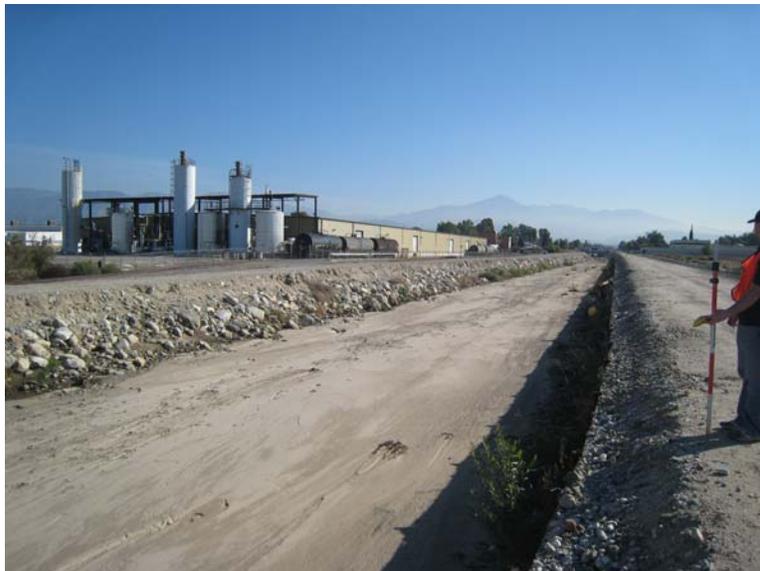
Site No. 17: Mission Channel Restoration Site is located at Tippecanoe Avenue crossing and extends west for approximately 1550 feet in the City of San Bernardino. This section of the channel is classified as EHM with corrugated metal piles on the southern bank and river rock on the northern bank. The corrugated metal piles are deteriorating and there is bank erosion. The channel invert shows signs of aggradation due to the downstream drop structure. There is room to widen the channel to the south. The stretch of channel upstream of Tippecanoe Avenue is in the same condition, but it has significantly less room to expand.

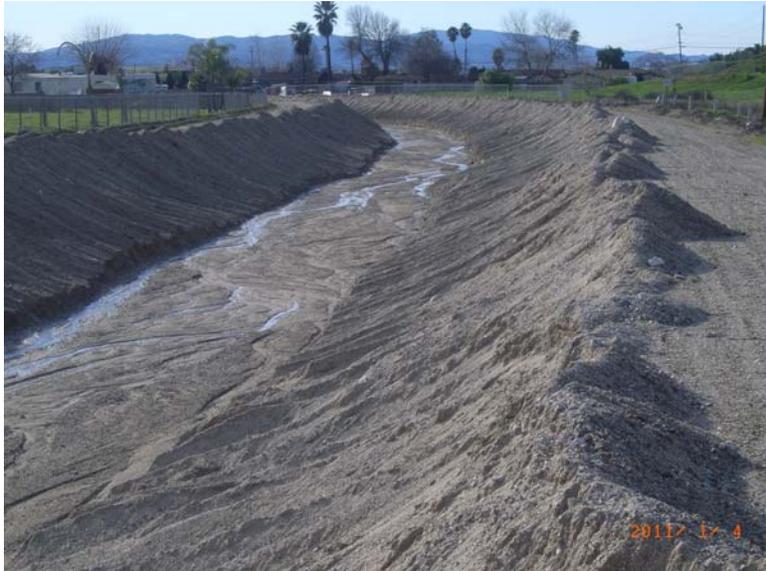
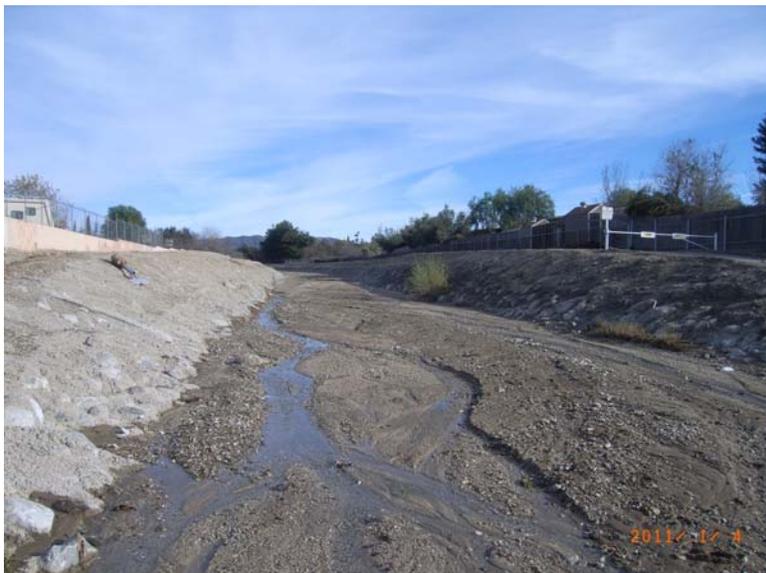
Site No. 18: Wildwood Creek Restoration Site is between Interstate 10 and 1300 feet east of Bryant Street in the City of Yucaipa. This section of the channel is classified as EHM and is a trapezoidal earthen channel. The channel had recently been maintained at the time of the site visit but there were signs that toe and bank erosion had occurred. Upstream of 6th Place, sections of the channel have grouted rip rap bank protection that is in good condition. The majority of the site has sufficient room to widen the channel.

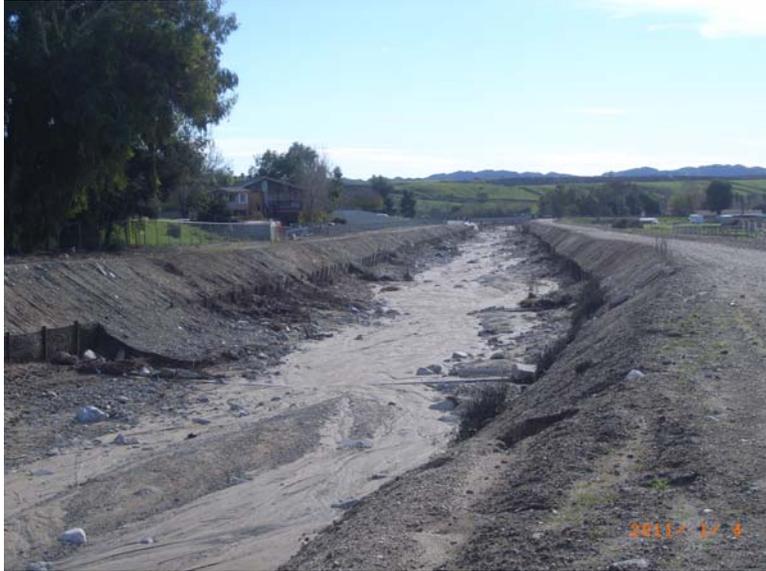
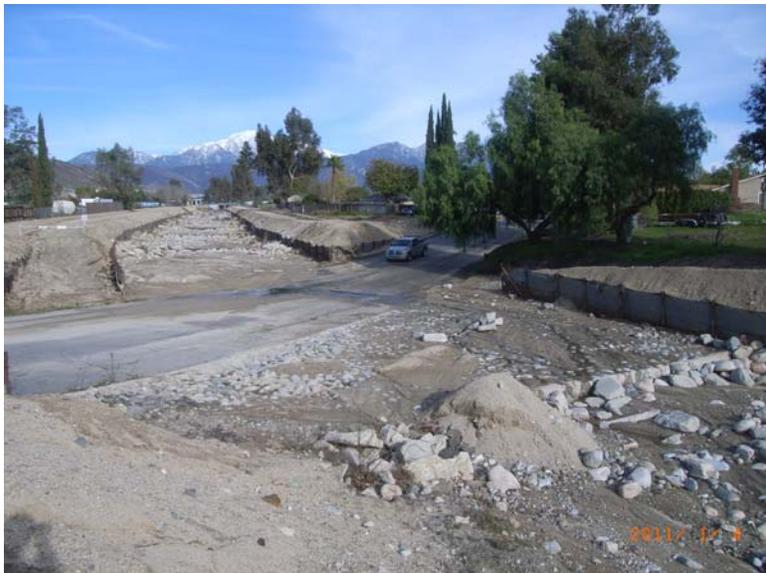
Site No. 19: Wilson Creek Restoration Site is located between 10th Street and Avenue E in the City of Yucaipa. This section of channel is classified as EHM and is an earthen, trapezoidal shaped earthen channel with corrugated metal piles protecting the banks. The corrugated metal piles are deteriorating, but significant erosion has not occurred to the toe or bank of the channel. The channel appears to be stabilized due to the drop structures located every 50 feet along the invert. The majority of the site has sufficient room to widen, but most areas seem to be privately owned and, in some stretches, the access roads would require modification.

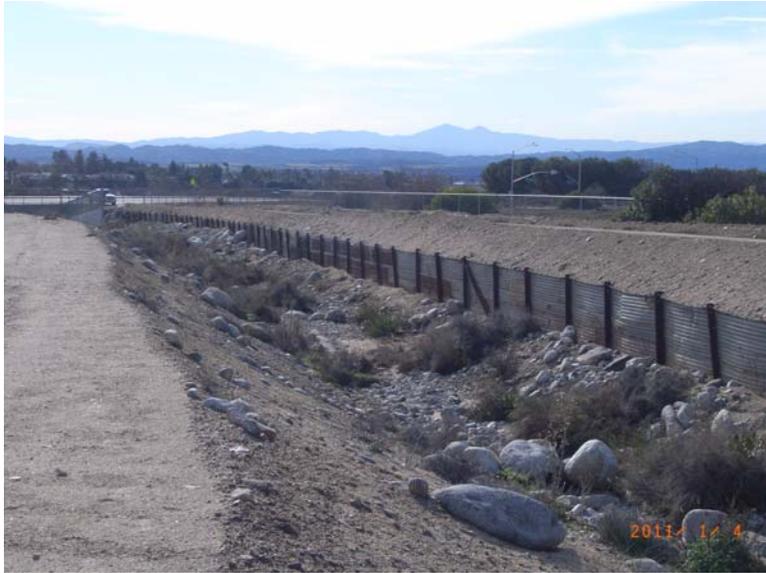
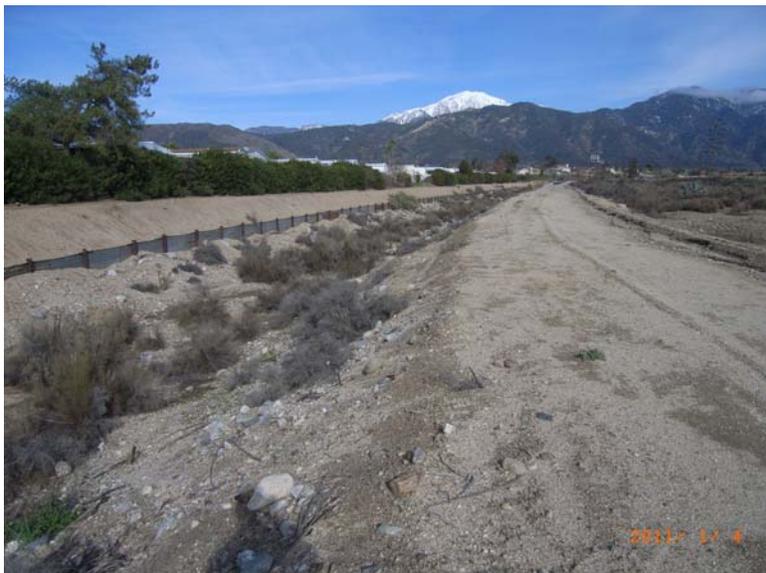
Site No. 20: Wilson Creek Restoration Site is located between Bryant Street and Oak Glen Road in the City of Yucaipa. This section of the channel is classified as EHM and is an earthen trapezoidal shaped channel with corrugated metal piles protecting the west bank and river rock protecting the invert and east bank. This site has non-EHM sections of channel up- and downstream. The channel shows signs of bank erosion and invert degradation. There is sufficient room to widen the channel to the east.
