Los Padres National Forest Road Repair Project

Figure 1:
Project Location Map

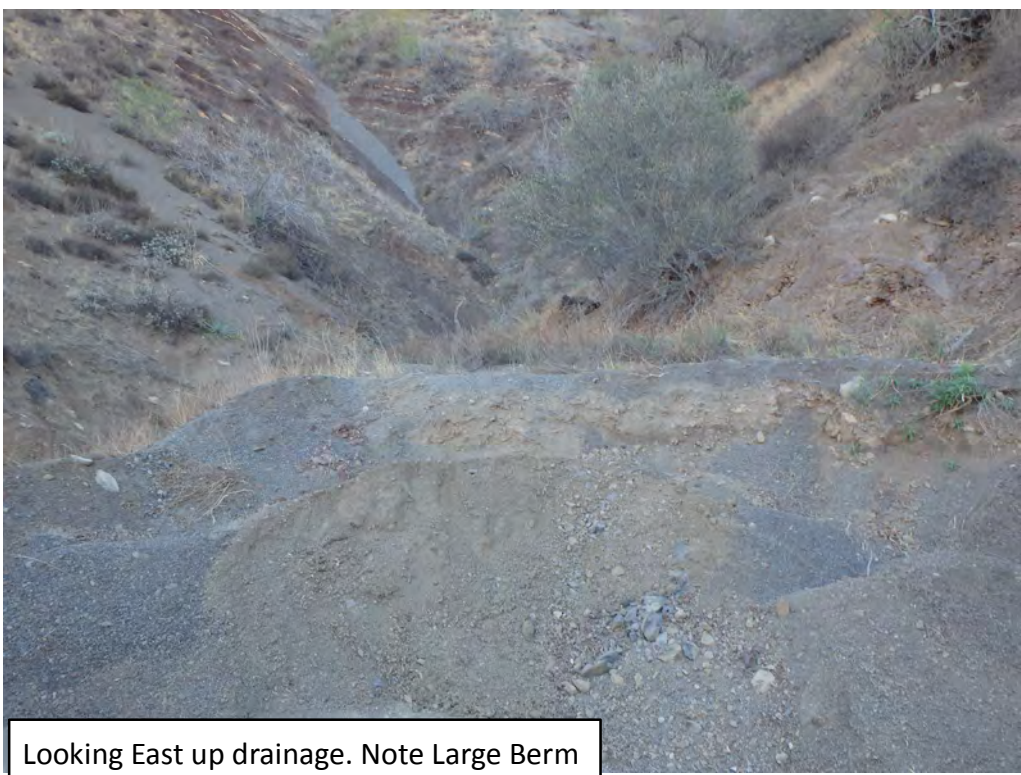
Looking East up drainage. Note Large Berm

Site 6N16 – 2.6 is located on an ephemeral drainage of Fourfork Creek, which is a tributary of Little Sespe Creek. Fourfork Creek was dry at the time of the 31 October 2011 site visit, but it was evident that high flows occur during large storms due to the amount of scour and sediment deposition. The culvert under Squaw Flat Road was plugged with debris. The stream channel is mostly devoid of vegetation, and has a few scattered mulefat shrubs and coastal scrub upland habitat.

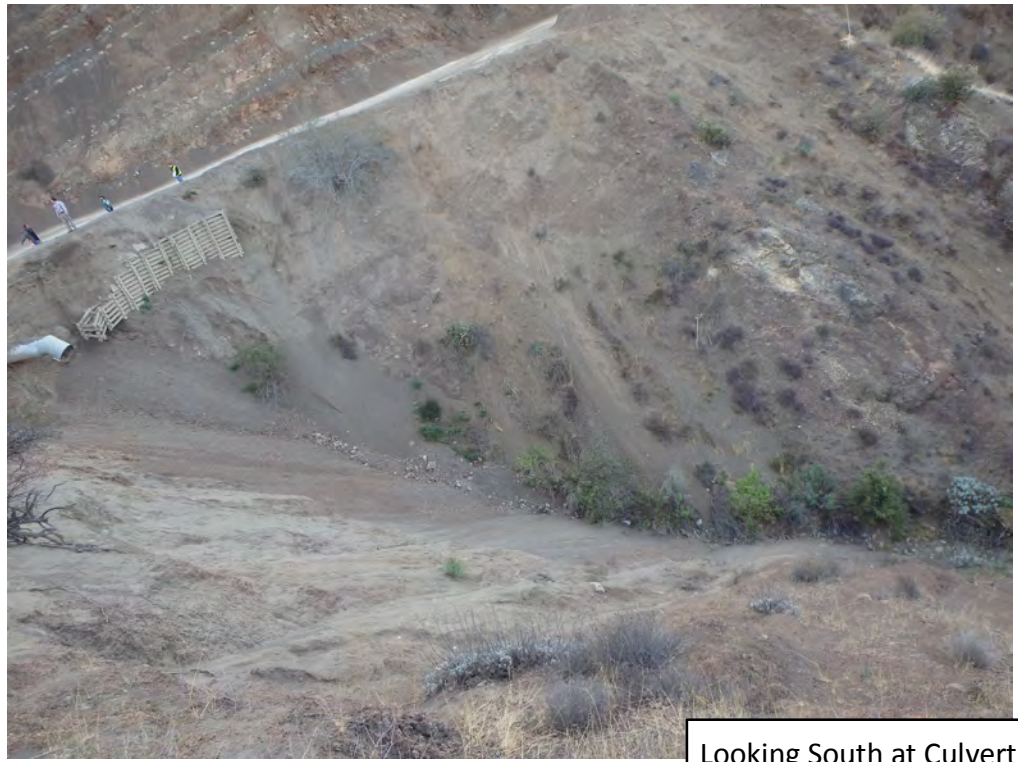
Looking South at Culvert

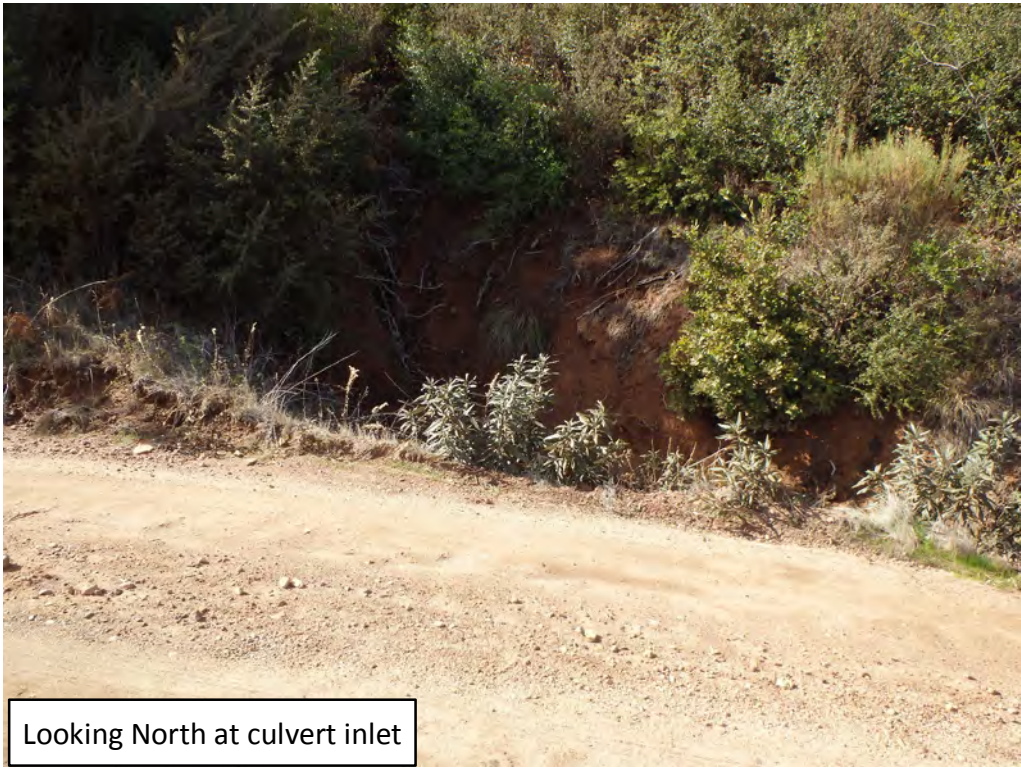
Looking North at culvert inlet

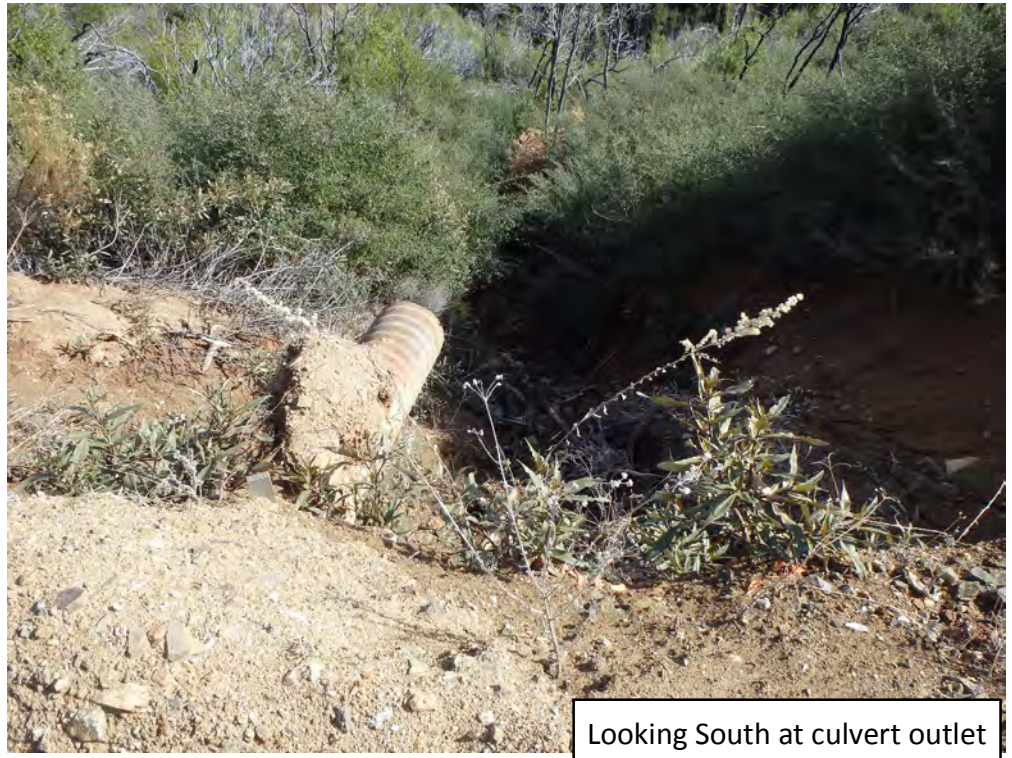
Looking South at culvert outlet

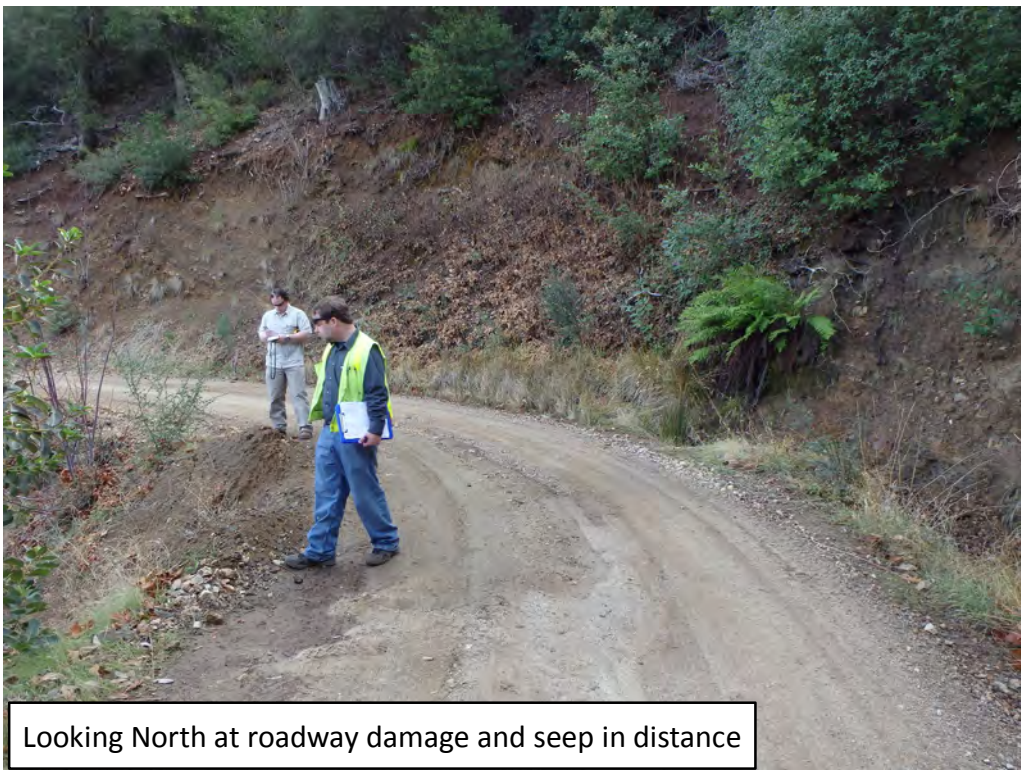
Looking North at roadway damage and seep in distance

Site 20S05.3 – 1.7 has a seep on the hillside that drips into a small pool on the side of the road that is a few inches deep. Wetland plants are located around the seep. The other sites are entirely in upland habitats.

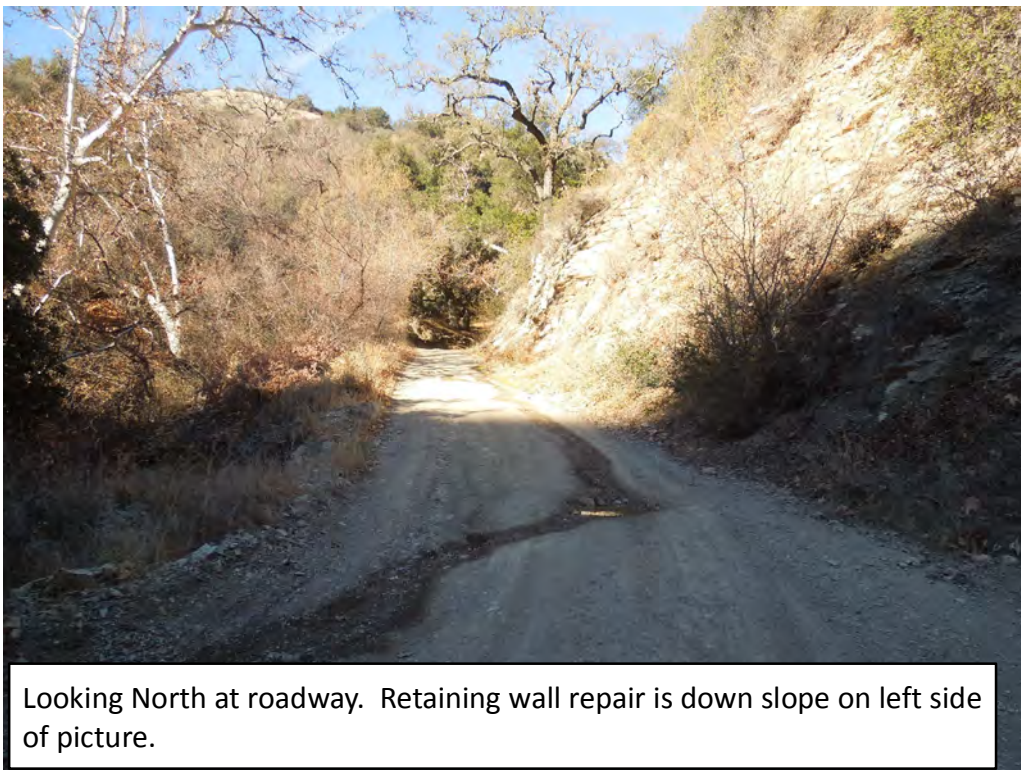
Looking North at roadway. Retaining wall repair is down slope on left side of picture.

Site 11N04.4-3.1 includes a work area of approximately 772 linear feet, and encompasses one culvert on Colson Canyon, a culvert on a tributary, and a retaining wall on a tributary at the confluence of Colson Canyon. The work area is within riparian habitat with the exception of the inlet side of the uppermost culvert, which is in a disturbed grassland that is used for recreational target shooting. There is a seep that surfaces along the edge of the road and runs down the road, entering the canyon at the location of the proposed retaining wall. The stream is perennial within the work area during most years, but dries up in the summer both up- and downstream from this area. The project site was visited on 18 October 2011, which was during an extended dry period, and water was present in the mainstem. Pools on either end of the lowermost culvert had water depth in excess of 1 foot, and there was dense cover by cattails, overhanging willows and other herbaceous vegetation. The two tributaries within the work area are ephemeral.

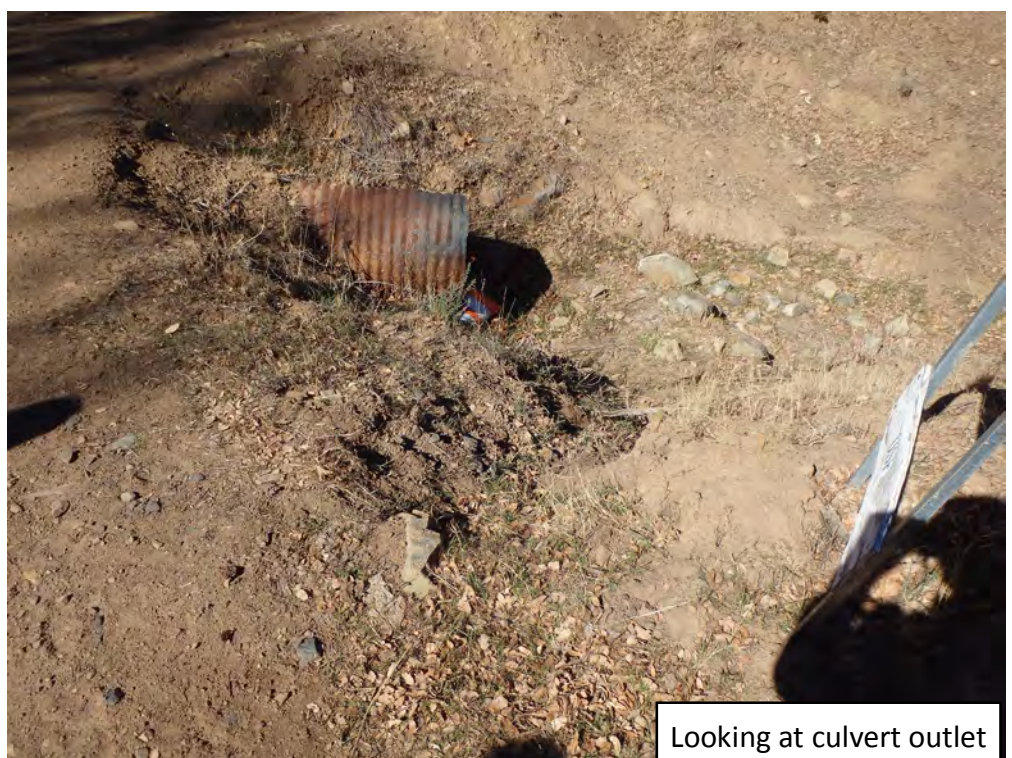
Looking at culvert outlet

Notes:
 Site 11N03 – 3.7 is at a crossing of an intermittent stream that has been channeled into a culvert. It is an unnamed tributary of Kerry Canyon. During the November 2011 site reconnaissance survey, water was standing in shallow pools. Mulefat, willow, and dried algae were present in the drainage bottom, and the surrounding habitat was mixed oak woodland. Cattle grazing has resulted in eroded stream banks.

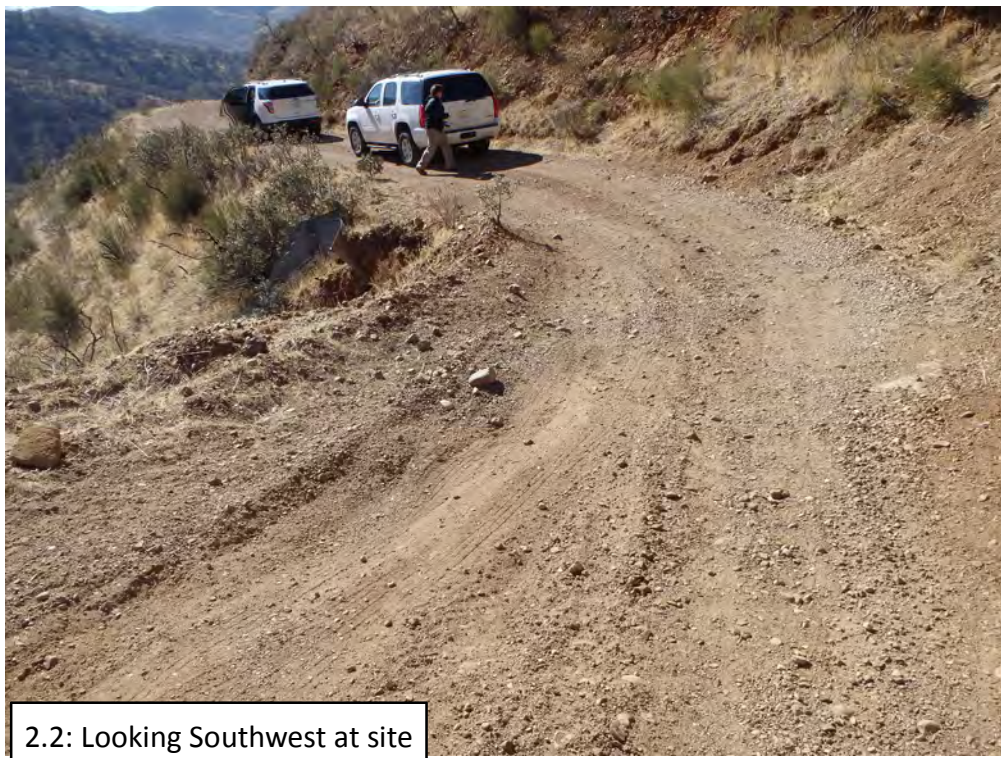
2.2: Looking Southwest at site

Site 11N03 – 2.2 had an overside drain installed into the berm, but it was not in line with the drainage crossing. Two small, dry drainages empty onto the road surface and it appeared that runoff flows down the road 30 to 40 feet before exiting through the overside drain that had washed out. On the upstream side of the road, the drainages are vegetated by upland species, consisting of non-native grassland and small burned shrubs. On the downstream side of the road, the drainage has western sycamore and mulefat and scour marks from prior water flows.

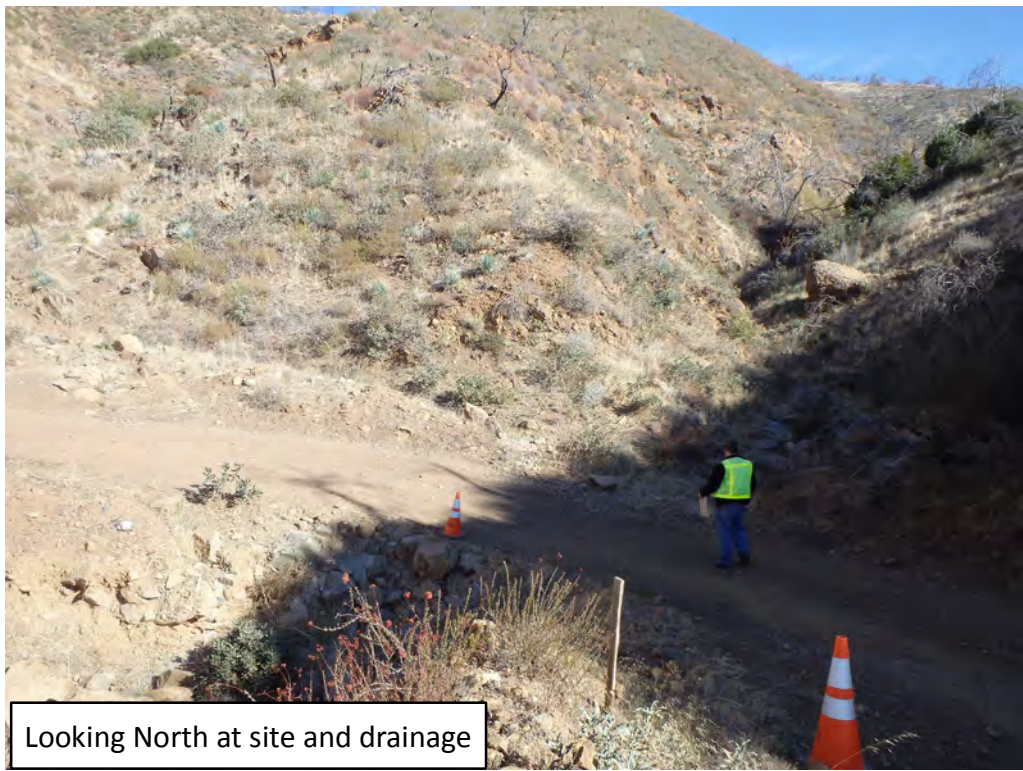
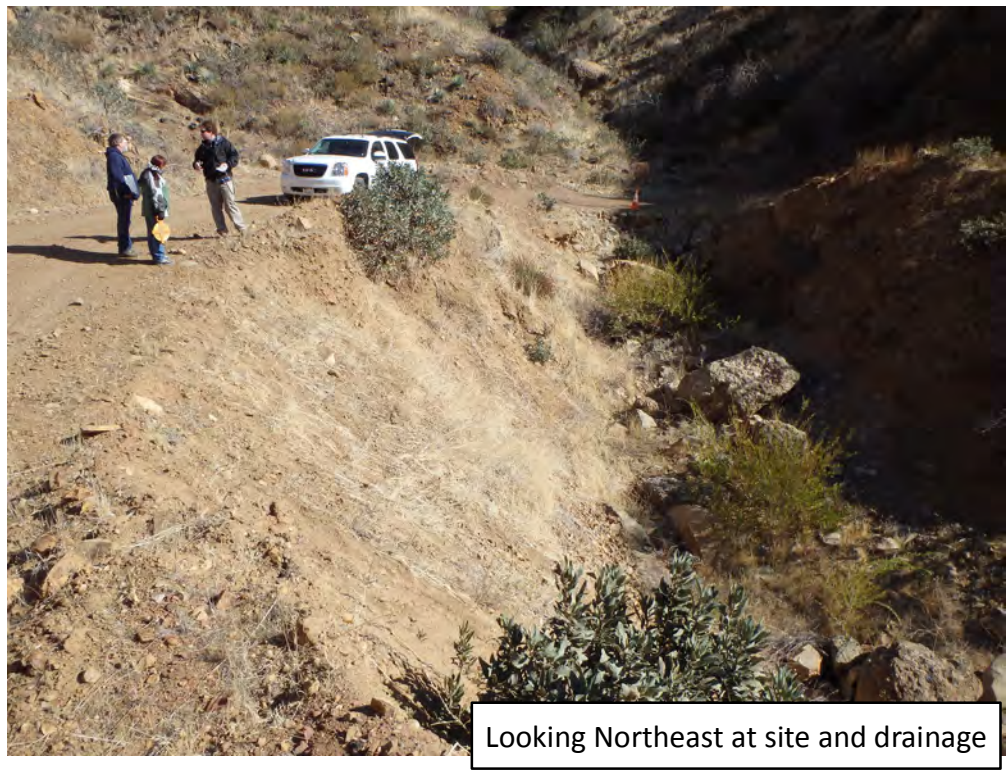
Looking North at site and drainage

Looking Northeast at site and drainage

Site 11N03 – 1.4 is a crossing of upper Kerry Canyon. The flows cross the road, and native rock from the stream was used to armor the road surface and create rip rap on the slopes. Two drainages meet on the road surface. During the November 2011 site visit, water was flowing in the larger drainage just upstream from the road, but it disappeared into fine sediments probably deposited after the fire and the Kerry Canyon on the downstream side was dry. Riparian and wetland plants were present on the upstream side, such as willows, western sycamore, seep spring monkeyflower, rabbitsfoot grass, curly dock, and dried algae. The downstream side had scattered large sycamores. Immediately downhill from the creek crossing is an area where the road fill is sliding into the stream channel. The slope was oversteepened, unvegetated, and comprised of loose soil. When the stream would be flowing, it appeared that there would be plunge pools but they would be less than 2 feet deep.

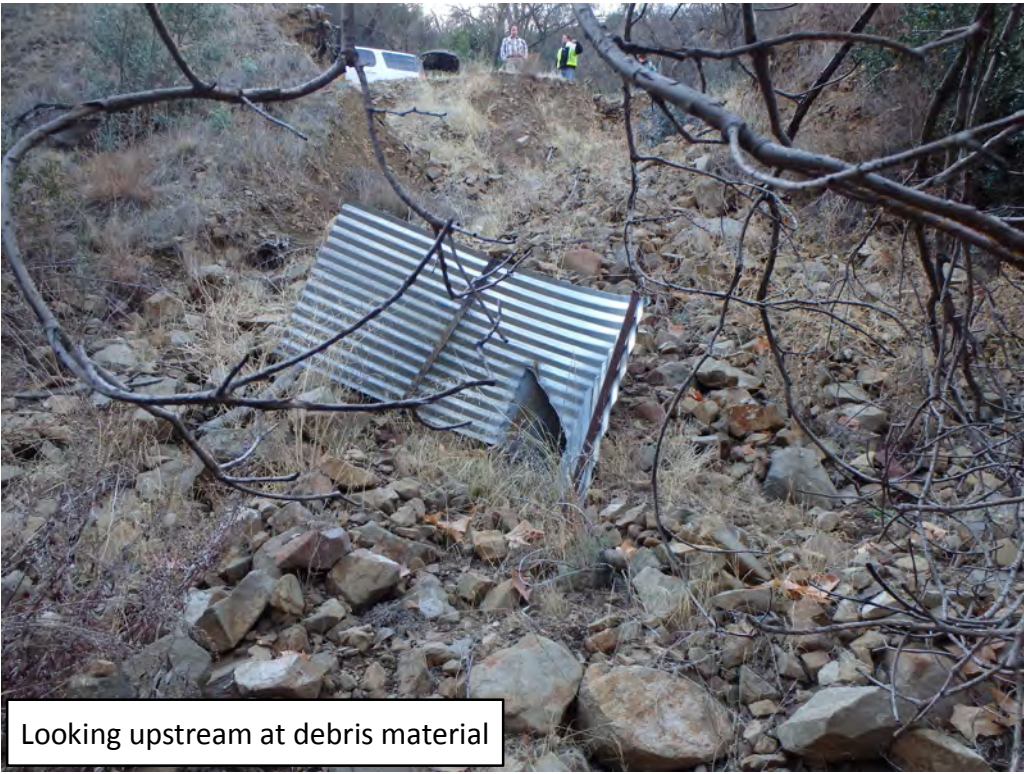
Looking upstream at debris material

Site 11N01 – 0.1 was on an ephemeral tributary to Bates Canyon. The channel was dry, rocky, and about 25 feet wide. The overstory trees were killed in the Zaca Fire, and the understory shrubs were regrowing. The vegetation consisted of California bay, live oak, and bigleaf maple.

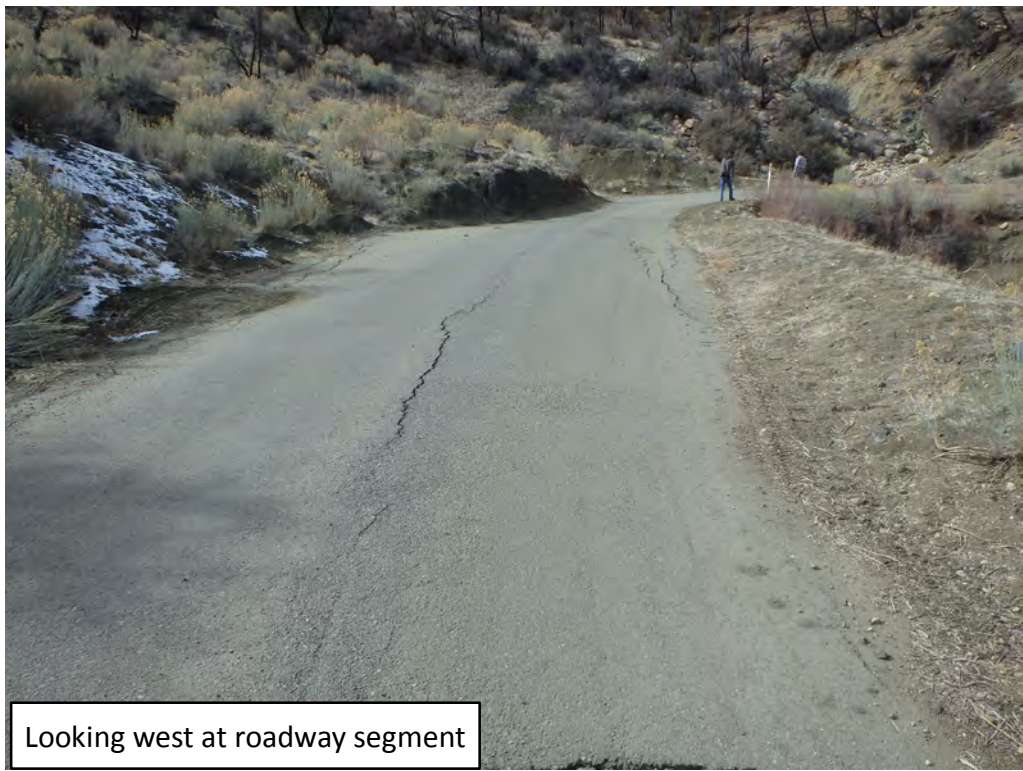
Looking west at roadway segment

At Site 7N03 – 1.1, an unnamed tributary to Lockwood Creek passes through Site 7N03 – 1.1, and is just downslope from Site 7N03 – 1.0. The soils are Lockwood Valley Clay, which is greenish in color and sparsely vegetated. The area burned in the 2006 Day Fire, killing many of the tall pine trees. The slide is vegetated by rabbitbrush and grasses. Pinyon pine and scrub oak were located nearby, and there were scattered small willows beside the stream channel. No water was present in the channel at the time of December 2011 and January 2013 site visits. The substrate in the streambed was rock and cobble, and the slope was relatively high and lacked pools.

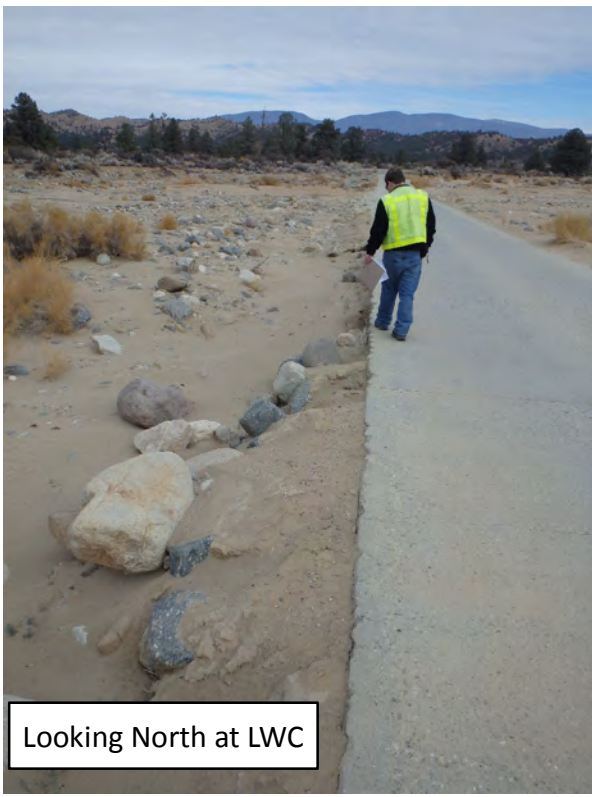
Looking North at LWC

Site 7N11 – 0.2: This site is in the MPRD, Ventura County, in the uppermost reach of the Cuyama River in an area known as Ozena. The site is located 1.2 miles upstream from the confluence with Reyes Creek. Reyes Creek Road is paved and provides access to the privately owned Camp Sheideck and Reyes Creek Bar and Grill, as well as Reyes Creek Campground and forest service hiking trails. The river flows only during and for a short time following storms. The riverbed is sand/silt with rocks, and is vegetated only by scattered rabbitbrush. The area in which the work will be done is in an alternate channel separated from the low-flow channel. The habitat surrounding the river channel is chaparral.

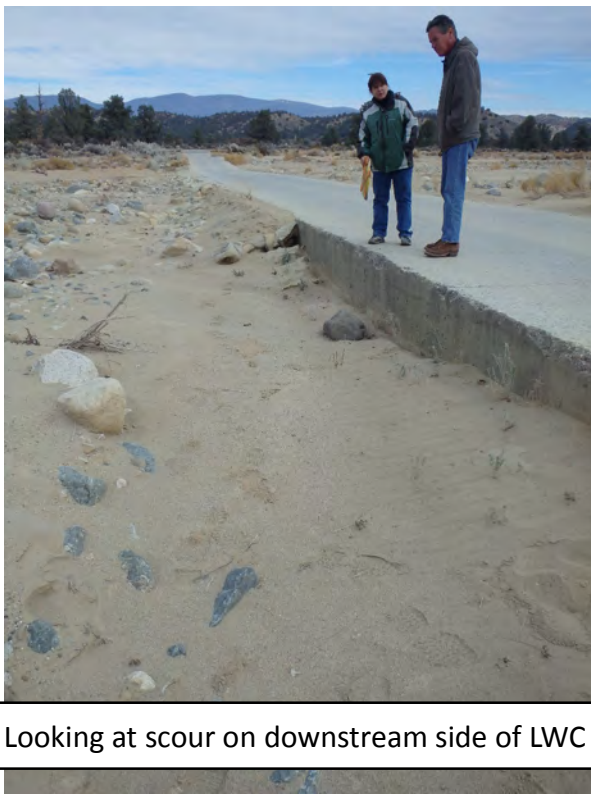
Looking at scour on downstream side of LWC

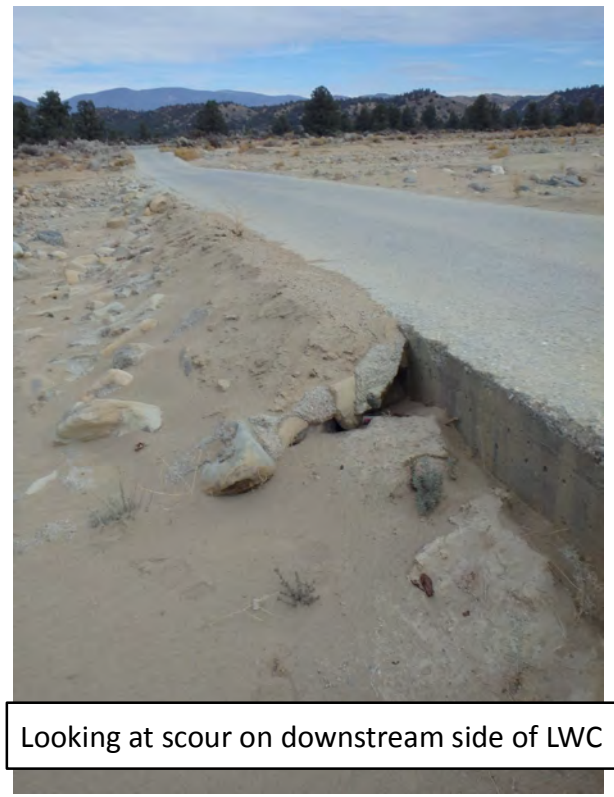
Looking at scour on downstream side of LWC

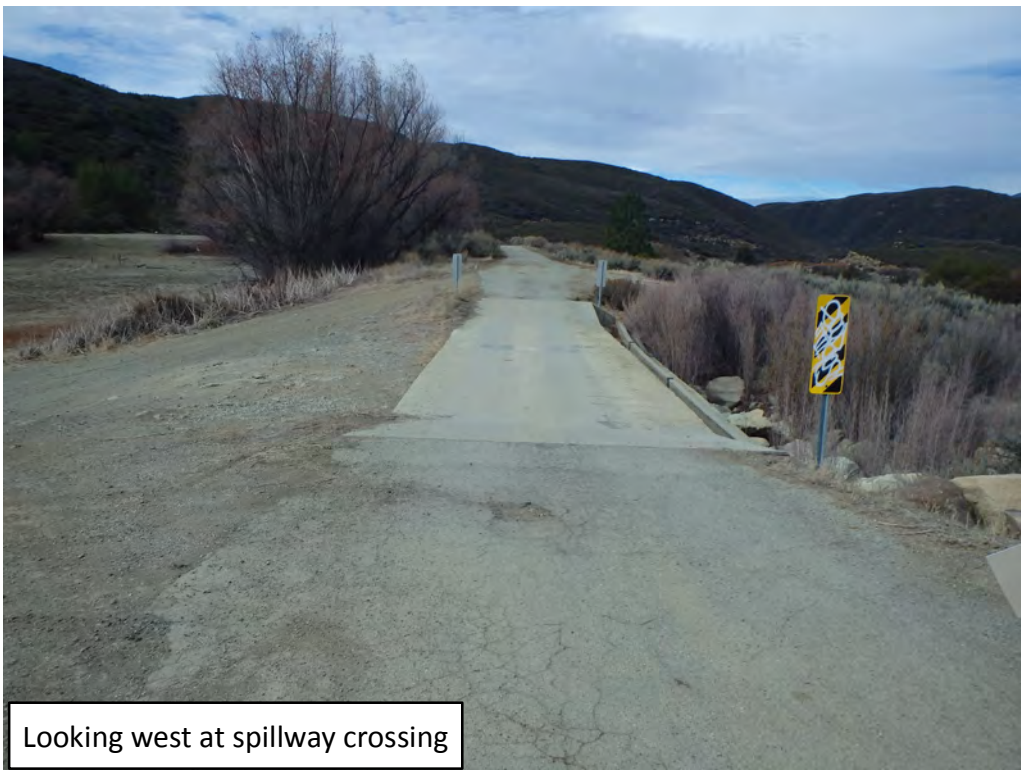
Looking west at spillway crossing

Site 6N31F – 0.2 is located on Lower Rose Valley Lake. The project area is a concrete spillway at the outlet side of the lake that also serves as a low water road crossing. The lake has a few areas with bare shore that are used for recreation, and most of the perimeter is vegetated by bulrushes, cattails, and willows. Submergent vegetation and algae fill most of the lake, especially during times of low water. Rose Valley Creek dries up during the summer of most years both up- and downstream of the lake. In the channel downstream of the project site, the substrate is rocky and there is sparse cover by riparian shrubs such as mulefat.

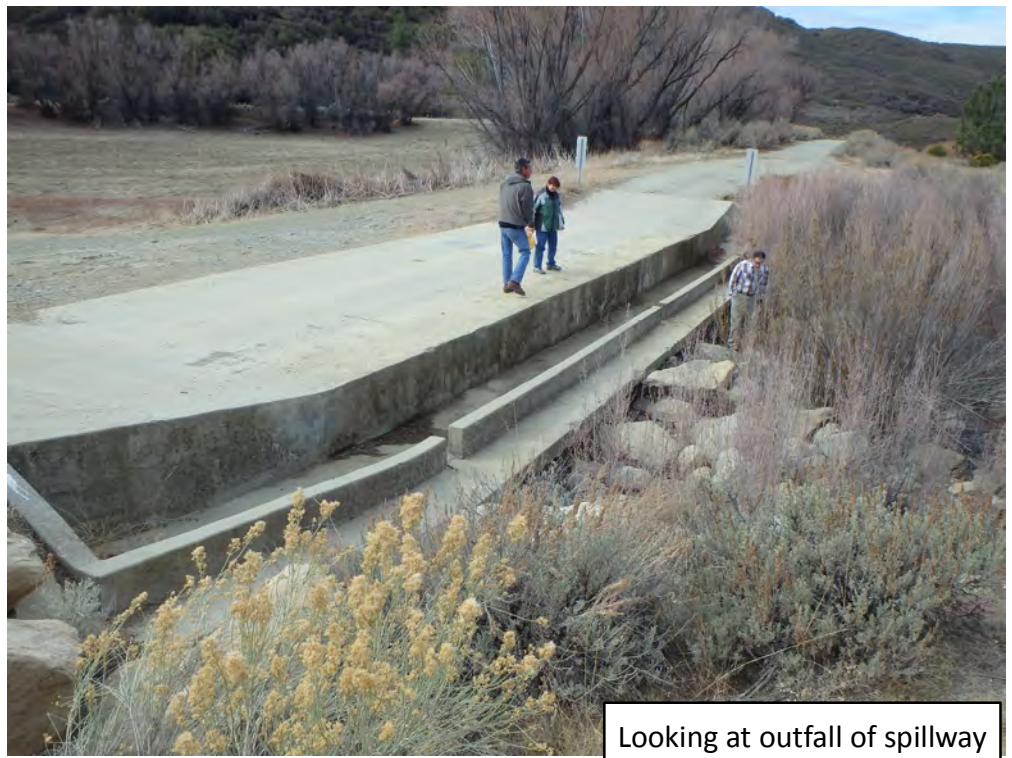
Looking at outfall of spillway

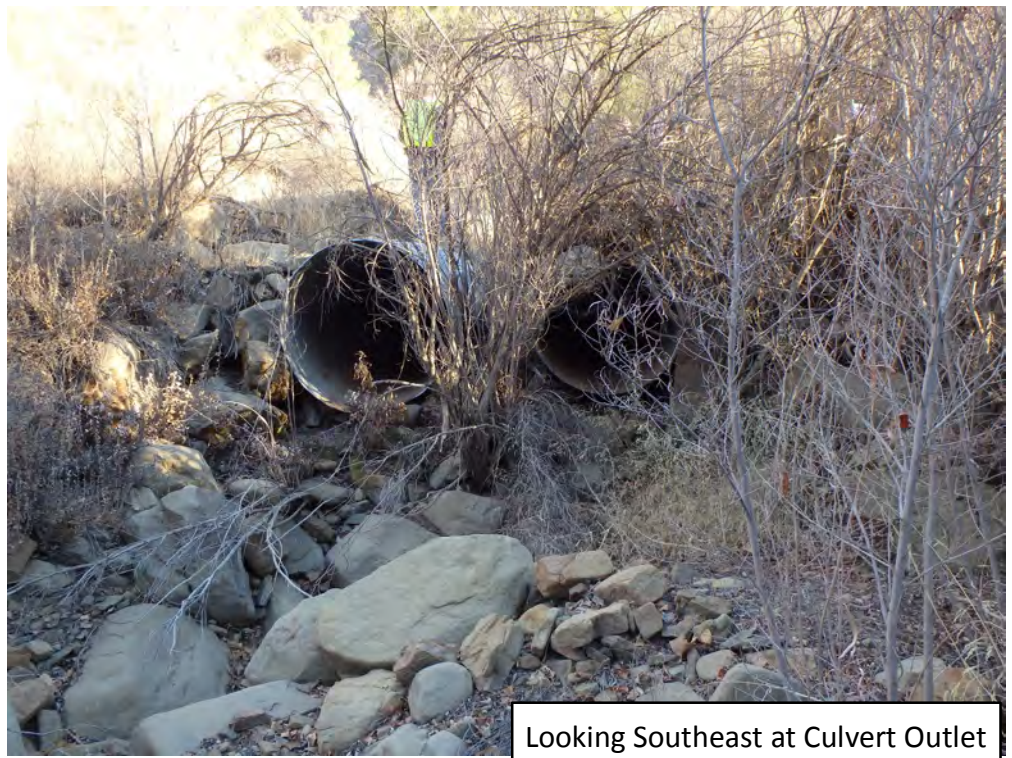
Looking Southeast at Culvert Outlet

Site 5N16 – 1.2 consists of a culvert on an ephemeral tributary in which the outfall end of the culverts lies within the Agua Caliente Creek stream channel at the confluence of these two streams. Willows were present at the washed out end of the culvert, and thus the work would be conducted within the riparian habitat.

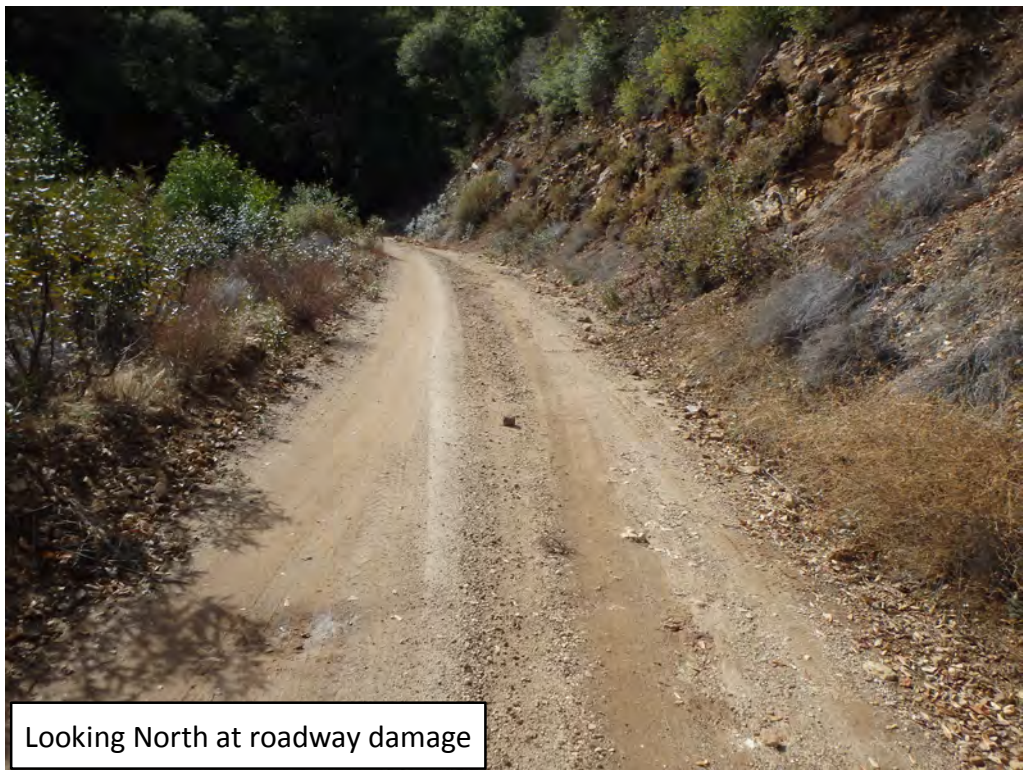
Looking North at roadway damage

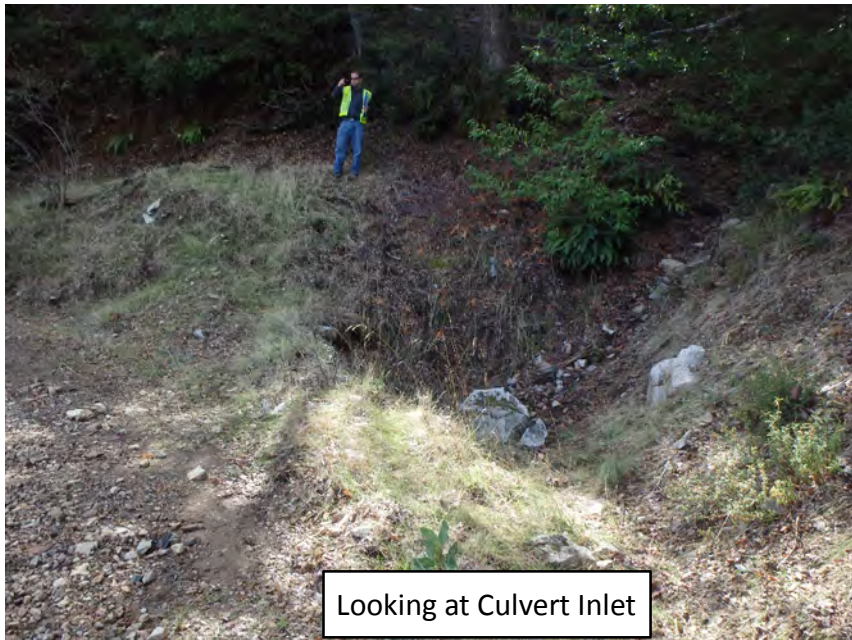
Looking at Culvert Inlet

This culvert crosses a potential tributary* to a water of the U.S. in work area.

The NWI show a PSS wetland at this area but photos of site don't appear to show wetland vegetation in this area.
