### **Written Testimony and Expert Report of Martha McDonnell (Exhibit Allegra-3)**

**DECLARATION OF MARTHA  
MCDONNELL IN SUPPORT OF  
PLAINTIFFS' MOTION FOR  
PRELIMINARY INJUNCTION**

18 August, 2003  
Project No. 03286

Subject: **7884 JON WAY**  
Granite Bay, California  
*GEOTECHNICAL RECONNAISSANCE RELATED TO SUBSURFACE WATER  
CONDITIONS*

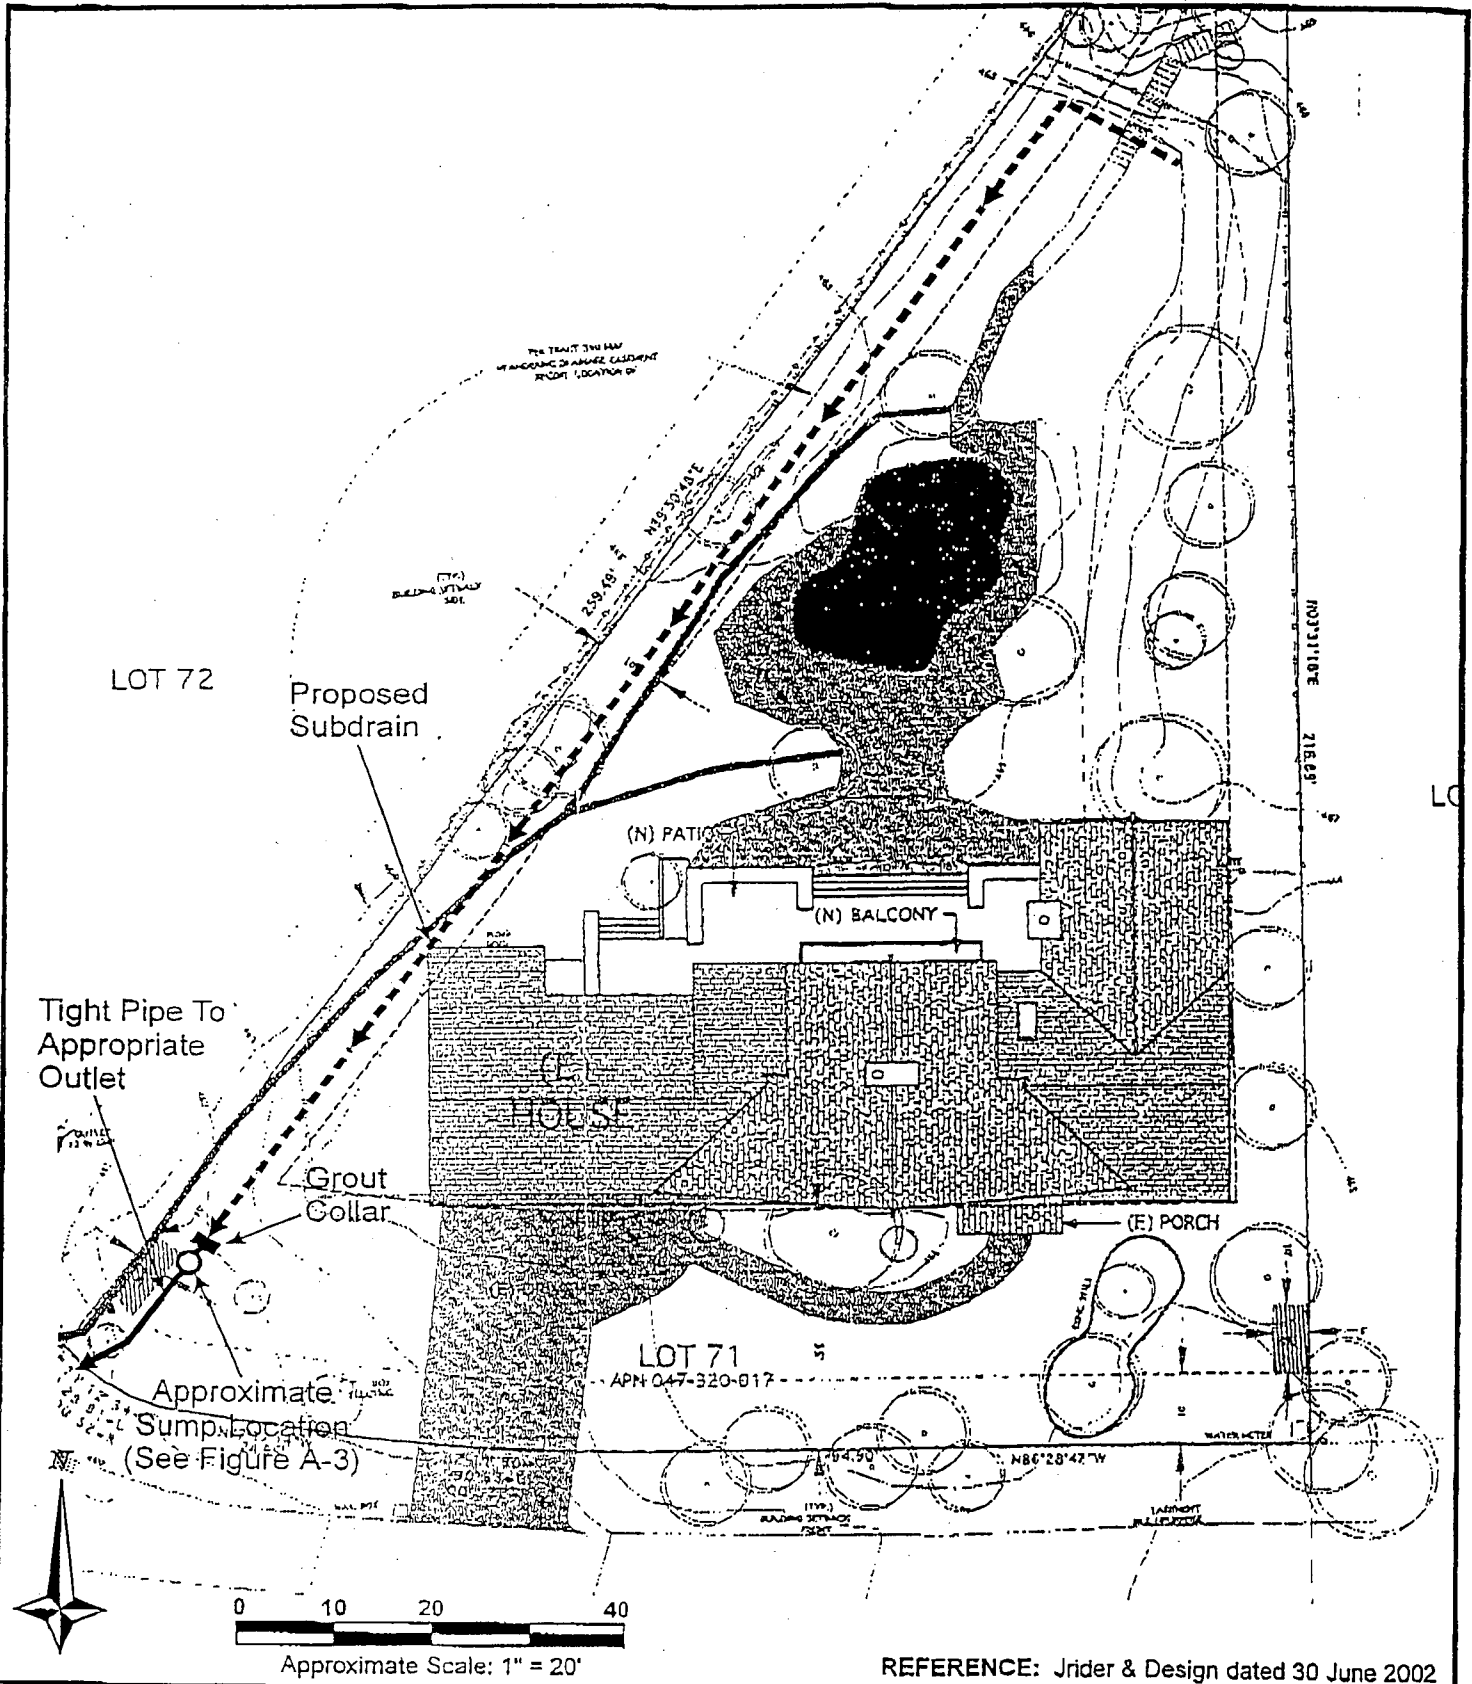
FIGURE  
 A-1

Based on the results of our research and observations, it is our professional opinion that the primary source of the water observed is seepage from the adjacent lake. Our rough measurements of groundwater levels within the exploration points show a hydraulic gradient to the north indicating that the lake is the source of the subsurface water. We suspect that seepage is occurring both through the bottom of the lake and through the toe of the embankment; an additional source of seepage appears to be the former drainage swale present between Lots 25 and 26 (aka Lots 71 & 72). The CMP outlet daylights on the adjacent property Lot 26 (aka Lot 72) near the toe of the embankment; the pipe does not include seepage cutoff collars (typically used to reduce seepage flow) and does not outlet into closed storm drain system. The former drainage swale intended to convey water toward the front of the lots appears to have been partially backfilled. Given the absence of a cutoff trench at the toe, water from the lake is likely continuing to flow through trench backfill and into the former drainage swale.

For immediate relief purposes, we recommend that a new subdrain be installed along the south and east property line to intercept subsurface water flow as shown on Figure 1. The drain should be deepened into bedrock materials a minimum depth of 1 foot to intercept water which may be perched along the soil/bedrock contact. We recommend that the drain be designed as a gravity flow system which discharges into the drain inlet located at the Jon Drive/ Hidden Lakes Drive intersection. Given the elevation of the property and depth to water, a minimum pipe gradient of 0.5 percent should be maintained. A sump should be positioned near the outlet as a precaution should additional dewatering be required due to excess lake seepage, outflow and rainfall. The last 20 foot of the drain line should be a solid "tight" pipe with a grout collar positioned at the junction of the perforated and tight pipe to reduce the potential for water migrating from the line back to the home.
