Re: Credit Verification and Annual Monitoring and Reporting for Pepperwood Preserve Sediment Reduction Project SRNO-2H

Pepperwood Preserve Sediment Reduction Implementation Project
Appendix A- BMP Monitoring Field Sheets

Photos taken May 15, 2014

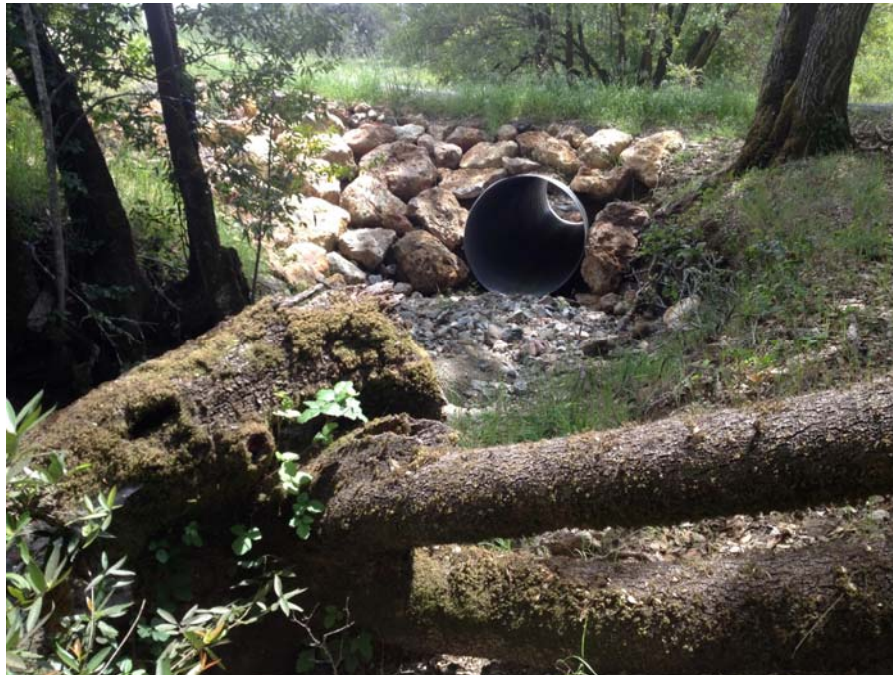
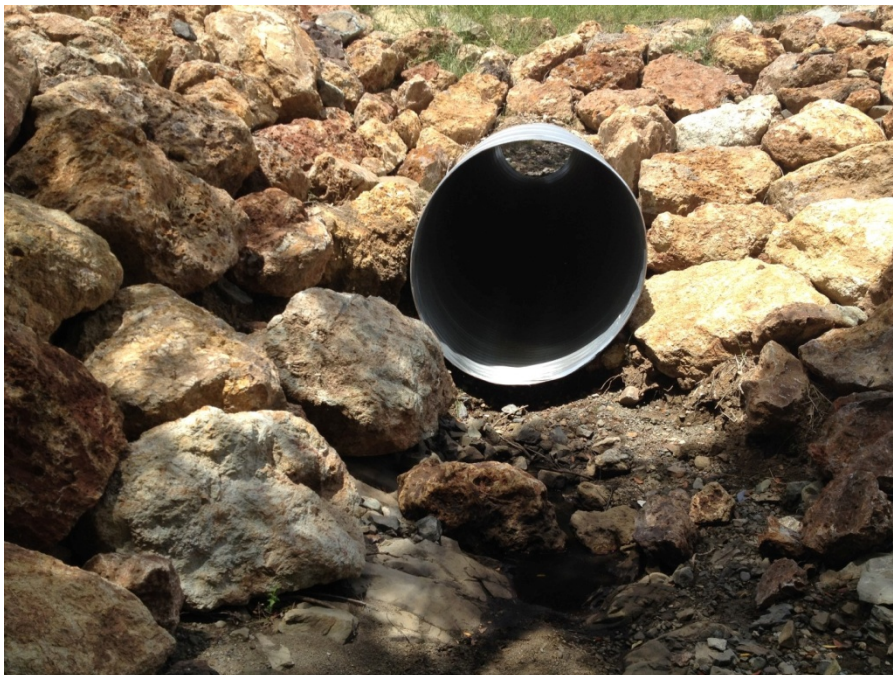
PWA Site #6 inlet

- All BMPs were found to be functional and properly maintained. Please note treatment areas to watch include the following:
 - Site 7.2: Landslide should be monitored for further movement.
 - Site 6: Rock armor on outlet of stream crossing should be monitored for further movement.
 - RD 26: Monitor rolling dip due to visible tire ruts.
 - RD 27: Monitor rolling dip due to visible tire ruts.
 - Site 33: Monitor road bed due to visible tire ruts.

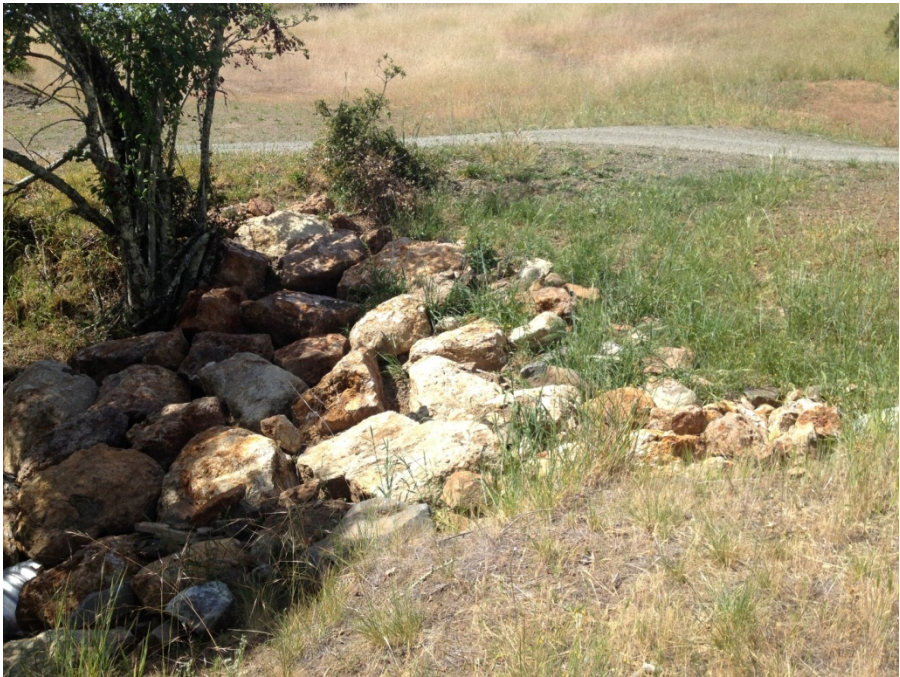
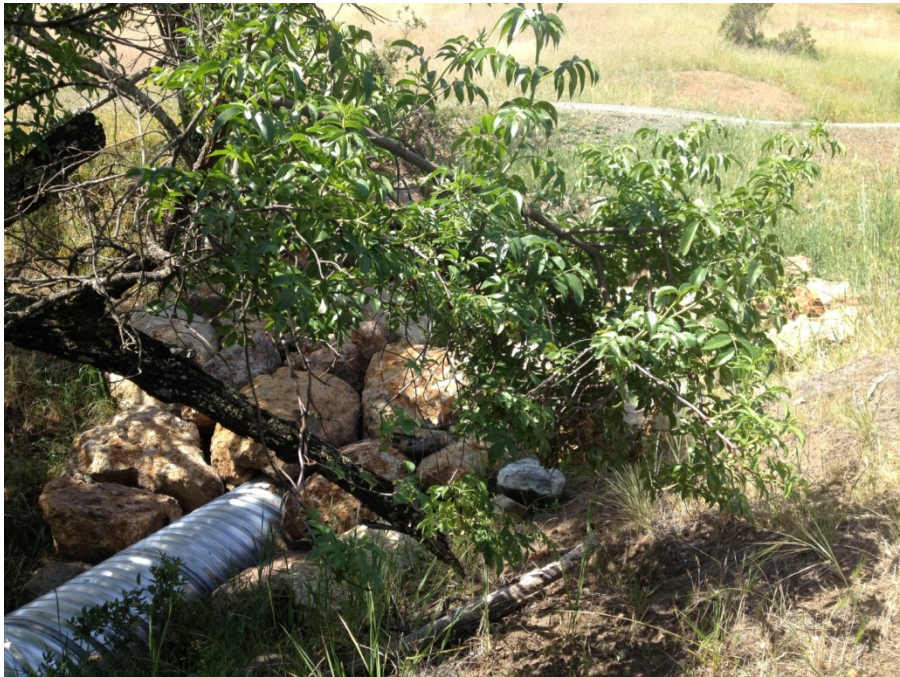
PWA Site #7

<i>Distance on road (feet)</i>	<i>PWA site#</i>	<i>Road treatment</i>	<i>Site / treatment description</i>	<i>Observations (Note any deficiencies)</i>	<i>Is BMP operating/maintained properly?</i>	<i>Photo taken? (Check box)</i>
25+30	7	CD 1	<p>Site 7: Stream crossing with 12" rusted and plugged culvert.</p> <ol style="list-style-type: none"> 1. Replaced with 24" x 60' long culvert at base of fill in natural channel alignment. 2. Transitioned existing stream channel above road into new lowered inlet and added 5 yd³ of 1'-2' rip rap at new grade change and inboard fillslope. 3. Installed 20 yd³ of 1'-3' riprap on outboard fillslope. 4. Installed a critical dip on right hingeline to eliminate diversion potential down road. 5. Re-rocked the road surface. 	24" Culvert in good condition and functioning well. Rock armor intact and functioning. Critical dip looks stable.	<input checked="" type="checkbox"/> Y <input type="checkbox"/> N	<input checked="" type="checkbox"/>

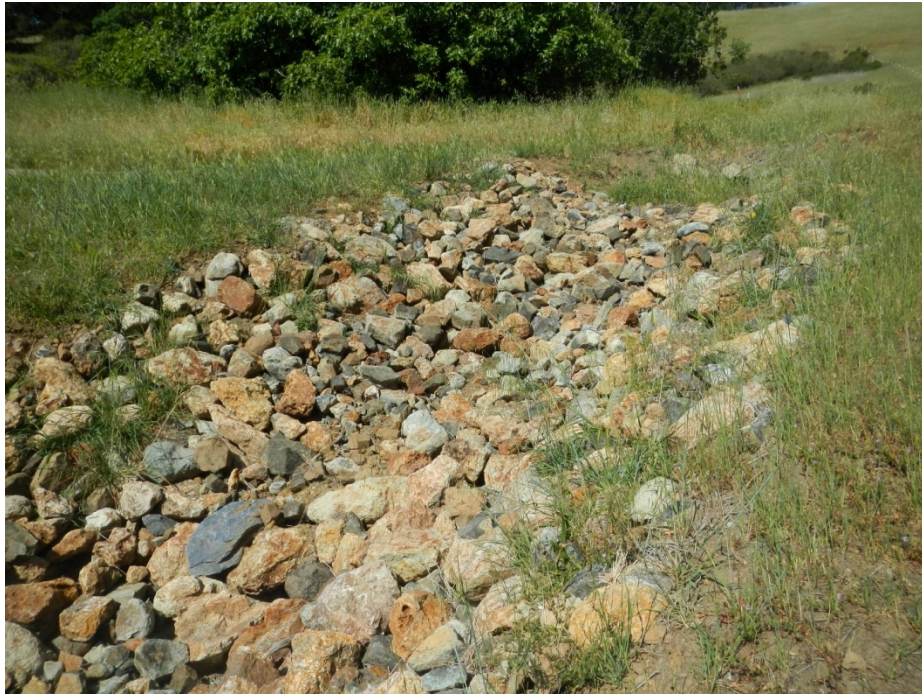
PWA Site # 7.1

21+20	7.1	GCS 1	<p>Site 7.1: Existing 12" ditch relief culvert draining springs with 5' active headcut ~15' below culvert.</p> <ol style="list-style-type: none"> 1. Installed a grade control structure at headcut using 20 yd³ of 0.5' -1.5' mixed riprap with u-shape. 2. Spoiled locally on hillslope and road. 	Grade control rock armor is still in place and functioning well. No erosion observed and 12" DRC still in good condition.	<input checked="" type="checkbox"/> Y <input type="checkbox"/> N	<input checked="" type="checkbox"/>
21+70		RD 52	<ol style="list-style-type: none"> 1. Installed a type 1 rolling dip. 2. Re-rocked the road surface. 	RD functioning well with no erosion	<input checked="" type="checkbox"/> Y <input type="checkbox"/> N	
23+80			Added 3 yd ³ of 1'-2' riprap to inlet area of existing 18" ditch relief culvert.	Rock armor intact and functioning well	<input checked="" type="checkbox"/> Y <input type="checkbox"/> N

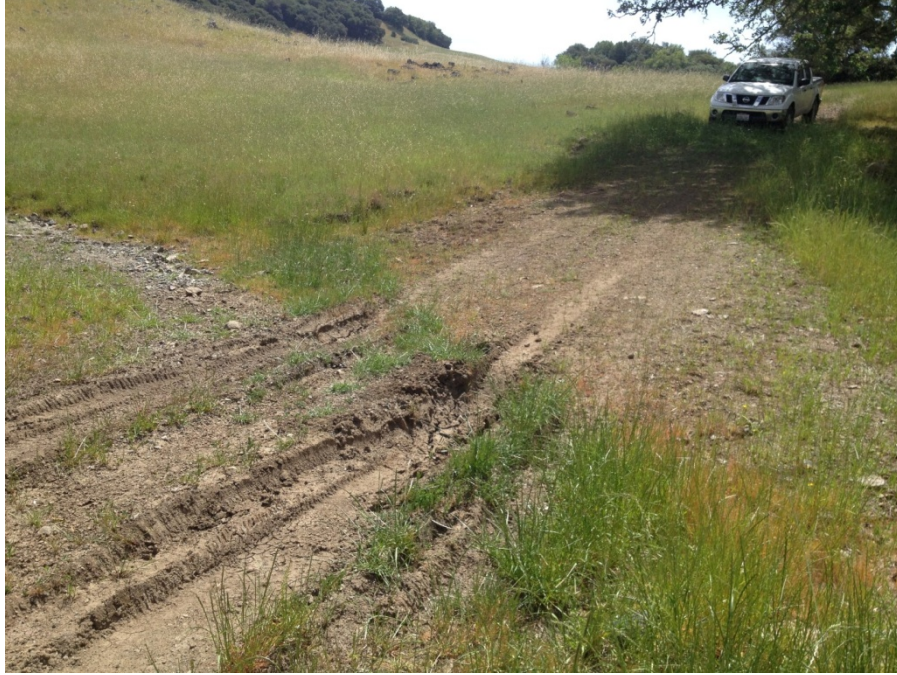
PWA Site # 33 – Tire ruts in road

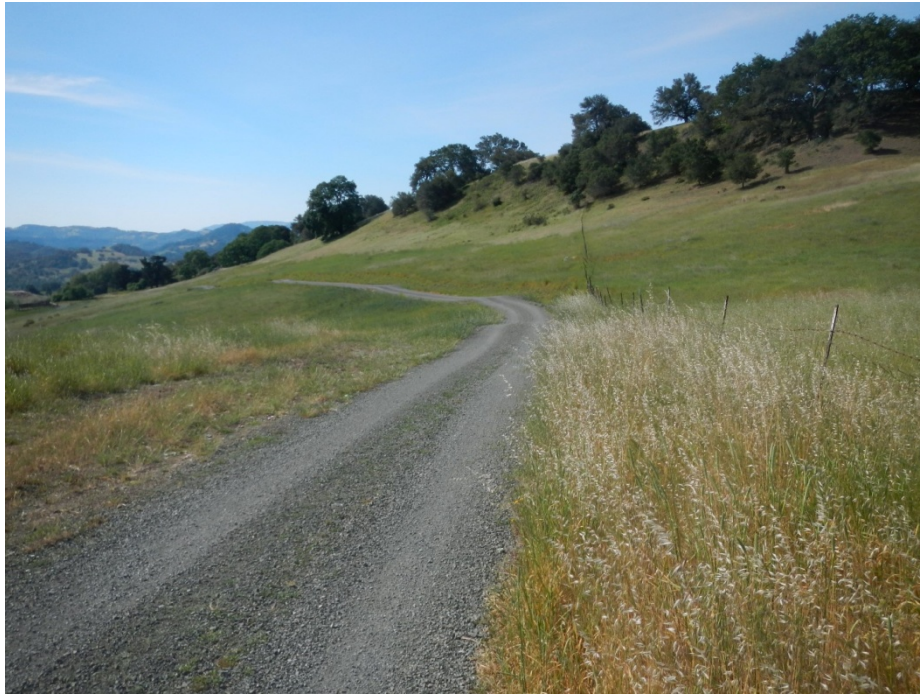
PWA # RD46

08+30		RD 46.1	1. Installed a type 1 rolling dip. 2. Re-rocked the road surface. 3. No treatments at existing 12" ditch relief culvert.	RD functioning well with no erosion, 12" DRC in good condition and functioning well	<input checked="" type="checkbox"/> Y <input type="checkbox"/> N	
09+50		RD 47	1. Installed a type 3 rolling dip. 2. Re-rocked the road surface.	RD functioning well with no erosion	<input checked="" type="checkbox"/> Y <input type="checkbox"/> N	
11+50		RD 48	1. Installed a type 3 rolling dip. 2. Re-rocked the road surface.	RD functioning well with no erosion	<input checked="" type="checkbox"/> Y <input type="checkbox"/> N
