California Regional Water Quality Control Board Central Coast Region

CALIFORNIA WATER CODE SECTION 13267 REQUEST FOR REPORT, HWY 58 AREA PROPERTY, SAN LUIS OBISPO COUNTY

NOTICE OF VIOLATION; STORM WATER PERMITTING REQUIREMENTS; KELEGIAN RANCH PROPERTY; SANTA MARGARITA; SAN LUIS OBISPO COUNTY

SUBJECT: Assessment of Sediment Conditions and Possible Impacts to Beneficial Uses from Sediment on the Kelegian and Pierson Properties

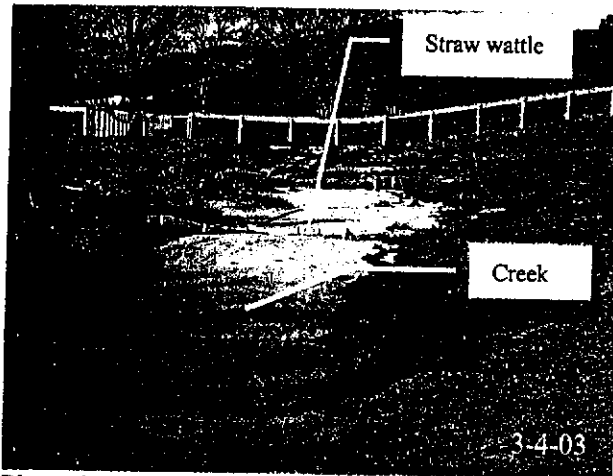
You have not installed straw wattles and enviroberm sediment controls as shown on the erosion control plan, or removed accumulated sediment from sediment control devices that are in place as outlined in your SWPPP. Sediment controls are ineffective once filled with sediment (Photo 3).

Photo 3 – Overwhelmed straw wattle in blue line creek.

You have failed to implement an effective combination of erosion and sediment control as required by the Permit, resulting in surface water sediment discharges. You are required to install effective erosion and sediment controls to protect area creeks immediately. You have failed to implement a SWPPP in compliance with Part C.2 of the Permit. You must submit an updated copy of your SWPPP, with an implementation schedule by March 21, 2003.

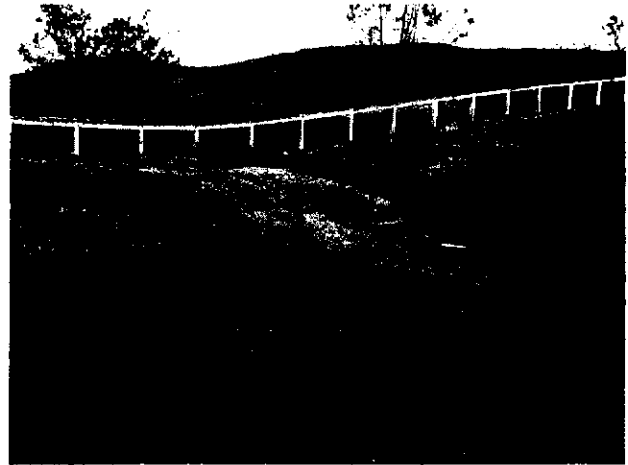
Widespread gully erosion resulted in sediment discharge into the unnamed tributary to the Huerhuero Creek (Photos 3, 4). Some sediment control measures were installed within the tributary creek. Hay bales and straw waddles installed across the directional flow of water are not BMPs. There was no erosion or sediment control on the cleared hillsides. Sediment and erosion controls should be in place to protect the creek. Installation of sediment controls within the creek trap the sediment in the water body itself, which is detrimental to the creek.

Photo 4 – Sediment overwhelmed hay bale check dam.

You have failed to implement an effective combination of erosion and sediment control as required by the Permit, resulting in surface water sediment discharges. You are required to install effective erosion and sediment controls to protect area creeks immediately. Erosion control BMPs may include bonded fiber matrix, blankets, mulch, straw, or other means that prevent erosion.

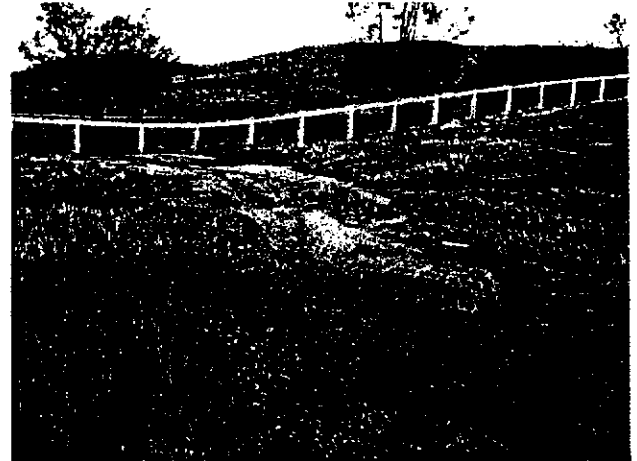
Widespread gully erosion resulted in sediment discharge into the unnamed tributary to the Huerhuero Creek (Photos 3, 4). Some sediment control measures were installed within the tributary creek. Hay bales and straw waddles installed across the directional flow of water are not BMPs. There was no erosion or sediment control on the cleared hillsides. Sediment and erosion controls should be in place to protect the creek. Installation of sediment controls within the creek trap the sediment in the water body itself, which is detrimental to the creek.

Photo 4 – Sediment overwhelmed hay bale check dam.

You have failed to implement an effective combination of erosion and sediment control as required by the Permit, resulting in surface water sediment discharges. You are required to install effective erosion and sediment controls to protect area creeks immediately. Erosion control BMPs may include bonded fiber matrix, blankets, mulch, straw, or other means that prevent erosion.

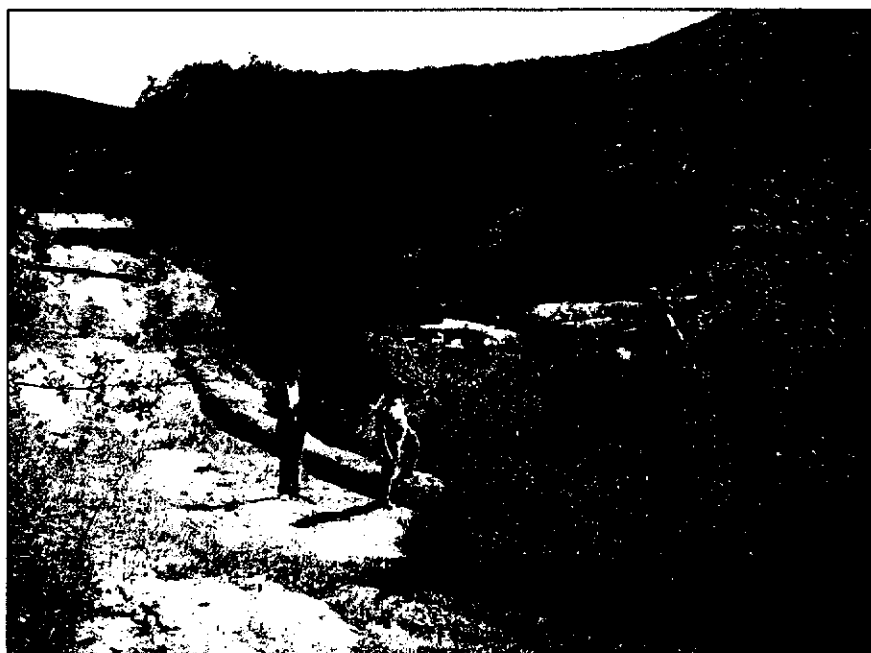
Figure 8 Pierson Property - Looking SE into unnamed tributary (former stock tank in middle distance)

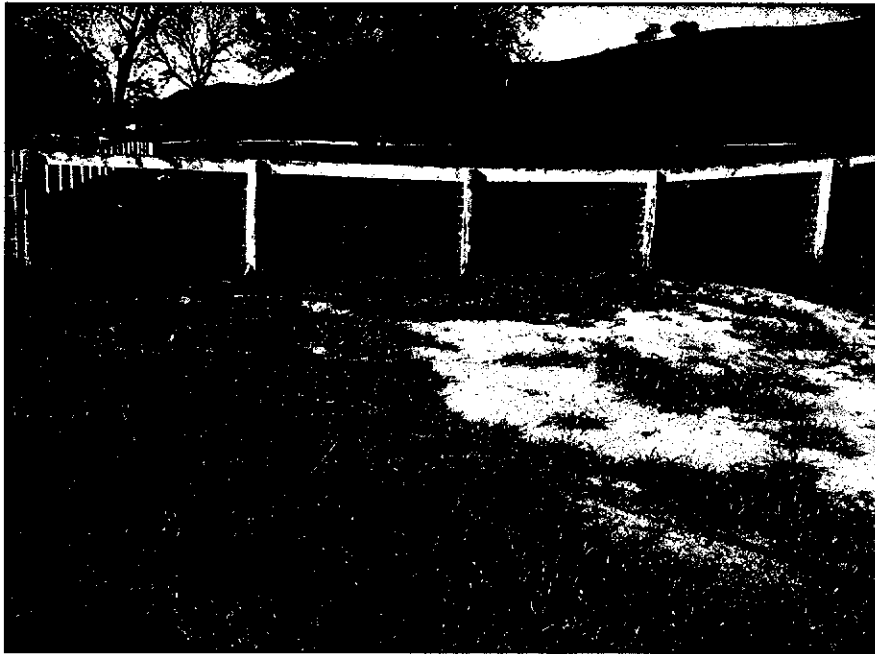
I observed sediment deposits upstream of the fence (see Figure 11) located along the property line. It appears that organic matter was lodged against the fence and acted as a fairly effective barrier to sediment transport. Very little sediment was noted on the adjacent property north of the fence. The sediment deposit is fan shaped with the base located along the fence with a width of approximately 35 feet. The sediment deposit extends uphill from the fence approximately 300 feet (see Figure 12 for upper extent of deposition). Small areas of sediment deposition were observed in the swale above the larger deposit shown in Figure 11 and Figure 12. An example of the grubbed area upstream of the swale, as it appeared prior to revegetation is shown in Figure 13.

**Figure 11 Kelegian Property - Sediment deposition along fence line, looking north to adjacent property
(Photo: Ryan Lodge March 3, 2003)**
