NOTICE OF VIOLATION - DELAVEAGA GOLF COURSE, SANTA CRUZ, SANTA CRUZ COUNTY; WDID#344C330064

Inspection Photos, De LaVeaga Golf Course, Santa Cruz
January 12, 2005

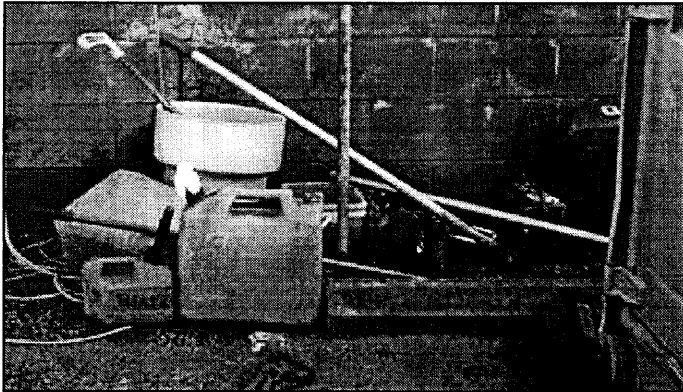
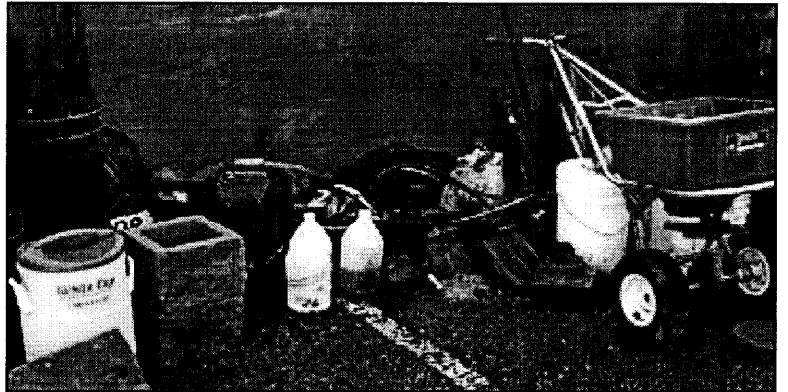
Above and Right: Containers and battery exposed to rain and runoff in construction trailer area. These items should be in secondary containment.

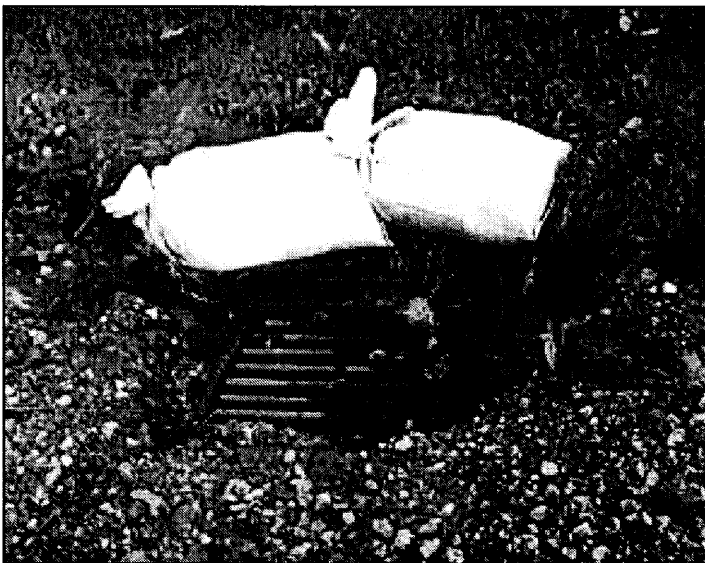
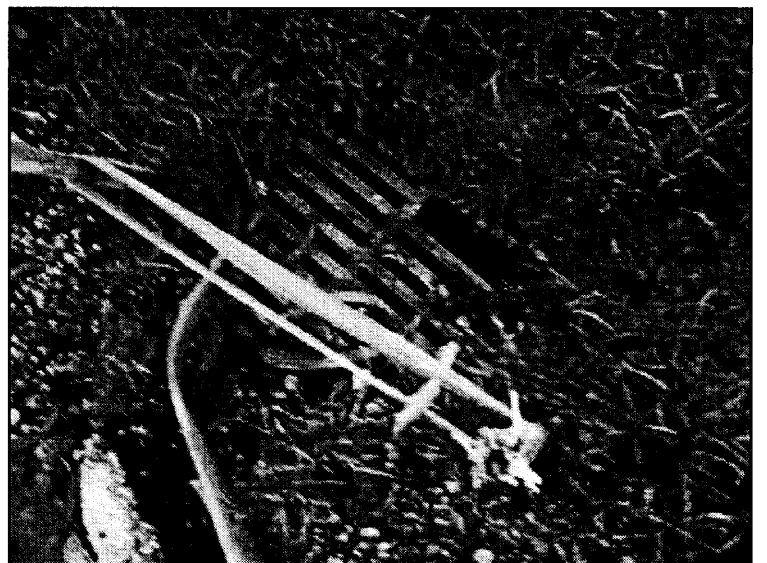
Below and Below Right: Unprotected storm drain inlets.

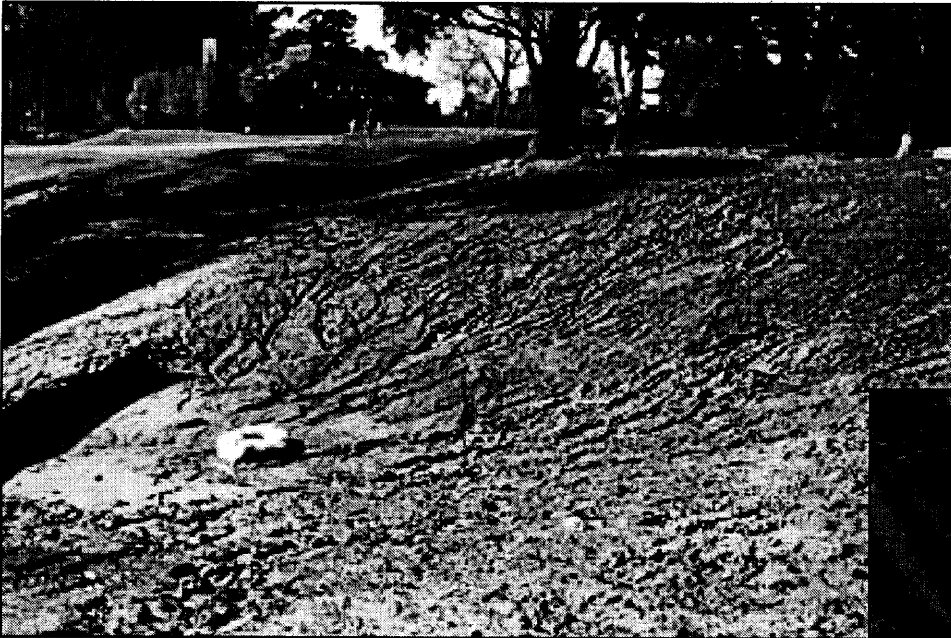
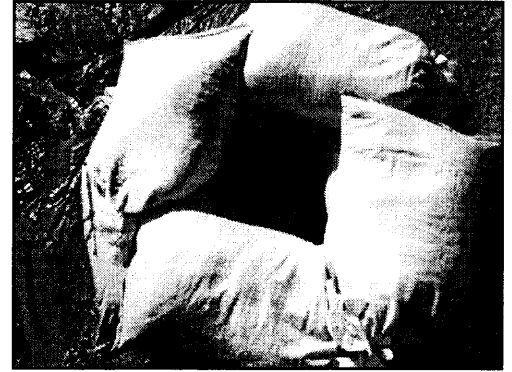
Above and Right: Greens Complex 18 drainage inlet protection added since last inspection. However there is still significant erosion on slopes (above) and a hole in the filter fabric (right).

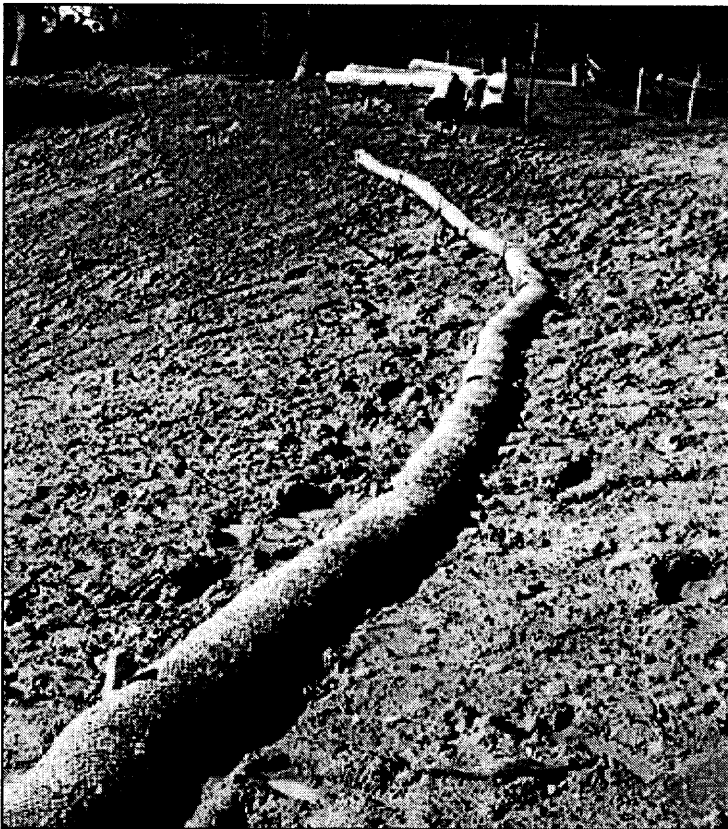
Left: Fiber rolls at Greens Complex 18 not properly staked. Improperly installed fiber rolls are not effective in filtering runoff or slowing it down.

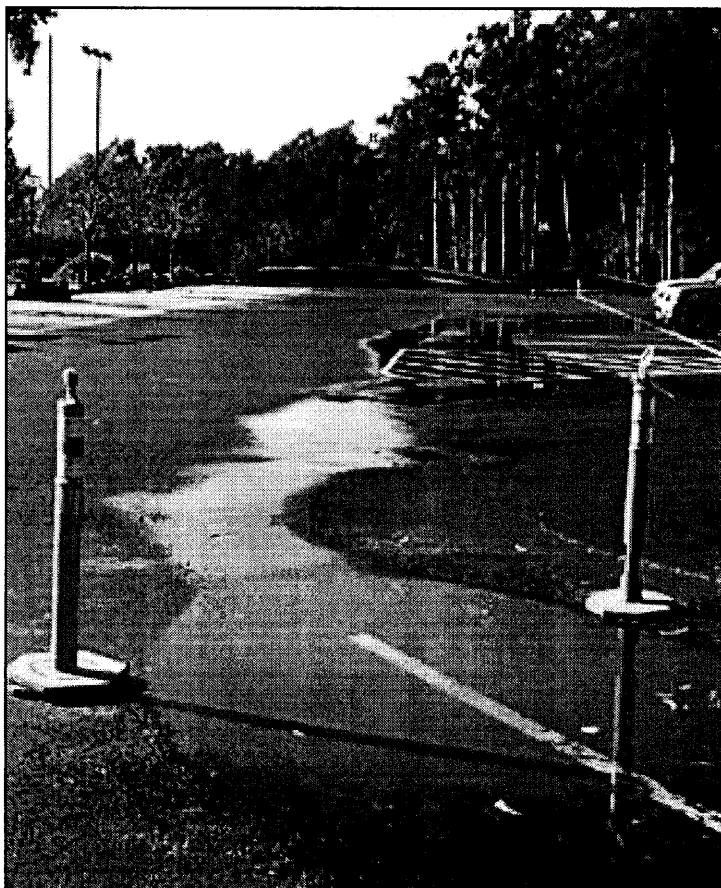
Left and Above: Dewatering (of planter area of clubhouse parking lot) was occurring when staff arrived at the site. Staff is concerned about site dewatering procedures, as person dewatering did not employ any dewatering best management practices, and did not monitor the discharge point before leaving the area. However, when staff observed the discharge point, it appeared water had not yet bypassed sandbags at the parking lot low point.

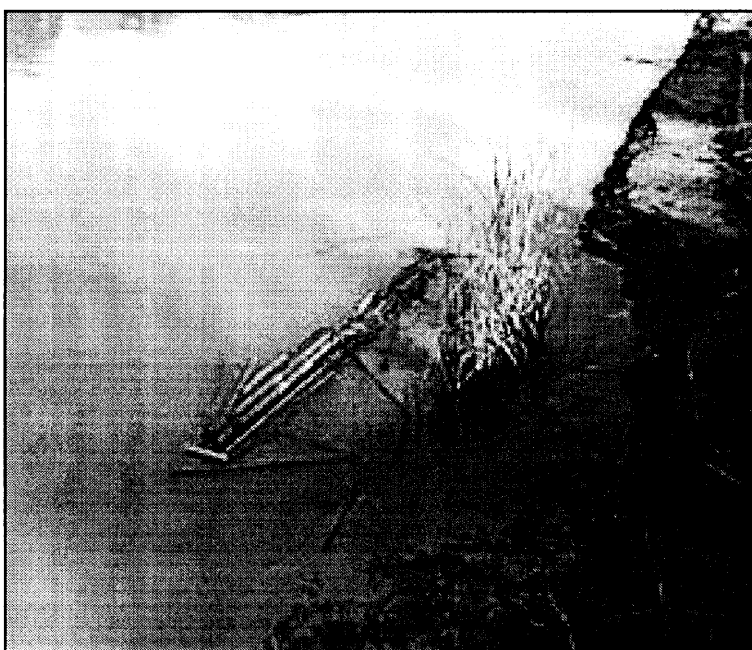
Left: Pond near Greens Complex 18 discharges to canyons without treatment.

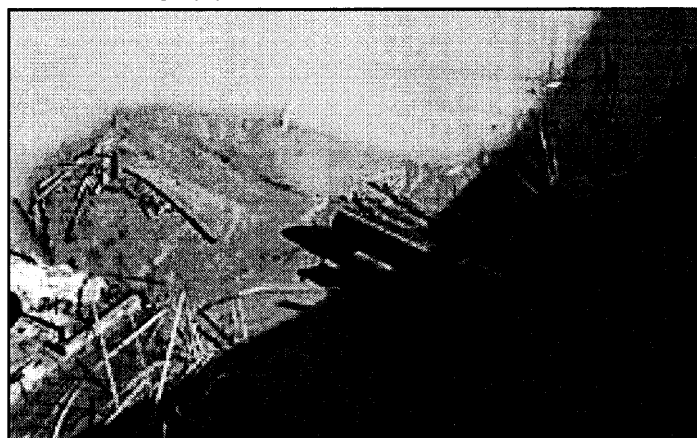
Below: Some construction areas drain to pond. Photo shows muddy water in pond and accumulated sediment below drainage pipe.

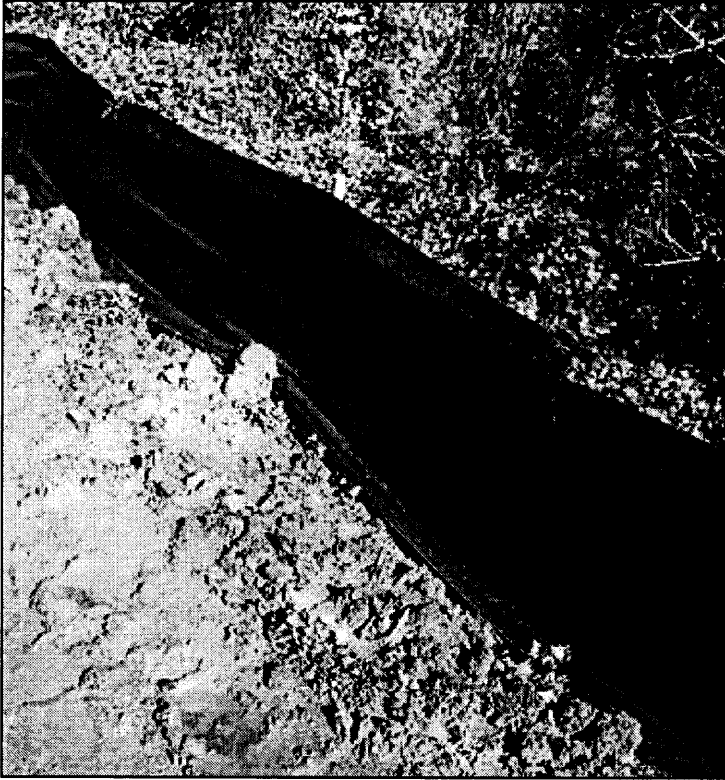
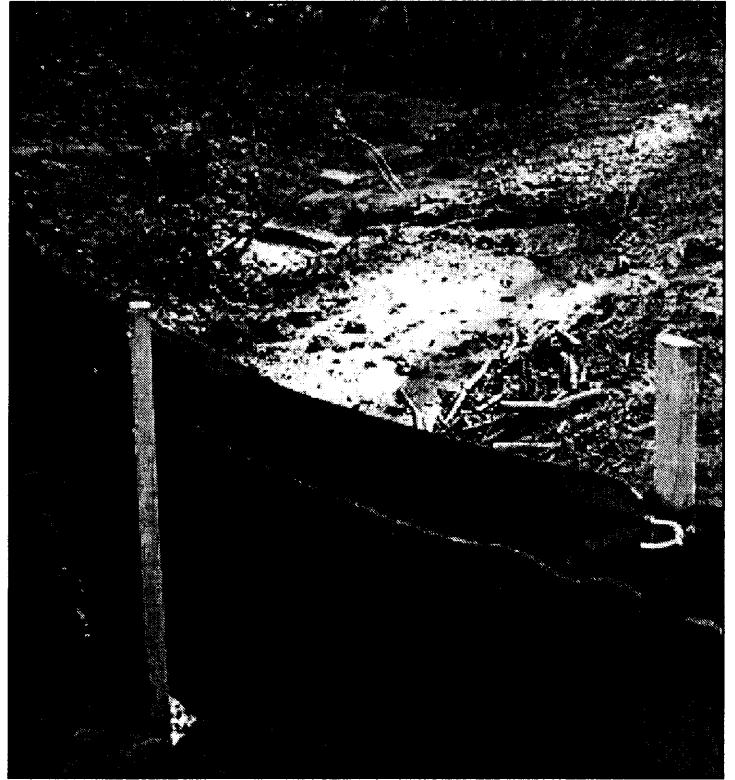
This Page: Onsite silt fences improperly installed. Silt fences are not trenched in at the bottom to prevent runoff from flowing under fences.

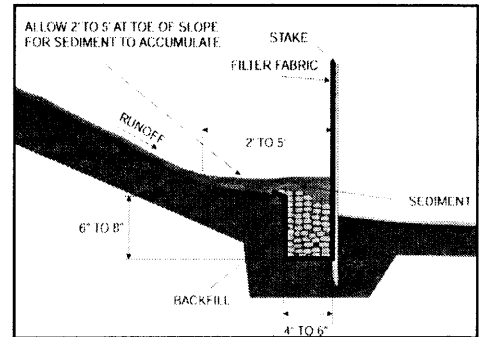
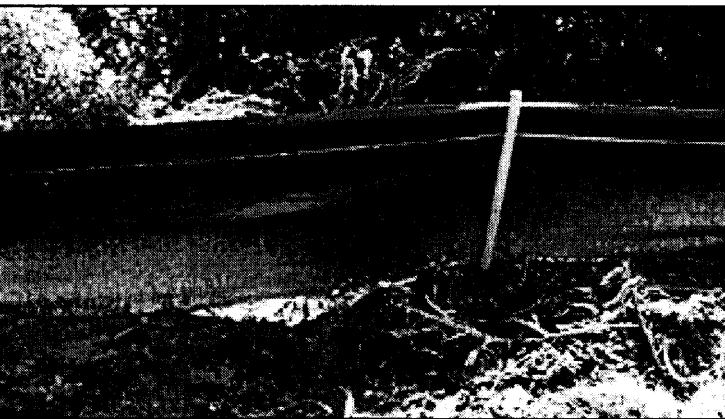
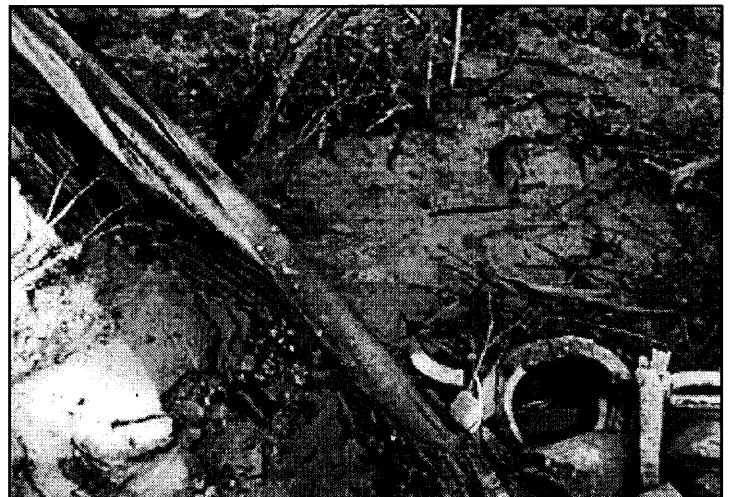
Above and Below: Sediment traveled under silt fences to canyons.

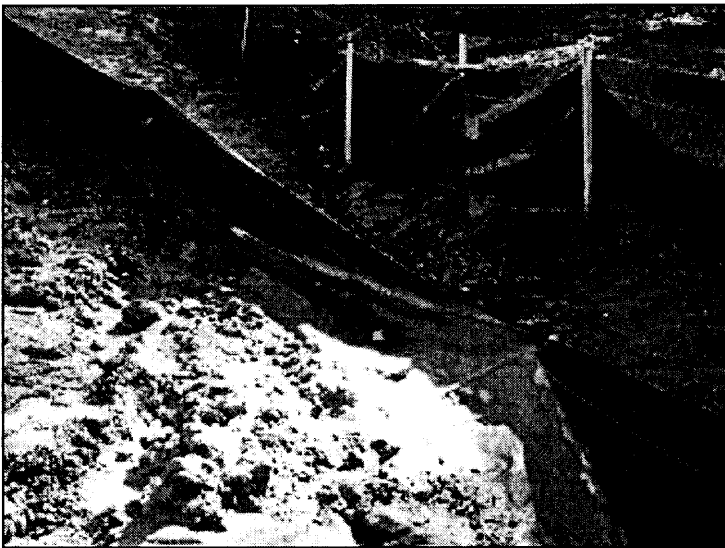
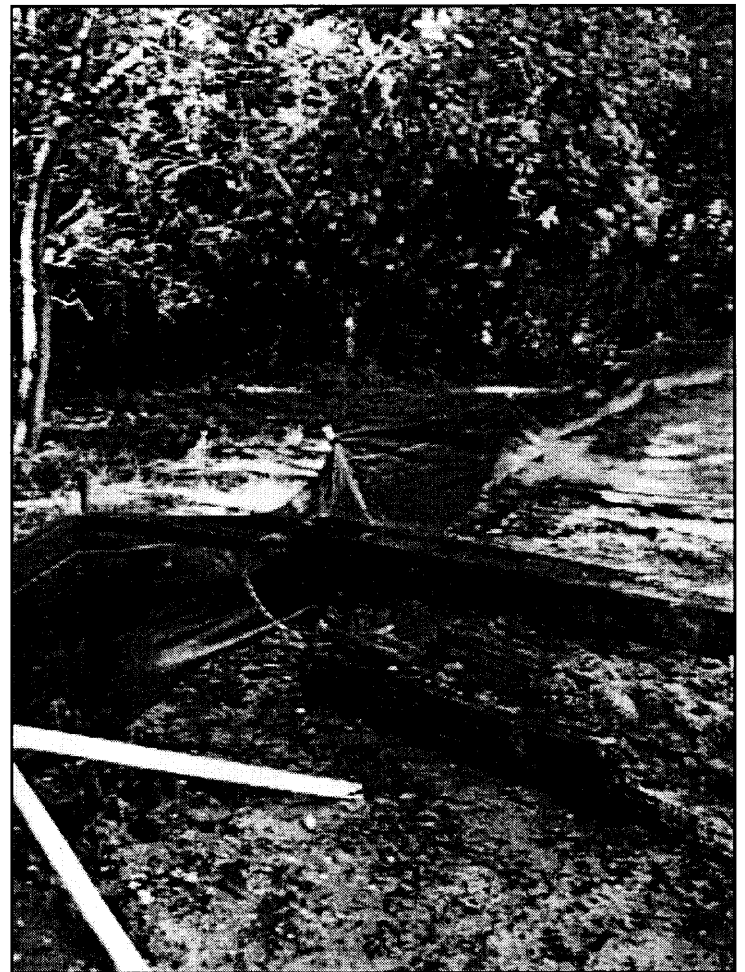
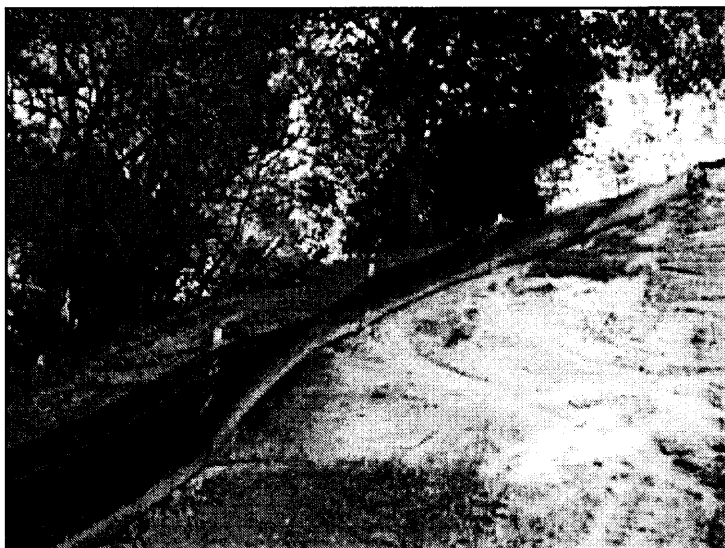
This Page: Silt fences in need of maintenance and/or replacement in various areas of site.

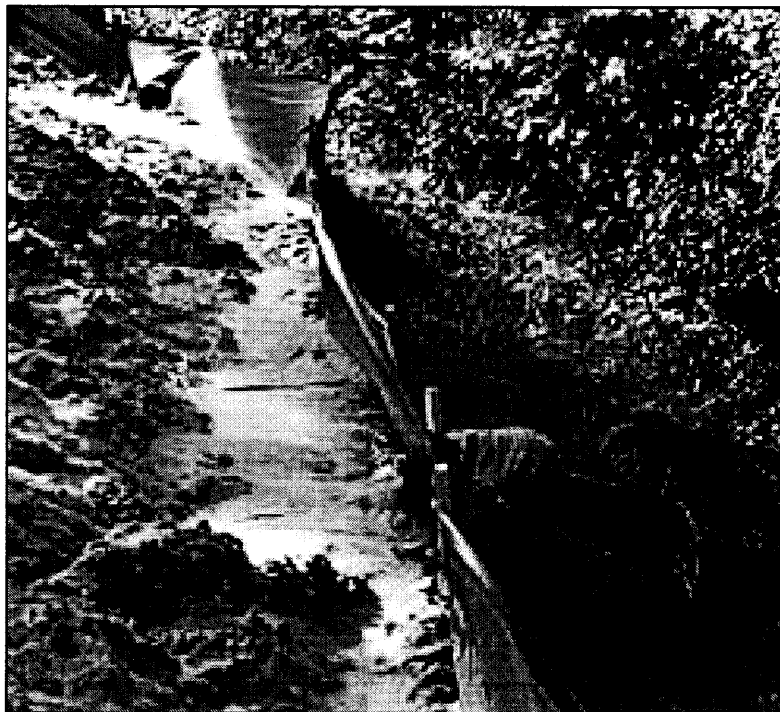
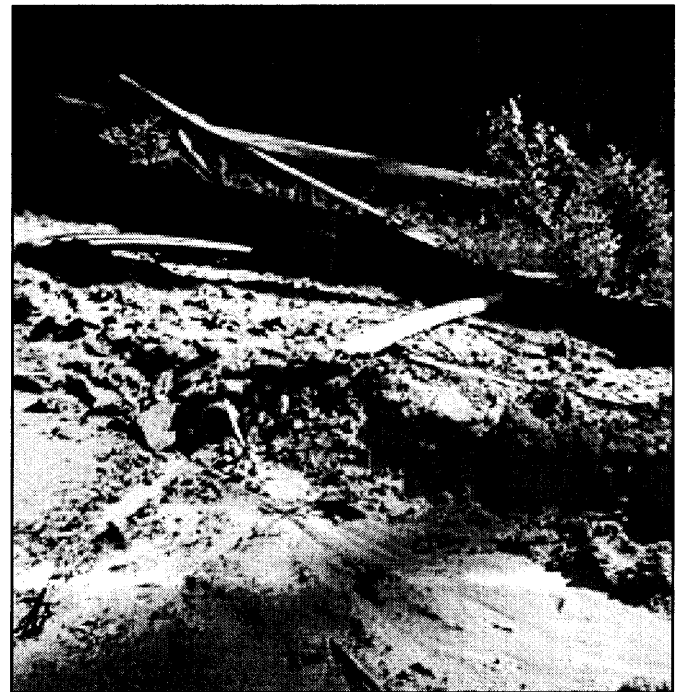
This Page: Pipes through and under silt fences in various locations on site. Such a design does not filter the runoff flowing through pipes, and results in sediment discharge.

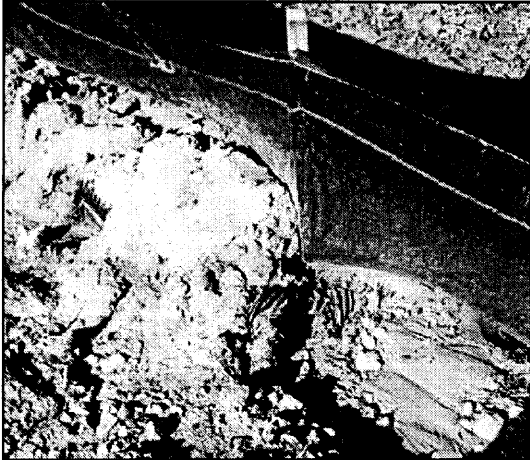
Top Left: Sediment-covered pipe going under/through silt fence in Greens Complex 5.

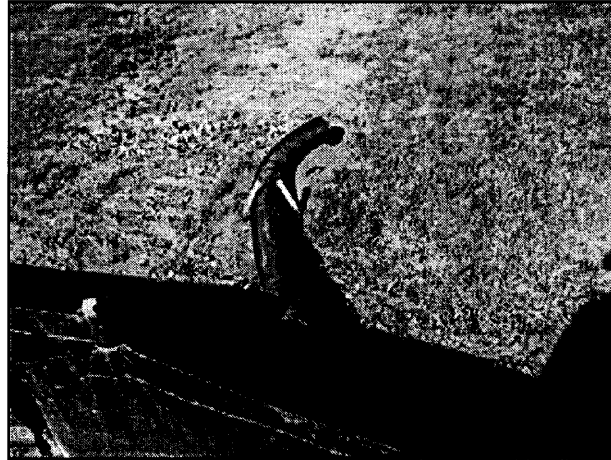
Top Right: pipe on other side of fence. Sediment in grass is evidence of muddy water discharge from pipe.

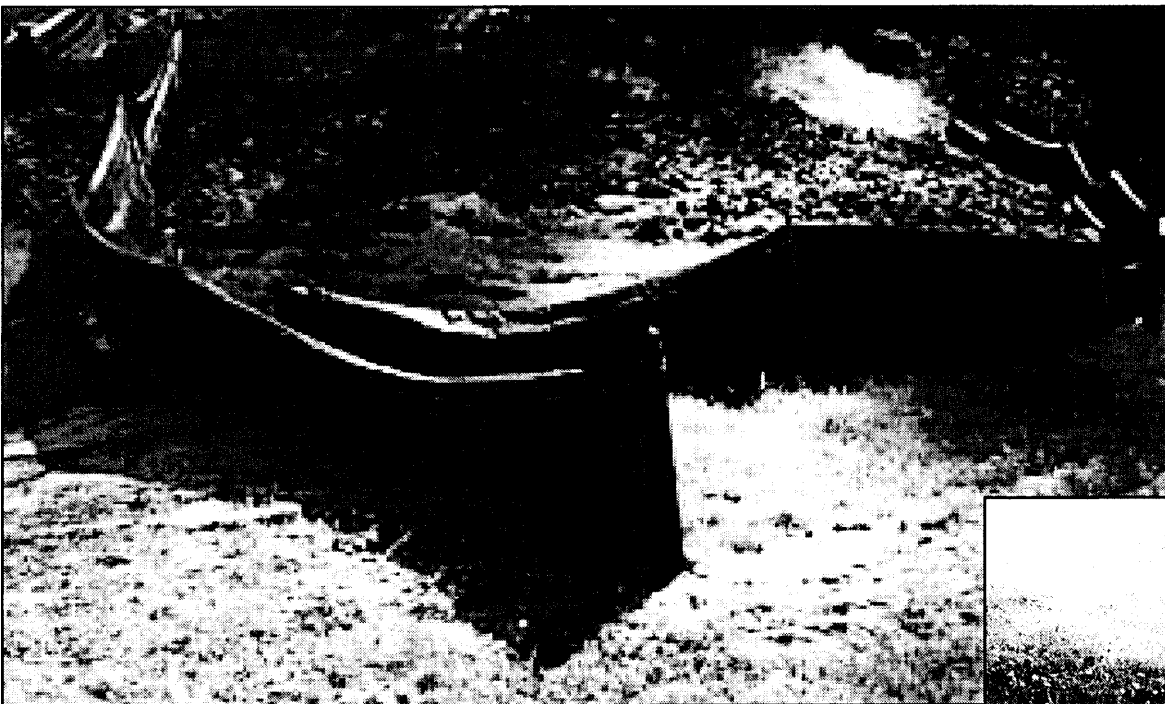
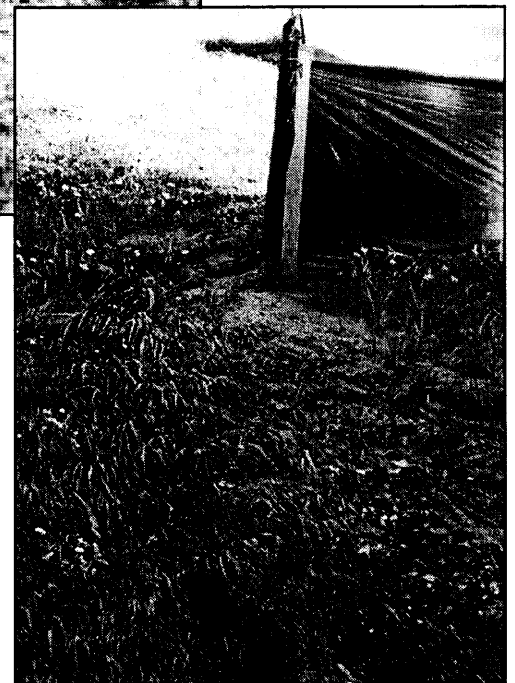
Above and Right: Silt fence and sediment deposited behind and around edge of silt fence at Greens Complex 5. Sediment and flattened grass show path of sediment-laden water around silt fence.

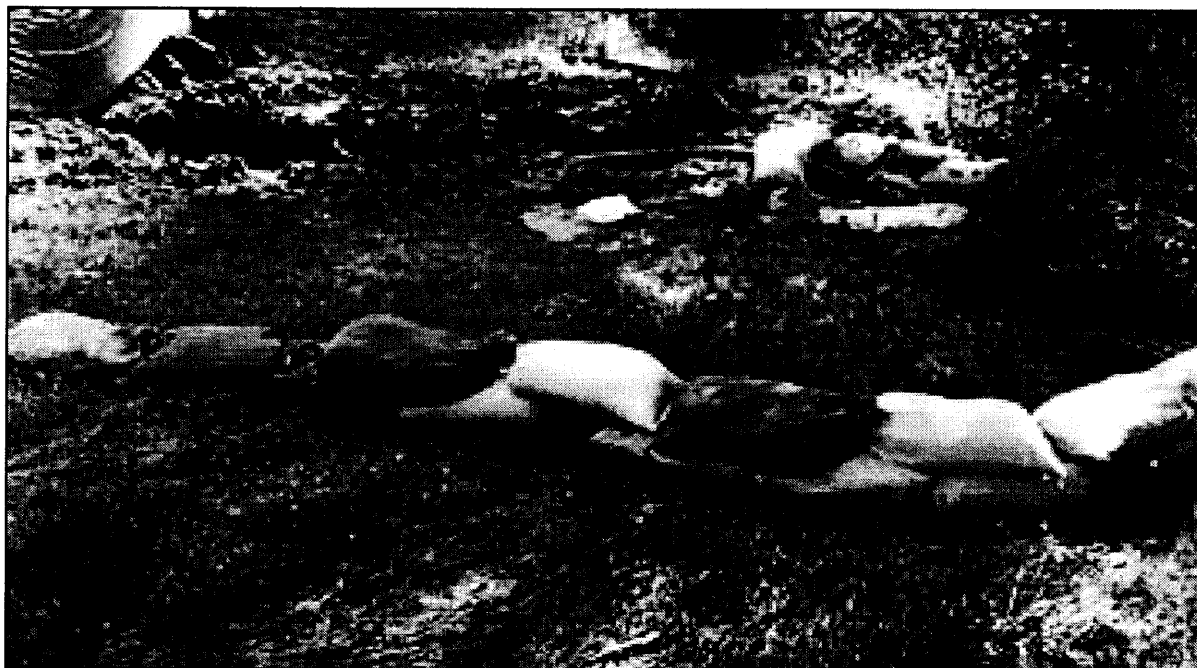
Above: Greens Complex 5. Pipes convey runoff between sandbags.

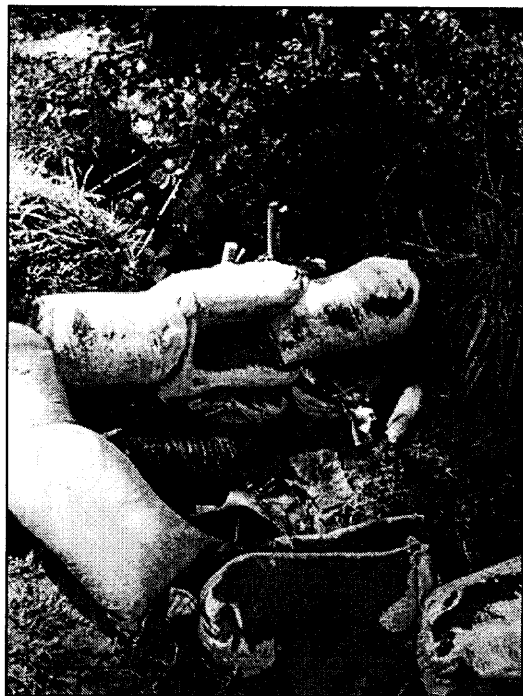
Left: Greens Complex 5 discharge point. Pipe and sandbags at edge of golf course, adjacent to canyon. No sediment controls beyond this point.

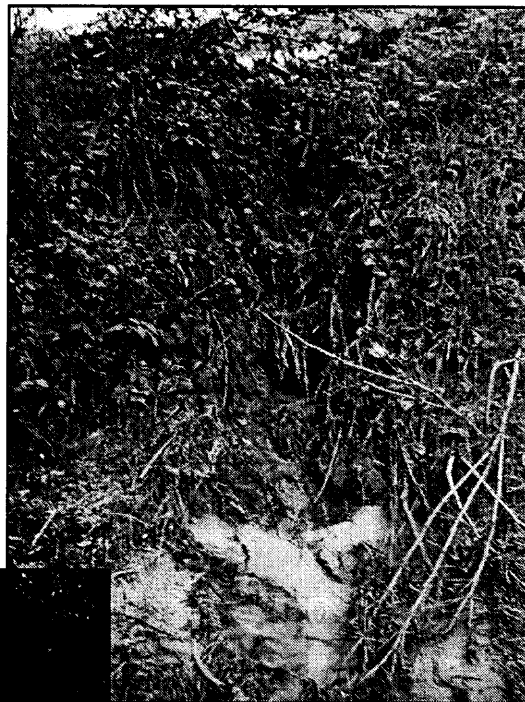
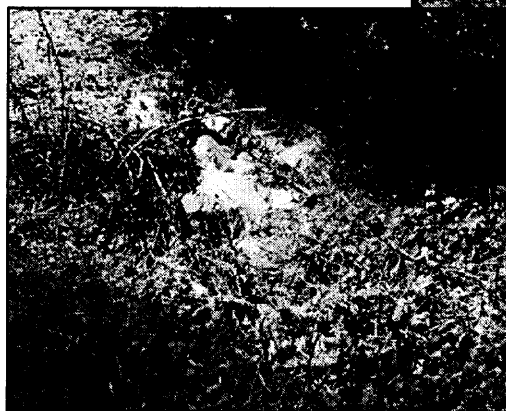
Right and Below: Erosion and sediment deposits in canyon directly below sandbags at Greens Complex 5 discharge point.

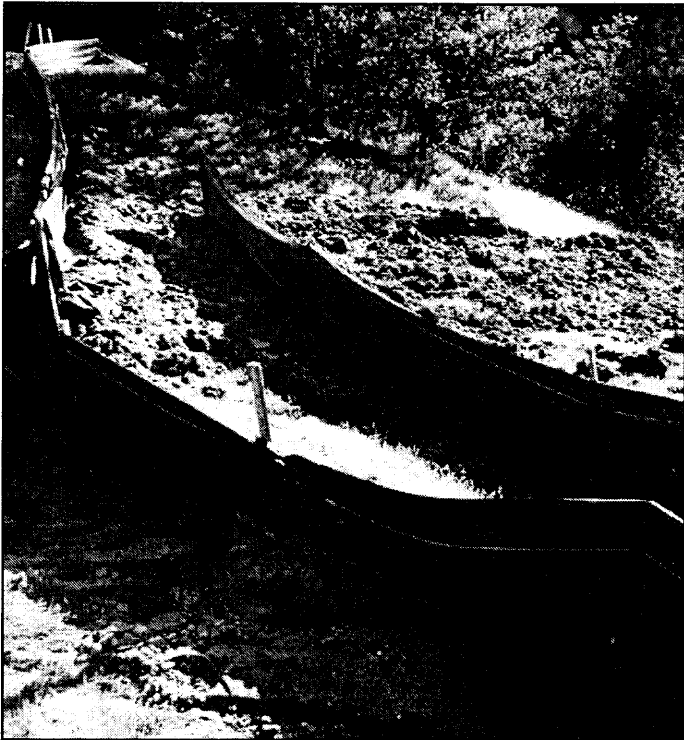
Above: Greens Complex 5. Sediment on both sides of silt fences (third silt fence to right is not visible in above photo).

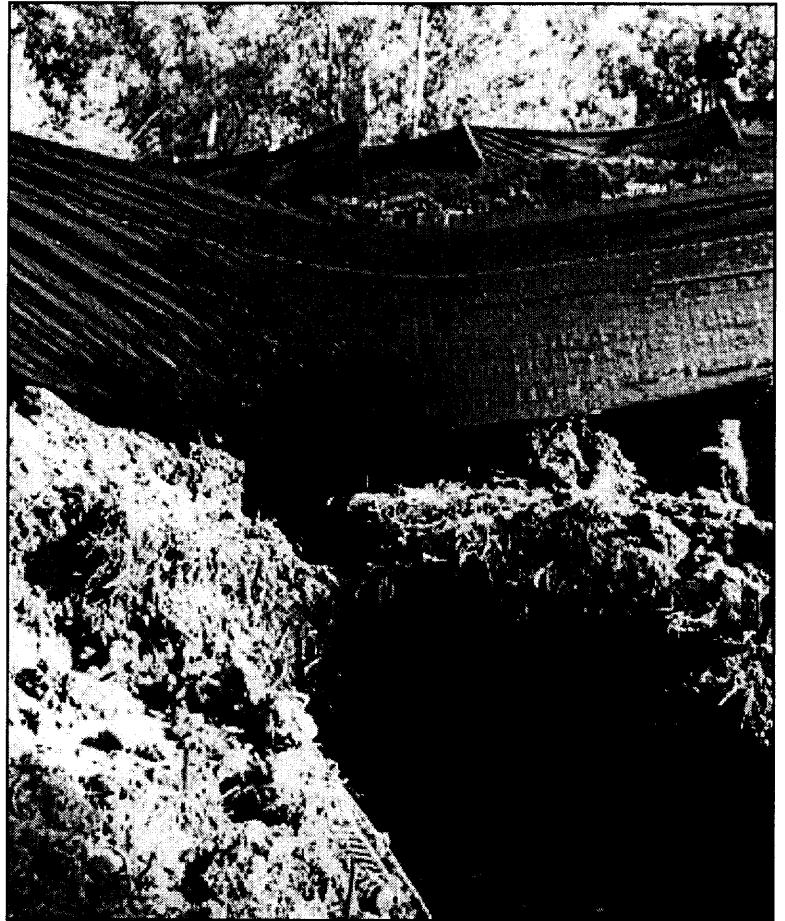
Right: Erosion/trench below third silt fence.

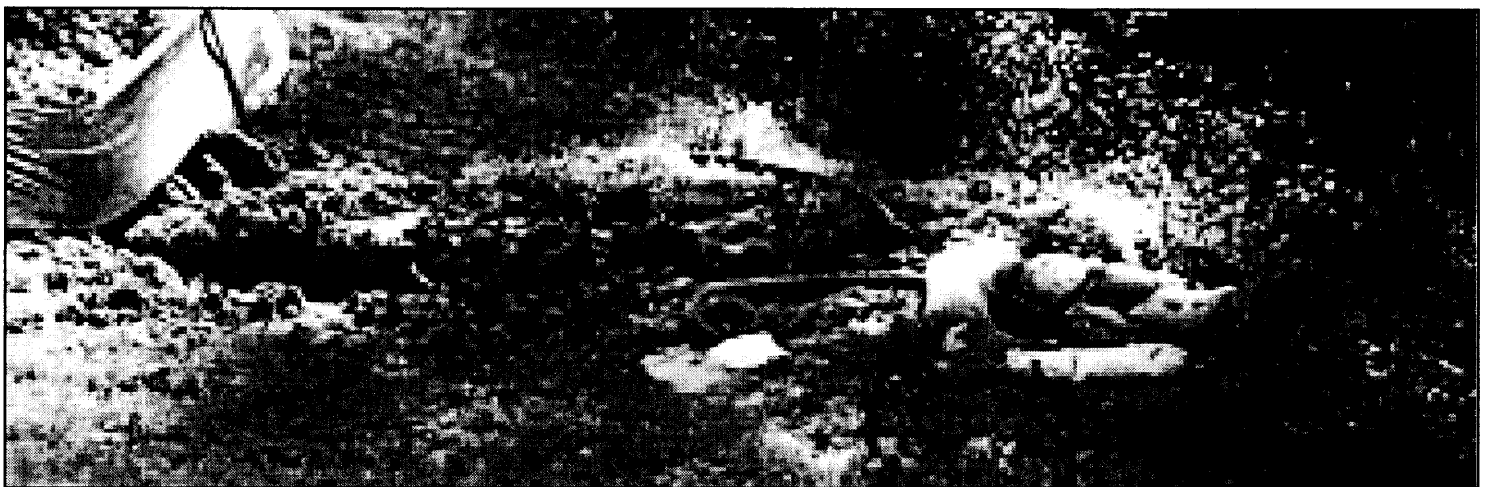
Below: Third silt fence (left side of photo) and erosion/trench with pipe into Greens Complex 5 discharge point.
