CALIFORNIA REGIONAL WATER QUALITY CONTROL BOARD
CENTRAL VALLEY REGION

CLEANUP AND ABATEMENT ORDER R5-2019-0703
FOR
MARIA VALENCIA
ASSESSOR PARCEL 012-010-70
LAKE COUNTY

Attachment A – 8 August 2018 Notice of Violation and 22 May 2018 Inspection Report
Attachment B – 16 November 2018 Notice of Violation and 18 September 2018 Inspection Report

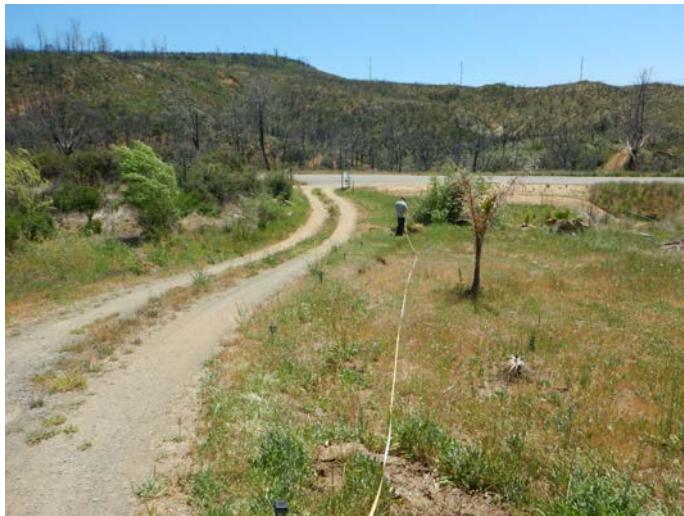
Photo 1. View looking at the private road and Morgan Valley Road.

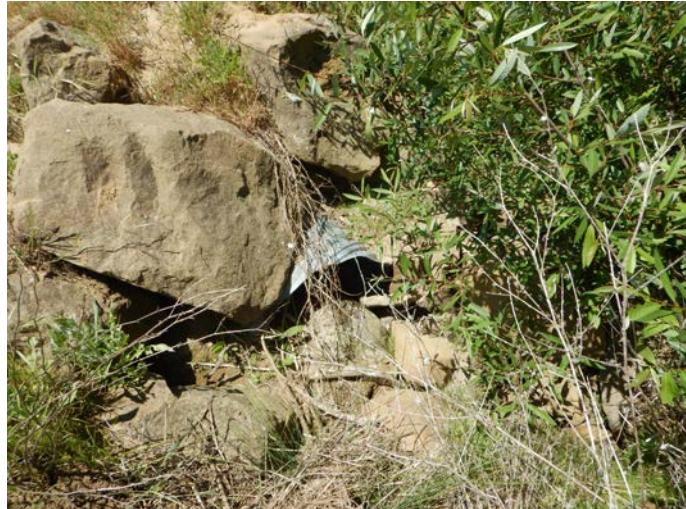
- 6) Located on the private drive accessing the property was a partially plugged CMP watercourse crossing. The inlet of the CMP was partially plugged with large angular rocks and fine sediment, resulting in the accumulation of fine sediment in the drainage basin above the CMP and in a nearby road drainage ditch. At the outlet of the CMP, road fill material had failed and created a vertical cut-bank directly above the outlet, resulting in an accumulation of material at the base of the CMP. Staff calculated approximately 22 cubic yards of earthen material had been deposited within the Class III watercourse during construction of the watercourse crossing. Additionally, west of the watercourse crossing an erosional gully had formed in the road surface as a result of surface water ponding above the plugged CMP inlet. The plugged inlet caused water to divert out of the natural channel and flow over the top of the road surface leading to erosion of the road surface.

Photo 3. View looking at the plugged Inlet of the corrugated metal pipe (CMP). Inlet basin is filled with cobble and fine sediment.

1. The evaluation shall assess the current crossing's ability to pass 100-year flood flows and plans for stabilization and/or replacement of the culvert.

2. If the culvert is determined to require replacement, the culvert shall be sized to accommodate 100-year flood flows along with associated debris loads. Reconstruction of the crossing shall include plans to address diversion potential and shall include adequate armoring to prevent erosion of the upstream and downstream fill slopes.

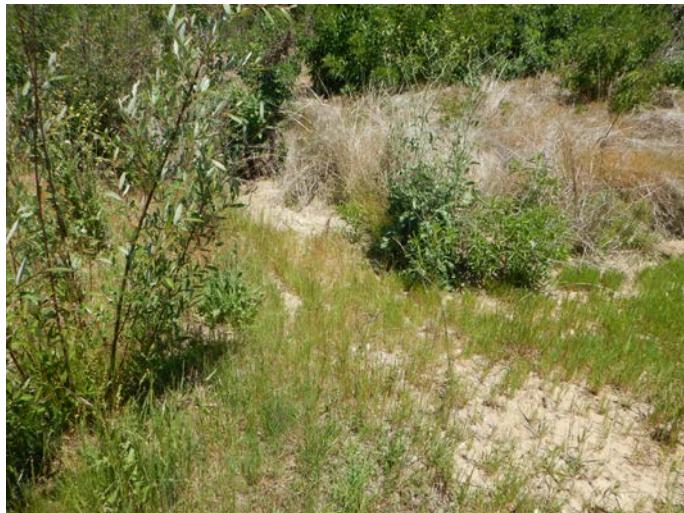
Photo 5. View looking at class III watercourse channel where large amounts of fine sediment have accumulated behind the plugged Watercourse Crossing.

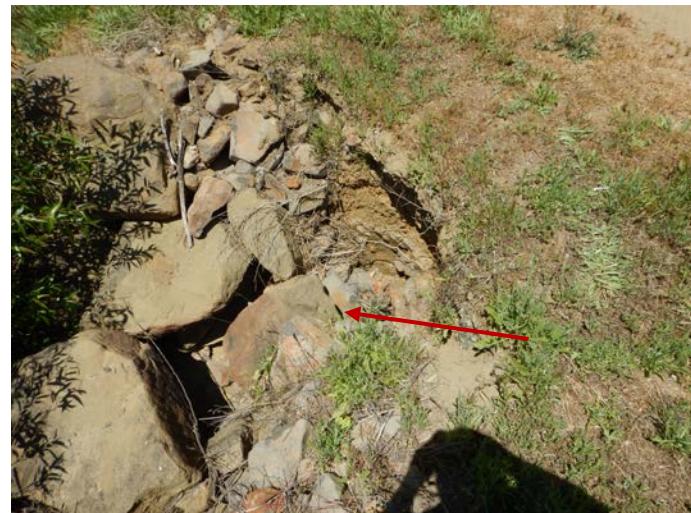
Photo 6. View looking at the eroded vertical fill slope above the outlet of the Watercourse Crossing. Large boulders and cobbles have obstructed the outlet. Red arrow points to the outlet of the culvert.

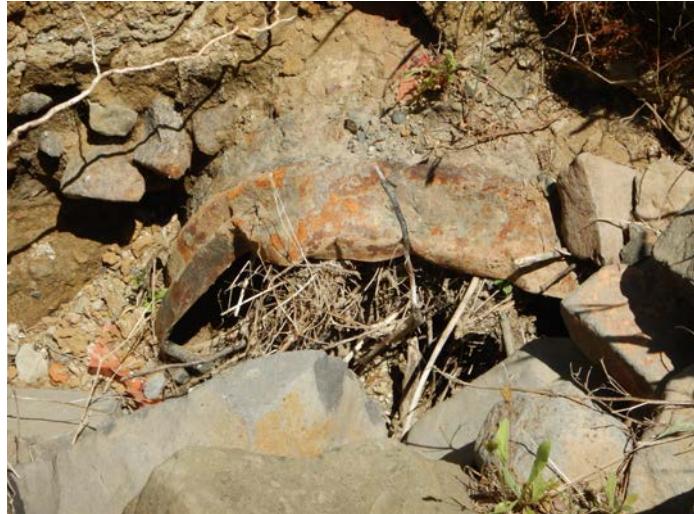
Photo 7. View looking at the plugged outlet of the Watercourse Crossing.

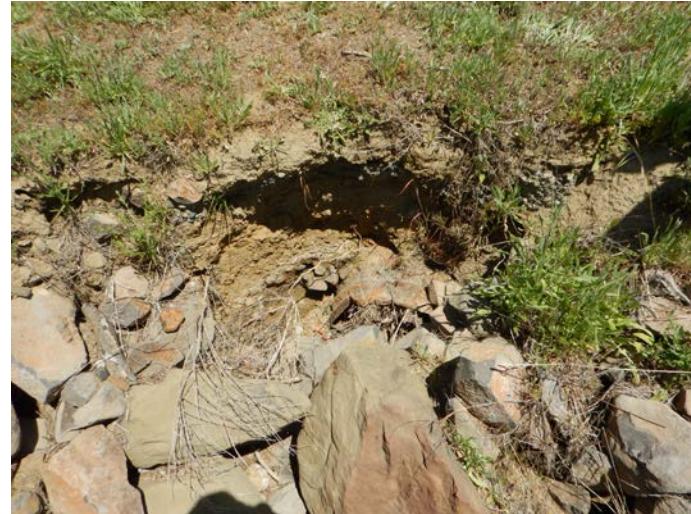
Photo 8. View looking at the overall condition of the outlet of the Watercourse Crossing. Culvert outlet is plugged with sediment and woody debris.

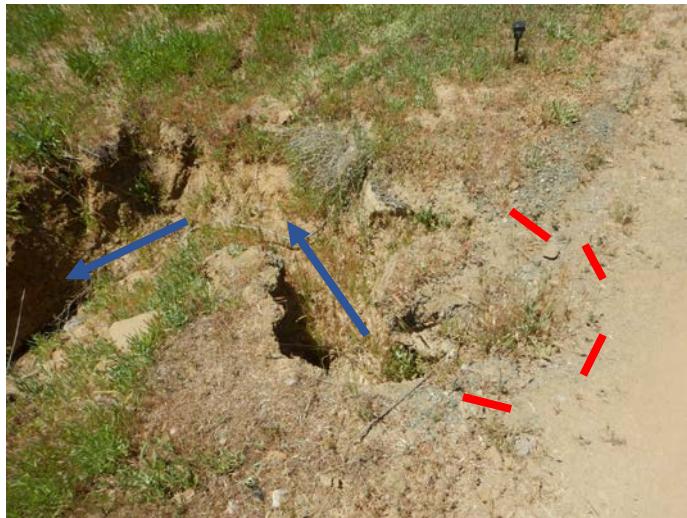
Photo 9. View of the fill slope west of the culvert outlet. The gully in the road has created a head cut into the road surface. Blue arrows depict flow path. Red dashes show propagating head cut.

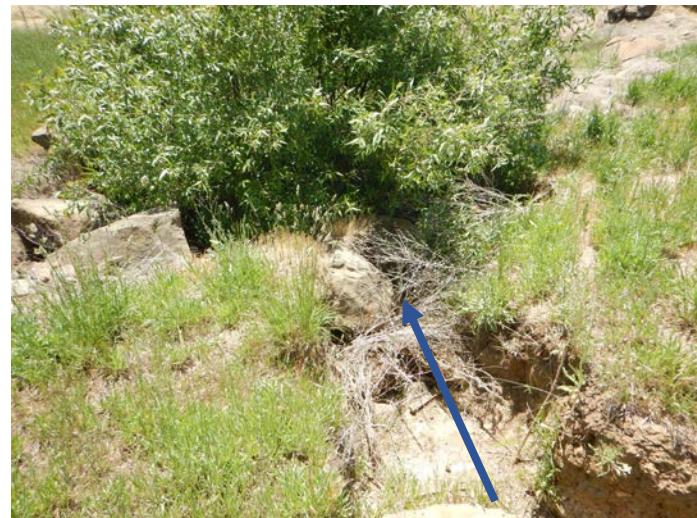
Photo 10. View of the gully west of the Watercourse Crossing. Blue arrow depicts flow direction.

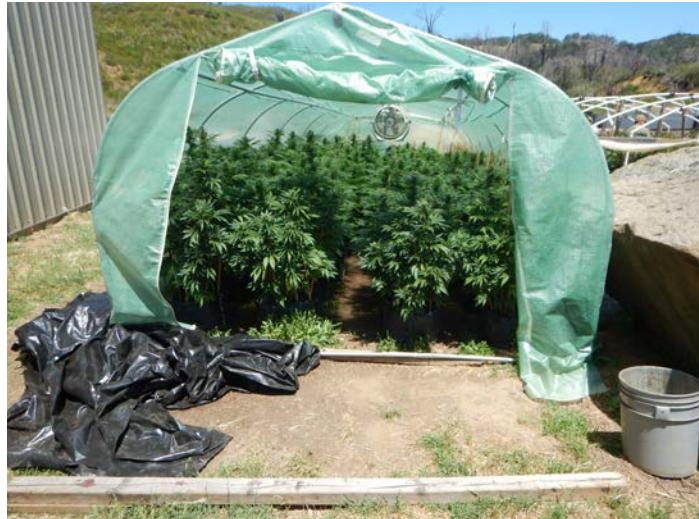
Photo 11. Cultivation Area One, Visible in view are two constructed hoop houses with mature cannabis plants being cultivated in plastic pots.

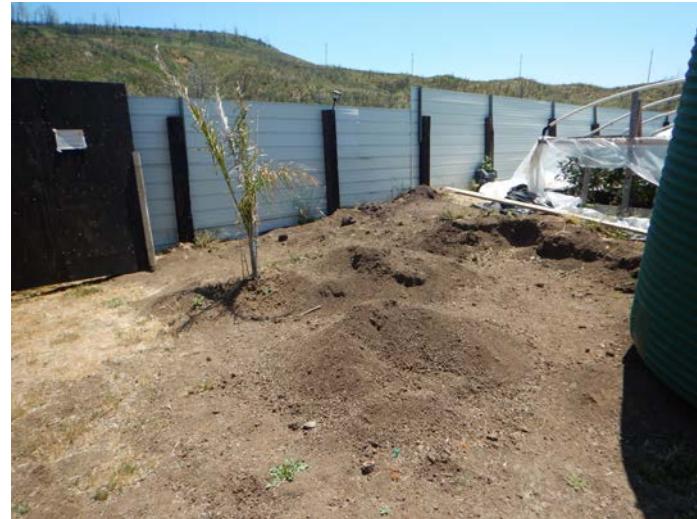
Photo 12. View of the stock pile of imported potting soil. Stock pile is not covered nor has the proper containment best management practices (BMP's).

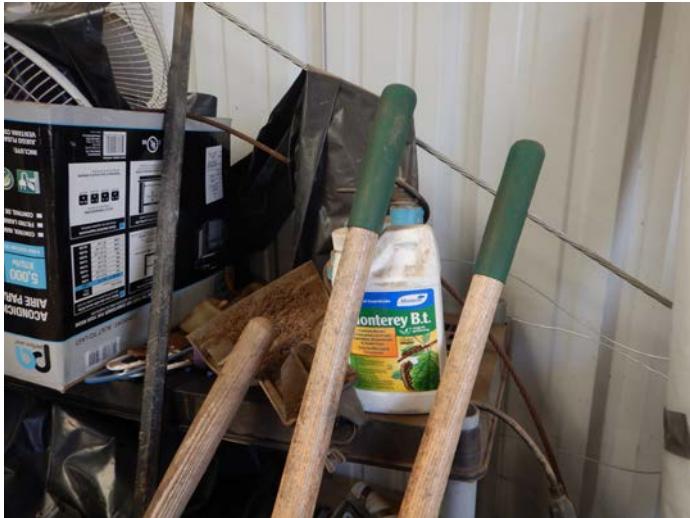
Photo 13. A capped bottle of insecticide stored in the permanent shop. The insecticide is a commonly used biological insecticide that is Organic Materials Review Institute (OMRI) certified.

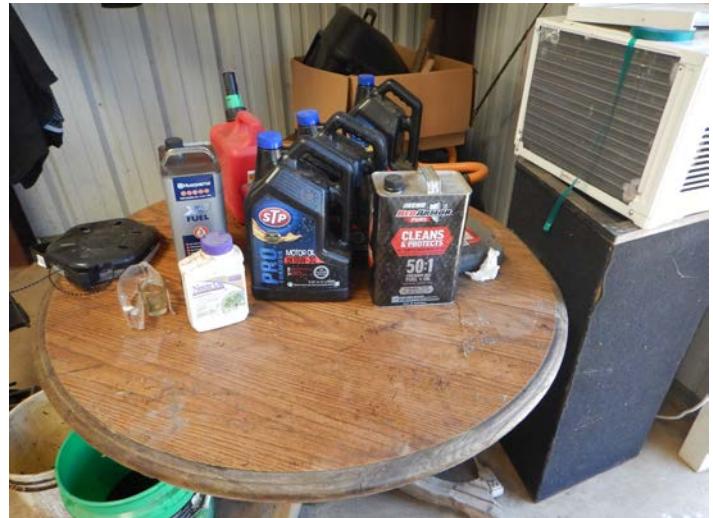
Photo 14. Variety of petroleum products stored permanent shed. The uncovered white and green five-gallon buckets on the lower left of the photo contained an unknown liquid.

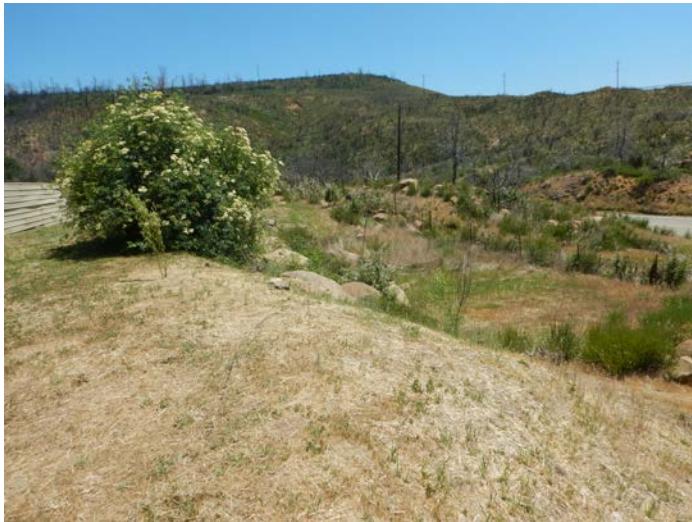
Photo 15. Well vegetated fill slopes of the graded pad, with rock slope protection (RSP). Permanent shop and Cultivation Area One are located to the left of the photo.

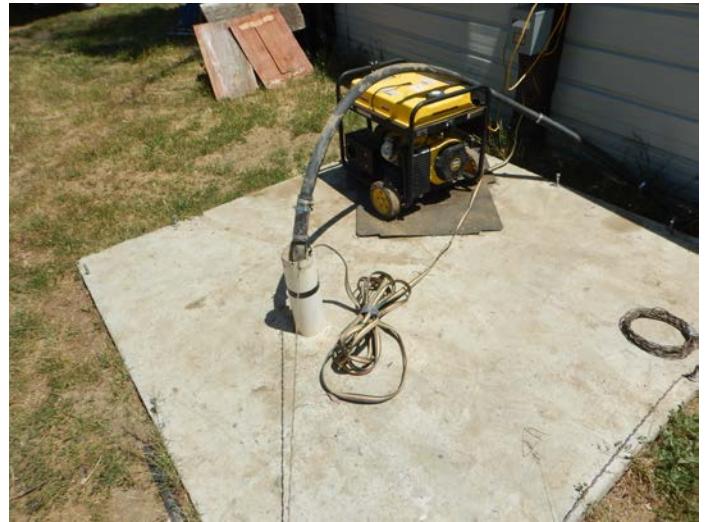
Photo 16. View of the well. The well head is uncapped, with rubber tubing and an extension cord extending down the hole.

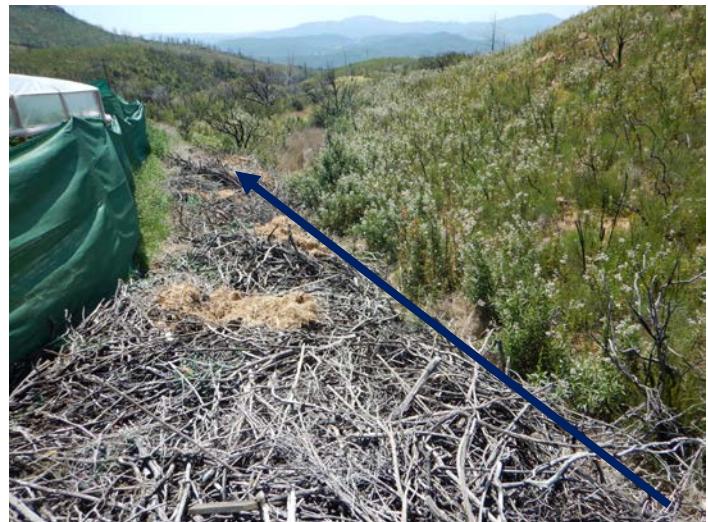
Photo 18. View of vegetation slash on the fill slope of the graded pad. Blue arrowed line shows general location of the Class III watercourse and flow direction.

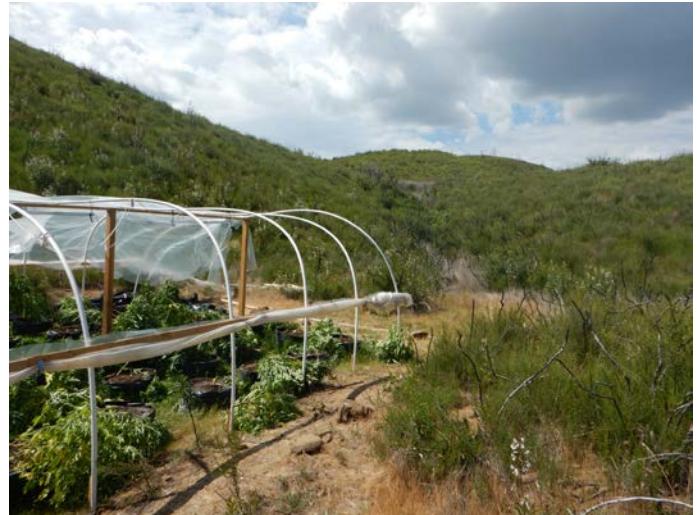
Photo 20. View of Cultivation Area Three which is placed within a low gradient portion of a Class III watercourse.

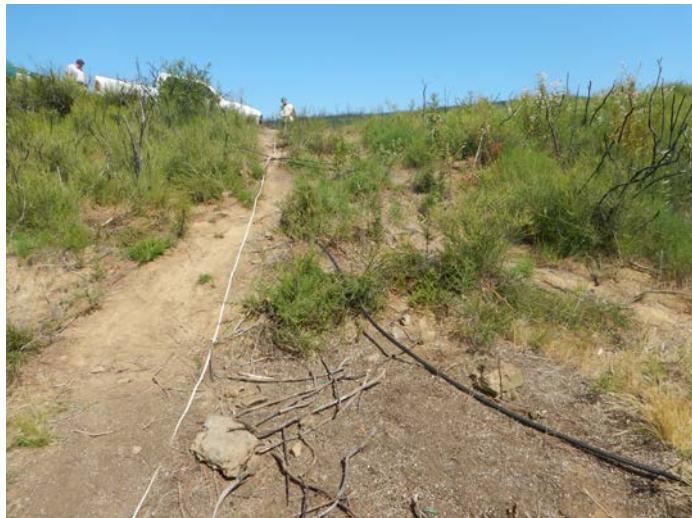
Photo 21. View looking at the foot path that accesses Cultivation Area Three.

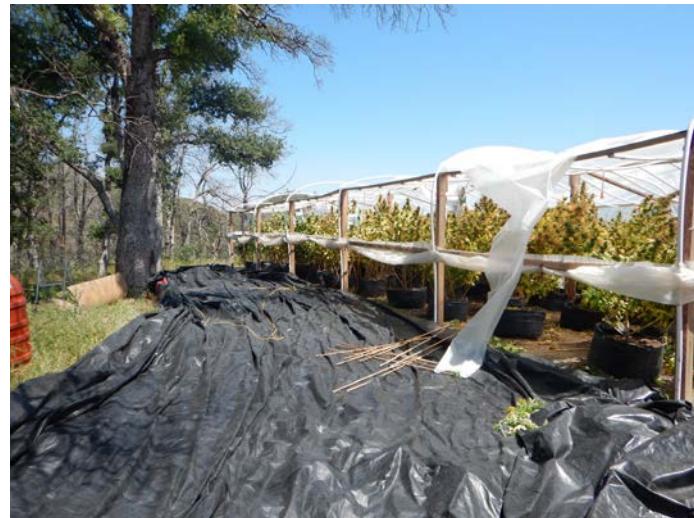
Photo 22. View looking south east at Cultivation Area Four.

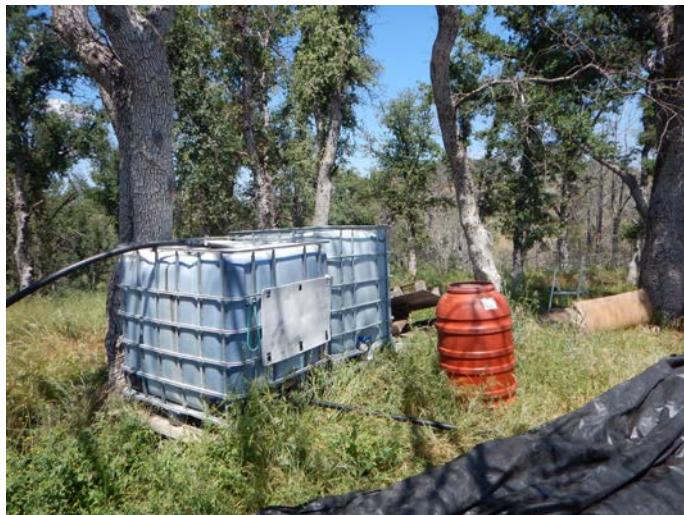
Photo 23. View looking at northern edge of Cultivation Four and the two IBC's and one 50-gallon barrel. These were filled with an unknown liquid.

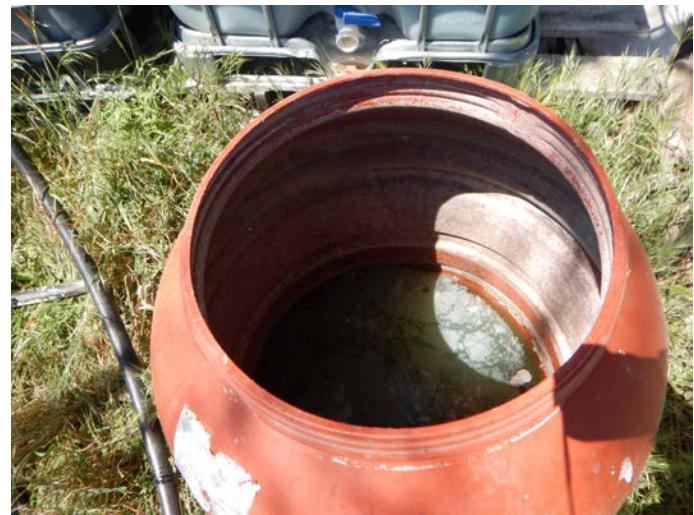
Photo 24. View looking at the uncovered 50-gallon barrel containing an unknown liquid.

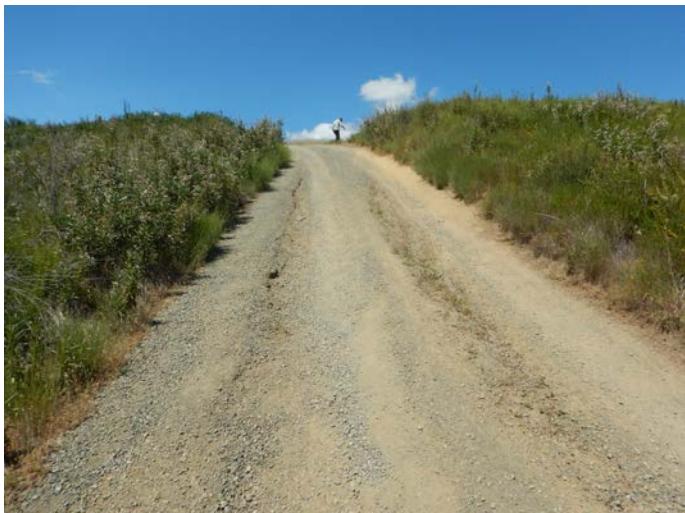
Photo 25. View looking up grade of the Ridge Access Road. Slope was measured at 25% grade at spot of rill erosion on road surface.

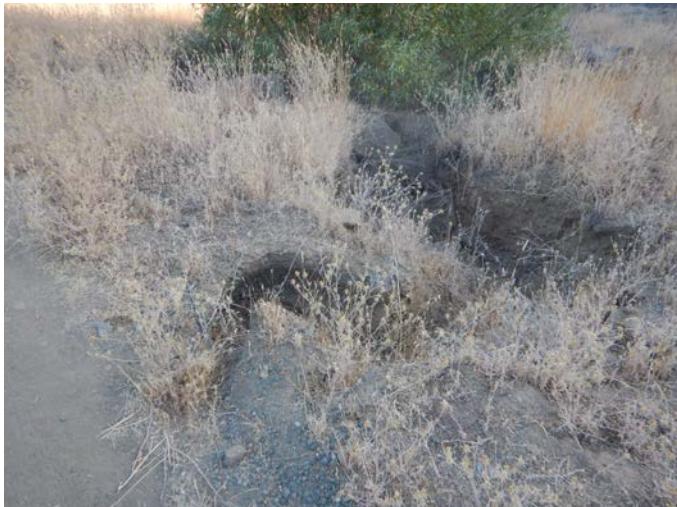
Photo 3. View looking at the erosional gully in the road fill on the western side of the Watercourse Crossing. Staff documented that it was in the same condition as the previous inspection.

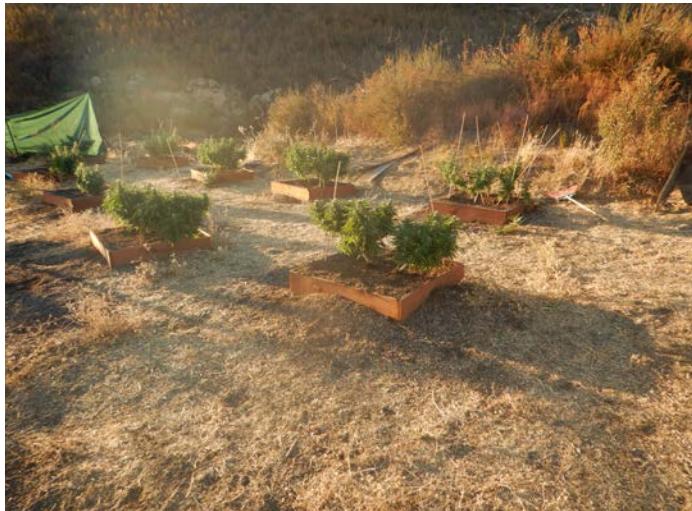
Photo 7. View looking at the active cannabis cultivation in Cultivation Area Two.

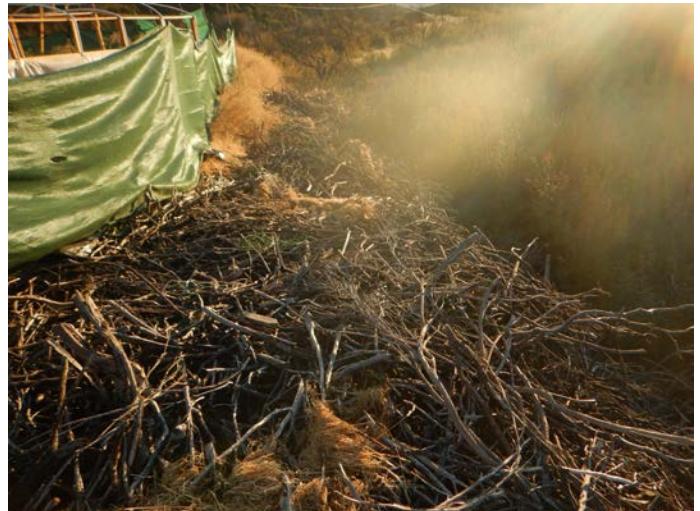
Photo 8. View looking at the vegetative slash placed adjacent to and within the unnamed Class III watercourse at Cultivation Area Two.

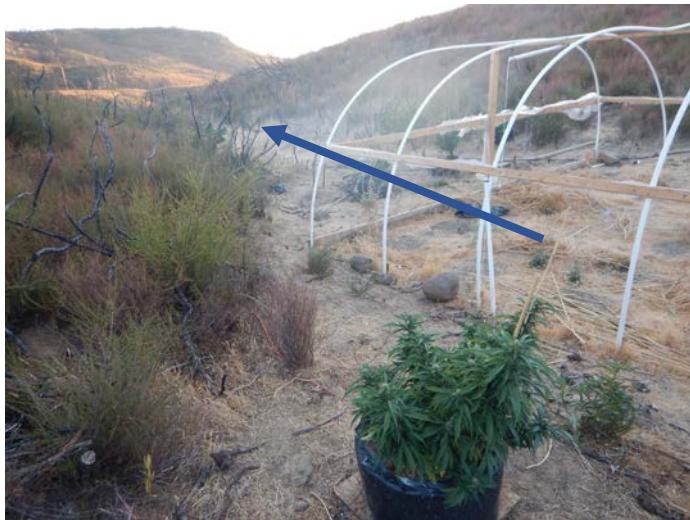
Photo 9. Cultivation Area Three, looking south and downstream. View looking at the inactive hoop house and the expanded disturbed area downstream. Cultivation was active within the Class III watercourse channel at this location. Blue arrow shows location of the flow path of the Class III watercourse.

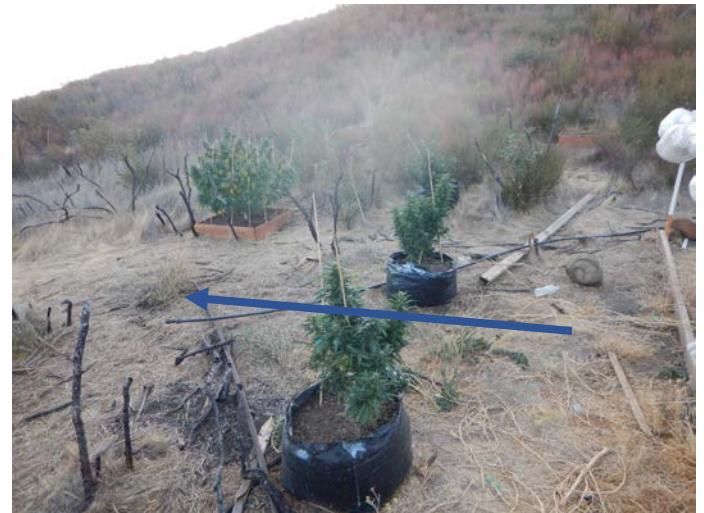
Photo 10. View of active cultivation adjacent to and within the Class III watercourse in Cultivation Area Three.

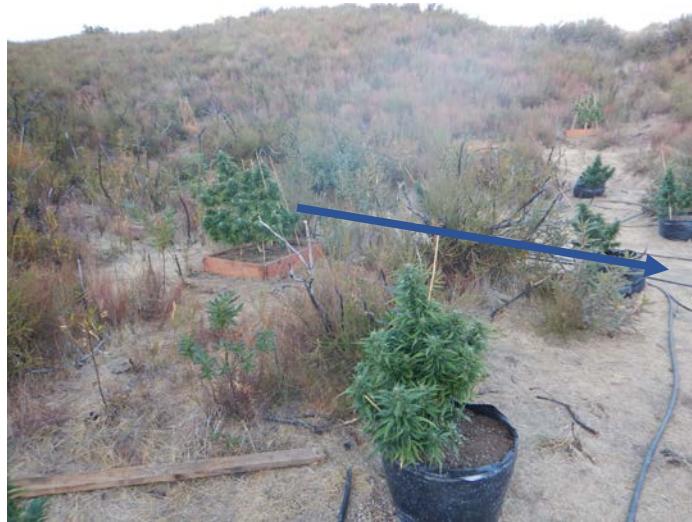
Photo 11. View looking Northeast at the active cultivation and the expanded disturbed area upslope and upstream at Cultivation Area Three. Blue arrows show location and direction of flow of the Class III watercourse.

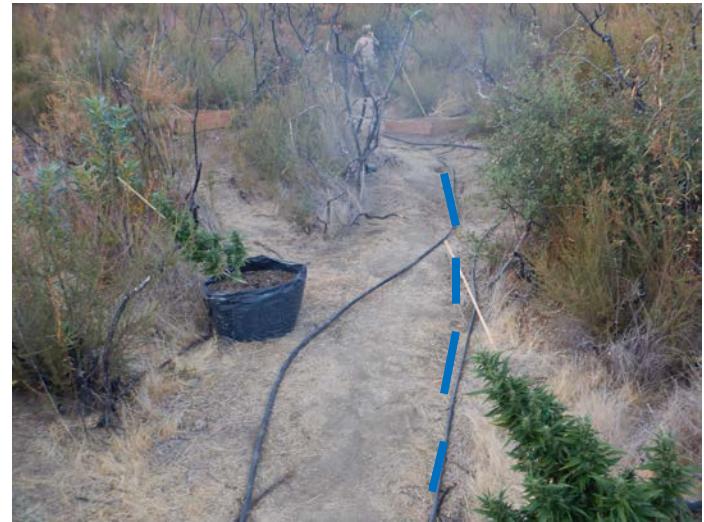
Photo 12. View of active cannabis cultivation in Cultivation Area Three. The dashed blue line shows the approximate location of the defined Class III watercourse channel.

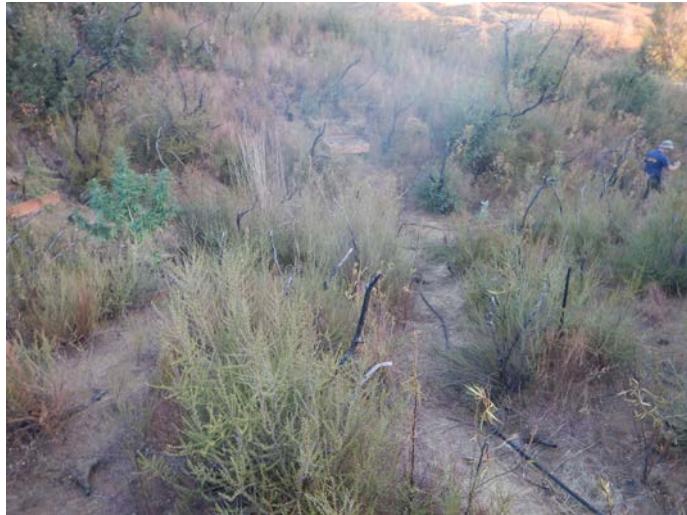
Photo 15. View looking east at the Cultivation Area Five, located in a Class III watercourse.

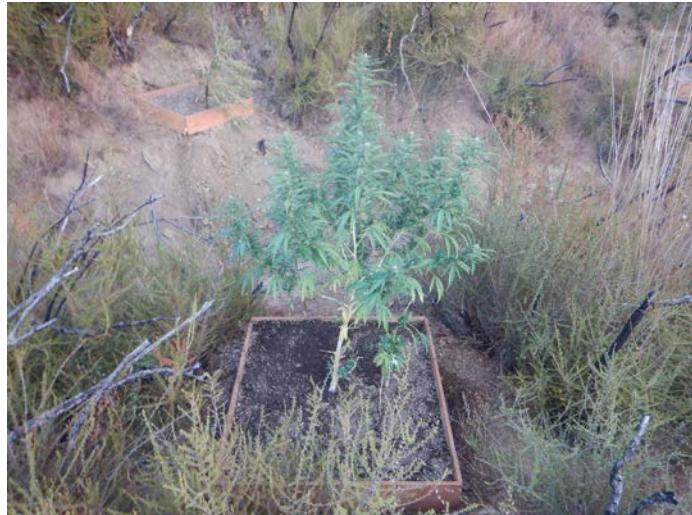
Photo 16. View of the constructed lumber grow boxes placed on the native soil surface containing imported potting soil in Cultivation Area Five.

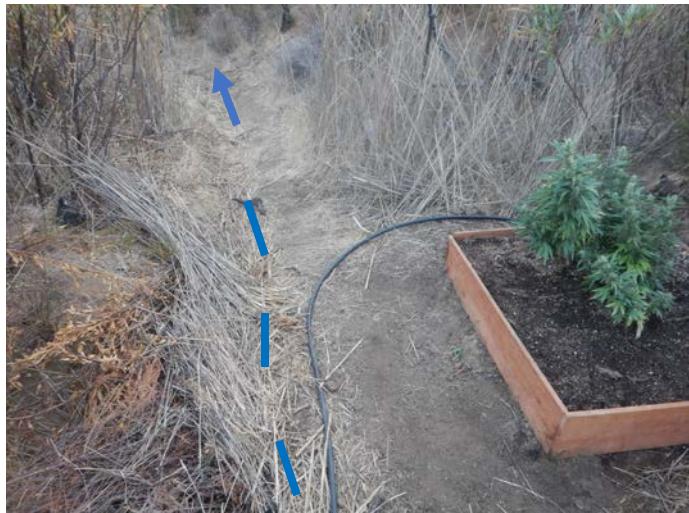
Photo 17. View looking at the proximity of the constructed lumber grow boxes to the Class III watercourse in Cultivation Area Five. Note, dashed and arrowed blue line shows approximate path of flow of Class III watercourse.

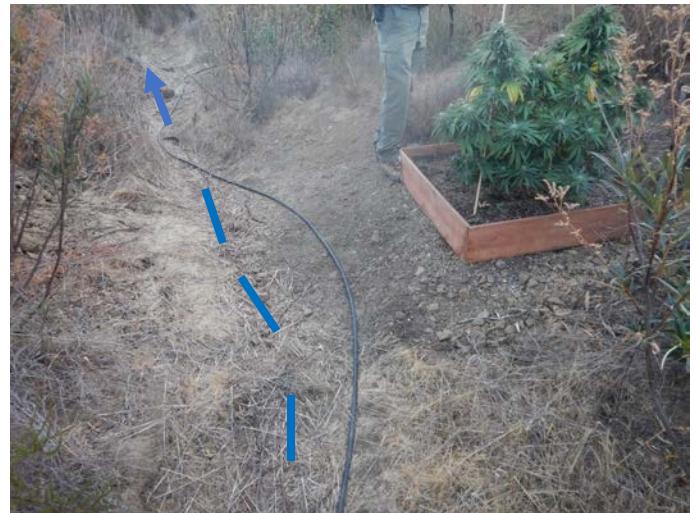
Photo 18. View of the soil disturbance and placement of excavated soil in and near the Class III watercourse in Cultivation Area Five. Note, dashed and arrowed blue line shows approximate path of flow of Class III watercourse.

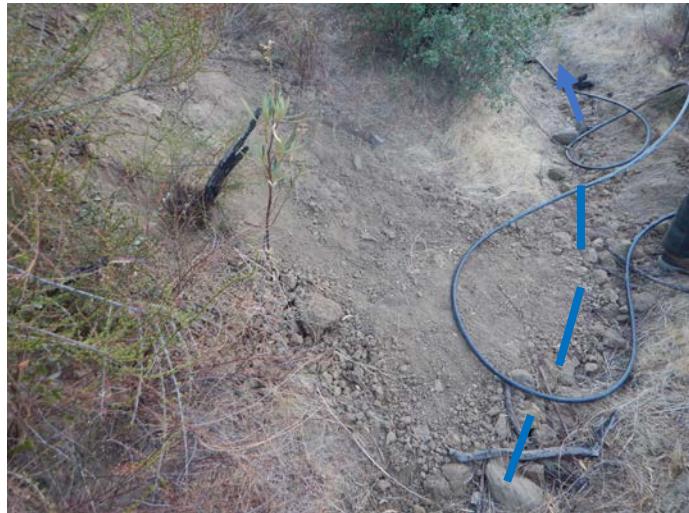
Photo 19. Excavated native soil placed in the Class III watercourse in Cultivation Area Five. Note, dashed and arrowed blue line shows approximate path of flow of Class III watercourse.

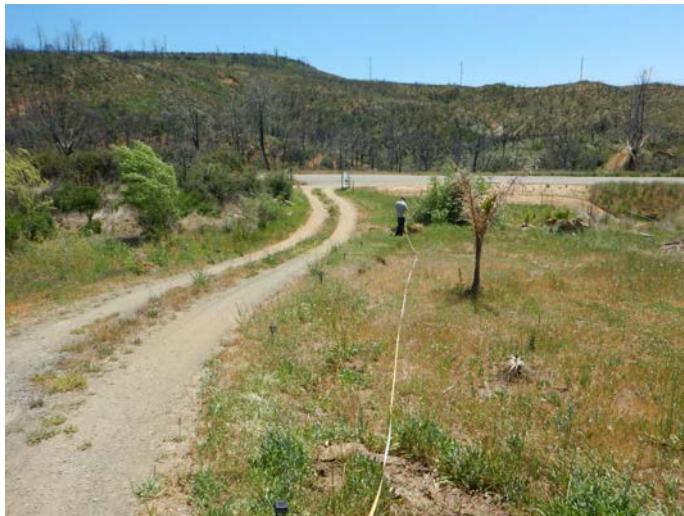
Photo 1. View looking at the private road and Morgan Valley Road.

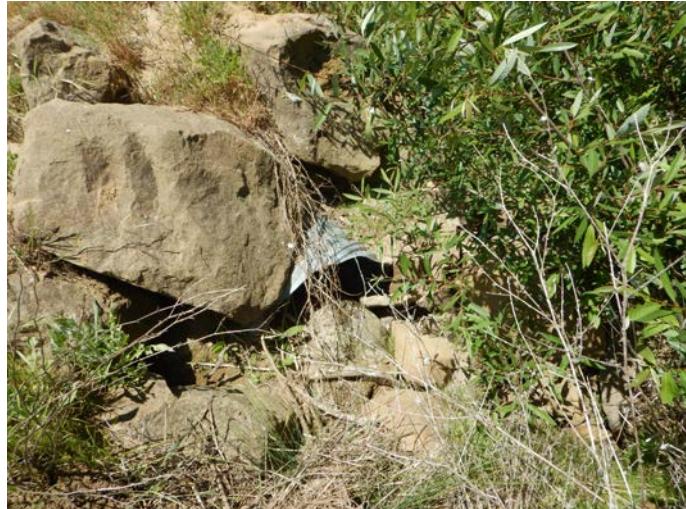
Photo 3. View looking at the plugged Inlet of the corrugated metal pipe (CMP). Inlet basin is filled with cobble and fine sediment.

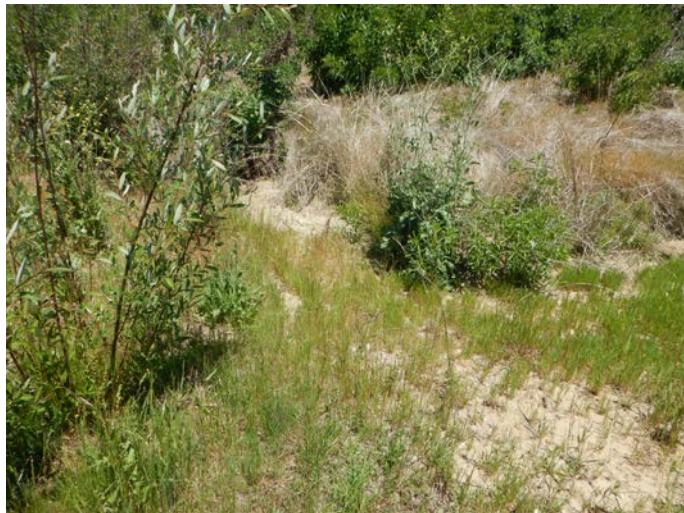
Photo 5. View looking at class III watercourse channel where large amounts of fine sediment have accumulated behind the plugged Watercourse Crossing.

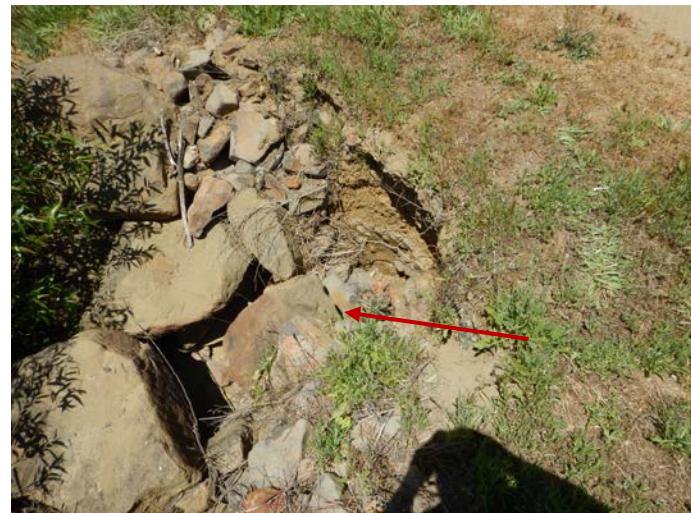
Photo 6. View looking at the eroded vertical fill slope above the outlet of the Watercourse Crossing. Large boulders and cobbles have obstructed the outlet. Red arrow points to the outlet of the culvert.

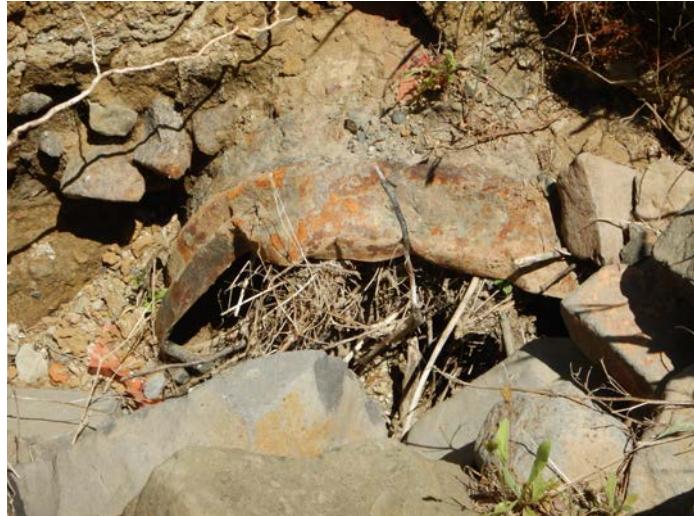
Photo 7. View looking at the plugged outlet of the Watercourse Crossing.

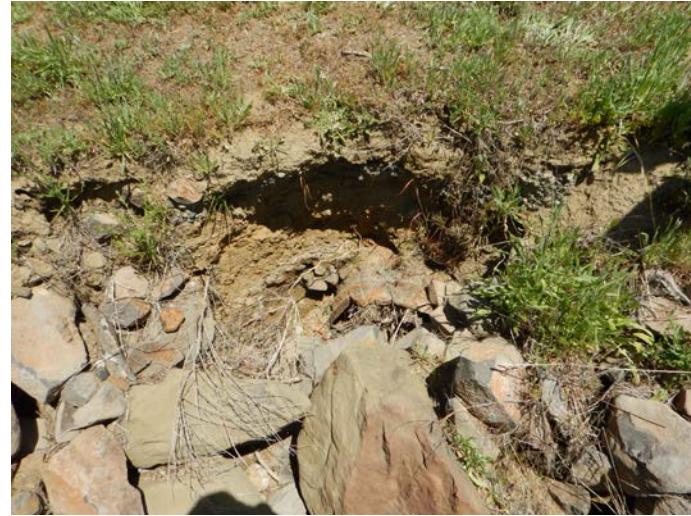
Photo 8. View looking at the overall condition of the outlet of the Watercourse Crossing. Culvert outlet is plugged with sediment and woody debris.

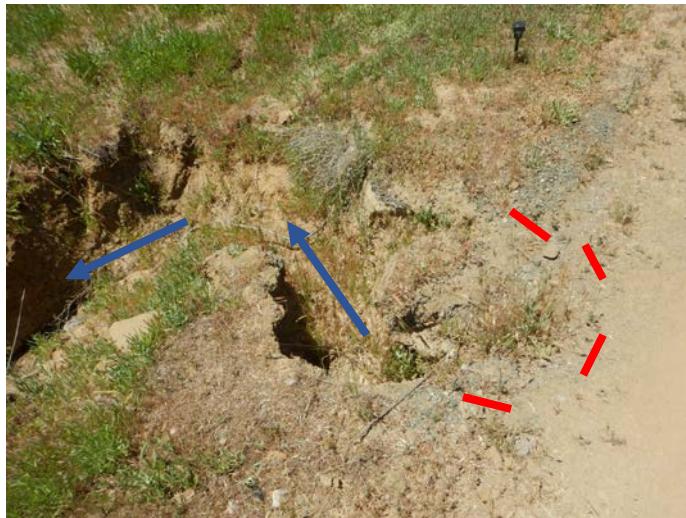
Photo 9. View of the fill slope west of the culvert outlet. The gully in the road has created a head cut into the road surface. Blue arrows depict flow path. Red dashes show propagating head cut.

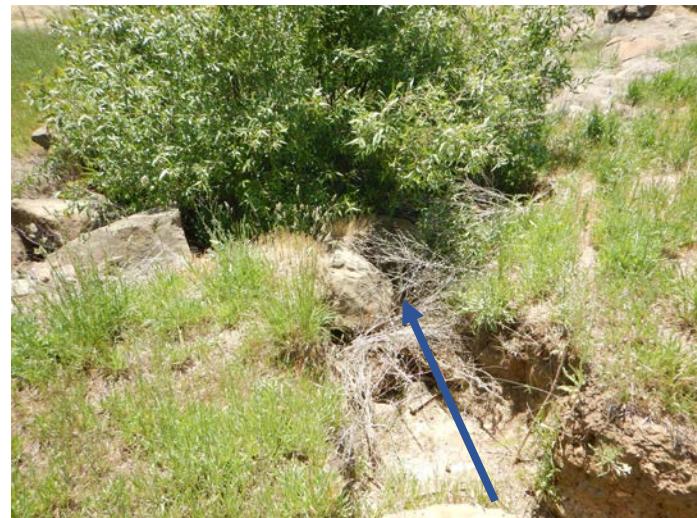
Photo 10. View of the gully west of the Watercourse Crossing. Blue arrow depicts flow direction.

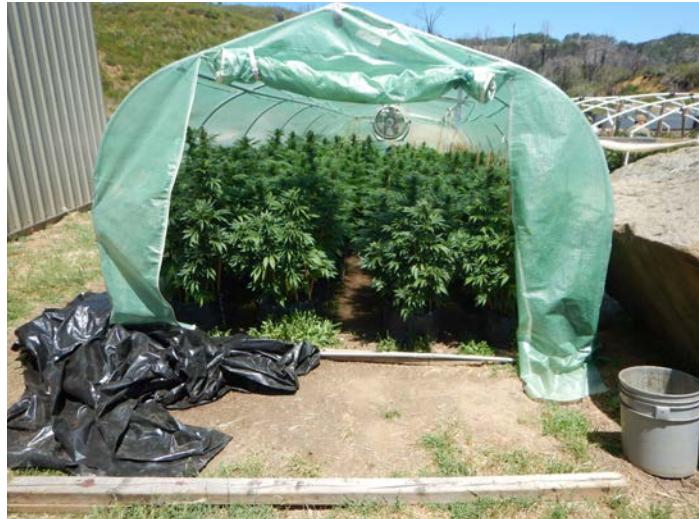
Photo 11. Cultivation Area One, Visible in view are two constructed hoop houses with mature cannabis plants being cultivated in plastic pots.

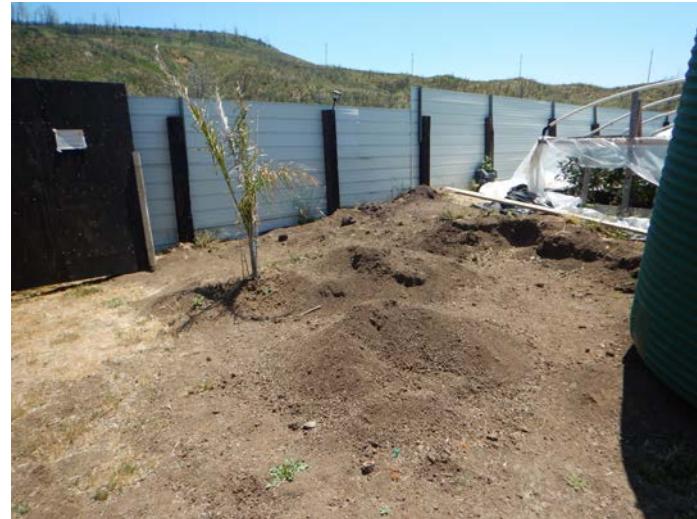
Photo 12. View of the stock pile of imported potting soil. Stock pile is not covered nor has the proper containment best management practices (BMP's).

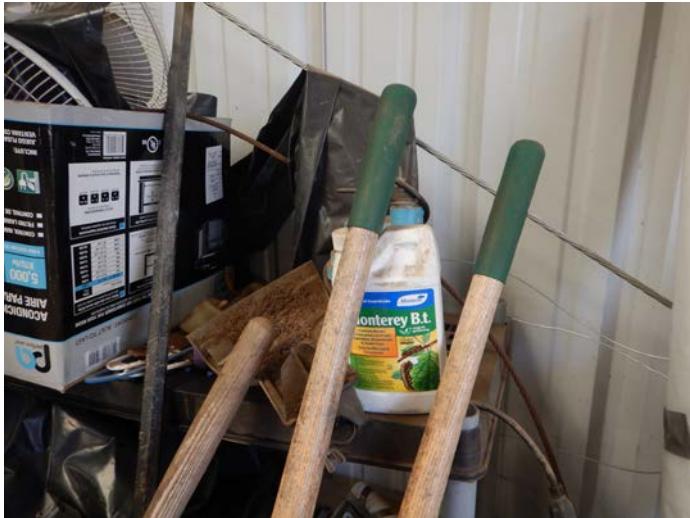
Photo 13. A capped bottle of insecticide stored in the permanent shop. The insecticide is a commonly used biological insecticide that is Organic Materials Review Institute (OMRI) certified.

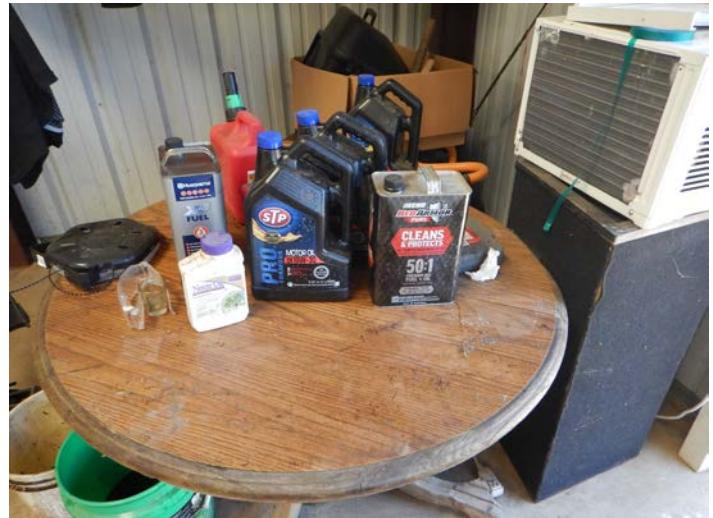
Photo 14. Variety of petroleum products stored permanent shed. The uncovered white and green five-gallon buckets on the lower left of the photo contained an unknown liquid.

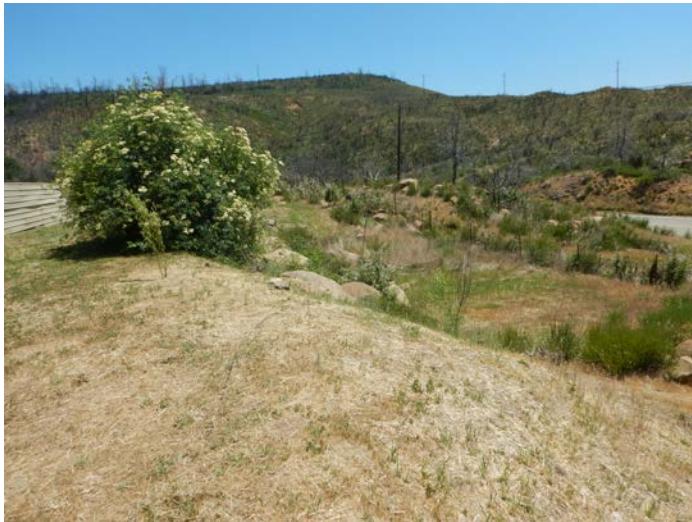
Photo 15. Well vegetated fill slopes of the graded pad, with rock slope protection (RSP). Permanent shop and Cultivation Area One are located to the left of the photo.

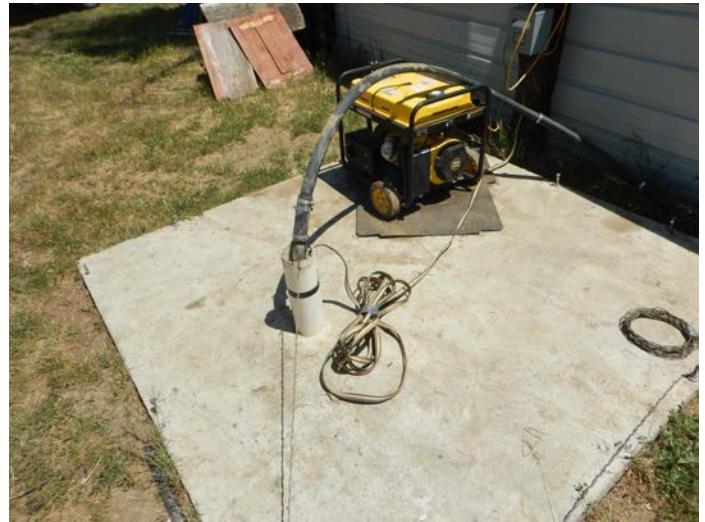
Photo 16. View of the well. The well head is uncapped, with rubber tubing and an extension cord extending down the hole.

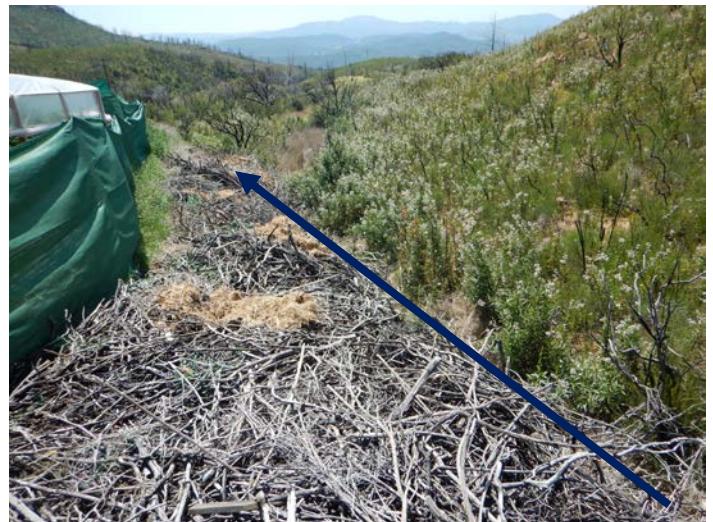
Photo 18. View of vegetation slash on the fill slope of the graded pad. Blue arrowed line shows general location of the Class III watercourse and flow direction.

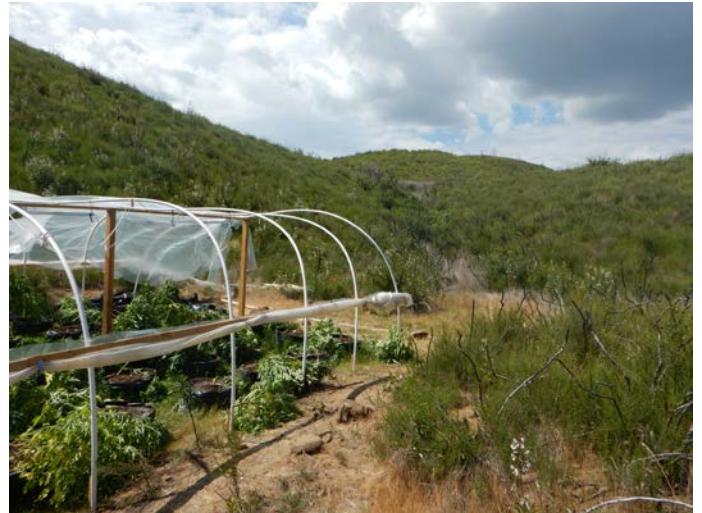
Photo 20. View of Cultivation Area Three which is placed within a low gradient portion of a Class III watercourse.

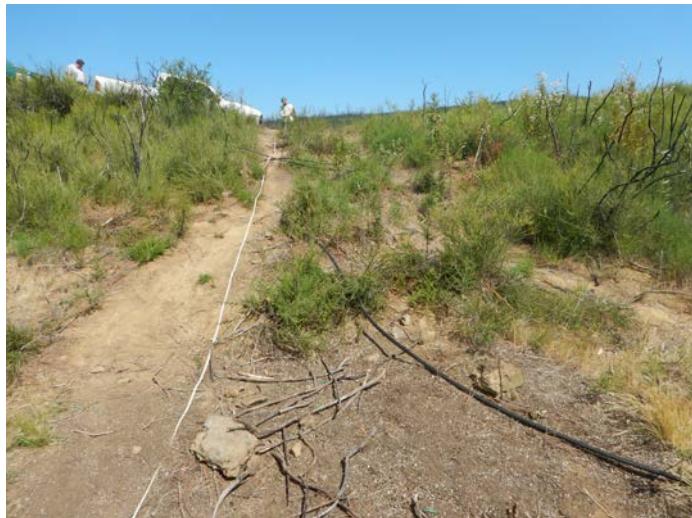
Photo 21. View looking at the foot path that accesses Cultivation Area Three.

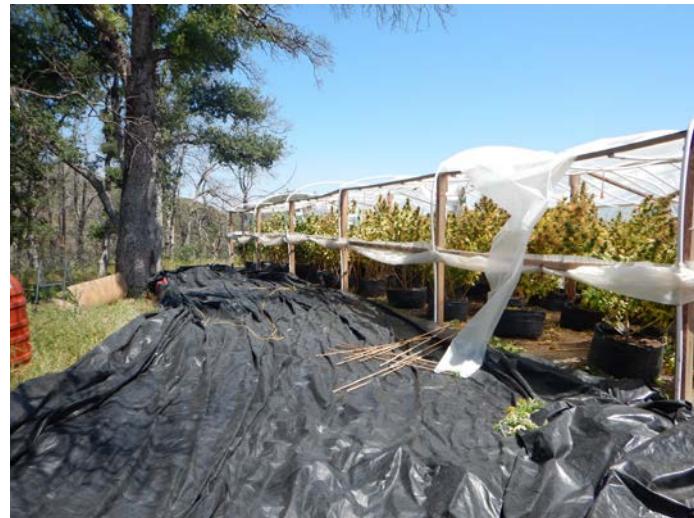
Photo 22. View looking south east at Cultivation Area Four.

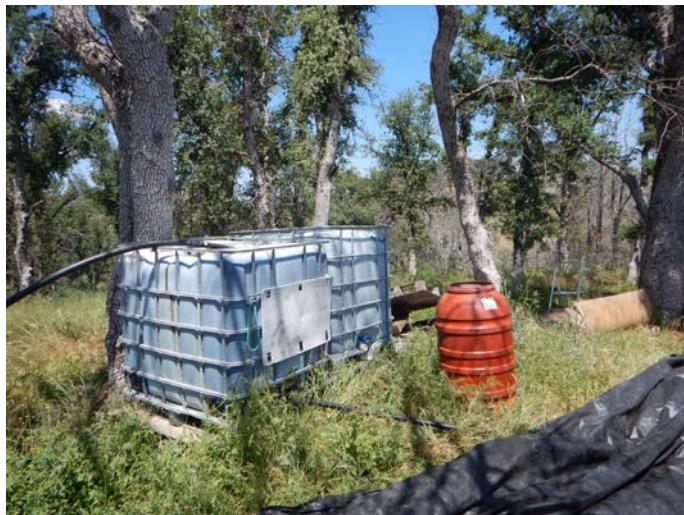
Photo 23. View looking at northern edge of Cultivation Four and the two IBC's and one 50-gallon barrel. These were filled with an unknown liquid.
