**Leviathan Mine
December 2012
TAC Meeting
Lahontan Water Board**

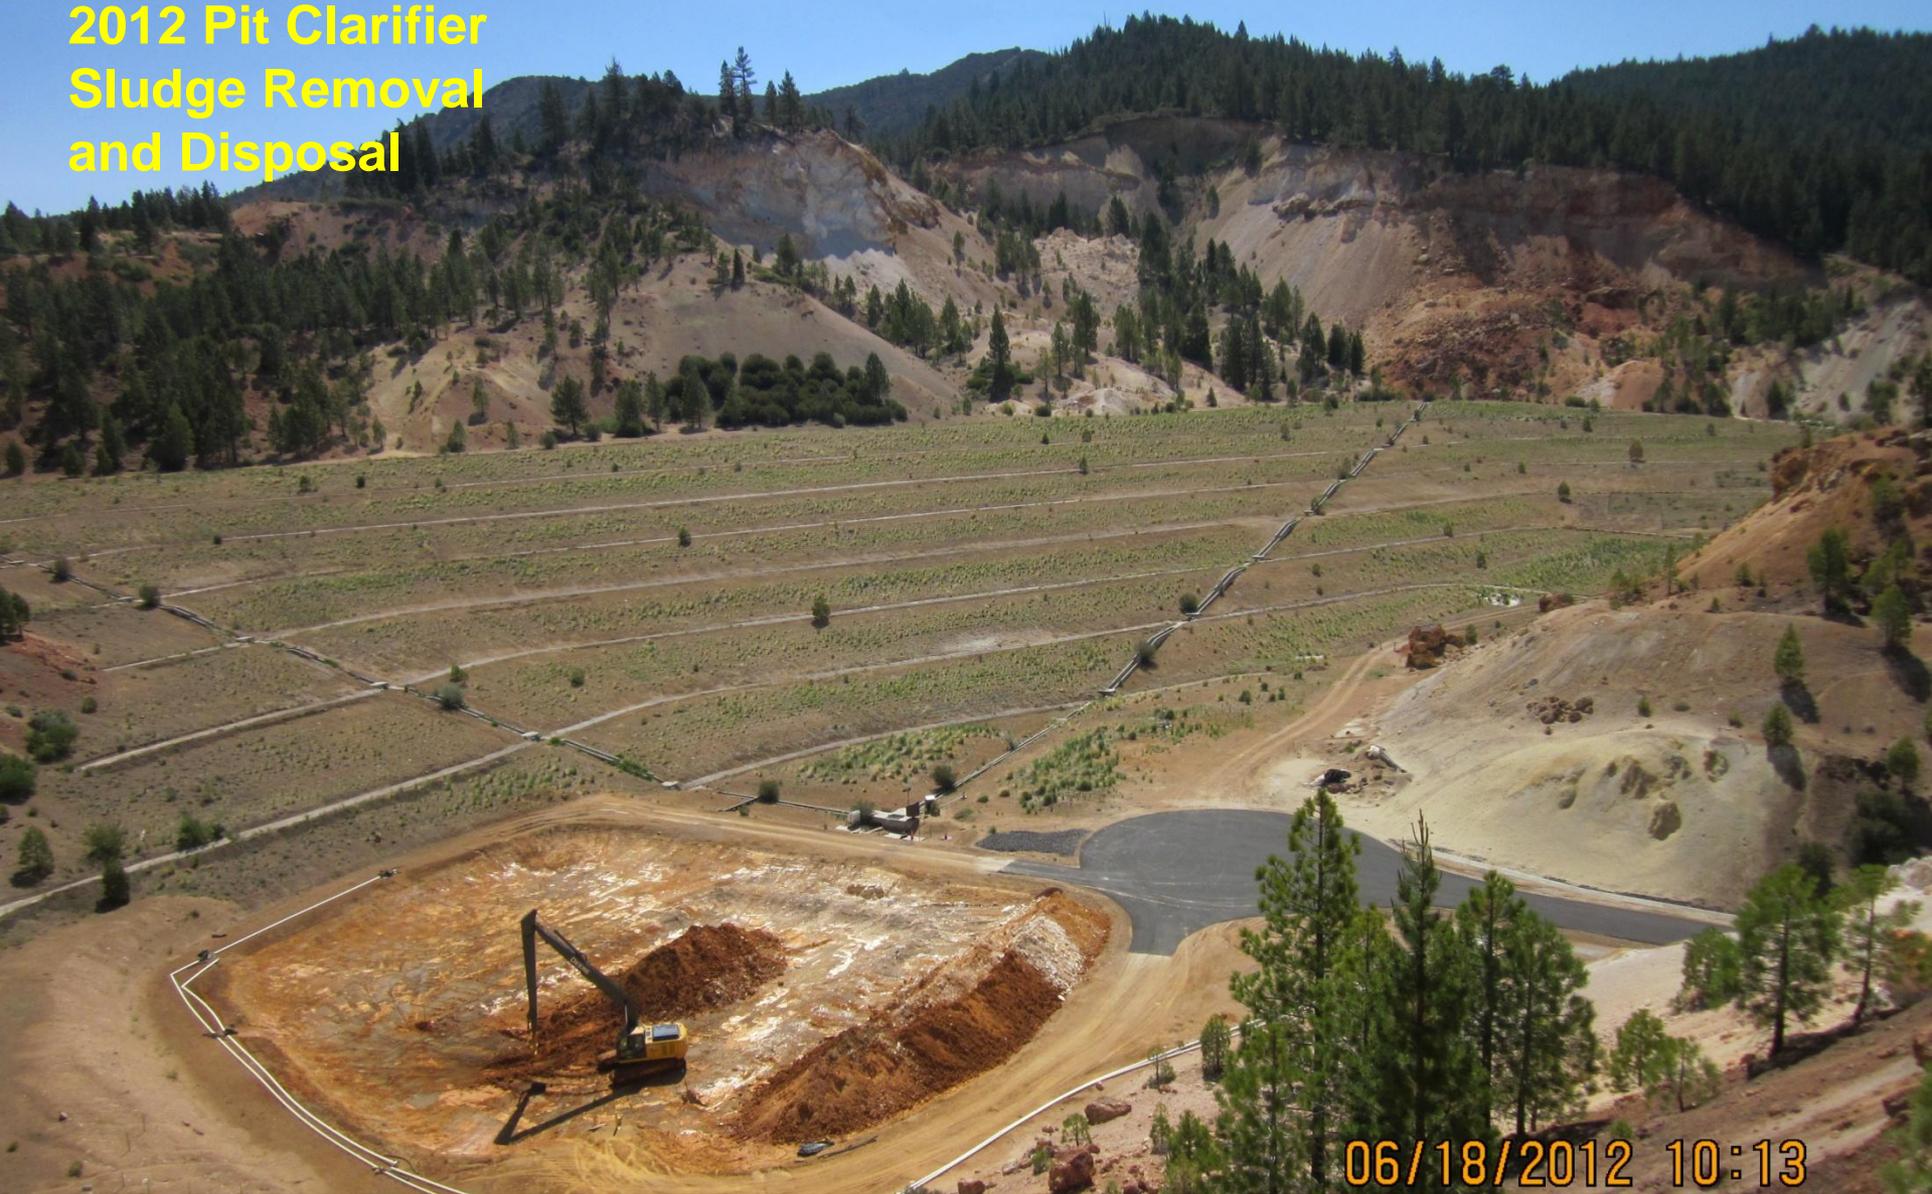
2012 Pit Clarifier Sludge Removal and Disposal

- Approximately 1,000 tons of sludge were hauled off site for disposal in late June.
- Sludge generated during the treatment of 9.8 million gallons of AMD in 2011.

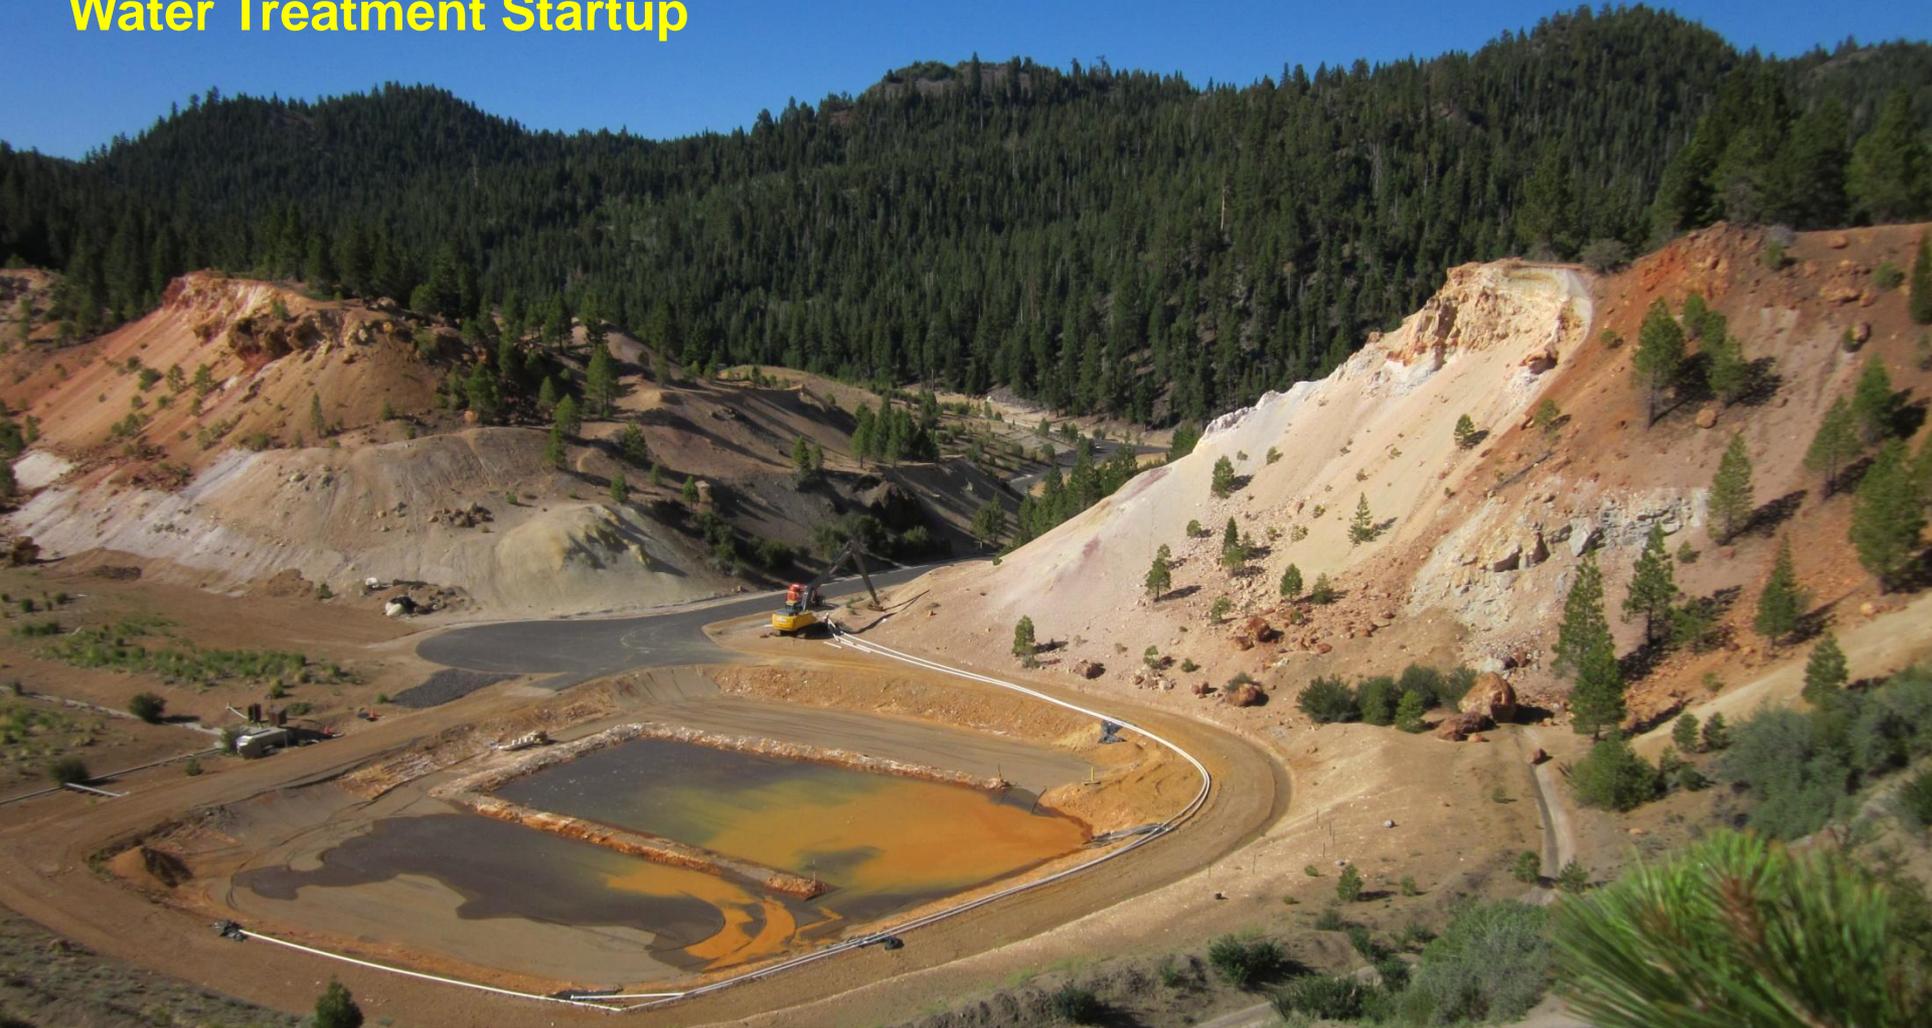
2012 Summer Pond Water Treatment Startup

- Pit Clarifier sand layer replenished following sludge disposal in 2012
- Assembly of pond water treatment plant
- Discharge of treated AMD to the Pit Clarifier began on July 9, 2012
- Discharge of treated AMD to Leviathan Creek began on July 12, 2012

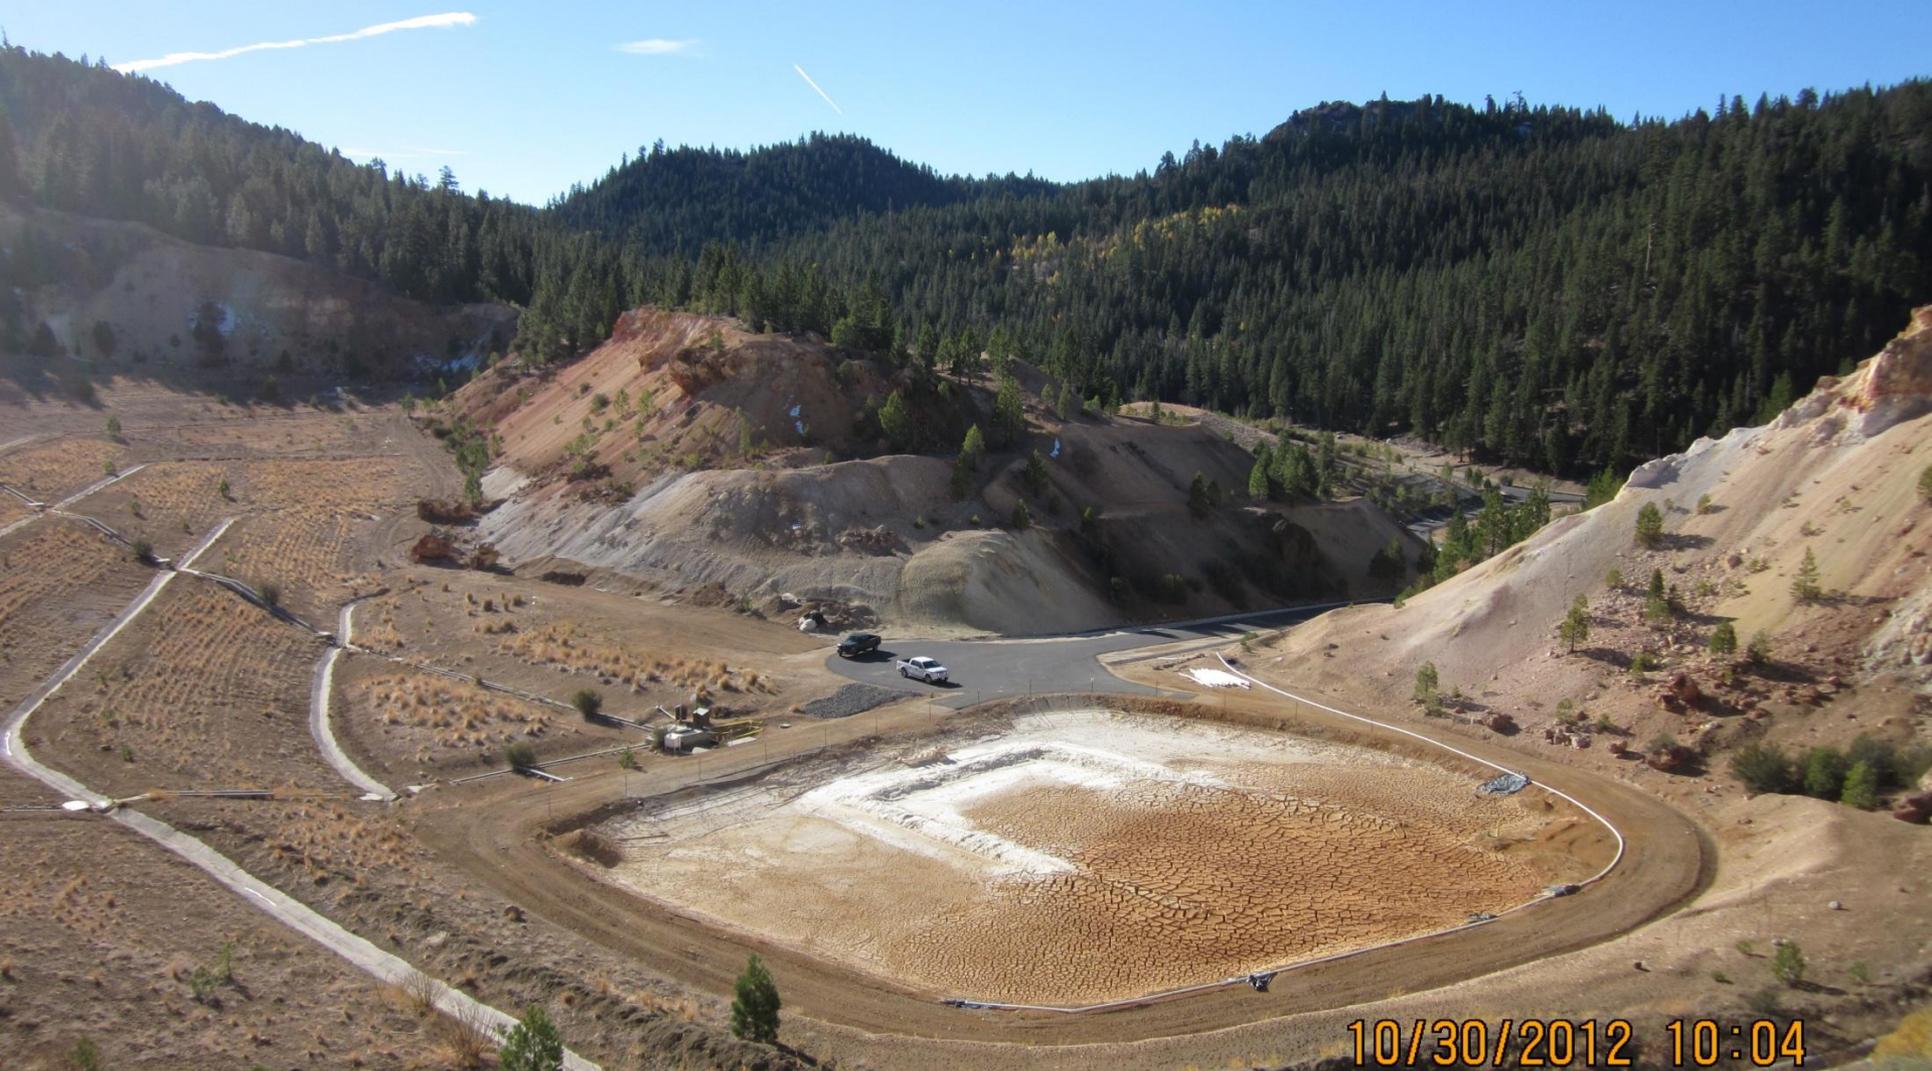
Sludge generated is contained in the pit clarifier

~ 240 – 300 tons of sludge generated during the 2012 season will be hauled off site for disposal in 2013.

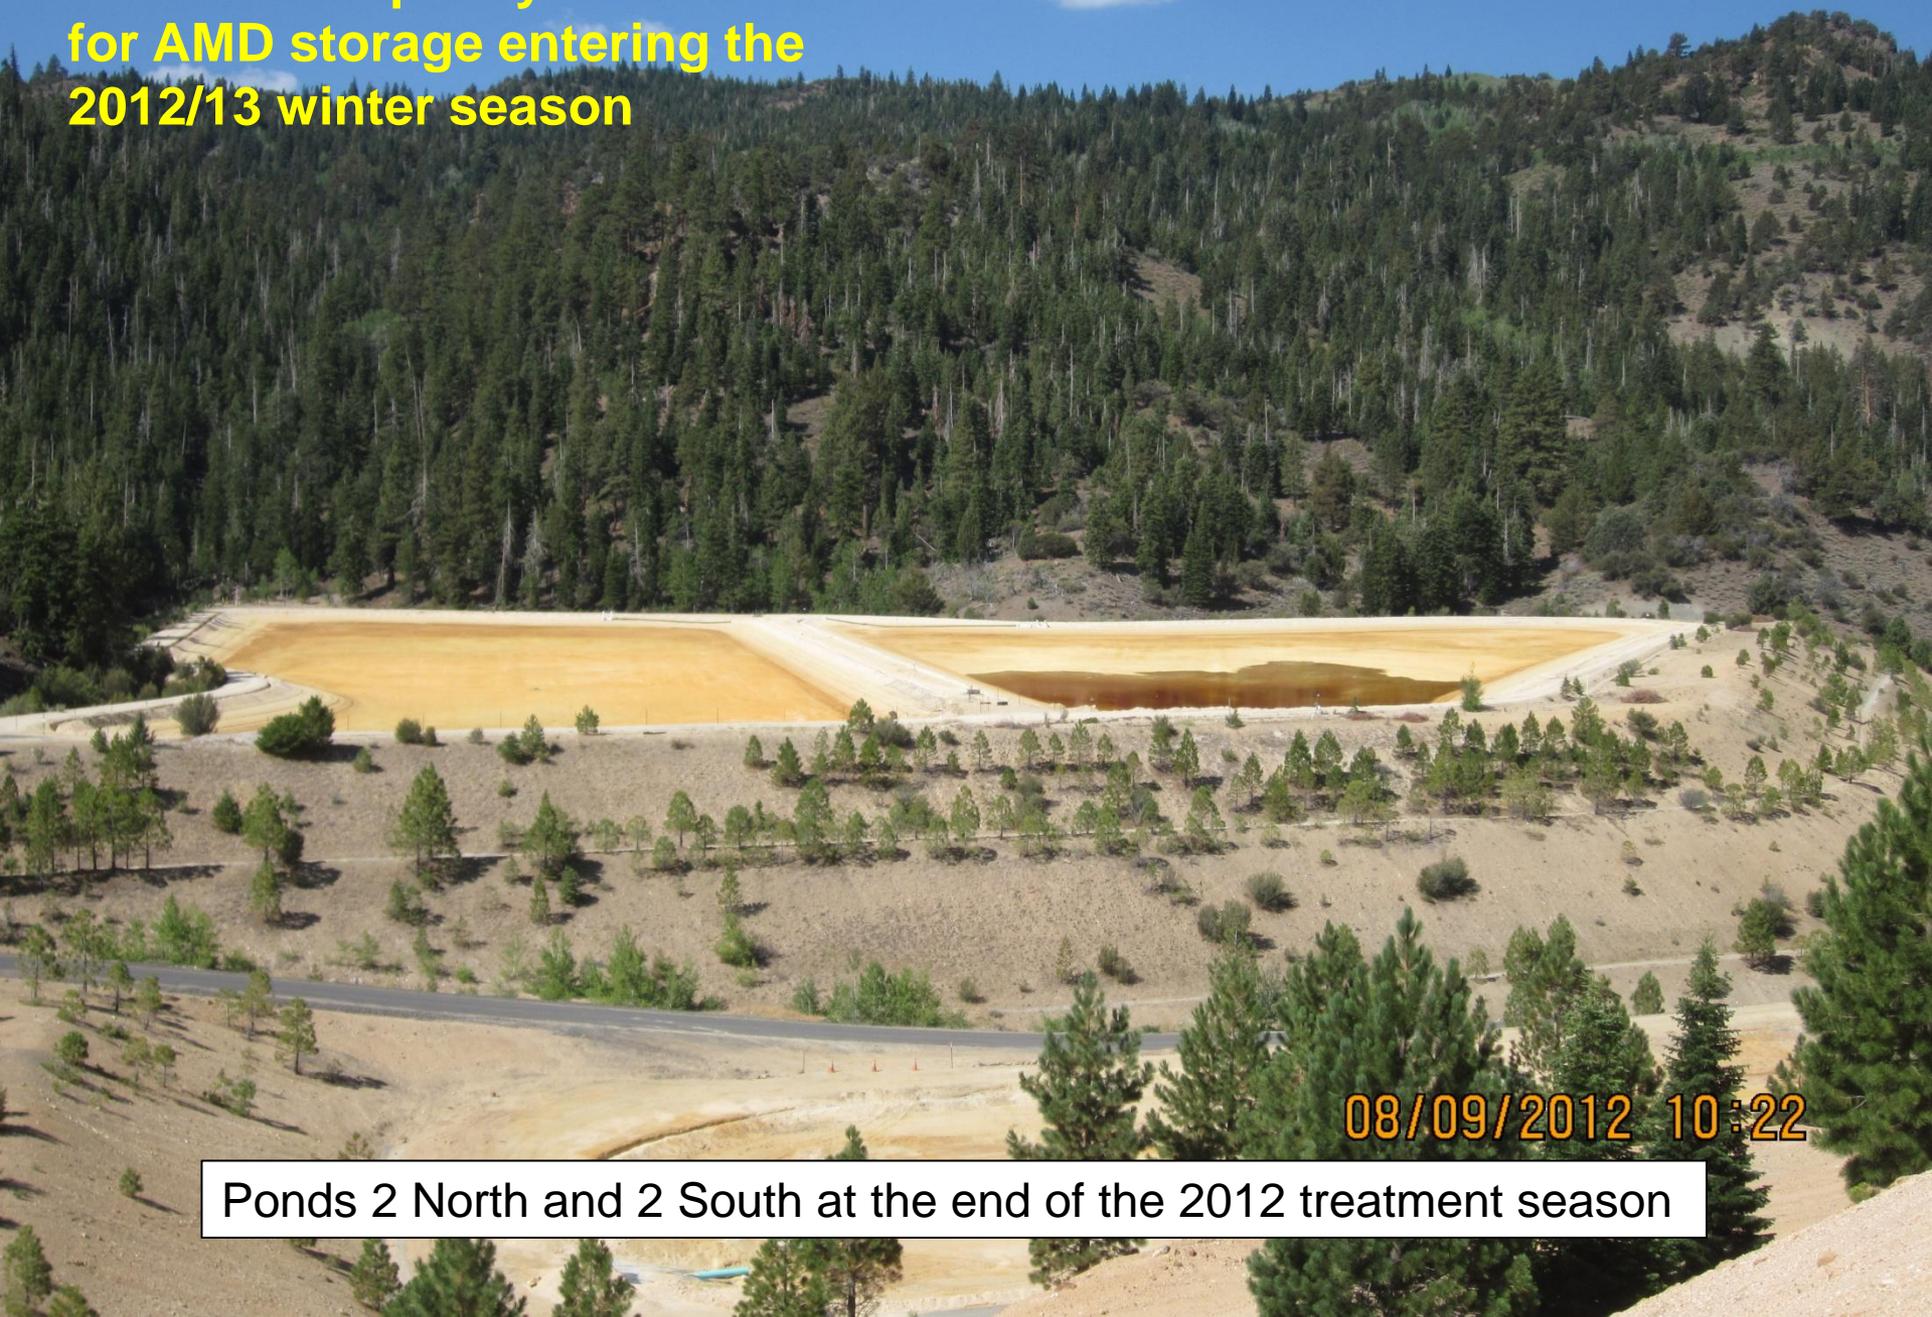
Ponds 2 North and 2 South at the end of the 2012 treatment season

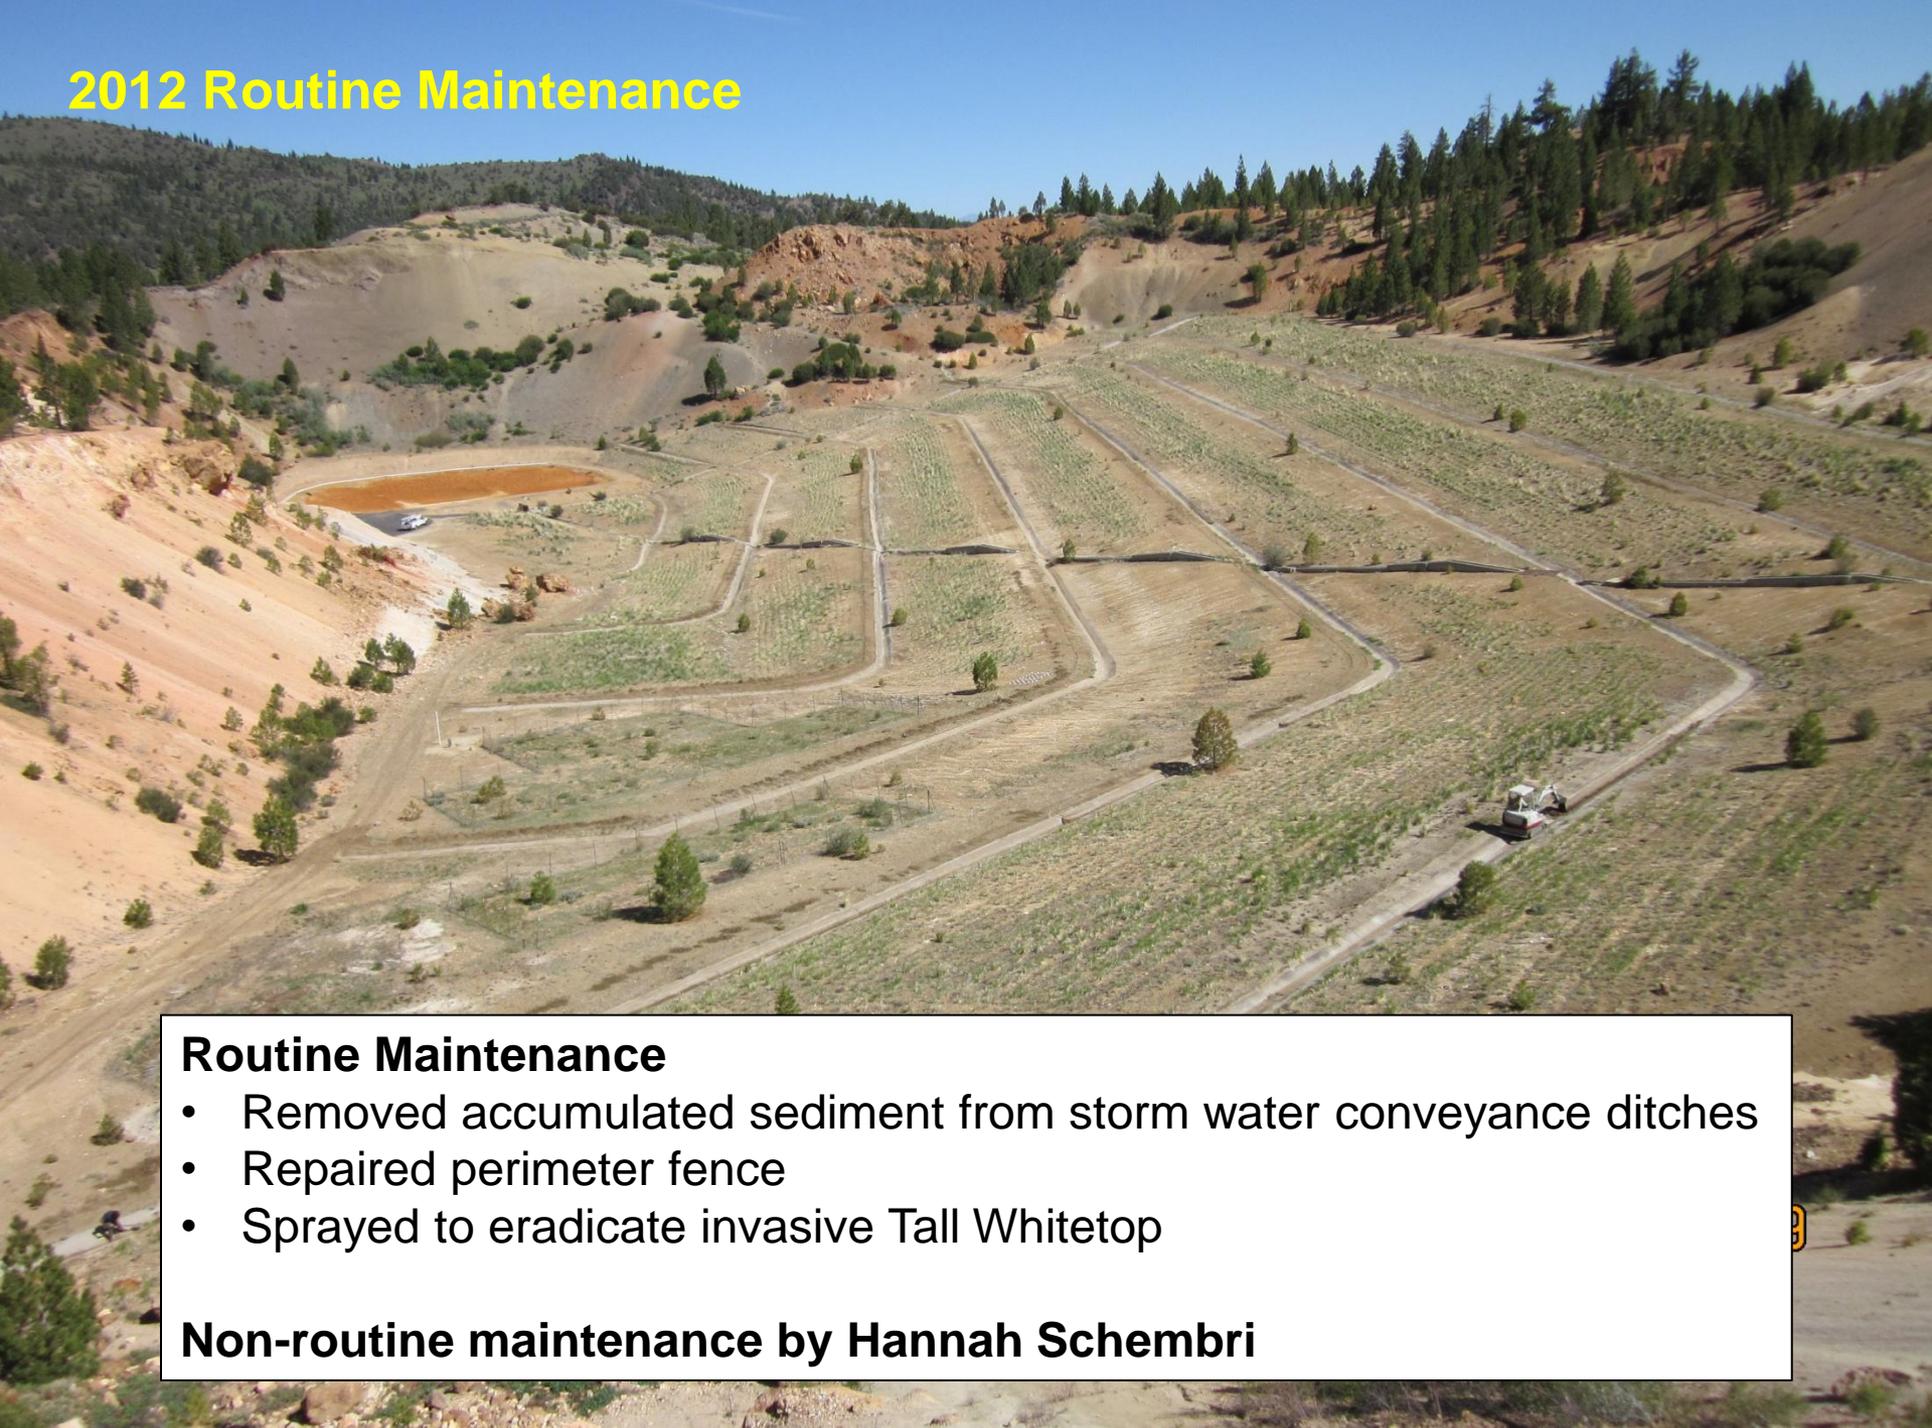
2012 Routine Maintenance

- Removed accumulated sediment from storm water conveyance ditches
- Repaired perimeter fence
- Sprayed to eradicate invasive Tall Whitetop

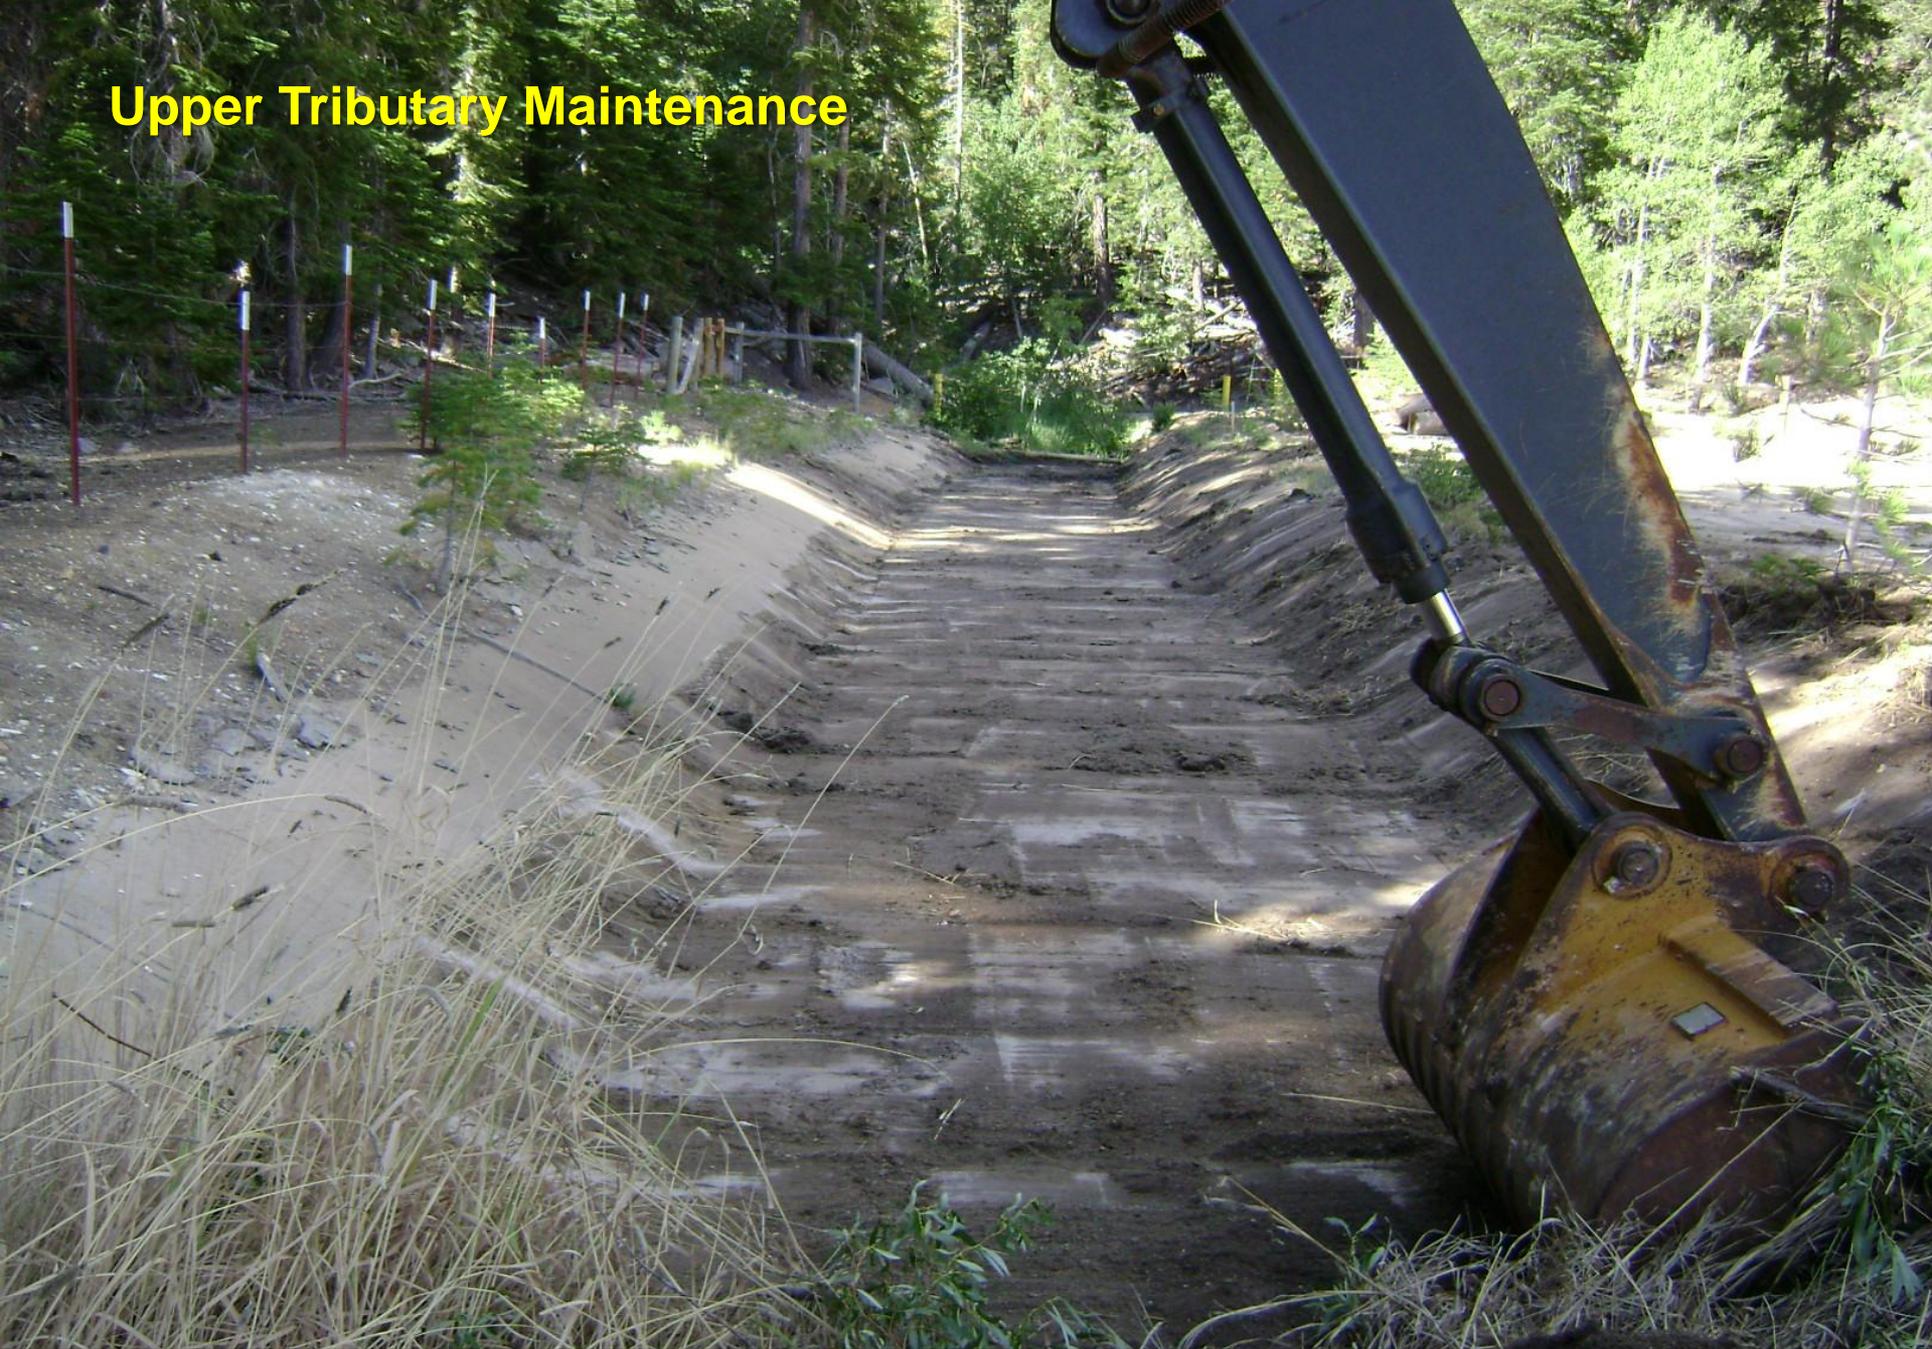
Upper Tributary Maintenance

- Removed accumulated sediment/debris from Upper Tributary conveyance channel

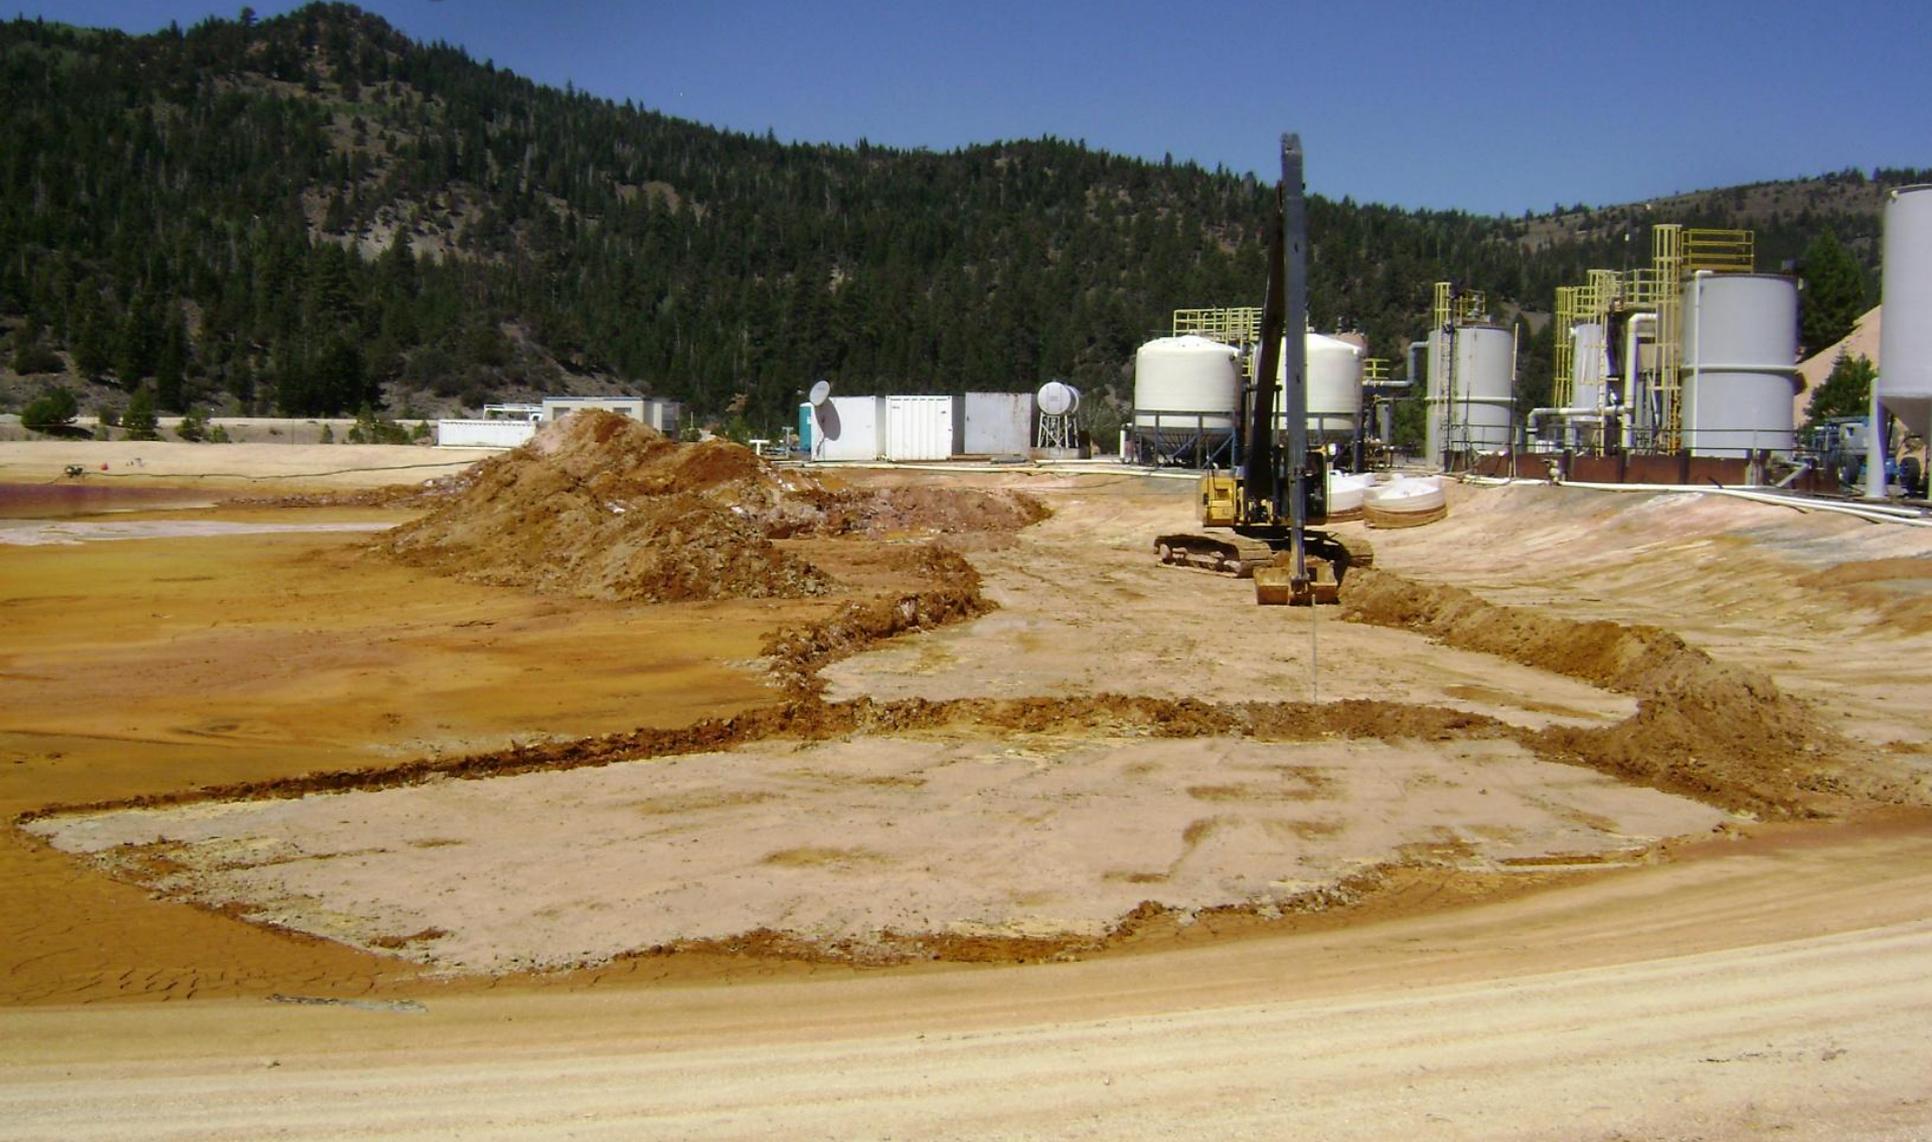
Pond 1 Sludge Removal

- Removed approx. 1660 tons of material from Pond 1
- Used long-arm tracked excavator and skid steer

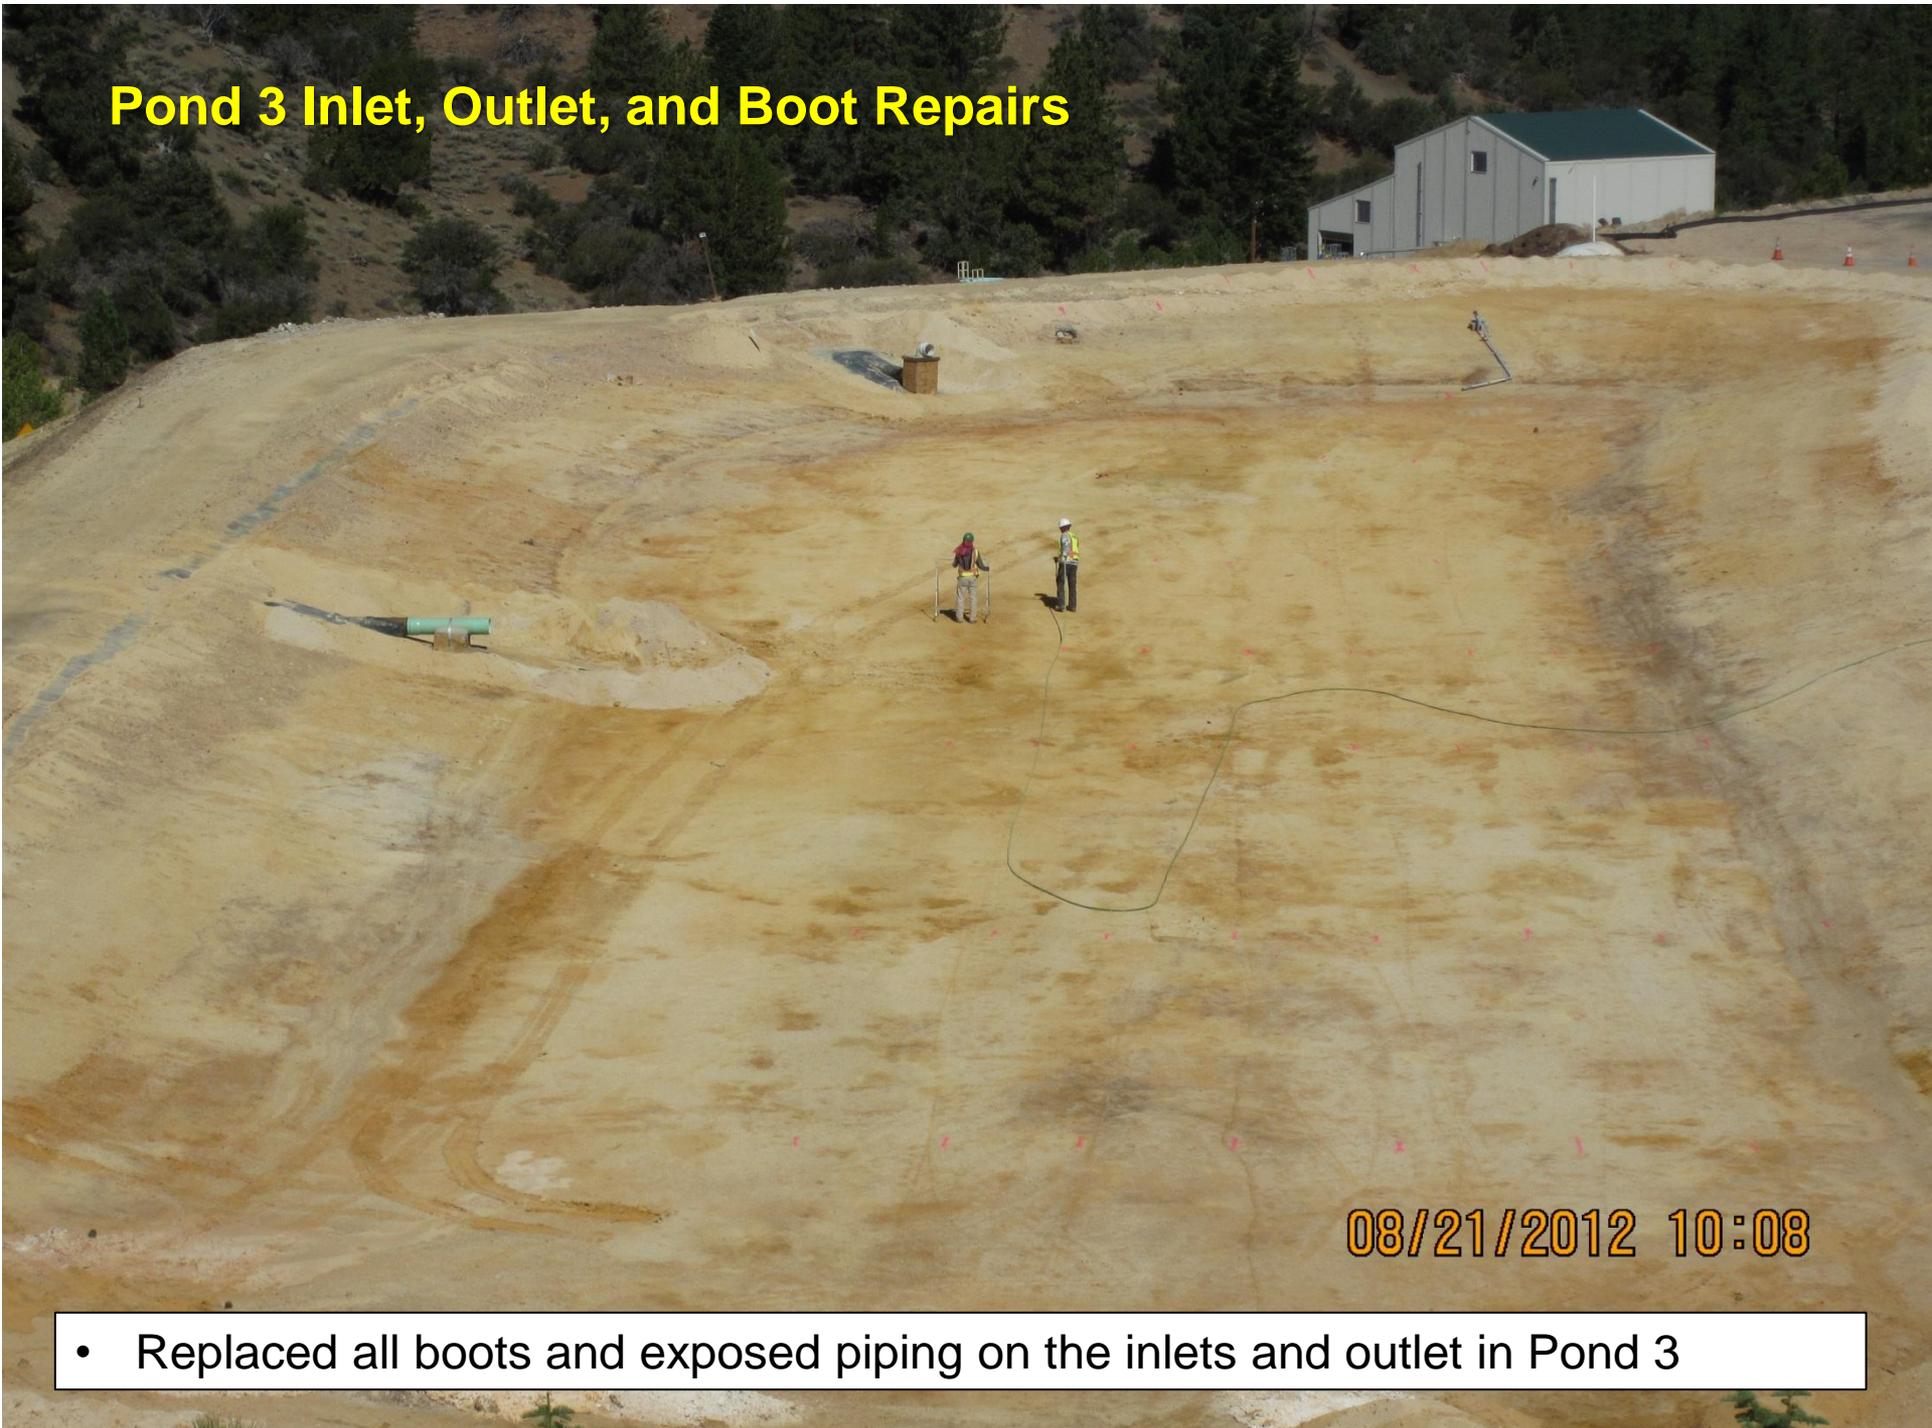
Pond 3 Inlet, Outlet, and Boot Repairs

- Replaced all boots and exposed piping on the inlets and outlet in Pond 3

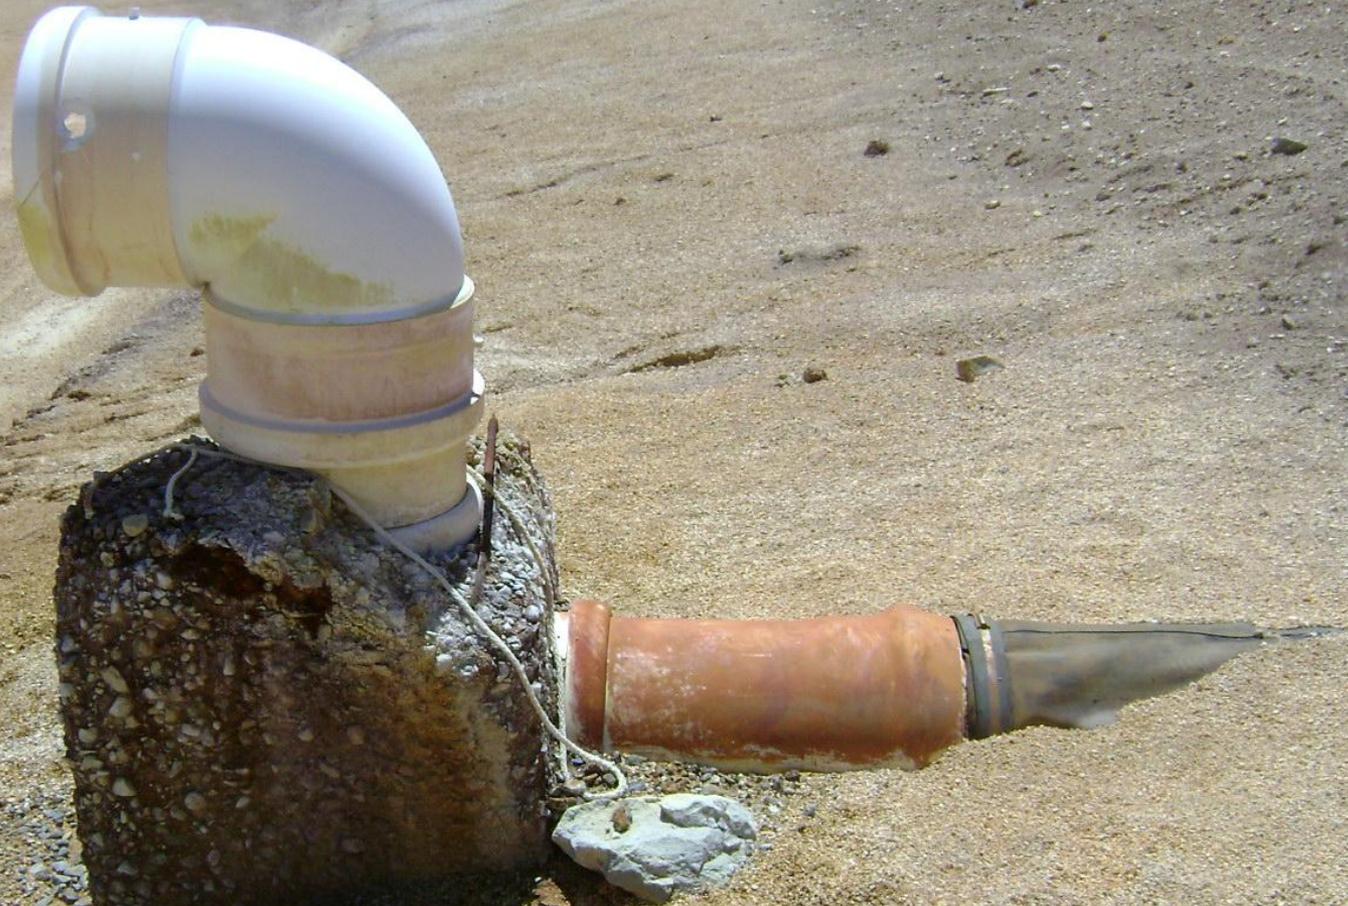
Pond 3 Inlet, Outlet, and Boot Repairs

- Pond 2 inlet prior to repairs

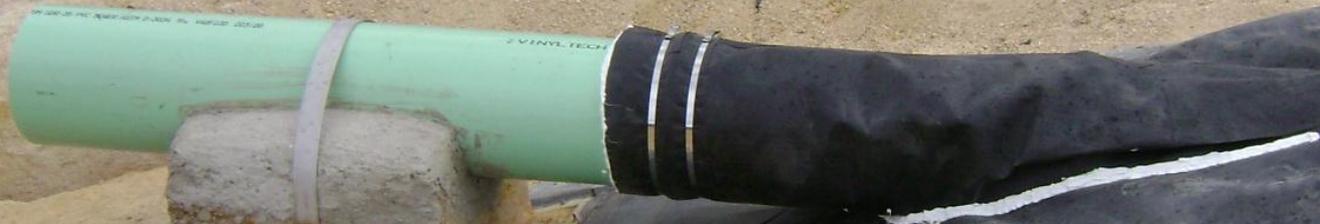
Pond 3 Inlet, Outlet, and Boot Repairs

- Enhanced stability of piping with stainless steel tie down on Pond 2 inlet
