**Leviathan Mine
December 2012
TAC Meeting
Lahontan Water Board**

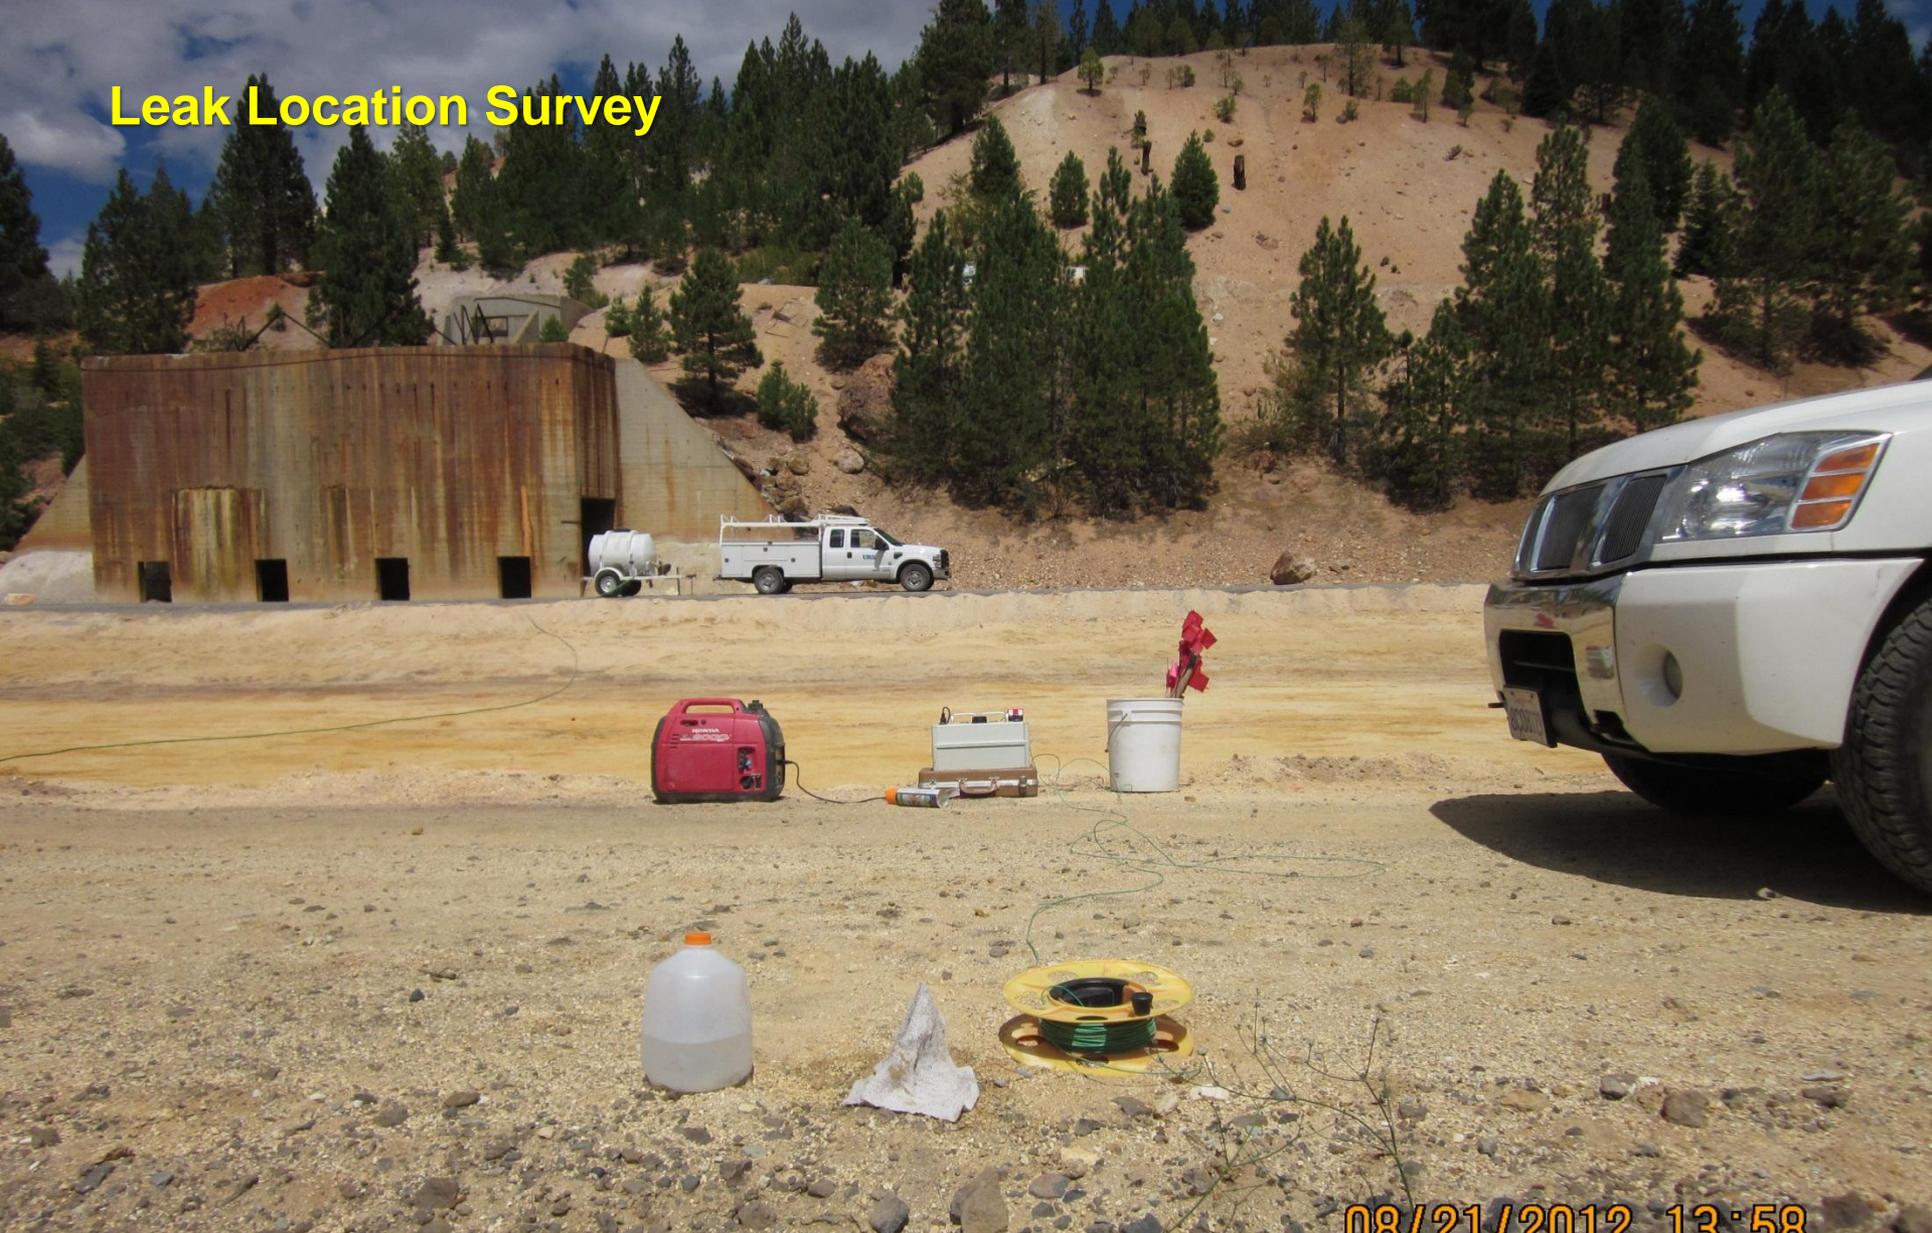
Leak Location Survey

- Conducted leak location survey on Pond 1, Pond 2 North and South, and Pond 3
- Used equipment to create a voltage potential throughout the earth cover material in survey area to detect anomalies

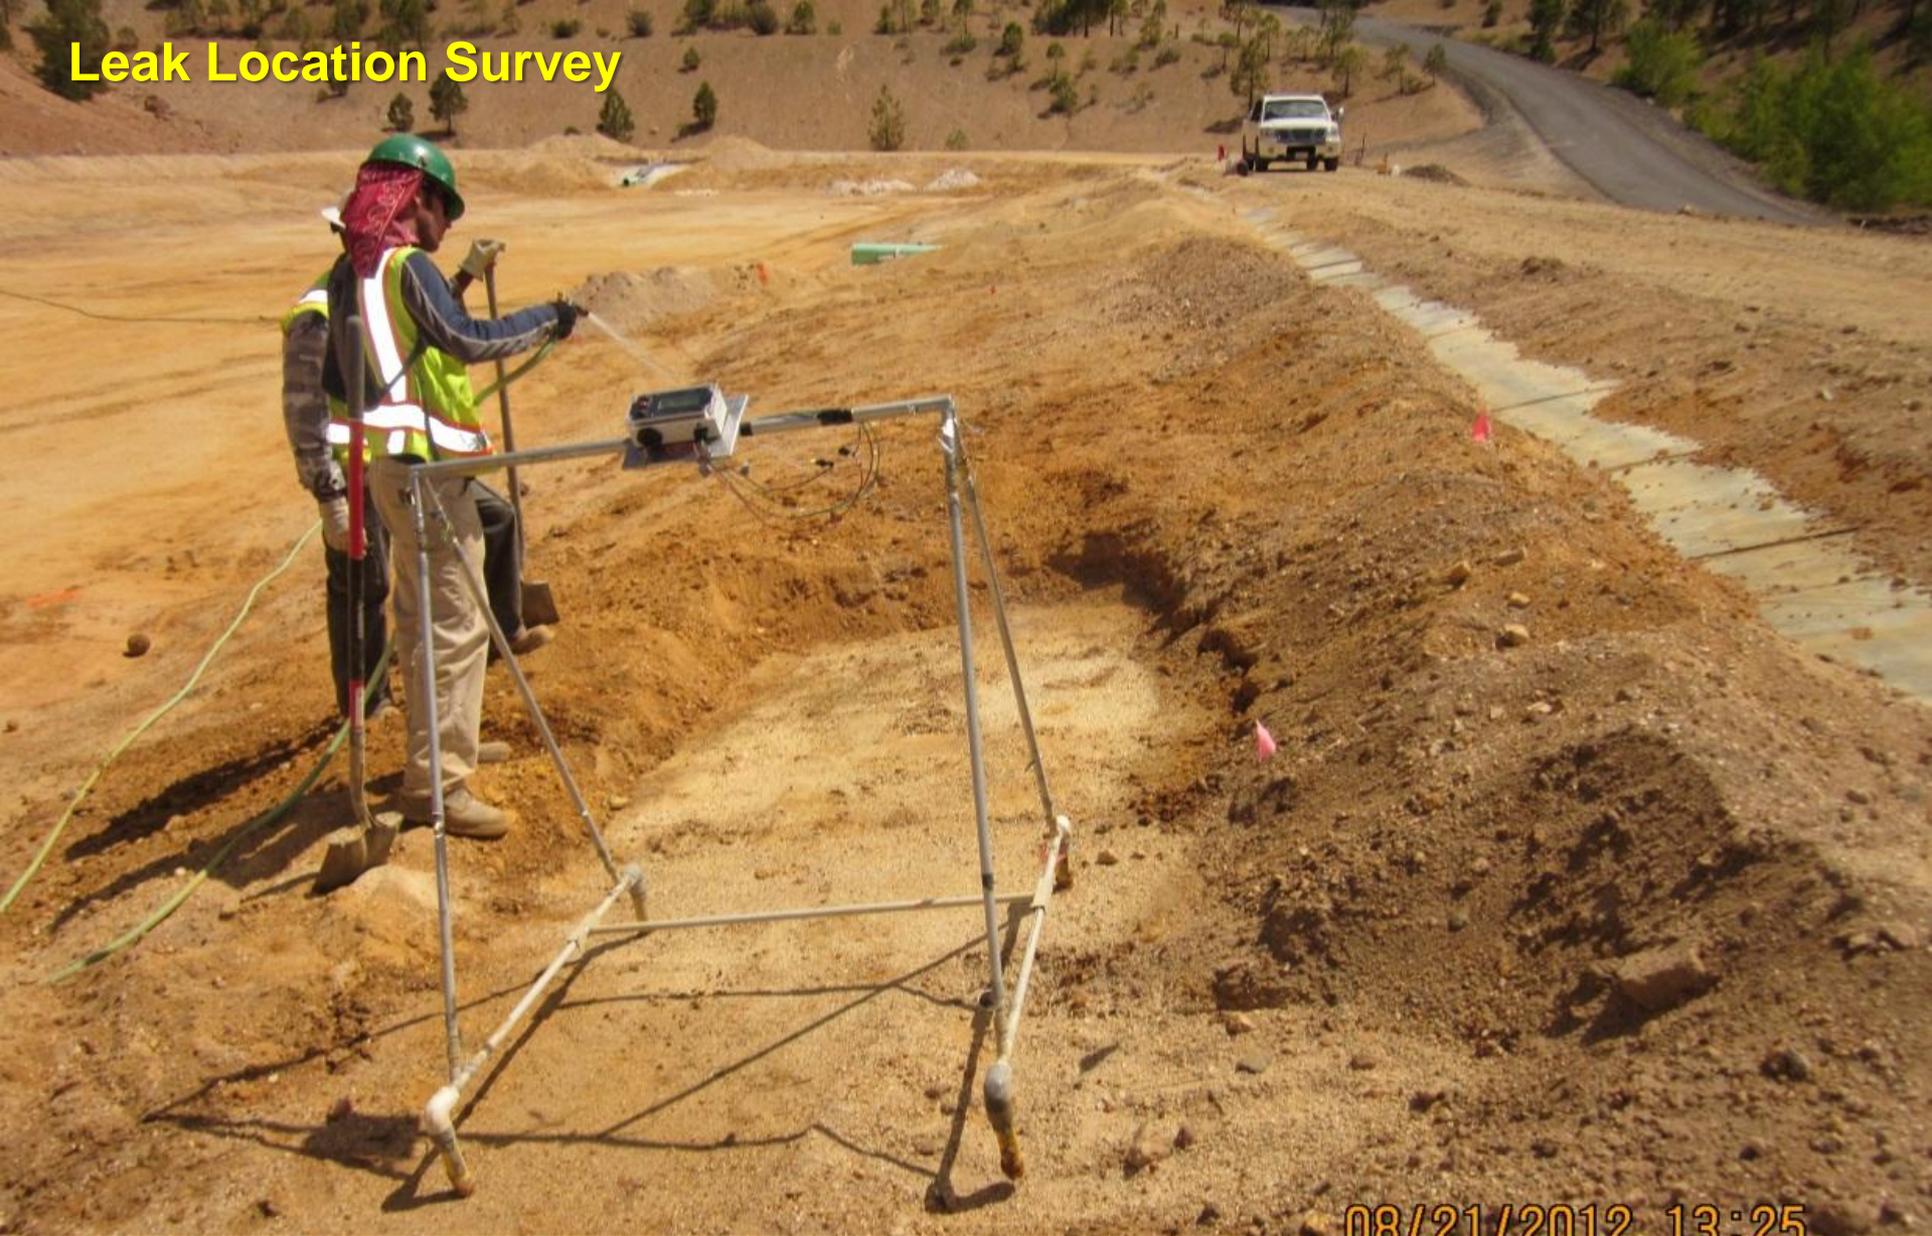
- Double Dipole used for Leak Location Survey
- Isolation trenches surrounding the area to be surveyed (Pond 3)
- Calibration process required a certain moisture content for pond liner cover material

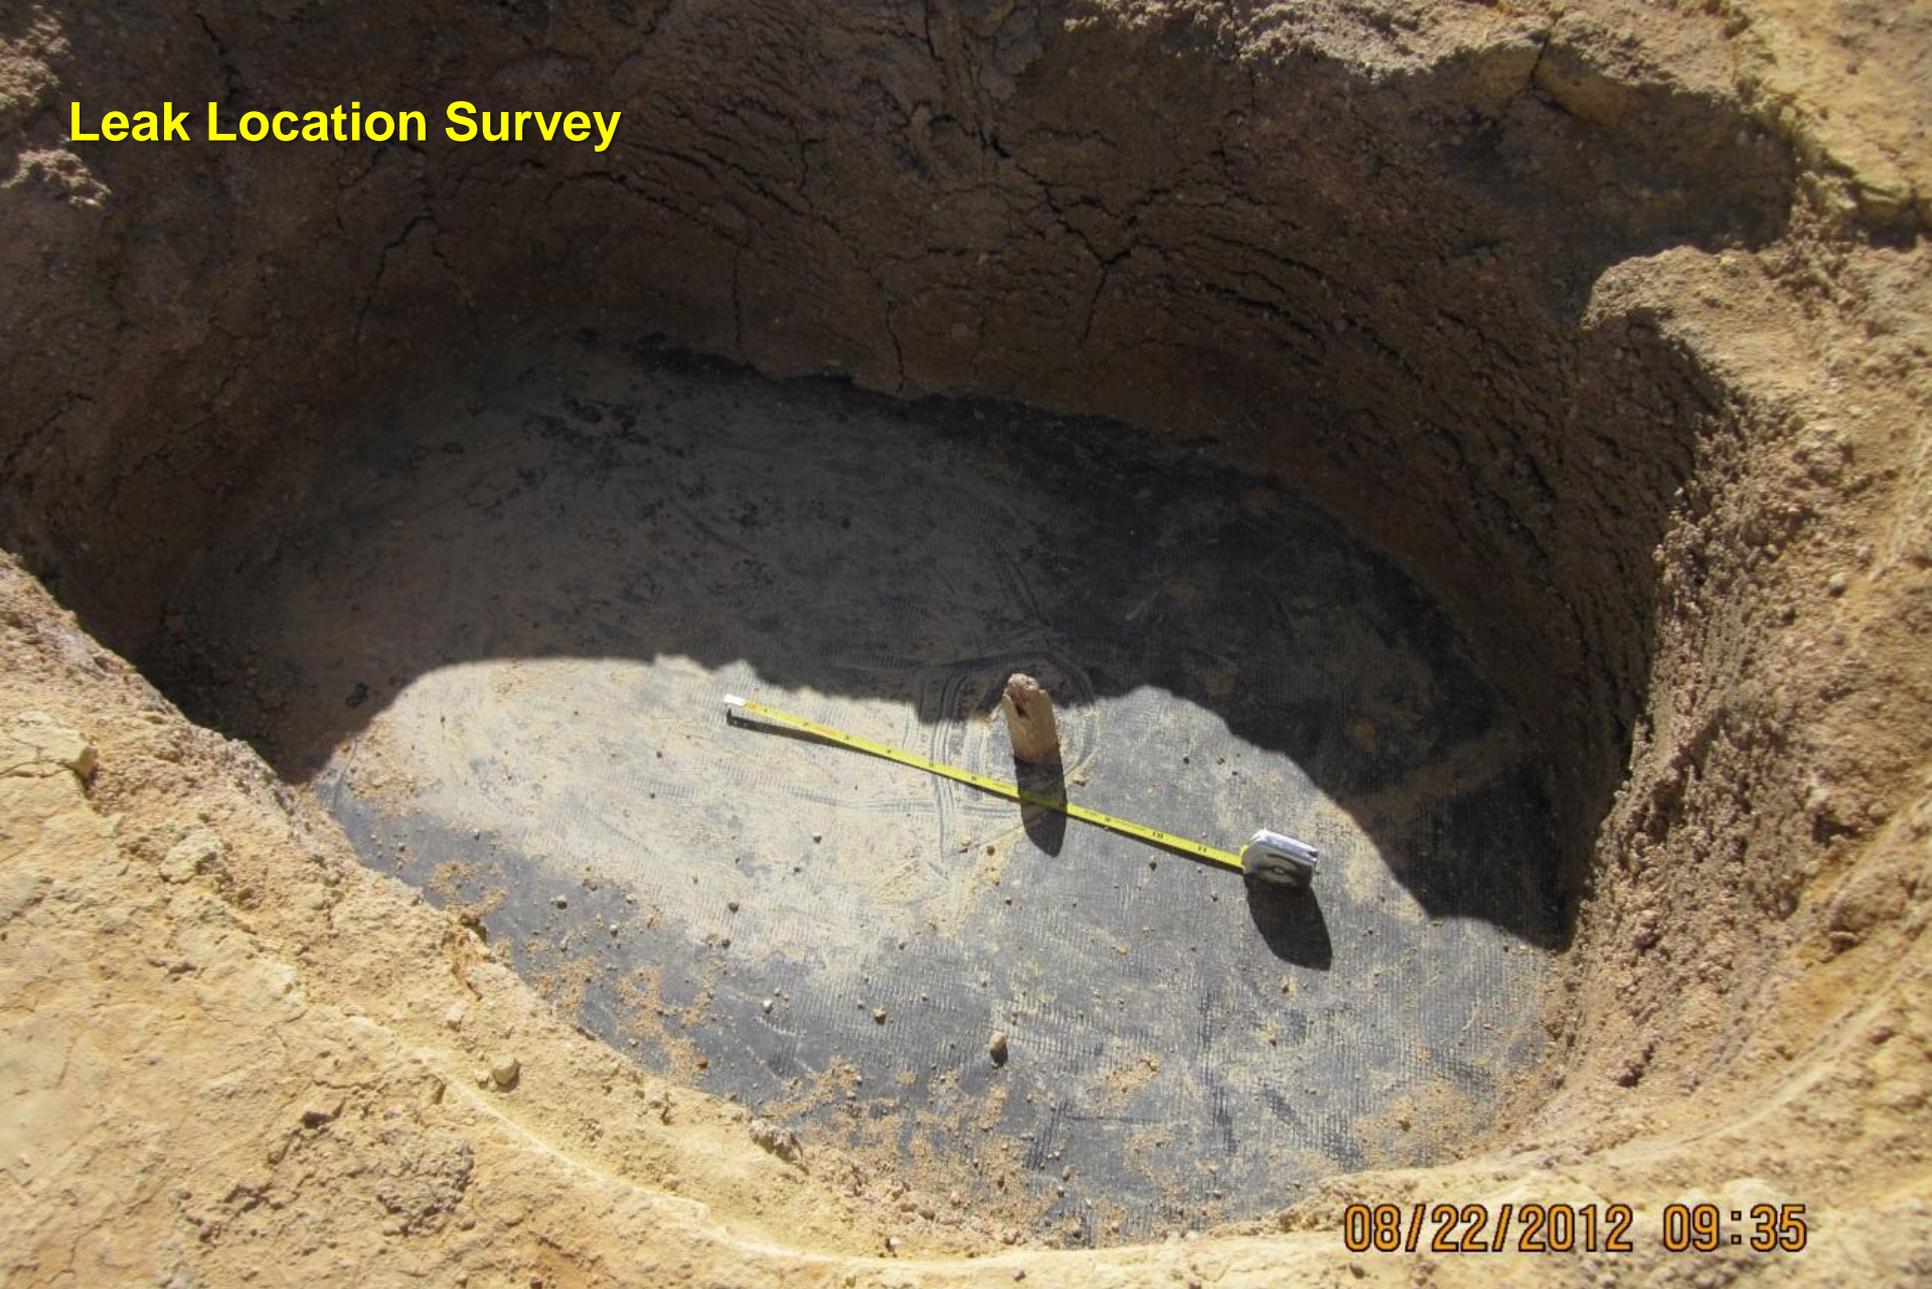
Leak Location Survey

- Located two holes – one wooden grading stake in Pond 2 South, and one two inch hole in Pond 1 that was created during sludge removal activities
