## Los Angeles Regional Water Quality Control Board

## **FACILITY INSPECTION REPORT**

**Facility Name:** Tierra Rejada Landfill (CI-4294)

Summary: Assessed postclosure maintenance conditions. Discharger continuing to make

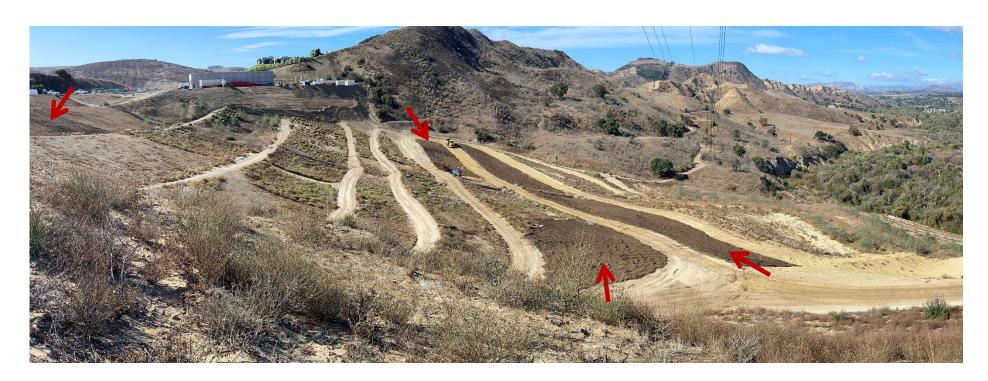
Figure 1:

View looking west of the final cover on side slopes in the western portion of the Landfill. Drainage system improvements are in good shape and mulch was being placed and track-walked in areas where the vegetative cover had failed to develop (arrows).

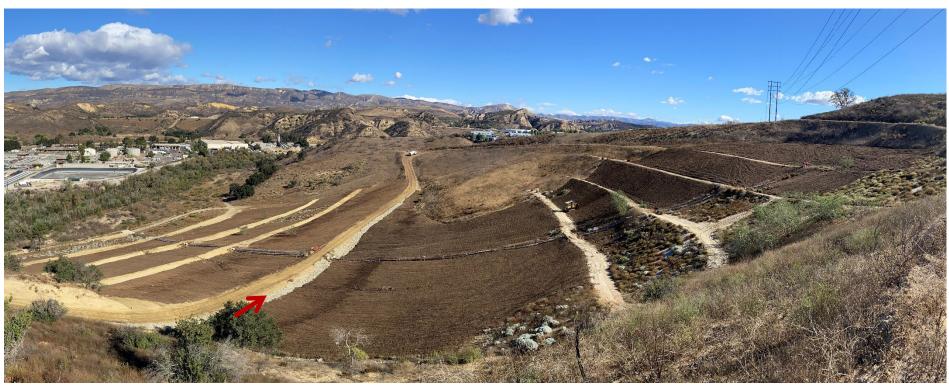
Figure 2:

View looking east of the repaired cover on side slopes in the eastern portion of the Landfill. The central down drain constructed of galvanized piping remained in good shape. A portion of a rock lined ditch (arrow) was expanded. Similarly, mulch was being placed and track-walked in areas where the vegetative cover had failed to develop which included most of the side-slopes on the eastern portion of the Landfill.

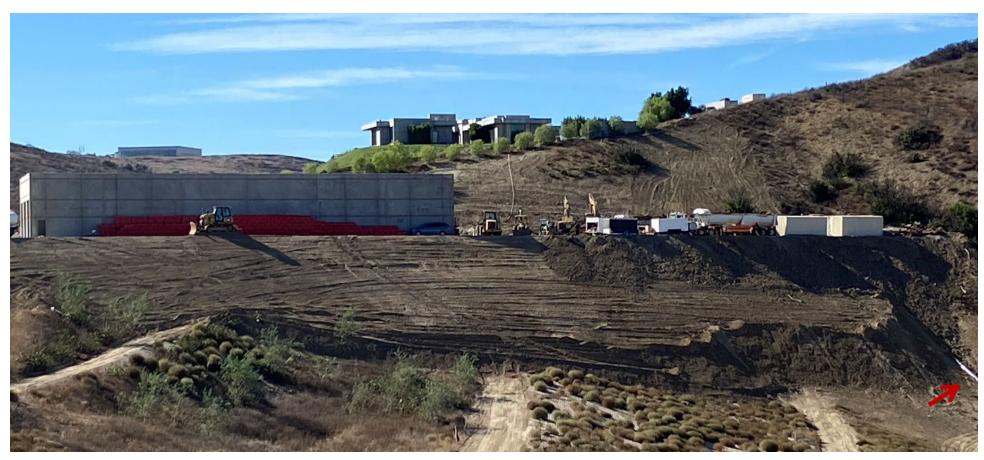
Figure 3:

- 2. A large earth fill, being constructed by a neighbor to the Landfill, may have been placed on refuse fill.
- 3. See attached photographs.

View looking southwest at the neighboring property. The property owner continues to import soils (estimated at approximately 50,000 cubic yards) to construct a large earth fill and pad for a commercial building. It is unclear whether the earthworks were constructed as an engineered fill. However, there is concern that refuse fill extend beyond the property boundary and beneath the earthworks. Moreover, the constructed slopes are very steep (approximately 1:1 in areas) and a drainage pipe (arrow) installed by the Consortium has been partially covered, though it was not designed to be buried.
