Los Angeles Regional Water Quality Control Board

FACILITY INSPECTION REPORT

Facility Name: Tierra Rejada Landfill (CI-4294)

Date of Inspection: February 2, 2023, 10:00 AM – 11:30 AM, announced

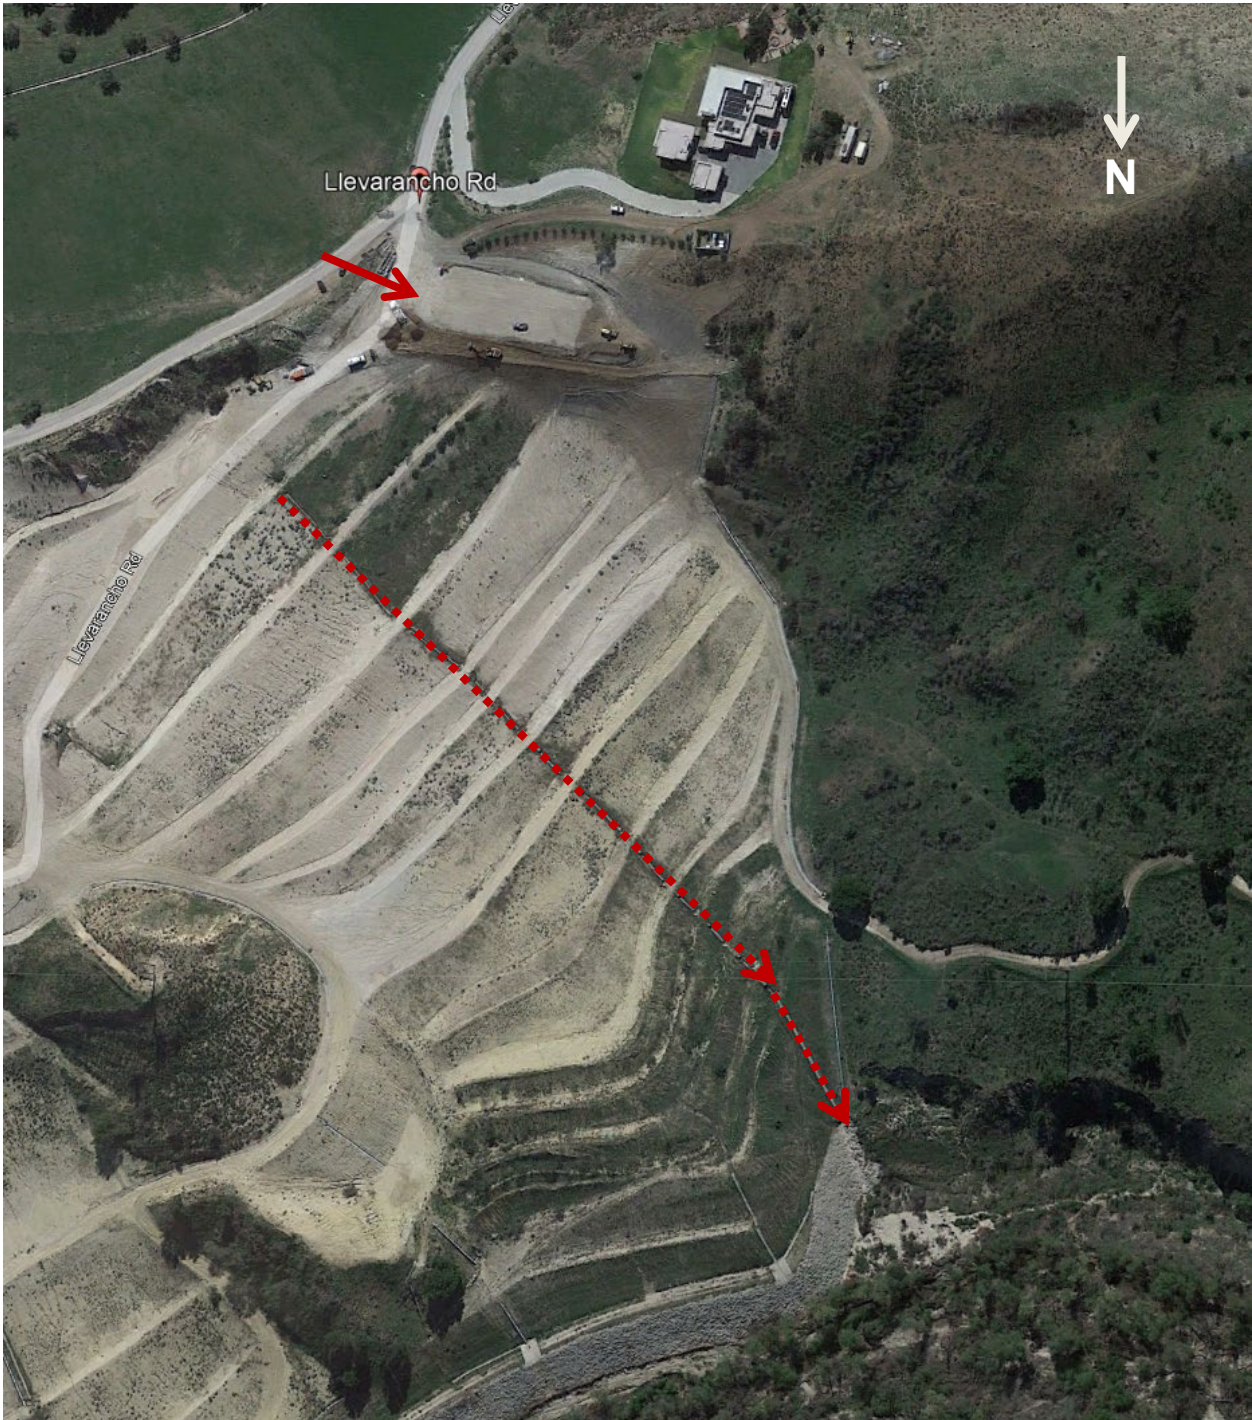
Figure 1:
Satellite image of the grading project during construction (arrow). Uncontrolled stormwater flows from the project area are conveyed onto Landfill benches then to the downdrain on the western perimeter of the Landfill (dashed arrow) that discharges to the Arroyo Simi.

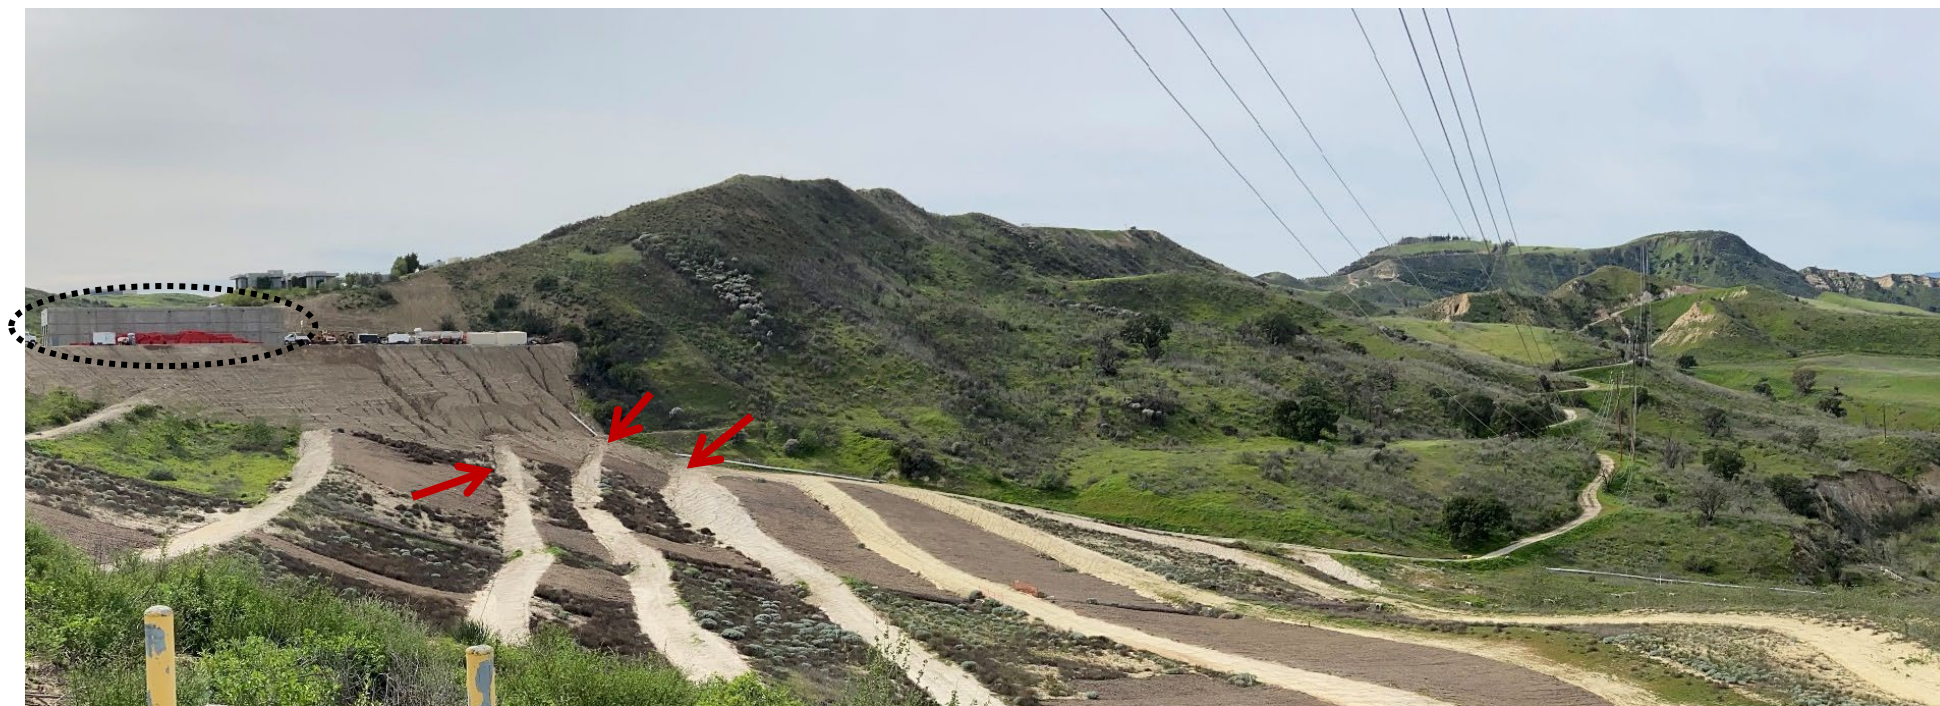
Figure 2:

1. There was severe erosion of the soil fill, with substantial amounts of sediment transported onto the Landfill, impacting the recently completed drainage grades, with the potential to damage drainage control and vegetative cover systems along the western perimeter of the Landfill. Because of the proximity of the construction project to the Arroyo Simi, it is reasonable to believe that a significant amount of suspended sediments may have been released to the Arroyo downstream of the Landfill during the recent storms. Moreover, the damaged slopes remain highly susceptible to continued erosion.
2. Staff was informed that VRSD is taking legal actions against the owner of the accessory structure for damages caused by sediment released from the soil fill.
3. See attached photographs.

View looking west showing the accessory structure (dashed line) and soil fill in relation to the western margin of the Landfill and Arroyo Simi. Sediment eroded from the project area was conveyed onto Landfill (arrows) damaging recently reconstructed bench grades.

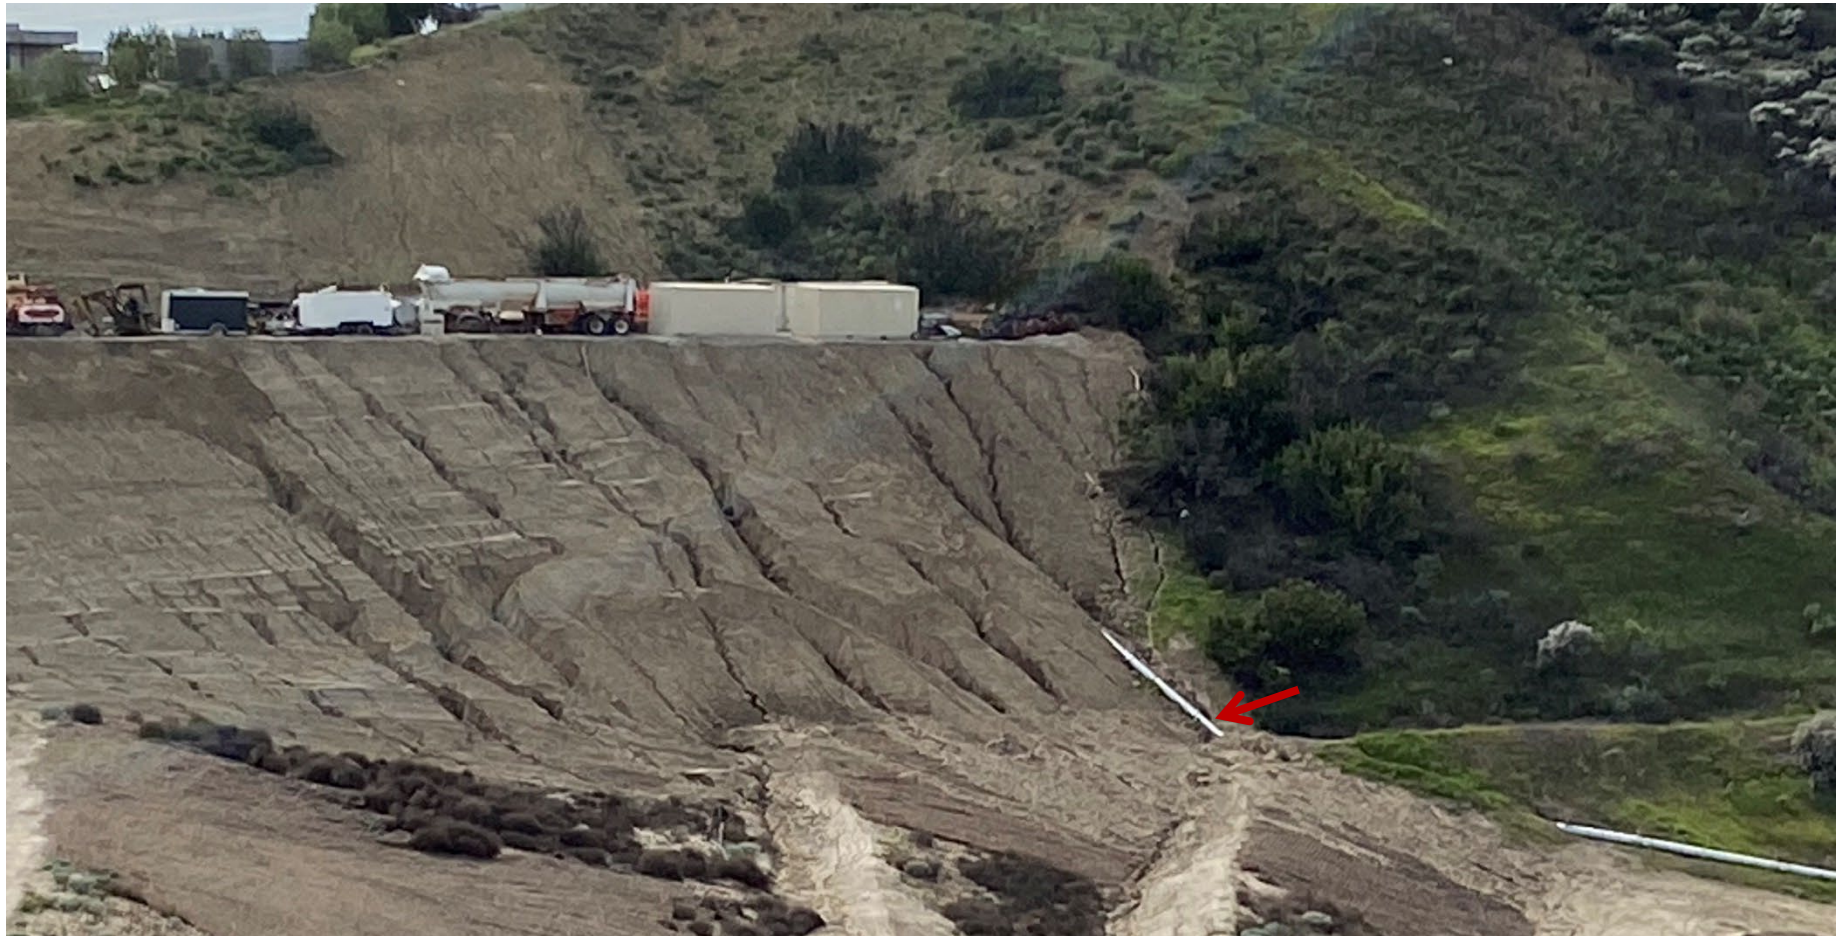
Figure 3:

Closed up view of the severely eroded soil fill. The Landfill property boundary in the area is approximately at the slope break (arrow). Note the absence of erosion control measures on the soil fill. The corrugated metal down drain was constructed as part of the Landfill final cover repairs following the Easy fire to capture stormwater run-on from the previously existing canyon in the area. The soil fill partially buried and altered the design conditions for the down drain pipe.

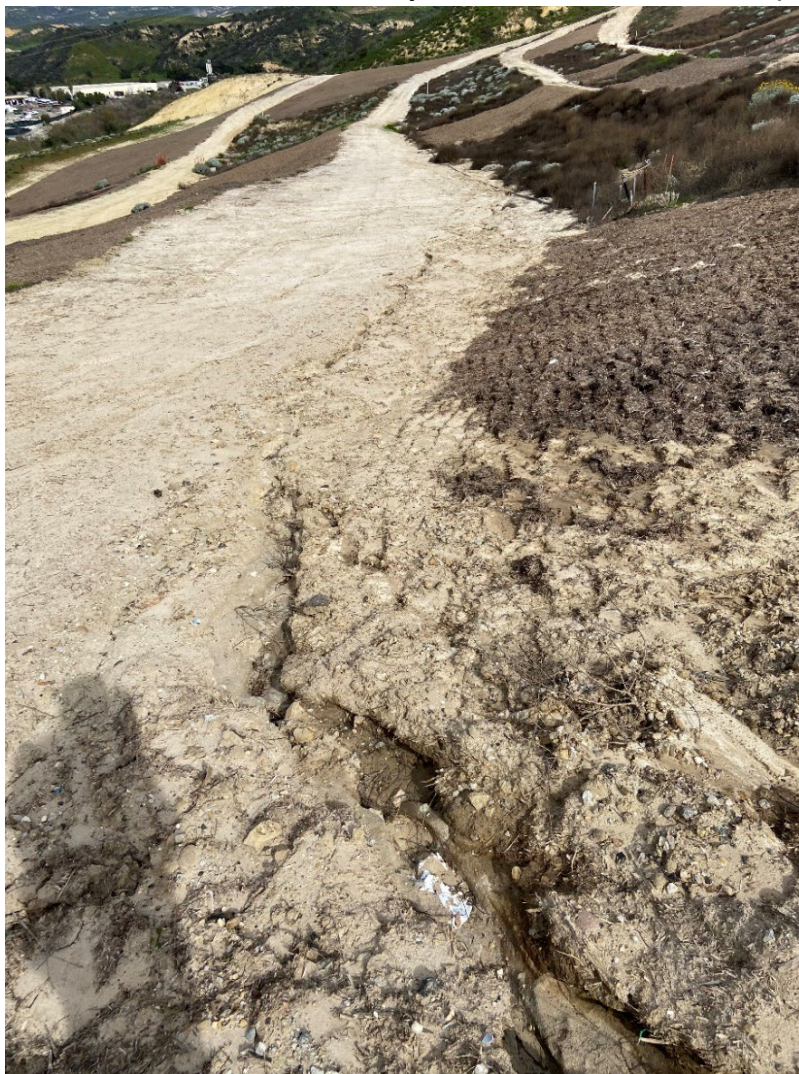
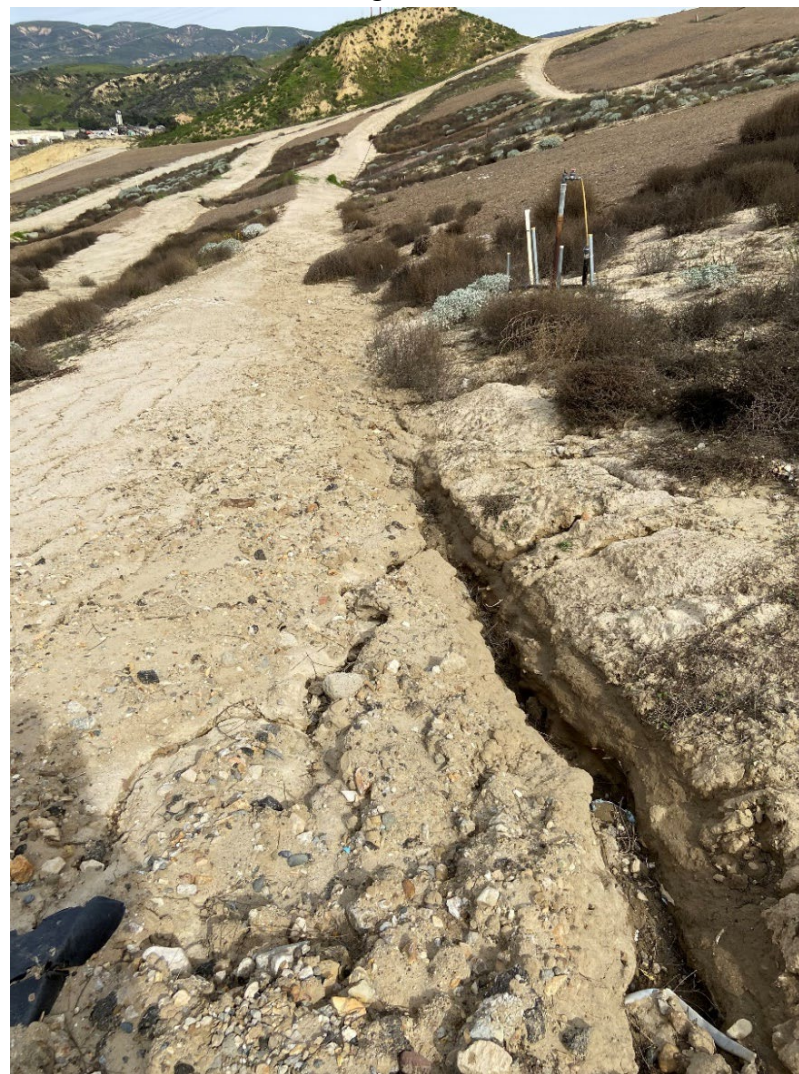
Figure 4:

Closeup views of benches immediately downgradient of the project area. Uncontrolled stormwater run-on flows resulted in erosion and sediment accumulation on Landfill benches. Continued damage may alter the ability of these benches to effectively direct stormwater to the perimeter downdrain as designed.
