CONSTRUCTION STORMWATER INSPECTION REPORT
(State Water Resources Control Board Order 2009-0009, NPDES No. CAS000002)

4 56CN607700	2/21/2023	Unknown	Unknown
WDID NUMBER	NOI PROCESSING DATE	CONSTRUCTION START DATE	CONSTRUCTION END DATE
Private Residence	1509 Darcy Avenue	Simi Valley, CA	93065
CONSTRUCTION SITE NAME	ADDRESS	CITY	ZIP
Corey Evans	Owner	714-225-4723	
DISCHARGER / REPRESENTATIVE PRESENT DURING THE INSPECTION	TITLE	PHONE NUMBER	
Private Individual	Corey Evans	714-225-4723	
SITE OWNER NAME / COMPANY	LEGAL RESPONSIBLE PARTY'S NAME (LRP)	PHONE NO	
Same as Above			
PRIMARY DEVELOPER	DEVELOPER CONTACT NAME	PHONE NO.

Additional Inspection Findings and Observations:

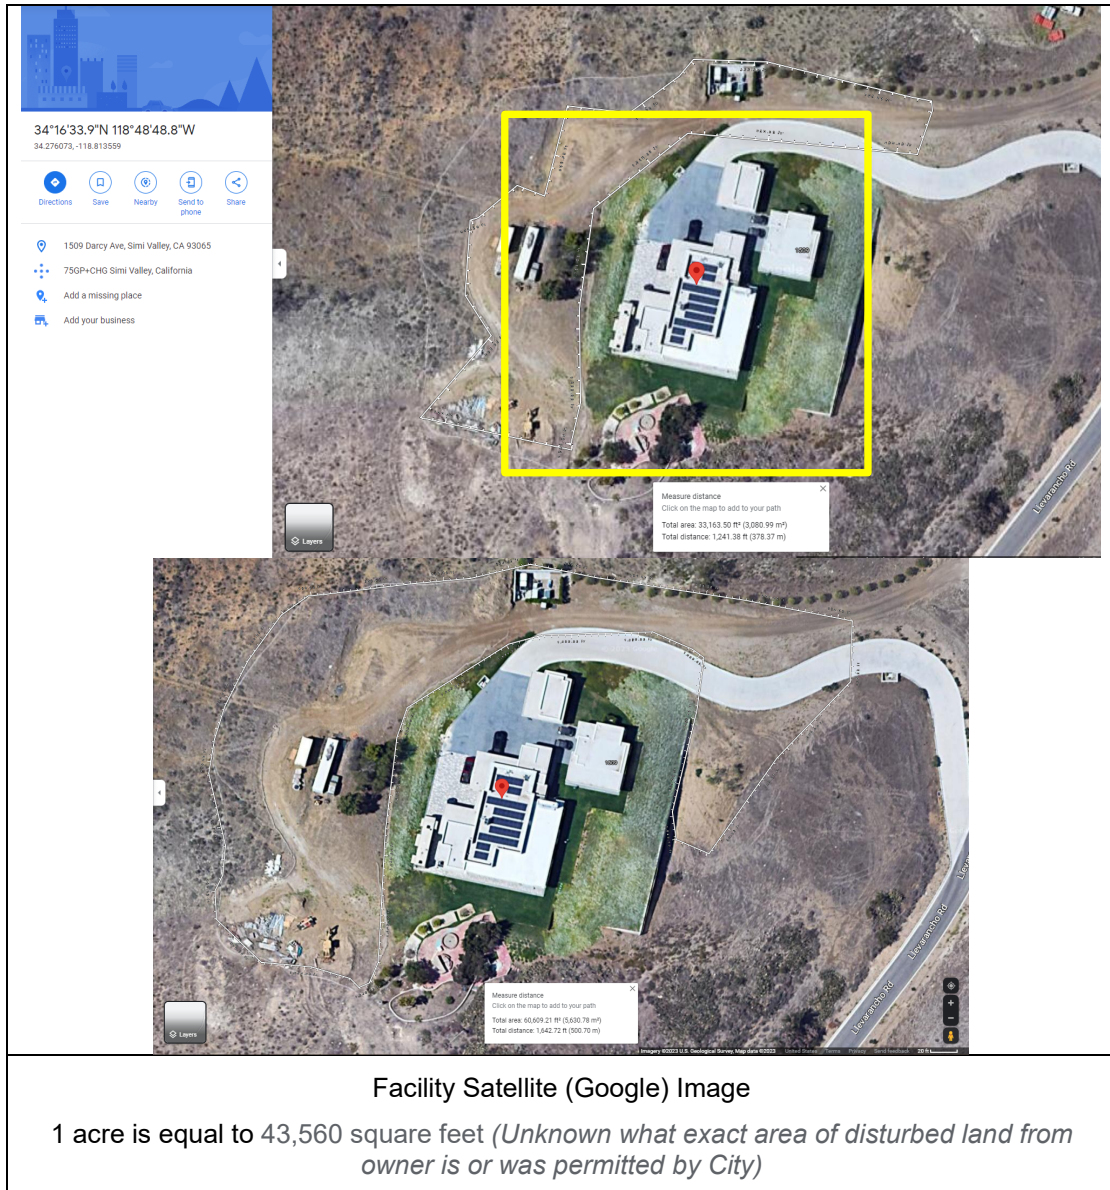
Facility Satellite (Google) Image

1 acre is equal to 43,560 square feet (*Unknown what exact area of disturbed land from owner is or was permitted by City*)

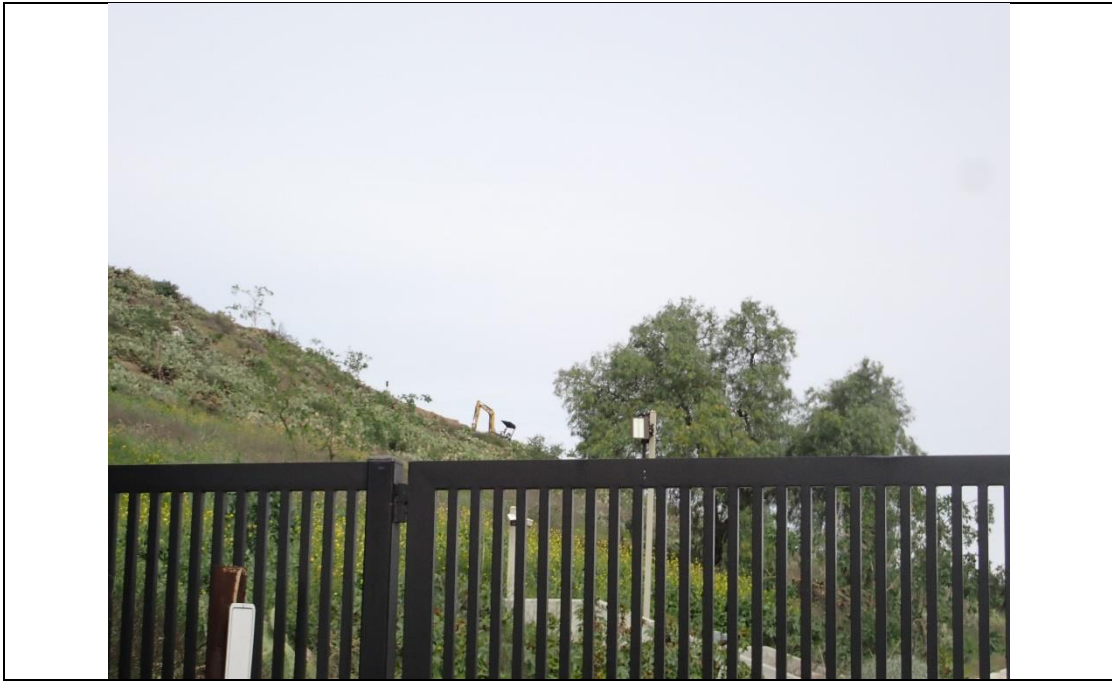
Photograph 1
Gated Entrance to Residence / Construction Equipment is Shown on Hillside Above

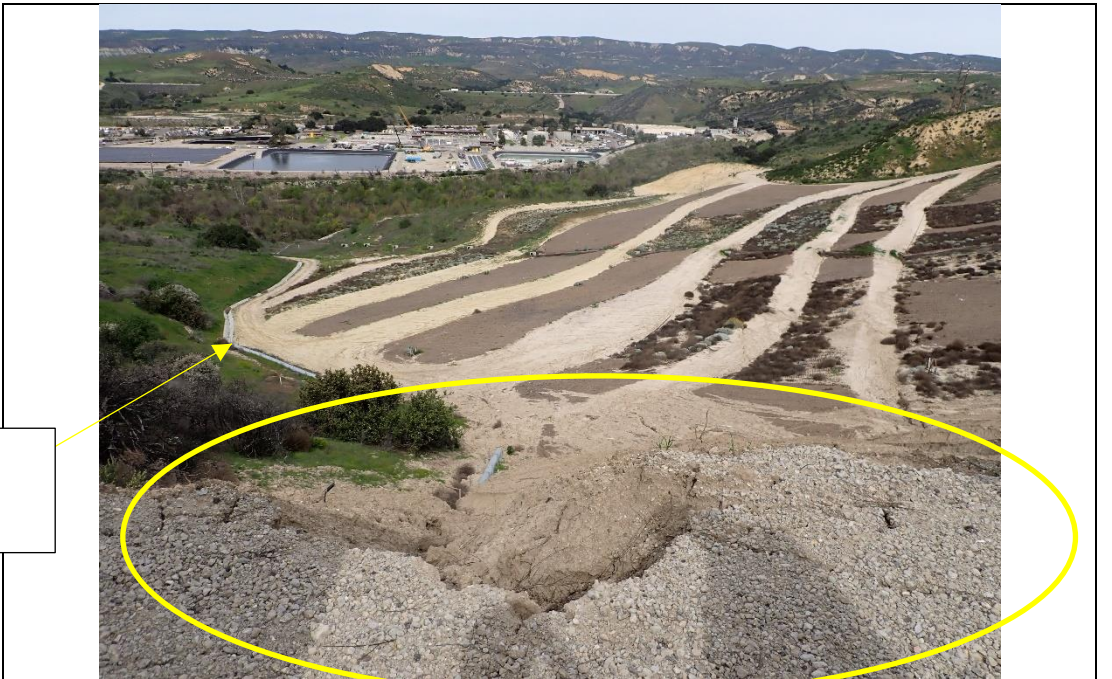
Mr. Evans indicated that the Site is currently under a Stop Work Order and that all construction has been completed. While at the Site, Staff observed that the graded pad is cracking and starting to erode. Stabilization of all disturbed areas has not yet occurred. A large number of construction equipment observed at the Site was indicated by Mr. Evans to be for the pool construction at his main house.

Landfill Drainage
Pipe Outlet into
Drainage Channel

Photograph 2
Pad Cracking / Eroding – Landfill Below and Drainage Pipe

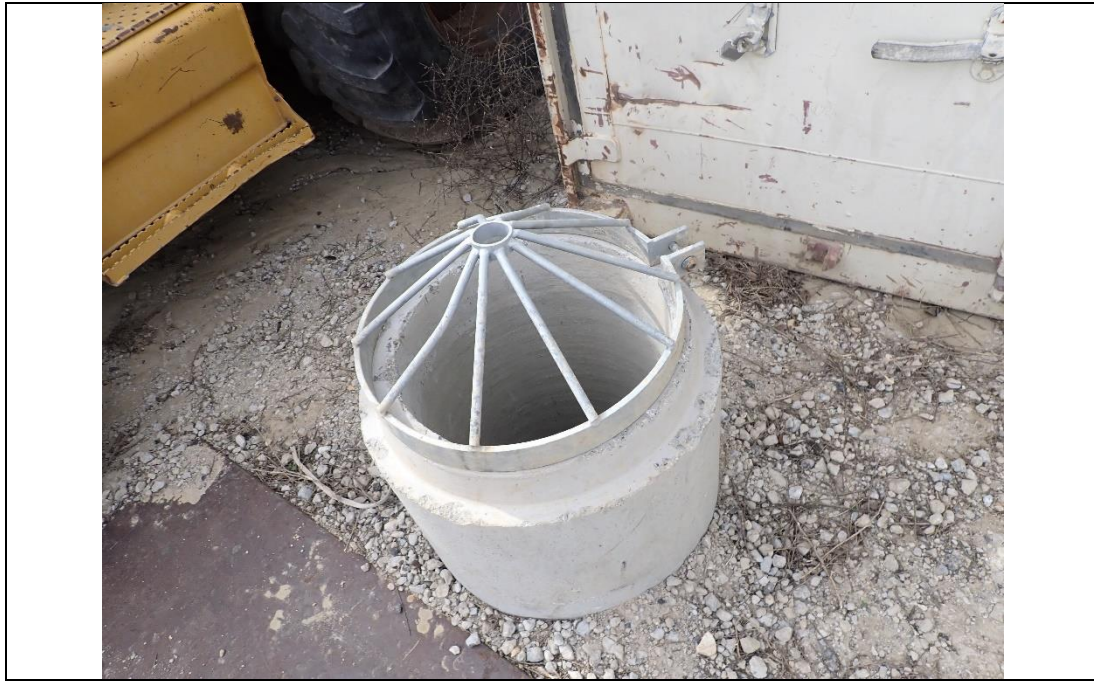
Photograph 3
Drain Inlet Riser Leading to Landfill Drainage Below

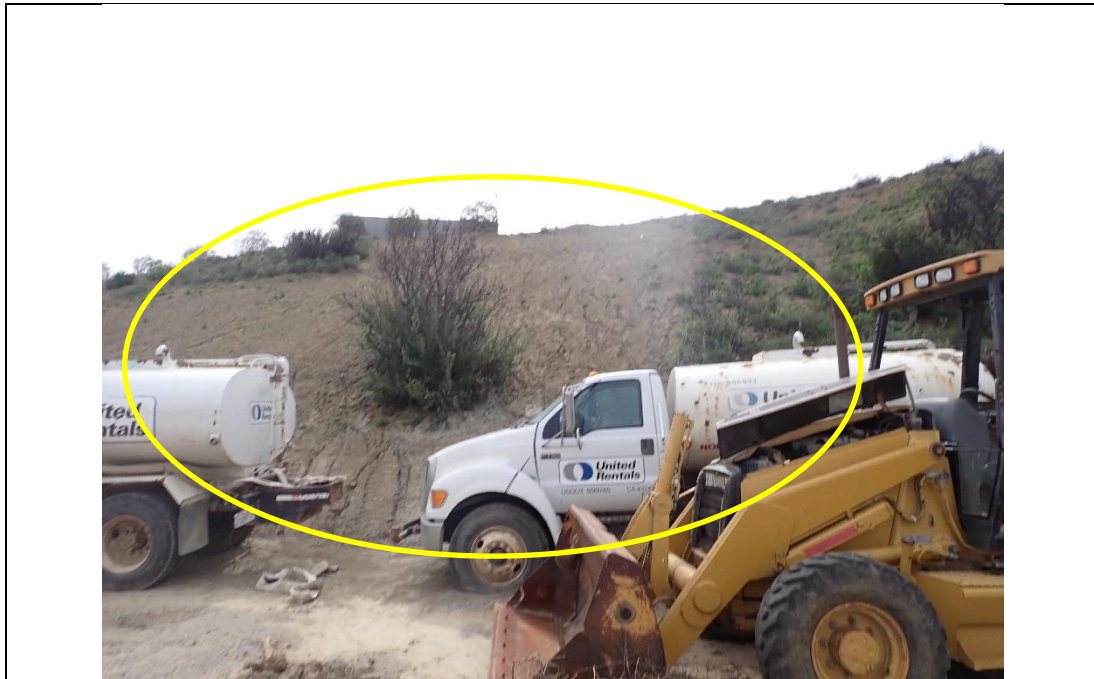
Photograph 4
Staged Equipment / Erosion on Hillside (Unsure if Grading Occurred with Rest of Project)

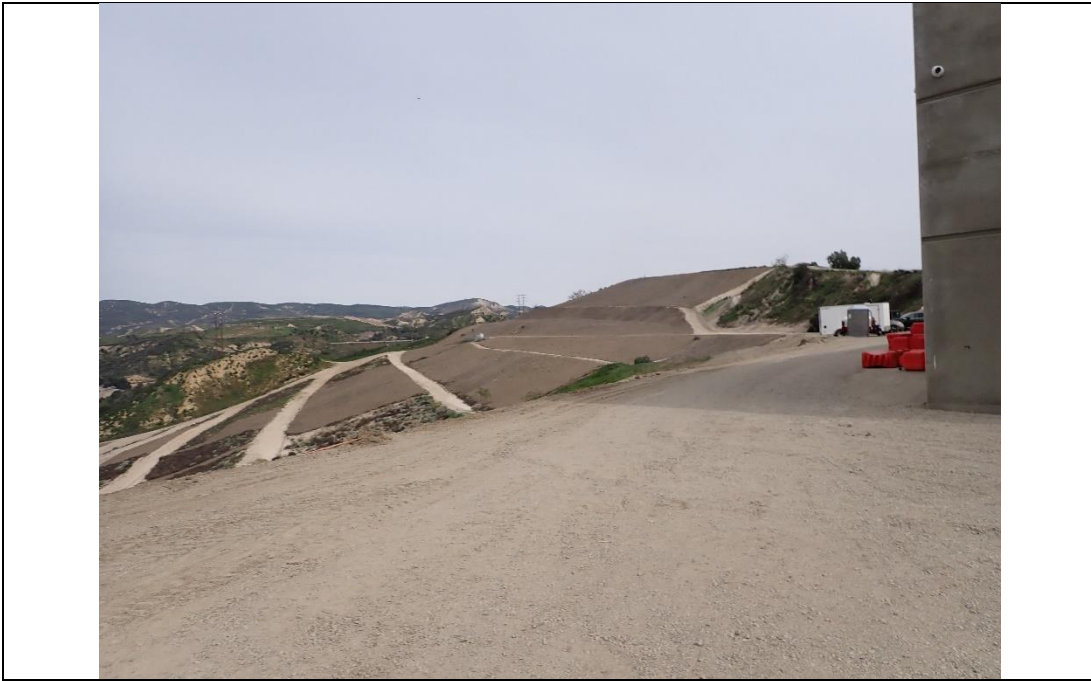
Photograph 5
Completed Building on Pad (Right) and Landfill (Ahead)

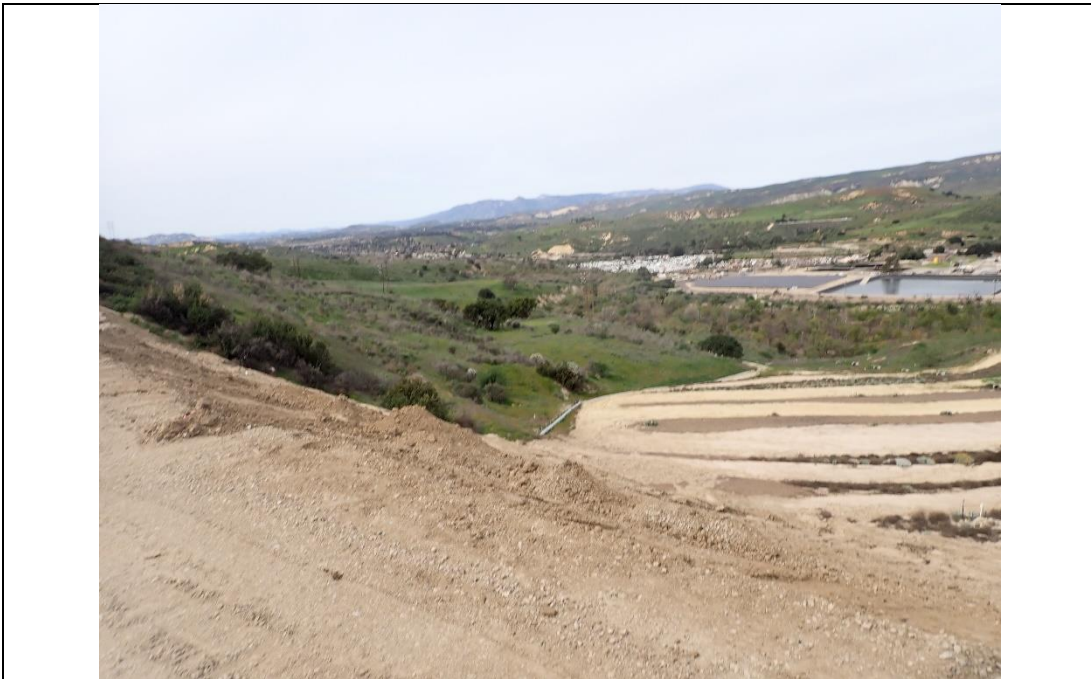
Photograph 6
Graded Pad / Landfill Below and Drainage Pipe Shown

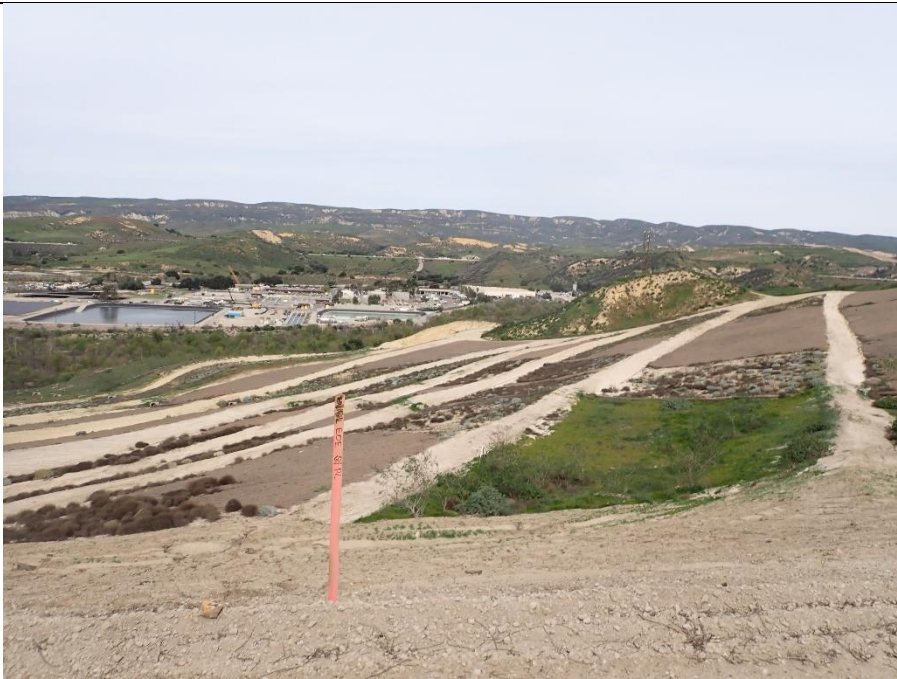
Photograph 7
Surveyor's Stake for Property Boundary Assessment (Results Not Provided to Staff) /
Landfill Ahead in the Distance

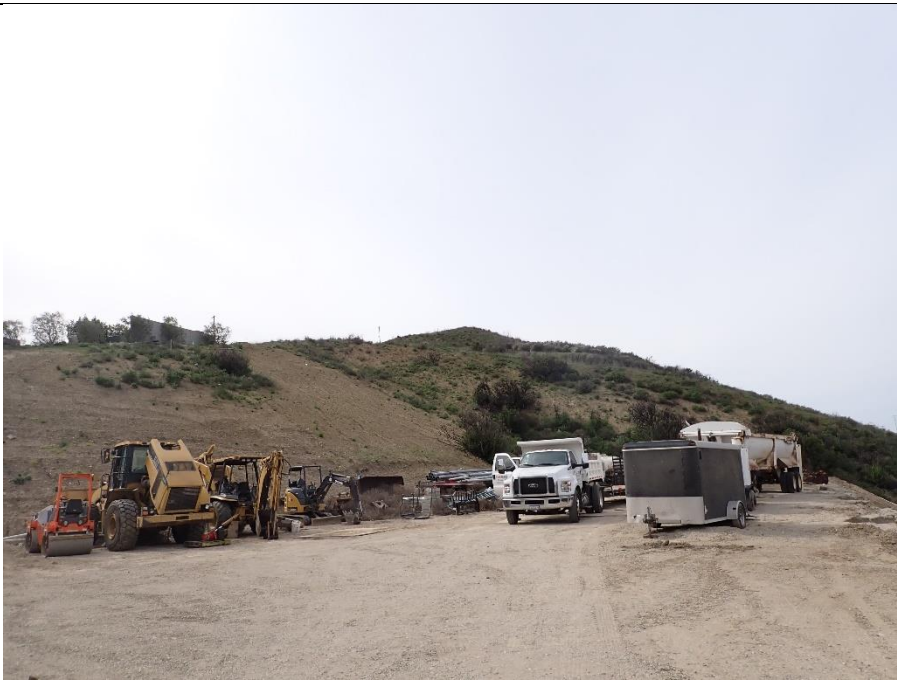
Photograph 8
Construction Equipment Staged on Pad

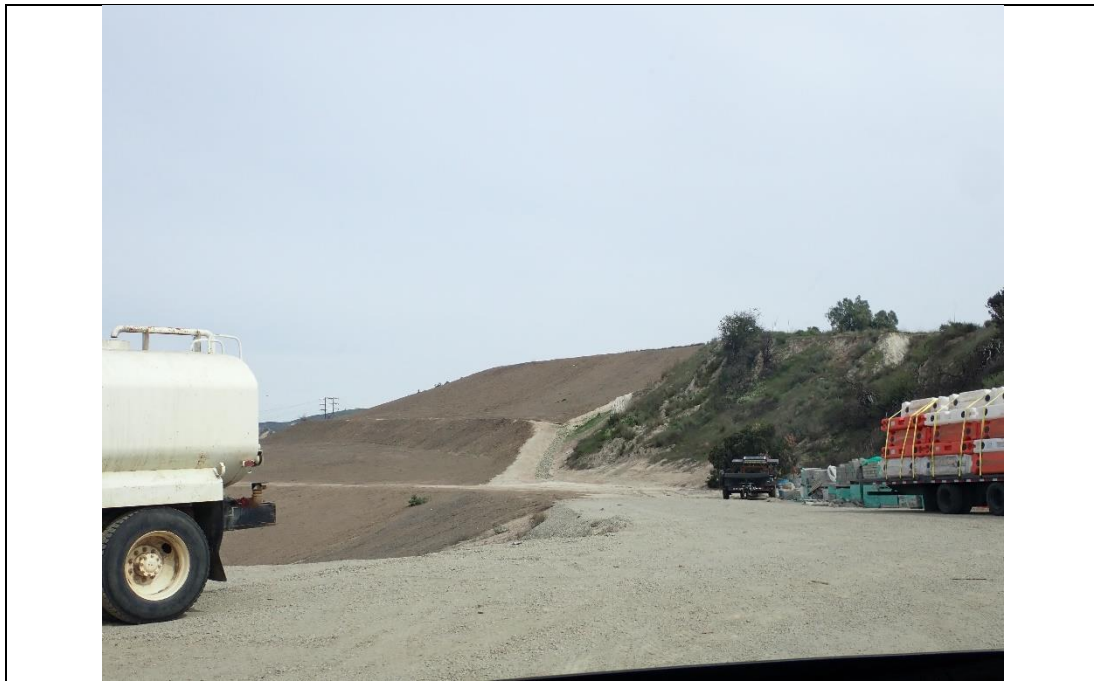
Photograph 9
Drainage Swale Leading to Pad (Appears to be Landfill Property / Unknown Boundary)

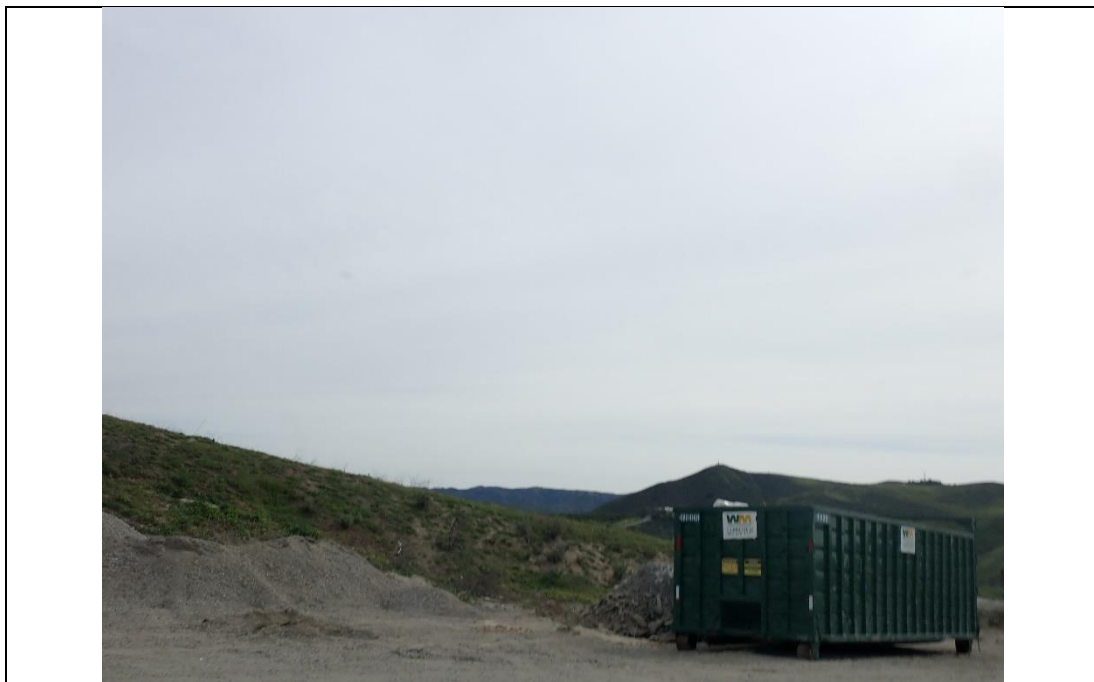
Photograph 10
Dumpster and Staged Soil Piles on Pad

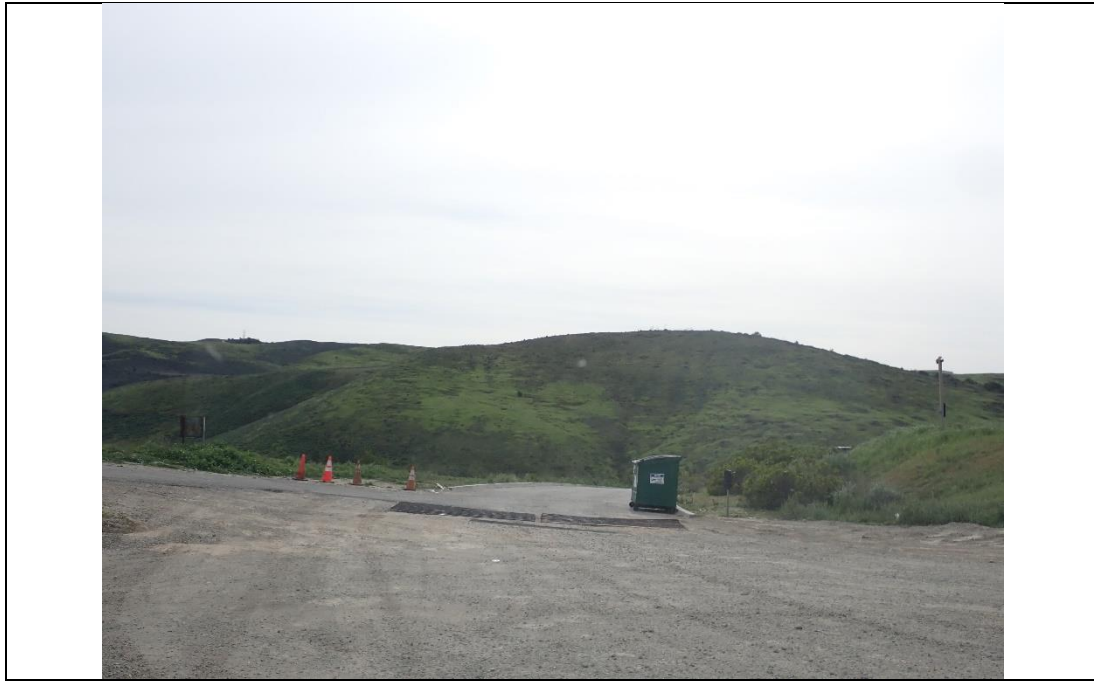
Photograph 11
Rumble Plates Installed Prior To Driveway
