Los Angeles Regional Water Quality Control Board

INSPECTION REPORT

DATE OF INSPECTION: April 12, 2017

April 12, 2017 Inspection Report
APNs 2821-002-023; 2821-009-030; 2821-009-031

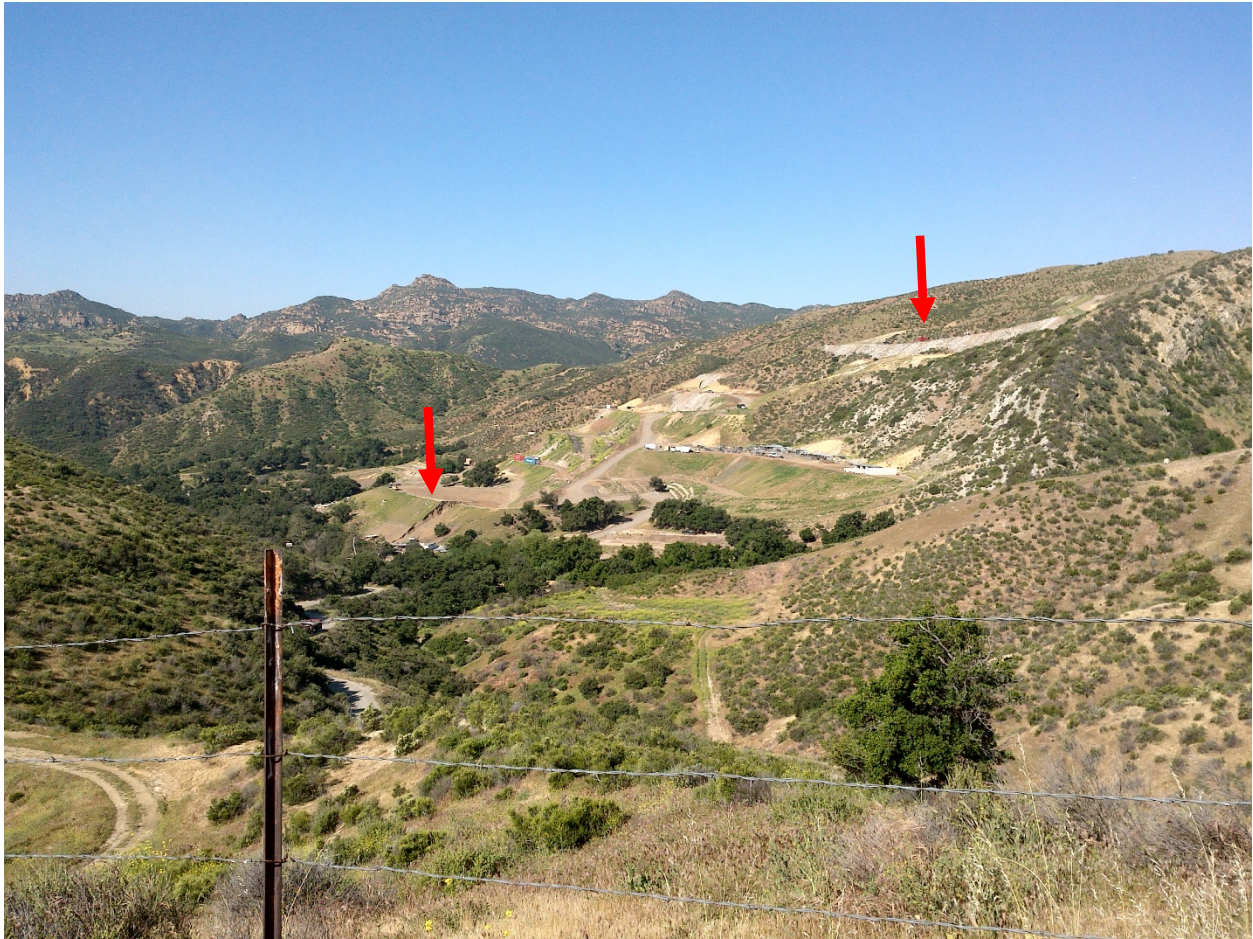
Photo 1. View looking southwest from Photo location 1. Showing parcels 2821-009-030 and 2821-009-031, which are owned Mr. Wayne Fishback and Cepheid V, LLC respectively. The barbed wire fence is the border between Parcels 2821-008-902 owned by MRCA and 2821-009-034 owned by the Alajajian Family Trust. The photo was taken at Longitude -118 36 21.75 and Latitude 34 18 22.79 on April 12, 2017. The arrows indicate the location of close-up views in the following photos.

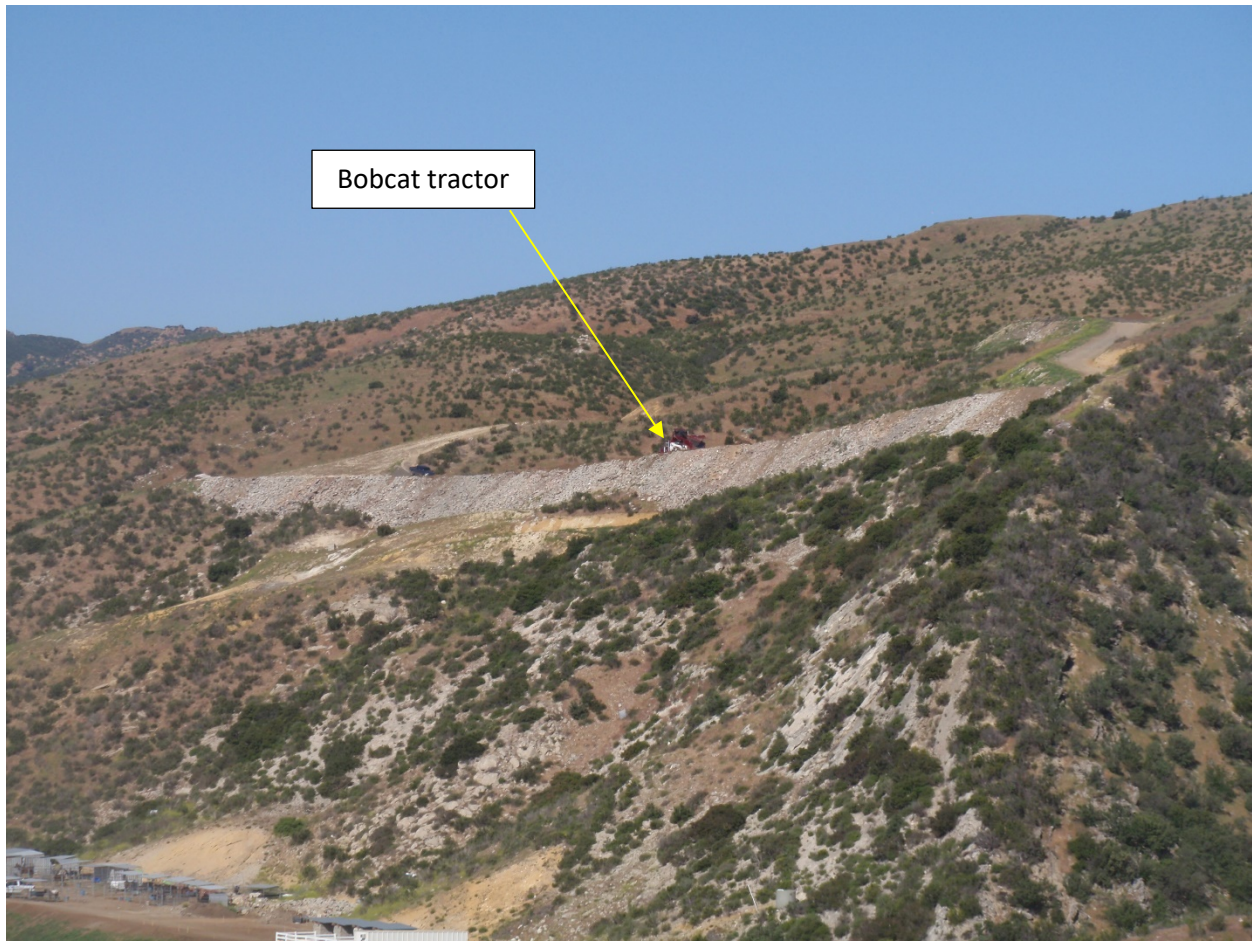
We observed large trucks traveling uphill on the property to the northwest and a bobcat tractor working on a hillside on the property (Photo 2). We also observed the canyon that was carved into a graded slope during the February 2017 rain events that was referenced in the Ex Parte Application for Clarification (Photo 3). Sandbags that had fallen down the fill slope were visible (Photo 4). Photos of the slope during the October 17, 2016 inspection have been attached that illustrate the change in condition of the slope from October 17, 2016 to April 12, 2017 (Photos 5 and 6). Sandbags from the sandbag wall that had fallen down the fill slope were present during the October 17, 2016 inspection.

Photo 2. View looking Southwest from Photo Location 1. Showing the location of bobcat tractor doing work on a roadway previously constructed by Mr. Fishback in parcels 2821-009-030 and 2821-009-031, which are owned by Mr. Wayne Fishback and Cepheid V, LLC respectively. Haul trucks observed on Browns Canyon Road driving to the Site were seen driving to this location and discharging materials onto the roadway. The photo was taken at Longitude -118 36 21.75 and Latitude 34 18 22.79 on April 12, 2017.

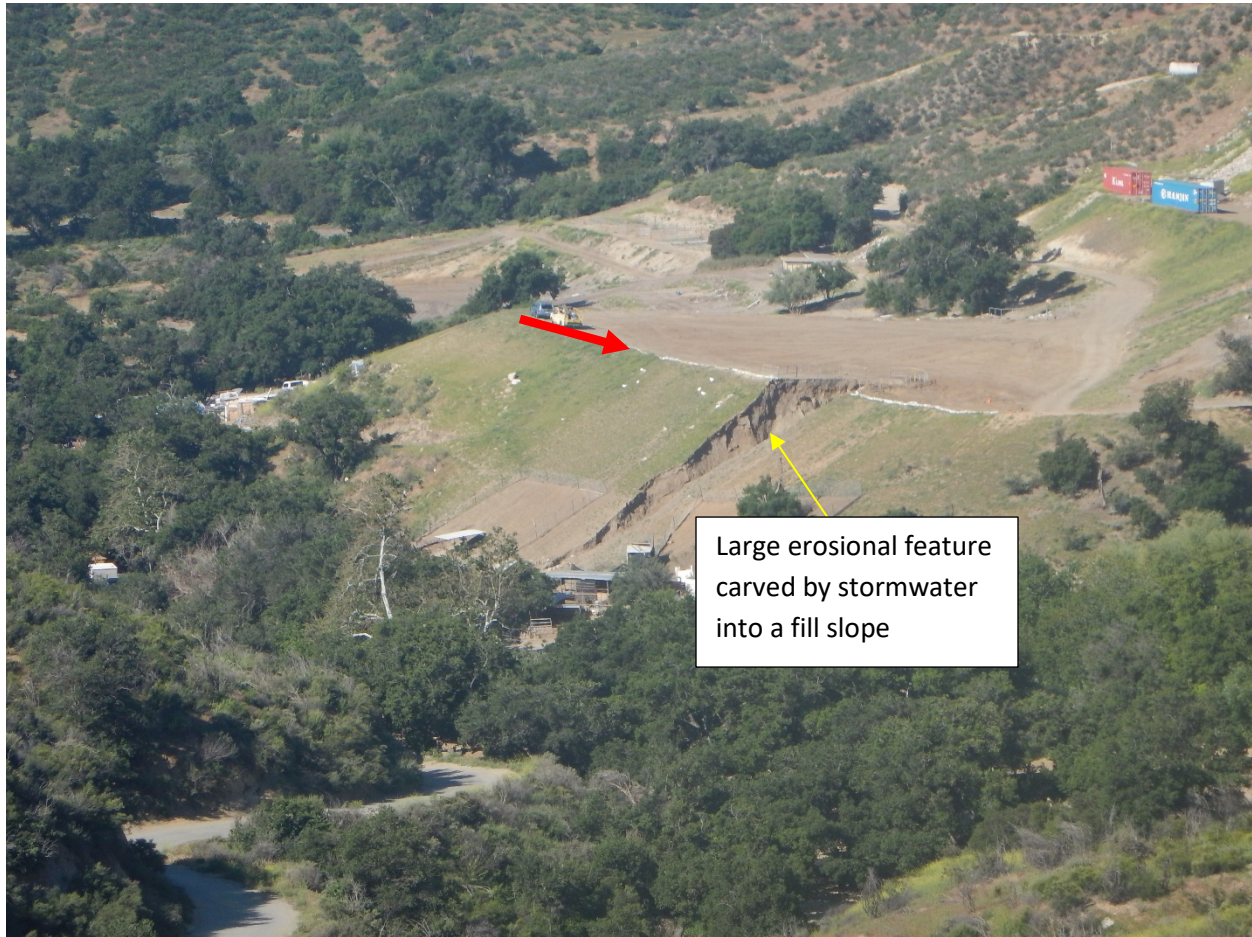
Photo 3. View looking southwest from Photo Location 1. Showing canyon carved into slope in parcels 2821-009-030 and 2821-009-031, which are owned by Mr. Wayne Fishback and Cepheid V, LLC respectively. The base elevation of the large erosional scour is in the immediate vicinity of the Ybarra Creek bed. It can be inferred from this photo that all the stormwater scoured fill materials were transported into Ybarra Creek. The red arrow indicates the remnant sandbag wall, presumably the wall that Mr. Fishback alleges was sabotaged. The photo was taken at Longitude -118 36 21.75 and Latitude 34 18 22.79 on April 12, 2017.

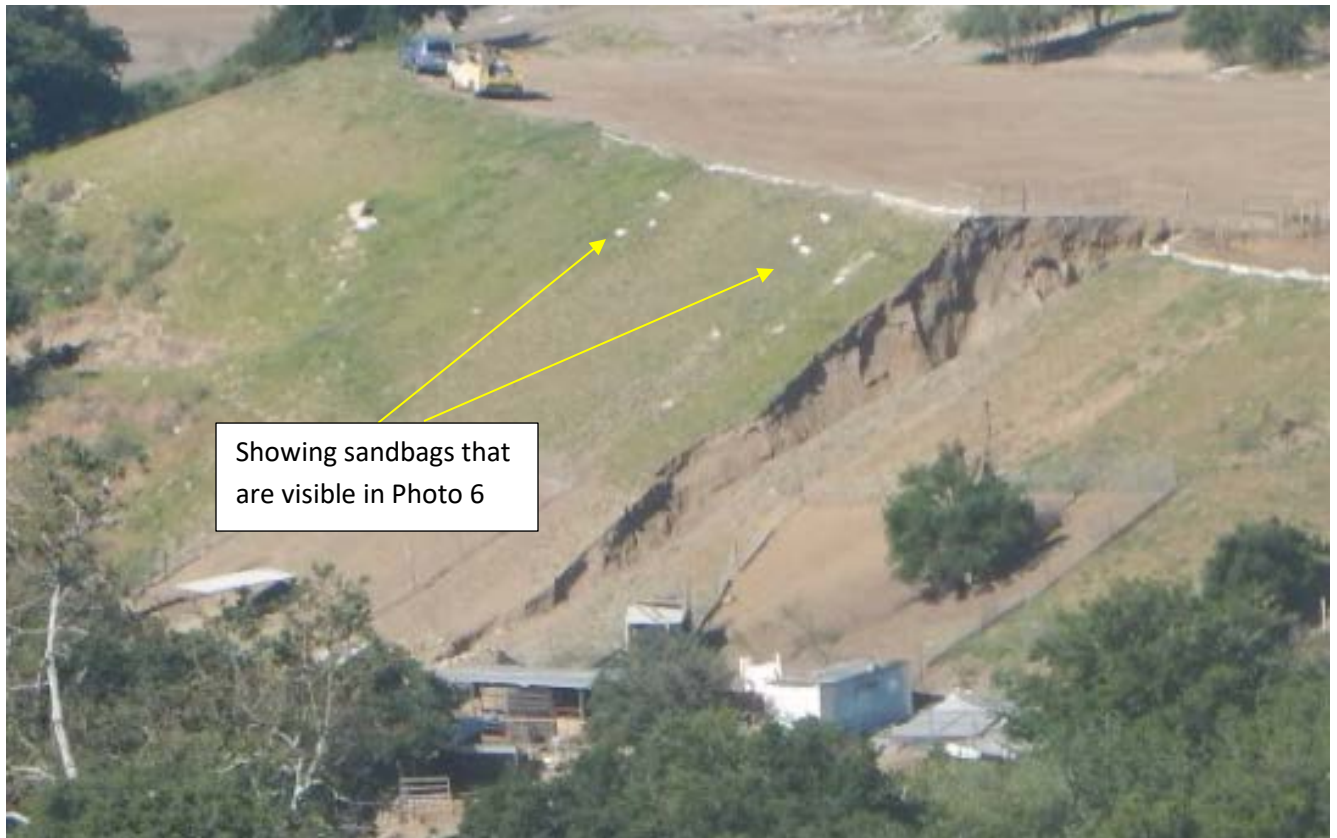
Photo 4. View looking southwest from Photo Location 1. Close up of Photo 3. Showing the sandbags from the sandbag wall that have fallen down the fill slope. These sandbags are visible in Photo 6 and were present during the October 17, 2016 Inspection.

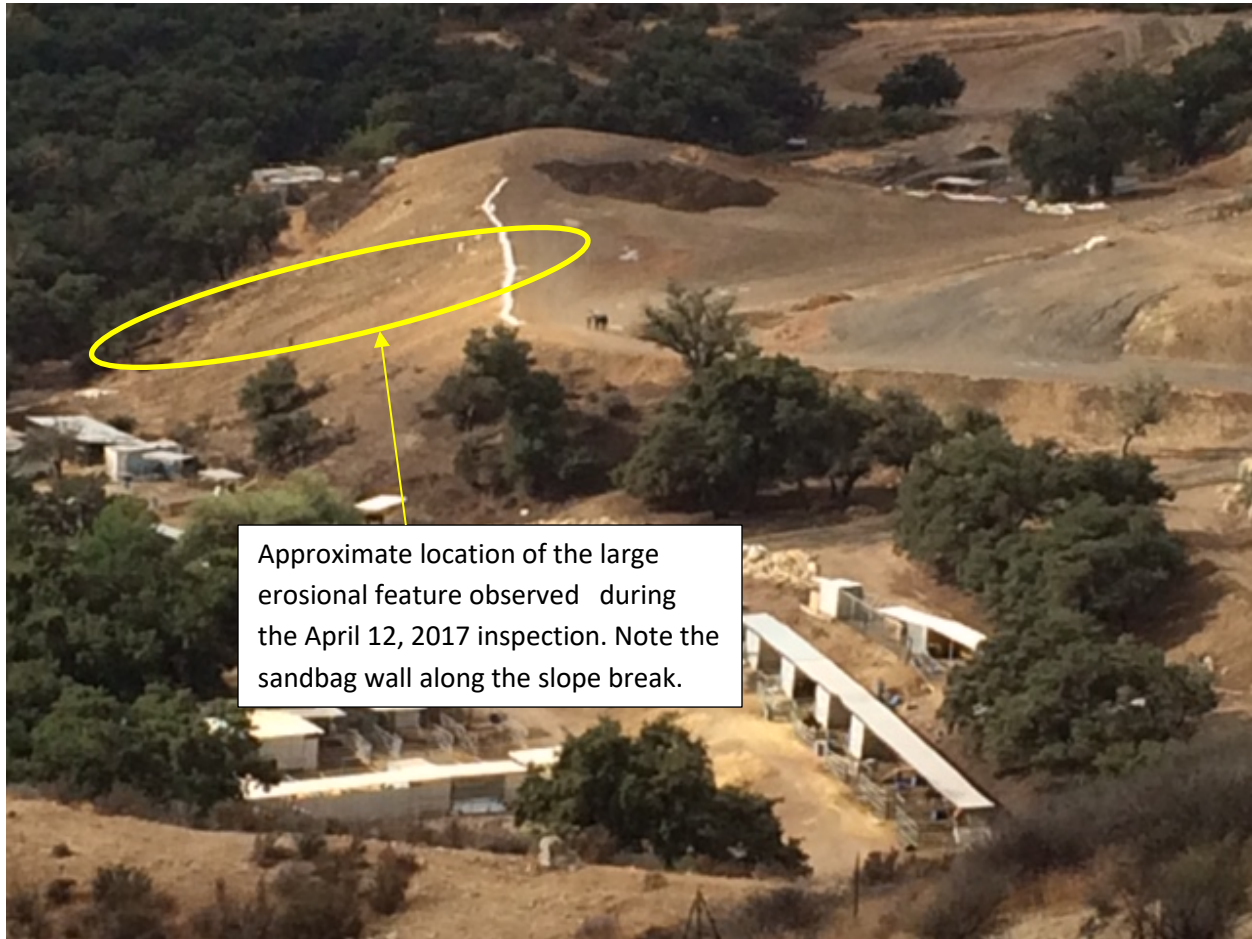
Approximate location of the large erosional feature observed during the April 12, 2017 inspection. Note the sandbag wall along the slope break.

Photo 5. Showing the same area shown in Photo 3 during the October 17, 2016 inspection. Photo was taken at a different angle than Photo 3.

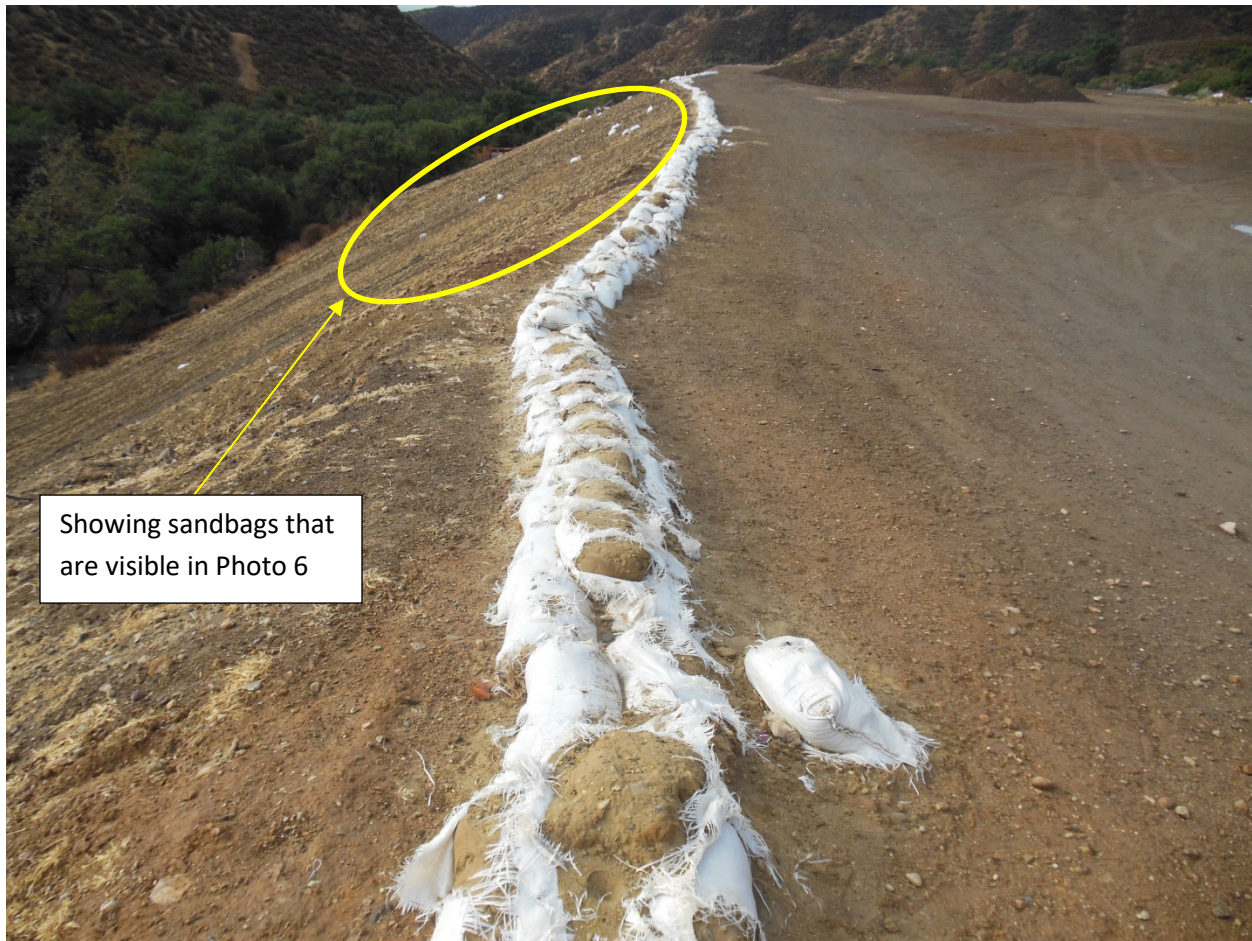
Photo 6. Close up of the sandbag wall along the slope break of the fill slope in Photos 3 and 4 during the October 17, 2016 inspection. The sandbag wall is above the large erosional scour that later developed during the February 2017 rainstorms. The photo shows that number sandbags from the sandbag wall have already fallen down the fill slope. The photo also shows that the sandbags, as of October 17, 2016, were deteriorated and releasing sediment so that they could not function as an effective best management practice (BMP) for subsequent winter storms.

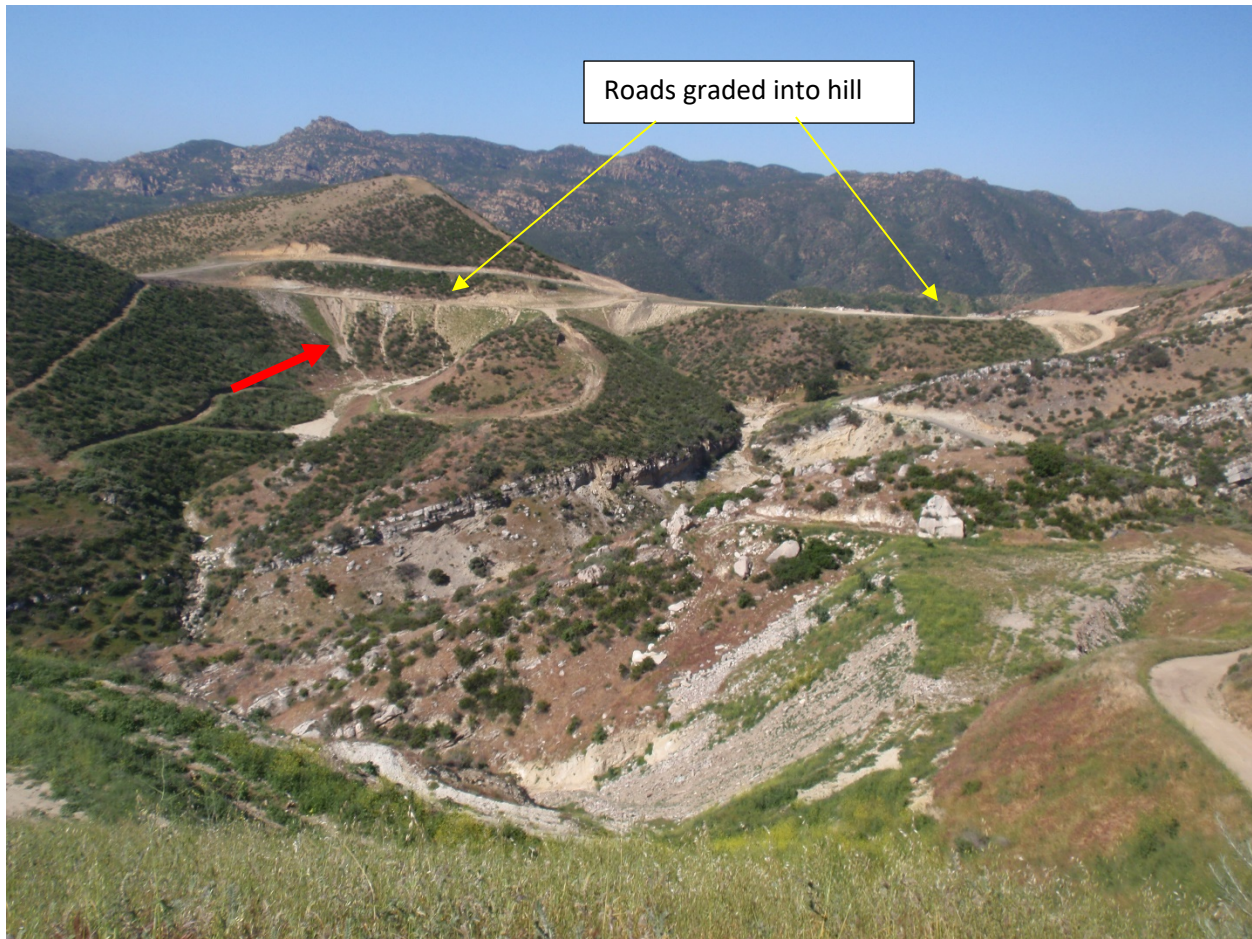
We proceeded to parcel 2821-002-905 which is owned by MRCA. From this parcel we were able to view Mr. Wayne Fishback's parcel 2821-002-023 to the south and southwest (Photos 7 and 8). From this point graded roads were visible running along a hilltop in parcel 2821-002-023 (Photos 7 and 8). These roads were noted in the October 17, 2016 inspection report. Deposited material that appeared to be crushed cement and sediment also was visible from this location on parcel 2821-002-023 near the access road (Photo 8). The location where we took Photos 7 and 8 is shown in Map 1 labeled Photo Location 2. Regional Board staff did not take pictures of the area shown in Photo 7 during the October 17, 2016 inspection.

Photo 7. View looking south from Photo Location 2. Showing parcel 2821-002-023 owned by Mr. Wayne Fishback and roads graded onto hilltop in the parcel. The red arrow indicates where large erosional scours were visible in below graded roadways. The significant erosion indicates poor design or the lack of drainage controls to effectively convey stormwater from the roadways. This photo was taken from parcel 2821-002-905 owned by MRCA at Longitude -118 36 41.788 and Latitude 34 18 39.224 on April 12, 2017.

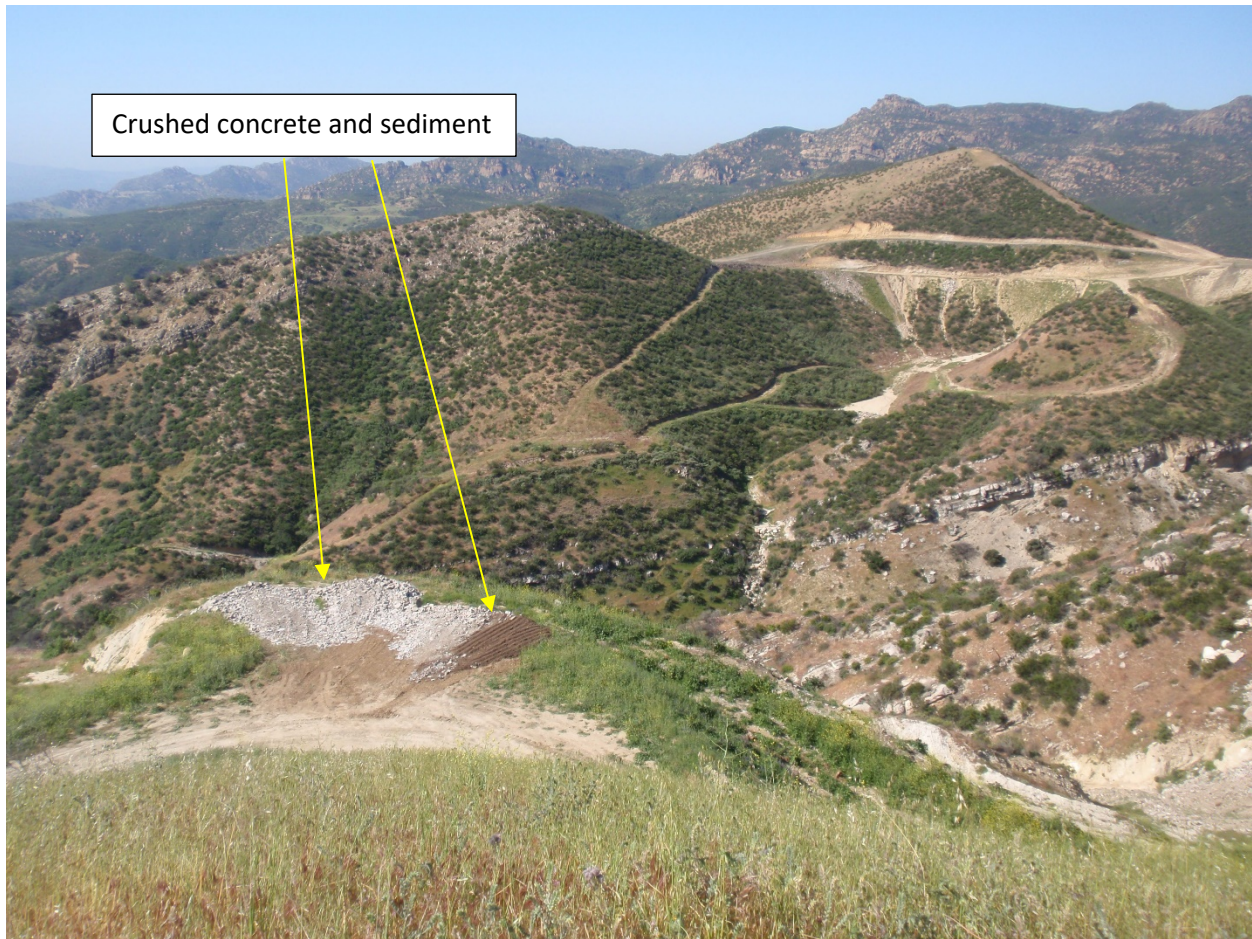
Photo 8. View looking south from Photo Location 2. Showing parcel 2821-002-023 owned by Mr. Wayne Fishback and what appears to be crushed concrete and sediment near an access road in the parcel. This photo was taken from parcel 2821-002-905 owned by MRCA at Longitude -118 36 41.788 and Latitude 34 18 39.224 on April 12, 2017.
