## North Coast Regional Water Quality Control Board

Subject: Cannabis Waste Discharge Regulatory Program Compliance Inspection,  
Inspection of Trinity County APN(s) 024-010-044-000

### FACILITIES INSPECTION REPORT

## Attachment B – Inspection Map and Photolog

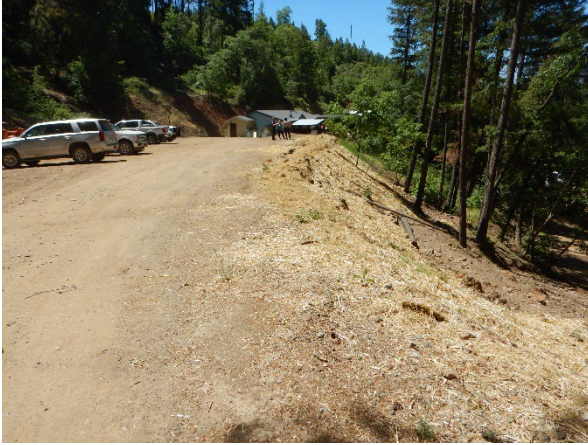
Photo 1: Main parking area and within graded area A1.

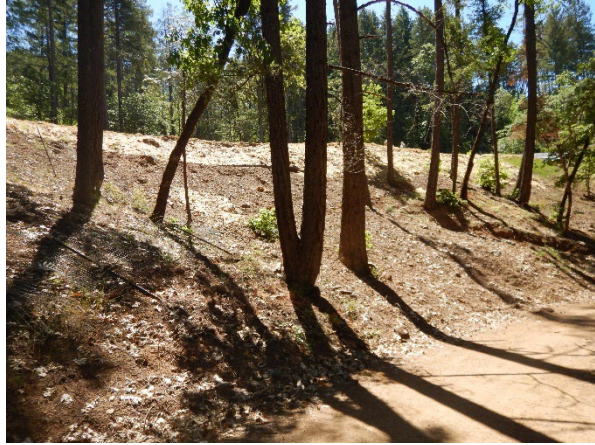
Photo 2: View looking upslope within A1 from lower road.

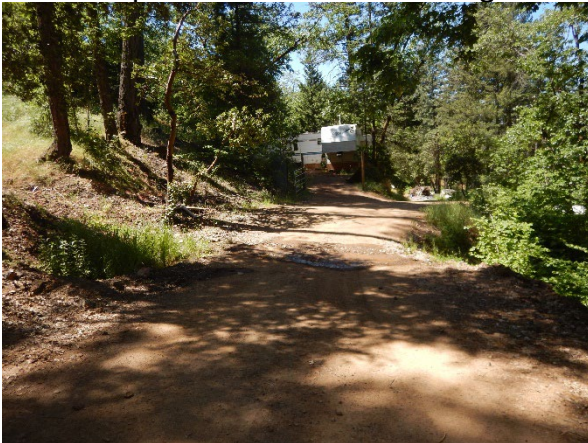
Photo 3: P2 within A1, looking at undeveloped watercourse crossing.

#1 Submit an application for work in surface waters to remove fill placed in surface waters, restore impacted watercourse channels, and replace undersized, nonexistent, or improperly placed watercourse crossing infrastructure.

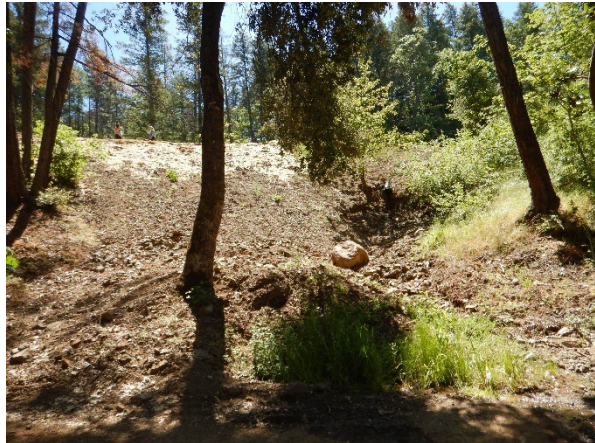
Photo 4: Looking up slope from P2 within A1.

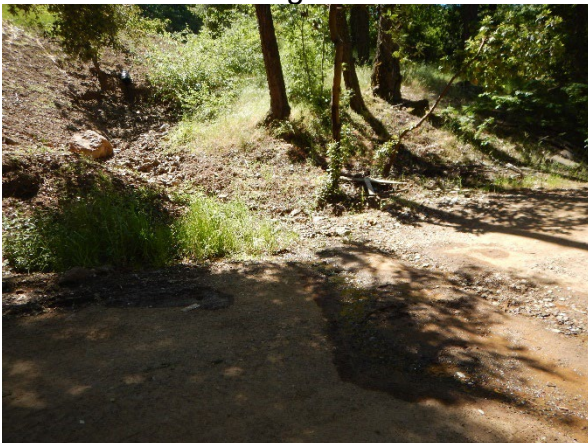
Photo 5: Closer view of undeveloped watercourse crossing at P2 within A1.

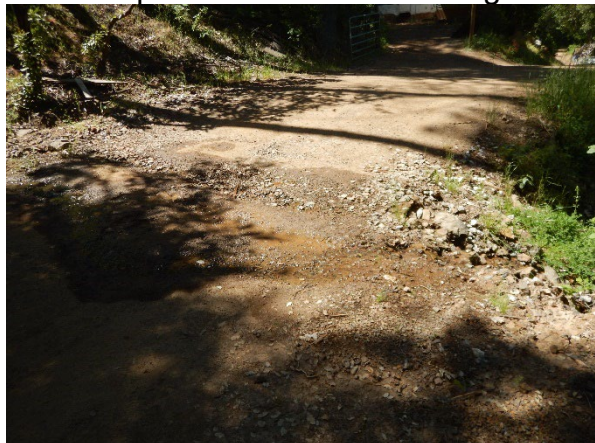
Photo 6: Water flowing across road at undeveloped watercourse crossing P2.

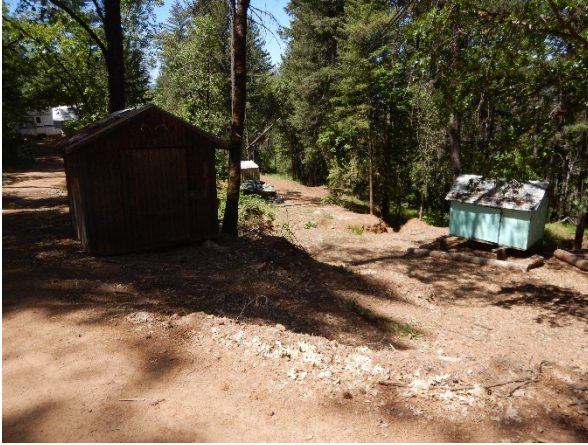
Photo 7: View looking downslope from P2 within A1.

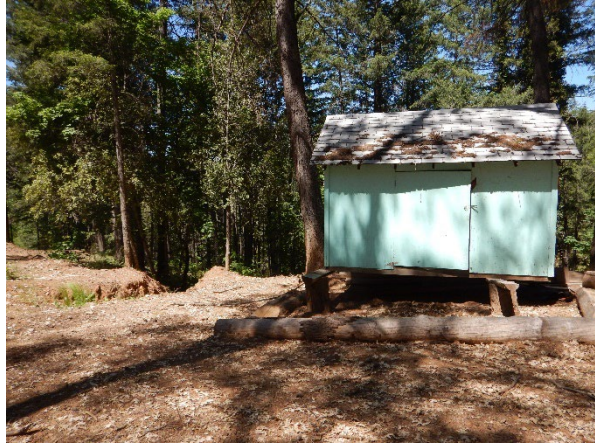
Photo 8: View looking downslope from P2 at P5 within A1.

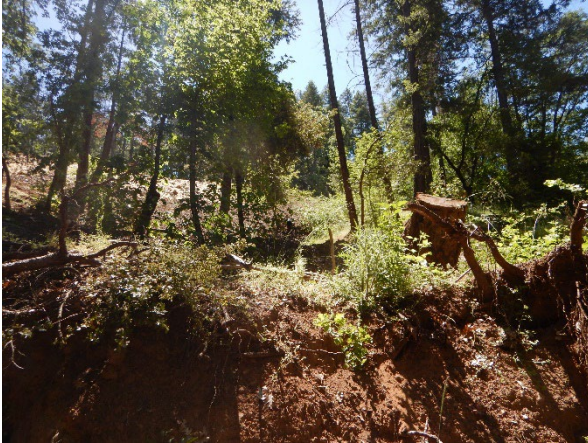
Photo 9: Looking upslope watercourse P5 towards P1 and parking area within A1.

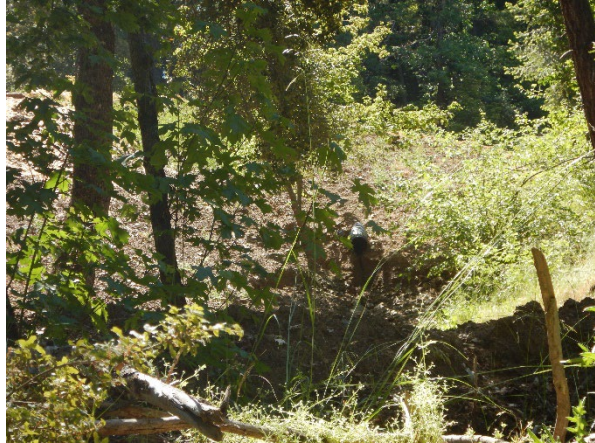
Photo 10: Closer view of P1, looking upslope from P5.

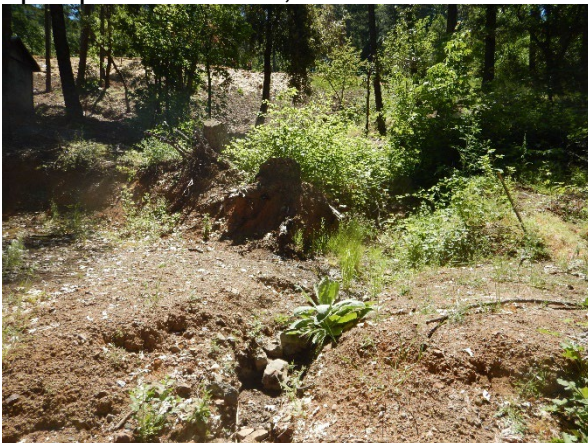
Photo 11: View of watercourse P5 looking upslope towards P1, within A1.

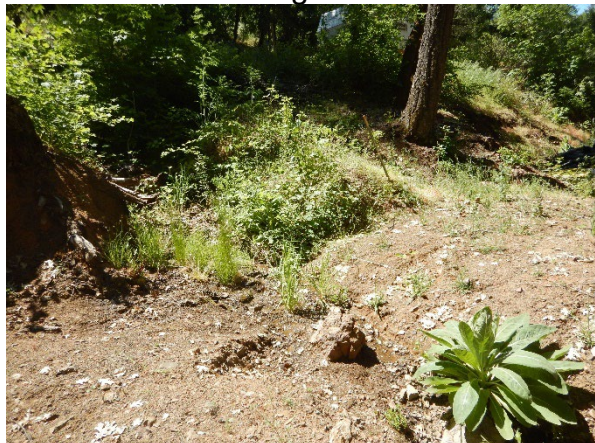
Photo 12: Closer view of the undeveloped watercourse crossing and P5.

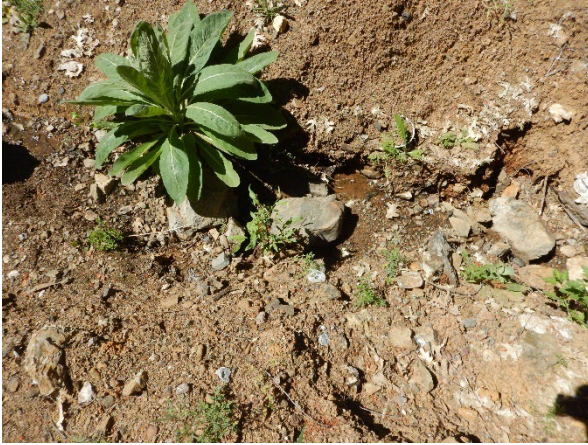
Photo 13: Water flowing within undeveloped watercourse crossing P5.

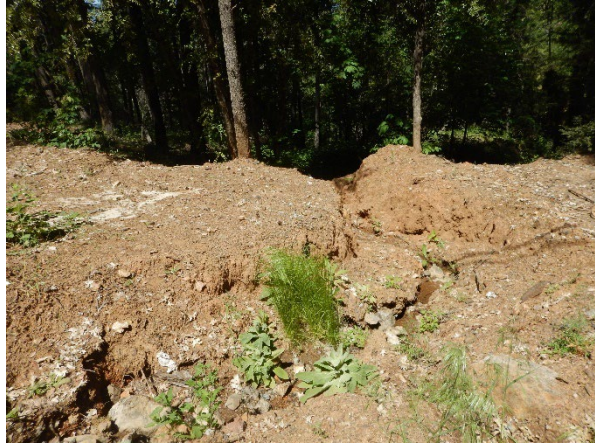
Photo 14: Looking down slope at the channelization of watercourse P5.

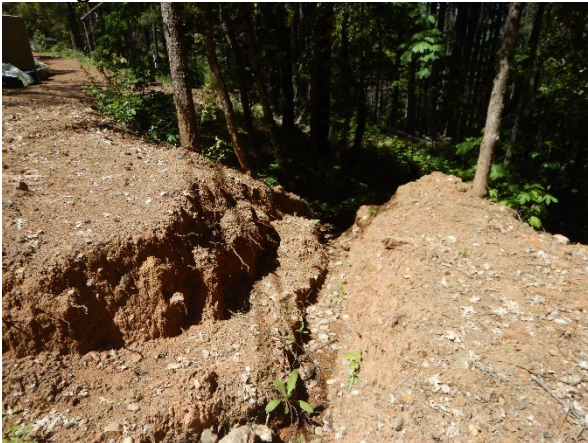
Photo 15: Channel of watercourse P5 through loose fill within A1.

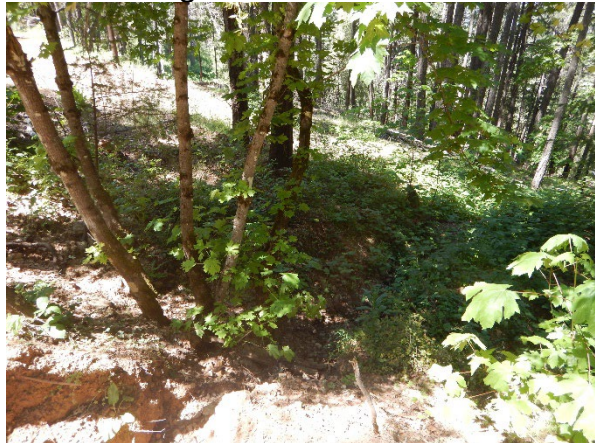
Photo 16: Current channel of watercourse P5 at the edge of A1.

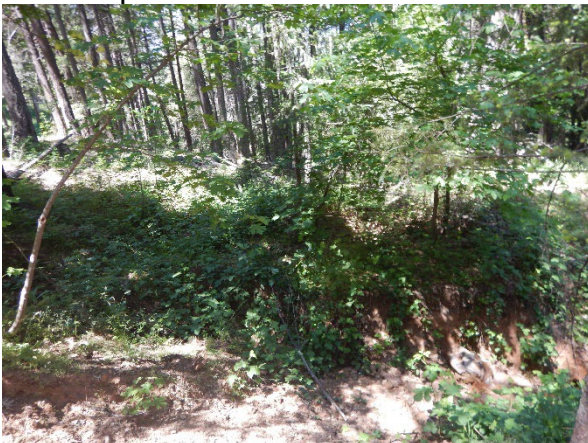
Photo 17: Additional view of channel downslope P5.

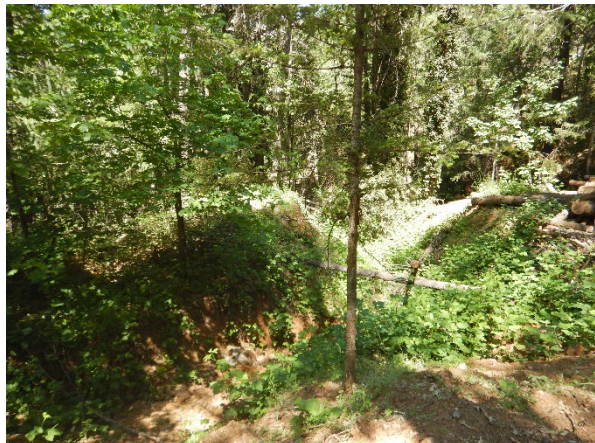
Photo 18: Previous deeply incised channel of watercourse P5 within A1.

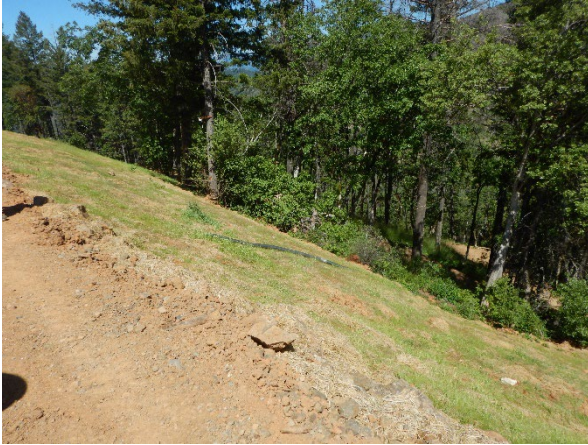
Photo 19: View looking west at an older landslide P8.

#2 Provide an engineering plan and proposal to stabilize the current landslides on the Property for Regional Water Board concurrence.

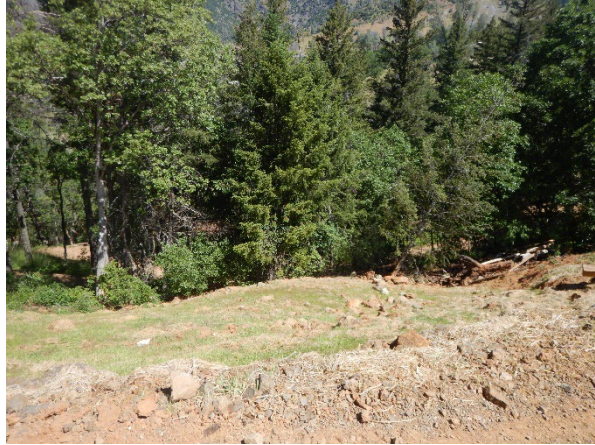
Photo 20: View looking downslope at older landslide P8.

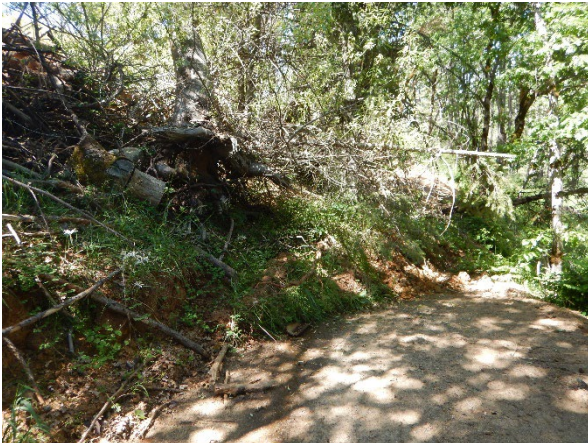
Photo 21: View of landslide movement on road below P8.

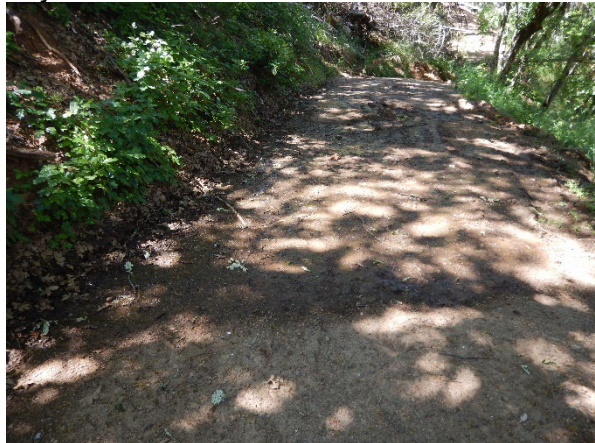
Photo 22: Water flowing across road adjacent to toe of landslide P8.

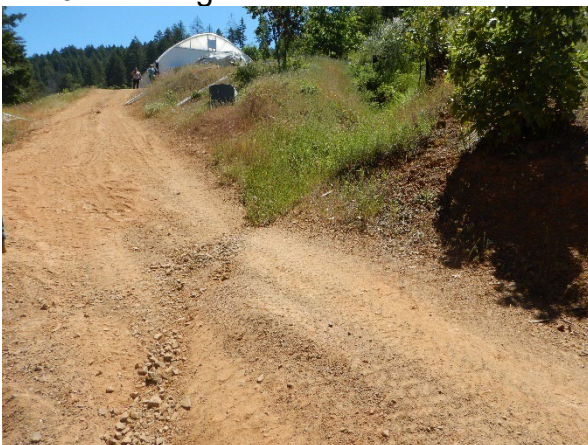
Photo 23: View of flow path across road at P9 west of greenhouses.

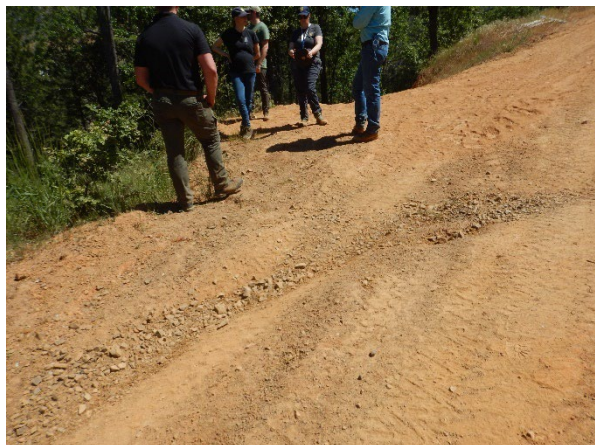
Photo 24: Continued view of P9 flow path across the road.

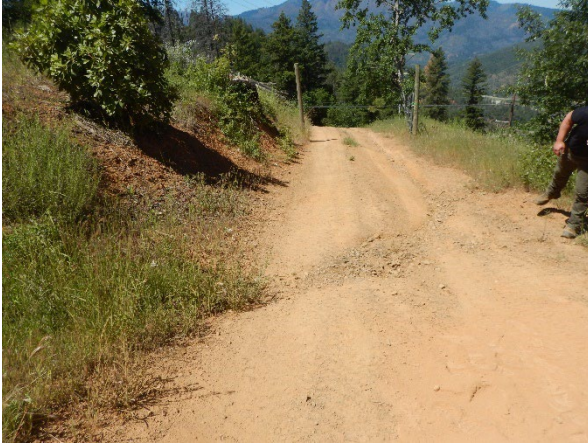
Photo 25: Exent of undeveloped watercourse crossing P9, looking west.

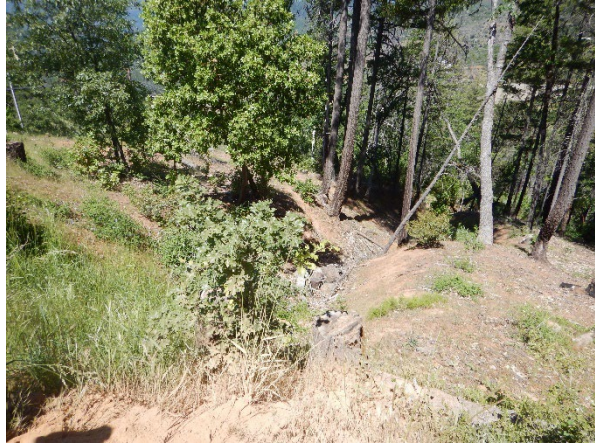
Photo 26: Channel downslope of P9, looking north -northwest.

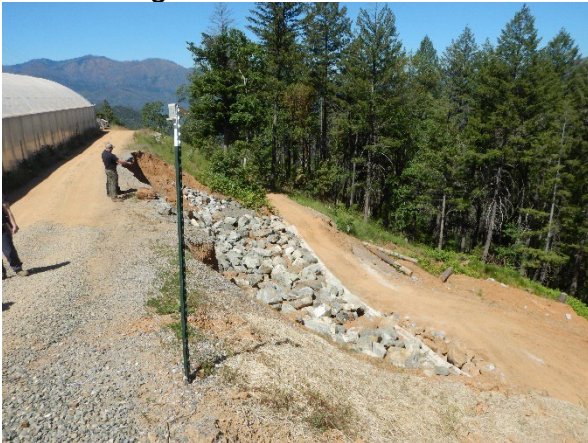
Photo 27: View of lower landslide P10 and rocking to minimize additional failure.

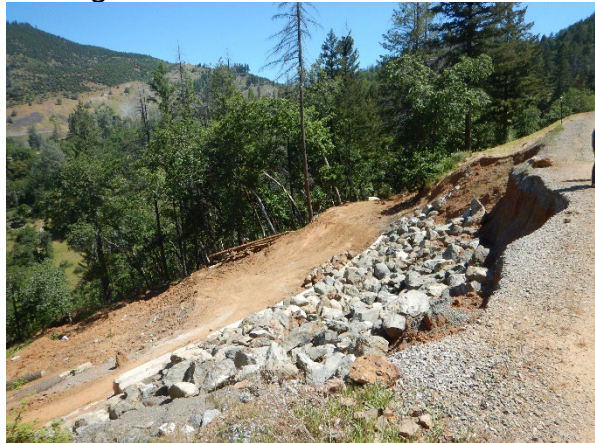
Photo 28: View of lower landslide P10 looking East.

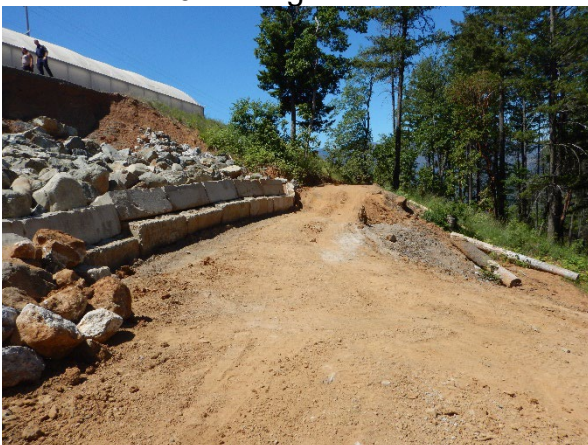
Photo 29: View from below lower landslide P10 looking West.

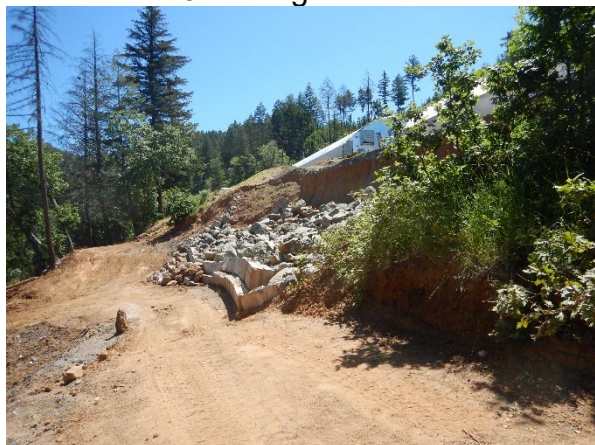
Photo 30: View from below lower landslide P10 looking East.

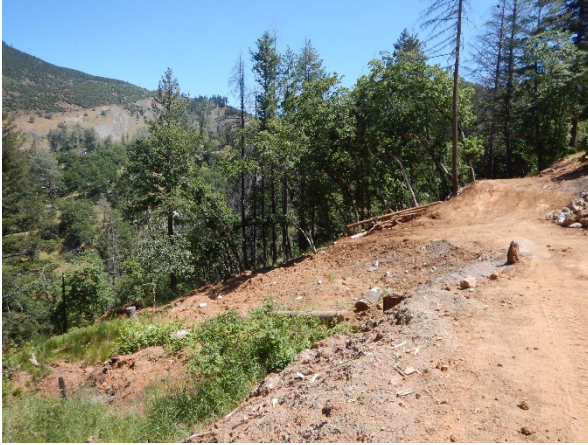
Photo 31: Looking downslope at lower landslide P10 slide mass.

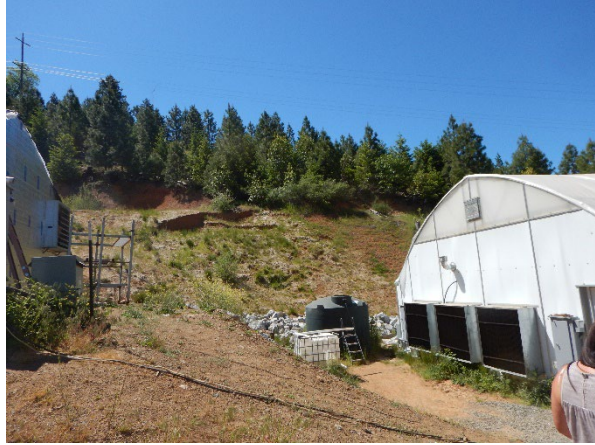
Photo 32: View of upper landslide P10 located above greenhouses.

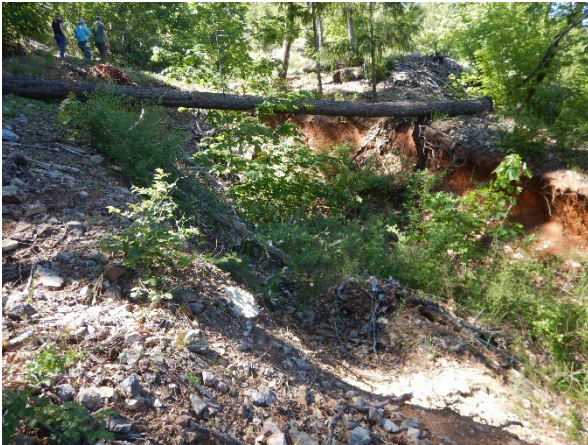
Photo 33: View looking upslope at watercourse P11.

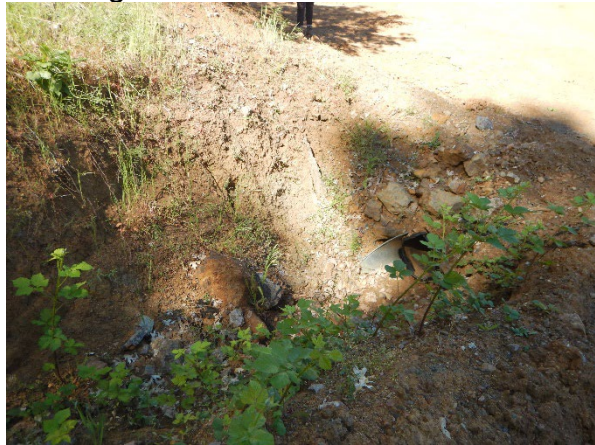
Photo 34: View of inlet of culverted crossing at watercourse P11.

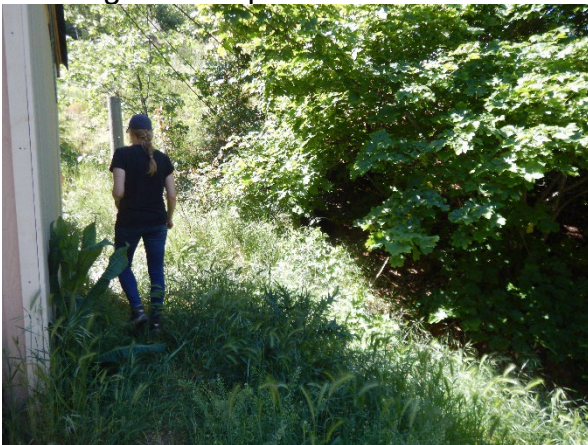
Photo 35: Outlet of culverted watercourse crossing downslope of P11.

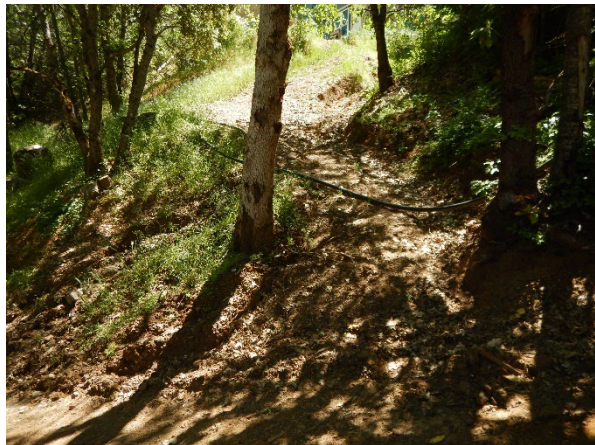
Photo 36: P7 the downslope portion of watercourse P11.
