EXHIBIT B

DRY CLEANERS— A MAJOR SOURCE OF PCE IN GROUND WATER

27 March 1992

**REGIONAL WATER QUALITY CONTROL BOARD
CENTRAL VALLEY REGION**

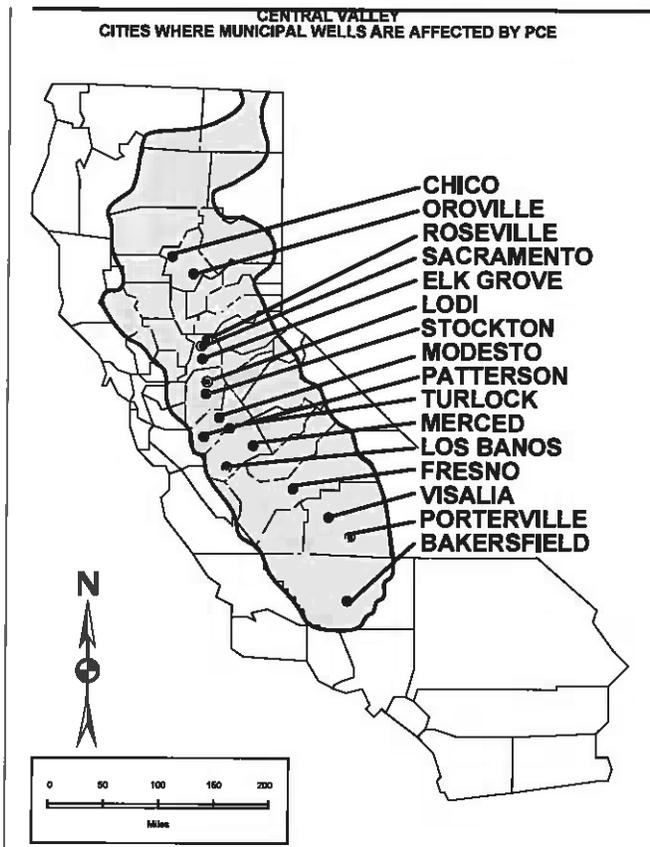
Tetrachloroethylene (PCE), a known carcinogen, has degraded at least 215 wells in the Central Valley of California. Figure 1 illustrates the extent of the problem. The majority of these wells are large system municipal wells of 200 connections of more. The Chico, Sacramento, Modesto, Fresno, Turlock, Lodi and Merced areas all have wells with levels of PCE above 0.8 ppb which is the estimated one in a million incremental cancer risk (8). The Maximum Contaminant Level (MCL) set by the Department of Health Services for drinking water is five ppb. Forty-seven of the 215 wells have PCE levels above the MCL.

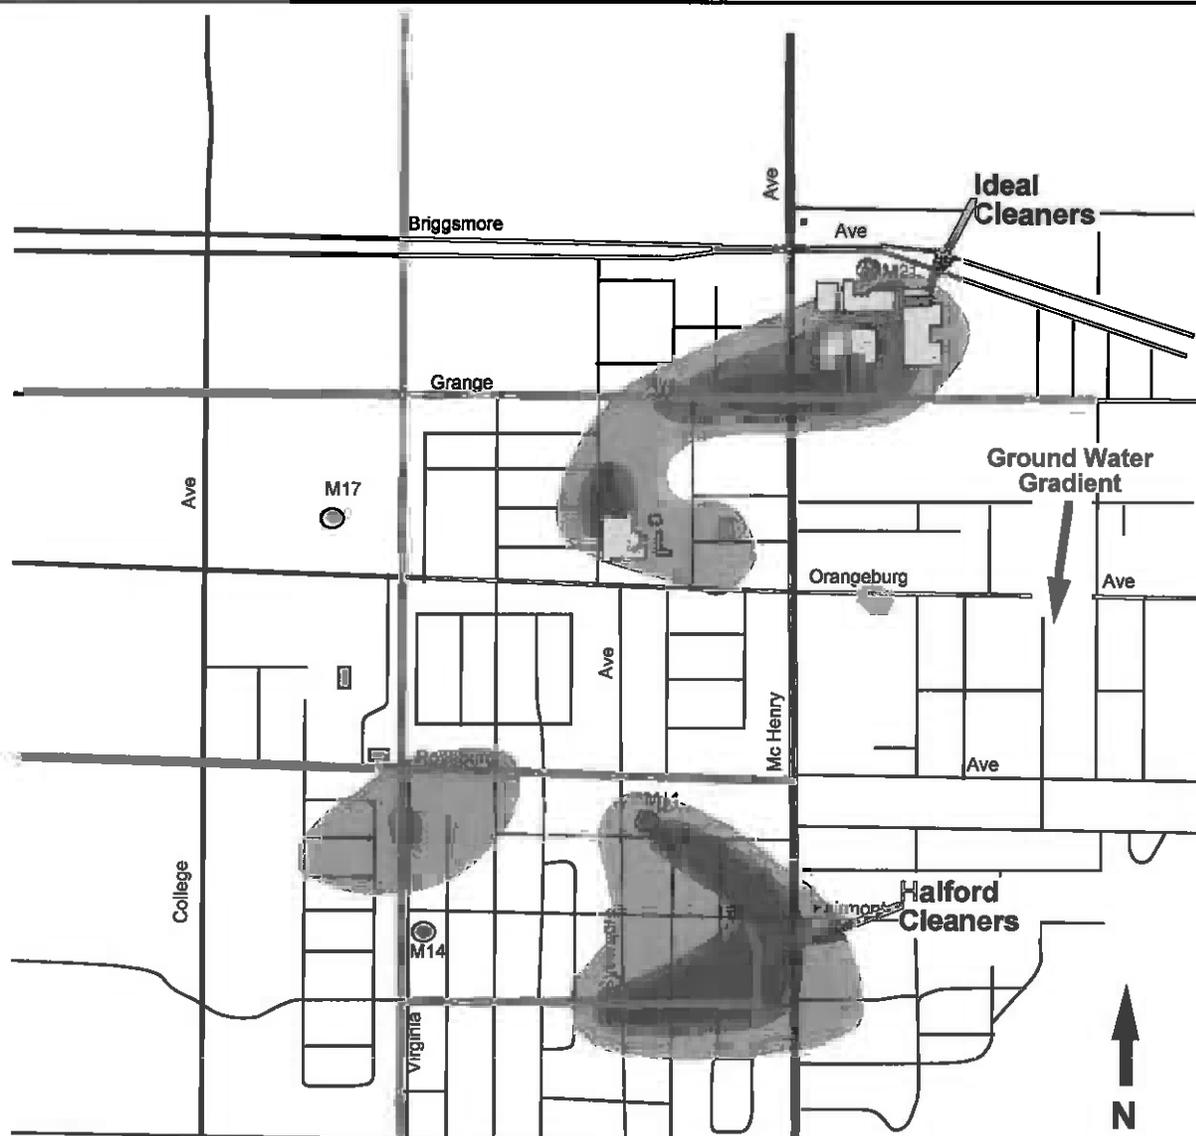
Figure 14

Figures 13 through 16 are maps showing results of soil gas surveys from Turlock, Modesto, Lodi and Merced which illustrate that PCE vapors are higher along the sewer lines. The highest counts are usually near the cleaners, but the counts continue high from the sites down the sewer line.

<p>CITY OF MODESTO WELL 11, 14 & 21 SOIL GAS SURVEY AND SEWER LINE LOCATIONS</p>	<p>PCE ION COUNTS (in thousands)</p>		Municipal Well
	10 - 50	50 - 150	Active Dry Cleaner
	>150		Inactive Dry Cleaner
			Other Buildings
			Sewer Lines

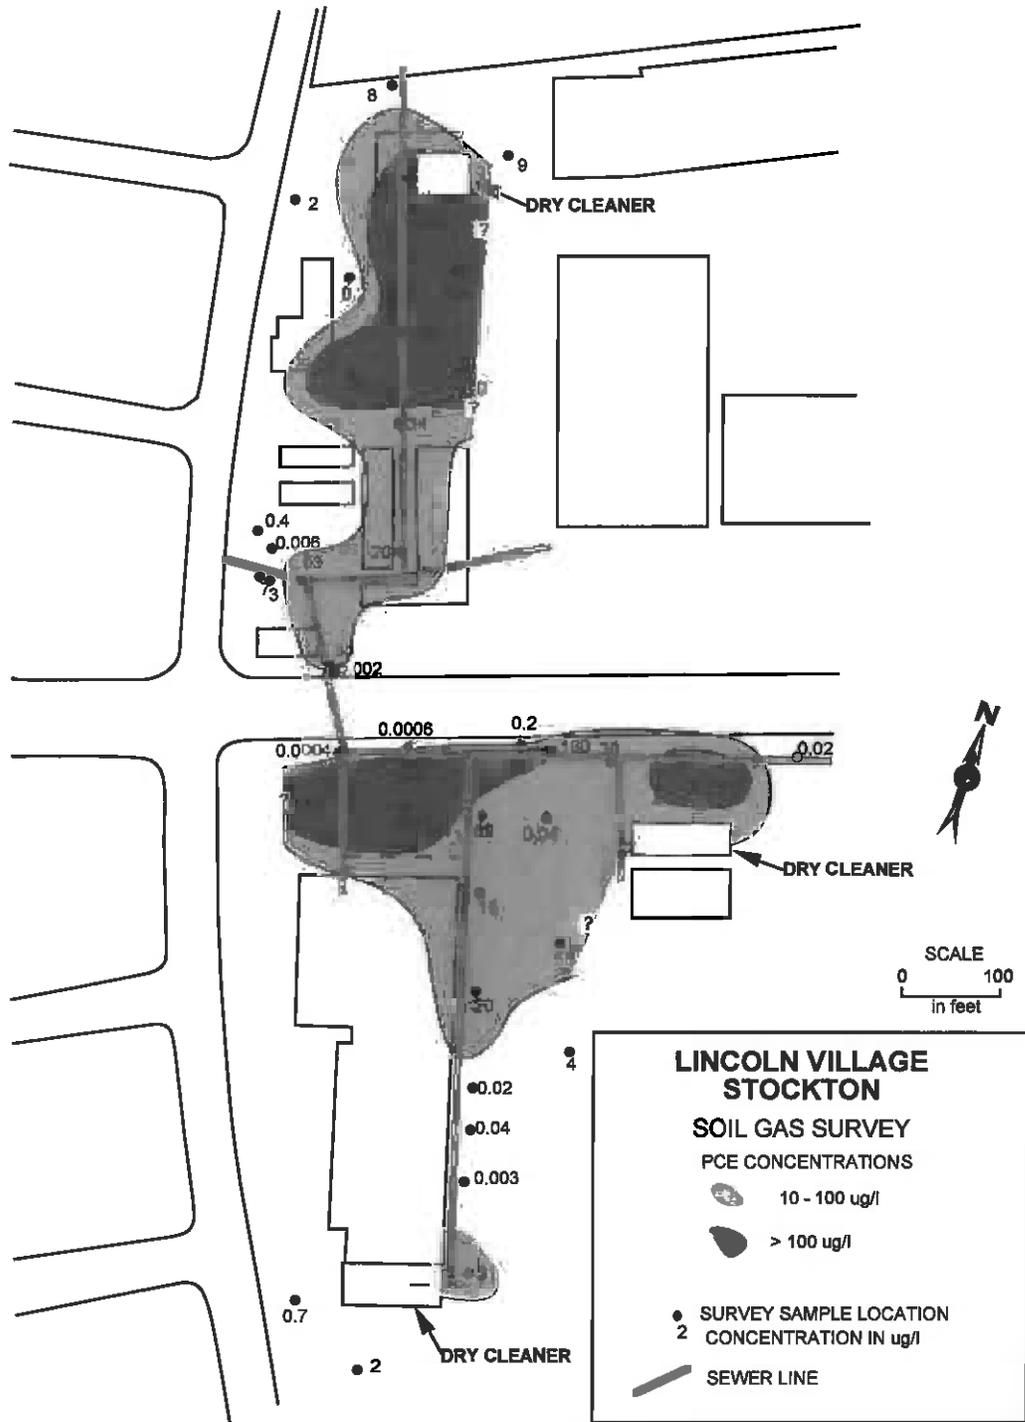
Figure 17

and ran the sample through a gas chromatograph. This survey also indicates high concentrations of PCE vapor along the sewer line (Figure 17). There are

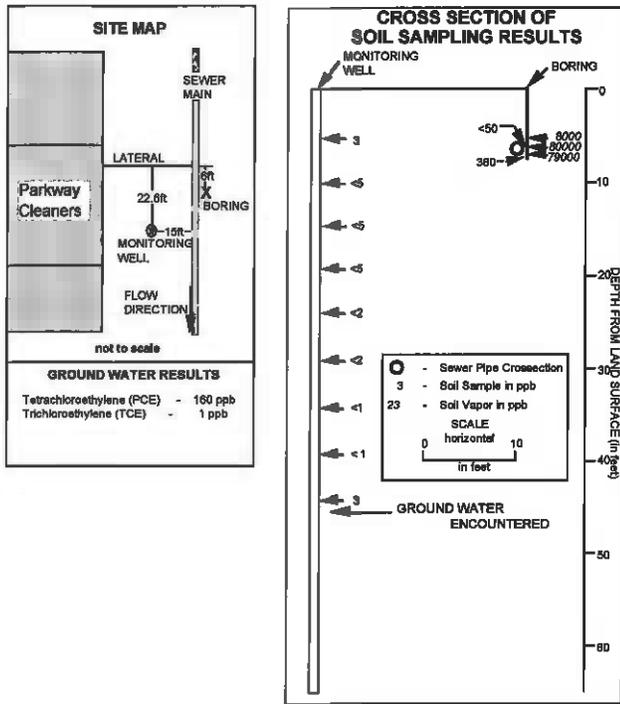
Figure 19

higher than was found in the MW. Also, soil vapor samples in the City boring contained up to 80,000 ppb PCE.

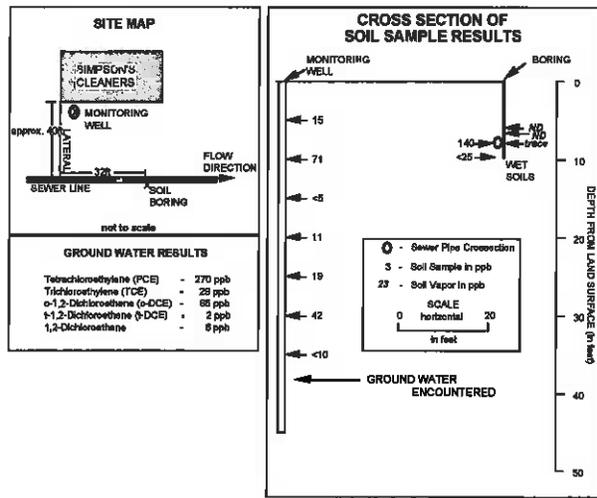
Figure 20 illustrates the data from the Simpson's Cleaners site. Soil samples taken during the drilling of the MW at the southwest corner of the facility had PCE levels from non-detect to 71 ppb. The shallow ground water sample had 270 ppb PCE and also contained 29 ppb trichloroethylene (TCE), 65 ppb cis-1,2-dichloroethene (DCE), two ppb trans-1,2-DCE, and 6 ppb 1,2-dichloroethane, all of which are breakdown

products of PCE. The MCL for TCE is 5 ppb and for DCE is 6 ppb.

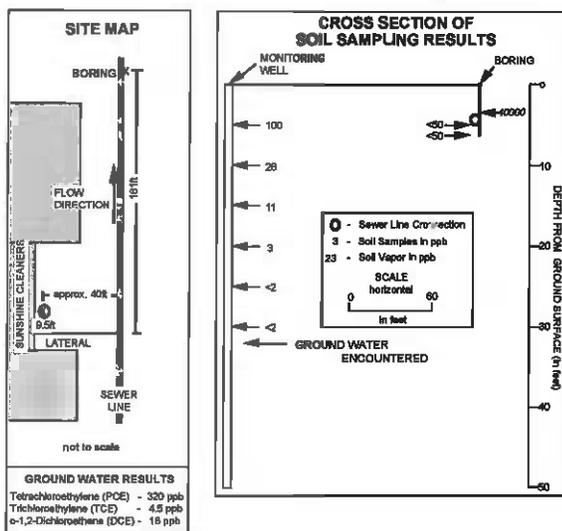
Figure 21

100 ppb. The ground water sample had 320 ppb PCE, 4.5 ppb TCE and 18 ppb DCE.

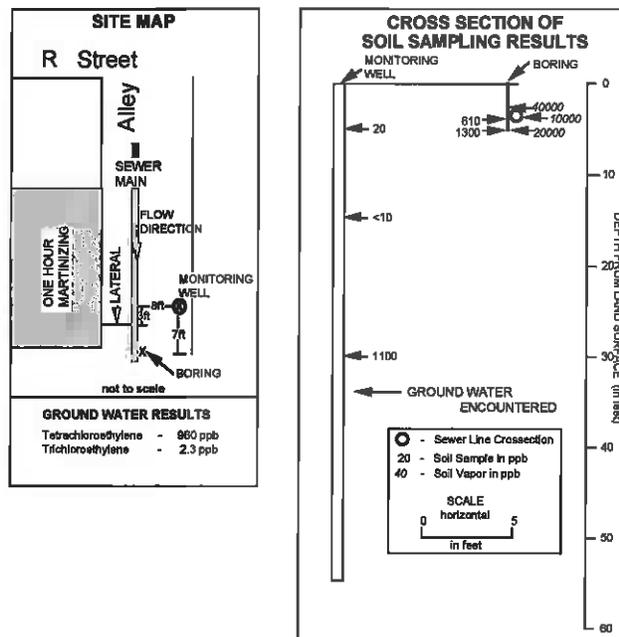
Figure 22

from the cleaner's northwest wall. PCE levels in the soil samples taken during drilling of the MW were low in the upper 20 feet ranging from nondetect to 20 ppb, but near the ground water a soil sample had 1,100 ppb PCE. The ground water sample had PCE and TCE with concentrations of 960 ppb and 2.3 ppb, respectively.

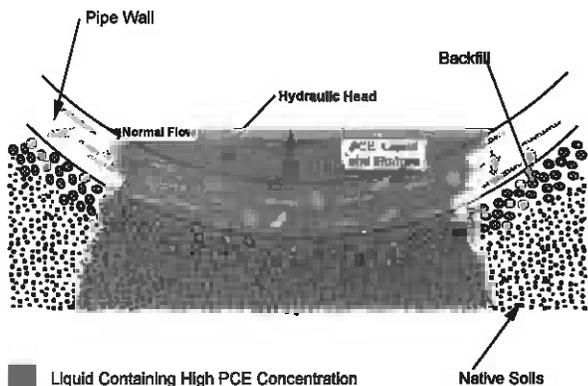
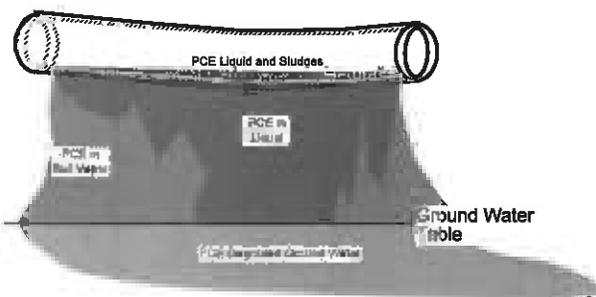
Figure 23

By this method, PCE-containing wastewater or PCE liquid penetrates a sewer pipe without any breaks. In this case liquid leaves the pipe and enters the vadose zone (Figure 23). Sewer pipe is not impermeable to water or PCE. When liquid collects in a low spot of the sewer pipe, it cause an increase in the hydraulic

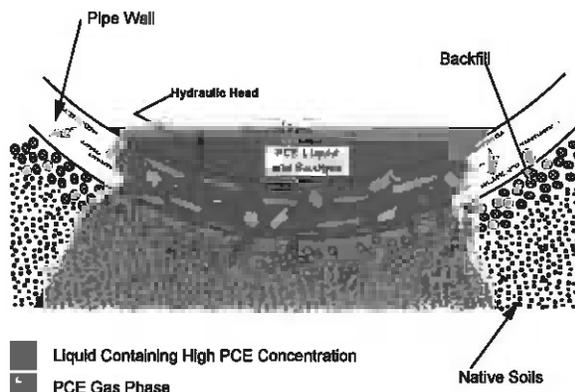
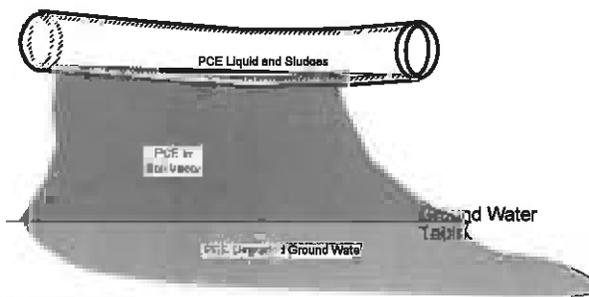
Figure 24

into the vadose zone. In this method, the pipe walls still have a high concentration of PCE-containing liquids (Figure 24). Being volatile, PCE turns into a gas at the liquid-soil vapor interface at the outer edge of the pipe. Since the vapor density of PCE is 5.83 times greater than air, the PCE gas in soil vapor would sink towards ground water, causing ground water degradation.

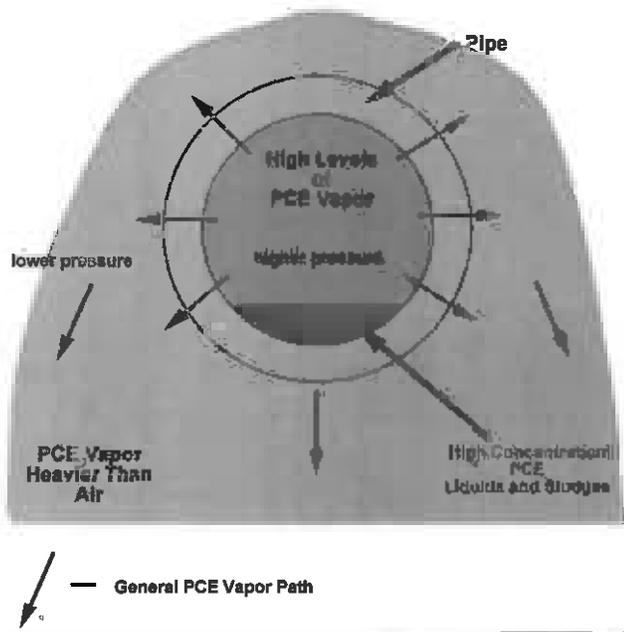
Figure 25

In this method, PCE volatilizes inside the pipe and moves as a gas through the sewer pipe wall (Figure 25). The piping material is not designed to contain gas. The concentration of PCE gas in the pipe is greater than in the surrounding soils causing a concentration gradient. This causes a dispersion through the

sewer pipe to the less concentrated area. Another reason gas will penetrate the pipe is due to pressure. The gasses inside the pipe may increase the pressure above atmospheric. This would cause a pressure gradient from higher pressure in the pipe to lower pressure in the vadose zone. The gradient would force PCE gas into the vadose zone. As described above, PCE gas is heavier than air and so would tend to sink towards ground water.

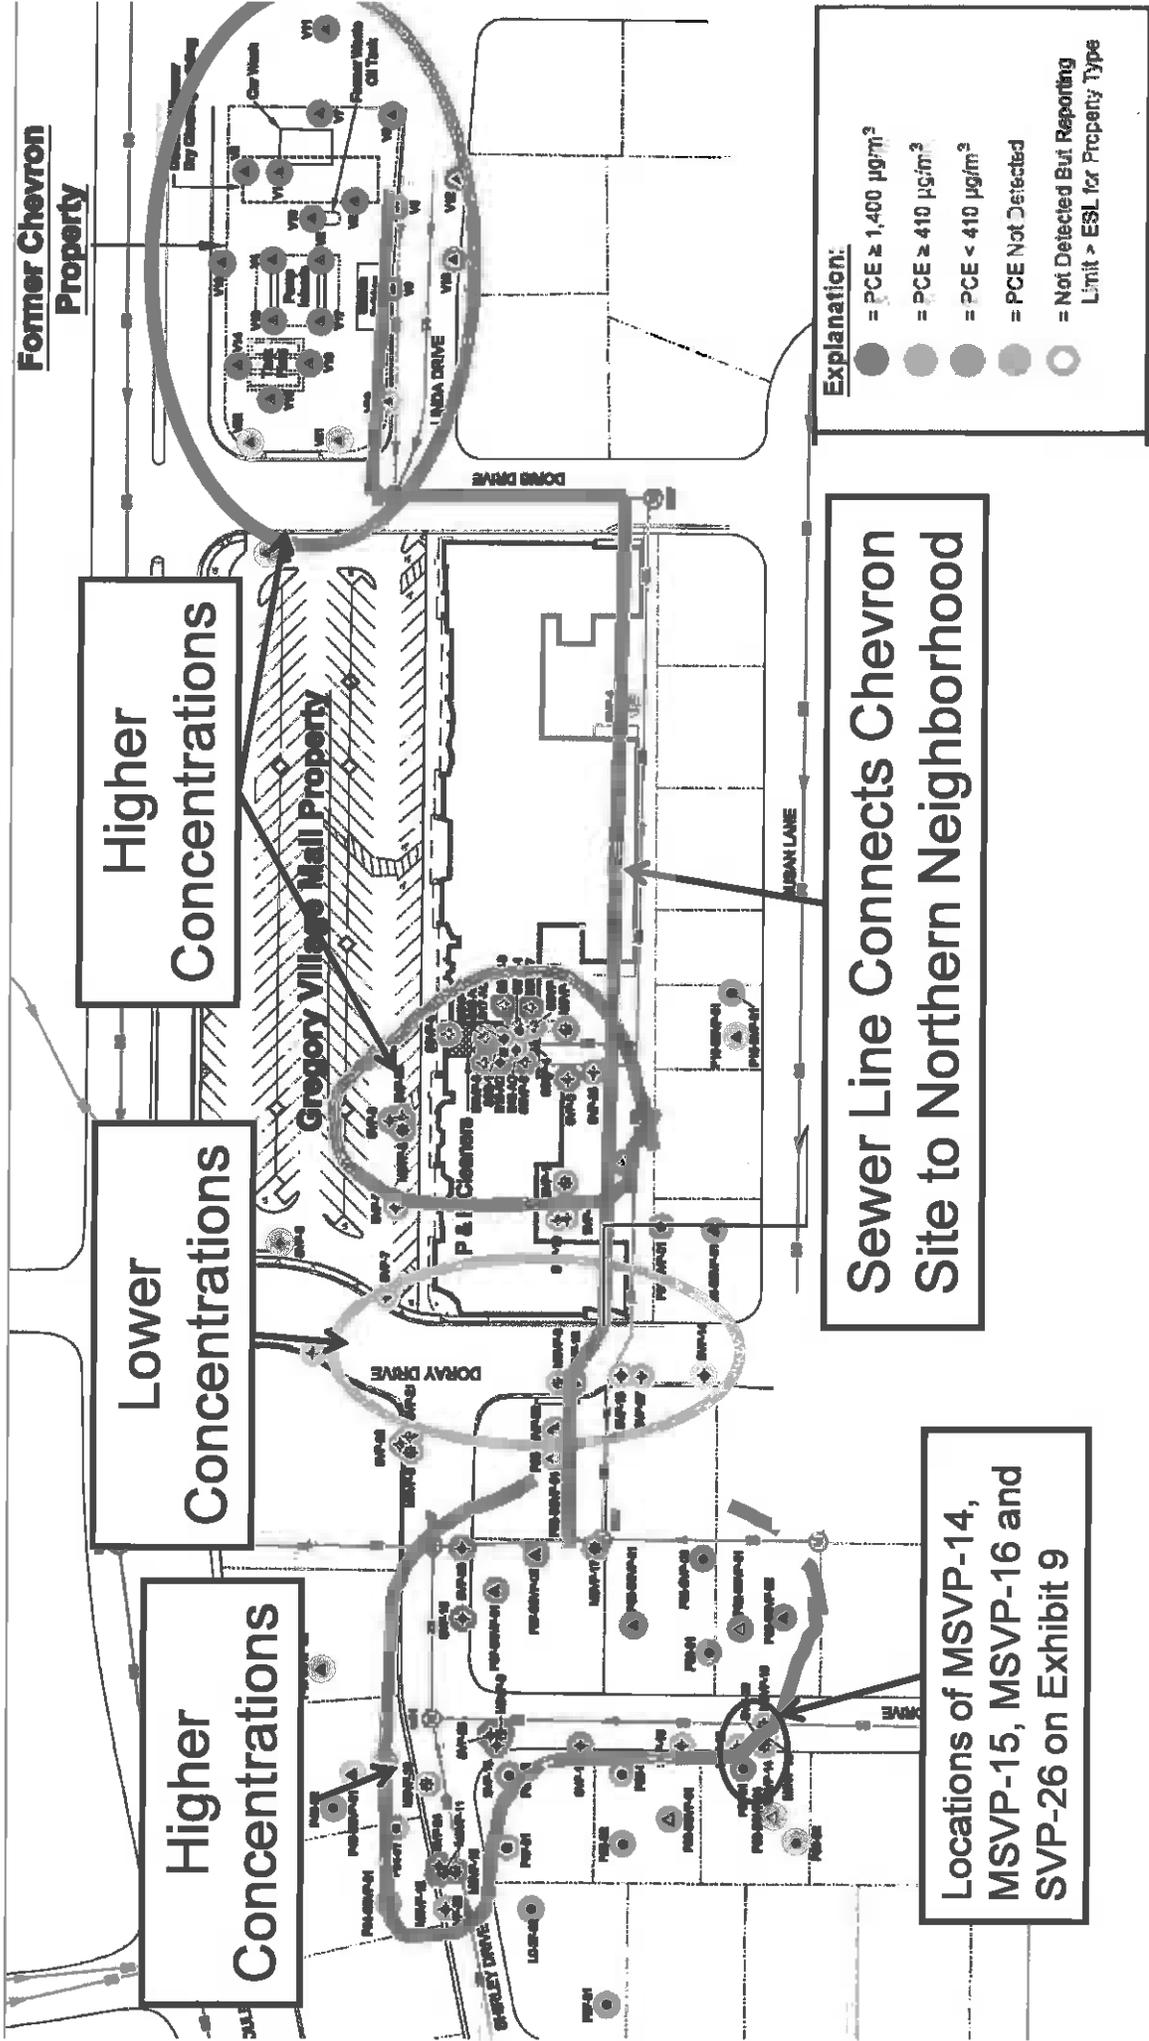
Separate Areas of High PCE Concentrations in Soil Vapor Indicate Separate Releases

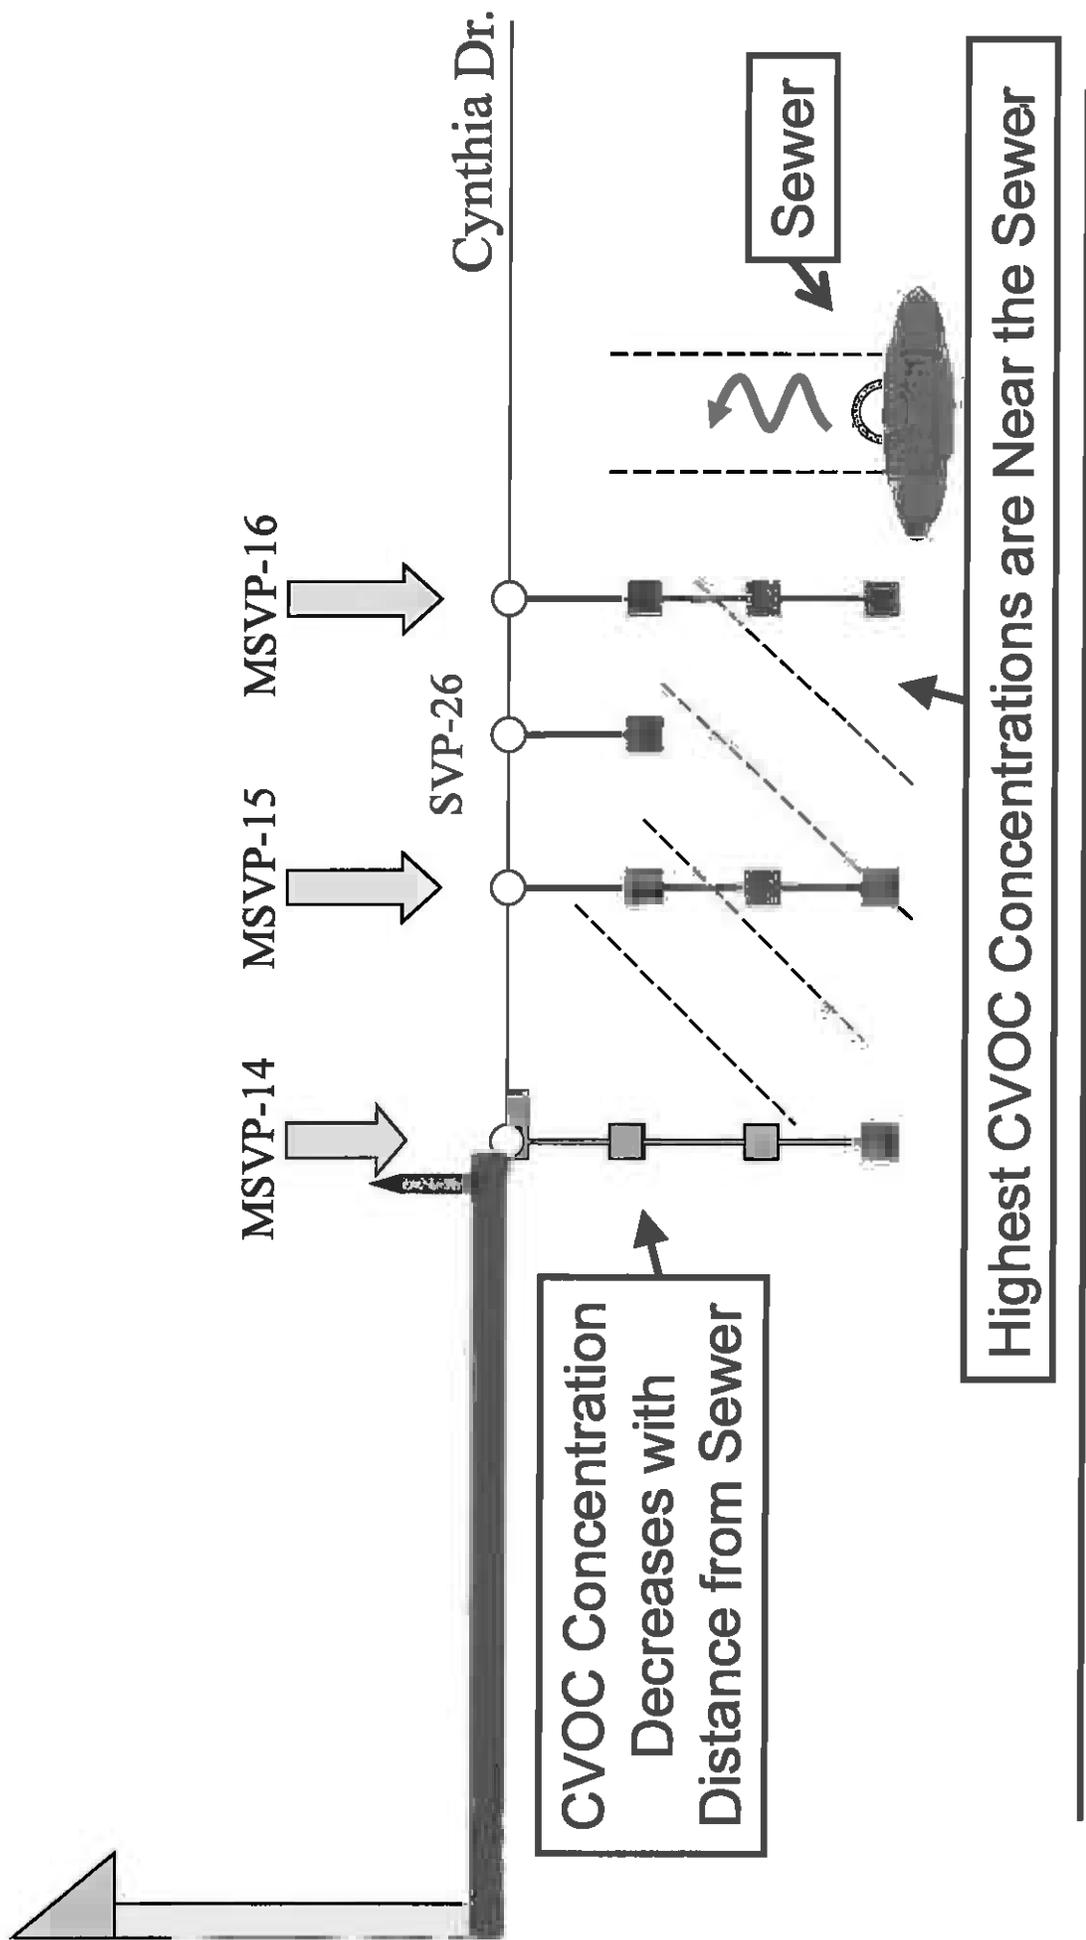
CVOC Concentrations In Soil Vapor are Highest Near the Sewer

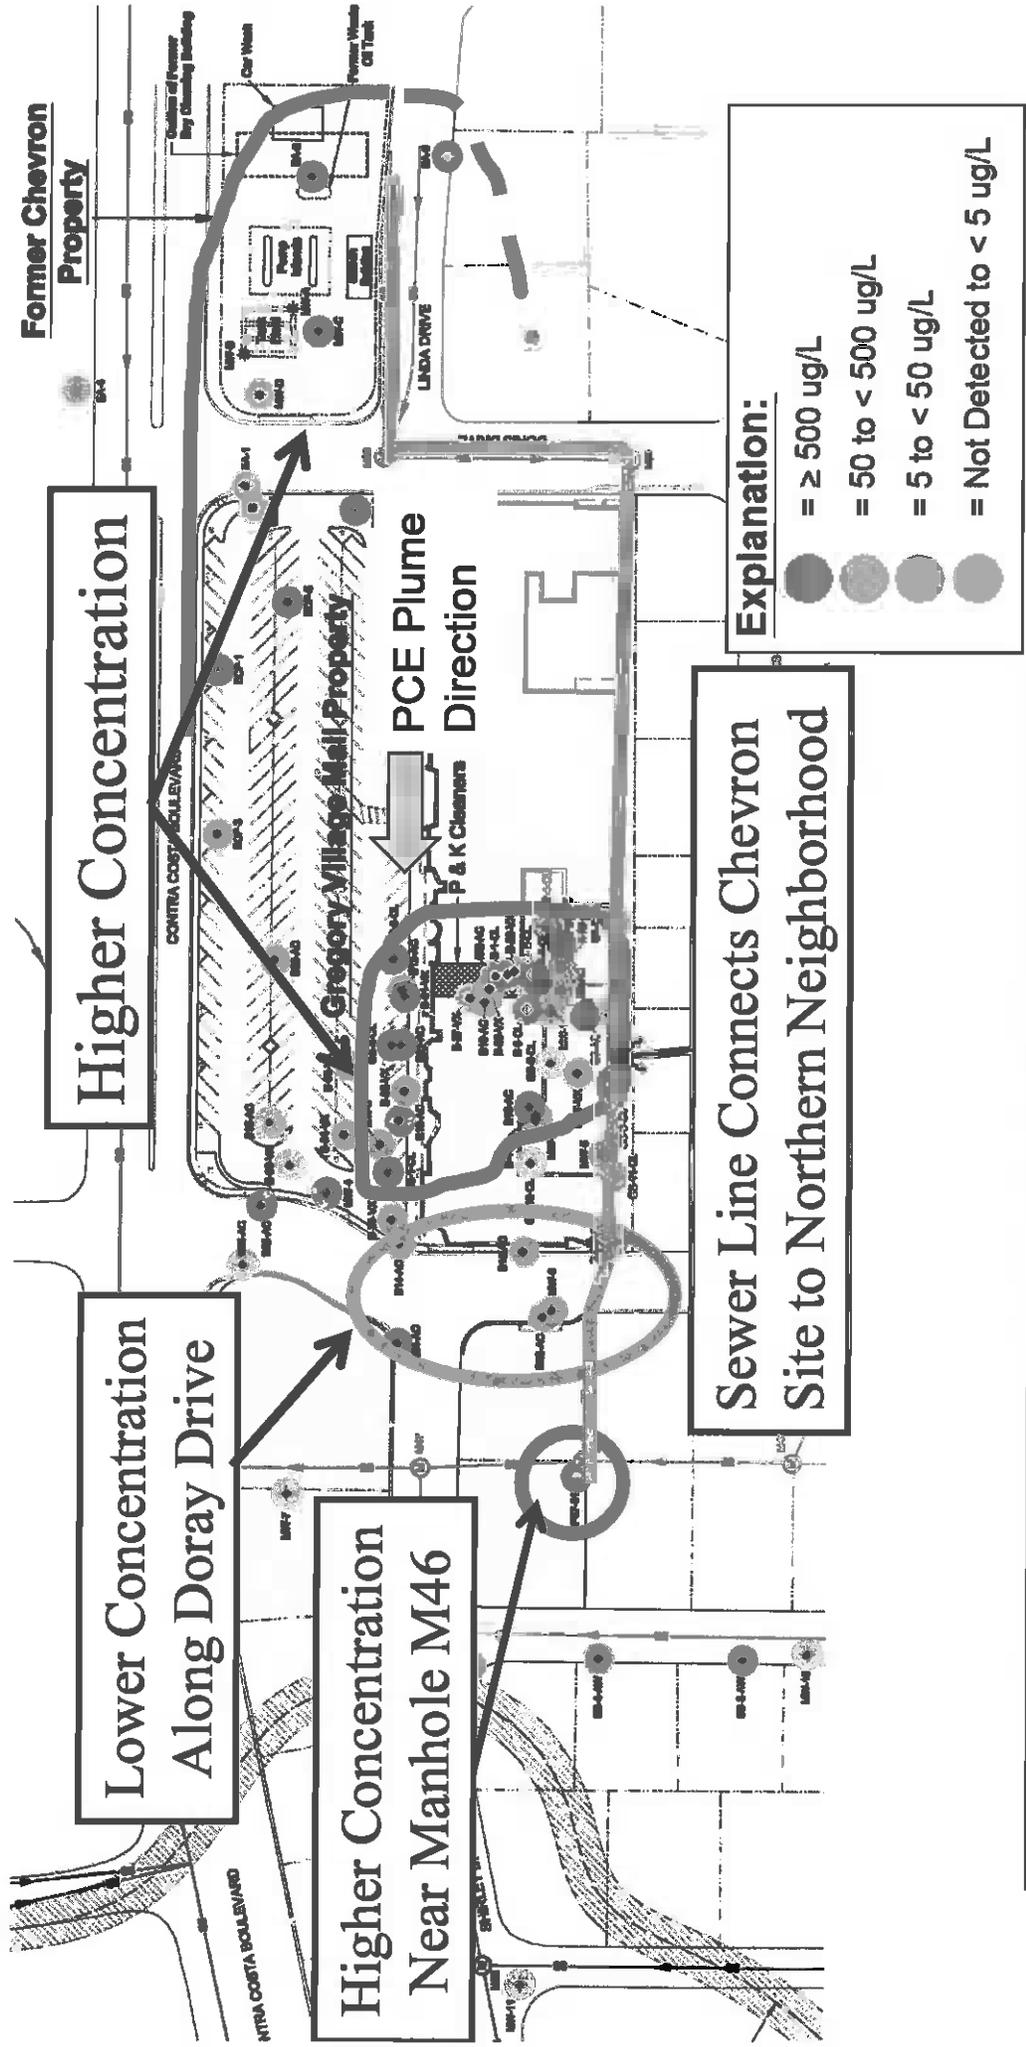
Separate Areas of High PCE Concentrations in Groundwater Indicate Separate Releases

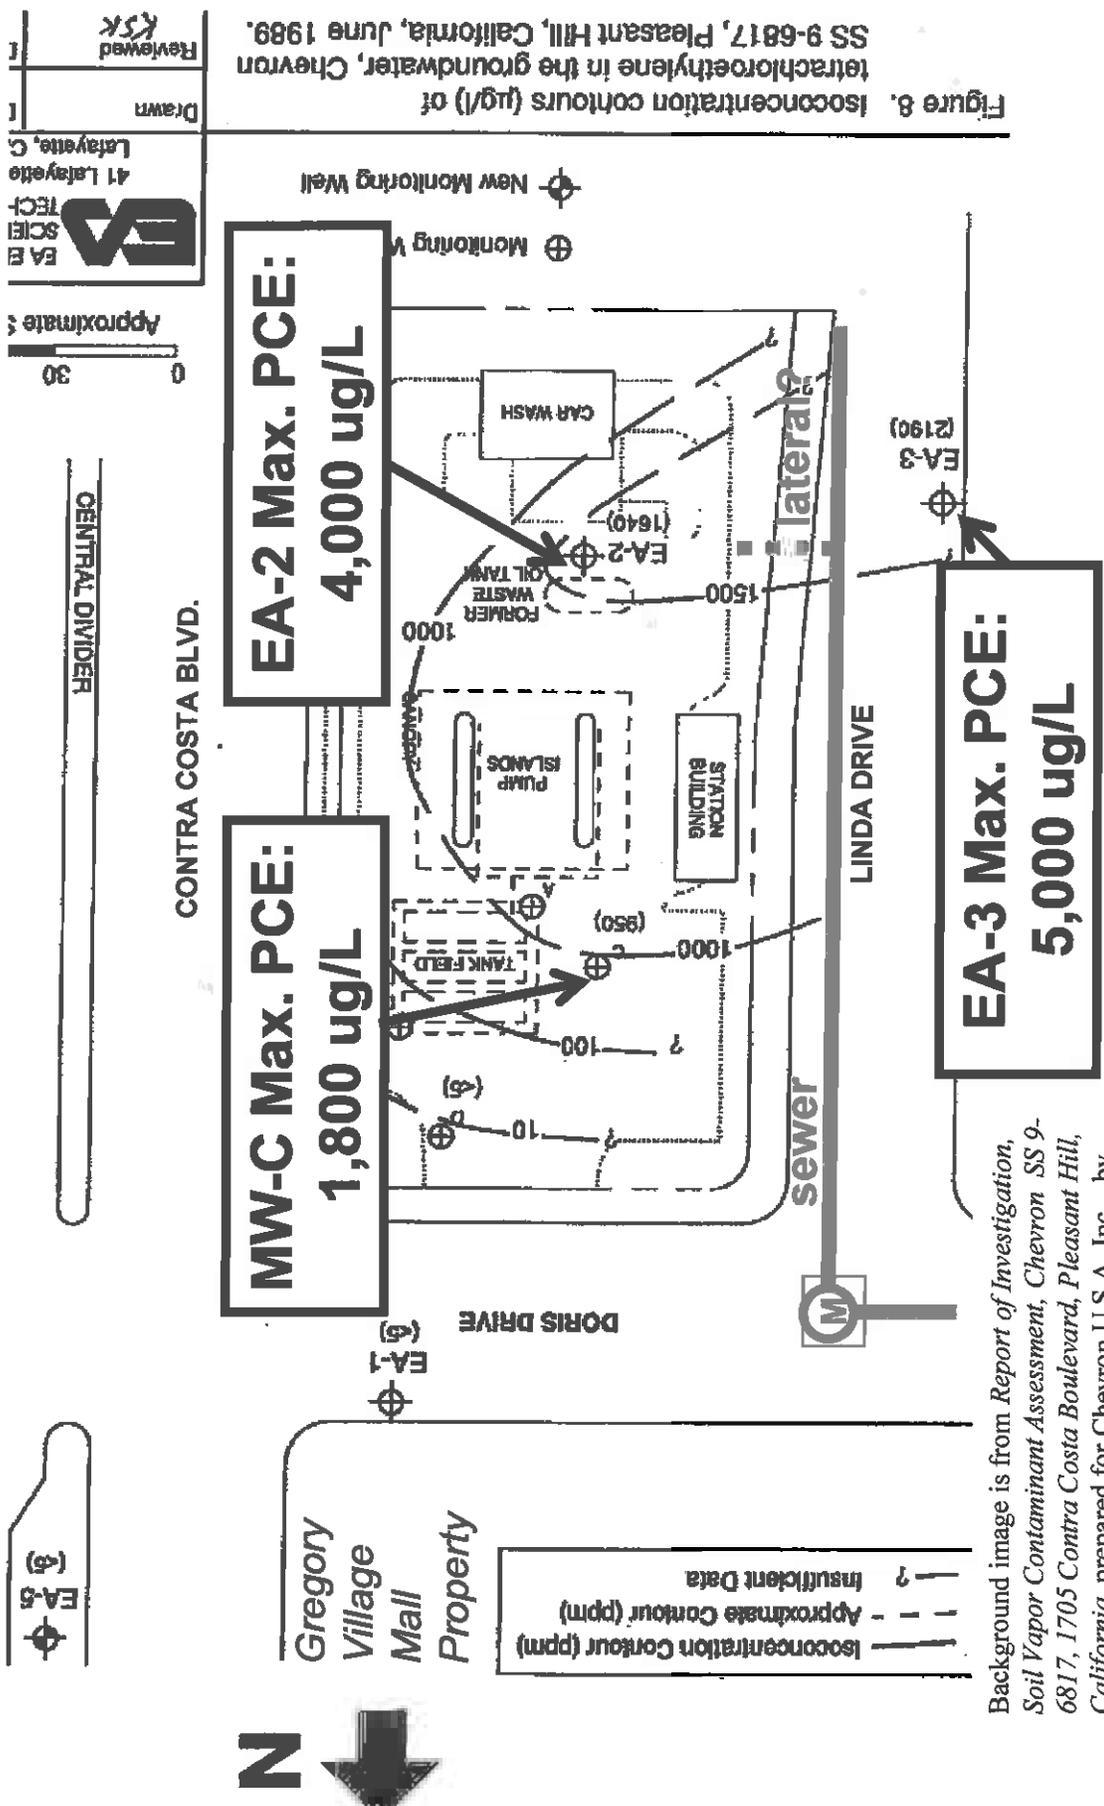
The highest concentration of PCE in groundwater anywhere at the Chevron Site is in Linda Drive near the CCCSD sewer at former monitoring well EA-3 located cross-gradient from the Chevron Site. Chevron's investigations show very high concentrations of PCE and other CVOCs in soil, soil vapor, and groundwater on the Chevron Site and in Linda Drive near the sewer line (*Report of Investigation* by EA Engineering, Science and Technology, Inc., 3 February 1989, and *Additional Site Investigation Report and Site Conceptual Model* by Conestoga-Rovers & Associates, Inc., 2 March 2012). At monitoring well EA-3 in Linda Drive, Chevron detected PCE in soil at 328 micrograms per kilogram from a sample that would have been collected from above the groundwater table and thus resulted from sewer leakage. PCE was detected in groundwater at 5,000 ug/L (Exhibit 10 attached), the highest concentration detected anywhere at Sites 1 and 2, at the same location. A 1977 CCCSD sewer inspection report for Linda Drive describes the sewer as "in very poor shape has lots of cracks," but the replacement apparently did not occur until 10 years later (see Firestone 7/3/2012 letter to B. Wolfe (see Exhibit 23 to that letter)).

PCE in Groundwater in Linda Drive Cross-Gradient from Chevron Site Indicative of a Sewer Leak

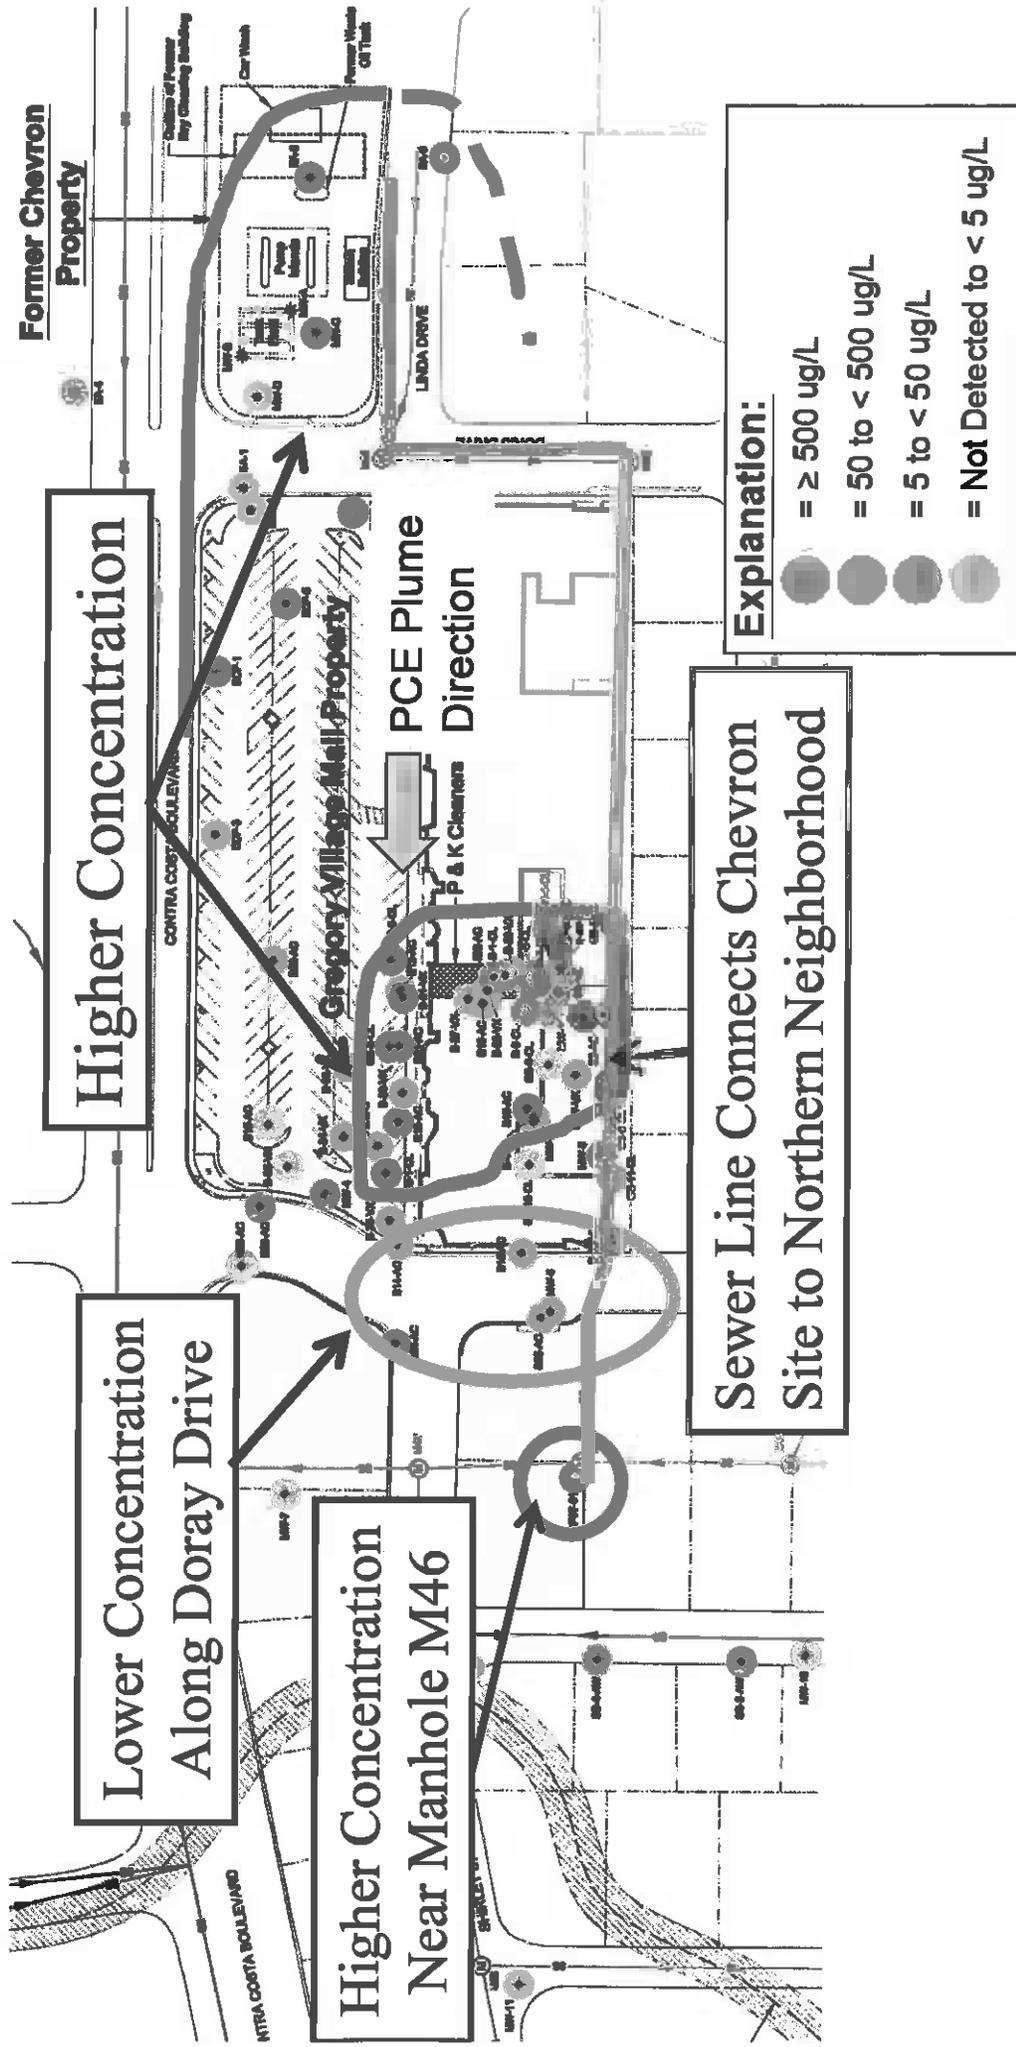
same time, monitoring well EA-3 located in Linda Drive was sampled and had PCE and TCE in groundwater at 5,000 ug/L and 750 ug/L, respectively.

Separate Areas of High PCE Concentrations in Groundwater Indicate Separate Releases

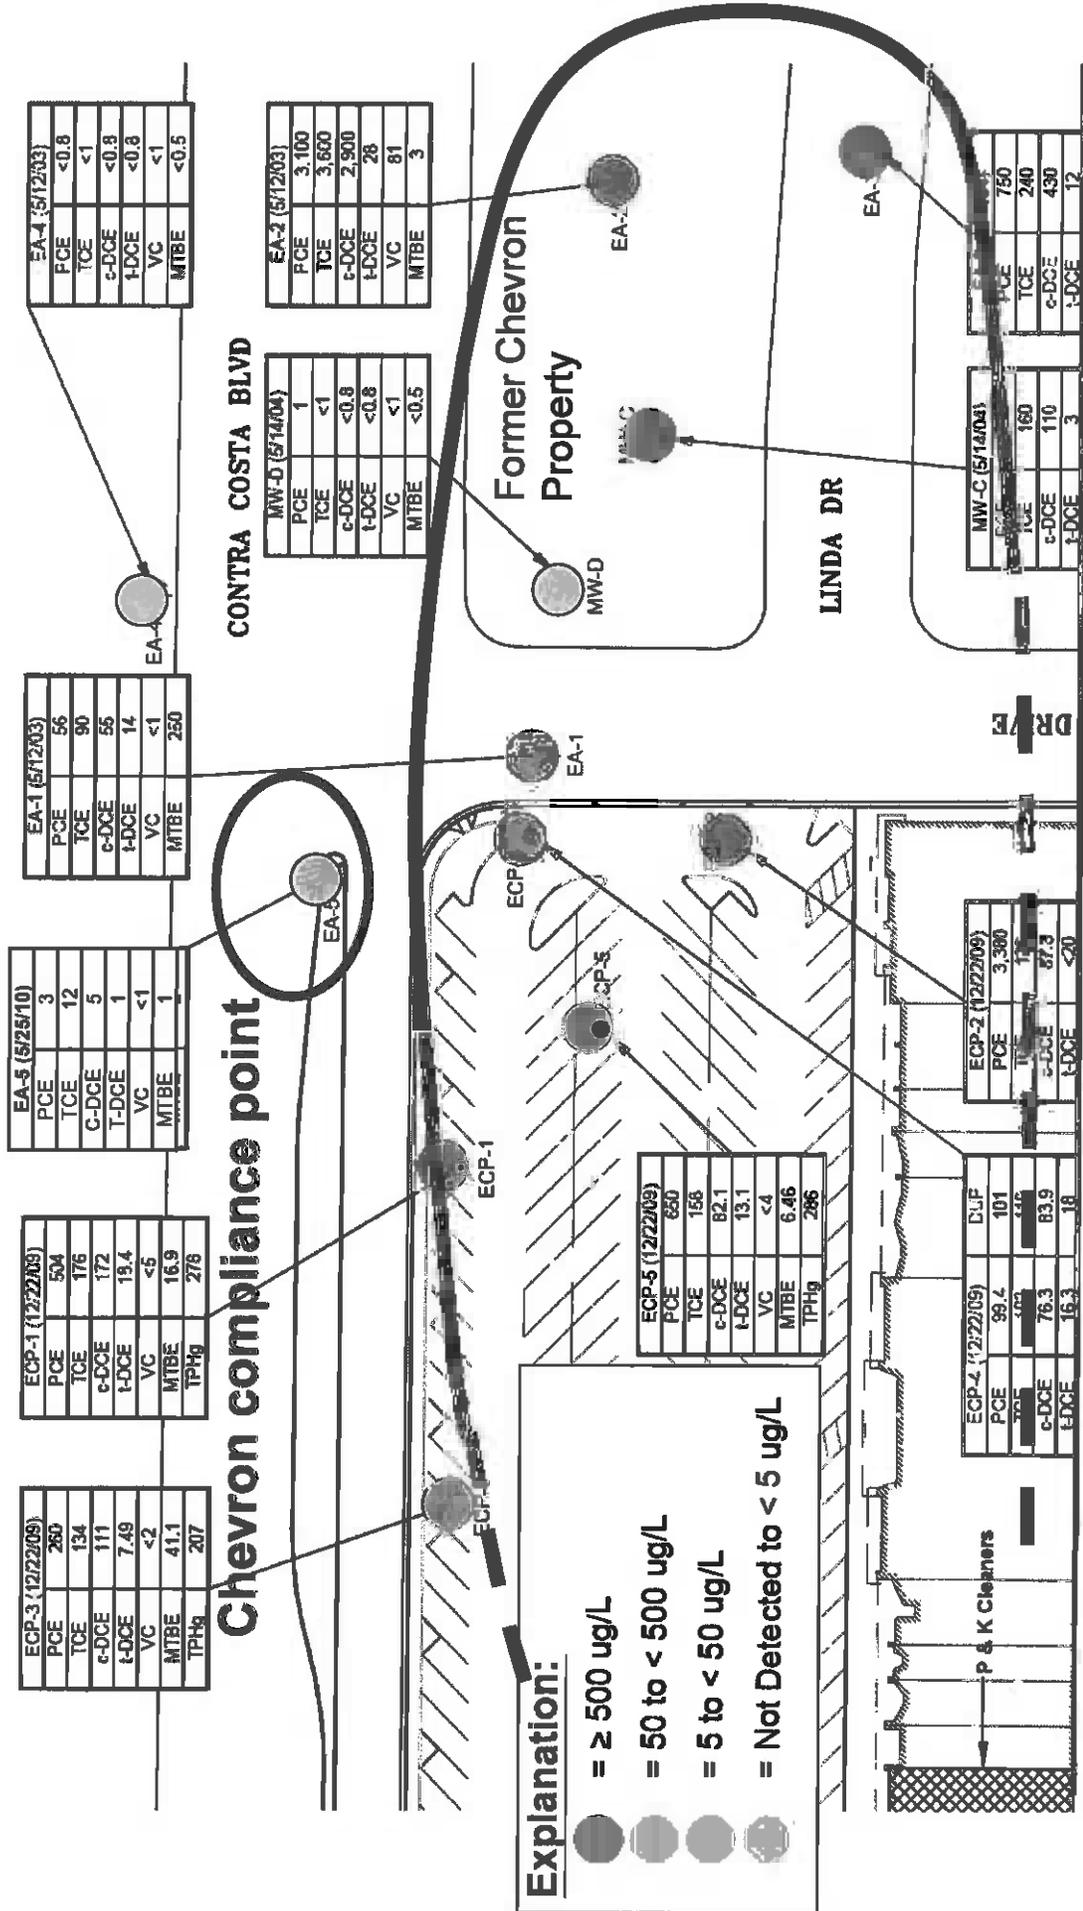
Chevron Compliance Point and Only Well is NOT in the Chevron Plume

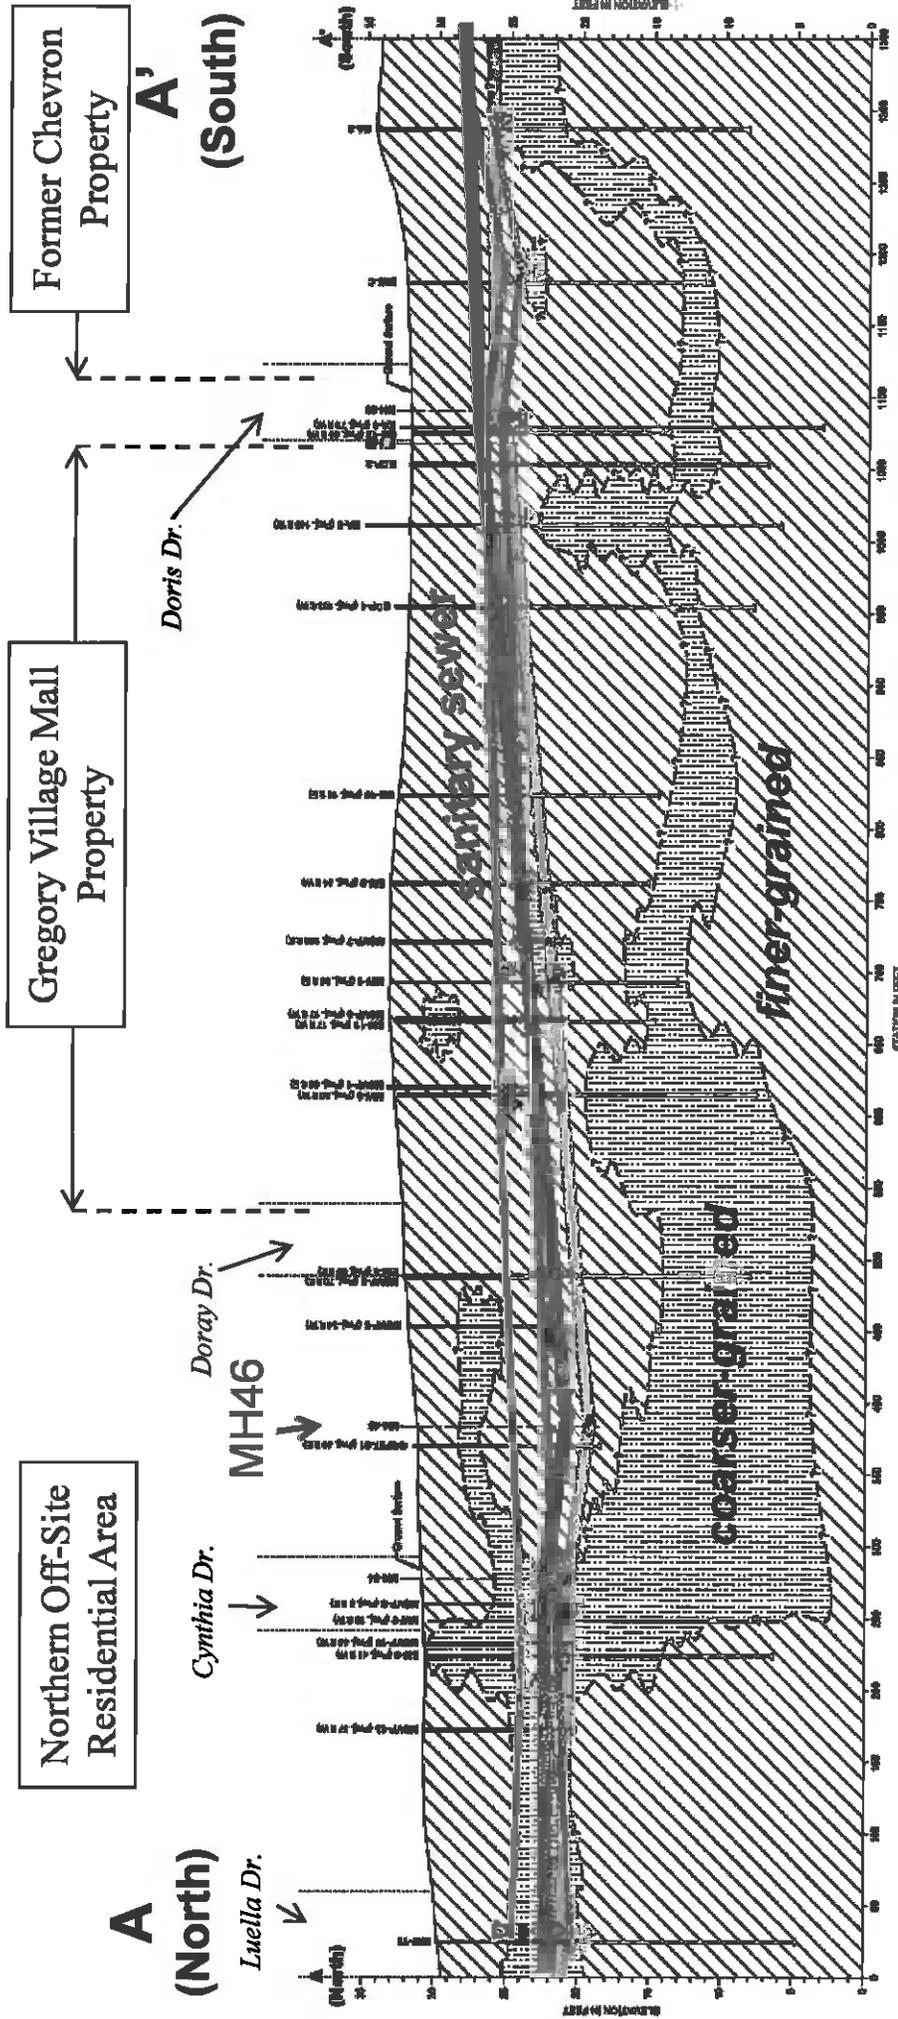
CCCCSD's Sanitary Sewer is Installed Near or Below the Water Table

Blue lines are the water table range

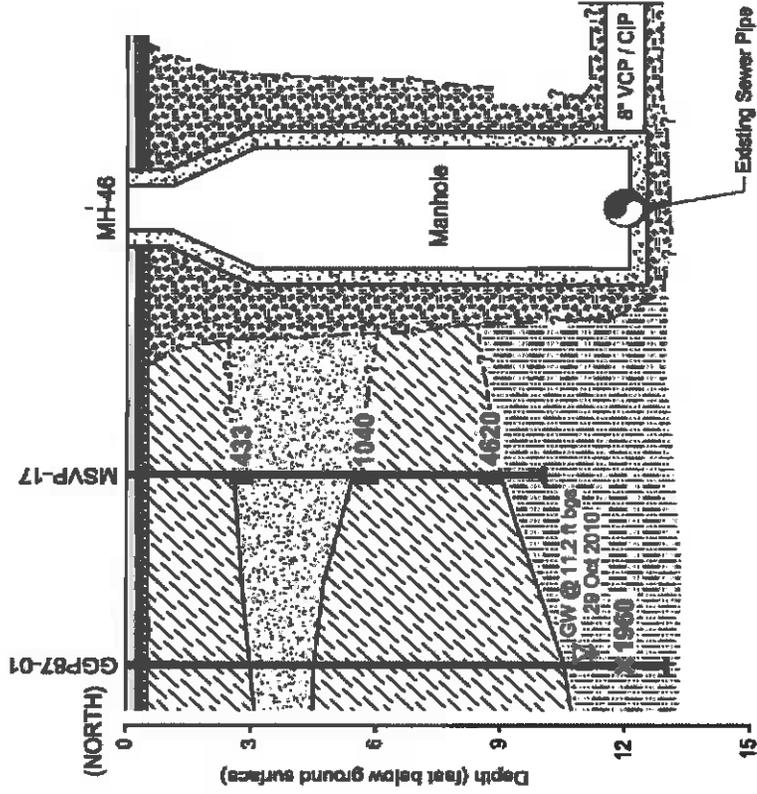
PCE in Soil Vapor and Groundwater Near Manhole M46 is Consistent with a Sewer Leak

Sewer line and bottom of manhole M46 are at or below the water table
