EXHIBIT B

DRY CLEANERS— A MAJOR SOURCE OF PCE IN GROUND WATER

27 March 1992

**REGIONAL WATER QUALITY CONTROL BOARD
CENTRAL VALLEY REGION**

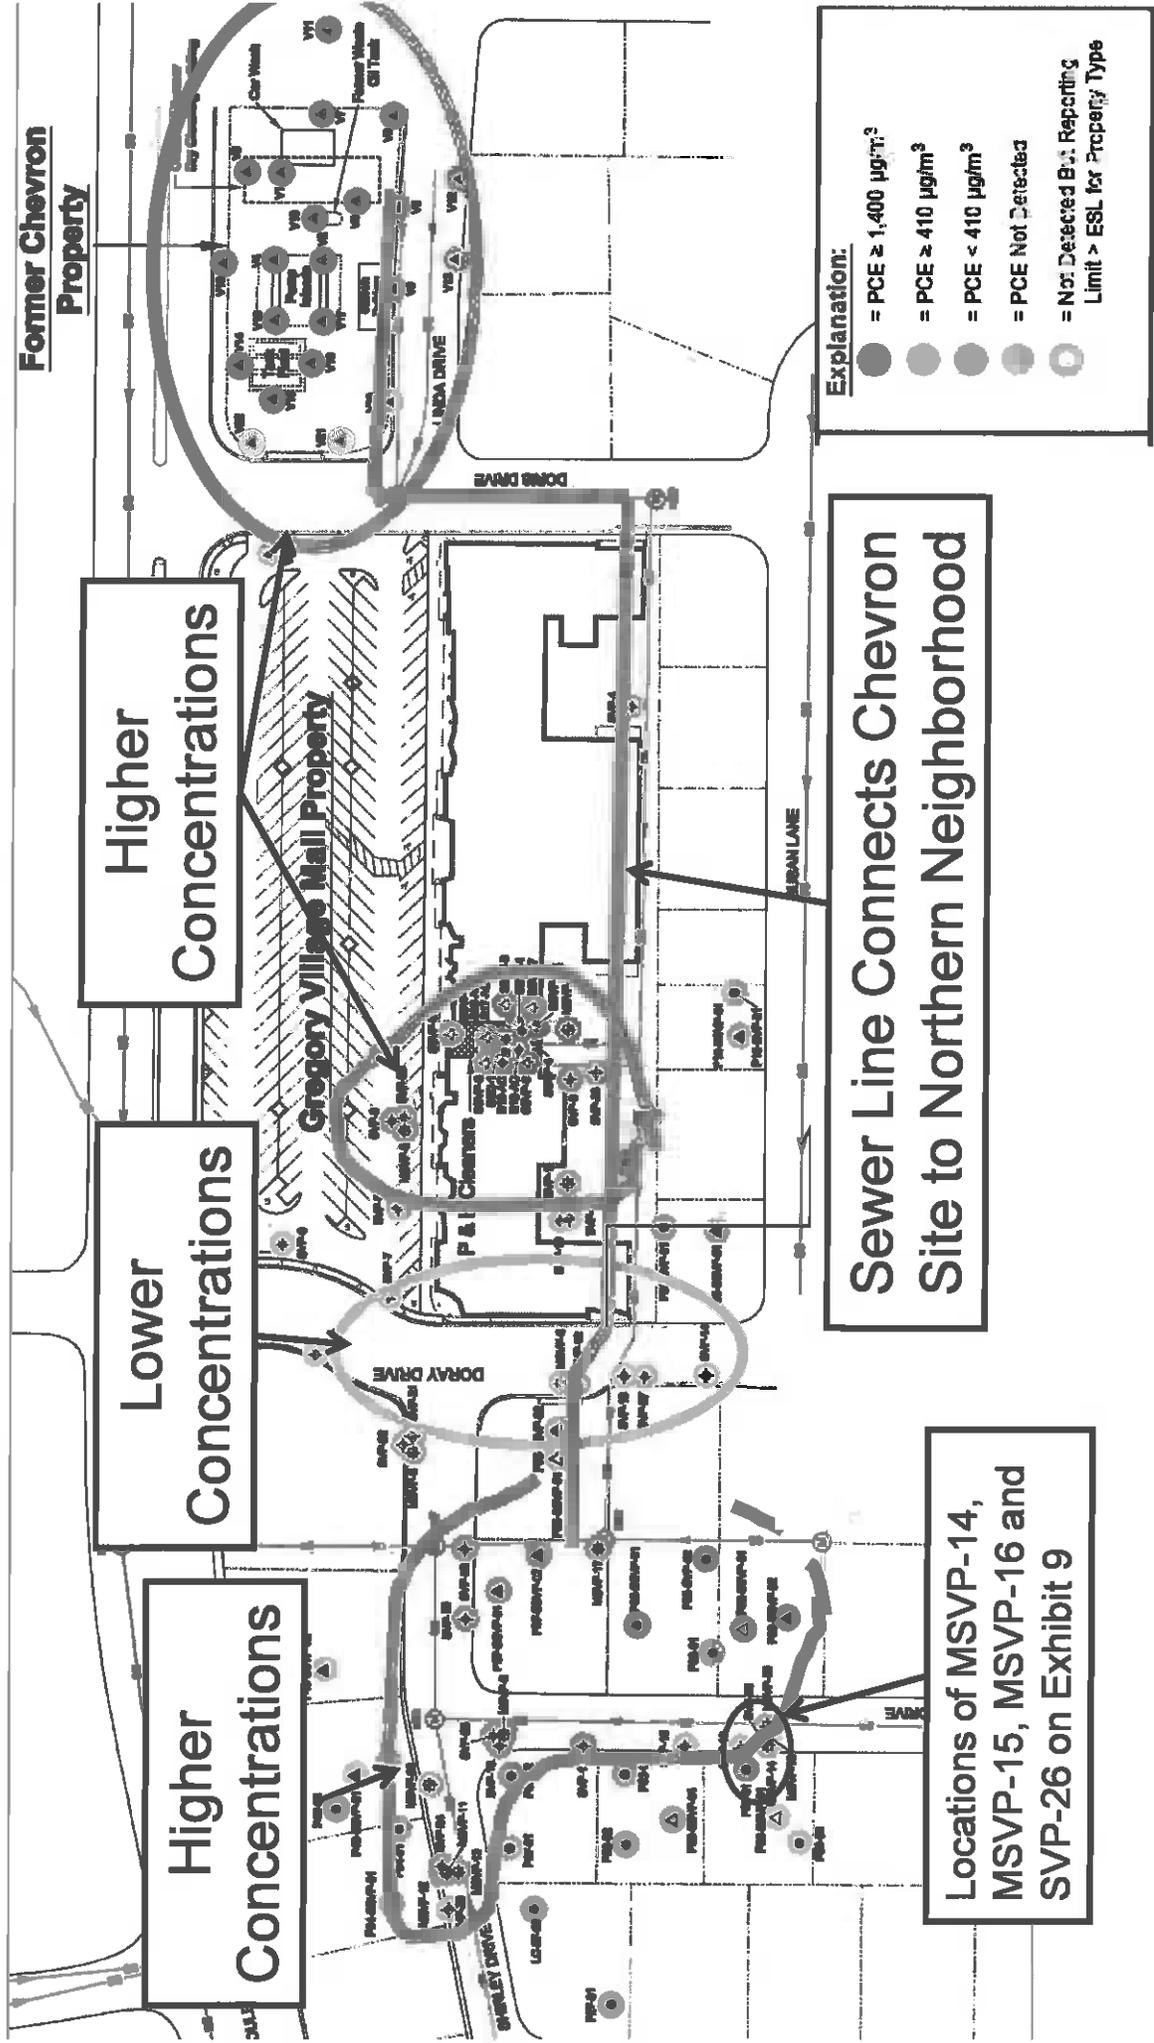
Separate Areas of High PCE Concentrations in Soil Vapor Indicate Separate Releases

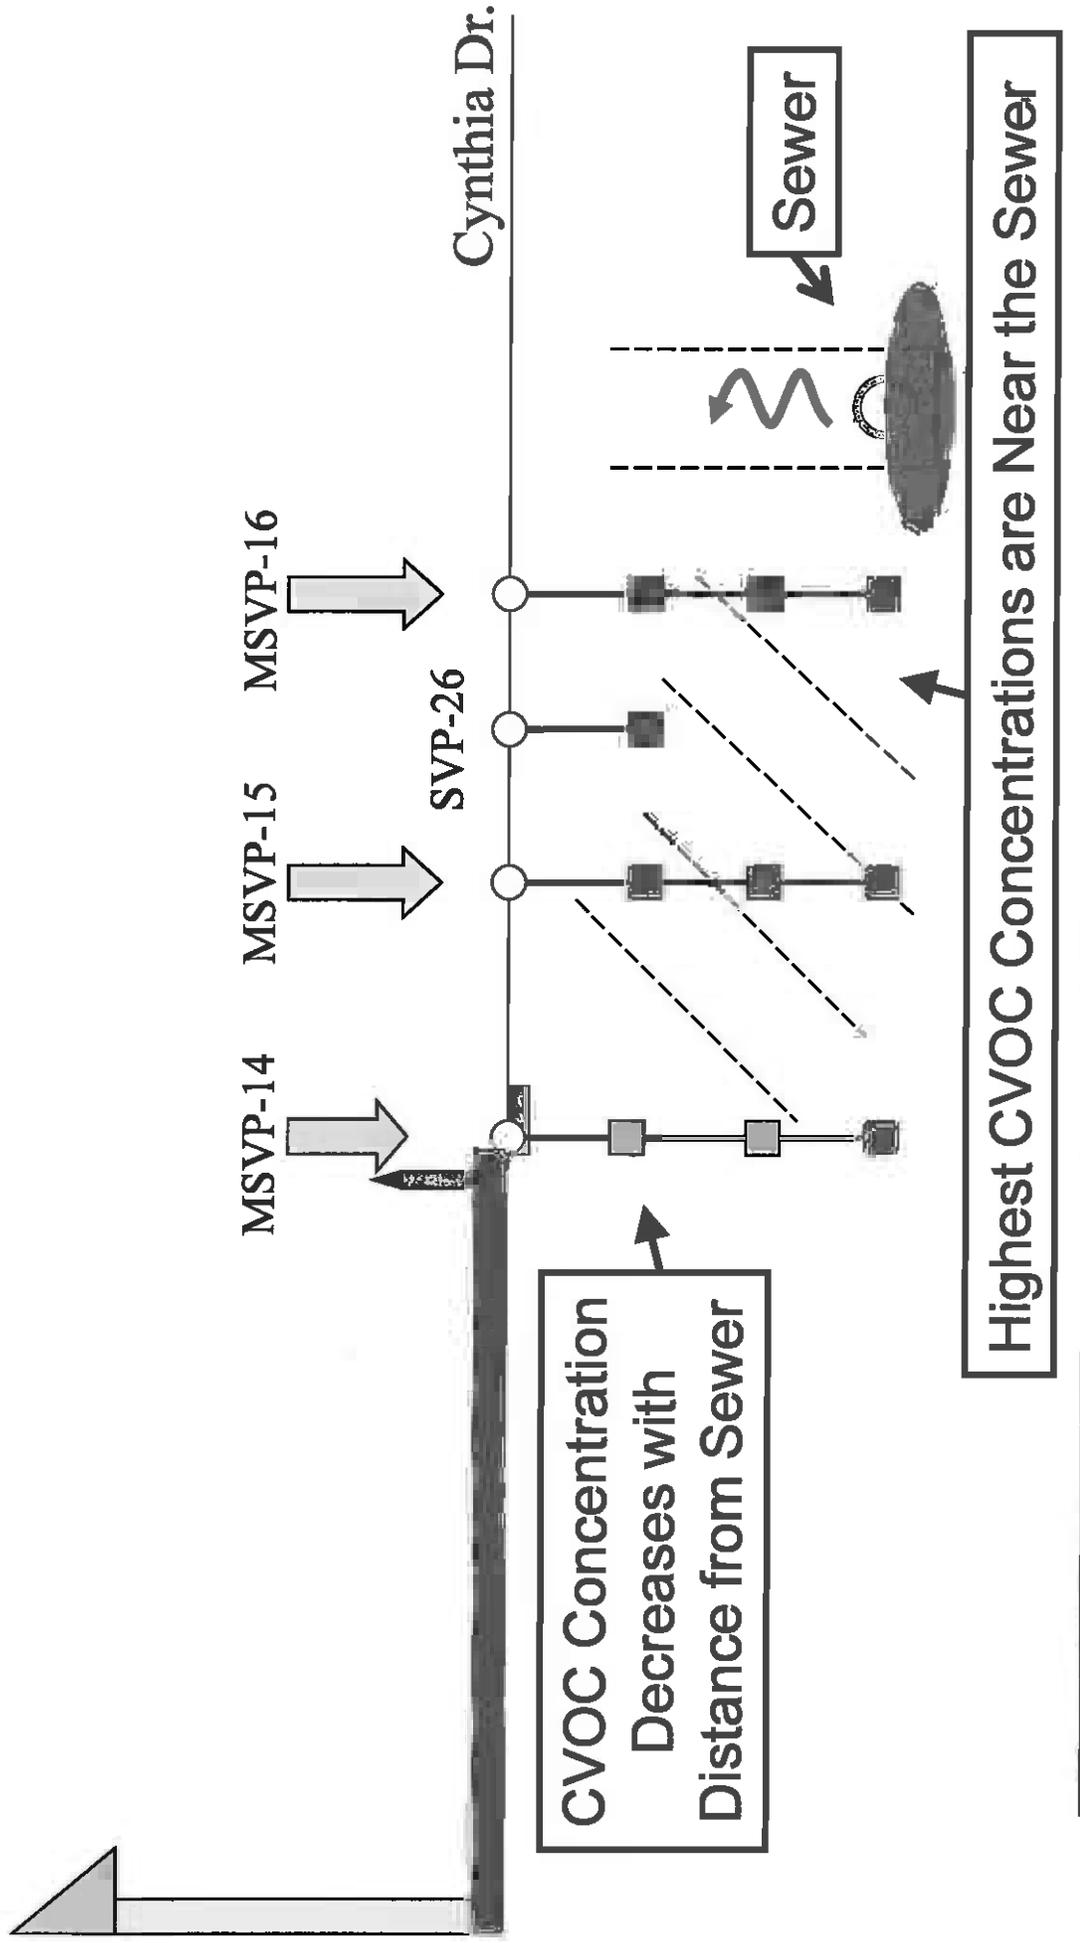
CVOC Concentrations In Soil Vapor are Highest Near the Sewer

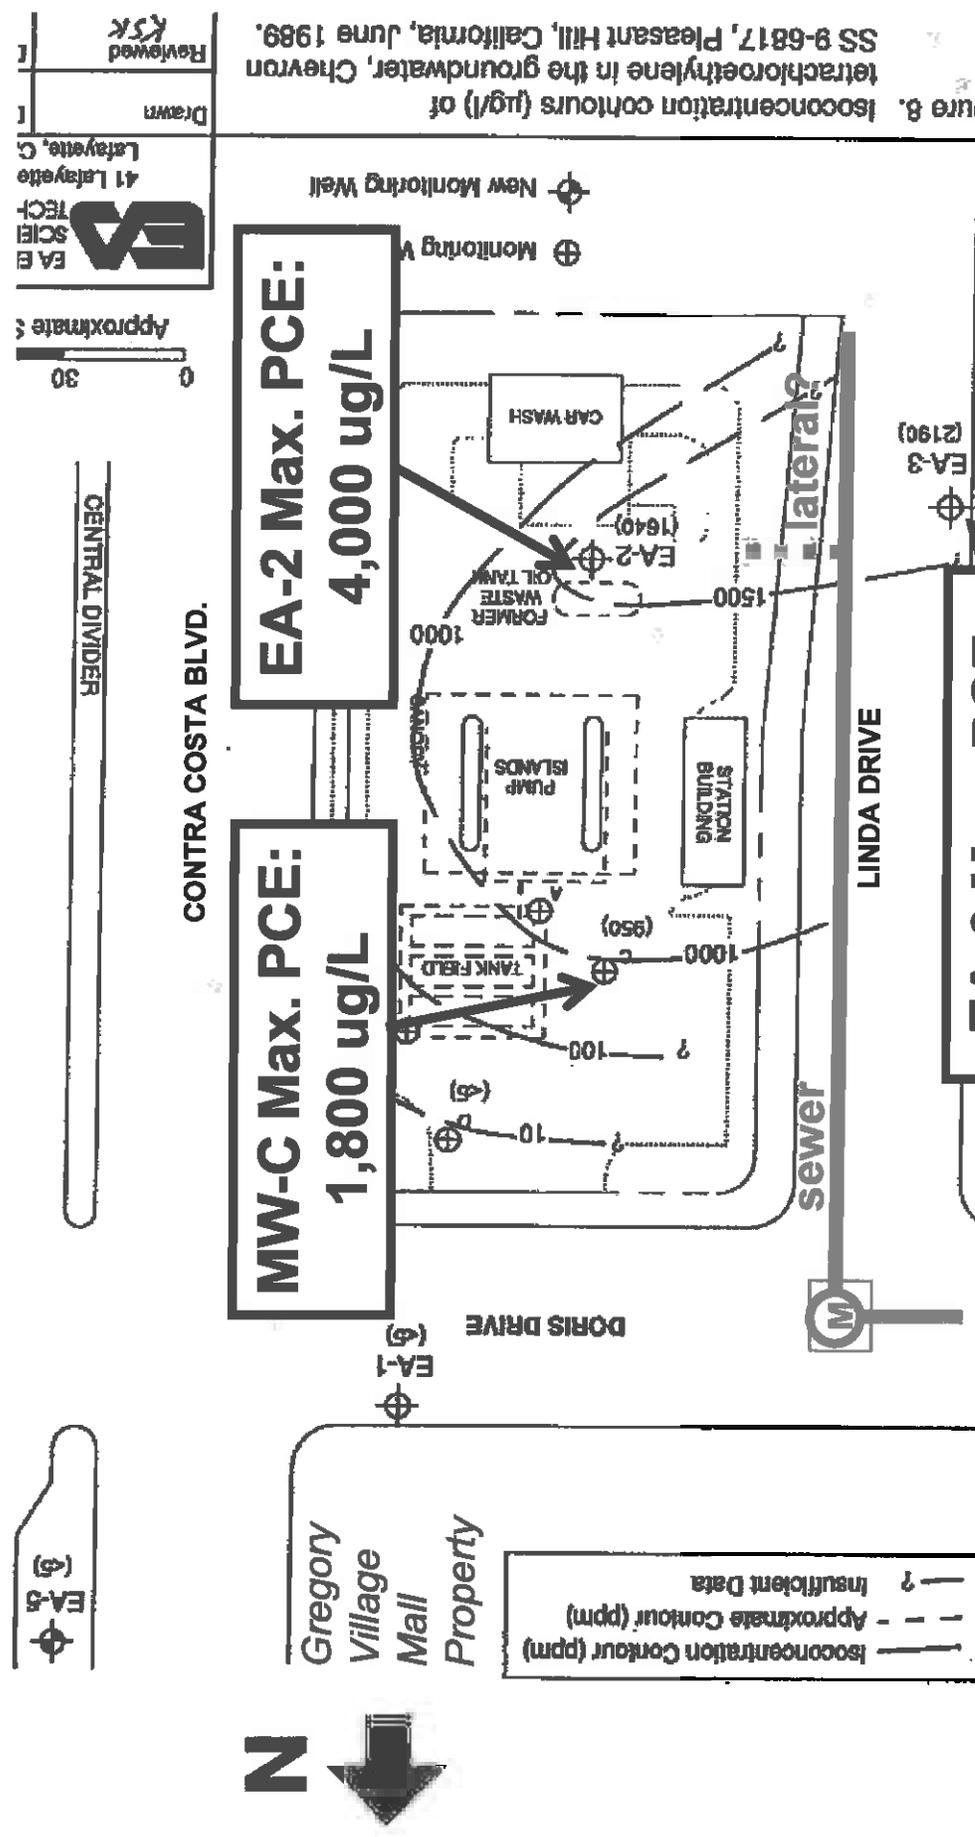
PCE in Groundwater in Linda Drive Cross-Gradient from Chevron Site Indicative of a Sewer Leak
