Re: Required Technical Report in Response Notice of Violation NO. R9-2007-0050, WDID NO. 9 37C322900, reference number CWU:10-3022900.02:neilb

SPRINTER

Required Technical Report (RTR) Response to NOV No. R9-2007-0050

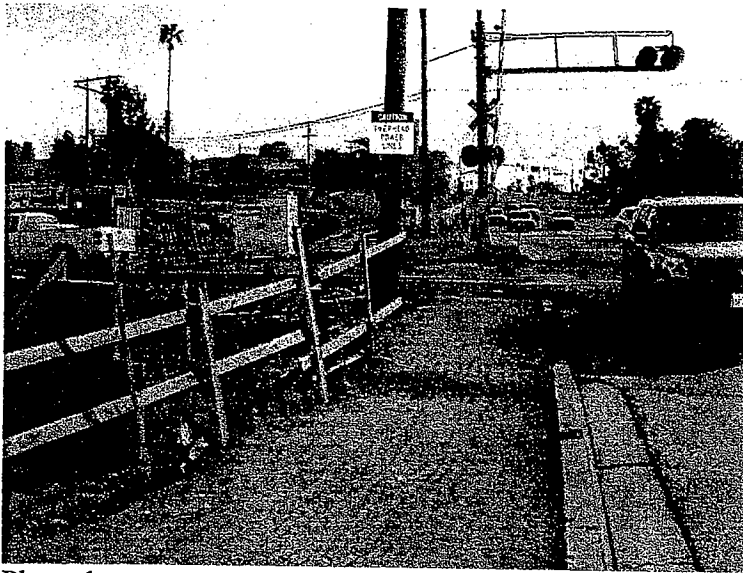
Photo 1
Tracking on Escondido Ave no longer occurring. Response to NOV Photo1.

Immediate Action: NCTD contractors added additional aggregate to the tracking control BMPs at Mar Vista Drive and Escondido Avenue. In order to eliminate the tracking, NCTD contractors placed additional rock to levels that met the required BMP specifications for length width and depth. Three to six inches of crushed aggregate was placed at a depth of 12" for 50 feet. The re-constructed BMP is as wide as the entrance to the site.

Site Status: The added BMPs are in place and have been working adequately. (See Photographs 1, 8 and 14)

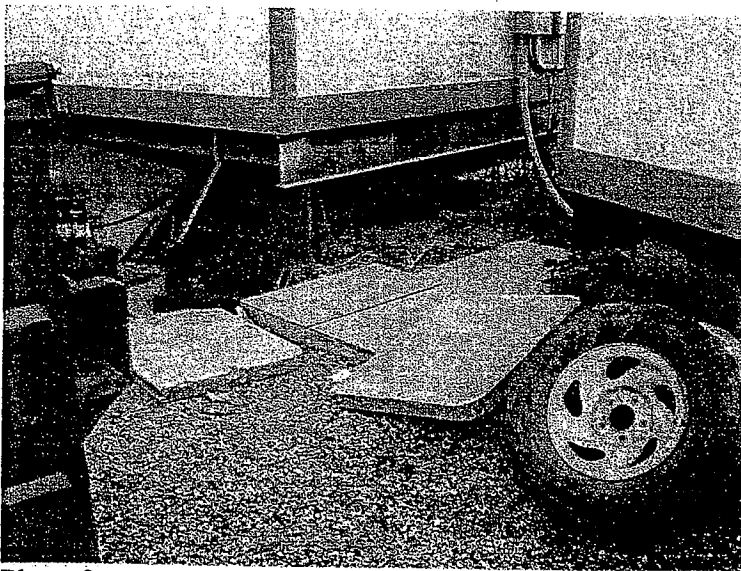
Photo 2
Gas can put into containment. Response to NOV photo 2.

Immediate Action: NCTD contractors properly disposed of all construction trash in trash containers. NCTD contractors have continued to ensure that the trash container lids at Escondido Avenue remain closed when not in use. Additionally, NCTD contractors have covered and/or removed the asphalt stockpile, and put the gasoline container into secondary containment.

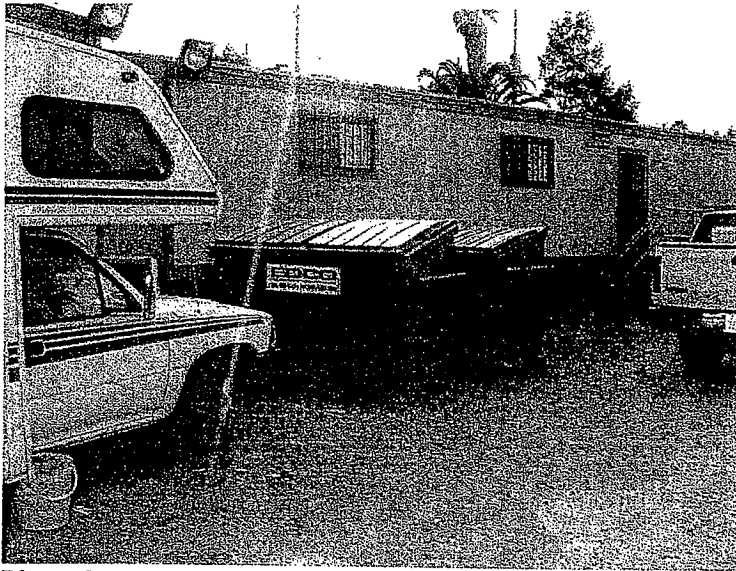
Photo 3

Trash containers in work yard are covered to keep water out. Response to NOV photo 3.

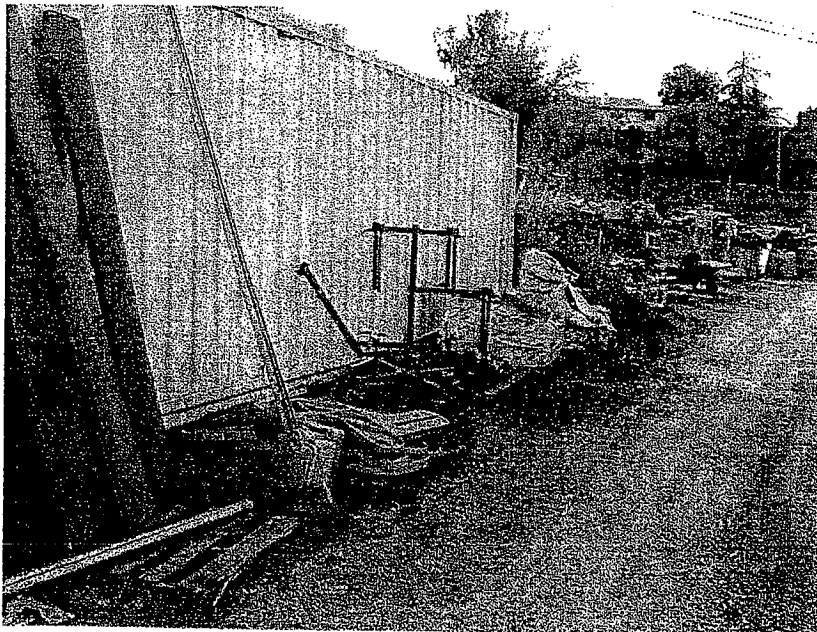
Photo 4

Trash in the materials storage area has been picked up. Response to NOV photo 4.

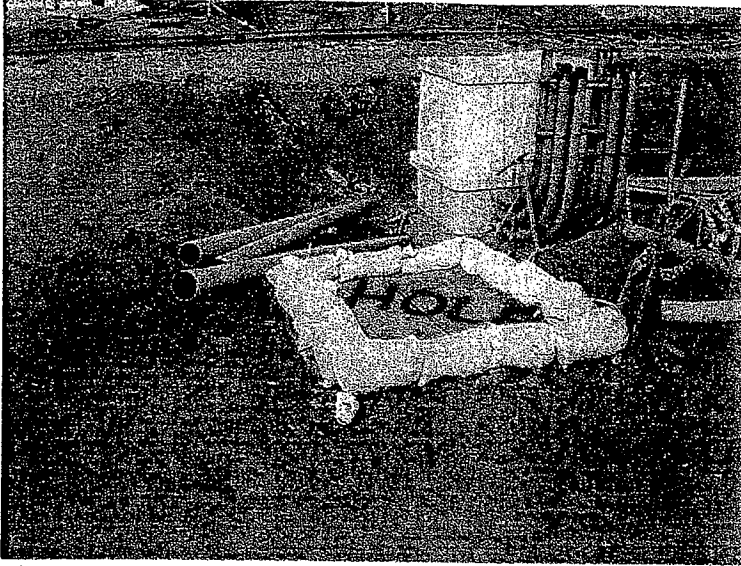
Inlet in NOV Photo 5 has been removed and new DI is being installed.

Immediate Action: NCTD contractors performed maintenance to the existing Best Management Practices ("BMPs") at the respective inlets, and added more BMPs to the inlet at the Mar Vista Drive storage yard. NCTD contractors have additionally removed the inlet east of Escondido Avenue, and are constructing a new drop inlet that is protected with gravel bags (photos 5 16,17, and 18).

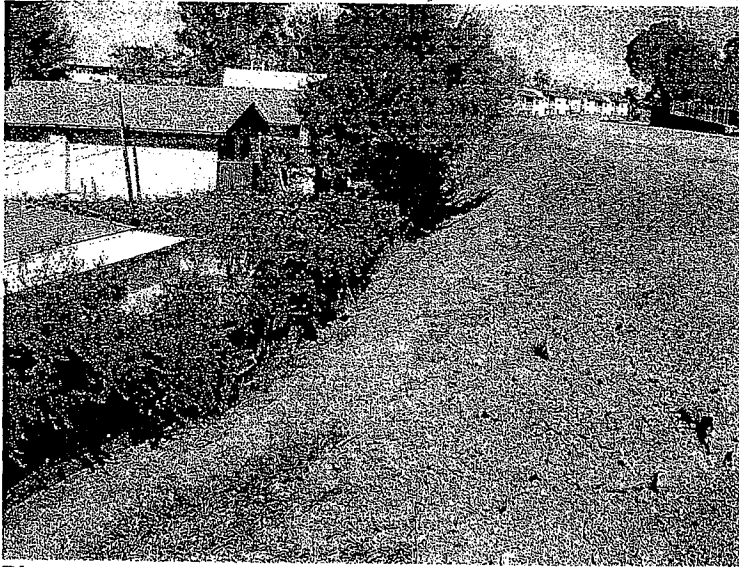
Photo 6

Slope sprayed with soil binder. Response to NOV photo #6.

Immediate Action: NCTD contractors placed soil binder (wood fiber mulch) on all identified disturbed areas. NCTD contractors have applied a total of 600,000 square feet of soil binder to disturbed areas in the last month. More is scheduled to be placed in the coming month as slopes are completed. NCTD contractors have additionally repaired any known erosion rills.

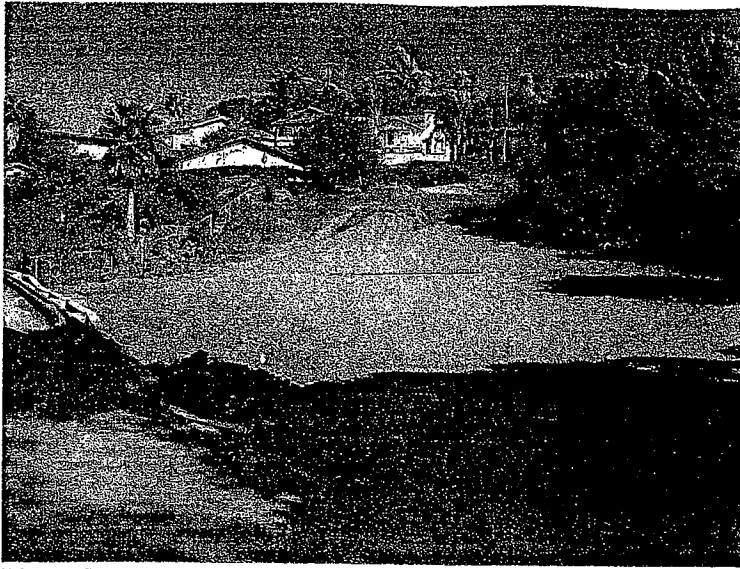
Photo 7
Inactive area sprayed with soil binder. NOV Photo # 7.

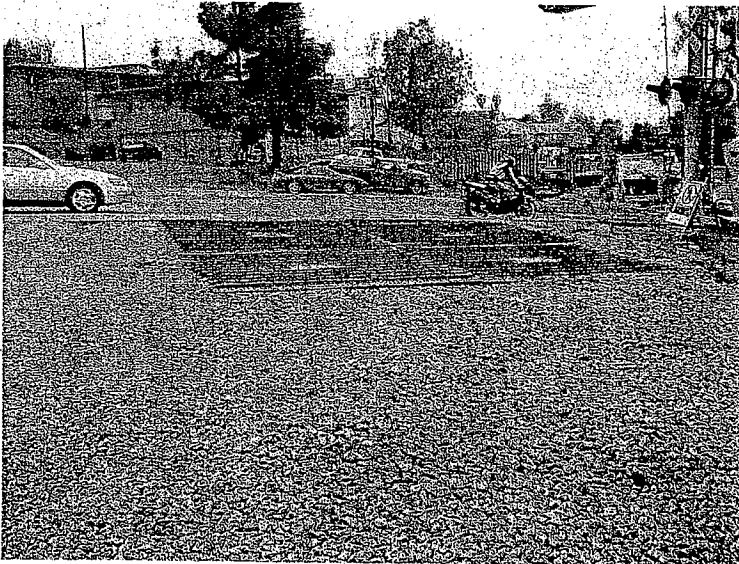
Photo 8
Tracking control BMP installed at Escondido Avenue. NOV photo 10.

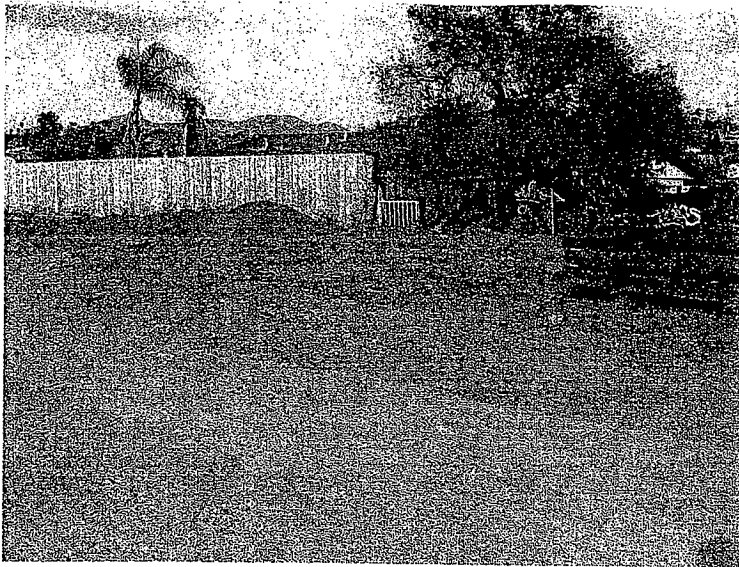
Photo 9
Concrete waste cleaned up. Response to NOV photo 11 and 12.

Immediate Action: NCTD contractors cleaned up all concrete waste that was observed during the site inspections within 24 hours and disposed of it properly. NCTD contractors instructed all concrete crews ensure that they wash out their equipment in the appropriate areas e.g. the washout pits.

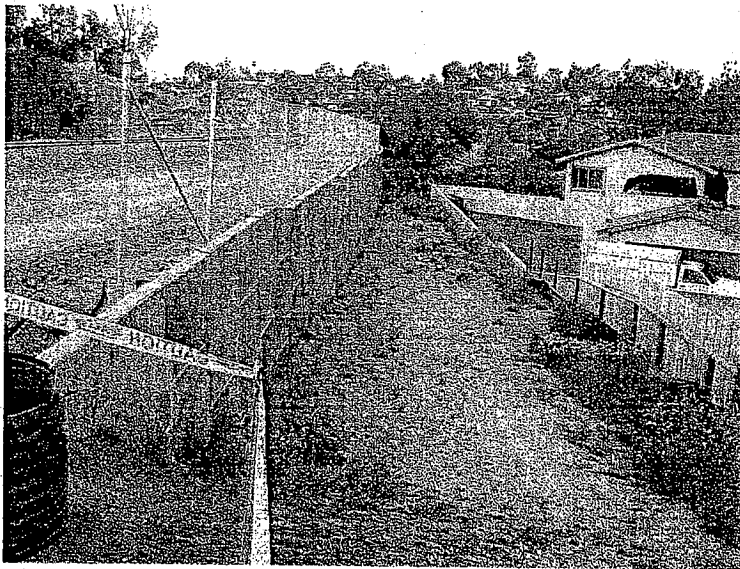
Photo 10
Trash cleaned up. Response to NOV Photo 13.

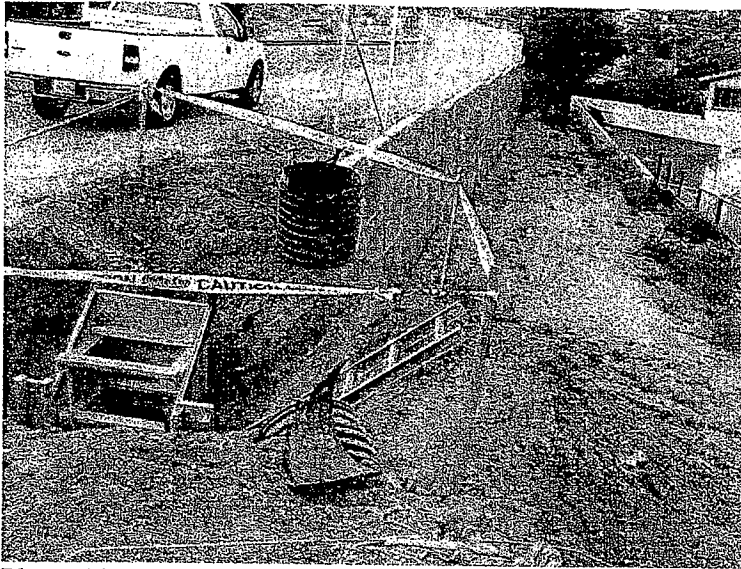
Photo 11
Area where erosion gully was has been excavated for new DI installation. Response to NOV photo 14.

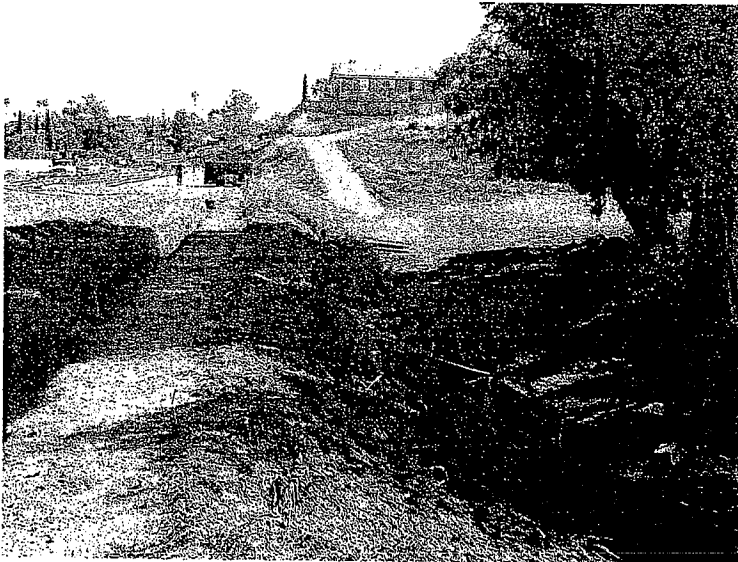
Photo 12
Inactive area sprayed with soil binder. Response to NOV photo 15.

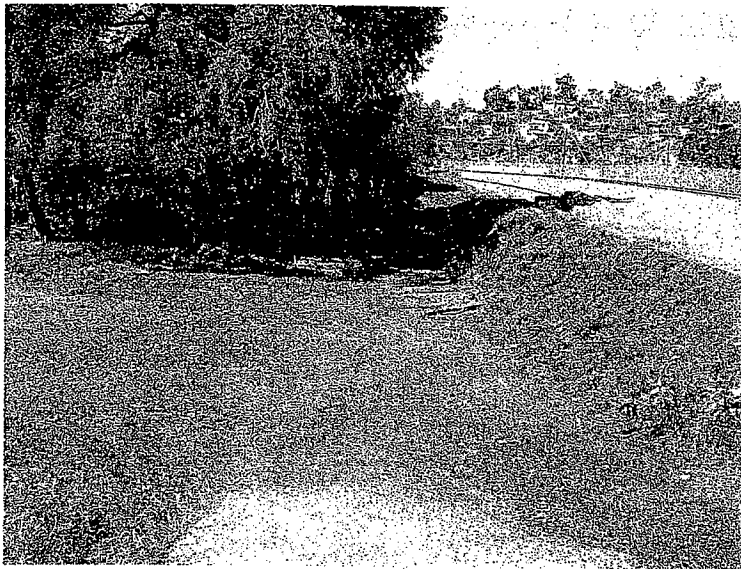
Photo 13
Inactive area sprayed with soil binder. Response to NOV photos 16 & 18.

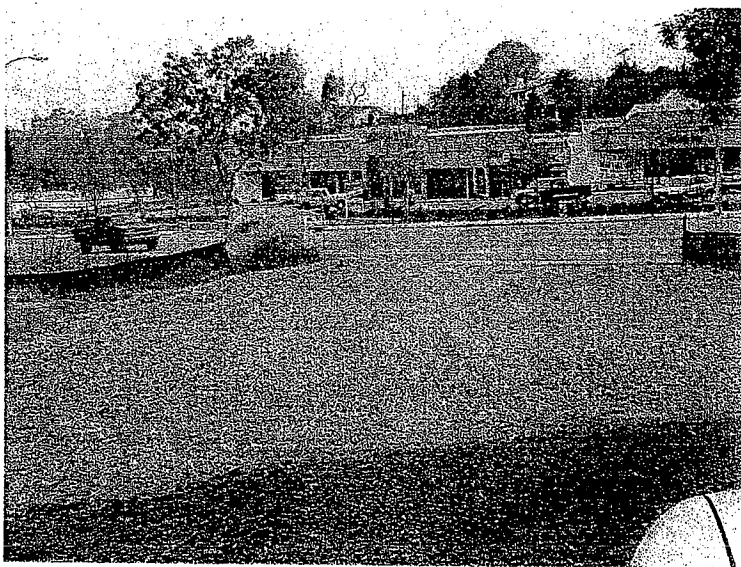
Photo 14
Tracking control BMP installed at the Mar Vista Yard. NOV photo 19.

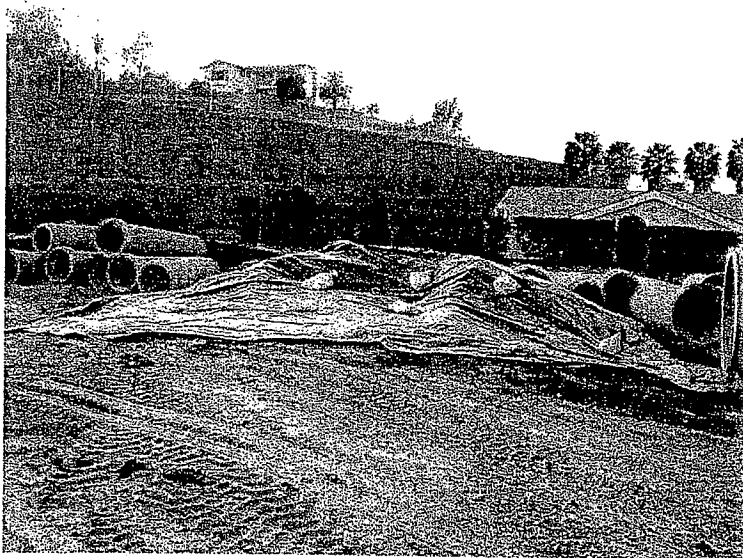
Photo 15
Asphalt stockpile has been completely covered with plastic. Response to NOV photo 21.

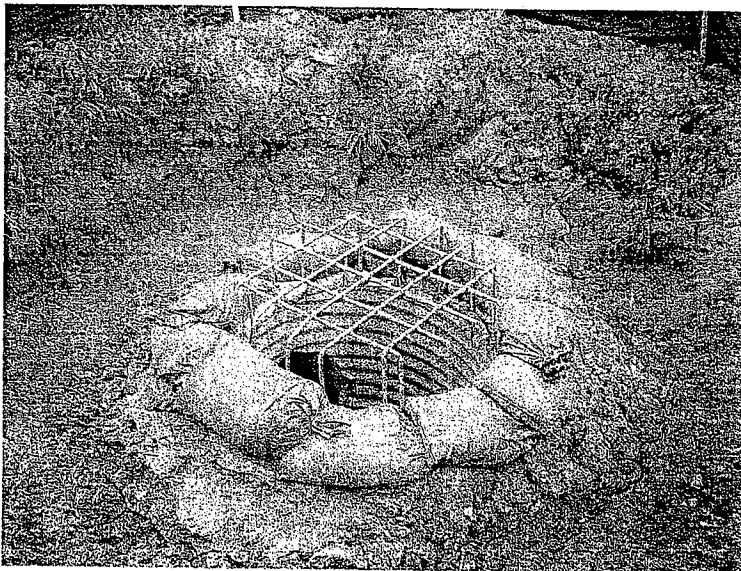
Photo 16
DI protected with gravel bags. NOV photo 22.

Immediate Action: NCTD contractors placed additional gravel bags, fiber rolls, and silt fences along the construction site perimeter and at the storm drain inlets. NCTD contractors repaired all failed BMPs and added additional BMPs to ensure effectiveness.

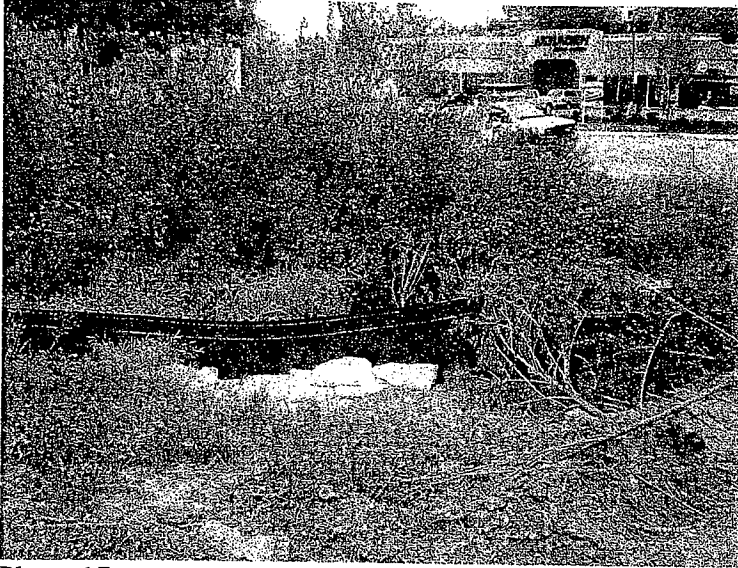
Photo 17

Additional silt fence and gravel bags placed before inlet at the Mar Vista yard. NOV photo 22.

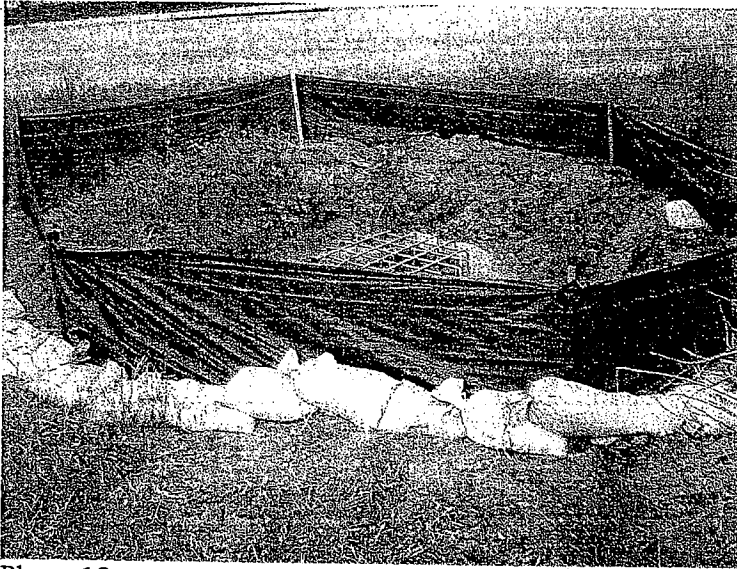
Photo 18

DI at the Mar Vista yard protected with silt fence and gravel bags. Response to NOV photo 22.

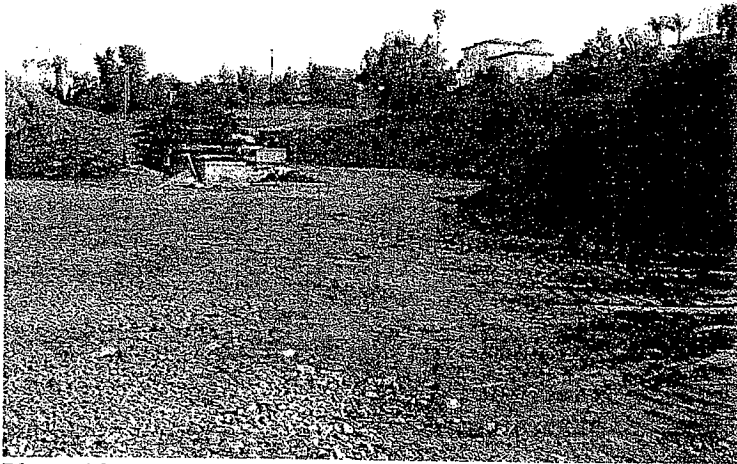
Photo 19

Response to NOV photo 23 and 24. Trash has been cleaned up and properly disposed of. Soil stockpiles are active.

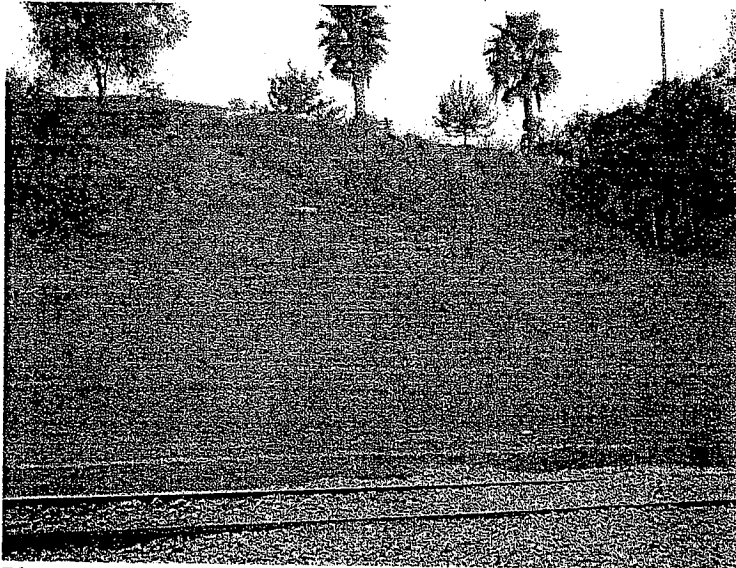
Photo 20

Completed slope at the Mar Vista yard sprayed with wood fiber mulch. Response to NOV photo 25.

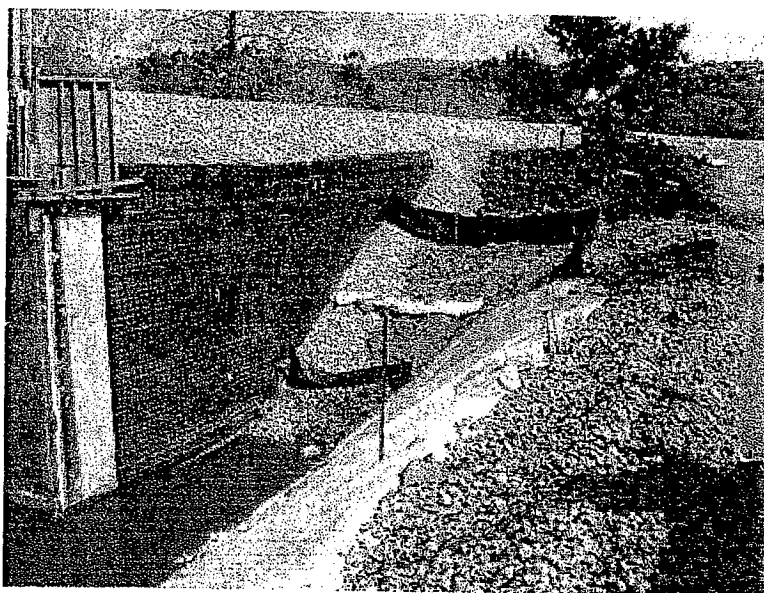
Photo 21

Slope where bridge construction is taking place. NOV photo 26 states that erosion control is needed. Slope is in active construction.

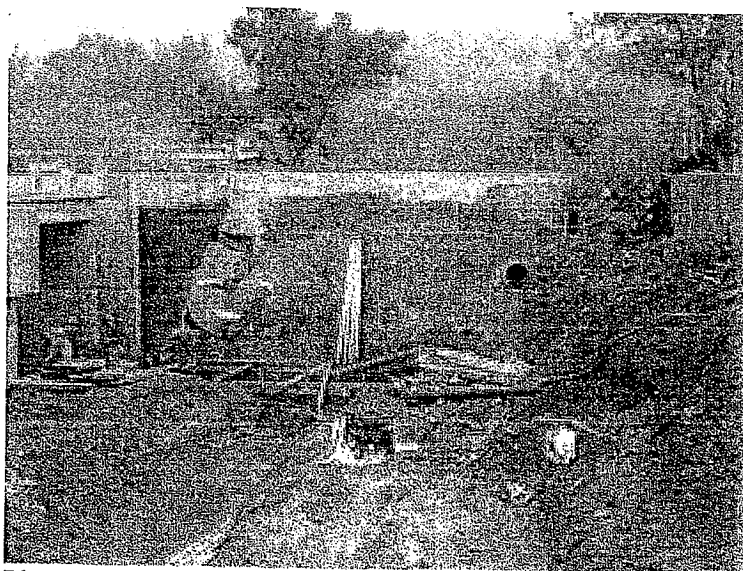
Photo 22

Active bridge construction on slope where it was stated that soil stabilization was needed.

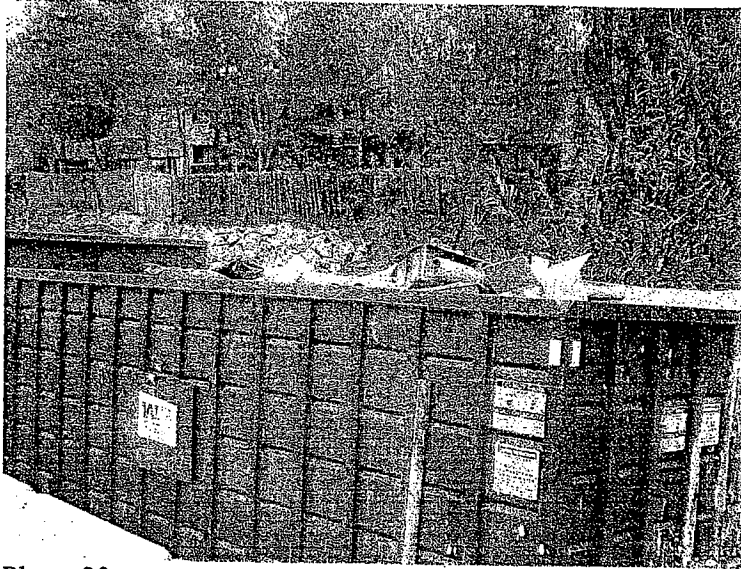
Photo 23-
Trash container at Buena Creek for trash disposal. Response to NOV photo 28.

Immediate Action: NCTD contractors properly placed all construction trash in trash containers (See Photographs 24 and 25).

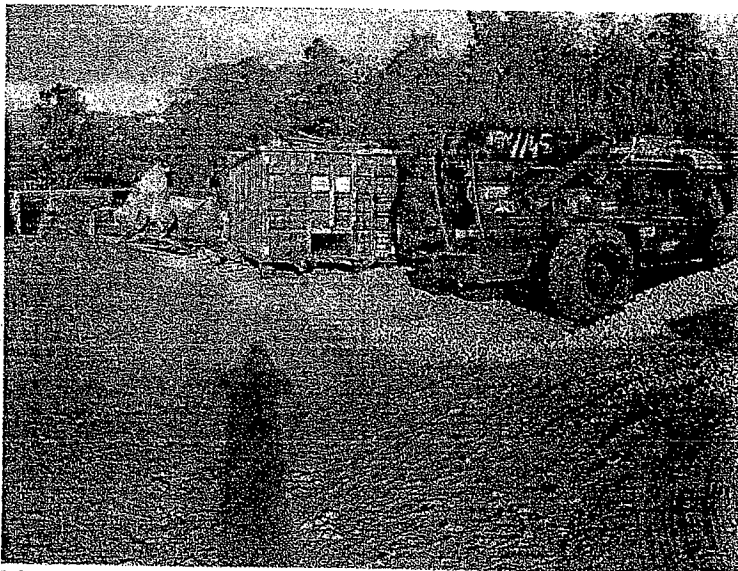
Photo 24
Area at Buena Creek where trash was piled up. Trash has been placed into the trash container. Response to NOV photo 28.

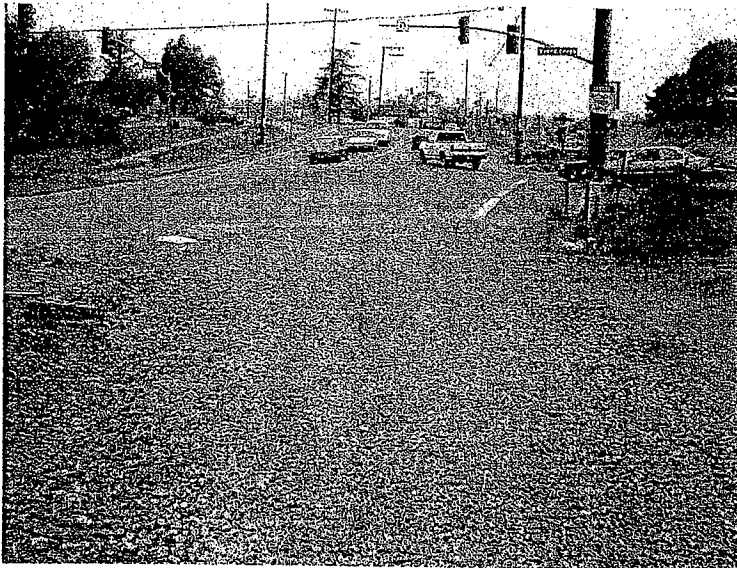
Photo 25
Tracking control BMP installed at Buena Creek. NOV photo 29.

Immediate Action: NCTD contractors have reconstructed and added additional aggregate to the tracking control BMPs. NCTD contractors placed the additional rock at levels that meet the required BMP specification.

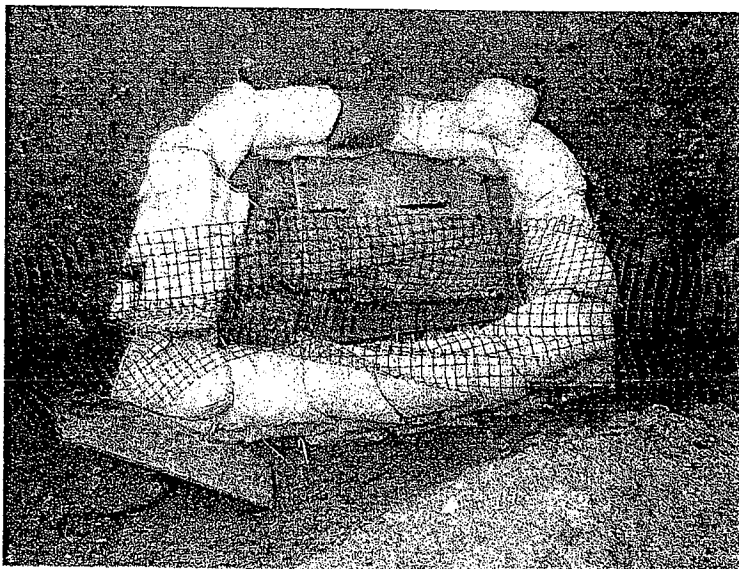
Photo 26
DI in the rear of WCRC yard protected with gravel bags. NOV photo 30.

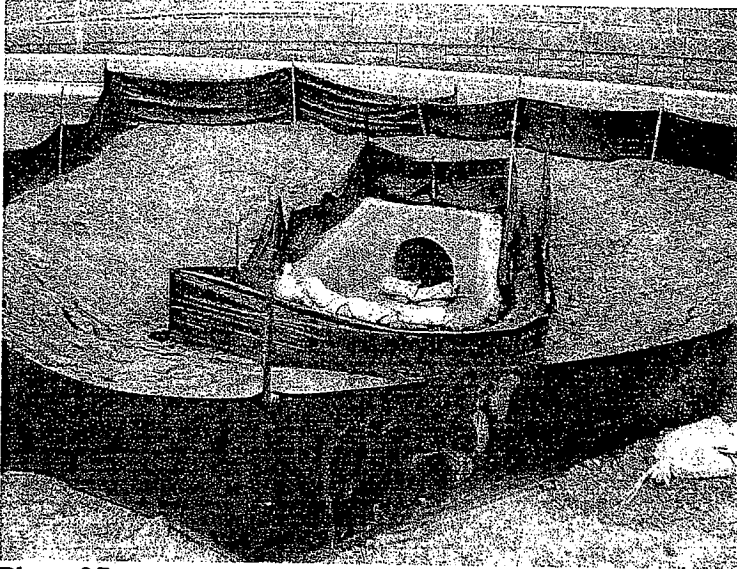
Photo 27

DI on Barham Drive in San Marcos Protected with additional BMPs. This inlet is being replaced with a grated drop inlet, which will eliminate this problem. Photo 31 in the NOV.

Immediate Action: NCTD contractors placed new or additional gravel bags around all storm drain inlets at the construction yard on Armorlite Drive, along Barham Drive and along the railroad construction site to ensure proper protection. (See Photographs 27, 31, 32, 33, 34, 35, 36, 37, 38, 39, 40 and 41).

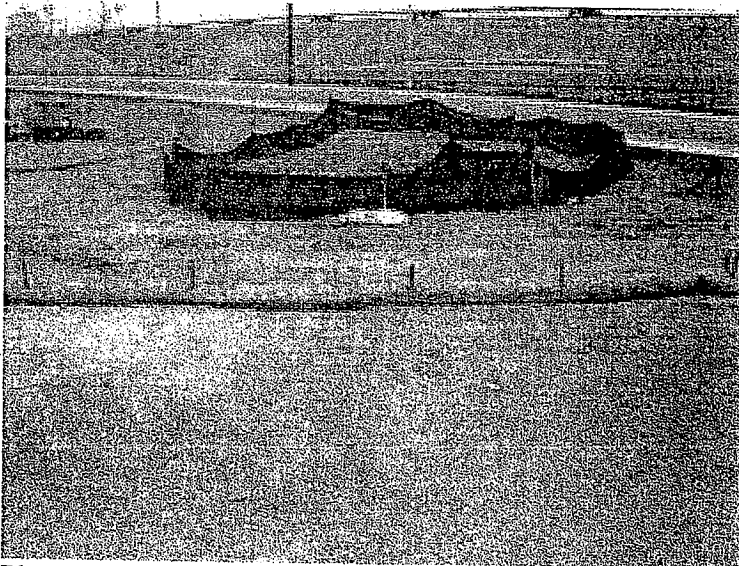
Photo 28

DI on Barham Drive in San Marcos Protected with additional BMPs. Photo 31 in the NOV.

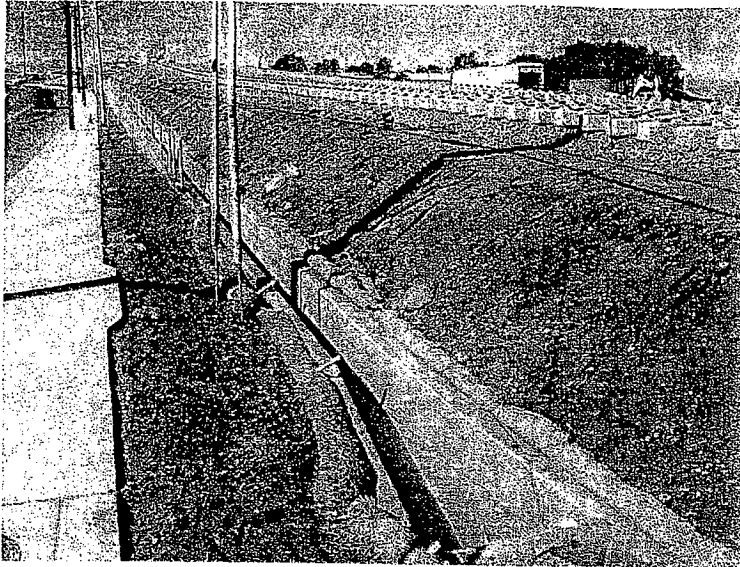
Photo 29

Response to NOV photo 32. New fiber rolls were placed along the channel. Slope was under irrigation construction. Notice the new sprinkler heads. This slope will be scheduled to be stabilized with Hydroseed, a permanent BMP.

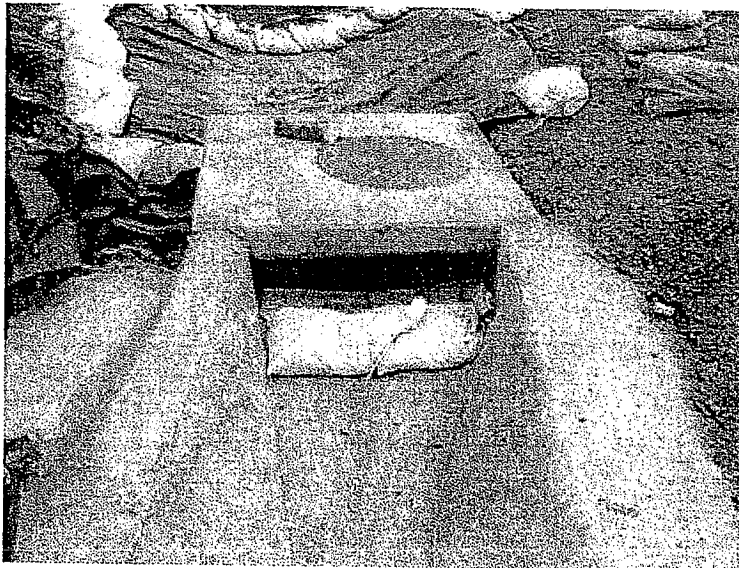
Photo 30

Response to NOV photo 33. New bags have been placed in front of the inlet.

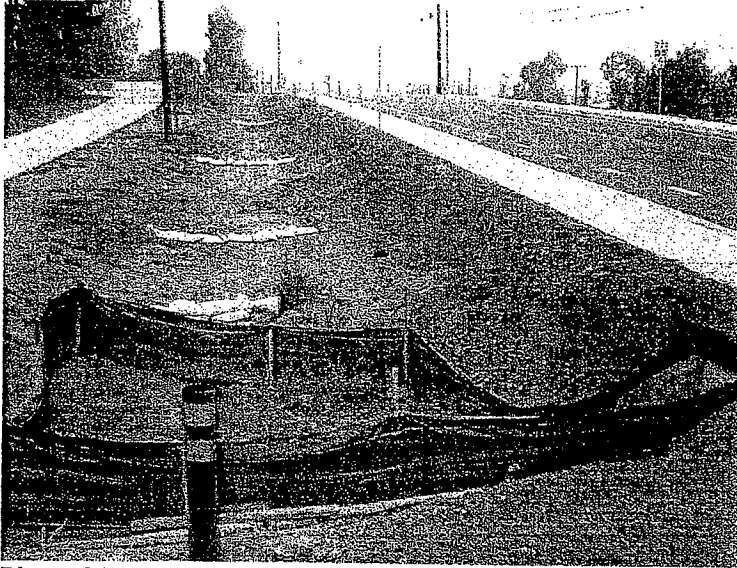
Photo 31
DI with protection of silt fence. Gravel bag check dams placed upstream. NOV photo 34.

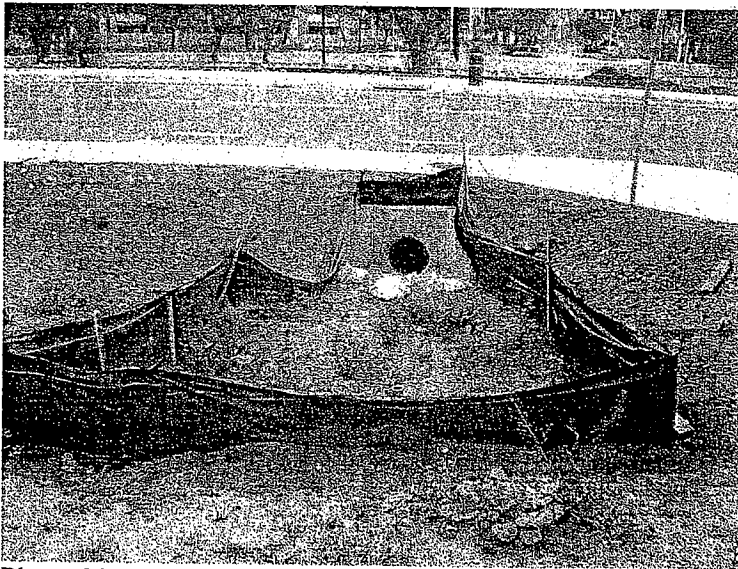
Photo 32
DI with protection of silt fence and gravel bags. NOV photo 34.

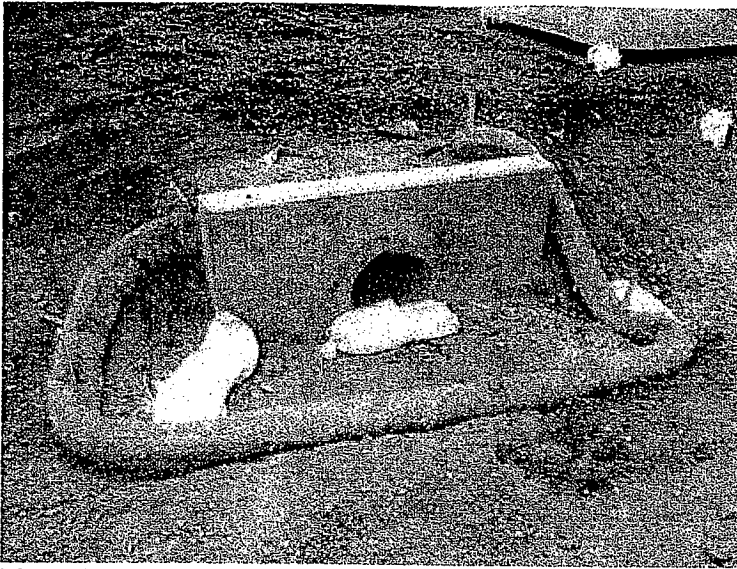
Photo 33

Response to NOV photo 35. Inlet has been protected with gravel bags and fiber rolls.

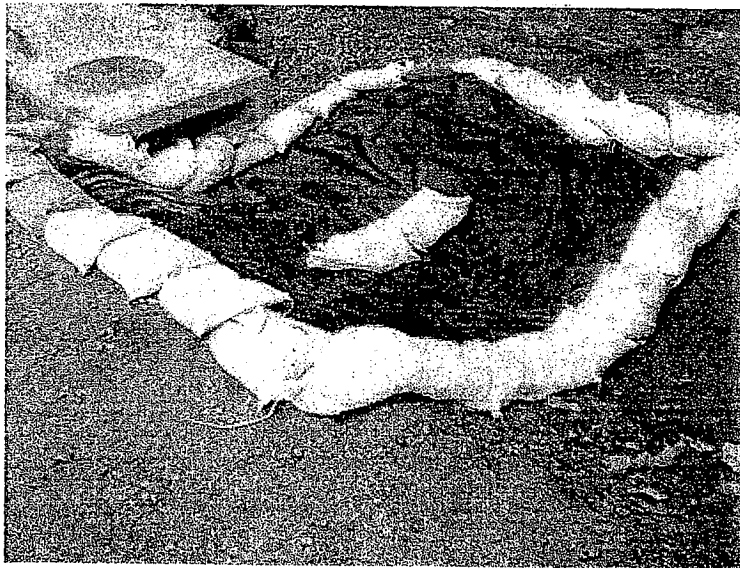
Photo 34

Response to NOV photo 37. Inlet has been well protected.

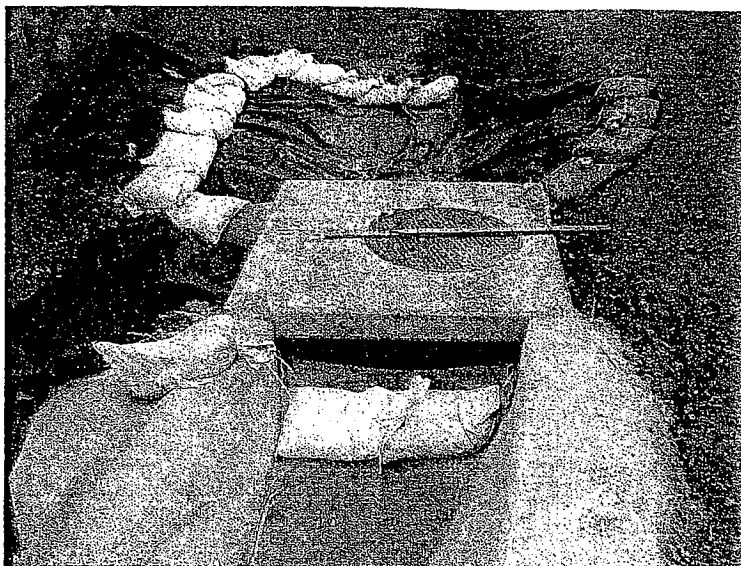
Photo 35
Inlet with gravel bag protection. NOV photo 38.

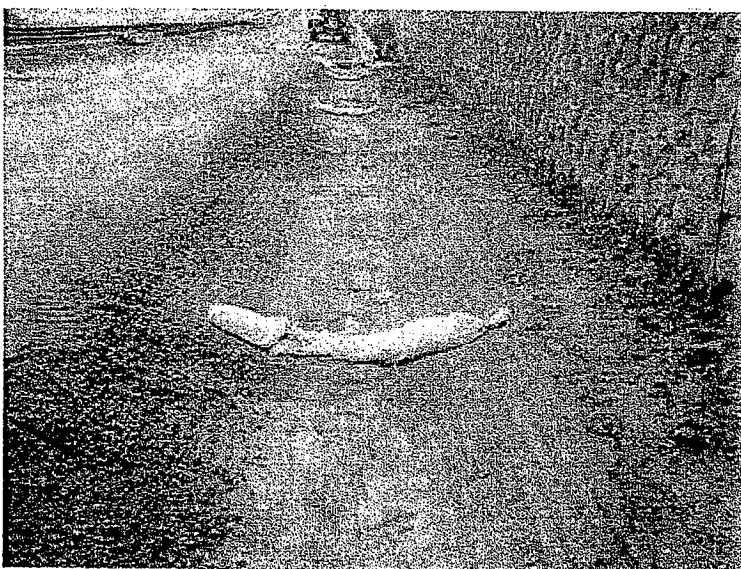
Photo 36
Earthen ditch with gravel bag check dams in it.

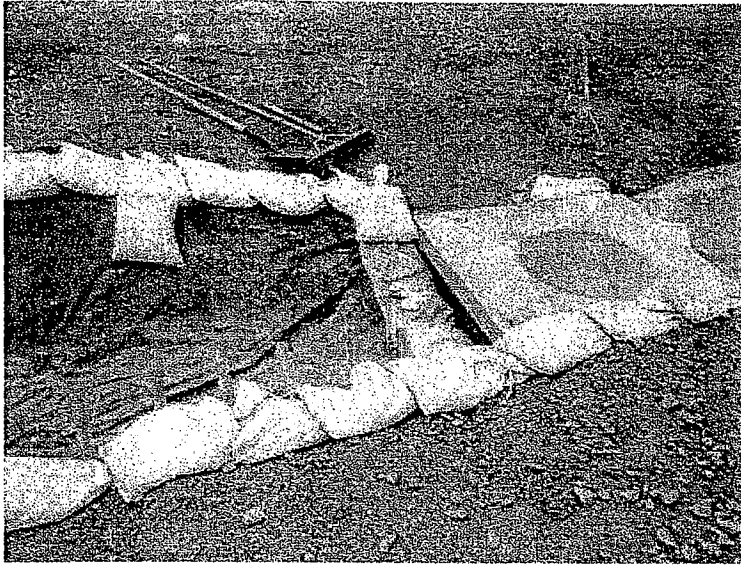
Photo 37
Inlet with gravel bag protection. NOV photo 38.

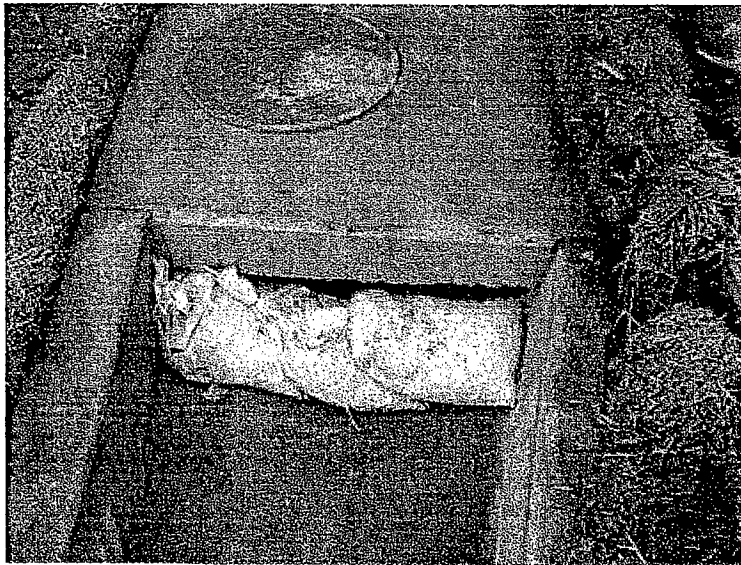
Photo 38
Inlet with gravel bag protection. NOV photo 38.

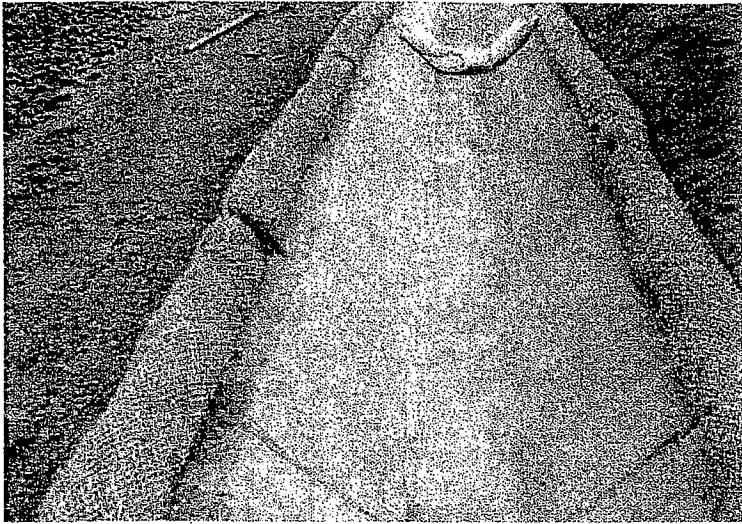
Concrete channel with gravel bag check dams in the channel and fiber rolls along the edge. Photo 39 of the NOV.

placed new fiber rolls and/or gravel bag check dams along the length of the channel (photos 30, 31, 32, 33, 34, 35, 36, 37, 38, 39, 40, and 41).

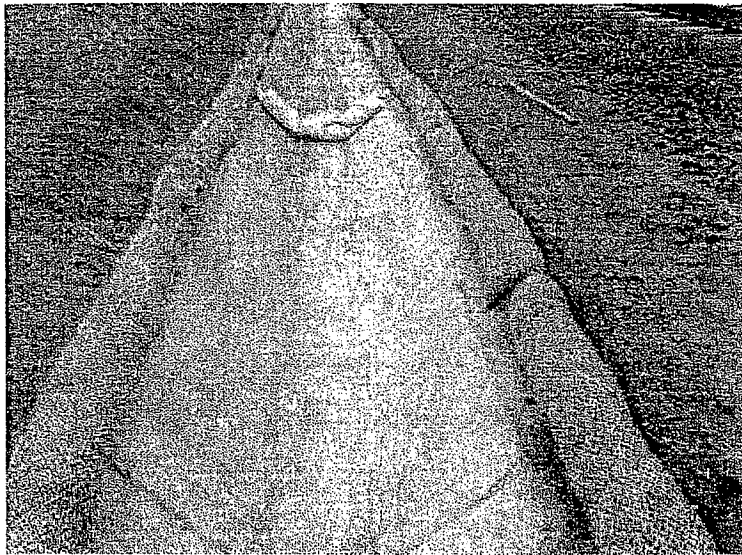
Photo 40

Concrete channel with gravel bag check dams in the channel. Photo 39 of the NOV.
