**Re: ADDITIONAL INFORMATION SUBMITTAL for INVESTIGATIVE ORDER NO. R9-2007-0060, DISCHARGE OF UNTREATED SEWAGE INTO BUENA VISTA LAGOON WITHIN THE CITY OF CARLSBAD, SAN DIEGO COUNTY (Reference: NCRU:01-0743.02 & 01-0764.02:ebecker)**

**CORROSION INVESTIGATION  
REVISED FINAL REPORT**

**CITY OF CARLSBAD  
24-INCH DUCTILE IRON FORCE MAIN FAILURE  
BUENA VISTA LAGOON  
Carlsbad, California  
NCRU: 01-0743.02 & 01-764.02:ebecker**

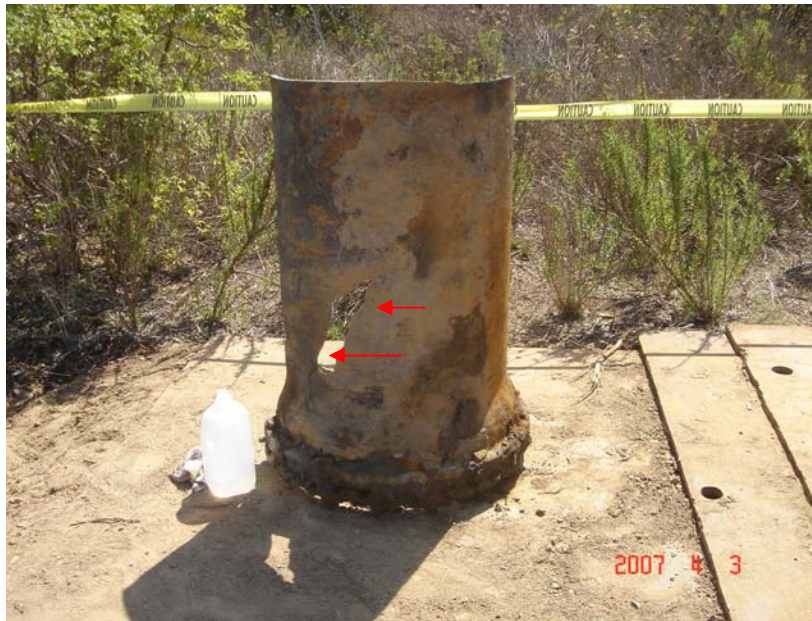
**Figure 2 – Sectioned pipe with failure (below springline)**

This is the condition of the pipe section, from below the springline, at the failure site. The leakage hole is in this section, red arrows.

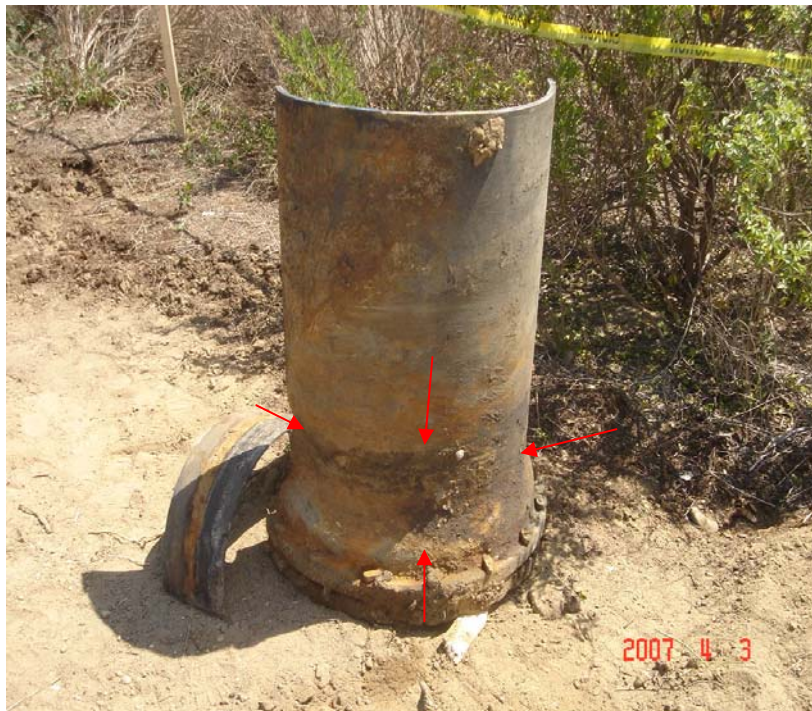
**Figure 3 – Sectioned pipe opposite side of failure (above springline)**

This is the section from above the spring line. This has not been cleaned, yet the band on the pipe adjacent to the bell can be seen. It is this band that delineates the taping of the PE encasement. There is no appreciable corrosion outside the encasement or above the springline. The four red arrows locate the area of the corroded band.

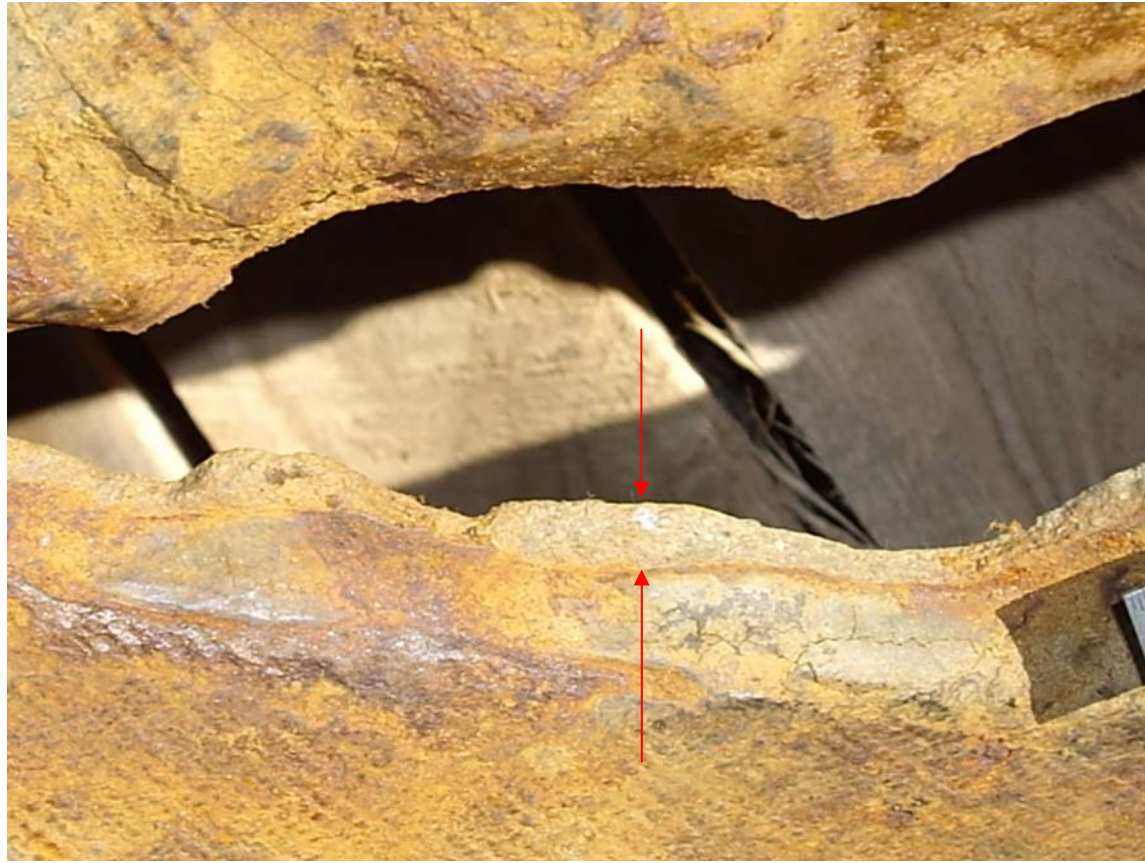
**Figure 4 - Corrosion hole close-up**

The stipple pattern from the foundry mold is still present. One characteristic of graphitic corrosion is that small details like this may still be seen but the iron has been removed due to corrosion. In this photo the stipple pattern has been retained on the corrosion product. The red arrows show the thickness of the cement liner. There is no metal left, corrosion has removed the supporting iron. The liner failed in a fast manner and not from a slow dissolution. There is no indication that the line had been thinned from a long period of time of leakage. This supports the conclusion that the leak was not slow with the hole gradually growing in size.

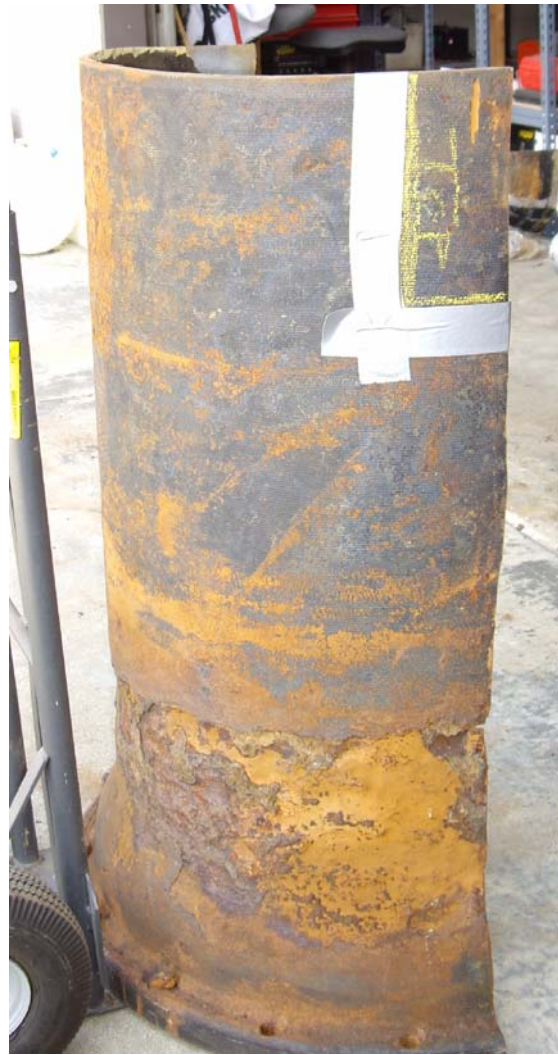
**Figure 5 - Cleaned upper section of pipe**

This is the pressure cleaned upper section. The heavily corroded area is the lower portion of the Figure. This is showing the area adjacent to the taped PE encasement. After the pipe was shot blasted, it was discovered that the liner was the only material left in some of these areas, the iron was gone due to corrosion. The marked area in the upper right locates where material was taken for the mechanical tests (Charpy impact bars, metallography and chemical analysis). A similar sample was taken 180° from this on the lower section. Figures 9 through 12 are from these locations.

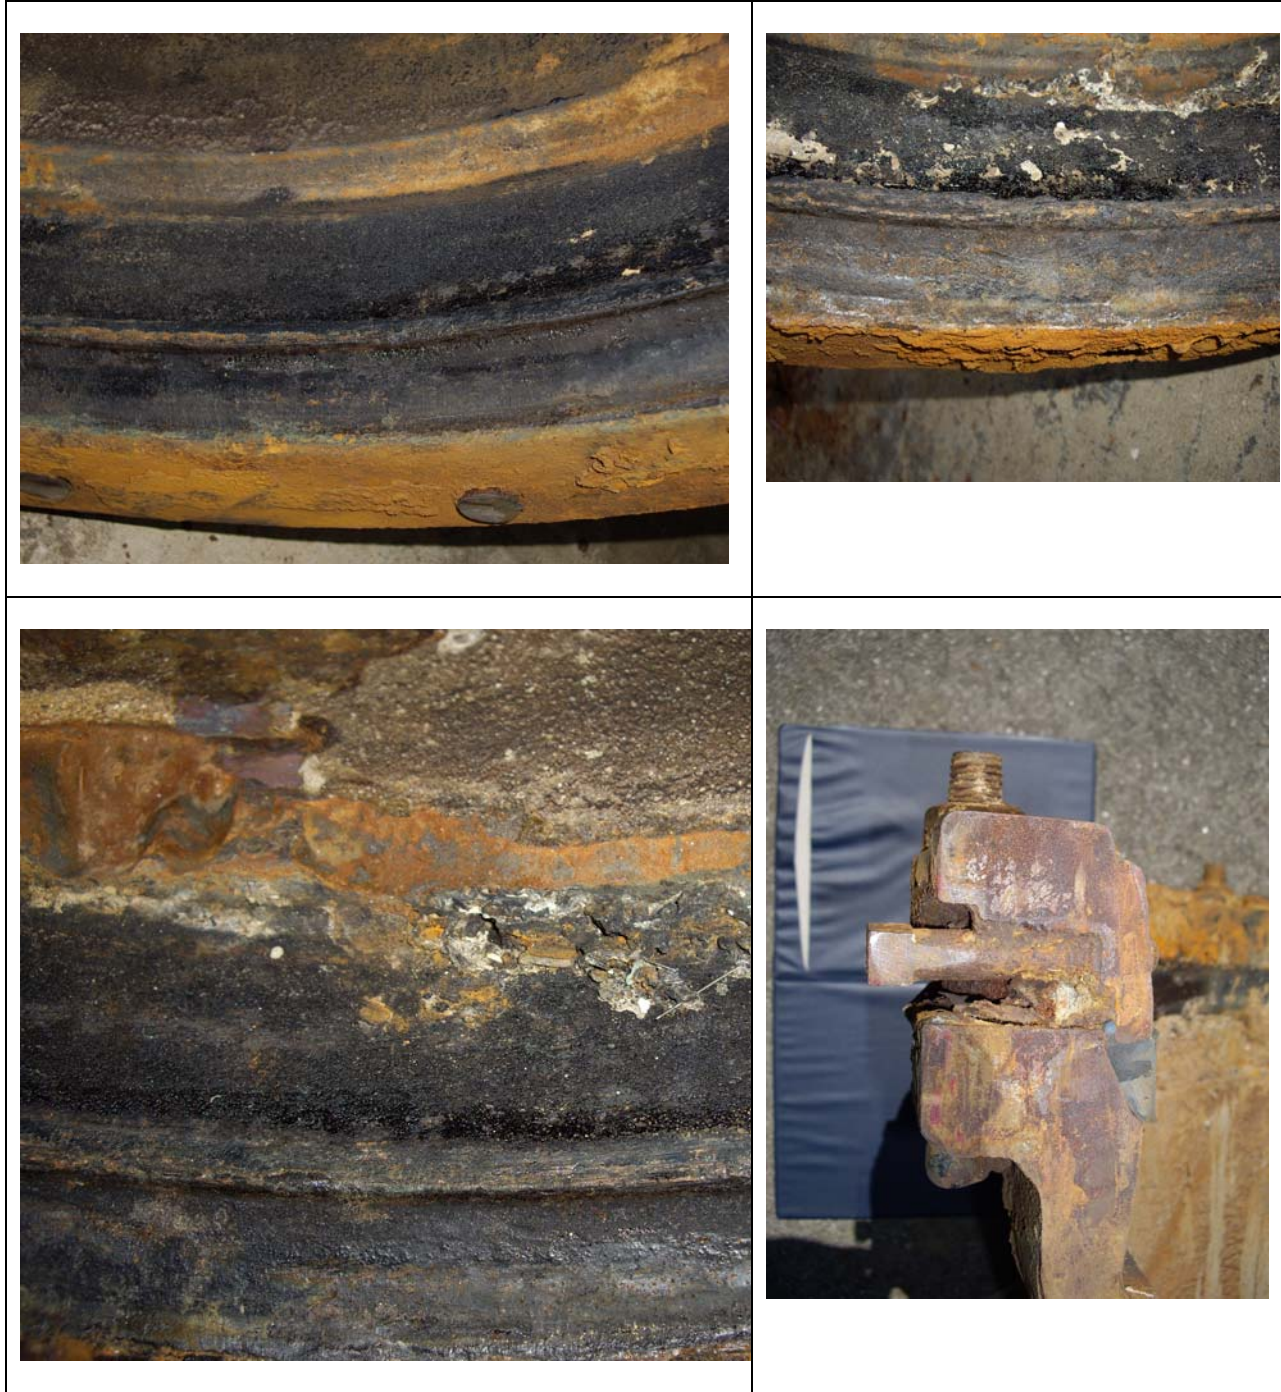
**Figure 6 – Four photos showing asphaltic coating and joint condition**

Three photos from Figure 6 above show the excellent condition of the asphaltic lining applied at the foundry and sealed by the gasket. The pristine condition of these pipe surfaces is certain evidence that there was no leaking at the compressed joint. The lower right photograph in Figure 6 is a section through the gasket material showing a good pipe joint. The inspection of the gasket's surface after removal of the flange showed the gasket material to be undamaged, consistent with a leak free joint.

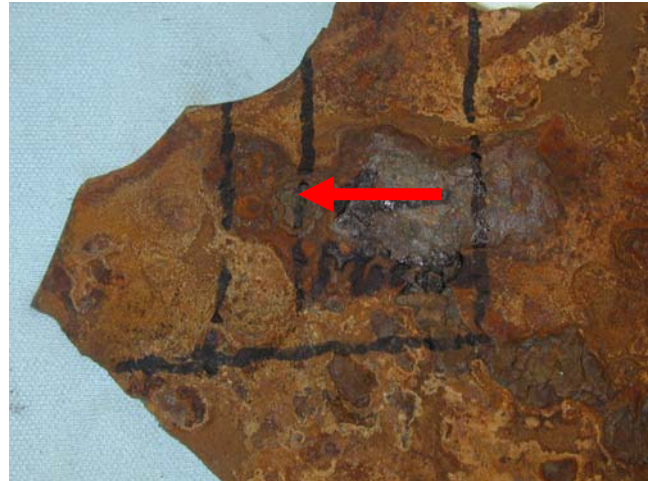
**Figure 7 – Pipe specimen identified for metallographic analysis**

Besides the metallographic examination taken from the area in Figure 5 another sample was taken from the bottom of a graphitic corrosion pit as seen in Figures 7 and 8. The red arrows locate the plane of sectioning through the remaining metal and the corrosion product.

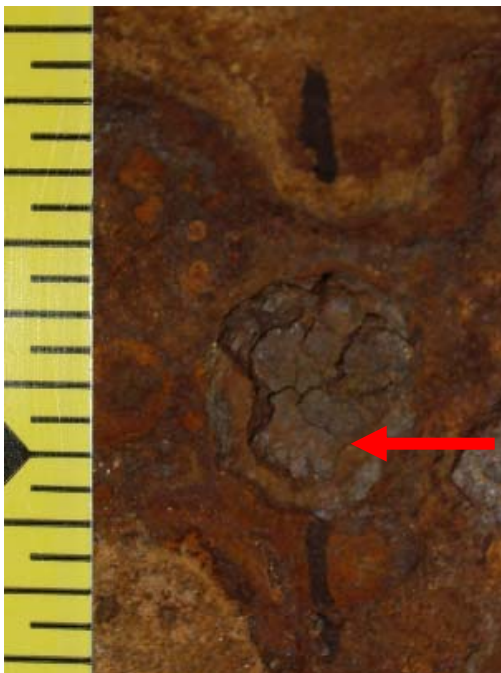
**Figure 8 – Close up of corrosion product**

Figure 8 is a close-up of the plane (red arrow) of sectioning through the corrosion product and the DIP base metal. The results of the metallography are shown in micrograph, Figure 13. The micrograph also shows the structure of the DIP to be vermicular as the inside diameter is approached. The same structure as seen in Figure 11.

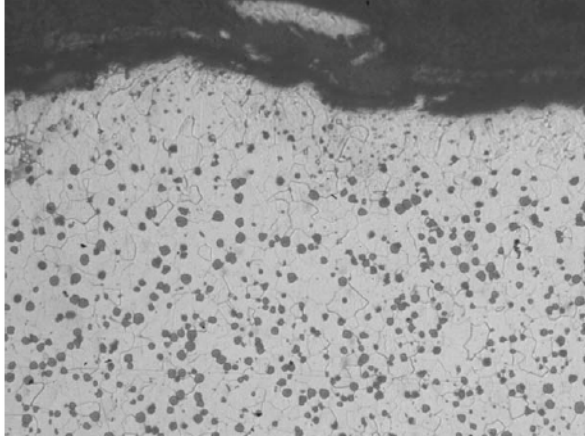
**Figure 9 - Light micrograph of pipe surface**

The microstructure is typical of that for ductile iron. The graphite nodules are dispersed. This is an acceptable microstructure. It meets the ASTM A247 Type I and Type II chart. It is of interest that this shows no corrosion or loss of metal on the outside surface of the pipe in this specific area.

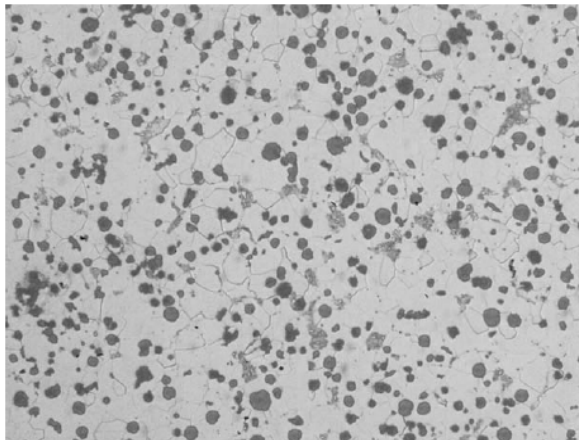
**Figure 10 - Light micrograph of pipe core**

This shows the microstructure of the mid section of the wall of the ductile iron. Some of the graphite nodules are well shaped and some are showing an irregular, non preferred shape. The microstructure is starting to decay and exhibit the structure of that found in grey iron. It meets the ASTM A247 Type II chart.

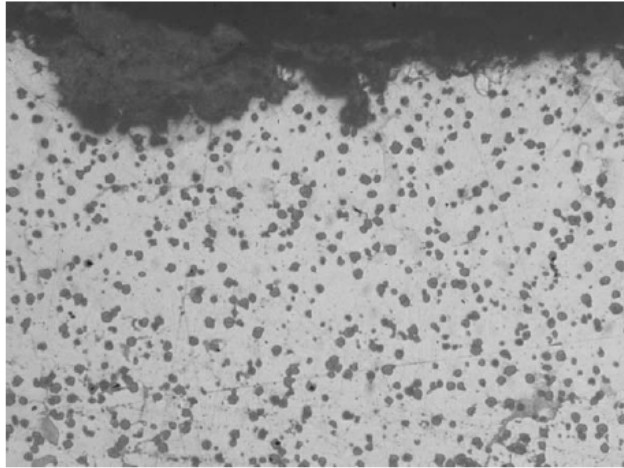
**Figure 12 - Light micrograph of pipe surface (below springline)**

The micrographs of the specimen taken at 180°, Lower Specimen (Figure 12), are similar to the previous micrographs, Figures 9, 10, 11). The outside diameter surface does show more

corrosion than this one. This is consistent with the cause of corrosion failure presented in this report. The specimen from the lower section is below the springline and would see some more metal loss than the upper section.

The microstructure is typical of that for ductile iron. The graphite nodules are well shaped and evenly dispersed. This is an acceptable microstructure. It meets the ASTM A247 Type I. chart. Because this was taken from the lowest outer section of the DIP it does evidence slightly more corrosion.

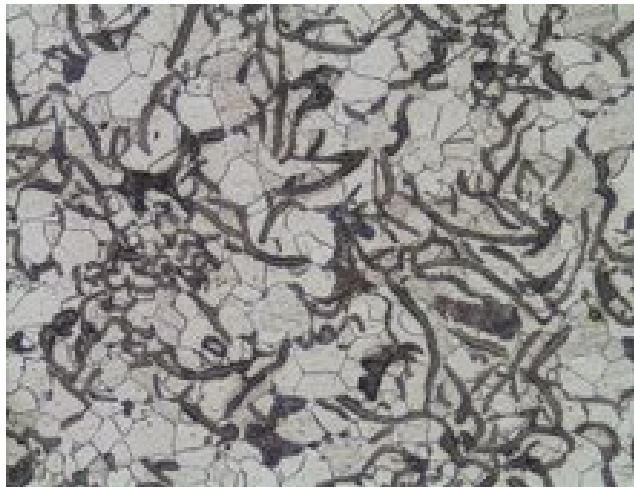
Figure 13 is the microstructure of the iron located below the corrosion pit, (Figure 8). The pit is due to graphitic corrosion.

This is not ductile iron. It is the same vermicular structure as seen in Figure 12. There are no graphite nodules in the microstructure. This is not an acceptable microstructure for impact resistance. The microstructure has no susceptibility or resistance to corrosion over that of a nodular structure. The cement liner was protecting this structure from corrosion from the inside of the pipe. The corrosion came from the outside diameter thought the nodular structure. The corrosion rate would be similar between the nodular graphite and this vermicular structure.

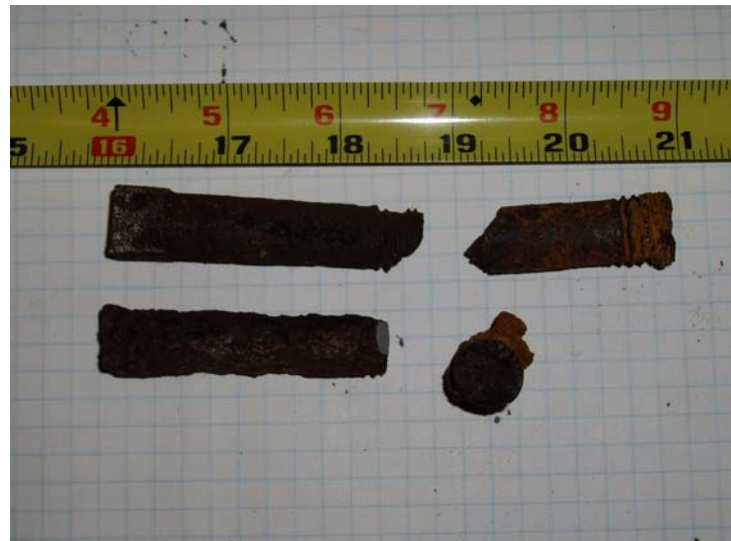
Figure 14 – Corrosion of fasteners

Figure 14 above shows two sets of fasteners. The left is surface corroded grey iron. It is heavy and the fracture surface is clean and metallic in appearance. The pieces on the right are the same fasteners but they have undergone graphitic corrosion. They have very little weight because of the loss of the iron in the matrix

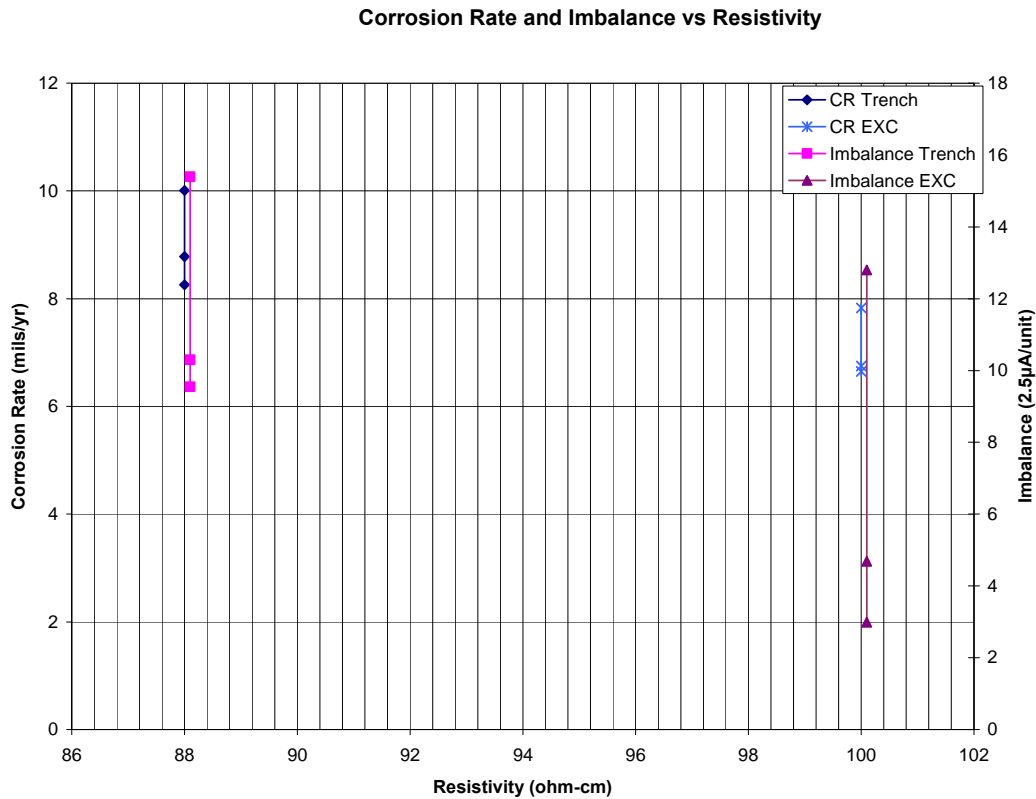
**Figure 15 - LPR Tests and ECI for Soil Samples from Excavation**

The measurements taken from both of the soil samples, shown in Figure 15 indicate that both general corrosion and localized corrosion are taking place.
