**CALIFORNIA REGIONAL WATER QUALITY CONTROL BOARD
SAN DIEGO REGION**

**PRELIMINARY
TECHNICAL ANALYSIS
SUPPORTING**

**SAN DIEGO UNIFIED SCHOOL DISTRICT
FOR
FAILURE TO COMPLY
WITH**

**ORDER NO. 99-08-DWQ
WASTE DISCHARGE REQUIREMENTS
FOR DISCHARGES OF STORMWATER RUNOFF
ASSOCIATED WITH CONSTRUCTION ACTIVITY
(WDID No. 9 37C329152)**

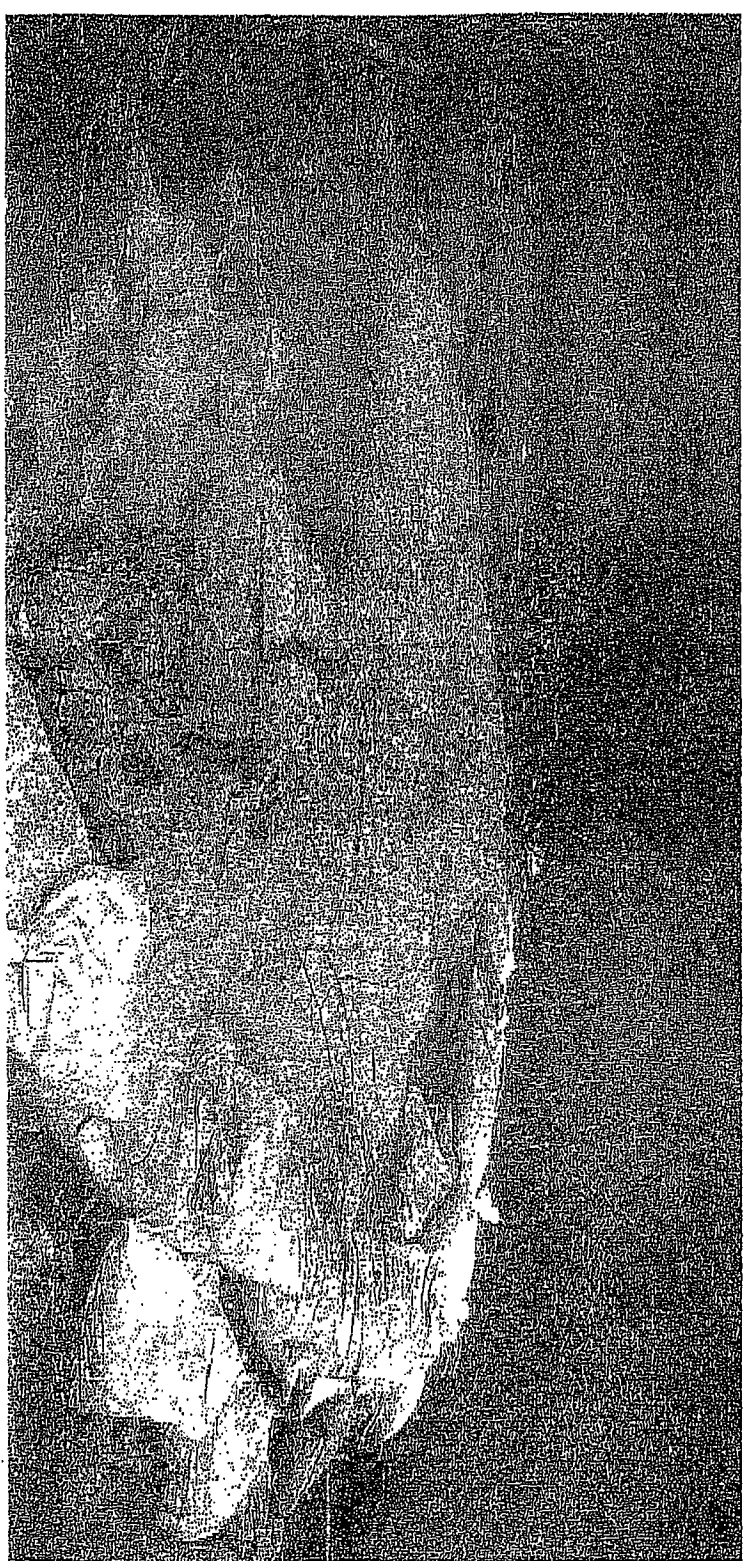
Image shows: BMPs installed in the water of state. BMPs not maintained.
Sediment discharged to Carrol Canyon downstream.

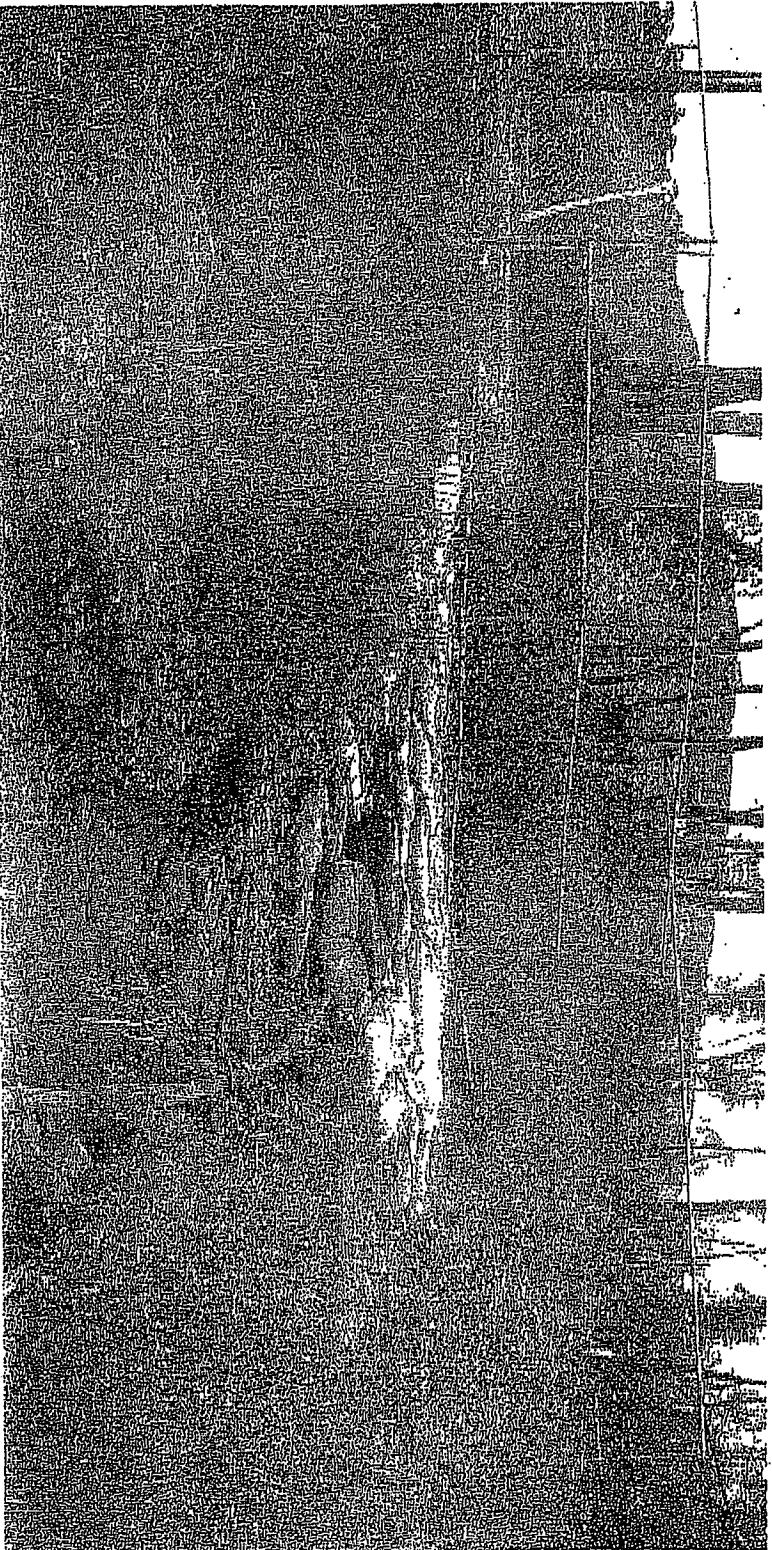
Image IMG P0688 WDID #9 37C329152;

Image shows: BMPs installed in the water of state. BMPs not maintained. Sediment discharged to Carrol Canyon downstream.

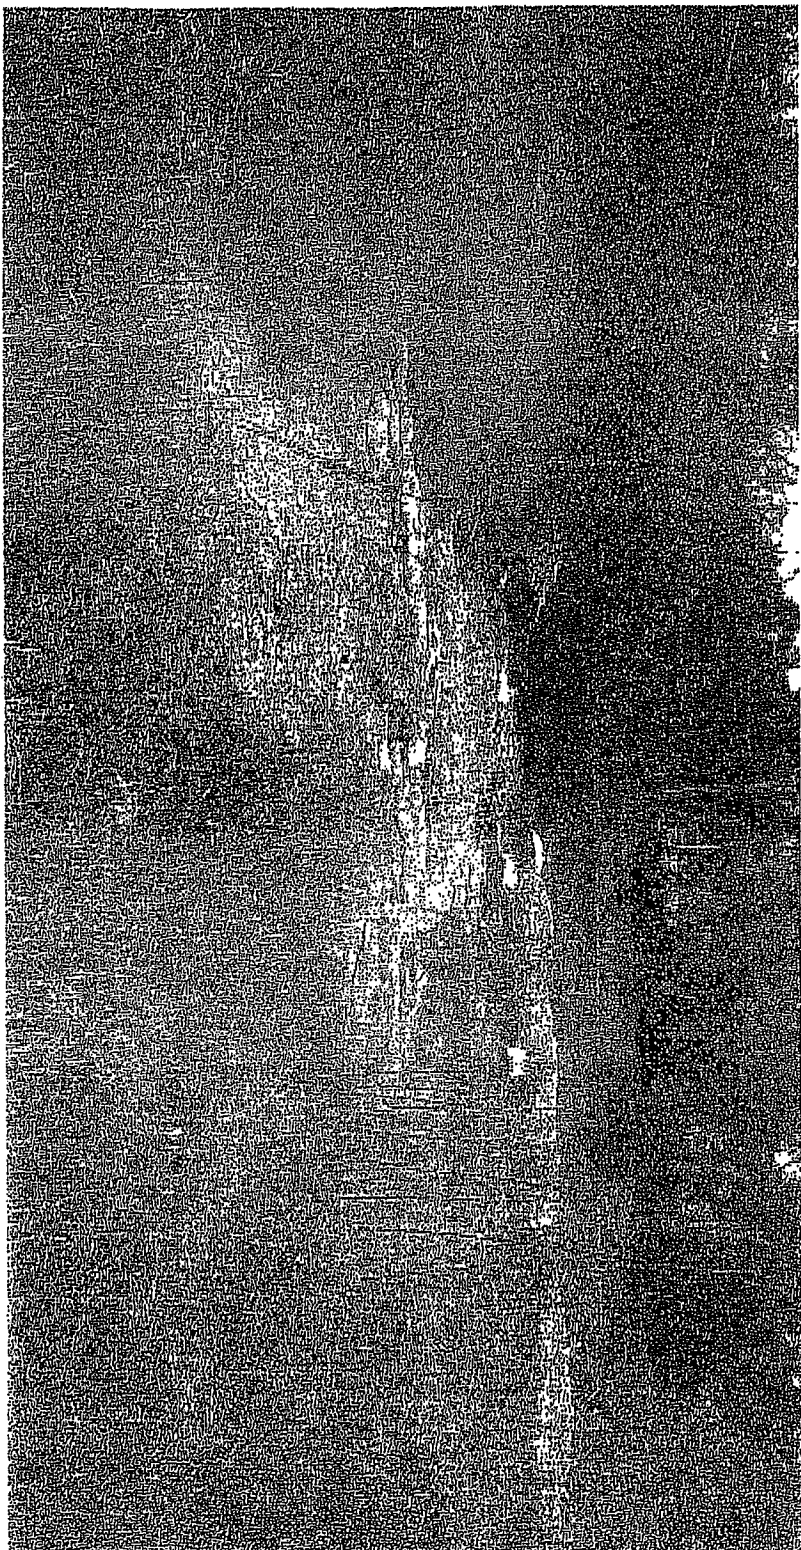
Image IMG P0690, WDID #9 37C329152;

Image shows: No BMPs for erosion and sediment control for mass grading and dirt piles when there was more than 50 percent of chances of rain.

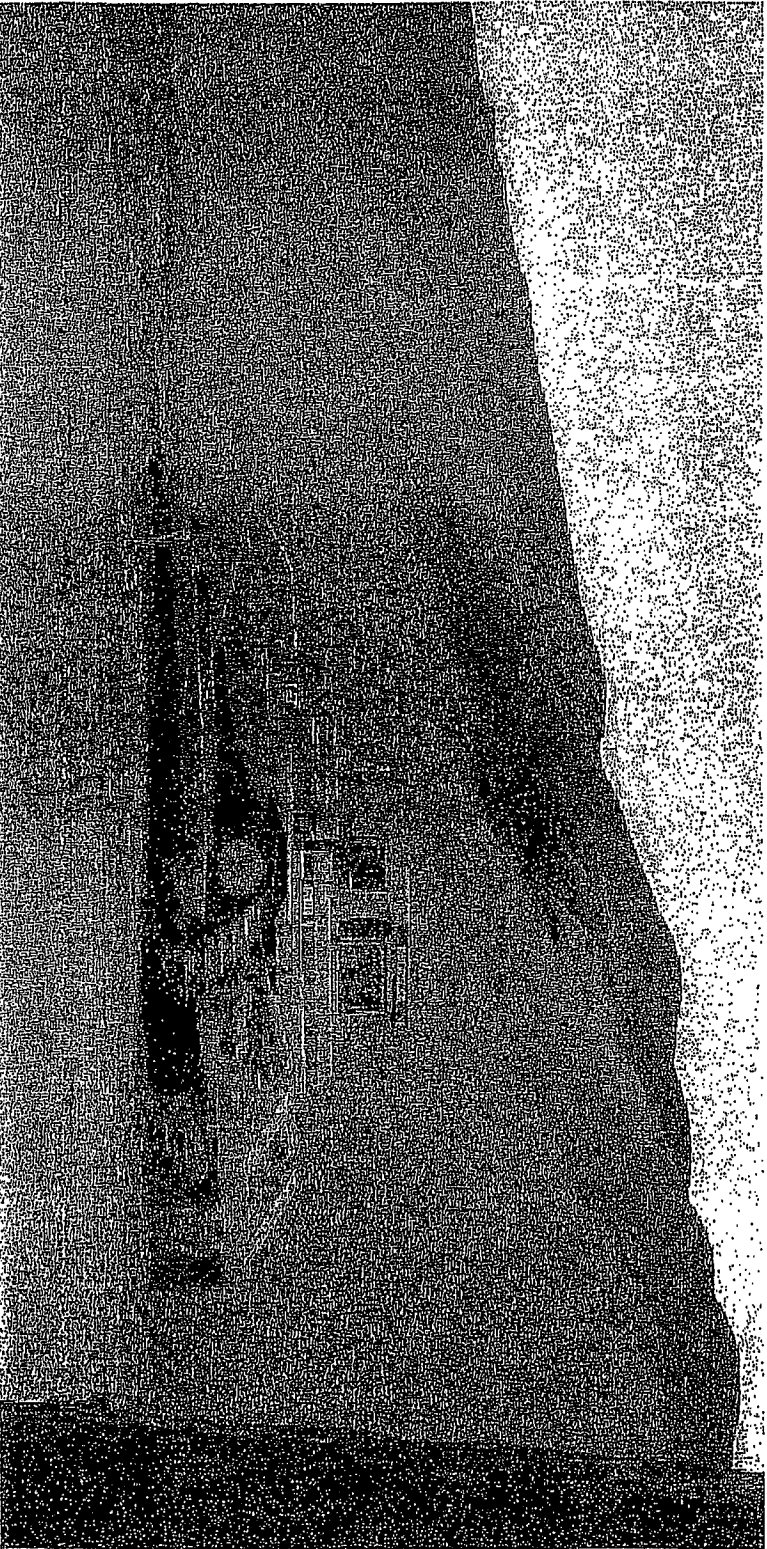
Image IMG P0693 WDID #9 37C329152;
Taken by Dat Quach, RWQCB-SD, between 1400 and 1500 on 03-18-
2005

Image shows: No BMPs for erosion and sediment control for mass
grading and dirt piles when there was more than 50 percent of chances
of rain.

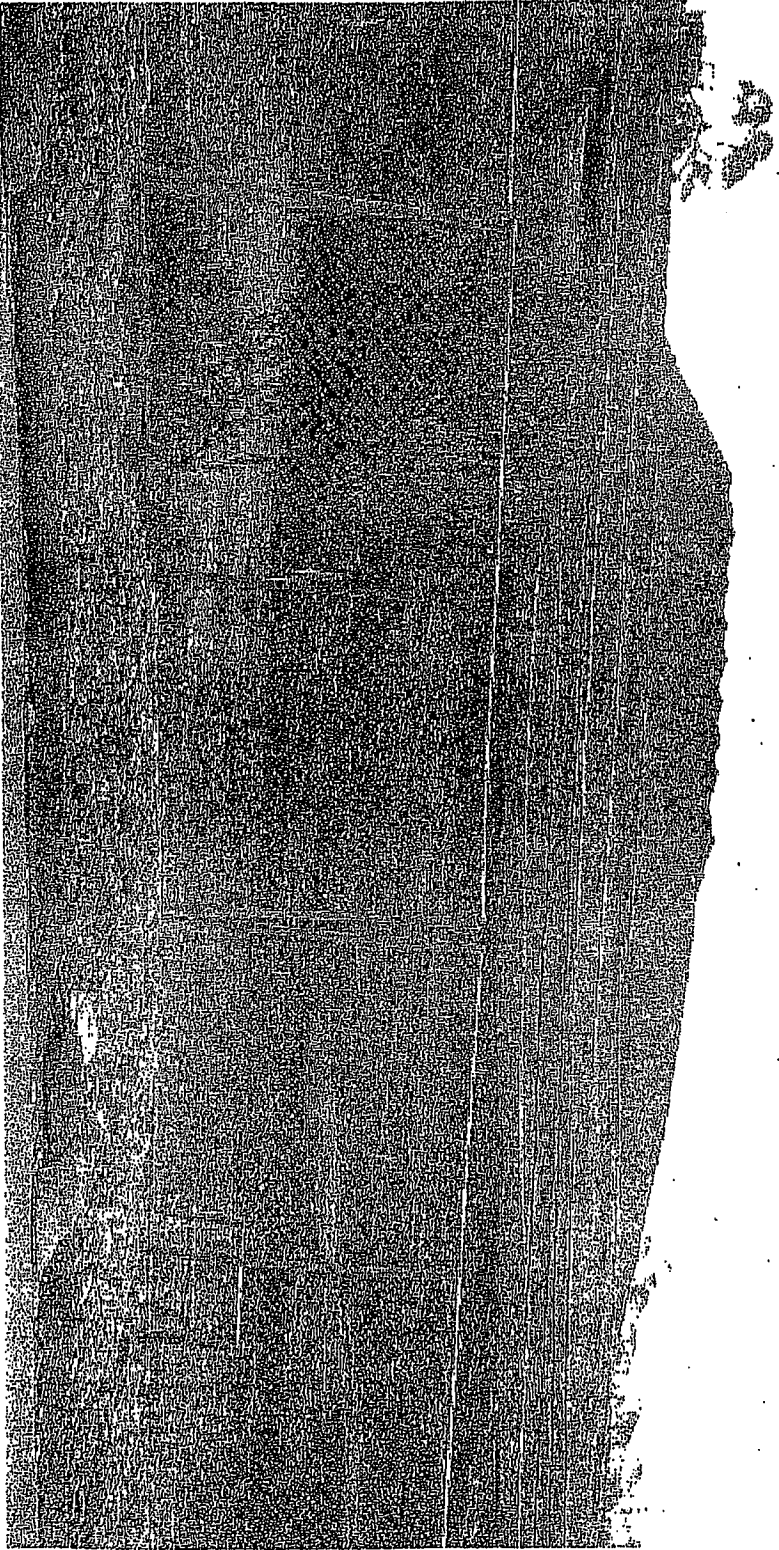
Image IMG P0696 WDID #9 37C329152;

Image shows: No BMPs for erosion and sediment control for mass grading and dirt piles when there was more than 50 percent of chances of rain.

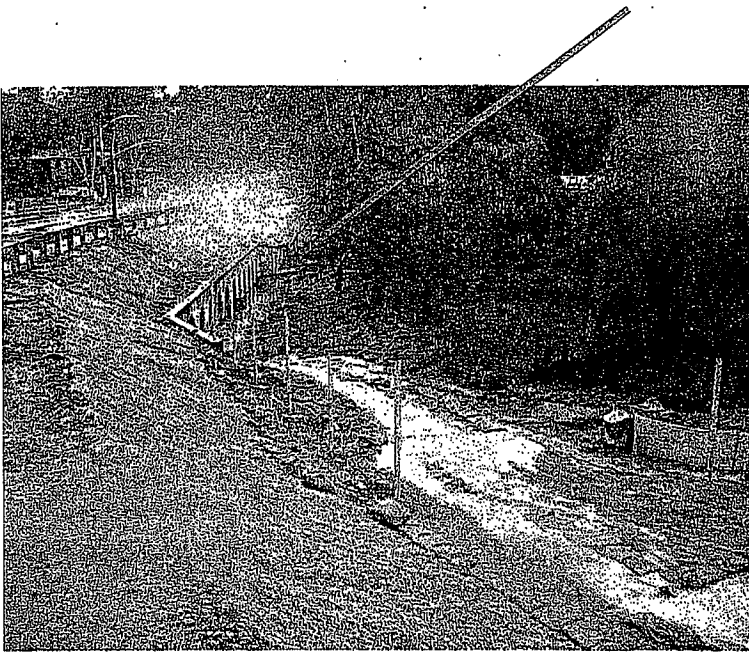
149. Sediment and sediment-laden water entering Carroll Canyon Creek. Arrow points to the culverts for Carroll Canyon Creek going under Avenue of Nations.

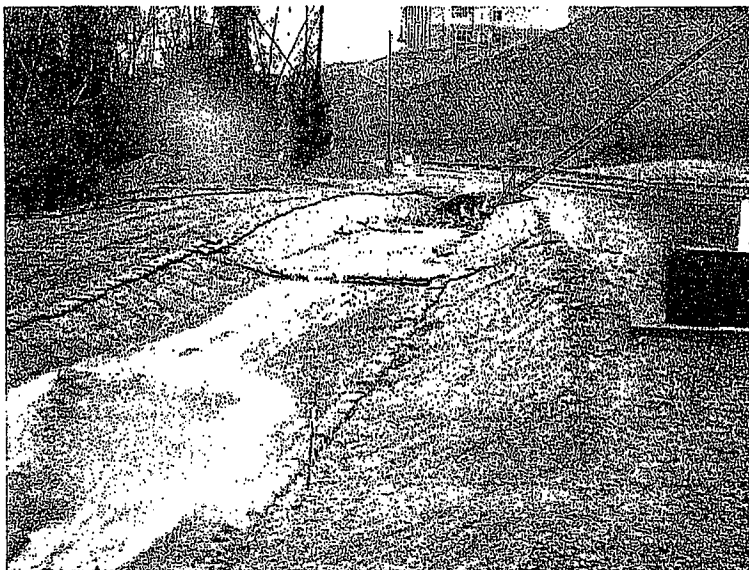
150. Photo is looking upstream of the discharge in photo 149. Sediment-laden runoff is flowing from a storm drain culvert outlet pointed out by the arrow.

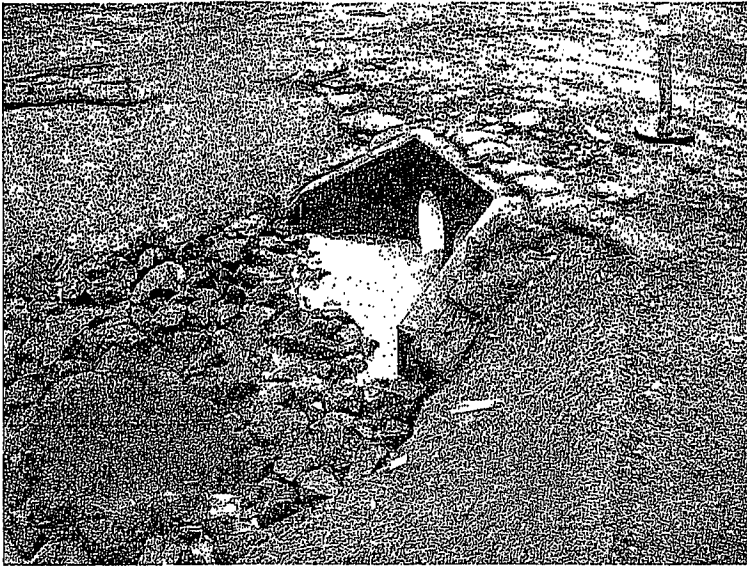
151. A closer look at the storm drain culvert discharging the sediment-laden runoff.

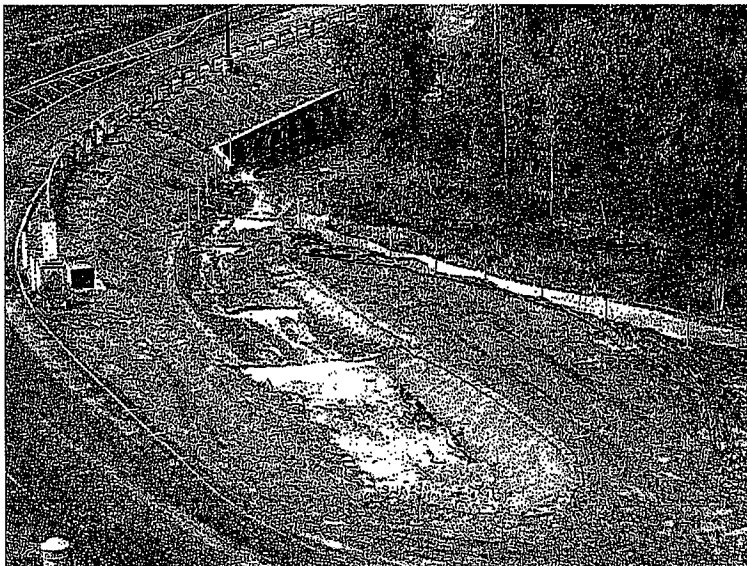
196. Photo taken later in the day after the rain has stopped. This photo was taken from above at the school site shows an overview of the discharge.

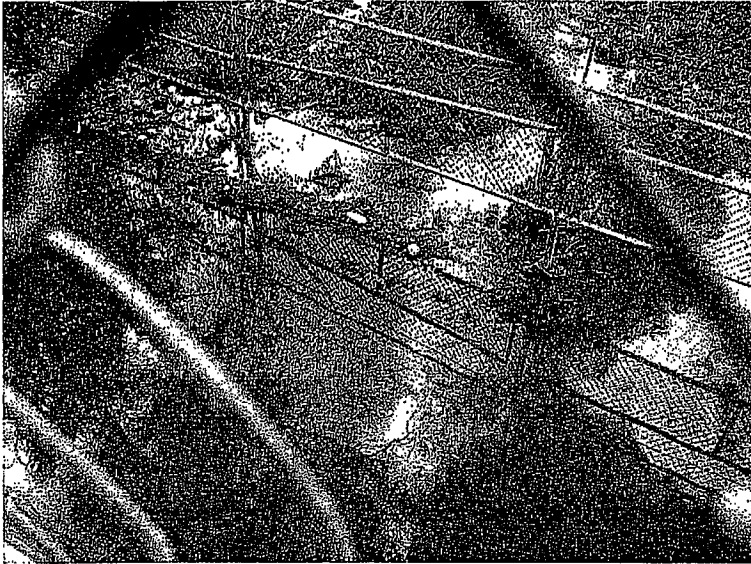
205. Downstream of the Avenue of Nations culverts crossing Carroll Canyon Creek, the creek water is very turbid along the south bank where the construction site discharges.

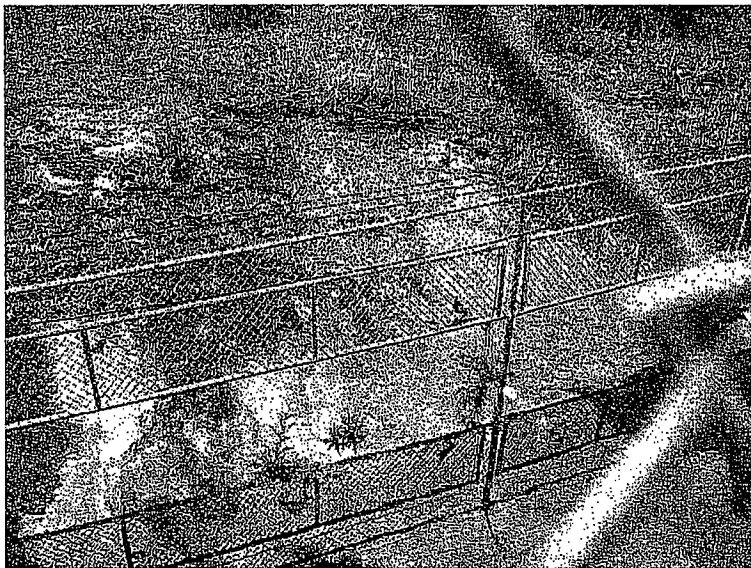
206. Downstream of the Avenue of Nations culverts crossing Carroll Canyon Creek, the creek water is clear along the northern bank not receiving construction site discharges.

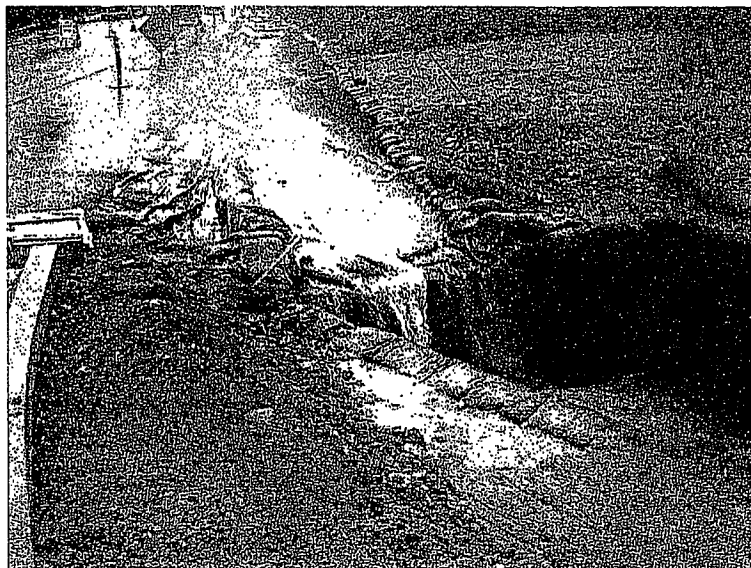
152. This is the culvert entrance to photo 151 on the south side of Avenue of Nations receiving sediment-laden runoff.

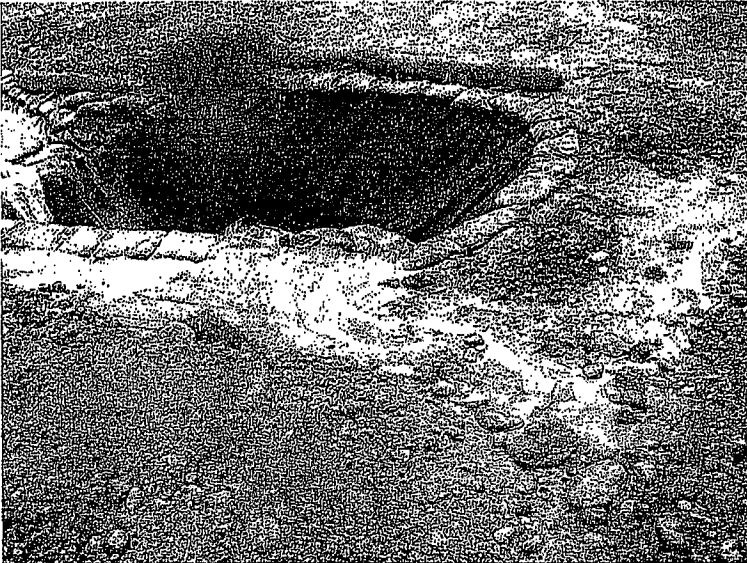
153. Another view of the culvert entrance on the south side of Avenue of Nations, shows sediment and sediment-laden water entering the storm drain culvert from another side.

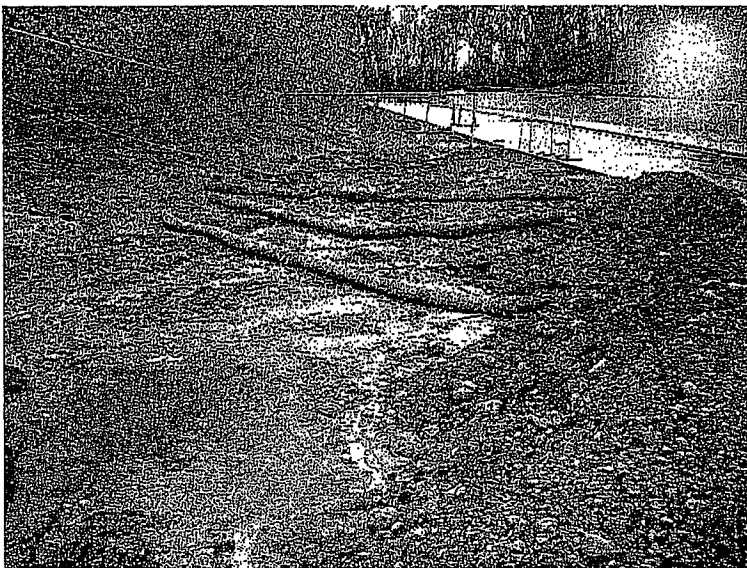
154. Upstream of the culvert entrance on the western side, no erosion controls have been implemented. Fiber rolls have not been trenched in and staked therefore they are doing little to stop the sediment flows.

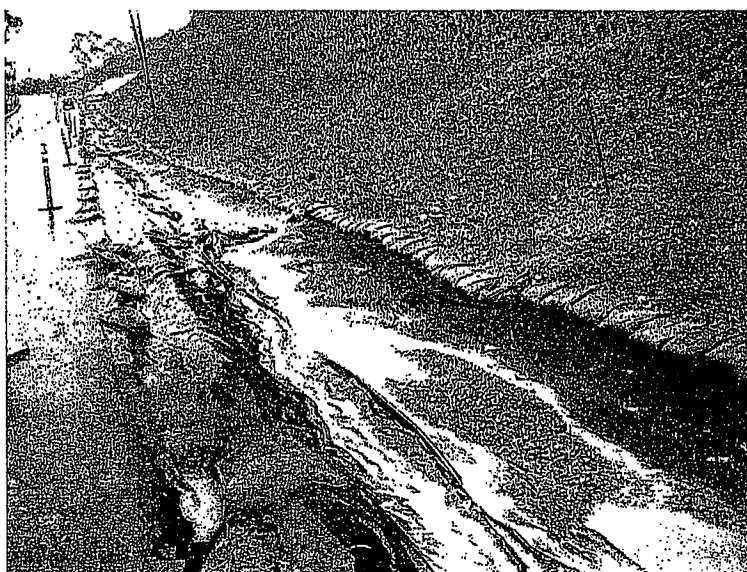
We traveled east on Avenue of Nations following the plastic lined ditch. The plastic lined ditch had sediment and sediment laden water flowing in it (Photo 157). At various points along the slope above the ditch, we saw slope failures and sediment laden runoff discharges to the plastic lined ditch (Photos 156 and 159). The plastic lined ditch ended at a storm drain outlet at the east end of the construction project (Photo 160). Joe Ciaccio, superintendent for Soltek Pacific, stopped on the street to speak with us. We told him that we would go meet with him at the construction trailer. We entered the school site but could not find the construction trailer. We walked around the school's front paved entrance. A storm drain inlet was overwhelmed with sediment and sediment-laden water at the paved entrance to the school (Photo 163). The medians in the parking lot did not have sediment controls on the perimeter and sediment-laden water was flowing off them (Photo 164). Sediment tracking was observed and no perimeter sediment controls were implemented behind the curb (Photo 166). Gasoline cans were stored outside without cover or containment to minimize exposure to storm water (Photo 167).

157. This plastic lined ditch is along the south side of the Avenue of Nations. The ditch terminates at the culvert in photo 153. Inadequate sediment controls along the face of the slope and the toe of the slope. Sediment laden water and sediment in the ditch.

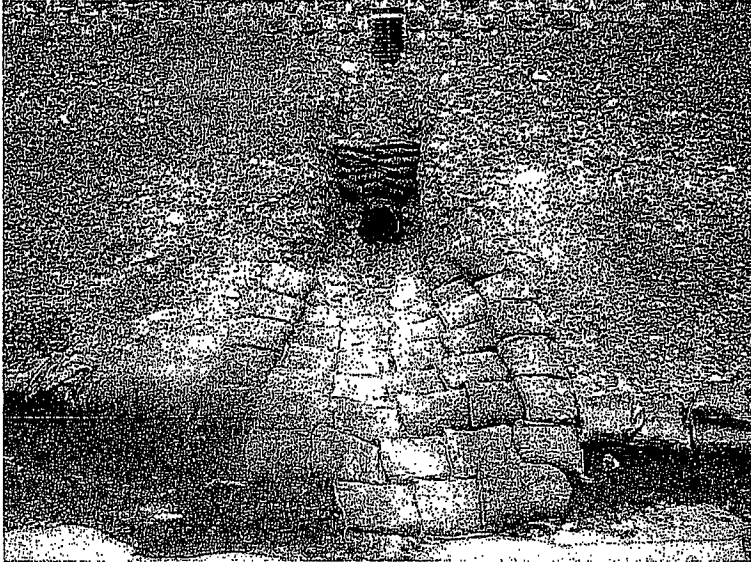
156. A runoff discharge point upstream to the east of the culvert in photo 153. Sediment-laden runoff flows out of the pipe across the gravel bags and into the plastic lined ditch.

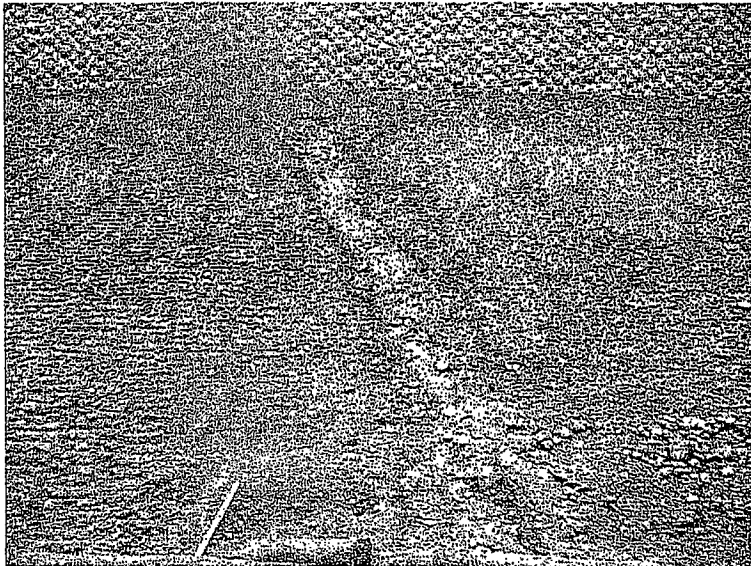
159. Slope failure is causing a discharge of sediment and sediment laden water. Slope face has no fiber rolls.

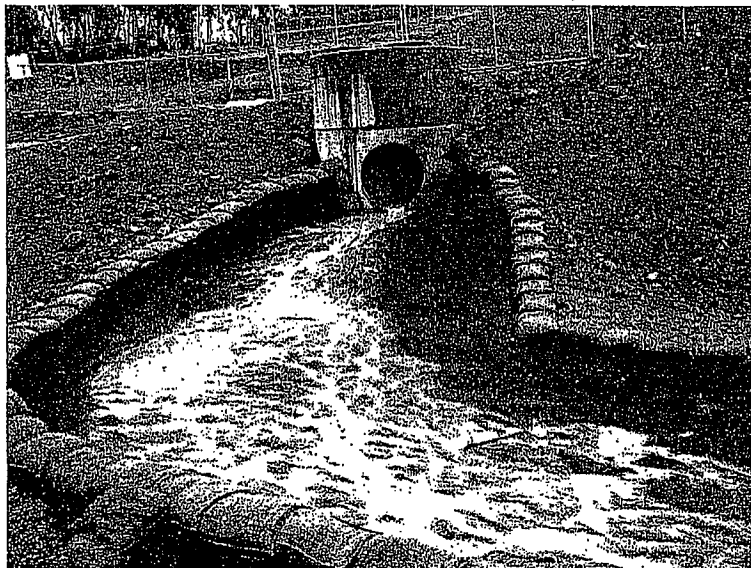
160. Storm drain outfall to the plastic lined ditch along the south side of Avenue of Nations.

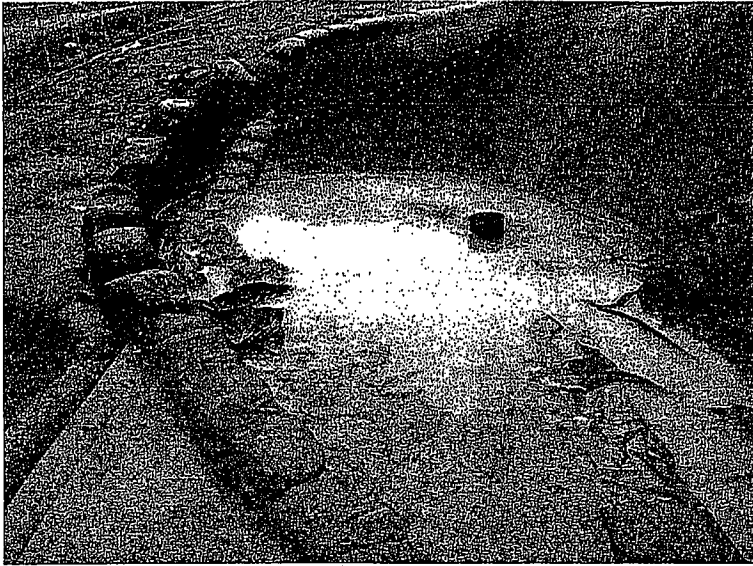
163. A storm drain inlet that goes to the discharge point in photo 160. The inlet is overwhelmed with sediment and sediment-laden water.

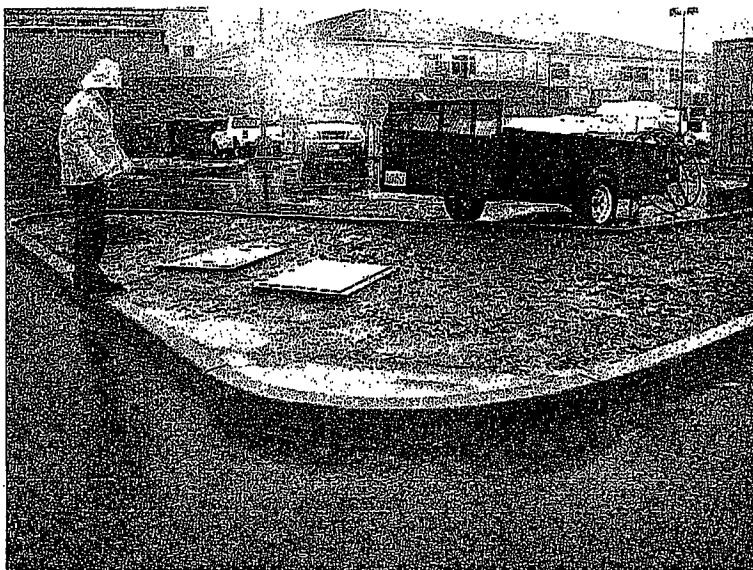
164. Medians in the school parking lot did not have any sediment controls.

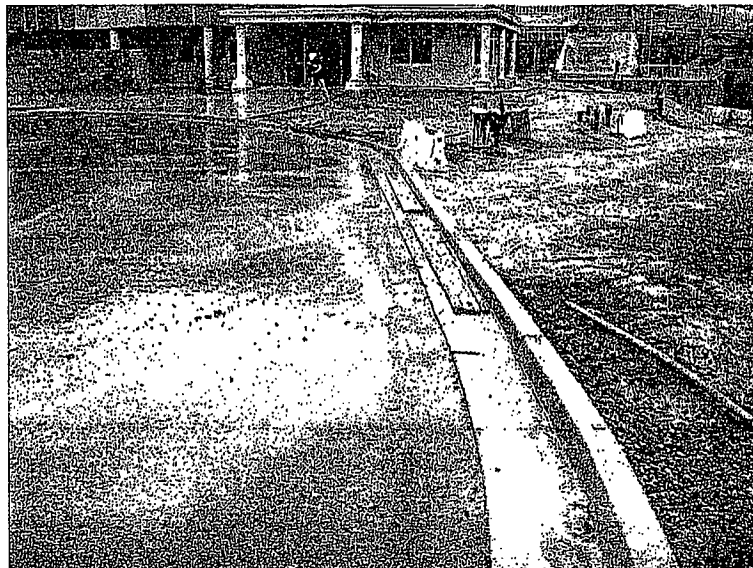
166. Sediment is tracked onto the street. No sediment controls have been implemented behind the curb.

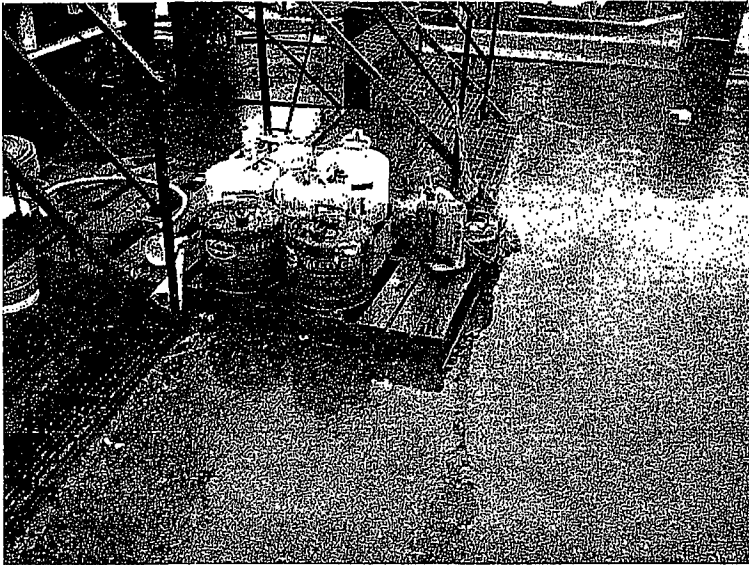
167. Gasoline storage has inadequate cover or containment to minimize storm water exposure.

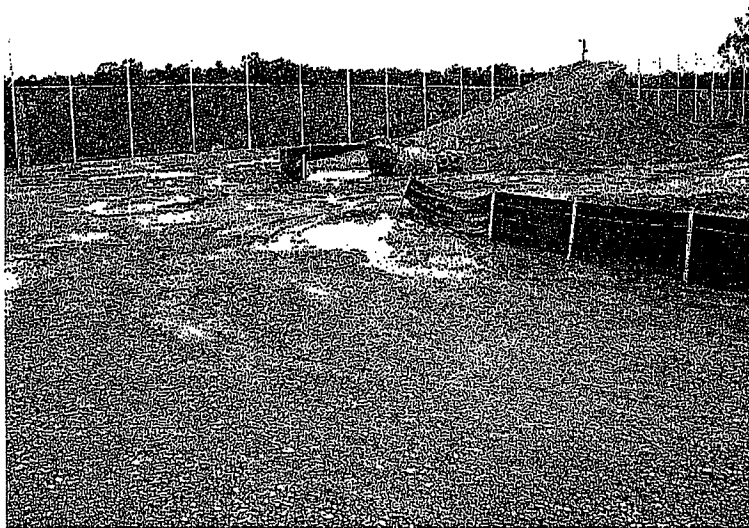
174. Silt fence around a stockpile is damaged and missing.

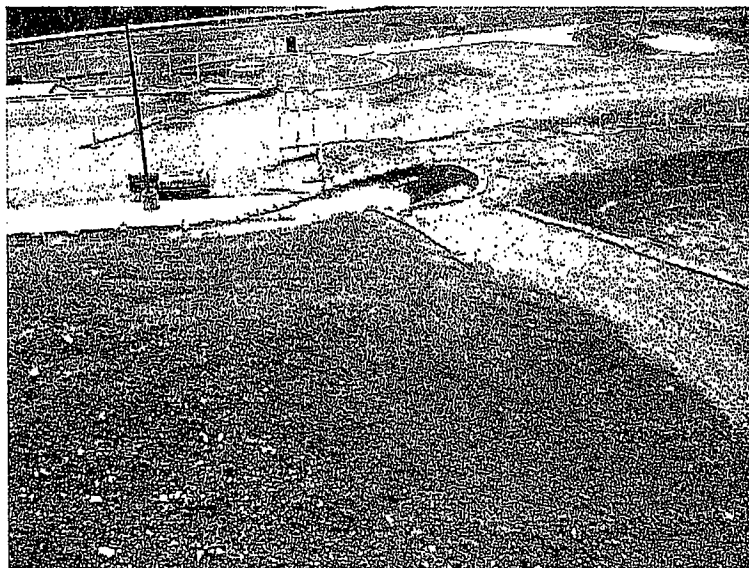
176. Looking downhill from the south towards the inlet in photo 163. Inadequate sediment and erosion controls are on the hill.

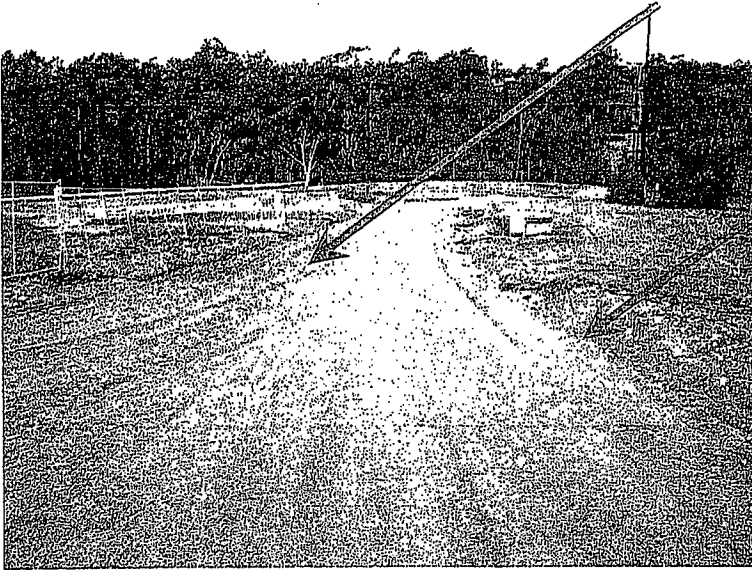
179. Farther uphill than photo 176, but also looking down towards the inlet in photo 163. The arrow points to 2 small rivulets of sediment-laden water running down the access road.

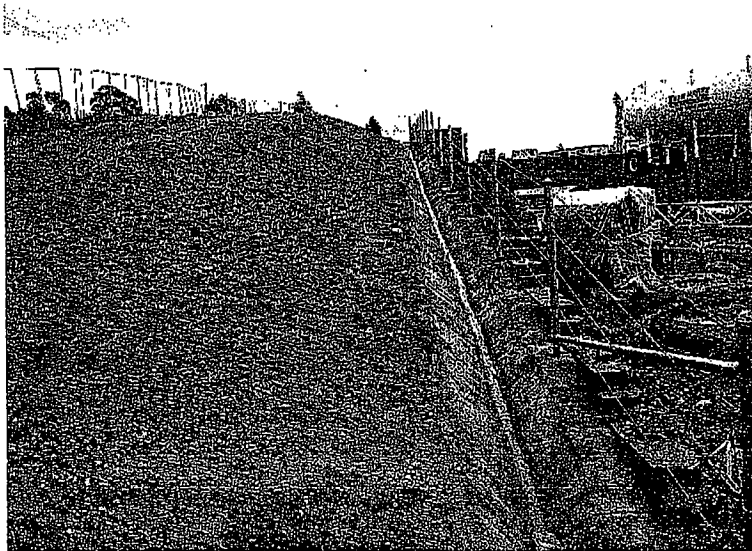
178. Upstream of the inlet in photo 177, the slope has no sediment controls along the toe of slope or in the concrete v-ditch.

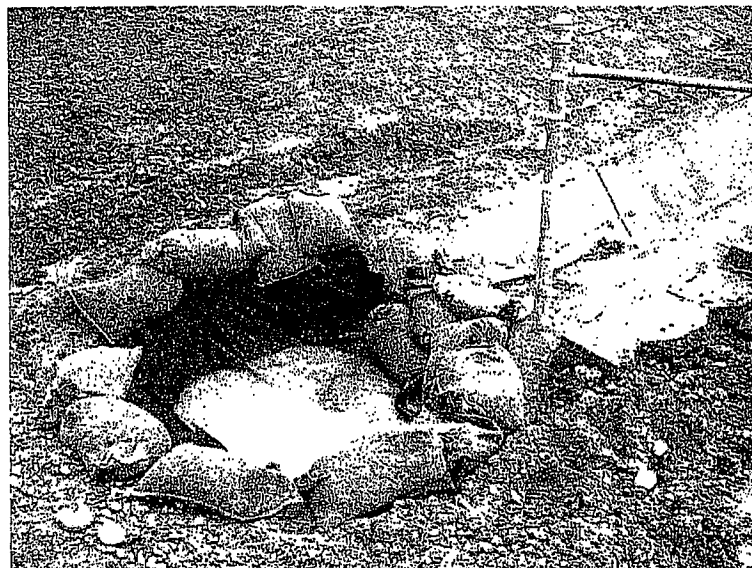
177. A storm drain inlet with sediment laden water.

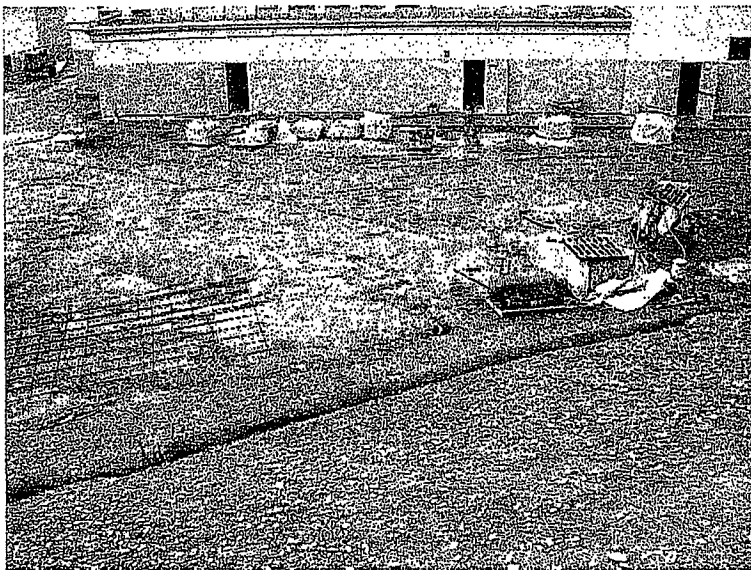
173. Material wash water spills are on the ground.

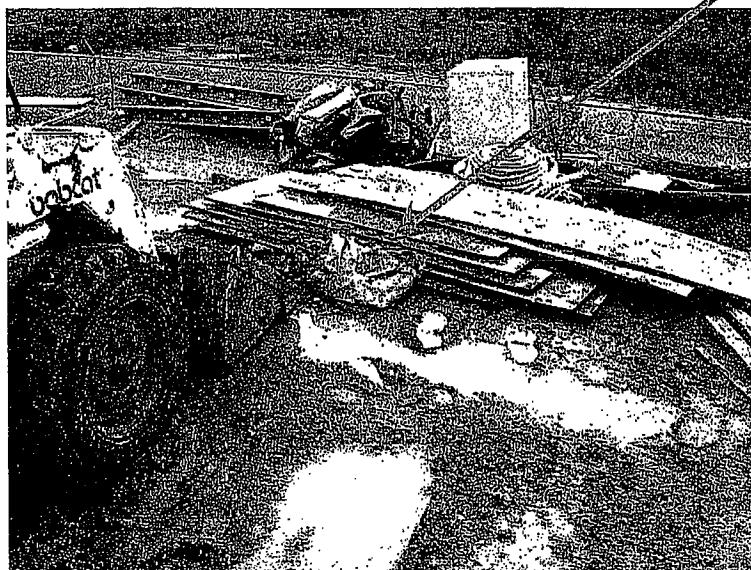
181. The arrow points to an open bag of concrete mix left out in the rain.

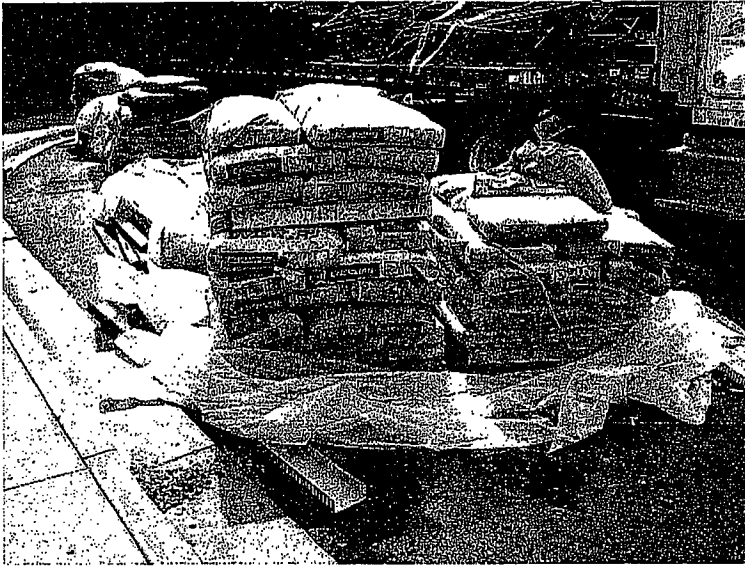
182. Bags of lime left out in the rain without cover.

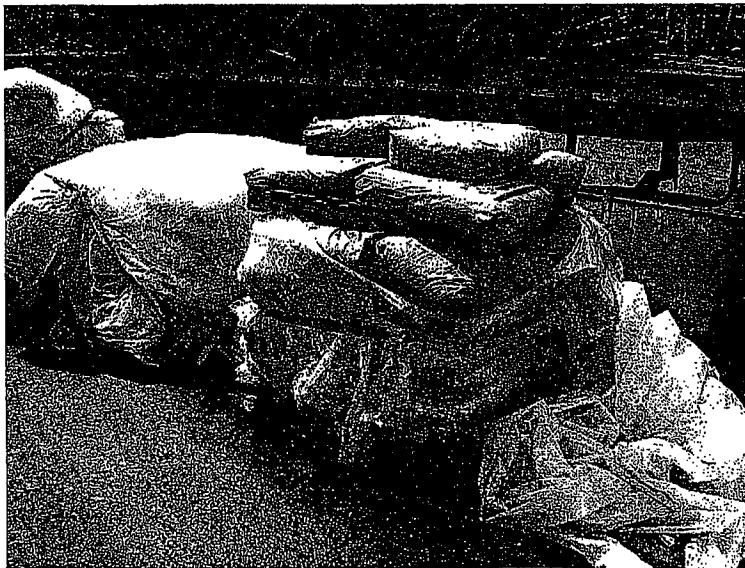
183. More material bags left out in the rain.

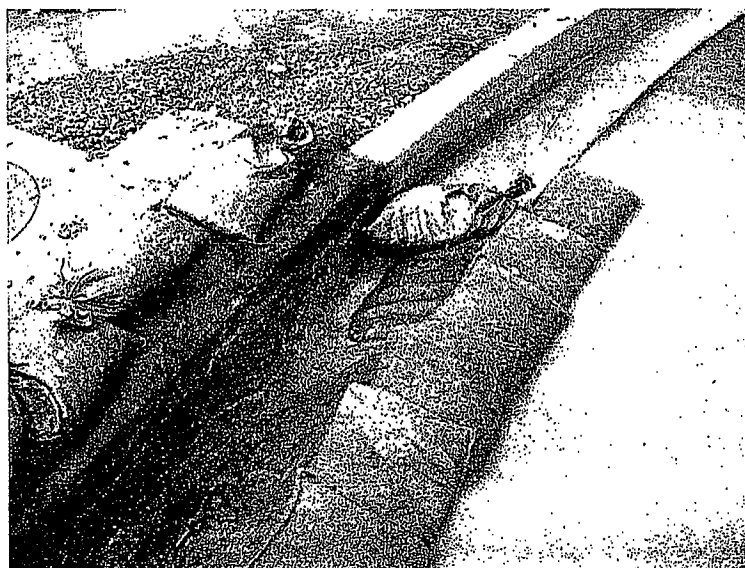
185. Sediment laden water entering a storm drain inlet with inadequate protection.

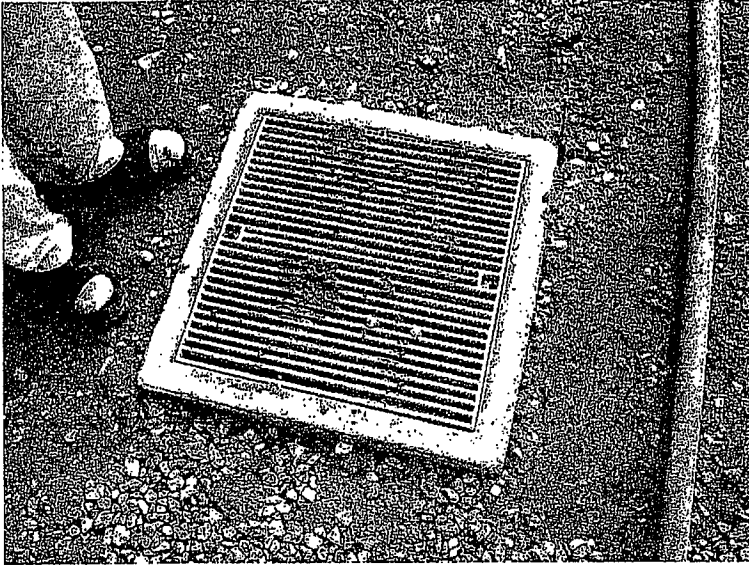
186. Storm drain inlet has no sediment protections.

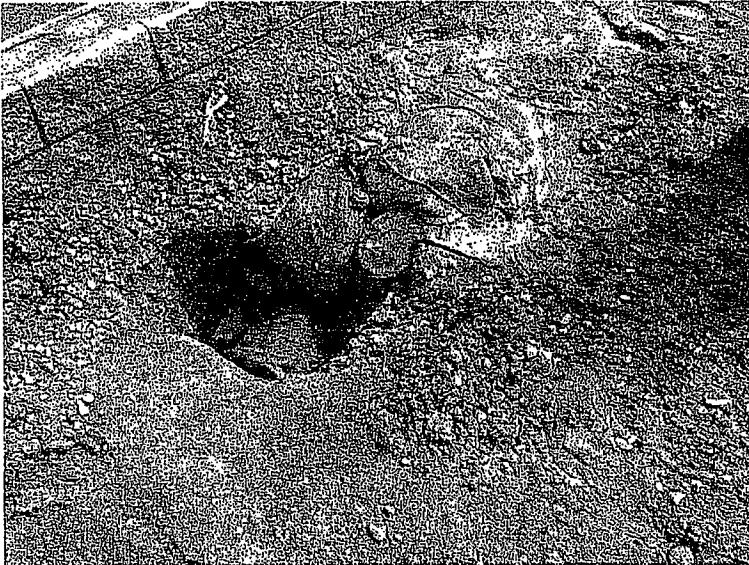
187. Storm drain inlet that is covered with filter fabric and gravel bags has been overwhelmed by sediment flows.

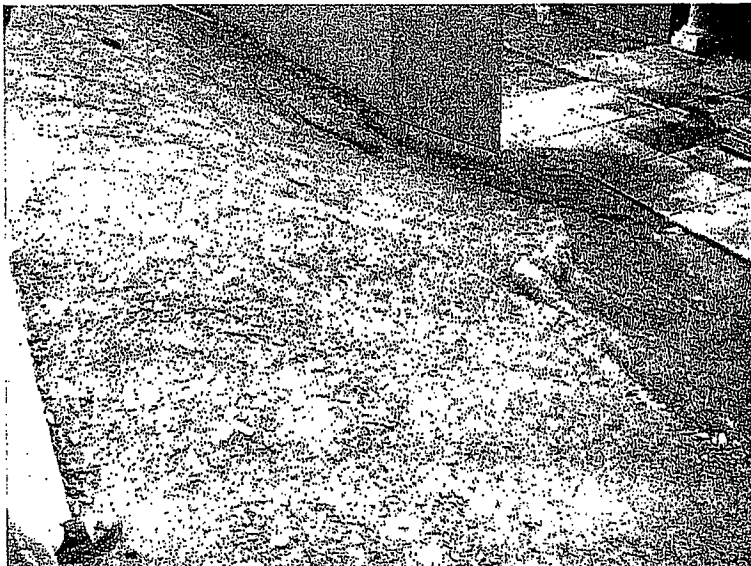
188. A slope with inadequate sediment controls. The fiber roll has failed. An erosion gully is running along the slope next to the wall.

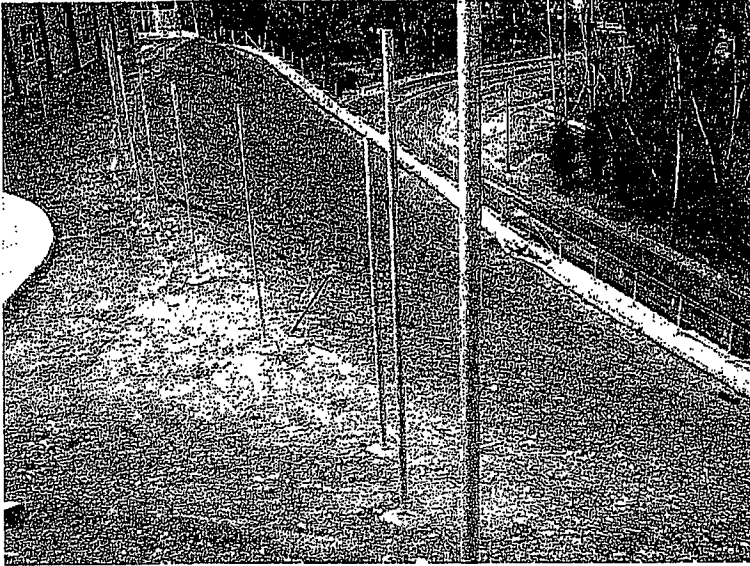
189. A large slope does not have fiber rolls along the face of the slope.

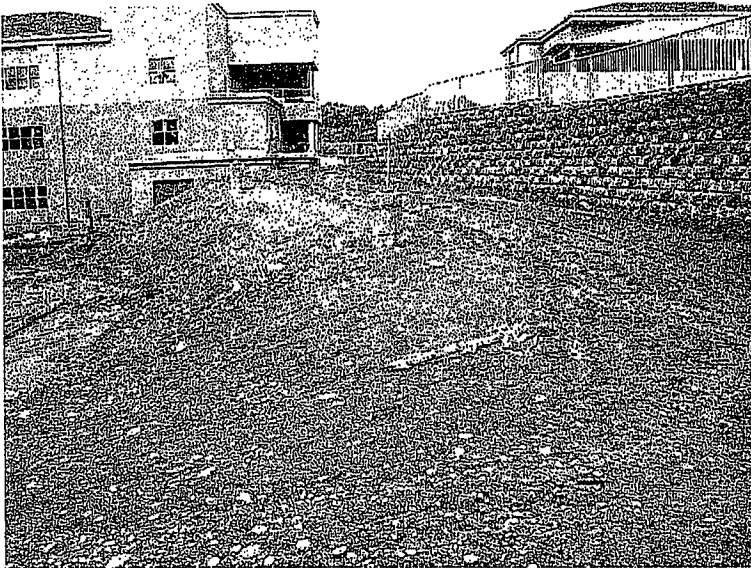
192. A slope has no erosion or sediment controls. A construction access road has no sediment controls.

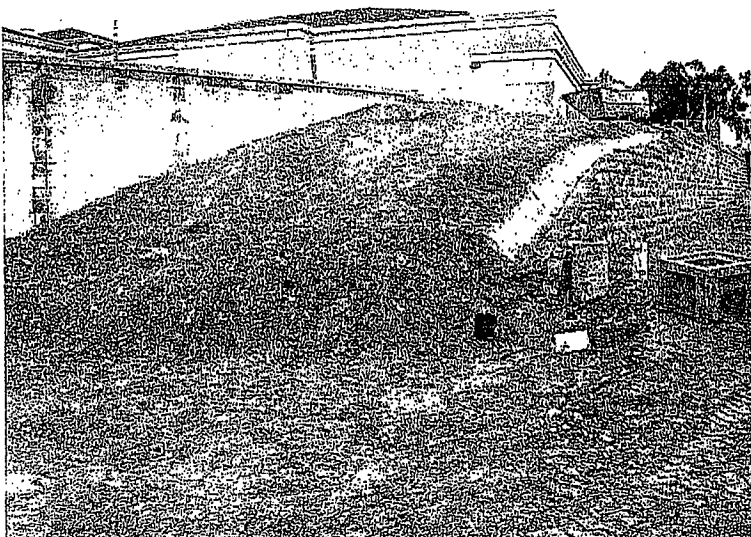
200. A slope with no erosion or sediment controls.

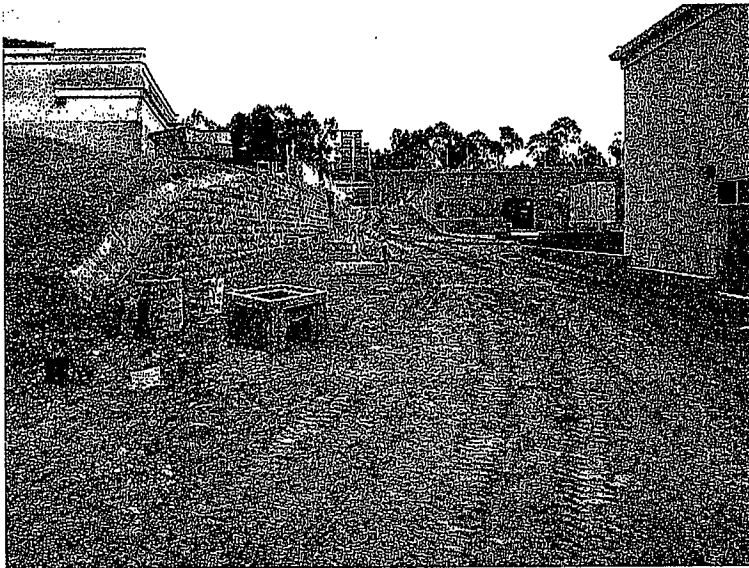
201. A construction access road with no sediment controls.

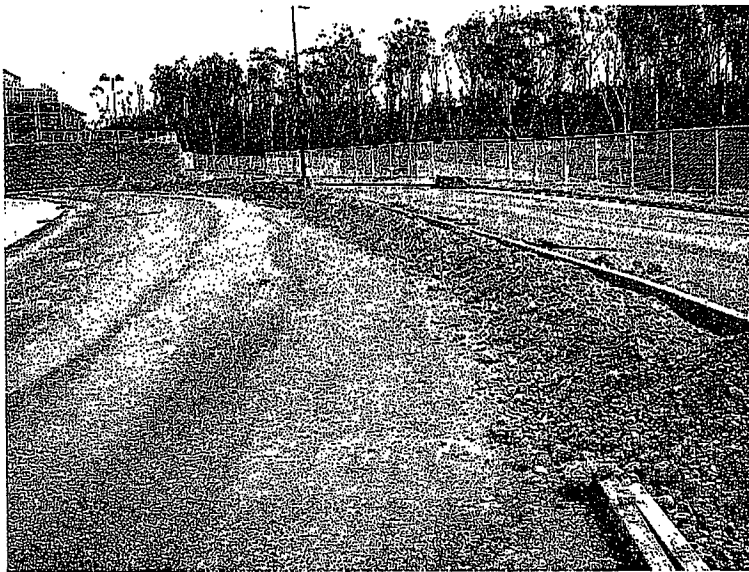
193. Dirt stockpiled on the street with no controls to minimize contact with runoff.

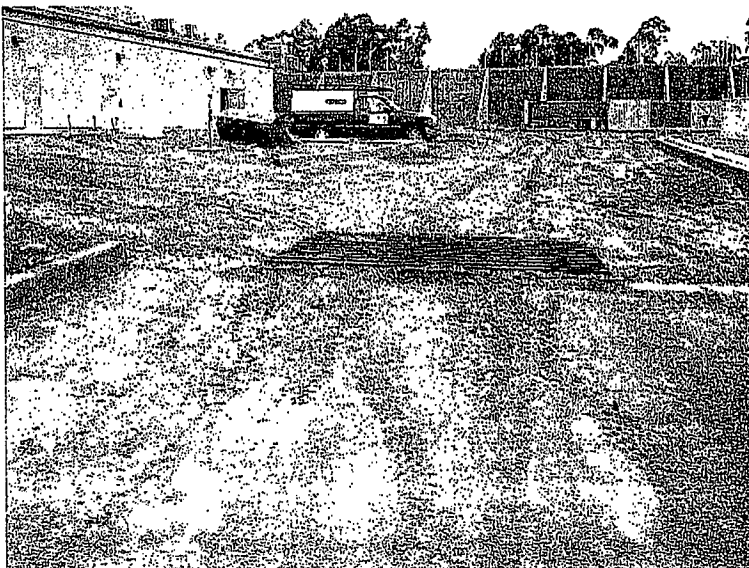
198. Construction exit has inadequate BMPs to prevent sediment tracking. They have one rumble plate and no gravel. Significant amounts of sediment have been tracked onto the paved surface.
