**CALIFORNIA REGIONAL WATER QUALITY CONTROL BOARD
SAN DIEGO REGION**

**PRELIMINARY
TECHNICAL ANALYSIS
SUPPORTING**

**SAN DIEGO UNIFIED SCHOOL DISTRICT
FOR
FAILURE TO COMPLY
WITH**

**ORDER NO. 99-08-DWQ
WASTE DISCHARGE REQUIREMENTS
FOR DISCHARGES OF STORMWATER RUNOFF
ASSOCIATED WITH CONSTRUCTION ACTIVITY
(WDID No. 9 37C329152)**

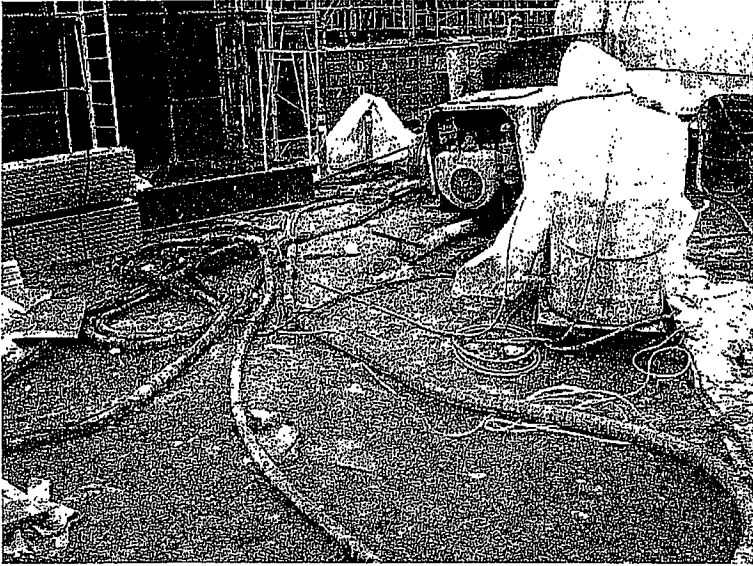
199. Material spills are on the ground with no containment to minimize contact with runoff.

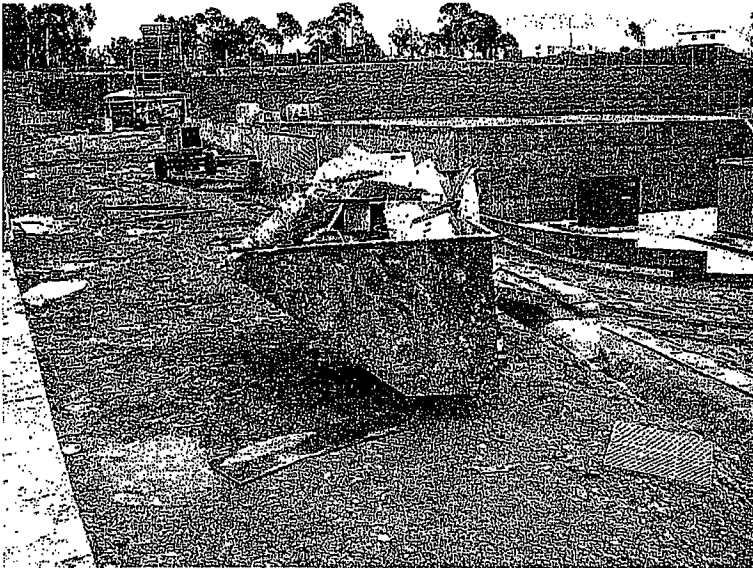
204. Construction trash is not covered to minimize contact with storm water.

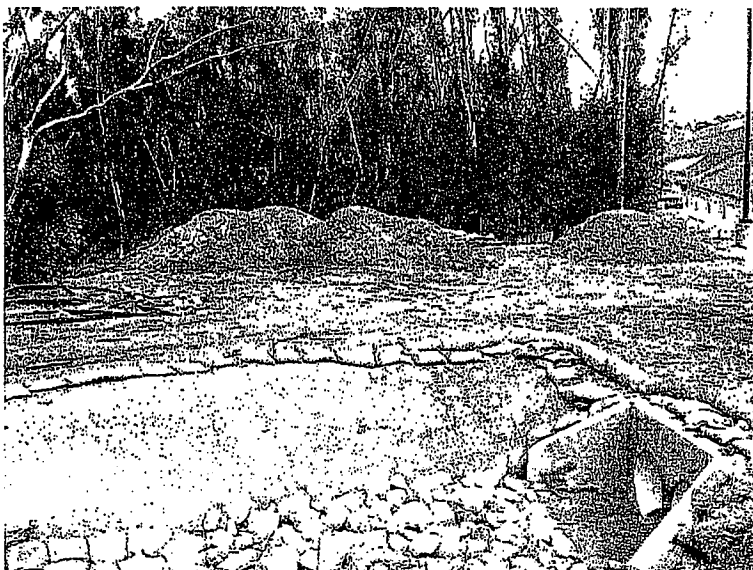
210. Soil stockpiles near Carroll Canyon Creek do not have cover or containment.

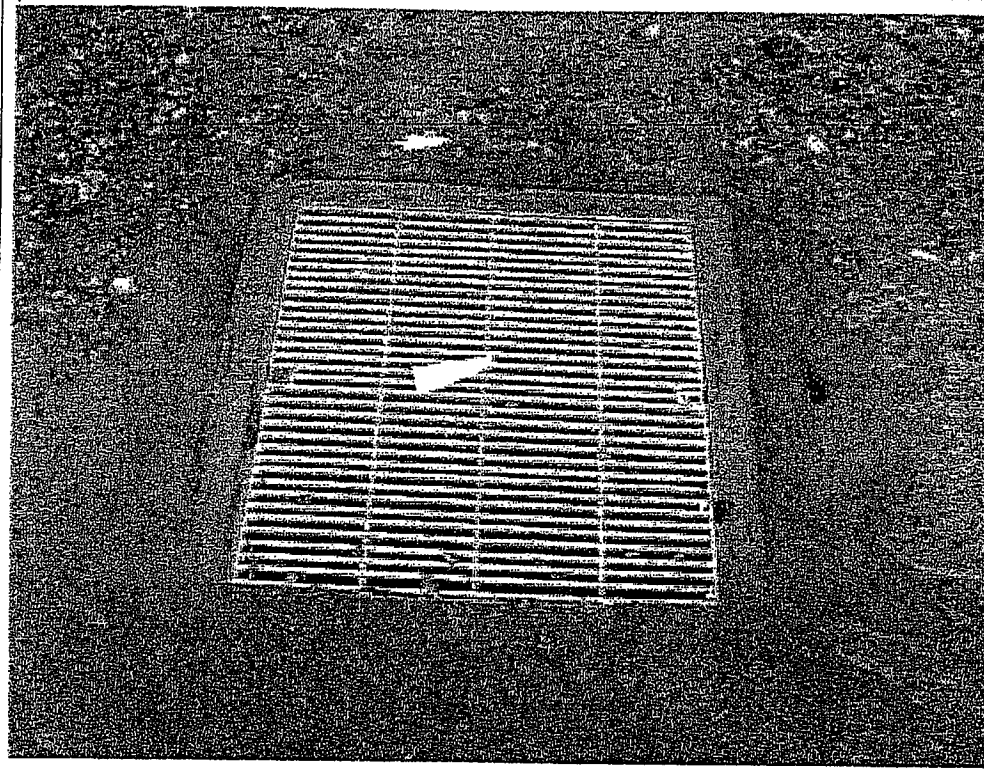
Photograph #11

Comments:
Drain inlet near building in north central portion of site with no protection.

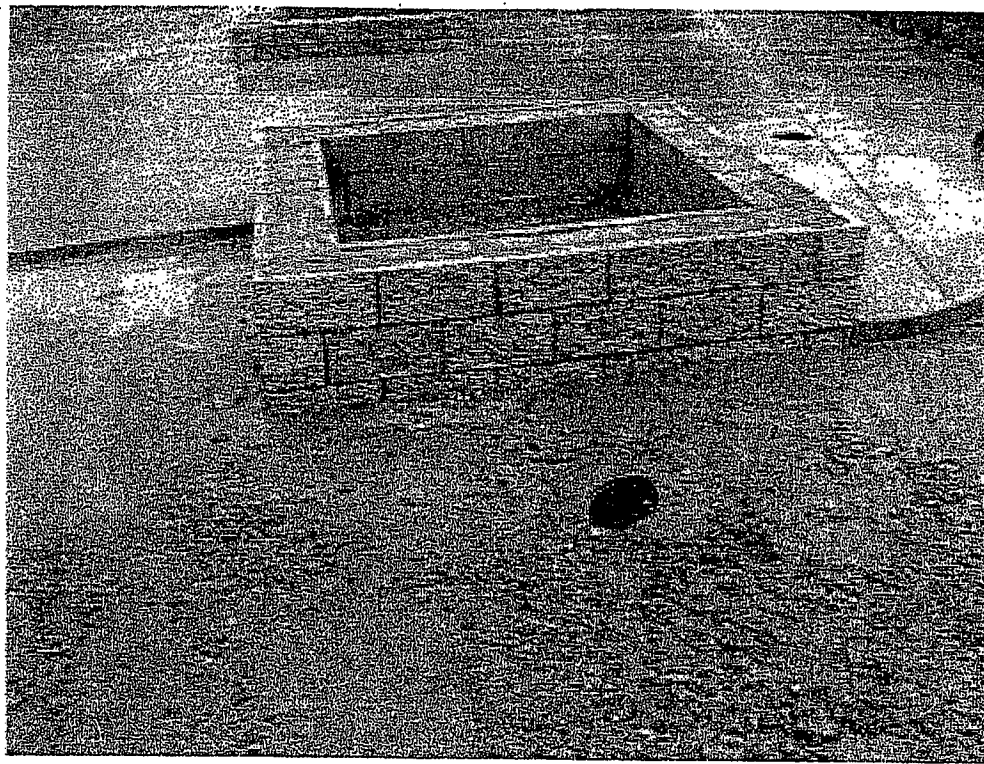
Photograph #13

Comments:
Storm drain stub up located at grade and receiving runoff.

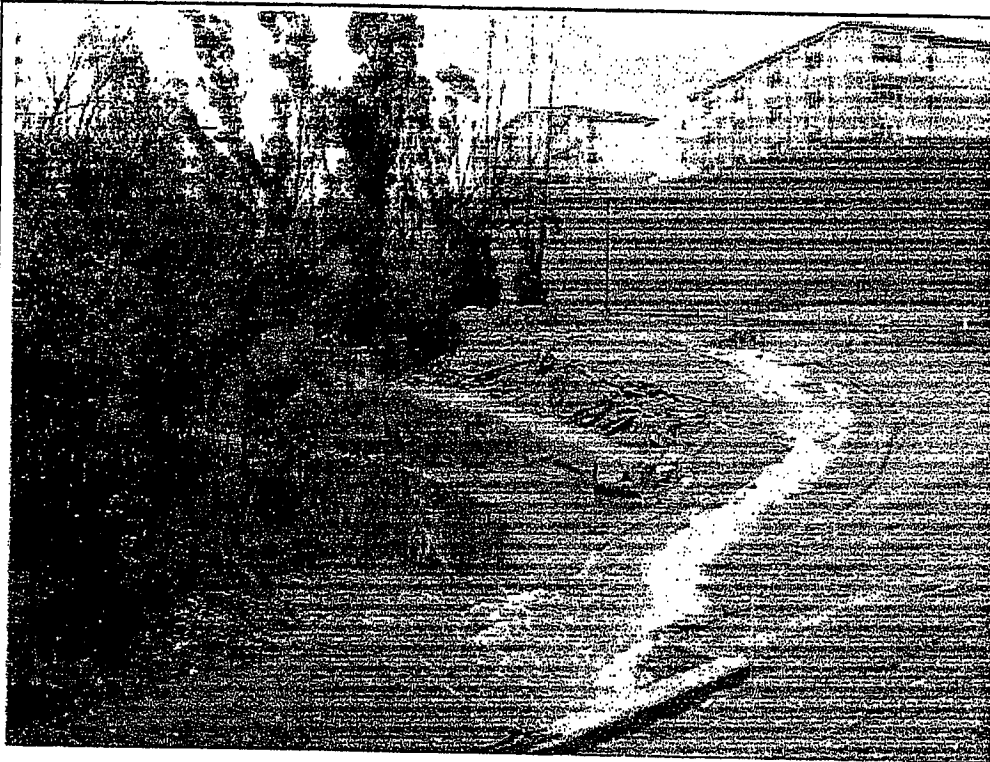
Photograph #5

Comments:
Stormwater runoff from north of Avenue of Nations outfall commingling with Carroll Canyon Creek.
