**Subject: Notice of Violation No. R9-2014-0018, Casa Mira View,  
NPDES Order No. 2009-0009-DWQ, Statewide Construction General Storm Water  
Permit**

**NOTICE OF VIOLATION**  
**No. R9-2014-0018**

Casa Mira View

Facility: Casa Mira View, WDID 9 37C353628  
Inspection Date: 01/09/2014

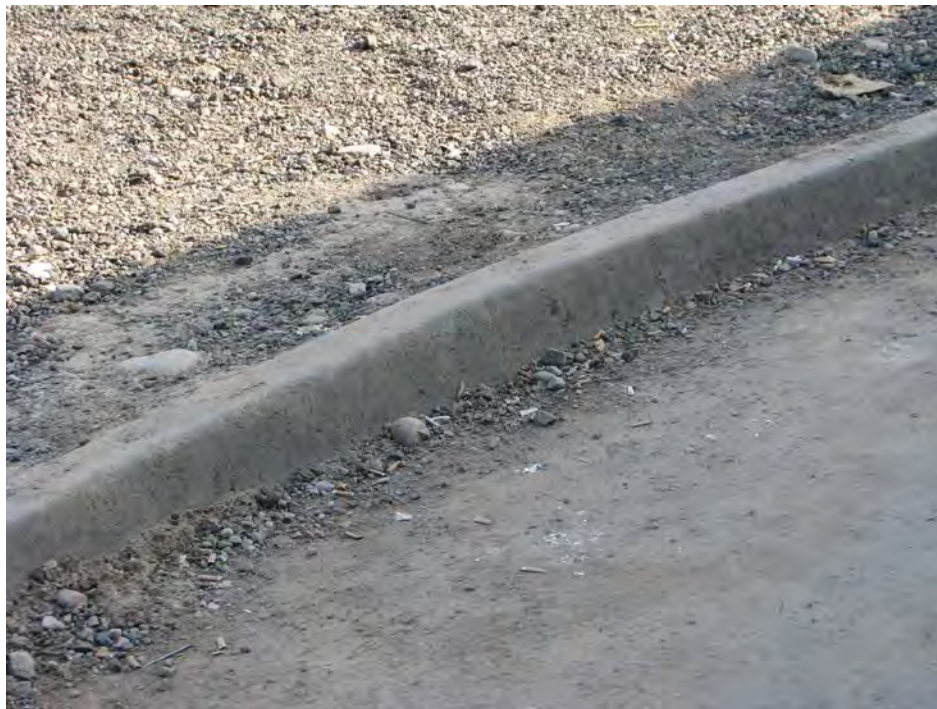
1. The site was littered with cigarette butts, trash, debris, and other construction-related waste throughout. (See Figures 1-4, 14-25).
2. None of the finished curbs within the site had sediment control BMPs (such as silt fence) installed. As a result, the streets were covered in sediment (Figures 1, 3, 16-22).
3. There were no sediment control BMPs at one construction site exit/entrance located on Mira Lee Way, and sediment had been tracked into the street (Figure 5).
4. There was an uncovered stockpile, although it appeared to be active (Figure 6).
5. Two concrete wash-out bins were leaking, and waste material discharged to the surrounding the soil (Figures 7-8).

Figure 1. Near trailer; cigarette butts

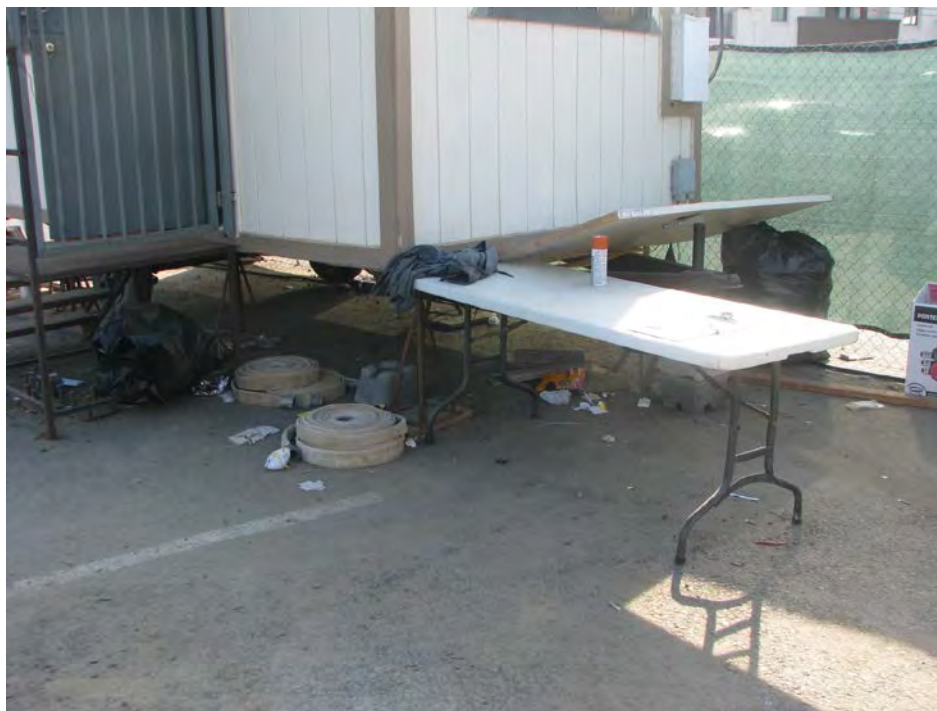
Figure 2. Trailer, debris and trash

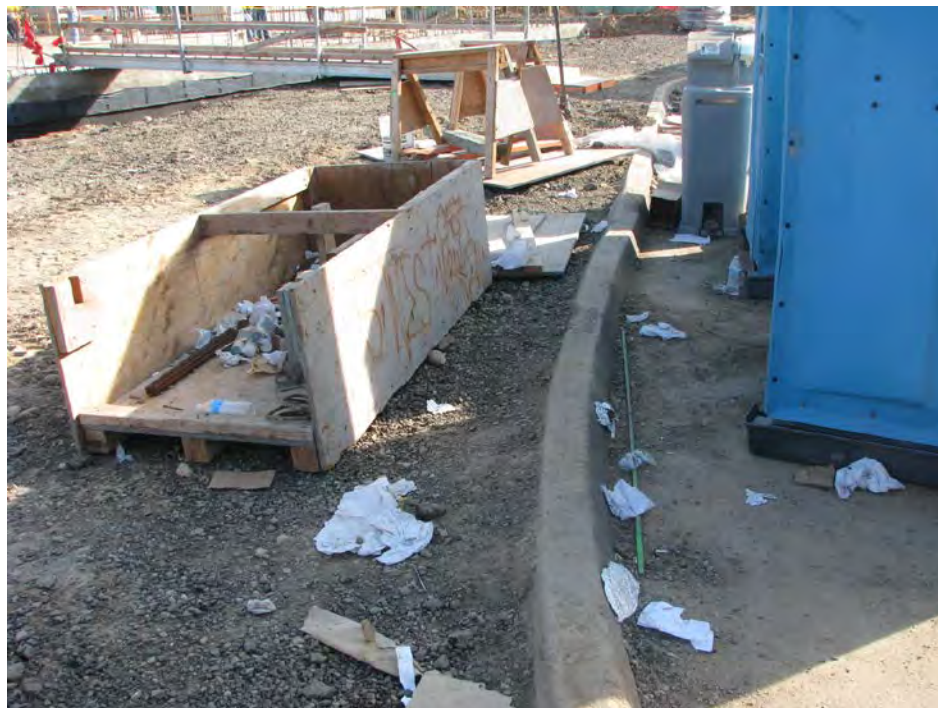
Figure 3. Site interior; trash

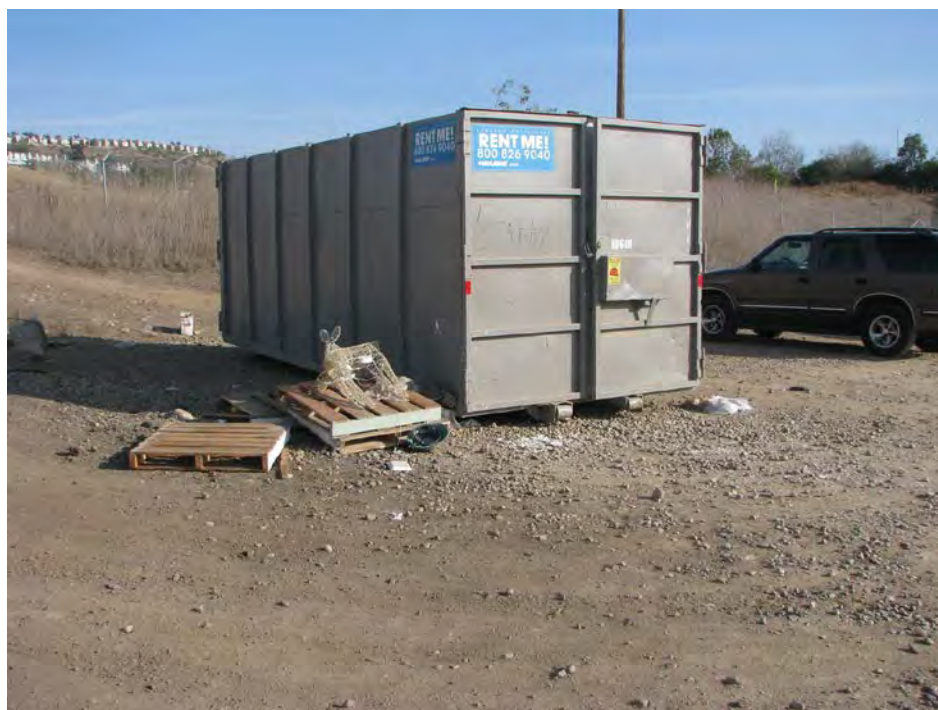
Figure 4. Site interior; construction debris

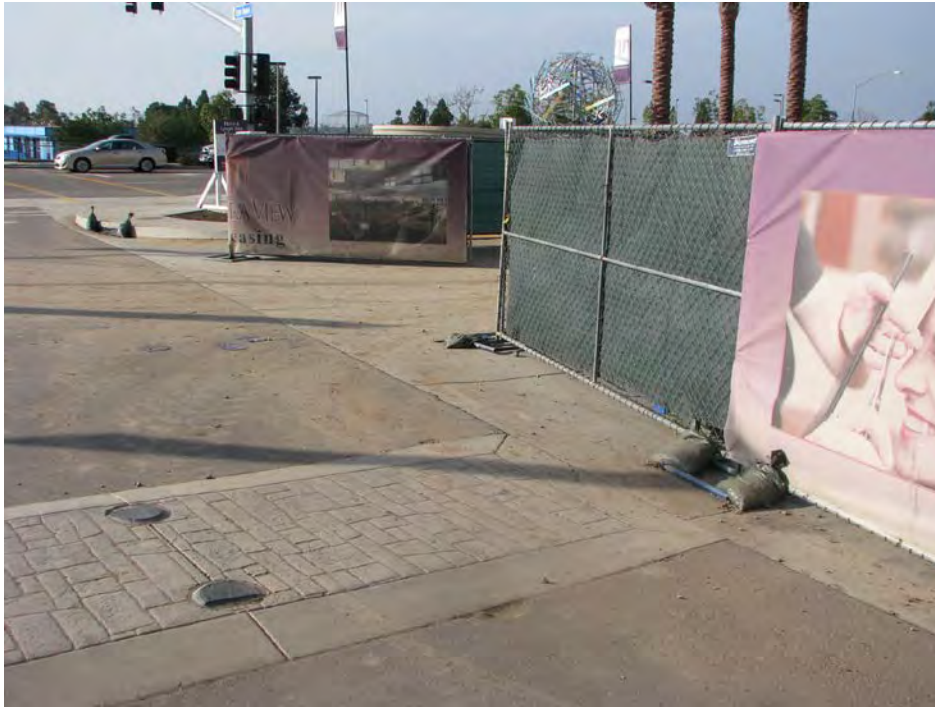
Figure 5. South-facing construction entrance; no BMPs; sediment tracking onto street

5. The concrete washout BMPs must be fixed or replaced to prevent leaks. Concrete waste must not be allowed to come into contact with bare ground.
6. Site entrance/exit BMPs are required.

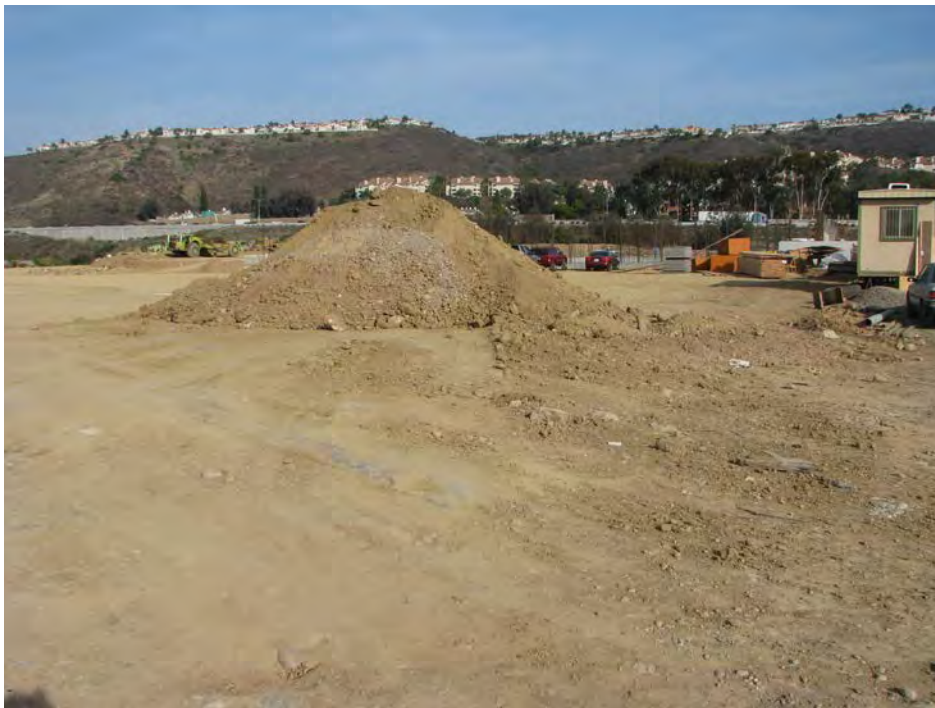
Figure 6. Sediment stockpile

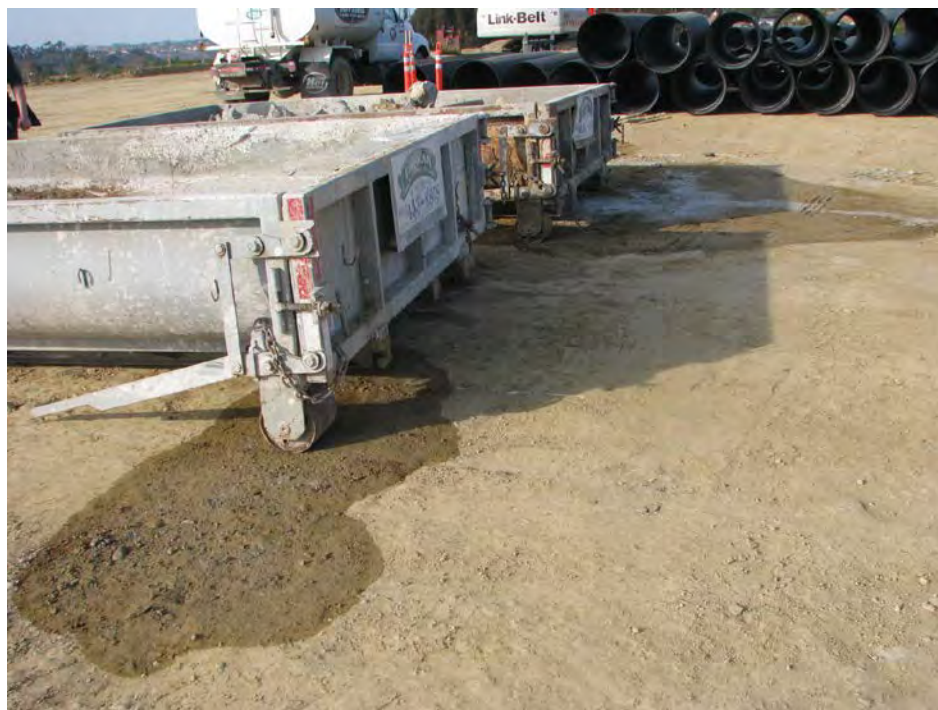
Figure 7. Leaking concrete washouts

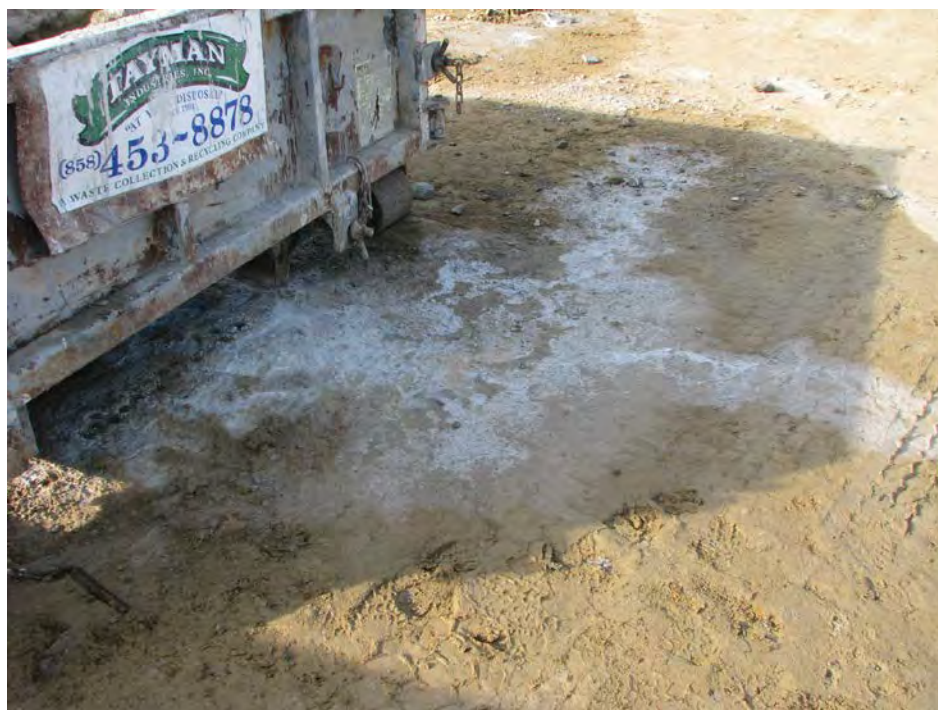
Figure 8. Concrete staining on soil from leaking washouts

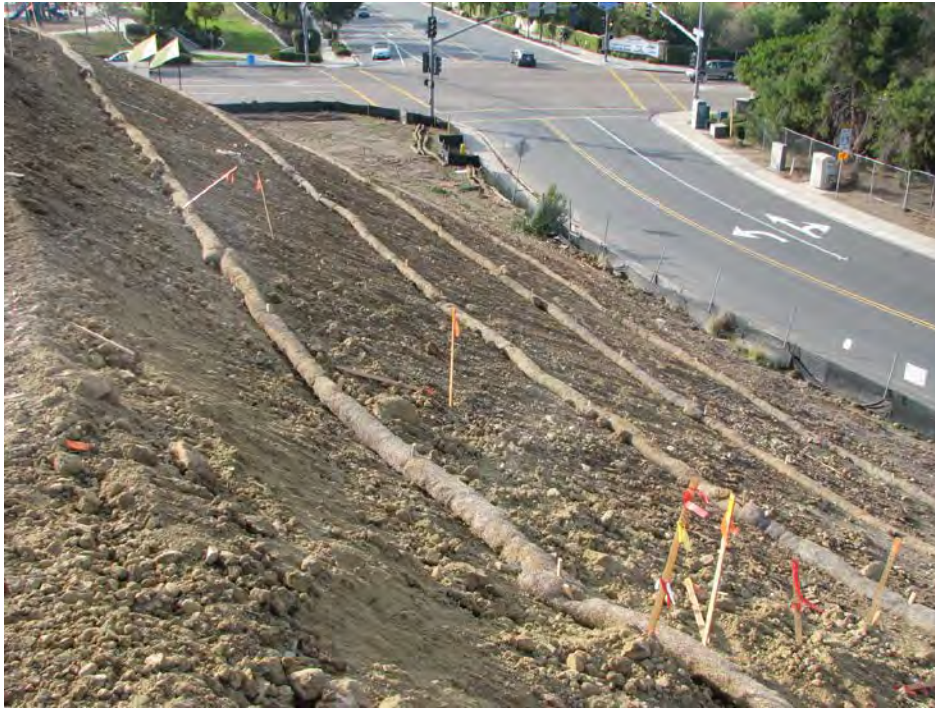
Figure 9. Slope on north side with no erosion control

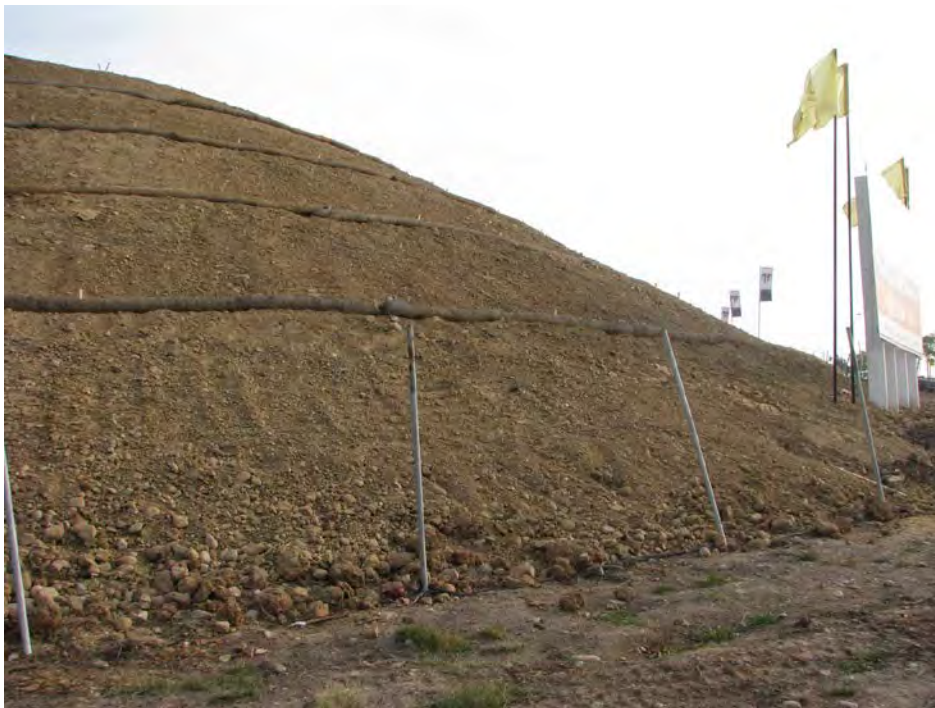
Figure 10. Slope is 2:1 Horizontal: Vertical according to SWPPP

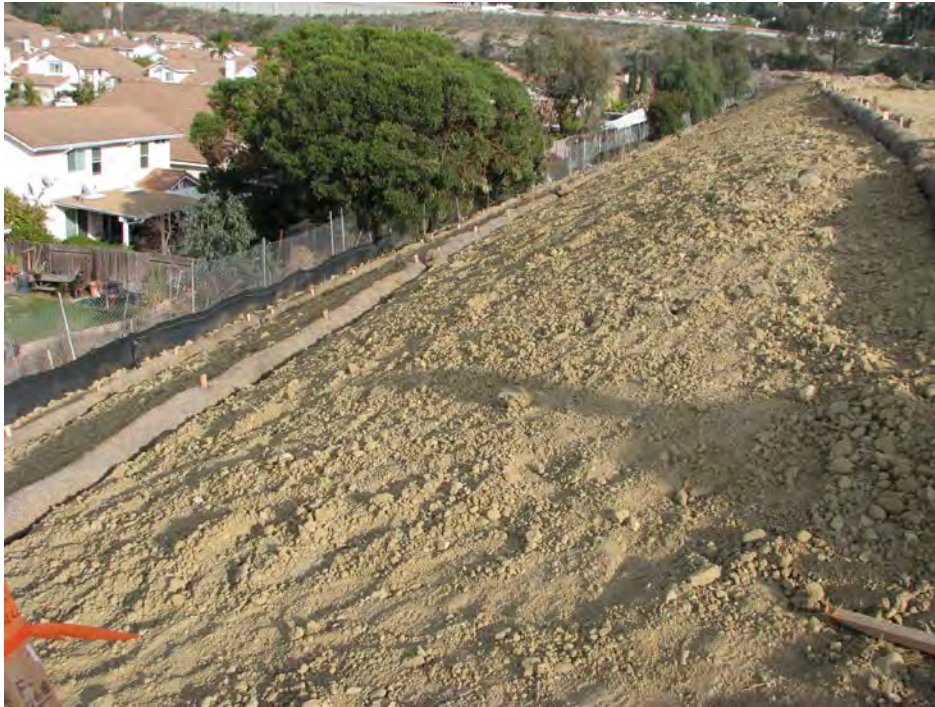
Figure 11. North slope looking easterly

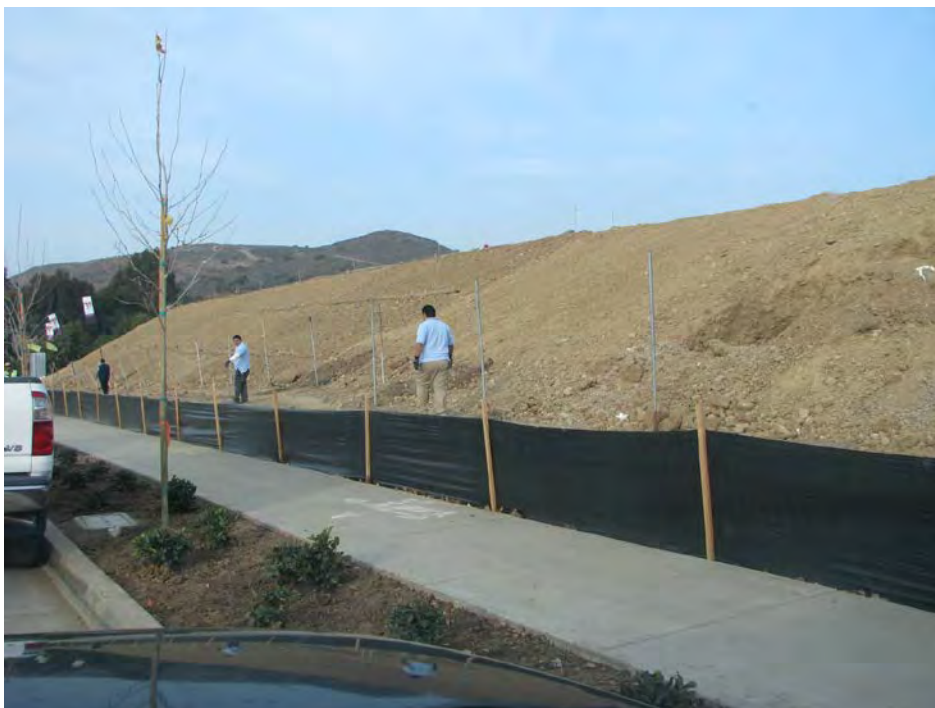
Figure 12. Slope on west side of property

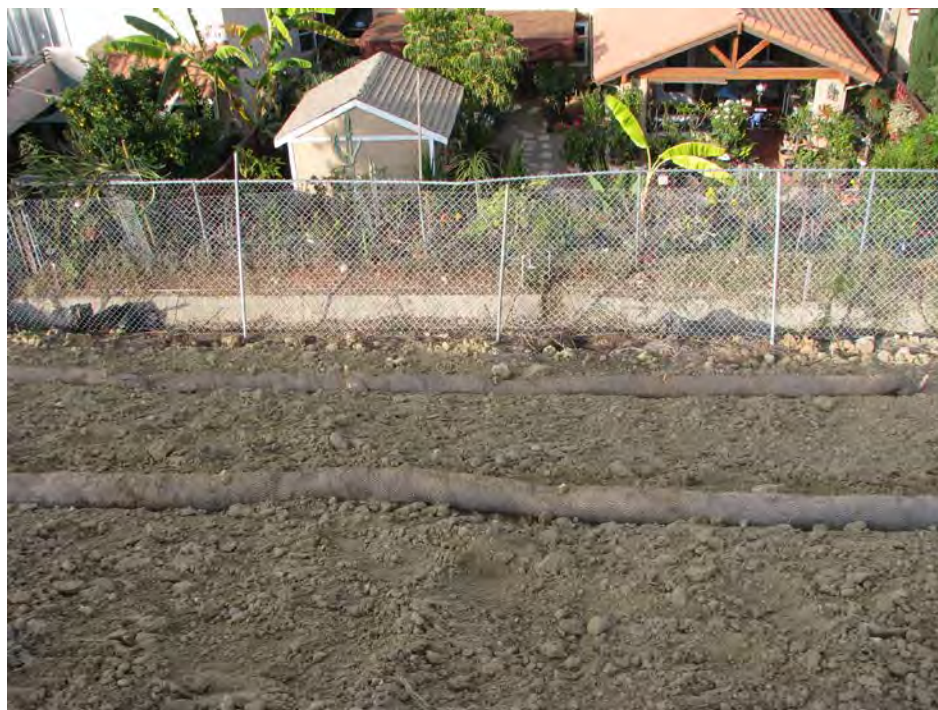
7. The silt fence along the north side of the property had fallen and was in need of repair (Figure 13).
8. Sediment control BMPs throughout the site need replacement or had not been maintained. Examples include broken gravel bags (Figure 22).

Figure 13. Damaged silt fence

3. All sediment control BMPs must be adequately maintained. The silt fence on the north side of the property requires replacement.
4. Sediment control BMPs such as silt fence should be installed at finished curbs to prevent sediment from reaching the streets.

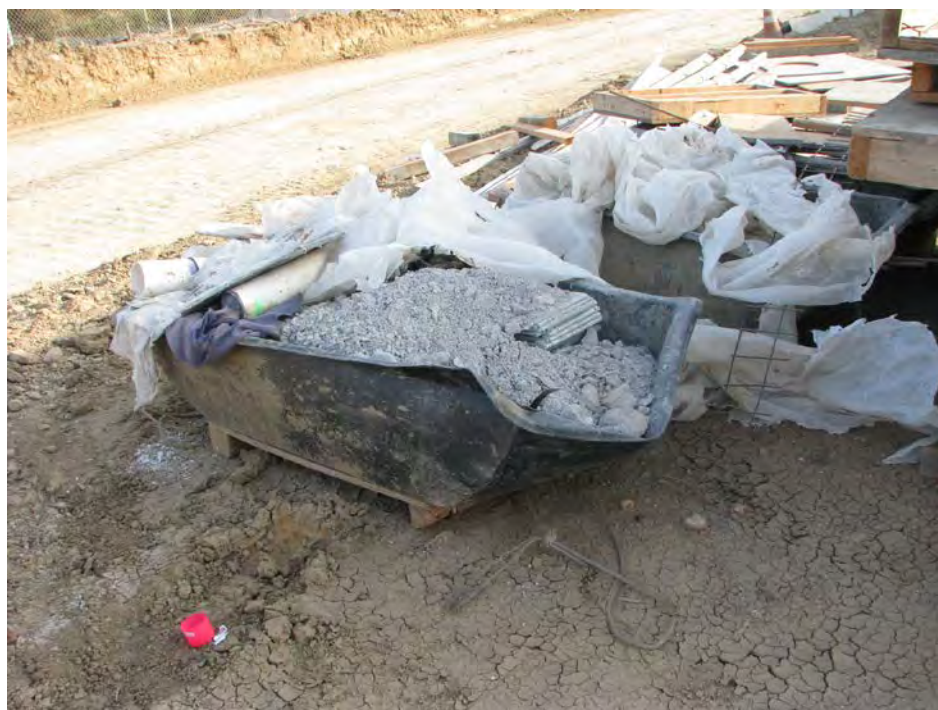
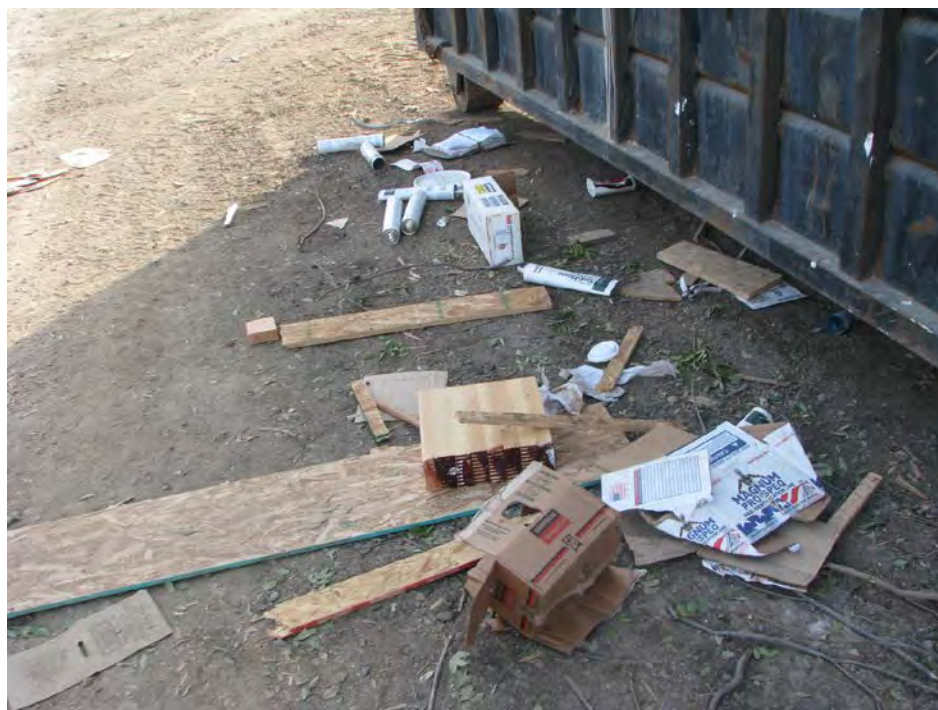
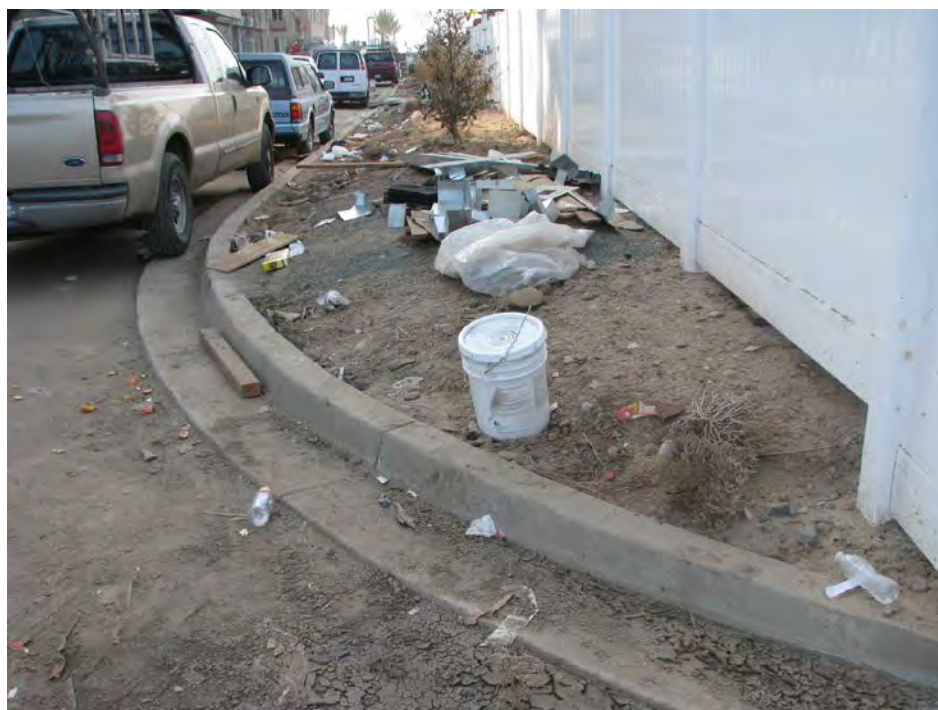
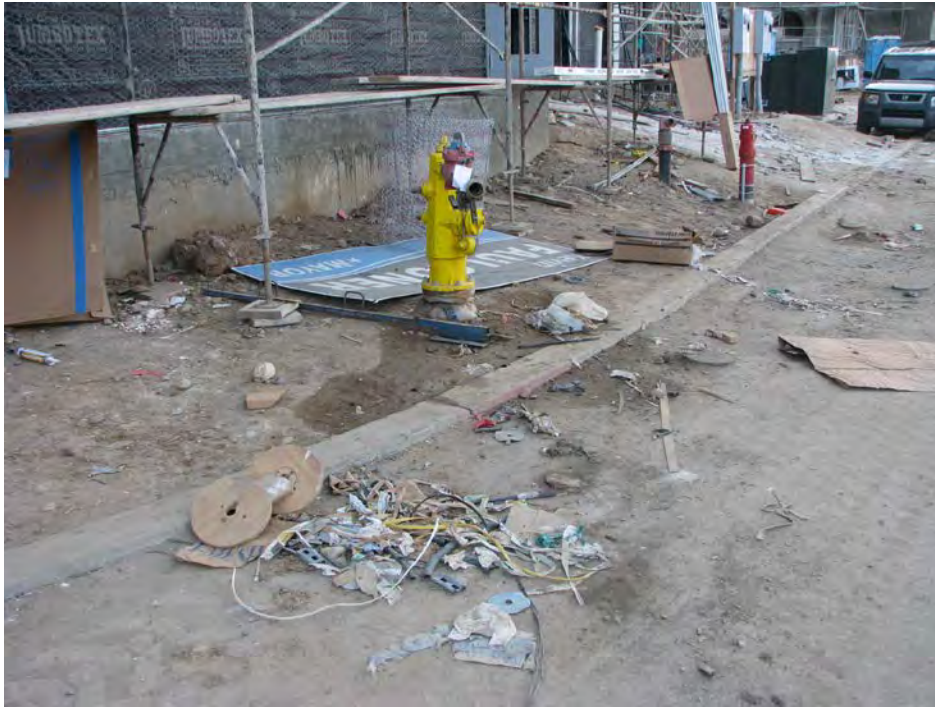
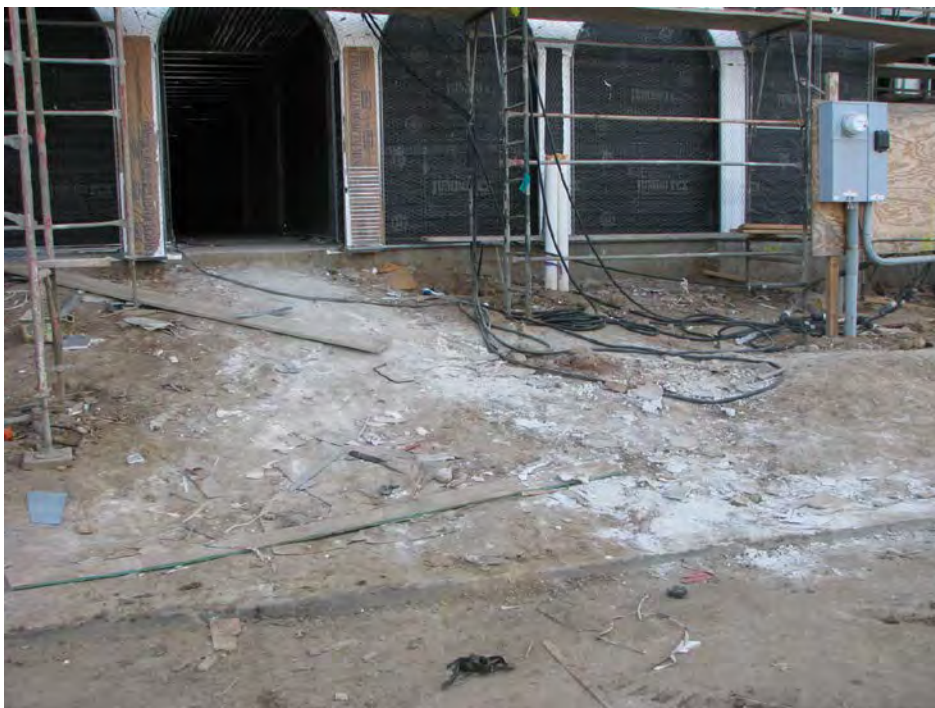
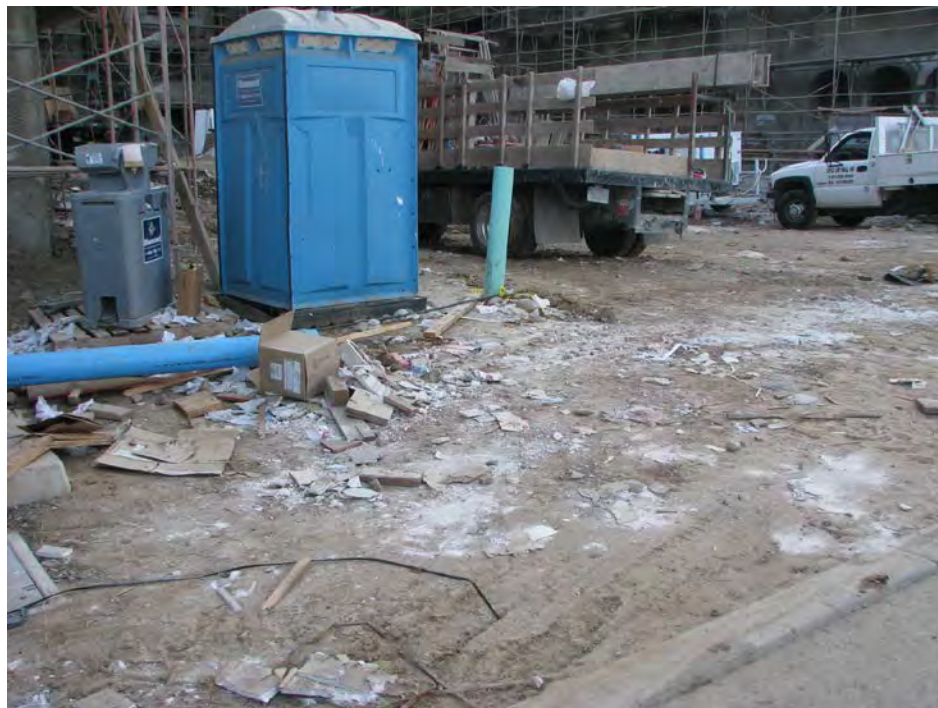
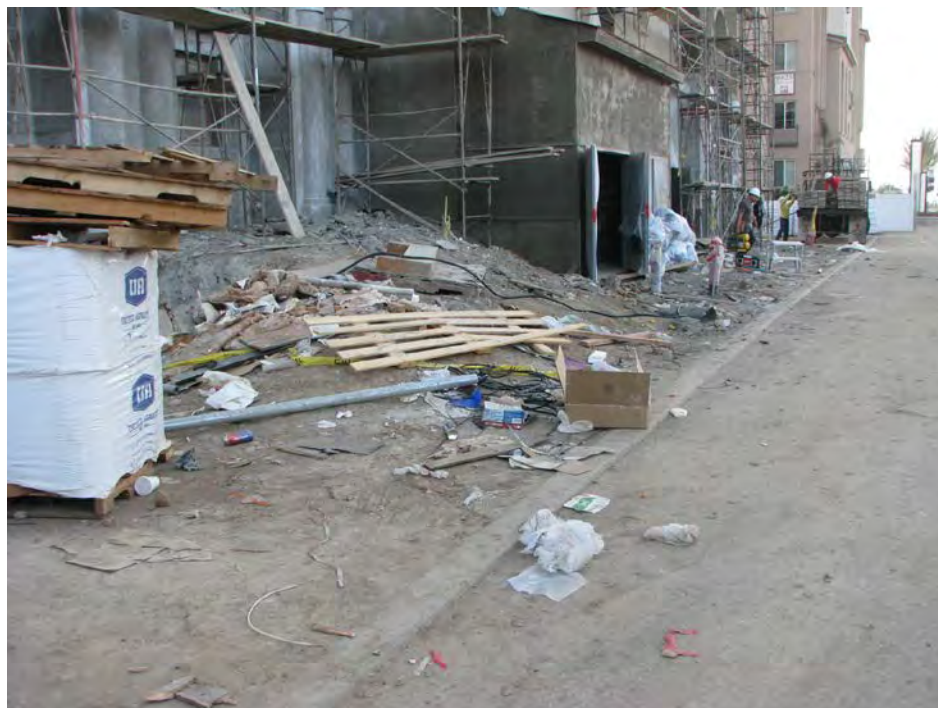
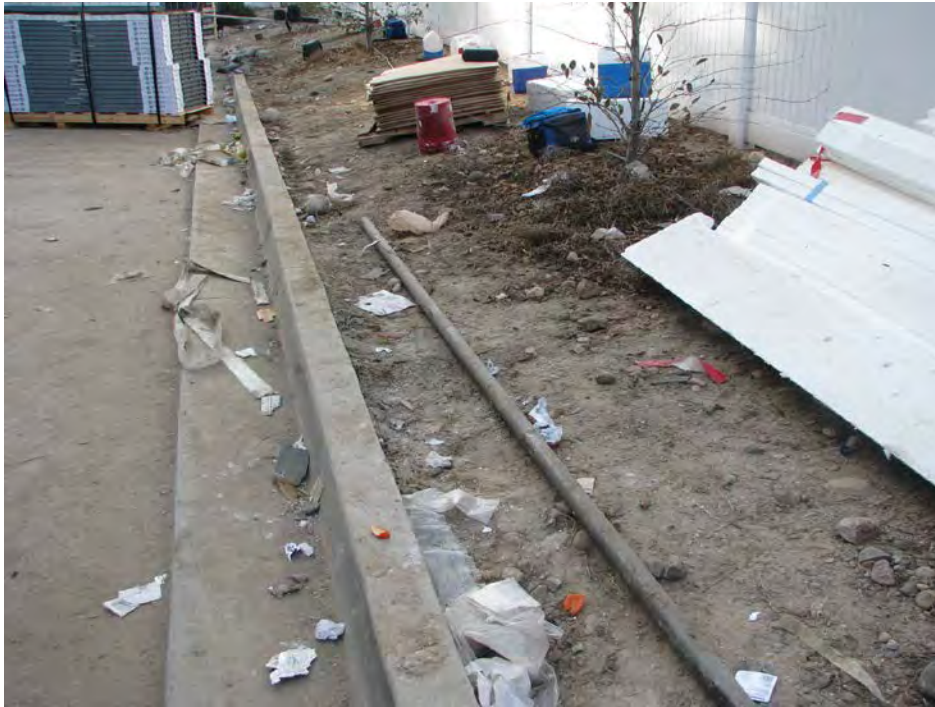
Figure 14. Construction debris

Figure 15. Construction debris

Figure 16. Construction debris

Figure 17. Construction debris

Figure 18. Construction debris

Figure 19. Construction debris

Figure 20. Construction debris

Figure 21. Construction debris

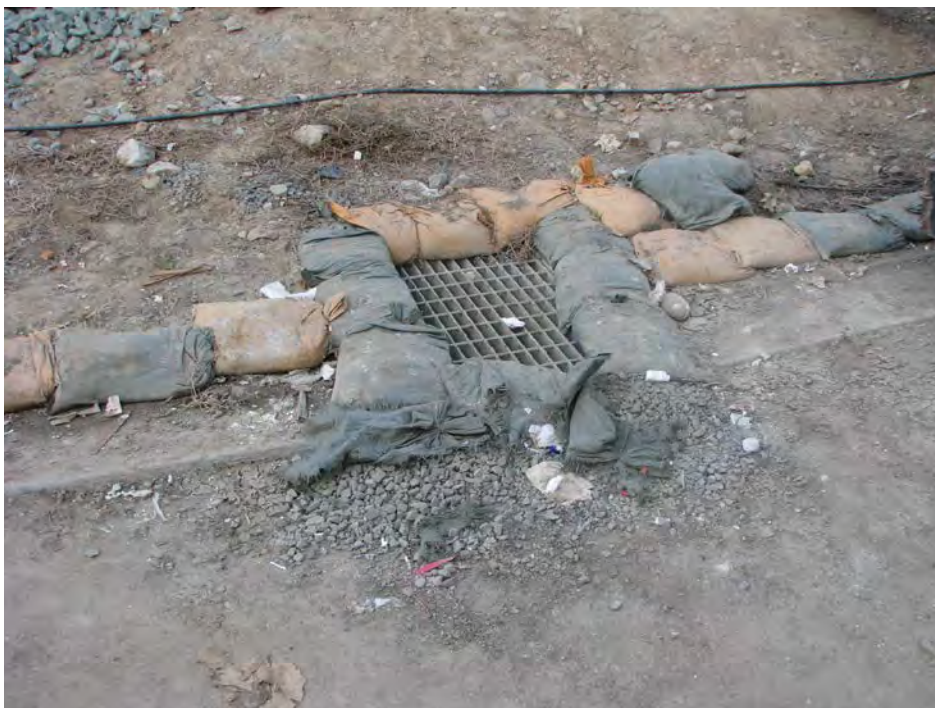
Figure 22. Broken gravel bags

7. Storm drain inlets within the construction site require protection to prevent sediment, trash, and construction debris from entering.
8. Gravel bags that have been broken need replacing.

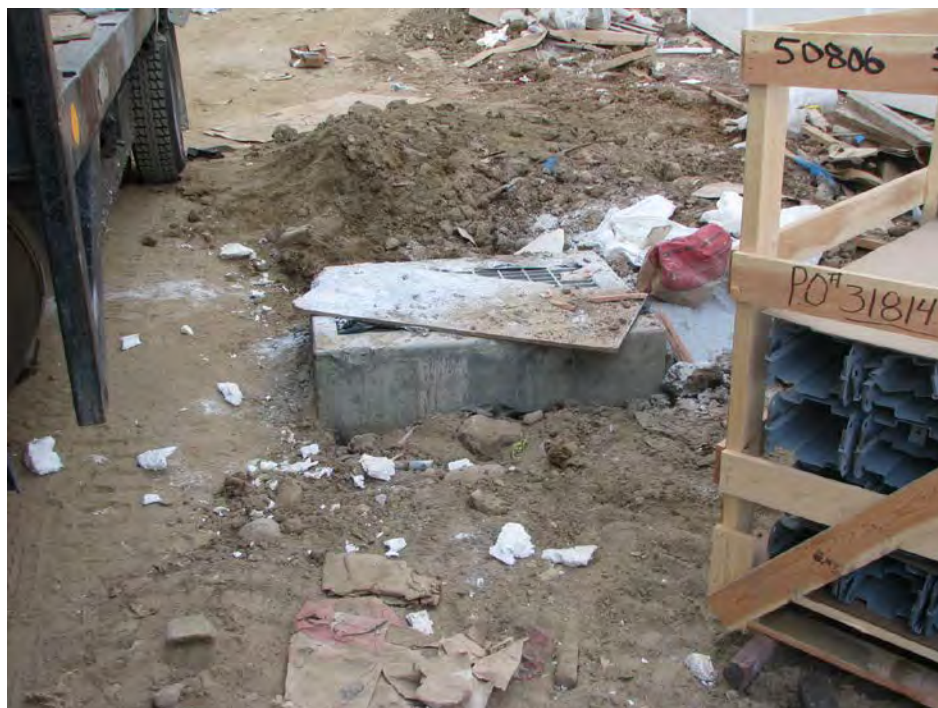
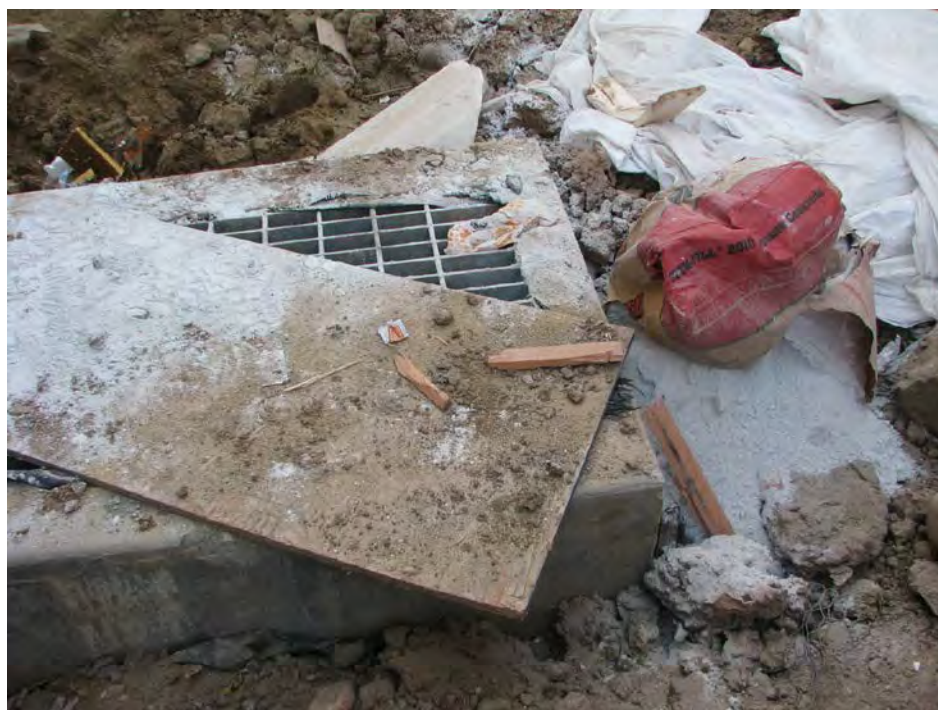
9. Mortar mix and other construction wastes had entered an unprotected inlet (Figures 23-24).
10. Several chemical containers were found throughout the site without secondary containment or other proper storage practices (Figure 25).

Figure 23. Storm drain littered with construction debris

Figure 24. Storm drain littered with construction debris

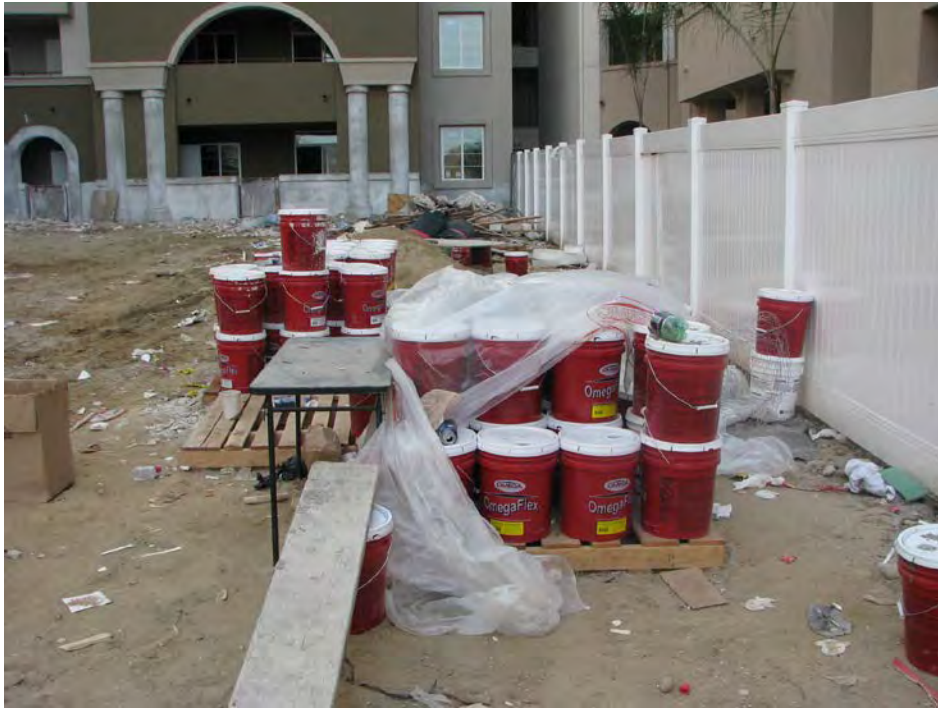
Figure 25. Improperly stored chemicals

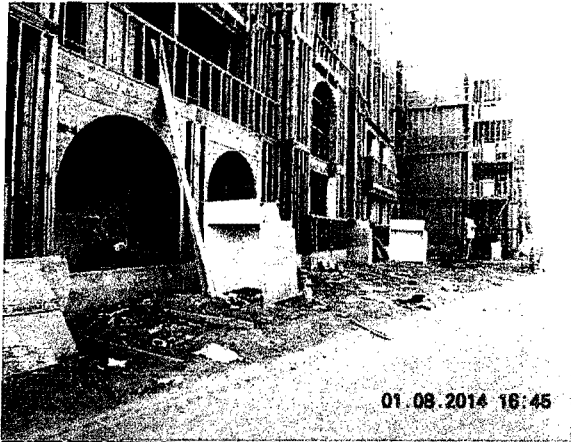
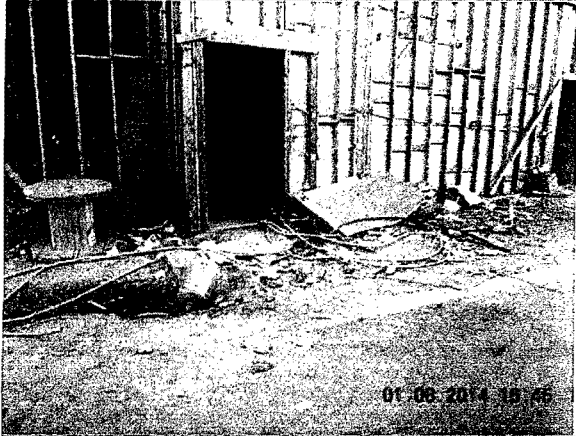
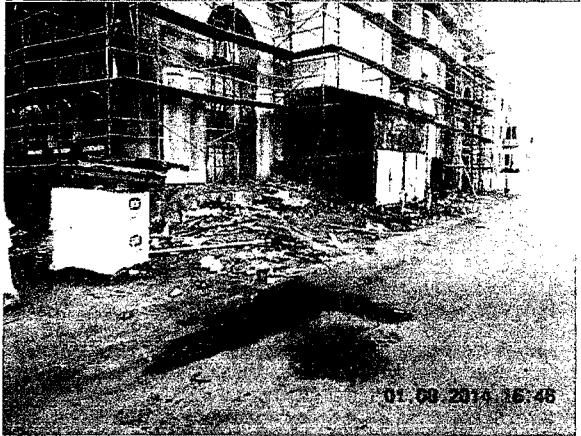
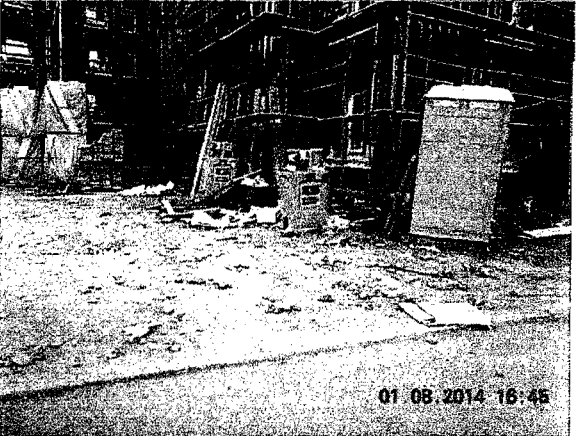
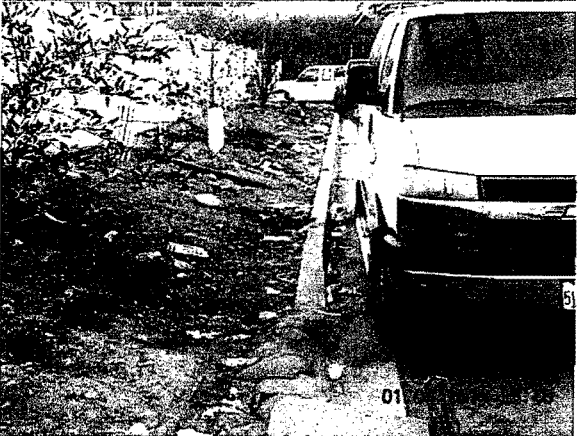
#18  
Debris

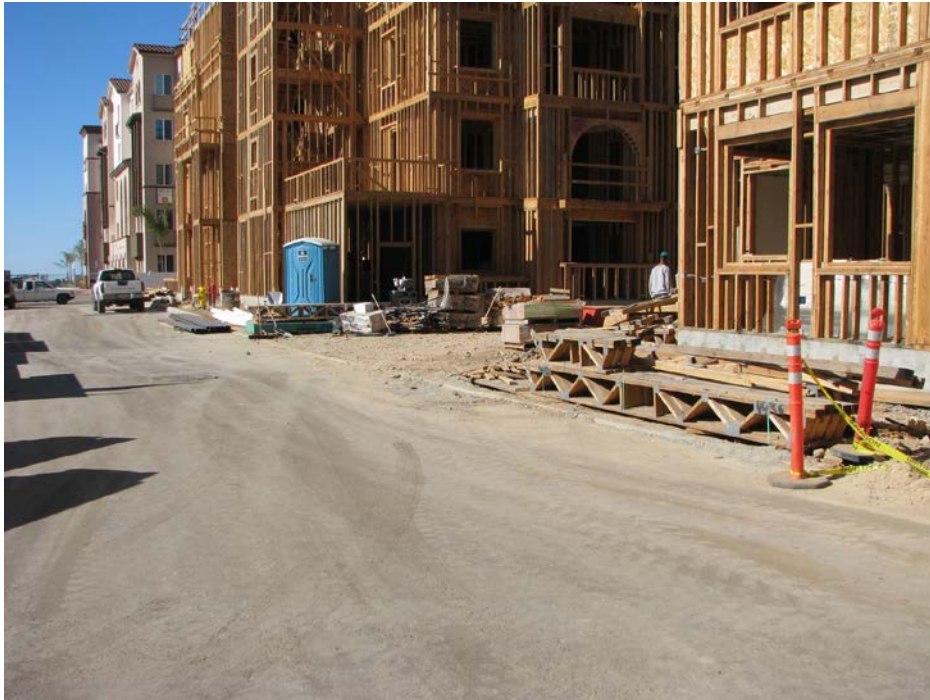
1. The finished roads within the site have been swept and are much cleaner than the previous site visit (Figures 1-2, 4).
2. One storm drain on the east side requires improved protection (Figure 3).
3. Sandbags had been replaced; however, additional BMPs are needed to prevent sediment from reaching the street (Figure 5).
4. A trash bin was overflowing (Figure 7).
5. Cigarettes in front of the trailers had been swept (Figure 8).
6. The leaking concrete wash-out bins were replaced or fixed (Figure 9).
7. The exterior slopes had adequate erosion control BMPs (Figures 10-11).

Figure 1. South side of active construction site

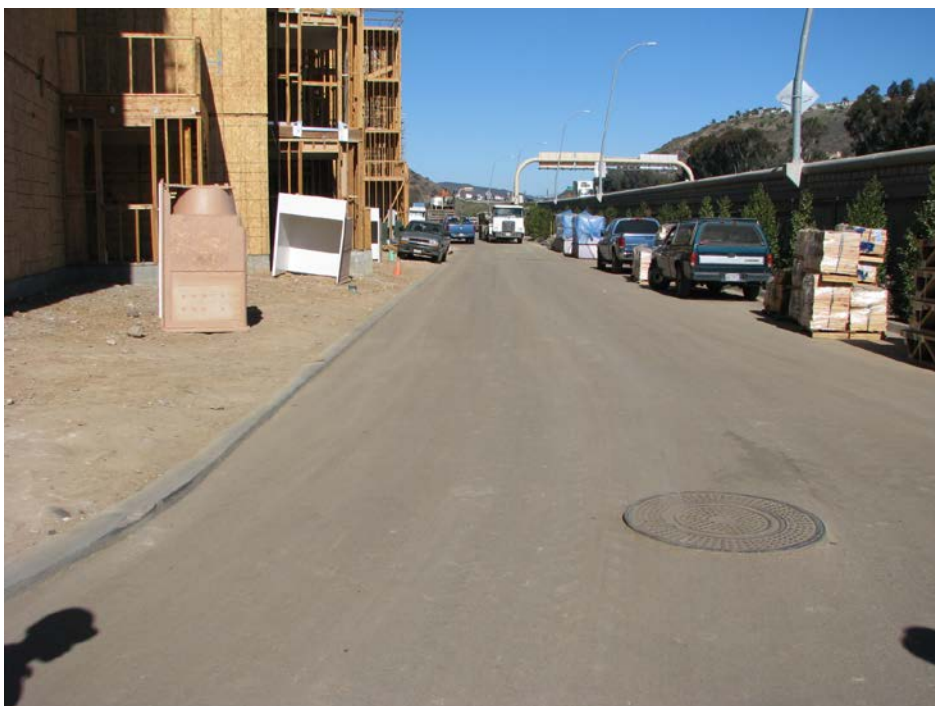
Figure 2. East side of active constructive site

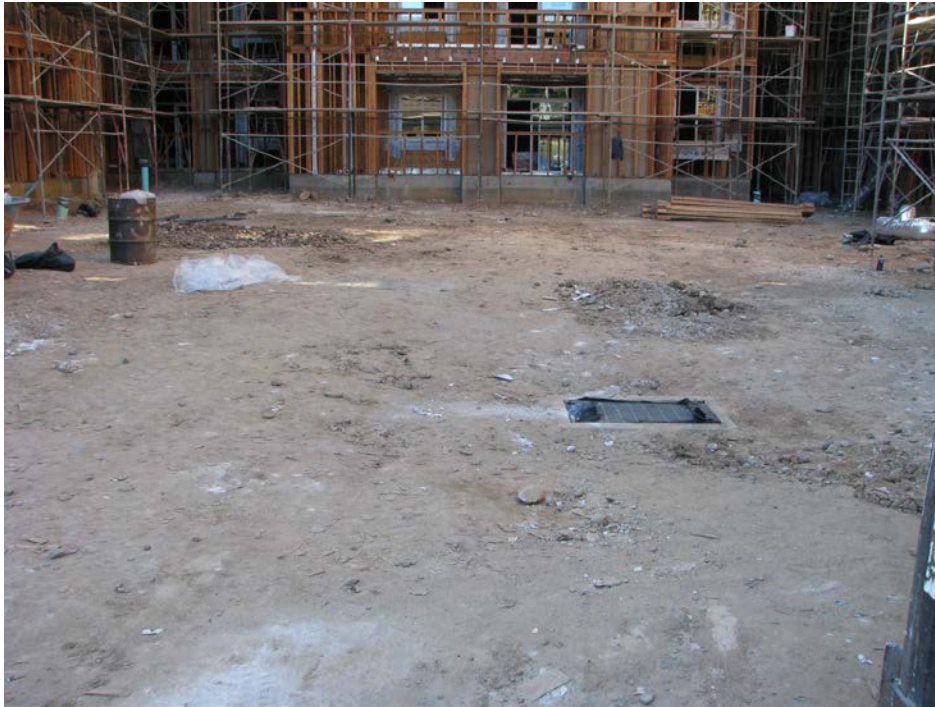
Figure 3. Site interior; inlet requires better protection

5. Storm drain inlets within the construction site require protection to prevent sediment, trash, and construction debris from entering.
6. Additional site entrance/exit BMPs should be implemented since tracking in the street was still observed.

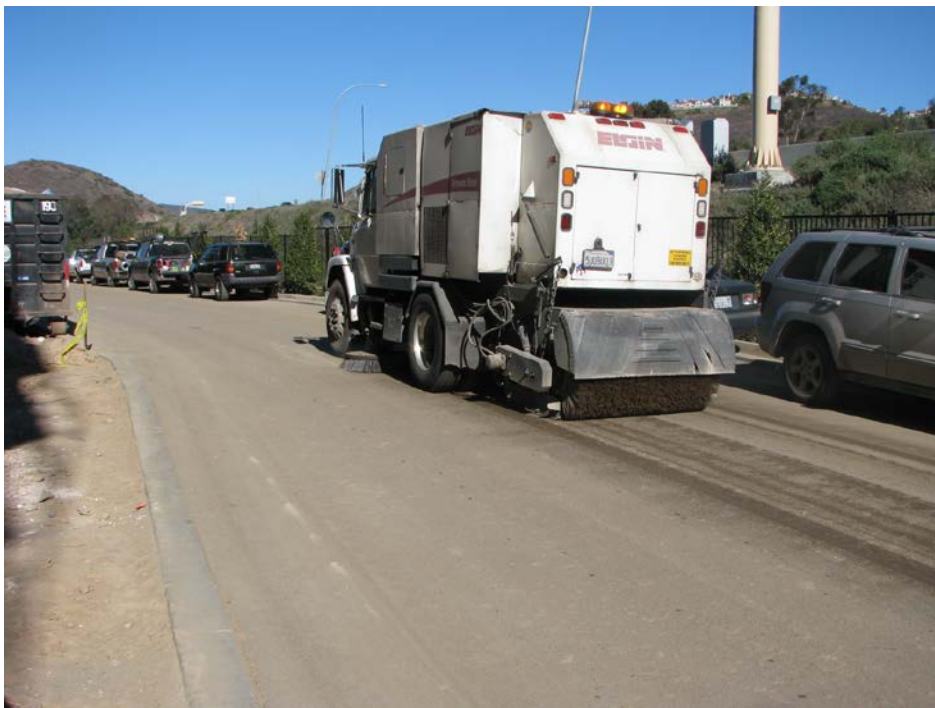
Figure 4. Street sweeper on east side

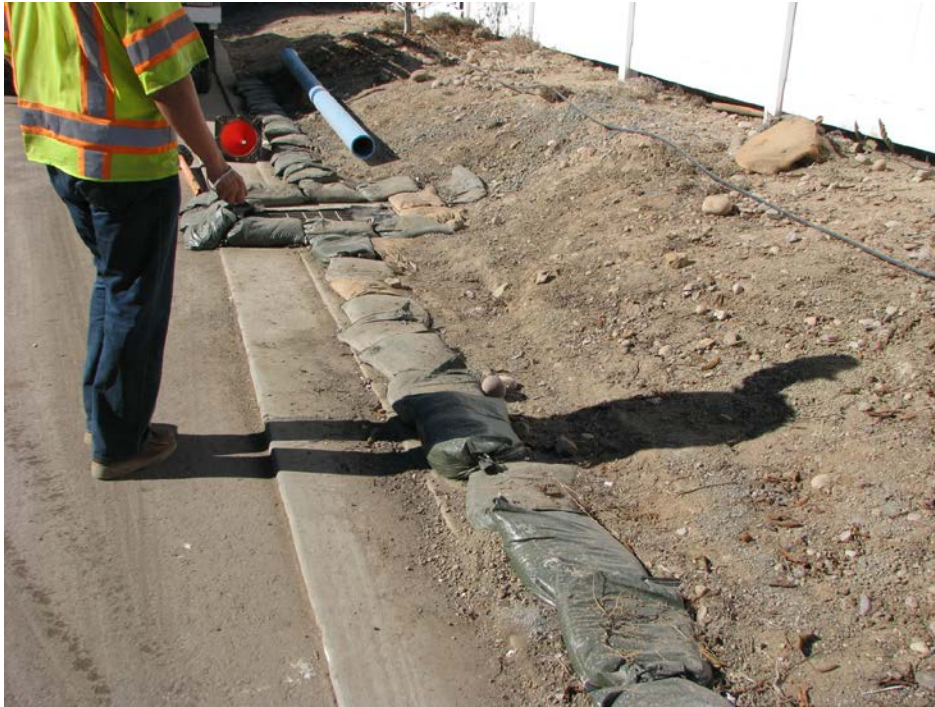
Figure 5. Site interior; linear sediment control BMPs not effective

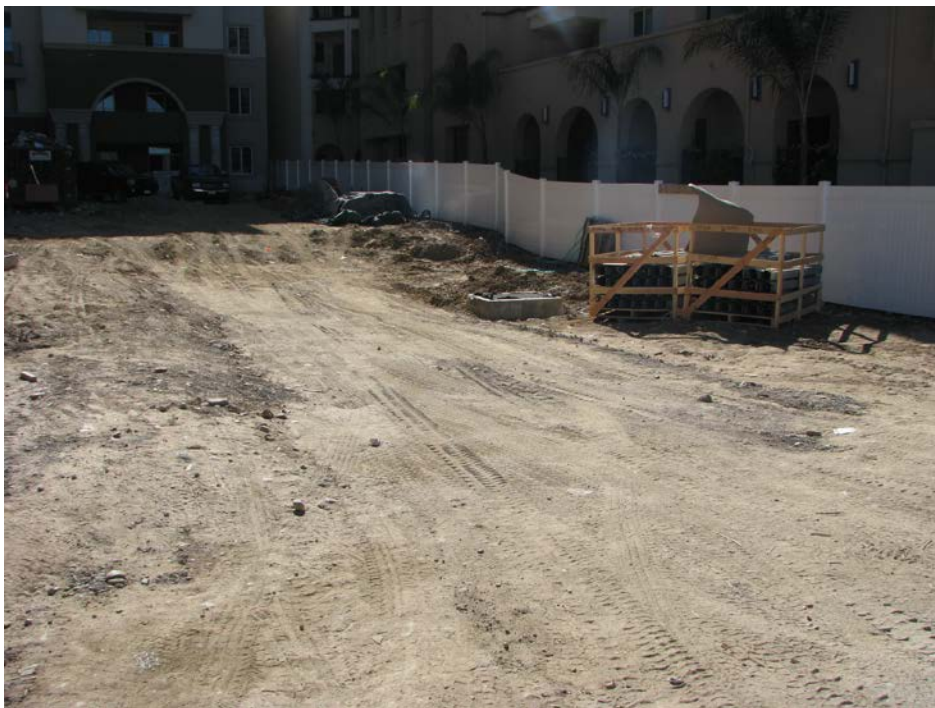
Figure 6. Site interior; trash and debris has been removed
