**Subject: Notice of Violation No. R9-2014-0018, Casa Mira View,  
NPDES Order No. 2009-0009-DWQ, Statewide Construction General Storm Water  
Permit**

**NOTICE OF VIOLATION**  
**No. R9-2014-0018**

Casa Mira View

Facility: Casa Mira View, WDID 9 37C353628  
Inspection Date: 01/09/2014

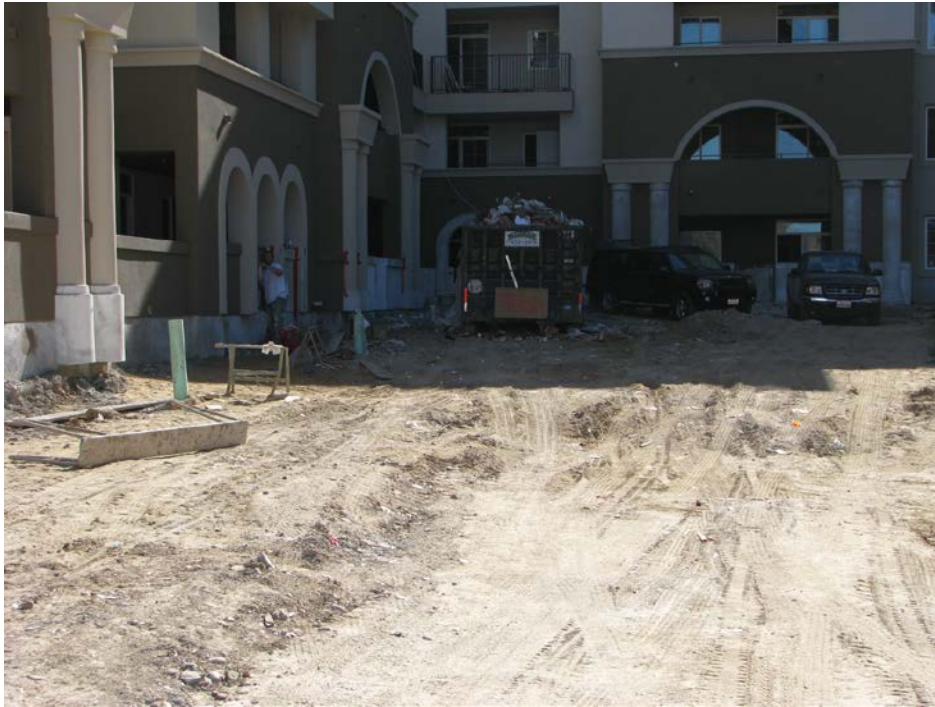
Figure 7. Site interior with overflowing waste bin

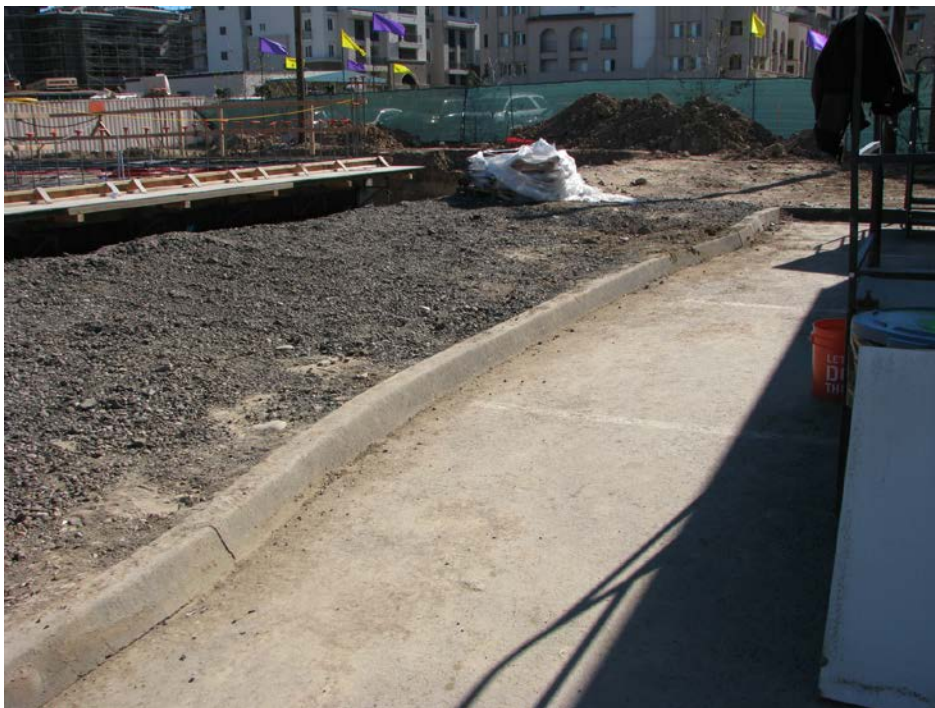
Figure 8. Curb in front of trailer; cigarettes have been swept up

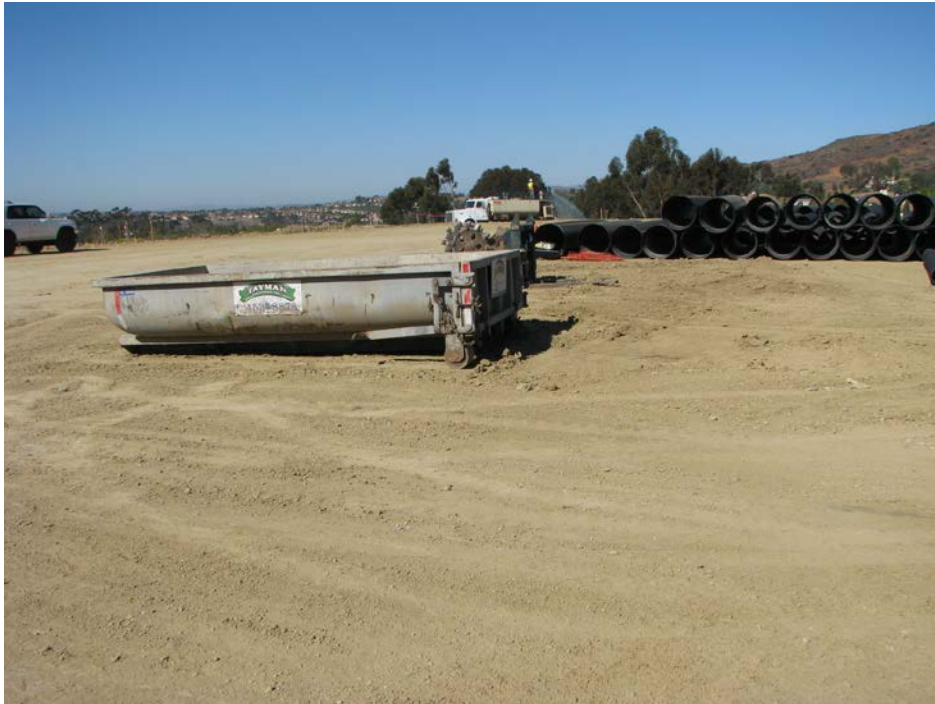
Figure 9. Leaking concrete waste bin has been replaced

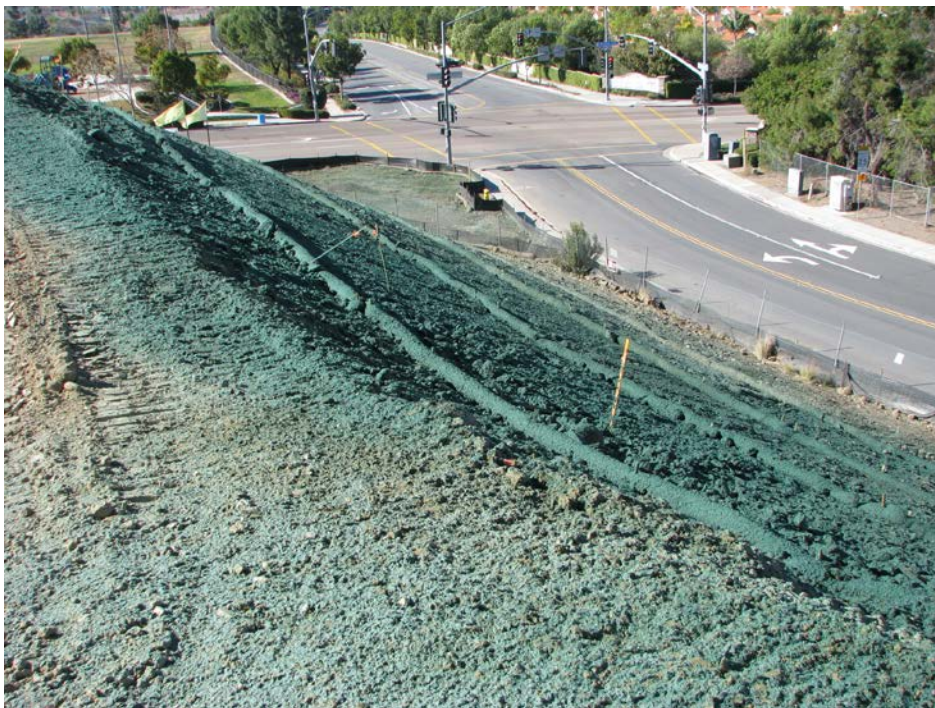
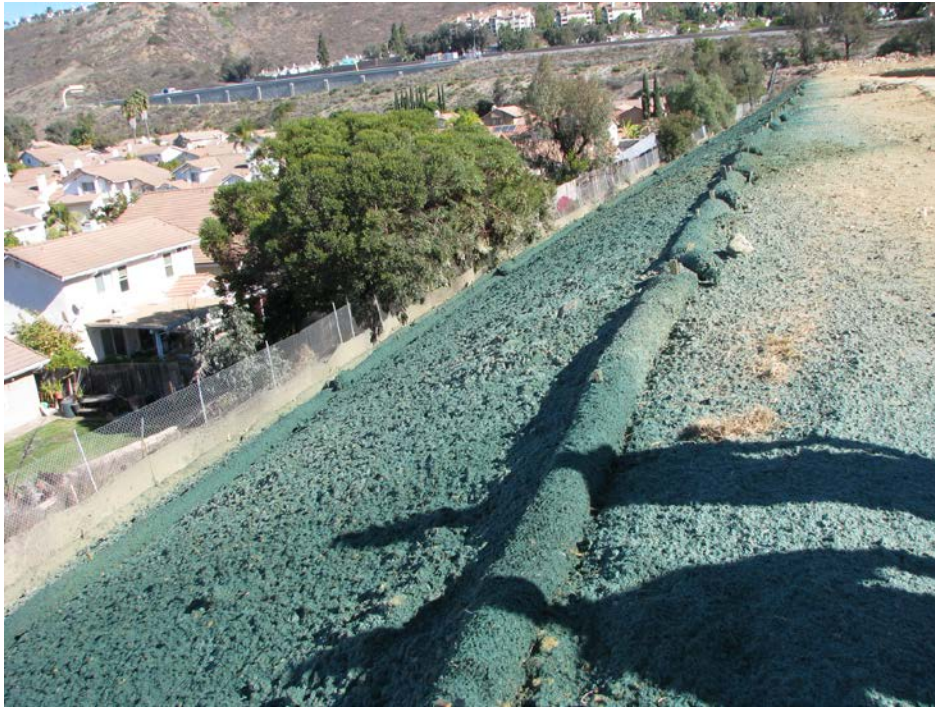
1. The finished roads within the site have been swept and are much cleaner than the previous site visit (Figures 1-2, 4).
2. One storm drain on the east side requires improved protection (Figure 3).
3. Sandbags had been replaced; however, additional BMPs are needed to prevent sediment from reaching the street (Figure 5).
4. A trash bin was overflowing (Figure 7).
5. Cigarettes in front of the trailers had been swept (Figure 8).
6. The leaking concrete wash-out bins were replaced or fixed (Figure 9).
7. The exterior slopes had adequate erosion control BMPs (Figures 10-11).

Figure 10. North slope has erosion control BMPs

Figure 11. North slope has erosion control BMPs

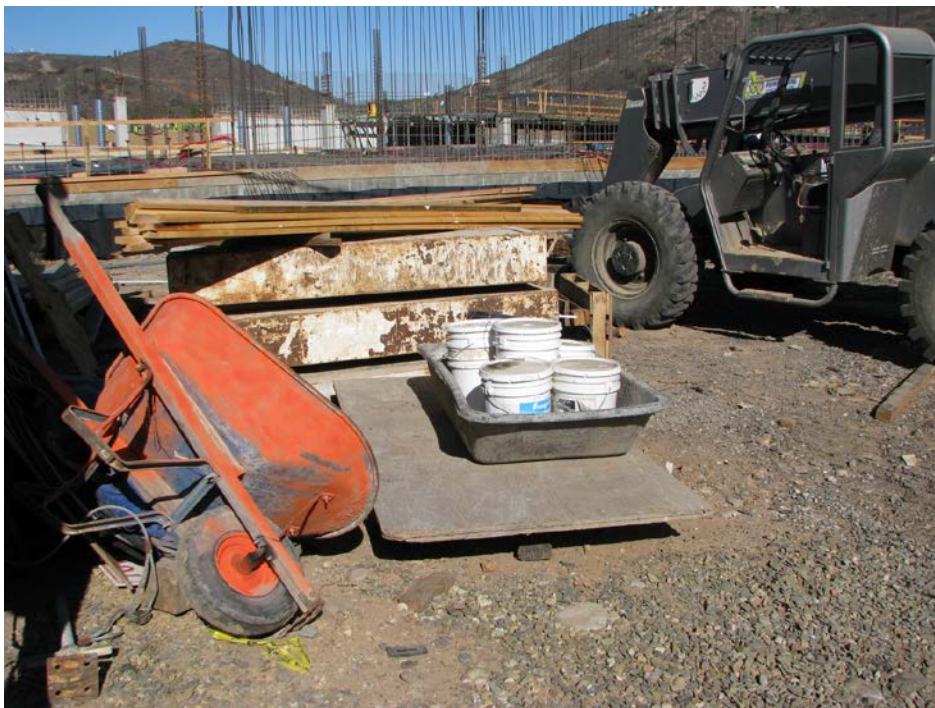
8. Chemical containers had secondary containment and the site was much tidier than the previous inspection (Figure 12).
9. There were no sediment control BMPs at one construction site exit/entrance located on Mira Lee Way, and sediment had been tracked into the street (Figures 13-14). Site operators indicated that this area is swept; however, a structural BMP such as gravel or shaker plates should be considered since street sweeping does not occur daily.
10. We found some fiber rolls that could be used in the event of rain; however, overall the site contains inadequate stockpiled BMPs. Mr. Melbourn asked that the site operators produce a list of stockpiled BMPs within two weeks.

Figure 12. Chemicals with secondary containment

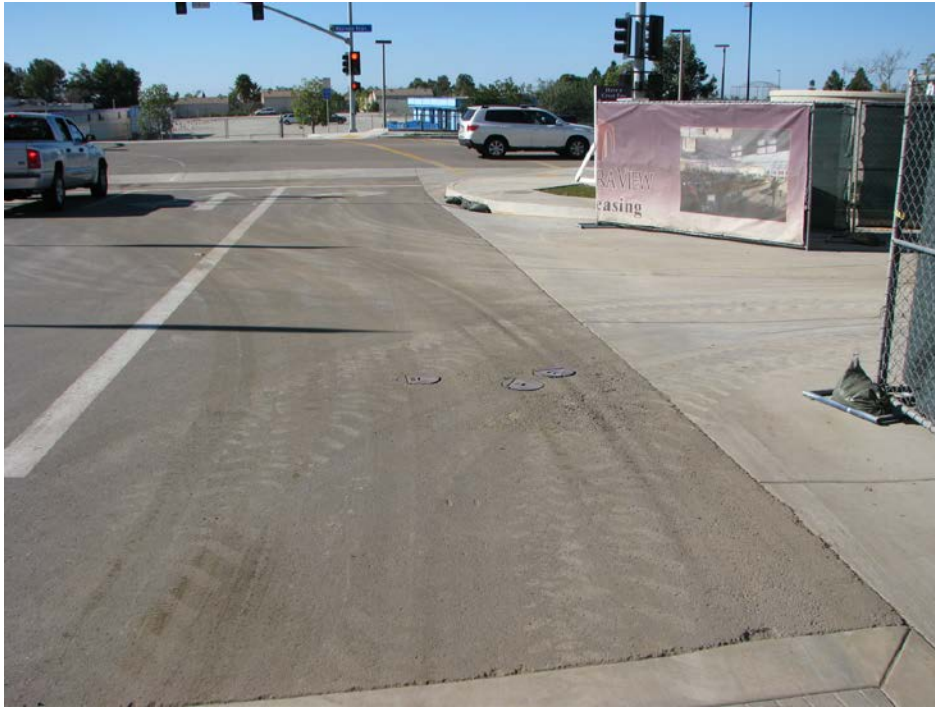
Figure 13. Construction entrance shows tracking

5. Storm drain inlets within the construction site require protection to prevent sediment, trash, and construction debris from entering.
6. Additional site entrance/exit BMPs should be implemented since tracking in the street was still observed.

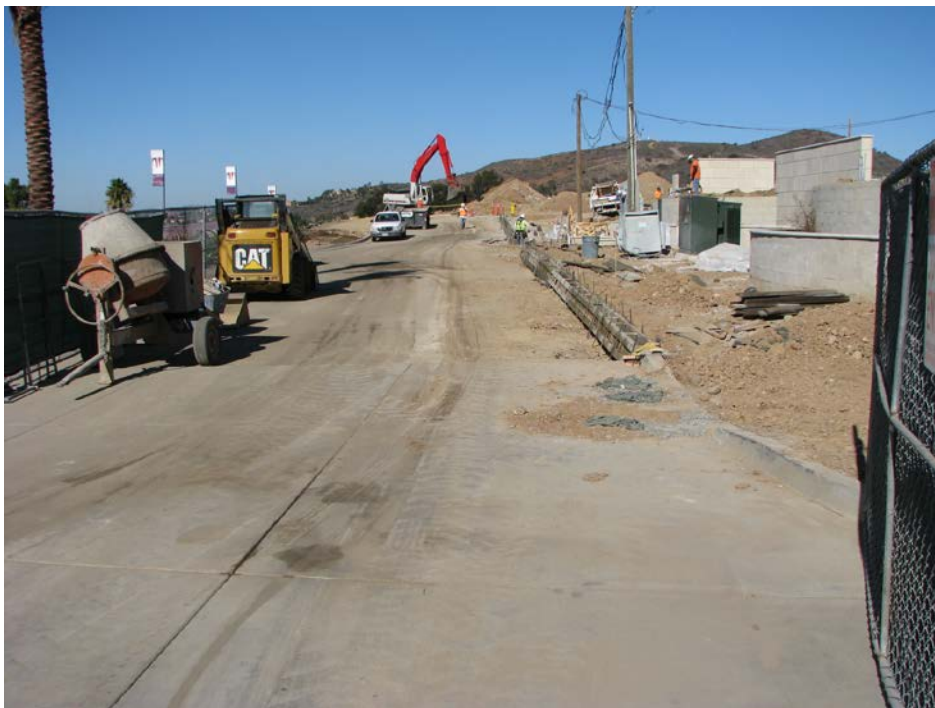
Figure 14. Looking north into construction site from entrance in Fig. 13
