## California Regional Water Quality Control Board, San Diego Region

**Subject: Notice of Violation No. R9-2014-0024, City of San Diego Construction Management Program, NPDES Order Nos. R9-2013-0001 and R9-2007-0001, Municipal Storm Water Permits**

**NOTICE OF VIOLATION  
No. R9-2014-0024**

Facility: Torrey Hills Unit 19  
Inspection Date: 09/20/2013

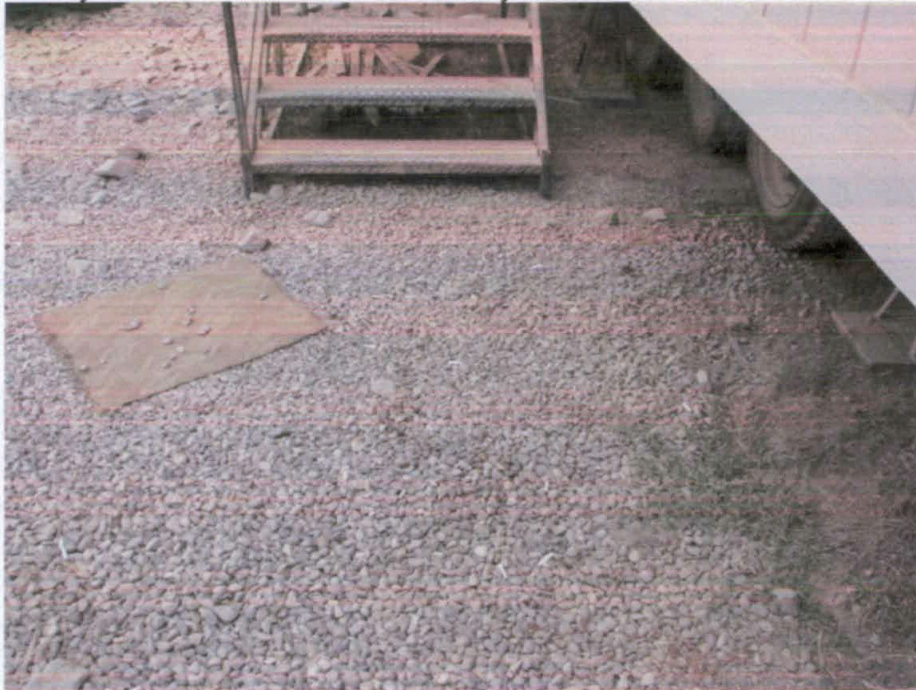
Figure 1. Trailer entrance; cigarette butts

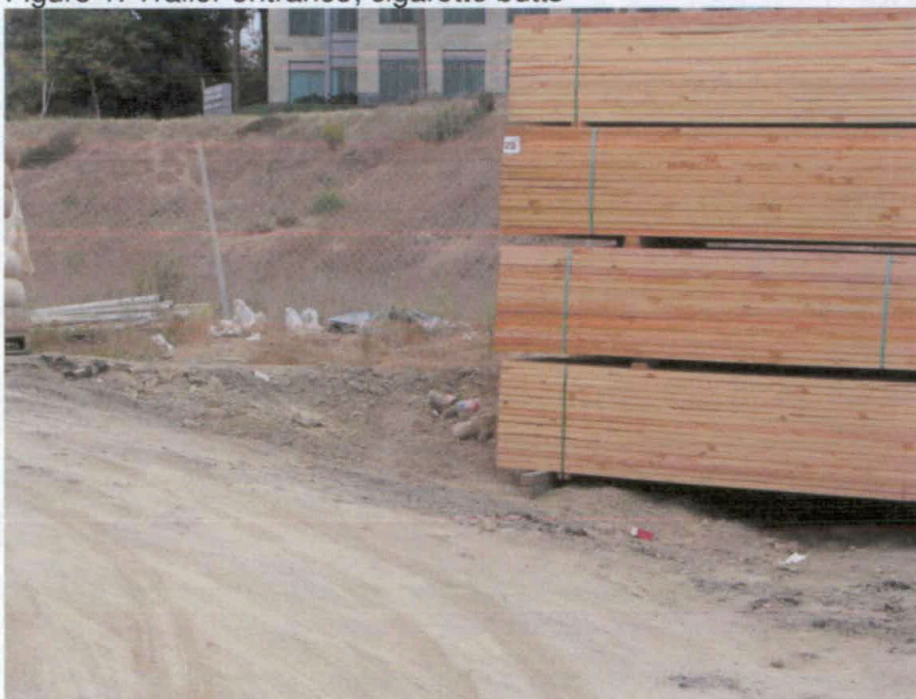
Figure 2. Near south entrance; trash area

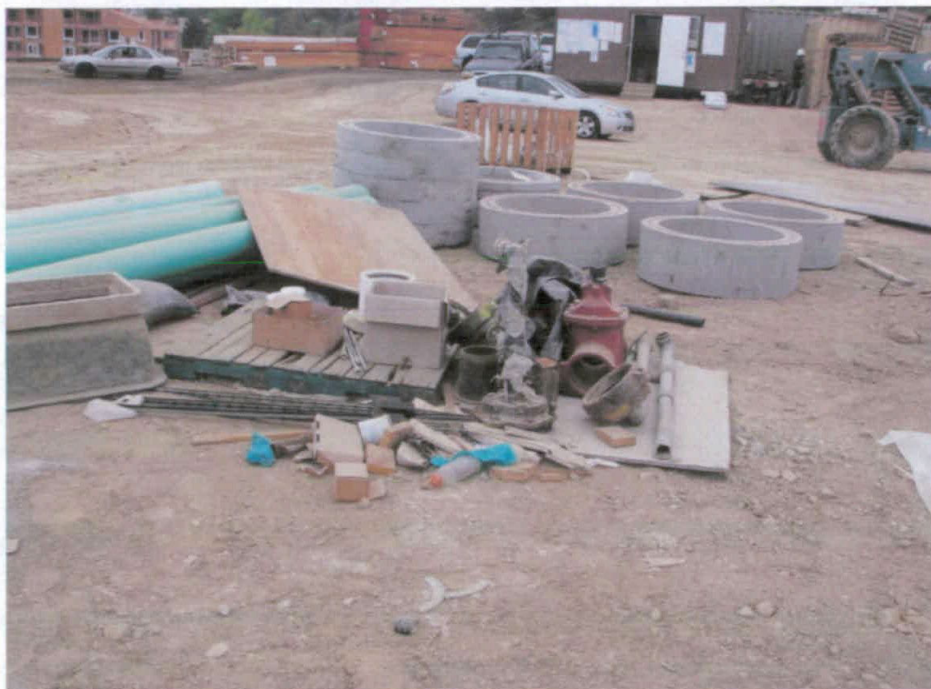
Figure 3. Site interior; construction debris

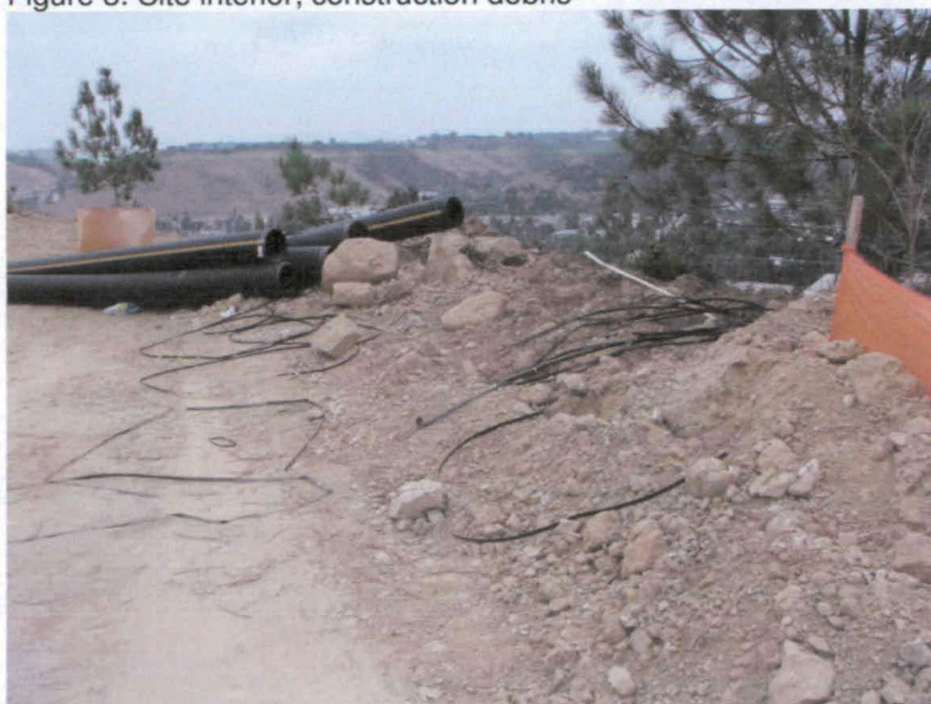
Figure 4. South west side; construction debris

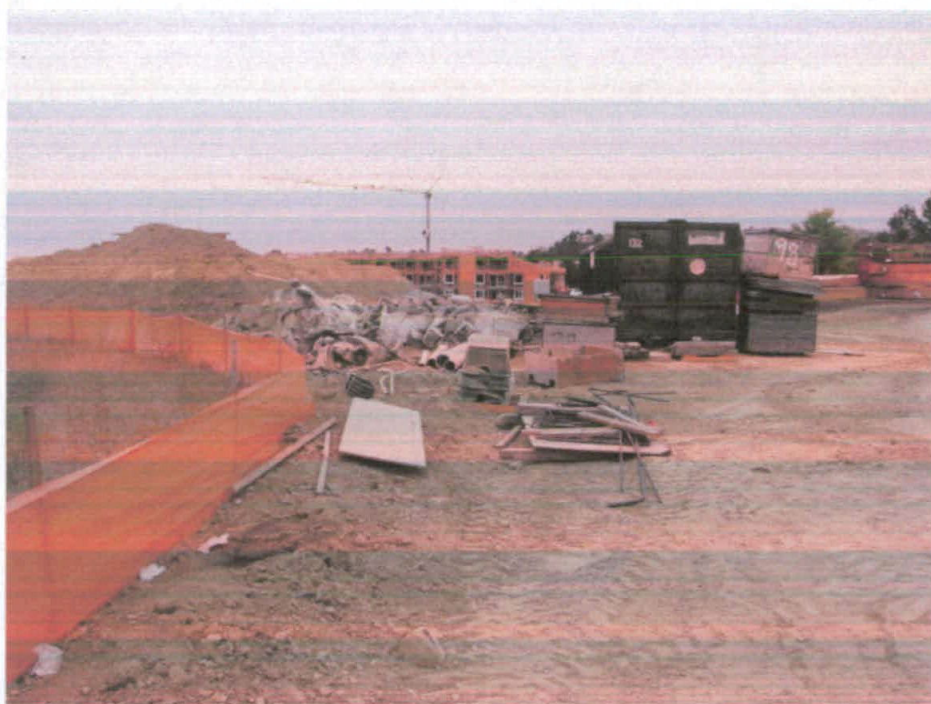
Figure 5. Site interior; construction debris

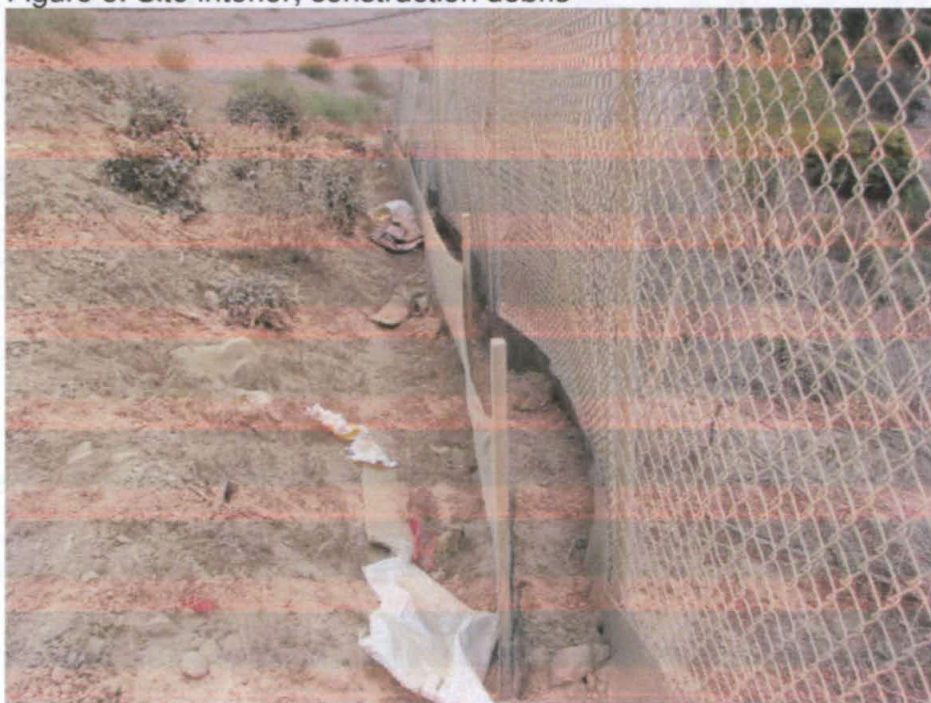
Figure 6. West perimeter; trash

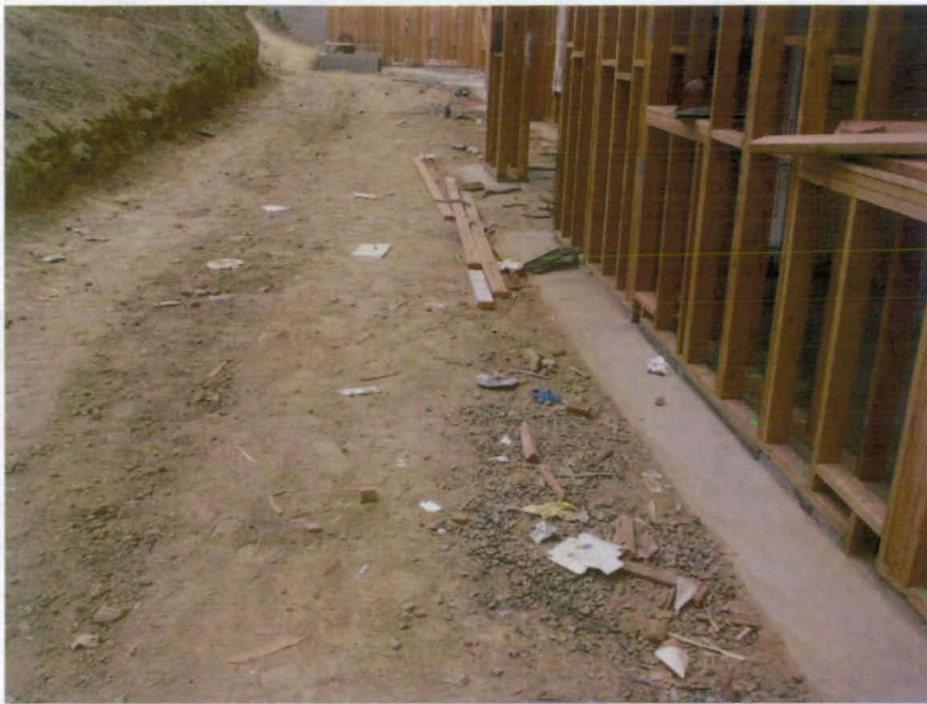
Figure 7. Site interior; trash

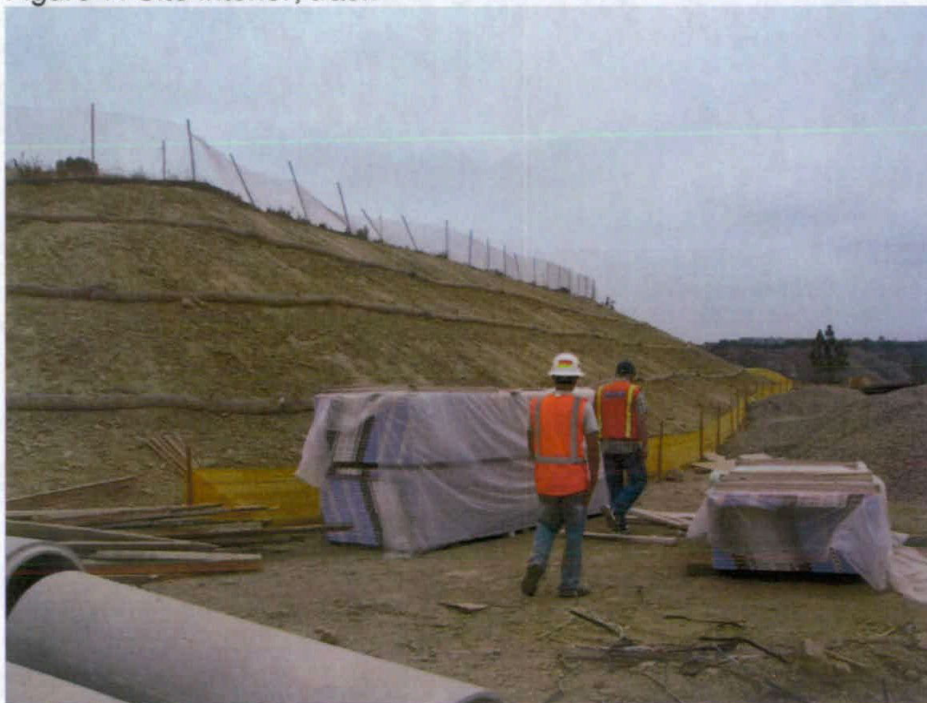
2. The site had inadequate erosion control and sediment control BMPs throughout the site.
3. The steep slopes on the east side of the site had fiber rolls and a silt fence at the toe of the slope. However, there was no erosion control. The slopes were bare and require erosion control BMPs because they are at risk for mobilization during a heavy rain (Figure 8).

Figure 8. Slope east side; bare soil

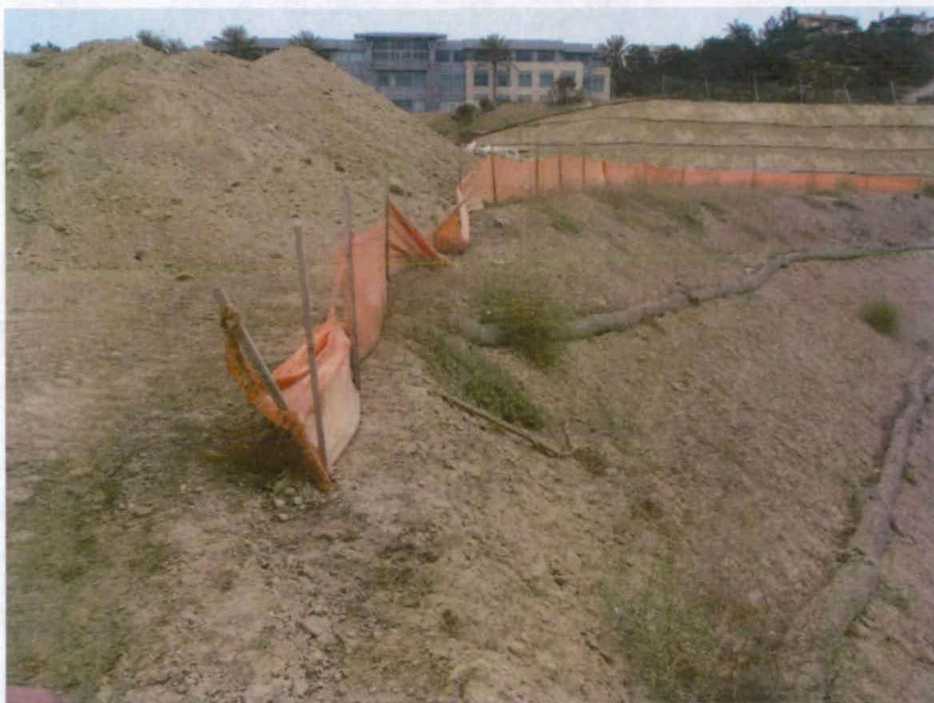
4. There is a stockpile located next to a steep slope. The silt fence between the stockpile and slope is in need of repair (Figures 9). Mr. Do was unaware of when the adjacent/downstream slope had been last sprayed with hydroseed.

Figure 9. Sediment stockpile with broken silt fence

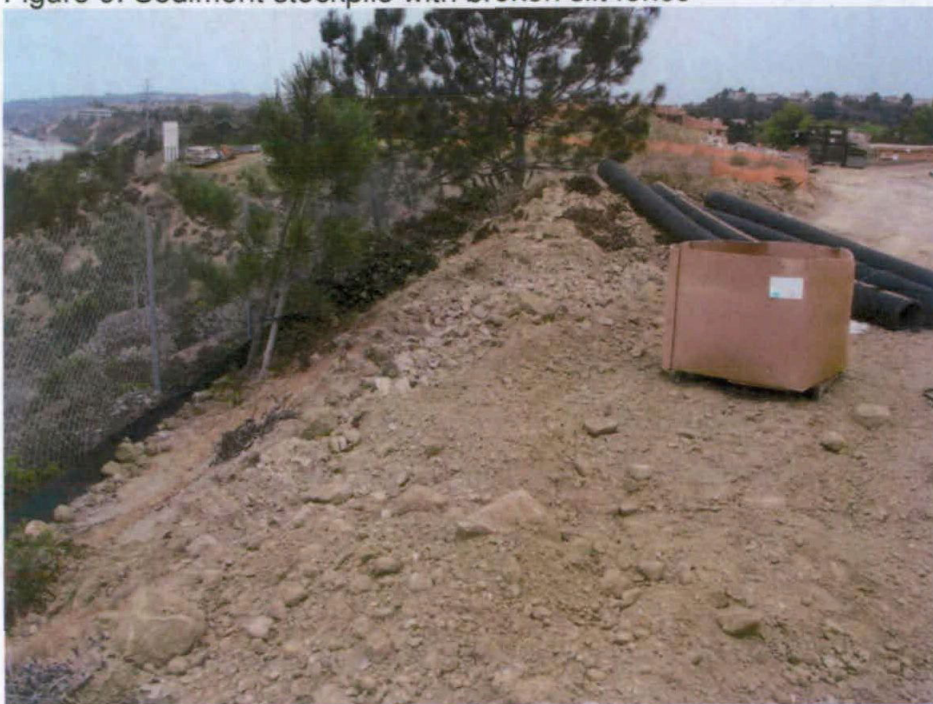
5. The site generally slopes towards the westerly direction. The perimeter controls along the west side were inadequate for containing the sediment within the construction site (Figures 10-12). There was evidence of a sediment discharge from the site and onto the adjacent downstream property (Figure 12).

Figure 10. Perimeter south west side

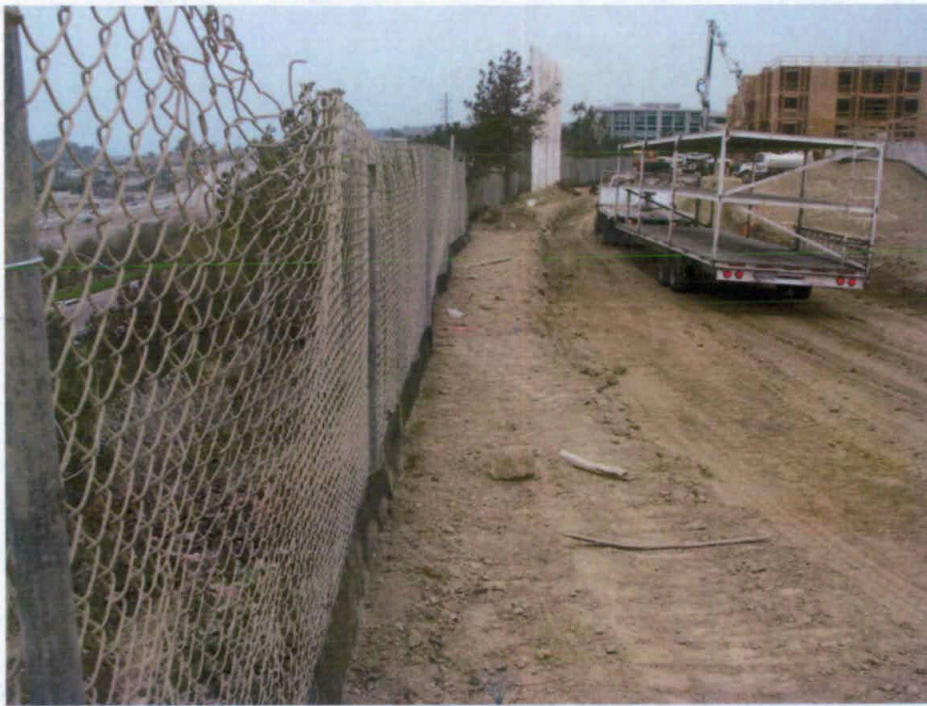
Figure 11. Perimeter west side

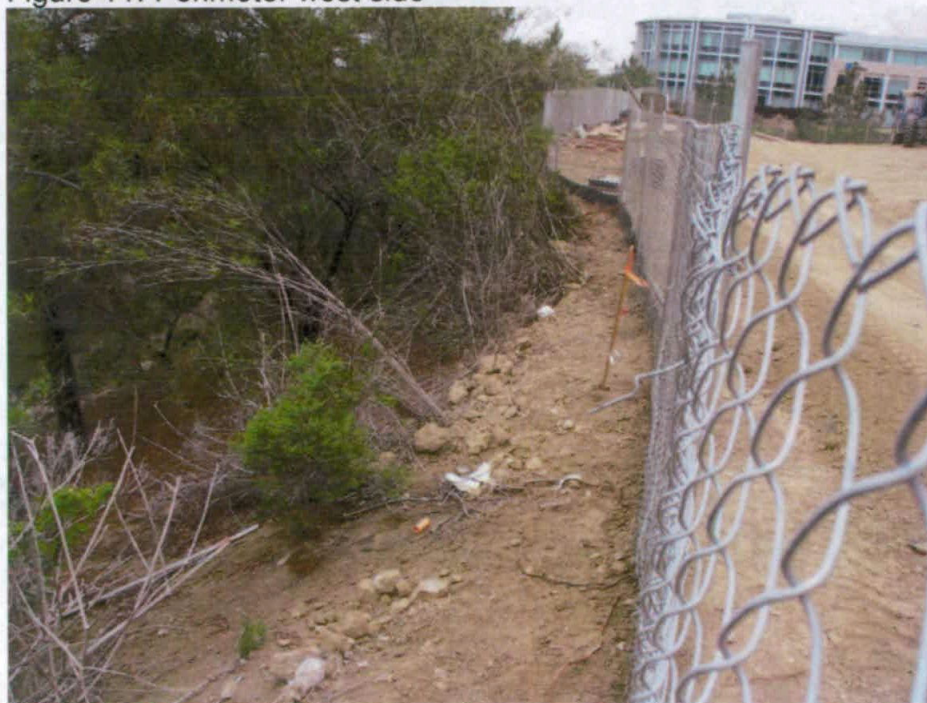
Figure 12. Sediment discharge outside site boundary

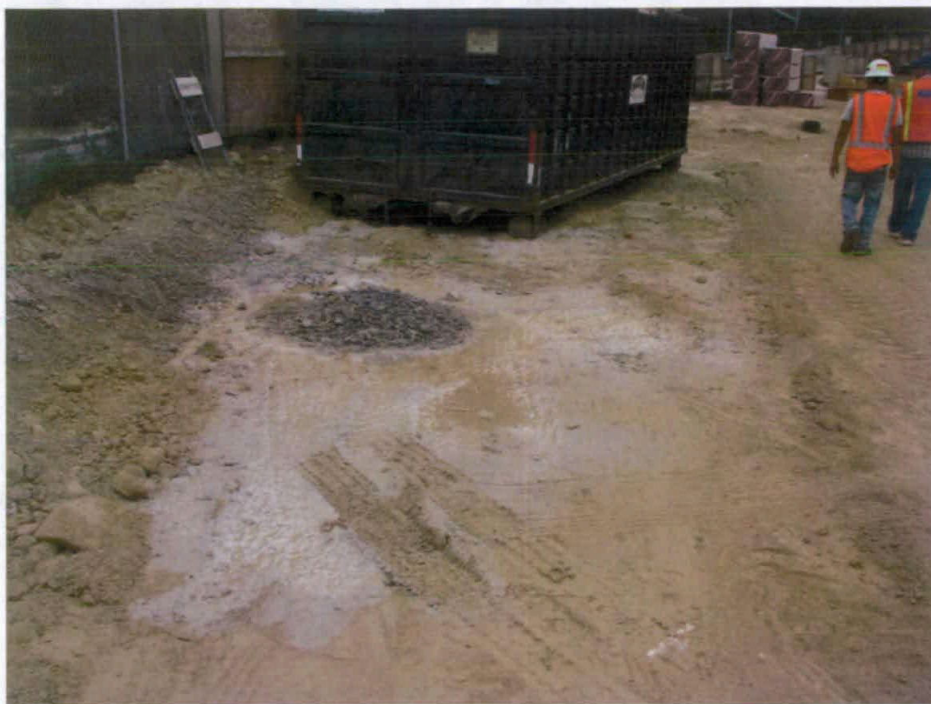
Figure 13. Concrete washout with no containment

5. A designated concrete washout area for the site must be established and used. Concrete must not be allowed to come into contact with bare ground.
6. Site entrance/exit BMPs are inadequate and require maintenance.

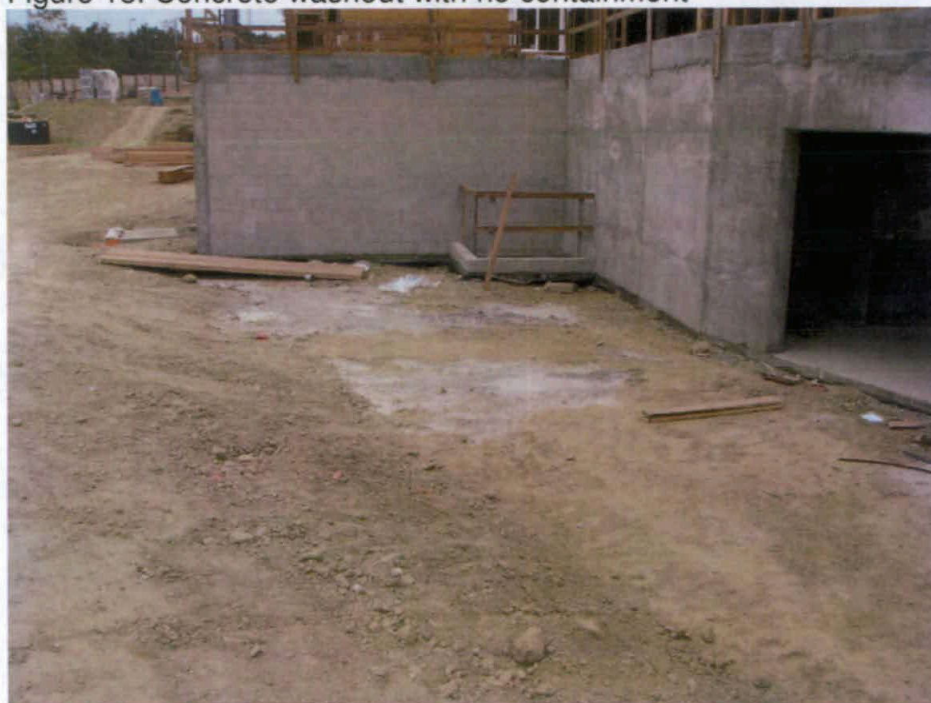
Figure 14. Concrete washout with no containment

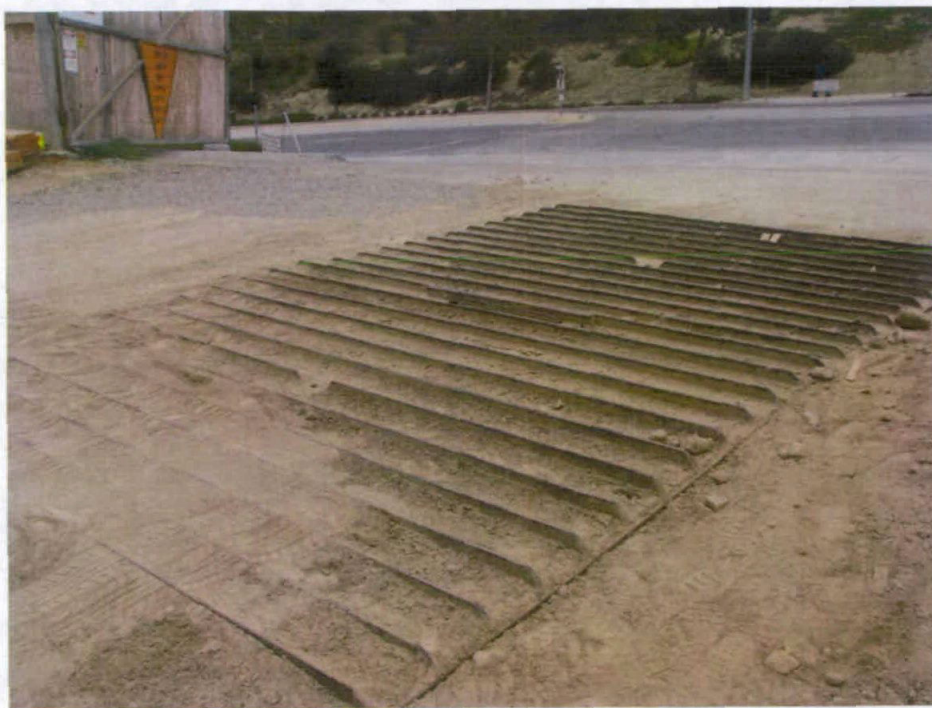
Figure 15. Shaker plates north entrance

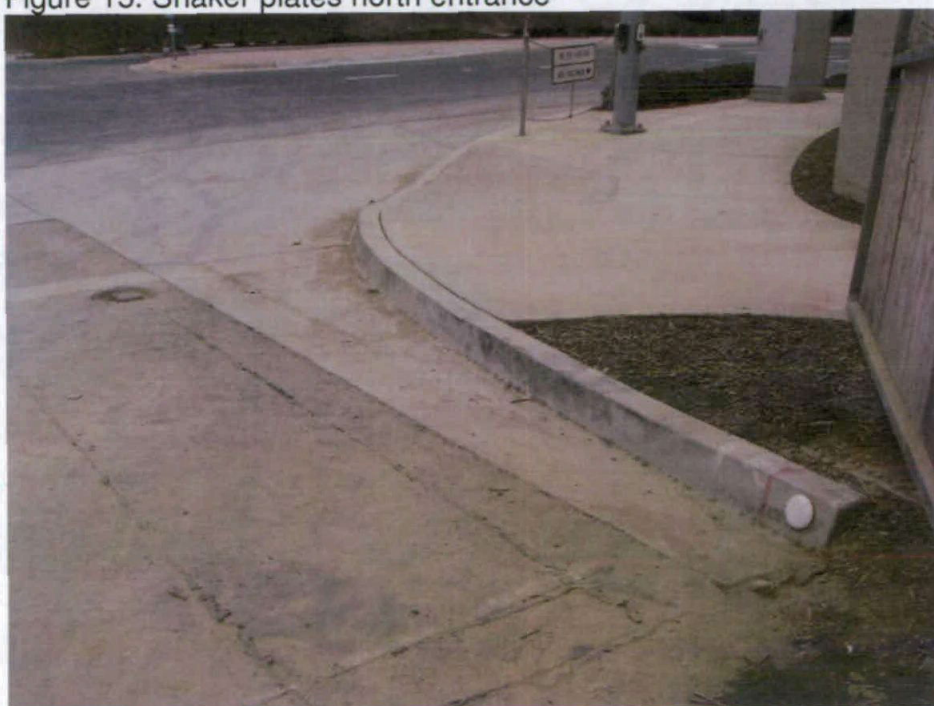
Figure 16. Public street outside construction site

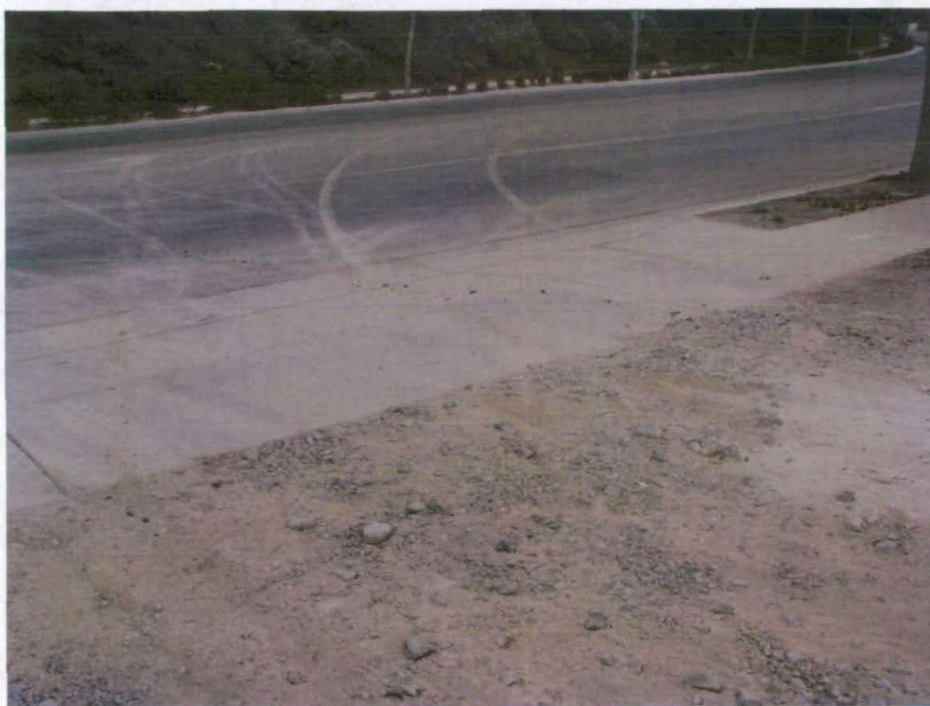
Figure 17. Gravel at south entrance

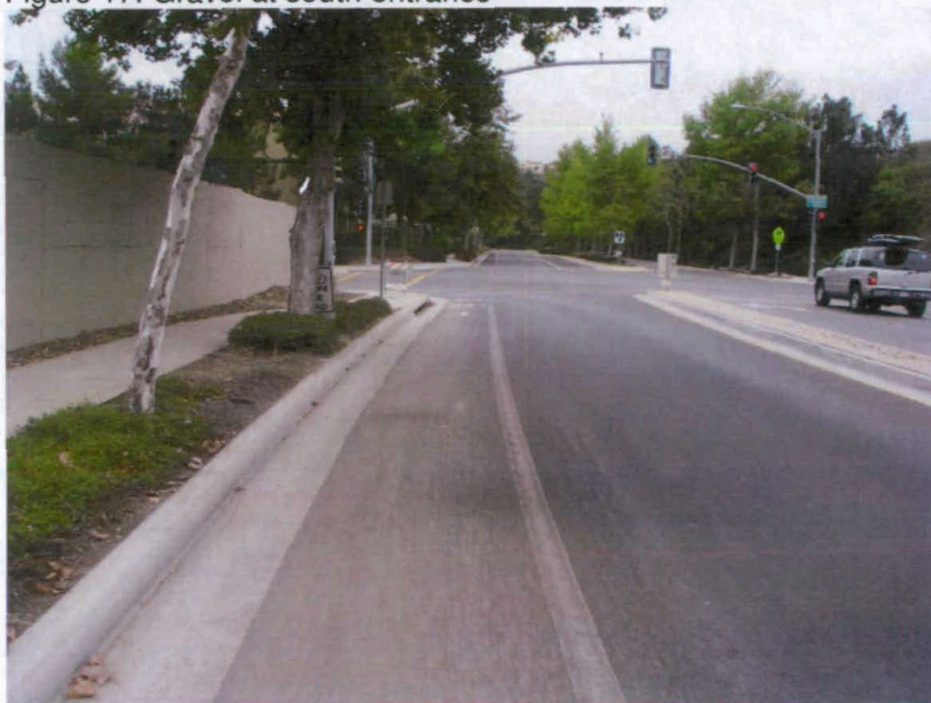
Figure 18. Nearest storm drain downstream; no inlet protection

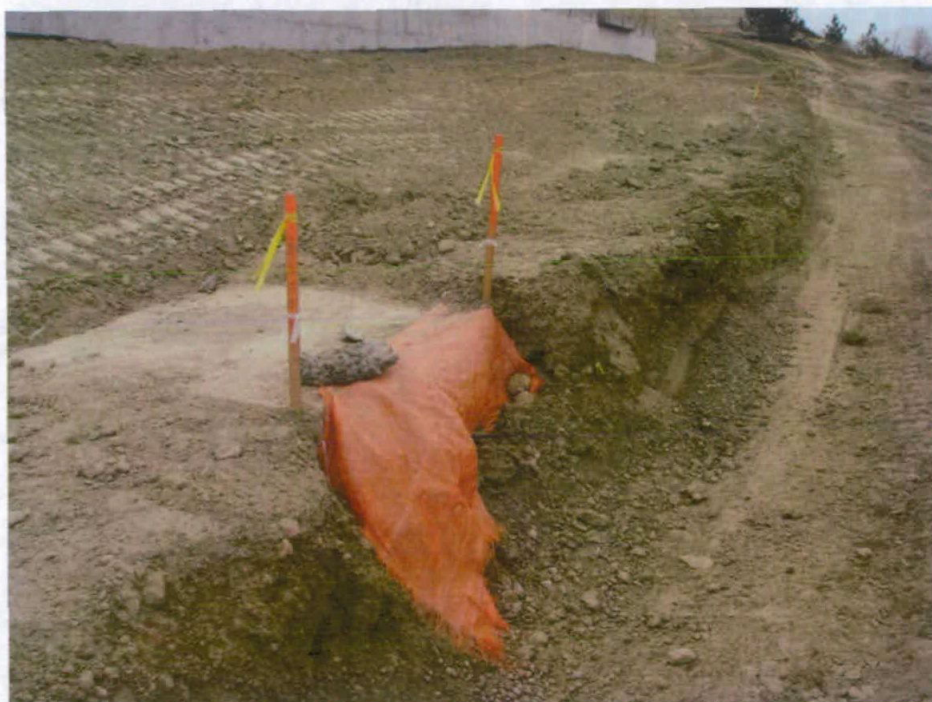
Figure 19. Live storm drain covered with permeable fabric

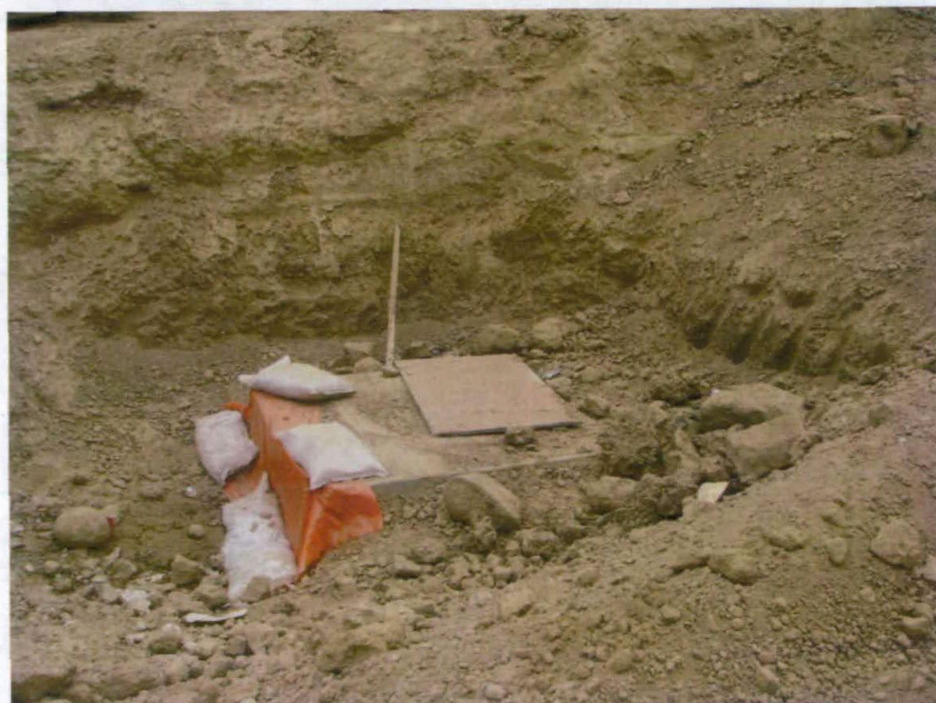
Figure 20. Live storm drain covered with permeable fabric

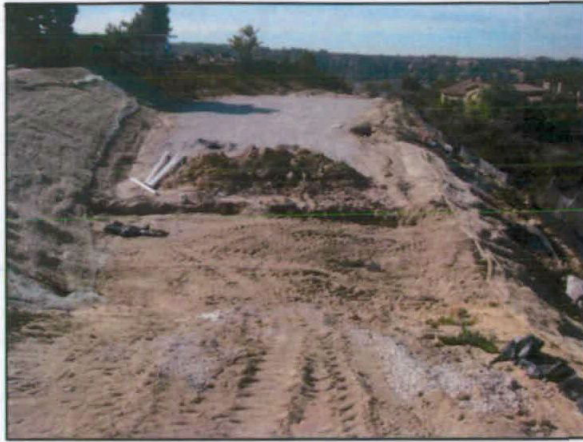
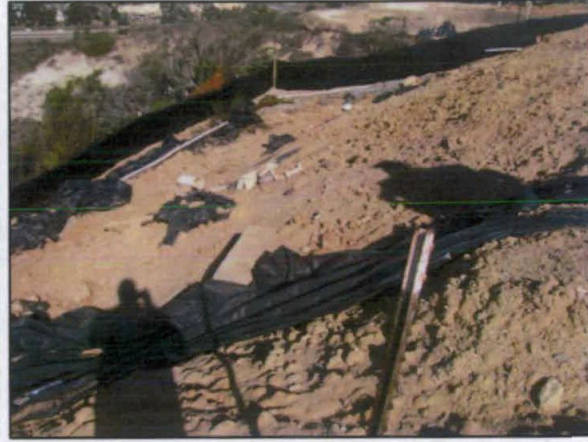
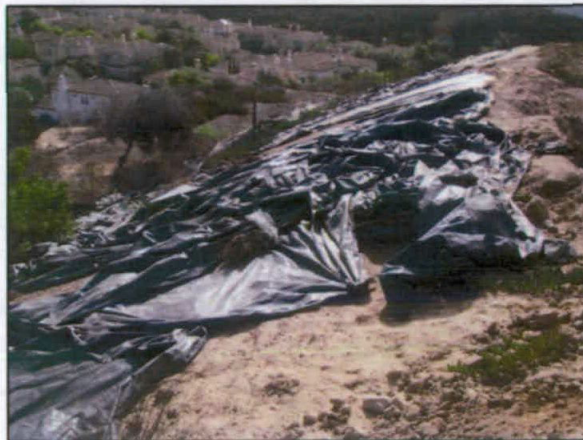
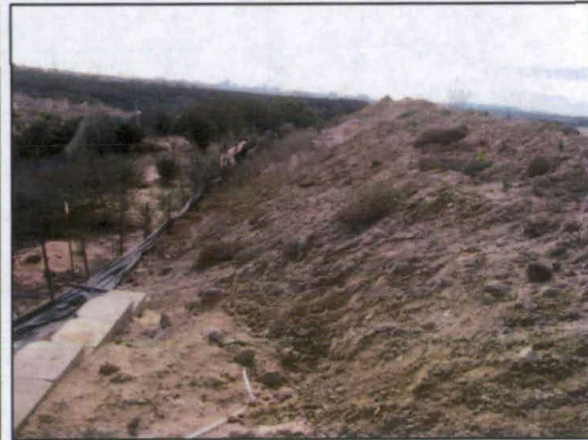
- a. Several slopes located in the interior and exterior of the site appeared to be inactive and had inadequately implemented, inadequately maintained, or did not have erosion control BMPs to provide effective soil cover and stabilization (see Photos 1-4);

- d. Linear sediment controls were not observed along the toe of slopes and grade breaks of exposed slopes, as required for Risk Level 2 sites (see Photos 1-4)

**Photos 1-4** show lack of erosion and sediment control BMPs required to be implemented by Risk Level 2 dischargers for slopes throughout the site.

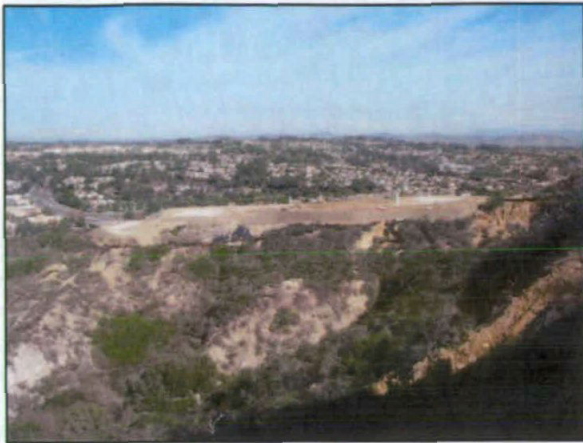
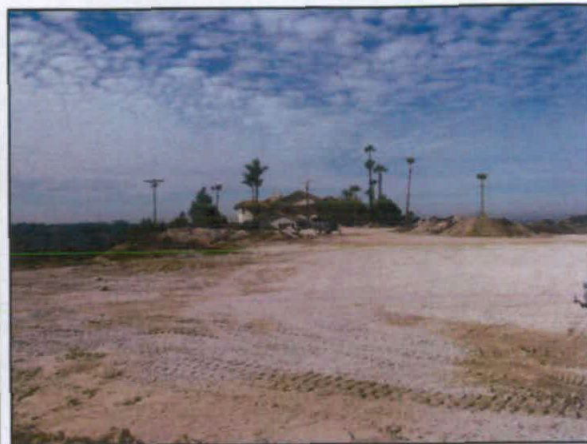
- b. Most of the building pads appeared to be inactive and had a layer of gravel, but no erosion control BMPs (e.g. soil binder, bonded fiber mulch) providing effective soil cover were observed (see Photos 1, 5 and 6);

**Photos 5-6** show lack of erosion control BMPs implemented to provide effective soil cover for building pads that appears to be inactive at the site (also see Photo 1).

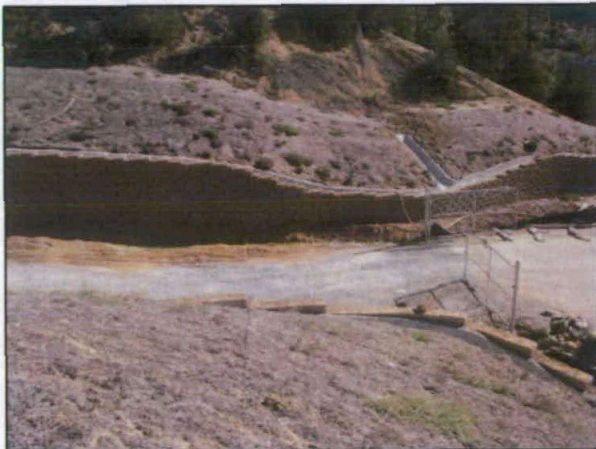
Photo 7

- e. Silt fence was observed around the perimeter of the site, but did not appear to be adequately maintained to sufficiently control erosion and sediment discharges from the site (see Photos 4 and 7); and

**Photo 7** shows the entrance/exit to site lacking adequate stabilization to control erosion and sediment discharges from the site, and lack of BMPs to prevent tracking of sediment from the site.

5. Refresh or replace rock and/or place additional BMPs (e.g., shaker plate or rumble strip, stone pads, concrete or steel wash racks) at entrance/exit to site to prevent offsite vehicle tracking of sediment;

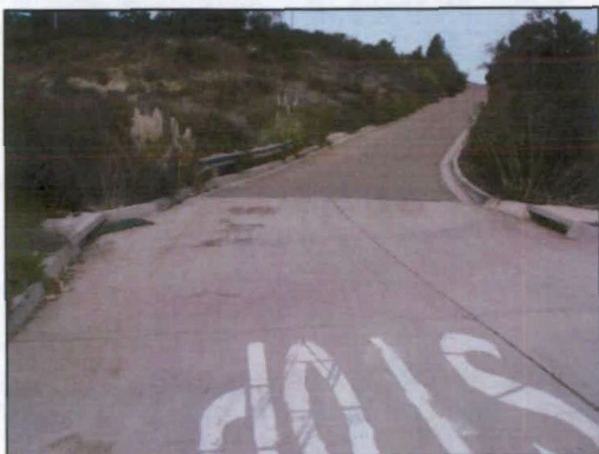
Photo 8

9. Storm drain inlets were inadequately protected, and evidence of sediment in surface runoff discharged from the site leading to the inlets was observed (see Photos 8).

**Photo 8** shows lack of BMPs to protect storm drain inlets, with evidence of sediment in surface runoff discharged from the site leading to the inlets.

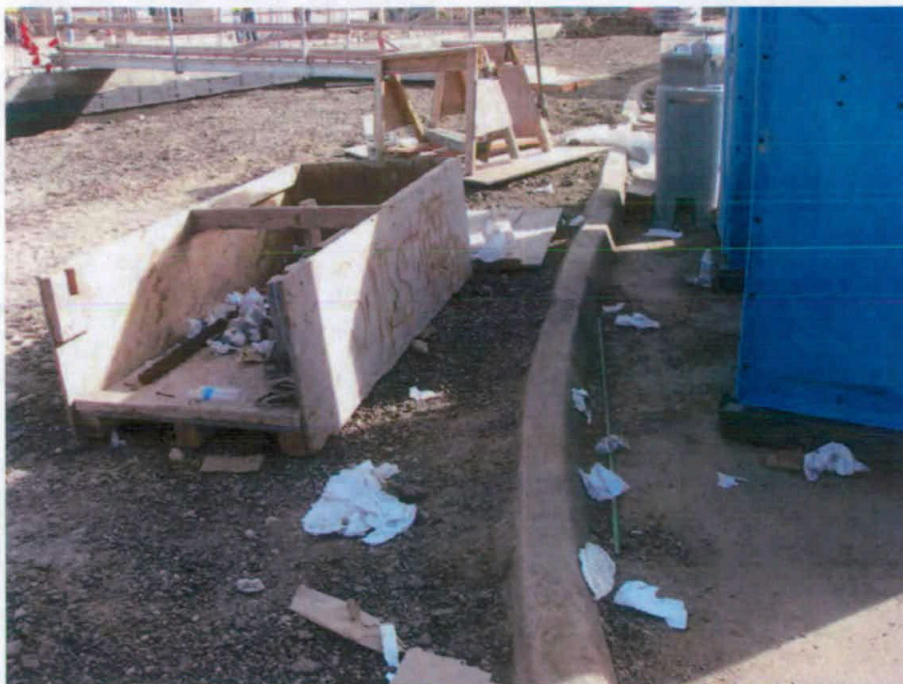
1. The site was littered with cigarette butts, trash, debris, and other construction-related waste throughout. (See Figures 1-4, 14-25).
2. None of the finished curbs within the site had sediment control BMPs (such as silt fence) installed. As a result, the streets were covered in sediment (Figures 1, 3, 16-22).
3. There were no sediment control BMPs at one construction site exit/entrance located on Mira Lee Way, and sediment had been tracked into the street (Figure 5).
4. There was an uncovered stockpile, although it appeared to be active (Figure 6).
5. Two concrete wash-out bins were leaking, and waste material discharged to the surrounding the soil (Figures 7-8).

Figure 3. Site interior; trash

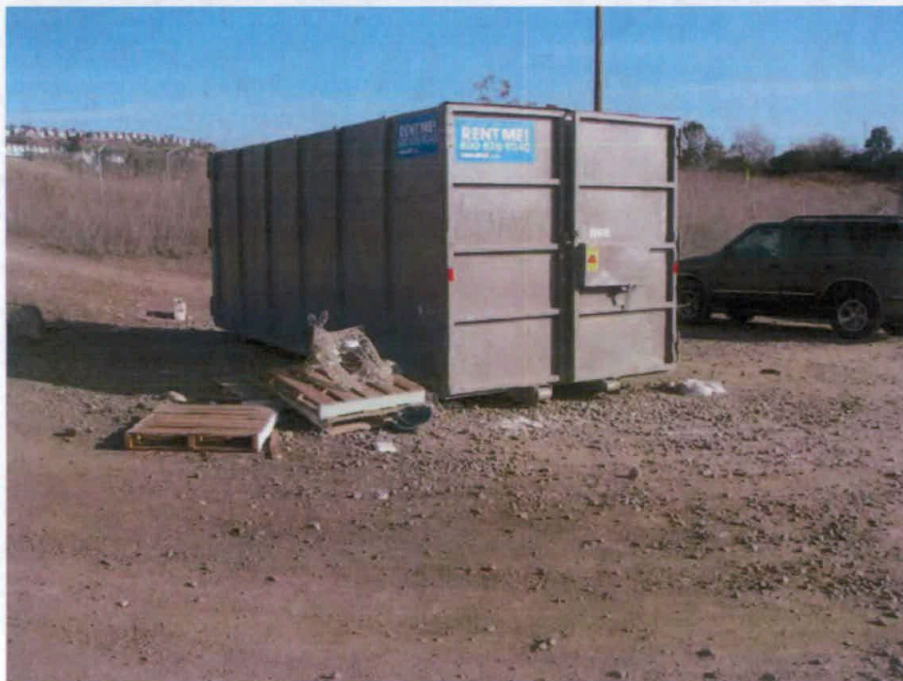
Figure 4. Site interior; construction debris

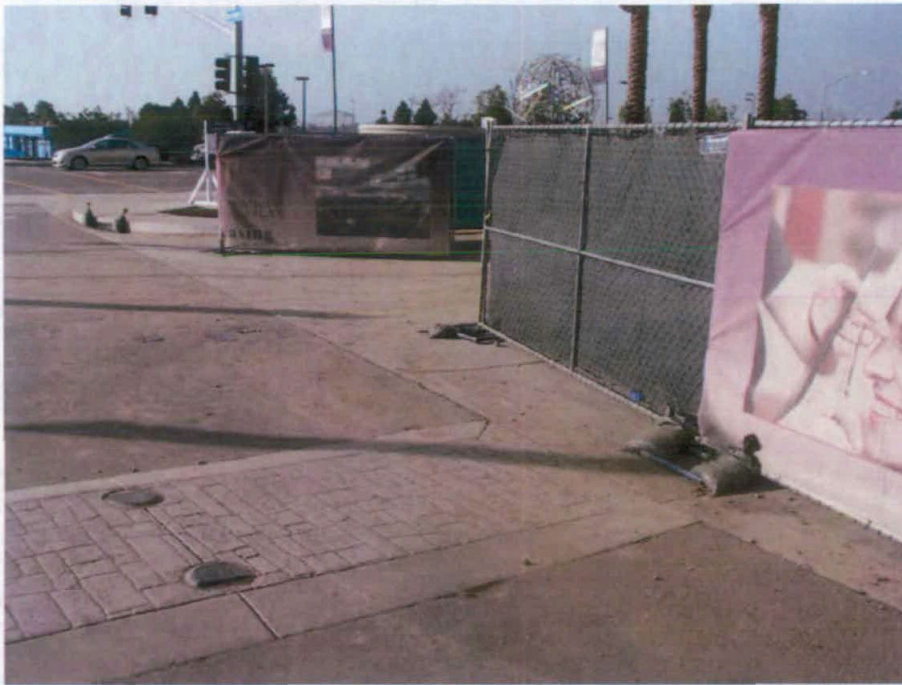
Figure 5. South-facing construction entrance; no BMPs; sediment tracking onto street

5. The concrete washout BMPs must be fixed or replaced to prevent leaks. Concrete waste must not be allowed to come into contact with bare ground.
6. Site entrance/exit BMPs are required.

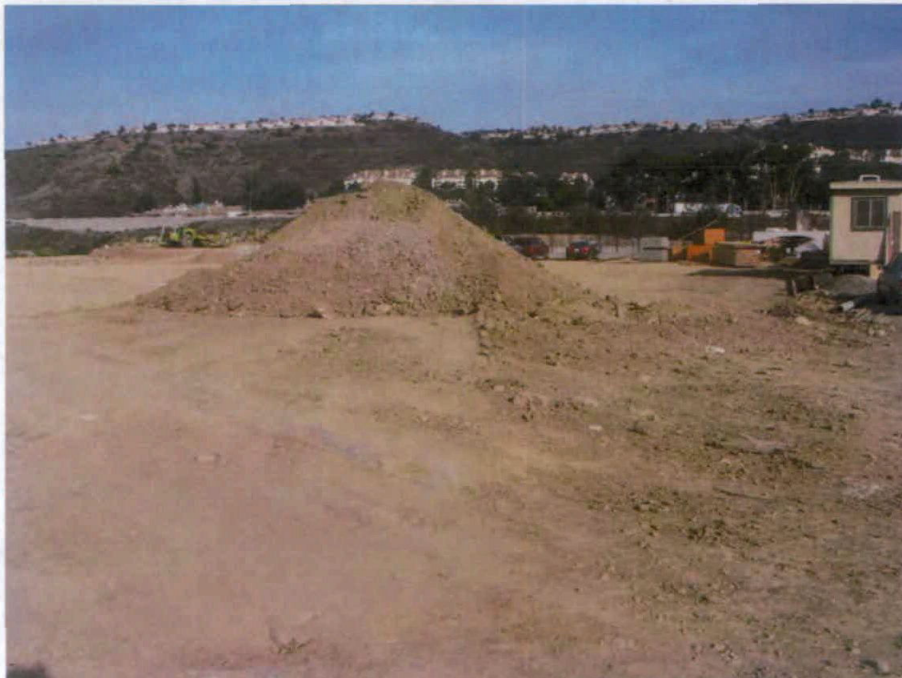
Figure 6. Sediment stockpile

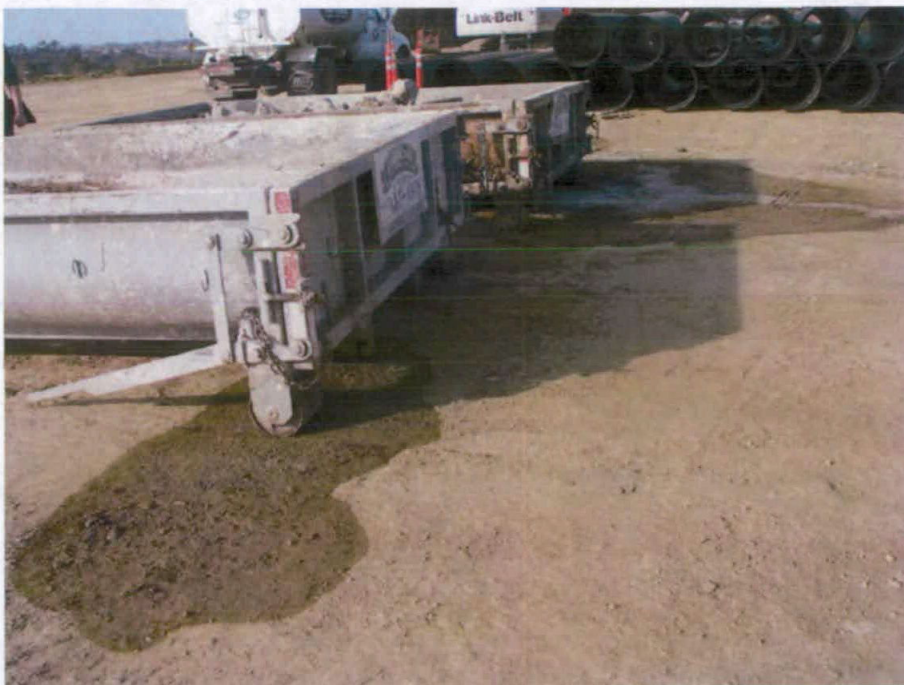
Figure 7. Leaking concrete washouts

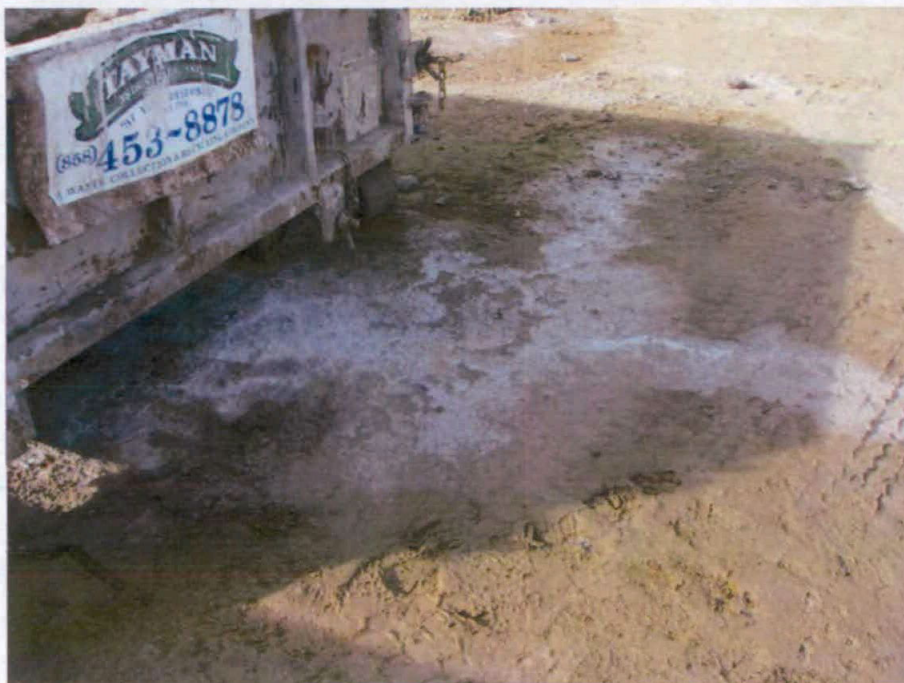
Figure 8. Concrete staining on soil from leaking washouts

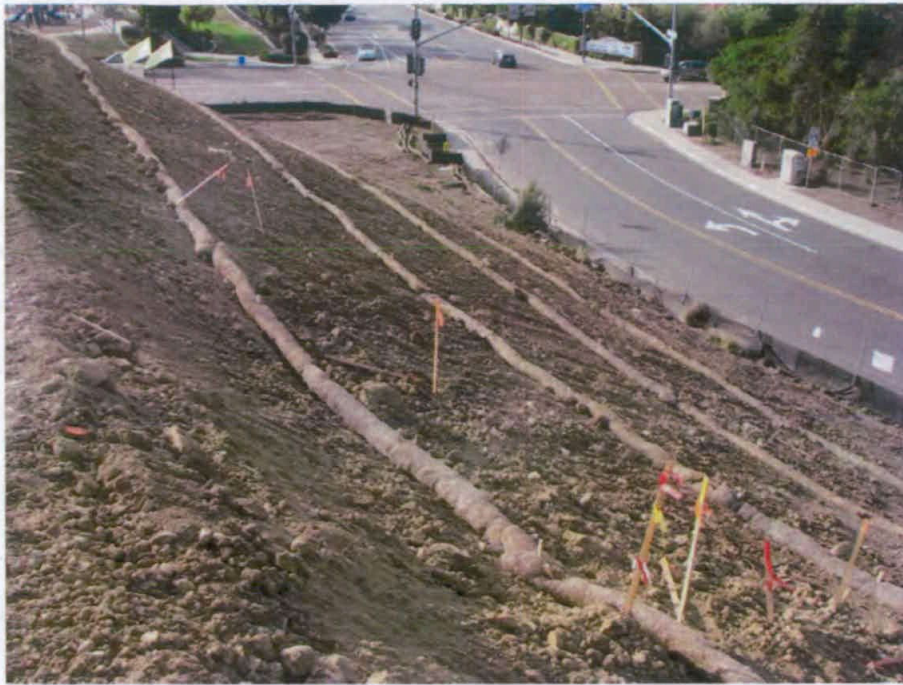
Figure 9. Slope on north side with no erosion control

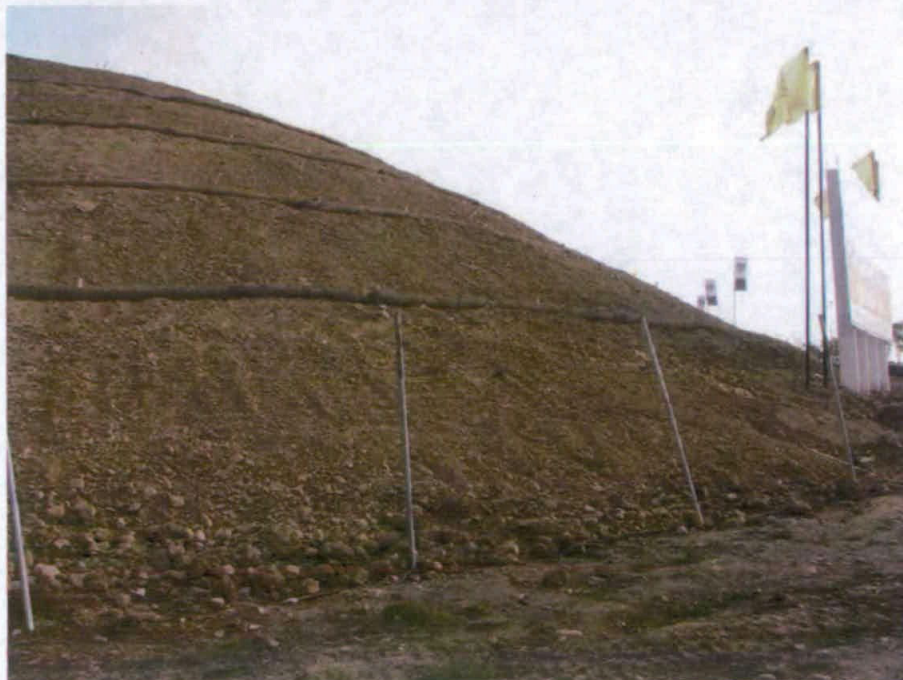
Figure 10. Slope is 2:1 Horizontal: Vertical according to SWPPP

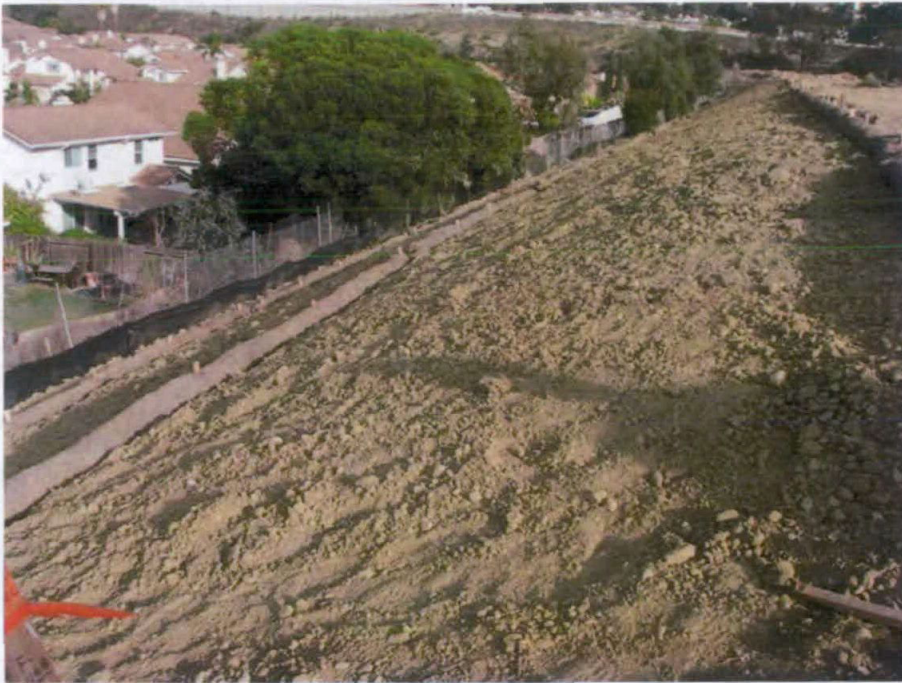
Figure 11. North slope looking easterly

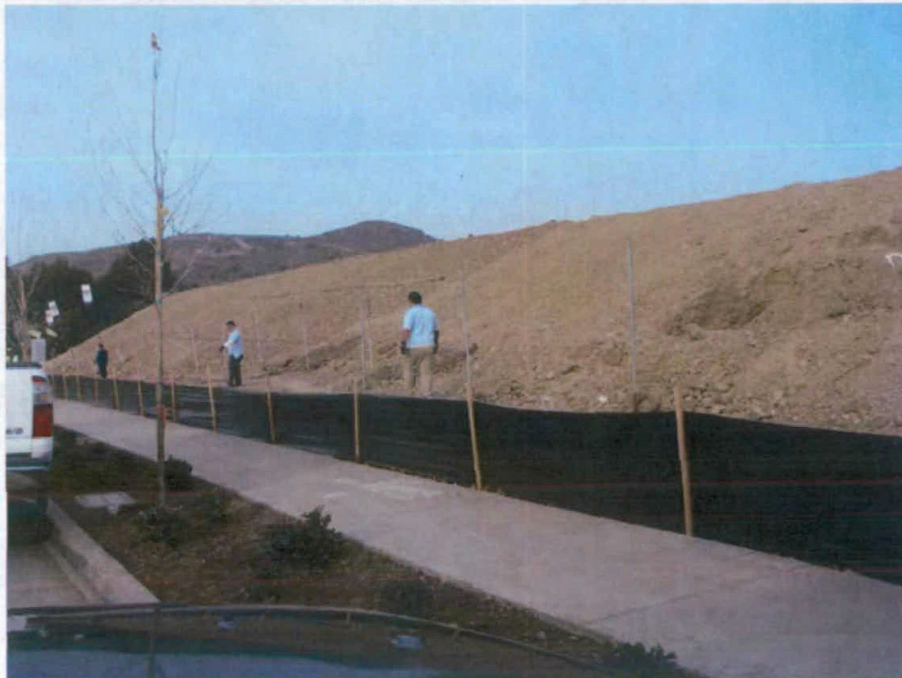
Figure 12. Slope on west side of property
