## California Regional Water Quality Control Board, San Diego Region

**Subject: Notice of Violation No. R9-2014-0024, City of San Diego Construction Management Program, NPDES Order Nos. R9-2013-0001 and R9-2007-0001, Municipal Storm Water Permits**

**NOTICE OF VIOLATION  
No. R9-2014-0024**

Facility: Torrey Hills Unit 19  
Inspection Date: 09/20/2013

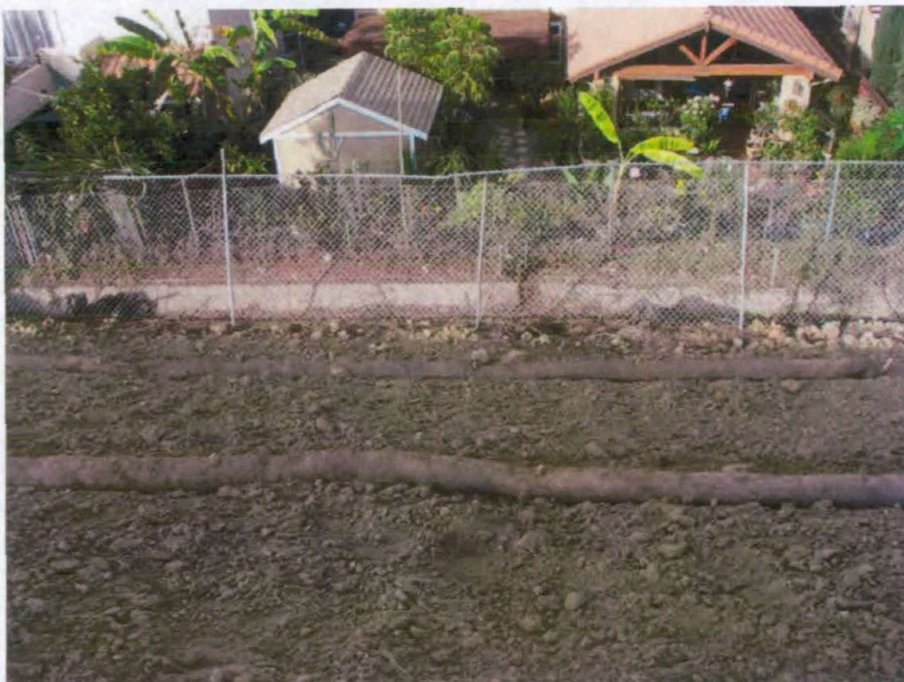
7. The silt fence along the north side of the property had fallen and was in need of repair (Figure 13).
8. Sediment control BMPs throughout the site need replacement or had not been maintained. Examples include broken gravel bags (Figure 22).

Figure 13. Damaged silt fence

3. All sediment control BMPs must be adequately maintained. The silt fence on the north side of the property requires replacement.
4. Sediment control BMPs such as silt fence should be installed at finished curbs to prevent sediment from reaching the streets.

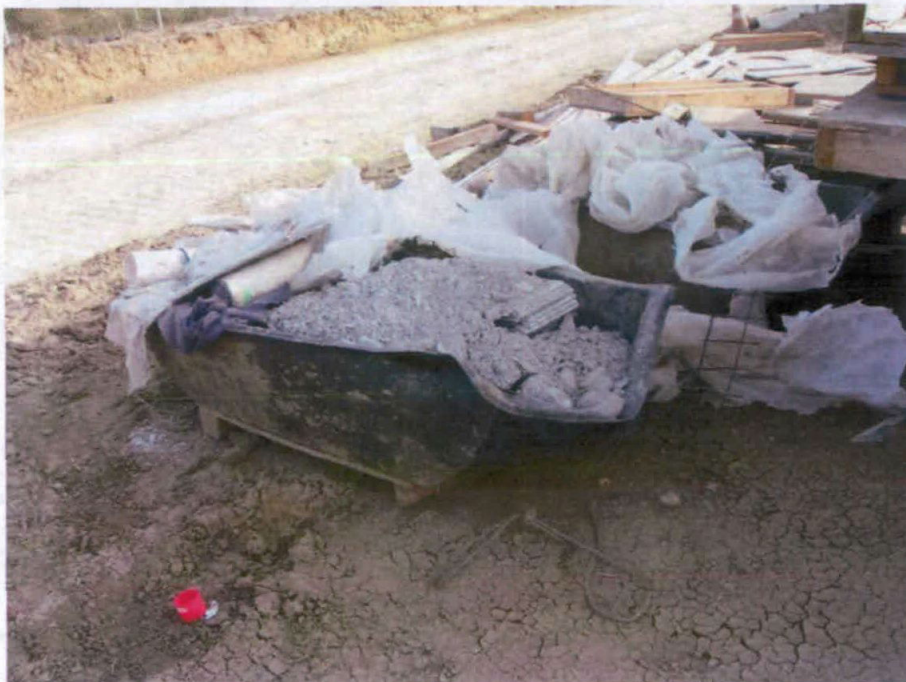
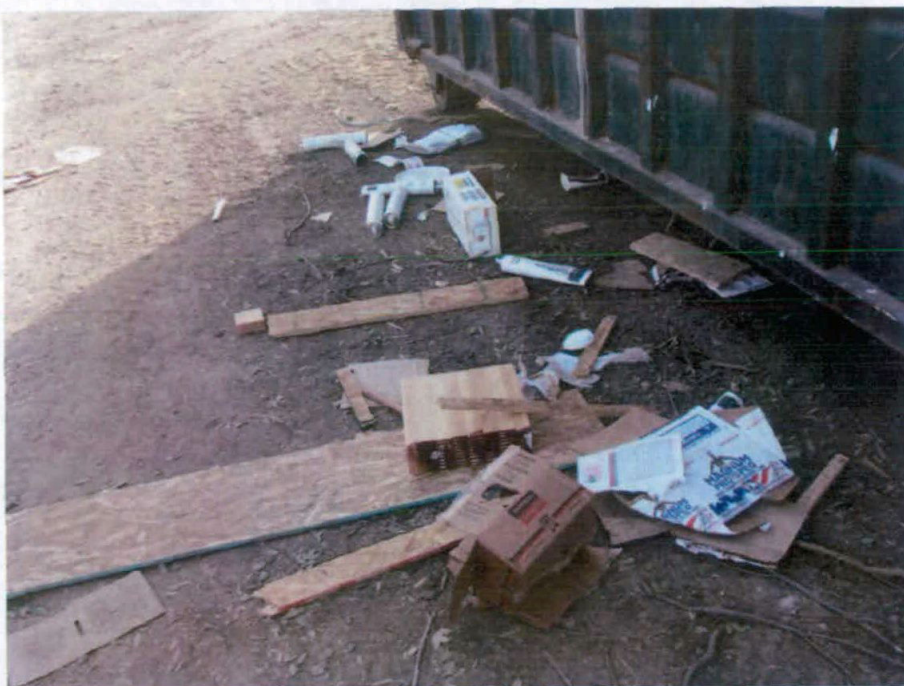
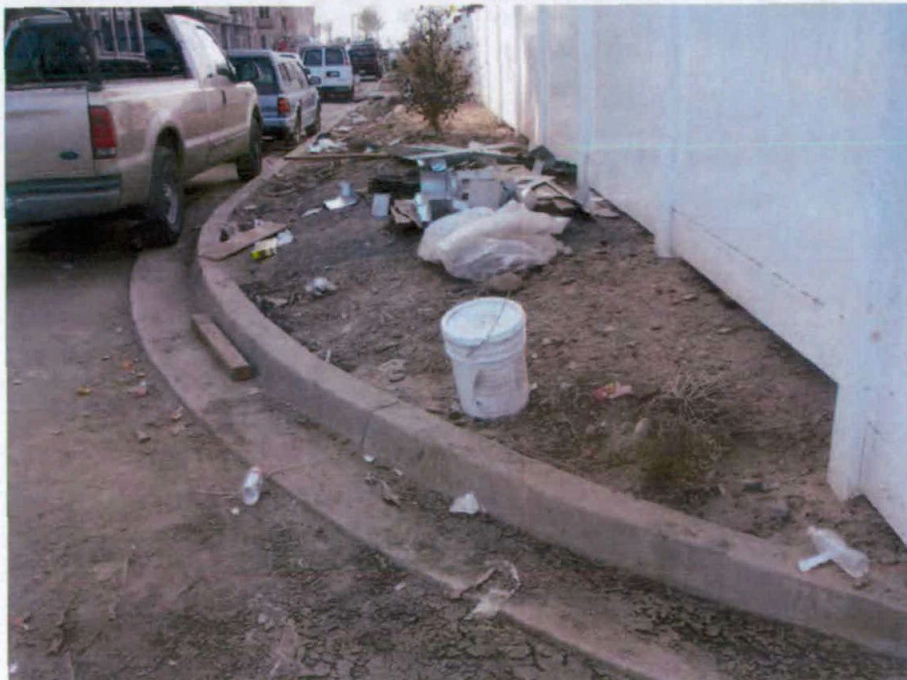
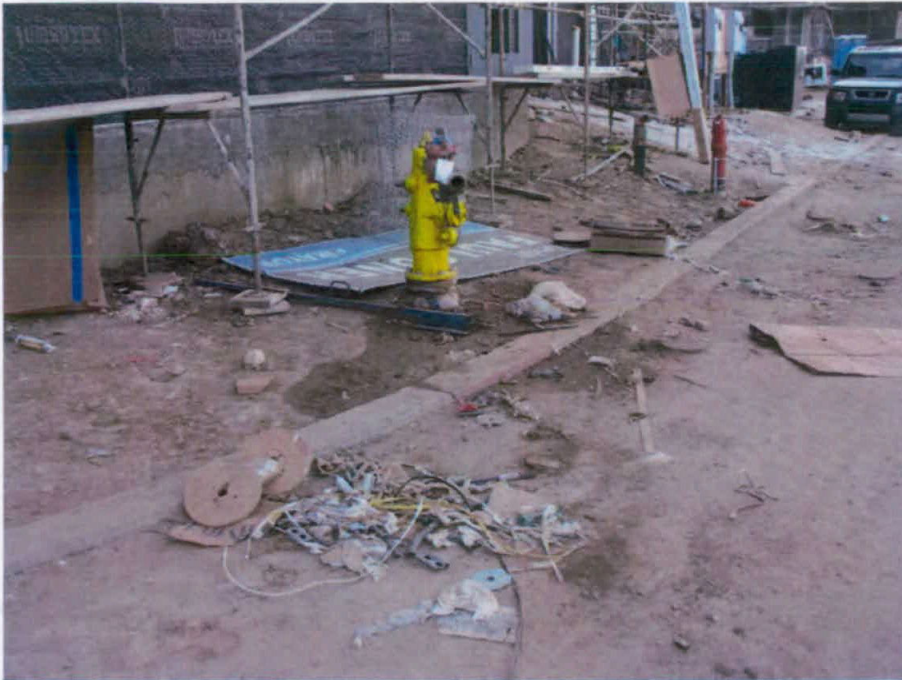
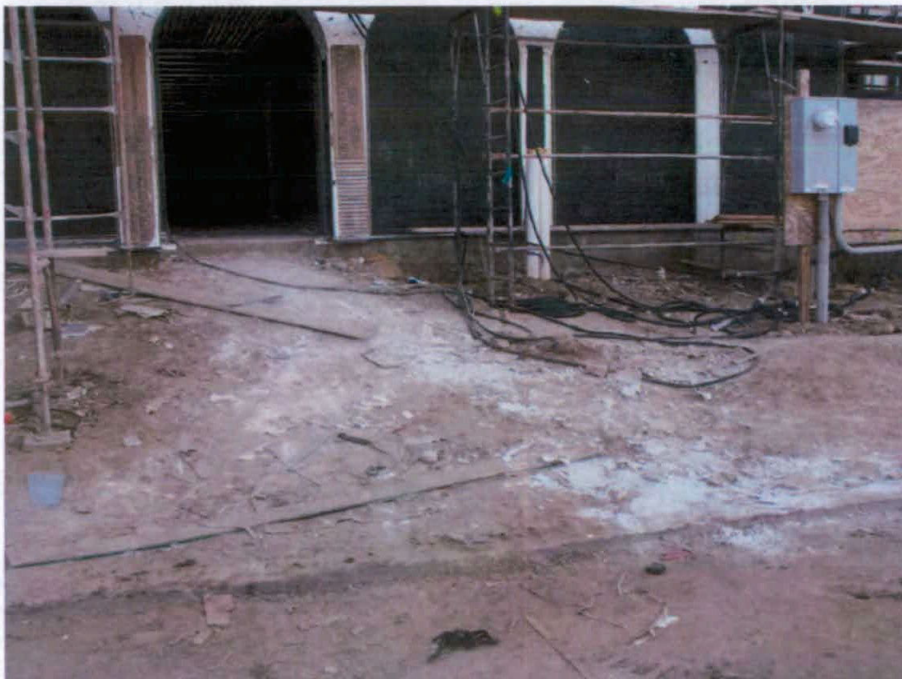
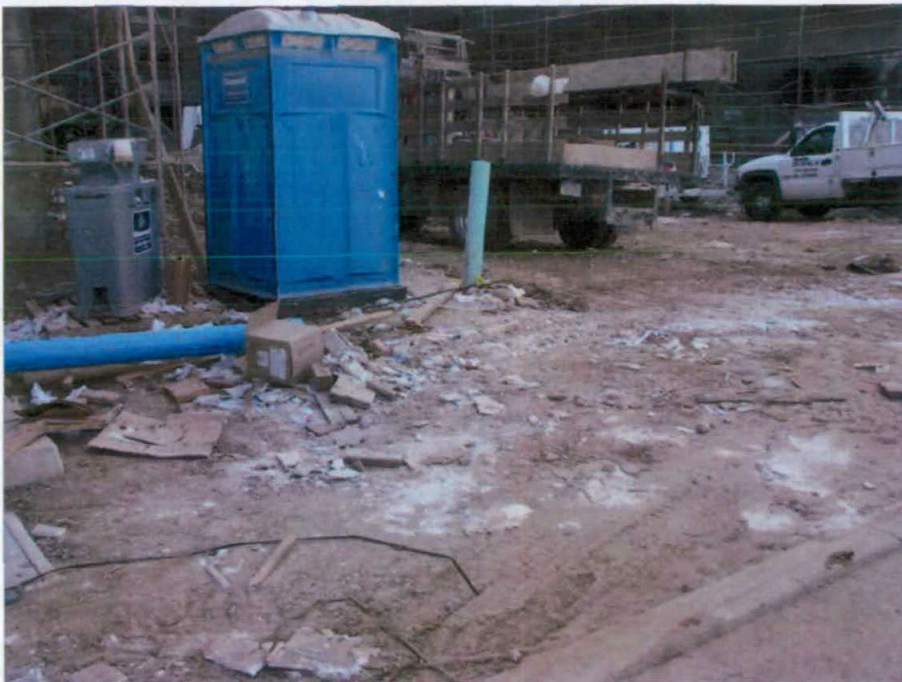
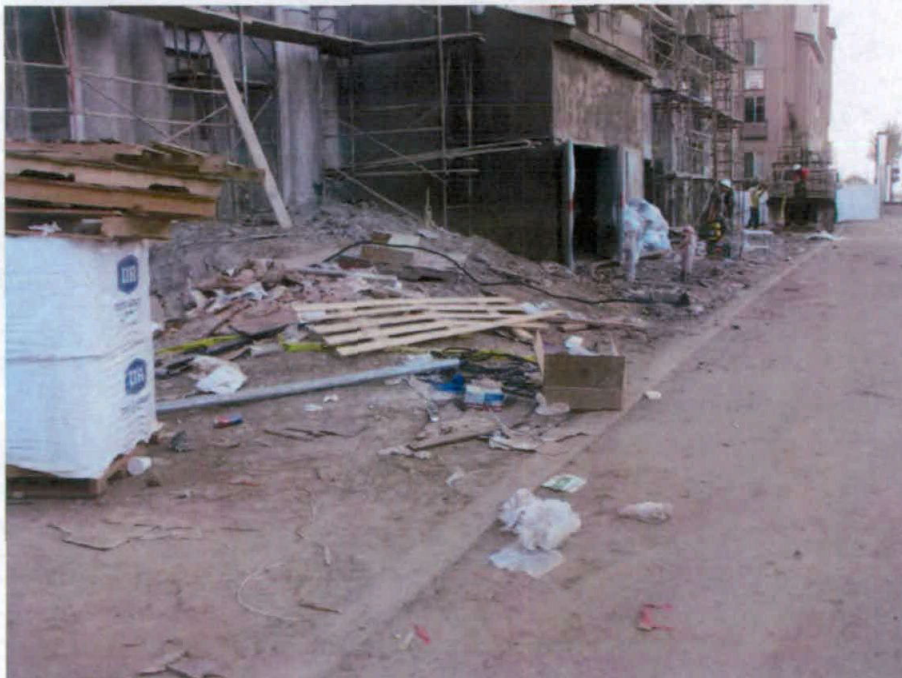
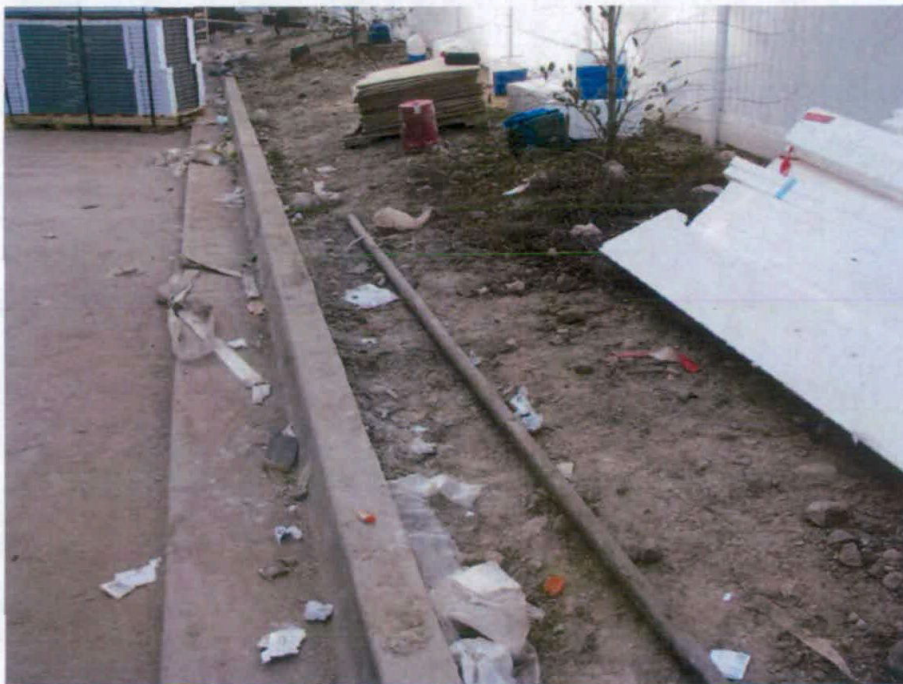
1. The site was littered with cigarette butts, trash, debris, and other construction-related waste throughout. (See Figures 1-4, 14-25).
2. None of the finished curbs within the site had sediment control BMPs (such as silt fence) installed. As a result, the streets were covered in sediment (Figures 1, 3, 16-22).
3. There were no sediment control BMPs at one construction site exit/entrance located on Mira Lee Way, and sediment had been tracked into the street (Figure 5).
4. There was an uncovered stockpile, although it appeared to be active (Figure 6).
5. Two concrete wash-out bins were leaking, and waste material discharged to the surrounding the soil (Figures 7-8).

Figure 14. Construction debris

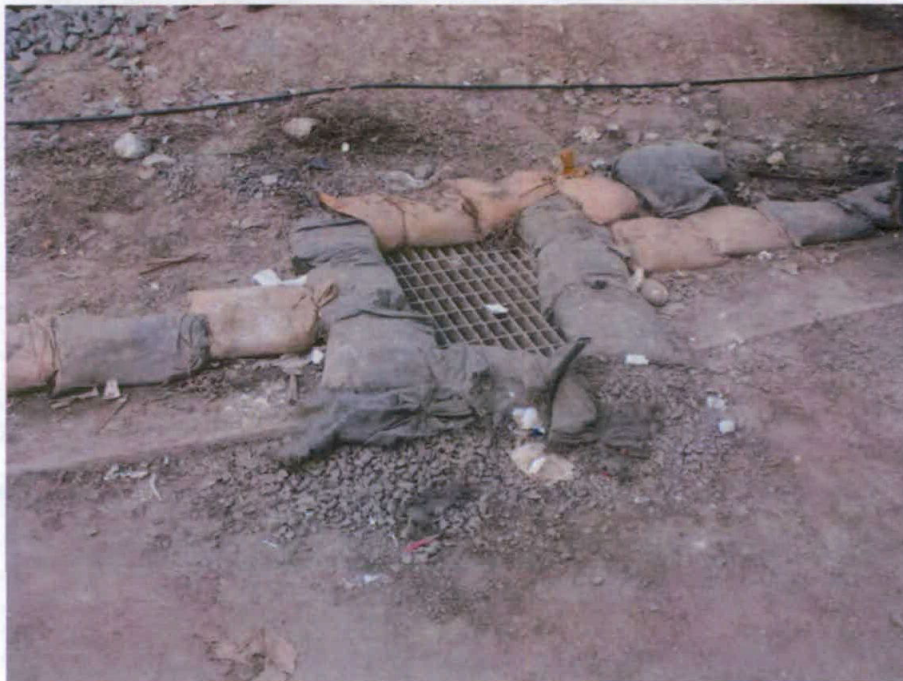
Figure 22. Broken gravel bags

7. Storm drain inlets within the construction site require protection to prevent sediment, trash, and construction debris from entering.
8. Gravel bags that have been broken need replacing.

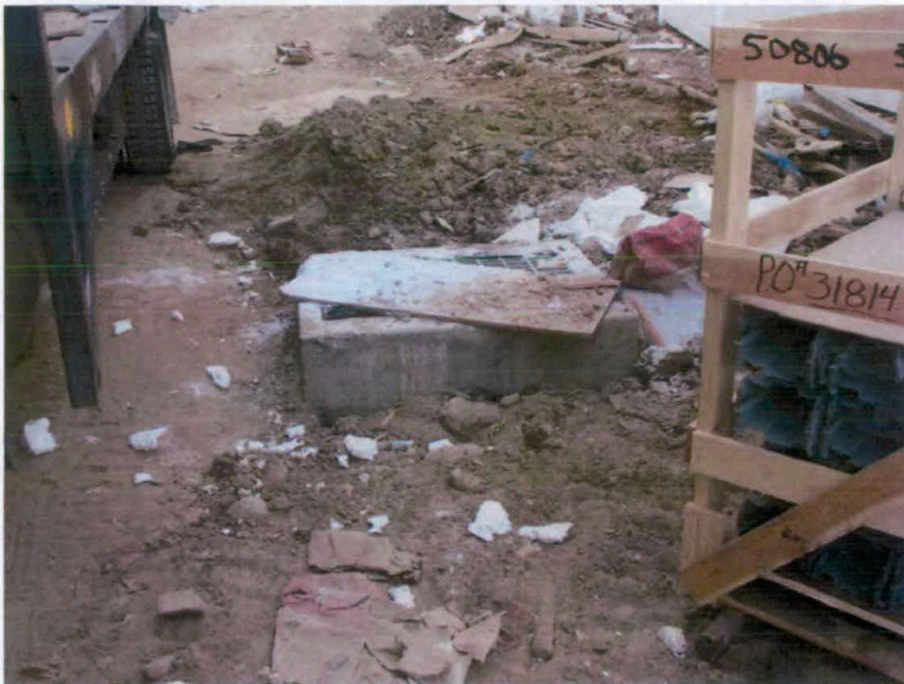
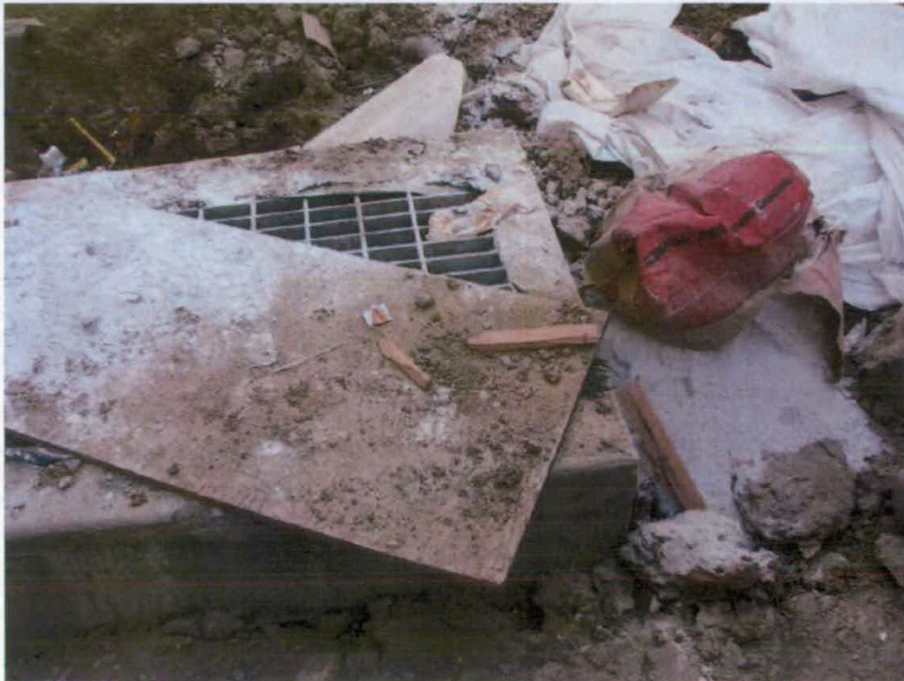
9. Mortar mix and other construction wastes had entered an unprotected inlet (Figures 23-24).
10. Several chemical containers were found throughout the site without secondary containment or other proper storage practices (Figure 25).

Figure 23. Storm drain littered with construction debris

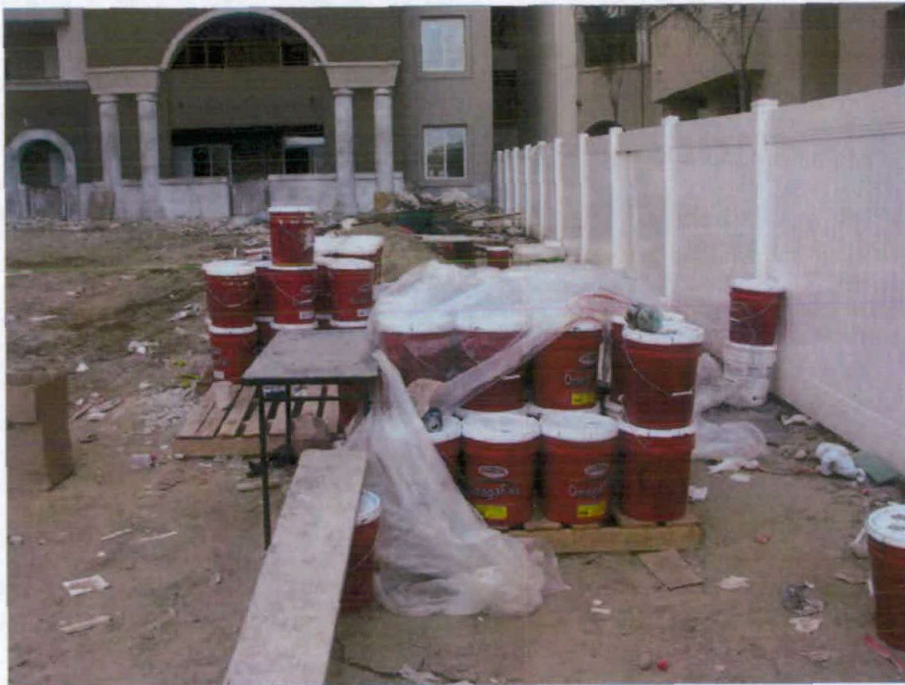
Figure 25. Improperly stored chemicals
