**Exhibit No. 1**

# NOTICE

DATE: 12/2/14  
PROJECT: VALENCIA  
PROJECT #: GR-1692  
ADDRESS: SAN AITO PL

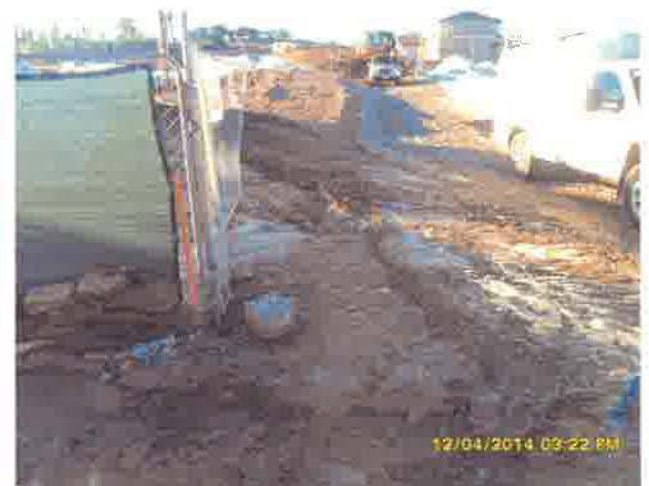
Sediment in street.

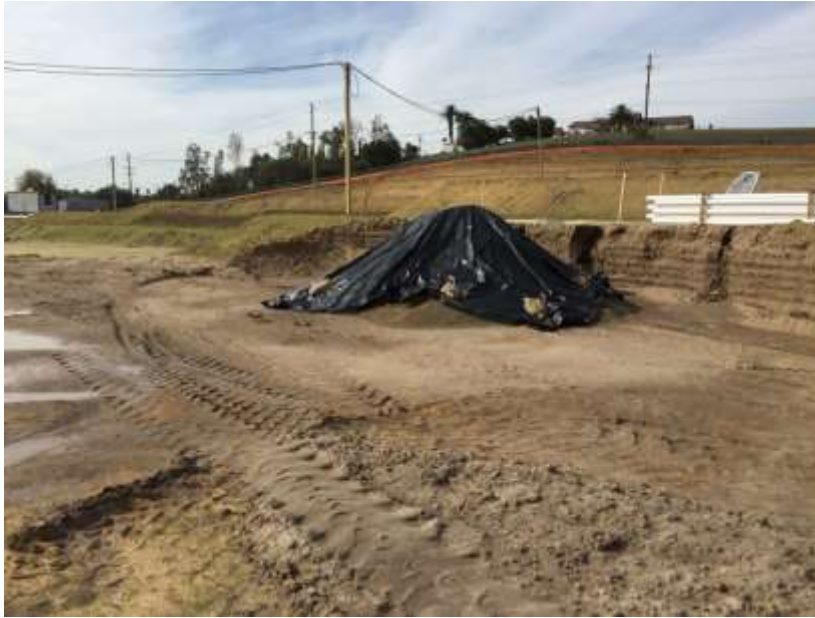
1. Several **stockpiles observed without adequate containment** (See Photo 1). Evidence of erosion and sediment transport from the stockpile observed during the inspection. All construction sites are required to contain and securely protect stockpiled waste material from wind and rain at all times unless actively being used.

**Photo 1** shows soil **stockpile without adequate containment**. Evidence of erosion and sediment transport along that base of the stockpile. Most stockpiles observed during inspection lacked adequate containment.

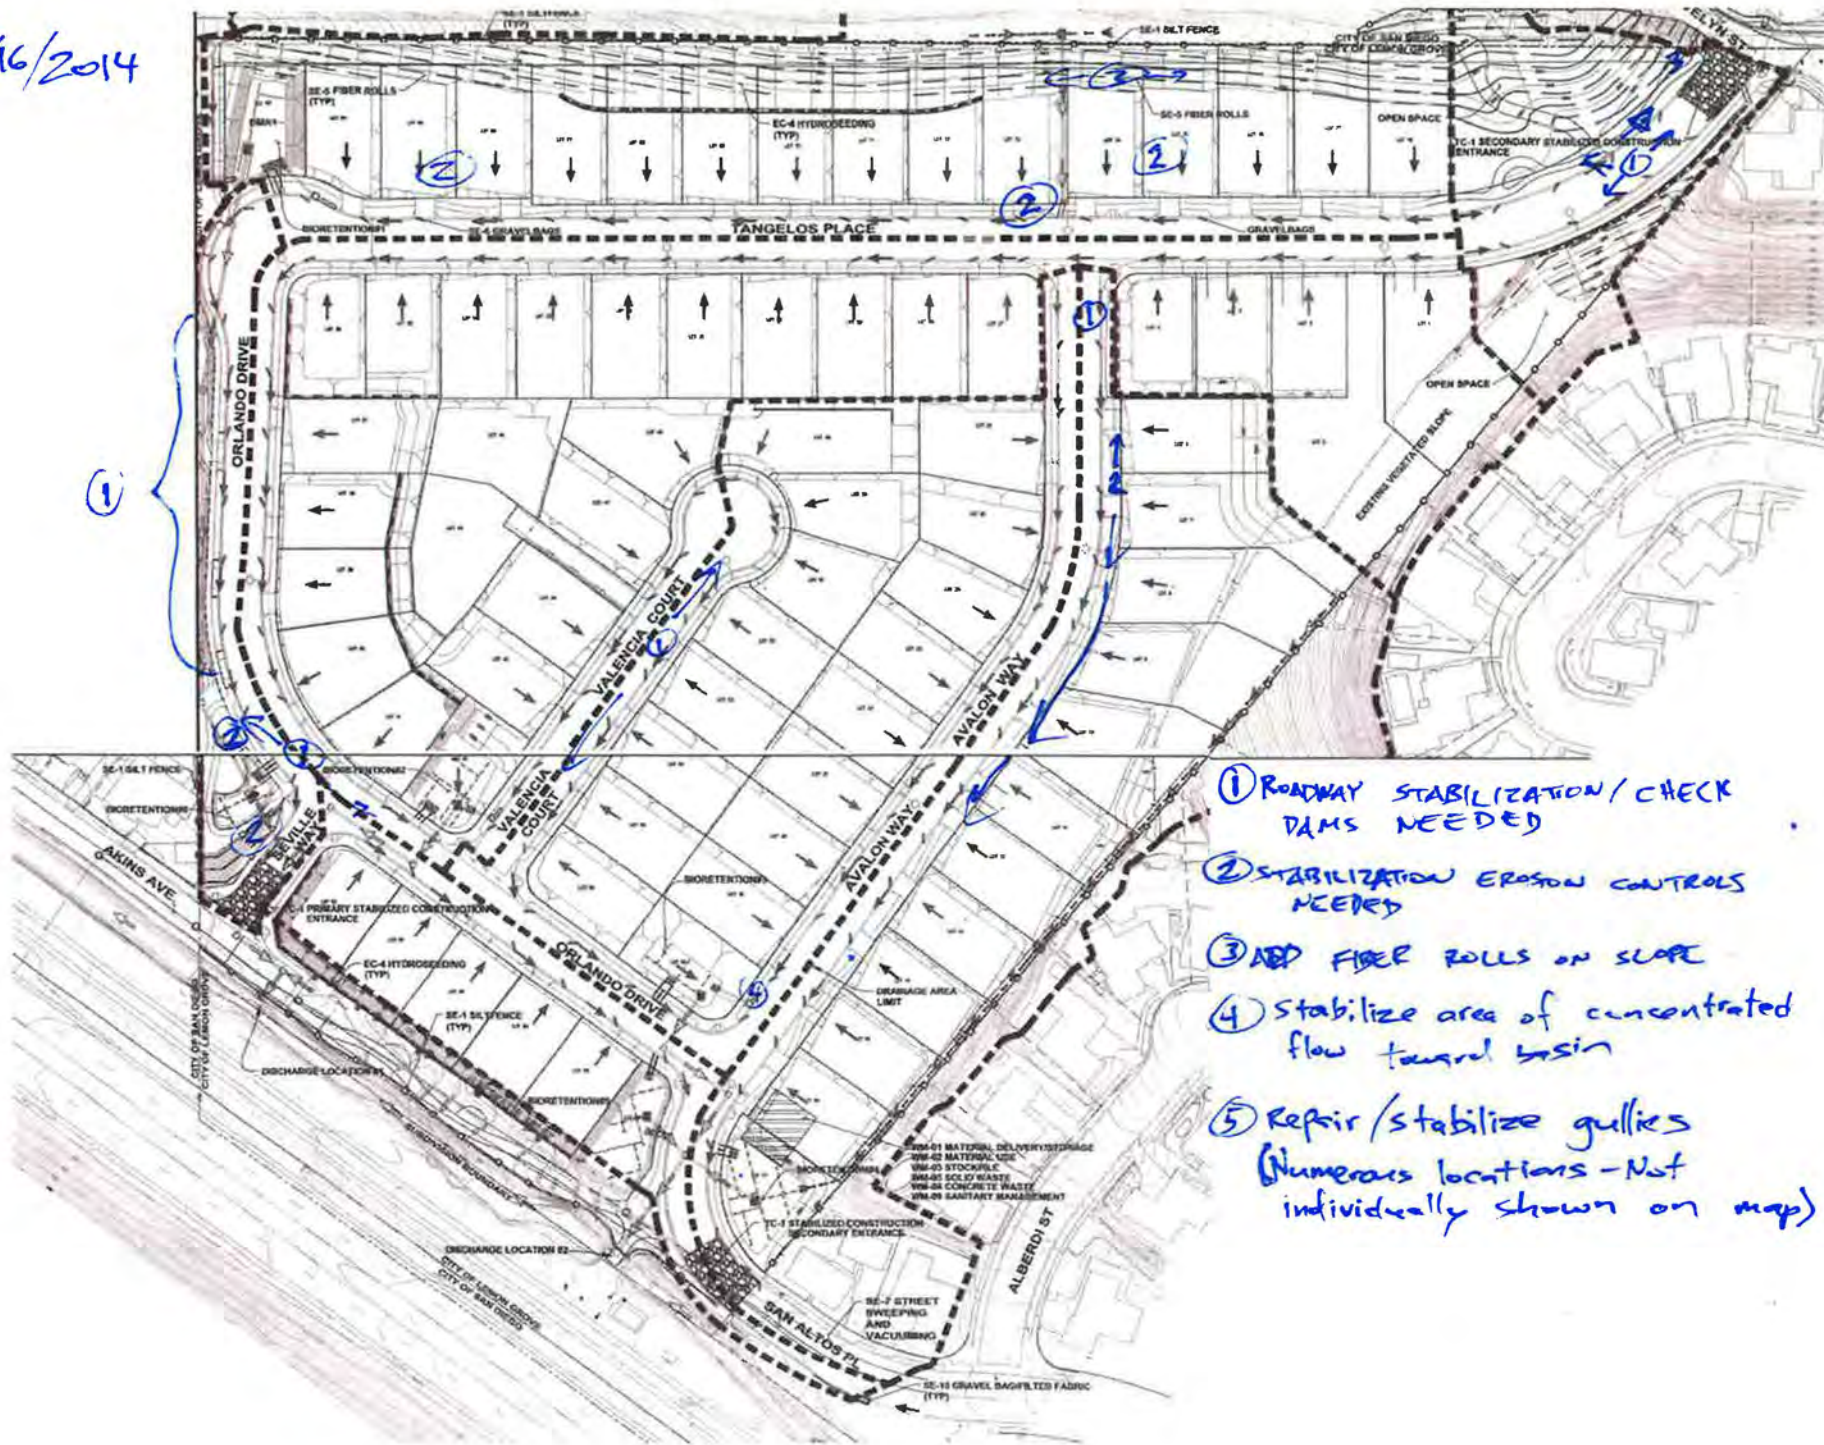
- ① ROADWAY STABILIZATION/CHECK DAMS NEEDED
- ② STABILIZATION EROSION CONTROLS NEEDED
- ③ ADD FIBER ROLLS ON SLOPE
- ④ Stabilize area of concentrated flow toward basin
- ⑤ Repair/stabilize gullies  
(Numerous locations - Not individually shown on map)

- COMPLETE ROADWAY STABILIZATION & CHECK DAMS. STABILIZE AREA WHERE CONCENTRATED FLOW FROM ROAD IS DIRECTED TO BASIN
- ADD EROSION CONTROLS TO STABILIZE REMAINING PADS, SLOPES AT EDGES OF PADS AND AREA NEAR ENTRANCE ON AKINS
- ADD FIBER ROLLS ON SLOPES ON WESTERN EDGE
- REPAIR & STABILIZE GULLIES THROUGHOUT SITE

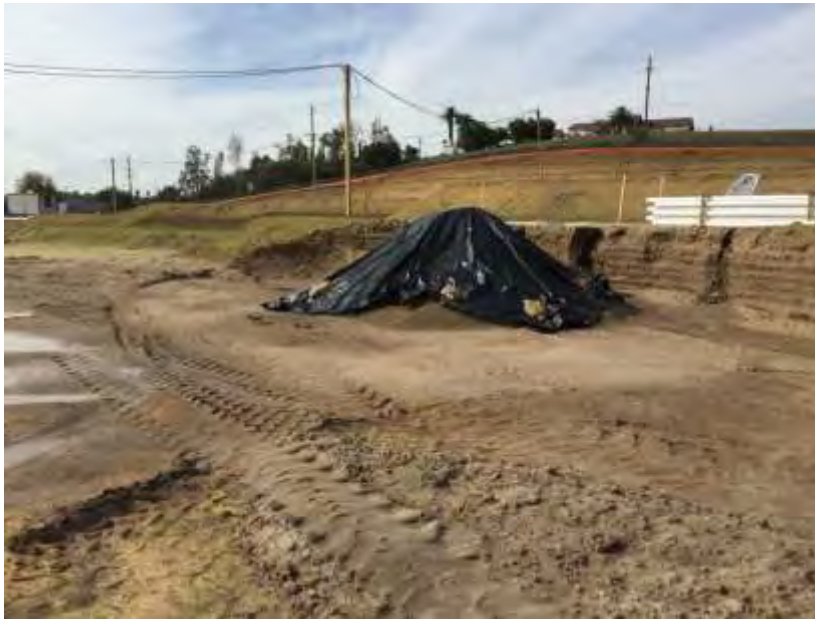
**Photo 1** shows soil stockpile without adequate containment. Evidence of erosion and sediment transport along that base of the stockpile. Most stockpiles observed during inspection lacked adequate containment.

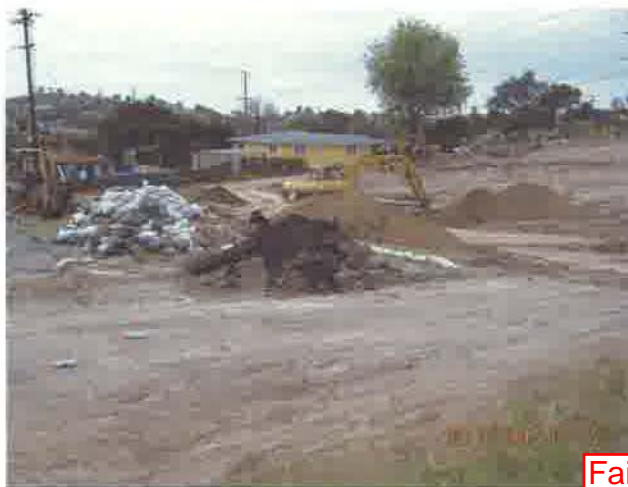
Failure to cover and provide secondary containment.

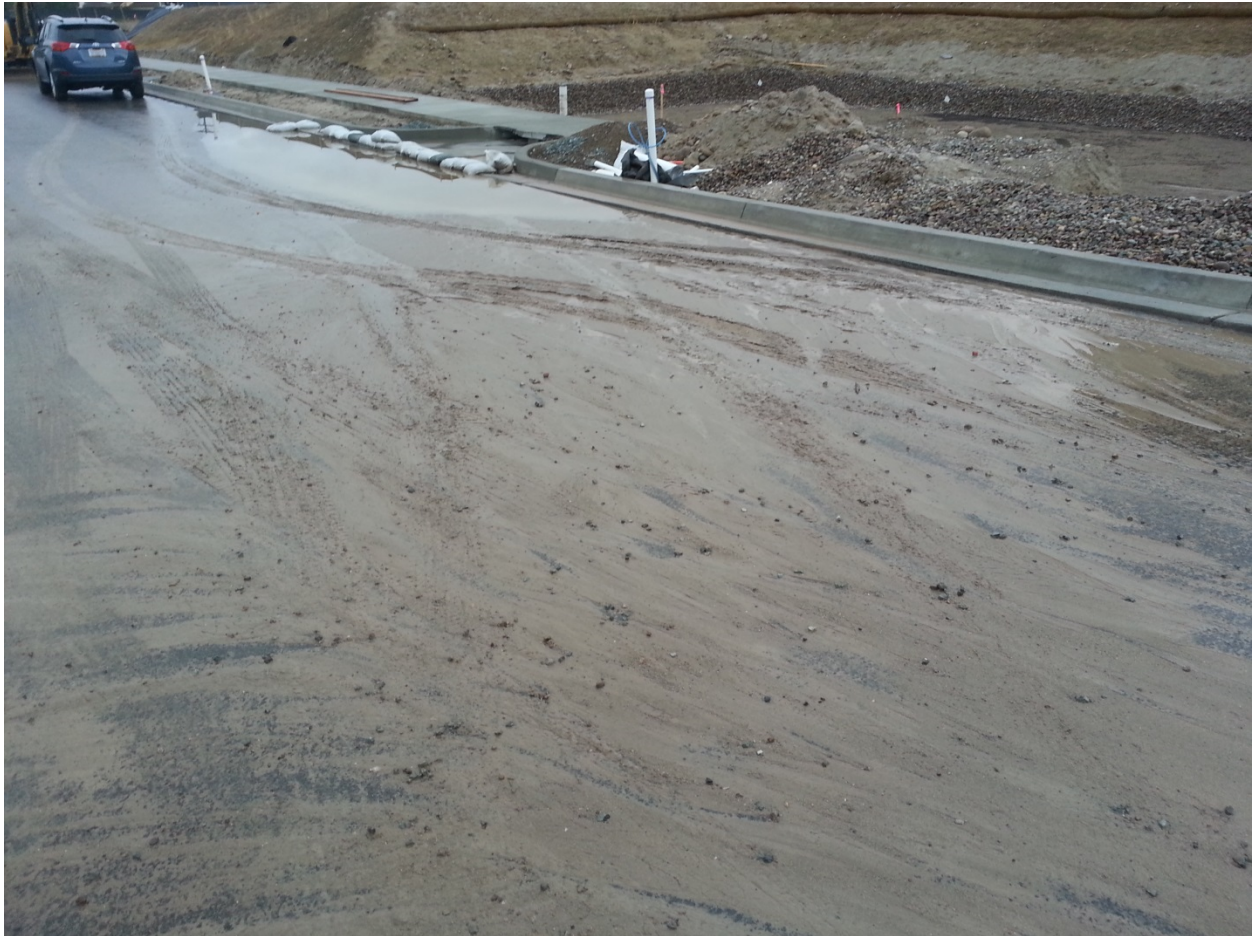
**Photograph No. 1:** 20150508\_191716.jpg, taken by Frank Melbourne, San Diego Water Board

**Photograph No. 1** looks west at Orlando Drive from San Altos Place. The photograph displays a **sediment discharge** from disturbed construction areas into the street. The sediment was an inch thick in some areas. Displayed slopes in the photograph show signs of erosion, and were lacking erosion and sediment control BMPs at their base. Parkway strips failed to have sediment control BMPs. There was no site personnel available to cleanup discharged sediment or maintain/reinforce failed BMPs. There was an absence of run-on/run-off control BMPs. For example there were no gravel bag chevrons or check dams along the street to slow down the runoff flow.

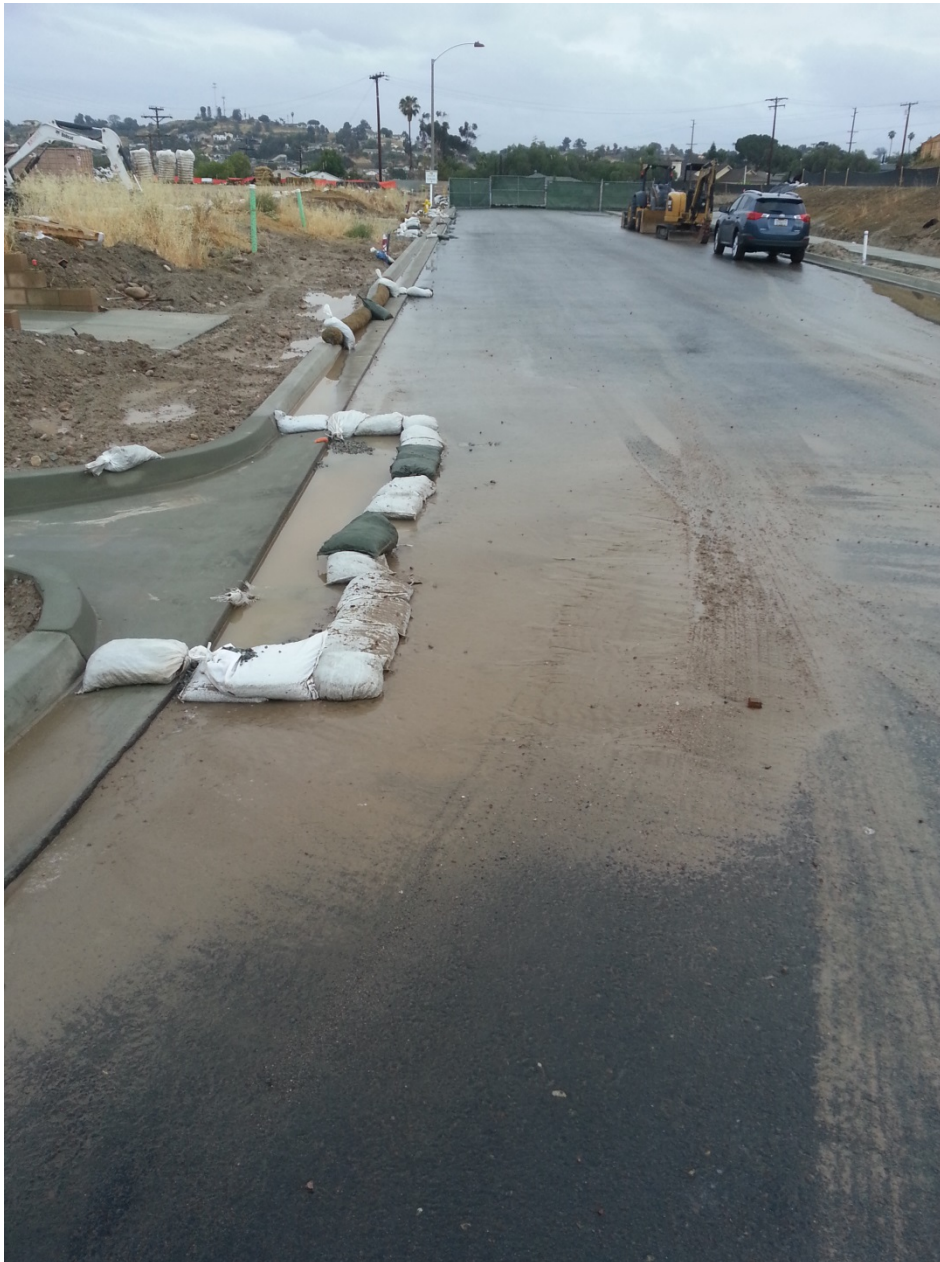
**Photograph No. 2:** 20150508\_191734.jpg, taken by Frank Melbourne, San Diego Water Board

**Photograph No. 2** looks southwest at Orlando Drive from San Altos Place. The photograph displays a **sediment discharge** from disturbed construction areas into the street. The photograph also displays unprotected (absent erosion control BMPs) disturbed soil and a lack of sediment controls above street gutters. The gravel bags deployed to protect the storm drain inlet were ineffective as evidenced by the turbid sediment laden storm water on the inside edges of the gravel bags. Again the use of gravel bag chevrons could have been implemented in the street.
