California Water Service Company Polhemus Creek Spills - Inspection Photos -

Photos were taken by Regional Water Board Staff during staff's site inspection of September 28, 2007. The inspection's purpose was to assess the aquatic impacts resulting from the California Water Service Company's September 25 & 27, 2007, chloraminated potable water discharges to Polhemus Creek.

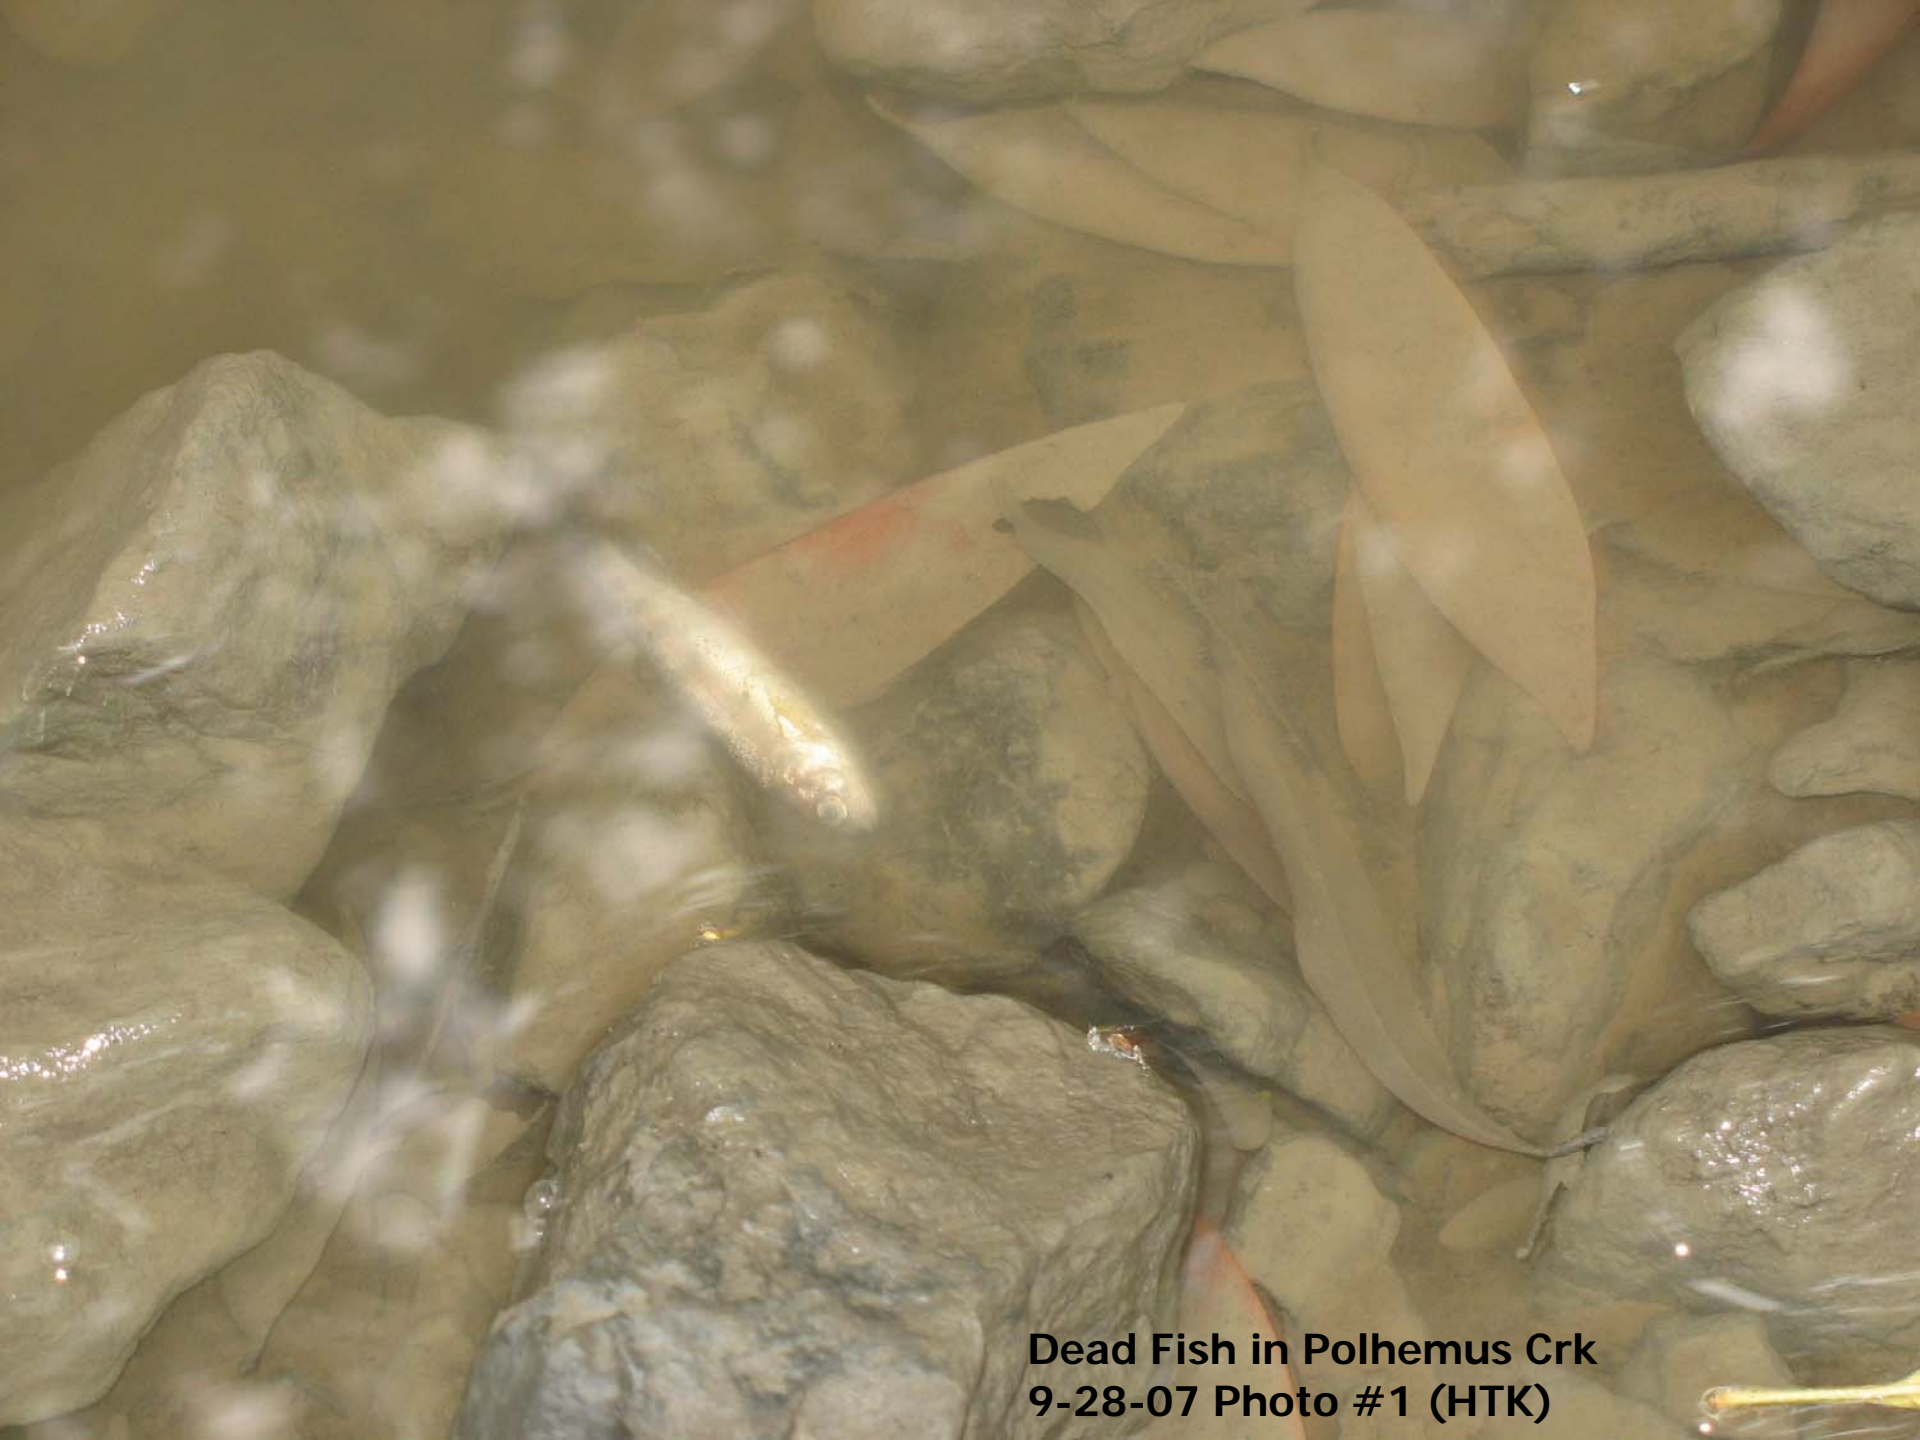
**Dead Fish in Polhemus Crk
9-28-07 Photo #1 (HTK)**

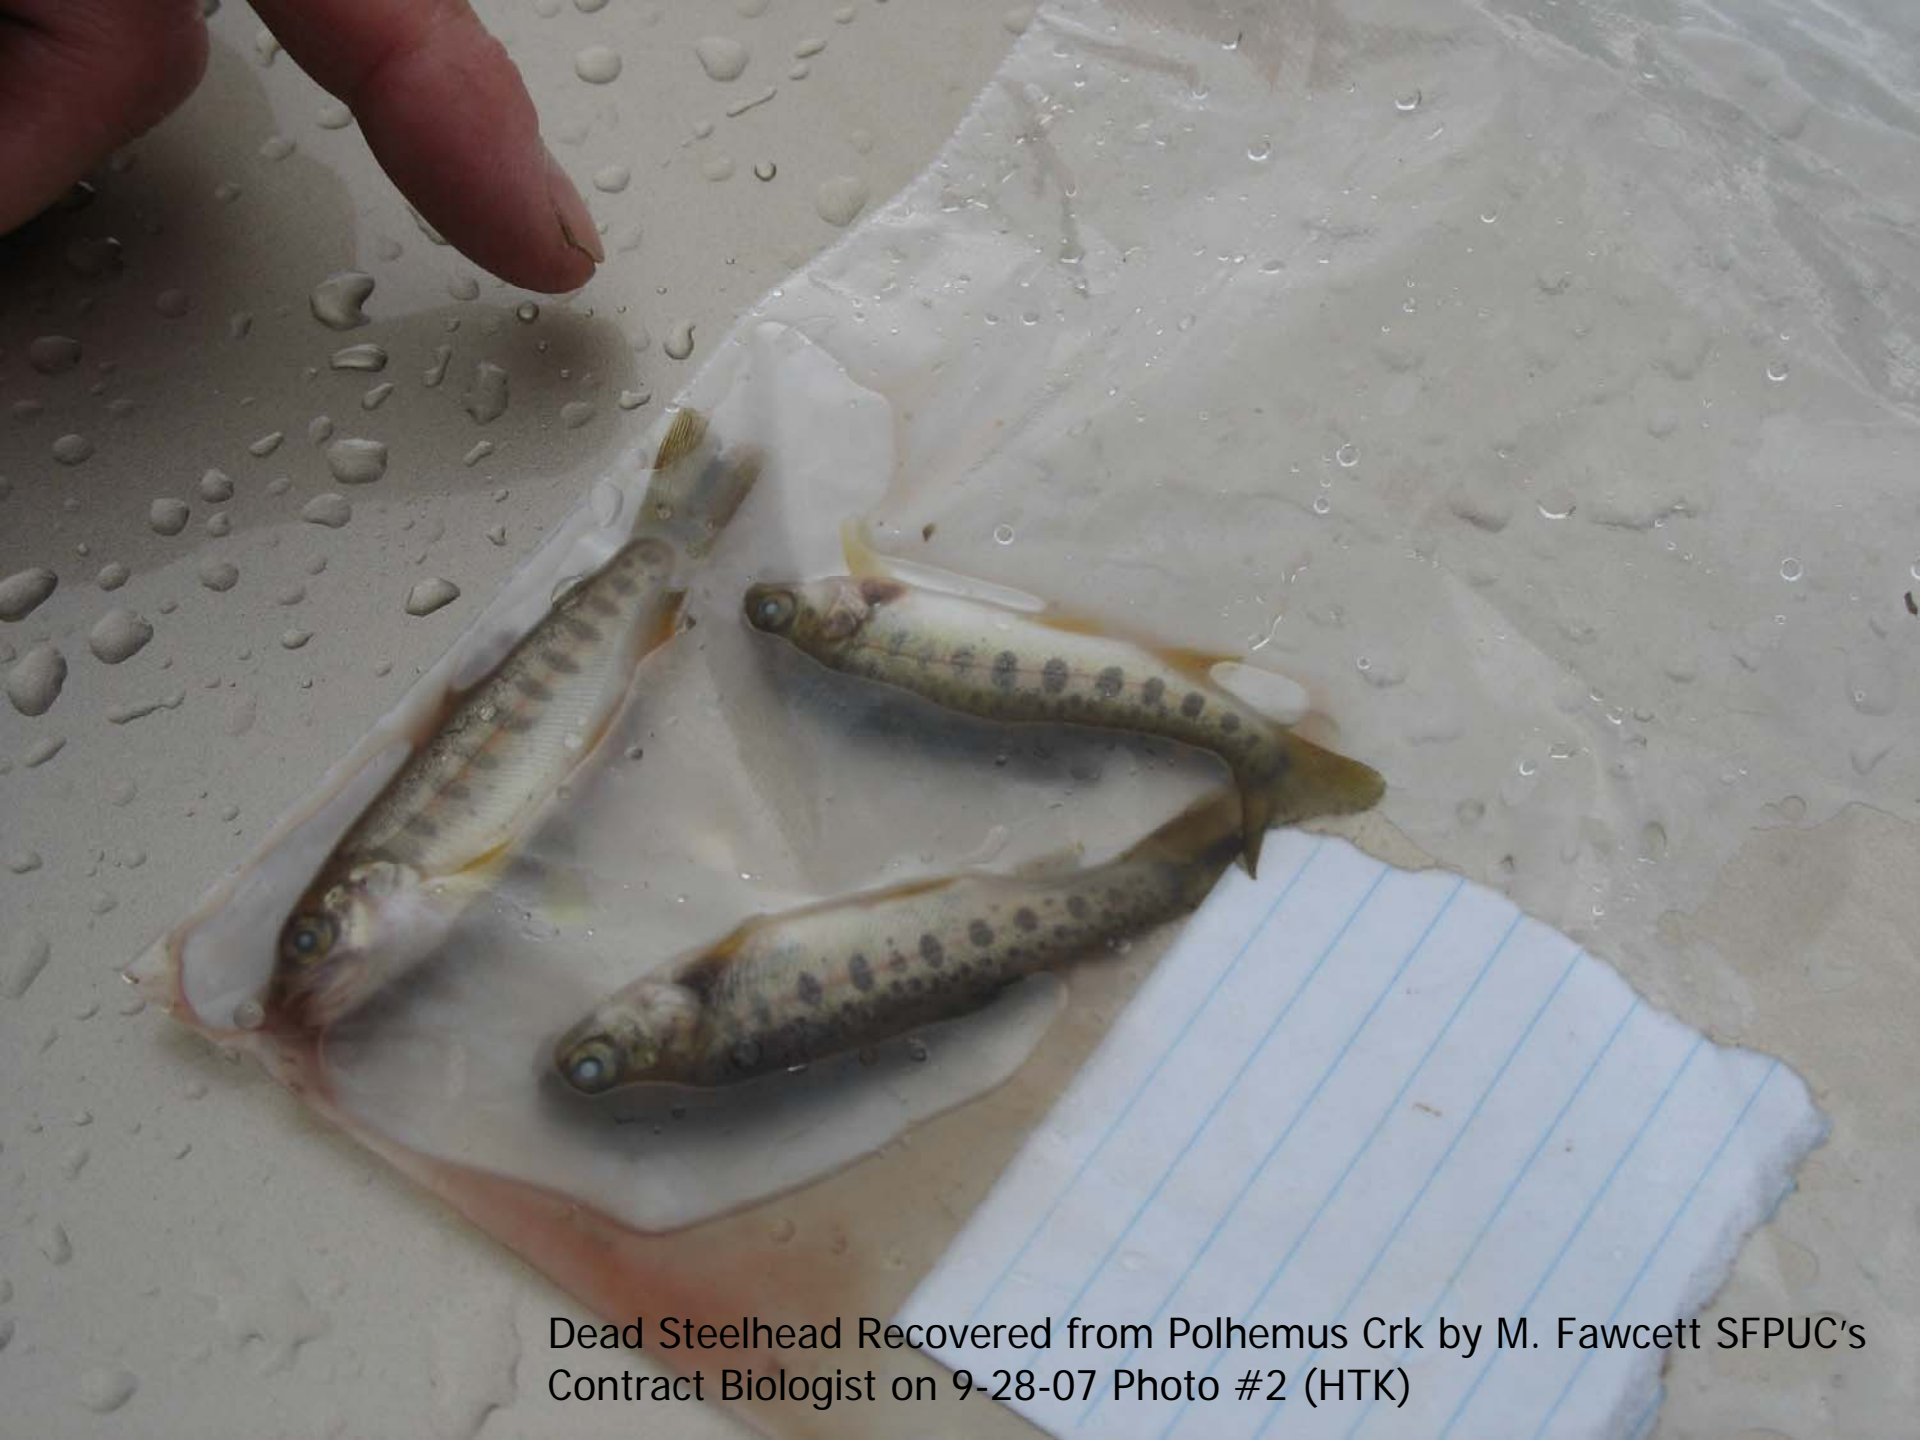
Dead Steelhead Recovered from Polhemus Crk by M. Fawcett SFPUC's Contract Biologist on 9-28-07 Photo #2 (HTK)

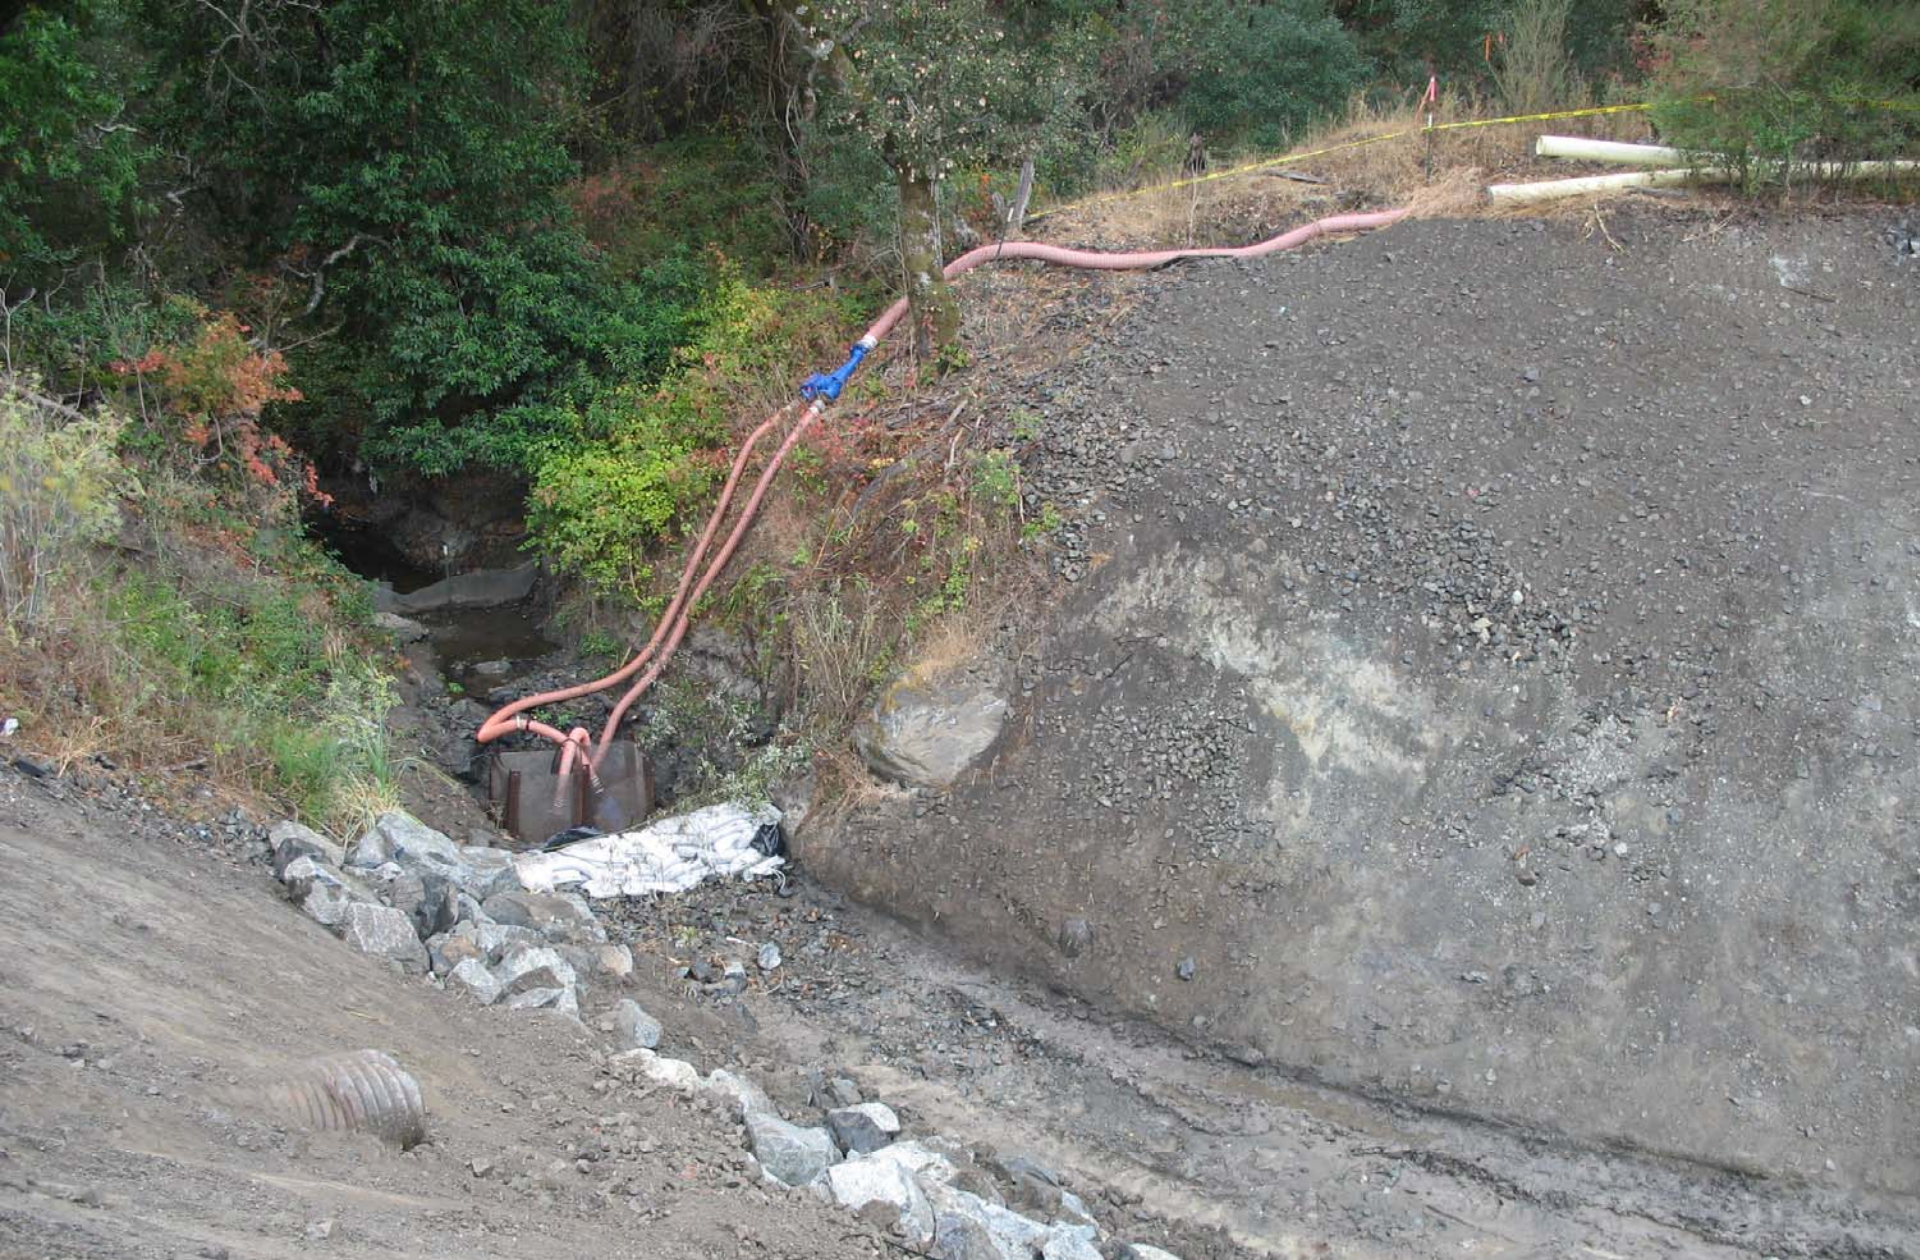
Dewatering Pumps and Cofferdam at Polhemus Crk Restoration Site – Upstream (South End) of Isolated Work Area 9-28-07 Photo #3 (HTK)

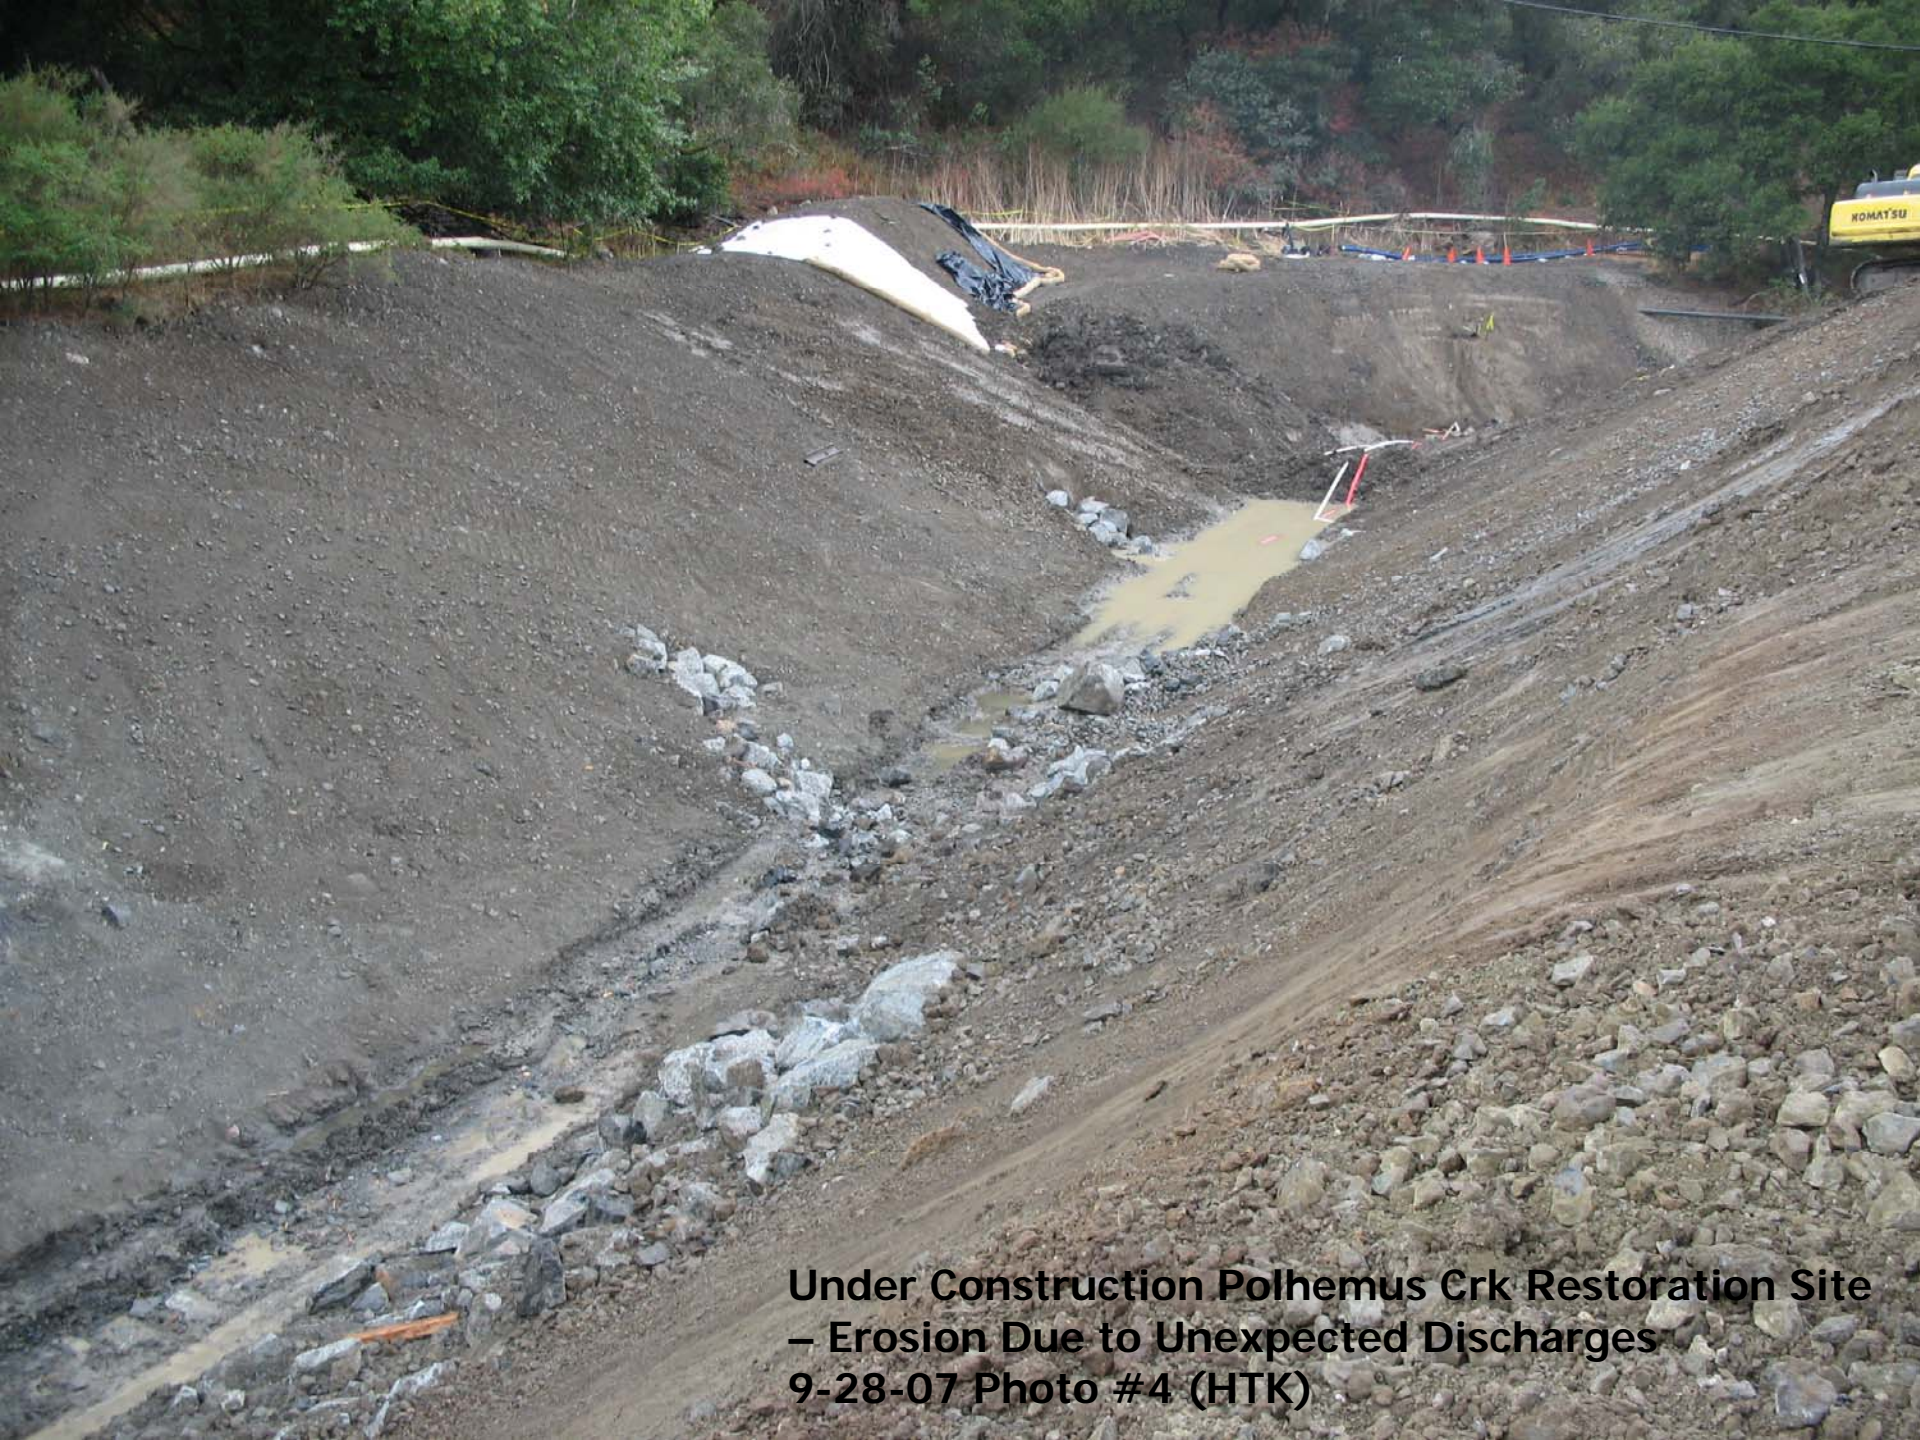
**Under Construction Polhemus Crk Restoration Site
– Erosion Due to Unexpected Discharges
9-28-07 Photo #4 (HTK)**

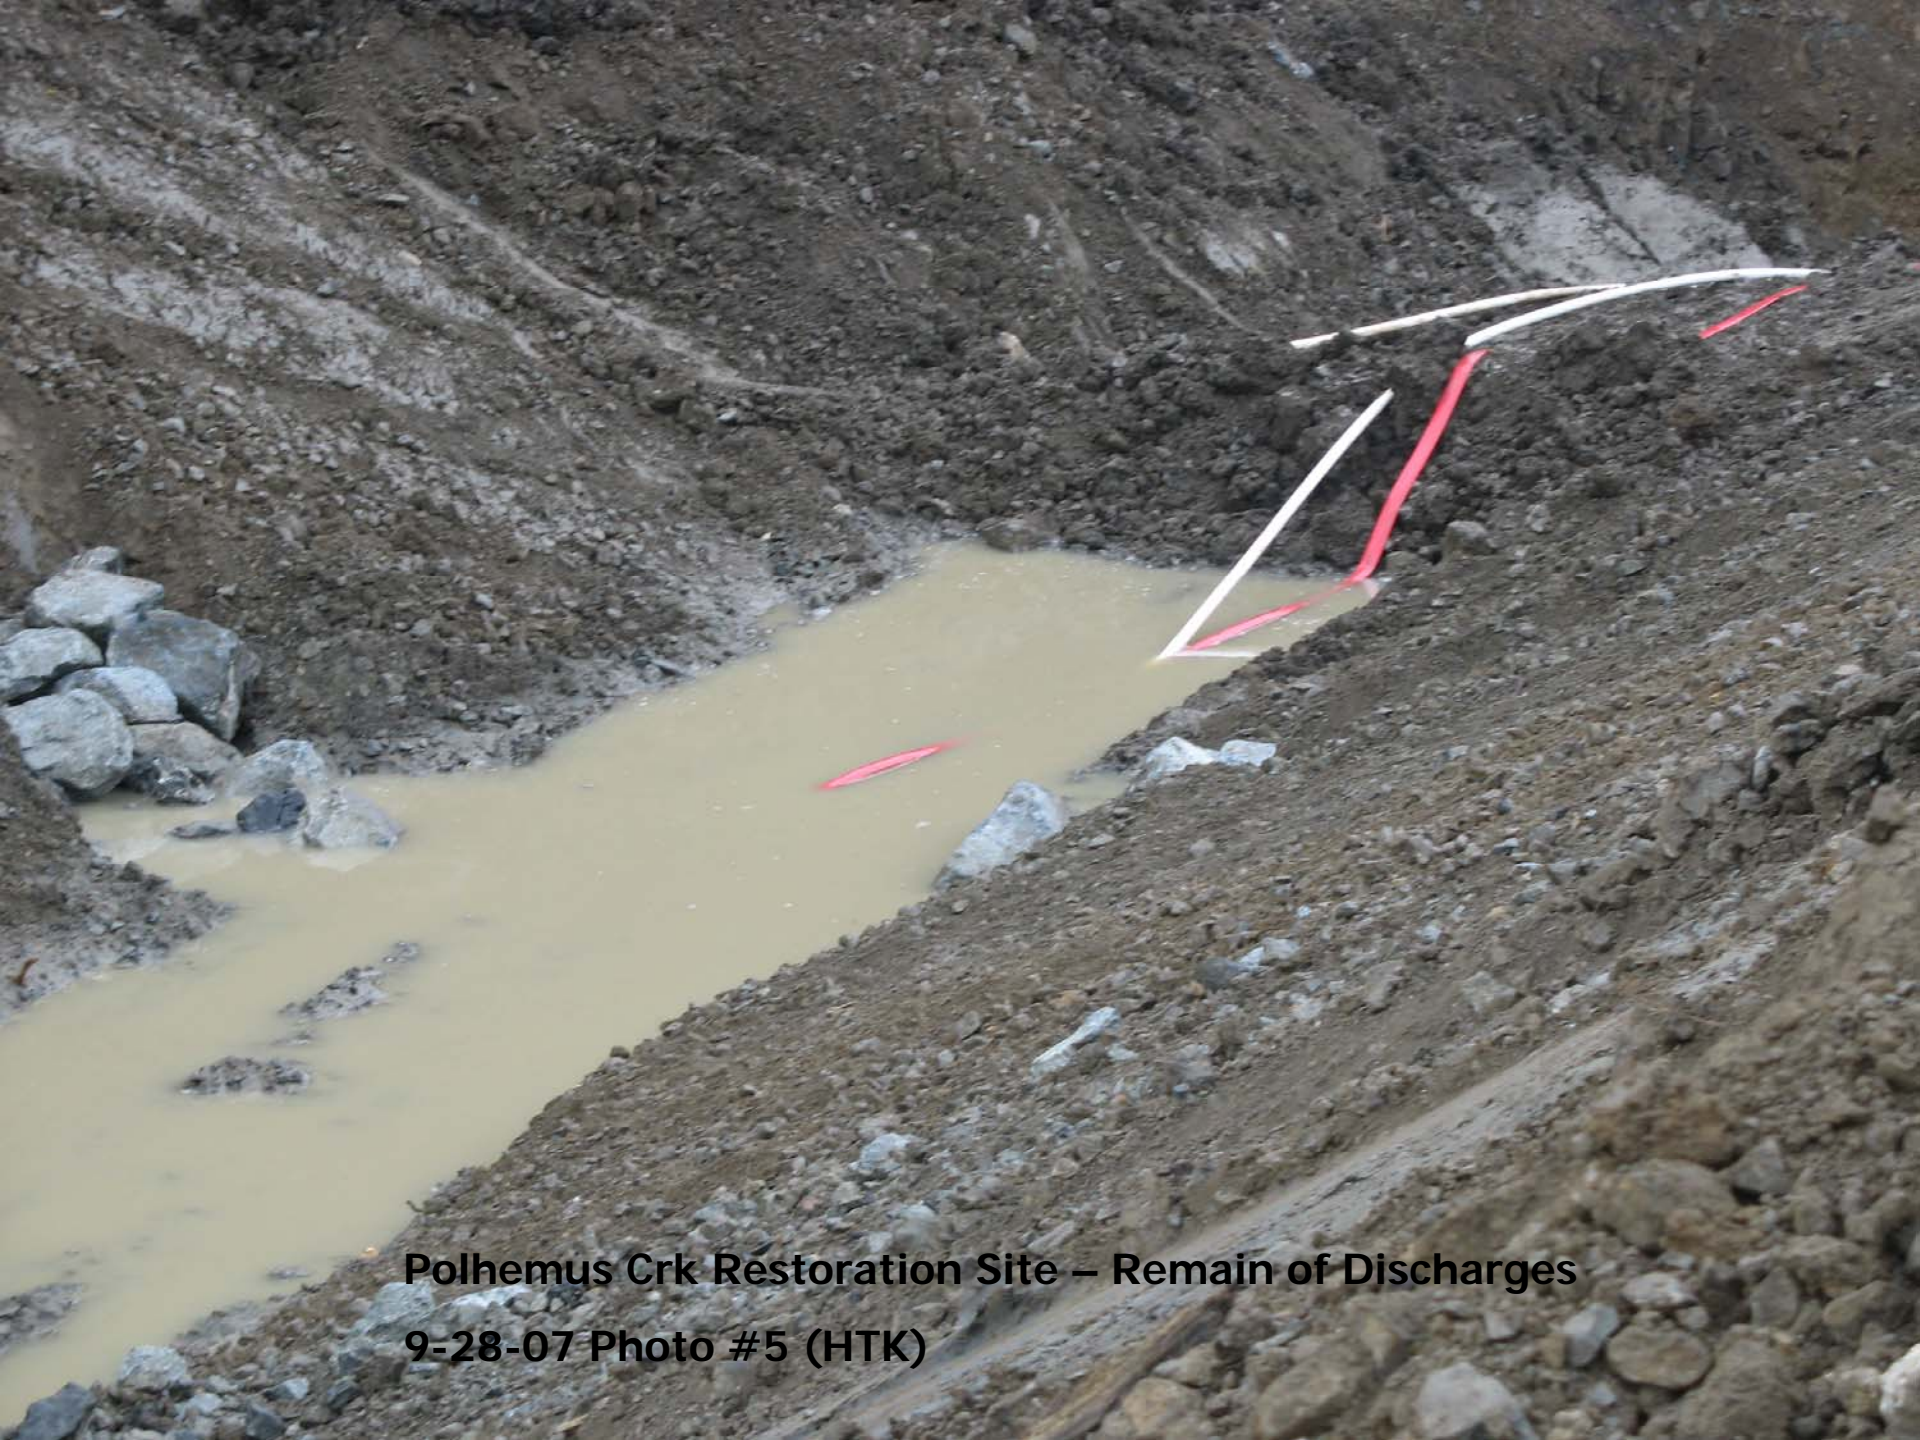
**Polhemus Crk Restoration Site – Remain of Discharges
9-28-07 Photo #5 (HTK)**

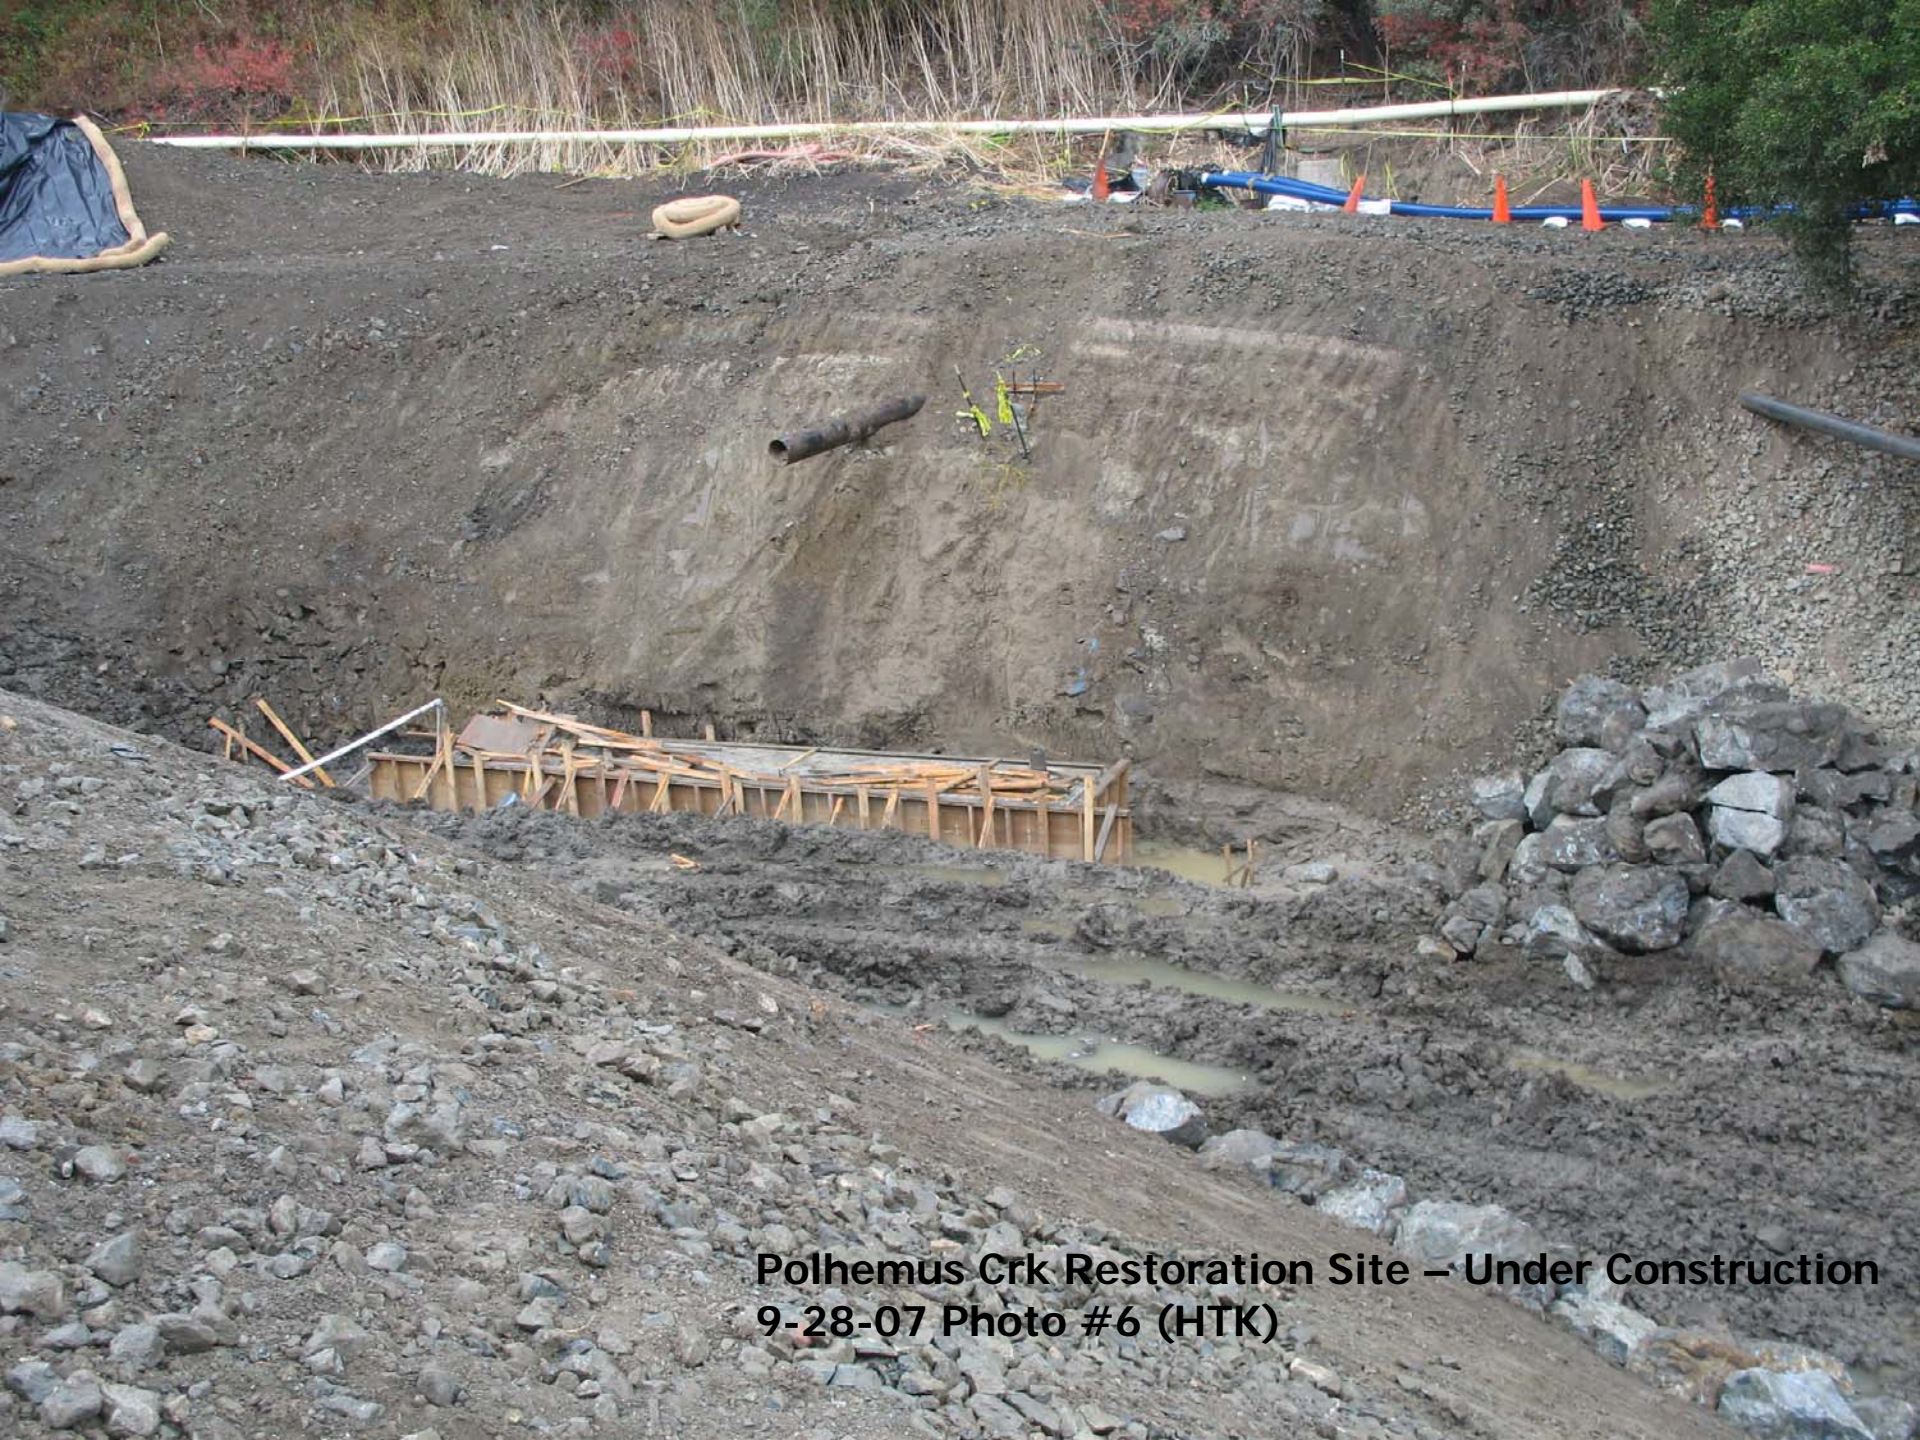
**Polhemus Crk Restoration Site – Under Construction
9-28-07 Photo #6 (HTK)**

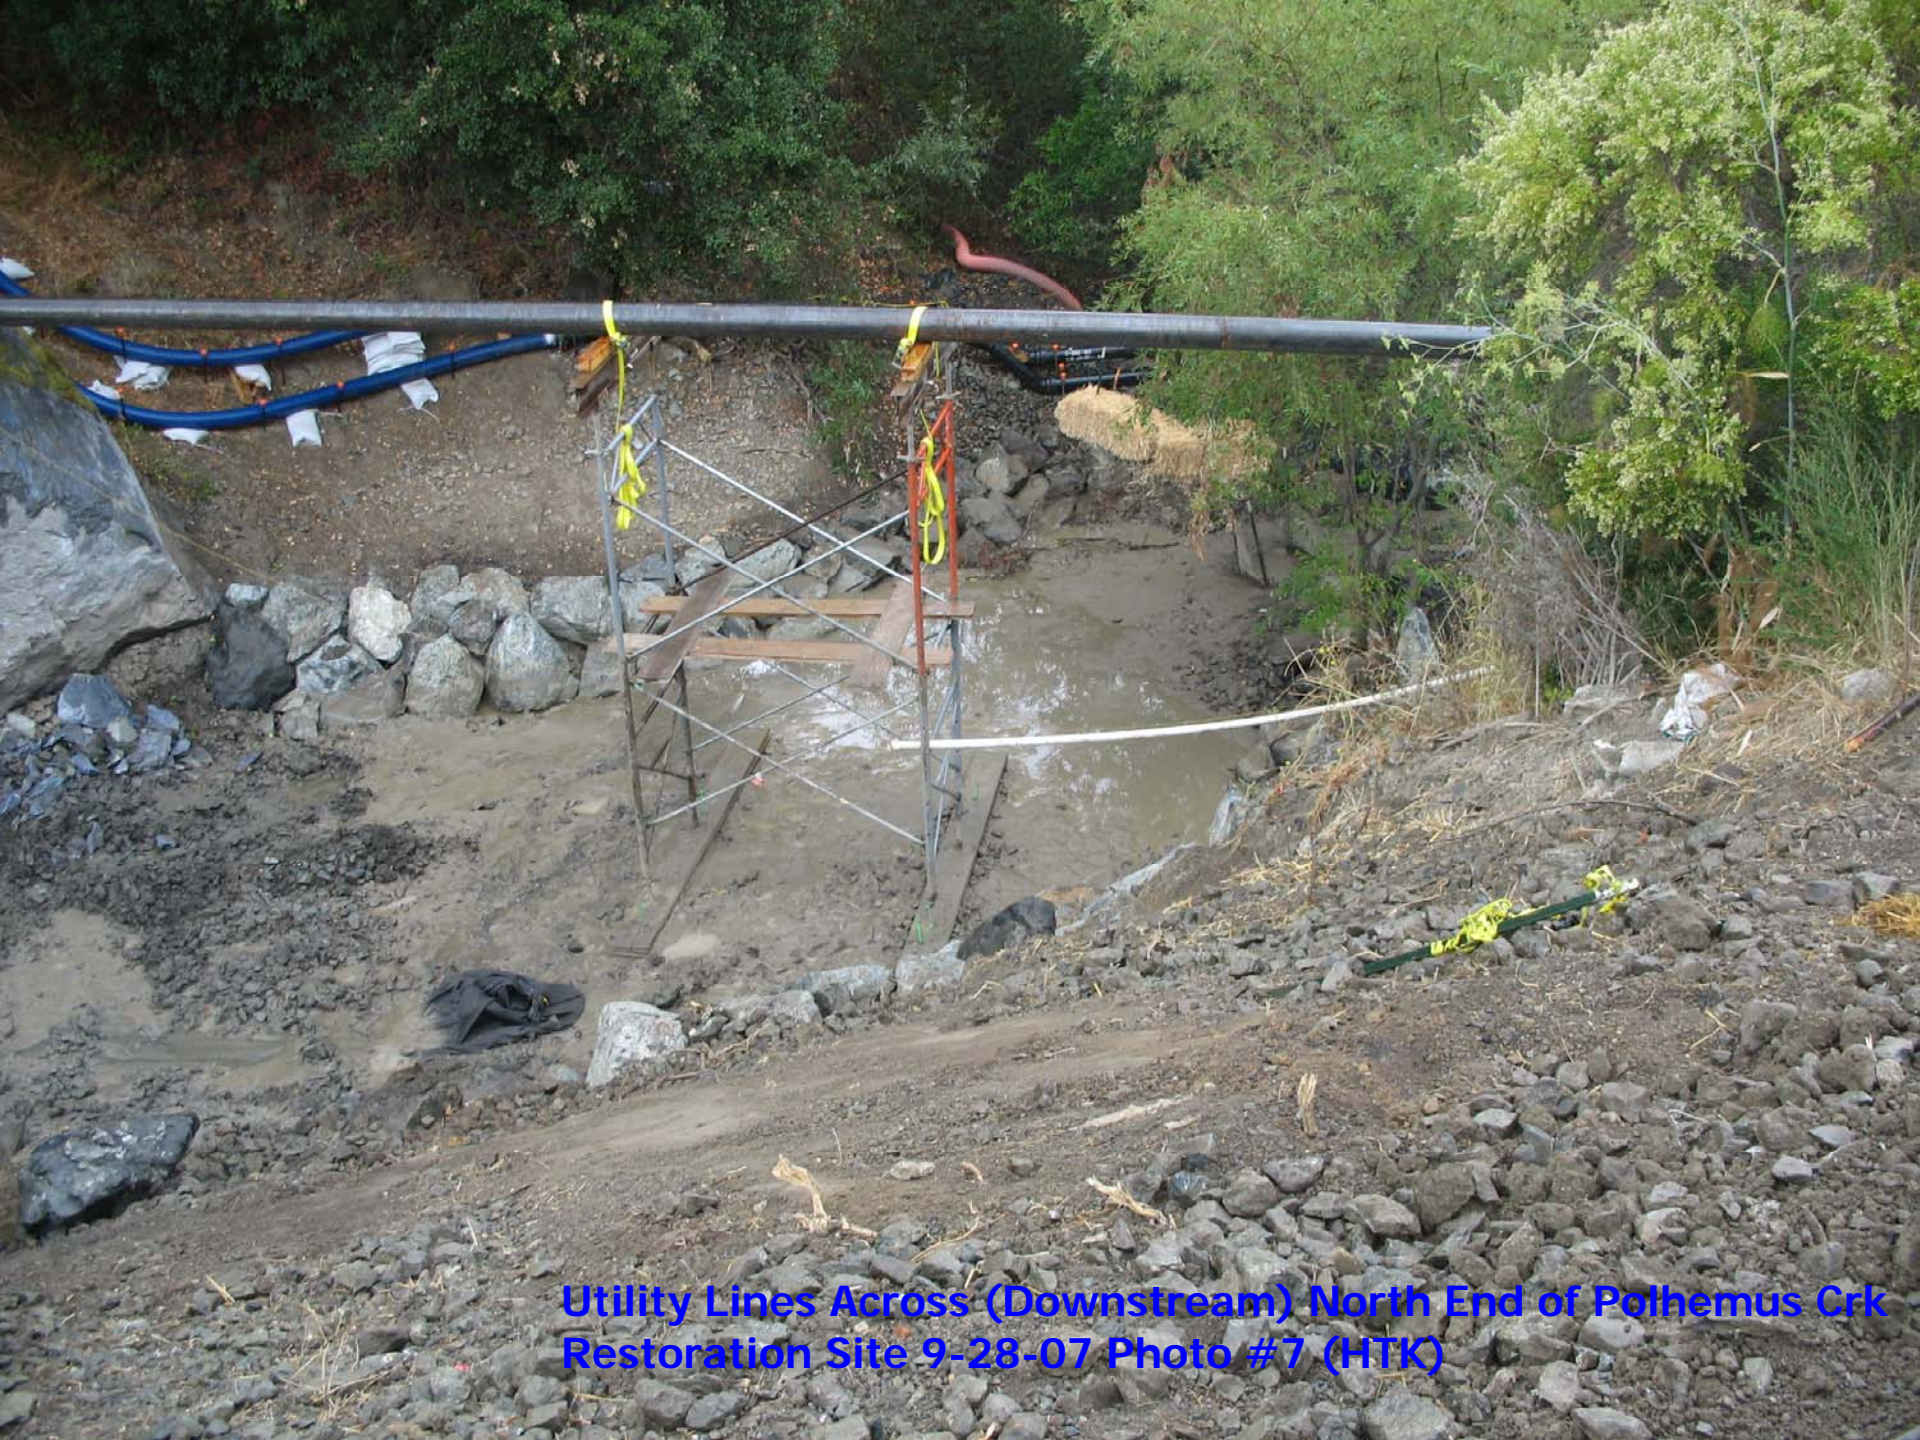
Utility Lines Across (Downstream) North End of Polhemus Crk
Restoration Site 9-28-07 Photo #7 (HTK)

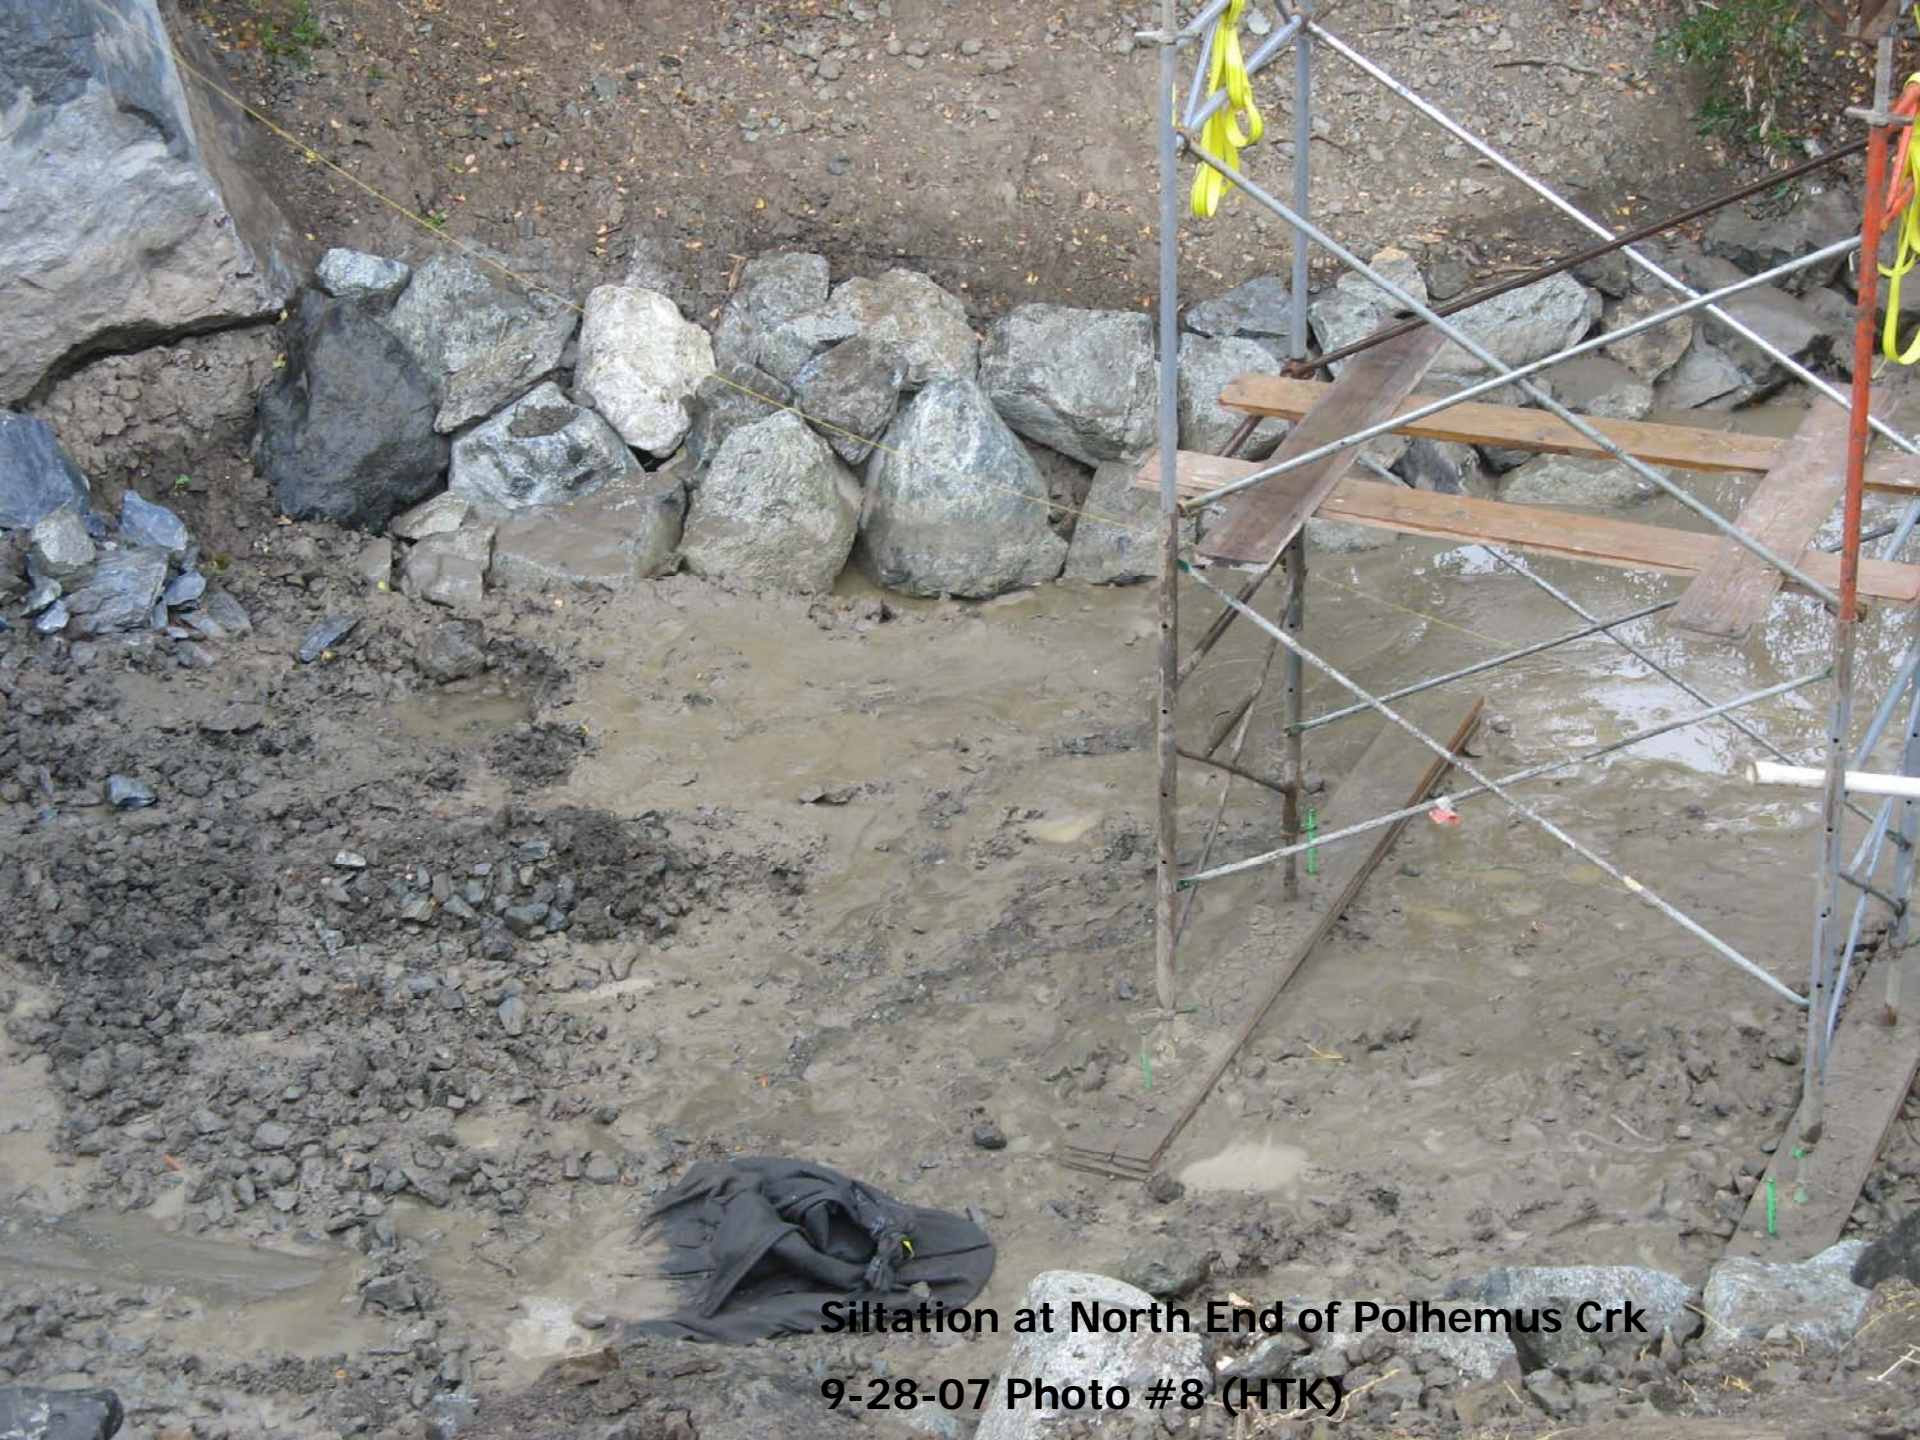
**Siltation at North End of Polhemus Crk
9-28-07 Photo #8 (HTK)**
