California Water Service Company Polhemus Creek Spills - Inspection Photos -

Photos were taken by Regional Water Board Staff during staff's site inspection of September 28, 2007. The inspection's purpose was to assess the aquatic impacts resulting from the California Water Service Company's September 25 & 27, 2007, chloraminated potable water discharges to Polhemus Creek.

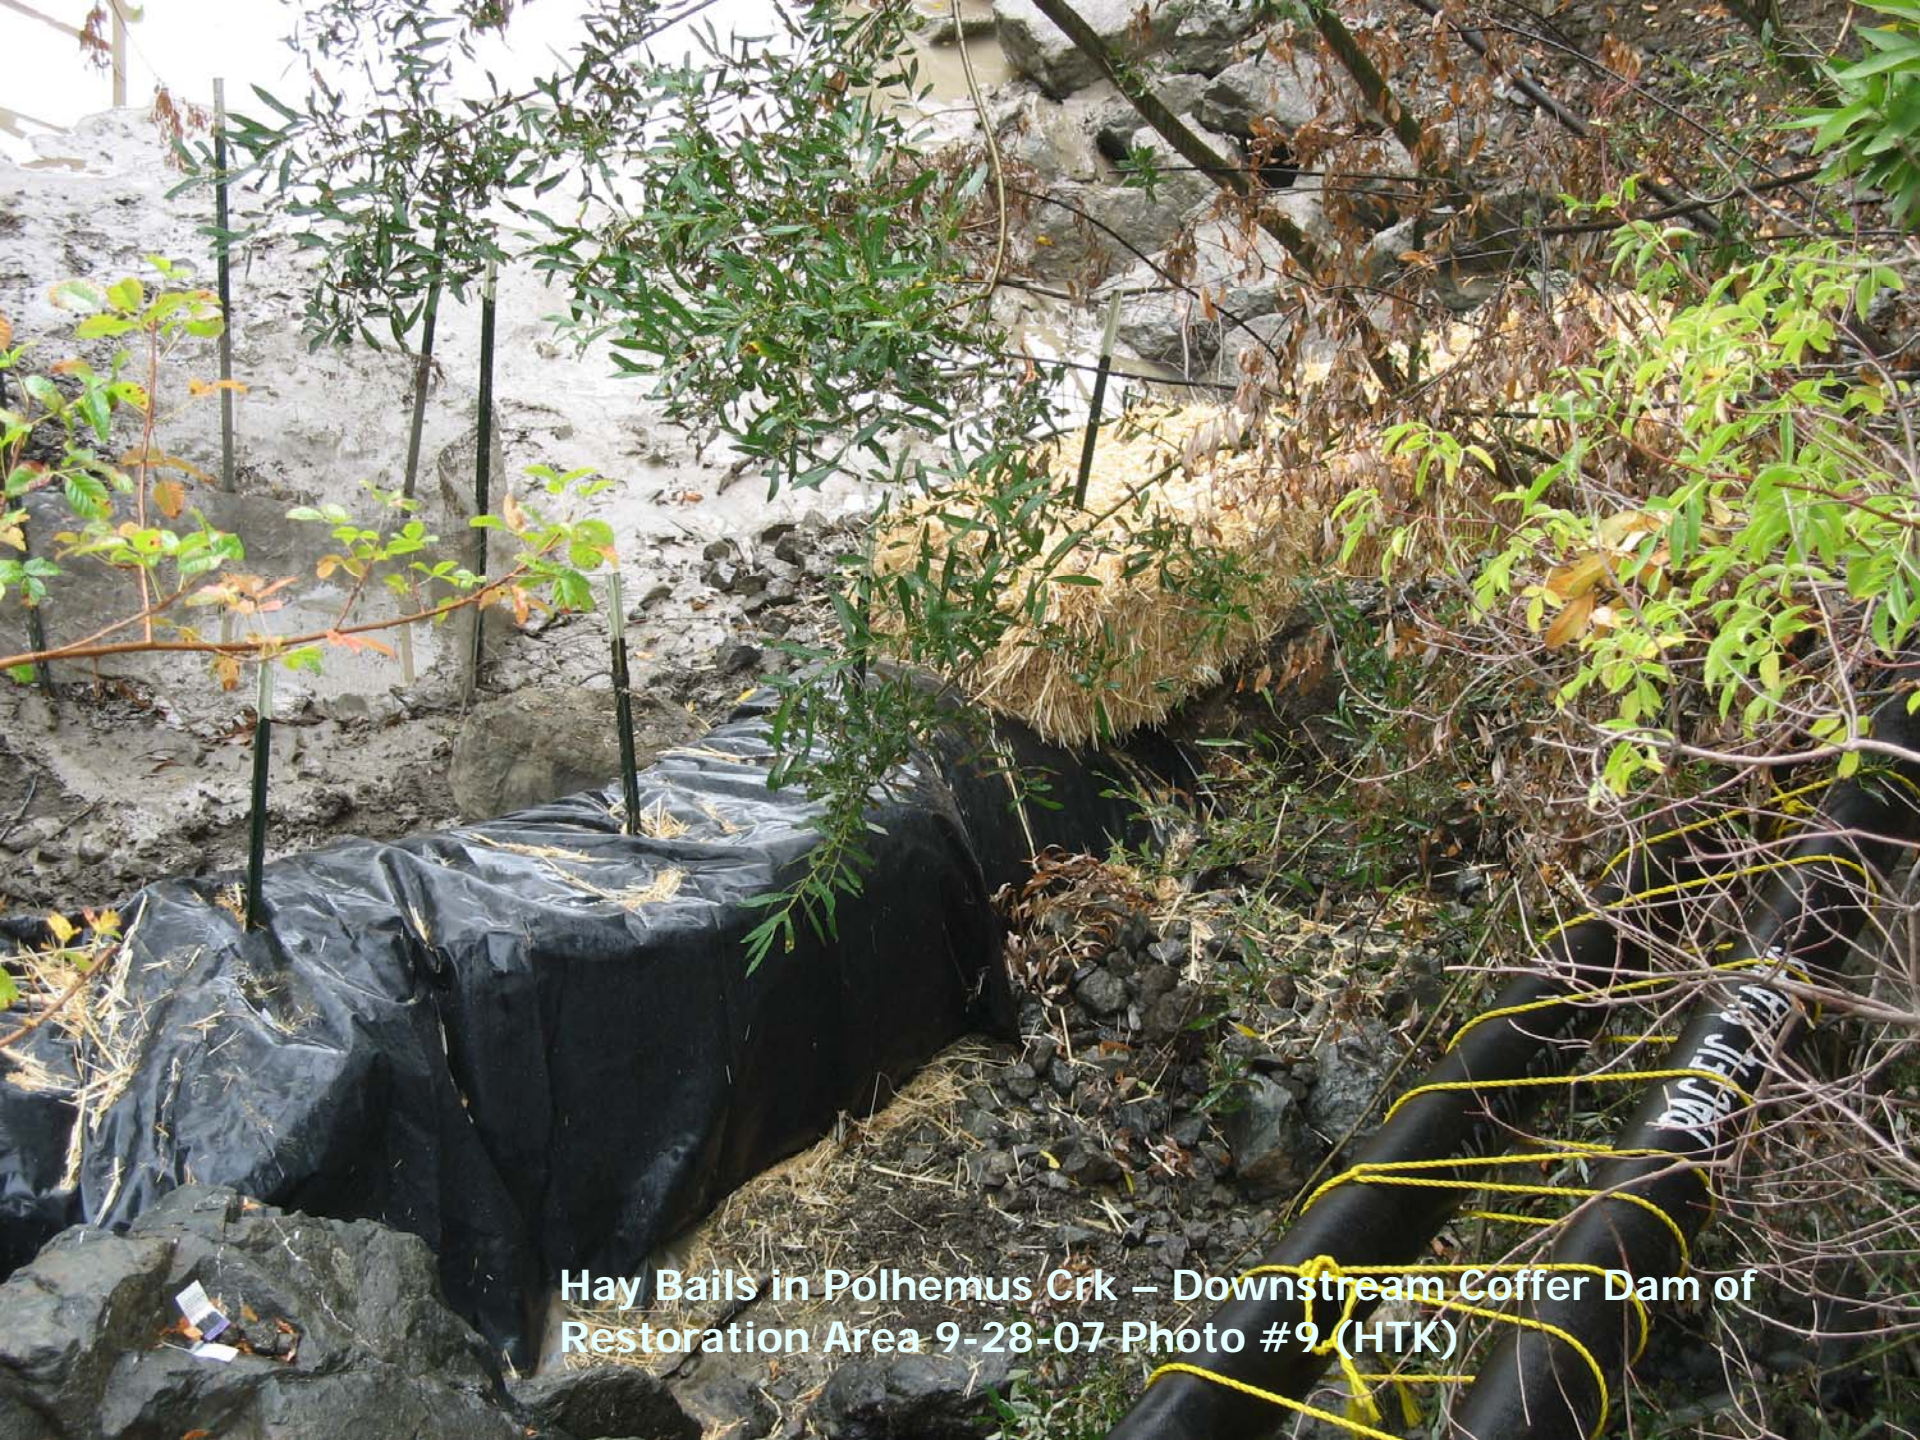
Hay Bails in Polhemus Crk – Downstream Coffer Dam of Restoration Area 9-28-07 Photo #9 (HTK)

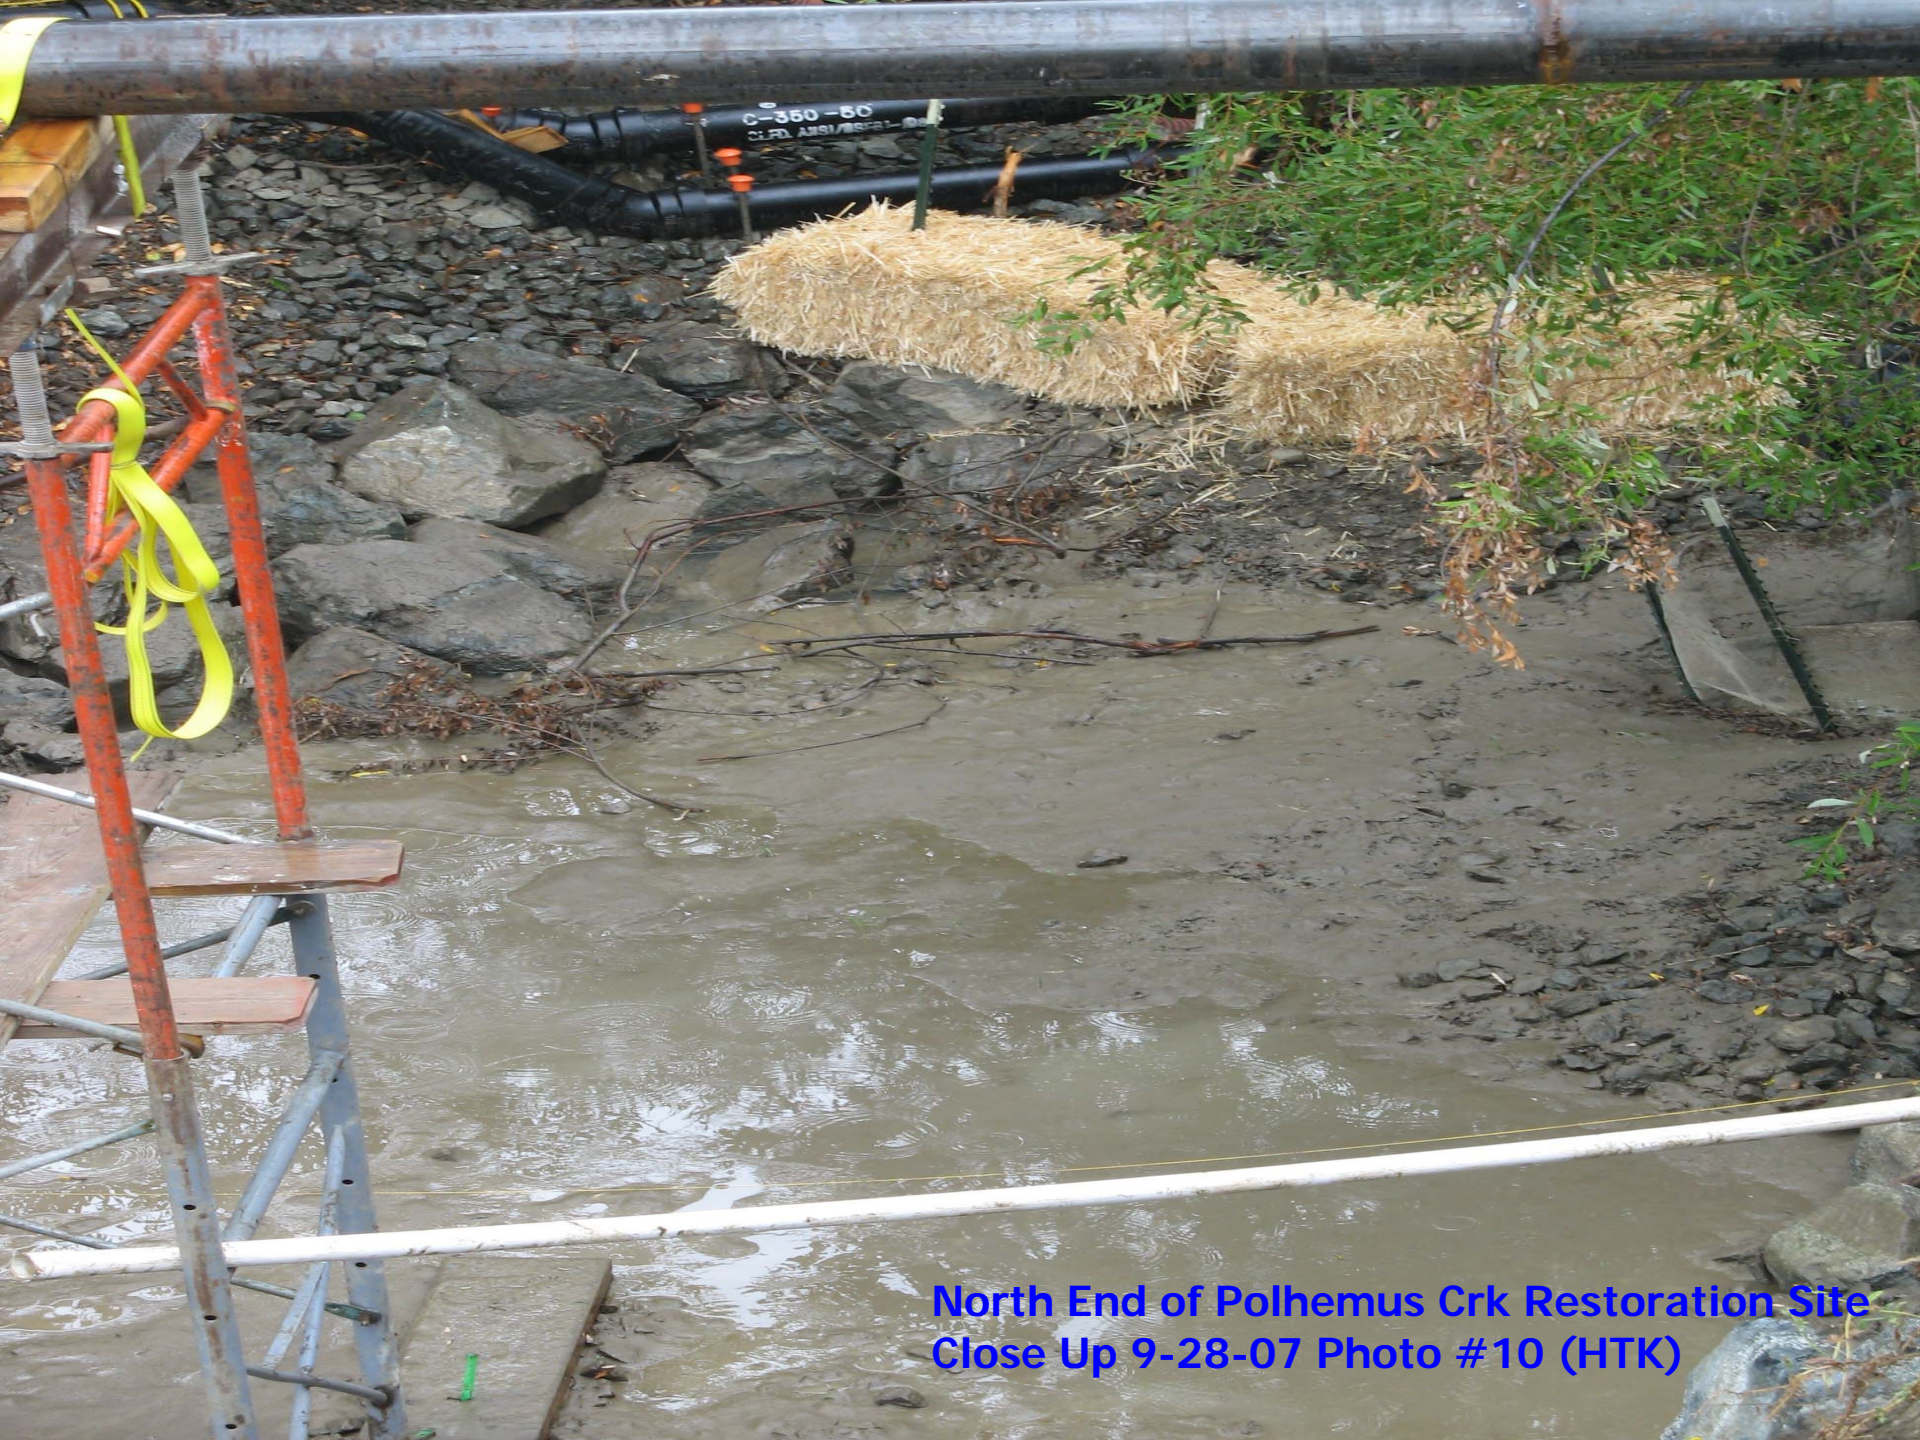
North End of Polhemus Crk Restoration Site
Close Up 9-28-07 Photo #10 (HTK)

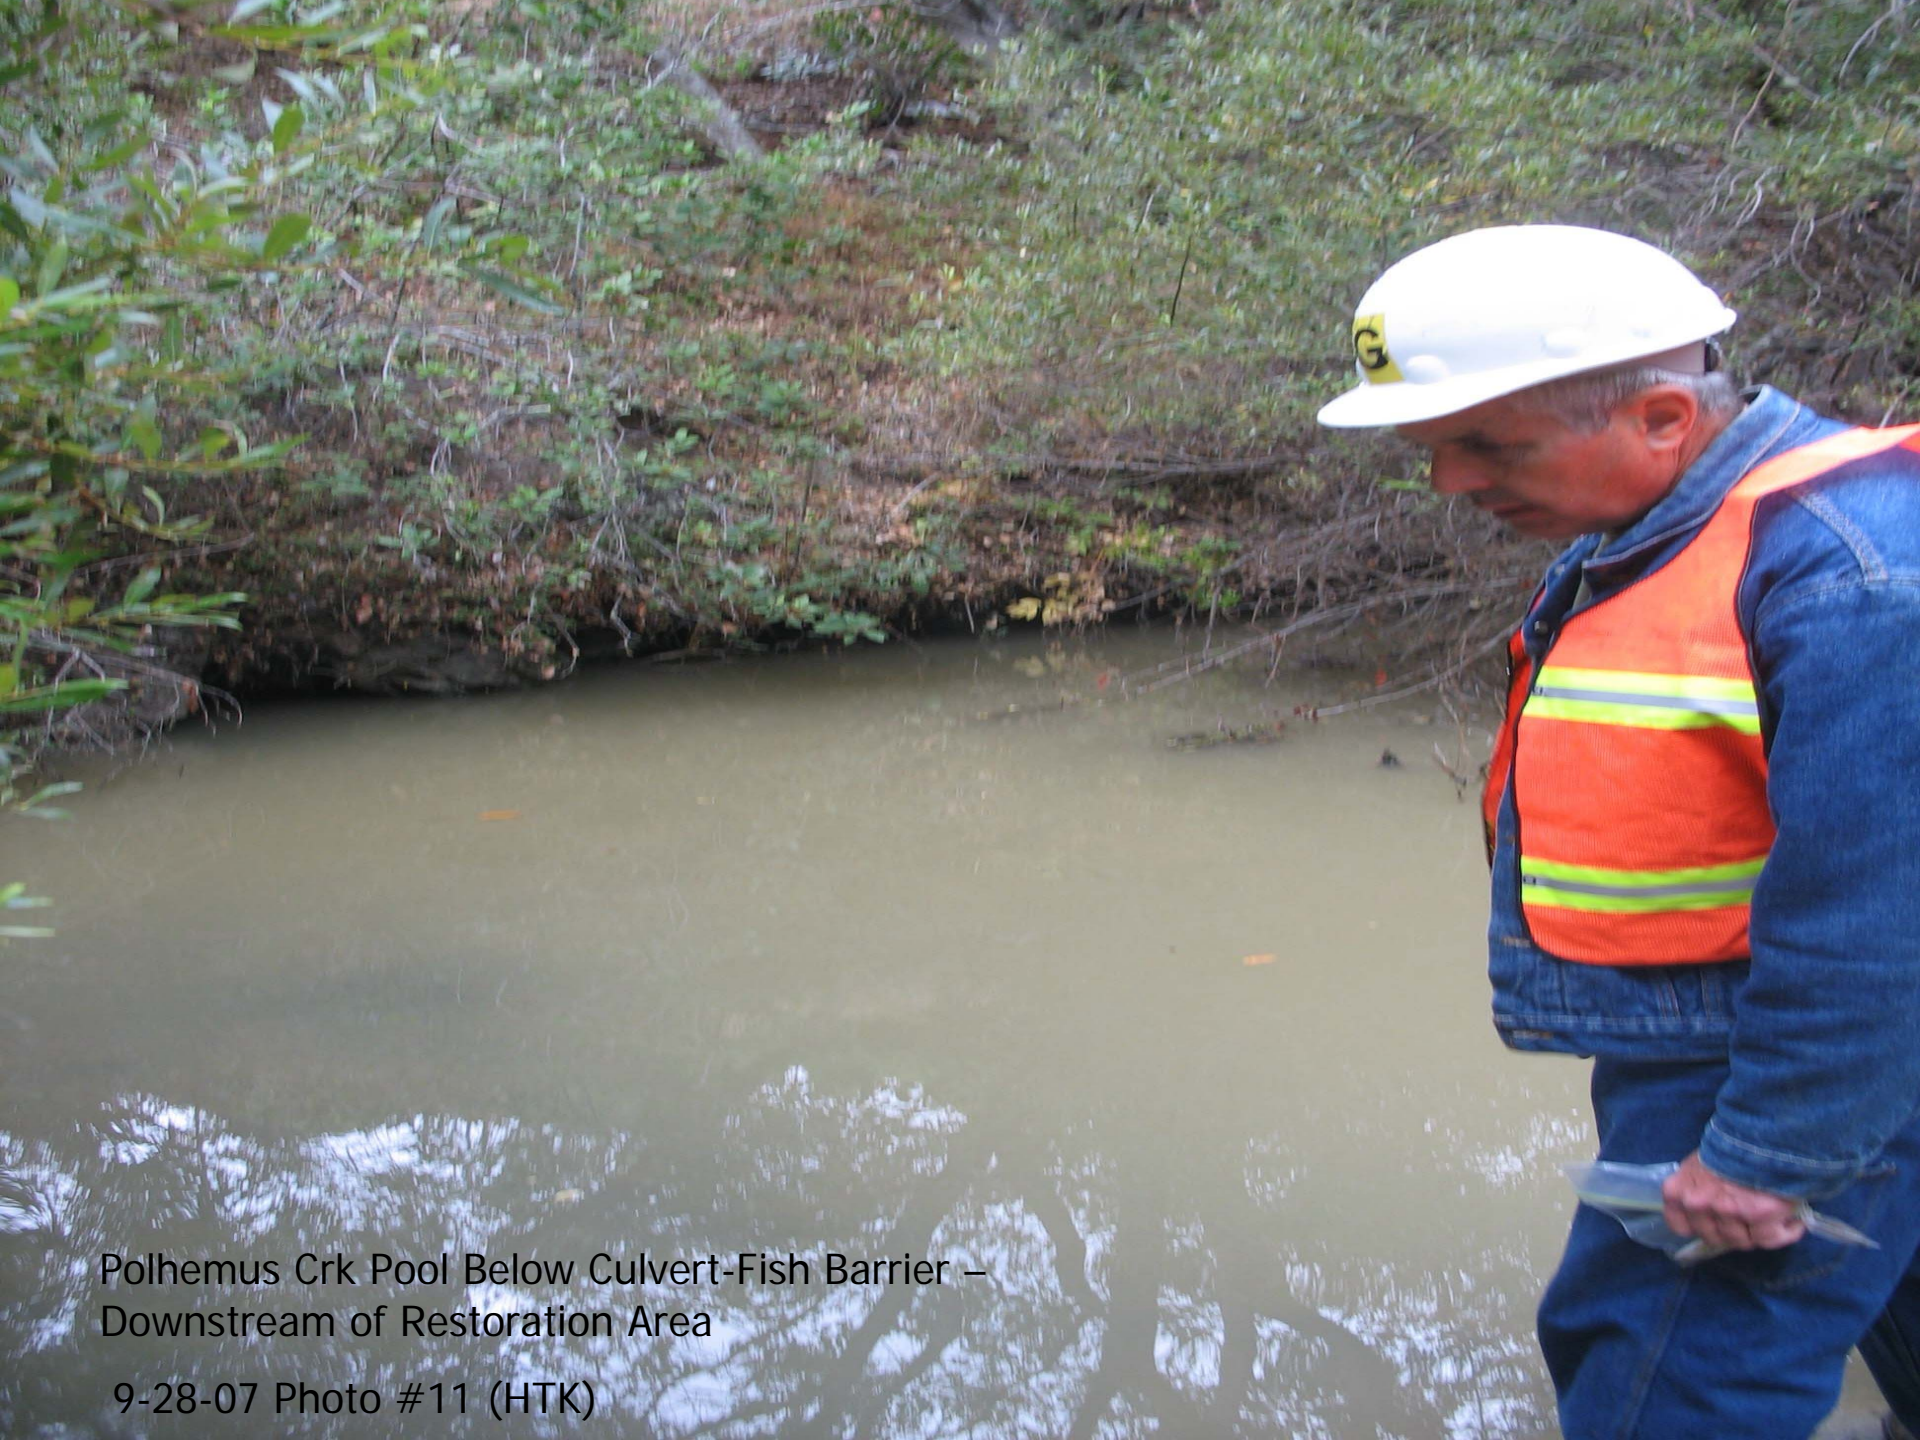
9-28-07 Photo #11 (HTK)

Polhemus Crk Pool Below Culvert-Fish Barrier –
Downstream of Restoration Area

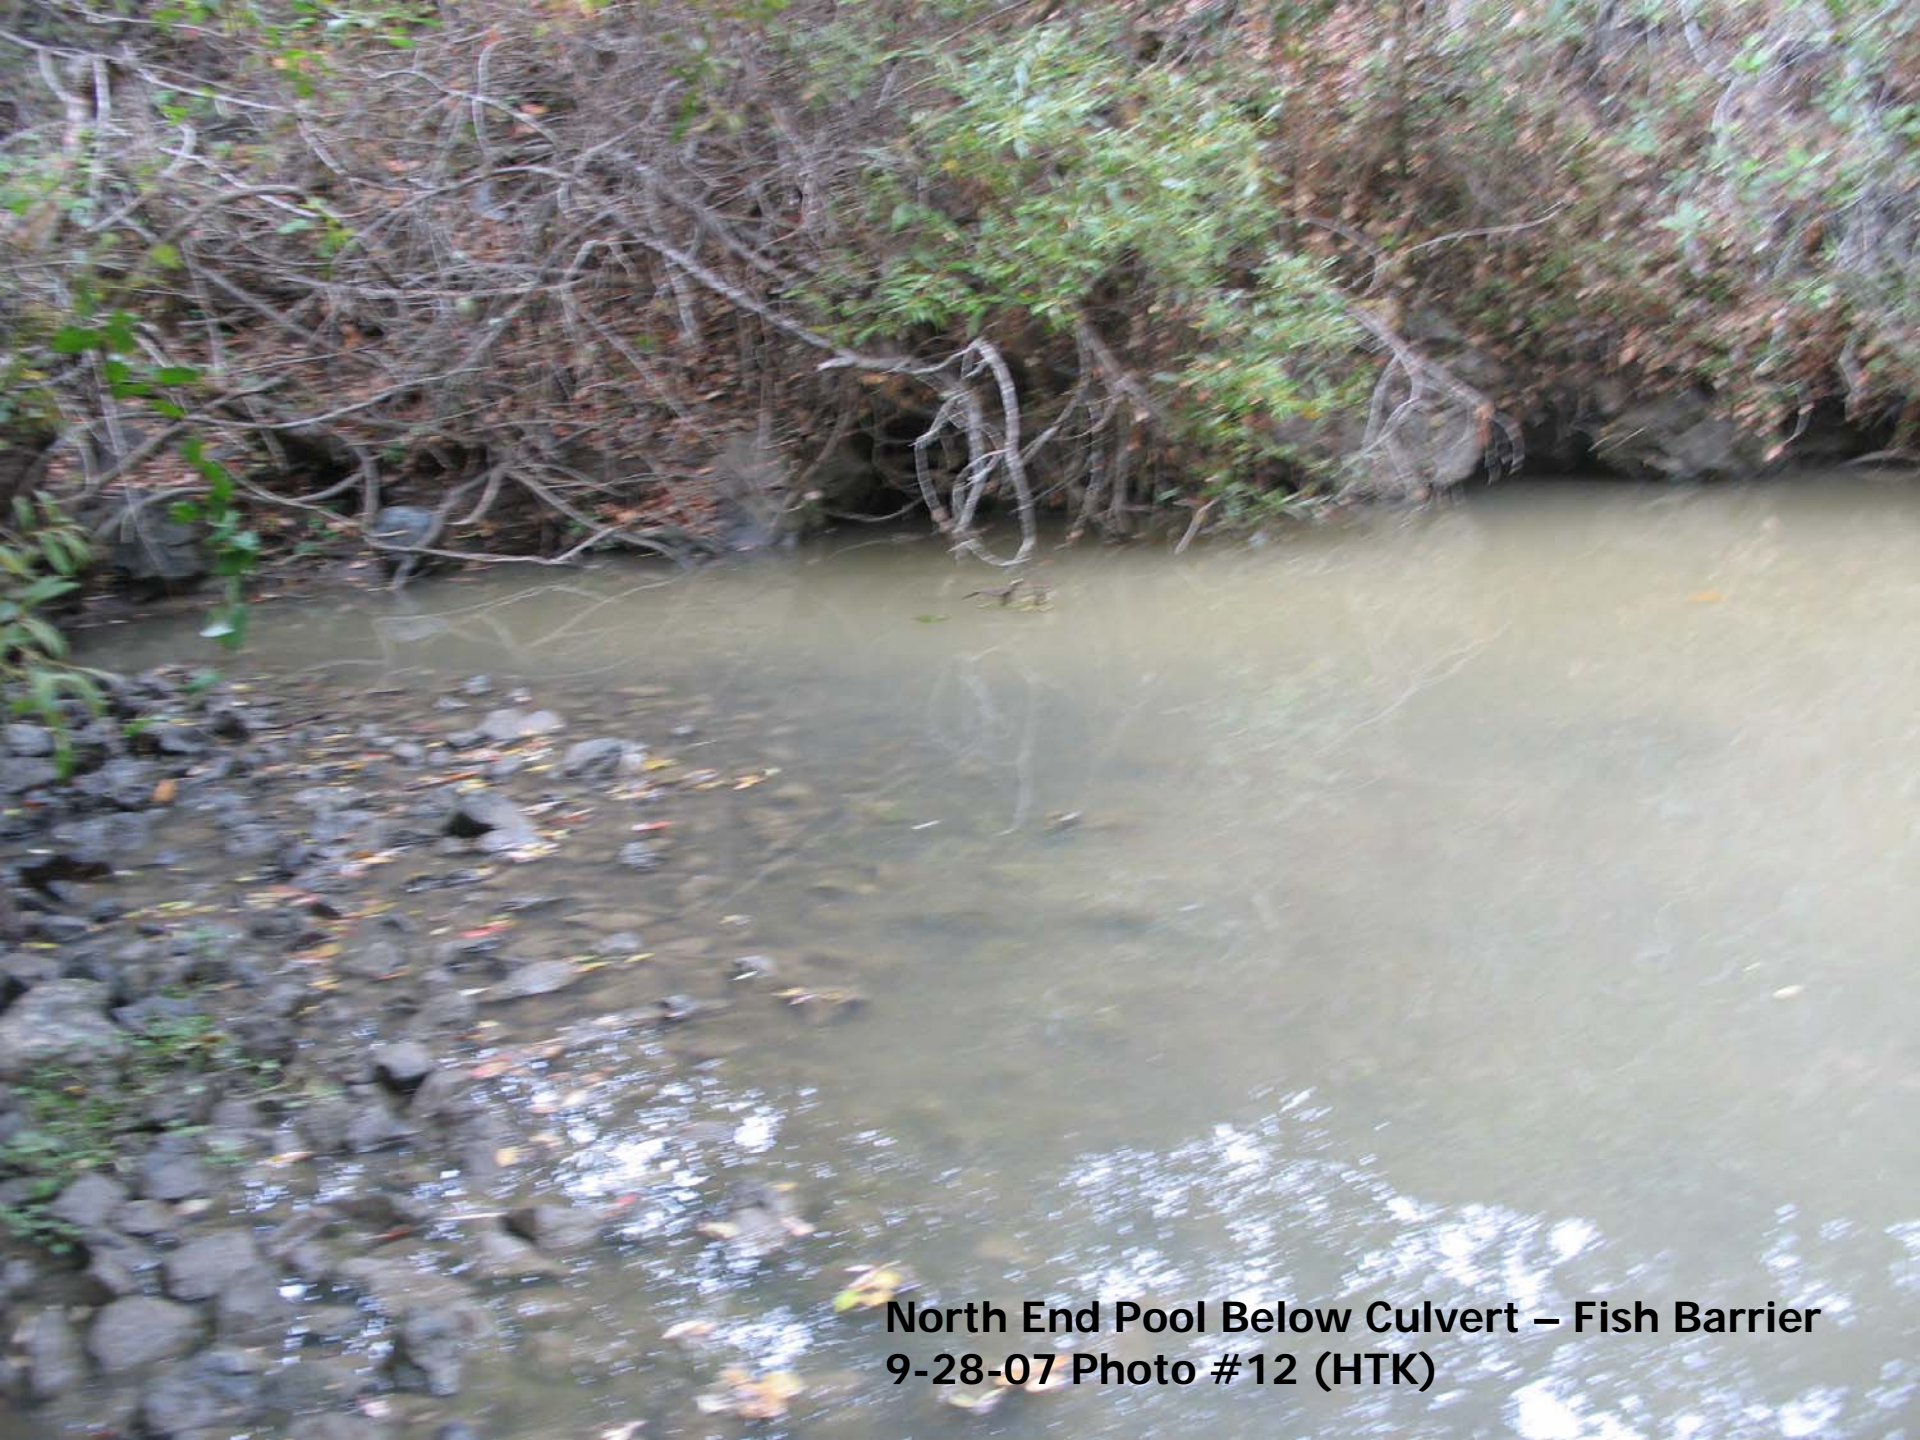
**North End Pool Below Culvert – Fish Barrier
9-28-07 Photo #12 (HTK)**

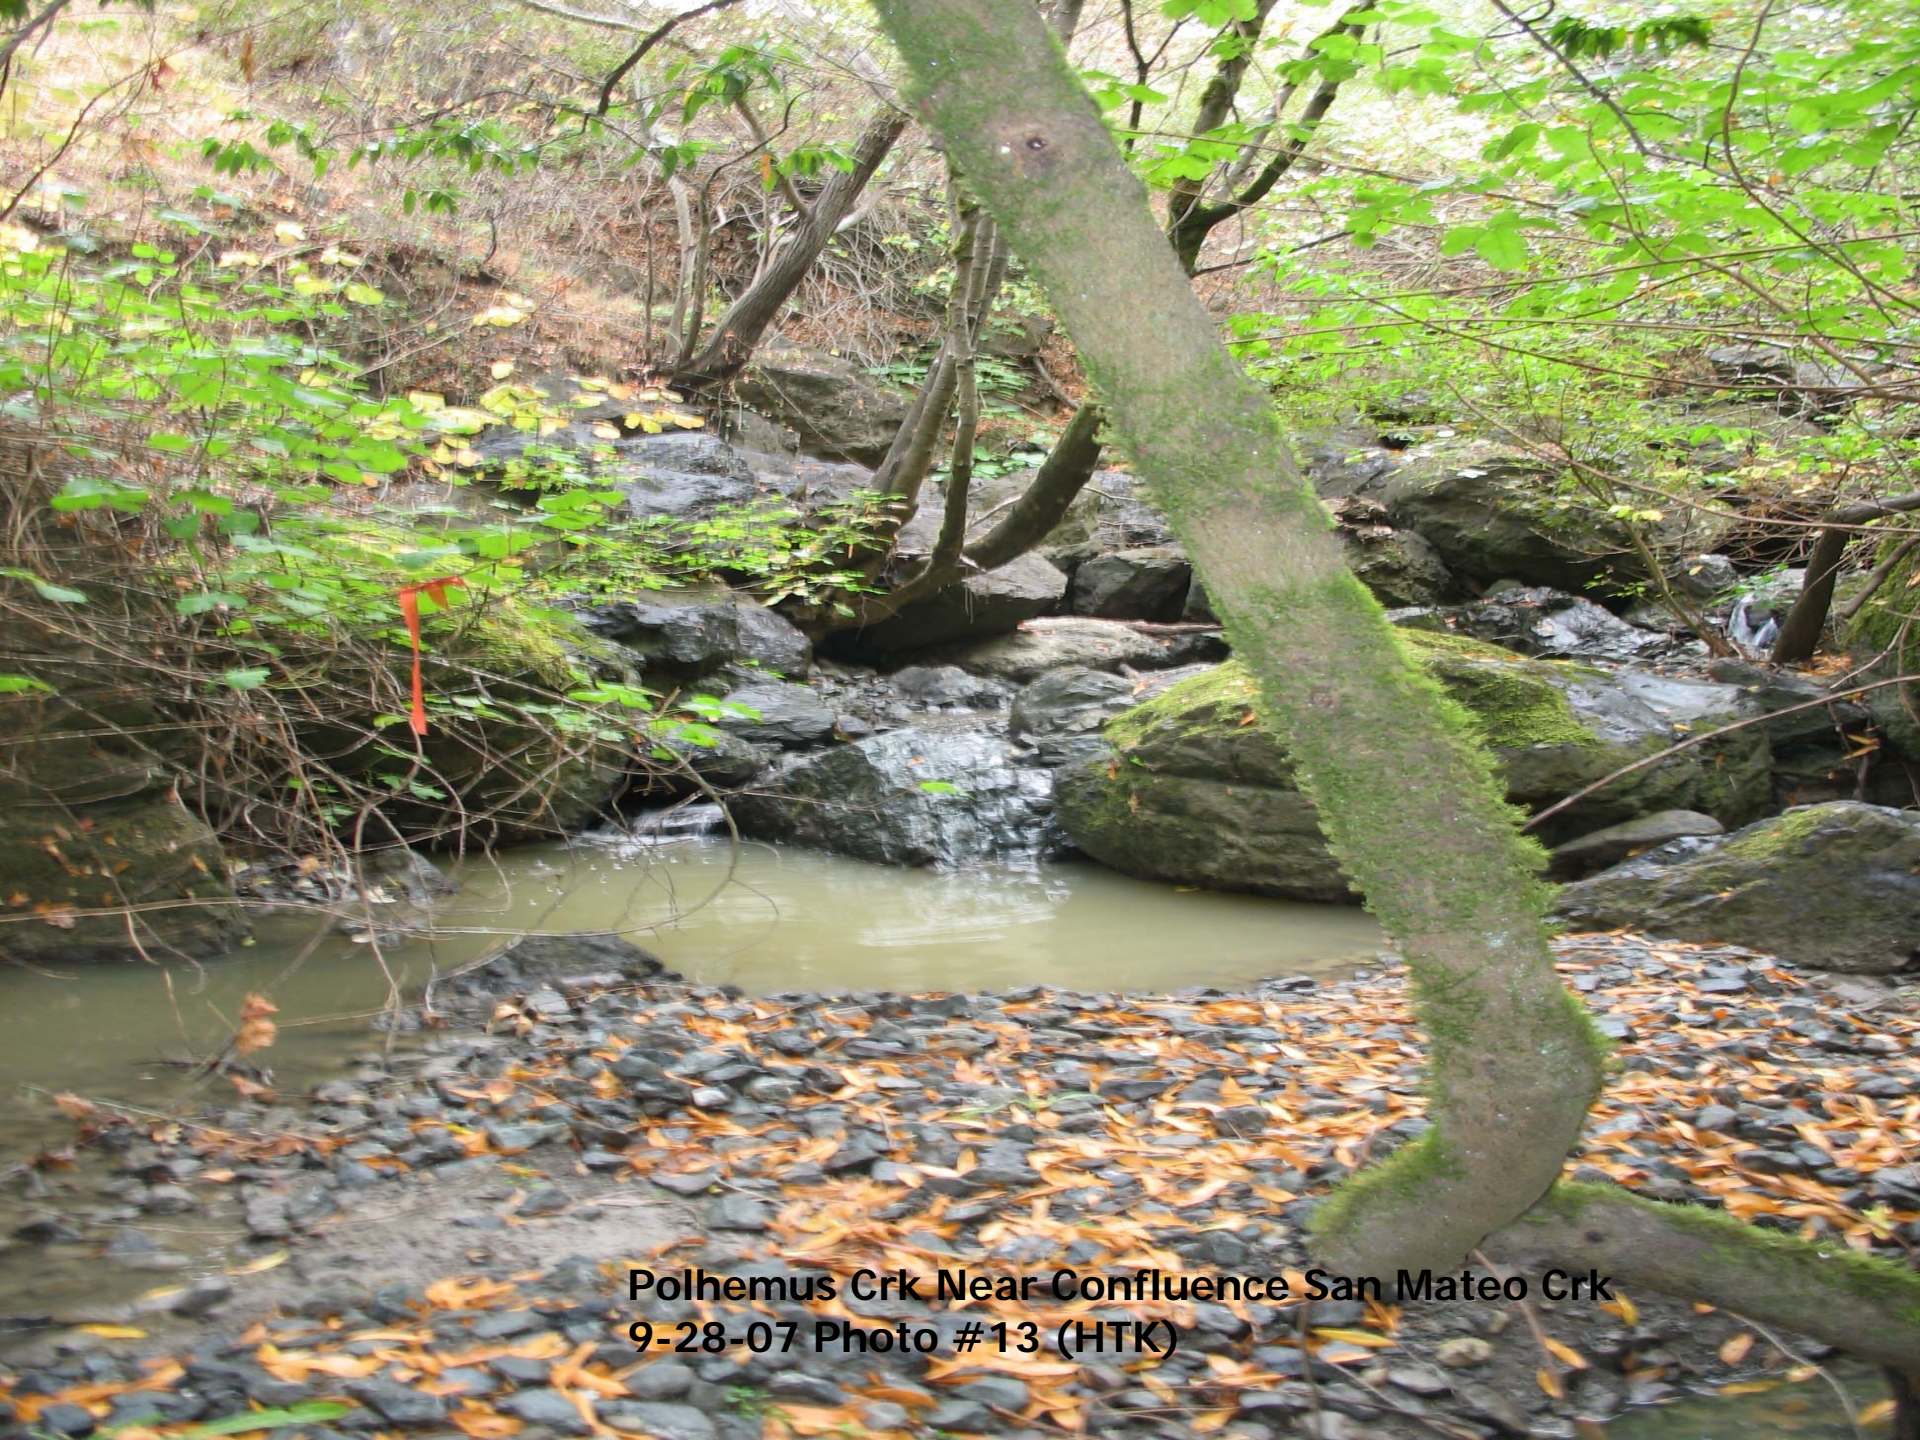
**Polhemus Crk Near Confluence San Mateo Crk
9-28-07 Photo #13 (HTK)**

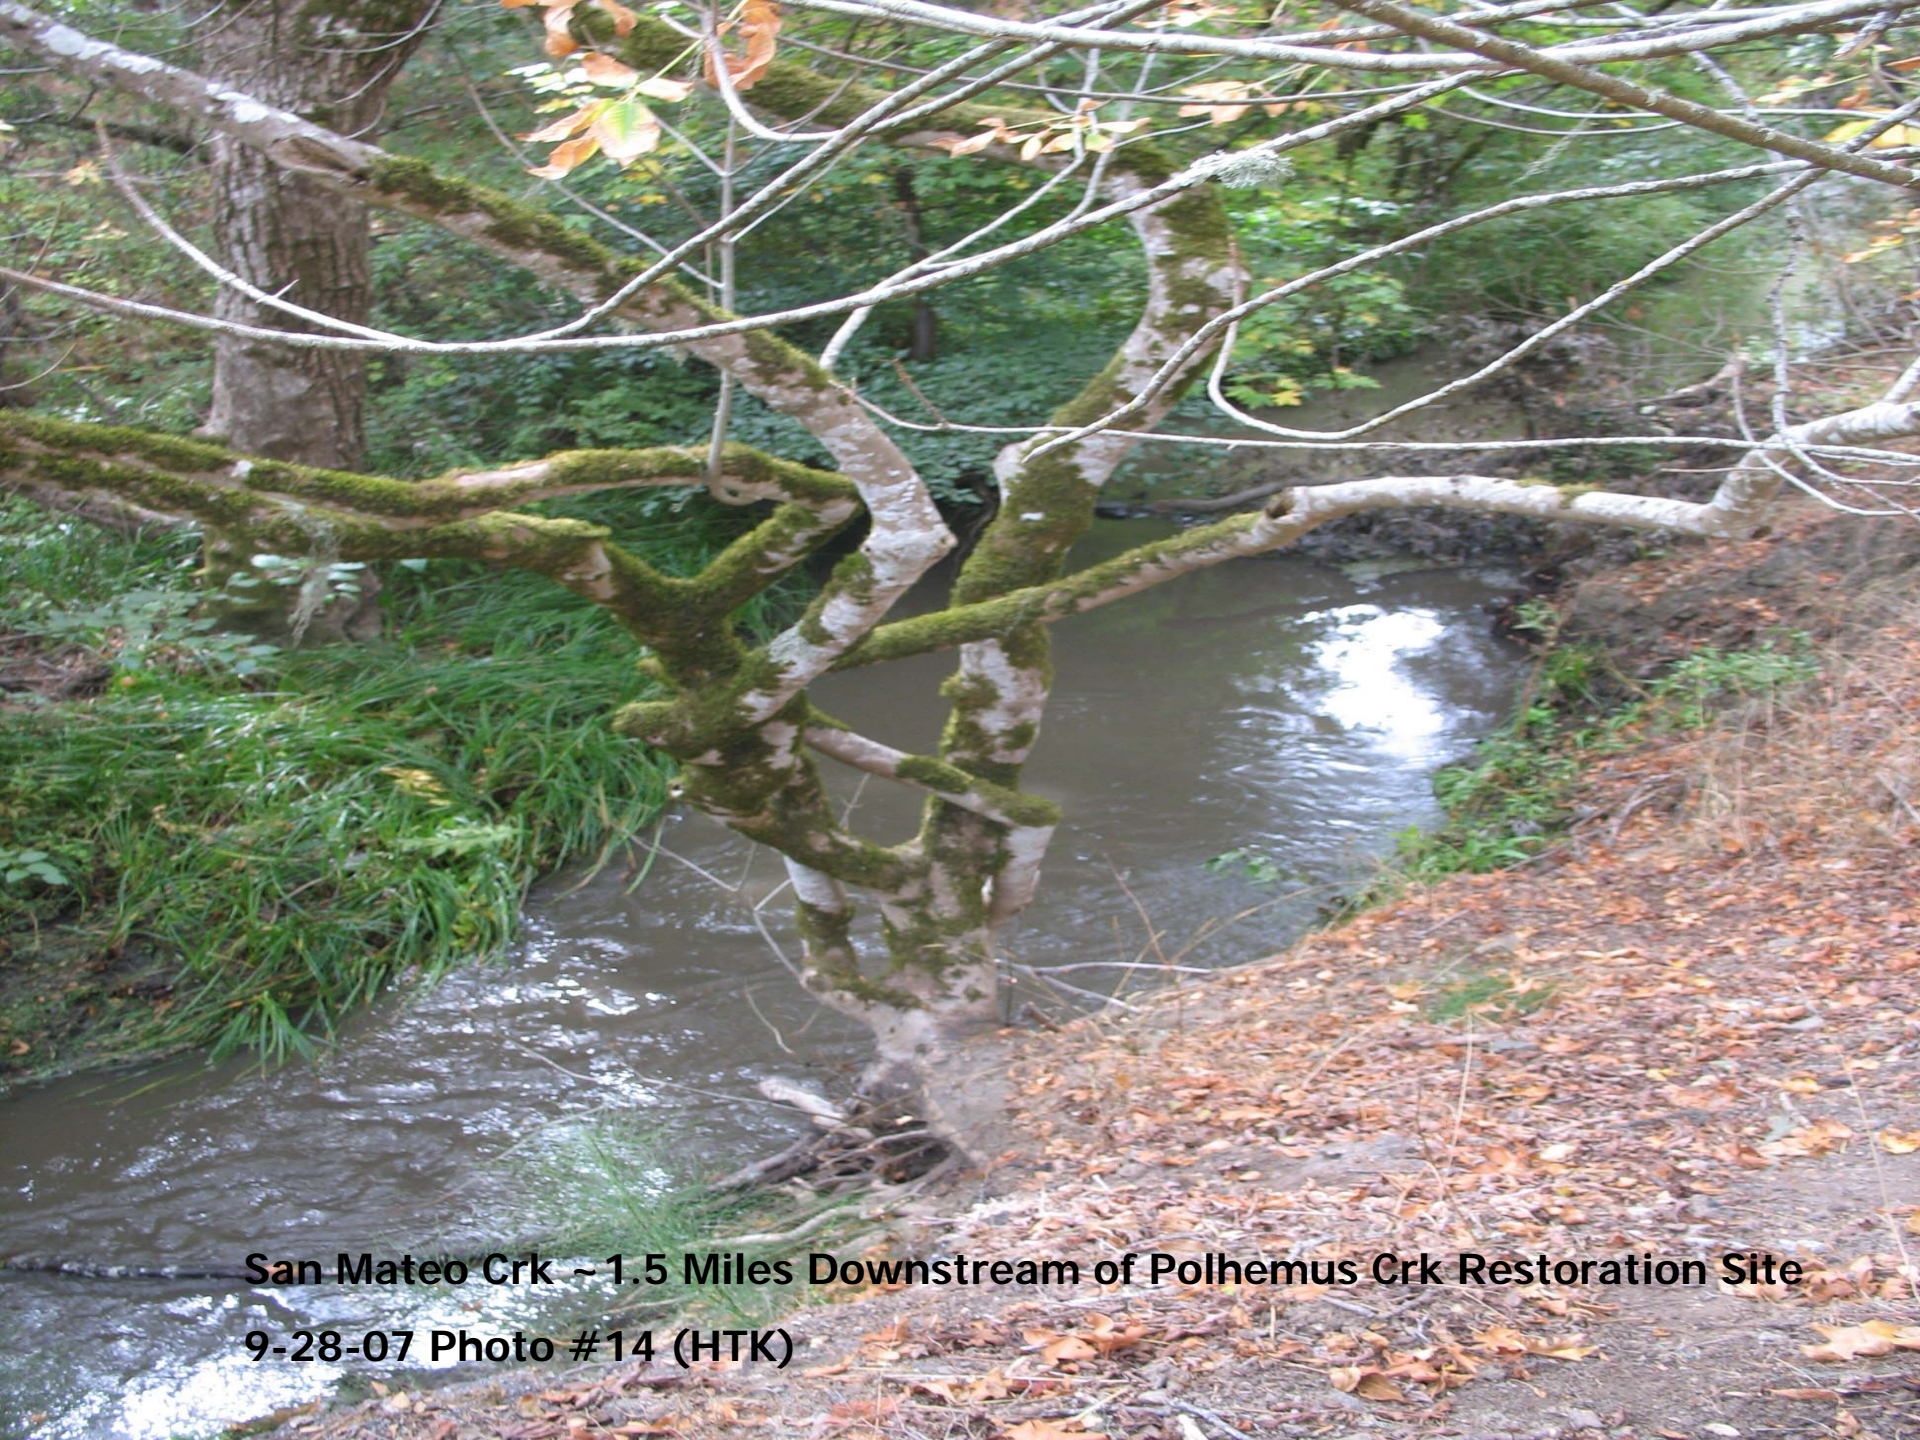
**San Mateo Crk ~ 1.5 Miles Downstream of Polhemus Crk Restoration Site
9-28-07 Photo #14 (HTK)**

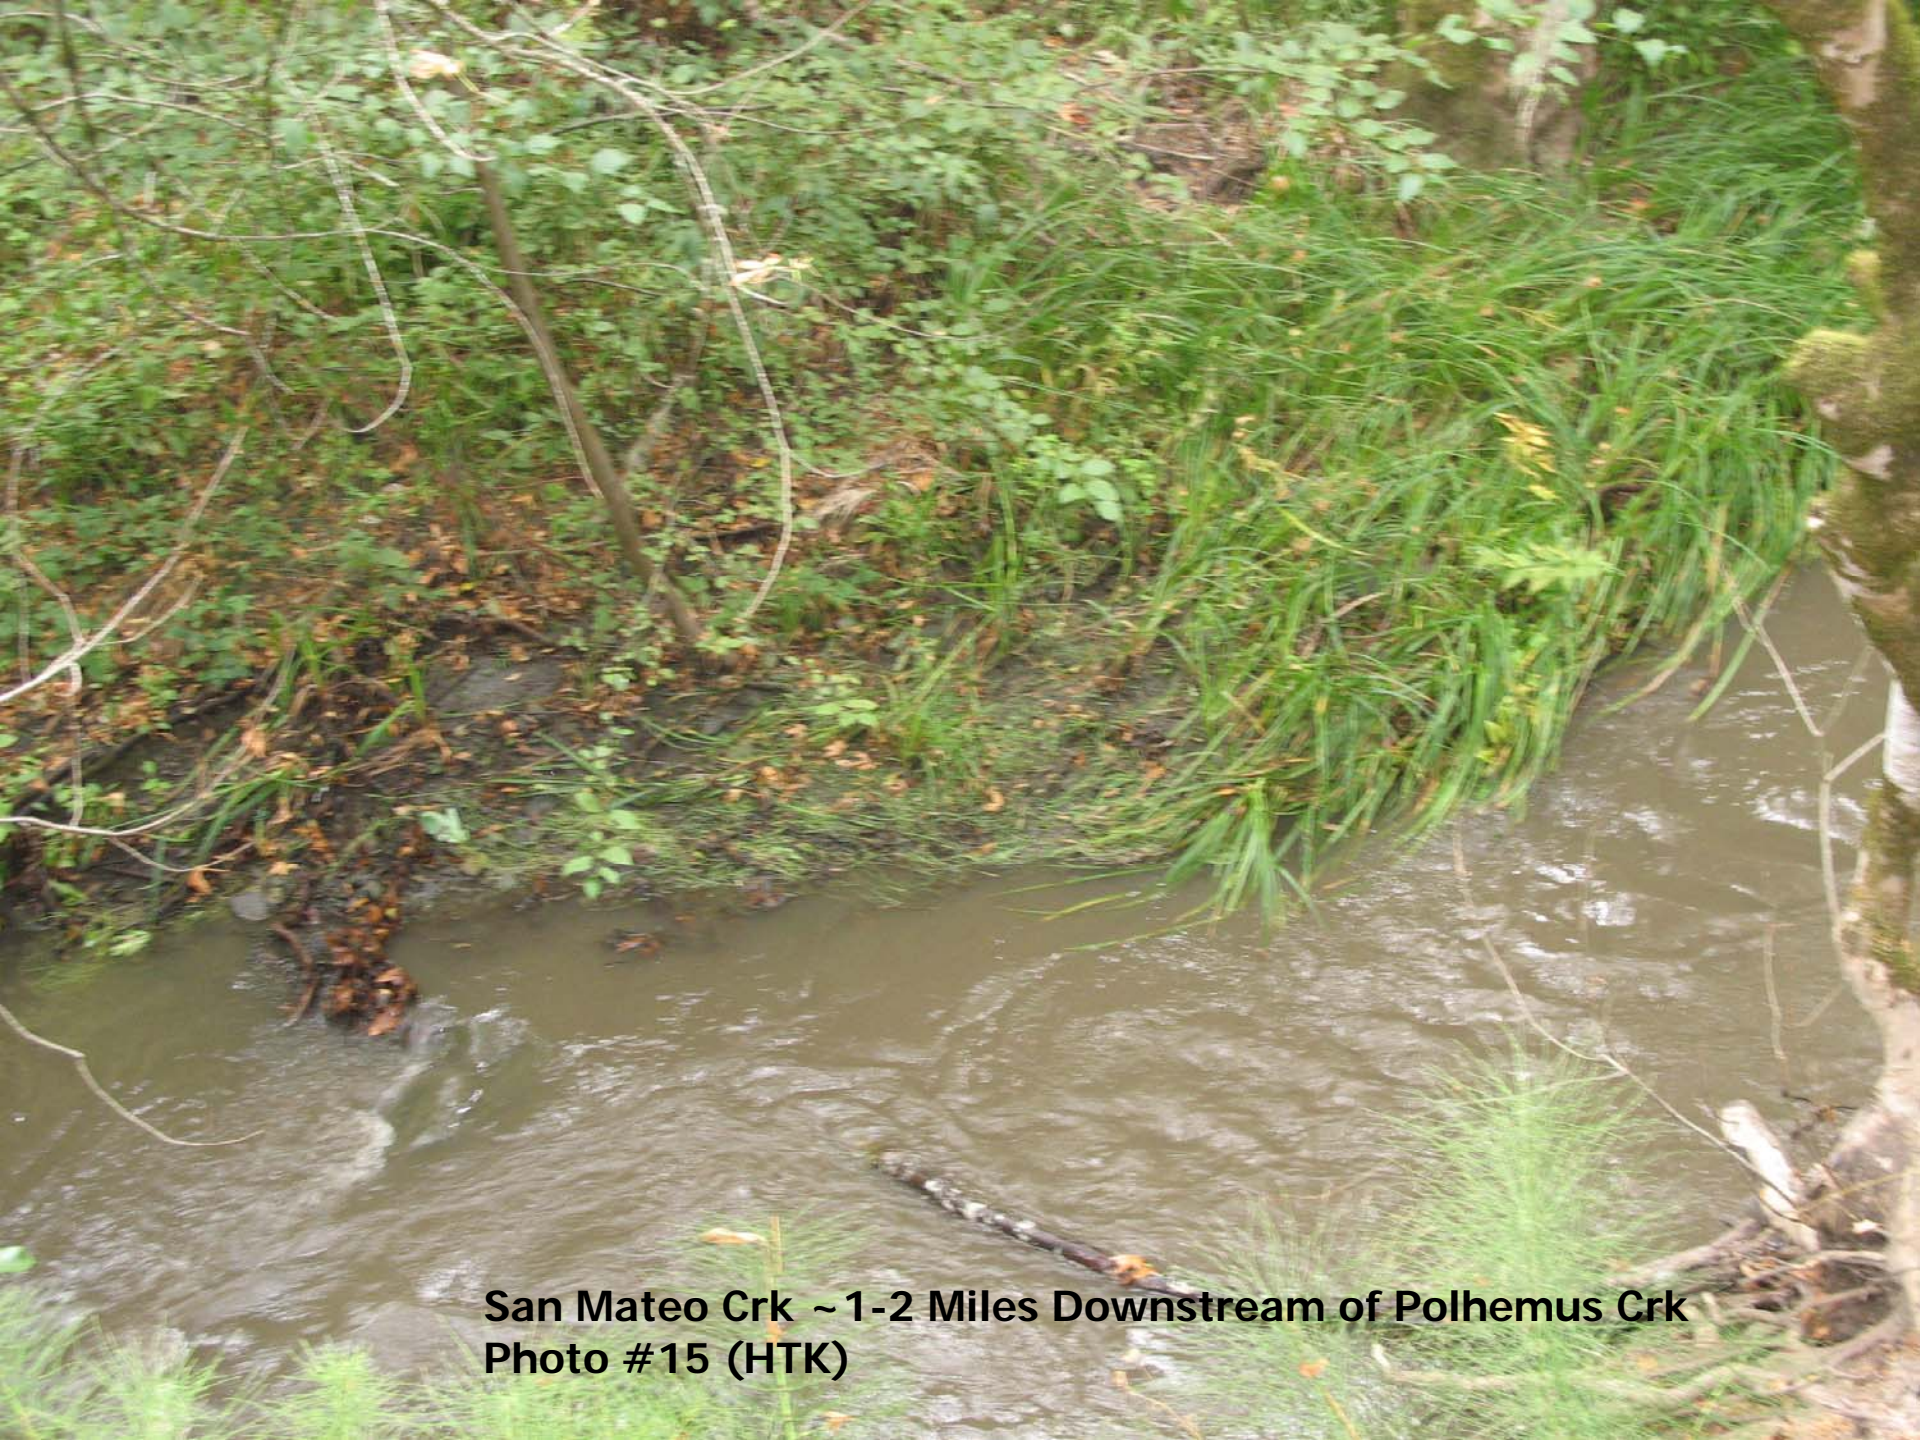
**San Mateo Crk ~ 1-2 Miles Downstream of Polhemus Crk
Photo #15 (HTK)**
