CLEANUP TEAM STAFF REPORT

**CALIFORNIA REGIONAL WATER QUALITY CONTROL BOARD
SAN FRANCISCO BAY REGION**

Cleanup Team Staff Report

**Basis for Recommendation to Adopt Initial Site Cleanup Requirements Orders (SCRs)
Naming:**

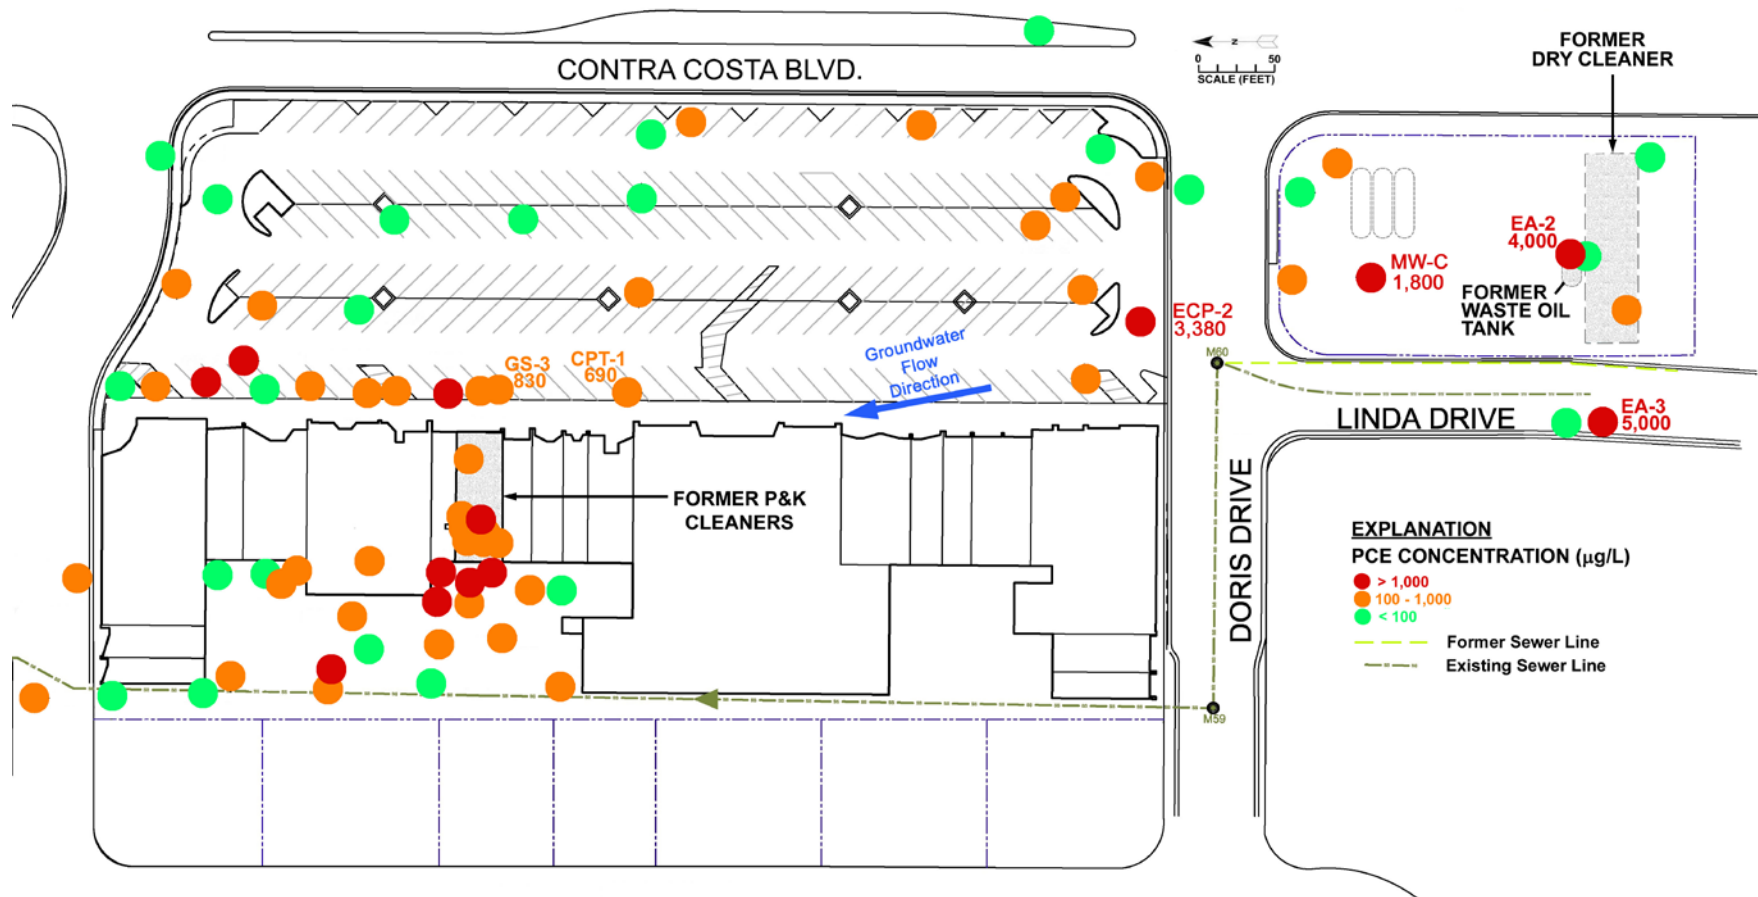
Figure 3: Maximum PCE Concentrations in Groundwater at 1643 and 1705 Contra Costa Boulevard and Immediate Vicinity, Pleasant Hill, Contra Costa County

The historical maximum detections of critical CVOCs associated with both sites are listed in Table 1. Groundwater data indicates the CVOC plume from Site 2 has commingled with the CVOC plume from Site 1 (Figure 3).

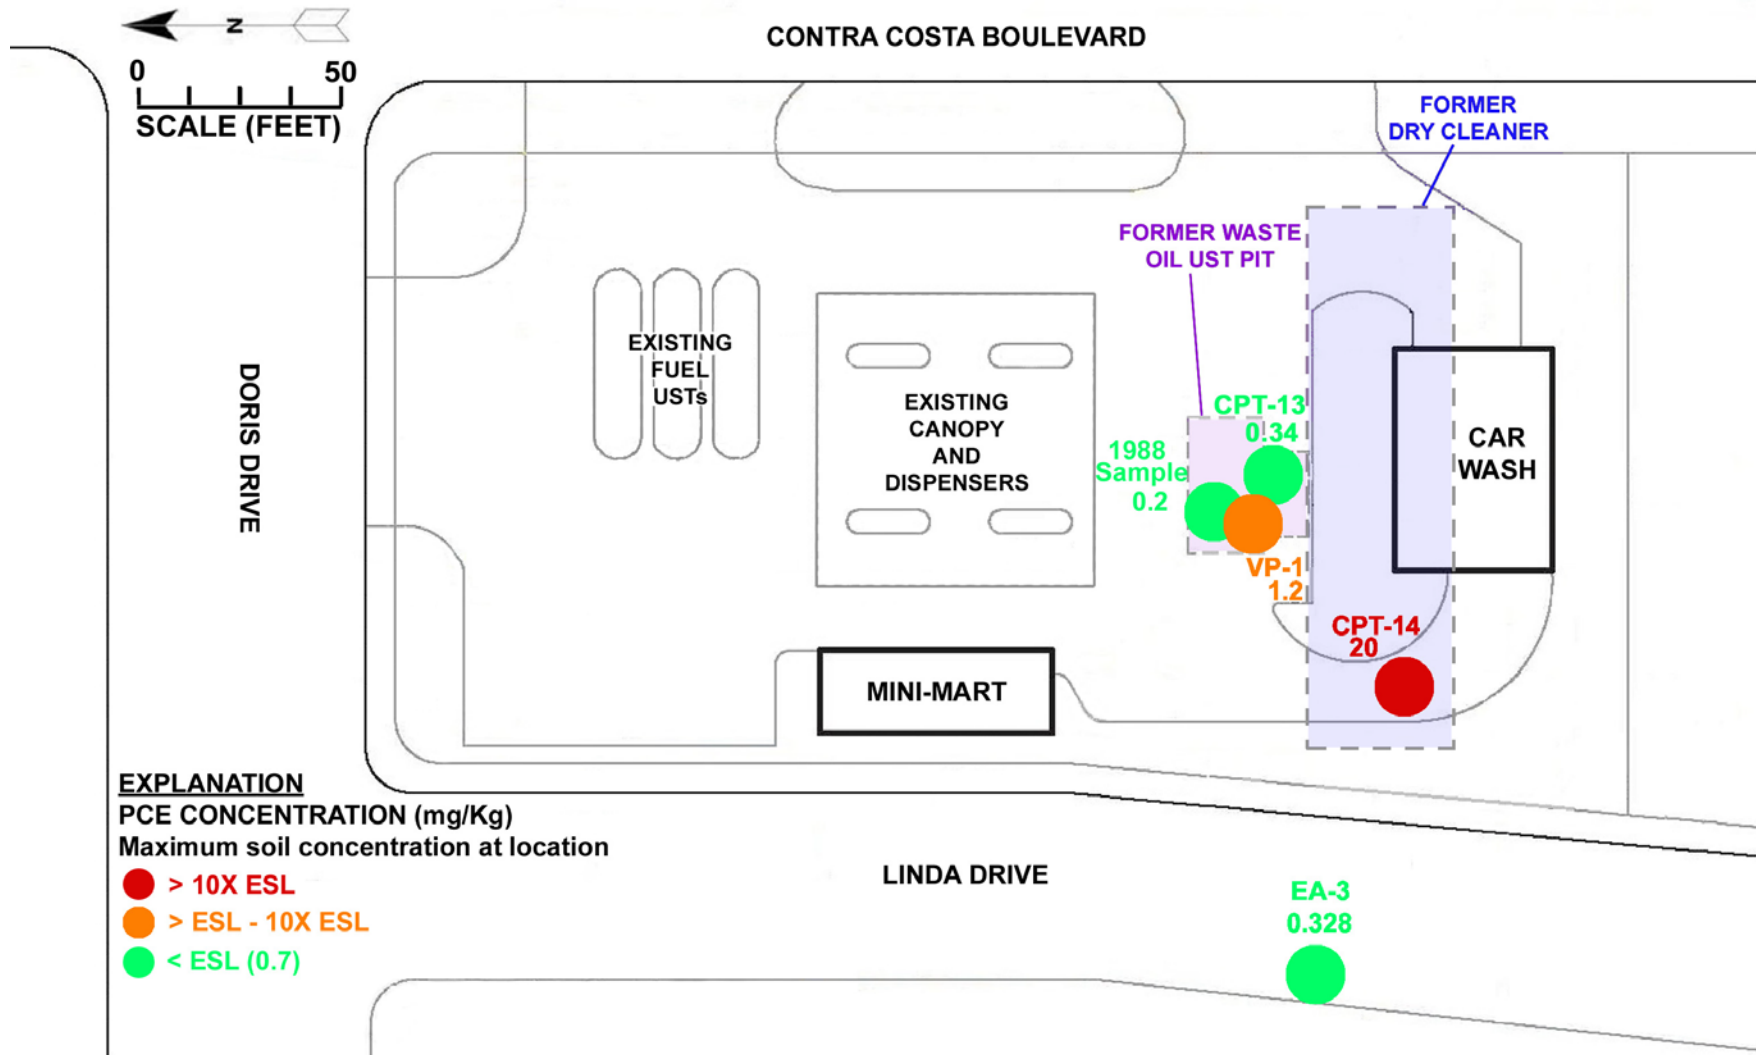
Figure 4: Maximum PCE Concentrations in Soil at 1705 Contra Costa Boulevard and Immediate Vicinity, Pleasant Hill, Contra Costa County

High CVOC soil concentrations generally reflect a specific release point/area. Figures 4 and 7 show the maximum concentrations of PCE and TCE detected in various soil samples collected within and near the former steel waste oil UST.

A soil sample collected within the tank pit at 10 feet below grade in 1988 contained 0.2 mg/kg of PCE and 0.035 mg/kg of TCE. In December 2011, a soil sample collected at a depth of five feet within the former waste oil UST excavation from vapor probe boring VP-1 contained PCE and TCE at 1.2 mg/kg and 1.4 mg/kg, respectively. Another soil sample collected at a depth of 9.5 feet from boring CPT-13, which was also advanced adjacent to/within the former waste oil UST pit, contained PCE at 0.34 mg/kg and TCE at 0.21 mg/kg, respectively.

The soil data depicted on Figures 4 and 7 indicates a distinct CVOC release from the former steel waste oil UST.

High CVOC soil concentrations generally reflect a specific release point/area. As shown on Figure 4, the maximum detected concentration of PCE from a soil sample collected within the footprint of the former dry cleaner is 20 mg/kg, from boring CPT-14.

The soil data depicted on Figures 4 and 7 likely reflects a distinct CVOC release from the former dry cleaner.

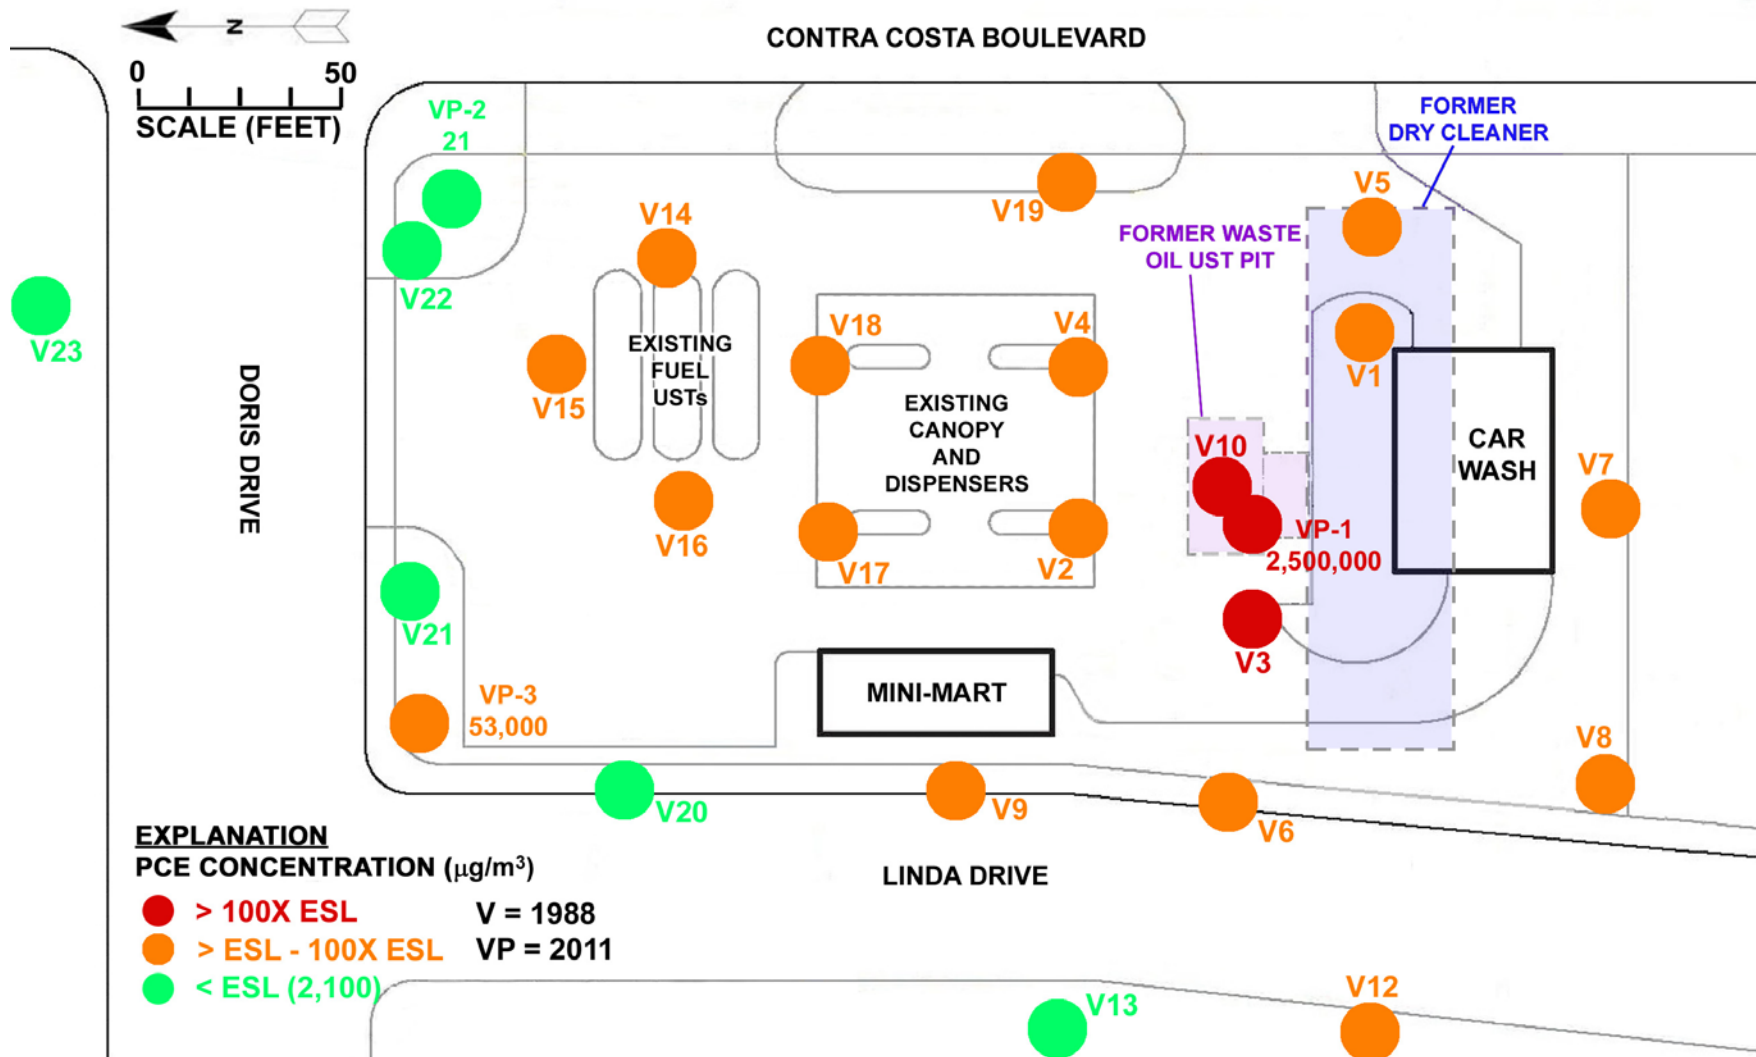
Figure 5: Maximum PCE Concentrations in Soil Vapor at 1705 Contra Costa Boulevard and Immediate Vicinity, Pleasant Hill, Contra Costa County

High soil vapor concentrations generally reflect a specific release point/area. Figures 5 and 8 show the maximum concentrations of PCE and TCE detected in various soil vapor samples collected within and near the former steel waste oil UST.

In May 1988, very high concentrations of PCE (up to 3,247,500 $\mu\text{g}/\text{m}^3$) and TCE (up to 109,500 $\mu\text{g}/\text{m}^3$) were detected in a soil vapor sample collected from probe V10, which was advanced directly within the former waste oil UST pit. In contrast, the maximum PCE concentrations detected in V2 and V3, two 1988 soil vapor probes advanced about 25 feet north and 25 feet west of V10, were 40,800 $\mu\text{g}/\text{m}^3$ and 900,000 $\mu\text{g}/\text{m}^3$, respectively.

Soil vapor sampling conducted by Chevron in 2011 revealed the highest concentrations of PCE and TCE in soil vapor (e.g., 2,500,000 $\mu\text{g}/\text{m}^3$ and 2,100,000 $\mu\text{g}/\text{m}^3$, respectively), from VP-1, a soil vapor point installed less than 10 feet away from V10.

The soil vapor data depicted on Figures 5 and 8 indicates a distinct CVOC release occurred from the former steel waste oil UST.

High soil vapor concentrations generally reflect a specific release point/area. Figures 5 and 8 show the maximum concentrations of PCE and TCE detected in various soil vapor samples collected within and around the former dry cleaner.

In 1988 four soil vapor probes were installed on the former dry cleaner parcel. The maximum detected concentrations of PCE and TCE were 19,347 $\mu\text{g}/\text{m}^3$ and 1,095 $\mu\text{g}/\text{m}^3$, respectively, from vapor probe V1 located approximately 25 feet east of EA-2. These

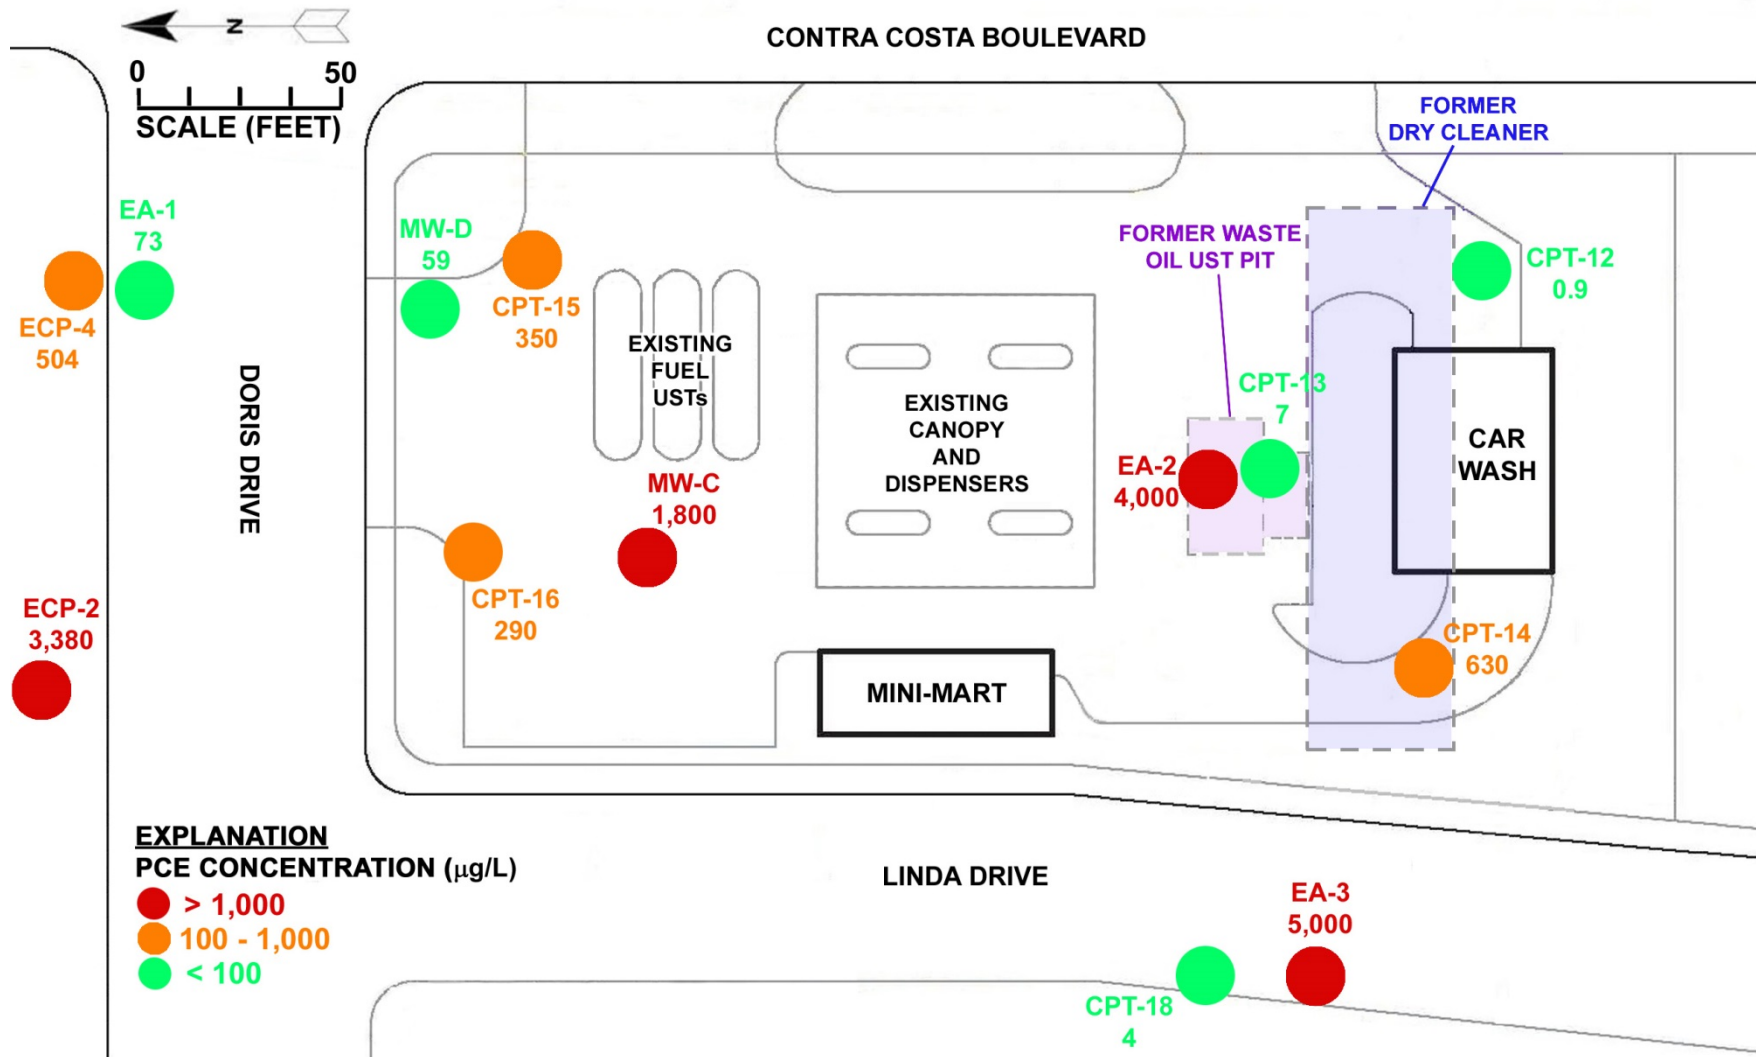
Figure 6: Maximum PCE Concentrations in Groundwater at the 1705 Contra Costa Boulevard Property and Immediate Vicinity, Pleasant Hill, Contra Costa County

High groundwater concentrations generally reflect a specific release point/area. Figures 6 and 9 show the maximum concentrations of PCE and TCE detected in various groundwater samples collected within and near the former steel waste oil UST.

In December 1987-January 1988, approximately one year after Chevron purchased and merged the two properties into a single parcel, groundwater samples analyzed from on-Site monitoring well MW-C (located about 100 feet north of the former waste oil UST) detected PCE at 1,800 $\mu\text{g}/\text{L}$ and TCE at 570 $\mu\text{g}/\text{L}$. In January 1989, PCE and TCE were detected in on-Site monitoring well EA-2, which was installed within the filled excavation of the former waste oil USTs, at < 0.5 $\mu\text{g}/\text{L}$ and 1,700 $\mu\text{g}/\text{L}$. A February 1989 EA report stated "Well EA-2 was installed near SVCA point V10 (the location of the former waste oil tanks), the point of highest chlorinated hydrocarbons in the soil gas." A September 1989 EA report indicates a groundwater sample from EA-2 contained TCE at 2,700 $\mu\text{g}/\text{L}$, while the PCE concentration was < 25 $\mu\text{g}/\text{L}$. The 1989 groundwater data are additional

Based on the above information and the groundwater data depicted on Figures 6 and 9, Staff conclude that a distinct CVOC release from the former steel waste oil UST occurred.

High groundwater concentrations generally reflect a specific release point/area. Figures 6 and 9 show the maximum concentrations of PCE and TCE detected in various groundwater samples collected within the former dry cleaner footprint. The maximum concentrations of PCE and TCE detected in groundwater were from samples collected and analyzed from CPT-14 were 630 $\mu\text{g}/\text{L}$ and 8 $\mu\text{g}/\text{L}$, respectively.

The groundwater data depicted on Figures 6 and 9 generally indicates a separate and distinct CVOC release from the former dry cleaner on Site 2.
