San Francisco Bay Regional Water Quality Control Board

SUBJECT: Inspection Report for Reza Valiyee Property, May 2016, Contra Costa County

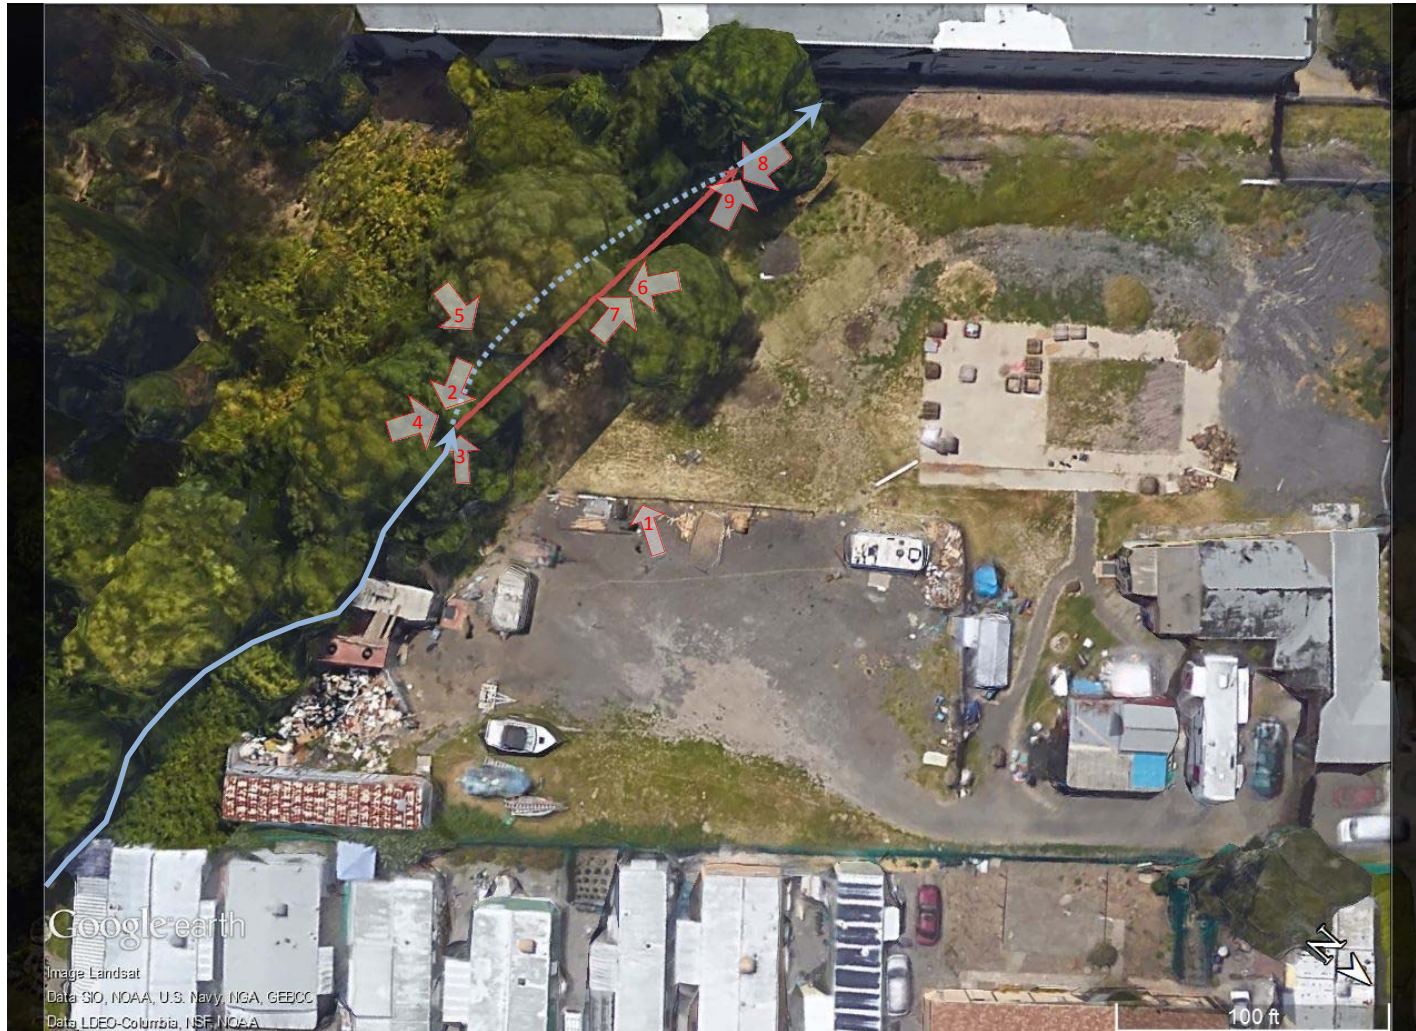
Figure A1: Inspection Photograph Locations

Image downloaded from Google Earth Pro on May 11, 2016, and modified by Regional Board staff. Light blue arrows show approximate current creek flow. Dark blue arrows show approximate location of creek flow before installation of culvert. Red arrows show approximate culvert flow. Grey arrows with red outline show photograph location and direction.

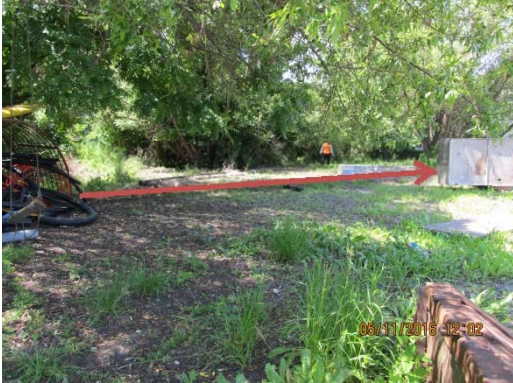
Photograph 1: Red arrow show approximate distance of culvert.

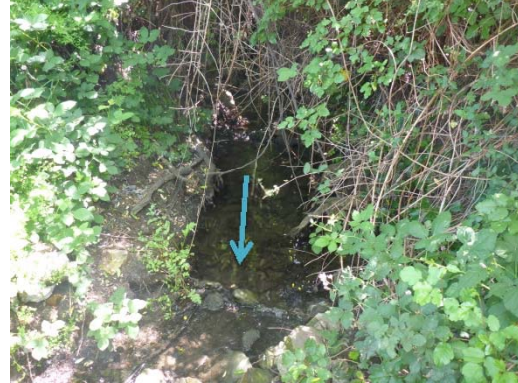
Photograph 2: Appian Creek and riparian vegetation upstream of the culvert.

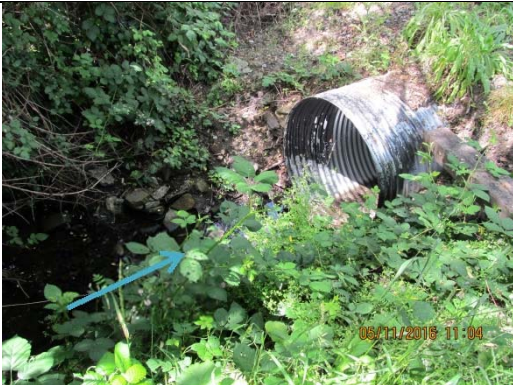
Photograph 3: Entrance of the culvert at upstream end.

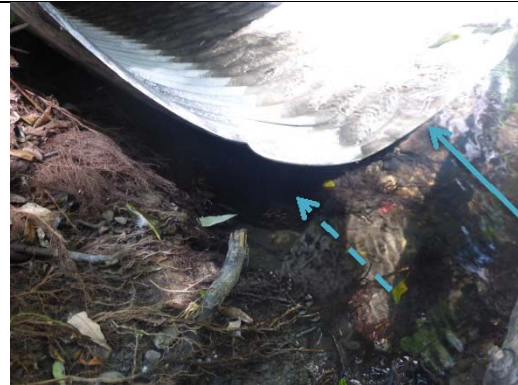
Photograph 4: Entrance of the culvert. The bottom of the channel upstream of the culvert was approximately three inches above the bottom of the culvert.

We observed the creek flowing into the culvert (solid arrow) and apparent underflow beneath the culvert (dashed arrow).

Based on our visual observations, the velocity at the entrance of the culvert appeared to be much higher than at the exit of the culvert.

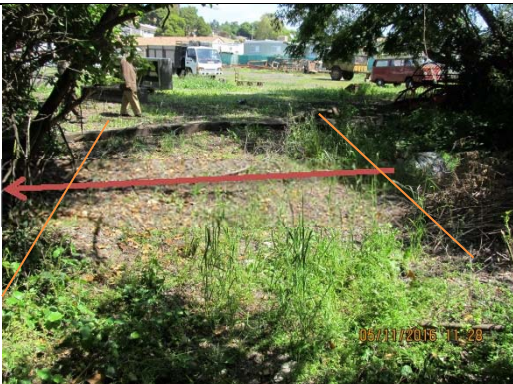
The area between the orange lines had a lower density of vegetation, and the vegetation looked different from the area outside the orange lines. Mr. Valiye said that the creek crossing area was altered so that he could "access the back of his property."

<p>Photograph 5: Crossing constructed across Appian Creek (thin orange lines). The arrows show the approximate location of the culvert below the crossing and the direction of stream flow.</p>

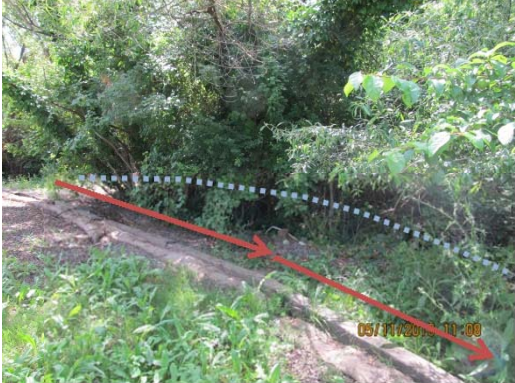
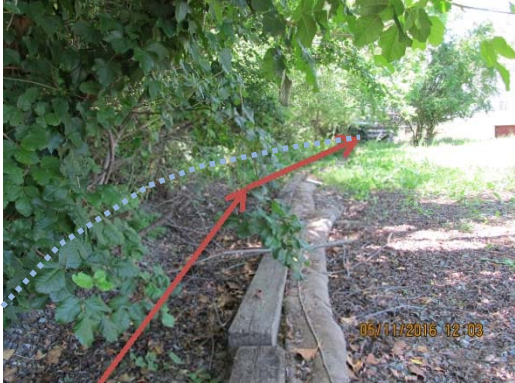
<p>Photograph 6</p>	<p>Photograph 7</p>
<p>The apparent original channel of the creek was approximately 10 feet south of the new channel of the culvert.</p> <p>Our estimates of the course of the original channel of the creek were based on presence and location of the strip of riparian vegetation and a linear depression in the center of it, and our estimate of the location of the culvert was based on visual observations and estimates of the angles and distances we saw from the exposed ends of the culvert.</p>

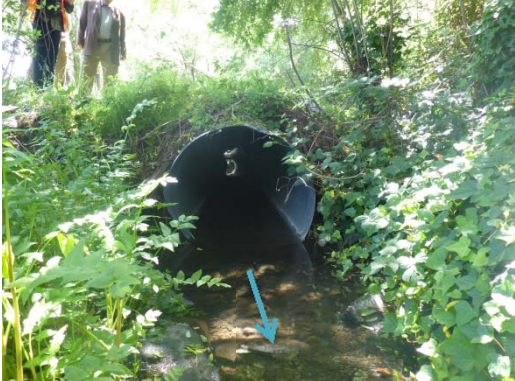
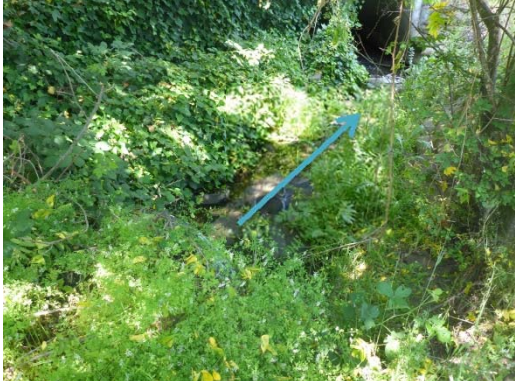
<p>Photograph 8: Exit of the culvert. We observed a lower velocity than at the entrance.</p>	<p>Photograph 9: Appian Creek and riparian vegetation downstream of the culvert. Appian Creek flows into a tunnel under a neighboring apartment building.</p>
